Re-Evaluation Bridge Inspection Report

- 2014 -

Piedmont & Northern Railway

Mt. Holly Subdivision

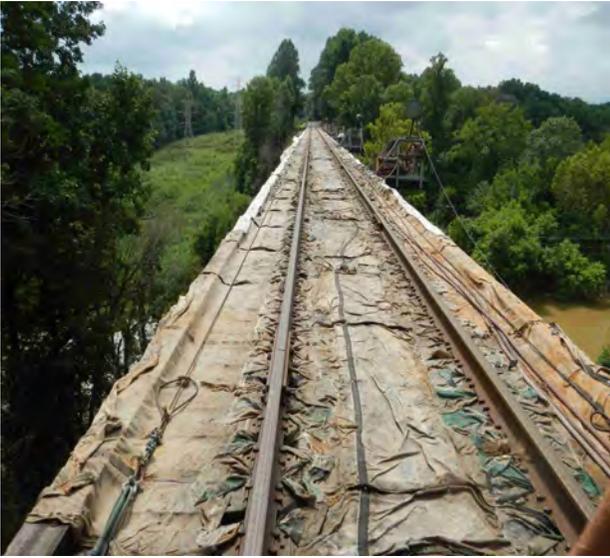
Bridge 19.30 Section 1 Deck View

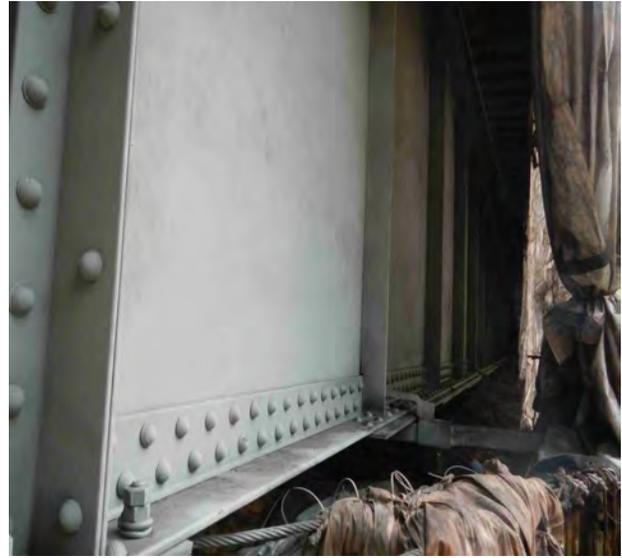
Bridge 19.30 Section 1 - New Paint on Girder

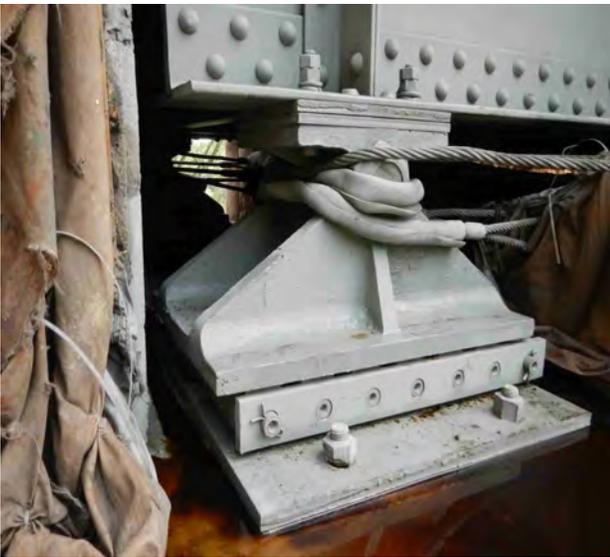
Abutment 1	
Bearings	Bearings are extended to the North
Approach	OK
Ties	OK
Parapet Ties	OK
Guard Timber	OK
Wingwalls	OK
Platform	OK
Other	Limited access to bridge due to repairs at the time of inspection

Bridge 19.30 Section 1 Typical Abutment Bearing

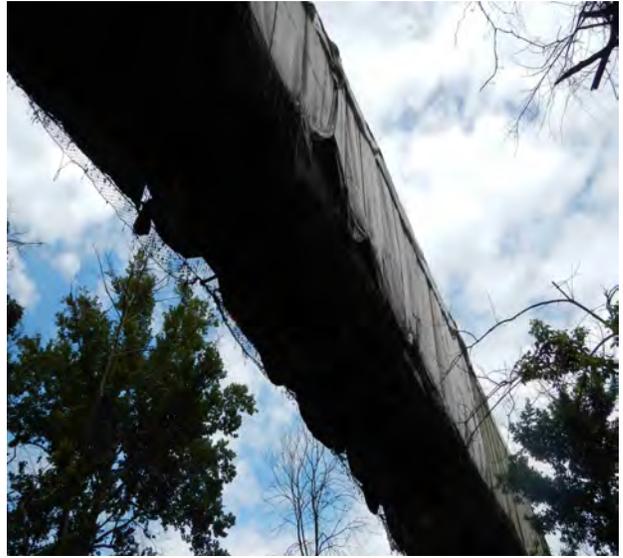
Findings:	Finding Notes:
Span 1 Floor System	Minor corrosion to all Steel throughout Minor pitting to Top and Bottom Flange Angles of Stringers
Span 2 Floor System	Minor corrosion to all Steel throughout Minor pitting to Top and Bottom Flange Angles of Stringers
Ties	OK
Guard Timber	OK
Walkout Platforms	OK
Other	Limited access to bridge due to repairs at the time of inspection

Bridge 19.30 Section 2 View from Below

Item#	Priority	Who Fixes	Repair Description
1	3	Railroad	Perform an Underwater Inspection of Substructure

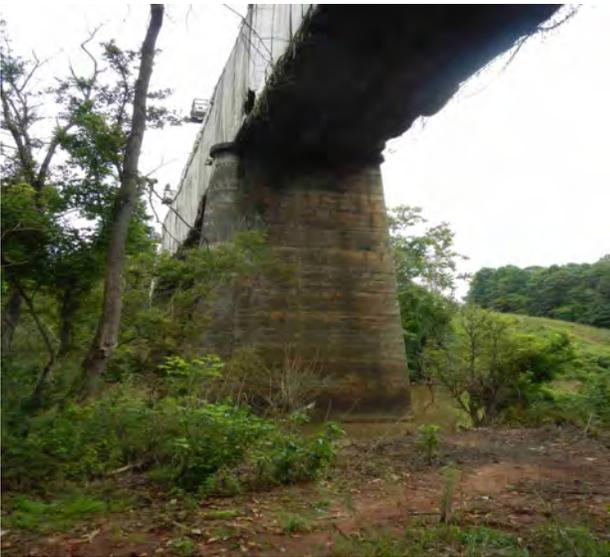
Bridge 19.30 Section 2 Typical Pier

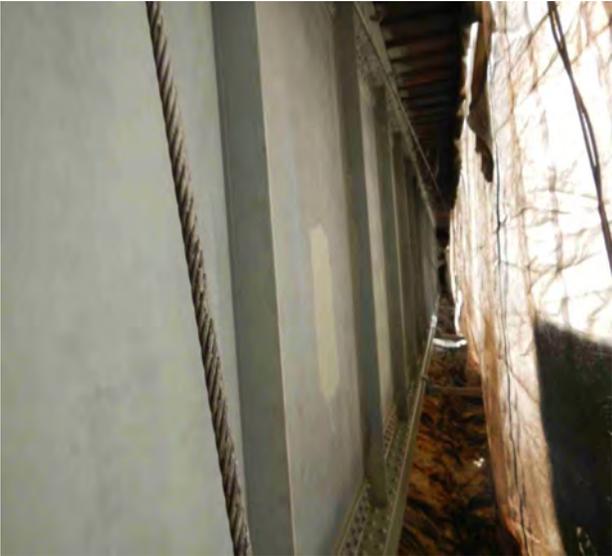
Bridge 19.30 Section 3 - New Paint on Girder

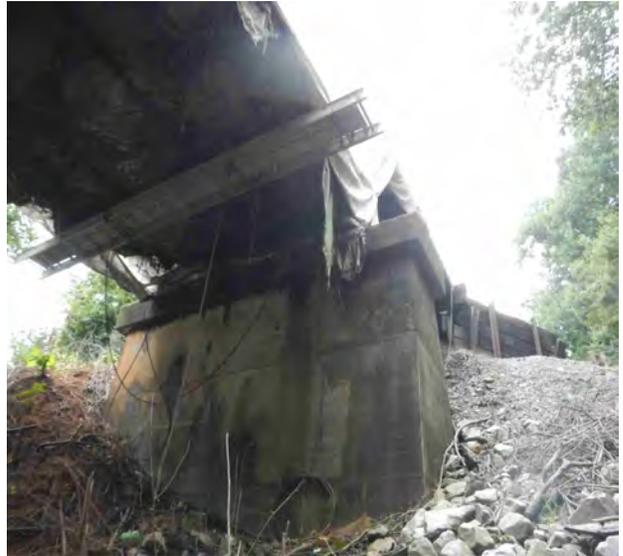
Abutment 1	Backwall - Losing fill on West side
Bearings	Minor corrosion
Approach	Low
Ties	OK
Guard Timber	OK
East Wingwall	OK
West Wingwall	Losing Fill
Platform	OK
Other	Limited access to bridge due to repairs at the time of inspection

Bridge 19.30 Section 3 Abutment

Item#	Priority	Who Fixes	Repair Description
1	4	Railroad	Add ballast and tamp up approach

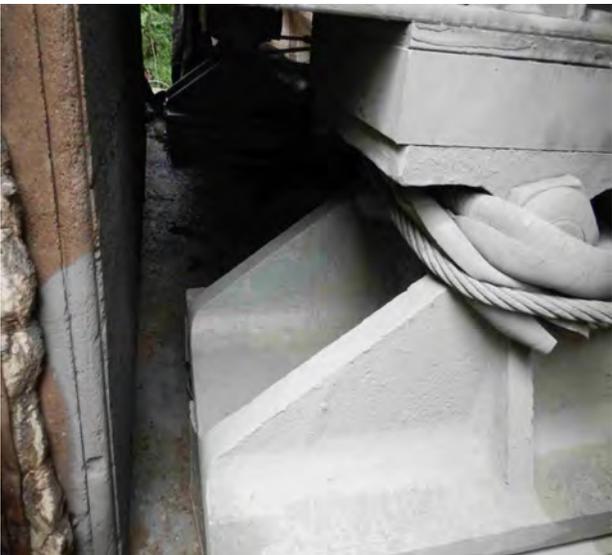
Bridge 19.30 Section 3 Abutment Bearings

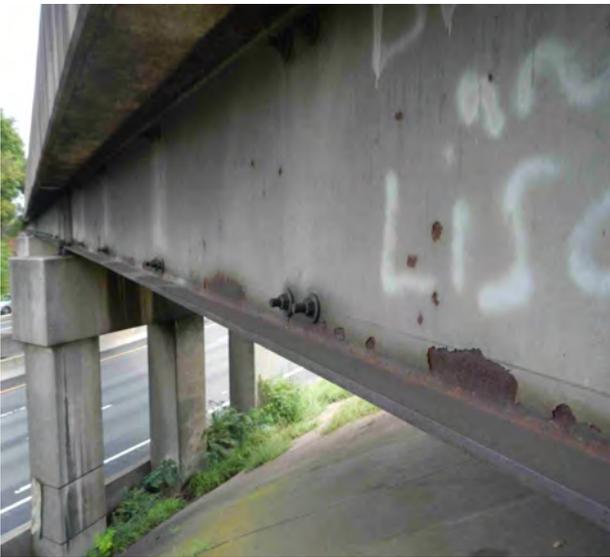
Findings:	Finding Notes:
Abutment 1	
Bearings	Minor corrosion to bearings
Span 1	
Beams	Minor corrosion to Top Flange Angles at Concrete Slab Interface Minor paint peeling to Beams near Bottom Flange Angles
Span 2	
Beams	Minor corrosion to Top Flange Angles at Concrete Slab Interface Minor paint peeling to Beams near Bottom Flange Angles
Span 3	
Beams	Minor corrosion to Top Flange Angles at Concrete Slab Interface Minor paint peeling to Beams near Bottom Flange Angles
Span 4	
Beams	Minor corrosion to Top Flange Angles at Concrete Slab Interface Minor paint peeling to Beams near Bottom Flange Angles
Span 5	
Beams	Minor corrosion to Top Flange Angles at Concrete Slab Interface Minor paint peeling to Beams near Bottom Flange Angles
Approaches	OK
Line and Surface	OK
Handrail	OK
Other	No significant defects located at the time of this inspection

Bridge 21.50 Minor Corrosion to Beam Web at Bottom Flange Angle

Item#	Priority	Who Fixes	Repair Description
1	5	Railroad	Continue to inspect bridge on a regular railroad inspection schedule

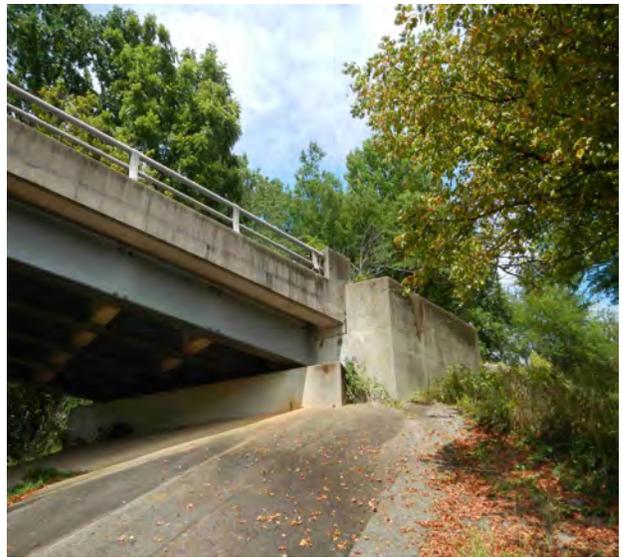
Bridge 21.50 Typical Abutment

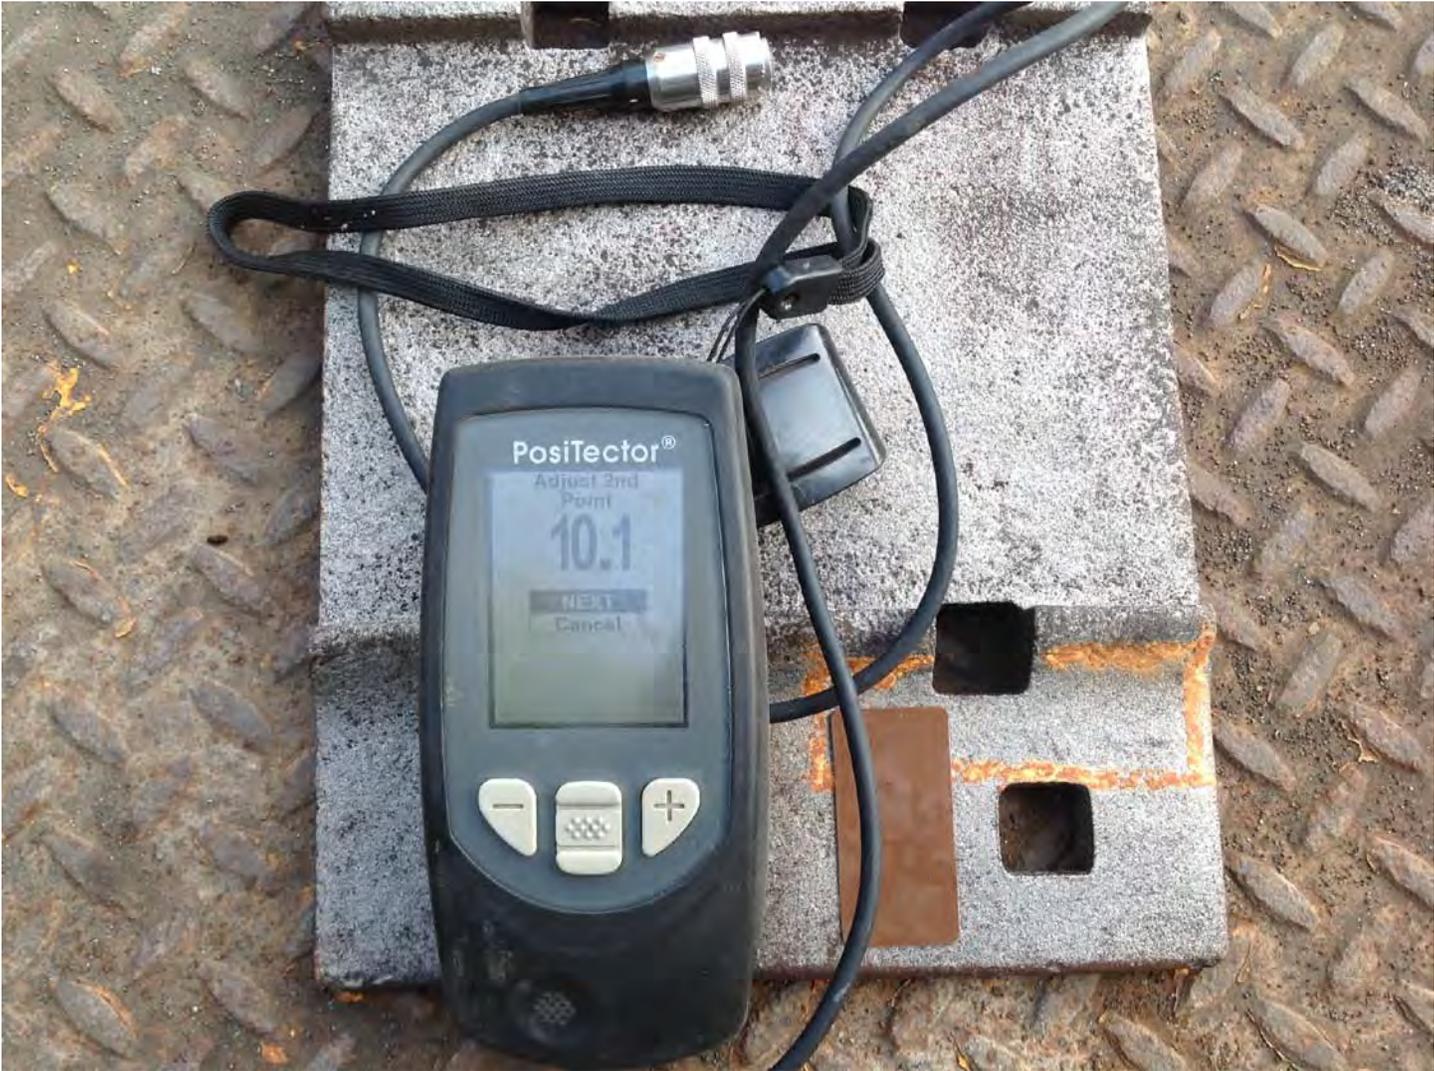
Picture #2

The contractor provided a DFT gage adjustment plate that was a railroad spike plate. I performed a two point gauge adjustment using the blast profile as one point and a 10.1 mil shim as the other point see picture #2. We started our inspection and found multiple DFT readings that were not in accordance with the contract requirements for acceptable dry film thickness requirements. Then Contractor cited the DFT adjustment plate did not represent the blast profile or the magnetic properties of the structure. I then asked where is the gage adjustment standard that is required by the contract in which he stated that he thought that paragraph in the contract referred to a visual blast comparison. I offered the Contractor the option to re-adjust our gages on a blasted plate that I possess, in which he agreed. I again performed a two point gauge adjustment using the blast profile as one point and a 9.9 mil shim as the other point see picture #3.

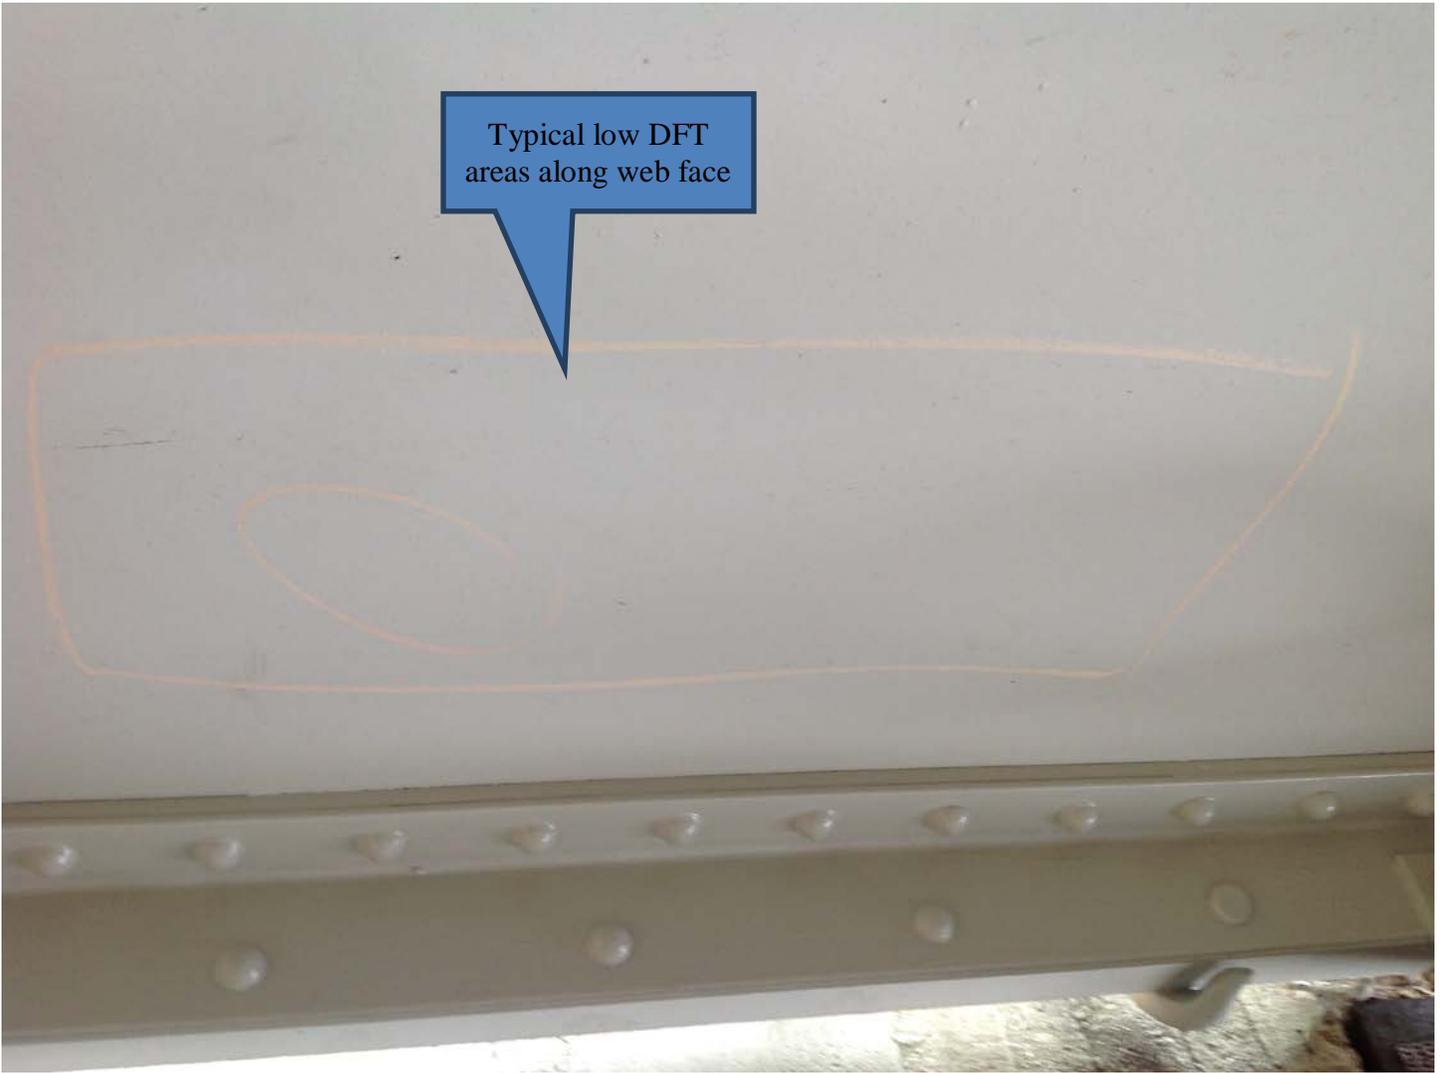
Picture #4

- a. Span 1 & Span 3
 - i. DFT areas that were below the 80% minimum on girder web panels, angle cross members and bottom of top flange members see picture #4, #5 & #6 respectively.
- b. Span 2
 - i. DFT areas that were below the 80% minimum on the inside of vertical chord members shown in picture #7, bottom of horizontal angle bracing shown in picture #8, inside sway bracing plates shown in picture #9 and vertical bracing angles as shown in picture #10.
- c. All Spans
 - i. Perform touch up on all areas where rigging was attached and or damage painted during containment assembly removal. All bare steel areas are to be cleaned touched up with a zinc rich paint and apply remaining top coats as needed see picture set #11.

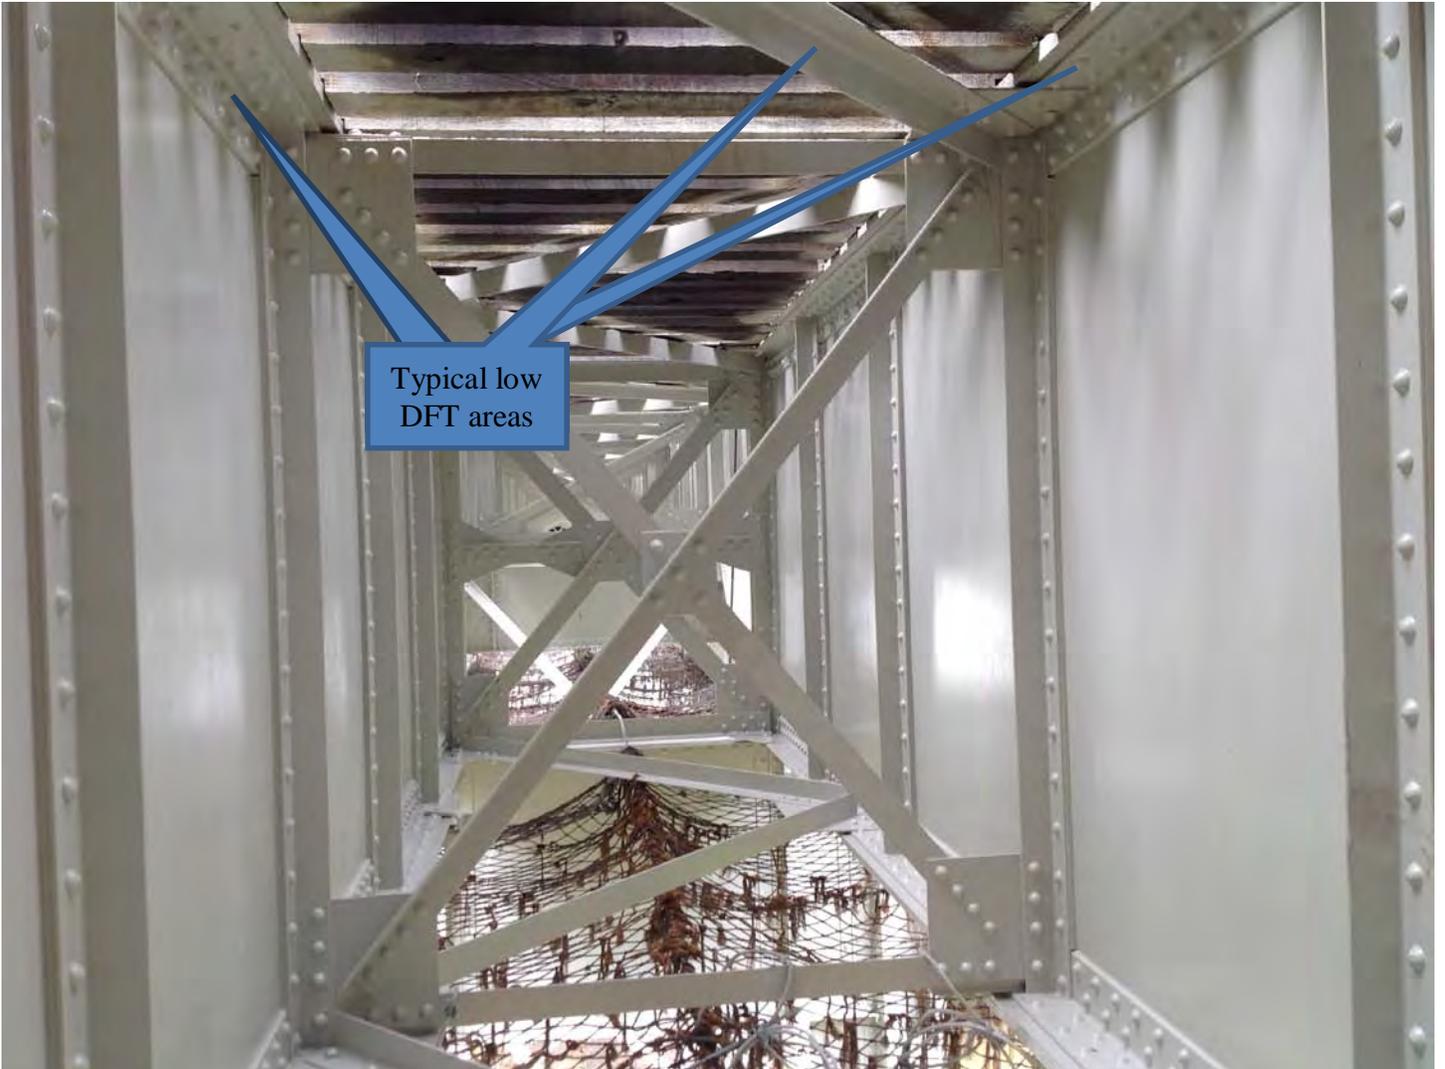
Picture #6

Typical low
DFT areas

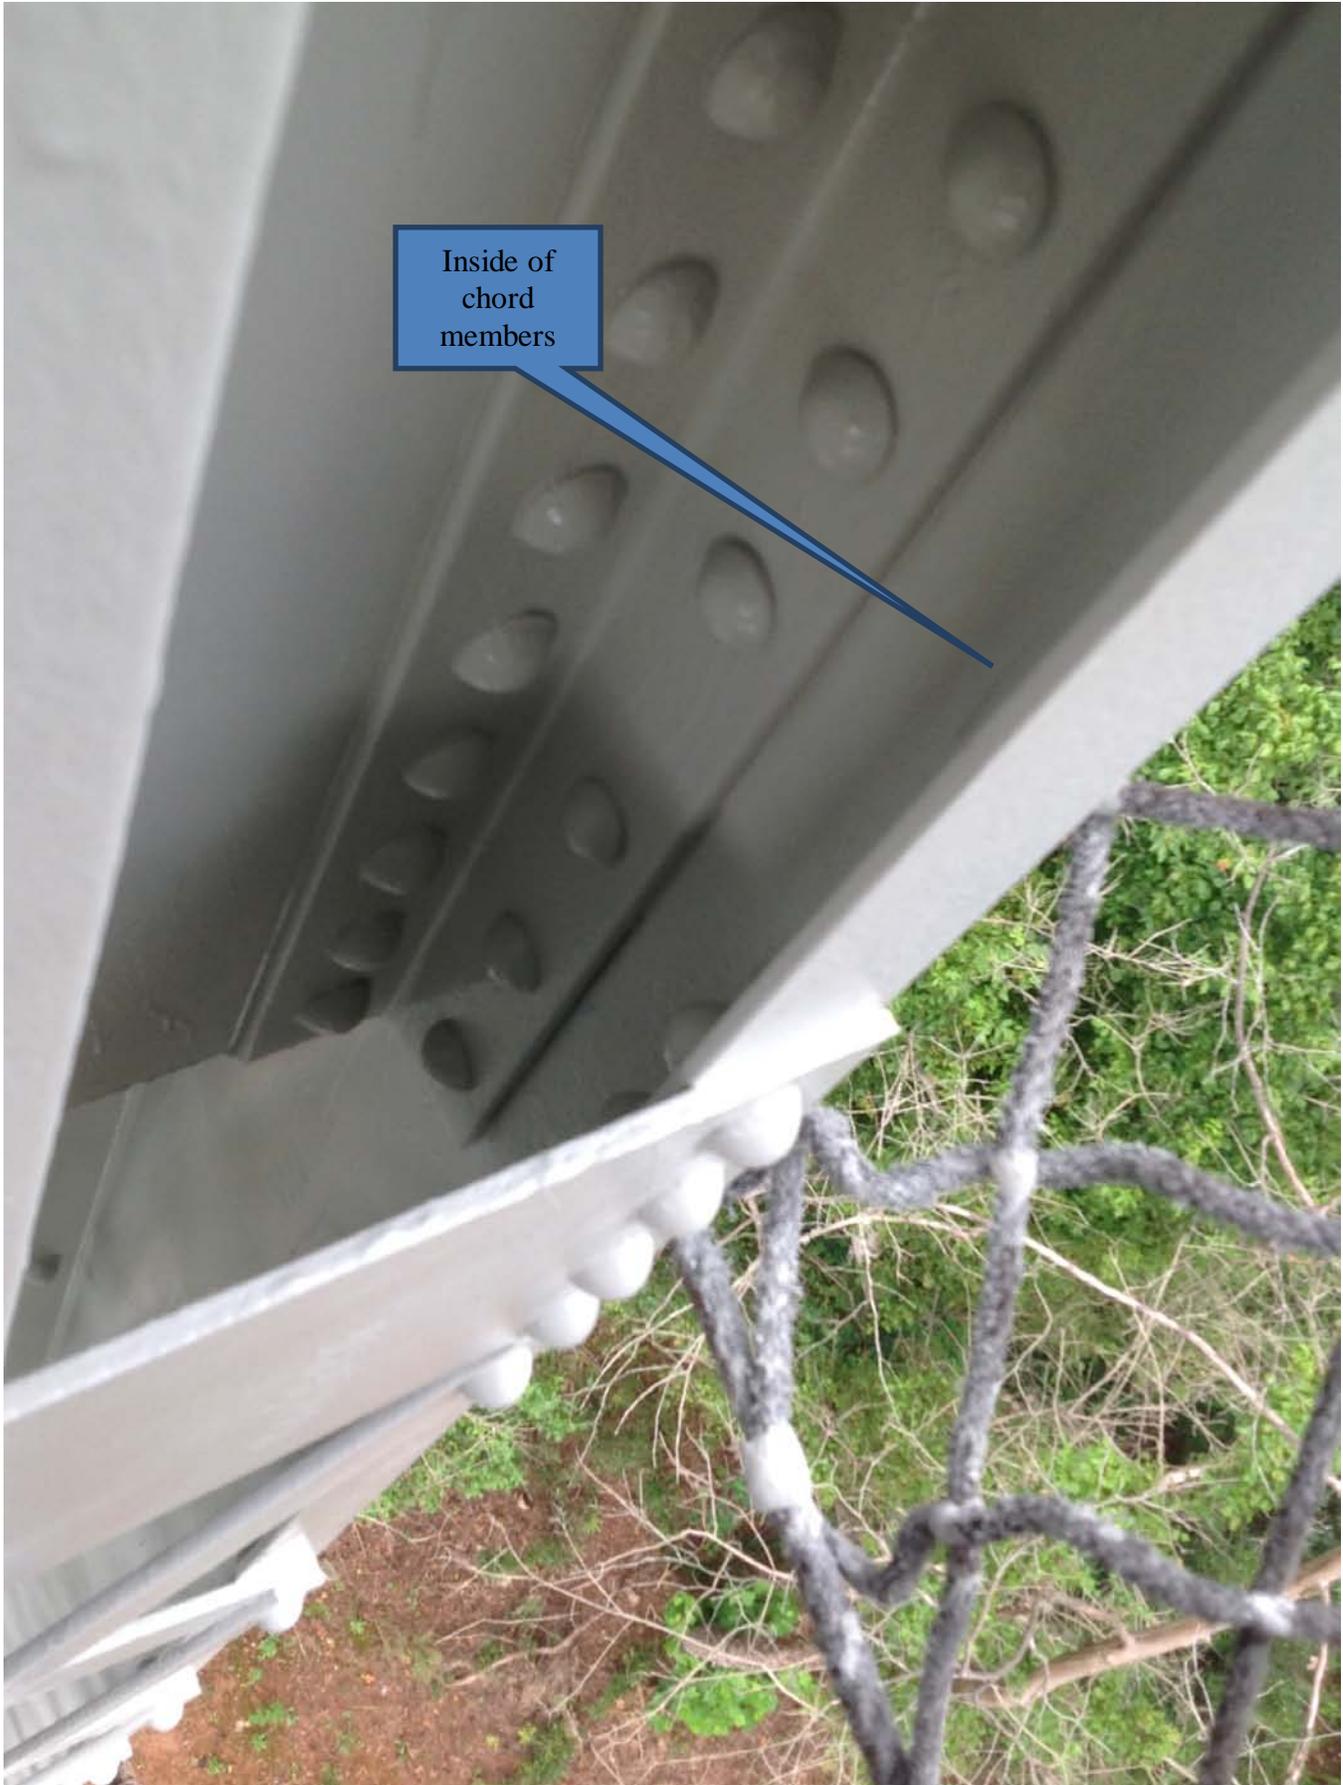
Picture #7

Inside of
chord
members

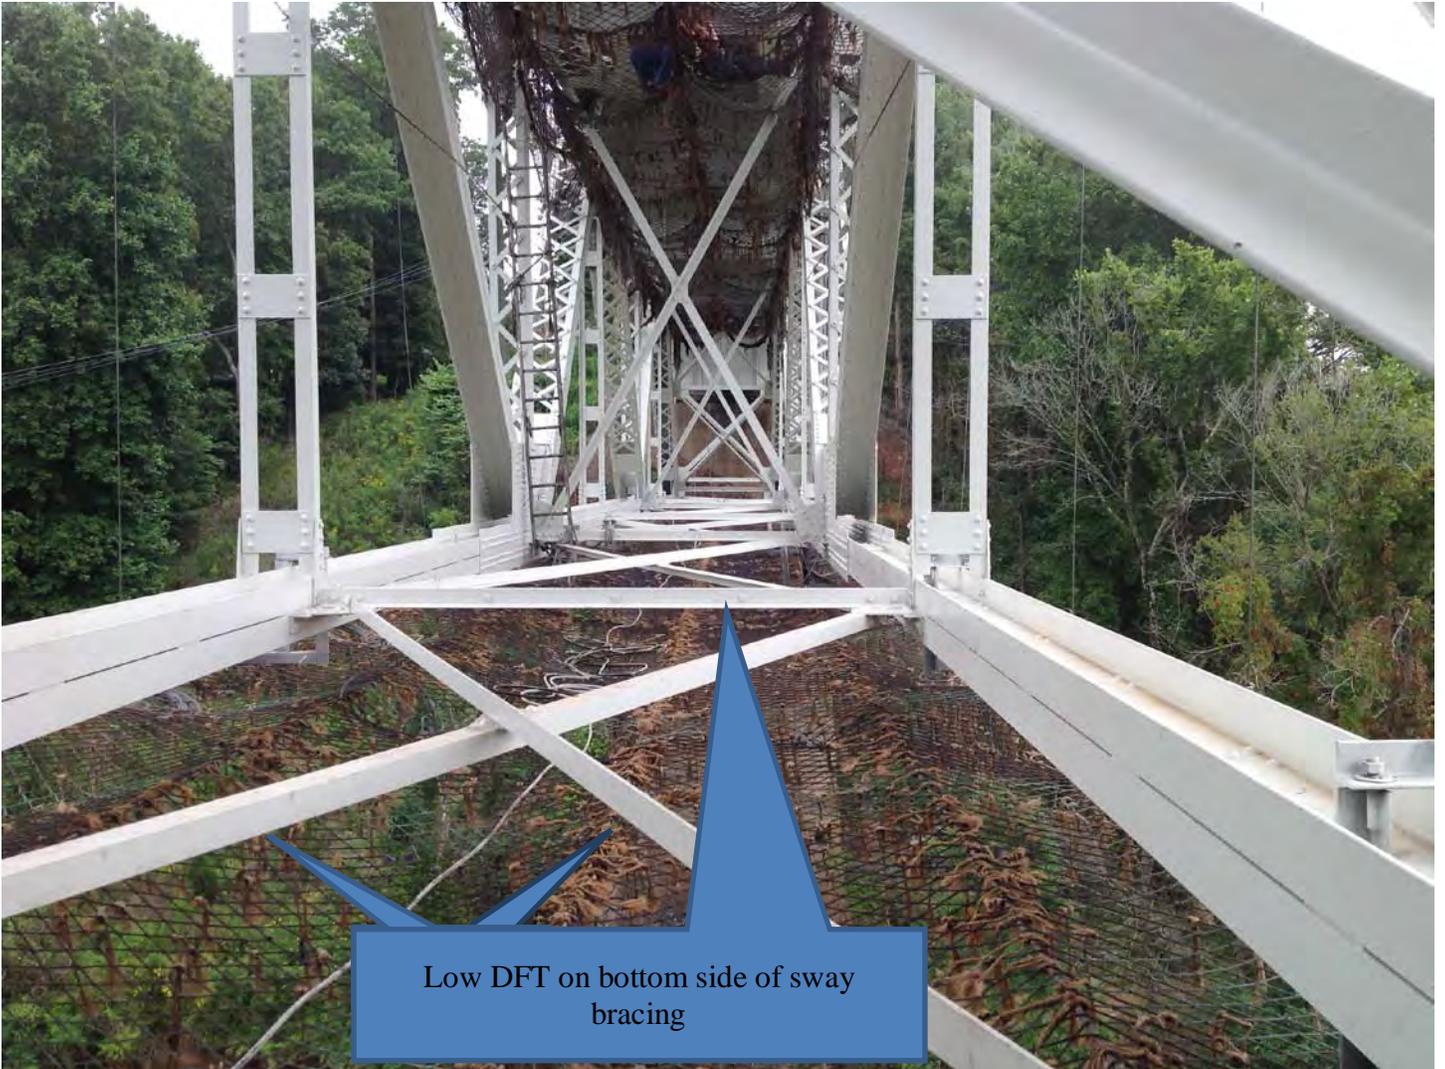
Picture #8

Low DFT on bottom side of sway
bracing

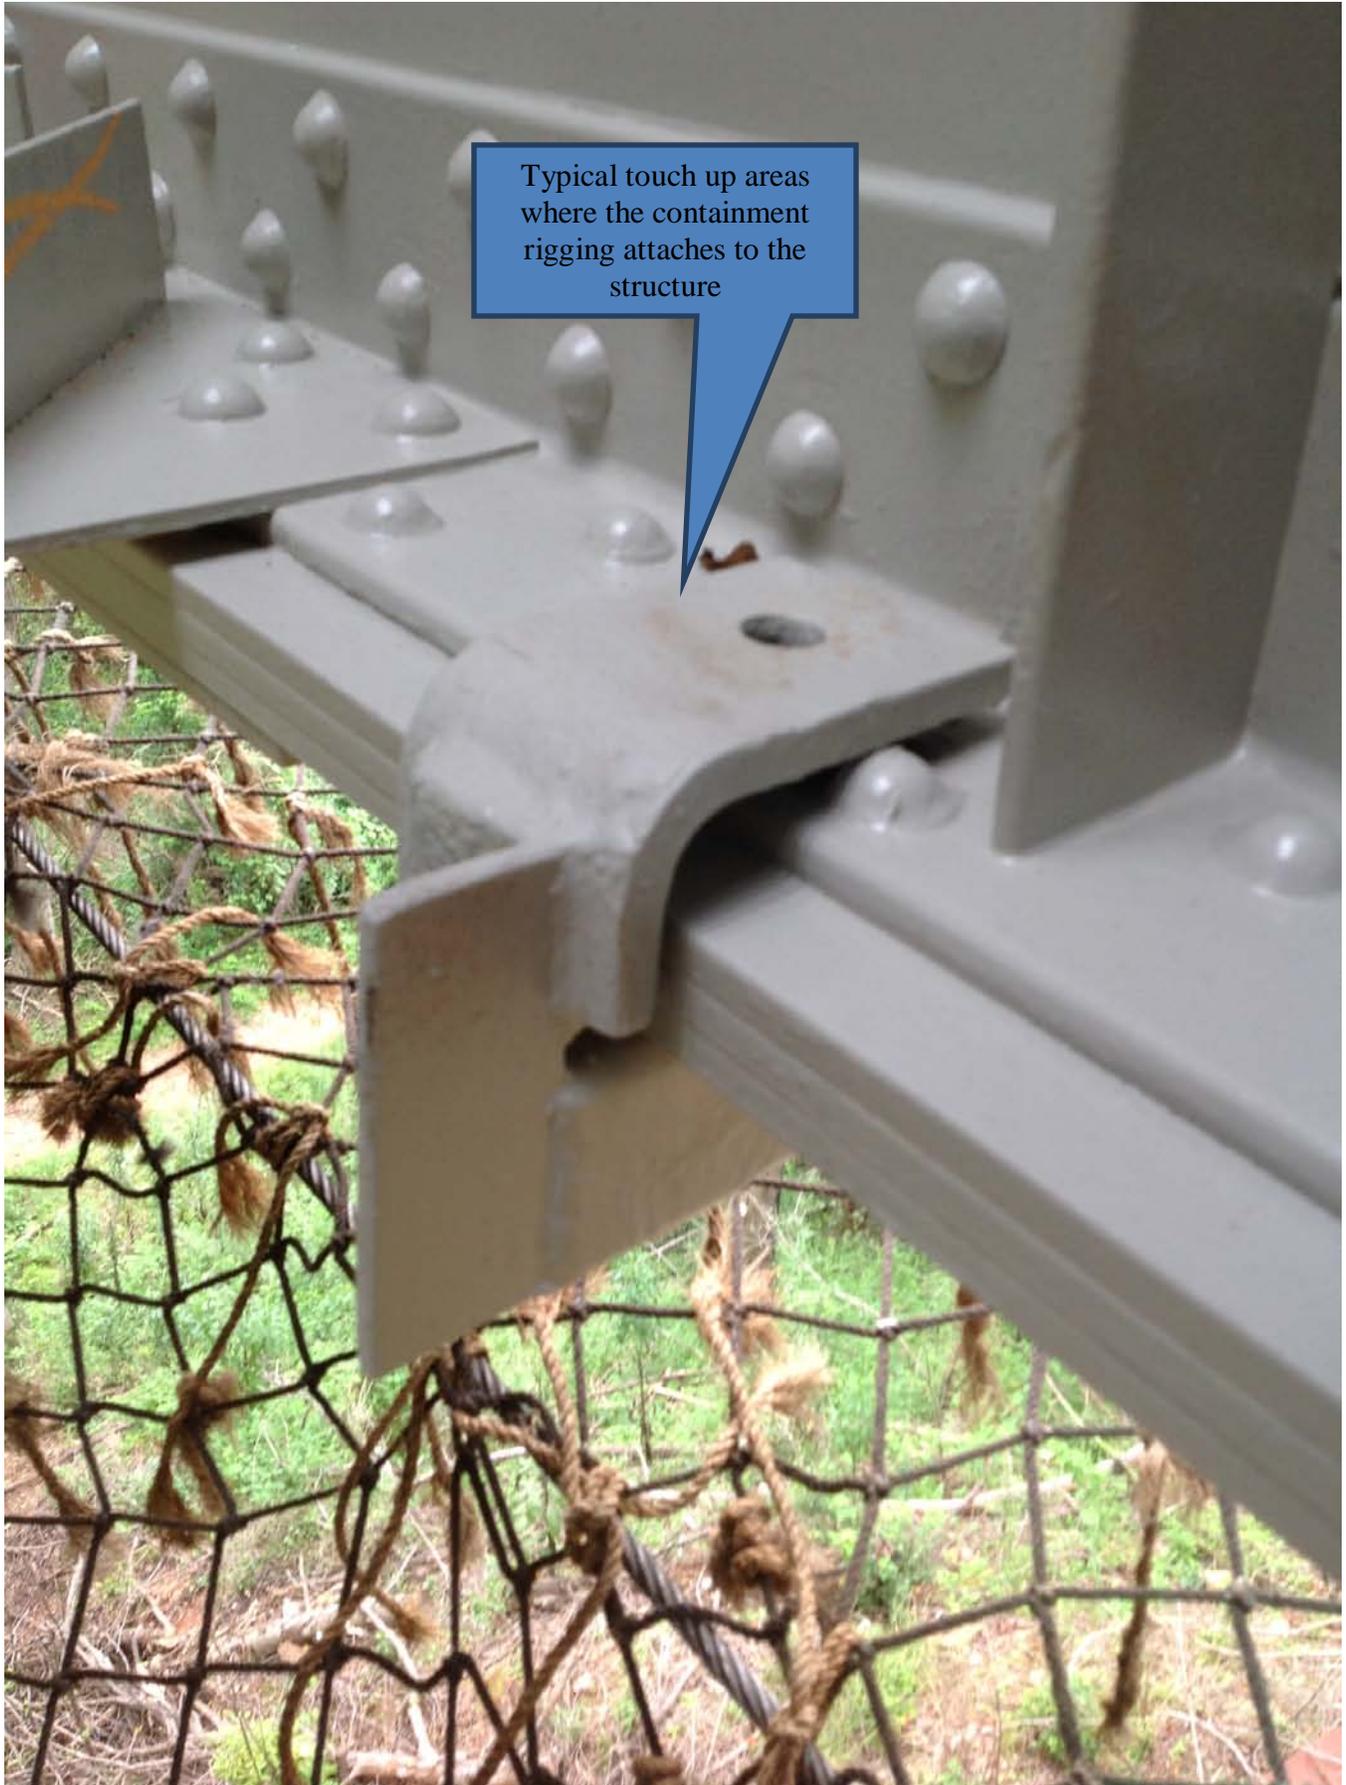
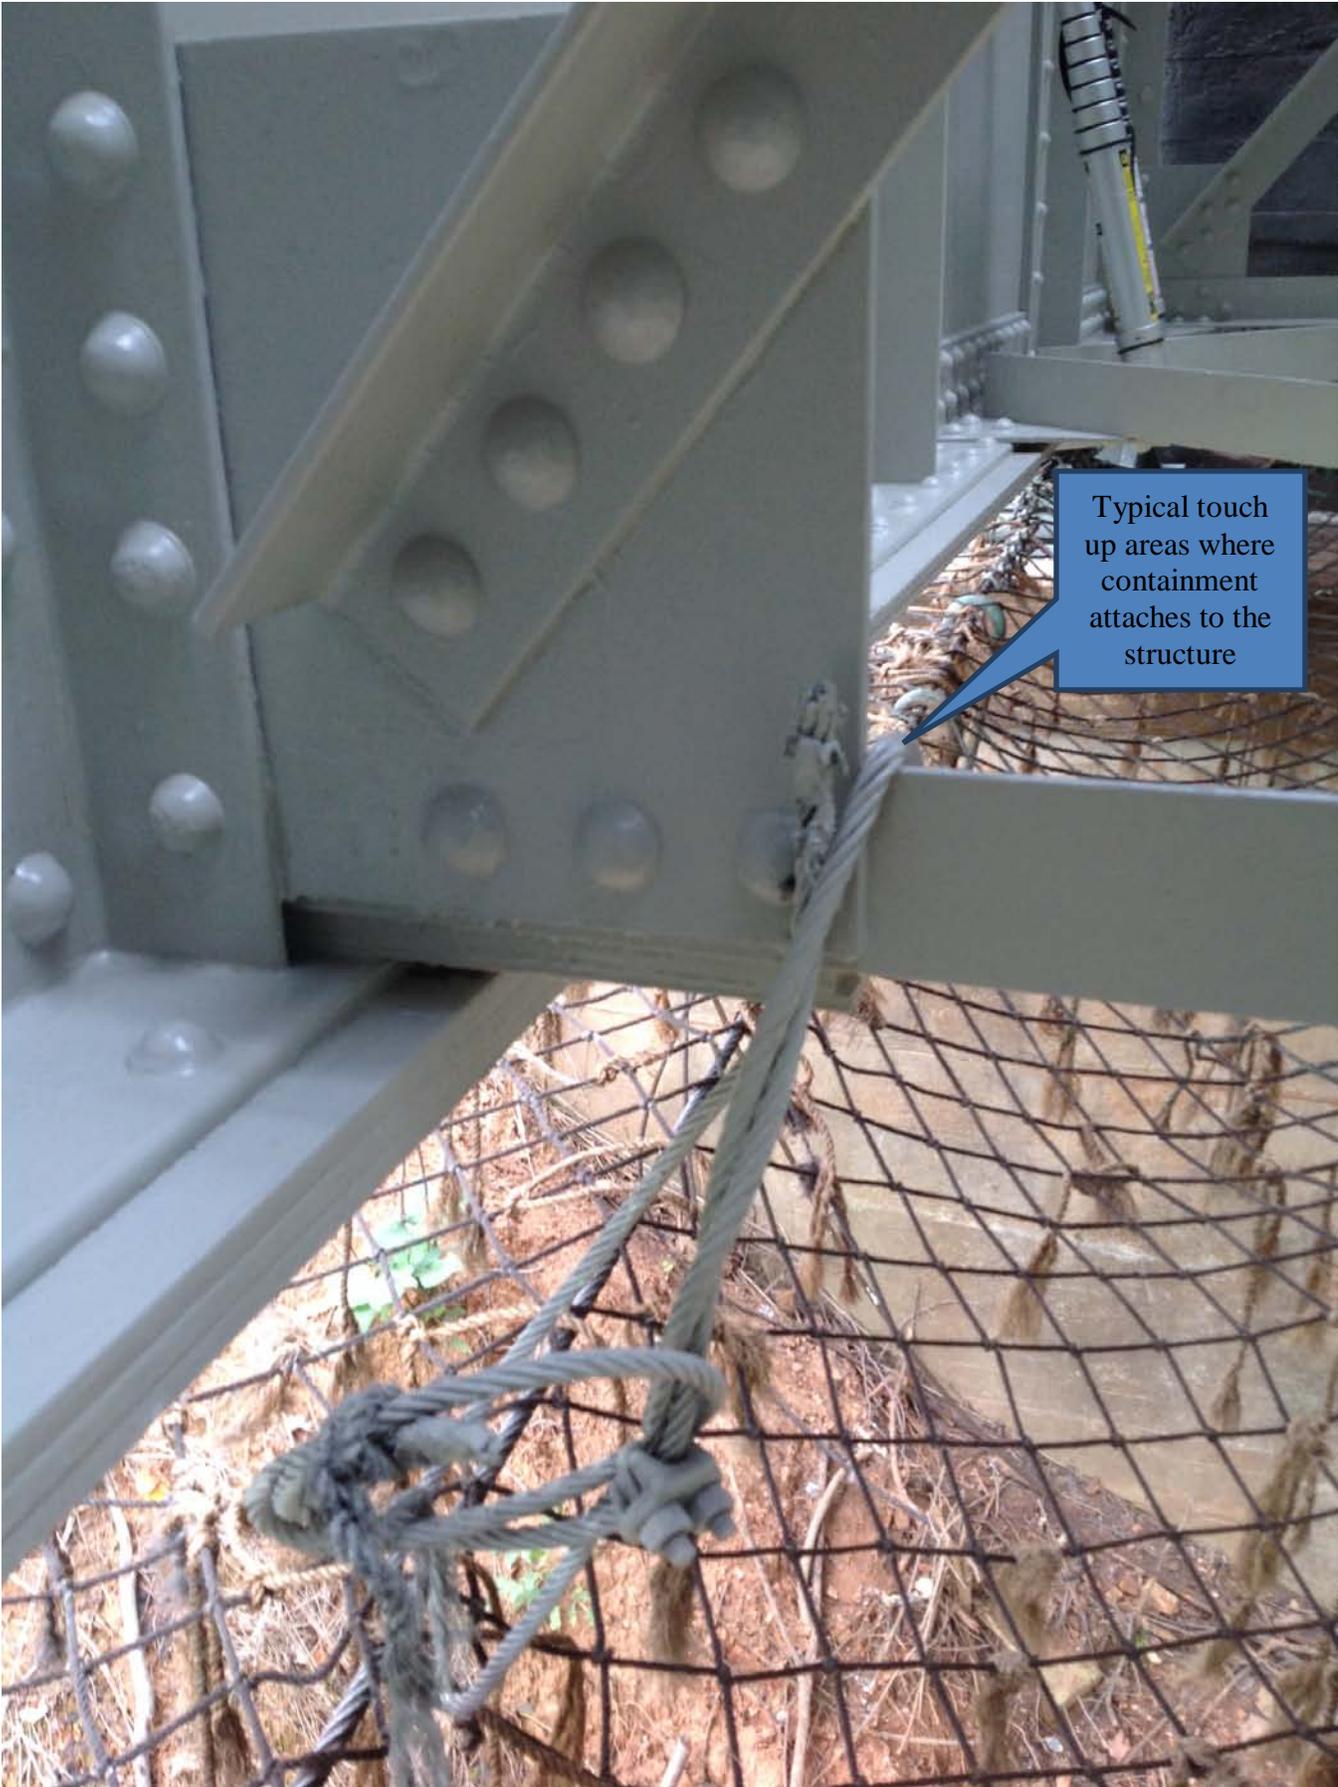
Picture Set #11

Typical touch up areas where the containment rigging attaches to the structure

Typical touch up areas where containment attaches to the structure
