# *Ecusta Rail Trail Planning Study & Economic Impact Analysis*

March 2012

## *Rail Line Structural Assessment*

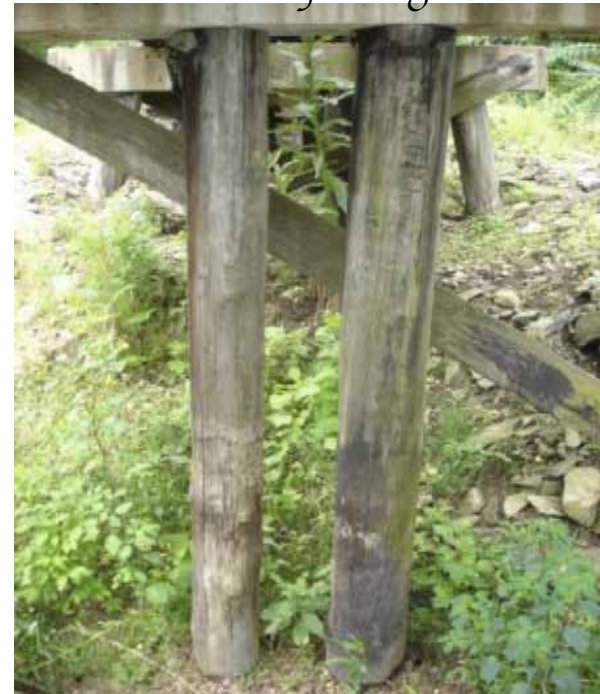
**Substructure:** – Both back walls are in poor condition with signs of decay, deterioration, and severe weathering. There is minor undermining and detaching of wing walls. Timber caps are in satisfactory condition with top 1/2" deteriorated. Timber piles show no signs of deterioration and only minor weathering, but do show signs

of deflecting. Metal sheathing shows signs of oxidation, resulting in severe corrosion. Wood shims show signs of severe deterioration. Substructure shows no signs of debris collection or vegetation growth. Sway braces show signs of minimal weathering and deterioration. Stone pile supports of river span show no signs of deflection or erosion. Metal bridge span shows surface rust, but no severe corrosion present.

## Timber Piles Deflecting

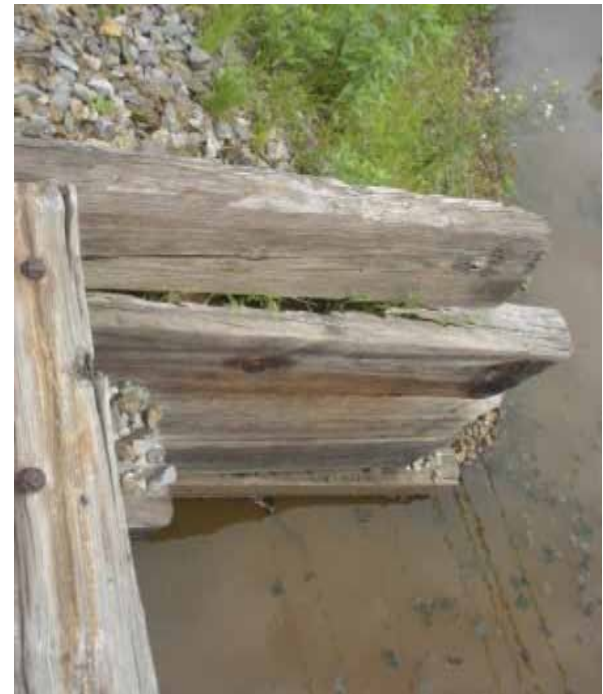
**Substructure** – Both back walls are in poor condition with signs of decay, deterioration and severe weathering. There is minor undermining and detaching walls. Timber piles show no signs of deterioration and only minor weathering; however, most of the piles are underwater (unknown depth). Wood shims show signs of severe deterioration. Substructure shows no signs of debris collection or vegetation growth.

## Back Wall

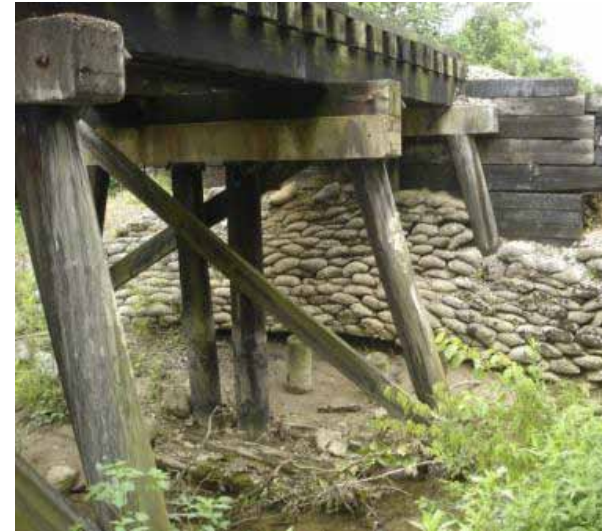
Substructure – Both back walls are in satisfactory condition, with minimal signs of deterioration and weathering. There is minor undermining and detachment of walls. North back wall constructed of concrete bags and timber ties.

## North Back Wall

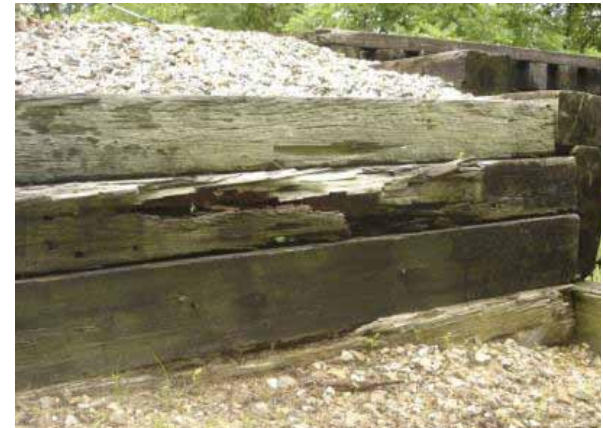
## Back Wall Deterioration

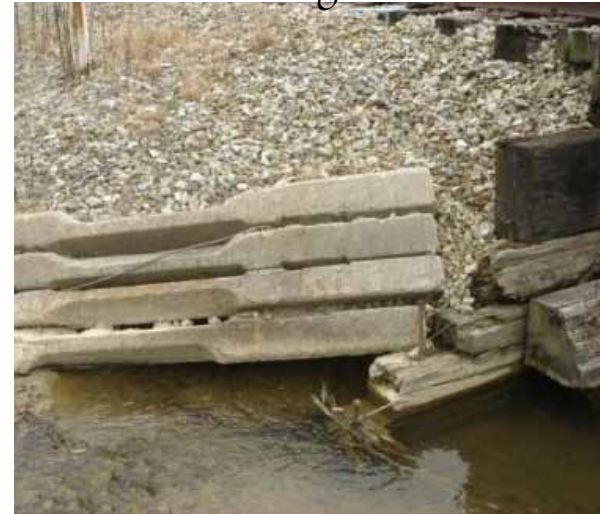
Substructure – Both back walls are in satisfactory condition with minimal signs of deterioration and weathering. South wing deflecting into stream and is constructed of stacked concrete ties. Minor undermining and detachment of walls. Back walls constructed of timber ties. Timber piles show signs of deterioration and minor weathering. Wood shims show signs of minor deterioration. Substructure shows signs of debris collection.

## Concrete Tie Wing Wall

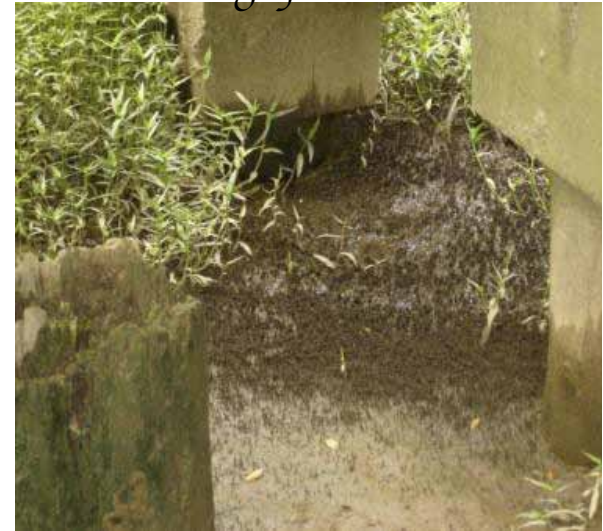
**Substructure** – Both back walls are in poor condition with signs of deterioration and weathering. Both back walls are further supported by stacked concrete ties. Minor undermining and detachment of walls are occurring as a result of frequent flooding. Back walls constructed of timber ties. Timber piles show signs of deterioration and weathering due to frequent flooding. Wood shims show signs of minor deterioration. Substructure shows signs of debris collection and significant vegetative growth.

## Undermining of Timber Piles

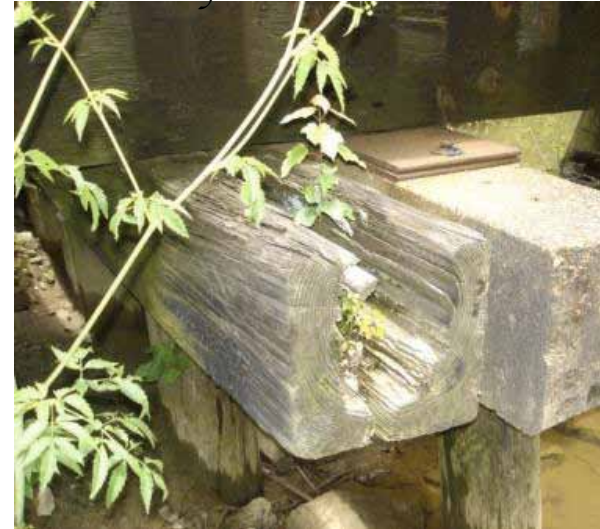
**Substructure** – Both back walls are in poor condition, with signs of deterioration and weathering. There is severe undermining and detachment of timber tie back walls. Timber piles show signs of deterioration and weathering due to frequent flooding. Wood shims show signs of minor deterioration. Substructure shows signs of debris collection and significant vegetative growth.

## Timber Cap Deterioration

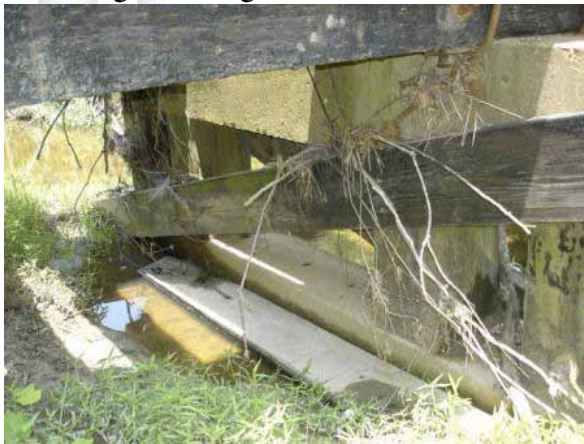
**Substructure** – Both back walls are in poor condition, with signs of decay, deterioration and severe weathering. There is minor undermining and detaching of walls. Timber piles show signs of deterioration and minor weathering due to frequent flooding; Timber piles' foundations are underwater (unknown depth). Wood shims

show signs of severe deterioration. Substructure shows significant signs of debris collection and vegetative growth due to frequent flooding.

## Debris and Visual Foundation During Drought

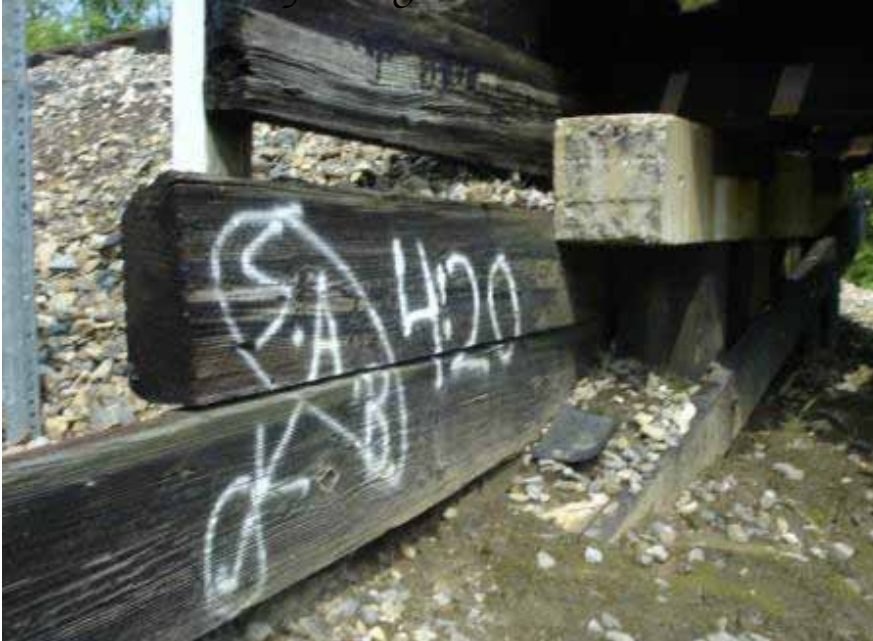
**Substructure** – Both back walls are in poor condition, with signs of decay, deterioration and severe weathering. There is minor undermining and detaching of wing walls. Timber caps are in satisfactory condition, with top 1/2" deteriorated. Timber piles show no signs of deterioration and only minor weathering, but do show signs

of deflecting. Metal sheathing showing signs of oxidation, resulting in severe corrosion. Wood shims show signs of severe deterioration. Substructure shows no signs of debris collection or vegetation growth. Sway braces show signs of minimal weathering and deterioration. Stone pile supports of river span show no signs of deflection and minimal erosion. Metal bridge span shows surface rust, but no severe corrosion present.

*Timber Piles Deflecting*

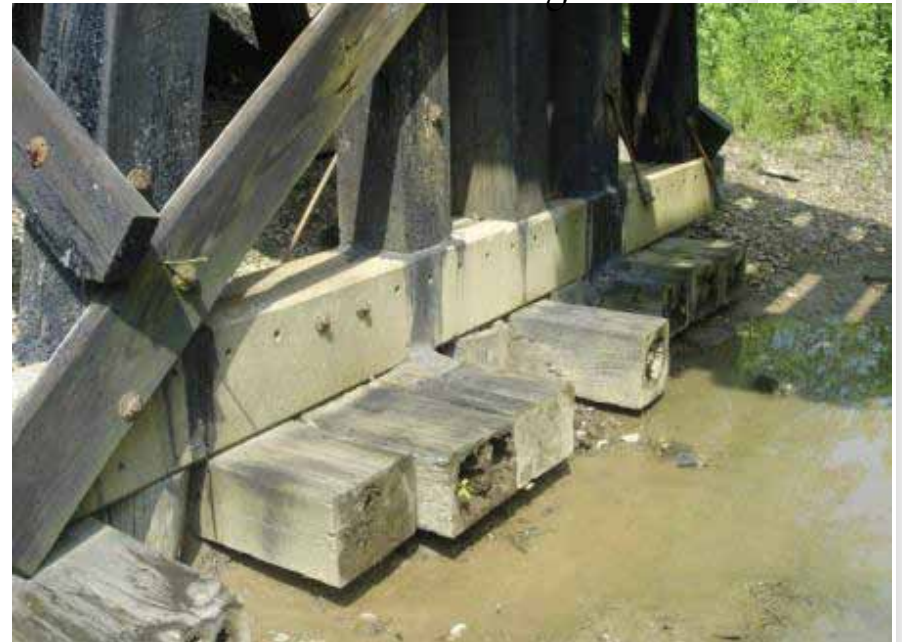
*Bent Foundation Undermining*

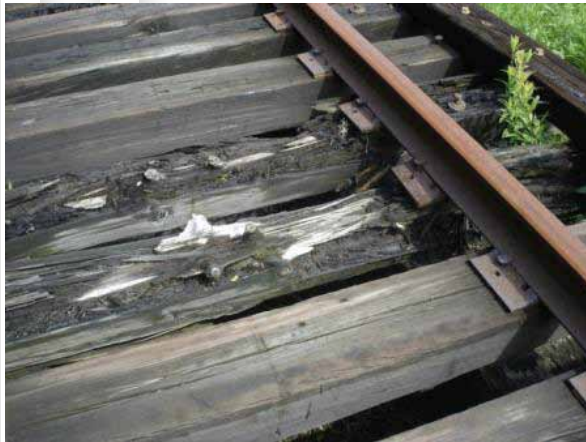
**Deck and Superstructure** – Ties are deteriorating and deflecting, causing shifts in overall alignment of superstructure. Girders are in satisfactory condition, with few areas of deterioration and minor weathering. Guard and running rails are deflecting, causing shift and detachment of decking.

## Tie Deterioration

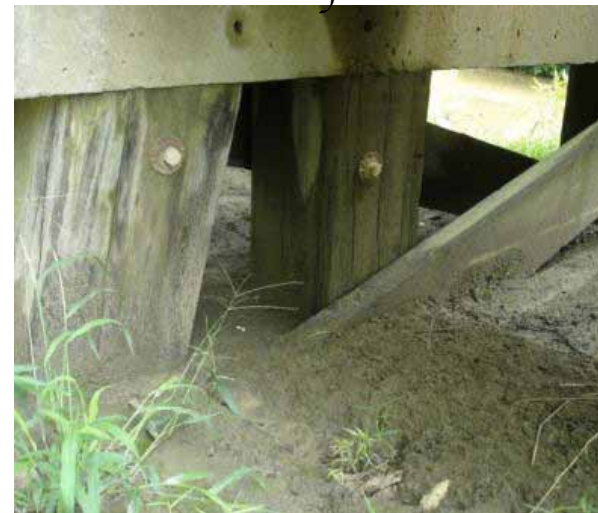
Sediment and undermining of timber piles and back walls is caused by frequent flooding.

## Sediment Build-up

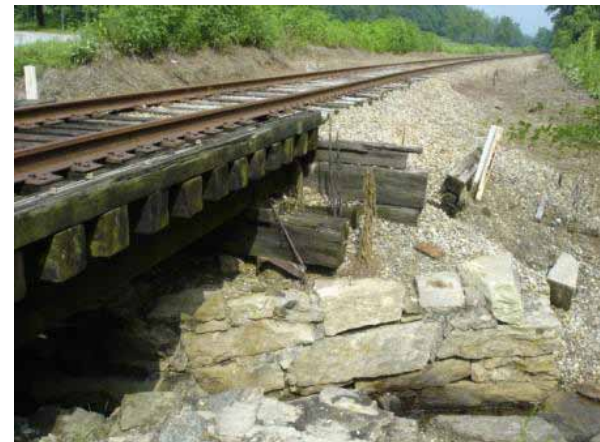
**Substructure** – Both back walls are in poor condition, with significant signs of decay, deterioration and weathering. There is severe undermining and deflection of both north and south back walls and wing walls. Sediment and undermining of stone foundation and back walls is caused by frequent flooding.

## North Back Wall and Stone Foundation

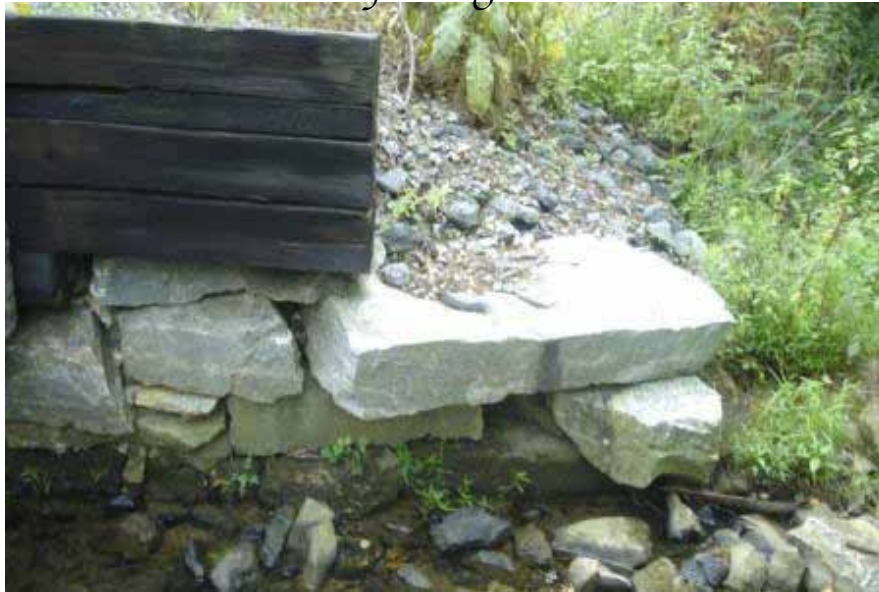
**Substructure** – Both back walls are in poor condition, with significant signs of decay, deterioration and weathering. There is severe undermining and deflection of both north and south back walls and wing walls. Sediment and undermining of stone foundation and back walls is caused by frequent flooding.

*North Back Wall Deflecting*

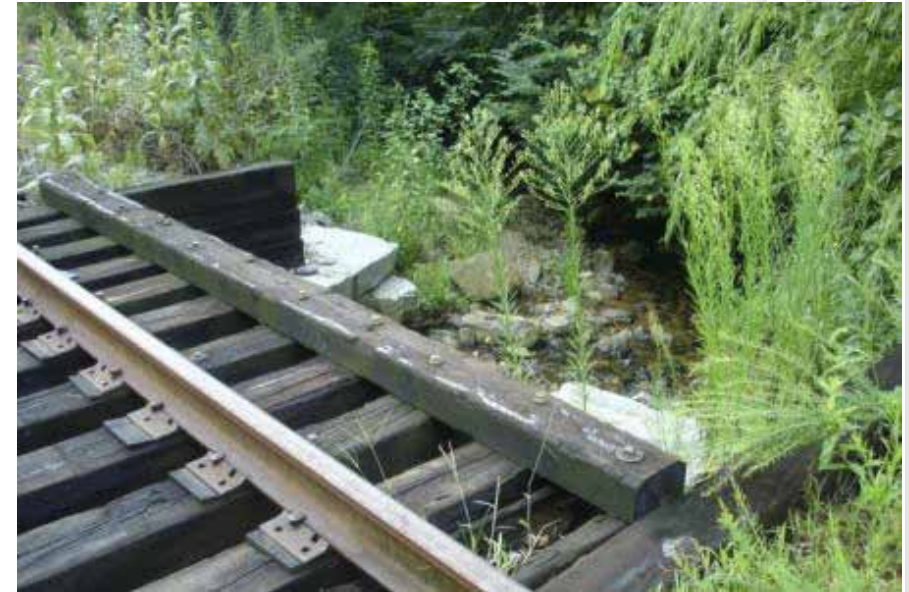
**Deck and Superstructure** – Ties are deteriorating and deflecting, causing shifts in overall alignment of superstructure. Girders are in satisfactory condition, with few areas of deterioration and minor weathering. Guard and running rails are deflecting, causing shift and detachment of decking and are in poor condition.

*Tie and Timber Deterioration*

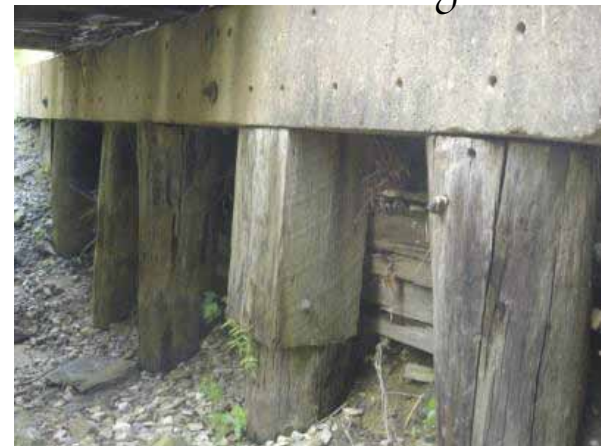
**Substructure** – Both back walls are in fair condition, with minor signs of deterioration and weathering. There is minor undermining and detaching of walls. Timber piles show signs of deterioration and minor weathering due to frequent flooding; Some timber piles and foundations of bents are underwater (unknown depth).

## Block Wall Undermining

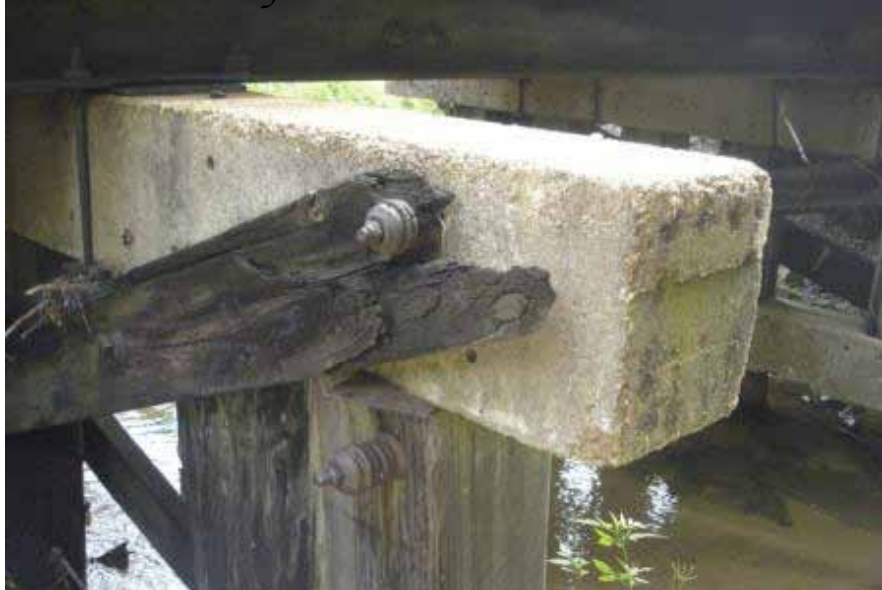
*Deterioration of Timber Cross Brace*

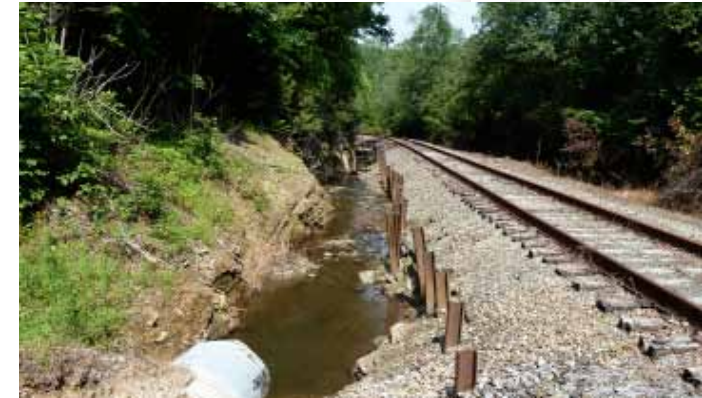
*There are some areas with erosion or other environmental degradation along the rail line that may require remediation.*
