NC DEPARTMENT OF TRANSPORTATION  
DIVISION OF HIGHWAYS  
STRUCTURE MANAGEMENT UNIT  
COUNTY: RUTHERFORD DIV: 13

## Structure Safety Inspection Report

BRIDGE NUMBER: 800239 BRIDGE NAME: \_\_\_\_\_ PREVIOUS BRIDGE NUMBER: \_\_\_\_\_

LATITUDE: 35.48940000 LONGITUDE: -81.99338000 ROUTE: SR1325 M.P.: 0.0

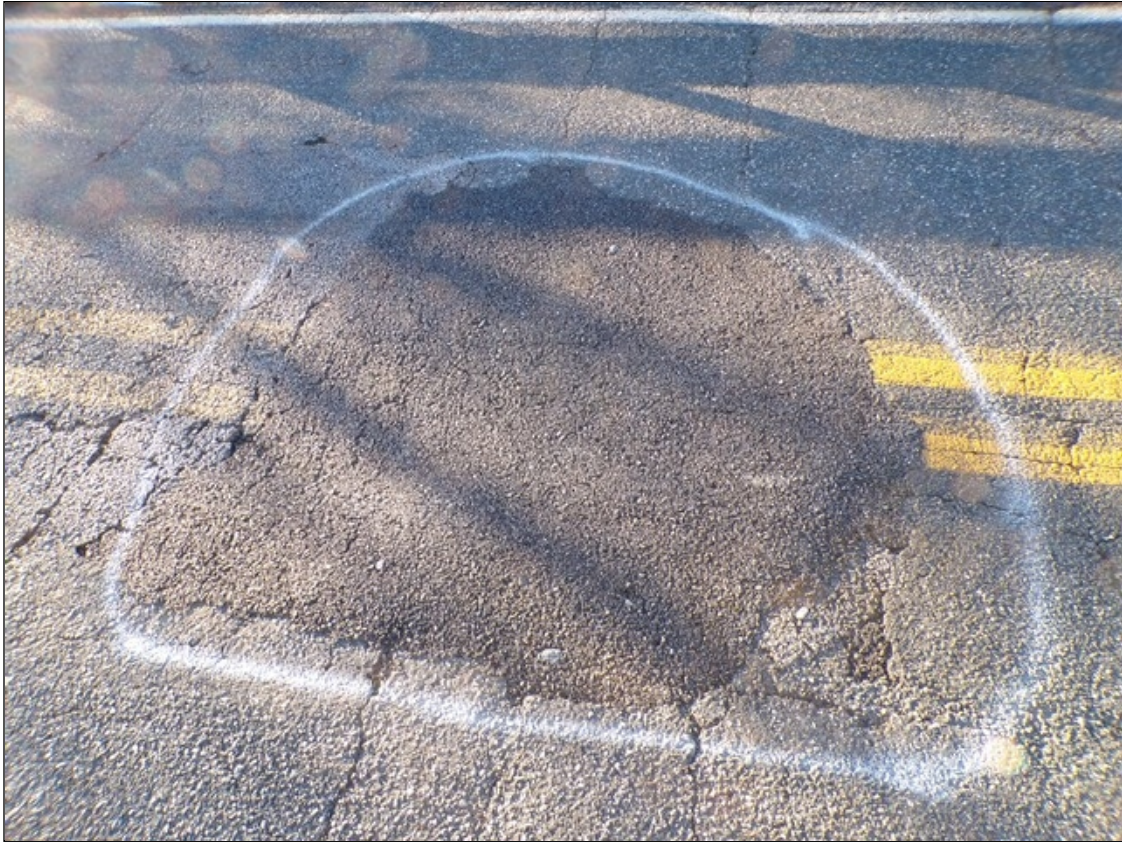
Span 1 Wearing Surface: (2) SOUND PATCH AT CENTERLINE (UP TO 8 FEET X 6 FEET) AT MIDSPAN

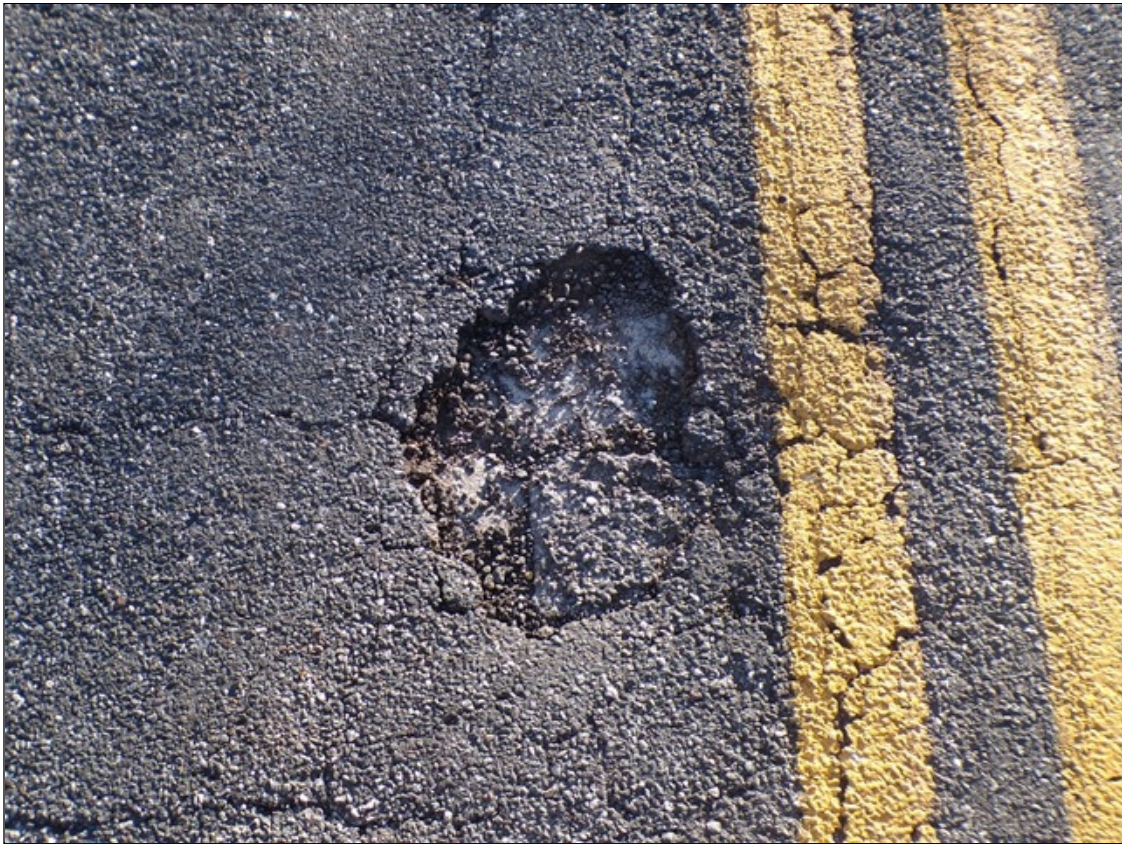
SPAN 3 Wearing Surface: LEFT LANE AT NEAR END PREVIOUS PATCH (18 INCH X 17 INCH X 1 INCH DEEP AREA OF MISSING ASPHALT WEARING SURFACE)

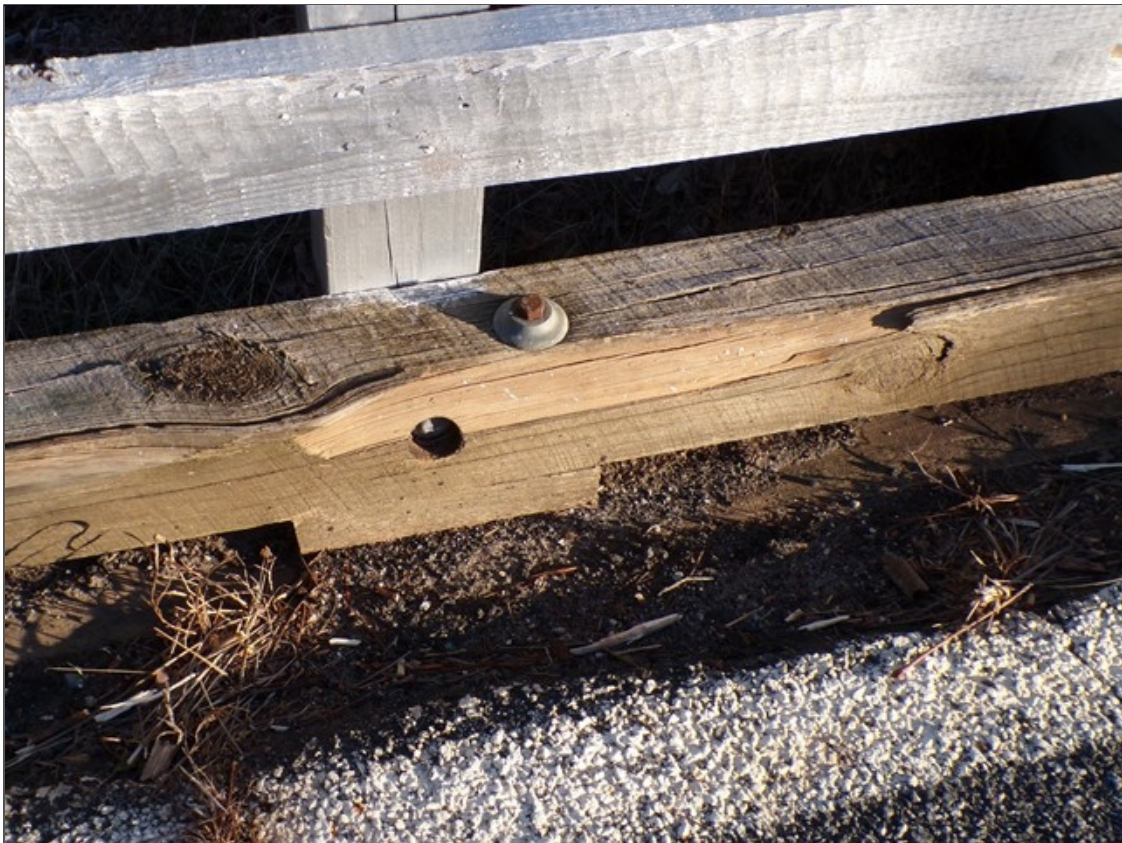
Span 3 Left Bridge Rail: (3) UP TO 48 INCH X 2 INCH X 1/2 INCH DEEP AREA OF DECAY ON CURB

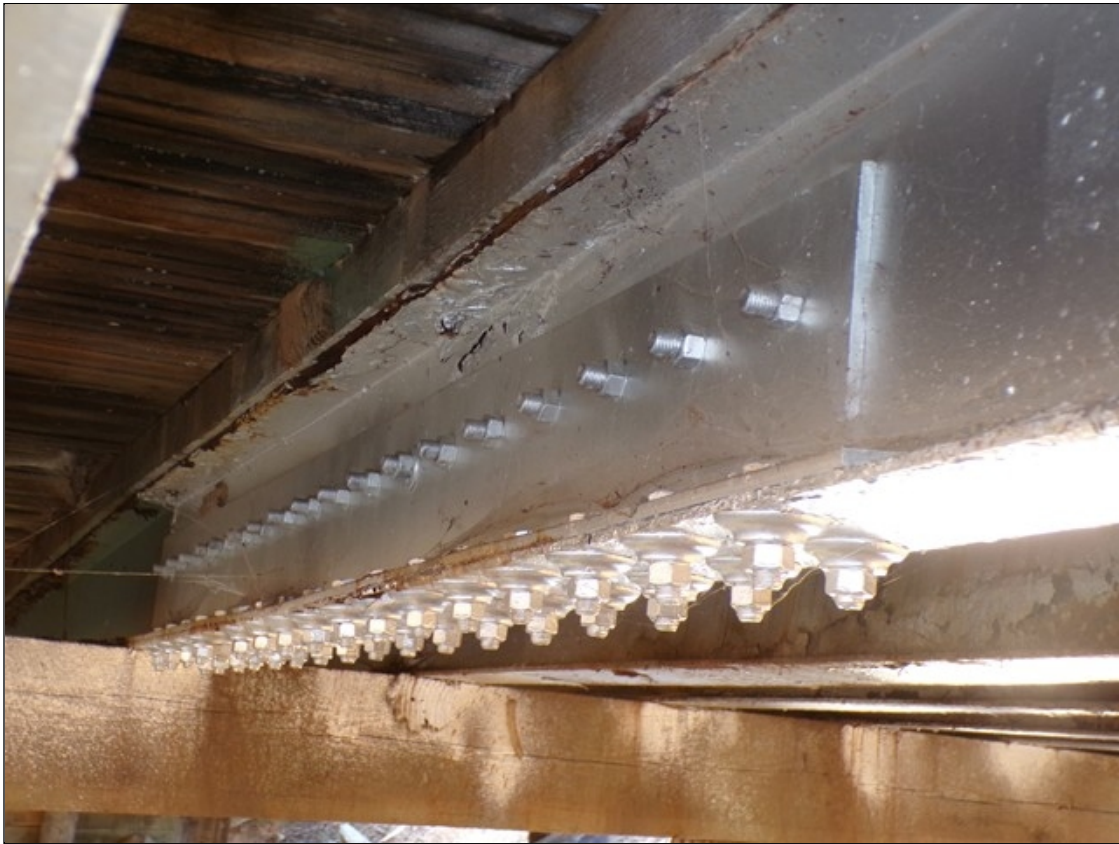
SPAN 1 BEAM 3: (2023 REPAIR) AT FAR END, 9 FEET LONG X 8 INCH HIGH X 3 INCH WIDE BOLTED PLATES ON BOTH SIDES REPAIRING PREVIOUS FULL WIDTH X 8 FEET LONG BOTTOM FLANGE SECTION LOSS

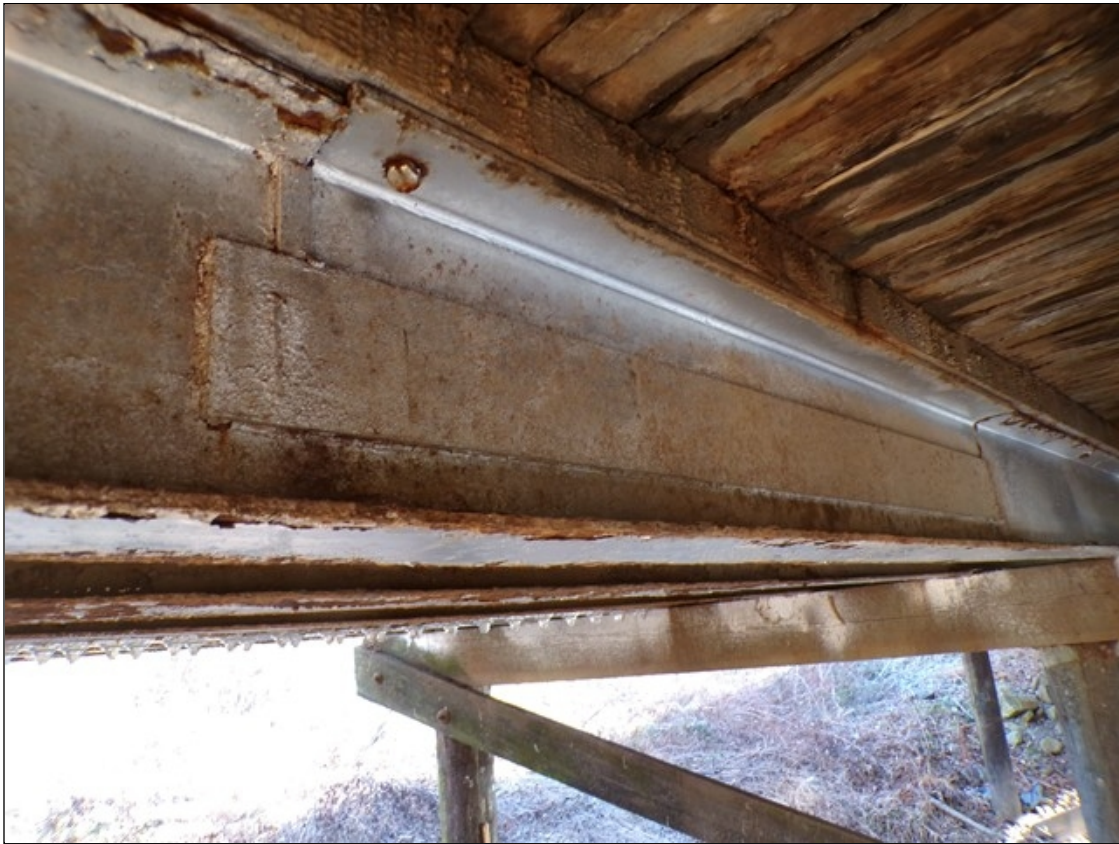
SPAN 1 BEAM 6: (2021 REPAIR) BEGINNING 6 FEET FROM BENT 1, REPAIR PLATES (56 INCH LONG, TOP FLANGE, 6.5 INCH X 1/2 INCH, AND WEB, 7 INCH X 1/4 INCH) WELDED INTO TOP FLANGE AND WEB AT LOCATION OF PREVIOUS DEFECT

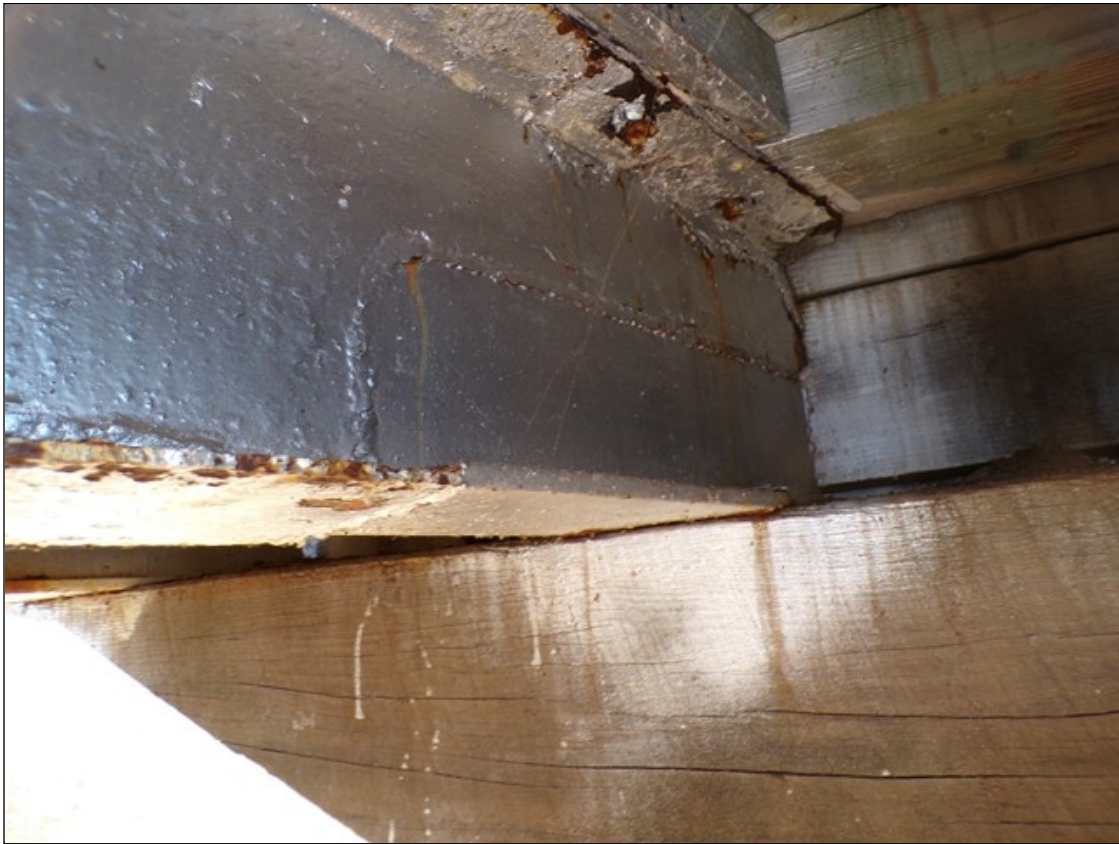
SPAN 1 BEAM 9: (2023 INSPECTION REPAIR) 20 INCH LONG X FULL WIDTH X 6 INCH HIGH WT SECTION WELDED TO NEAR END REPLACING BOTTOM FLANGE, 6.5 INCH X 1/2 INCH, AND LOWER WEB, 5.5 INCH X 1/4 INCH THICK, AT LOCATION OF PREVIOUS SECTION LOSS

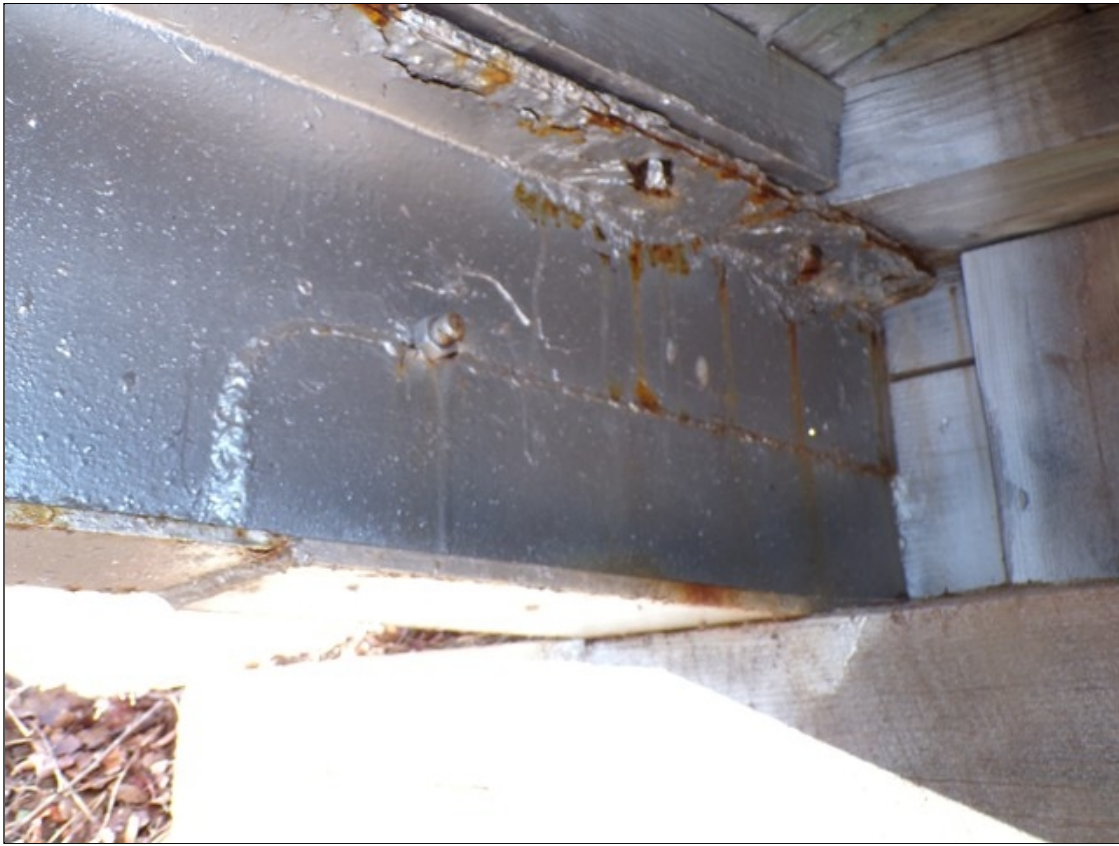
SPAN 1 BEAM 10: (2023 REPAIR) 23 INCH LONG X FULL WIDTH X 5 INCH HIGH WT SECTION WELDED TO NEAR END REPLACING BOTTOM FLANGE, FULL WIDTH X 1/2 INCH THICK, AND LOWER WEB, 5 INCH X 1/4 INCH, AT LOCATION OF PREVIOUS SECTION LOSS

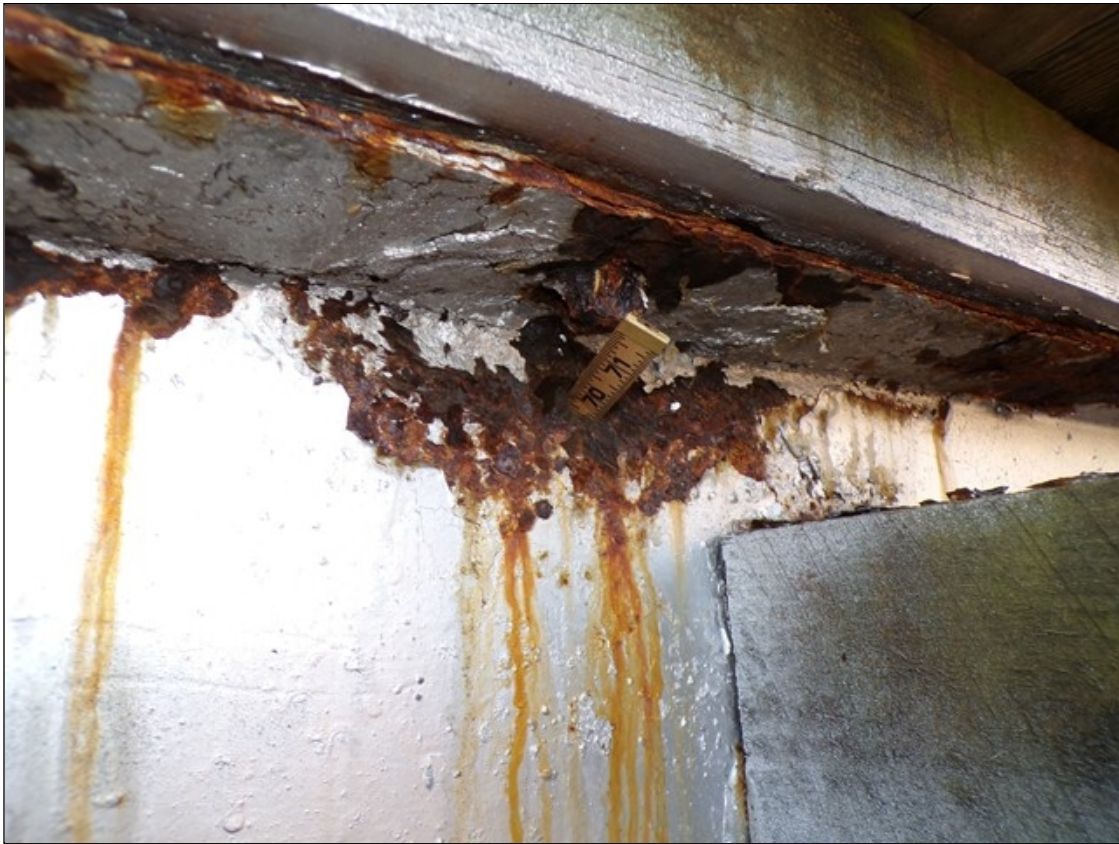
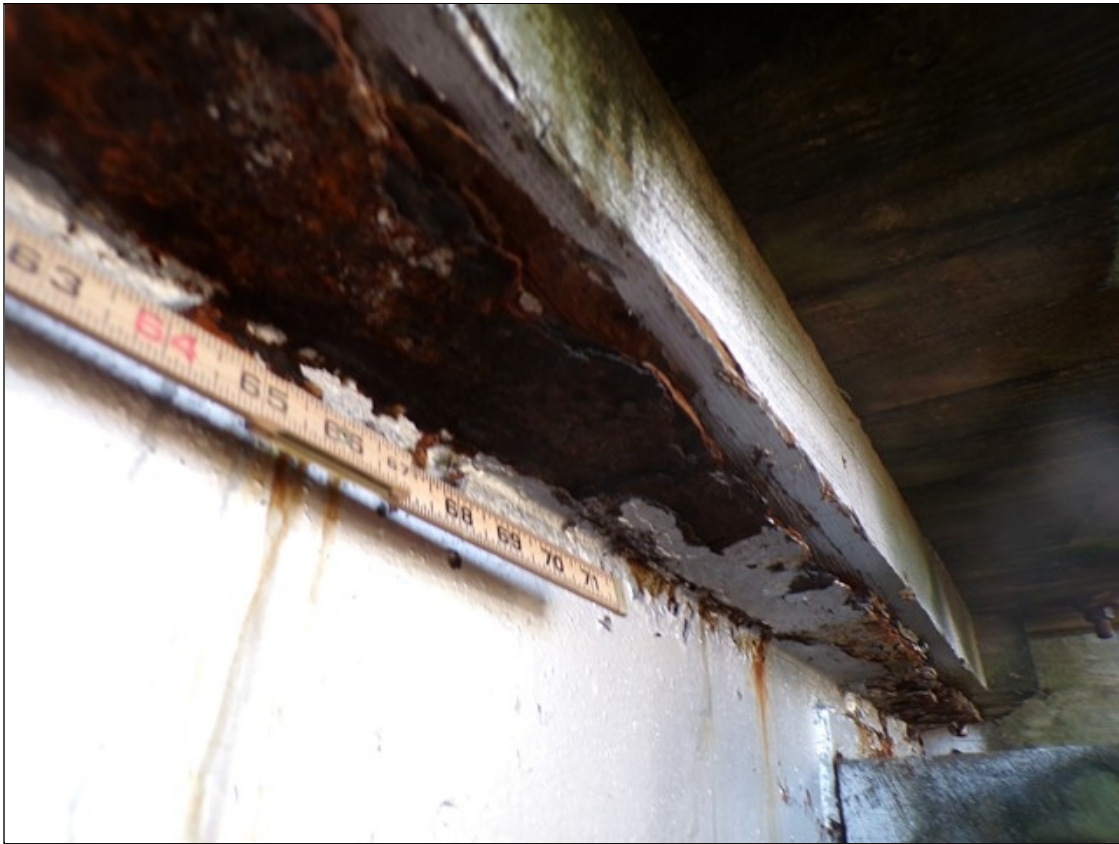
| 2 | Corrosion | 26 | SPAN 1 Beam 1: (PAR) TAPERED CORROSION WITH SECTION LOSS TO TOP FLANGE (WITH AREAS OF UP TO 100% SECTION LOSS) DOWN TO 1/8 INCH AVERAGE THICKNESS REMAINING AT EDGE FOR FULL WIDTH X FULL LENGTH AND WEB SECTION LOSS (DOWN TO 1/16 INCH THICKNESS REMAINING) TO BOTH SIDES, FOR (2) UP TO 3 INCH HIGH X UP TO 5 INCH LONG WITH 1 1/4 INCH X 3/4 INCH AREA OF 100% SECTION LOSS |

Span 1 Beam 1: (PAR) TAPERED CORROSION WITH SECTION LOSS TO TOP FLANGE (WITH AREAS OF UP TO 100% SECTION LOSS) DOWN TO 1/8 INCH AVERAGE THICKNESS REMAINING AT EDGE FOR FULL WIDTH X FULL LENGTH AND WEB SECTION LOSS (DOWN TO 1/16 INCH THICKNESS REMAINING) TO BOTH SIDES, FOR (2) UP TO 3 INCH HIGH X UP TO 5 INCH LONG WITH 1 1/4 INCH X 3/4 INCH AREA OF 100% SECTION LOSS

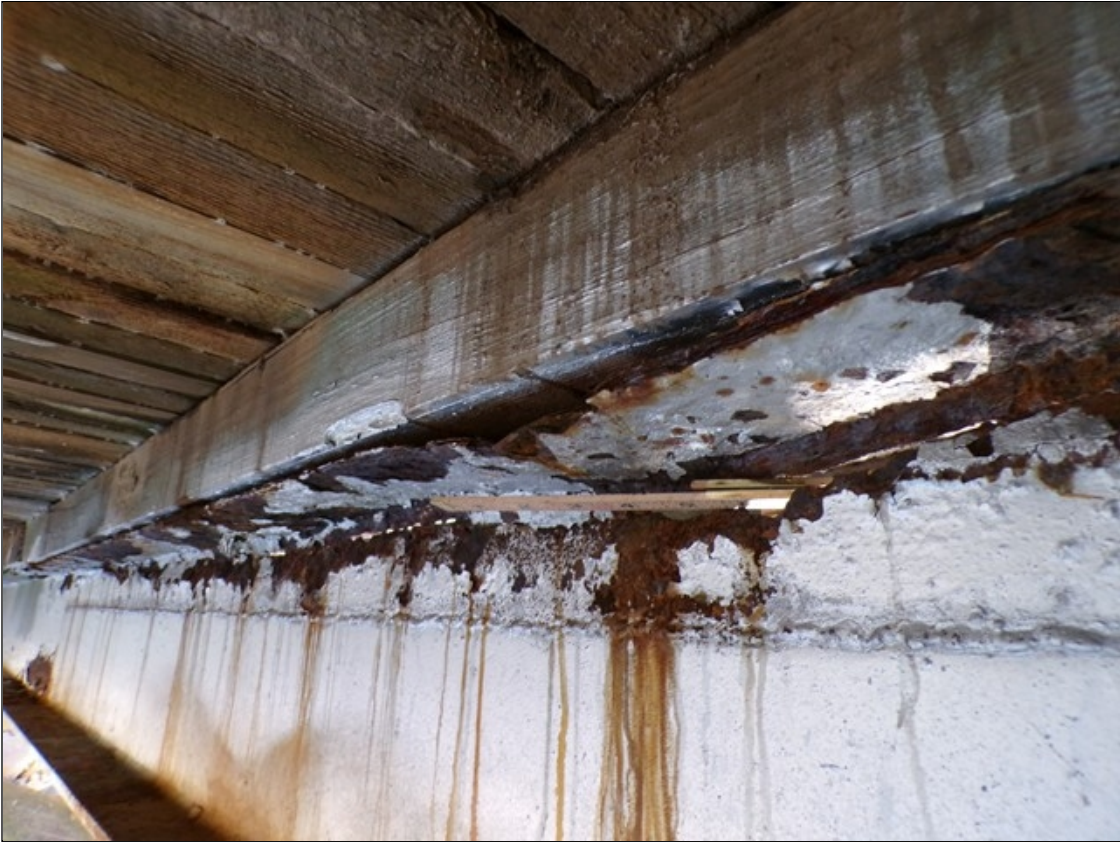
| 4 | Corrosion | 6 | SPAN 1 Beam 2: (PAR) STARTING 10 FEET FROM END BENT 1, AT 6 FEET REPAIR , UPPER WEB EXHIBITS HEAVY CORROSION (FOR 6 FEET LONG X UP TO 3 INCH HIGH) WITH RUSTED-THROUGH HOLES (HOLES ARE 21 INCH LONG X UP TO 2 INCH HIGH). THE AVERAGE SECTION REMAINING IS 0.09 INCH AND TOP FLANGE SECTION LOSS, FULL WIDTH X 3/16 INCH AVERAGE REMAINING WITH AREAS DOWN TO 1/16 INCH WITH 23 INCH X 3/4 INCH DEFLECTION ON TOP FLANGE |

Span 1 Beam 2: (PAR) STARTING 10 FEET FROM END BENT 1, AT 6 FEET REPAIR , UPPER WEB EXHIBITS HEAVY CORROSION (FOR 6 FEET LONG X UP TO 3 INCH HIGH) WITH RUSTED-THROUGH HOLES (HOLES ARE 21 INCH LONG X UP TO 2 INCH HIGH). THE AVERAGE SECTION REMAINING IS 0.09 INCH AND TOP FLANGE SECTION LOSS, FULL WIDTH X  $\frac{3}{16}$  INCH AVERAGE REMAINING WITH AREAS DOWN TO  $\frac{1}{16}$  INCH WITH 23 INCH X  $\frac{3}{4}$  INCH DEFLECTION ON TOP FLANGE

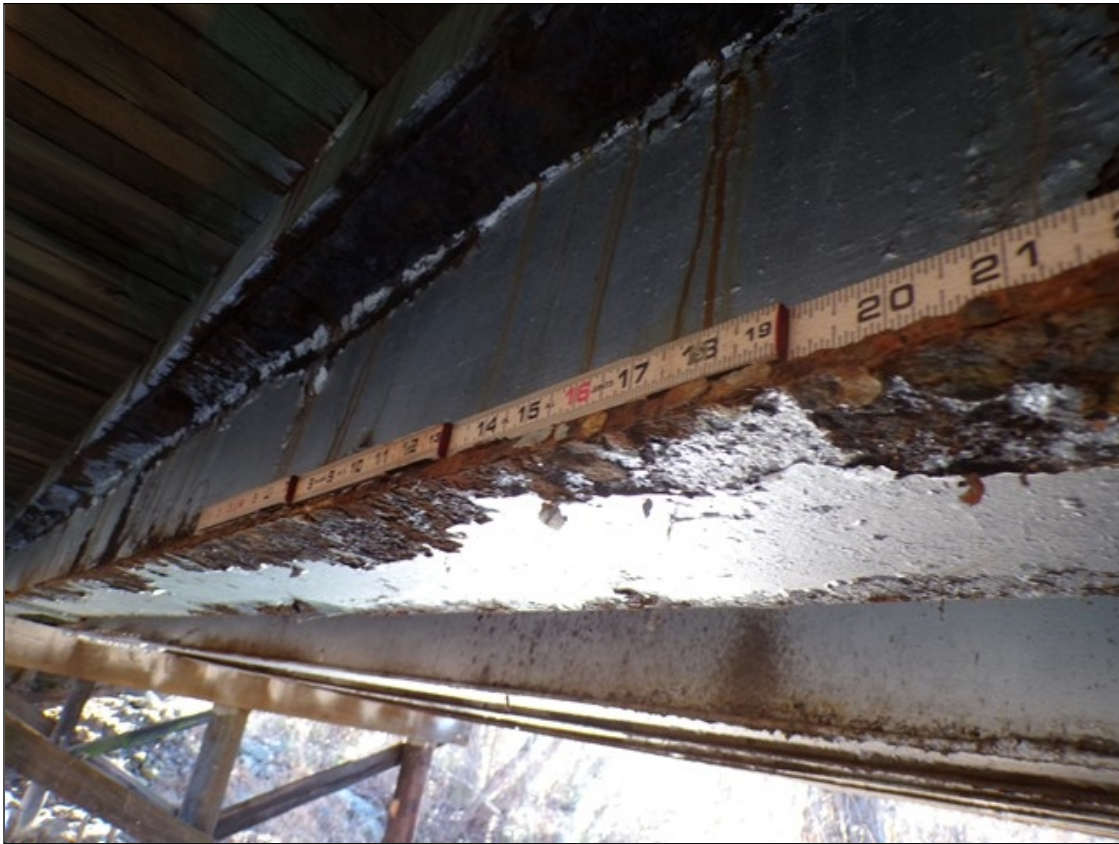
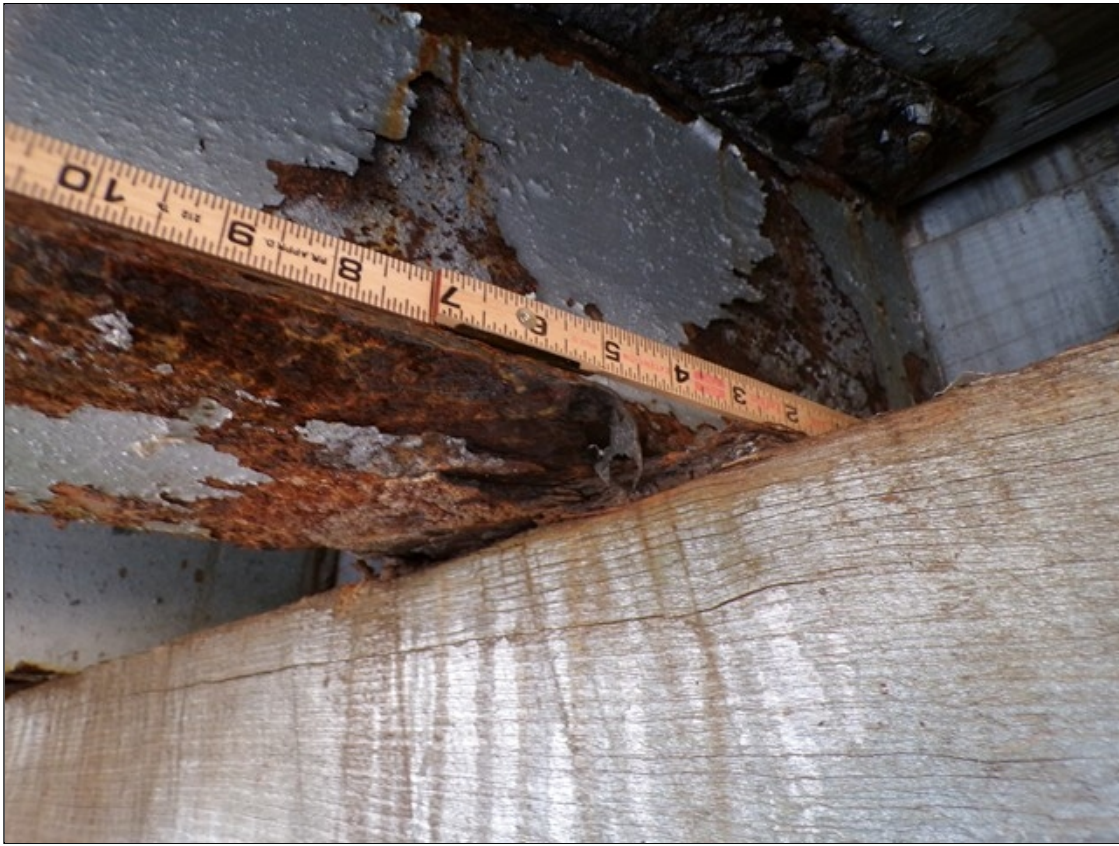
| 2 | Corrosion | 10 | SPAN 1 Beam 2: (PAR) AT NEAR END (FOR 10 FEET LONG), CORROSION WITH SECTION LOSS TO BOTTOM FLANGE (DOWN TO 1/4 INCH THICKNESS REMAINING) TO BOTH SIDES FOR 3 INCH WIDE WITH (2) UP TO 3 INCH X 1 1/2 INCH AREA OF 100% SECTION LOSS |

SPAN 1 Beam 2: (PAR) AT NEAR END (FOR 10 FEET LONG), CORROSION WITH SECTION LOSS TO BOTTOM FLANGE (DOWN TO 1/4 INCH THICKNESS REMAINING) TO BOTH SIDES FOR 3 INCH WIDE WITH (2) UP TO 3 INCH X 1 1/2 INCH AREA OF 100% SECTION LOSS

Span 1 Beam 2: (PAR) AT NEAR END (FOR 10 FEET LONG), CORROSION WITH SECTION LOSS TO BOTTOM FLANGE (DOWN TO 1/4 INCH THICKNESS REMAINING) WITH (2) UP TO 3 INCH X 1 1/2 INCH AREA OF 100% SECTION LOSS TO BOTH SIDES FOR 3 INCH WIDE

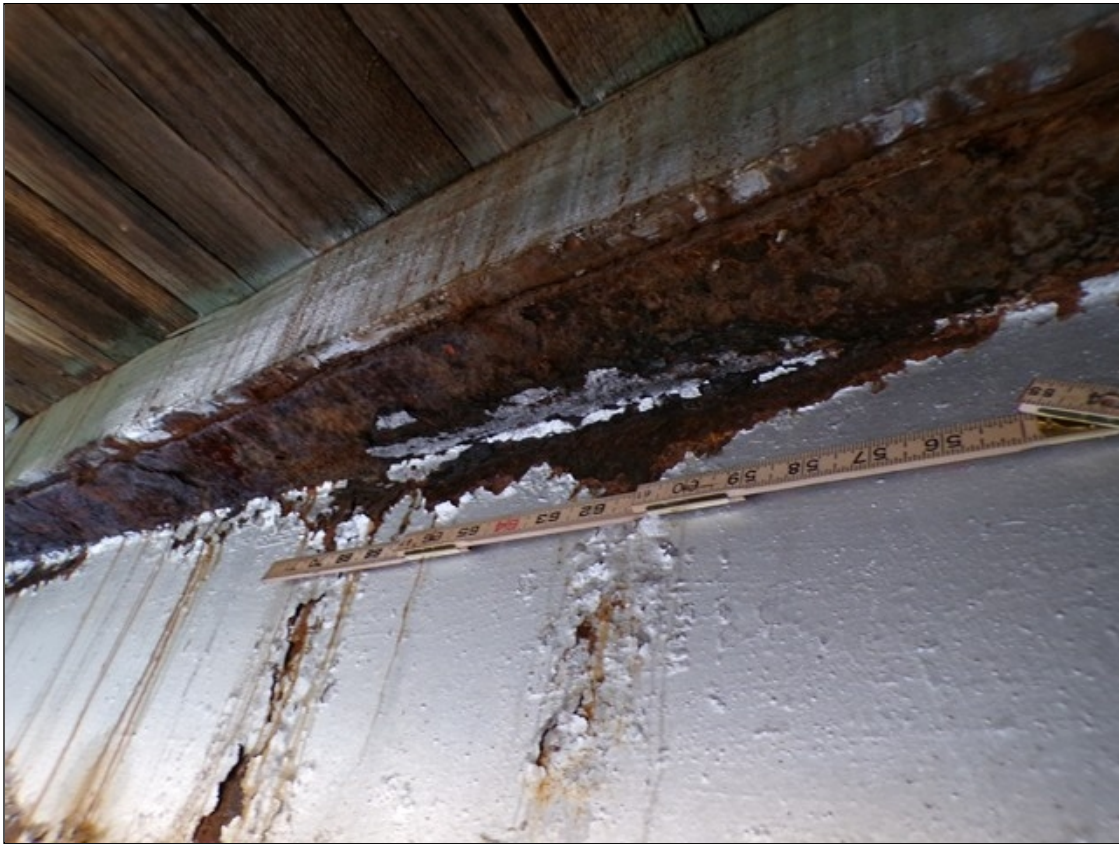
| 2 | Corrosion | 20 | SPAN 1 Beam 2: (PAR) AT NEAR END, TAPERED CORROSION WITH SECTION LOSS TO TOP FLANGE (DOWN TO 1/8 INCH AVERAGE THICKNESS REMAINING AT EDGE) FOR FULL WIDTH X 20 FEET, AND STARTING AT NEAR END, UPPER WEB SECTION LOSS (1/16 INCH AVERAGE THICKNESS REMAINING) FOR 2 INCH HIGH X 11 FEET LONG |

Span 1 Beam 2: (PAR) AT NEAR END, TAPERED CORROSION WITH SECTION LOSS TO TOP FLANGE (DOWN TO 1/8 INCH AVERAGE THICKNESS REMAINING AT EDGE) FOR FULL WIDTH X 20 FEET, AND STARTING AT NEAR END, UPPER WEB SECTION LOSS (1/16 INCH AVERAGE THICKNESS REMAINING) FOR 2 INCH HIGH X 11 FEET LONG

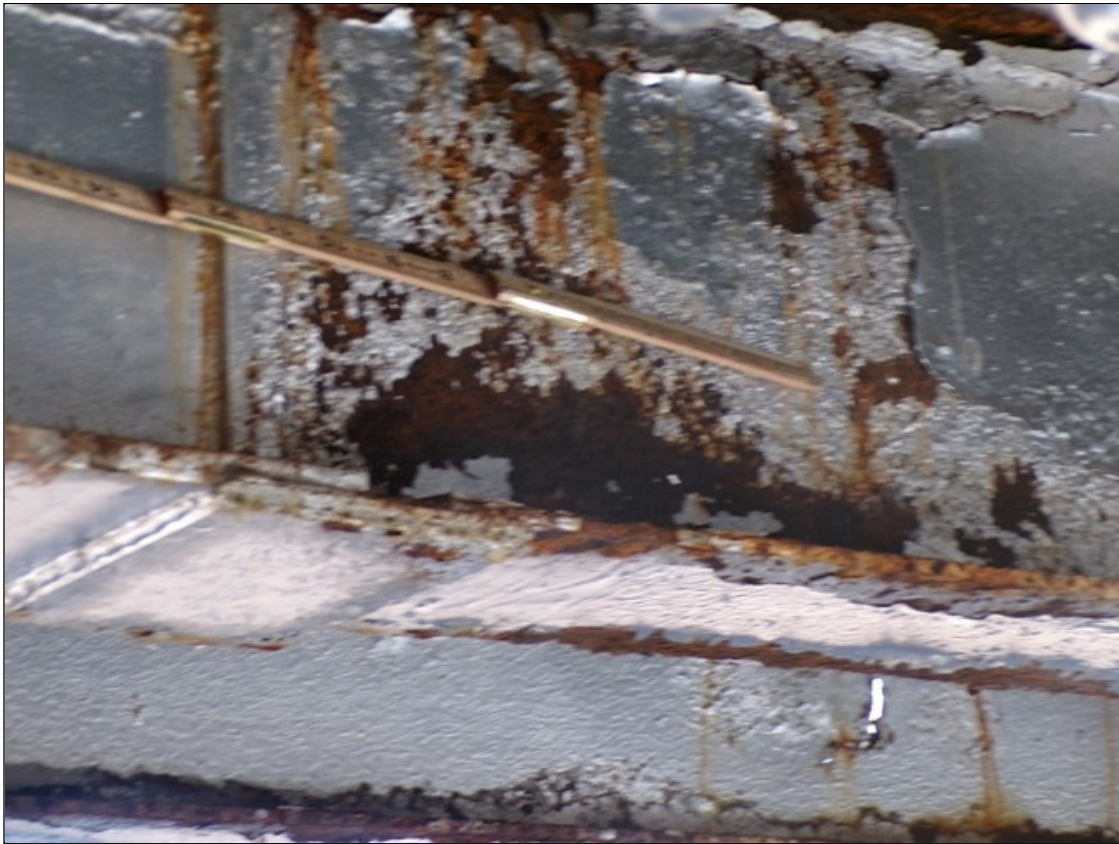
| 2 | Corrosion | 4 | SPAN 1 Beam 2: (PAR) 6 FEET FROM BENT 1, CORROSION WITH SECTION LOSS TO BOTTOM FLANGE (DOWN TO 0.15 INCH THICKNESS REMAINING) FOR FULL WIDTH X 4 FEET LONG, AND WEB SECTION LOSS (DOWN TO 1/8 INCH THICKNESS REMAINING) AT BOTH SIDES AND FOR FULL HEIGHT WITH CORROSION HOLE, 6 INCH X 1 INCH |

Span 1 Beam 2: (PAR) 6 FEET FROM BENT 1, CORROSION WITH SECTION LOSS TO BOTTOM FLANGE (DOWN TO 0.15 INCH THICKNESS REMAINING) FOR FULL WIDTH X 4 FEET LONG, AND WEB SECTION LOSS (DOWN TO 1/8 INCH THICKNESS REMAINING) AT BOTH SIDES AND FOR FULL HEIGHT WITH CORROSION HOLE, 6 INCH X 1 INCH

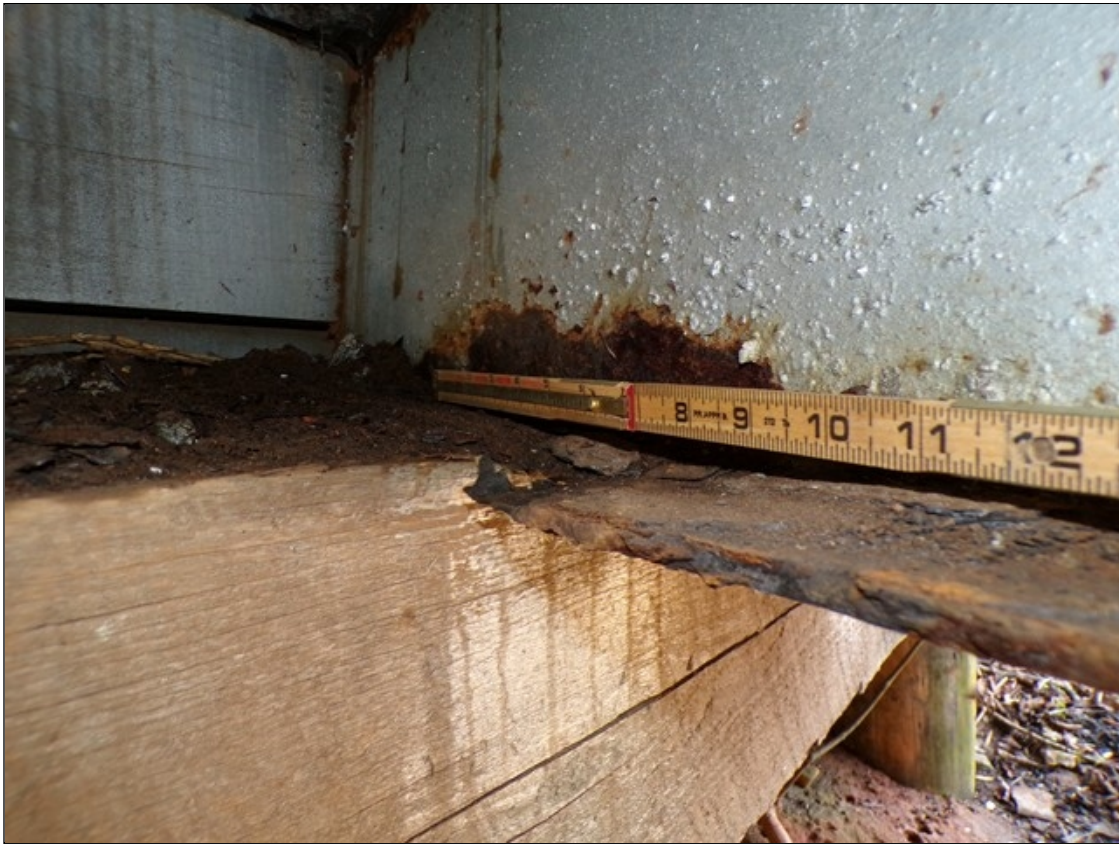
| 3 | Corrosion | 1 | SPAN 1 Beam 3: 5 INCH X 1 1/2 INCH DOWNWARD DEFLECTION WITH 9 INCH X FULL WIDTH AREA OF SECTION LOSS WITH KNIFE EDGE REMAINING AND 1 1/2 INCH X 1 INCH AREA OF 100% SECTION LOSS ON BOTH FLANGES AT END BENT 1 (PAR) |

SPAN 1 Beam 3: 5 INCH X 1 1/2 INCH DOWNWARD DEFLECTION WITH 9 INCH X FULL WIDTH AREA OF SECTION LOSS WITH KNIFE EDGE REMAINING AND 1 1/2 INCH X 1 INCH AREA OF 100% SECTION LOSS ON BOTH FLANGES AT END BENT 1 (PAR)

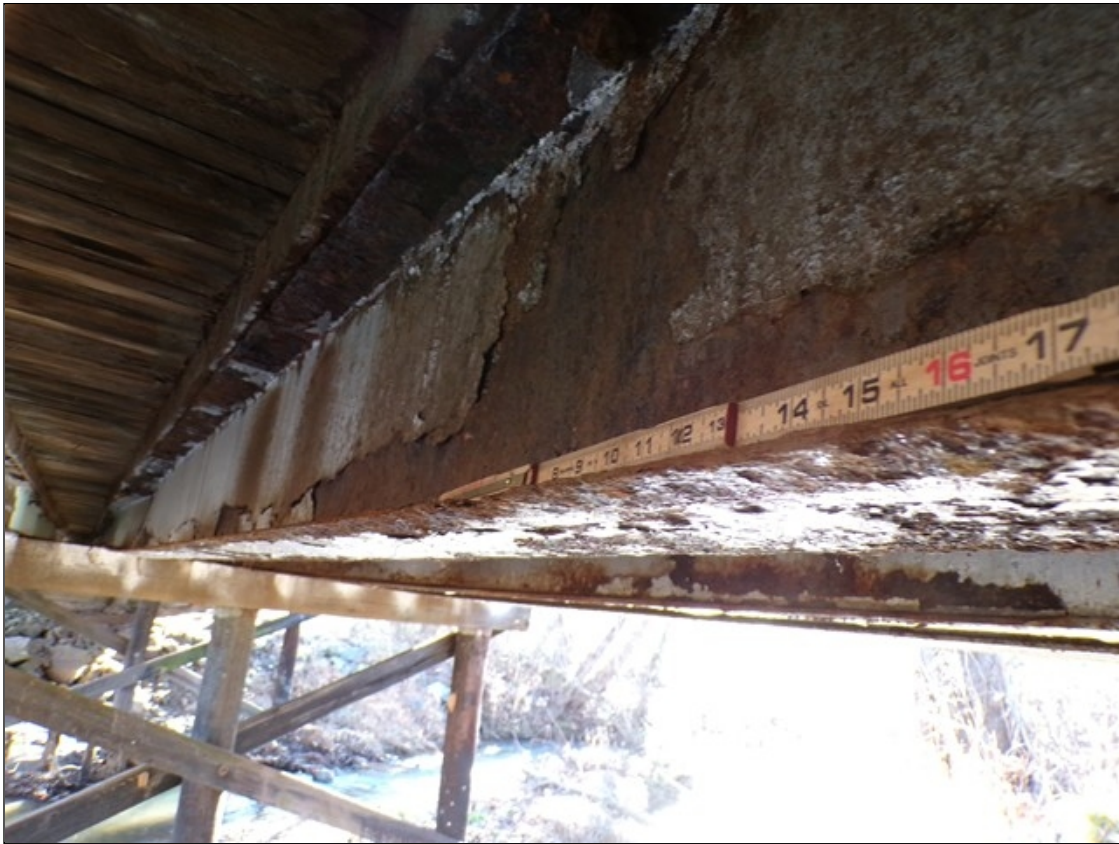
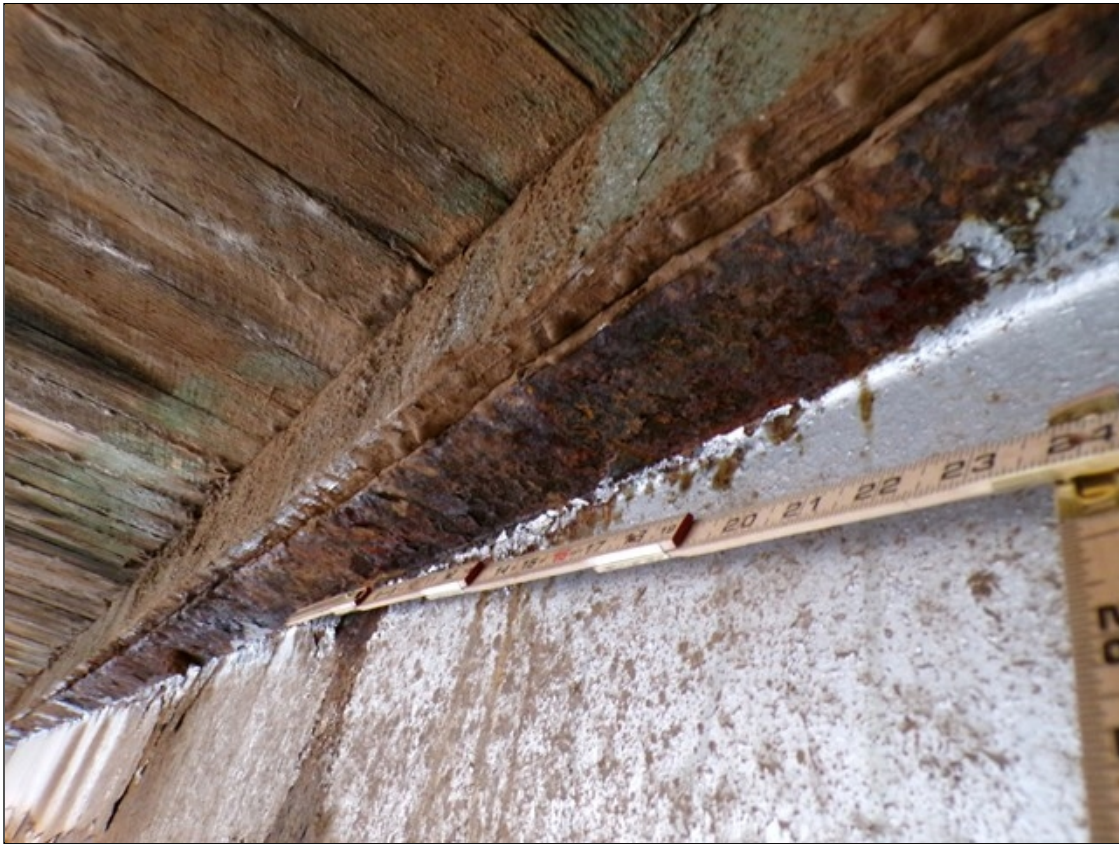
| Priority Level | Defect Type | Quantity | Defect Description |
|---|---|---|---|
| 2 | Corrosion | 14 | SPAN 1 Beam 4: (PAR) BEGINNING NEAR END, CORROSION WITH SECTION LOSS TO TOP FLANGE (1/8 INCH AVERAGE THICKNESS REMAINING) 3 INCH WIDE TO LEFT SIDE, AND 2 INCH WIDE TO RIGHT SIDE, BOTTOM FLANGE (DOWN TO KNIFE'S EDGE THICKNESS REMAINING ON BOTH SIDES WITH 0.12 INCH AVERAGE REMAINING) |

SPAN 1 Beam 4: (PAR) BEGINNING NEAR END, CORROSION WITH SECTION LOSS TO TOP FLANGE (1/8 INCH AVERAGE THICKNESS REMAINING) 3 INCH WIDE TO LEFT SIDE, AND 2 INCH WIDE TO RIGHT SIDE, BOTTOM FLANGE (DOWN TO KNIFE'S EDGE THICKNESS REMAINING ON BOTH SIDES WITH 0.12 INCH AVERAGE REMAINING)

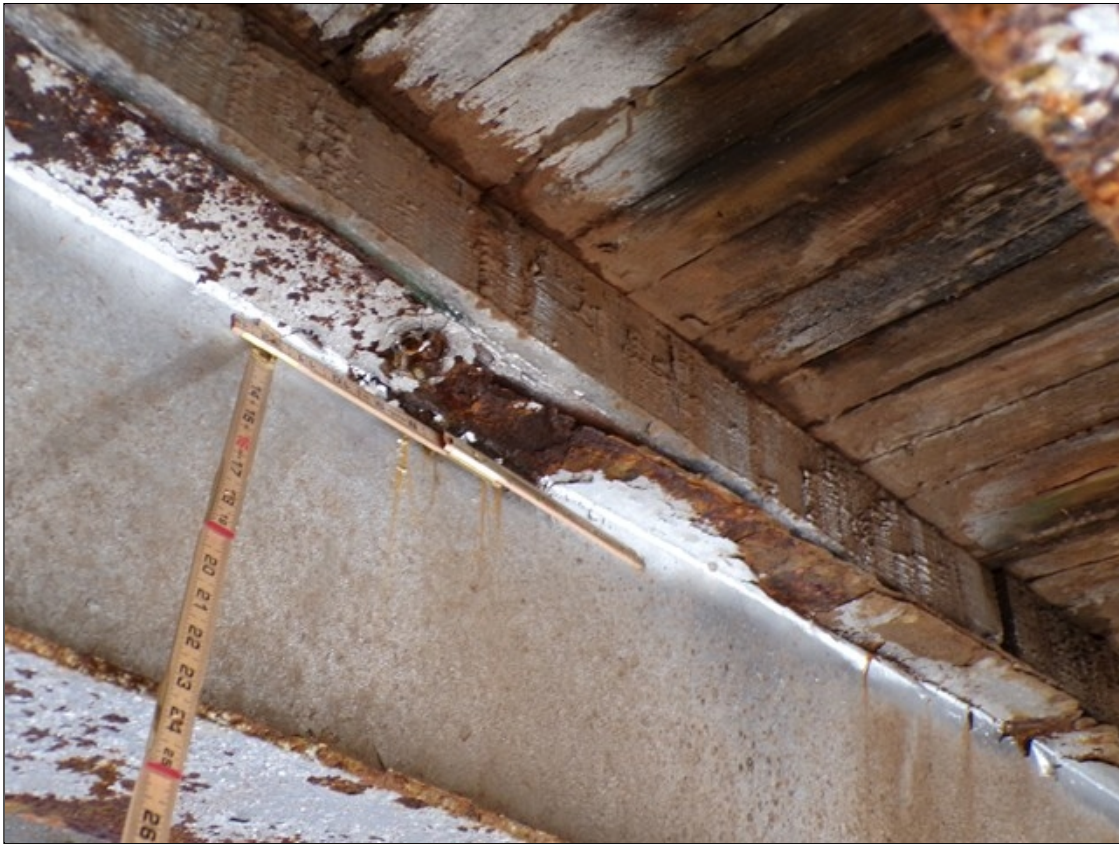
| Priority Level | Defect Type | Quantity | Defect Description |
|---|---|---|---|
| 2 | Corrosion | 8 | SPAN 1 Beam 4: (PAR) 6 FEET FROM FAR END, TAPERED CORROSION, 8 FEET LONG X DOWN TO KNIFE'S EDGE WITH AREAS OF COMPLETE SECTION LOSS ON LEFT FLANGE AT BOLT, 3 INCH DIAMETER AREA WITH SECTION LOSS TO BOLT (1/8 INCH AVERAGE REMAINING). BOTTOM WEB CORROSION, 4 INCH HIGH 1/8 INCH REMAINING AND BOTTOM FLANGE SECTION LOSS, FULL WIDTH X 0.21 INCH REMAINING |

Span 1 Beam 4: (PAR) 6 FEET FROM FAR END, TAPERED CORROSION, 8 FEET LONG X DOWN TO KNIFE'S EDGE WITH AREAS OF COMPLETE SECTION LOSS ON LEFT FLANGE AT BOLT, 3 INCH DIAMETER AREA WITH SECTION LOSS TO BOLT (1/8 INCH AVERAGE REMAINING). BOTTOM WEB CORROSION, 4 INCH HIGH 1/8 INCH REMAINING AND BOTTOM FLANGE SECTION LOSS, FULL WIDTH X 0.21 INCH REMAINING

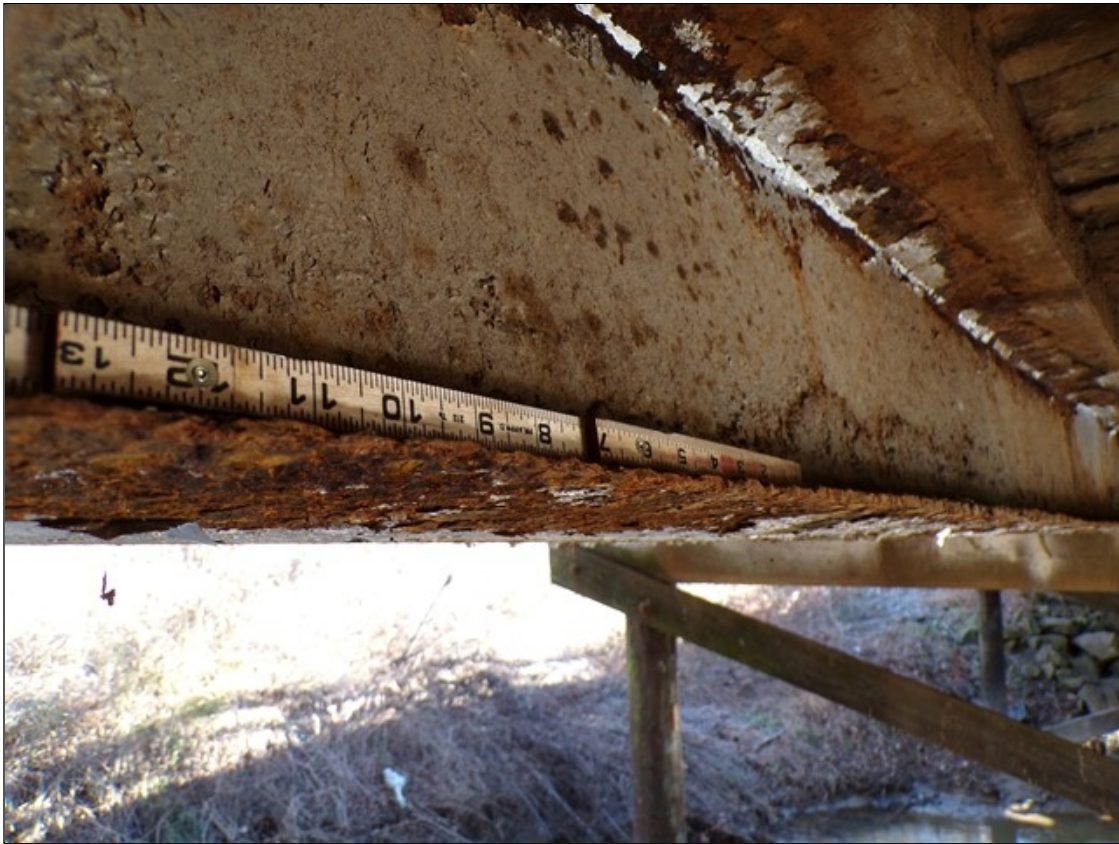
| Priority Level | Defect Type | Quantity | Defect Description |
|---|---|---|---|
| 2 | Corrosion | 20 | SPAN 1 Beam 5: (PAR) CORROSION WITH SECTION LOSS TO BOTTOM FLANGE (WITH AREAS OF DOWN TO KNIFE'S EDGE REMAINING) WITH 0.15 INCH AVERAGE THICKNESS REMAINING TO BOTH SIDES, FOR 3 INCH WIDE X 20 FEET LONG |

Span 1 Beam 5: (PAR) CORROSION WITH SECTION LOSS TO BOTTOM FLANGE (WITH AREAS OF DOWN TO KNIFE'S EDGE REMAINING) WITH 0.15 INCH AVERAGE THICKNESS REMAINING TO BOTH SIDES, FOR 3 INCH WIDE X 20 FEET LONG

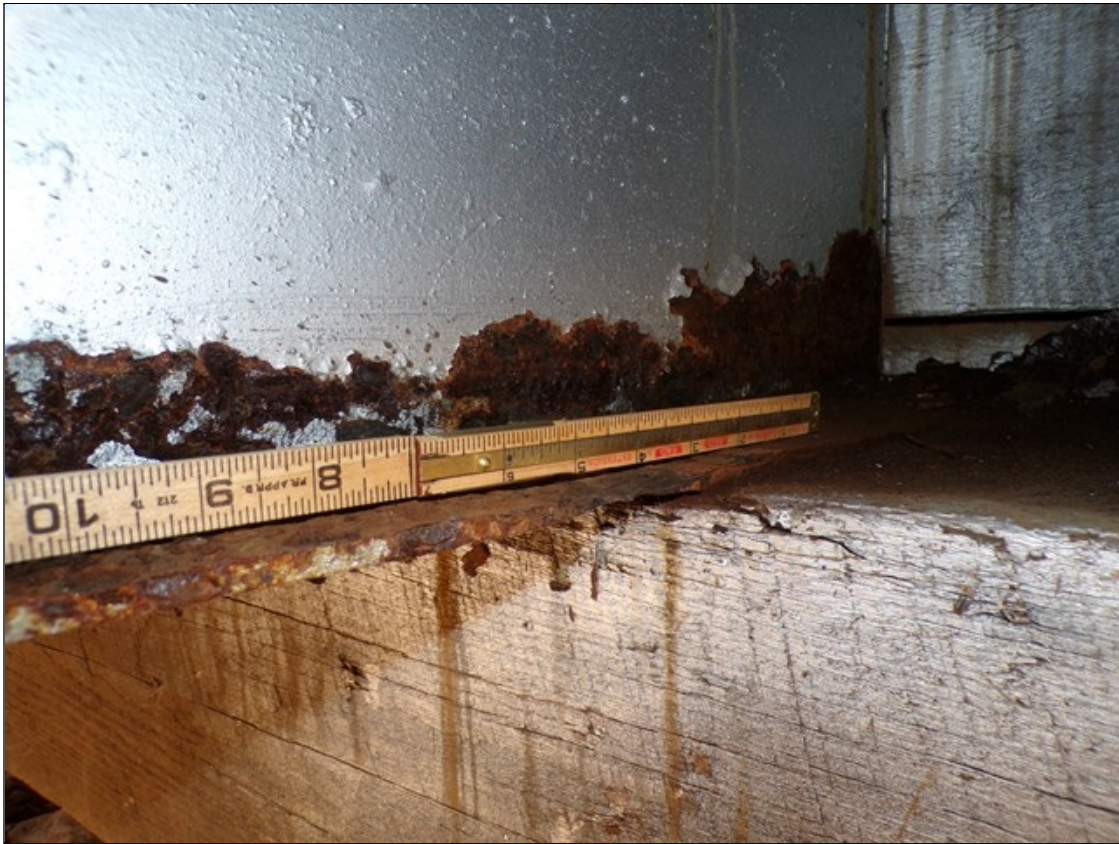
| Priority Level | Defect Type | Quantity | Defect Description |
|---|---|---|---|
| 2 | Corrosion | 2 | SPAN 1 Beam 6: (PAR) AT NEAR END, CORROSION WITH SECTION LOSS, BOTTOM FLANGE FOR FULL WIDTH X 14 INCH LONG, DOWN TO 1/16 INCH THICKNESS REMAINING |

Span 1 Beam 6: (PAR) AT NEAR END, CORROSION WITH SECTION LOSS, BOTTOM FLANGE FOR FULL WIDTH X 14 INCH LONG, DOWN TO 1/16 INCH THICKNESS REMAINING

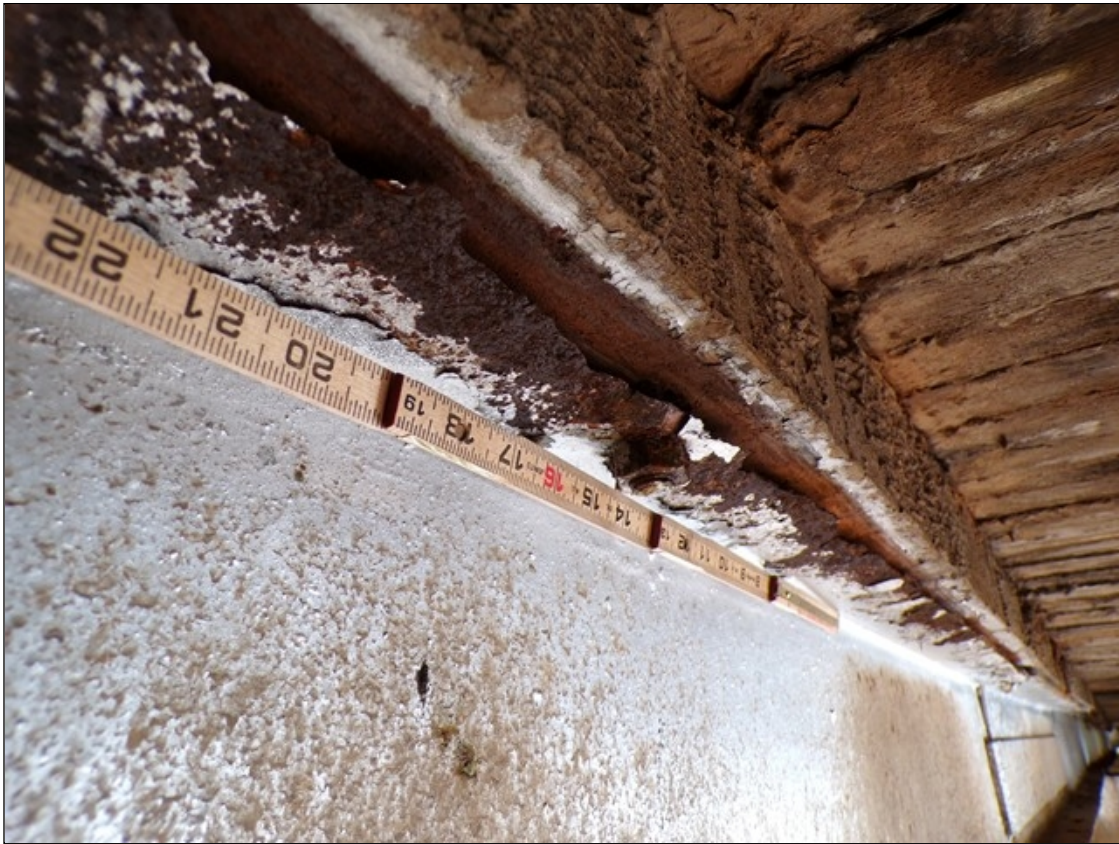
| Priority Level | Defect Type | Quantity | Defect Description |
|---|---|---|---|
| 2 | Corrosion | 17 | SPAN 1 Beam 6: (PAR) TOP FLANGE TAPERED CORROSION WITH SECTION LOSS BEGINNING AT NEAR END, 1/8 AVERAGE REMAINING DOWN TO KNIFE'S EDGE X FULL WIDTH X 17 FEET (WITH AREAS OF 100% SECTION LOSS 2 FEET X 1/2 INCH WIDE |

Span 1 Beam 6: (PAR) TOP FLANGE TAPERED CORROSION WITH SECTION LOSS BEGINNING AT NEAR END,  
1/8 AVERAGE REMAINING DOWN TO KNIFE'S EDGE X FULL WIDTH X 17 FEET (WITH AREAS OF 100%  
SECTION LOSS 2 FEET X 1/2 INCH WIDE

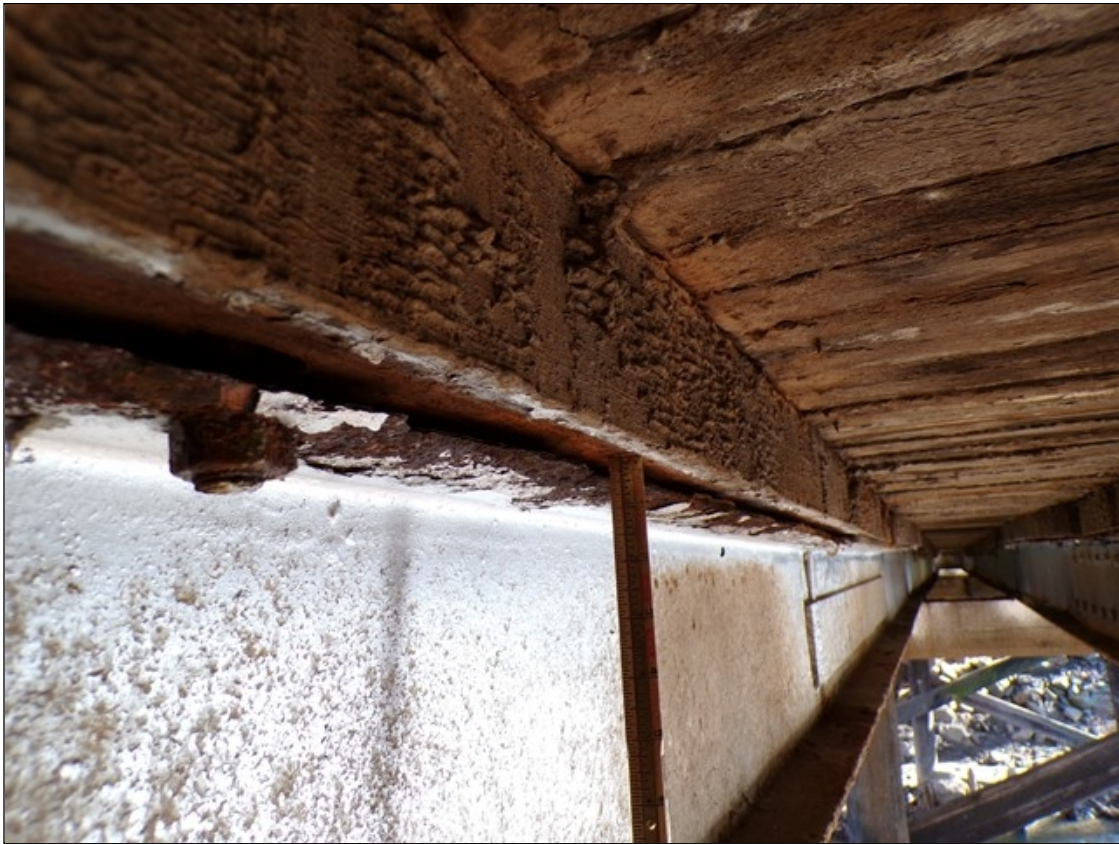
Span 1 Beam 6: (PAR) BEAM SAGGING UP TO 1 INCH FOR FULL LENGTH
