NC DEPARTMENT OF TRANSPORTATION  
DIVISION OF HIGHWAYS  
STRUCTURE MANAGEMENT UNIT  
COUNTY: RUTHERFORD DIV: 13

## Structure Safety Inspection Report

BRIDGE NUMBER: 800239 BRIDGE NAME: \_\_\_\_\_ PREVIOUS BRIDGE NUMBER: \_\_\_\_\_

LATITUDE: 35.48940000 LONGITUDE: -81.99338000 ROUTE: SR1325 M.P.: 0.0

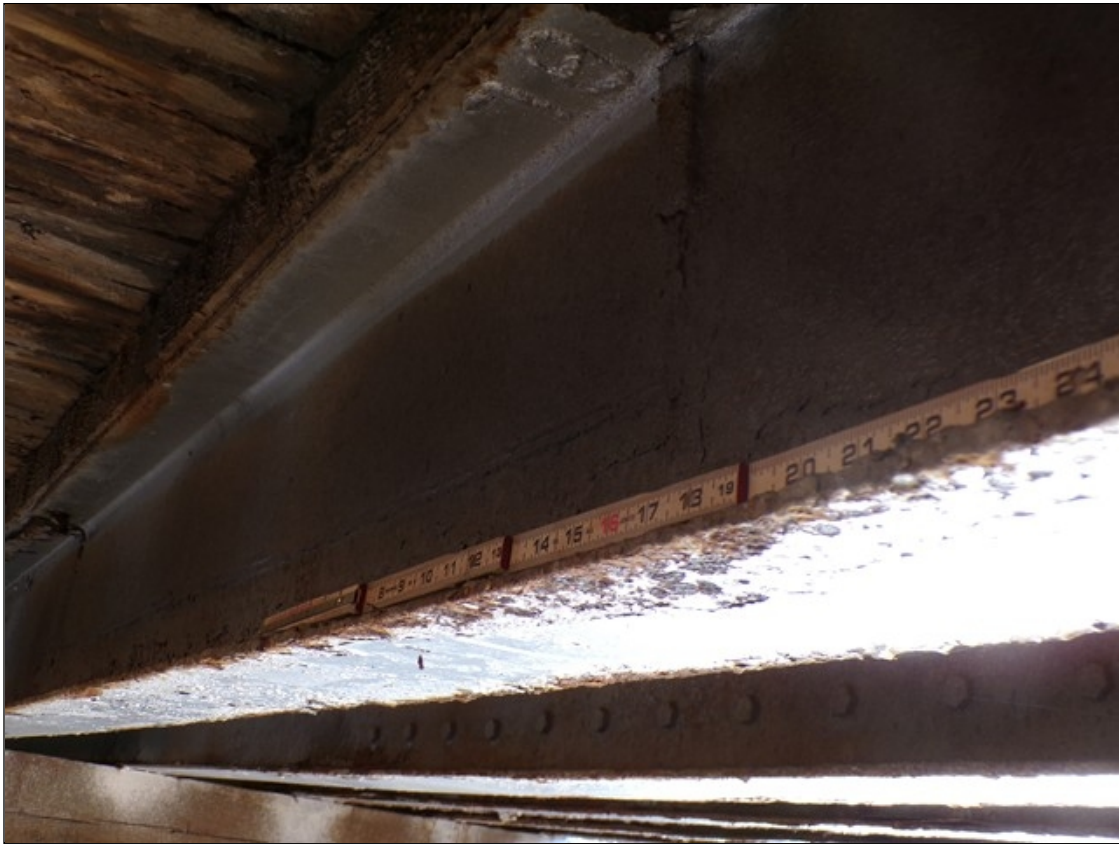
| Priority Level | Defect Type | Quantity | Defect Description |
|---|---|---|---|
| 1 | Corrosion | 12 | SPAN 1 Beam 6: (PAR) 12 FEET FROM NEAR END, BOTTOM FLANGE CORROSION WITH SECTION LOSS (DOWN TO 0.18 INCH THICKNESS REMAINING) TO BOTH SIDES, 2.5 INCH WIDE X 8 FEET LONG ON RIGHT SIDE AND 2.5 INCH WIDE X 12 FEET LONG ON LEFT SIDE. WEB CORROSION WITH SECTION LOSS AT BOTH FACES (2 INCH HIGH X DOWN TO 1/8 INCH THICKNESS REMAINING) |

Span 1 Beam 6: (PAR) 12 FEET FROM NEAR END, BOTTOM FLANGE CORROSION WITH SECTION LOSS (DOWN TO 0.18 INCH THICKNESS REMAINING) TO BOTH SIDES, 2.5 INCH WIDE X 8 FEET LONG ON RIGHT SIDE AND 2.5 INCH WIDE X 12 FEET LONG ON LEFT SIDE. WEB CORROSION WITH SECTION LOSS AT BOTH FACES (2 INCH HIGH X DOWN TO 1/8 INCH THICKNESS REMAINING)

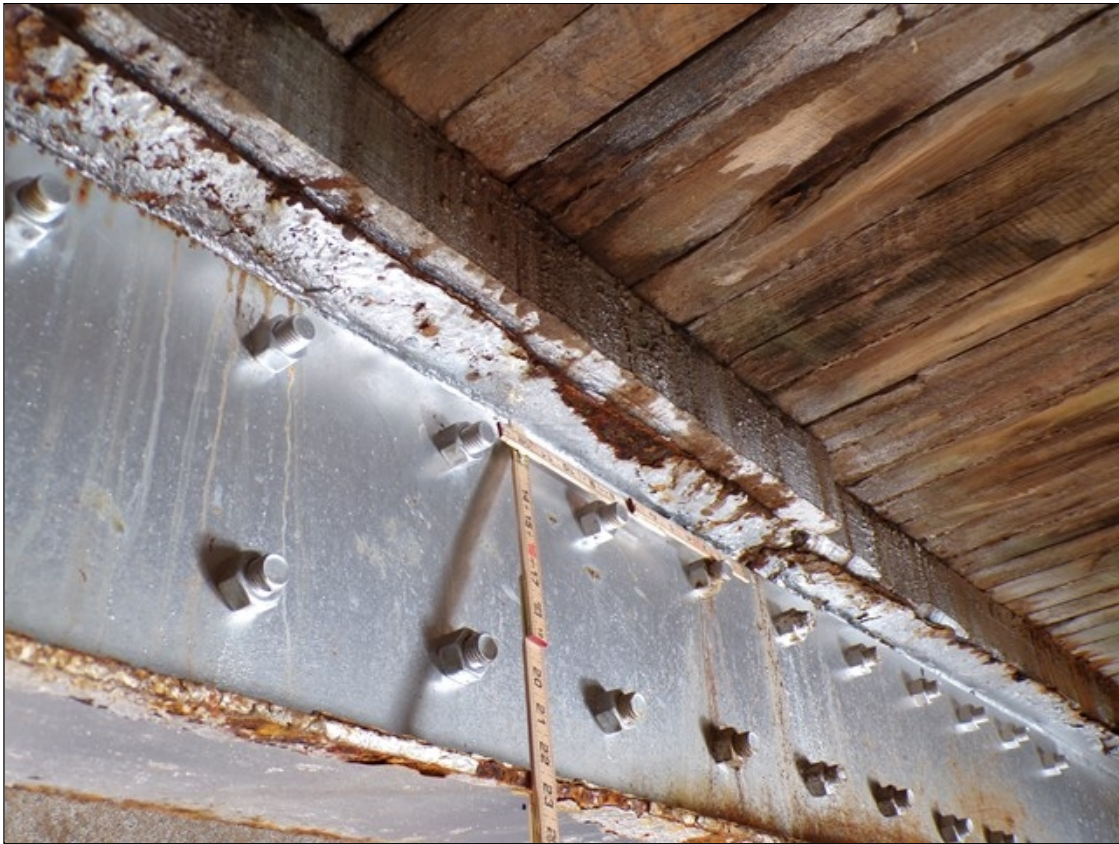
| Priority Level | Defect Type | Quantity | Defect Description |
|---|---|---|---|
| 2 | Corrosion | 12 | SPAN 1 Beam 7: (PAR) INTERMITTENT THROUGHOUT, TAPERED CORROSION WITH SECTION LOSS TOP FLANGE (12 FEET LONG X 1/2 INCH WIDE) WITH 1/8 INCH AVERAGE THICKNESS REMAINING AT EDGE AND WITH AREAS OF UP TO 100% SECTION LOSS X 3 FEET X 2 INCH, 8 FEET FROM BENT 1 |

Span 1 Beam 7: (PAR) INTERMITTENT THROUGHOUT, TAPERED CORROSION WITH SECTION LOSS TOP FLANGE (12 FEET LONG X 1/2 INCH WIDE) WITH 1/8 INCH AVERAGE THICKNESS REMAINING AT EDGE AND WITH AREAS OF UP TO 100% SECTION LOSS X 3 FEET X 2 INCH, 8 FEET FROM BENT 1

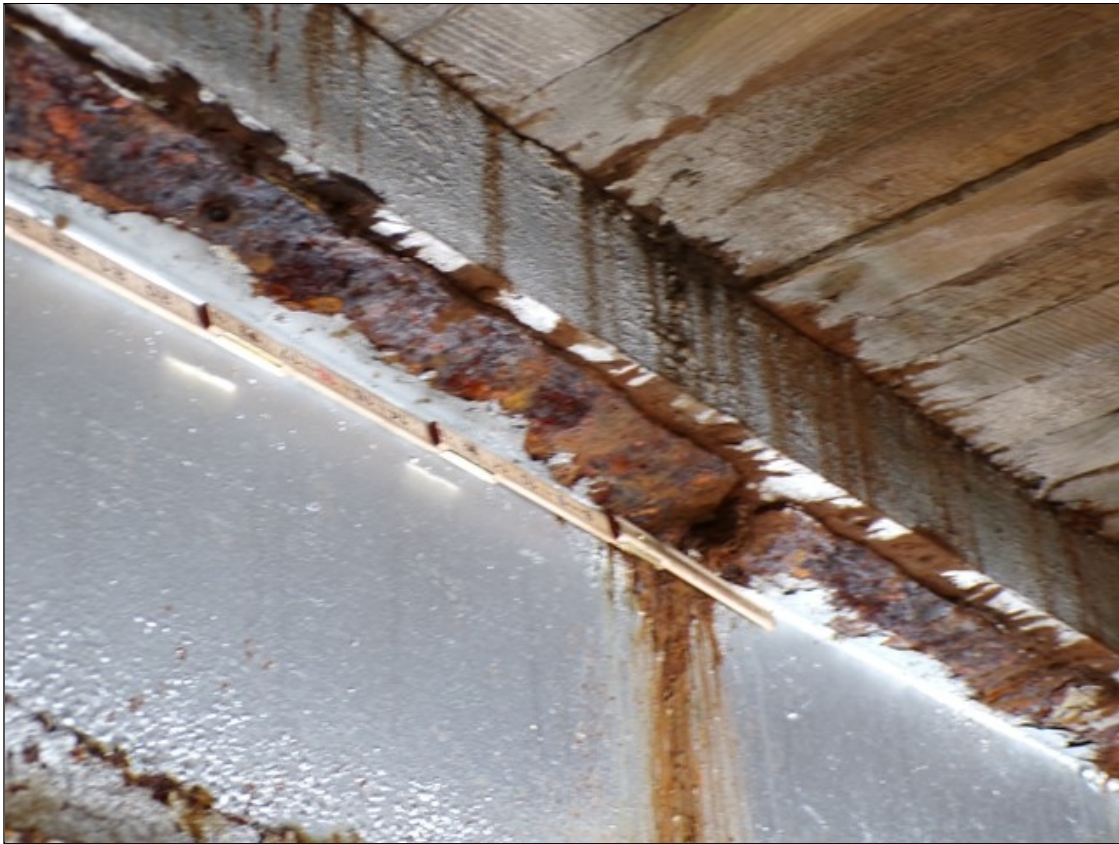
Span 1 Beam 8: (PAR) TOP FLANGE TAPERED CORROSION WITH SECTION LOSS 1/8 INCH AVERAGE REMAINING AT EDGE FULL WIDTH X FULL LENGTH (WITH (3) AREAS OF 100% SECTION LOSS X 32 INCH X 1 INCH SCATTERED THROUGHOUT)

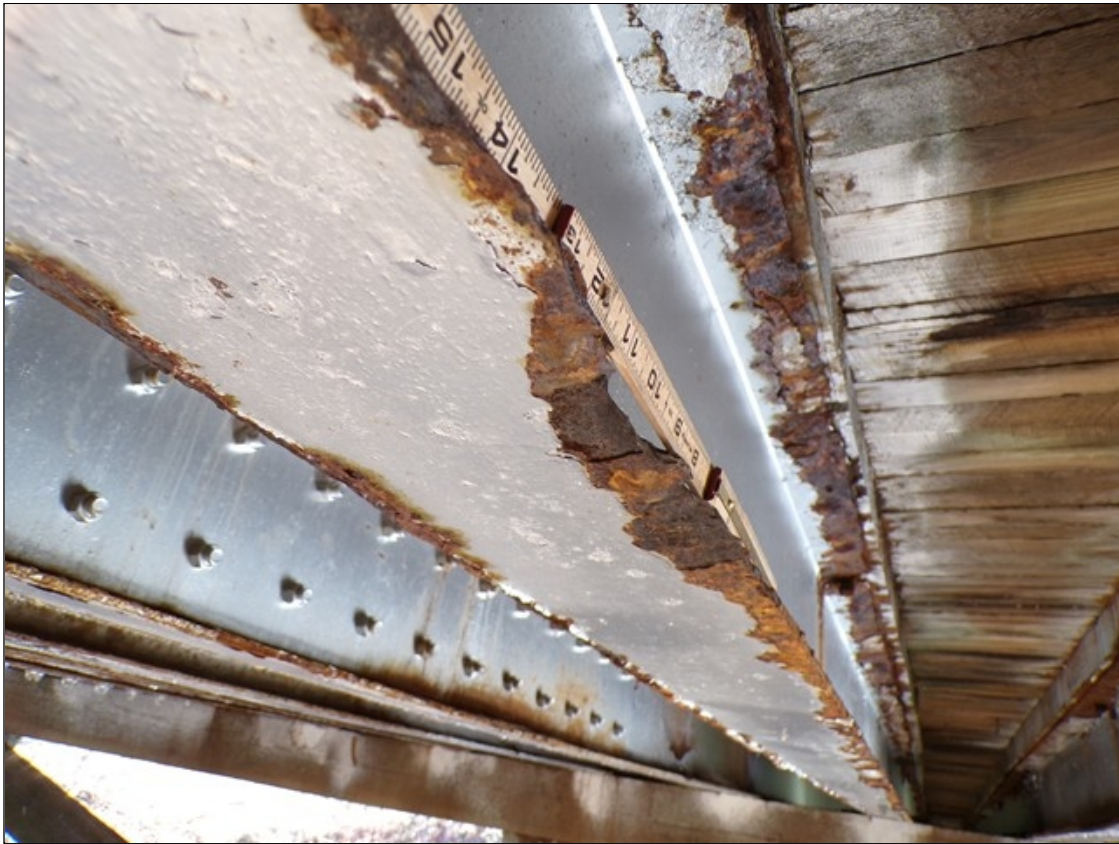
SPAN 1 Beam 8: (PAR) BEGINNING AT BENT 1, BOTTOM FLANGE CORROSION WITH SECTION LOSS (0.13 INCH THICKNESS X 2 INCH WIDE X 14 FEET LONG) UP TO KNIFE EDGE REMAINING AND 10 INCH X 1/2 INCH AREA OF 100% SECTION LOSS, LOWER WEB SECTION LOSS (FULL LENGTH X 3 INCH HIGH X 3/16 INCH REMAINING)

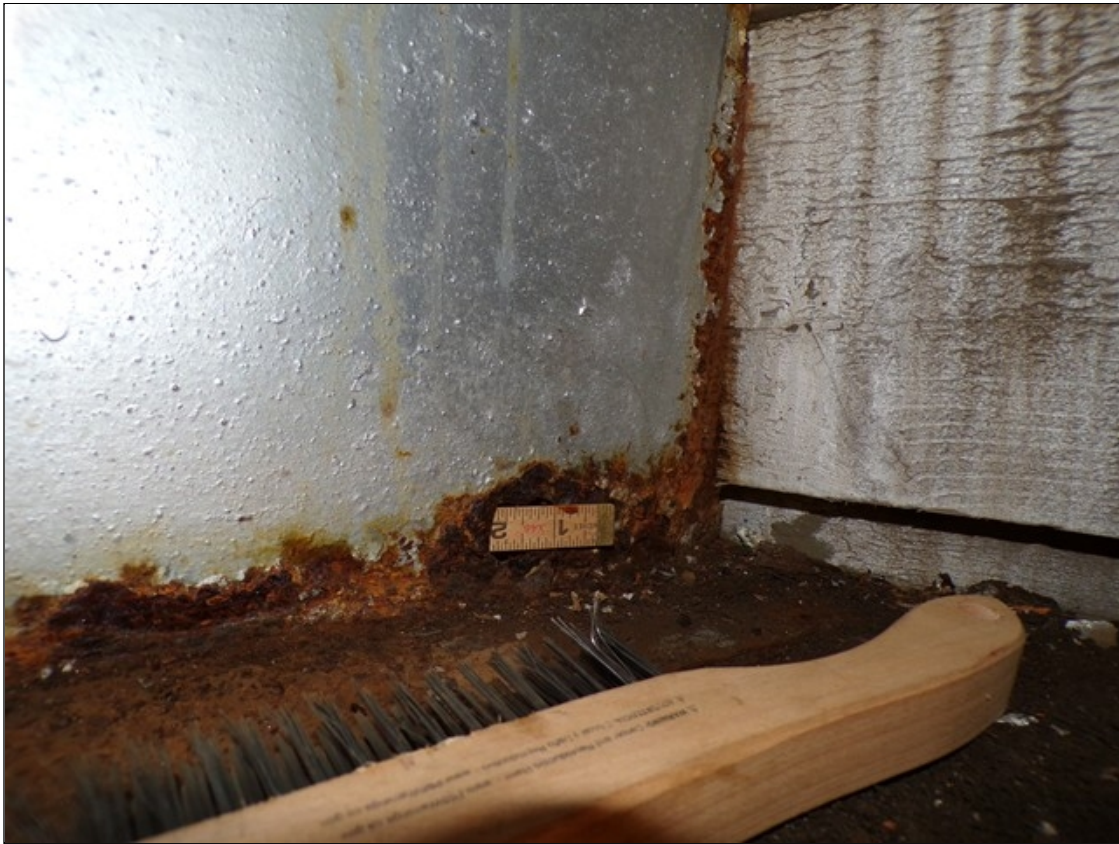
| Priority Level | Defect Type | Quantity | Defect Description |
|---|---|---|---|
| 3 | Corrosion | 26 | SPAN 1 Beam 8: (PAR) FULL LENGTH LOWER WEB CORROSION WITH SECTION LOSS, WITH 1/8 INCH AVERAGE THICKNESS REMAINING FOR 2 INCH HIGH X 16 INCH LONG. 2 INCH X 1 INCH HOLE PRESENT |

SPAN 1 Beam 8: (PAR) LOWER WEB FULL LENGTH CORROSION WITH SECTION LOSS, WITH 1/8 INCH AVERAGE THICKNESS REMAINING FOR 2 INCH HIGH X 16 INCH LONG. 2 INCH X 1 INCH HOLE PRESENT

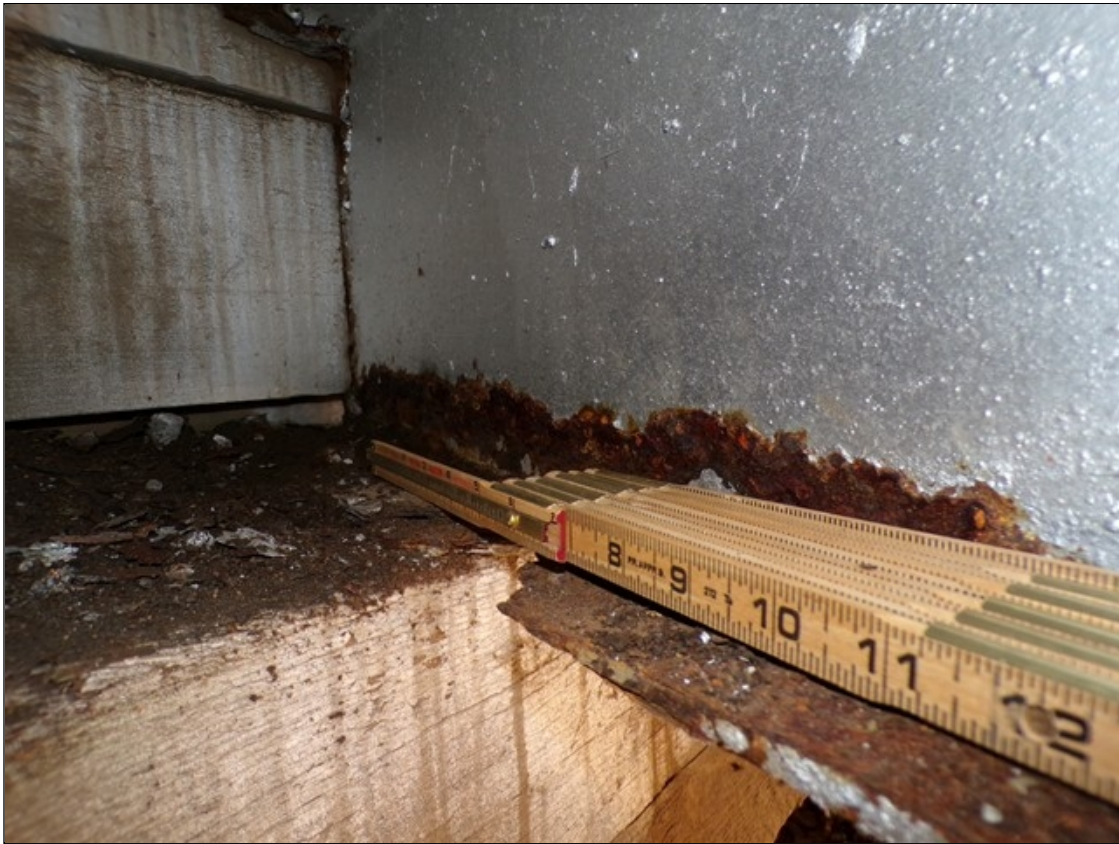
Span 1 Beam 8: (PAR) AT NEAR END, BOTTOM RIGHT FLANGE SECTION LOSS, 6 INCH X FULL WIDTH X KNIFE EDGE (WITH 100% SECTION LOSS 2.5 INCH LONG X 2 INCH WIDE) AND 6 INCH X 1 INCH X 1/4 INCH REMAINING ON LEFT SIDE

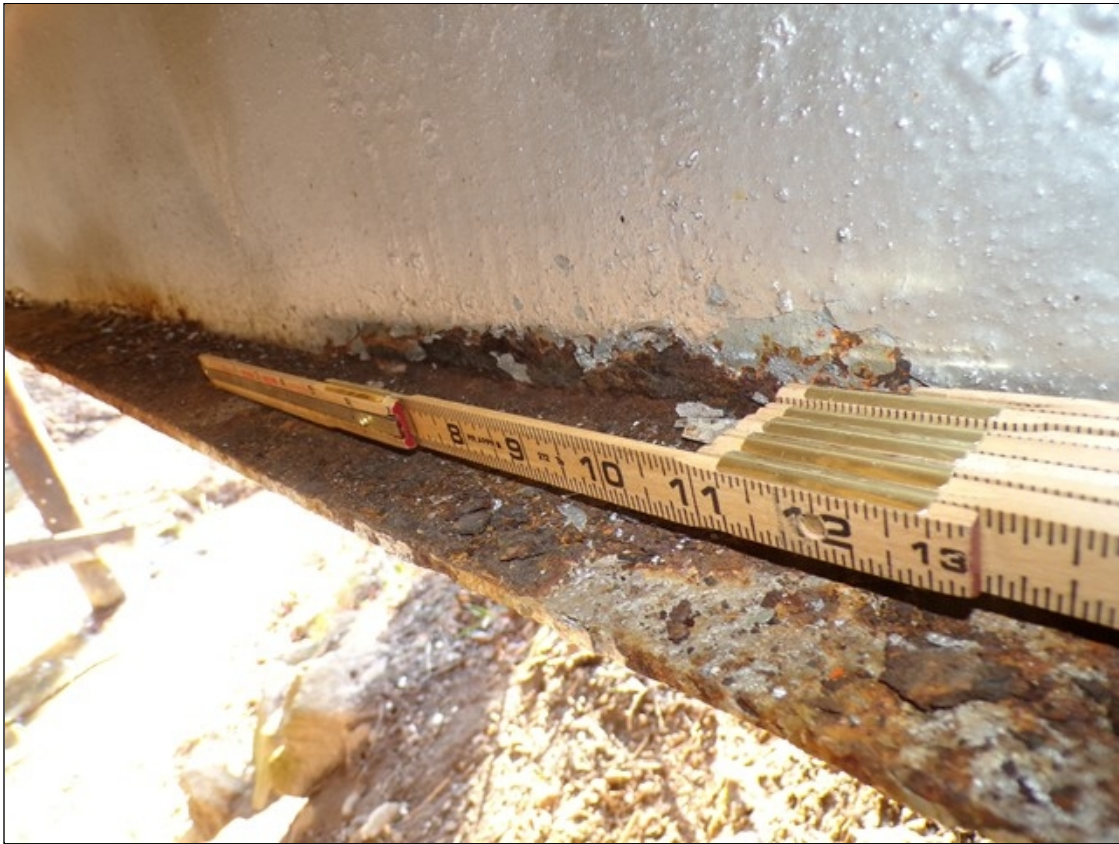
Span 1 Beam 9: (PAR) 2 FEET FROM NEAR END AT END OF WELDED REPAIR, BOTTOM FLANGE SECTION LOSS (0.19 INCH REMAINING) MISSALIGNED PLATE FOR FULL WIDTH WITH 1/8 INCH WIDE GAP FILLED WITH ONLY WELD MATERIAL

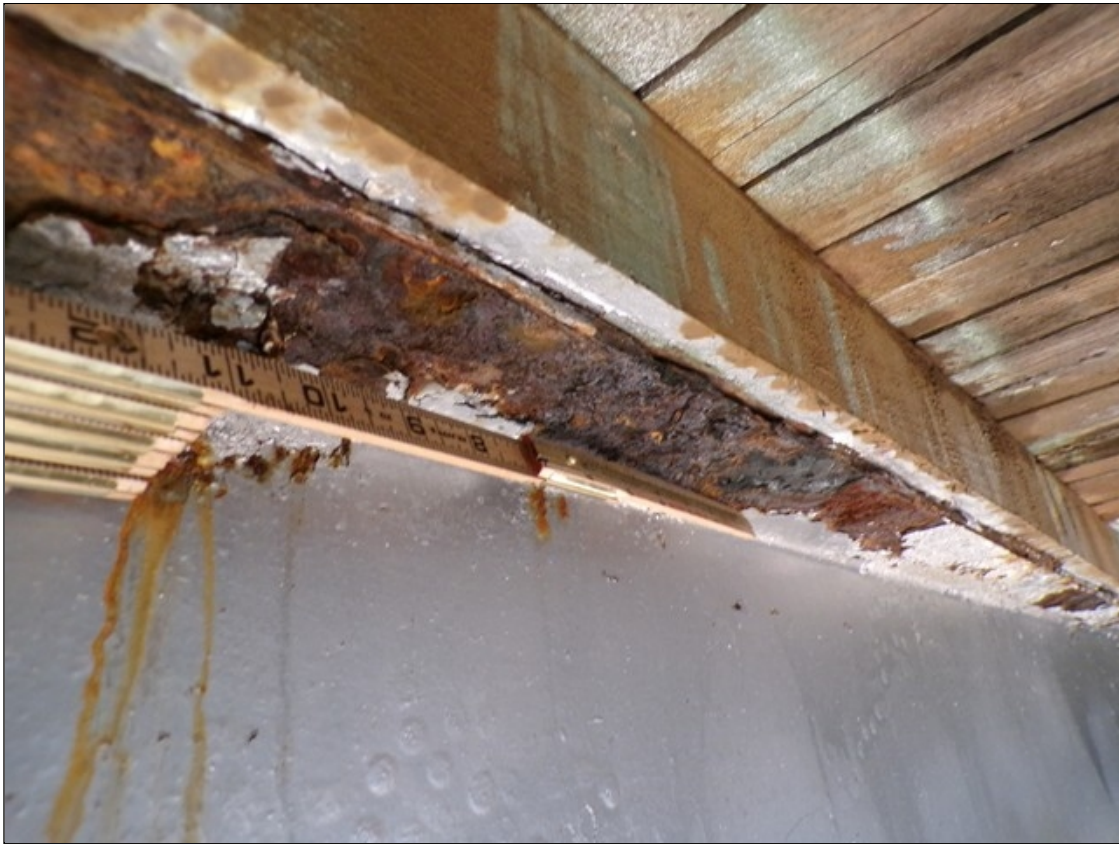
Span 1 Beam 9: (PAR) TAPERED CORROSION WITH SECTION LOSS TO TOP FLANGE (DOWN TO 1/8 INCH THICKNESS AVERAGE REMAINING WITH AREAS DOWN TO KNIFE'S EDGE) FOR FULL WIDTH AT BOTH SIDES INTERMITTENT THROUGHOUT

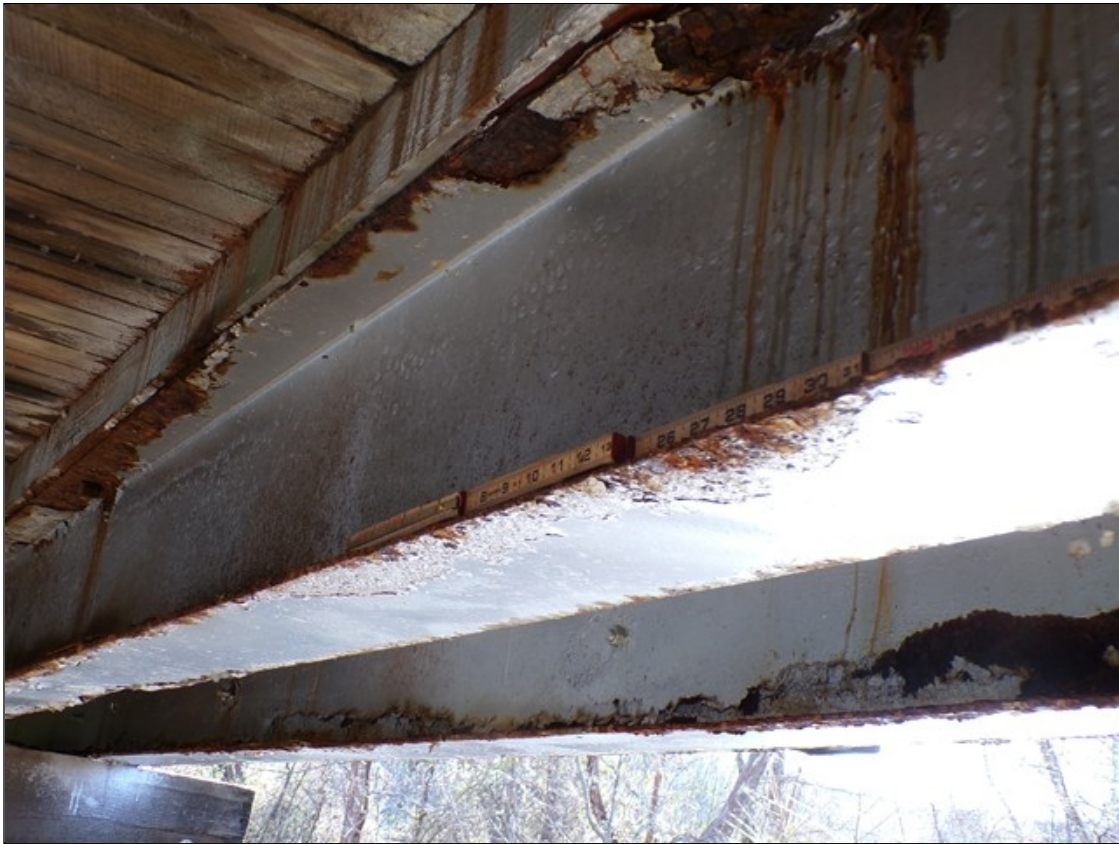
Span 1 Beam 9: (PAR) BOTTOM FLANGE CORROSION WITH SECTION LOSS 0.12 INCH AVERAGE THICKNESS REMAINING X FULL WIDTH X 18 FEET (WITH AREAS DOWN TO KNIFE'S EDGE SCATTERED THROUGHOUT)  
LOWER WEB SECTION LOSS 1/8 INCH THICK X 2 INCH HIGH

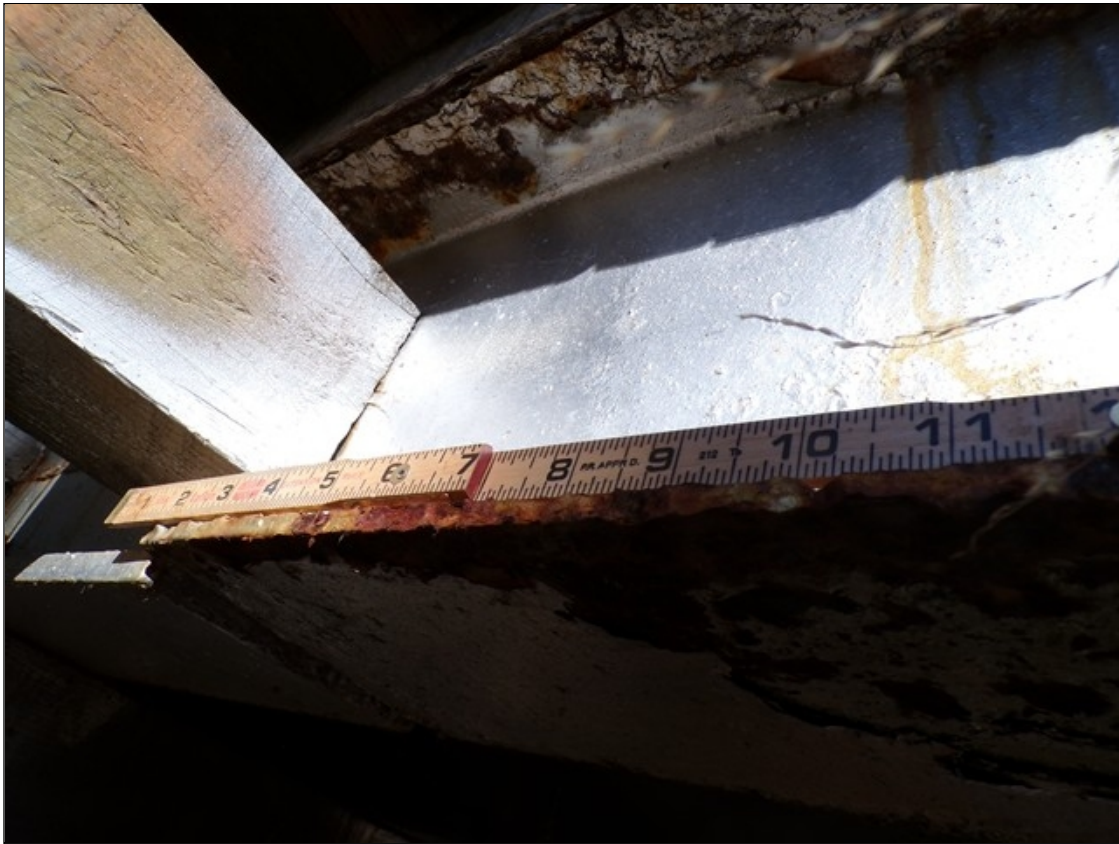
Span 1 Beam 10: (PAR) 2 FEET FROM NEAR END AT END OF WELDED REPAIR, BOTTOM FLANGE SECTION LOSS (1/8 INCH REMAINING) MISSALIGNED PLATE FOR FULL WIDTH WITH 1/8 INCH WIDE GAP FILLED WITH ONLY WELD MATERIAL

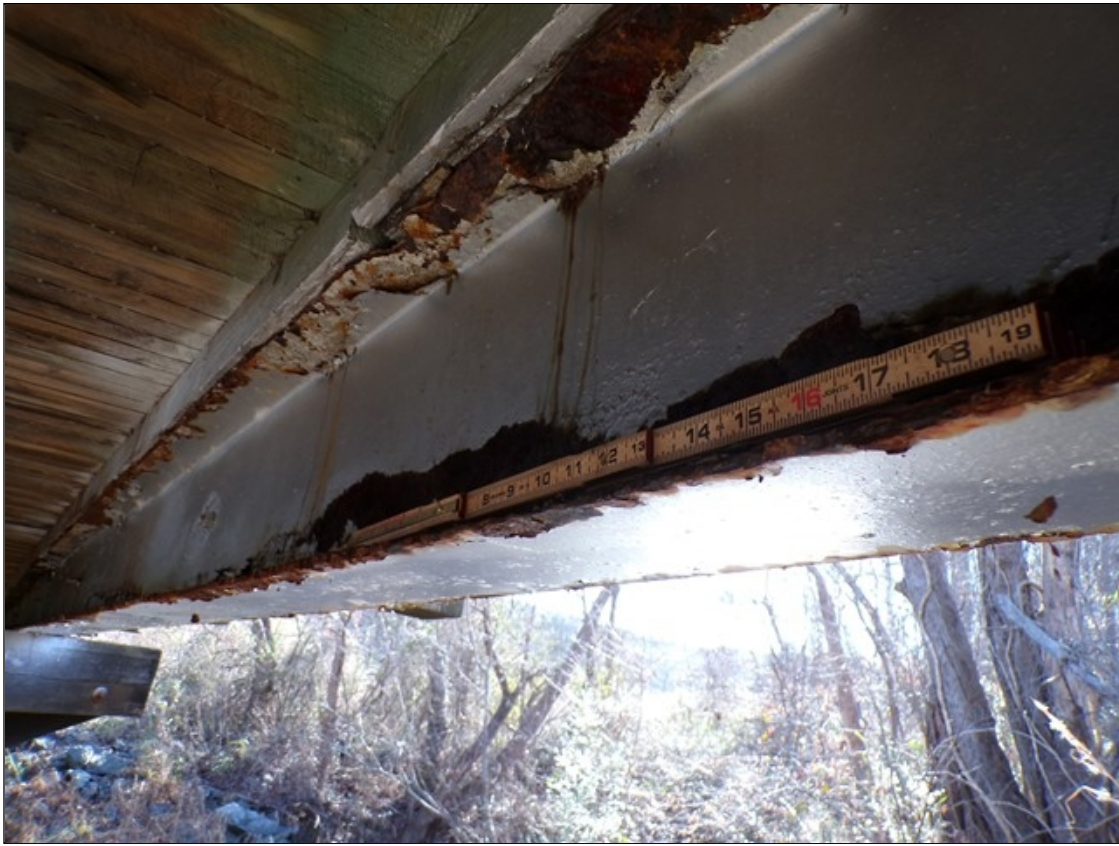
Span 1 Beam 10: (PAR) BOTTOM FLANGE CORROSION WITH SECTION LOSS 1/8 INCH AVERAGE THICKNESS REMAINING X 18 FEET AND WEB SECTION LOSS, (1/8 INCH THICK REMAINING X 4 INCH HIGH)

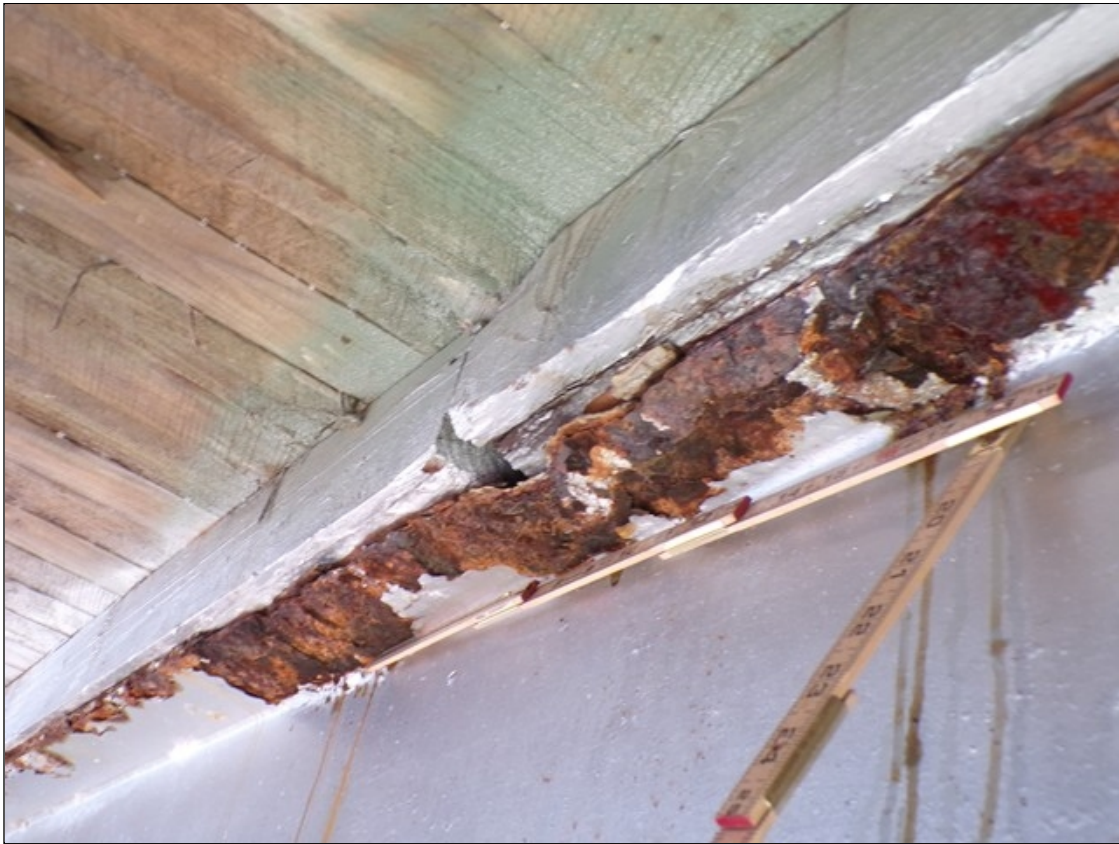
Span 1 Beam 10: (PAR) TOP FLANGE, TAPERED CORROSION WITH SECTION LOSS AT MIDSPAN, 1/8 INCH AVERAGE THICKNESS REMAINING X FULL WIDTH X FULL LENGTH (WITH AREAS OF 100% SECTION LOSS UP TO 26 INCH LONG X 1 INCH WIDE

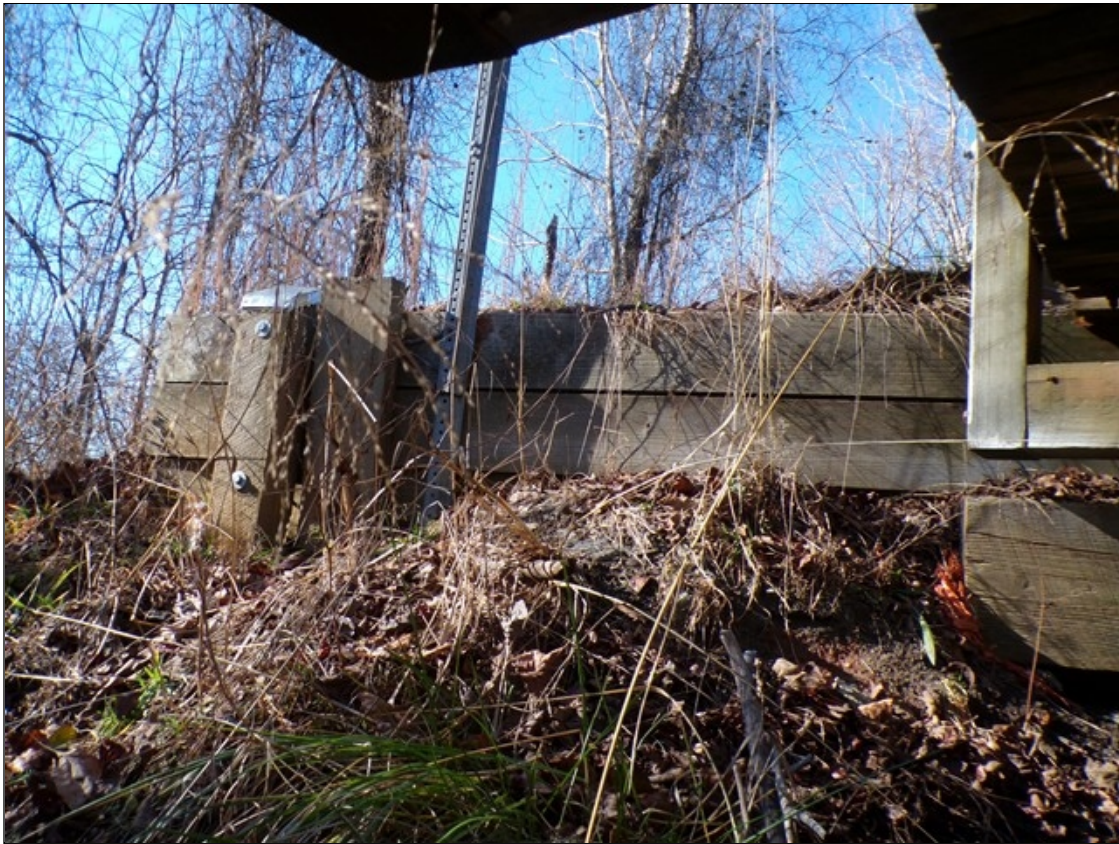
End Bent 1 Abutment: (2023 REPAIR) 7.5 INCH X 2.75 INCH PLANK AND 5.75 INCH SQUARE NEW SOLDIER PILE  
REPAIRING PREVIOUS DEFECT: UP TO 1 FOOT HIGH X 4 INCH LONG X UP TO 1.5 INCH DEEP AREA OF DECAY  
IN SOUTH FACE OF SOLDIER PILE AT SOUTHWEST CORNER

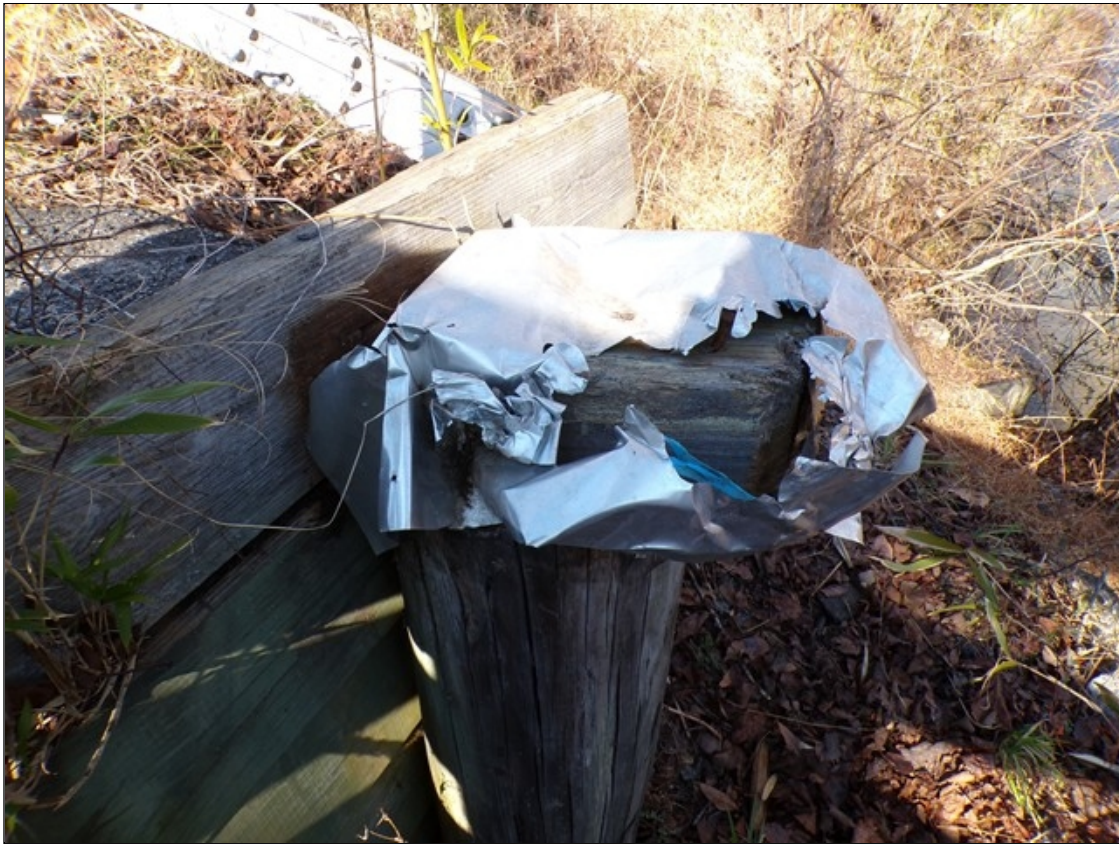
End Bent 1 Abutment: (2023 REPAIR) ALUMINUM SHEET COVERING THE EXTENT OF A PREVIOUS DEFECT AT LEFT SIDE SUPPORT PILE. THE PREVIOUS DEFECT WAS DECAY (UP TO 5 INCH HIGH X 3 INCH WIDTH X 2 INCH DEEP) AT TOP (REPAIR FAILING) (PAR)

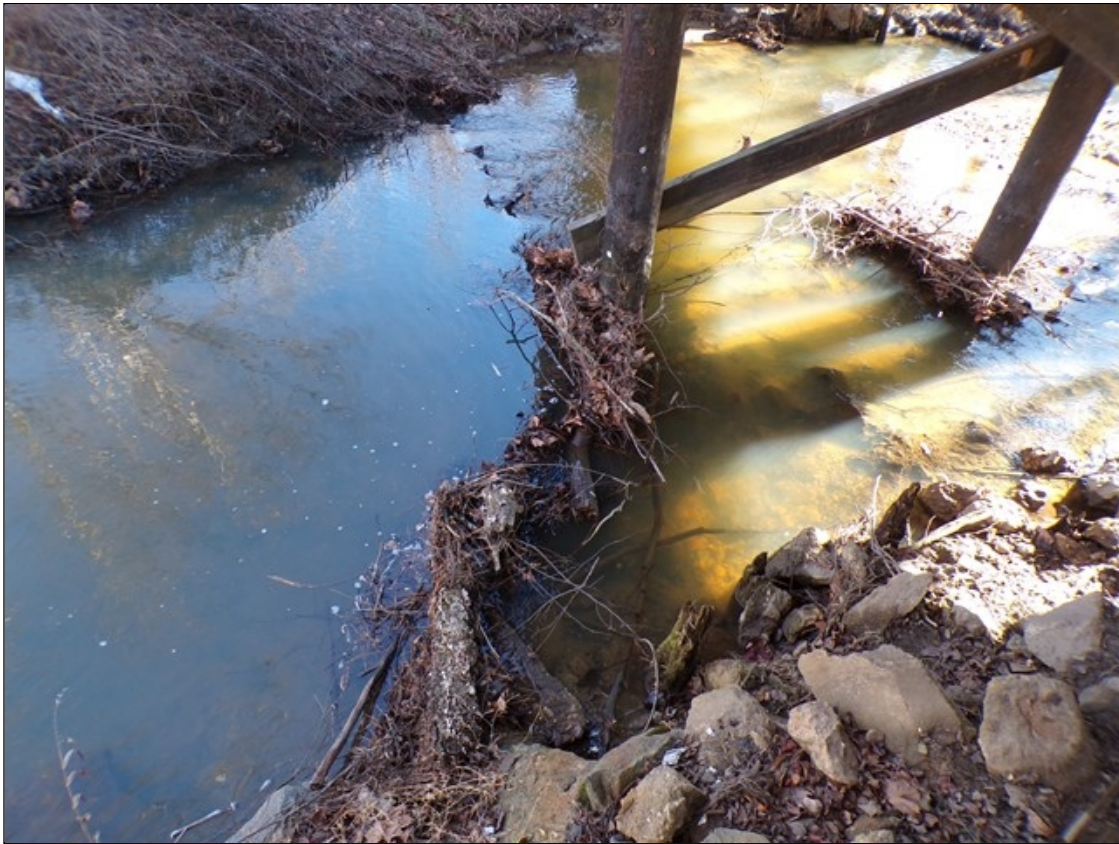
12 FEET X 3 FEET X 1 FOOT HIGH DRIFT AND DEBRIS AT PILE 1 OF BENT 1

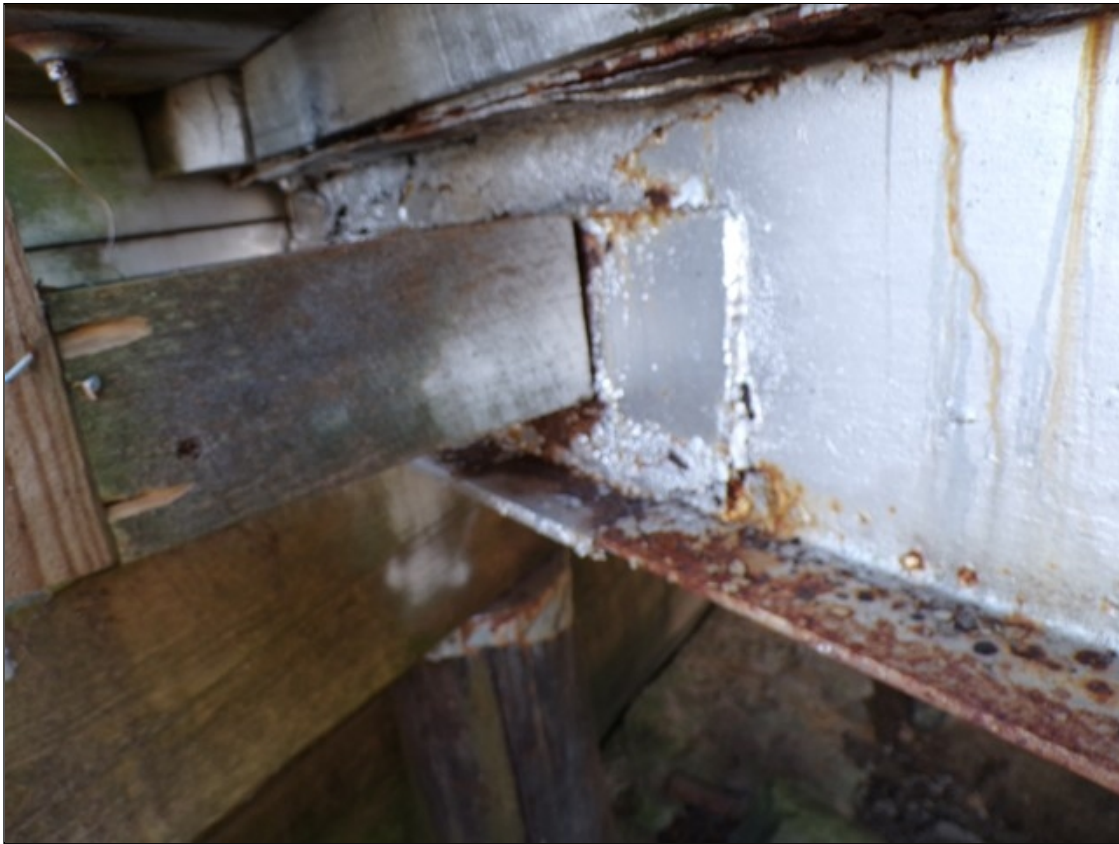
Span 3 Beam 1: BOTTOM FLANGE AND WEB REPAIR WELDED INTO FAR END OF BEAM EXHIBITING CORROSION WITH 1/16 INCH SECTION LOSS IN WEB PLATE (LOWER RIGHT WEB FOR 5 INCH HIGH X 3 FEET LONG) AND SURFACE SCALING ON LOWER LEFT WEB

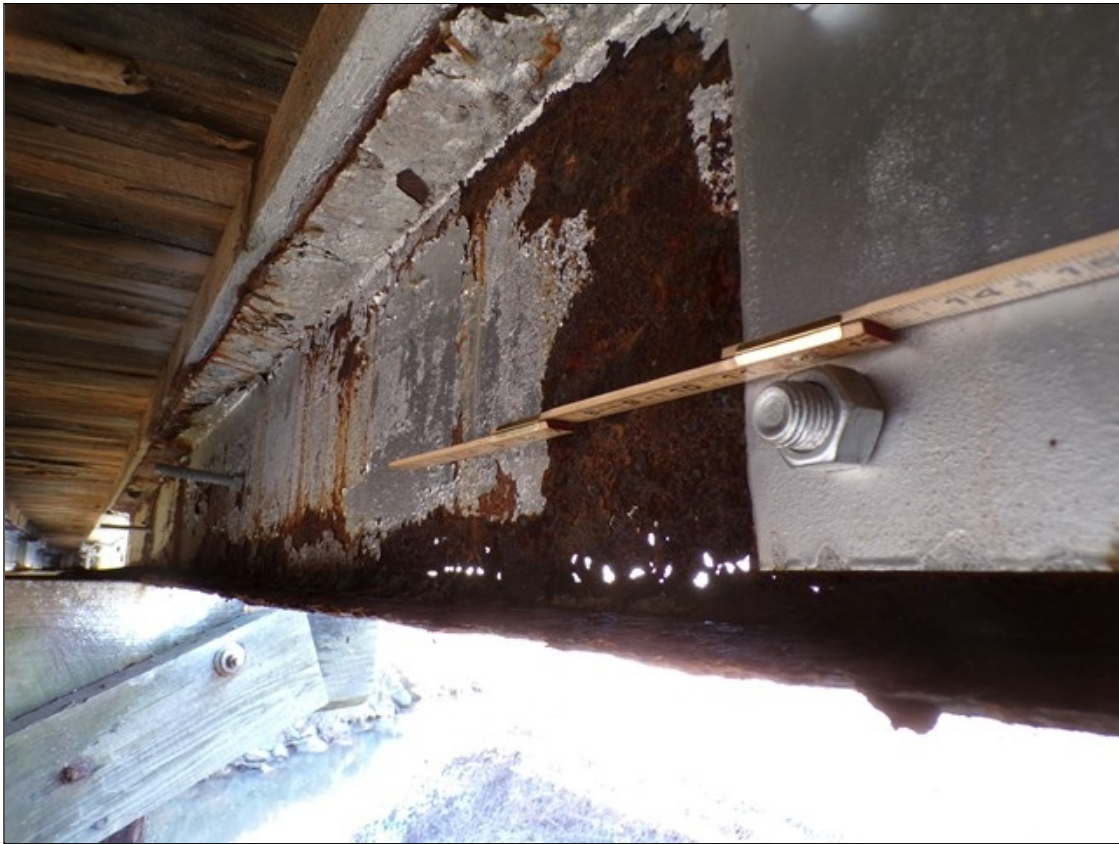
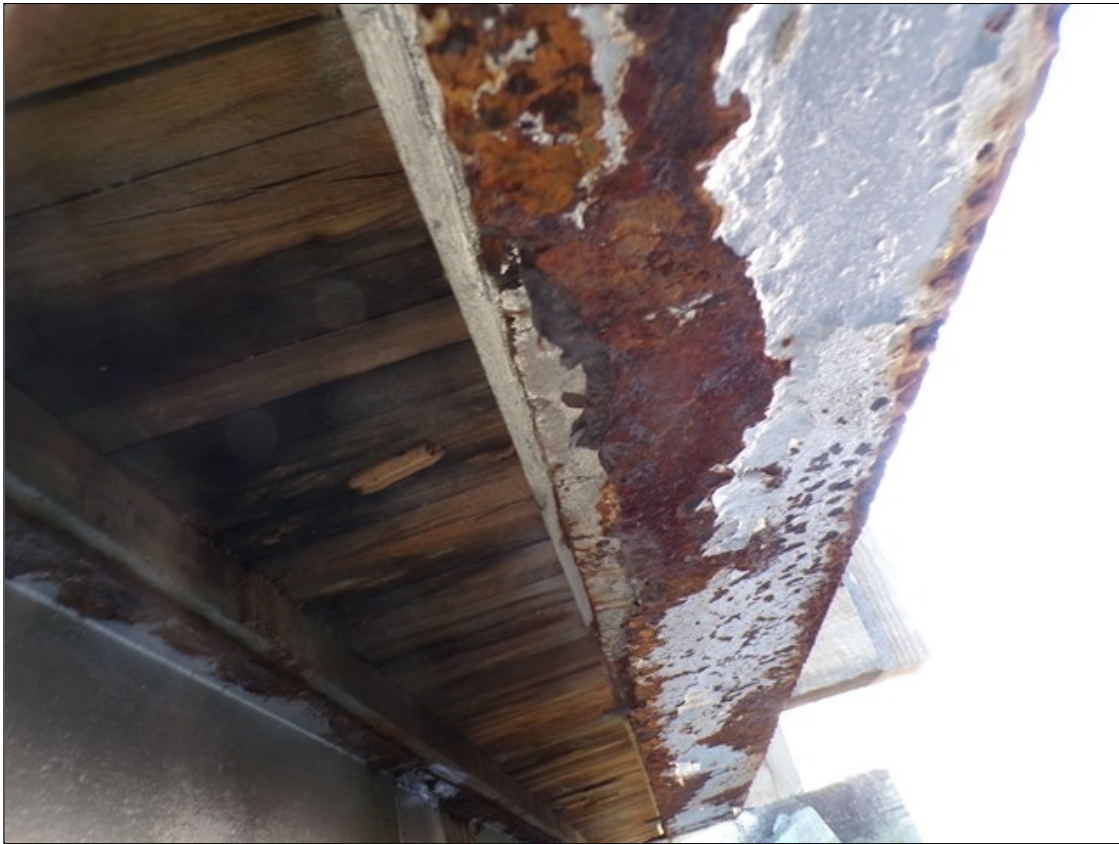
Span 3 Beam 1: (PAR) BOTTOM FLANGE CORROSION WITH SECTION LOSS, 0.11 INCH AVERAGE THICKNESS REMAINING X 24 FEET (WITH AREAS DOWN TO KNIFE'S EDGE) WITH 28 INCH X 1 INCH AREA OF COMPLETE SECTION LOSS, 4 FEET FROM BENT 2, (16 INCH X 1 INCH) AND WEB, (12 INCH X 1 1/2 INCH), 9 FEET FROM BENT 2

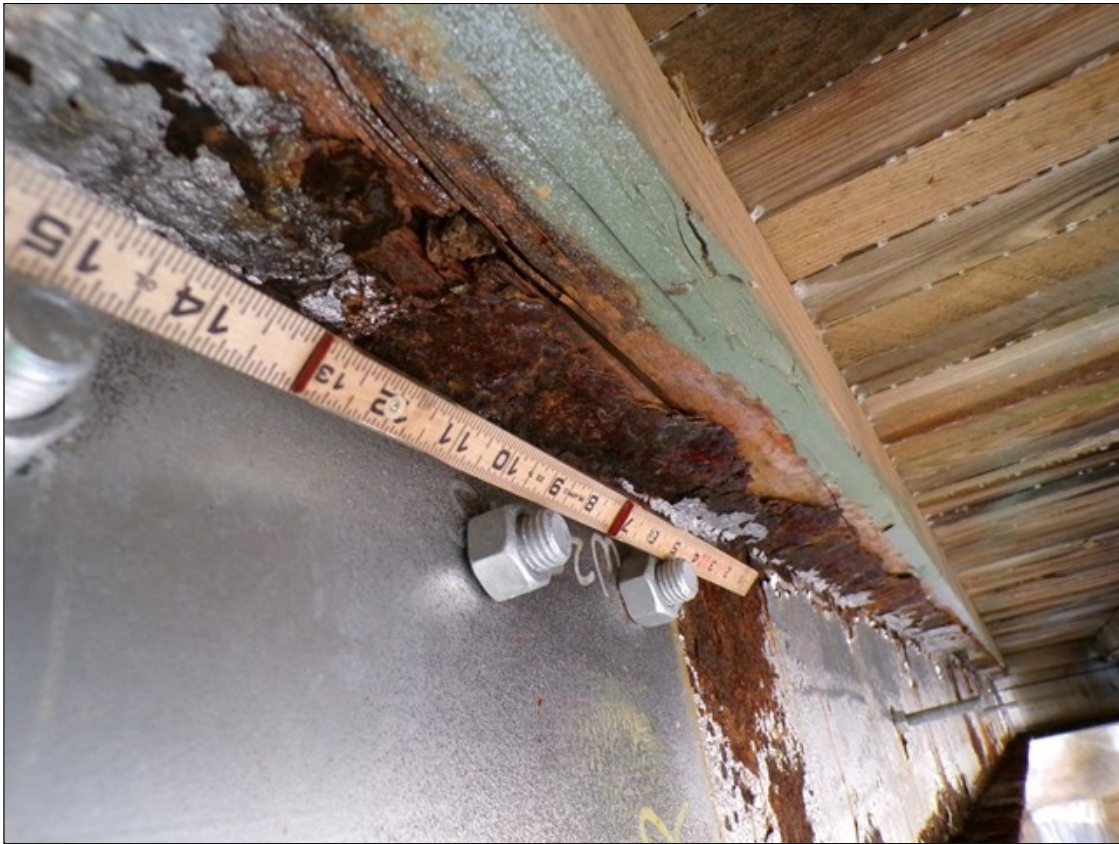
Span 3 Beam 1: (PAR) TOP FLANGE TAPERED CORROSION WITH SECTION LOSS, 1/8 INCH AVERAGE THICKNESS REMAINING X FULL LENGTH (DOWN KNIFE'S EDGE WITH MOST OF TOP FLANGE WIDTH REDUCED TO 4 INCH WIDE)

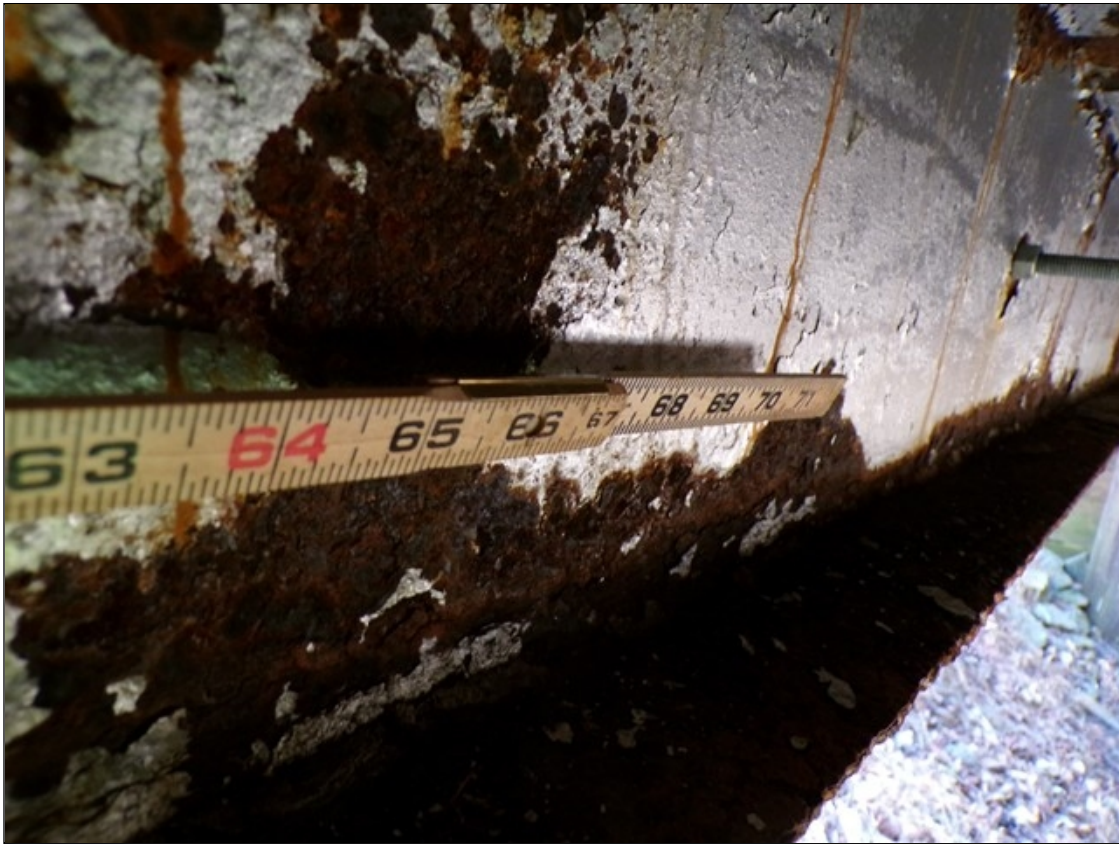
Span 3 Beam 1: (PAR) INTERMITTENT THROUGHOUT WEB, CORROSION WITH SECTION LOSS, 1/8 INCH AVERAGE THICKNESS X 4 INCH HIGH X 15 FEET

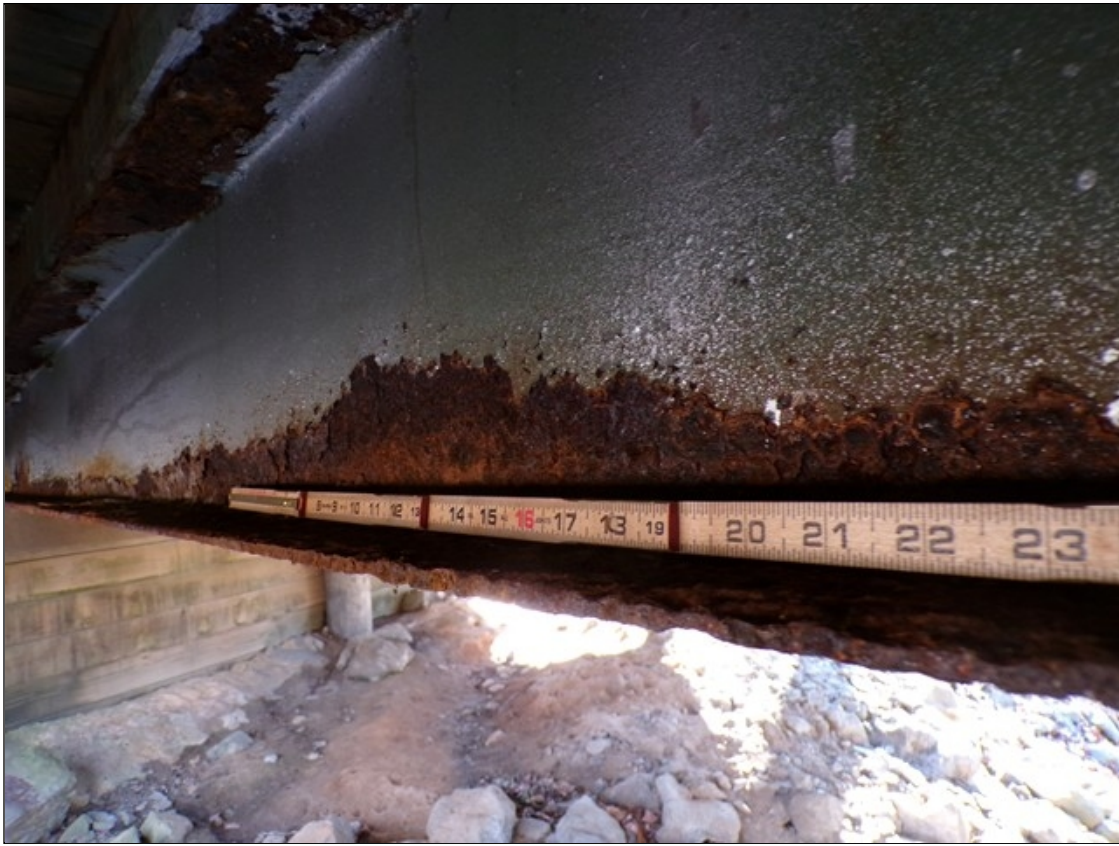
Span 3 Beam 2: (PAR) BOTTOM FLANGE CORROSION WITH SECTION LOSS, 0.27 INCH AVERAGE THICKNESS REMAINING X FULL WIDTH X FULL LENGTH, WITH WEB SECTION LOSS (3/16 AVERAGE THICKNESS REMAINING) FOR 3 INCH HIGH

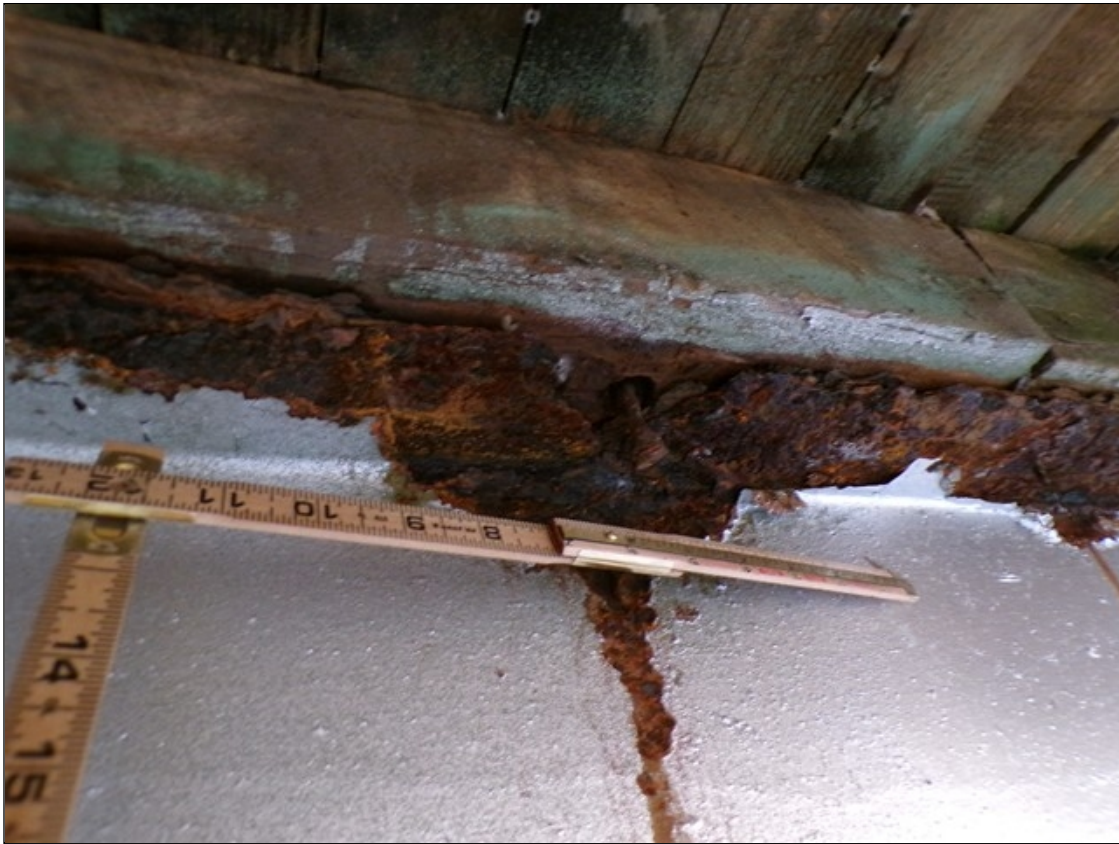
Span 3 Beam 2: (PAR) TOP FLANGE TAPERED CORROSION WITH SECTION LOSS, 1/8 INCH AVERAGE THICKNESS REMAINING X FULL WIDTH X FULL LENGTH (WITH (2) AREAS OF 100% SECTION LOSS X 6 INCH X 2 INCH)
