NC DEPARTMENT OF TRANSPORTATION  
DIVISION OF HIGHWAYS  
STRUCTURE MANAGEMENT UNIT  
COUNTY: RUTHERFORD DIV: 13

## Structure Safety Inspection Report

BRIDGE NUMBER: 800239 BRIDGE NAME: \_\_\_\_\_ PREVIOUS BRIDGE NUMBER: \_\_\_\_\_

LATITUDE: 35.48940000 LONGITUDE: -81.99338000 ROUTE: SR1325 M.P.: 0.0

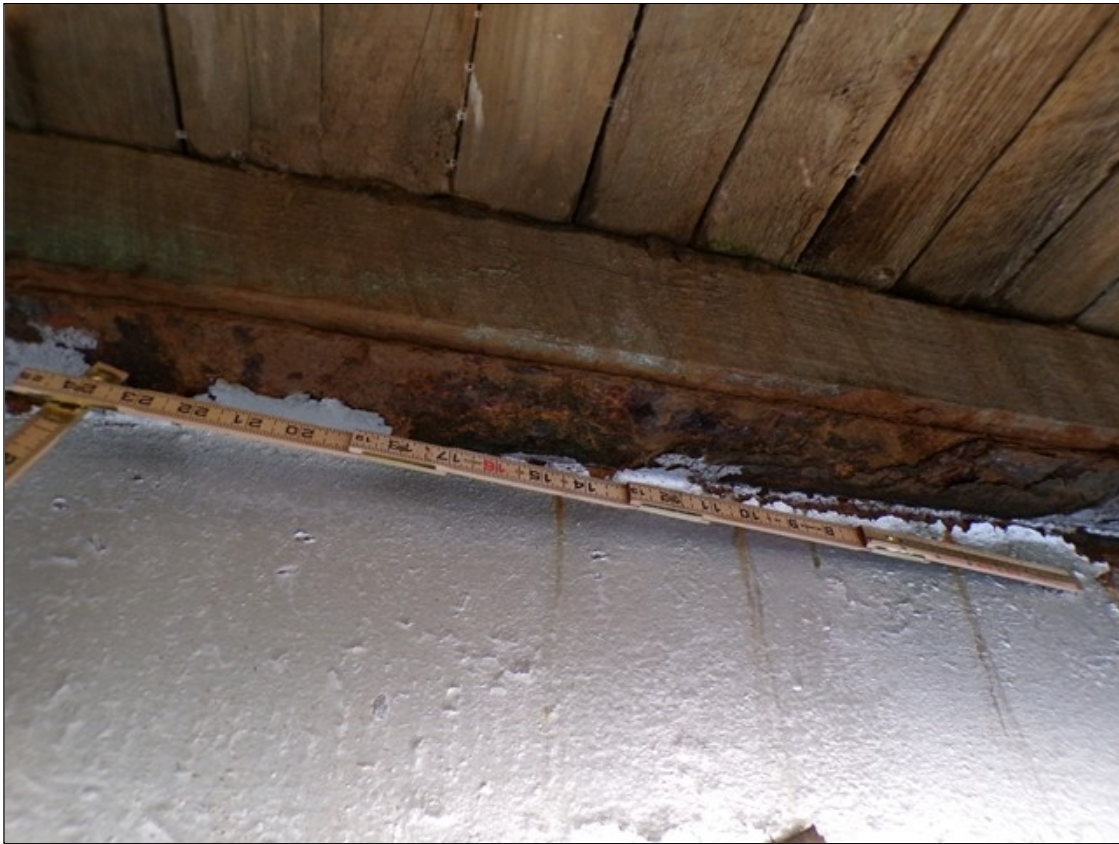
Span 3 Beam 3: (PAR) BEGINNING AT NEAR END, TOP FLANGE TAPERED CORROSION WITH SECTION LOSS (FULL WIDTH DOWN TO 1/8 INCH AVERAGE REMAINING) 16 FEET LONG

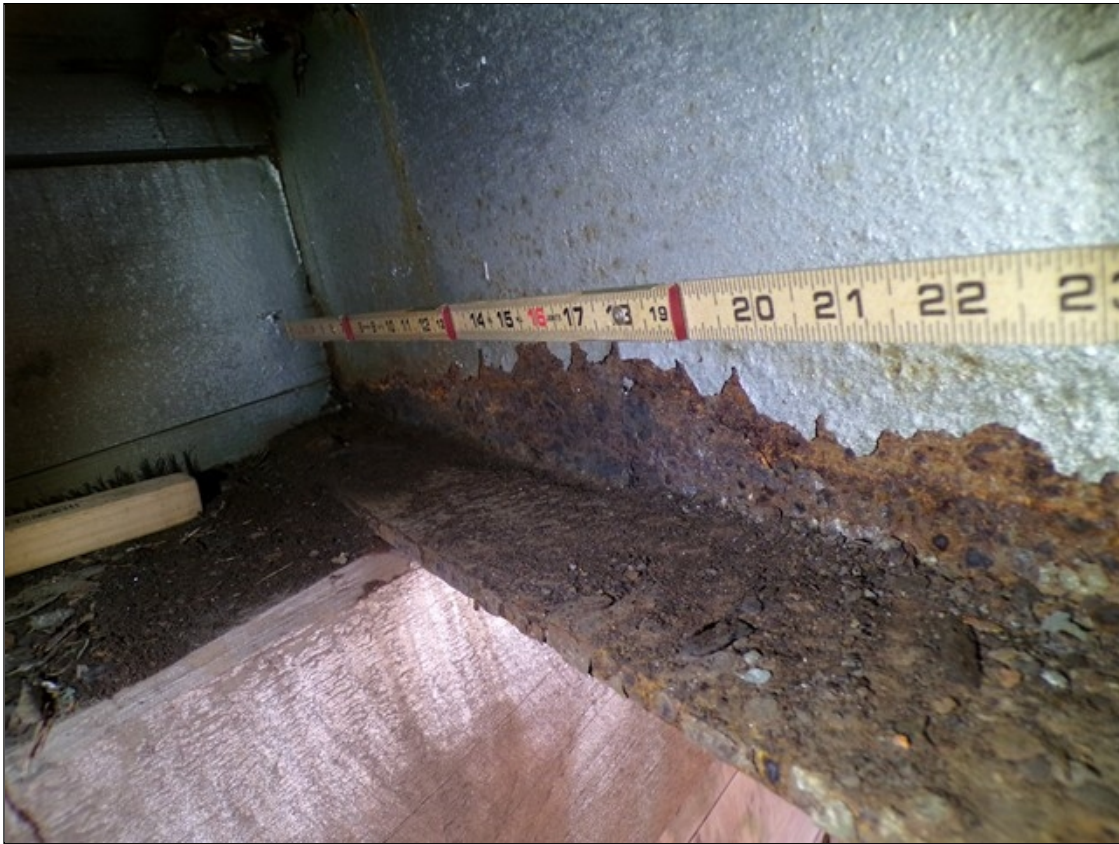
SPAN 3 Beam 3: AT FAR END, CORROSION WITH 1/16 INCH SECTION LOSS TO BASE OF WEB (21 INCH LONG X 1 INCH HIGH) DOWN TO 3/16 INCH AVERAGE THICKNESS REMAINING (PAR)

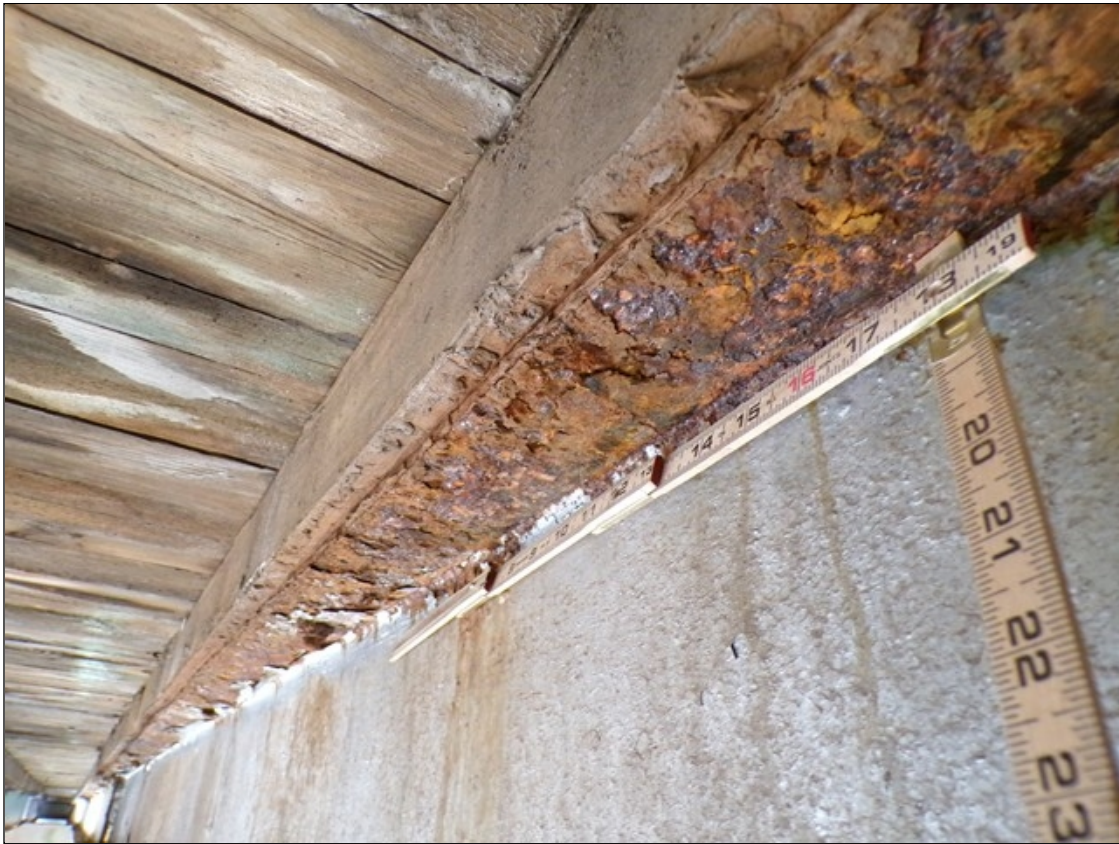
Span 3 Beam 4: (PAR) AT NEAR END, TAPERED CORROSION WITH SECTION LOSS FOR FULL WIDTH OF TOP FLANGE (DOWN TO 1/8 INCH AVERAGE THICKNESS REMAINING AT EDGE) FOR 16 FEET LONG

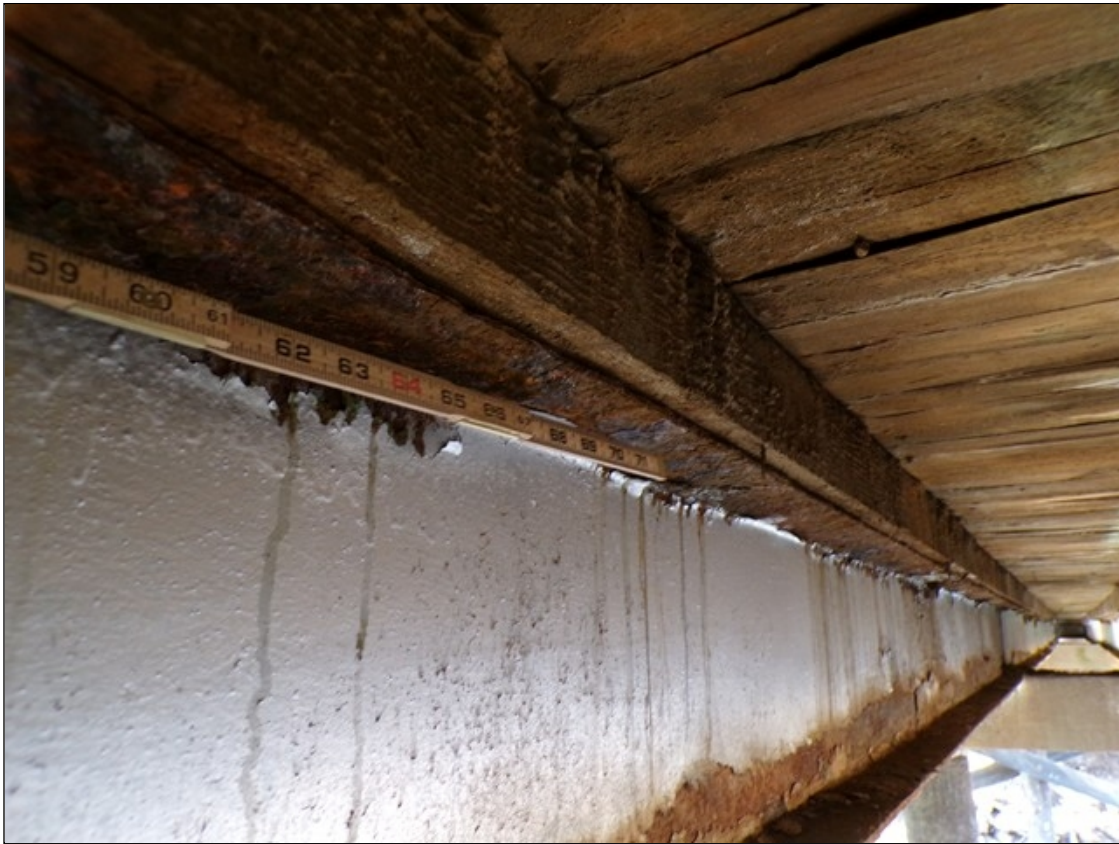
Span 3 Beam 5: (PAR) BEGINNING AT NEAR END, TAPERED CORROSION WITH SECTION LOSS FOR FULL WIDTH OF TOP FLANGE (DOWN TO 1/8 INCH AVERAGE THICKNESS REMAINING AT EDGE) FOR 15 FEET LONG

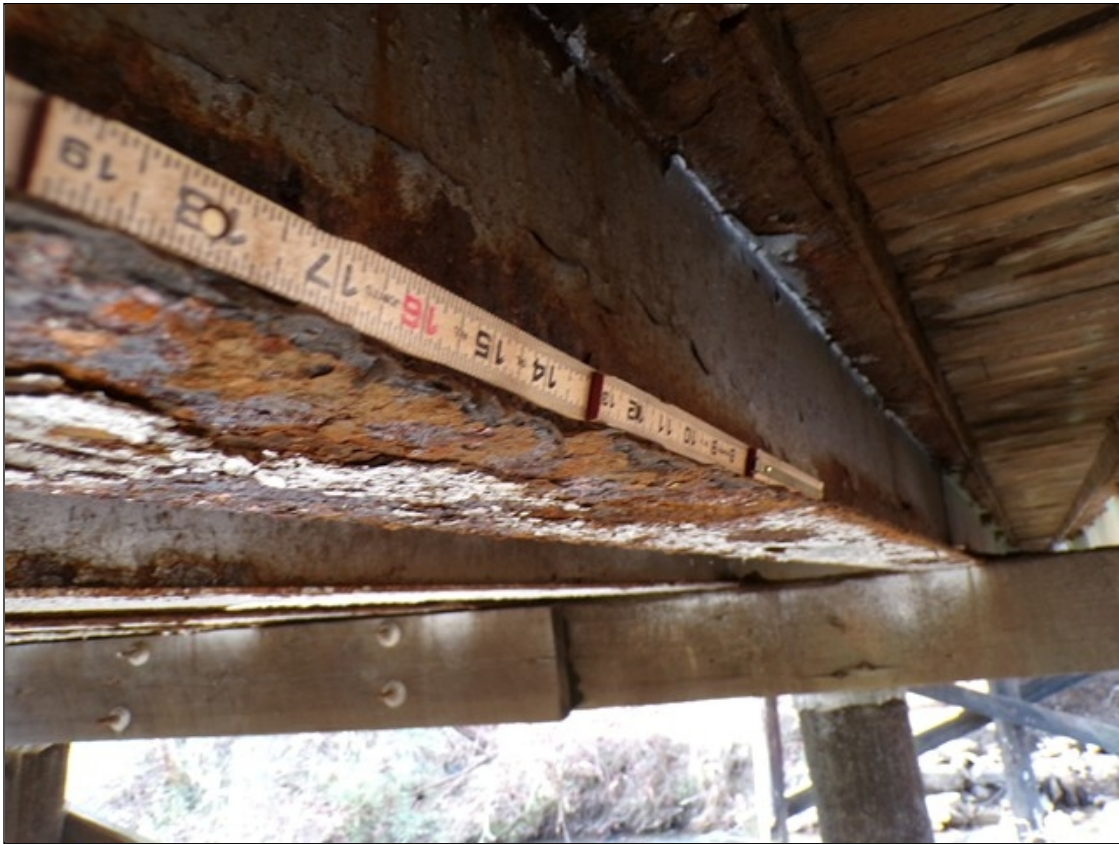
SPAN 3 Beam 5: (PAR) BEGINNING AT NEAR END, CORROSION WITH SECTION LOSS IN BOTTOM FLANGE (DOWN TO 0.23 INCH THICKNESS TO LEFT SIDE, AND KNIFE EDGE REMAINING WITH 15 INCH X 3/4 INCH AREA OF 100% SECTION LOSS TO RIGHT SIDE) UP TO 3 INCH WIDE X 13 FEET LONG, AND LOWER WEB SECTION LOSS (DOWN TO 3/16 INCH THICKNESS REMAINING) FOR 3 INCH HIGH

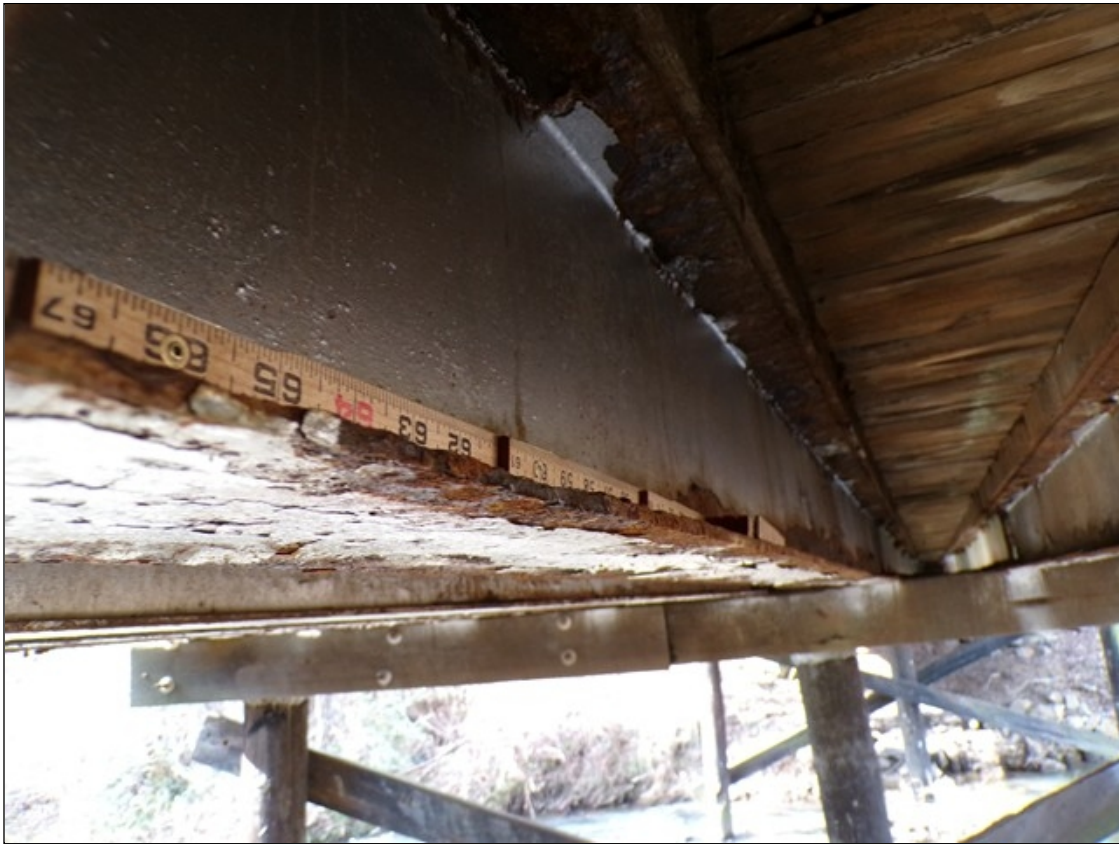
Span 3 Beam 5: 13 INCH X 1 1/2 INCH AREA OF 1/8 INCH SECTION LOSS (3/16 INCH REMAINING) ON BOTH SIDE OF BOTTOM FLANGE, 11 FEET FROM END BENT 2 (PAR)

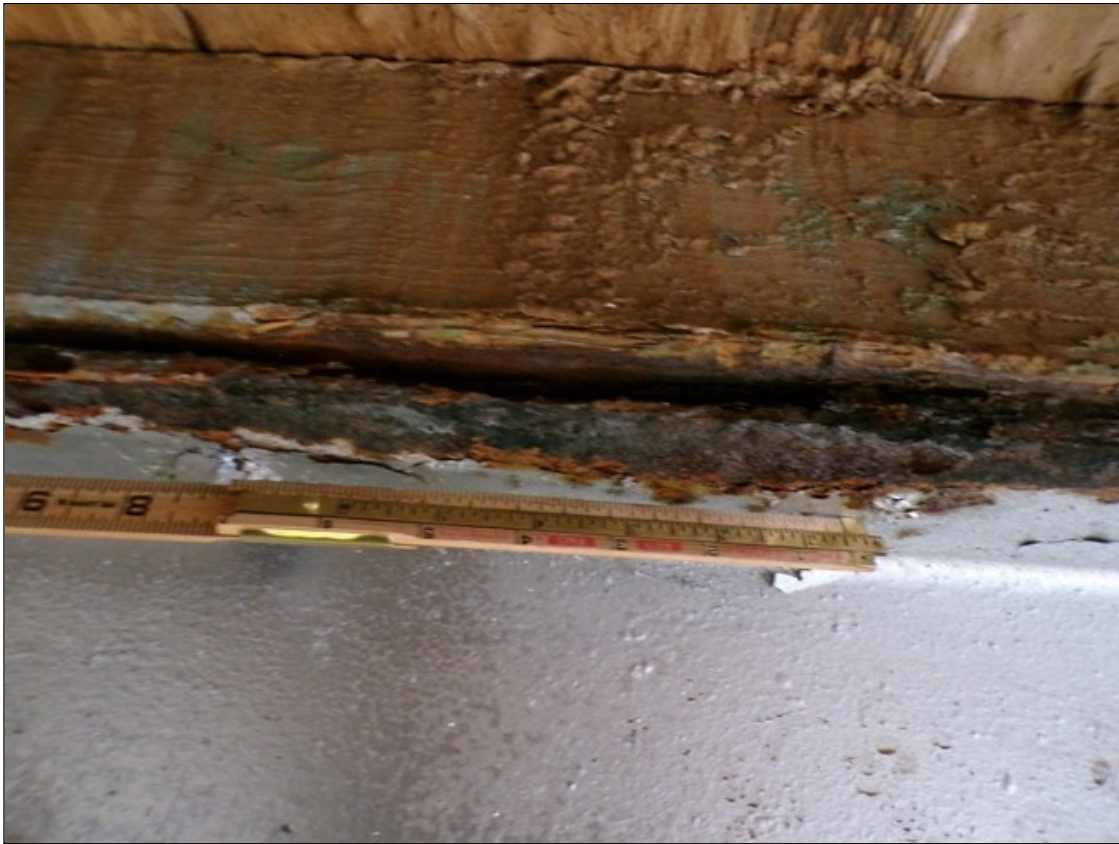
Span 3 Beam 6: (PAR) STARTING 5 FEET FROM NEAR END, TAPERED CORROSION WITH SECTION LOSS IN TOP FLANGE (DOWN TO 1/8 INCH AVERAGE THICKNESS REMAINING DOWN TO KNIFE'S EDGE) FOR FULL WIDTH X 20 FEET LONG

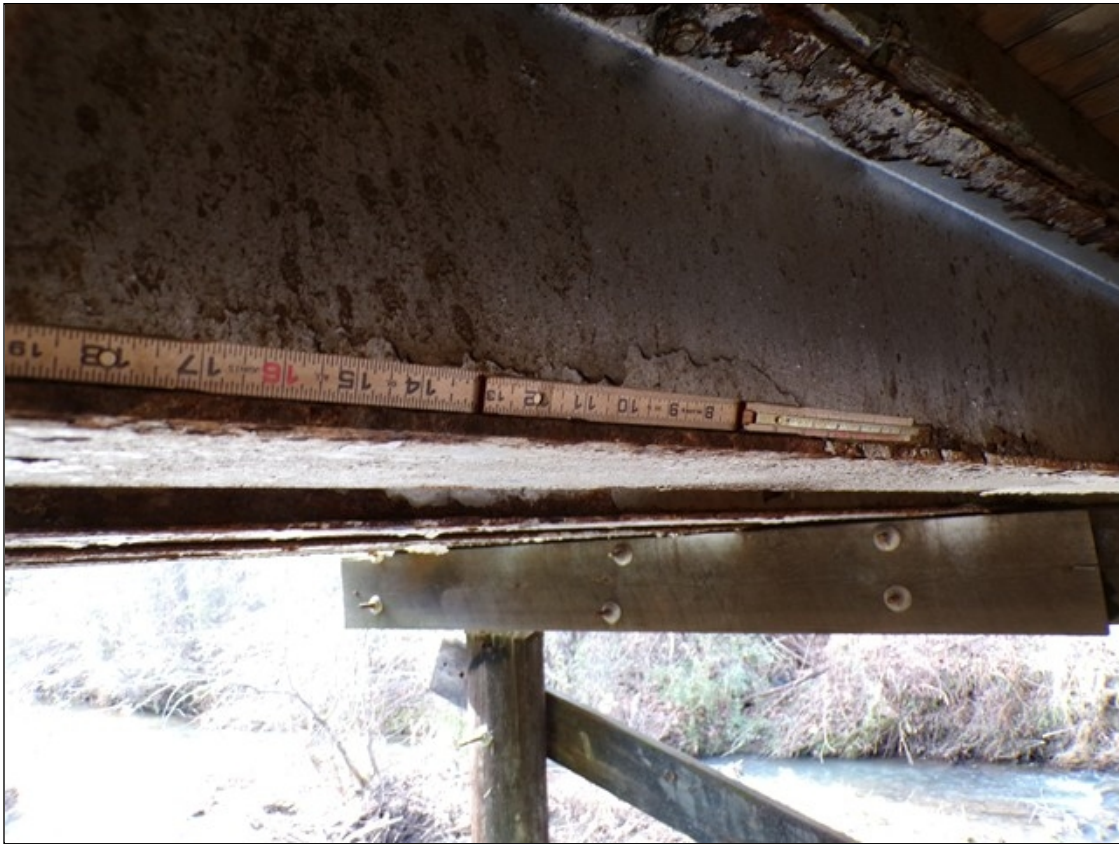
Span 3 Beam 6: STARTING 5 FEET FROM NEAR END, BOTTOM FLANGE SECTION LOSS (DOWN TO 0.21 INCH SECTION REMAINING) TO BOTH SIDES, FOR 2 INCH WIDE X 3 FEET LONG (PAR)

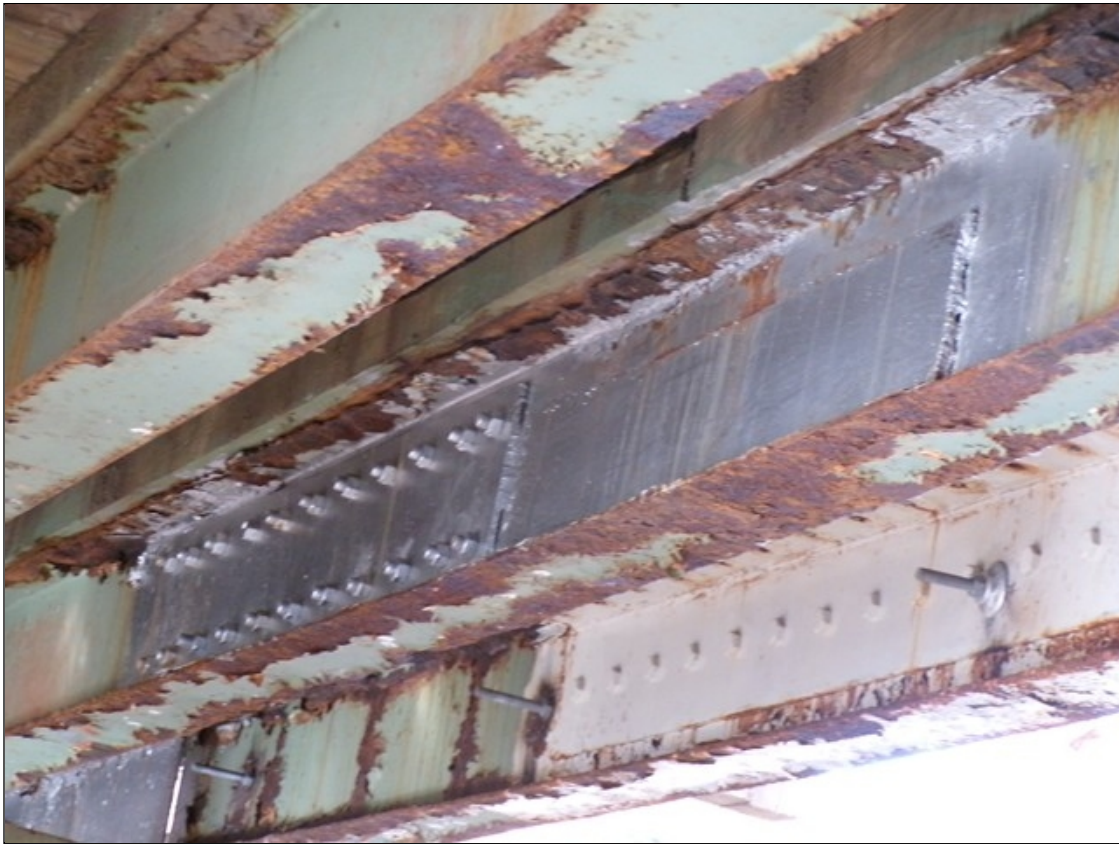
Span 2 Beam 2: AT FAR END, PREVIOUS WEB CORROSION HAS WELDED PLATE REPAIR (10 INCH X 8 INCH X 1/2 INCH THICK) BOTH SIDES

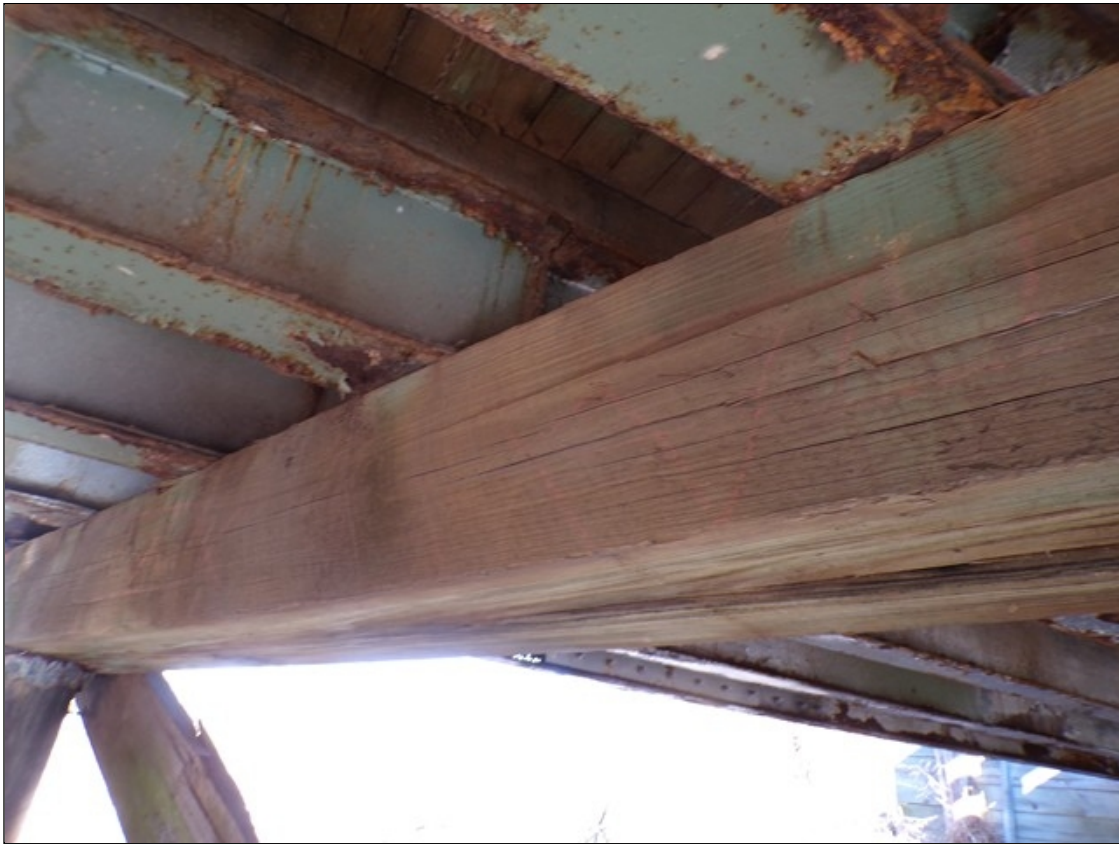
Bent 2 Cap 1: (PAR) NEAR SIDE BELOW BAYS 2-6, AREA OF DELAMINATION/DECAY (10 FEET LONG X 8 INCH HIGH X UP TO 1 INCH DEEP) HOLLOW WHEN SOUNDED

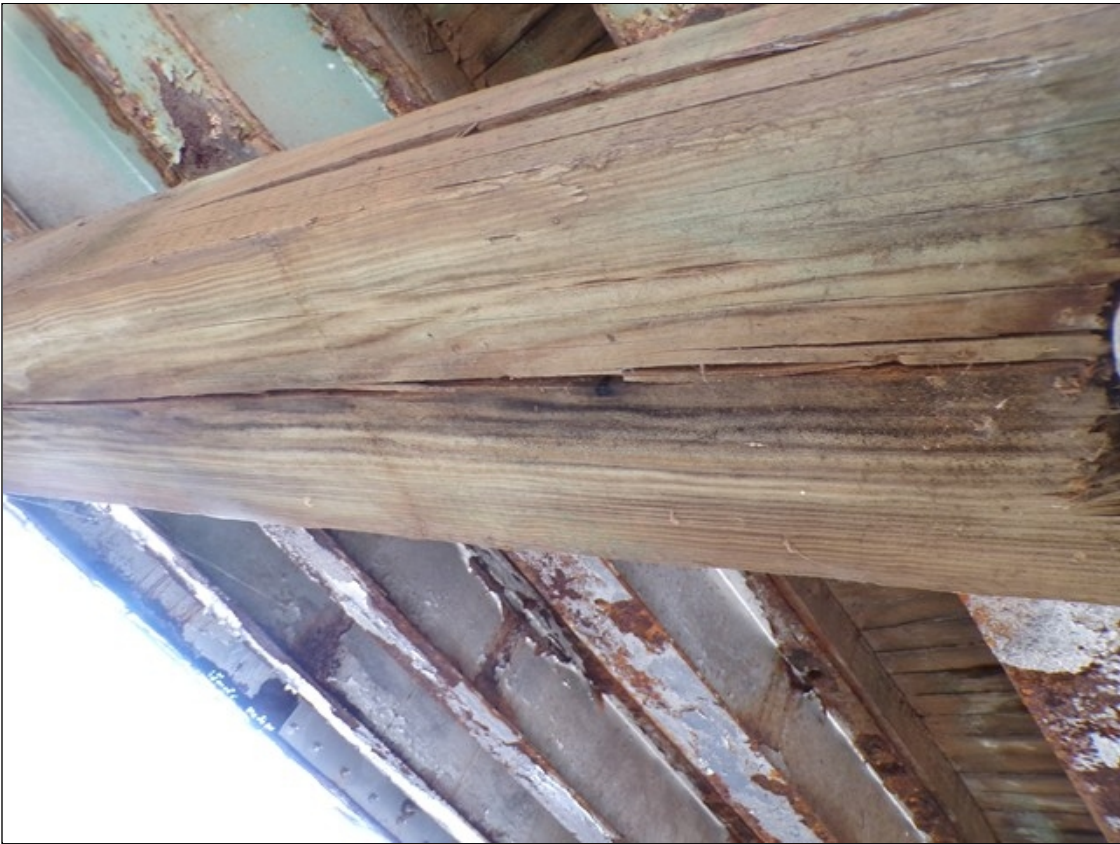
Bent 2 Cap 1: 5 FEET X 1/4 INCH UP TO 2 1/2 INCH DEEP SPLIT ON BOTTOM OF CAP BETWEEN PILES 1 AND 2 (PAR)

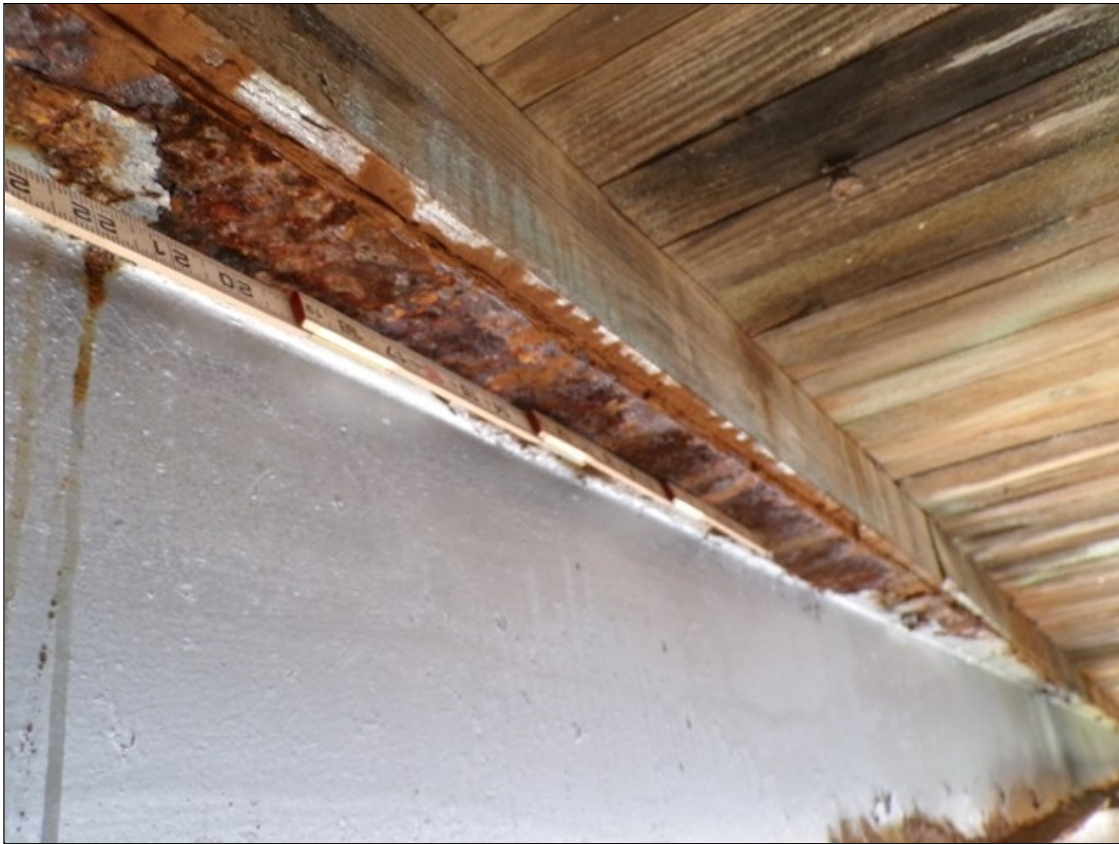
Span 3 Beam 7: (PAR) STARTING 6 FEET FROM NEAR END, TAPERED CORROSION WITH SECTION LOSS TO TOP FLANGE (DOWN TO 0.24 INCH THICKNESS REMAINING) TO BOTH SIDES, FOR 2.5 INCH WIDE X 20 FEET LONG

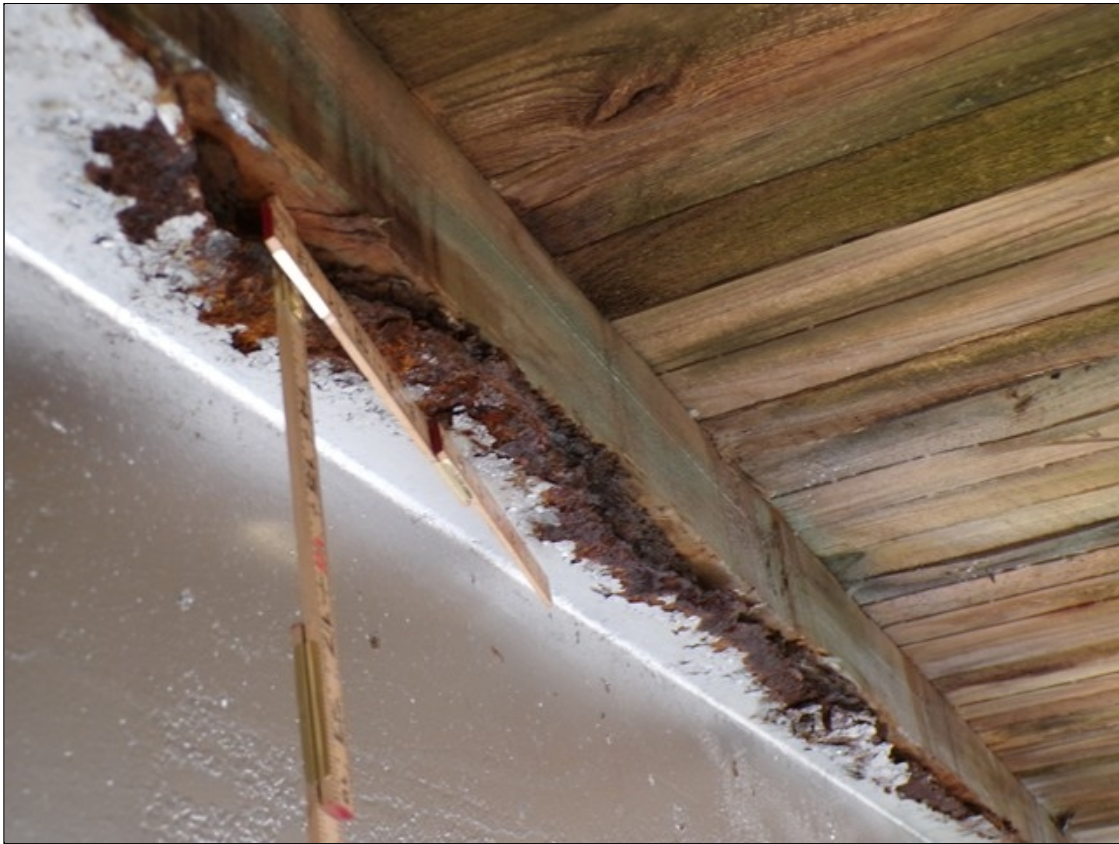
SPAN 3 Beam 9: (PAR) TAPERED CORROSION WITH SECTION LOSS AT TOP FLANGE 0.17 INCH AVERAGE THICKNESS REMAINING X FULL LENGTH (WITH (2) 5 FOOT AREAS REDUCED TO 5 INCH FLANGE WIDTH REMAINING X KNIFE'S EDGE)

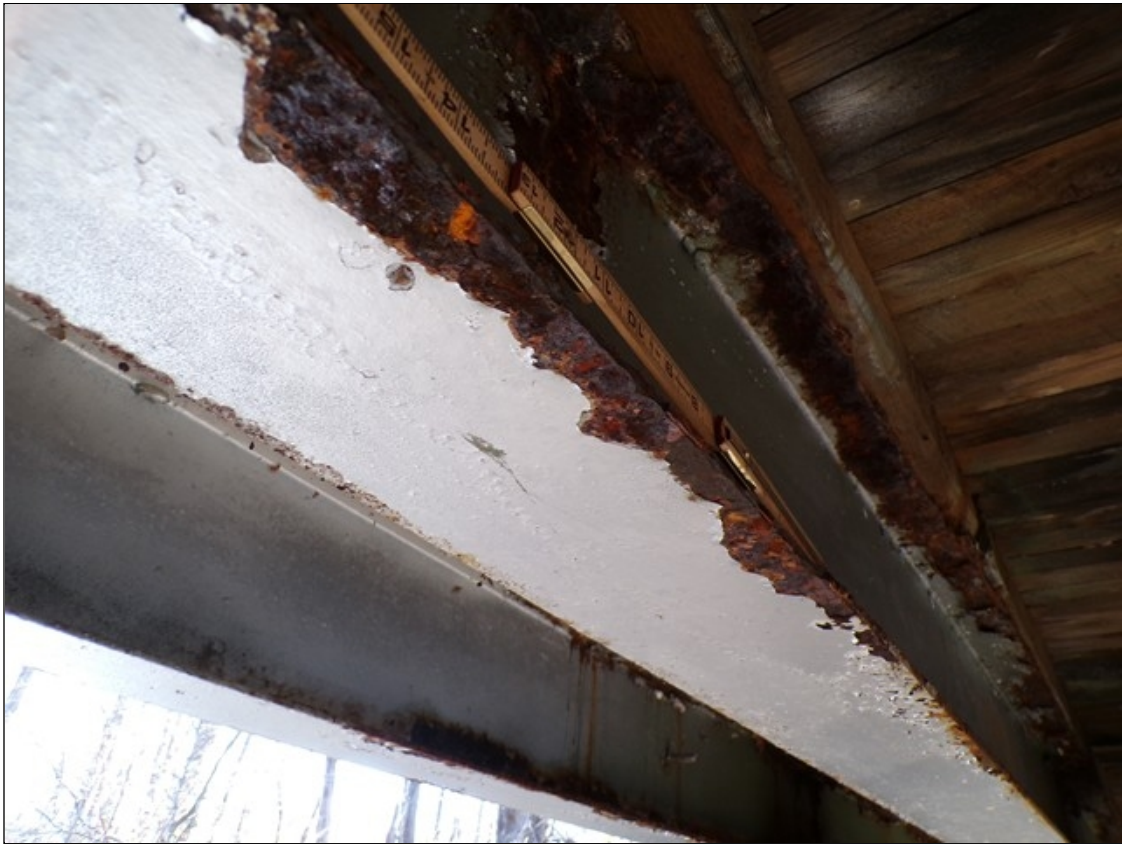
Span 3 Beam 9: STARTING 6 FEET FROM NEAR END (FOR 2 FEET LONG) AND AT NEAR END (FOR 2 FEET LONG), CORROSION WITH SECTION LOSS TO LEFT SIDE OF BOTTOM FLANGE (DOWN TO 1/4 INCH SECTION REMAINING) TO LEFT SIDE, FOR 2 INCH WIDE (PAR)

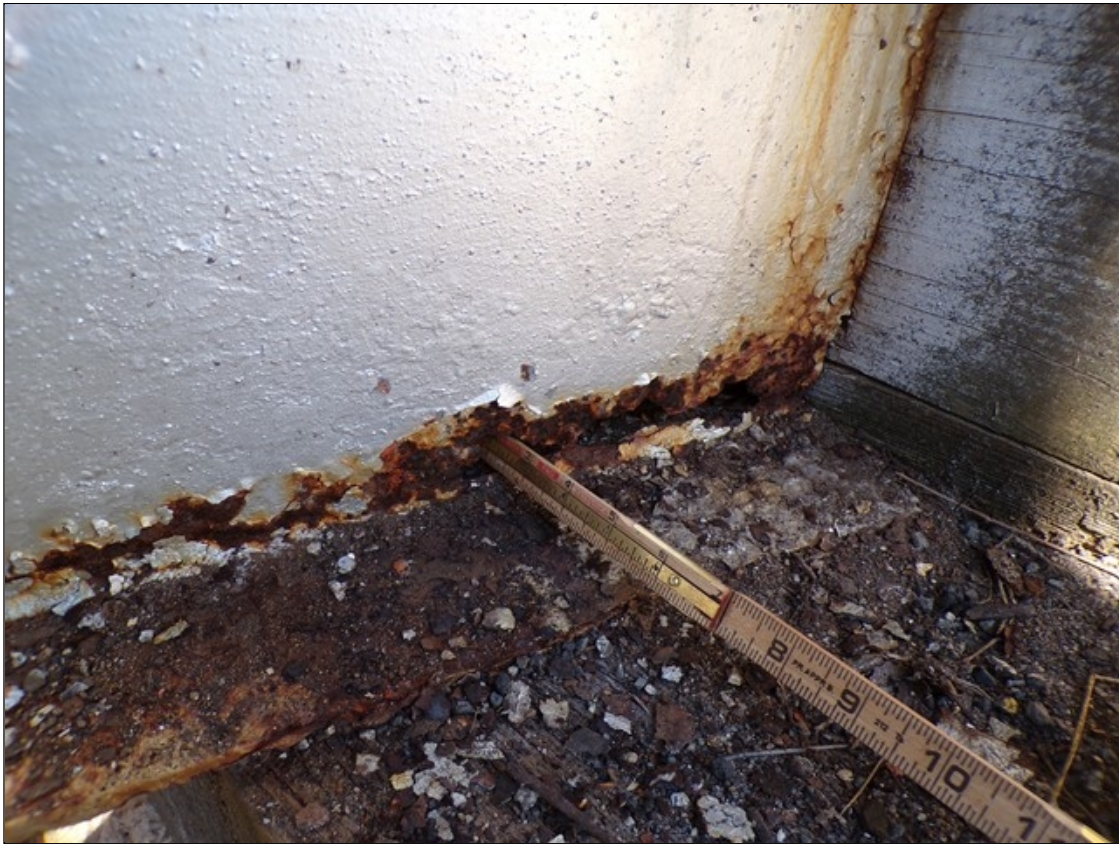
Span 3 Beam 10: (PAR) AT FAR END, CORROSION WITH COMPLETE SECTION LOSS IN LOWER WEB (1 INCH X 7 INCH LONG)
