PROJECT NO. **15BPR.164**  
**BEAUFORT** COUNTY  
TERMINAL: **AURORA**

STATE OF NORTH CAROLINA  
DEPARTMENT OF TRANSPORTATION  
RALEIGH

**LIFT BENT  
STEEL PILE  
REPAIR DETAILS**

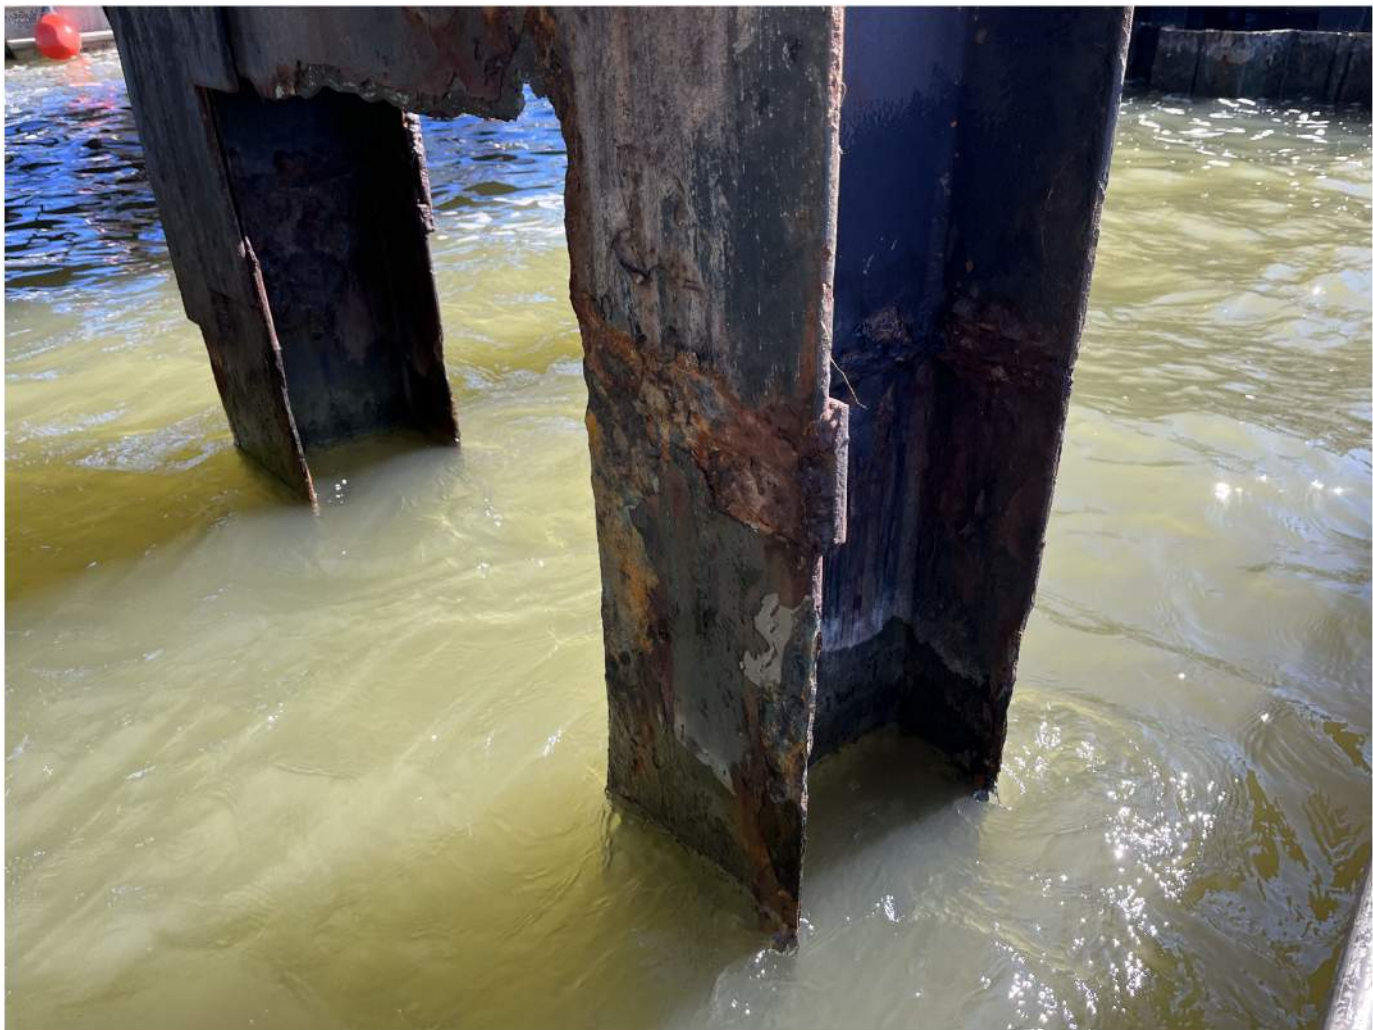
**NORTH FACE OF PILE 3**

| ESTIMATED STEEL PILE REPAIR QUANTITIES | | | | |
|---|---|---|---|---|
| | 3 | WELDED PLATE REPAIR | BETWEEN BRACING & WATER LINE | 87 |

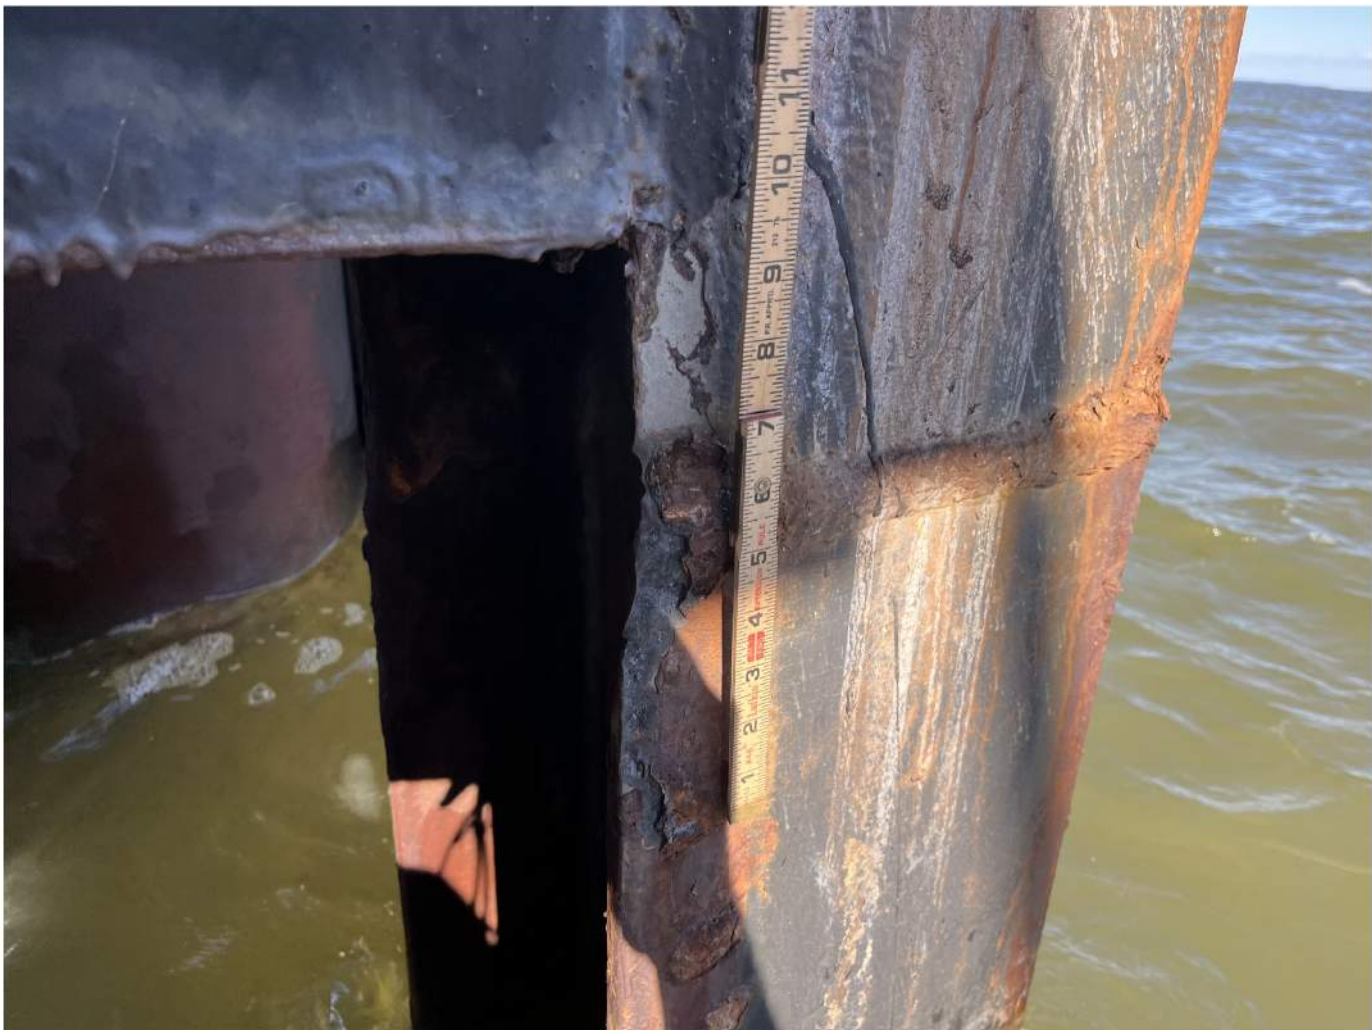
**SOUTH SIDE OF PILE 6**

| ESTIMATED STEEL PILE REPAIR QUANTITIES | | | | |
|---|---|---|---|---|
| | 6 | WELDED PLATE REPAIR | BETWEEN BRACING & WATERLINE | 41 |
