PROJECT NO. **15BPR.164**  
**BEAUFORT** COUNTY  
TERMINAL: **BAYVIEW**

STATE OF NORTH CAROLINA  
DEPARTMENT OF TRANSPORTATION  
RALEIGH

**STEEL BEAM CRACK  
REPAIR DETAILS**

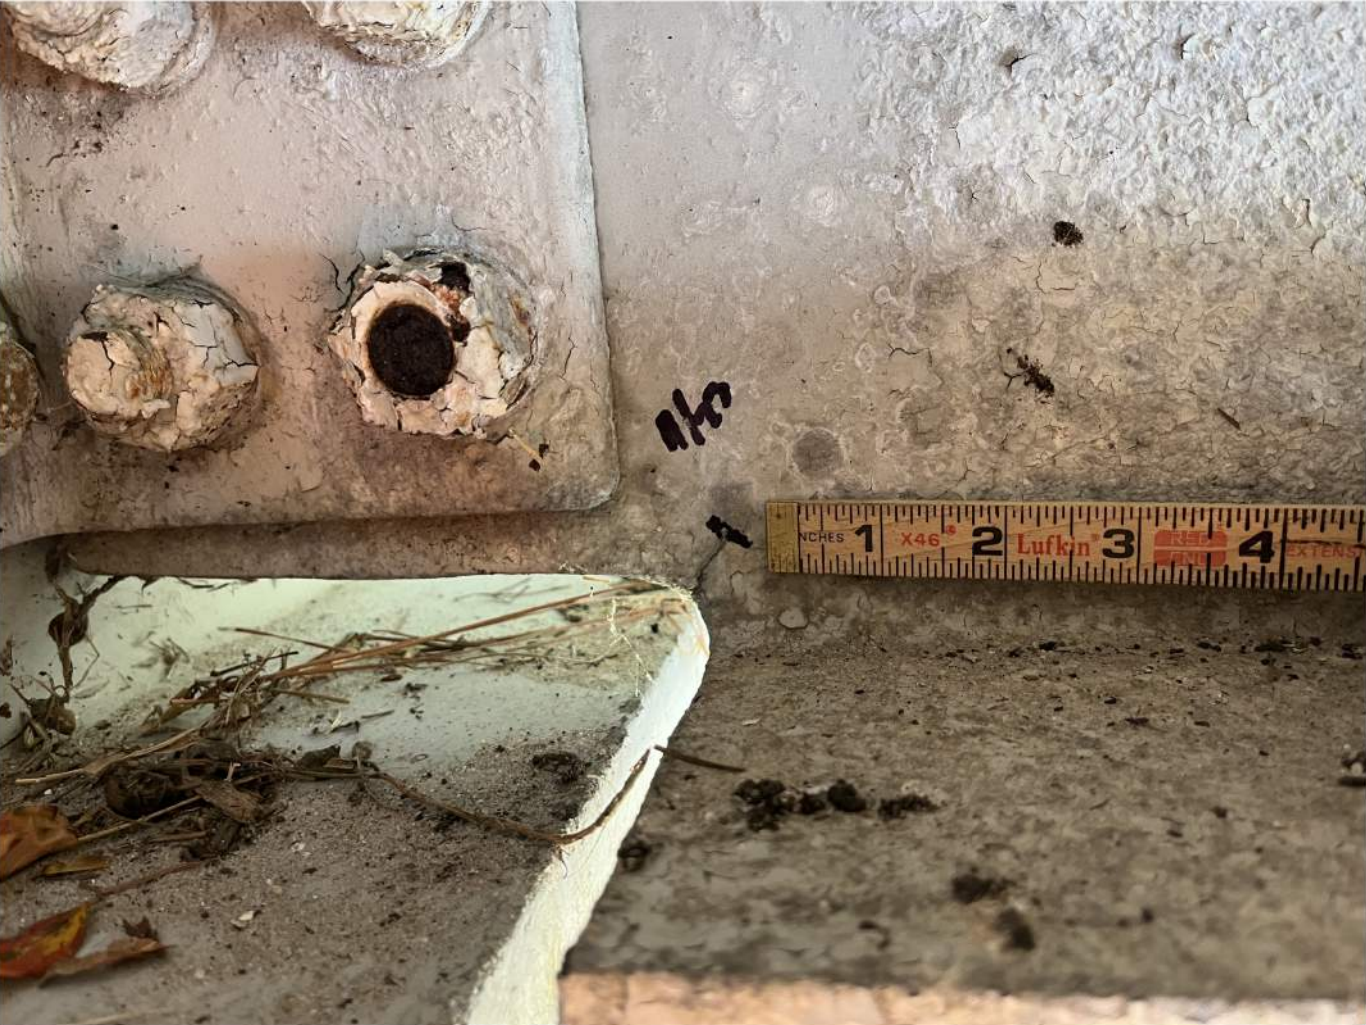
**NORTH FACE OF FLOORBEAM 9  
AT GIRDER 2**

(OTHER STEEL BEAM CRACK REPAIR AREAS SIMILAR)

IMAGES SHOW TWO EXAMPLES OF CRACKS NEEDING REPAIR. SEE "STEEL BEAM CRACK REPAIR LOCATION TABLE" FOR ALL CRACK REPAIR LOCATIONS.
