**HP12x53 STEEL PILE REPAIR DETAILS**

PROJECT NO. **15BPR.164**  
**BEAUFORT** COUNTY  
TERMINAL: **BAYVIEW**

STATE OF NORTH CAROLINA  
DEPARTMENT OF TRANSPORTATION  
RALEIGH

**STEEL PILE  
REPAIR DETAILS**

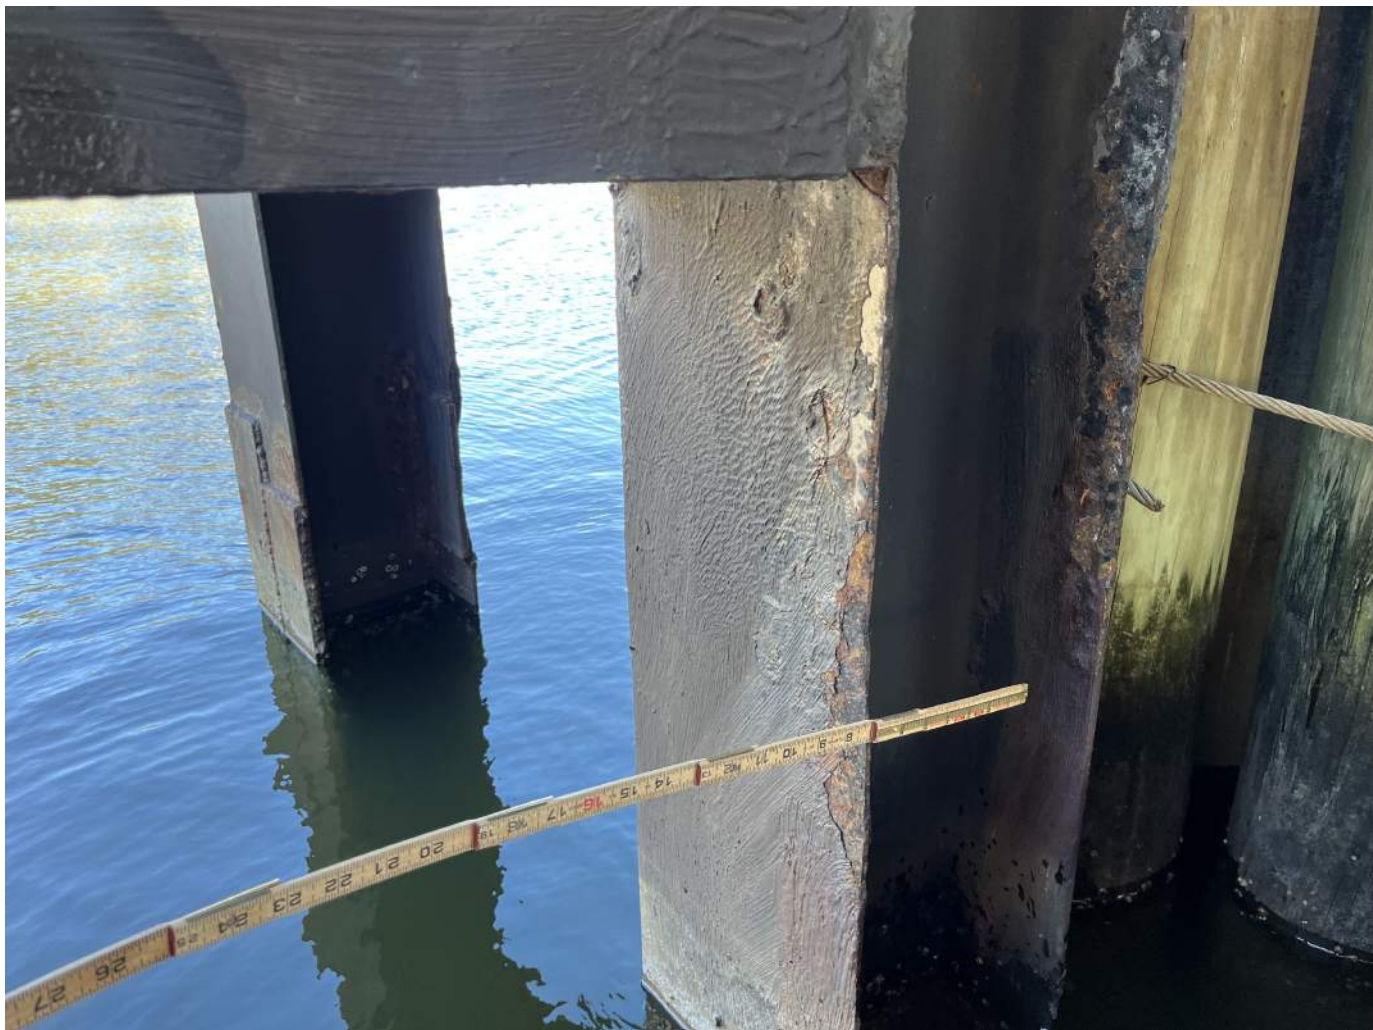
**NORTH FACE OF PILE 4**

| ESTIMATED STEEL PILE REPAIR QUANTITIES | | | | |
|---|---|---|---|---|
| | 4 | WELDED PLATE REPAIR | BETWEEN BRACING & WATERLINE | 87 |

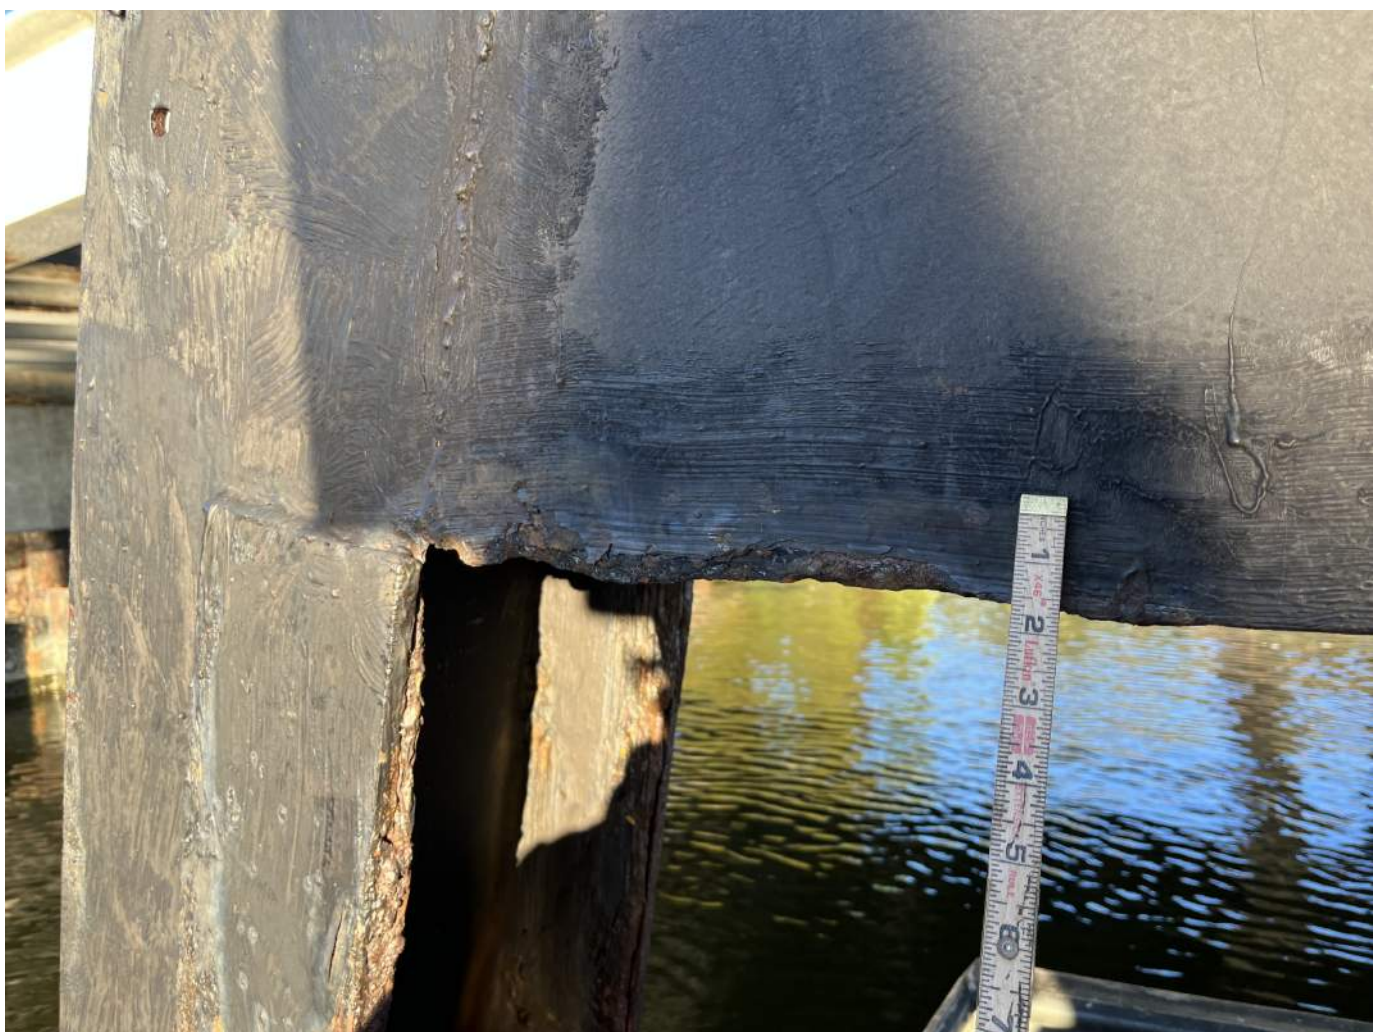
**RIGHT FACE OF P2 TO P5 BRACING**

| ESTIMATED STEEL PILE REPAIR QUANTITIES | | | | |
|---|---|---|---|---|
| | P2-P5 | WELDED PLATE REPAIR | HORIZONTAL BRACING MEMBER REPAIR | 72 |
