PROJECT NO. **15BPR.164**  
**BEAUFORT** COUNTY  
TERMINAL: **AURORA**

STATE OF NORTH CAROLINA  
DEPARTMENT OF TRANSPORTATION  
RALEIGH

## **STEEL BEAM CRACK REPAIR DETAILS**

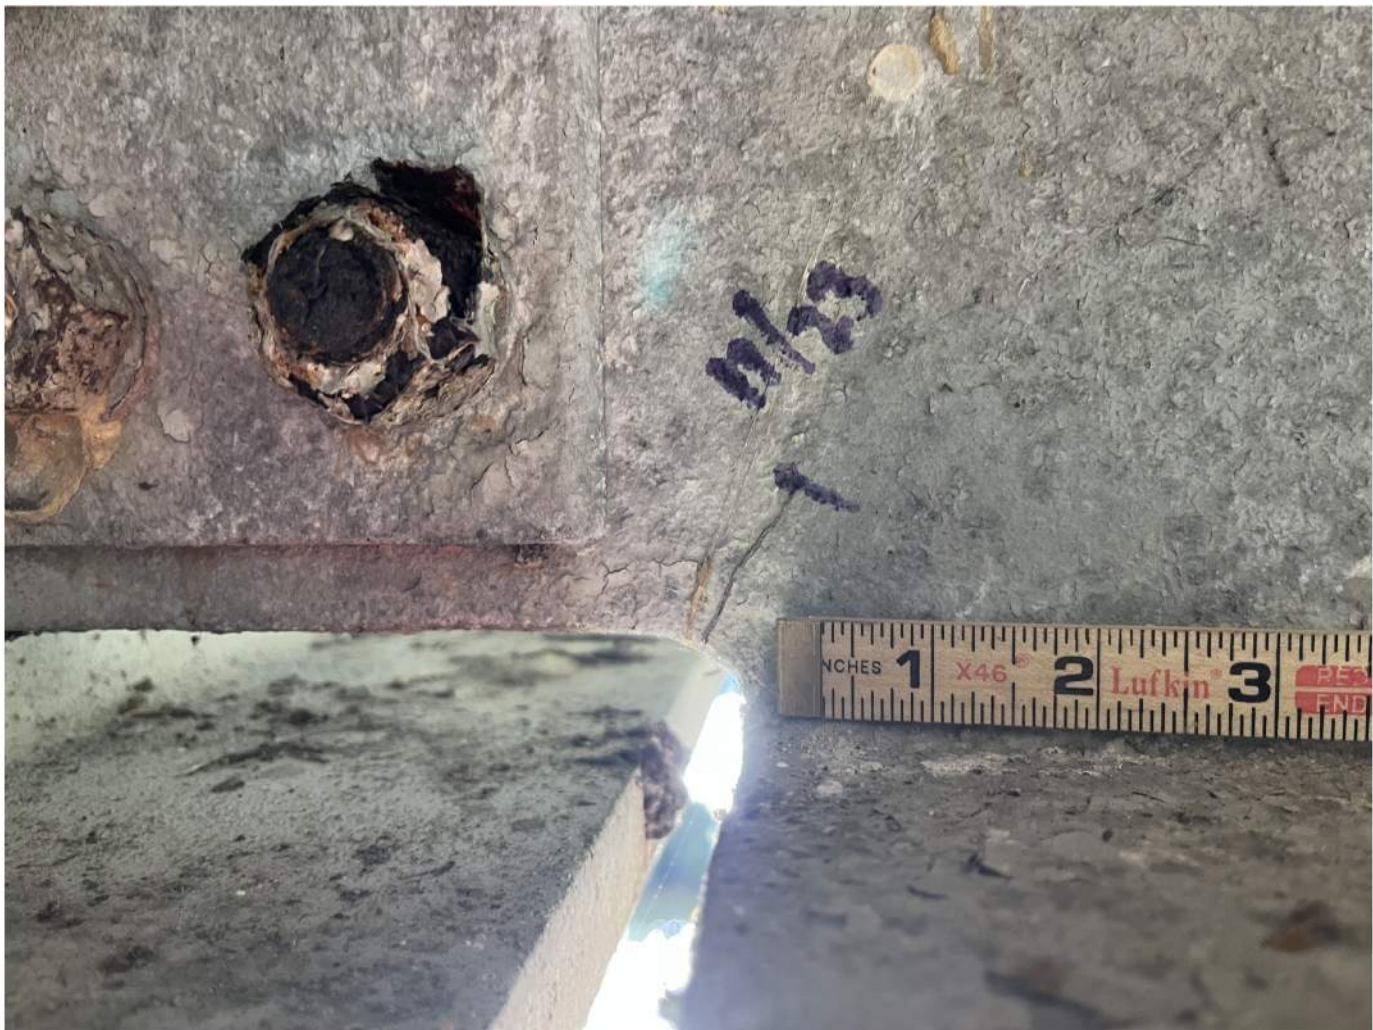
**NORTH FACE OF FLOORBEAM 9**  
**AT GIRDER 2**

(OTHER STEEL BEAM CRACK REPAIR AREAS SIMILAR)

IMAGES ARE TAKEN FROM SPECIAL INSPECTION REPORT DATED 11/02/2023. PRIOR TO BEGINNING ANY REPAIR WORK, FIELD VERIFY EXISTING CONDITIONS. IF EXISTING CONDITIONS VARY SIGNIFICANTLY FROM IMAGES SHOWN, NOTIFY THE ENGINEER IN WRITING PRIOR TO ORDERING MATERIALS OR BEGINNING REPAIR WORK.

IMAGES SHOW TWO EXAMPLES OF CRACKS NEEDING REPAIR. SEE "STEEL BEAM CRACK REPAIR LOCATION TABLE" FOR ALL CRACK REPAIR LOCATIONS.

1. LOCATE THE CRACK TIP USING MAGNETIC PARTICLE TESTING (MT) OR DYE-PENETRANT TESTING (PT). INSPECT BOTH SIDES OF THE PLATE TO ENSURE THE TIP IS NOT MISSED.

2. POSITION MAGNETIC BASED DRILL AS SHOWN RELATIVE TO THE AS-LOCATED CRACK TIP.
3. DRILL HOLE WITH ANNULAR CUTTER.
4. CHECK DRILLED PLATE AND REMOVED CORE FOR EVIDENCE OF CRACK TIP.

5. FOLLOWING REMOVAL OF THE CORE, REINSPECT THE EDGE OF THE DRILLED HOLE USING MT OR PT TO ENSURE THE CRACK TIP DOES NOT REMAIN.
6. SAND THE EDGES OF THE DRILLED HOLE USING AN 80 TO 100 GRIT FLAP WHEEL WITH AN ANGLE GRINDER ON THE EXTERIOR EDGES AND AN 80 TO 100 GRIT FLAP WHEEL WITH DIE GRINDER ON THE INTERIOR EDGES.

7. CLEAN AND PREPARE THE REPAIR AREA FOR FINISHING.
8. INSTALL 1-INCH DIA. BOLT WITH WASHER ON EACH WEB FACE.
9. PAINT THE EXPOSED STEEL AND CONNECTION COMPONENTS IN THE REPAIR AREA IN ACCORDANCE WITH SECTION 442-12 OF THE STANDARD SPECIFICATIONS, USING PAINT SYSTEM 4 FROM NCDOT'S STRUCTURAL STEEL SHOP COATINGS PROGRAM DOCUMENT, WITH TOPCOAT COLOR MATCHED TO THE EXISTING TOPCOAT COLOR.

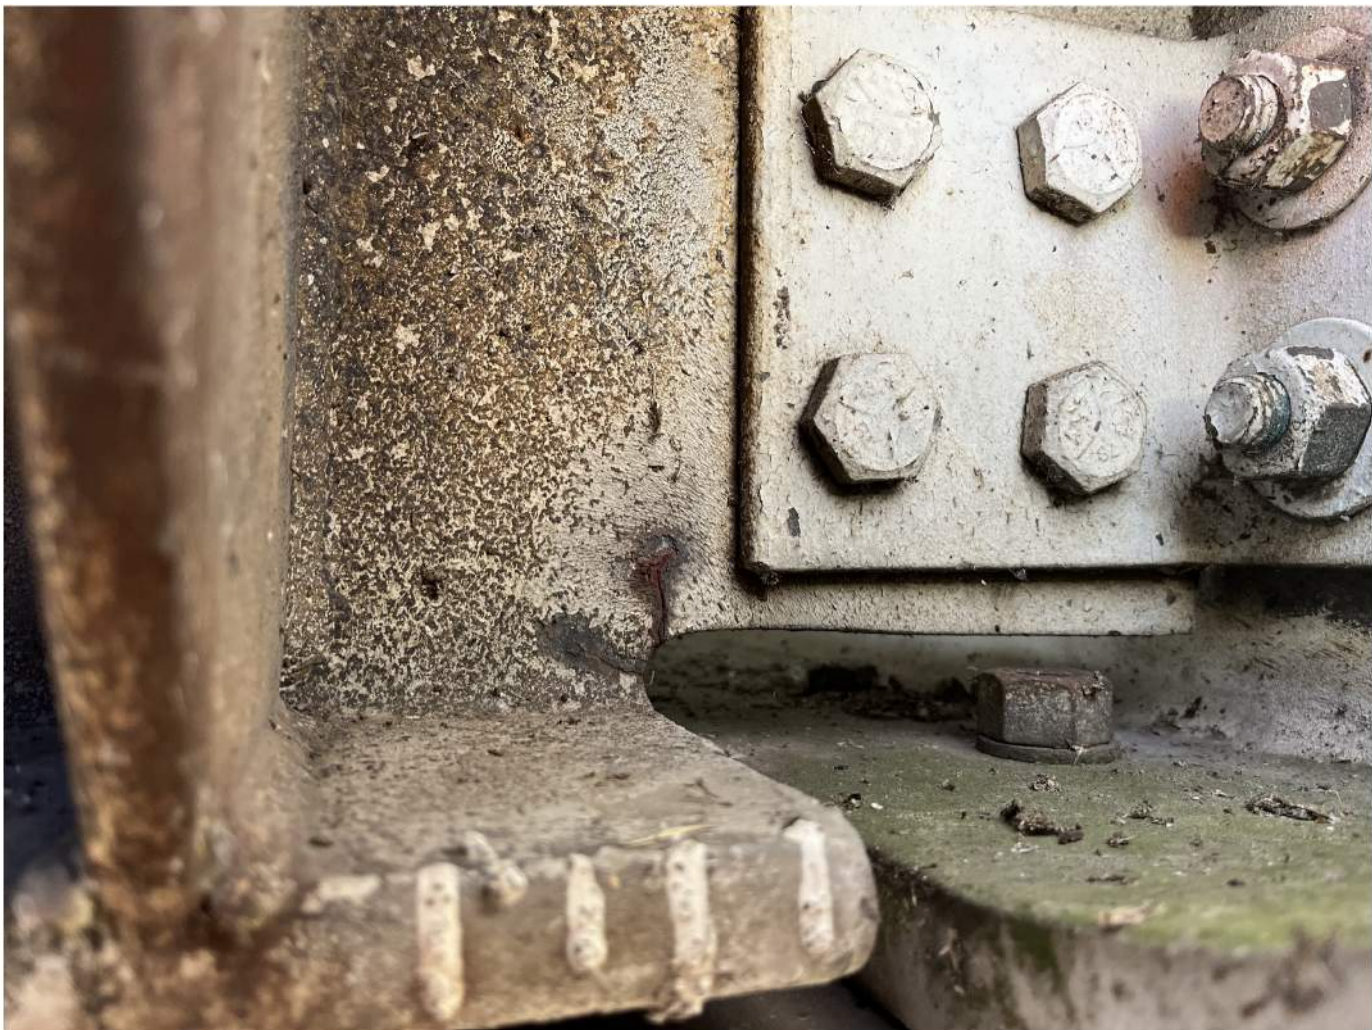
**NORTH FACE OF FLOORBEAM 11**  
**AT GIRDER 1**

(OTHER STEEL BEAM CRACK REPAIR AREAS SIMILAR)
