HP12x53 STEEL PILE REPAIR DETAILS

PROJECT NO. **15BPR.164**  
**BEAUFORT** COUNTY  
TERMINAL: **AURORA**

| STATE OF NORTH CAROLINA<br>DEPARTMENT OF TRANSPORTATION<br>RALEIGH | | | | | |
|---|---|---|---|---|---|
| BENT 1<br>STEEL PILE<br>REPAIR DETAILS | | | | | |
| SHEET NO. S1-05 | | | | | TOTAL SHEETS 34 |

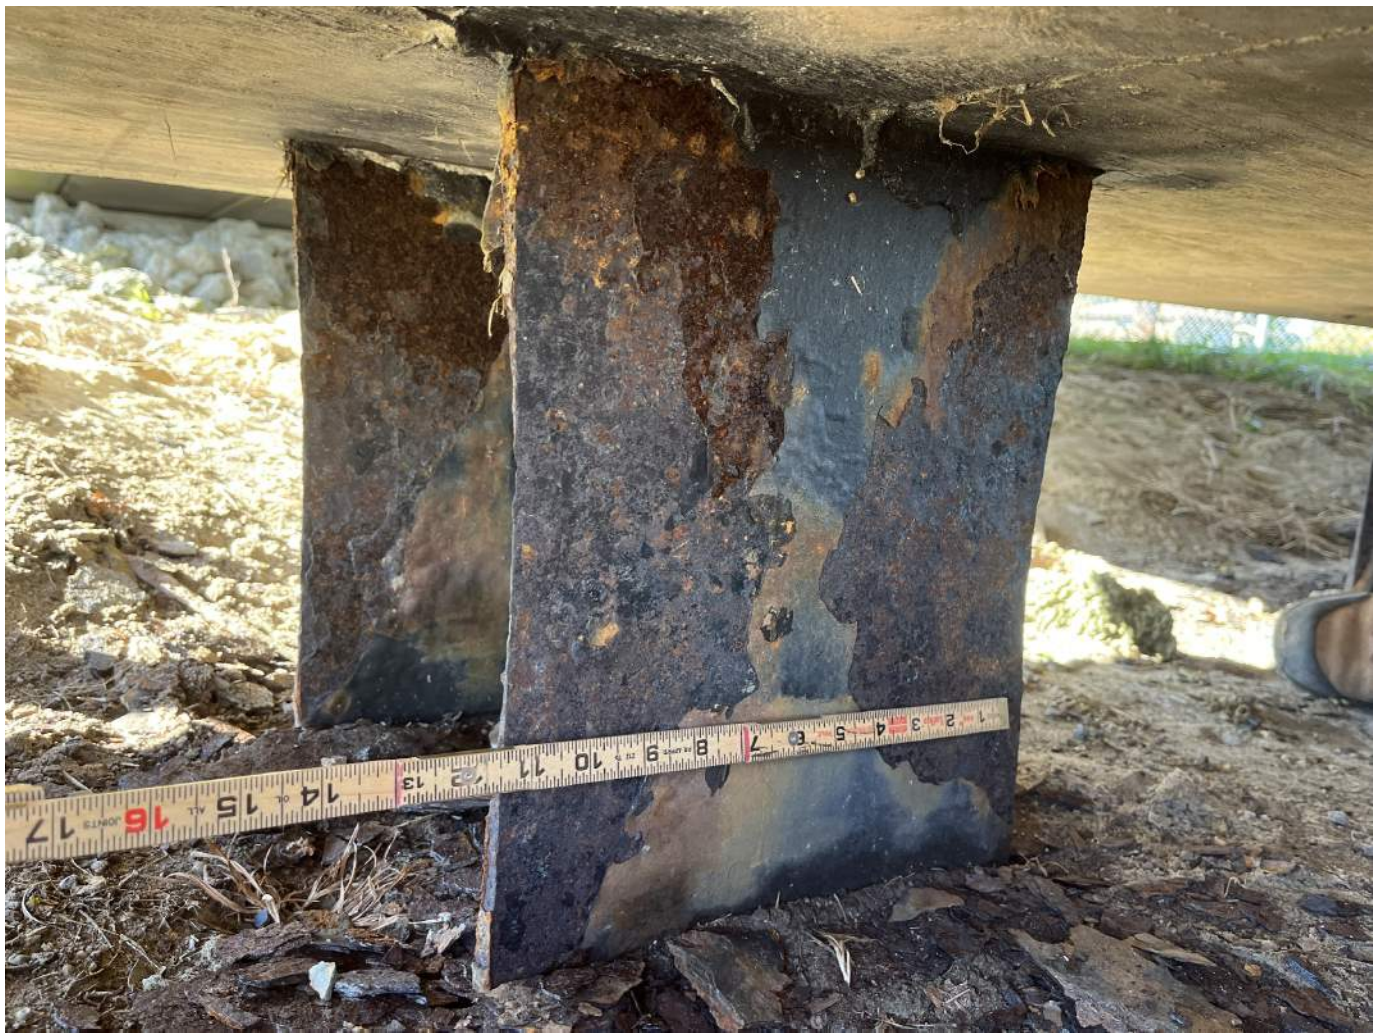
IMAGE OF PILE 4

(OTHER PILES SIMILAR)

IMAGES ARE TAKEN FROM SPECIAL INSPECTION REPORT DATED 11/02/2023. PRIOR TO BEGINNING ANY REPAIR WORK, FIELD VERIFY EXISTING CONDITIONS. IF EXISTING CONDITIONS VARY SIGNIFICANTLY FROM IMAGES SHOWN, NOTIFY THE ENGINEER IN WRITING PRIOR TO ORDERING MATERIALS OR BEGINNING REPAIR WORK.

| ESTIMATED STEEL PILE REPAIR QUANTITIES | | | | |
|---|---|---|---|---|
| | 4 | WELDED PLATE REPAIR | FULL HEIGHT OF EXPOSED PILE | 82 |

\* LOSSES IN EXCESS OF 33% TO ANY PILE FLANGE OR WEB SHALL BE DEFINED AS "SIGNIFICANT", PROMPTING REQUIREMENT OF WELDED STEEL PILE REPAIR MATERIAL AS SHOWN. MATERIAL SHALL BE INSTALLED AT DIMENSIONS SHOWN, SUBJECT TO ASSOCIATED LIMITS. RESULTING TOTAL CROSS-SECTIONAL AREA OF ANY REPAIRED FLANGE (OR WEB) SHALL EQUAL OR EXCEED THE AS-FABRICATED FLANGE (OR WEB) AREA PER ORIGINAL PILE DESIGNATION DIMENSIONS.

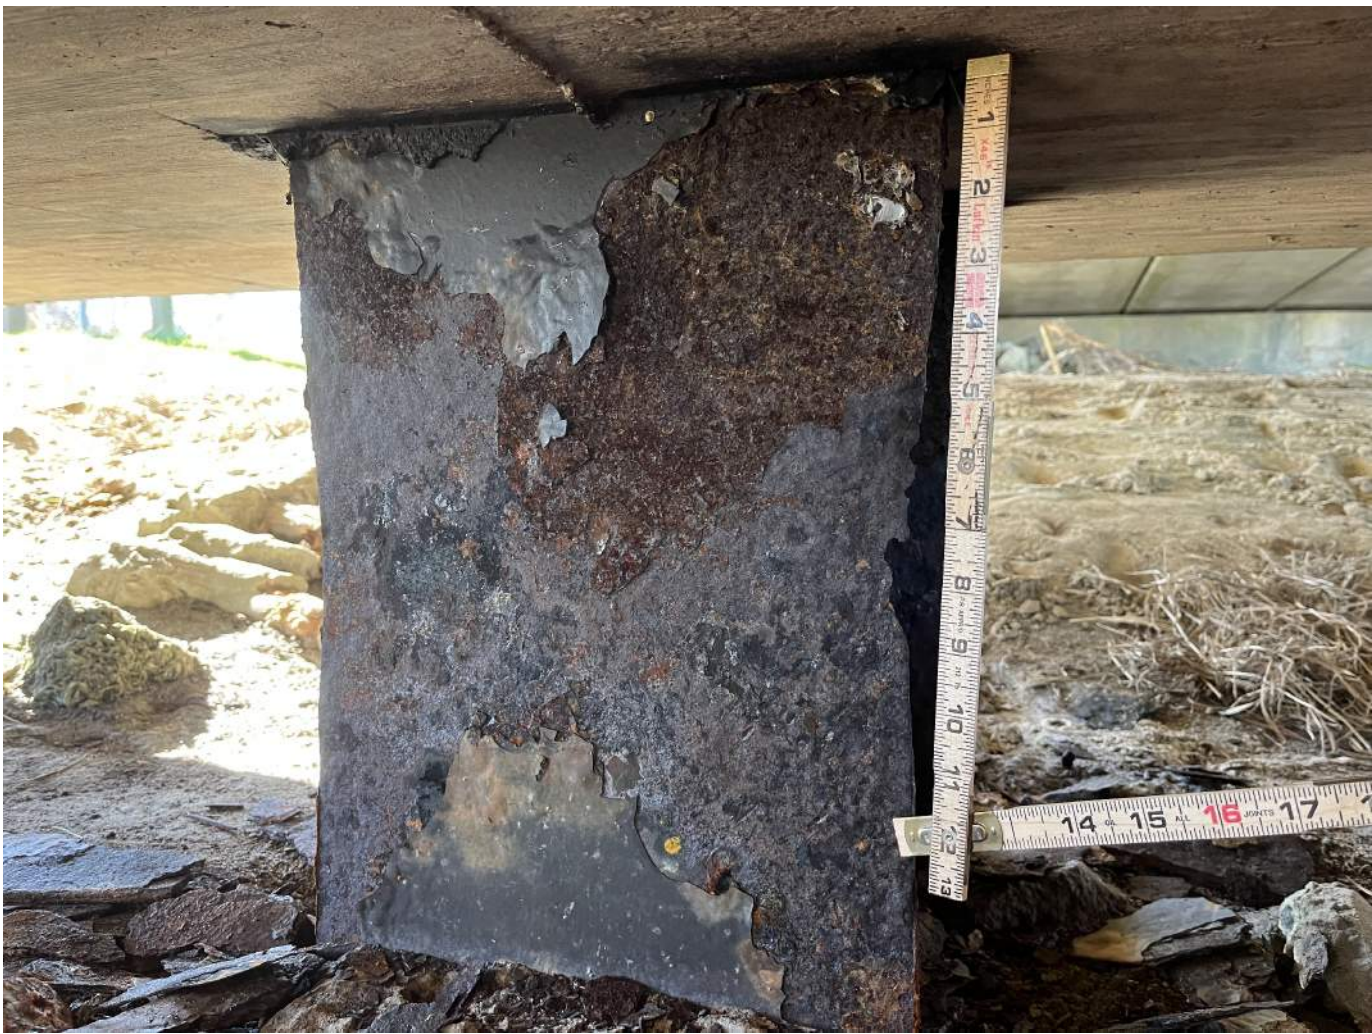
IMAGE OF PILE 3

(OTHER PILES SIMILAR)

| ESTIMATED STEEL PILE REPAIR QUANTITIES | | | | |
|---|---|---|---|---|
| | 3 | WELDED PLATE REPAIR | FULL HEIGHT OF EXPOSED PILE | 67 |

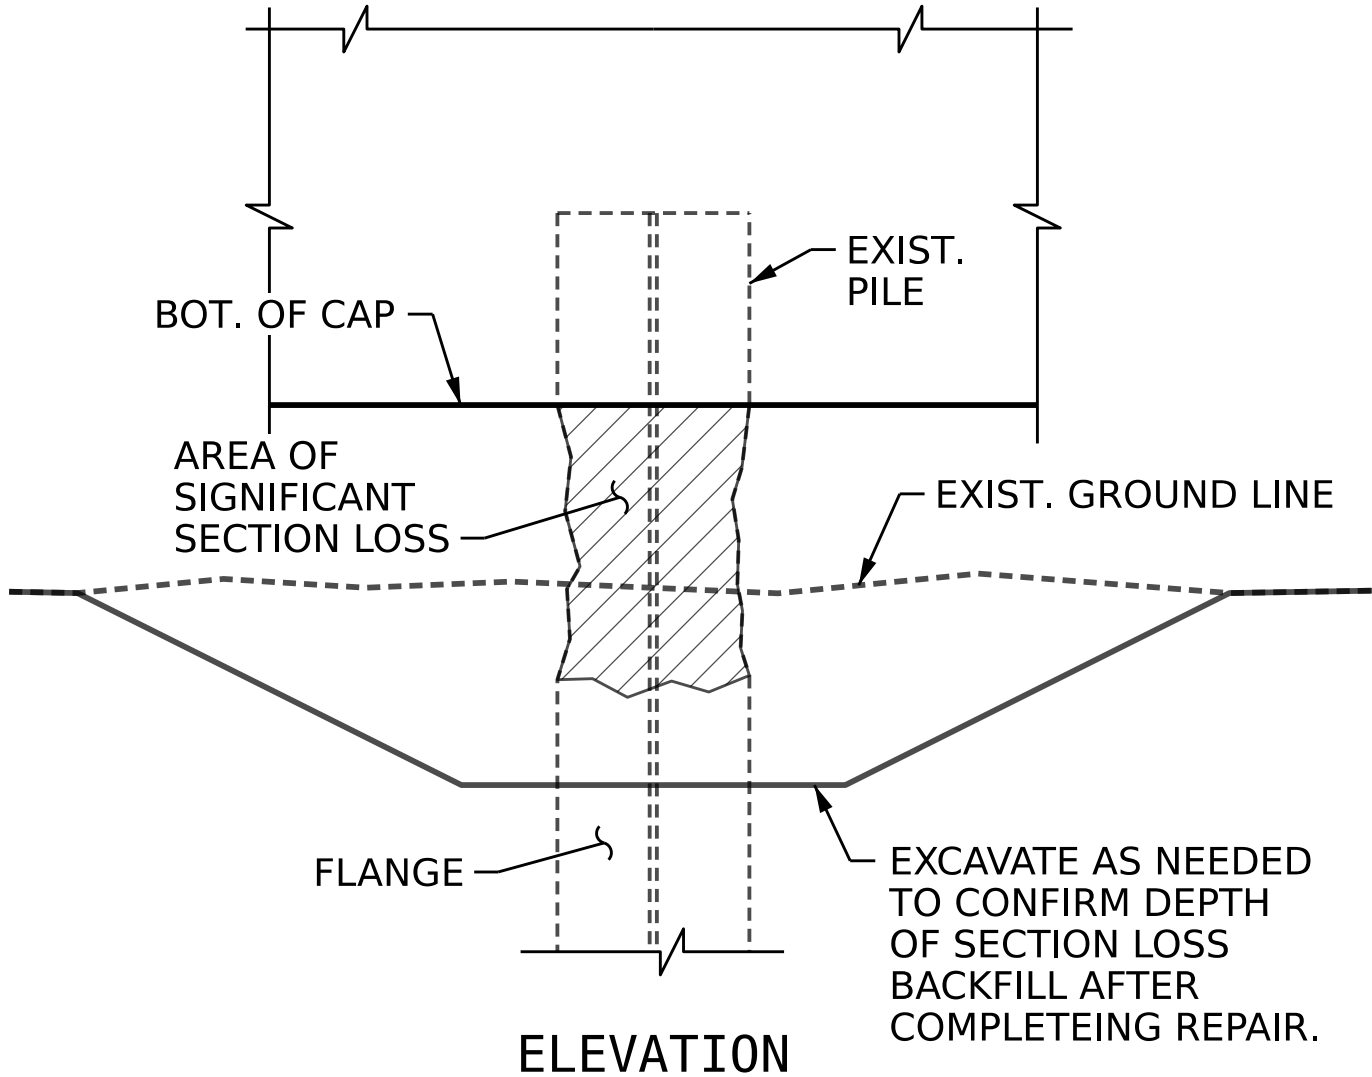
ELEVATION

EXISTING CONDITION
