PROJECT NO. **15BPR.164**  
**BEAUFORT** COUNTY  
TERMINAL: **AURORA**

STATE OF NORTH CAROLINA  
DEPARTMENT OF TRANSPORTATION  
RALEIGH

**BENT 2  
STEEL PILE  
REPAIR DETAILS**

| REVISIONS | | | | | | SHEET NO.<br>S1-06 |

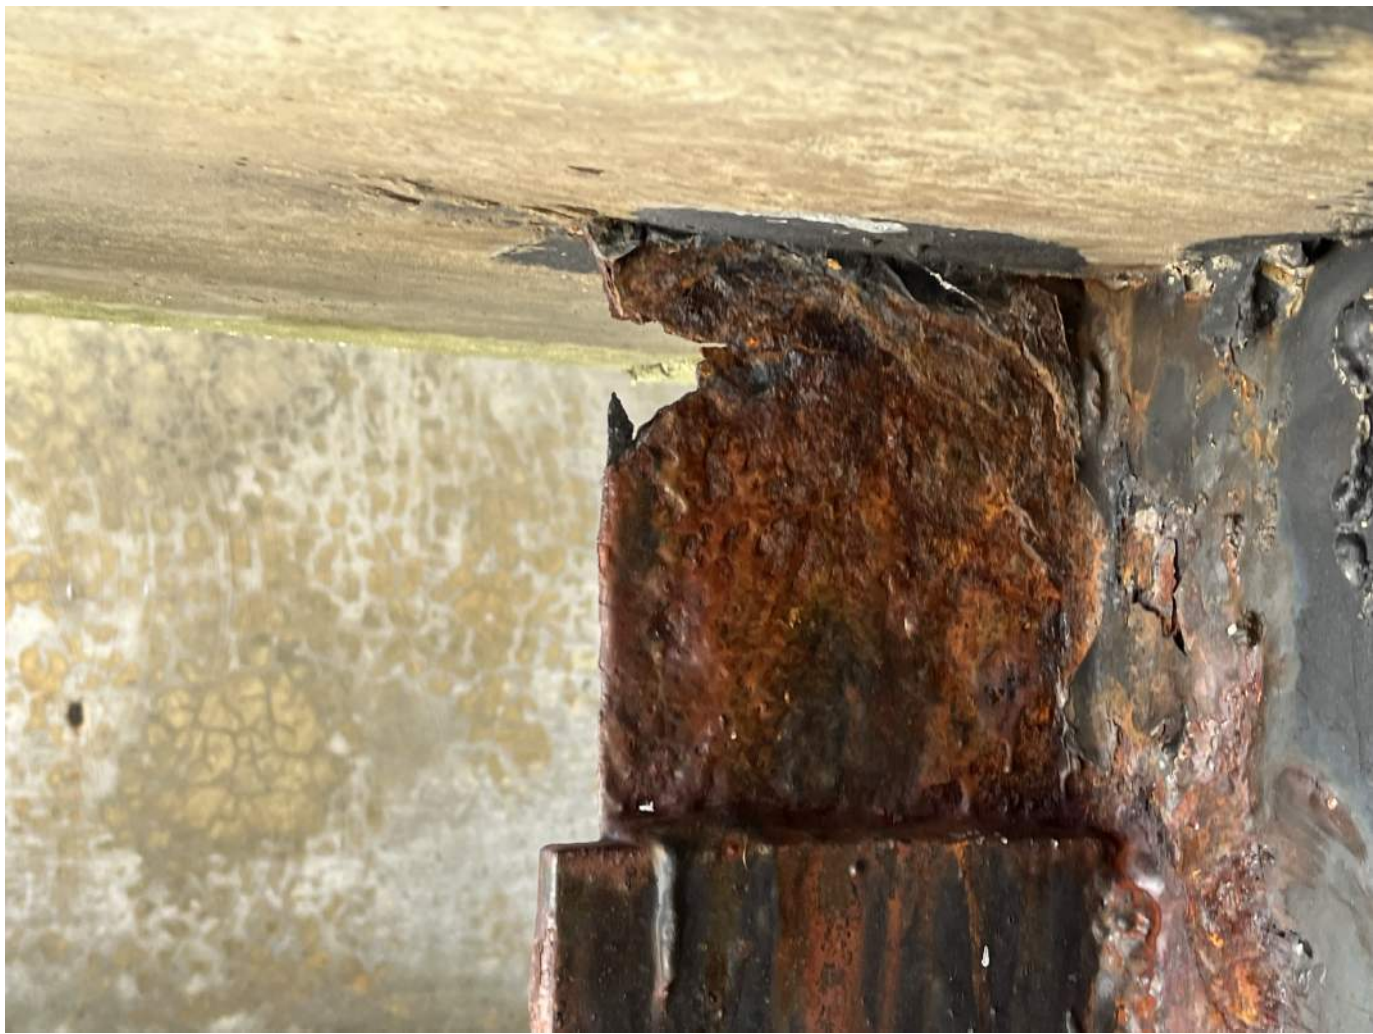
SOUTH FACE OF PILE 4

| ESTIMATED STEEL PILE REPAIR QUANTITIES | | | | QUANTITY (LBS.) |
|---|---|---|---|---|
| | 4 | WELDED PLATE REPAIR | ABOVE & BELOW EXISTING REPAIR PLATE | 72 |

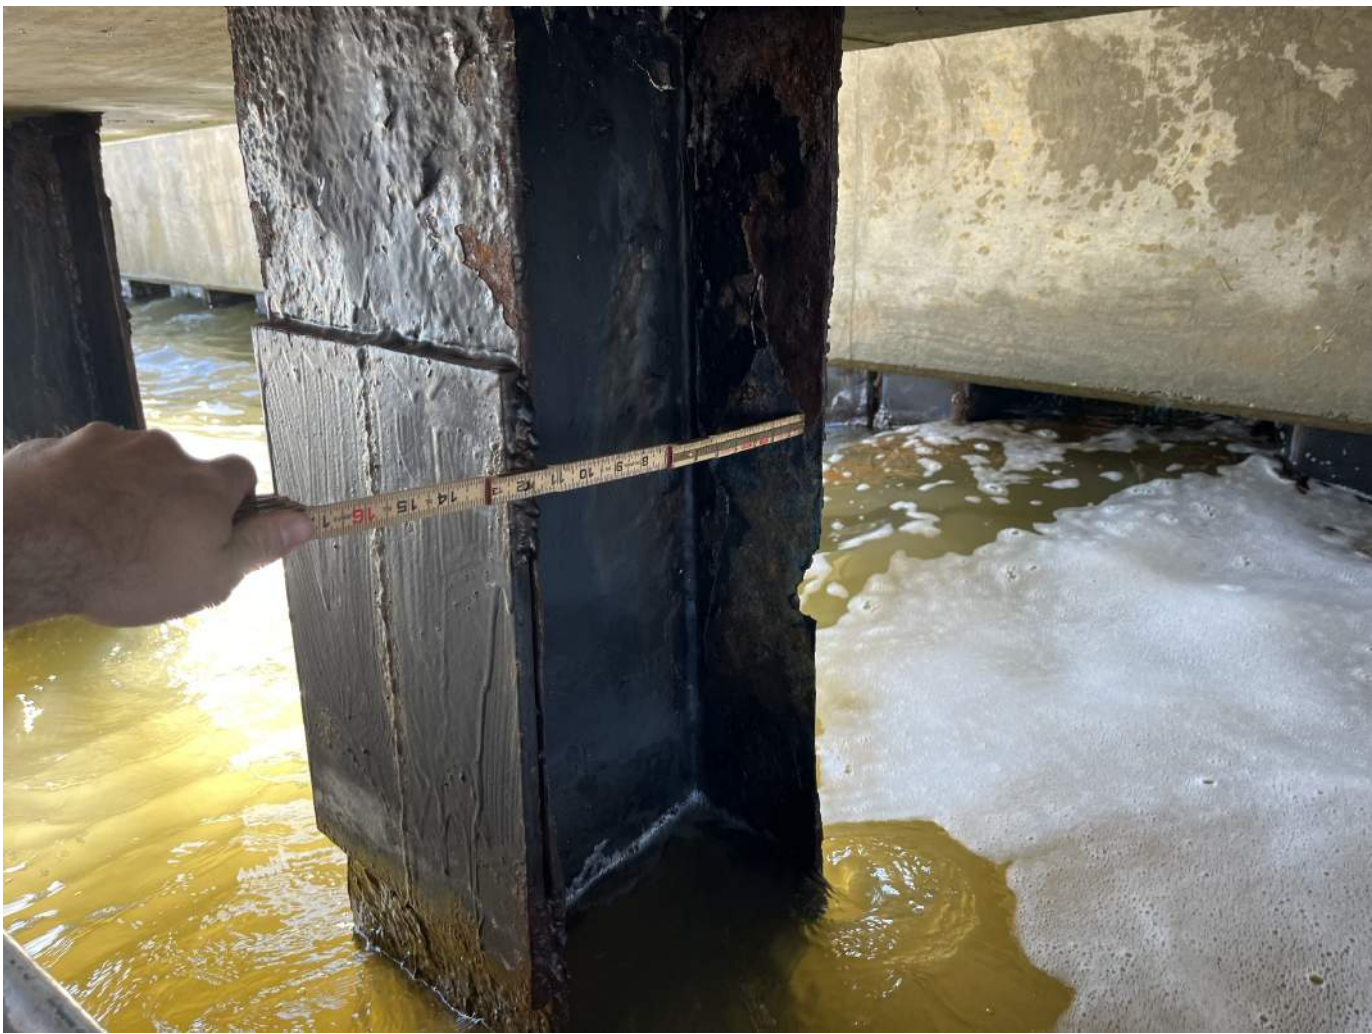
LEFT SIDE OF PILE 3

| ESTIMATED STEEL PILE REPAIR QUANTITIES | | | | QUANTITY (LBS.) |
|---|---|---|---|---|
| | 3 | WELDED PLATE REPAIR | ABOVE & BELOW EXISTING REPAIR PLATE, AT WATERLINE | 72 |

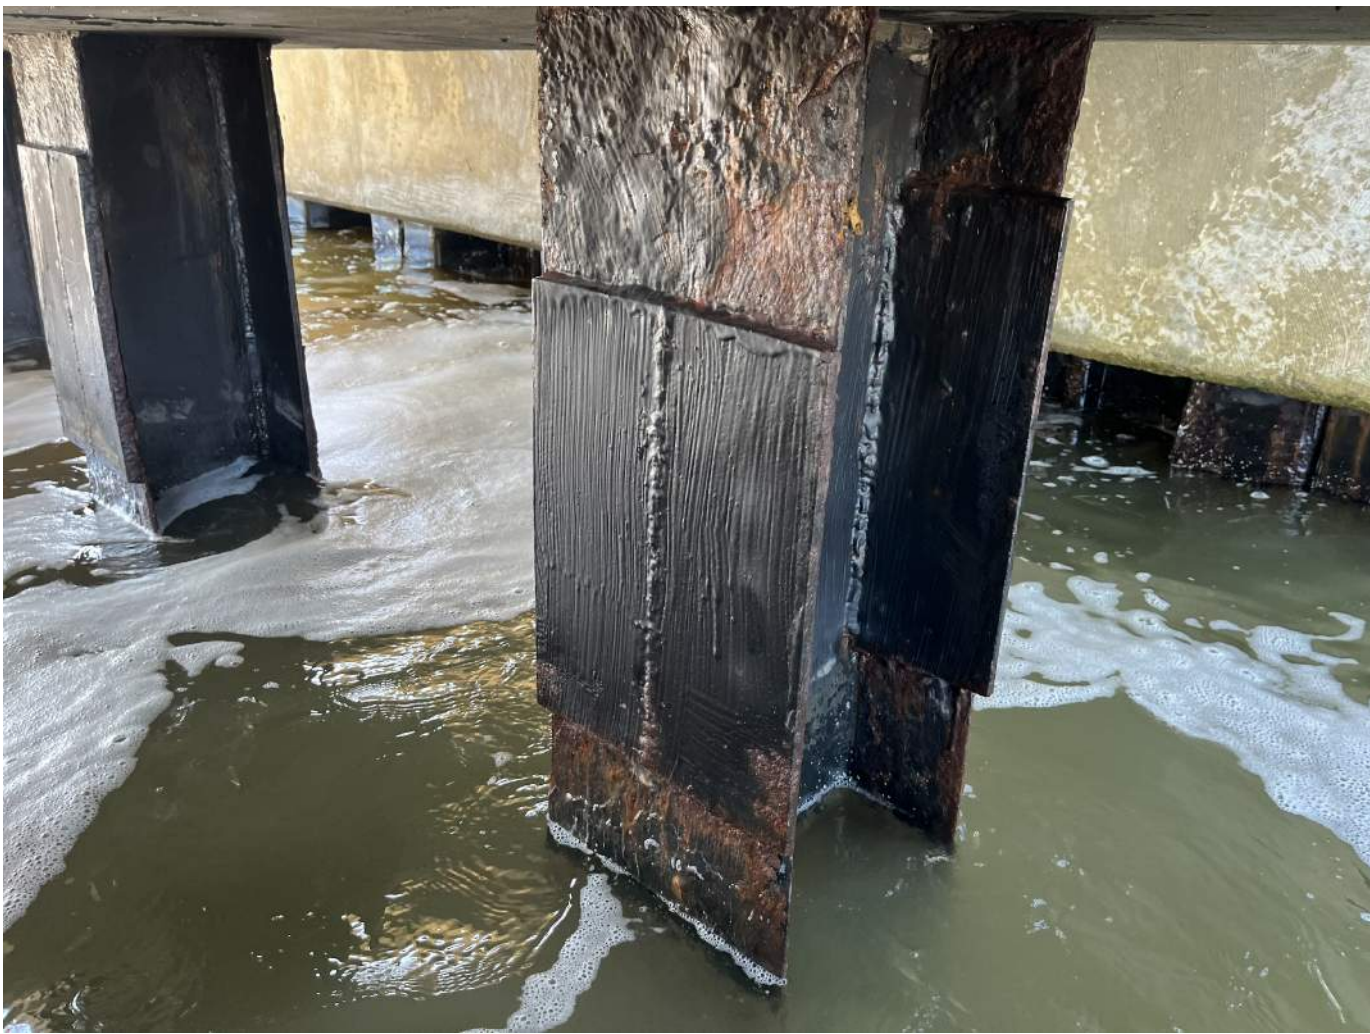
NORTH FACE OF PILE 1

| ESTIMATED STEEL PILE REPAIR QUANTITIES | | | | QUANTITY (LBS.) |
|---|---|---|---|---|
| 2 | 1 | WELDED PLATE REPAIR | ABOVE & BELOW EXISTING REPAIR PLATE, AT WATERLINE | 87 |
