# Underwater Inspection Report

## NC306 Ferry (South Terminal)

**Bridge: 060321**  
**Upstream Fascia**

**Aurora, North Carolina**  
**November 2, 2023**

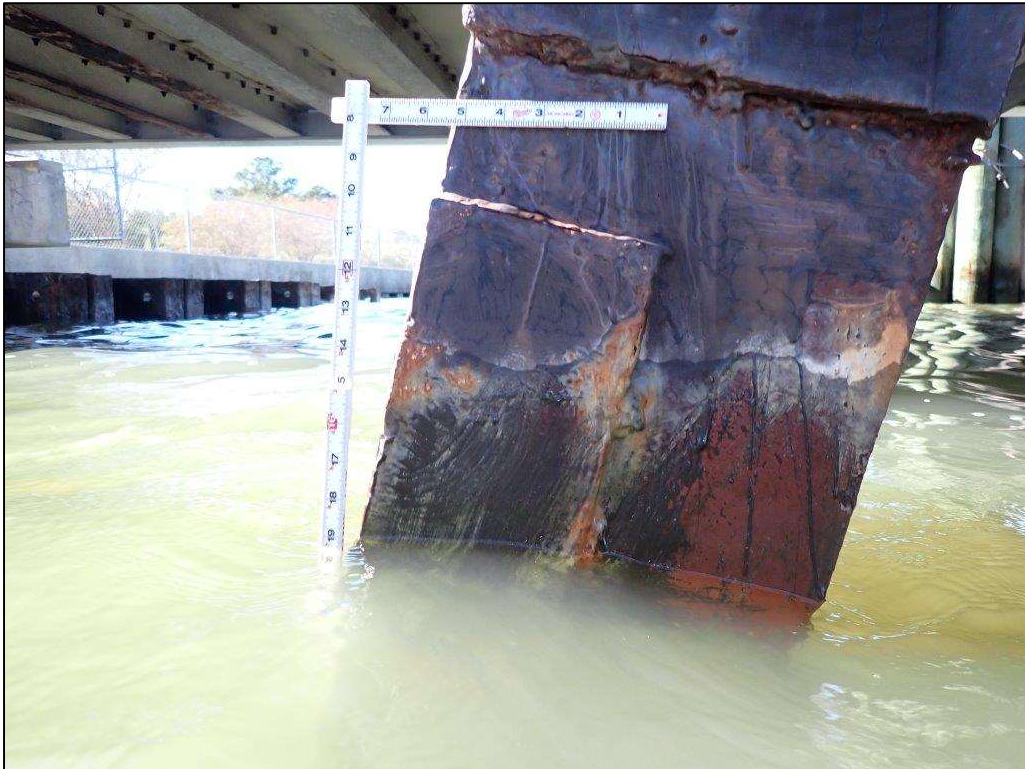
Photo 10: Typical Repair Plate, End Bent 2, Pile 2, Shown

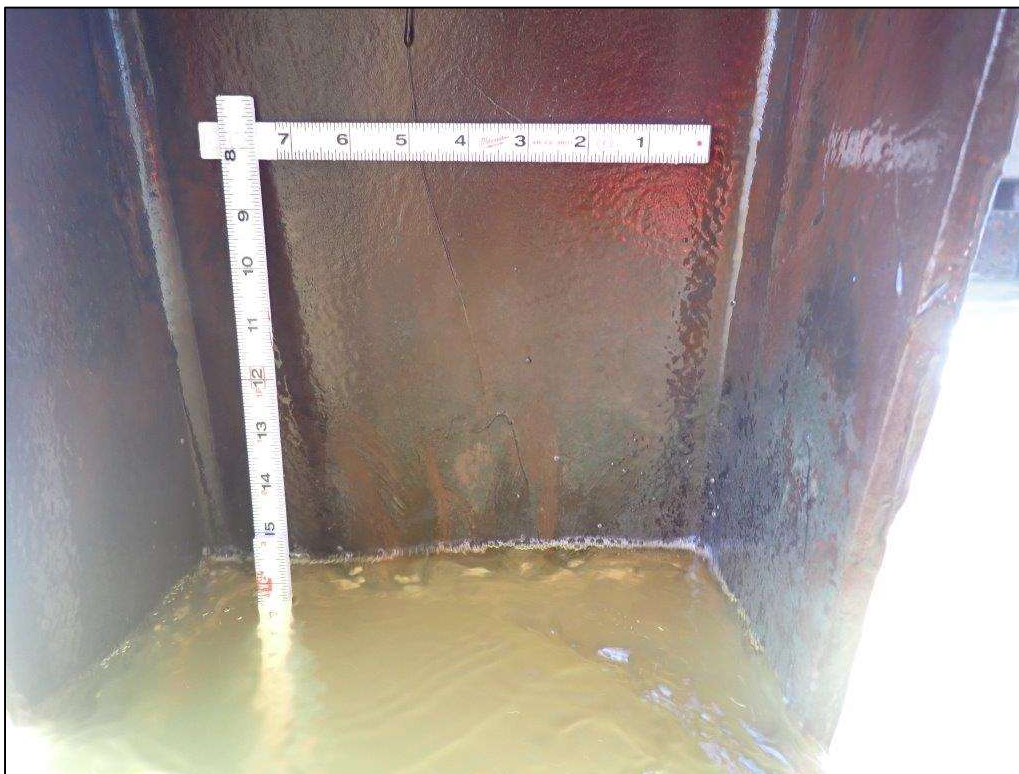
Photo 11: Typical Steel Pile Condition Above Waterline, End Bent 2, Pile 2

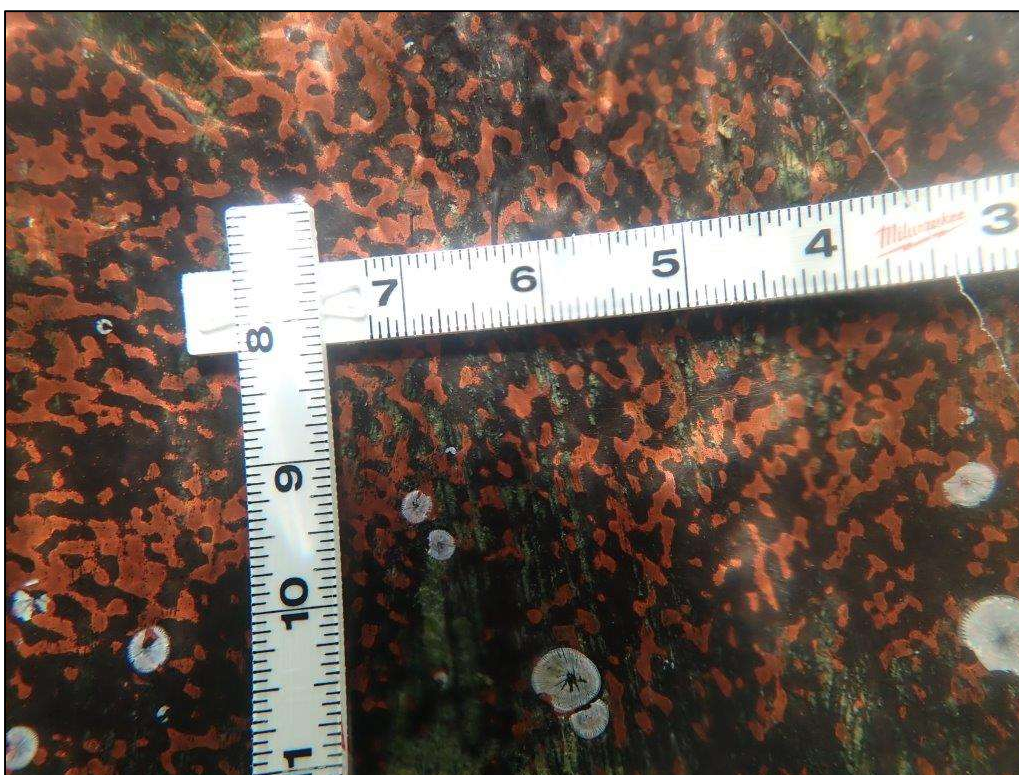
Photo 12: Typical Steel Pile Condition Below Waterline, End Bent 2, Pile 2

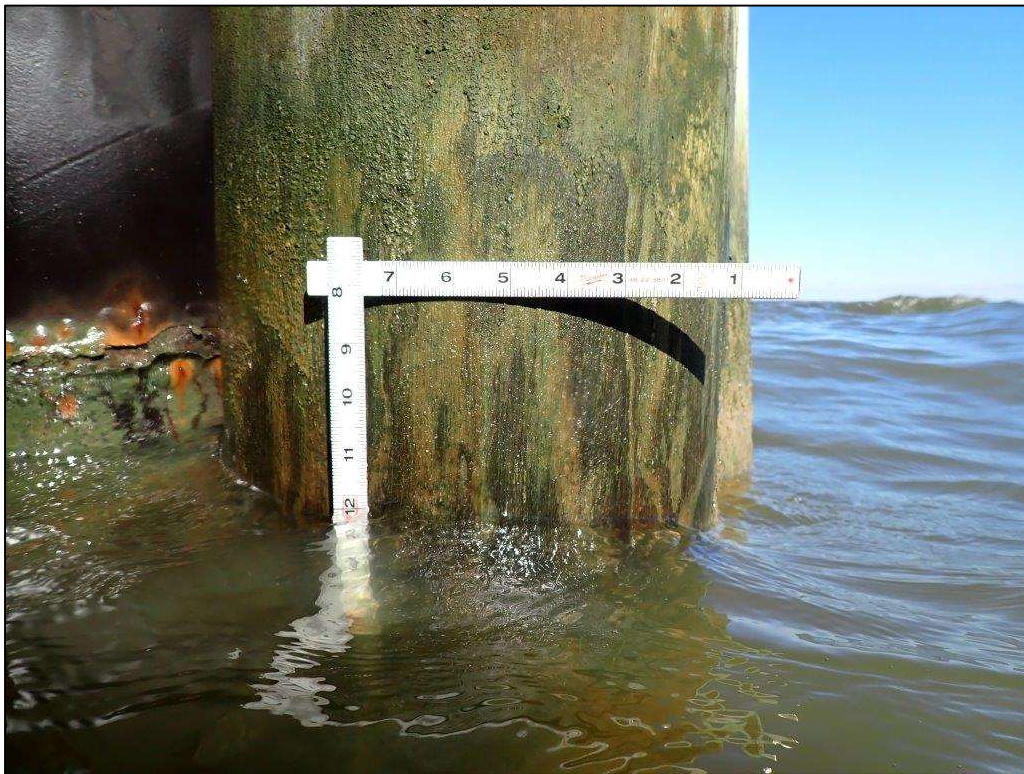
Photo 13: Typical Timber Dolphin Condition Above Waterline, Dolphin 2

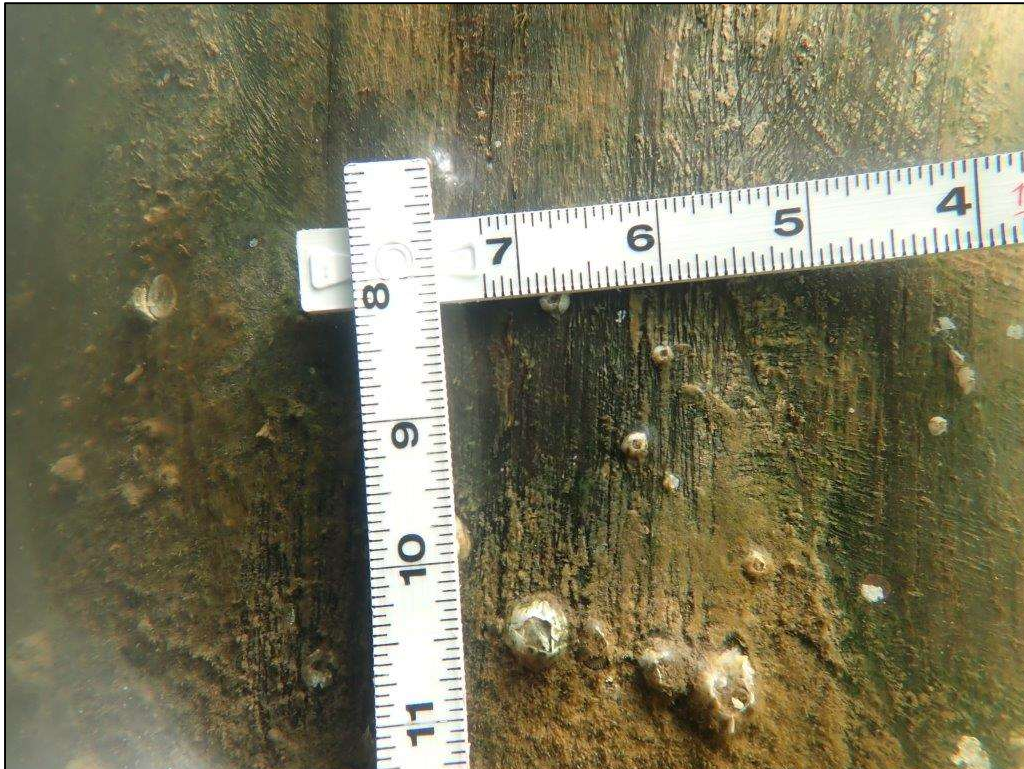
Photo 14: Typical Timber Dolphin Condition Below Waterline, Dolphin 2

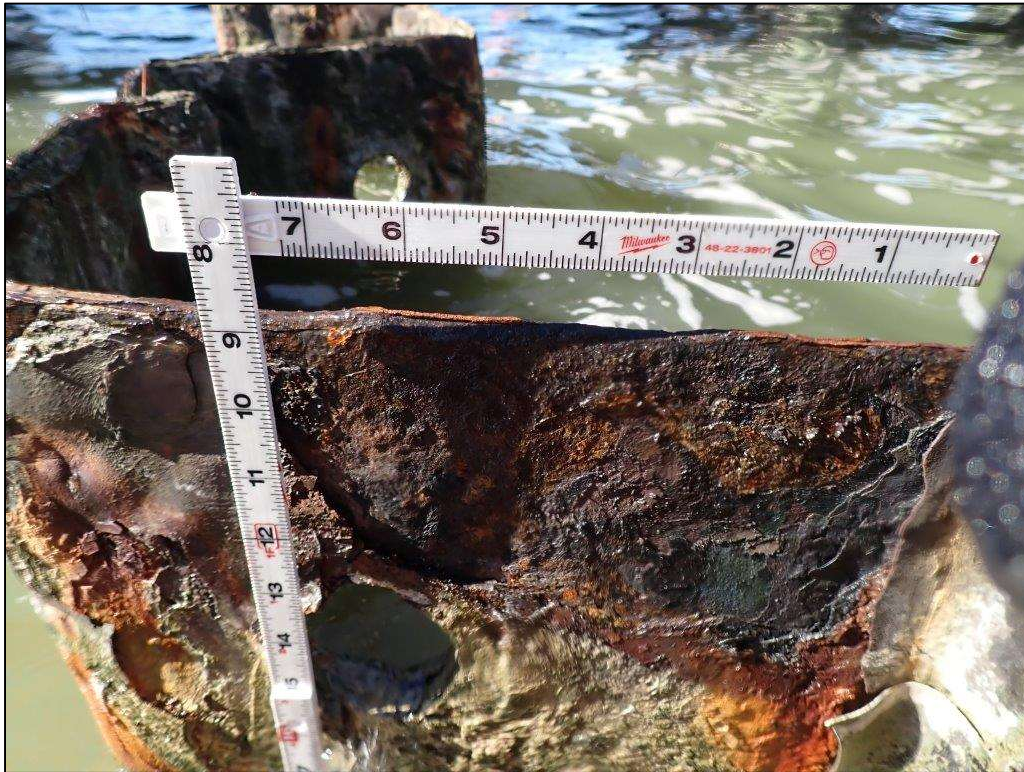
Photo 15: Typical Steel Splash Wall Condition Above Waterline

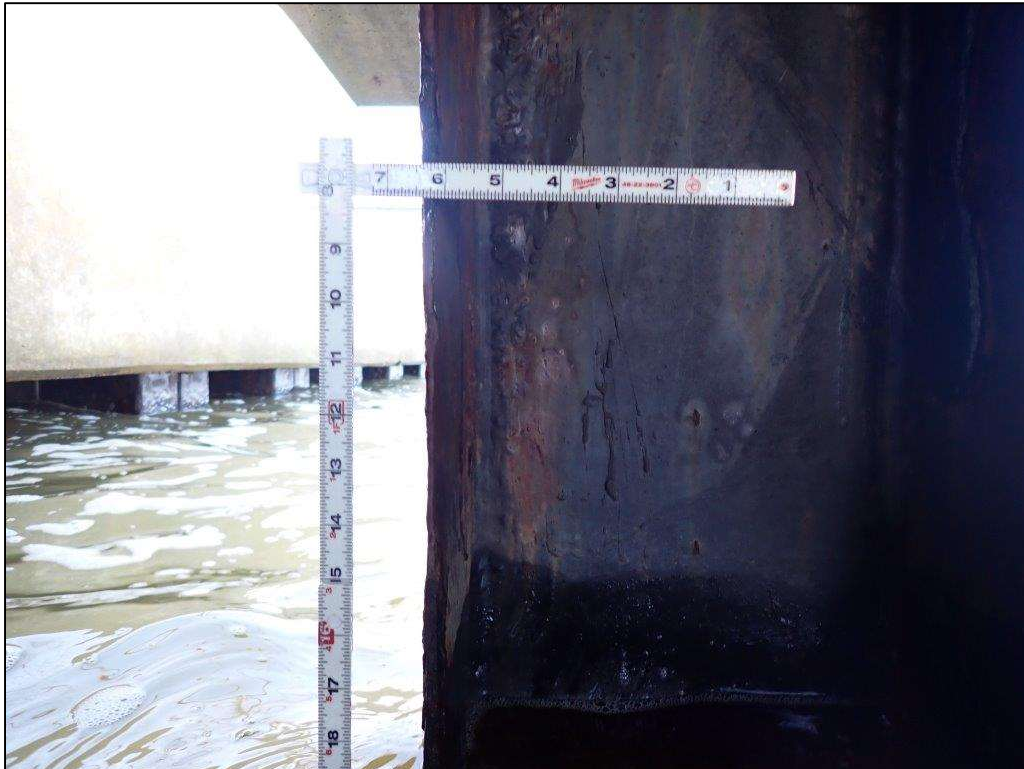
- All piles, from cap to channel bottom, all flanges, corrosion with section loss. Refer to Table 4 for representative steel section measurements at Pile 4.
- All piles, from cap to channel bottom, protective coating is peeling.
- Pile 1, southeast flange, from waterline to cap, corrosion with section loss and knife edging, 0.232 in. remaining section (Photo 16).
- Pile 3, southwest flange, from waterline to cap, corrosion with section loss, 0.208 in. remaining section (Photo 17).

Photo 16: Bent 2, Pile 1, Southeast Flange, Knife Edging

- Clean and coat or encase all piles in Bent 2 and End Bent 2.
- Replace all decayed dolphin fenders.
- Replace severed steel cables at Dolphins 4, 9, and 10.

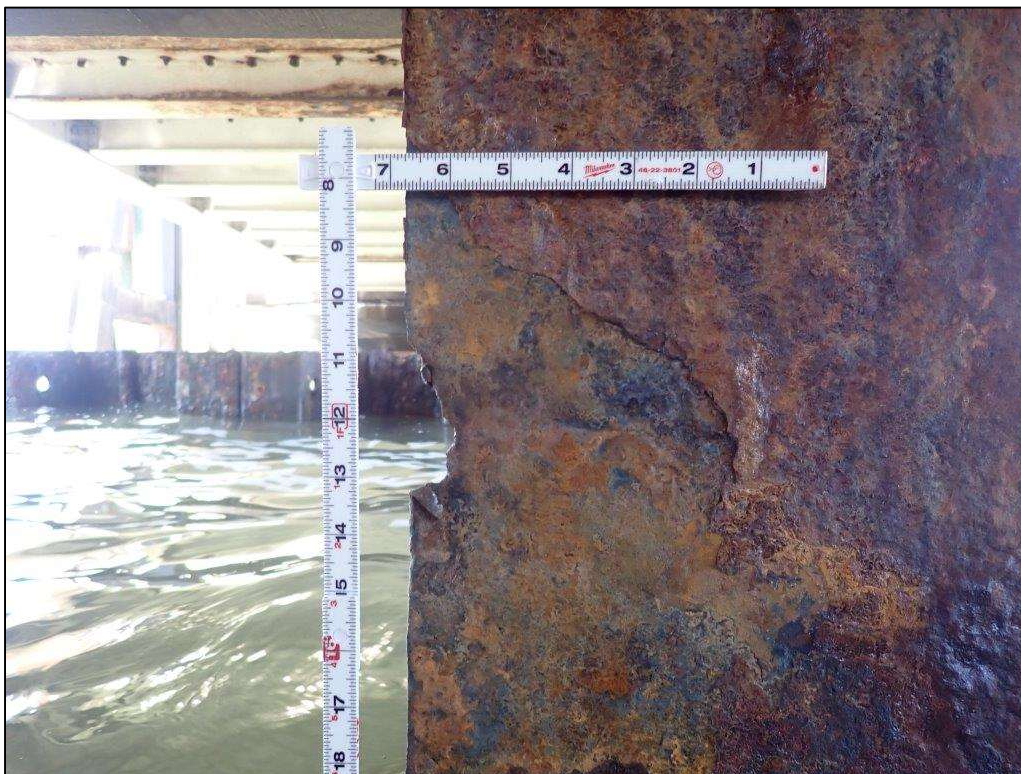
Photo 17: Bent 2, Pile 3, Southwest Flange, Section Loss

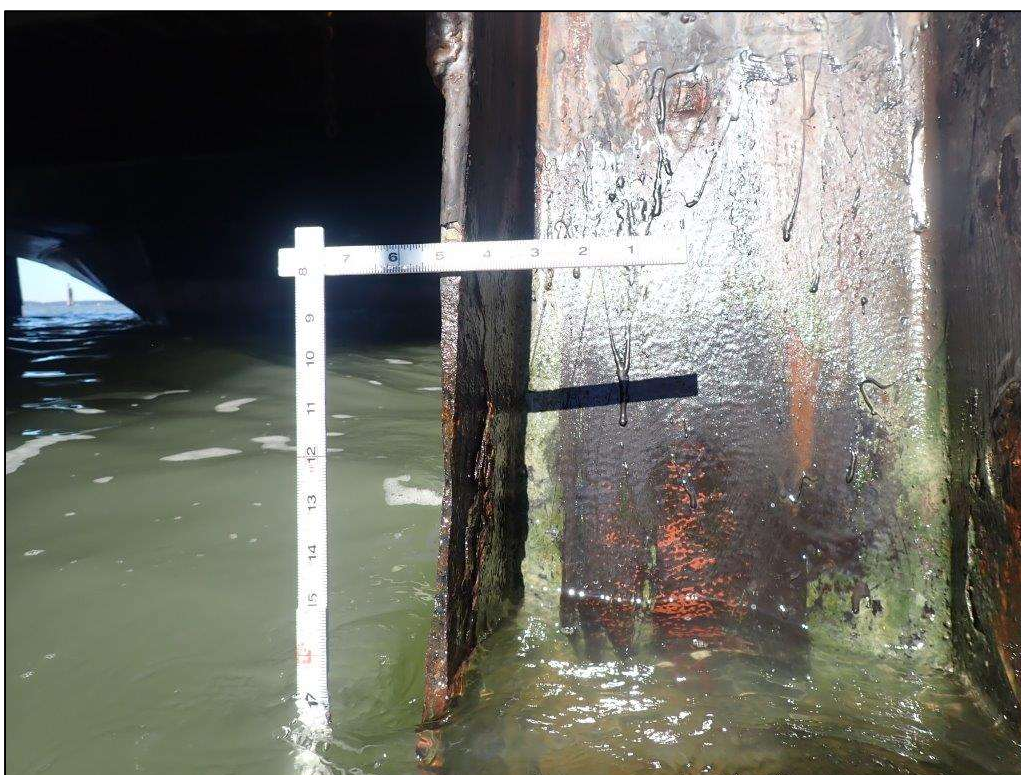
- All piles, from cross bracing to 1 ft. below waterline, all flanges, corrosion with up to 1/16 in. section loss. Refer to Table 4 for representative steel section measurements at Piles 2 and 3.
- All piles, along flange edges, isolated areas of section loss from construction damage, up to 3 in. high x 1/2 in. wide.
- Pile 2, southwest flange, from high watermark to channel bottom, corrosion with section loss, 0.335 in. remaining section (Photo 18).
- Pile 3, northeast flange, from waterline to cross bracing, corrosion with section loss and knife edging, 0.350 in. remaining section (Photo 19).
- Pile 3, northwest flange, from waterline to cross bracing, corrosion with section loss, 1/16 in. remaining at edge (Photo 20).
- Pile 4, northwest and southwest flanges, from 1.5 ft. above to 1 ft. below waterline, corrosion with section loss, 0.293 in. remaining section (Photo 21).

Photo 18: End Bent 2, Pile 2, Southwest Flange, Section Loss

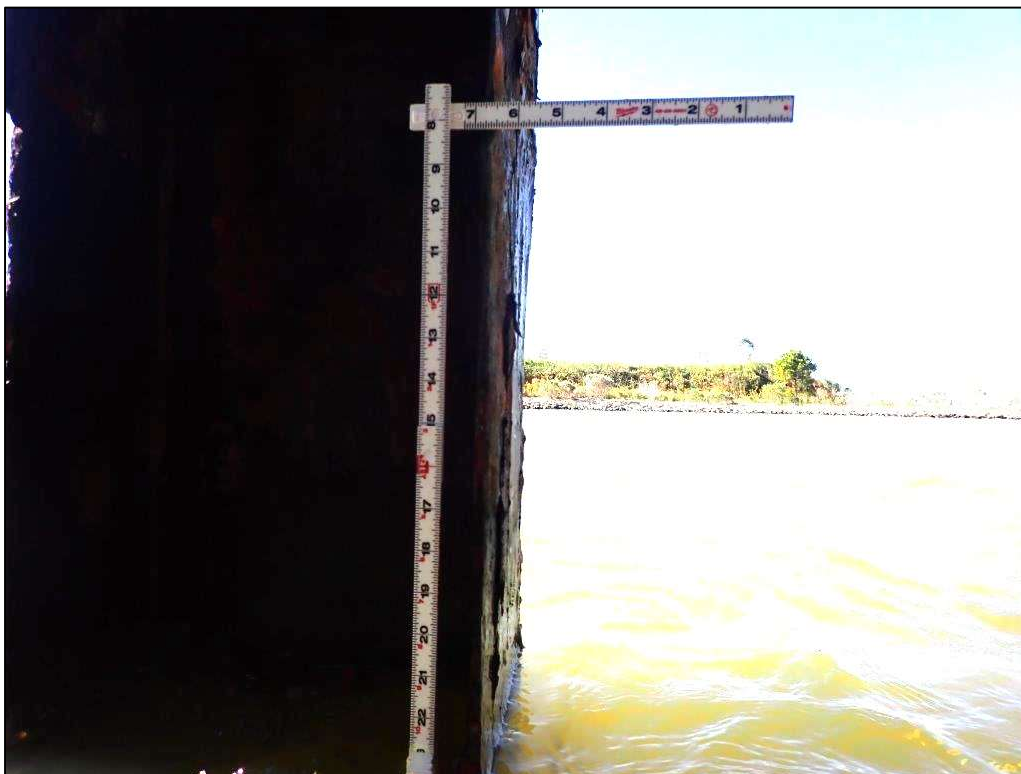
Photo 19: End Bent 2, Pile 3, Northeast Flange, Section Loss

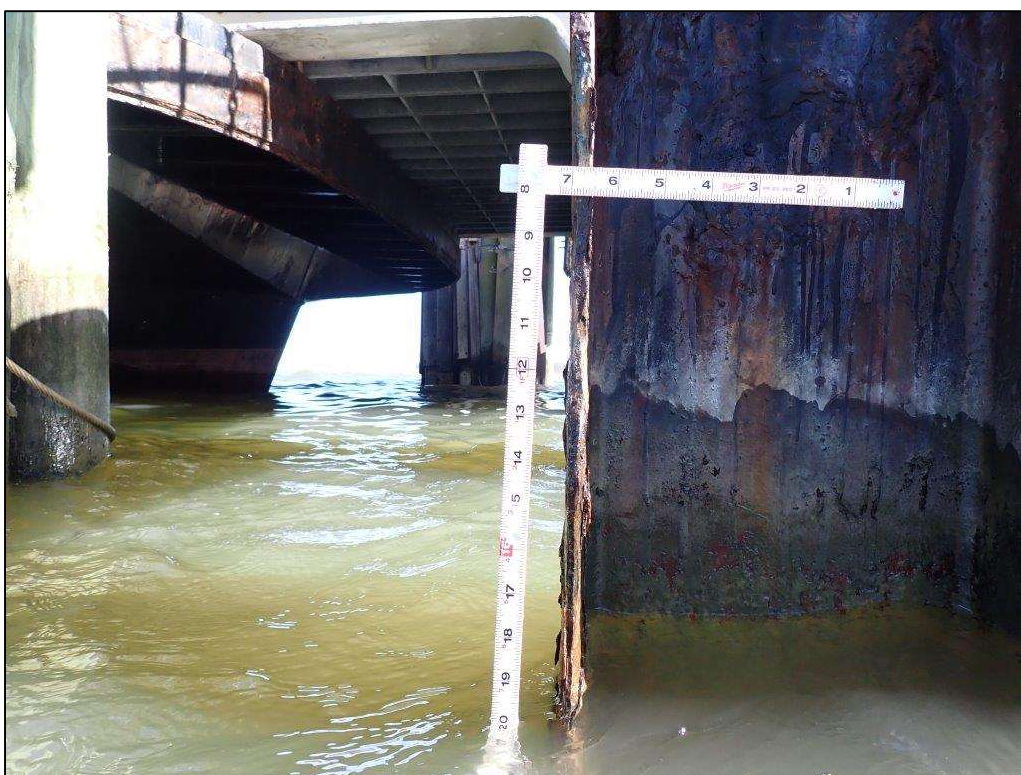
Photo 20: End Bent 2, Pile 3, Northwest Flange, Section Loss

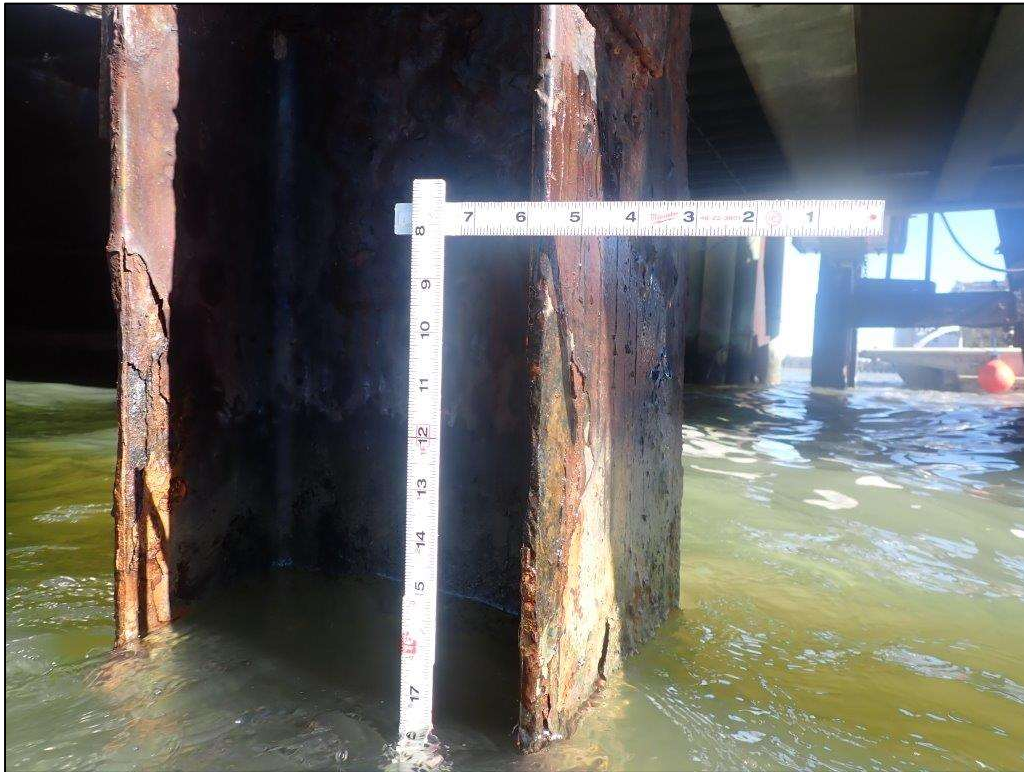
Photo 21: End Bent 2, Pile 4, Section Loss

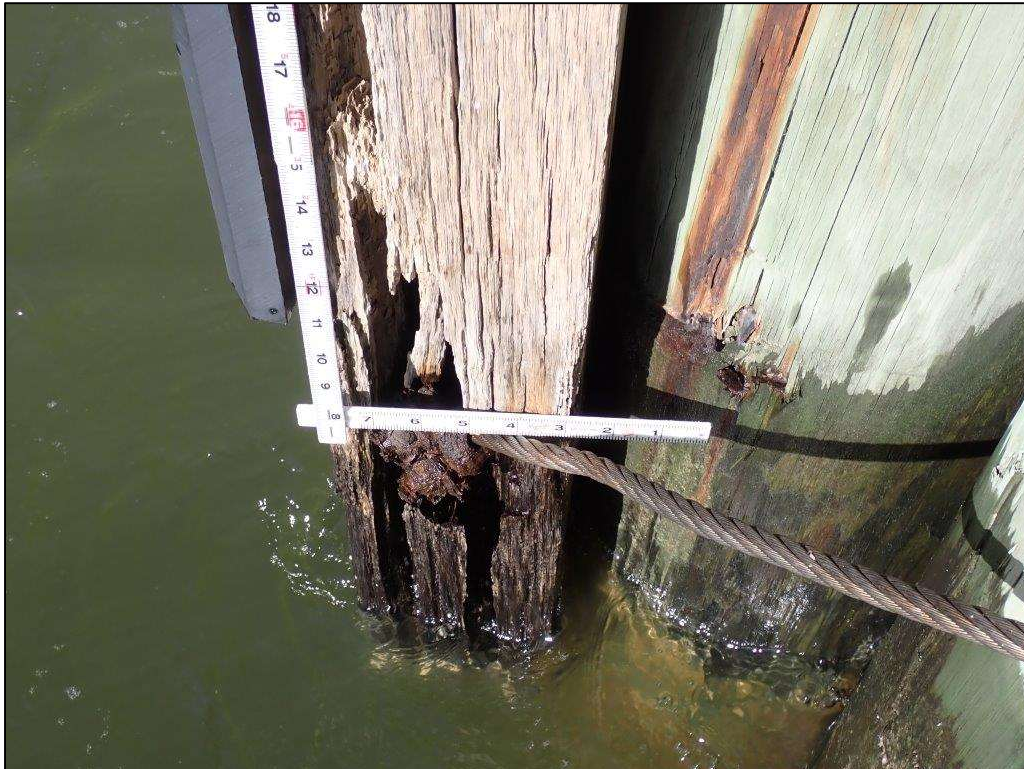
- All dolphin fenders, bottom 3 ft., decay, up to 100% loss (Photo 22).
- Dolphin 3, fenders, decay, full height, up to 100% loss (Photo 23).
- Dolphin 4, north and west quadrant, 1 ft. above waterline, steel cable wrap severed.
- Dolphin 5, fenders, decay, full height, up to 100% loss.
- Dolphin 9, east quadrant, 1 ft. above waterline, steel cable wrap severed.
- Dolphin 10, east quadrant, 1 ft. above waterline, steel cable wrap severed (Photo 24).

Photo 22: Dolphin Fenders, Typical Decay

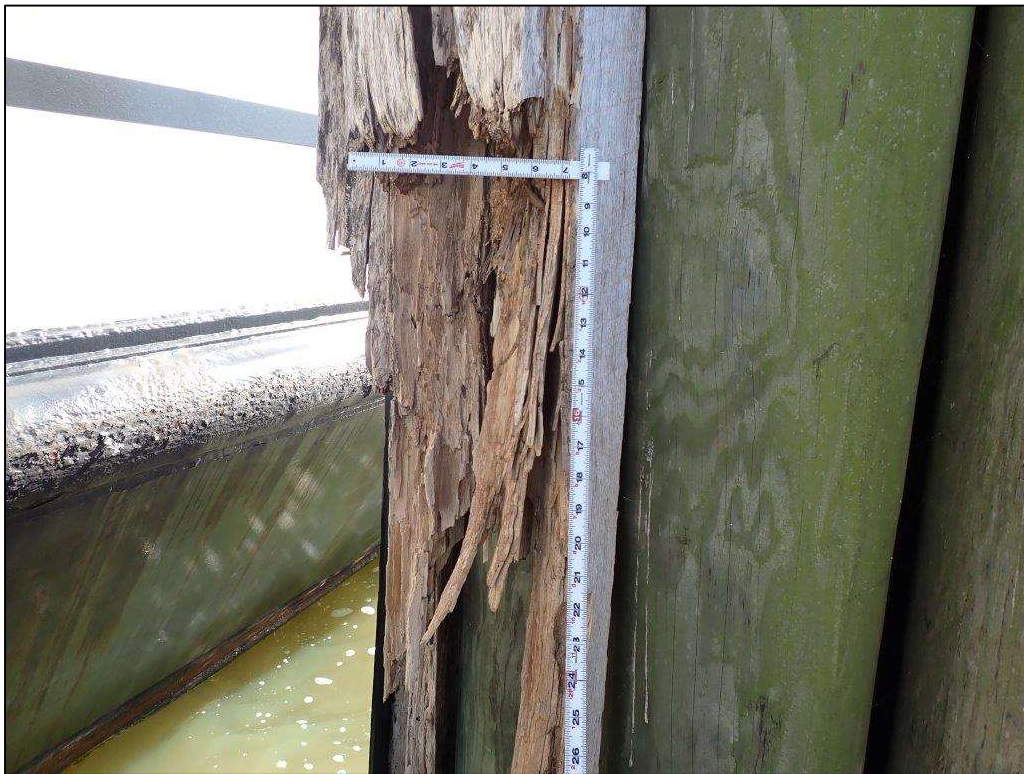
Photo 23: Dolphin 3, Fenders, Decay

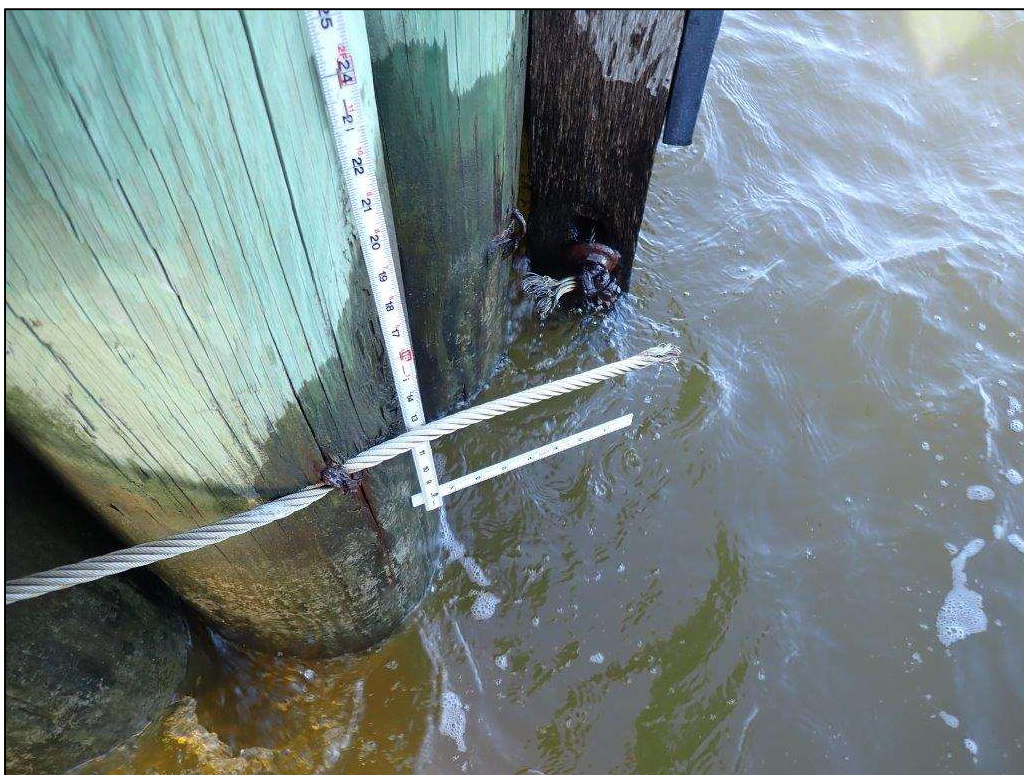
Photo 24: Dolphin 10, Steel Cable Severed
