# Underwater Inspection Report

## NC306 Ferry (North Terminal)

## Pamlico Sound

Bayview, North Carolina  
November 1, 2023

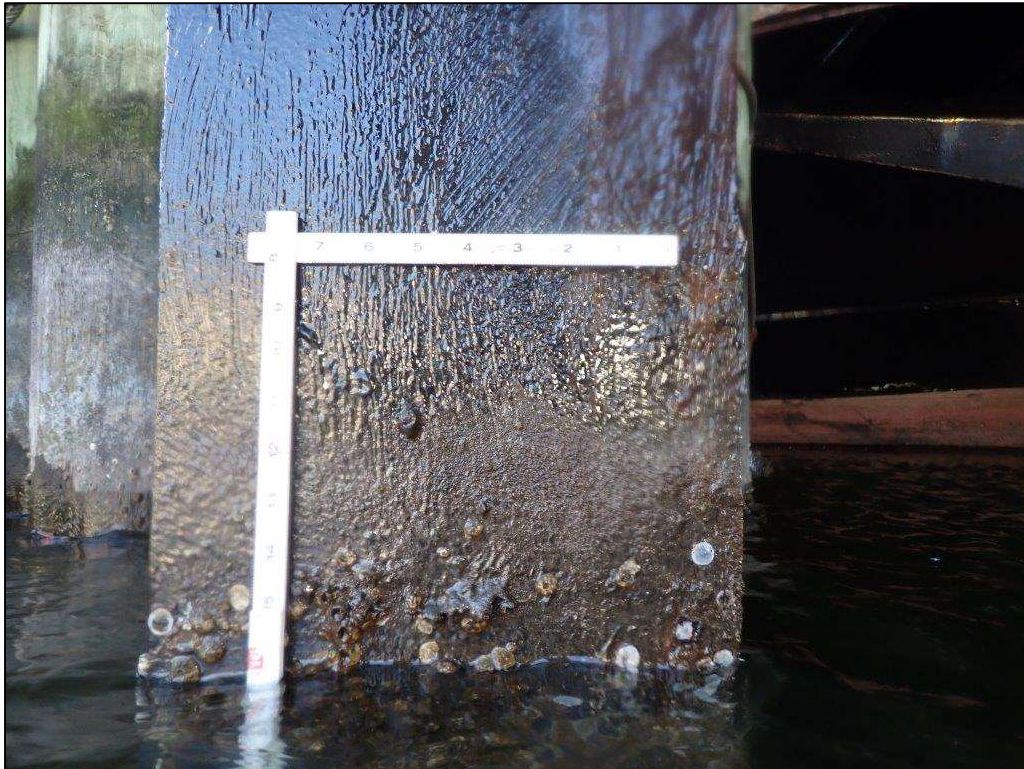
Photo 8: Typical Steel Pile Condition Above Waterline, End Bent 2, Pile 4

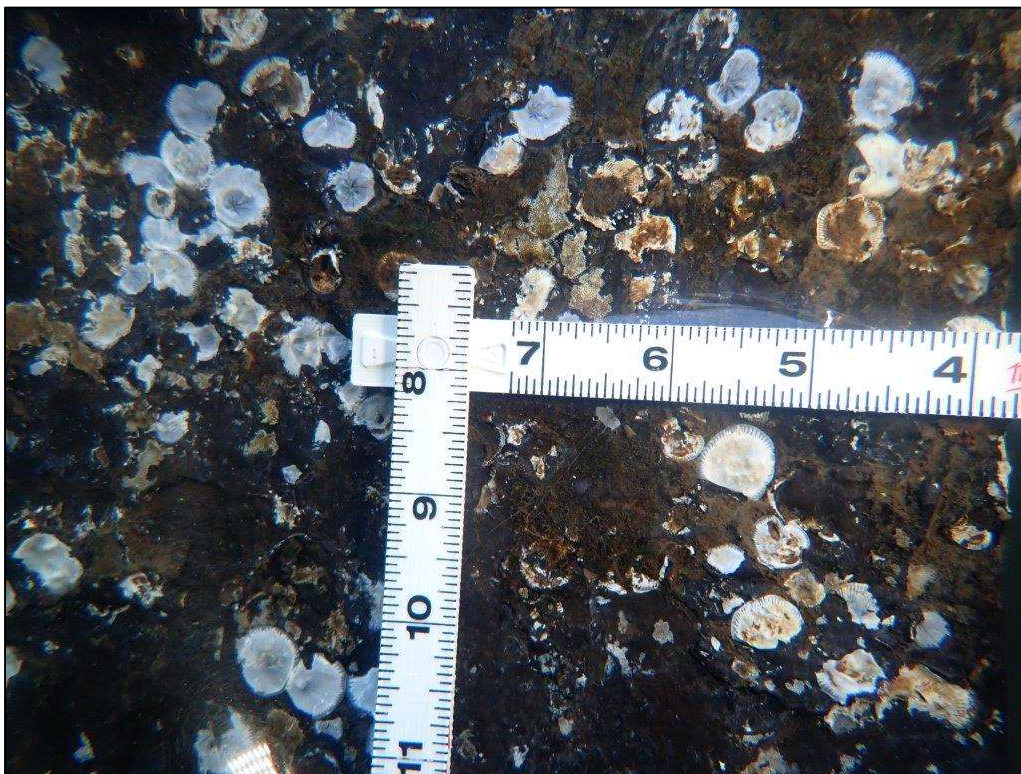
Photo 9: Typical Steel Pile Condition Below Waterline, End Bent 2, Pile 3

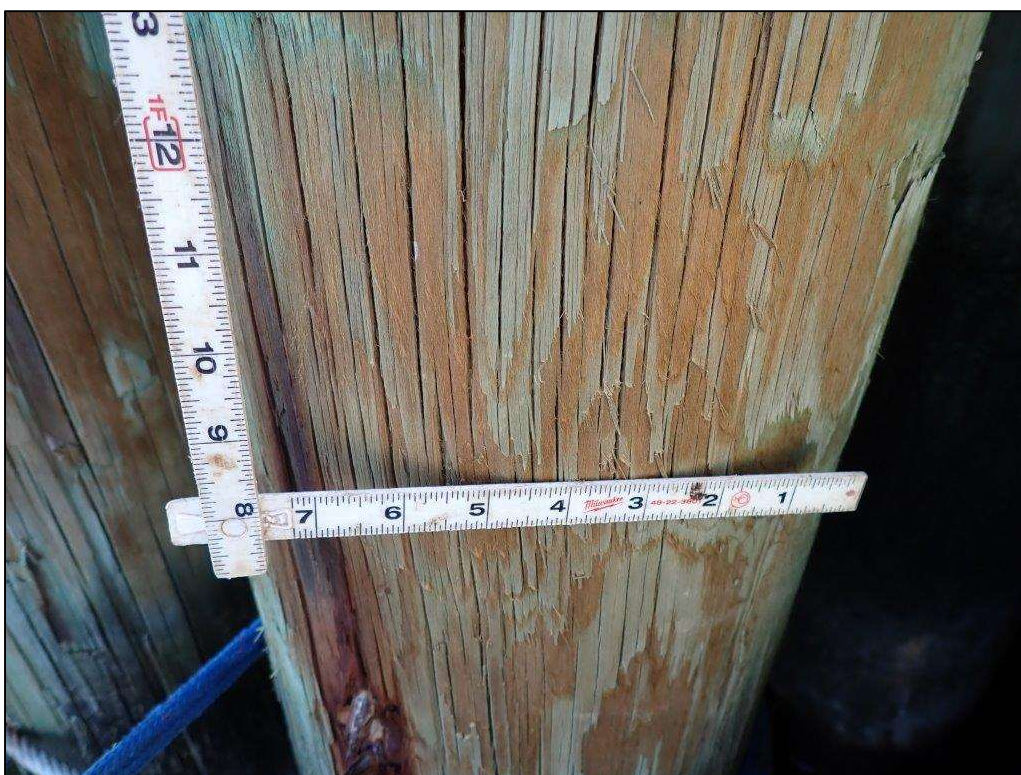
Photo 10: Typical Timber Dolphin Condition Above Waterline, Dolphin 7

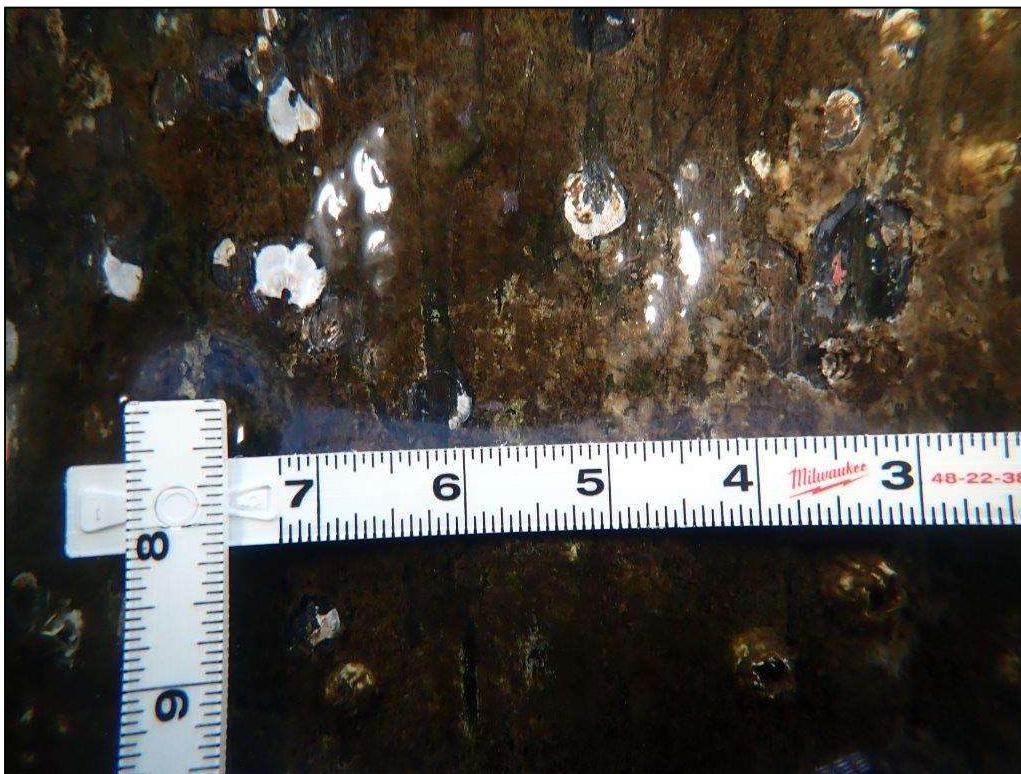
Photo 11: Typical Timber Dolphin Condition Below Waterline, Dolphin 7

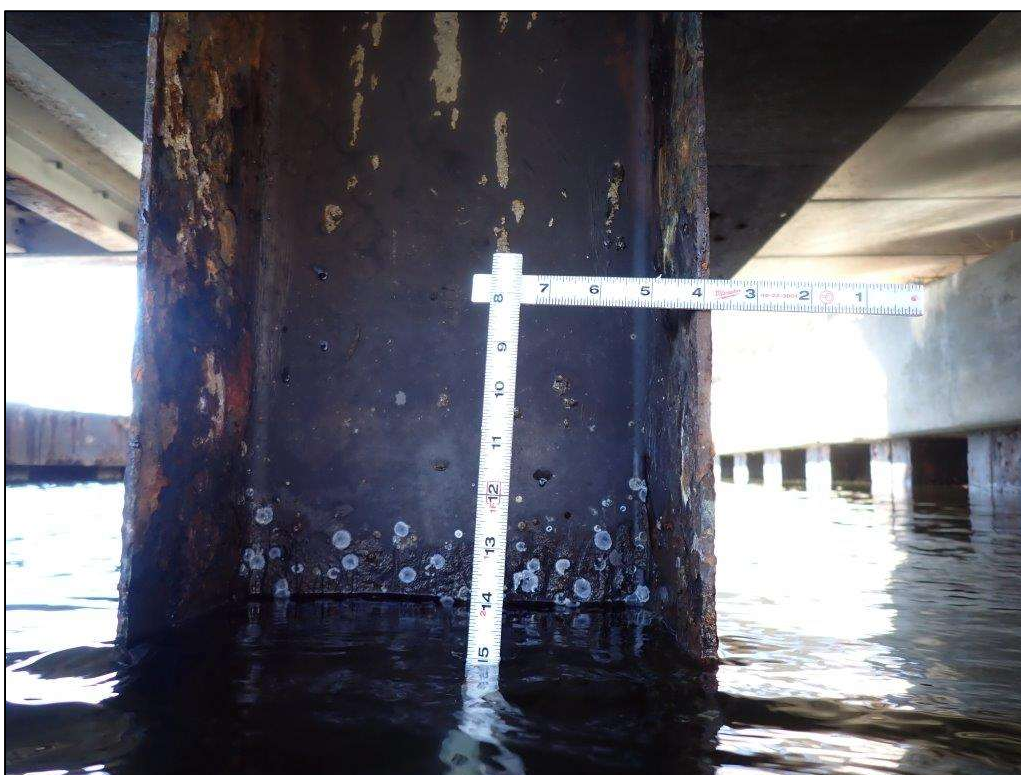
- All piles, from 2 ft. above waterline to channel bottom, all flanges and web, corrosion with section loss, with isolated areas of knife edging (Photo 12). Refer to Table 4 for representative steel section measurements at Pile 1.
- All piles, from cap to channel bottom, protective coating is peeling.
- Pile 1, northeast and southeast flanges, from waterline to channel bottom, isolated areas of section loss confined to the edge of the flange, up to 3 in. high x 1/2 in. wide (Photo 13).

Photo 12: Typical Section Loss on Flange Edges

- Clean and coat or encase all piles in Bent 2 and End Bent 2.
- Replace broken pile at Dolphin 8.
- Replace all decayed dolphin fenders.

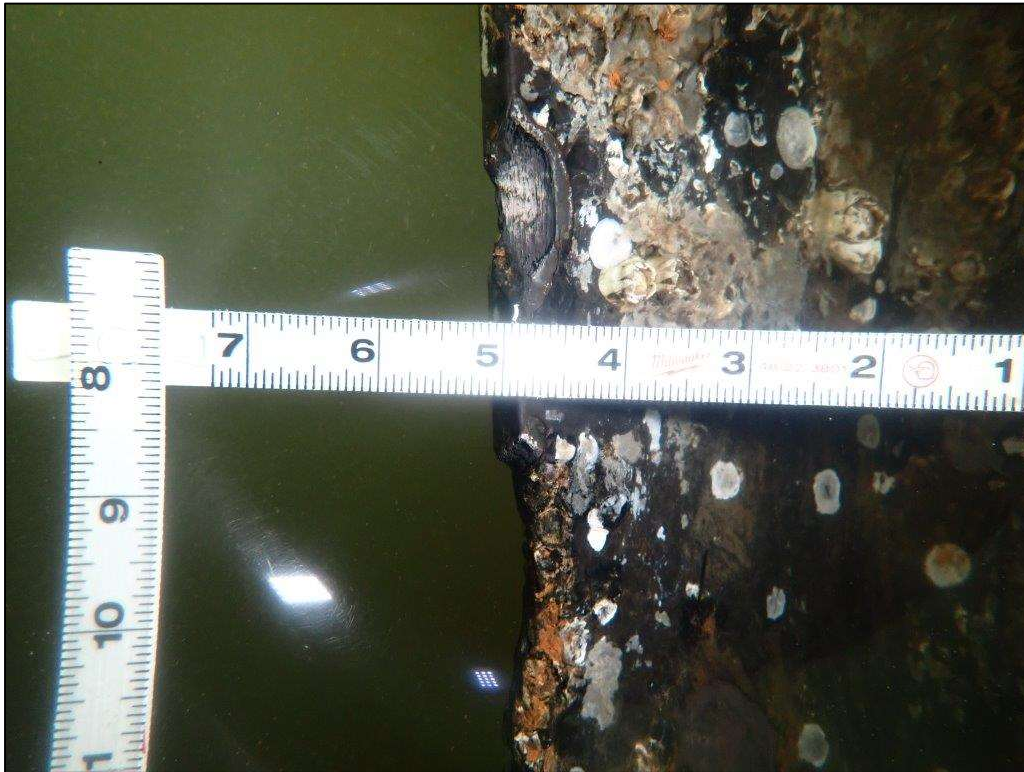
Photo 13: Bent 2, Pile 1, Areas of Section Loss Confined to the Flange Edge

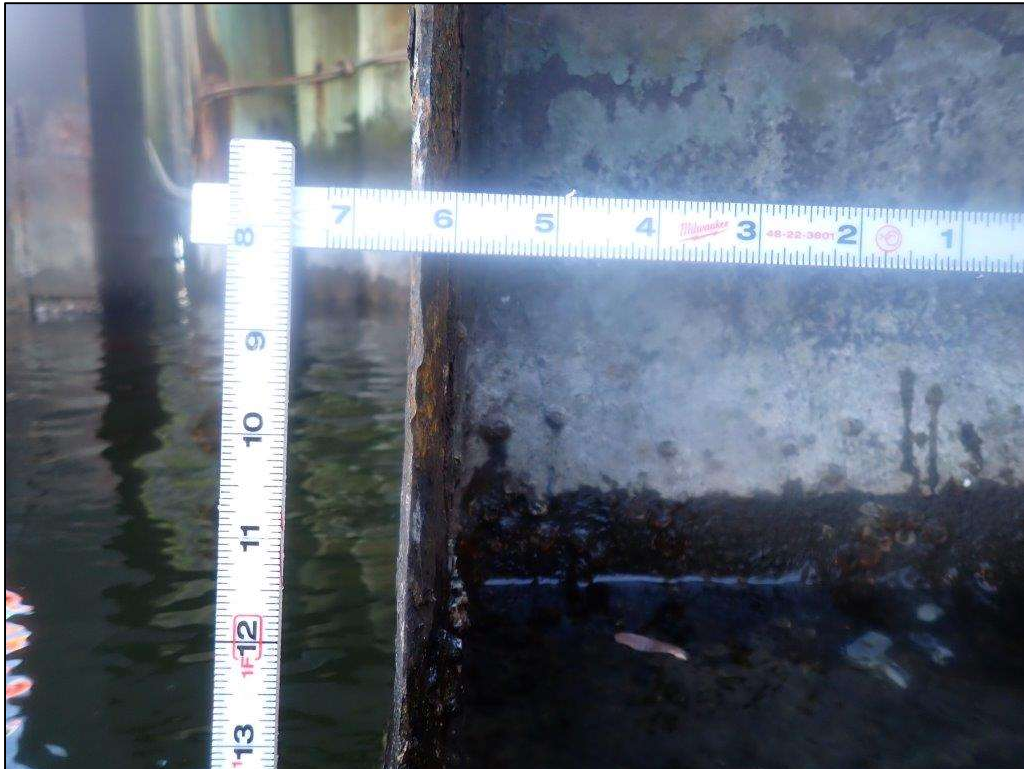
- Piles have been repaired with steel repair plates since the previous underwater inspection. Refer to Table 3 for the locations and dimensions of the repair plates.
- All piles, from 2 ft. above waterline to 1 ft. below waterline, all flanges, corrosion with 1/16 in. section loss. Refer to Table 4 for representative steel section measurements at Piles 2 and 3.
- Pile 1, northeast flange, from 2 ft. above waterline to waterline, section loss with knife edging, 0.387 in. remaining section (Photo 14).
- Pile 5, northeast flange, from 1.2 ft. above waterline to waterline, section loss, 0.418 in. remaining section (Photo 15).

Photo 14: End Bent 2, Pile 1, Section Loss

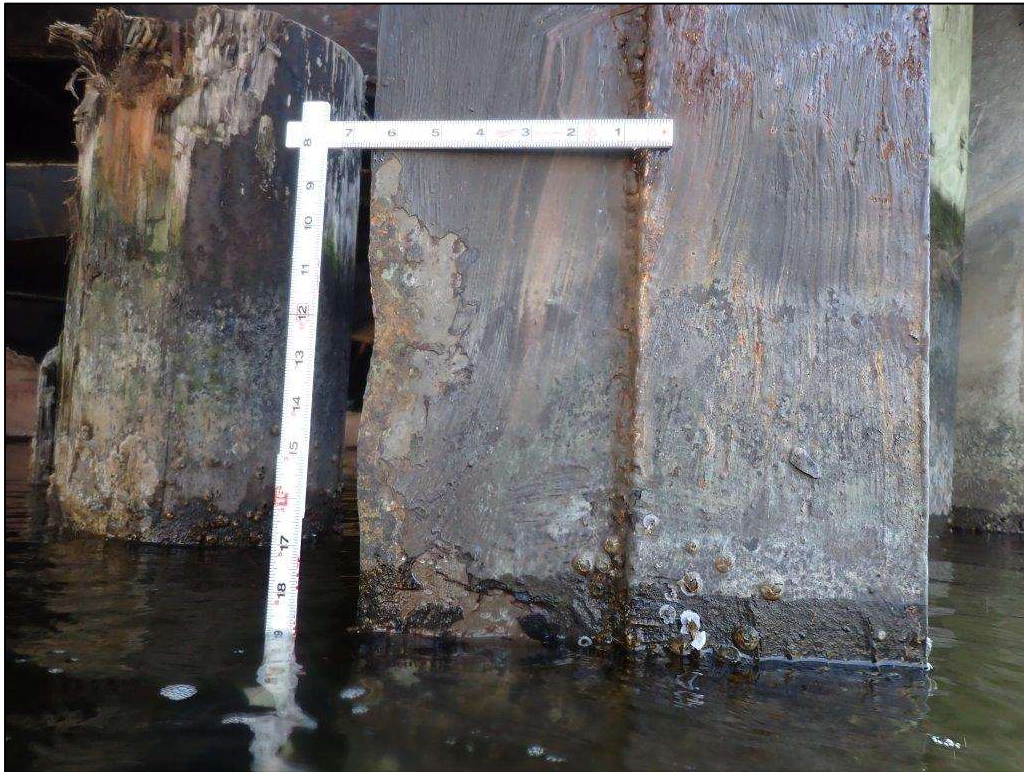
Photo 15: End Bent 2, Pile 5, Section Loss

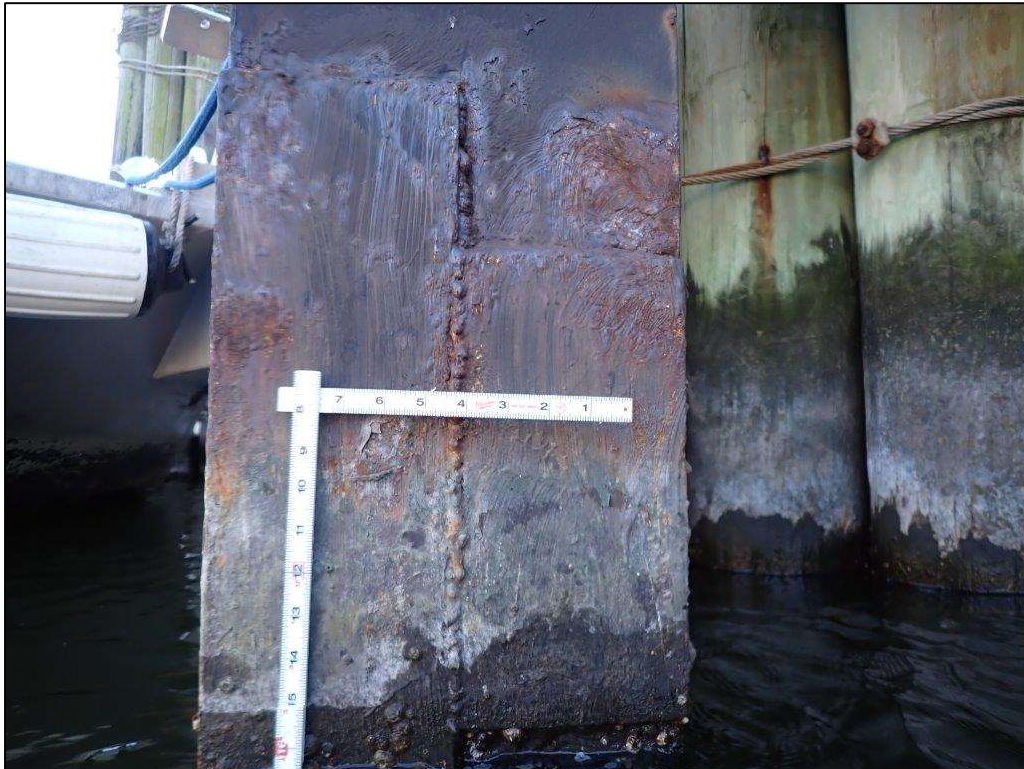
Photo 16: Typical Repair Plate, End Bent 2, Pile 3 Shown

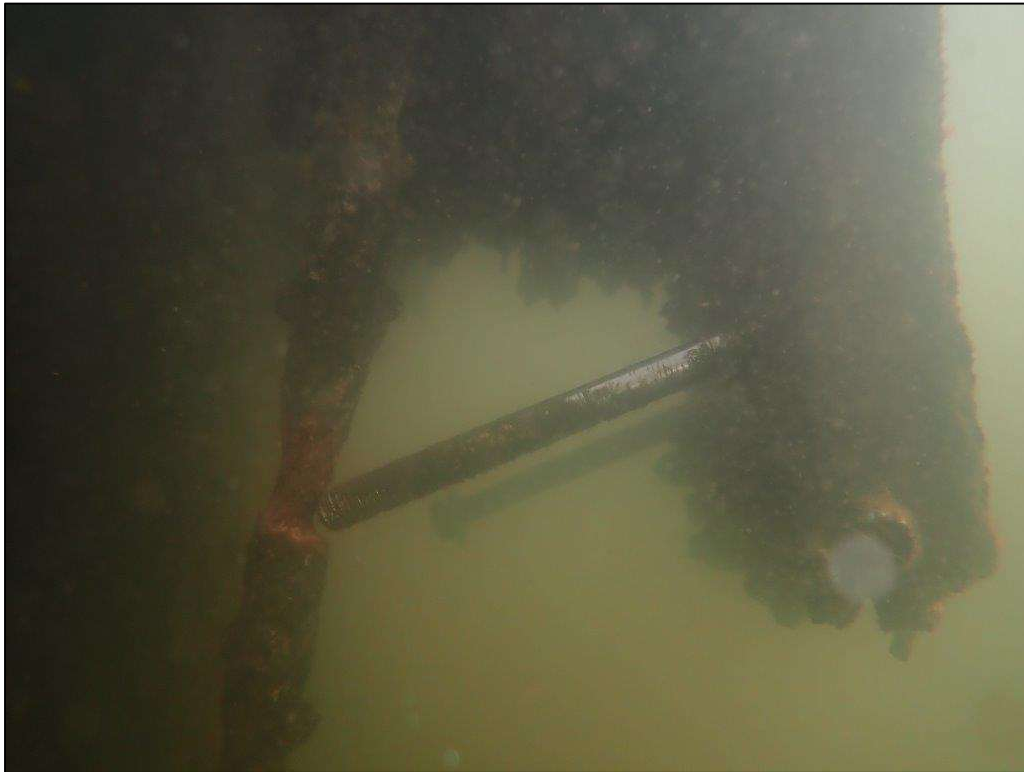
- All dolphin fenders, bottom 3 ft., decay, up to 100% loss (Photo 17).
- Dolphin 3, north quadrant, north pile, at waterline, decay, 1 ft. high x 10 in. wide x 3 in. deep (Photo 18).
- Dolphin 8, northeast quadrant, at waterline, broken pile (Photo 19).

Photo 17: Dolphin Fender, Typical Section Loss

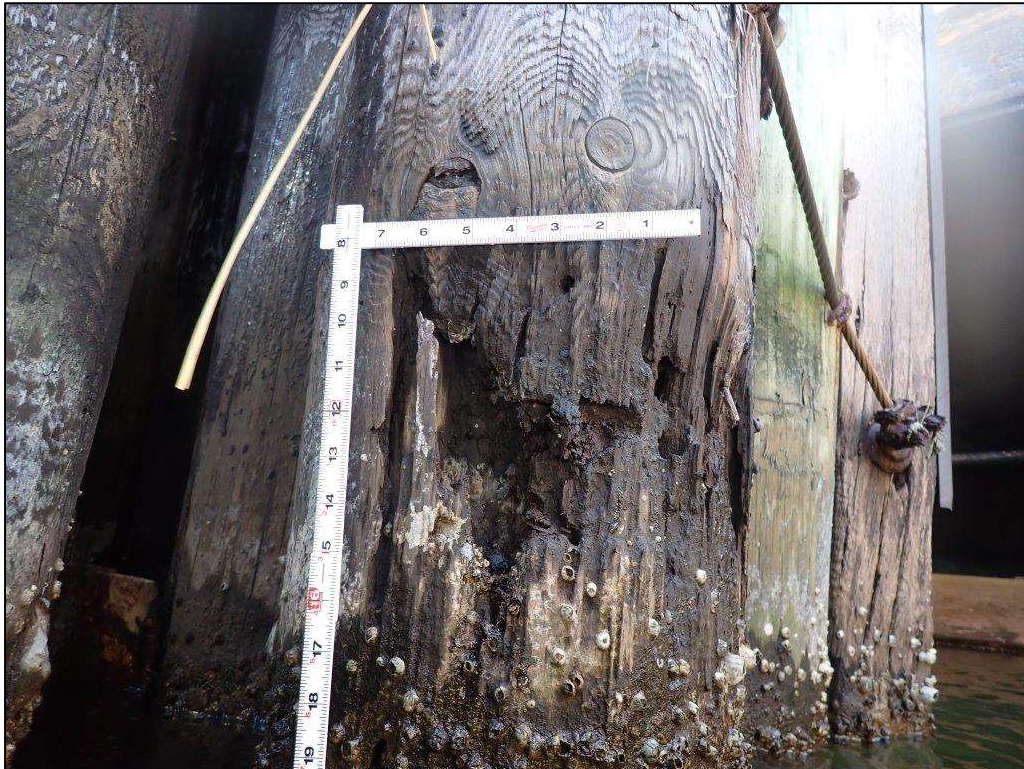
Photo 18: Dolphin 3, Decay

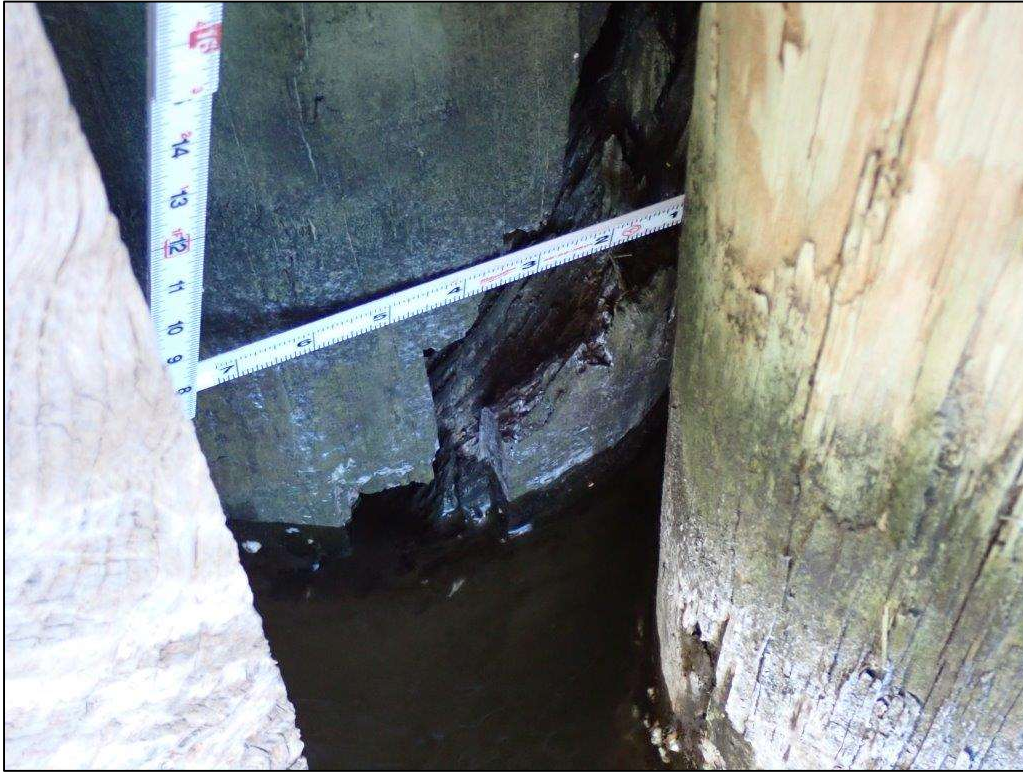
Photo 19: Dolphin 8, Broken Pile
