# BRIDGE INSPECTION REPORT

COUNTY: BEAUFORT BRIDGE NO.: 060321

ROUTE: NC306 FERRY TERMINAL ACROSS: PAMLICO SOUND

DESCRIPTION: APPROACH SPANS: PPC CORED SLABS; LIFT SPAN: STEEL FLOOR BEAM SYSTEM

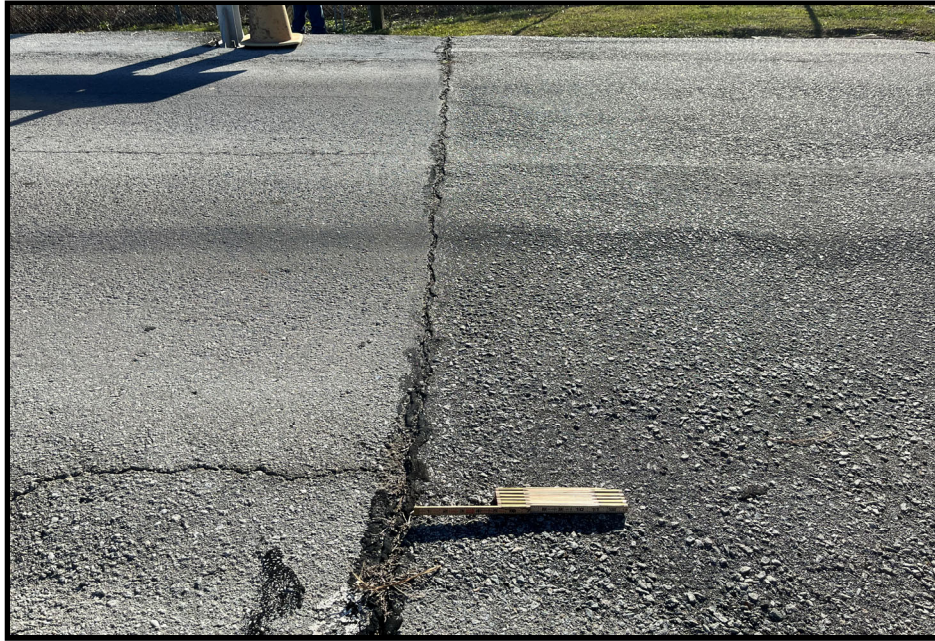
| STRUCTURAL ELEMENT DEFECT | UNIT | QUANTITY |
|---|---|---|
| 1. 1/2" TRANSVERSE CRACKS IN ASPHALT WEARING SURFACE ALONG END BENT 1 FILL FACE | SF | 18 |

1/2" TRANSVERSE CRACKS IN ASPHALT WEARING SURFACE ALONG END BENT 1 FILL FACE

| 1. SEAL CRACKS IN ASPHALT WEARING SURFACE IN SPANS 1 AND 2 | LF | 260 |

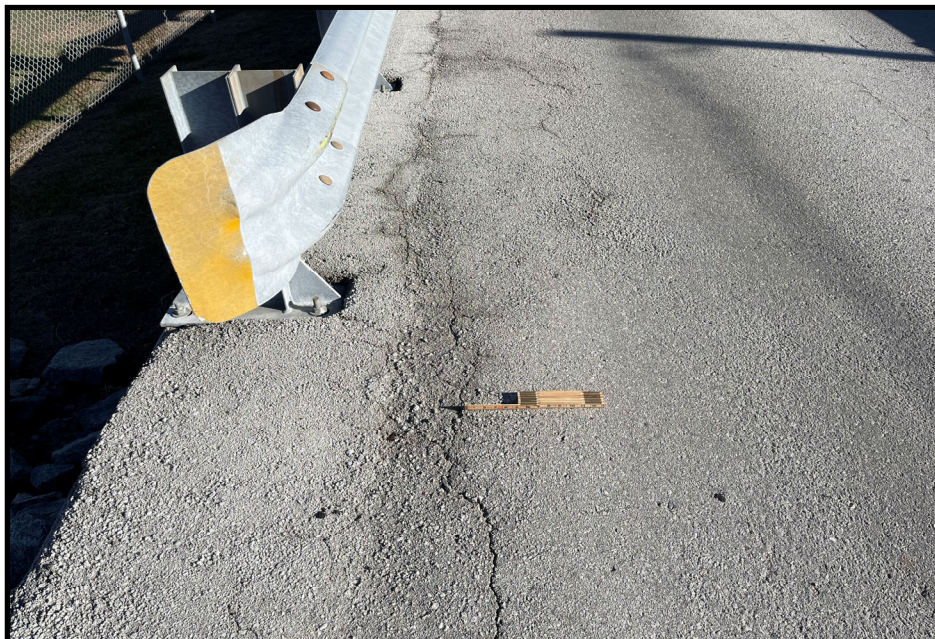
| STRUCTURAL ELEMENT DEFECT | UNIT | QUANTITY |
|---|---|---|
| 2. 1/8" LONGITUDINAL AND ALLIGATOR CRACKS IN ASPHALT WEARING SURFACE AT RANDOM | SF | 260 |

1/8" LONGITUDINAL AND ALLIGATOR CRACKS IN ASPHALT WEARING SURFACE AT RANDOM,  
CRACKS IN SPAN 1 SHOWN

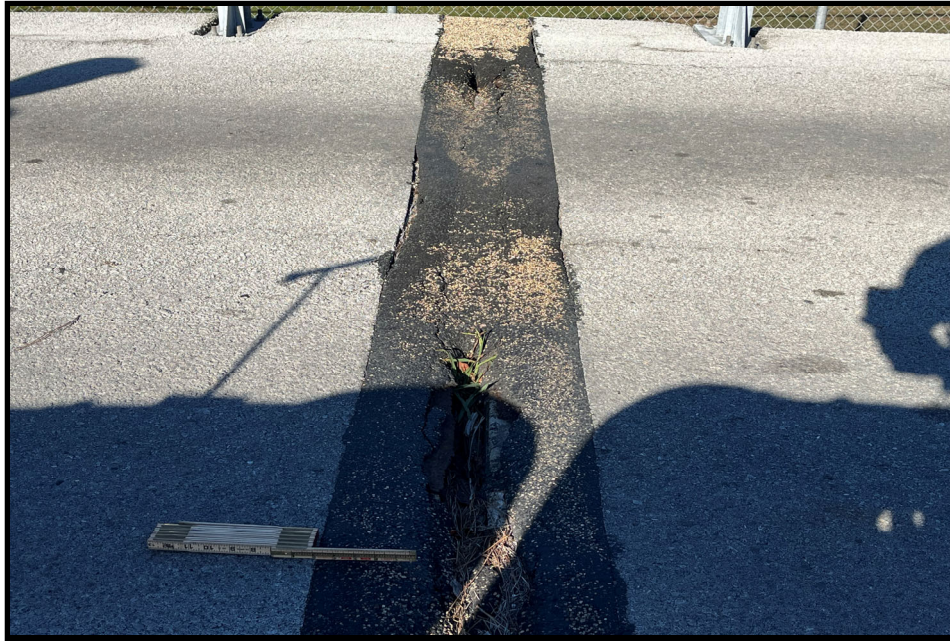
| STRUCTURAL ELEMENT DEFECT | UNIT | QUANTITY |
|---|---|---|
| 3. (2) AREAS OF MISSING ASPHALT AND JOINT MATERIAL UP TO 52" LONG X 7" WIDE AND 1/2" TRANSVERSE CRACKS IN ASPHALT OVERLAY ALONG BENT 1 JOINT | LF | 18 |

(2) AREAS OF MISSING ASPHALT AND JOINT MATERIAL UP TO 52" LONG X 7" WIDE AND 1/2" TRANSVERSE CRACKS IN ASPHALT OVERLAY ALONG BENT 1 JOINT

| REPAIR RECOMMENDATIONS | UNIT | QUANTITY |
|---|---|---|
| 1. REPLACE BENT 1 JOINT | LF | 18 |

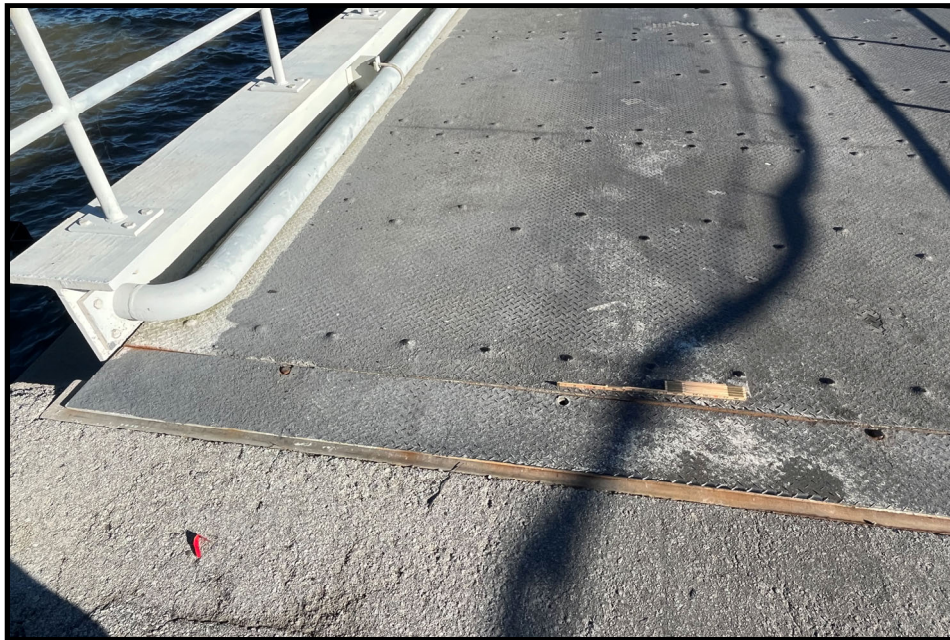
| STRUCTURAL ELEMENT DEFECT | UNIT | QUANTITY |
|---|---|---|
| 4. (1) MISSING BOLT IN STEEL COVER PLATE ALONG BENT 2 JOINT, APPROXIMATELY 51" TO RIGHT OF GIRDER 1 | EA | 1 |

(1) MISSING BOLT IN STEEL COVER PLATE ALONG BENT 2 JOINT, APPROXIMATELY 51" TO RIGHT OF GIRDER 1

| 2. REPLACE MISSING BOLT IN STEEL COVER PLATE ALONG BENT 2 JOINT | EA | 1 |

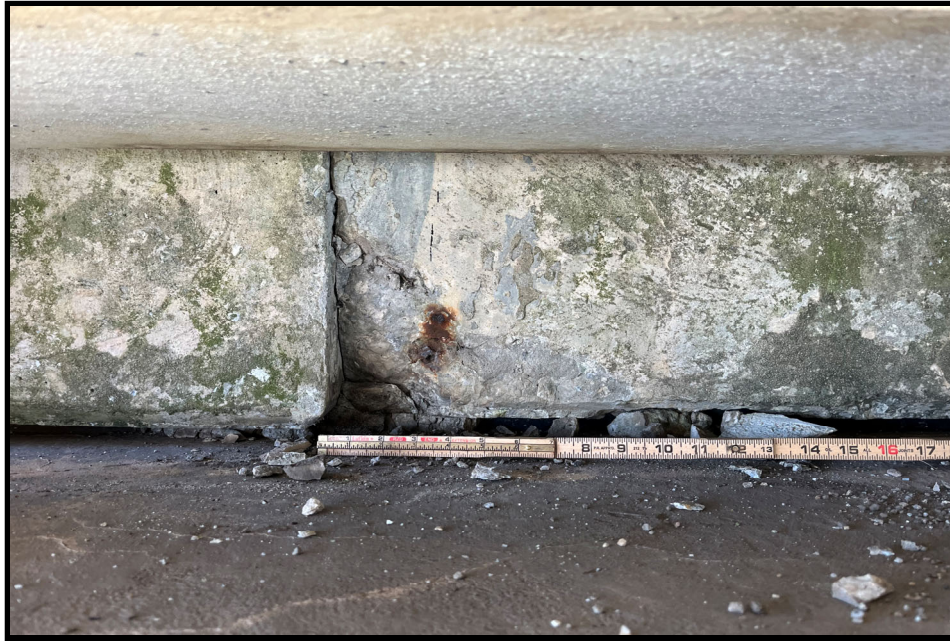
| STRUCTURAL ELEMENT DEFECT | UNIT | QUANTITY |
|---|---|---|
| 5. SPAN 2 UNIT 5: 8" X 5" X 2 1/2" DEEP SPALL WITH EXPOSED STRANDS IN END OF UNIT AT BENT 2 ADJACENT TO UNIT 6 | SF | 1 |

SPAN 2 UNIT 5: 8" X 5" X 2 1/2" DEEP SPALL WITH EXPOSED STRANDS IN END OF UNIT AT BENT 2 ADJACENT TO UNIT 6

| REPAIR RECOMMENDATIONS | UNIT | QUANTITY |
|---|---|---|
| 2. REPAIR SPALL WITH EXPOSED STRANDS IN SPAN 2 UNIT 5 | LF | 1 |

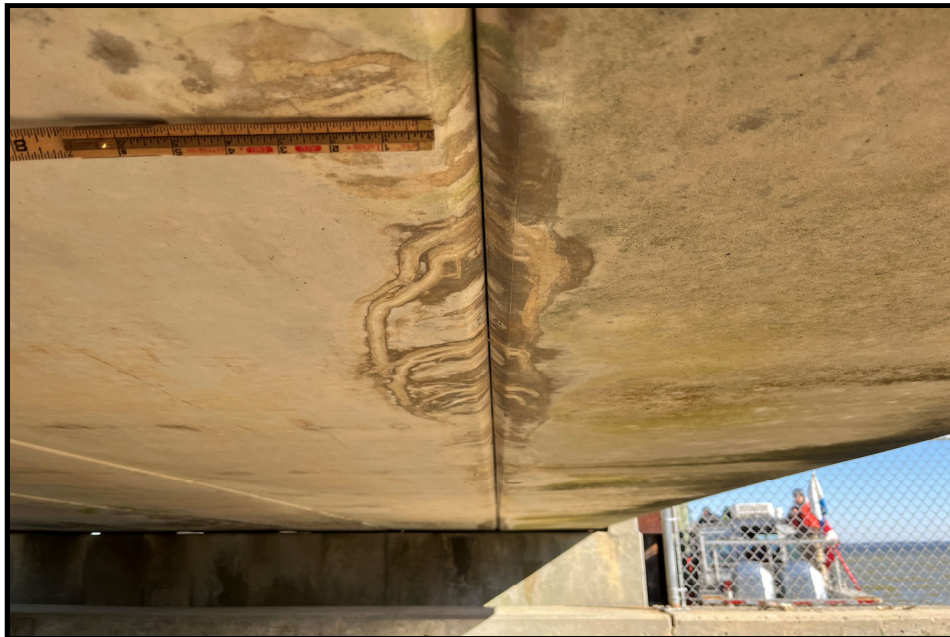
| STRUCTURAL ELEMENT DEFECT | UNIT | QUANTITY |
|---|---|---|
| 6. EFFLORESCENCE SEEPAGE BETWEEN UNITS IN VARIOUS LOCATIONS IN SPANS 1 AND 2 | LF | 72 |

EFFLORESCENCE SEEPAGE BETWEEN UNITS IN VARIOUS LOCATIONS IN SPANS 1 AND 2

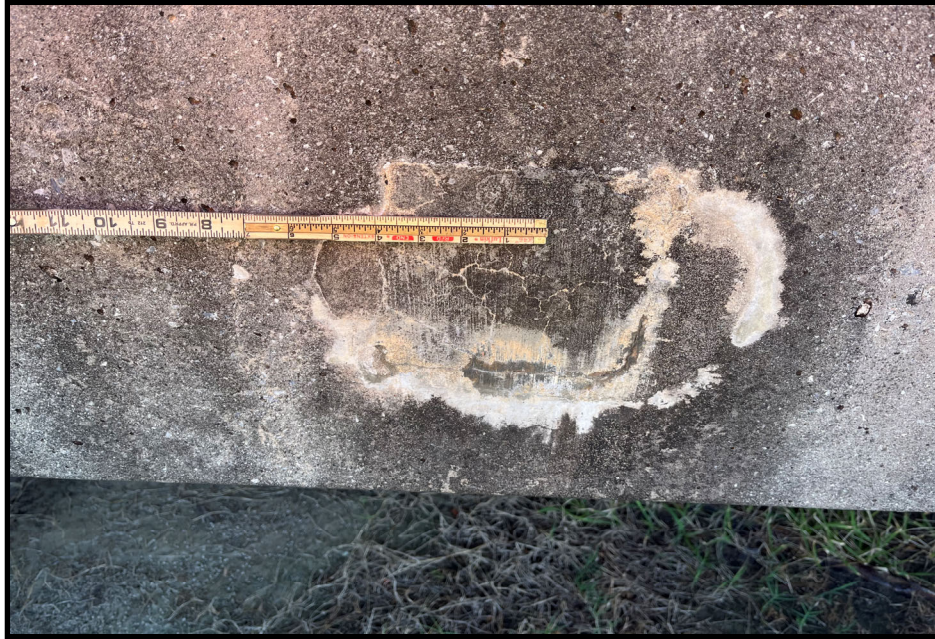
| STRUCTURAL ELEMENT DEFECT | UNIT | QUANTITY |
|---|---|---|
| 7. HAIRLINE MAP CRACKS WITH EFFLORESCENCE THROUGHOUT TRANSVERSE POST-TENSION GROUT POCKETS ON BOTH SIDES AT MIDSPAN OF SPANS 1 AND 2 | LF | 4 |

HAIRLINE MAP CRACKS WITH EFFLORESCENCE THROUGHOUT TRANSVERSE POST-TENSION GROUT POCKETS ON BOTH SIDES AT MIDSPAN OF SPANS 1 AND 2

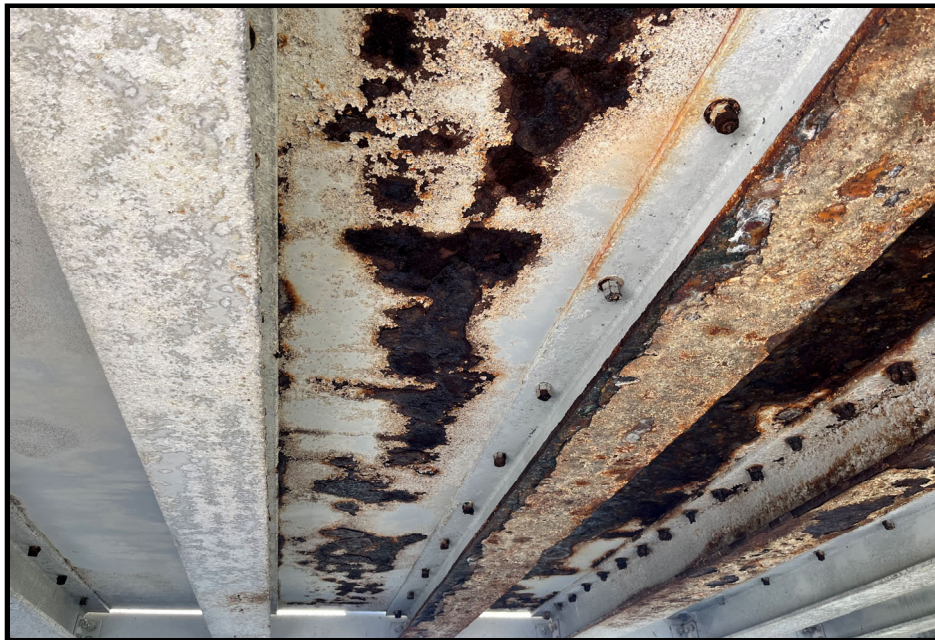
| STRUCTURAL ELEMENT DEFECT | UNIT | QUANTITY |
|---|---|---|
| 8. AREAS OF SURFACE CORROSION AND CORROSION WITH UP TO 1/8" LOSS OF SECTION IN BOTTOM OF DECK, PRIMARILY BETWEEN FLOORBEAMS 3 THRU 6 | SF | 92 |

AREAS OF SURFACE CORROSION AND CORROSION WITH UP TO 1/8" LOSS OF SECTION IN BOTTOM OF DECK PRIMARILY BETWEEN FLOORBEAMS 3 THRU 6

| 3. CLEAN AND PAINT ALL STEEL SUPERSTRUCTURE ELEMENTS | SF | 1955 |

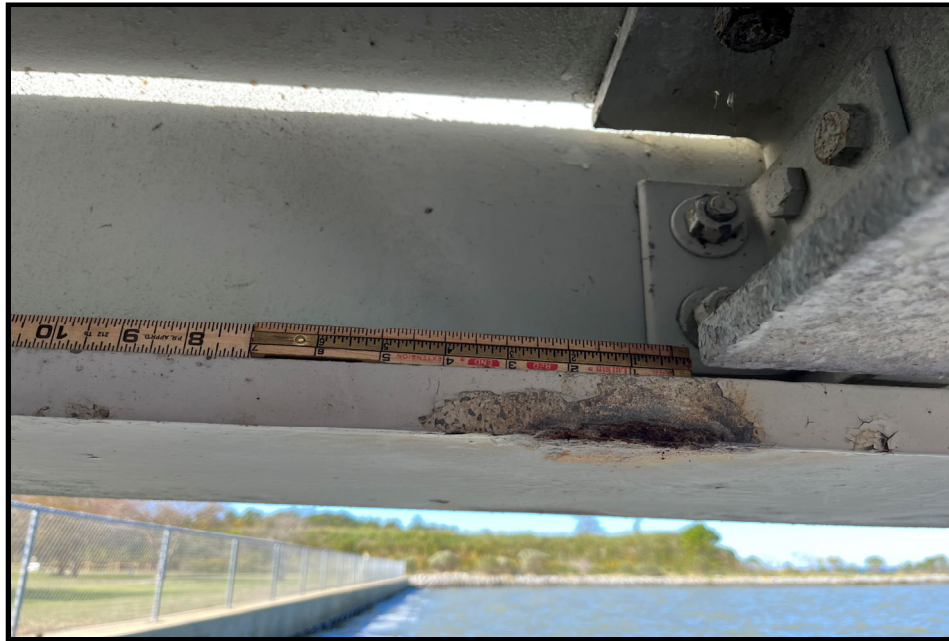
| STRUCTURAL ELEMENT DEFECT | UNIT | QUANTITY |
|---|---|---|
| 9. GIRDER 1: SURFACE CORROSION ALONG RIGHT EDGE OF BOTTOM FLANGE, APPROXIMATELY 5' FROM BENT 2 BEARING | LF | 1 |

GIRDER 1: SURFACE CORROSION ALONG RIGHT EDGE OF BOTTOM FLANGE, APPROXIMATELY 5' FROM BENT 2 BEARING

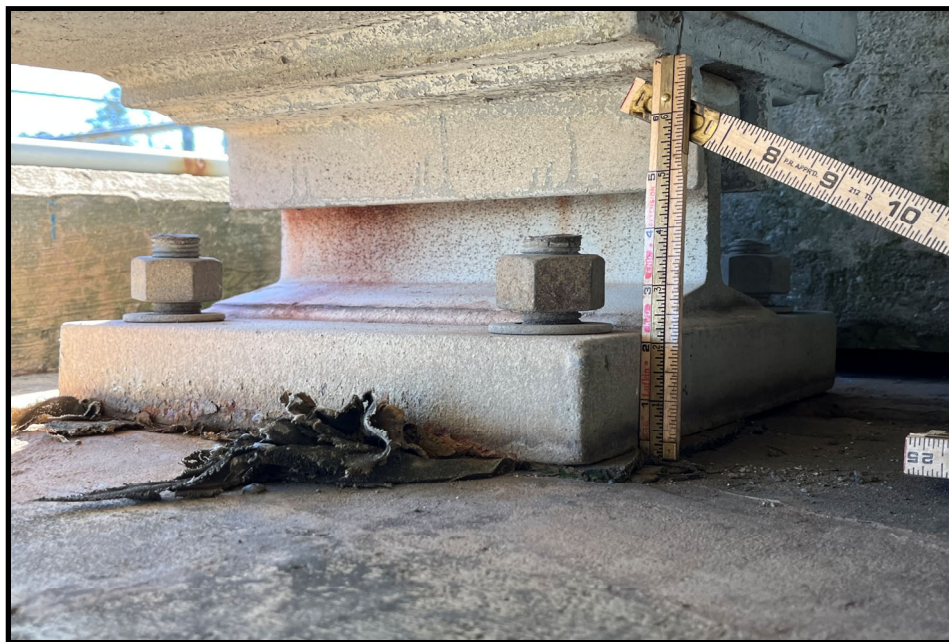
| STRUCTURAL ELEMENT DEFECT | UNIT | QUANTITY |
|---|---|---|
| 10. (8) OF (8) ANCHOR BOLTS NUTS NOT FULLY SEATED AT GIRDER 1 AND 2 BEARINGS AT BENT 2 (4 BOLTS PER BEARING) | EA | 8 |

(8) OF (8) ANCHOR BOLT NUTS NOT FULLY SEATED AT GIRDER 1 AND 2 BEARINGS AT BENT 2 (4 BOLTS PER BEARING), GIRDER 1 BEARING SHOWN

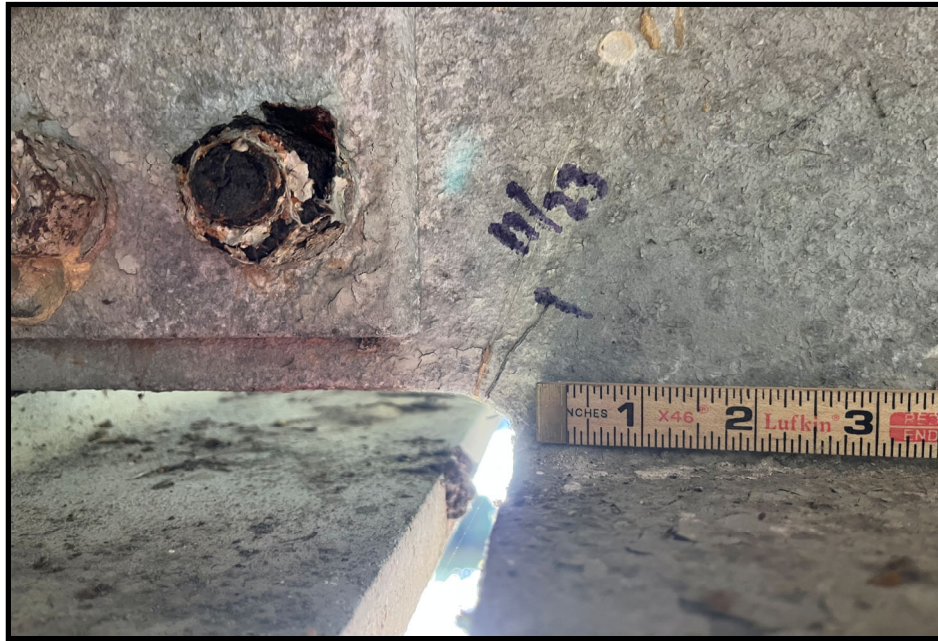
| STRUCTURAL ELEMENT DEFECT | UNIT | QUANTITY |
|---|---|---|
| 11. FLOORBEAMS: UP TO 1 1/2" LONG DIAGONAL HAIRLINE CRACKS IN BOTH FACES OF WEBS PROPAGATING FROM COPE RADIUS AT GIRDER CONNECTIONS IN THE FOLLOWING LOCATIONS:<br><div style="display: flex; justify-content: space-between; margin-top: 10px;"> <div style="width: 45%;"> FLOORBEAM 1 AT GIRDER 1<br/> FLOORBEAM 4 AT GIRDER 1<br/> FLOORBEAM 11 AT GIRDER 1 (x2) </div> <div style="width: 45%;"> FLOORBEAM 1 AT GIRDER 2<br/> FLOORBEAM 9 AT GIRDER 2<br/> FLOORBEAM 11 AT GIRDER 2 </div> </div> | LF | 6 |

FLOORBEAM 9: UP TO 1 1/2" LONG DIAGONAL HAIRLINE CRACKS IN BOTH FACES OF WEB PROPAGATING FROM COPE RADIUS AT GIRDER 2 CONNECTION, NORTH FACE SHOWN

| REPAIR RECOMMENDATIONS | UNIT | QUANTITY |
|---|---|---|
| 3. REPAIR CRACKS IN FLOORBEAMS AT GIRDER CONNECTIONS | LF | 6 |

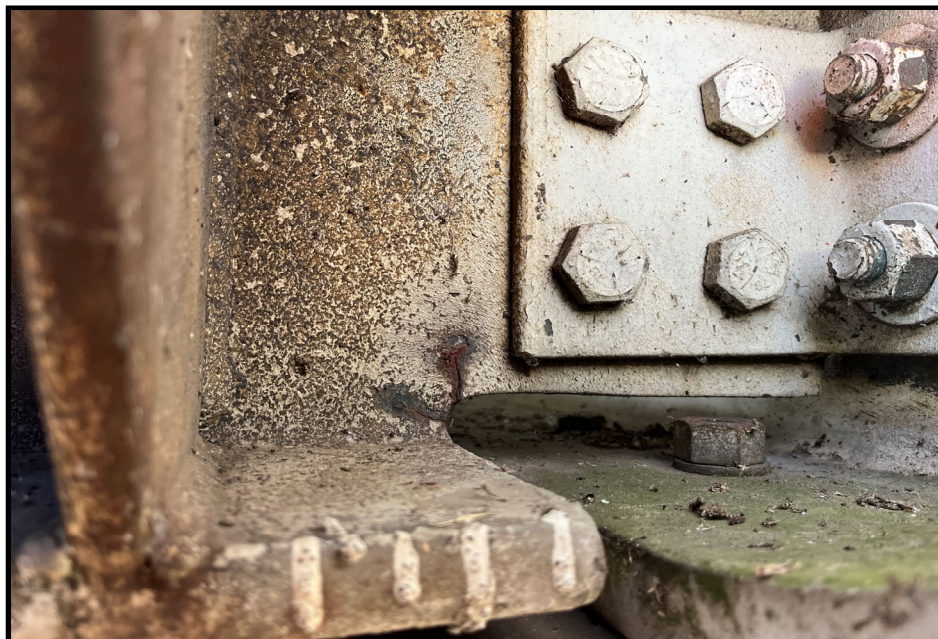
FLOORBEAM 11: (2) DIAGONAL HAIRLINE CRACKS UP TO 1/2" LONG IN BOTH FACES OF WEB PROPAGATING FROM COPE RADIUS AT GIRDER 1 CONNECTION, NORTH FACE SHOWN

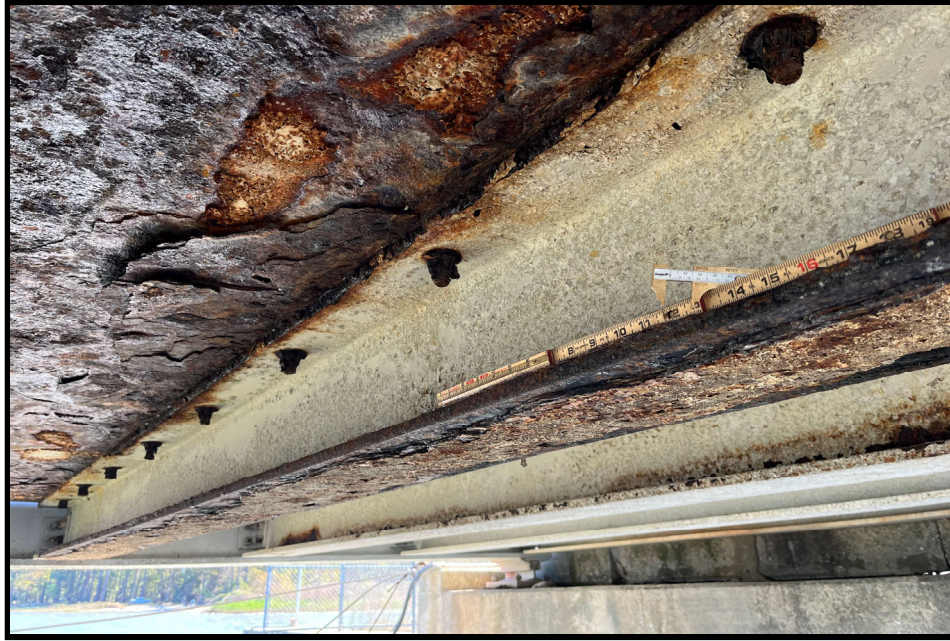
| STRUCTURAL ELEMENT DEFECT | UNIT | QUANTITY |
|---|---|---|
| 12. FLOORBEAMS 4 AND 5: AREAS OF CORROSION ALONG BOTTOM FLANGE UP TO 13' LONG X 10 1/8" WIDE DOWN TO 5/8" RESIDUAL FLANGE (3/4" ORIGINAL THICKNESS) AT MID LENGTH | LF | 25 |

FLOORBEAMS 4 AND 5: AREAS OF CORROSION ALONG BOTTOM FLANGE UP TO 13' LONG X 10 1/8" WIDE DOWN TO 5/8" RESIDUAL FLANGE (3/4" ORIGINAL THICKNESS) AT MID LENGTH, FLOORBEAM 4 NORTH FACE SHOWN

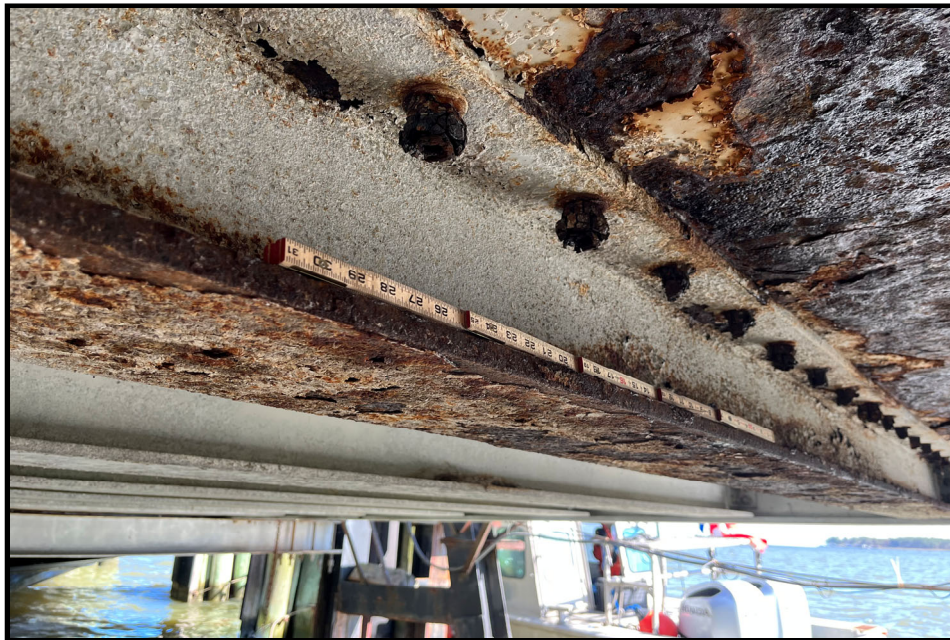
| STRUCTURAL ELEMENT DEFECT | UNIT | QUANTITY |
|---|---|---|
| 13. SURFACE CORROSION AND CORROSION WITH NO MEASURABLE LOSS OF SECTION ALONG FLOORBEAMS IN VARIOUS LOCATIONS, PRIMARILY IN FLOORBEAMS 3 THRU 6 | SF | 50 |

SURFACE CORROSION AND CORROSION WITH NO MEASURABLE LOSS OF SECTION ALONG FLOORBEAMS IN VARIOUS LOCATIONS, PRIMARILY IN FLOORBEAMS 3 THRU 6, FLOORBEAM 5 SOUTH FACE SHOWN

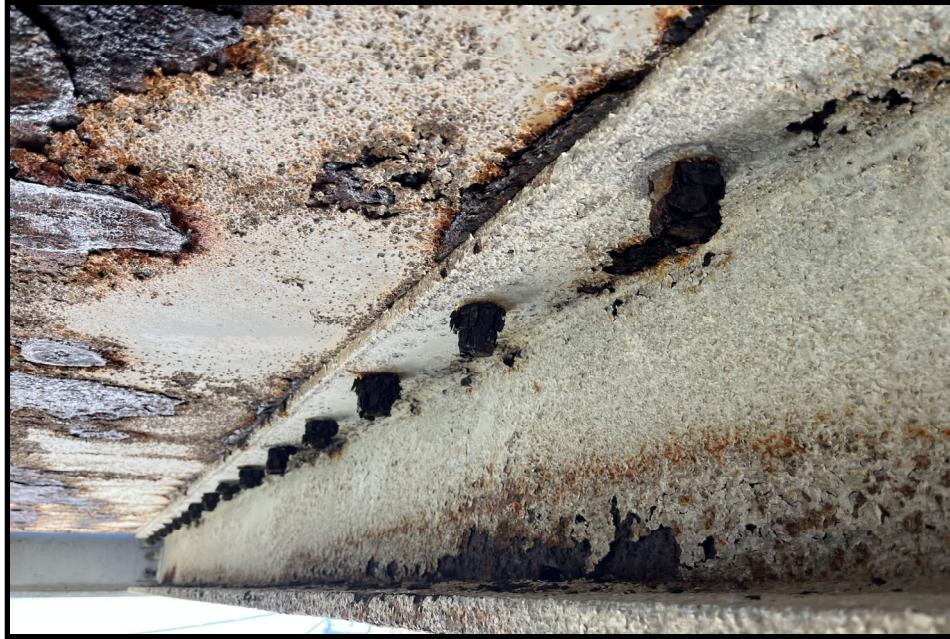
| STRUCTURAL ELEMENT DEFECT | UNIT | QUANTITY |
|---|---|---|
| 14. CORROSION WITH UP TO 50% LOSS OF SECTION THROUGHOUT DECK AND FLOORBEAM ATTACHMENT BOLTS AND NUTS IN VARIOUS LOCATIONS | EA | 162 |

CORROSION WITH UP TO 50% LOSS OF SECTION THROUGHOUT DECK AND FLOORBEAM ATTACHMENT BOLTS AND NUTS IN VARIOUS LOCATIONS, CONDITION ON NORTH SIDE OF FLOORBEAM 3 SHOWN

| 5. REPLACE DECK AND FLOORBEAM ATTACHMENT BOLTS AND NUTS WITH SECTION LOSS | EA | 162 |

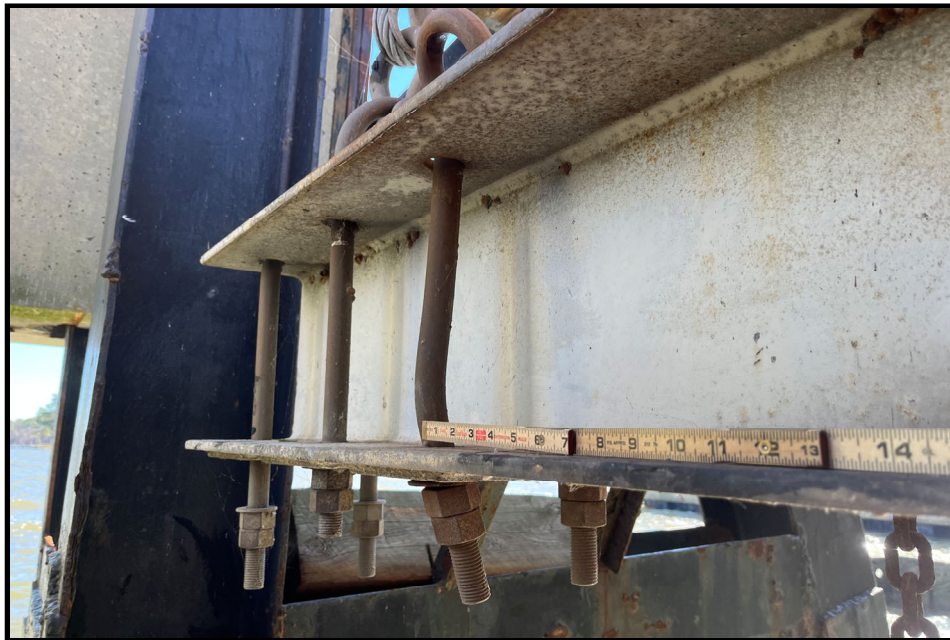
| STRUCTURAL ELEMENT DEFECT | UNIT | QUANTITY |
|---|---|---|
| 15. UP TO 8" X 1/2" DISTORTION OF U-BOLT ON NORTH SIDE AT RIGHT LIFT BEAM HYDRAULIC PISTON CONNECTION | EA | 1 |

UP TO 8" X 1/2" DISTORTION OF U-BOLT ON NORTH SIDE AT RIGHT LIFT BEAM HYDRAULIC PISTON CONNECTION

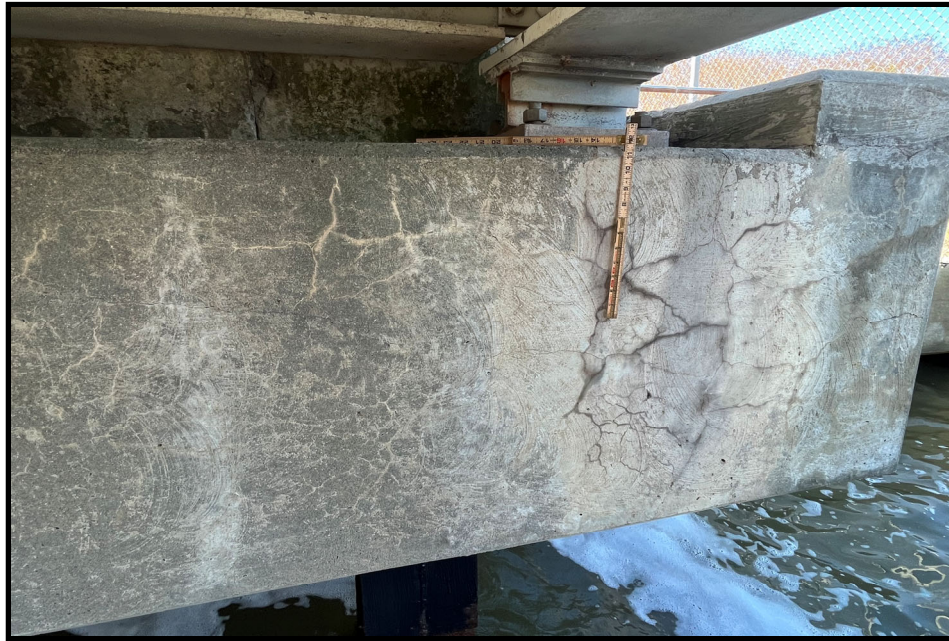
| STRUCTURAL ELEMENT DEFECT | UNIT | QUANTITY |
|---|---|---|
| 16. UP TO 0.016" TRANSVERSE, VERTICAL AND HORIZONTAL CRACKS AND HAIRLINE MAP CRACKS WITH AND WITHOUT EFFLORESCENCE THROUGHOUT CONCRETE CAPS | LF | 46 |

UP TO 0.016" TRANSVERSE, VERTICAL AND HORIZONTAL CRACKS AND HAIRLINE MAP CRACKS WITH AND WITHOUT EFFLORESCENCE THROUGHOUT CONCRETE CAPS, NORTH FACE OF BENT 2 AT LEFT END SHOWN

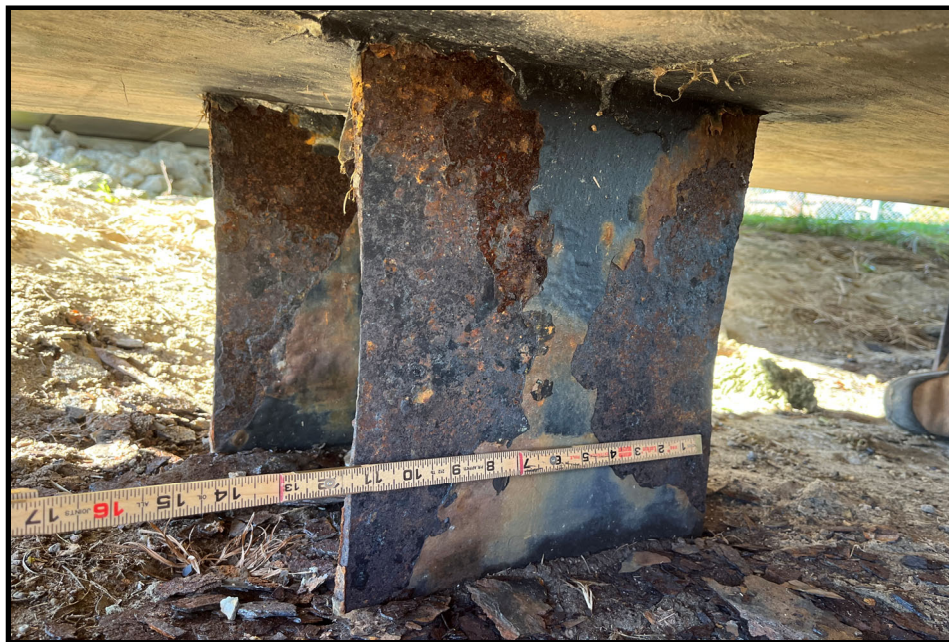
| STRUCTURAL ELEMENT DEFECT | UNIT | QUANTITY |
|---|---|---|
| 17. BENT 1 PILES: AREAS OF CORROSION ALONG BOTH FLANGES UP TO 18" HIGH X 12" WIDE DOWN TO KNIFE'S EDGE RESIDUAL FLANGE (9/16" ORIGINAL THICKNESS) AT BOTTOM OF CAP; TOTAL DEFECT LENGTHS PER PILE AS FOLLOWS:<br><div> <div>PILE 1: 3 LF</div> <div>PILE 2: 4 LF</div> <div>PILE 3: 2 LF</div> <div>PILE 4: 4 LF</div> </div> | LF<br>(TOTAL) | 13 |

BENT 1 PILES: AREAS OF CORROSION ALONG BOTH FLANGES UP TO 18" HIGH X 12" WIDE DOWN TO KNIFE'S EDGE RESIDUAL FLANGE (9/16" ORIGINAL THICKNESS) AT BOTTOM OF CAP, NORTH FACE OF PILE 4 SHOWN

| REPAIR RECOMMENDATIONS | UNIT | QUANTITY |
|---|---|---|
| 5. REPAIR PILES WITH ANY MEASURABLE LOSS OF SECTION IN FLANGES | LF | 39 |
| BENT 1 PILES: 13 LF | | |

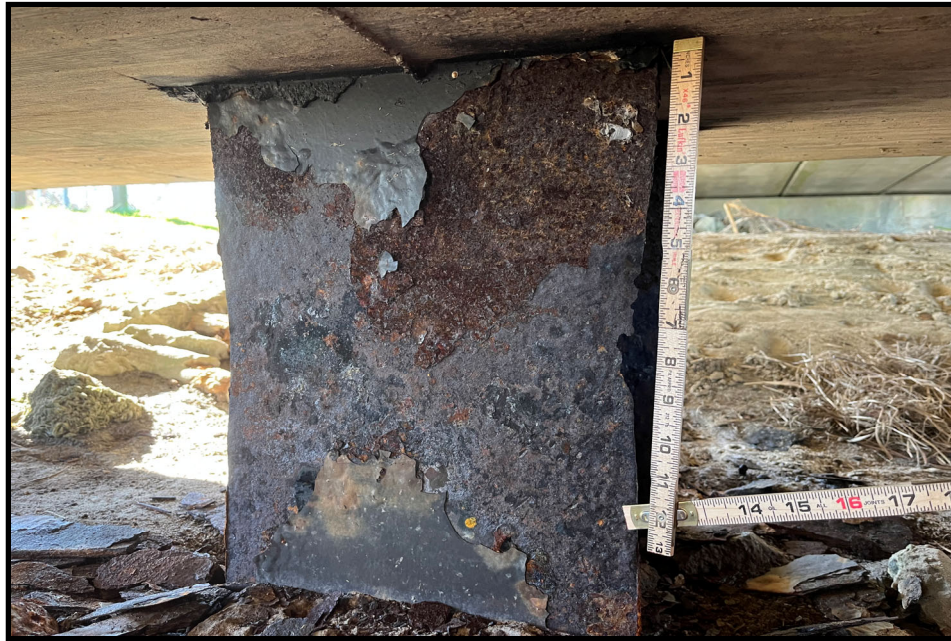
| STRUCTURAL ELEMENT DEFECT | UNIT | QUANTITY |
|---|---|---|
| 18. BENT 1 PILE 3: AREA OF CORROSION ALONG NORTH FLANGE UP TO 17" HIGH X 12" WIDE DOWN TO KNIFE'S EDGE RESIDUAL FLANGE (9/16" ORIGINAL THICKNESS) WITH 5" HIGH X 1/2" WIDE LOSS OF SECTION AT BOTTOM OF CAP | LF | 2 |

BENT 1 PILE 3: AREA OF CORROSION ALONG NORTH FLANGE UP TO 17" HIGH X 12" WIDE  
DOWN TO KNIFE'S EDGE RESIDUAL FLANGE (9/16" ORIGINAL THICKNESS) WITH 5" HIGH X 1/2"  
WIDE LOSS OF SECTION AT BOTTOM OF CAP

| REPAIR RECOMMENDATIONS | UNIT | QUANTITY |
|---|---|---|
| 4. REPAIR PILES WITH AREAS OF 100% SECTION LOSS | LF | 11 |
| BENT 1 PILE 3 NORTH FLANGE: 2 LF | | |

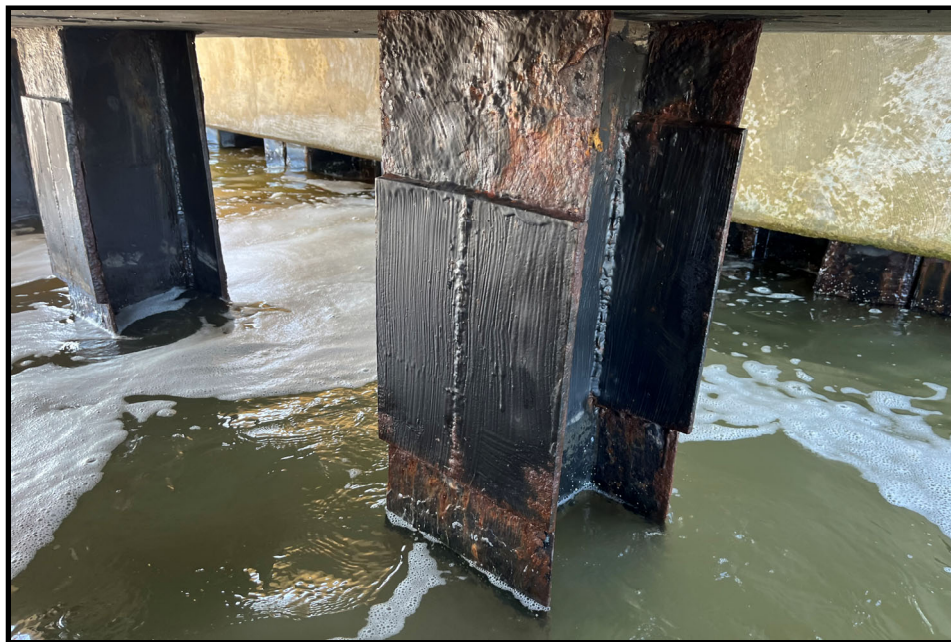
| STRUCTURAL ELEMENT DEFECT | UNIT | QUANTITY |
|---|---|---|
| 19. BENT 2 PILES: AREAS OF CORROSION ALONG BOTH FLANGES ABOVE AND BELOW WELDED PLATE REPAIRS UP TO 9" HIGH X 12" WIDE DOWN TO 1/8" RESIDUAL FLANGE (9/16" ORIGINAL THICKNESS) THROUGHOUT ALL PILES; TOTAL DEFECT LENGTHS PER PILE AS FOLLOWS:<br><div> <div>PILE 1: 4 LF</div> <div>PILE 2: 3 LF</div> <div>PILE 3: 2 LF</div> <div>PILE 4: 2 LF</div> </div> | LF<br>(TOTAL) | 11 |

BENT 2 PILES: AREAS OF CORROSION ALONG BOTH FLANGES ABOVE AND BELOW WELDED  
PLATE REPAIRS UP TO 9" HIGH X 12" WIDE DOWN TO 1/8" RESIDUAL FLANGE (9/16" ORIGINAL  
THICKNESS) THROUGHOUT ALL PILES, NORTH FACE OF PILE 1 SHOWN

| REPAIR RECOMMENDATIONS | UNIT | QUANTITY |
|---|---|---|
| BENT 2 PILES: 11 LF | | |

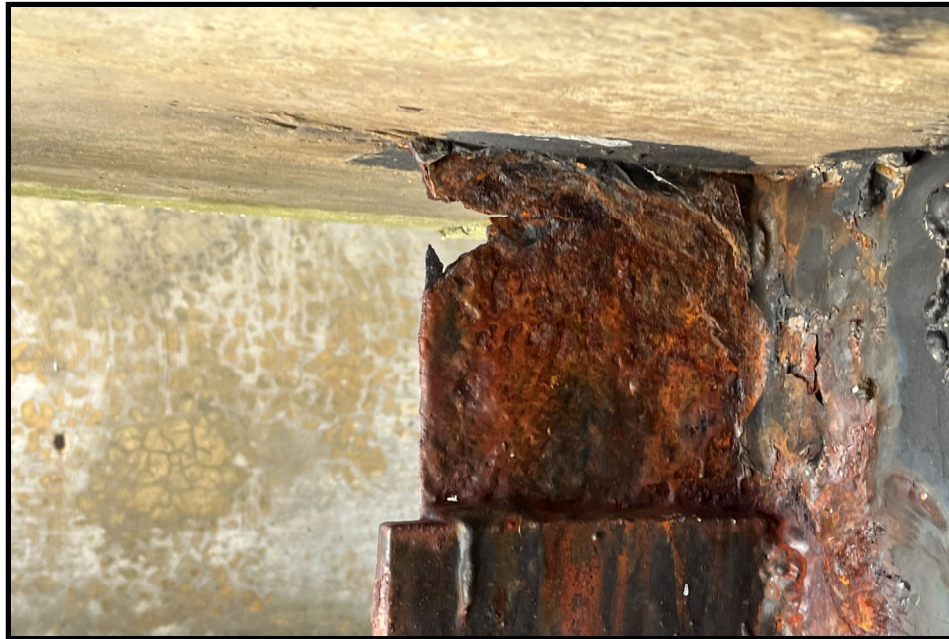
| STRUCTURAL ELEMENT DEFECT | UNIT | QUANTITY |
|---|---|---|
| 20. BENT 2 PILES 2 THRU 4: AREAS OF CORROSION ALONG SOUTH FLANGE ABOVE WELDED PLATE REPAIRS UP TO 5 1/2" HIGH X 12" WIDE DOWN TO KNIFE'S EDGE RESIDUAL FLANGE (9/16" ORIGINAL THICKNESS) WITH 2" WIDE X 1" HIGH LOSS OF SECTION AT BOTTOM OF CAP; TOTAL DEFECT LENGTHS PER PILE AS FOLLOWS:<br><div> <div>PILE 2: 1 LF</div> <div>PILE 3: 1 LF</div> <div>PILE 4: 1 LF</div> </div> | LF<br>(TOTAL) | 3 |

BENT 2 PILES 2 THRU 4: AREAS OF CORROSION ALONG SOUTH FLANGE ABOVE WELDED PLATE REPAIRS UP TO 5 1/2" HIGH X 12" WIDE DOWN TO KNIFE'S EDGE RESIDUAL FLANGE (9/16" ORIGINAL THICKNESS) WITH 2" WIDE X 1" HIGH LOSS OF SECTION AT BOTTOM OF CAP, SOUTH FACE OF PILE 4 SHOWN

| REPAIR RECOMMENDATIONS | UNIT | QUANTITY |
|---|---|---|
| BENT 2 PILE 4 SOUTH FLANGE: 1 LF | | |

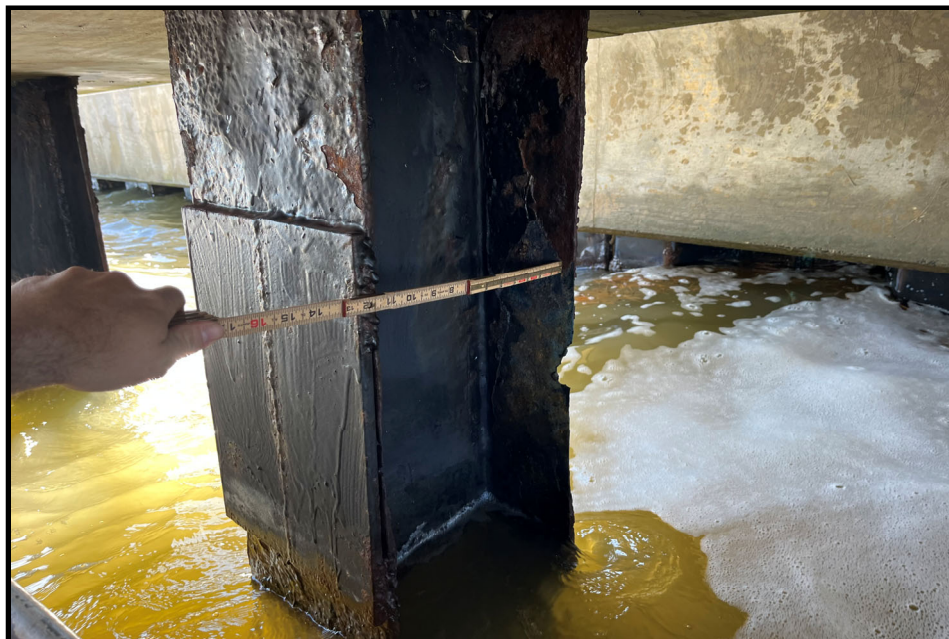
| STRUCTURAL ELEMENT DEFECT | UNIT | QUANTITY |
|---|---|---|
| 21. BENT 2 PILES 1 AND 3: AREAS OF CORROSION ALONG EDGES OF SOUTH FLANGE UP TO 36" HIGH X 6" WIDE DOWN TO KNIFE'S EDGE RESIDUAL FLANGE (9/16" ORIGINAL THICKNESS) WITH 2 1/2" HIGH AND 1" WIDE LOSS OF SECTION NEAR BOTTOM OF CAP<br>PILE 1: 3 LF                      PILE 3: 3 LF | LF<br>(TOTAL) | 6 |

BENT 2 PILES 1 AND 3: AREAS OF CORROSION ALONG EDGES OF SOUTH FLANGE UP TO 36" HIGH X 6" WIDE DOWN TO KNIFE'S EDGE RESIDUAL FLANGE (9/16" ORIGINAL THICKNESS) WITH 2 1/2" HIGH AND 1" WIDE LOSS OF SECTION NEAR BOTTOM OF CAP, LEFT SIDE OF PILE 3 SHOWN

| REPAIR RECOMMENDATIONS | UNIT | QUANTITY |
|---|---|---|
| BENT 2 PILE 3 SOUTH FLANGE: 1 LF | | |

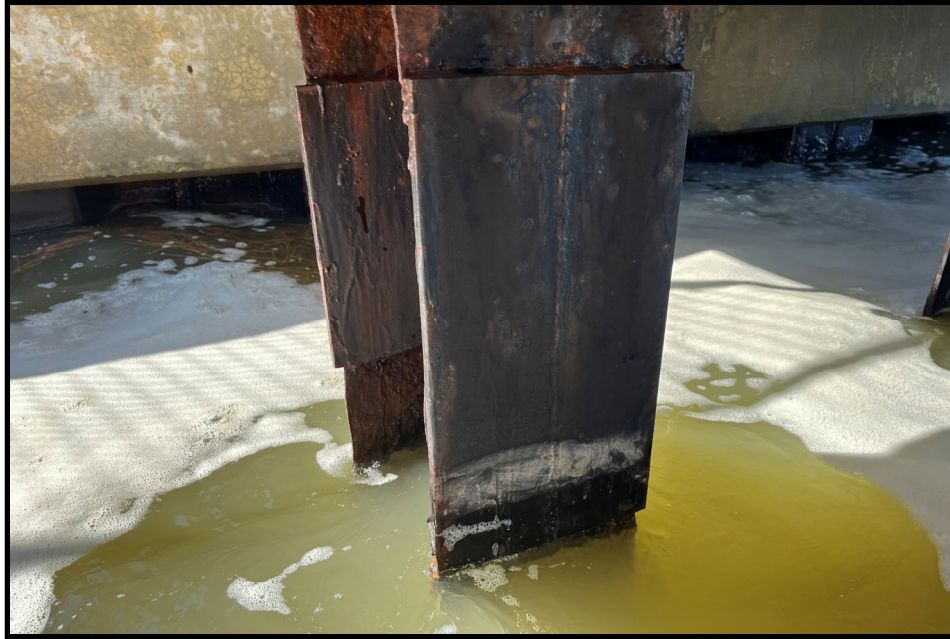
| STRUCTURAL ELEMENT DEFECT | UNIT | QUANTITY |
|---|---|---|
| 22. BENT 2 PILES: WELDED PLATE REPAIRS ALONG BOTH FLANGES UP TO 31" HIGH X 6" WIDE X 1/2" THICK THROUGHOUT ALL PILES NEAR BOTTOM OF CAP | LF | 29 |

BENT 2 PILES: WELDED PLATE REPAIRS ALONG BOTH FLANGES UP TO 31" HIGH X 6" WIDE X 1/2" THICK THROUGHOUT ALL PILES NEAR BOTTOM OF CAP, NORTH FACE OF PILE 4 SHOWN

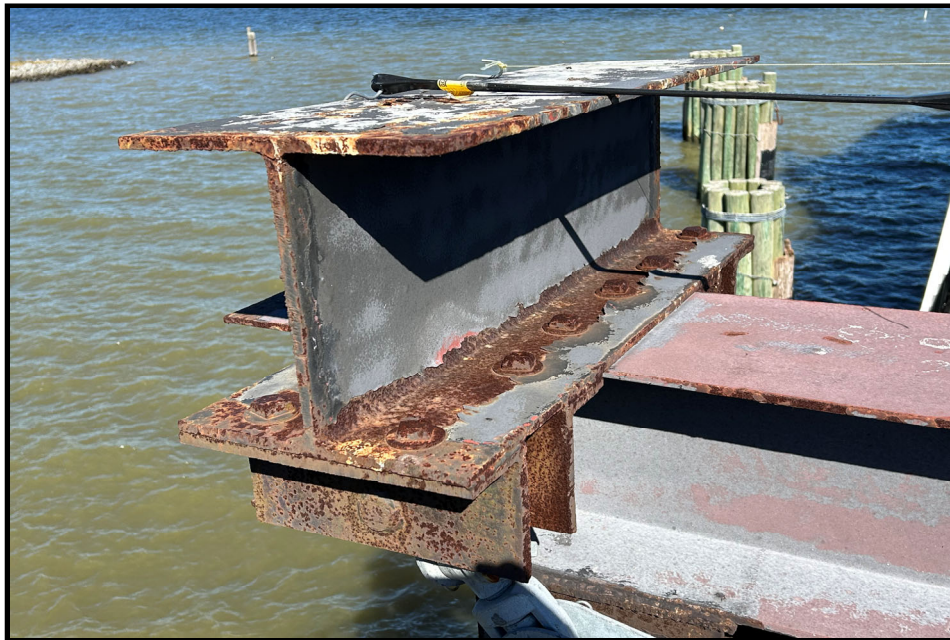
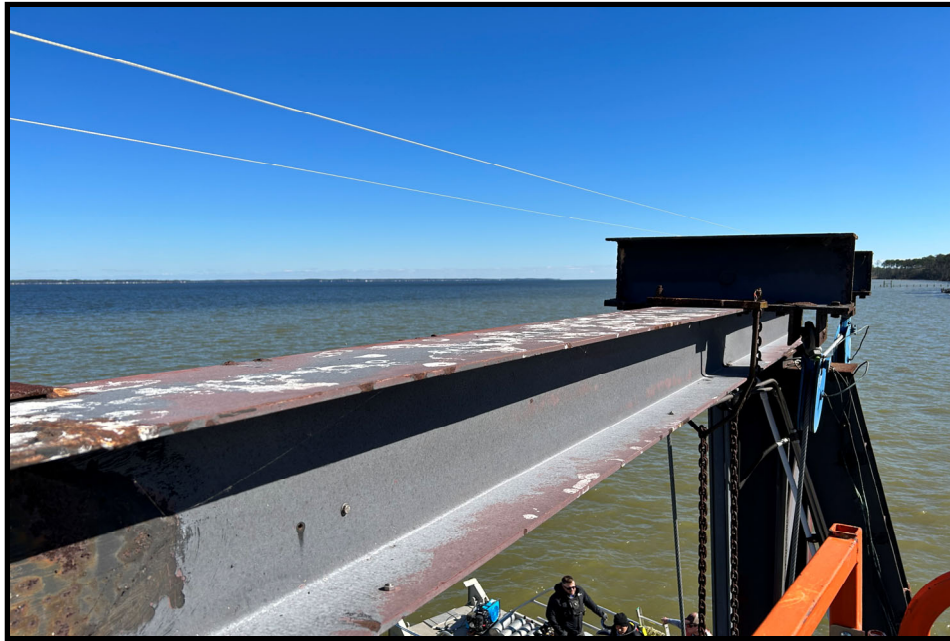
| STRUCTURAL ELEMENT DEFECT | UNIT | QUANTITY |
|---|---|---|
| 23. AREAS OF SURFACE CORROSION THROUGHOUT GANTRY TOP CAP AND PULLEY CONNECTION CROSS BEAMS IN VARIOUS LOCATIONS | LF | 47 |

AREAS OF SURFACE CORROSION THROUGHOUT GANTRY TOP CAP AND PULLEY CONNECTION CROSS BEAMS IN VARIOUS LOCATIONS, CROSS BEAM AT LEFT END SHOWN

AREAS OF SURFACE CORROSION THROUGHOUT GANTRY TOP CAP AND PULLEY CONNECTION CROSS BEAMS IN VARIOUS LOCATIONS, SOUTH FACE OF LIFT BENT CAP SHOWN

| 4. CLEAN AND PAINT ALL STEEL GANTRY ELEMENTS | SF | 1106 |

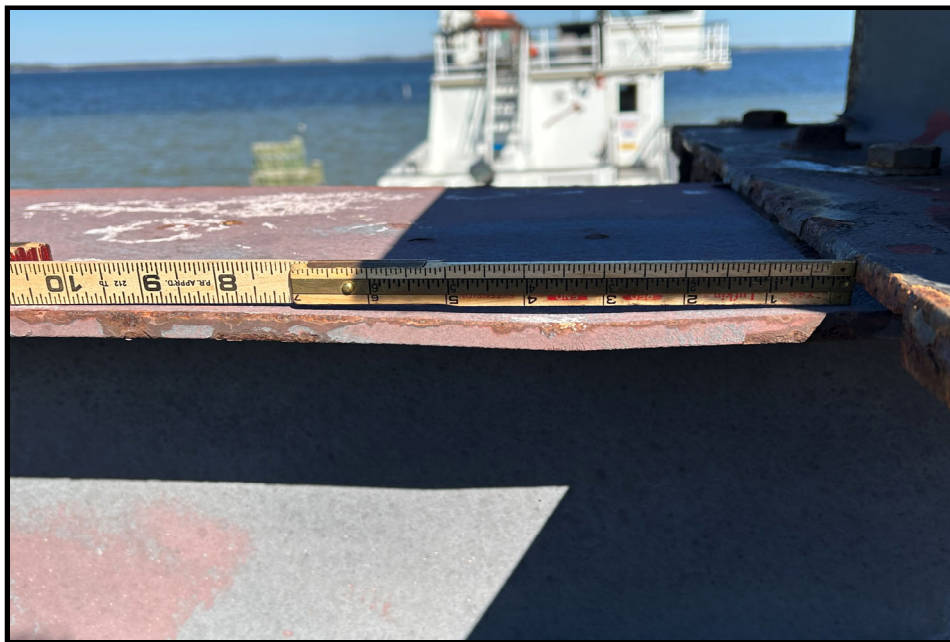
| STRUCTURAL ELEMENT DEFECT | UNIT | QUANTITY |
|---|---|---|
| 24. GANTRY TOP CAP: (2) AREAS OF DISTORTION UP TO 7" X 1/8" - (1) ALONG SOUTH EDGE OF TOP FLANGE TO LEFT OF PULLEY 2 CROSS BEAM, AND (1) ALONG NORTH EDGE TO LEFT OF PILE 4 | LF | 2 |

GANTRY TOP CAP: (2) AREAS OF DISTORTION UP TO 7" X 1/8" - (1) ALONG SOUTH EDGE OF TOP FLANGE TO LEFT OF PULLEY 2 CROSS BEAM, AND (1) ALONG NORTH EDGE TO LEFT OF PILE 4, CONDITION NEAR PULLY 2 CROSSBEAM SHOWN

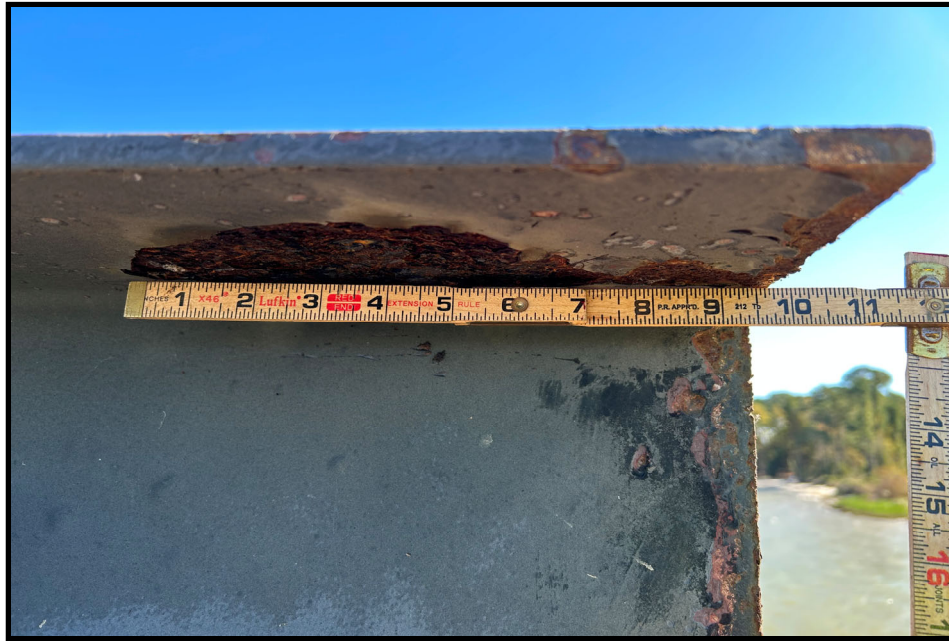
| STRUCTURAL ELEMENT DEFECT | UNIT | QUANTITY |
|---|---|---|
| 25. PULLEY 3 CROSS BEAM: 10" LONG X 3 3/4" WIDE AREA OF CORROSION WITH 1/16" LOSS OF SECTION IN BOTTOM OF TOP FLANGE ON LEFT SIDE EXTENDING FROM SOUTH END | LF | 1 |

PULLEY 3 CROSS BEAM: 10" LONG X 3 3/4" WIDE AREA OF CORROSION WITH 1/16" LOSS OF SECTION IN BOTTOM OF TOP FLANGE ON LEFT SIDE EXTENDING FROM SOUTH END

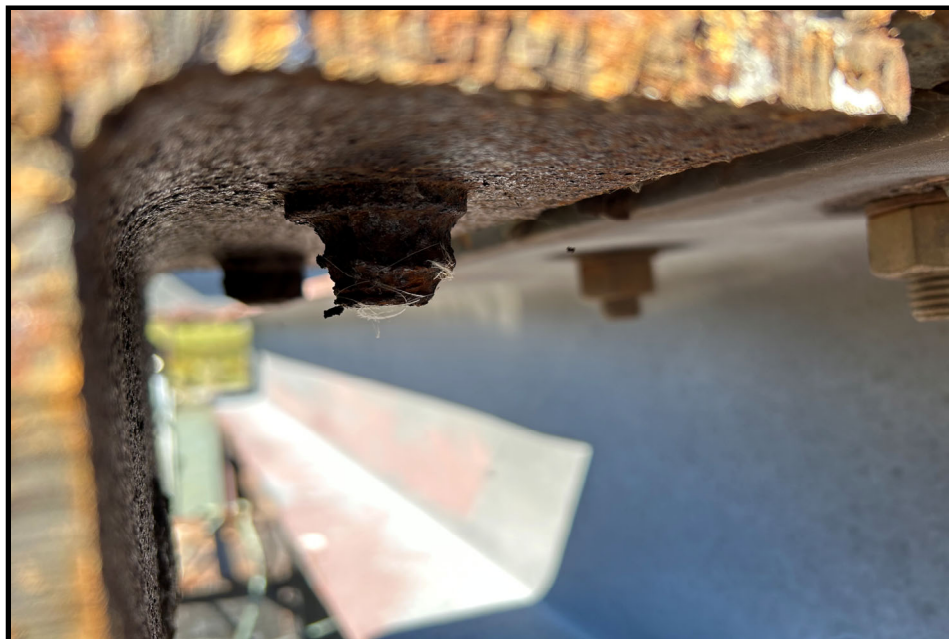
| STRUCTURAL ELEMENT DEFECT | UNIT | QUANTITY |
|---|---|---|
| 26. CORROSION WITH UP TO 100% LOSS OF SECTION THROUGHOUT CROSS BEAM AND PULLEY ATTACHMENT BOLTS AND NUTS IN VARIOUS LOCATIONS | EA | 12 |

CORROSION WITH UP TO 100% LOSS OF SECTION THROUGHOUT CROSS BEAM AND PULLEY ATTACHMENT BOLTS AND NUTS IN VARIOUS LOCATIONS

| REPAIR RECOMMENDATIONS | UNIT | QUANTITY |
|---|---|---|
| 6. REPLACE CROSS BEAM AND PULLEY ATTACHMENT BOLTS AND NUTS WITH SECTION LOSS | EA | 12 |

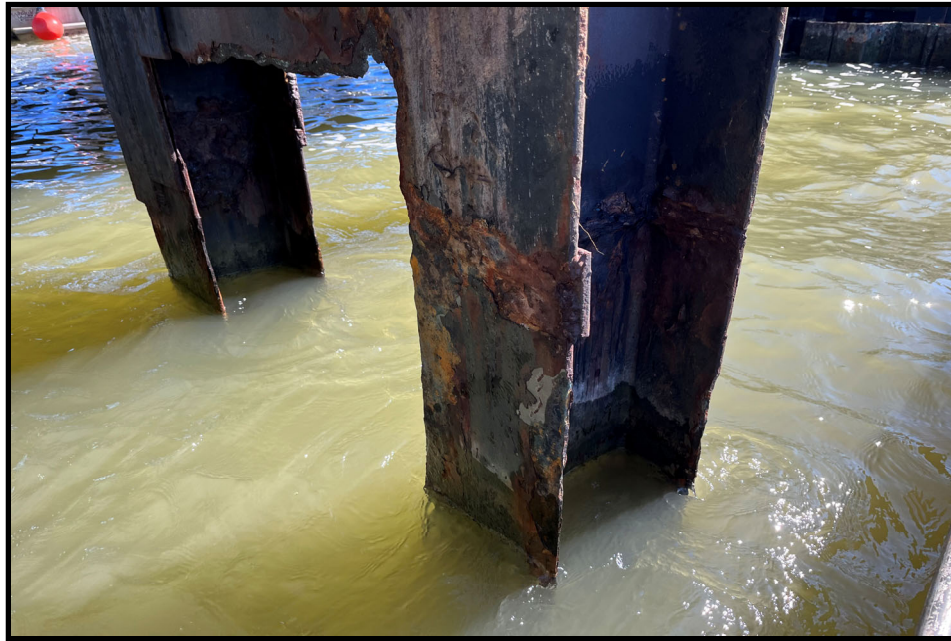
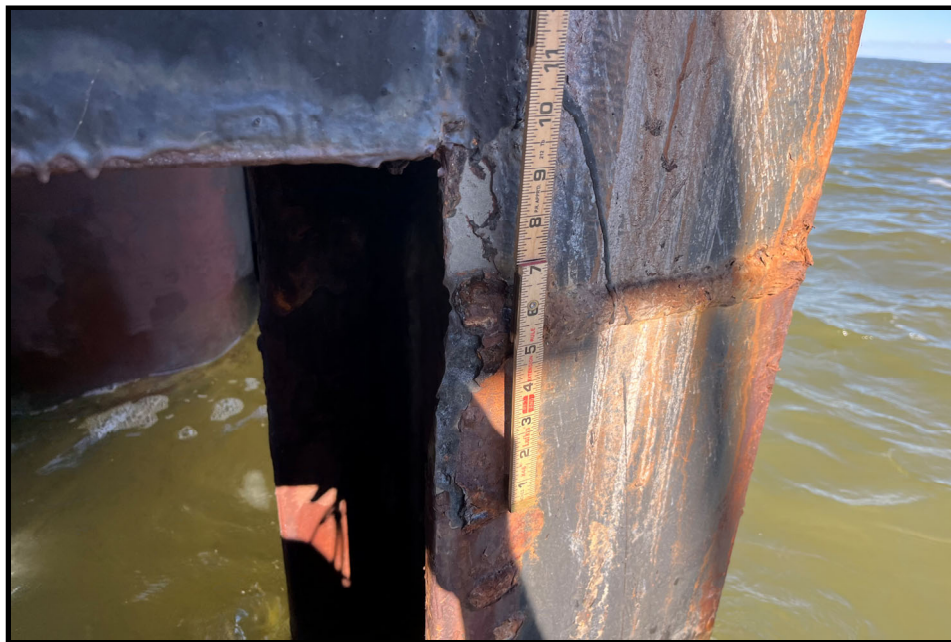
| STRUCTURAL ELEMENT DEFECT | UNIT | QUANTITY |
|---|---|---|
| 27. LIFT BENT PILES 2 THRU 6: AREAS OF CORROSION ALONG BOTH FLANGES UP TO 32" LONG X 12" WIDE DOWN TO KNIFE'S EDGE RESIDUAL FLANGE (9/16" ORIGINAL THICKNESS) BETWEEN BRACING AND WATERLINE IN VARIOUS LOCATIONS<br>PILE 2: 1 LF                      PILE 4: 4 LF                      PILE 6: 2 LF<br>PILE 3: 5 LF                      PILE 5: 3 LF | LF<br>(TOTAL) | 15 |

LIFT BENT PILES 2 THRU 6: AREAS OF CORROSION ALONG BOTH FLANGES UP TO 32" LONG X 12" WIDE DOWN TO KNIFE'S EDGE RESIDUAL FLANGE (9/16" ORIGINAL THICKNESS) BETWEEN BRACING AND WATERLINE IN VARIOUS LOCATIONS, NORTH FACE OF PILE 3 SHOWN

LIFT BENT PILES 2 THRU 6: AREAS OF CORROSION ALONG BOTH FLANGES UP TO 32" LONG X 12" WIDE DOWN TO KNIFE'S EDGE RESIDUAL FLANGE (9/16" ORIGINAL THICKNESS) BETWEEN BRACING AND WATERLINE IN VARIOUS LOCATIONS, PILE 6 SOUTH FACE SHOWN

| REPAIR RECOMMENDATIONS | UNIT | QUANTITY |
|---|---|---|
| LIFT BENT PILES: 15 LF | | |

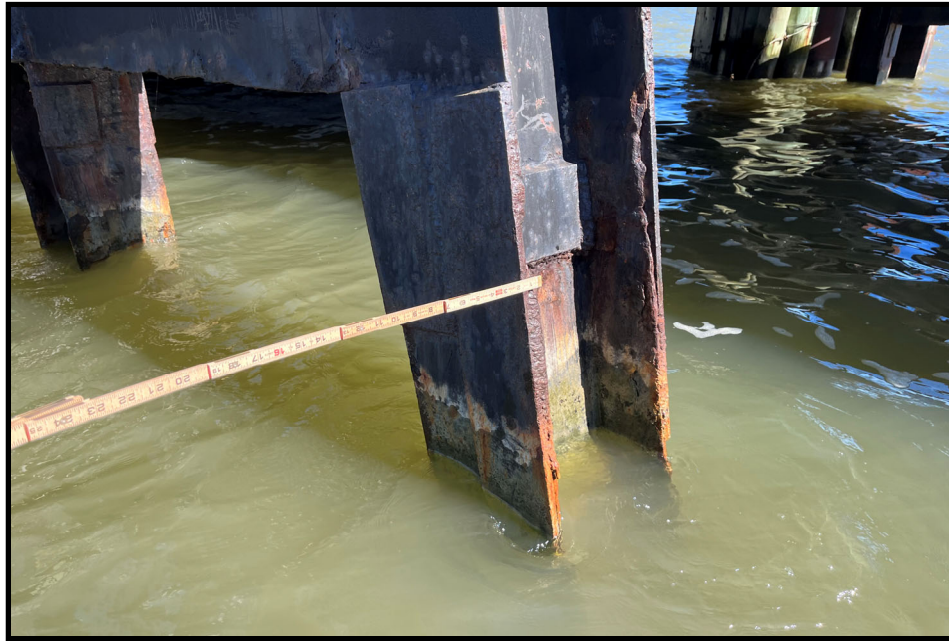
| STRUCTURAL ELEMENT DEFECT | UNIT | QUANTITY |
|---|---|---|
| 28. LIFT BENT PILES: WELDED PLATE REPAIRS ALONG FLANGES AND WEBS UP TO 36" HIGH X 6" WIDE X 1/2" THICK THROUGHOUT PILES FROM BRACING TO WATERLINE | LF | 41 |

LIFT BENT PILES: WELDED PLATE REPAIRS ALONG FLANGES AND WEBS UP TO 36" HIGH X 6" WIDE X 1/2" THICK THROUGHOUT PILES FROM BRACING TO WATERLINE, LEFT SIDE OF PILE 1 SHOWN
