# BRIDGE INSPECTION REPORT

COUNTY: BEAUFORT BRIDGE NO.: 060321

ROUTE: NC306 FERRY TERMINAL ACROSS: PAMLICO SOUND

DESCRIPTION: APPROACH SPANS: PPC CORED SLABS; LIFT SPAN: STEEL FLOOR BEAM SYSTEM

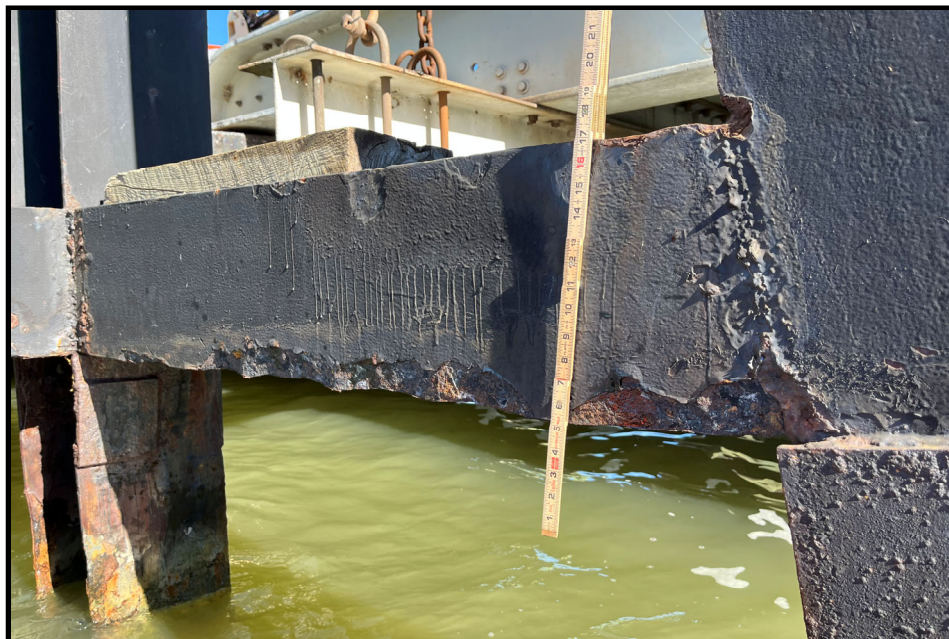
| STRUCTURAL ELEMENT DEFECT | UNIT | QUANTITY |
|---|---|---|
| 29. LIFT BENT PILE BRACING: AREAS OF CORROSION ALONG BOTH FLANGES NEAR WATERLINE UP TO 46" LONG X 3" HIGH DOWN TO KNIFE'S EDGE RESIDUAL FLANGE (9/16" ORIGINAL THICKNESS) WITH UP TO 30" LONG X 1/2" HIGH LOSS OF SECTION IN VARIOUS LOCATIONS | LF | 25 |

LIFT BENT PILE BRACING: AREAS OF CORROSION ALONG BOTH FLANGES NEAR WATERLINE UP TO 46" LONG X 3" HIGH DOWN TO KNIFE'S EDGE RESIDUAL FLANGE (9/16" ORIGINAL THICKNESS) WITH UP TO 30" LONG X 1/2" HIGH LOSS OF SECTION IN VARIOUS LOCATIONS, LEFT FACE OF P1-P3 BRACING SHOWN

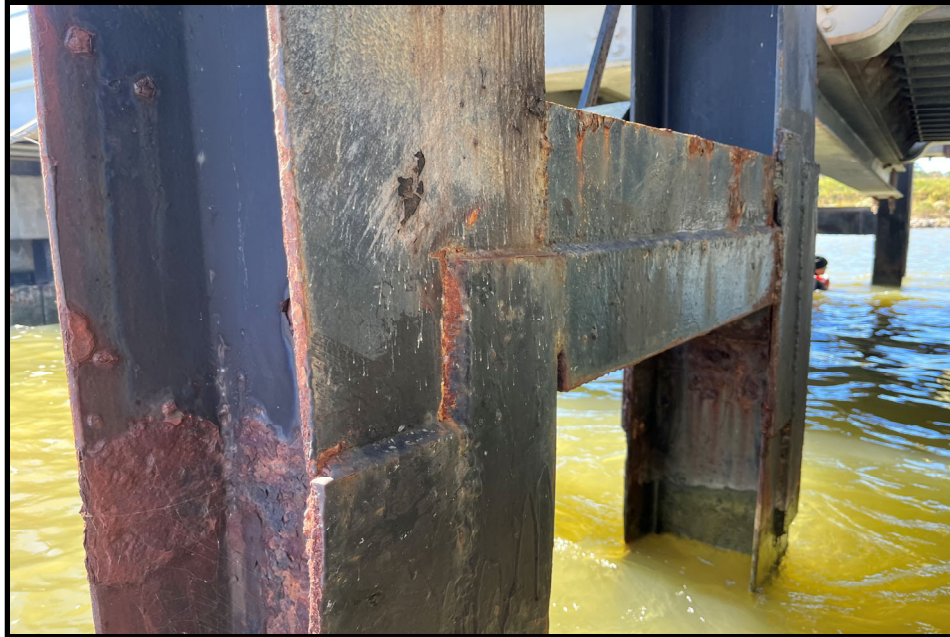
| STRUCTURAL ELEMENT DEFECT | UNIT | QUANTITY |
|---|---|---|
| 30. LIFT BENT PILE BRACING: WELDED PLATE REPAIRS ALONG BOTH FLANGES NEAR WATERLINE UP TO 33" LONG X 6" HIGH IN VARIOUS LOCATIONS | LF | 9 |

LIFT BENT PILE BRACING: WELDED PLATE REPAIRS ALONG BOTH FLANGES NEAR WATERLINE UP TO 33" LONG X 6" HIGH IN VARIOUS LOCATIONS, NORTH FACE OF P5-P6 BRACING SHOWN

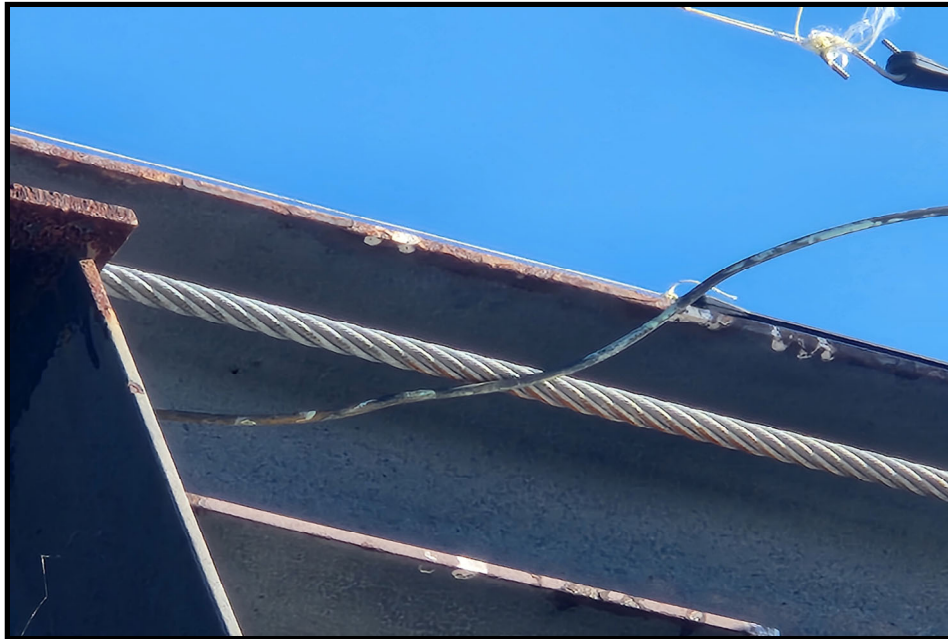
| 2. COUNTERWEIGHT SHEAVE RUBBING ON GREASE LINE AT SOUTHEAST OUTER CABLE | EA | 1 |

SOUTHEAST OUTER COUNTERWEIGHT SHEAVE CABLE RUBBING ON GREASE LINE

| REPAIR RECOMMENDATIONS | UNIT | QUANTITY |
|---|---|---|
| 2. MOVE GREASE LINE ON COUNTERWEIGHT SHEAVE AT SOUTHEAST OUTER CABLE | EA | 1 |

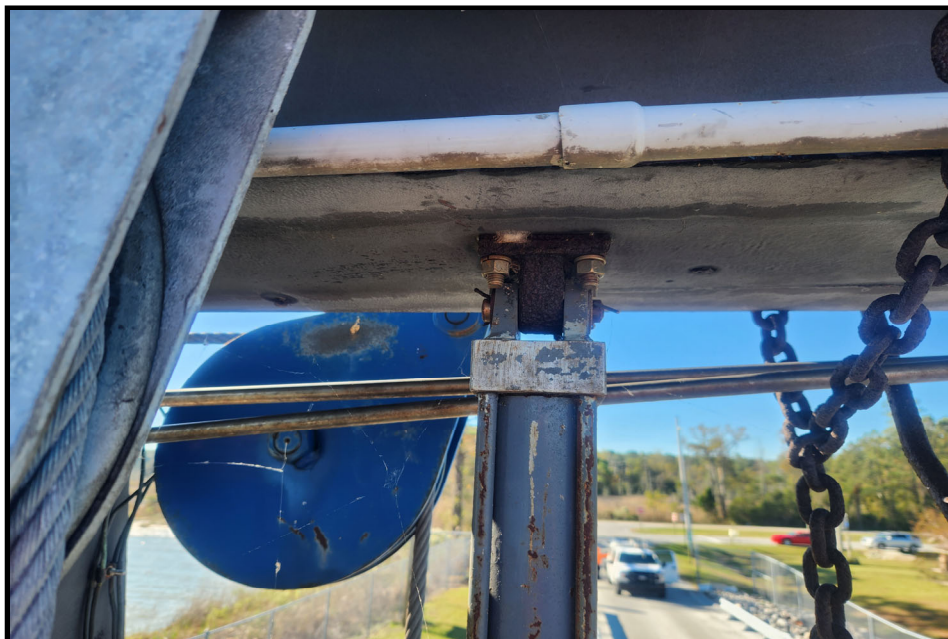
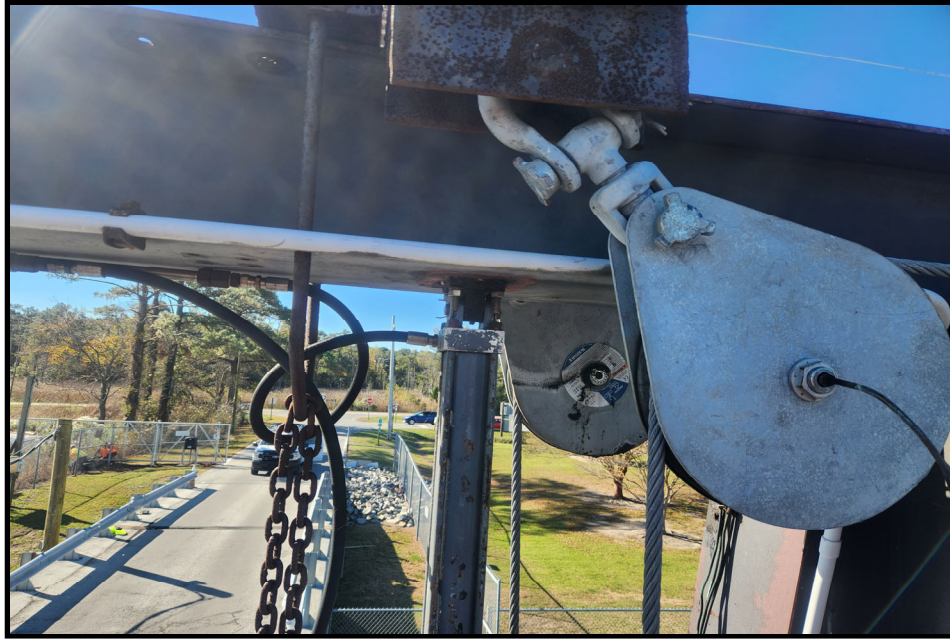
| 3. HYDRAULIC CYLINDER COTTER PINS BROKEN OR INCORRECTLY INSTALLED | EA | 4 |

EAST UPPER HYDRAULIC CYLINDER CLEVIS PIN COTTERS NOT INSTALLED CORRECTLY

WEST UPPER HYDRAULIC CYLINDER CLEVIS PIN COTTERS NOT INSTALLED CORRECTLY

| REPAIR RECOMMENDATIONS | UNIT | QUANTITY |
|---|---|---|
| 3. REPLACE BROKEN AND INCORRECTLY INSTALLED HYDRAULIC CYLINDER COTTER PINS | EA | 4 |

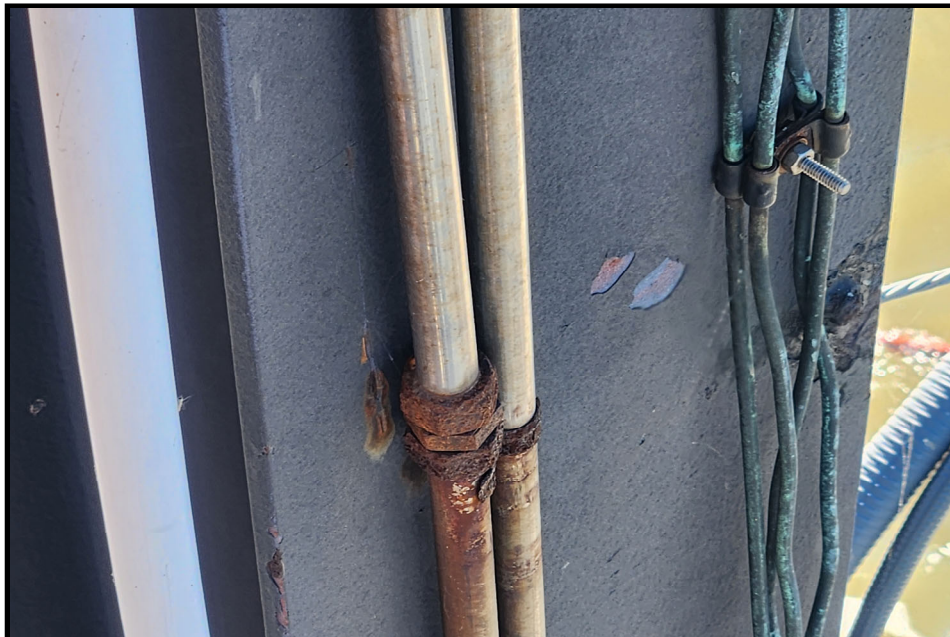
| 4. HYDRAULIC HARD PIPING CORRODED, MISSING CLAMPS OR RUBBING ON SUPPORT | EA | 2 |

CORRODED COUPLING FITTING ON HYDRAULIC PIPING

| REPAIR RECOMMENDATIONS | UNIT | QUANTITY |
|---|---|---|
| 4. REPLACE CORRODED FITTINGS ON HYDRAULIC HARD PIPING AND PROPERLY SECURE | EA | 2 |

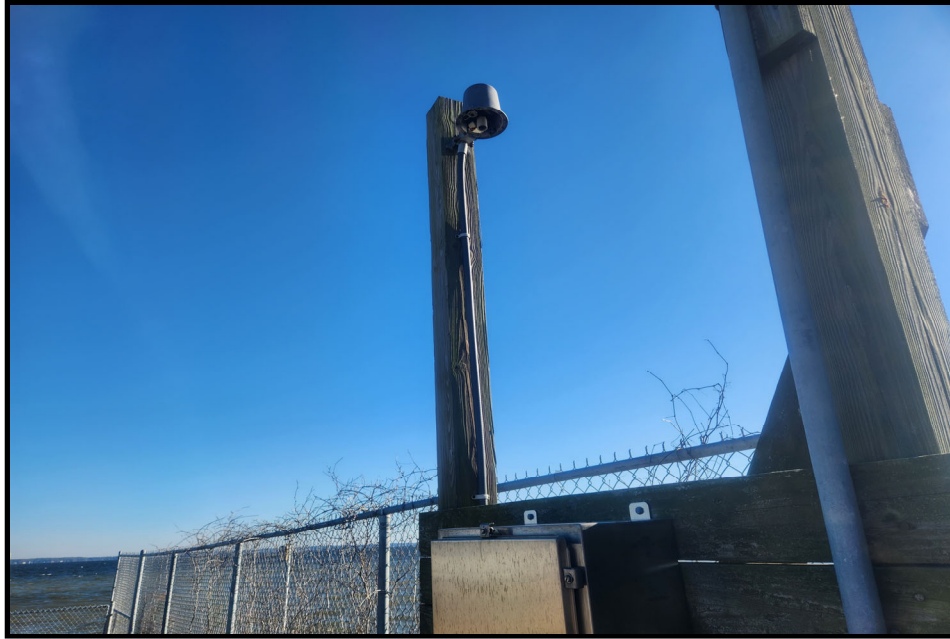
| 1. LIGHT AND GLOBE MISSING FROM AREA LIGHTING | EA | 1 |

LIGHT BULB AND GLOBE MISSING FROM AREA LIGHTING

| REPAIR RECOMMENDATIONS | UNIT | QUANTITY |
|---|---|---|
| 1. REPLACE LIGHT AND GLOBE FOR AREA LIGHTING | EA | 1 |

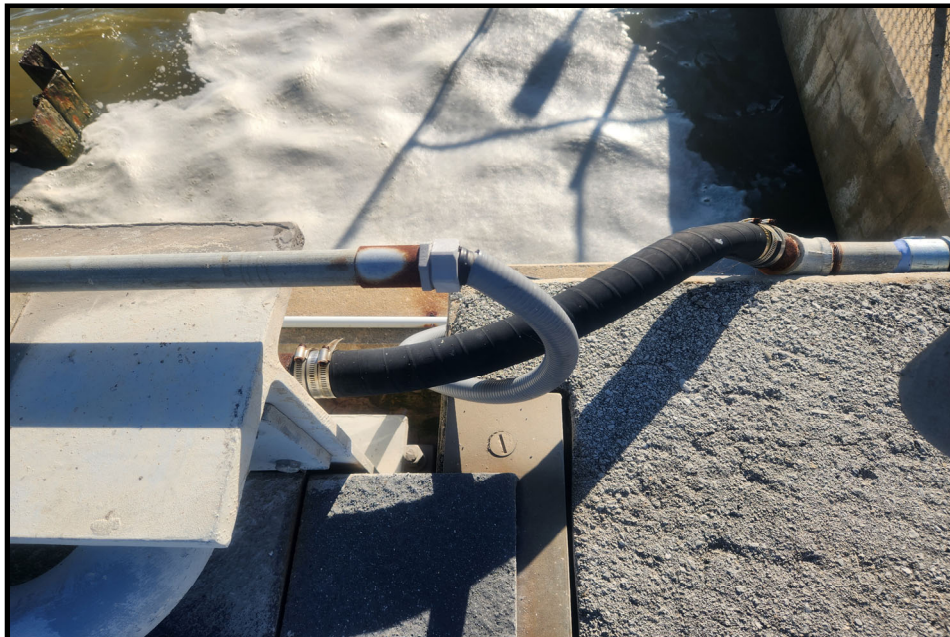
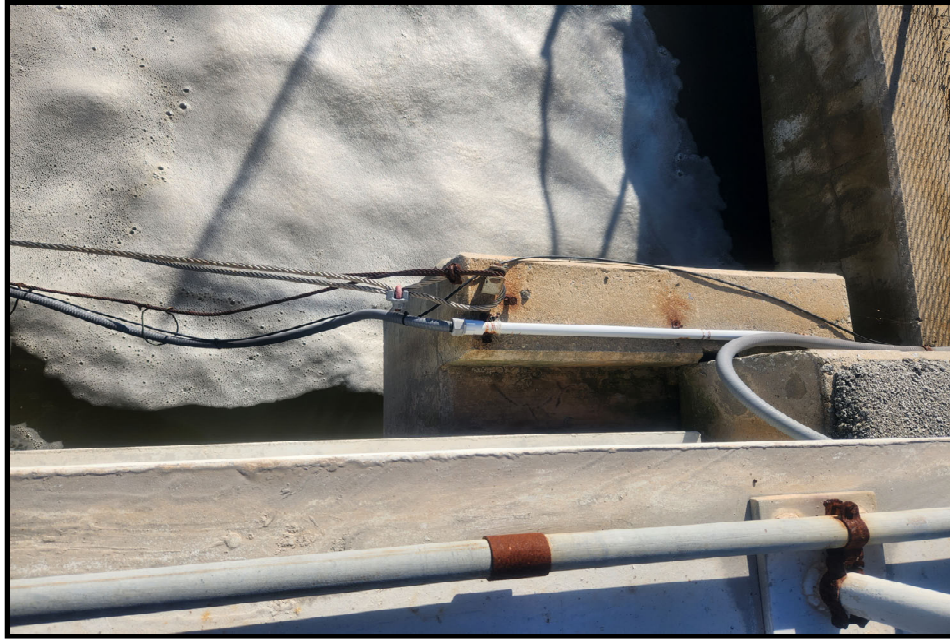
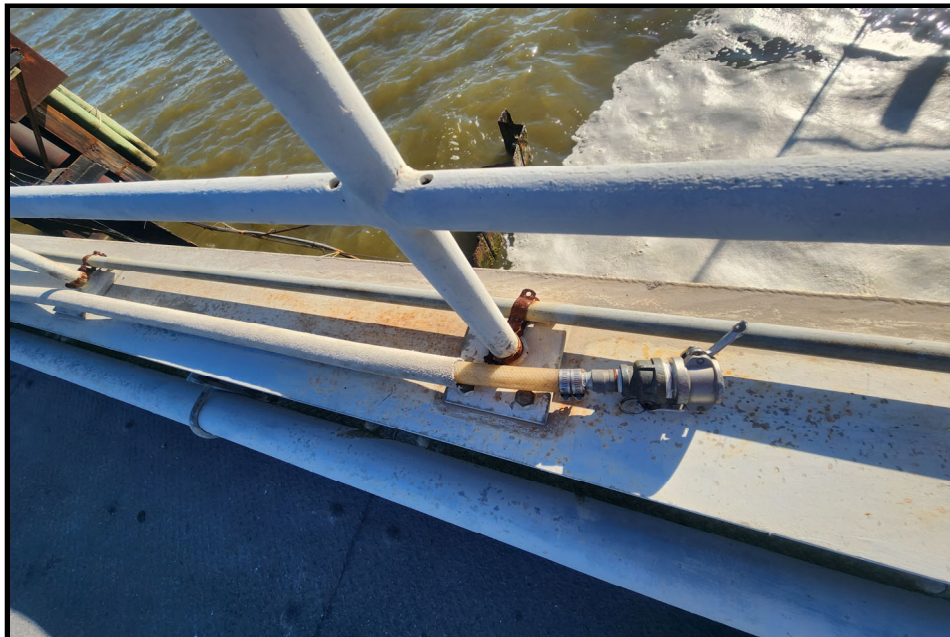
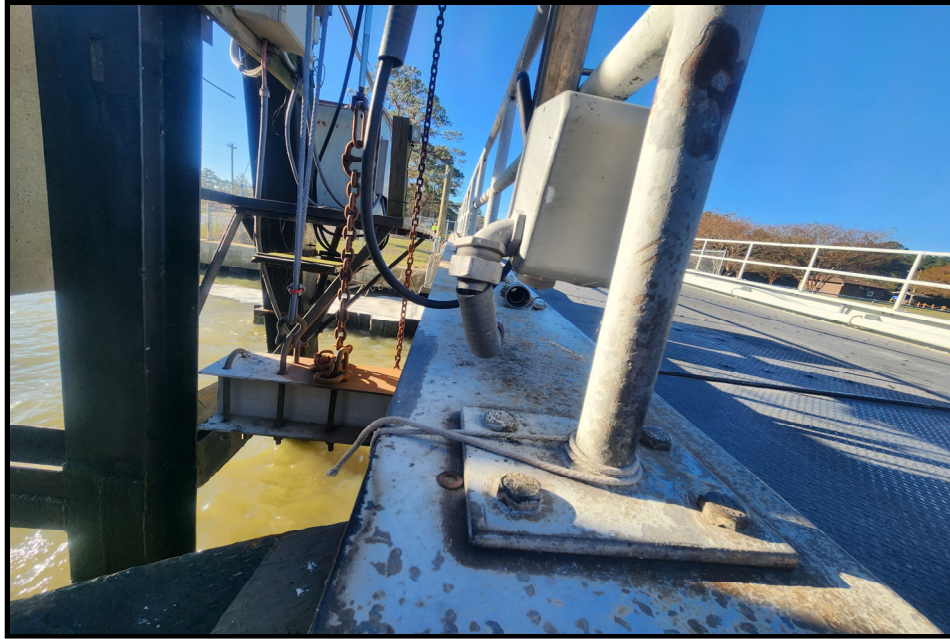
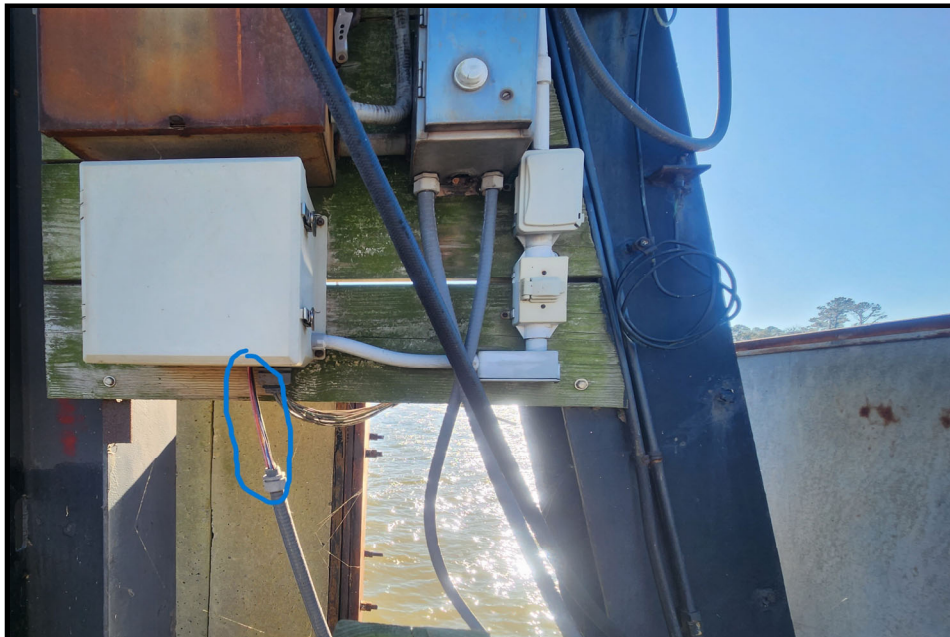
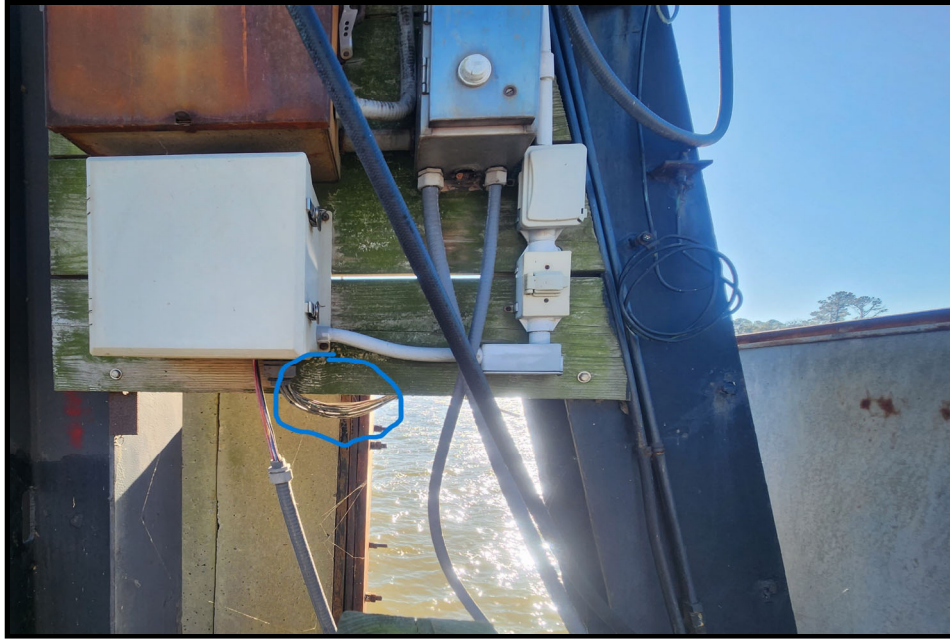
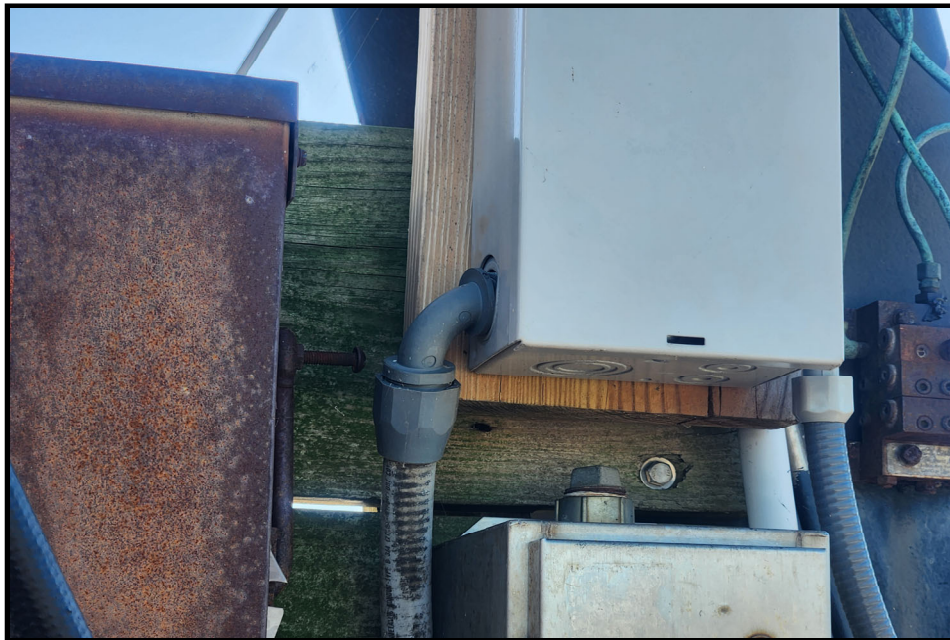
| 2. FLEXIBLE CONDUITS PULLED OUT, SUPPORT CLAMPS BROKEN OR HELD UP BY ZIP TIES | EA | 7 |

FLEXIBLE CONDUIT PULLED OUT OF FITTING

FLEXIBLE CONDUIT HELD BY ZIP TIES

CONDUIT CLAMP BROKEN

FLEXIBLE CONDUIT FITTING PULLED OUT OF JUNCTION BOX

CONDUIT FITTING PULLED OUT OF JUNCTION BOX

| REPAIR RECOMMENDATIONS | UNIT | QUANTITY |
|---|---|---|
| 2. REPAIR ALL PULLED OUT FLEXIBLE CONDUITS FROM FITTING AND PROPERLY SUPPORT CONDUITS | EA | 7 |

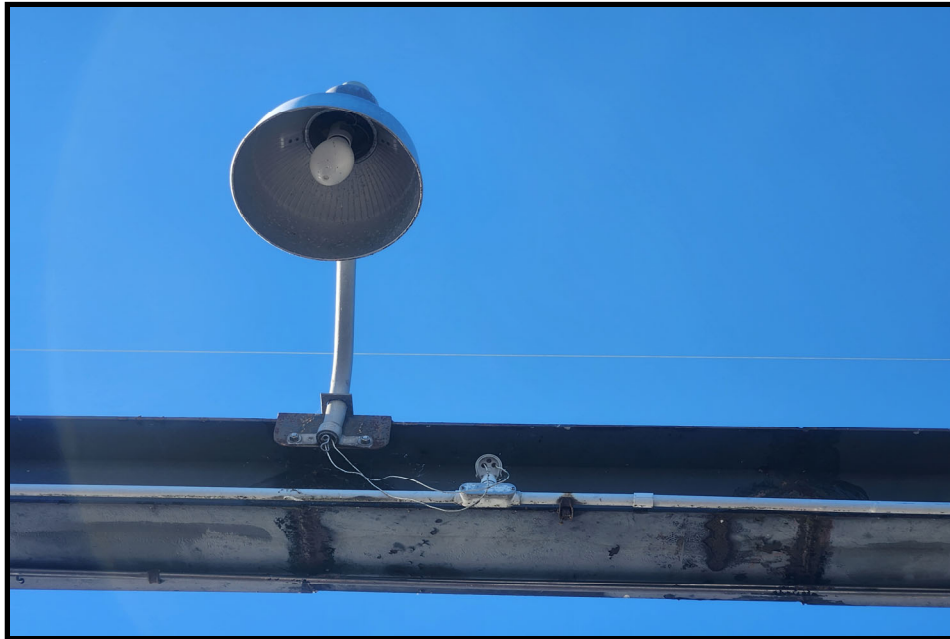
| 3. LIGHT ELECTRICAL WIRES NOT IN CONDUIT | EA | 1 |

LIGHT ELECTRICAL WIRES NOT IN CONDUIT

| REPAIR RECOMMENDATIONS | UNIT | QUANTITY |
|---|---|---|
| 3. INSTALL CONDUIT FOR LIGHT FIXTURE | EA | 1 |

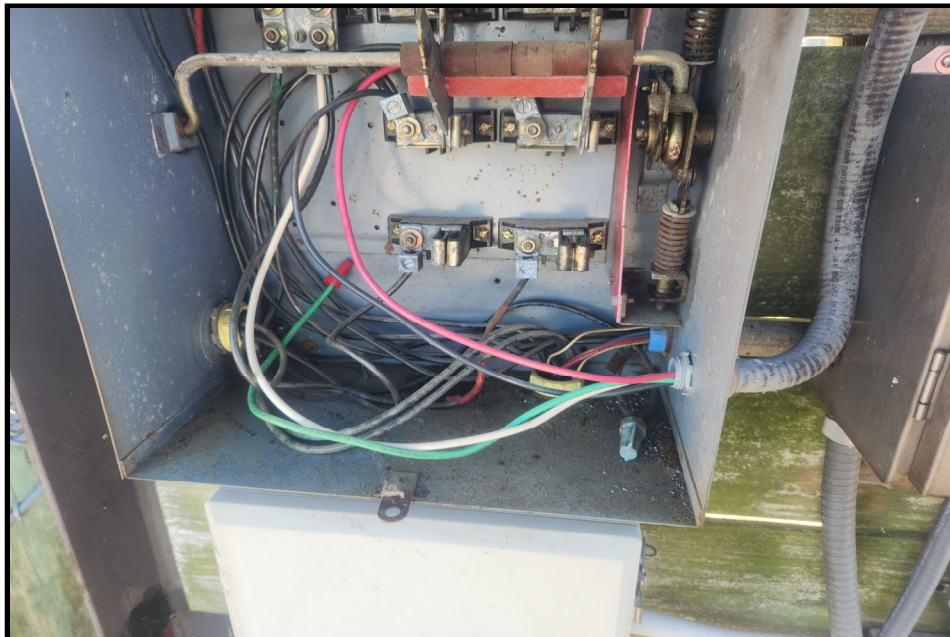
| 4. UNTERMINATED GROUND WIRE IN JUNCTION BOX | EA | 1 |

UNTERMINATED GROUND WIRE IN JUNCTION BOX

| REPAIR RECOMMENDATIONS | UNIT | QUANTITY |
|---|---|---|
| 4. PROPERLY TERMINATE GROUND WIRE IN JUNCTION BOX | EA | 1 |

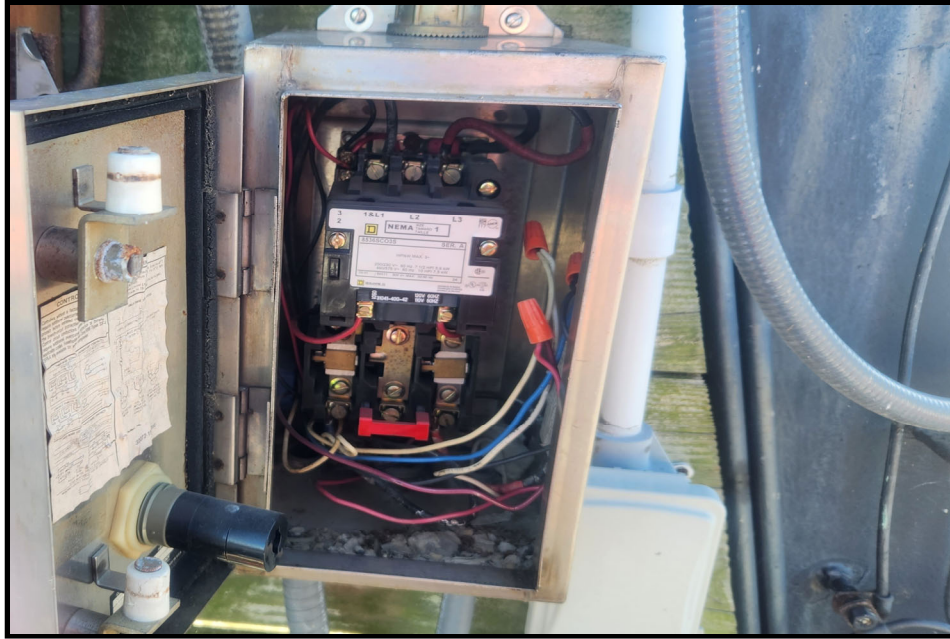
| 5. DEBRIS IN JUNCTION BOXES | EA | 2 |

DEBRIS IN JUNCTION BOX

| REPAIR RECOMMENDATIONS | UNIT | QUANTITY |
|---|---|---|
| 5. CLEAN INTERIOR OF JUNCTION BOXES AND REPLACE SEALS, OR REPLACE JUNCTION BOXES AS REQUIRED | EA | 2 |

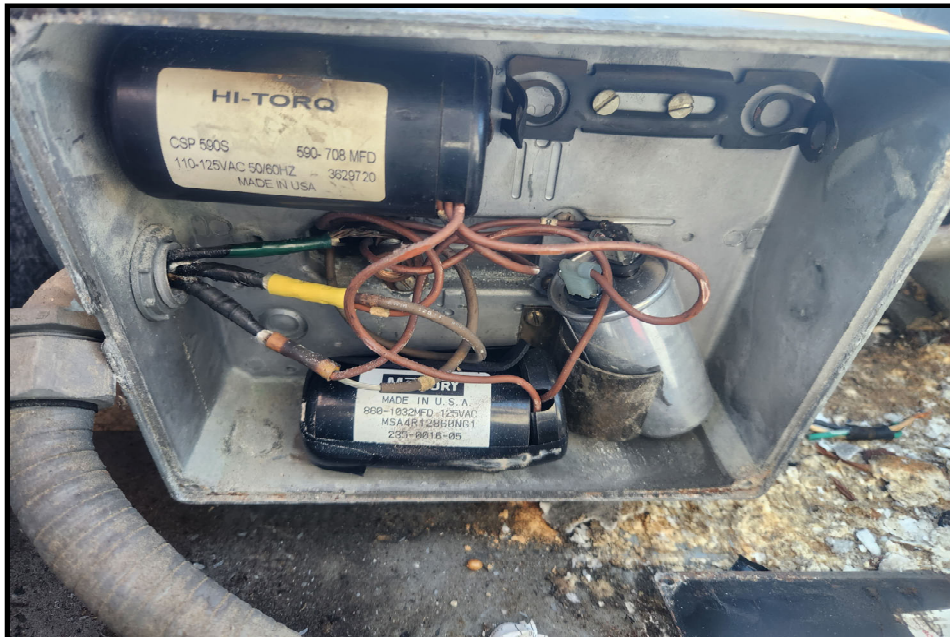
| 6. BURNT CONNECTOR ON HPU CAPACITOR | EA | 1 |

BURNT CONNECTOR ON HPU CAPACITOR

| REPAIR RECOMMENDATIONS | UNIT | QUANTITY |
|---|---|---|
| 6. REPLACE BURNT CONNECTOR ON HPU CAPACITOR | EA | 1 |
