# BRIDGE INSPECTION REPORT

COUNTY: BEAUFORT BRIDGE NO.: 060322

ROUTE: NC306 FERRY TERMINAL ACROSS: PAMLICO SOUND

INSPECTION DATE: 11/1/2023 OPERATING RATING: NOT RATED

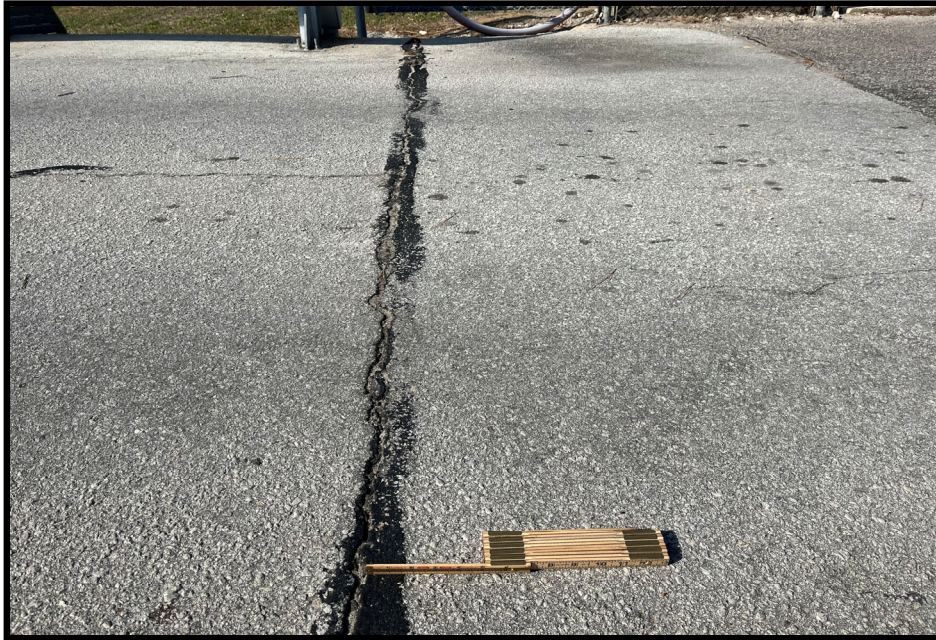
| STRUCTURAL ELEMENT DEFECT | UNIT | QUANTITY |
|---|---|---|
| 1. 1/2" TRANSVERSE CRACKS IN ASPHALT WEARING SURFACE ALONG END BENT 1 FILL FACE | SF | 18 |

1/2" TRANSVERSE CRACKS IN ASPHALT WEARING SURFACE ALONG END BENT 1 FILL FACE

| 1. SEAL CRACKS IN ASPHALT WEARING SURFACE IN SPANS 1 AND 2 | LF | 113 |

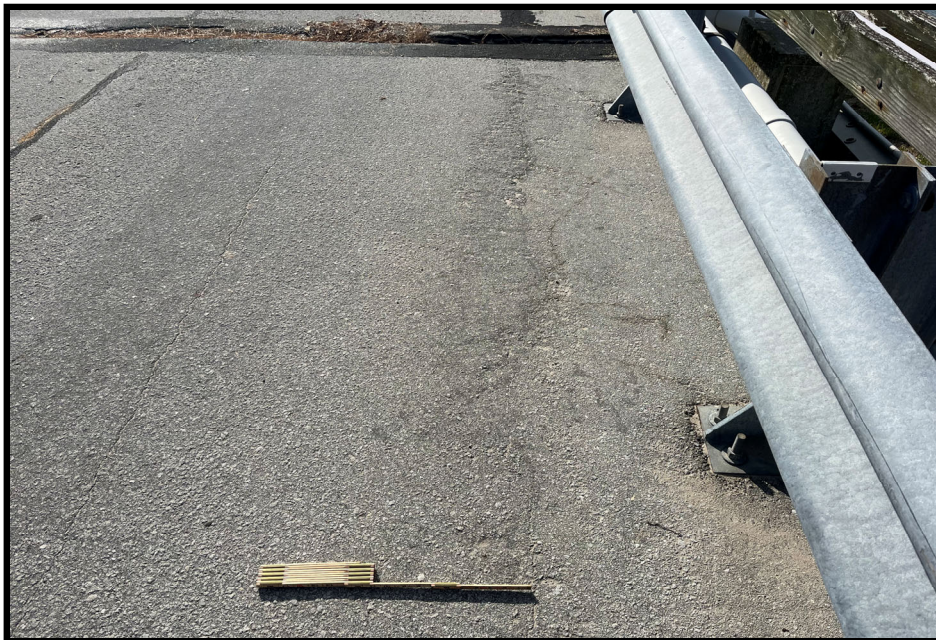
| STRUCTURAL ELEMENT DEFECT | UNIT | QUANTITY |
|---|---|---|
| 2. 1/8" LONGITUDINAL AND ALLIGATOR CRACKS IN ASPHALT WEARING SURFACE AT RANDOM | SF | 95 |

1/8" LONGITUDINAL AND ALLIGATOR CRACKS IN ASPHALT WEARING SURFACE AT RANDOM,  
CRACKS IN SPAN 1 SHOWN

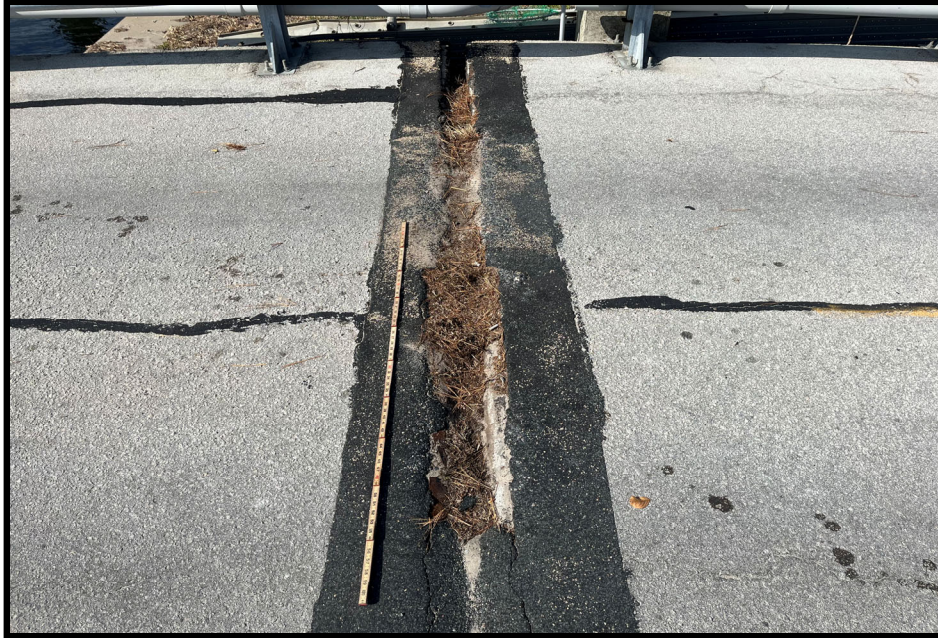
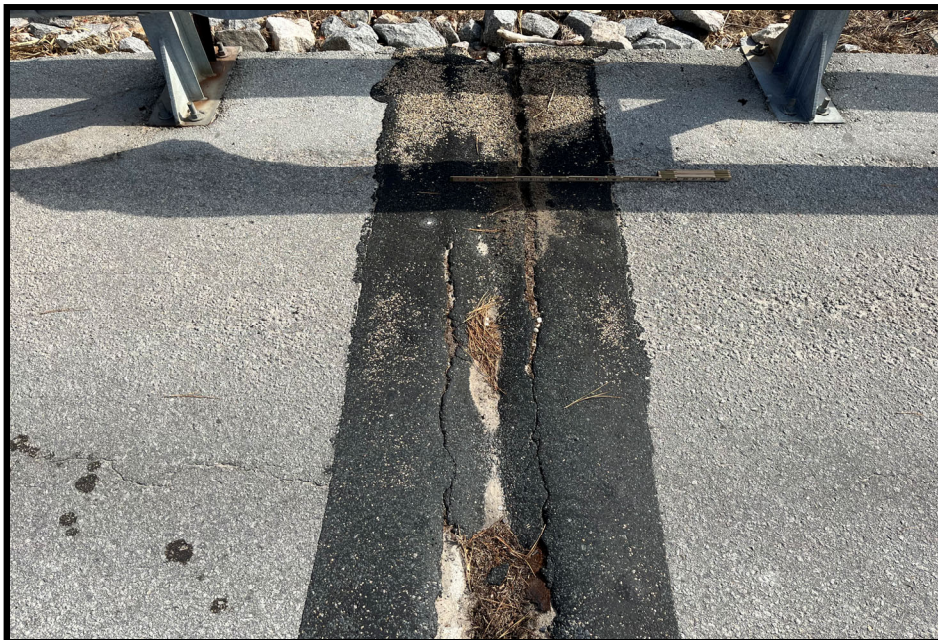
| STRUCTURAL ELEMENT DEFECT | UNIT | QUANTITY |
|---|---|---|
| 3. (2) AREAS OF MISSING JOINT MATERIAL UP TO 138" LONG X 7" WIDE, AND UP TO 1 1/2" TRANSVERSE CRACKS IN ASPHALT OVERLAY ALONG BENT 1 | LF | 18 |

(2) AREAS OF MISSING JOINT MATERIAL UP TO 138" LONG X 7" WIDE, AND UP TO 1 1/2" TRANSVERSE CRACKS IN ASPHALT OVERLAY ALONG BENT 1

| 1. REPLACE BENT 1 JOINT | LF | 18 |

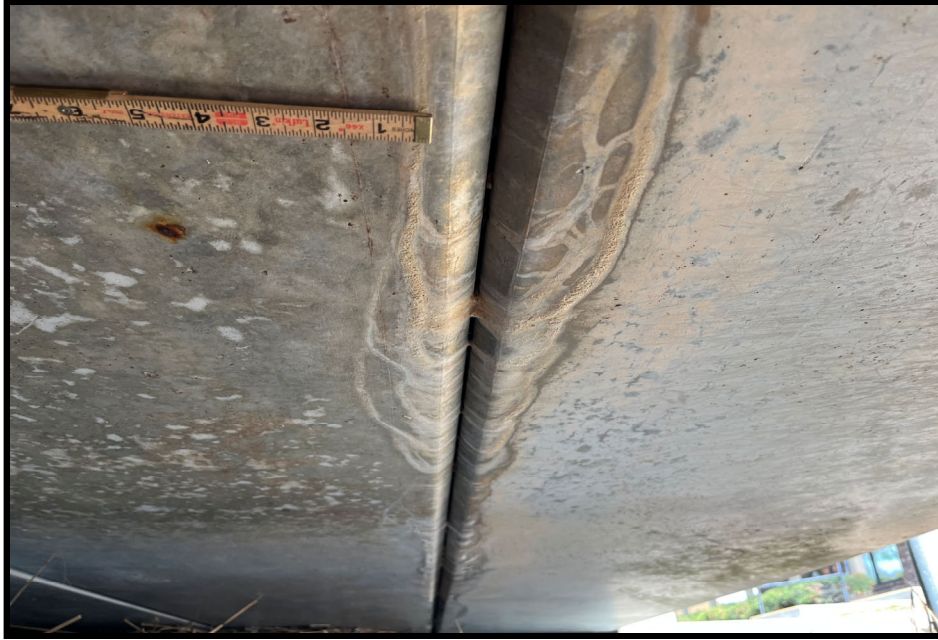
| STRUCTURAL ELEMENT DEFECT | UNIT | QUANTITY |
|---|---|---|
| 4. EFFLORESCENCE SEEPAGE BETWEEN UNITS IN VARIOUS LOCATIONS IN SPAN 2 | SF | 21 |

EFFLORESCENCE SEEPAGE BETWEEN UNITS IN VARIOUS LOCATIONS IN SPAN 2

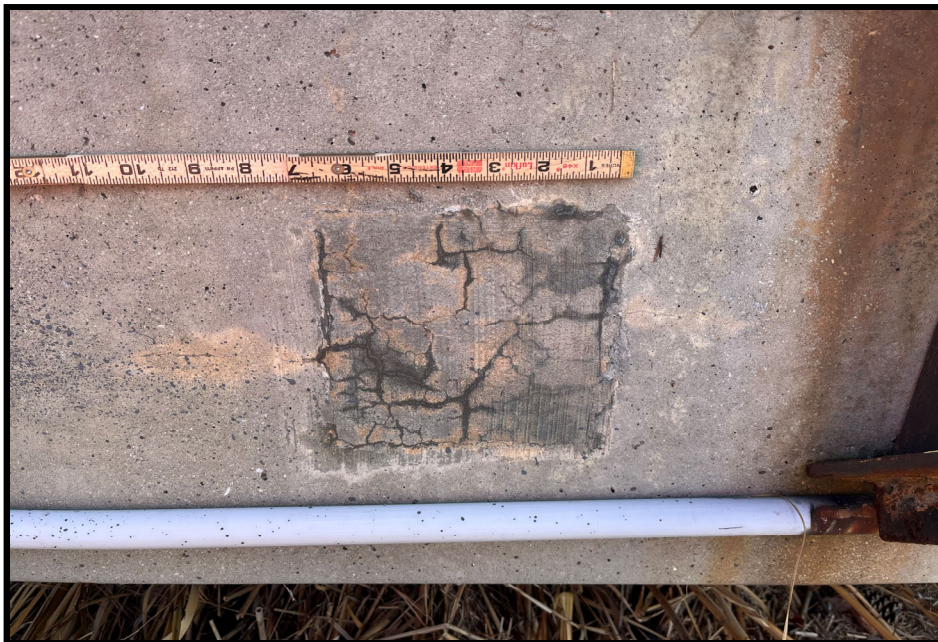
| STRUCTURAL ELEMENT DEFECT | UNIT | QUANTITY |
|---|---|---|
| 5. HAIRLINE MAP CRACKS WITH EFFLORESCENCE THROUGHOUT TRANSVERSE POST-TENSION GROUT POCKETS ON BOTH SIDES AT MIDSPAN IN SPANS 1 AND 2 | LF | 4 |

HAIRLINE MAP CRACKS WITH EFFLORESCENCE THROUGHOUT TRANSVERSE POST-TENSION GROUT POCKETS ON BOTH SIDES AT MIDSPAN IN SPANS 1 AND 2

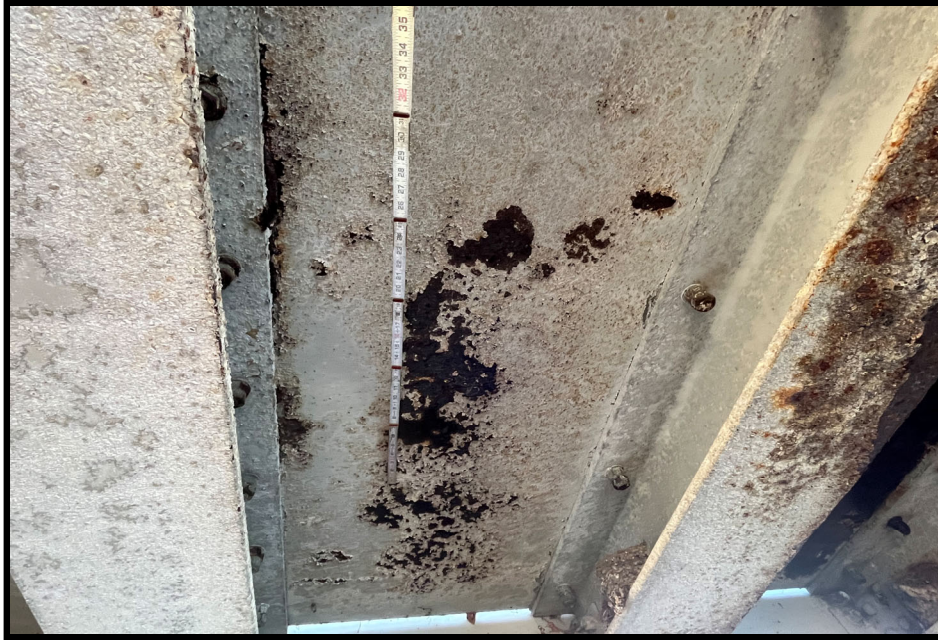
| STRUCTURAL ELEMENT DEFECT | UNIT | QUANTITY |
|---|---|---|
| 6. AREAS OF SURFACE CORROSION AND CORROSION WITH UP TO 1/8" LOSS OF SECTION IN BOTTOM OF DECK, PRIMARILY BETWEEN FLOORBEAMS 3 THRU 7 | SF | 110 |

AREAS OF SURFACE CORROSION AND CORROSION WITH UP TO 1/8" LOSS OF SECTION IN  
BOTTOM OF DECK, PRIMARILY BETWEEN FLOORBEAMS 3 THRU 7

| 2. CLEAN AND PAINT ALL STEEL SUPERSTRUCTURE ELEMENTS | SF | 1955 |

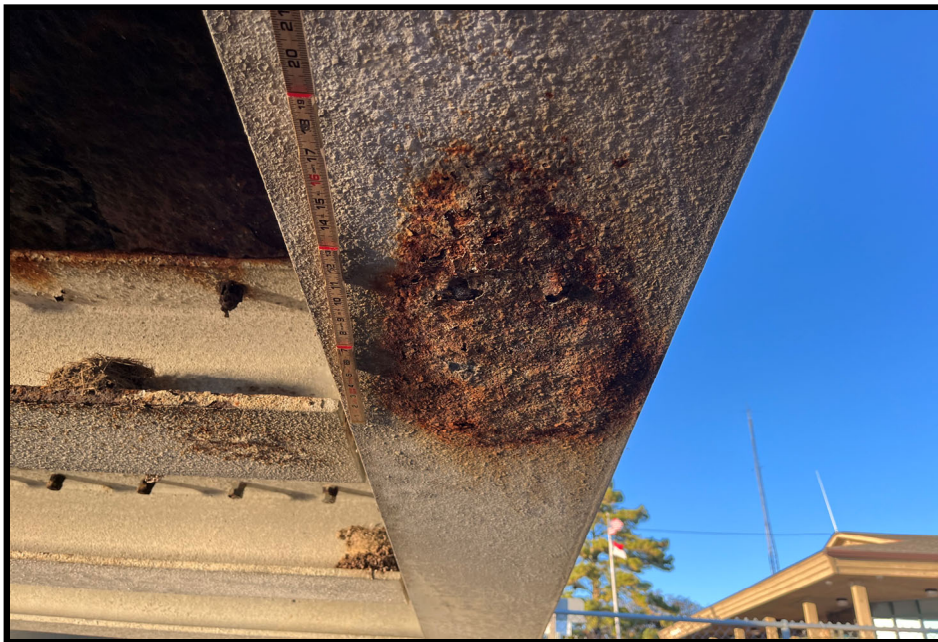
| STRUCTURAL ELEMENT DEFECT | UNIT | QUANTITY |
|---|---|---|
| 7. AREAS OF CORROSION WITH NO MEASURABLE LOSS OF SECTION UP TO 21" LONG X 11" WIDE ALONG BOTTOM FLANGE OF GIRDERS 1 AND 2 BETWEEN FLOORBEAMS 4 AND 5 | LF | 4 |

AREAS OF CORROSION WITH NO MEASURABLE LOSS OF SECTION UP TO 21" LONG X 11" WIDE  
ALONG BOTTOM FLANGE OF GIRDERS 1 AND 2 BETWEEN FLOOR BEAMS 4 AND 5, GIRDER 1  
SHOWN

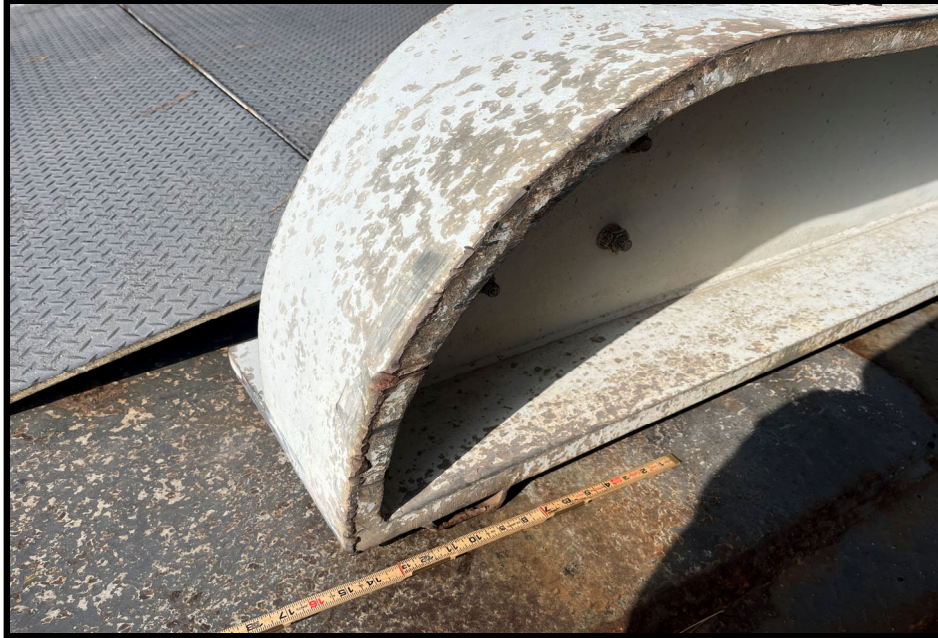
| STRUCTURAL ELEMENT DEFECT | UNIT | QUANTITY |
|---|---|---|
| 8. GIRDER 1: 16" SECTION OF UP TO 1/8" DEEP SCRAPES ALONG TOP FLANGE 1 AT FAR END | LF | 2 |

GIRDER 1: 16" SECTION OF UP TO 1/8" DEEP SCRAPES ALONG TOP FLANGE 1 AT FAR END

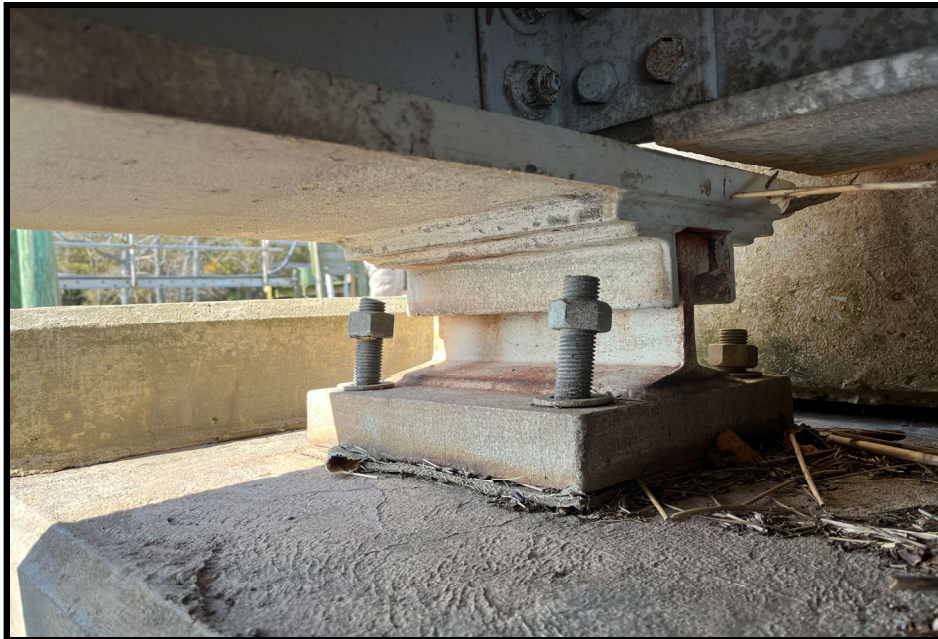
| STRUCTURAL ELEMENT DEFECT | UNIT | QUANTITY |
|---|---|---|
| 9. (8) OF (8) ANCHOR BOLT NUTS NOT FULLY SEATED AT GIRDER 1 AND 2 BEARINGS AT BENT 2 (4 BOLTS PER BEARING), GIRDER 2 BEARING SHOWN | EA | 8 |

(8) OF (8) ANCHOR BOLT NUTS NOT FULLY SEATED AT GIRDER 1 AND 2 BEARINGS AT BENT 2 (4 BOLTS PER BEARING), GIRDER 2 BEARING SHOWN

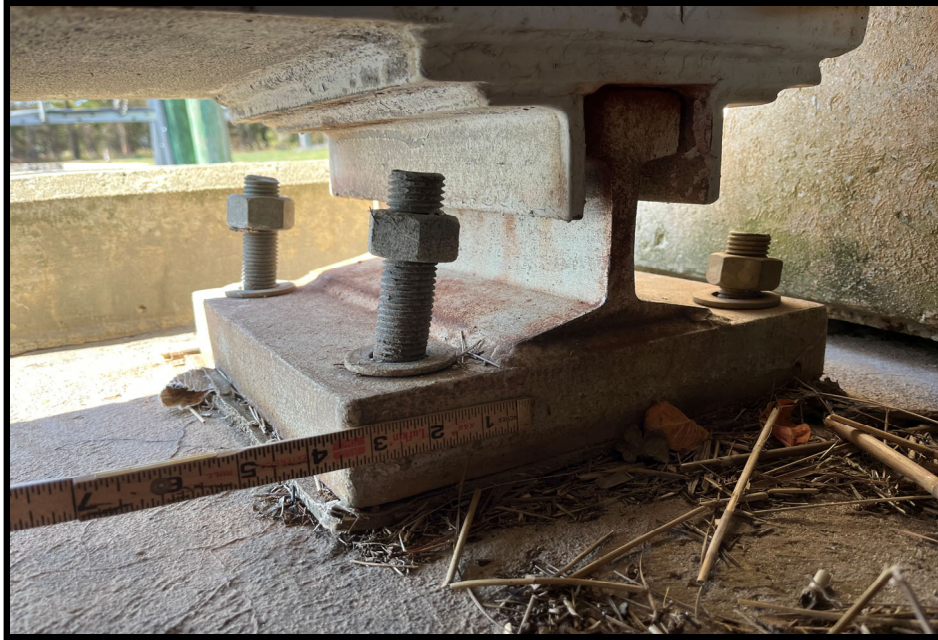
| STRUCTURAL ELEMENT DEFECT | UNIT | QUANTITY |
|---|---|---|
| 10. (4) OF (4) ANCHOR BOLTS LEANING 1/2" TO NORTH AT GIRDER 2 BEARING AT BENT 2 | EA | 4 |

(4) OF (4) ANCHOR BOLTS LEANING 1/2" TO NORTH AT GIRDER 2 BEARING AT BENT 2

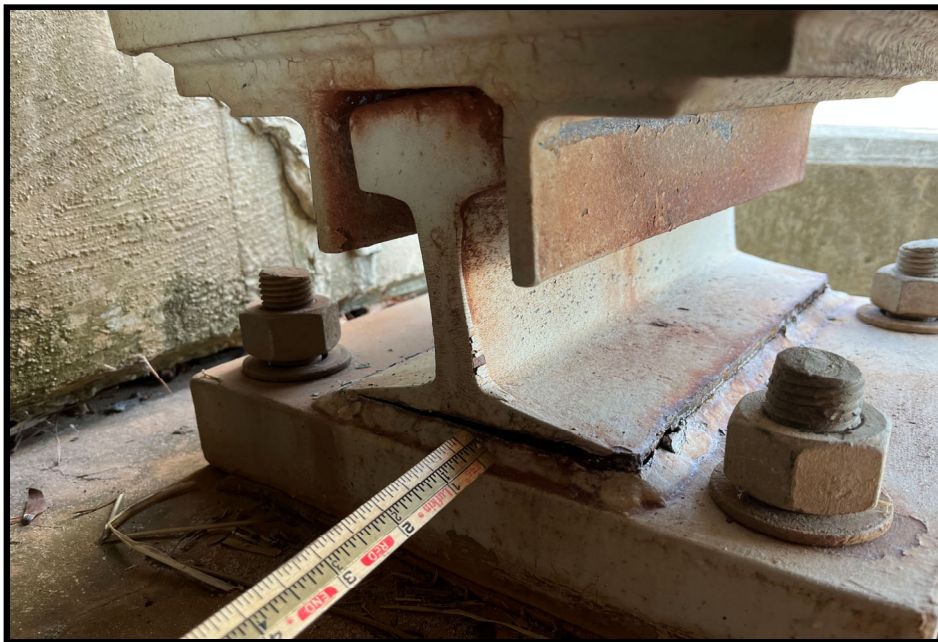
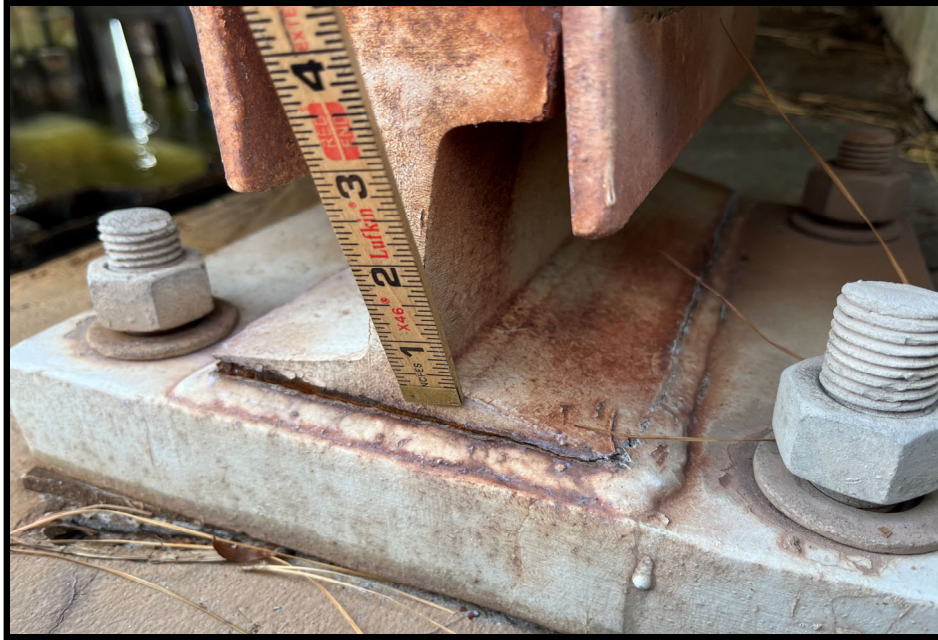
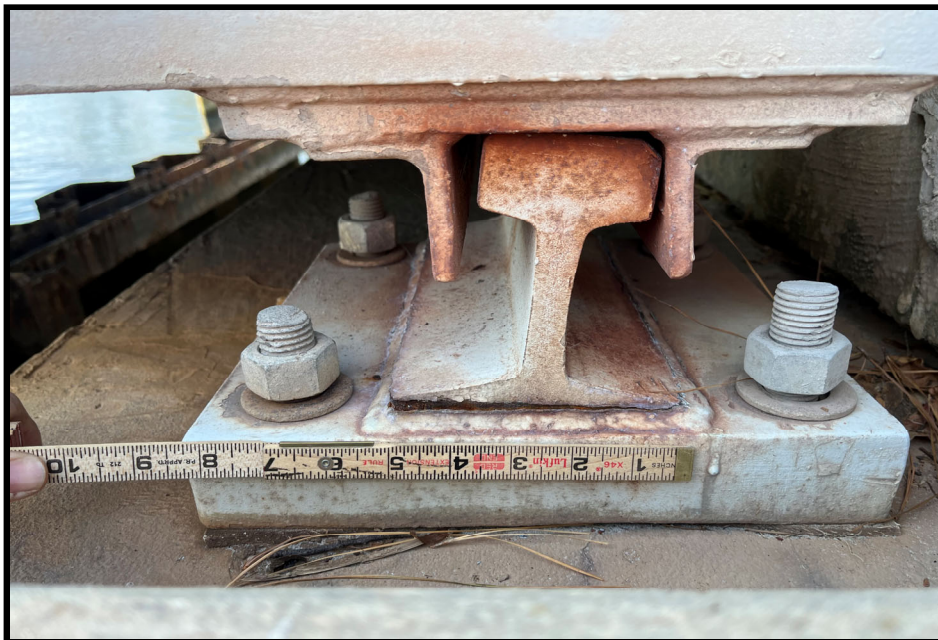
| STRUCTURAL ELEMENT DEFECT | UNIT | QUANTITY |
|---|---|---|
| 11. GIRDER 1 NEAR BEARING: BROKEN WELD BETWEEN RAIL AND MASONRY PLATE ALONG ALL EDGES ALLOWING RAIL TO ROTATE TO NORTH | EA | 1 |

GIRDER 1 NEAR BEARING: BROKEN WELD BETWEEN RAIL AND MASONRY PLATE ALONG ALL EDGES ALLOWING RAIL TO ROTATE TO NORTH

| 3. REPAIR BROKEN WELD AT GIRDER 1 NEAR BEARING | EA | 1 |

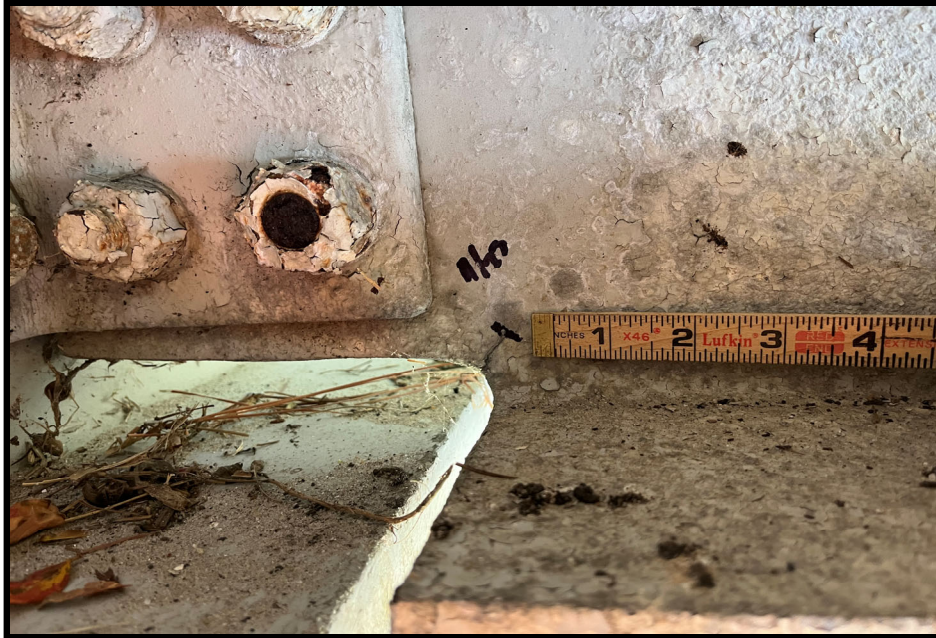
| STRUCTURAL ELEMENT DEFECT | UNIT | QUANTITY |
|---|---|---|
| 12. FLOORBEAMS: UP TO 1 1/2" LONG DIAGONAL HAIRLINE CRACKS IN BOTH FACES OF WEBS PROPAGATING FROM COPE RADIUS AT GIRDER CONNECTIONS IN THE FOLLOWING LOCATIONS: | LF | 6 |

FLOORBEAM 3: UP TO 1 1/2" LONG DIAGONAL HAIRLINE CRACKS IN BOTH FACES OF WEB PROPAGATING FROM COPE RADIUS AT GIRDER 2 CONNECTION, NORTH FACE SHOWN

| 2. REPAIR CRACKS IN FLOORBEAMS AT GIRDER CONNECTIONS | LF | 6 |

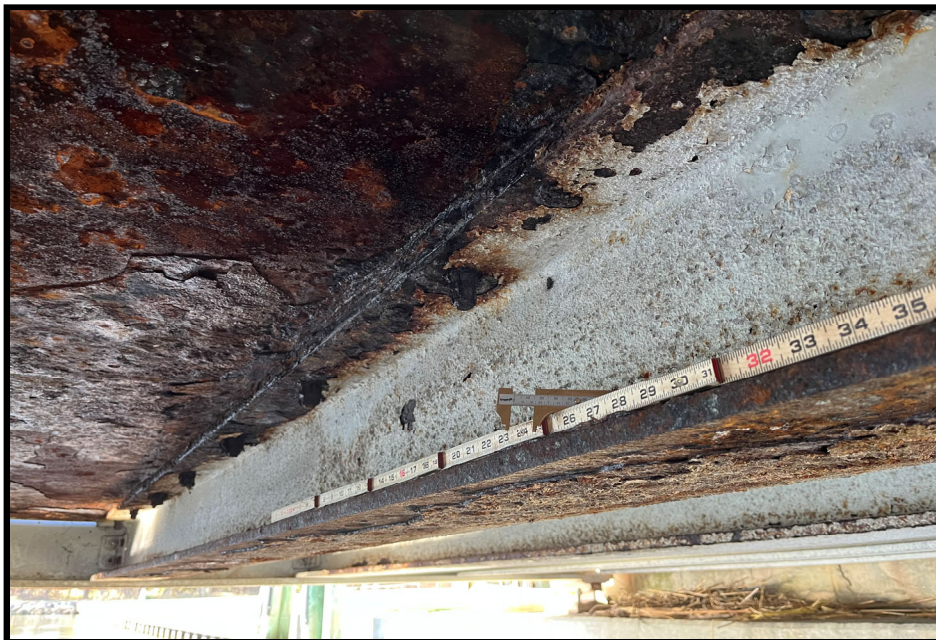
| STRUCTURAL ELEMENT DEFECT | UNIT | QUANTITY |
|---|---|---|
| 13. FLOORBEAMS 3, 4 AND 5: AREAS OF CORROSION ALONG BOTTOM FLANGE UP TO 11' LONG X 10 1/8" WIDE DOWN TO 11/16" RESIDUAL FLANGE (3/4" ORIGINAL THICKNESS) AT MID LENGTH | LF | 32 |

FLOORBEAMS 3, 4 AND 5: AREAS OF CORROSION ALONG BOTTOM FLANGE UP TO 11' LONG X 10 1/8" WIDE DOWN TO 11/16" RESIDUAL FLANGE (3/4" ORIGINAL THICKNESS) AT MID LENGTH, FLOORBEAM 4 SOUTH FACE SHOWN

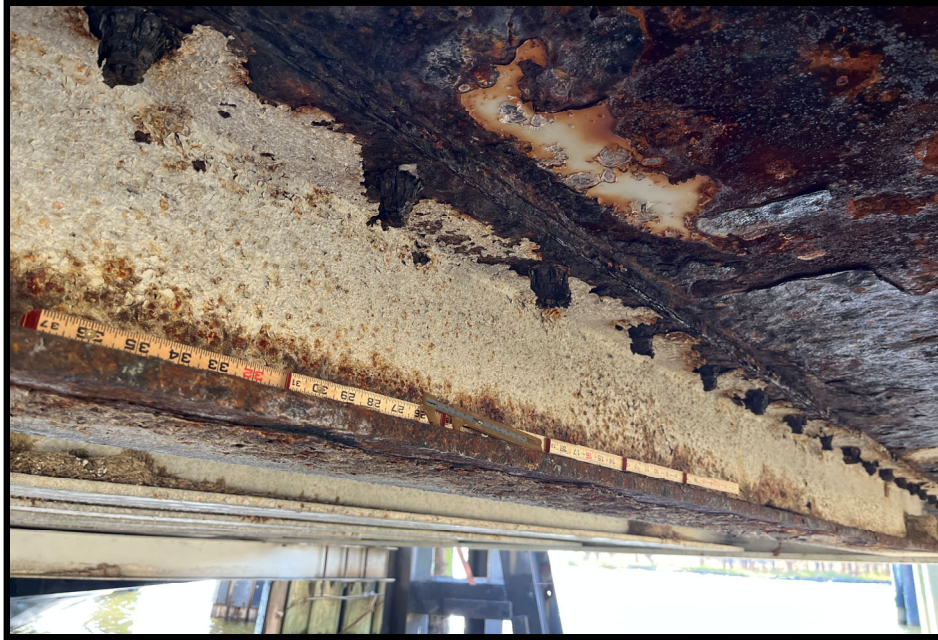
| STRUCTURAL ELEMENT DEFECT | UNIT | QUANTITY |
|---|---|---|
| 14. SURFACE CORROSION AND CORROSION WITH NO MEASURABLE LOSS OF SECTION ALONG FLOORBEAMS IN VARIOUS LOCATIONS, PRIMARILY IN FLOORBEAMS 4 AND 5 | SF | 50 |

SURFACE CORROSION AND CORROSION WITH NO MEASURABLE LOSS OF SECTION ALONG FLOORBEAMS IN VARIOUS LOCATIONS, PRIMARILY IN FLOORBEAMS 4 AND 5, FLOORBEAM 5 NORTH FACE SHOWN

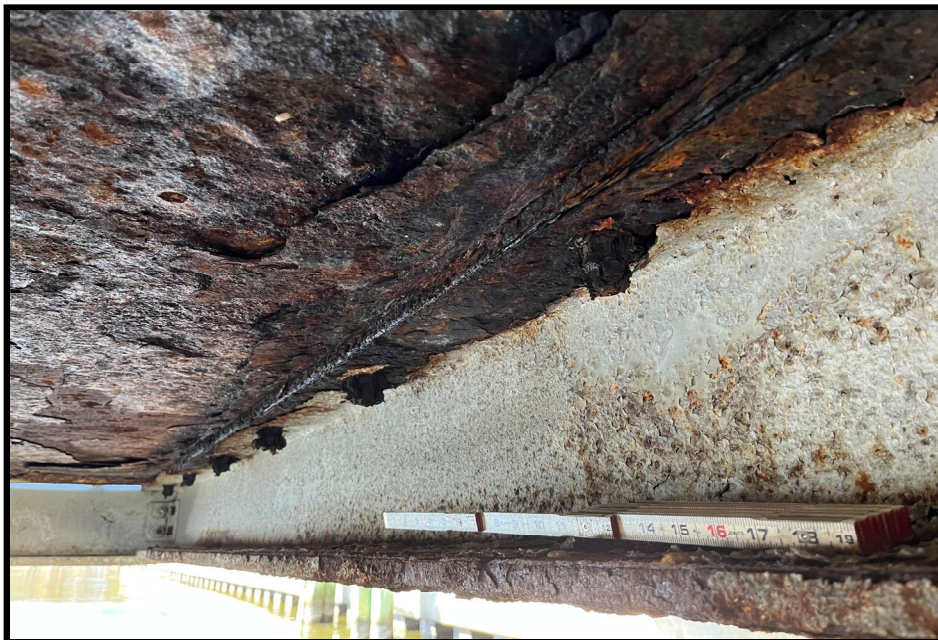
| STRUCTURAL ELEMENT DEFECT | UNIT | QUANTITY |
|---|---|---|
| 15. CORROSION WITH UP TO 100% LOSS OF SECTION THROUGHOUT DECK AND FLOORBEAM ATTACHMENT BOLTS AND NUTS IN VARIOUS LOCATIONS | EA | 132 |

CORROSION WITH UP TO 100% LOSS OF SECTION THROUGHOUT DECK AND FLOORBEAM ATTACHMENT BOLTS AND NUTS IN VARIOUS LOCATIONS, CONDITION ON SOUTH SIDE OF FLOORBEAM 4 SHOWN

| 4. REPLACE DECK AND FLOORBEAM ATTACHMENT BOLTS AND NUTS WITH SECTION LOSS | EA | 132 |

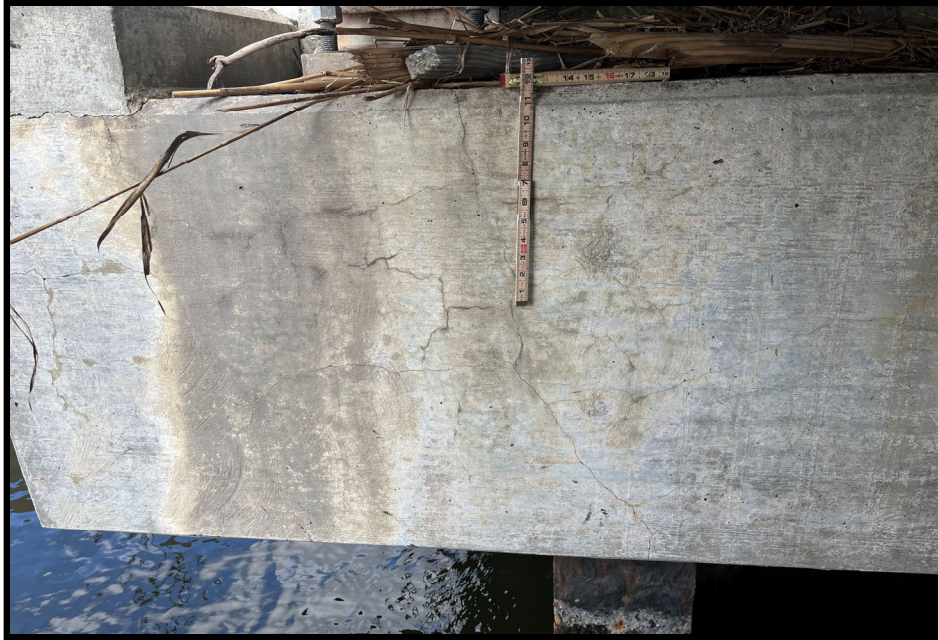
| STRUCTURAL ELEMENT DEFECT | UNIT | QUANTITY |
|---|---|---|
| 16. UP TO 0.012" TRANSVERSE, VERTICAL AND HORIZONTAL CRACKS AND HAIRLINE MAP CRACKS WITH AND WITHOUT EFFLORESCENCE THROUGHOUT CONCRETE CAPS | LF | 26 |

UP TO 0.012" TRANSVERSE, VERTICAL AND HORIZONTAL CRACKS AND HAIRLINE MAP CRACKS WITH AND WITHOUT EFFLORESCENCE THROUGHOUT LATERAL GUIDES AND CONCRETE CAPS, SOUTH FACE OF BENT 2 AT RIGHT END SHOWN

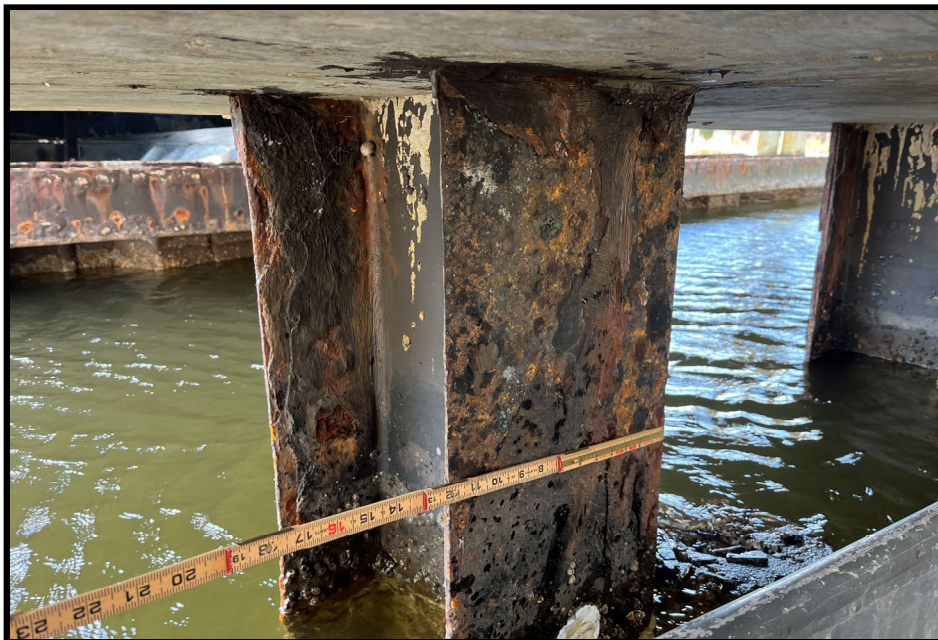
| STRUCTURAL ELEMENT DEFECT | UNIT | QUANTITY |
|---|---|---|
| 17. BENT 2 PILES: AREAS OF CORROSION ALONG BOTH FLANGES EXTENDING FROM BOTTOM OF CAP TO WATERLINE UP TO 23" HIGH X 11 3/4" WIDE DOWN TO KNIFE'S EDGE RESIDUAL FLANGE (9/16" ORIGINAL THICKNESS) THROUGHOUT ALL PILES; TOTAL DEFECT LENGTHS PER PILE AS FOLLOWS:<br><div style="display: flex; justify-content: space-around; margin-top: 5px;"> <div>PILE 1: 4 LF</div> <div>PILE 3: 4 LF</div> </div> <div style="display: flex; justify-content: space-around; margin-top: 5px;"> <div>PILE 2: 4 LF</div> <div>PILE 4: 4 LF</div> </div> | LF<br>(TOTAL) | 16 |

BENT 2 PILE 1: AREAS OF CORROSION ALONG BOTH FLANGES EXTENDING FROM BOTTOM OF CAP TO WATERLINE UP TO 23" HIGH X 11 3/4" WIDE DOWN TO KNIFE'S (9/16" ORIGINAL THICKNESS), NORTH FACE SHOWN

| 4. REPAIR PILES WITH ANY MEASURABLE LOSS OF SECTION IN FLANGES | LF | 37 |

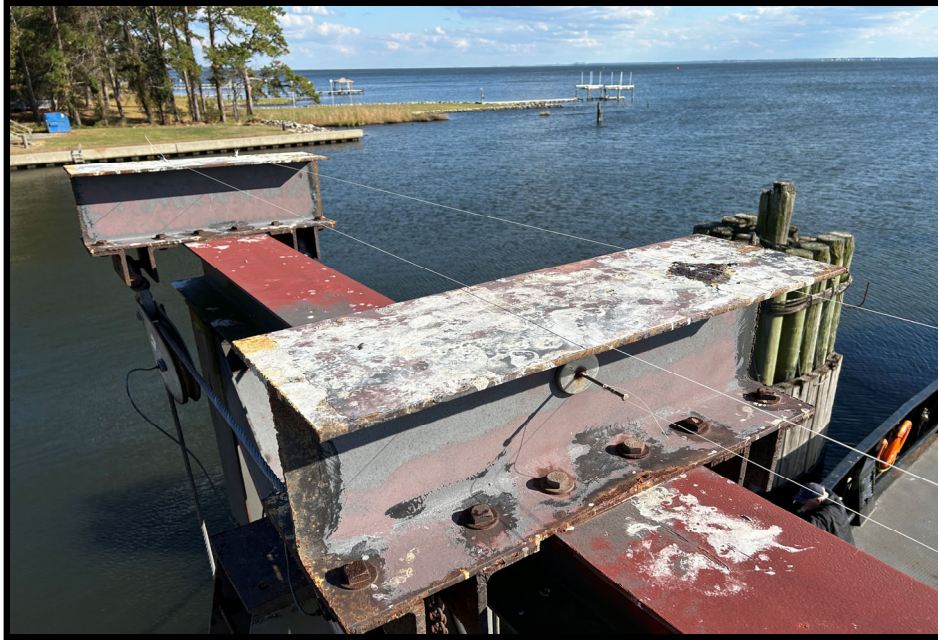
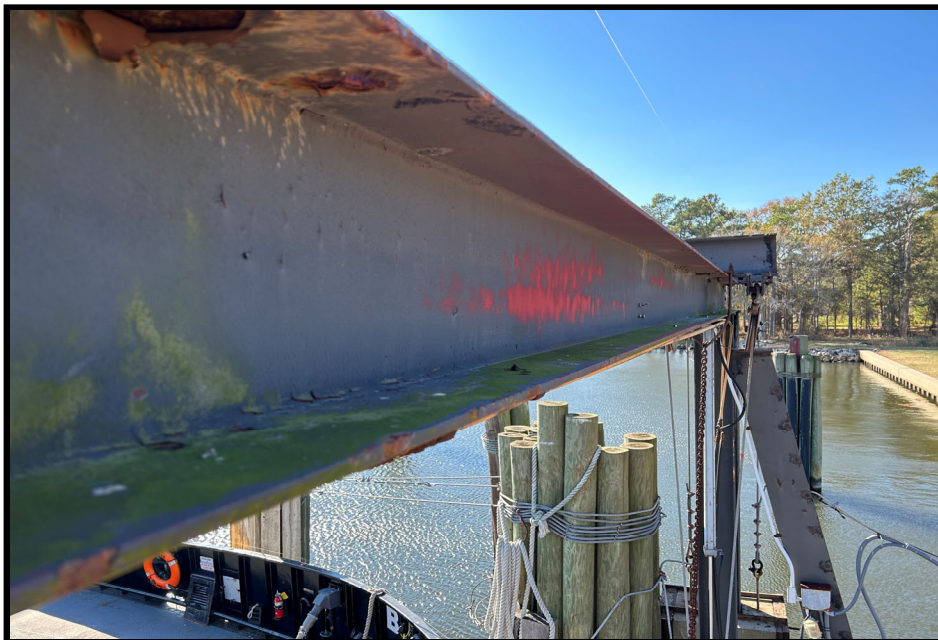
| STRUCTURAL ELEMENT DEFECT | UNIT | QUANTITY |
|---|---|---|
| 18. AREAS OF SURFACE CORROSION THROUGHOUT GANTRY TOP CAP AND PULLEY CONNECTION CROSS BEAMS IN VARIOUS LOCATIONS | LF | 47 |

AREAS OF SURFACE CORROSION THROUGHOUT GANTRY TOP CAP AND PULLEY CONNECTION CROSS BEAMS IN VARIOUS LOCATIONS, CROSS BEAMS SHOWN

AREAS OF SURFACE CORROSION THROUGHOUT GANTRY TOP CAP AND PULLEY CONNECTION CROSS BEAMS IN VARIOUS LOCATIONS, NORTH FACE OF GANTRY TOP CAP SHOWN

| 3. CLEAN AND PAINT ALL STEEL GANTRY ELEMENTS | SF | 1955 |

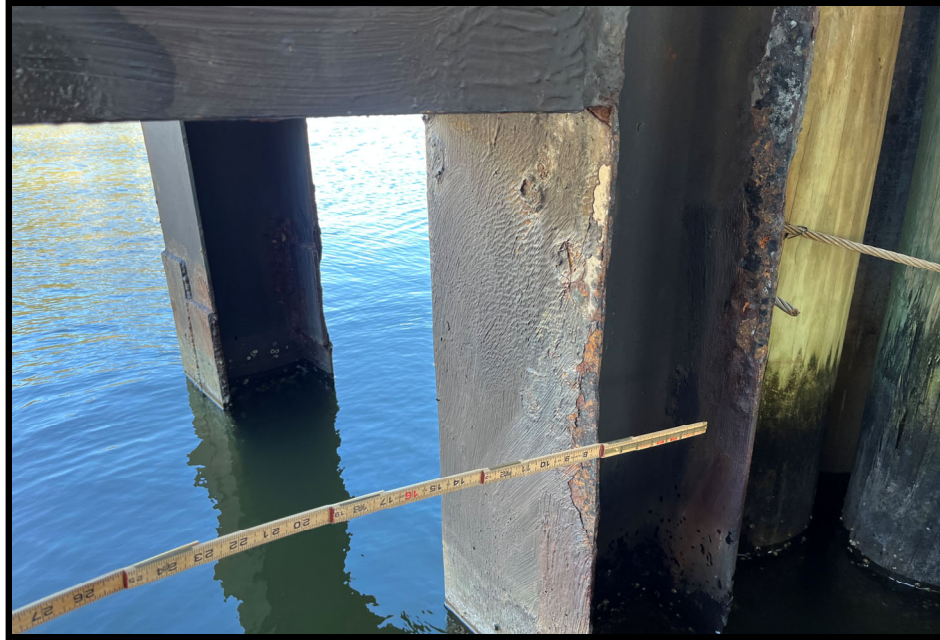
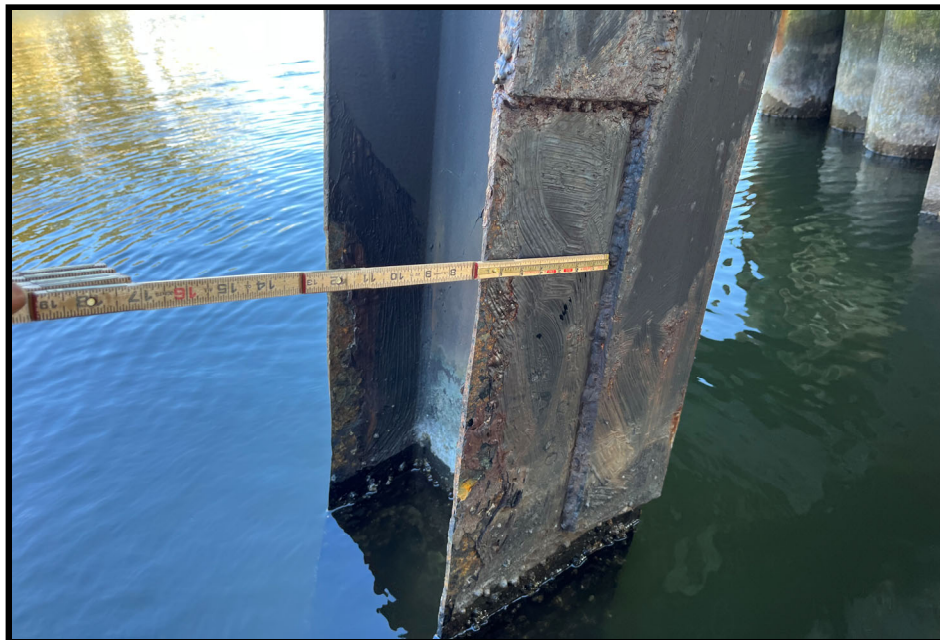
| STRUCTURAL ELEMENT DEFECT | UNIT | QUANTITY |
|---|---|---|
| 19. LIFT BENT PILES: AREAS OF CORROSION ALONG BOTH FLANGES UP TO 28" LONG X 12" WIDE DOWN TO KNIFE'S EDGE RESIDUAL FLANGE (9/16" ORIGINAL THICKNESS) BETWEEN BRACING AND WATERLINE IN VARIOUS LOCATIONS<br><div style="display: flex; justify-content: space-around; margin-top: 5px;"> <div>PILE 1: 4 LF</div> <div>PILE 3: 4 LF</div> <div>PILE 5: 2 LF</div> </div> <div style="display: flex; justify-content: space-around; margin-top: 5px;"> <div>PILE 2: 5 LF</div> <div>PILE 4: 5 LF</div> <div>PILE 6: 1 LF</div> </div> | LF<br>(TOTAL) | 21 |

LIFT BENT PILES 1 THRU 6: AREAS OF CORROSION ALONG BOTH FLANGES UP TO 32" LONG X 12" WIDE DOWN TO 1/8" RESIDUAL FLANGE (9/16" ORIGINAL THICKNESS) BETWEEN BRACING AND WATERLINE IN VARIOUS LOCATIONS, NORTH FACE OF PILE 4 SHOWN

LIFT BENT PILES 1 THRU 6: AREAS OF CORROSION ALONG BOTH FLANGES UP TO 32" LONG X 12" WIDE DOWN TO 1/8" RESIDUAL FLANGE (9/16" ORIGINAL THICKNESS) BETWEEN BRACING AND WATERLINE IN VARIOUS LOCATIONS, NORTH FACE OF PILE 1 SHOWN

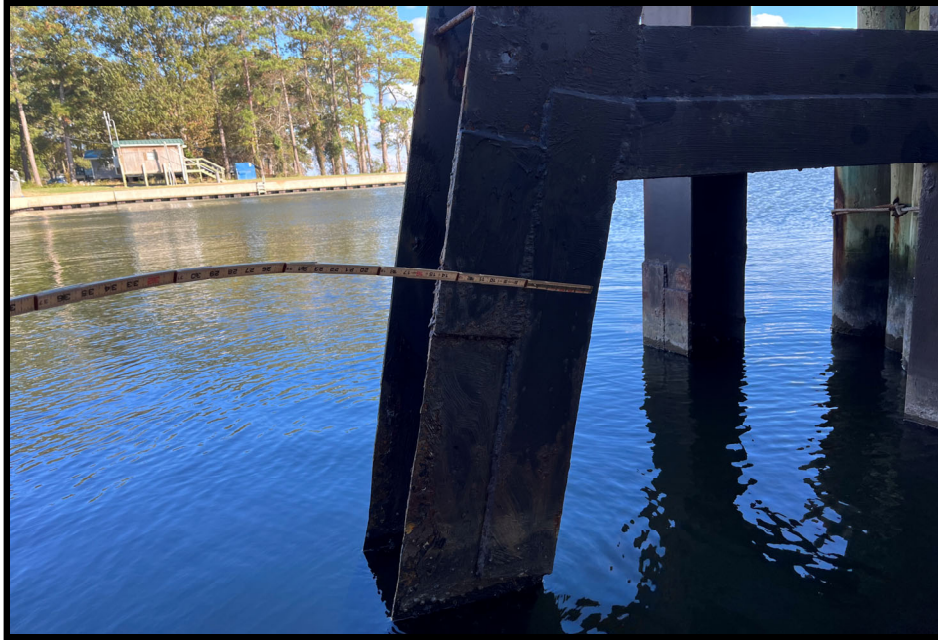
| STRUCTURAL ELEMENT DEFECT | UNIT | QUANTITY |
|---|---|---|
| 20. LIFT BENT PILES: WELDED PLATE REPAIRS ALONG FLANGES AND WEBS UP TO 39" HIGH X 6" WIDE X 1/2" THICK THROUGHOUT PILES FROM BRACING TO WATERLINE | LF | 24 |

LIFT BENT PILES: WELDED PLATE REPAIRS ALONG FLANGES AND WEBS UP TO 39" HIGH X 6" WIDE X 1/2" THICK THROUGHOUT PILES FROM BRACING TO WATERLINE, LEFT SIDE OF PILE 1 SHOWN

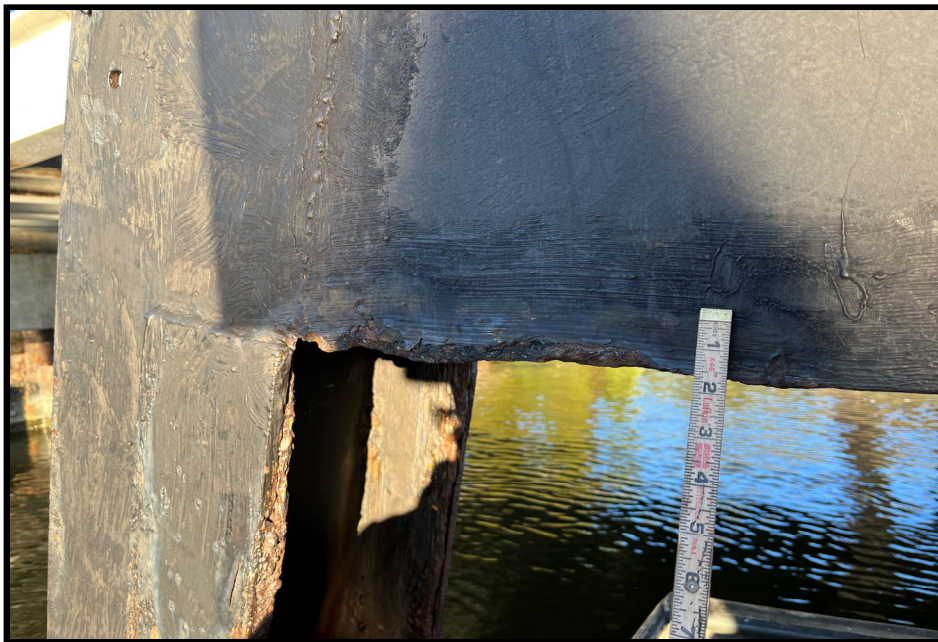
| STRUCTURAL ELEMENT DEFECT | UNIT | QUANTITY |
|---|---|---|
| 21. LIFT BENT PILE BRACING: AREAS OF CORROSION ALONG BOTH FLANGES NEAR WATERLINE UP TO 34" LONG X 4" HIGH DOWN TO KNIFE'S EDGE RESIDUAL FLANGE (9/16" ORIGINAL THICKNESS) WITH UP TO 12" LONG X 1/2" HIGH LOSS OF SECTION IN VARIOUS LOCATIONS | LF | 12 |

LIFT BENT PILE BRACING: AREAS OF CORROSION ALONG BOTH FLANGES NEAR WATERLINE UP TO 34" LONG X 4" HIGH DOWN TO KNIFE'S EDGE RESIDUAL FLANGE (9/16" ORIGINAL THICKNESS) WITH UP TO 12" LONG X 1/2" HIGH LOSS OF SECTION IN VARIOUS LOCATIONS, RIGHT FACE OF P2-P5 BRACING SHOWN

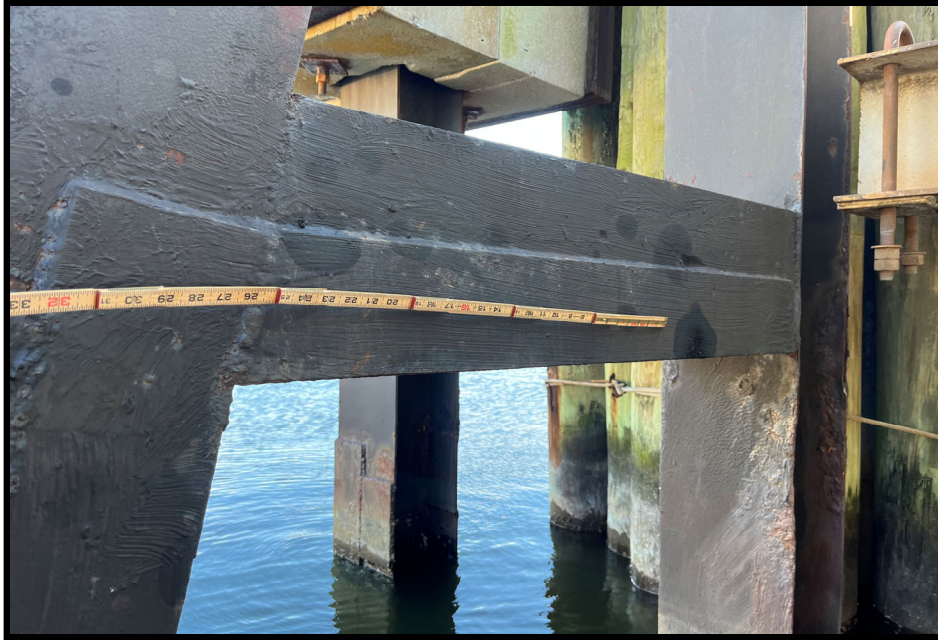
22. LIFT BENT PILE BRACING: WELDED PLATE REPAIRS ALONG BOTH FLANGES NEAR  
WATERLINE UP TO 43 1/2" LONG X 6" HIGH IN VARIOUS LOCATIONS

LIFT BENT PILE BRACING: WELDED PLATE REPAIRS ALONG BOTH FLANGES NEAR WATERLINE UP TO 44" LONG X 6" HIGH IN VARIOUS LOCATIONS, LEFT FACE OF P1-P4 BRACING SHOWN

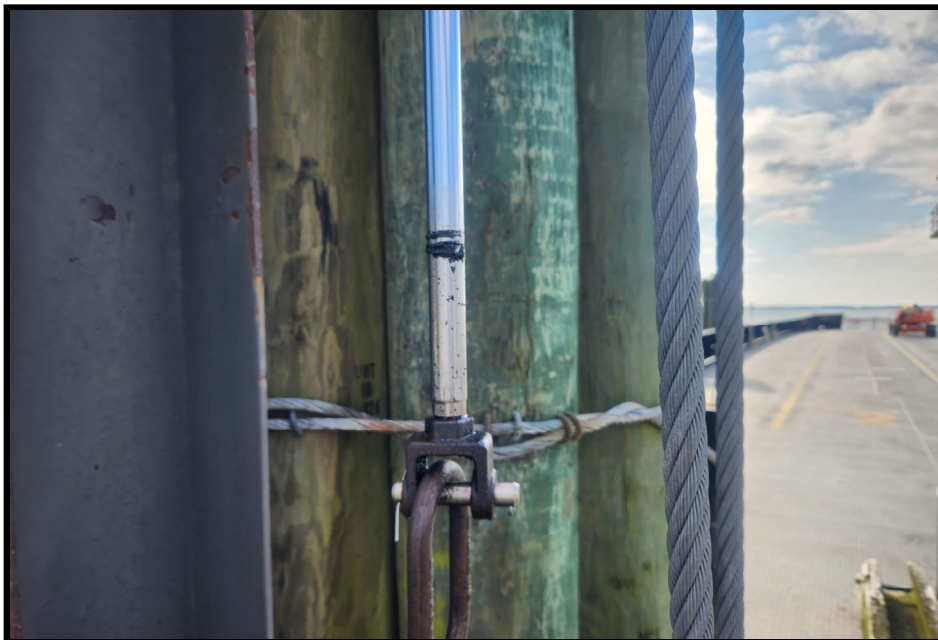
| 1. LEAKING SEAL ON EAST HYDRAULIC CYLINDER ROD | EA | 1 |

EAST CYLINDER LEAKING

| 1. REPLACE EAST HYDRAULIC CYLINDER ROD | EA | 1 |

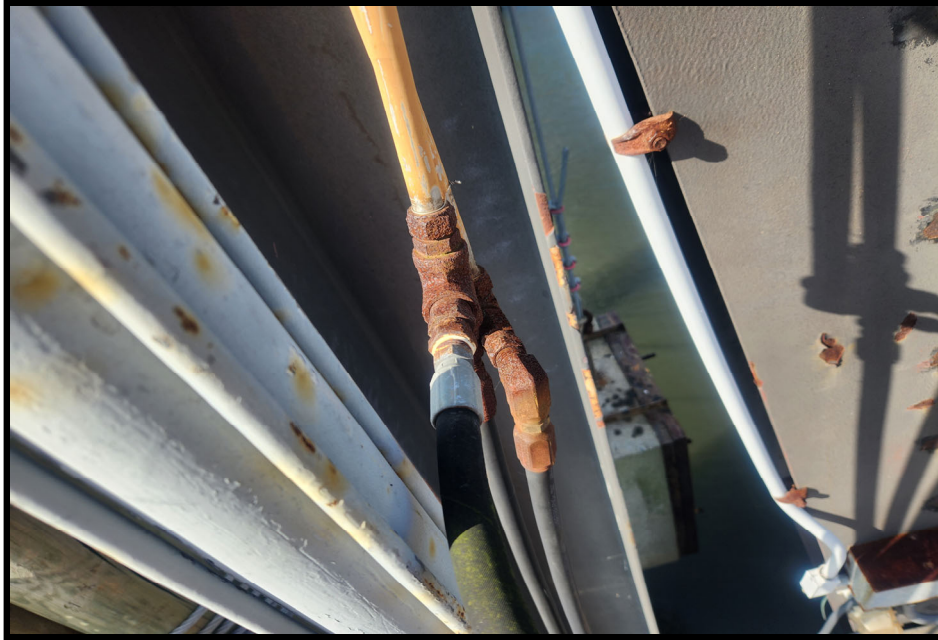
| 3. HYDRAULIC HARD PIPING CORRODED, MISSING CLAMPS OR RUBBING ON SUPPORT | EA | 1 |

CORRODED HYDRAULIC PIPING (TYP.)

| 2. REPLACE CORRODED FITTINGS ON HYDRAULIC HARD PIPING AND PROPERLY SECURE | EA | 1 |

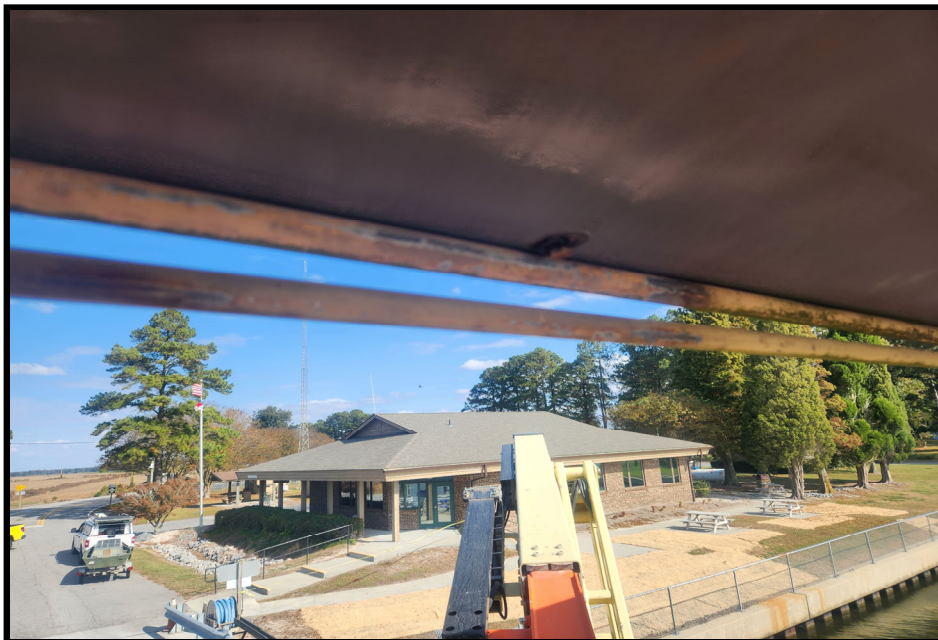
MISSING CLAMPS ON HYDRAULIC PIPING

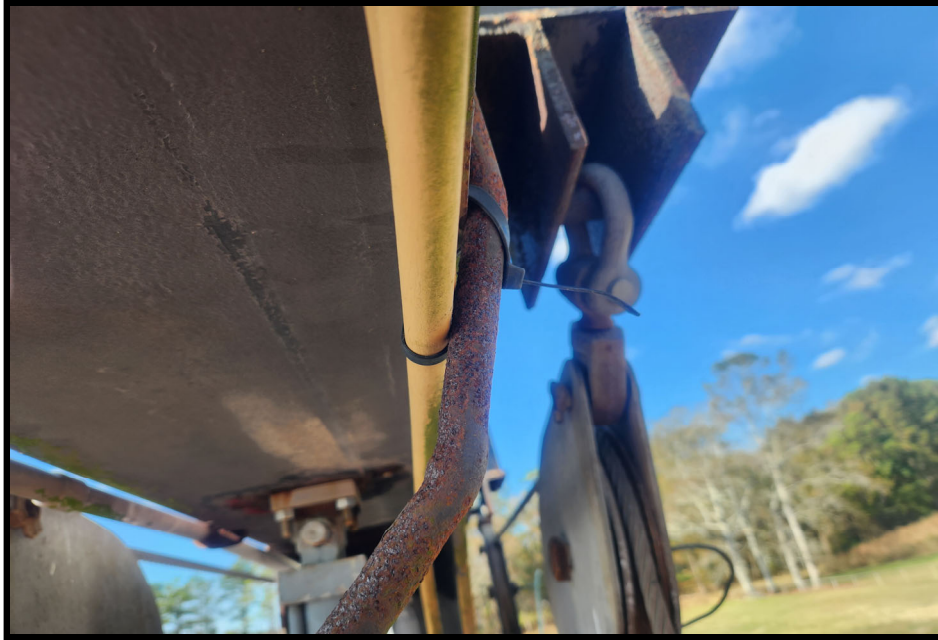
HYDRAULIC PIPING HELD WITH ZIP TIES

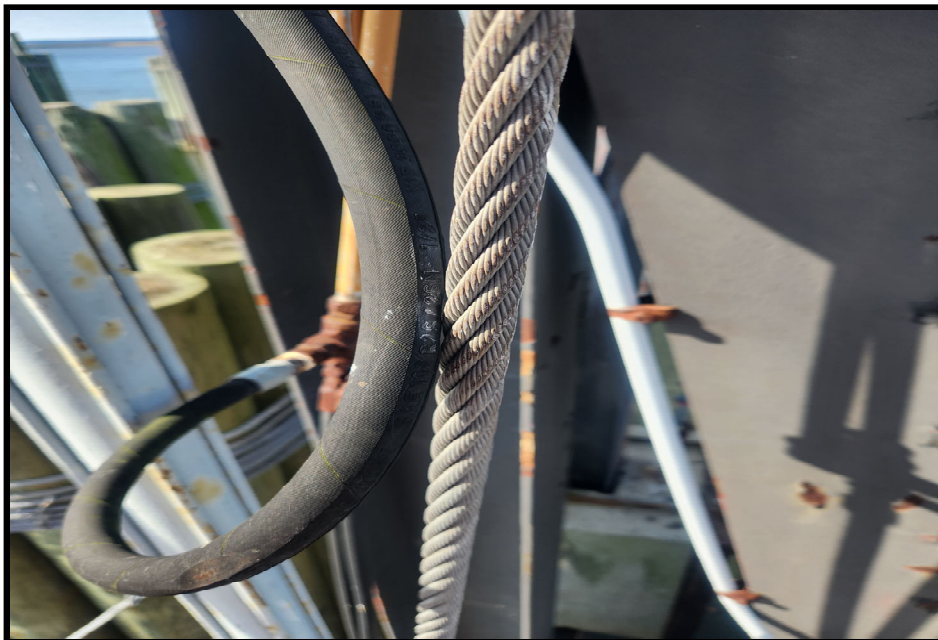
WEST UPPER CYLINDER HOSE RUBBING ON COUNTERWEIGHT CABLE

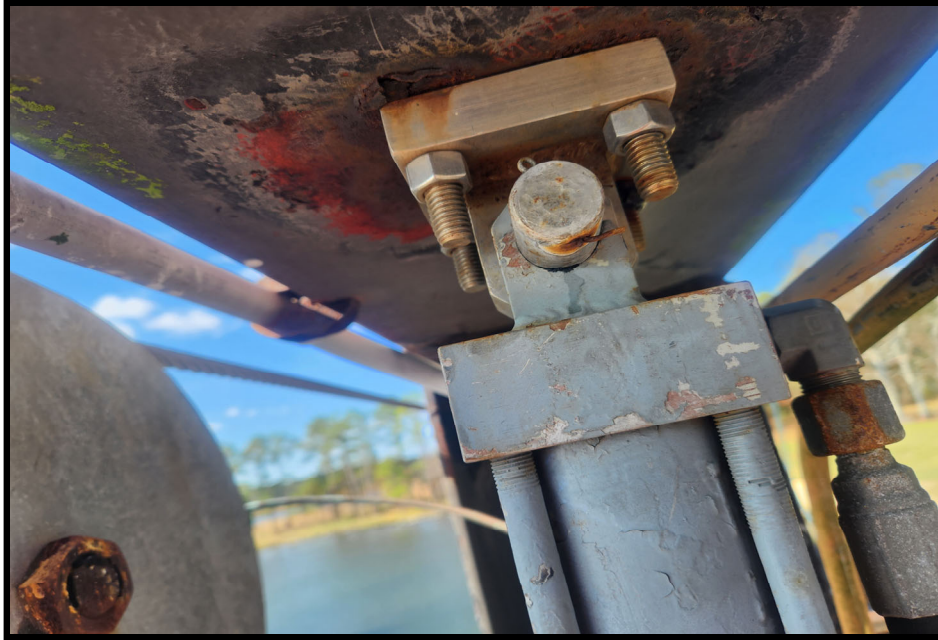
| 2. HYDRAULIC CYLINDER COTTER PINS BROKEN OR INCORRECTLY INSTALLED | EA | 2 |

WEST UPPER CYLINDER COTTER PIN BROKEN

| 3. REPLACE BROKEN AND INCORRECTLY INSTALLED HYDRAULIC CYLINDER COTTER PINS | EA | 2 |
