# BRIDGE INSPECTION REPORT

COUNTY: BEAUFORT BRIDGE NO.: 060322

ROUTE: NC306 FERRY TERMINAL ACROSS: PAMLICO SOUND

INSPECTION DATE: 11/1/2023 OPERATING RATING: NOT RATED

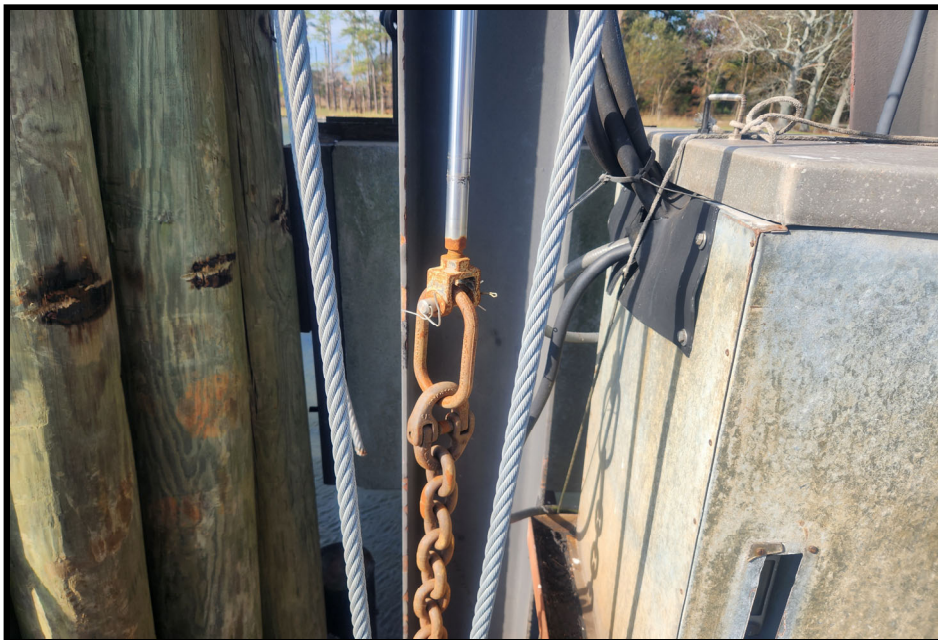
WEST LOWER CYLINDER COTTER PIN REPLACED WITH WIRE

| 3. REPLACE BROKEN AND INCORRECTLY INSTALLED HYDRAULIC CYLINDER COTTER PINS | EA | 2 |

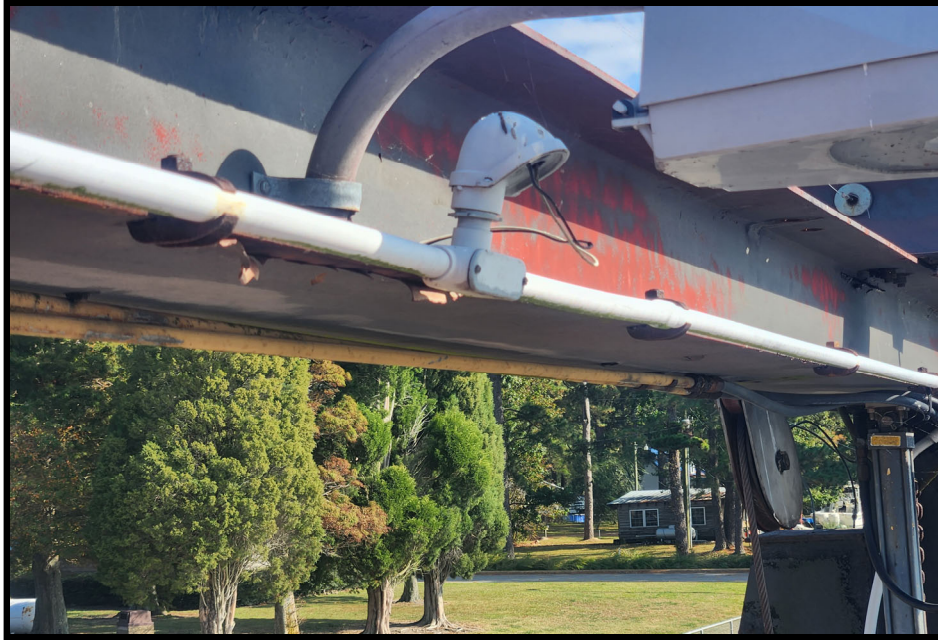
| 1. LIGHT ELECTRICAL WIRES NOT IN CONDUIT | EA | 1 |

LIGHT ELECTRICAL WIRES NOT IN CONDUIT

| 1. INSTALL CONDUIT FOR LIGHT FIXTURE | EA | 1 |

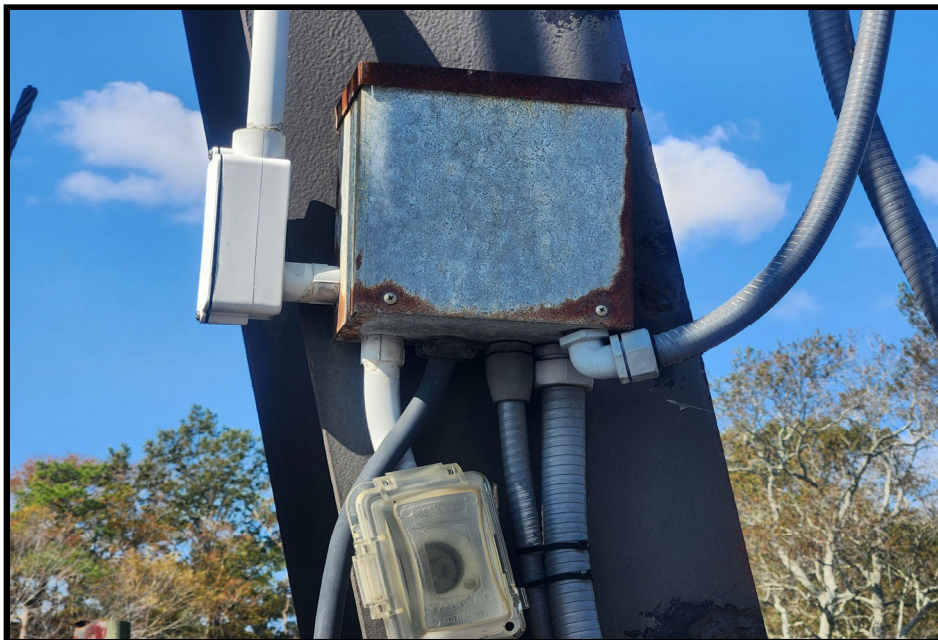
| 2. CRACKED, LOOSE OR BROKEN FLEXIBLE CONDUITS | EA | 4 |

FLEXIBLE CONDUIT FITTING LOOSE ON LIGHTING JUNCTION BOX

| 2. REPLACE ALL CRACKED, LOOSE OR BROKEN FLEXIBLE CONDUITS | EA | 4 |

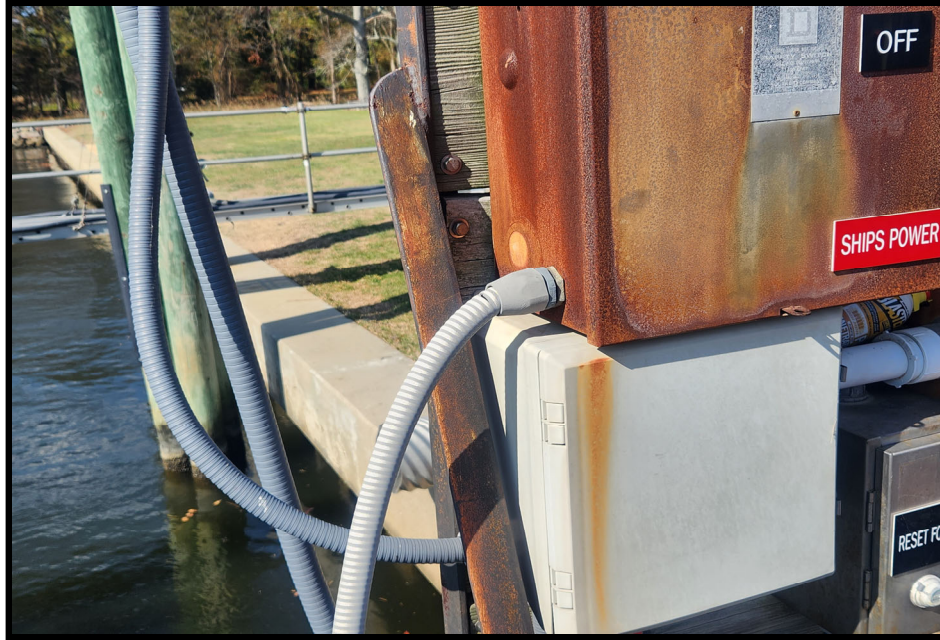
FLEXIBLE CONDUIT EXITING MAIN PANEL CRACKED

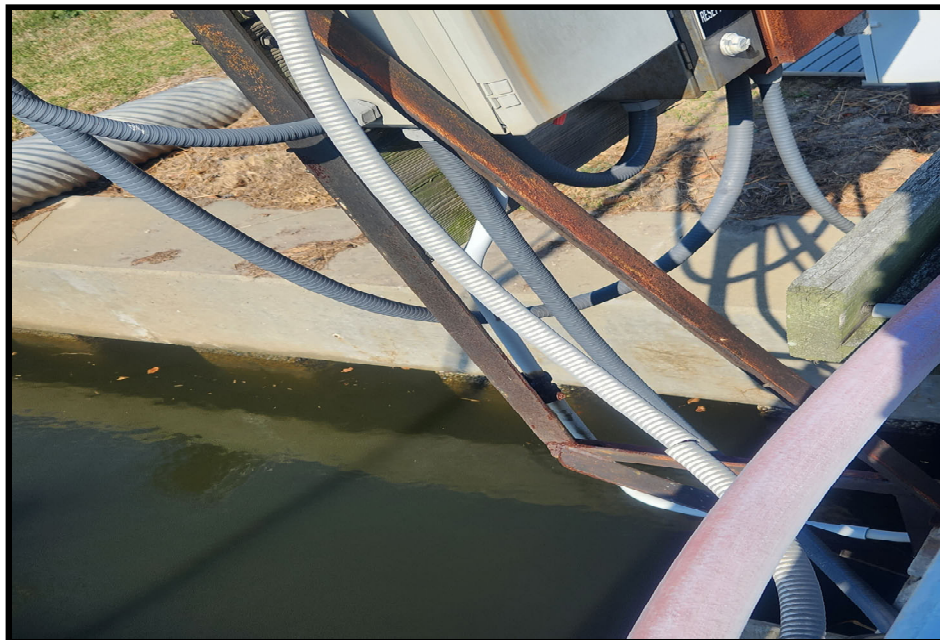
FLEXIBLE CONDUIT BROKEN

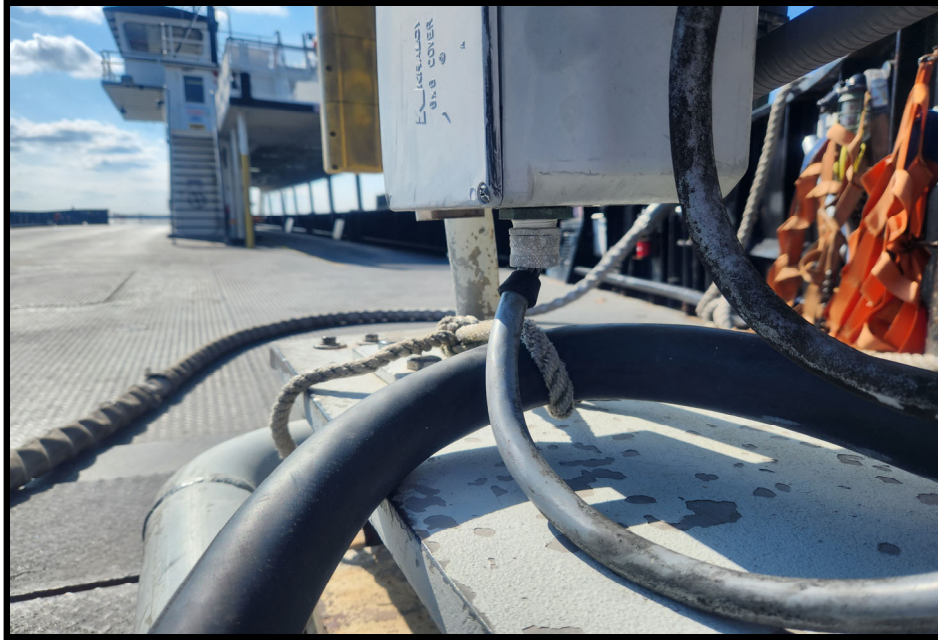
FLEXIBLE CONDUIT PULLED OUT OF JUNCTION BOX FITTING

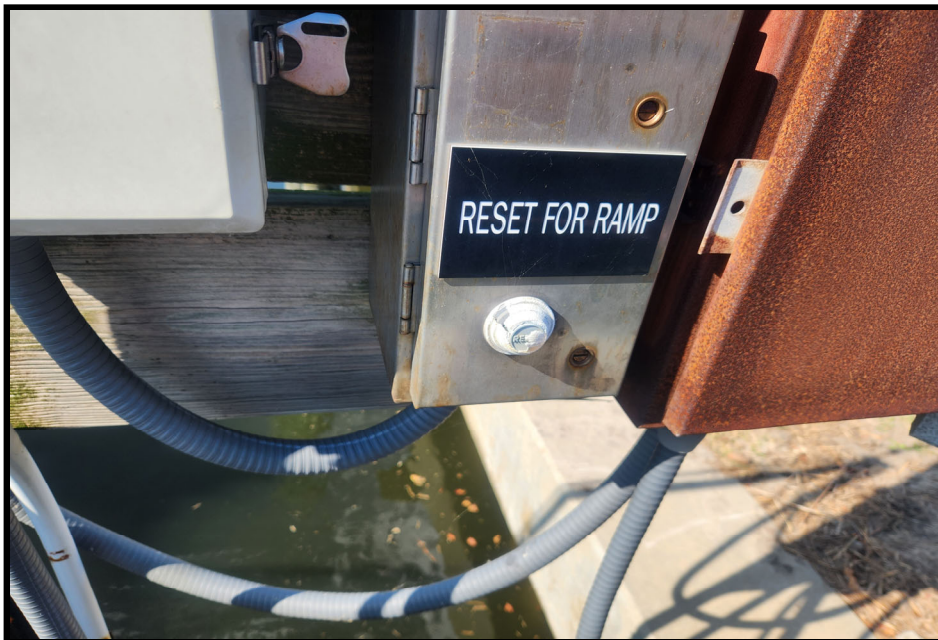
| 3. FAILED PROTECTIVE COVER SEAL ON RESET BREAKER | EA | 1 |

FAILED PROTECTIVE COVER SEAL ON RESET BREAKER

| 3. REPLACE PROTECTIVE COVER SEAL ON RESET BREAKER | EA | 1 |

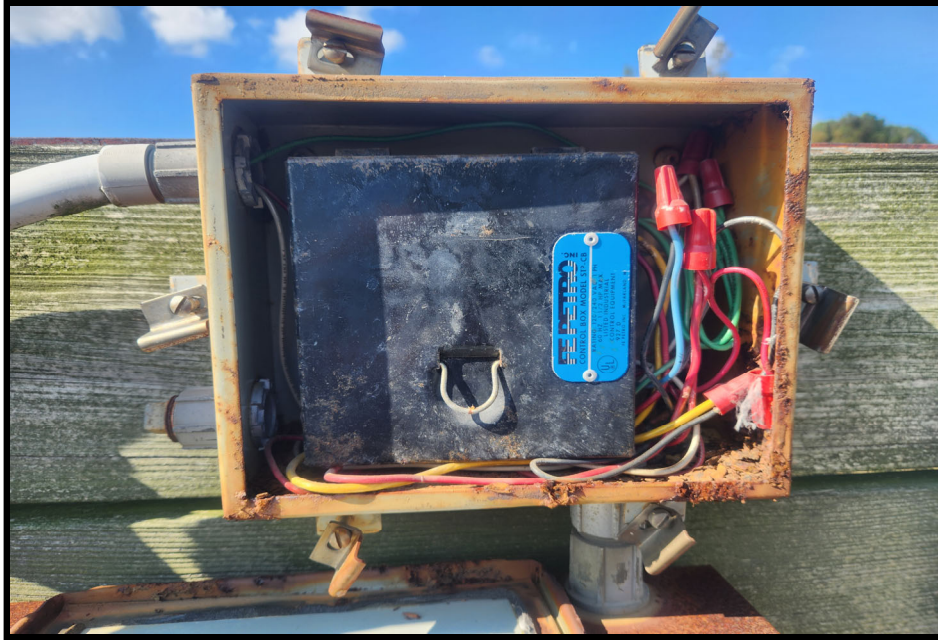
| 4. JUNCTION BOXES SEVERELY CORRODED AND / OR DEBRIS INSIDE | EA | 2 |

JUNCTION BOX SEVERELY CORRODED WITH DEBRIS INSIDE

| 4. CLEAN INTERIOR OF JUNCTION BOXES AND REPLACE SEALS, OR REPLACE JUNCTION BOXES AS REQUIRED | EA | 2 |

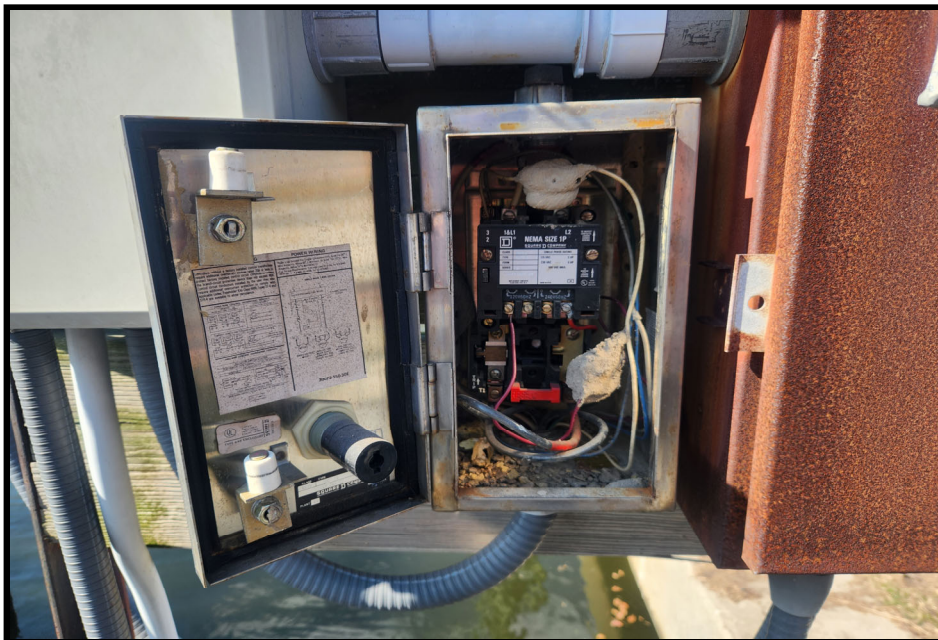
DEBRIS IN RESET BREAKER BOX

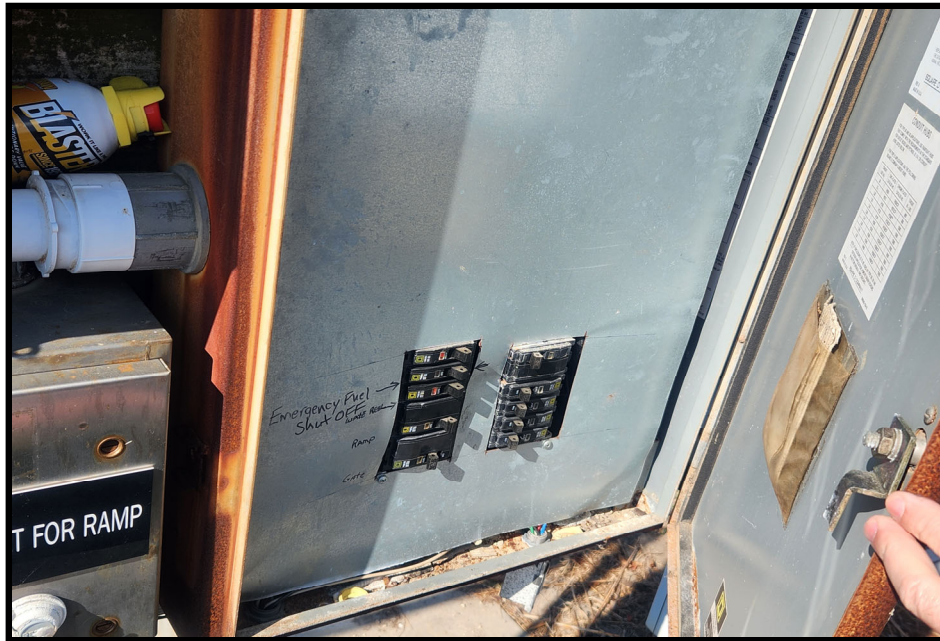
BREAKER BOX PANEL DOES NOT COVER WIRES COMPLETELY

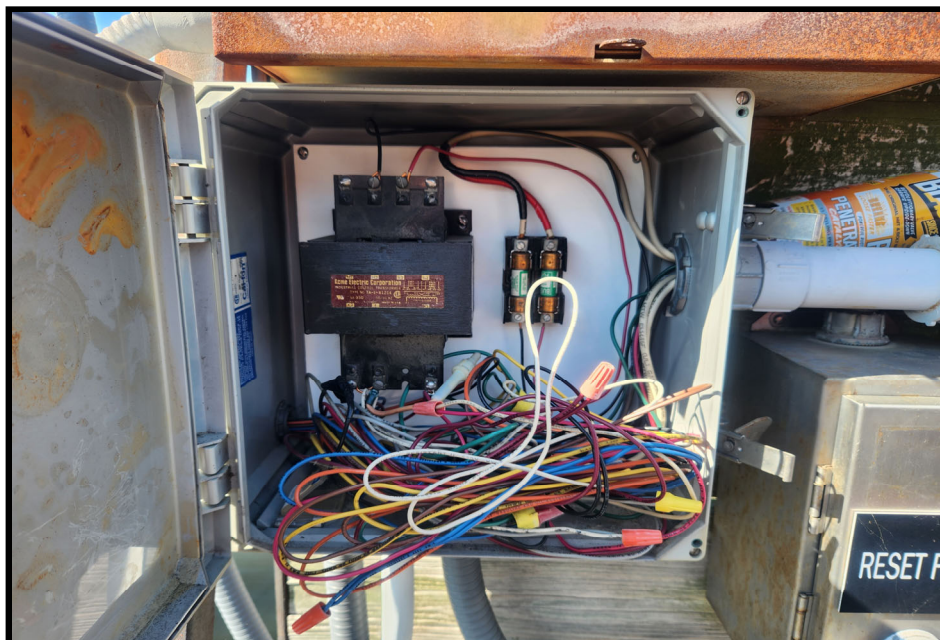
| 5. WIRES NOT LABELED OR PROPERLY LANDED IN POWER SUPPLY JUNCTION BOX | EA | 1 |

WIRES NOT LABELED OR PROPERLY LANDED IN POWER SUPPLY JUNCTION BOX

| 5. PROPERLY LAND AND LABEL WIRES IN POWER SUPPLY JUNCTION BOX | EA | 1 |
