NC DEPARTMENT OF TRANSPORTATION
 DIVISION OF HIGHWAYS
 STRUCTURE MANAGEMENT UNIT

Structure Safety Report

Supplemental Element Inspection

STRUCTURE NUMBER: 590330 SAP STRUCTURE NO: 0600330 FHWA STRUCTURE NO: 000000001190330

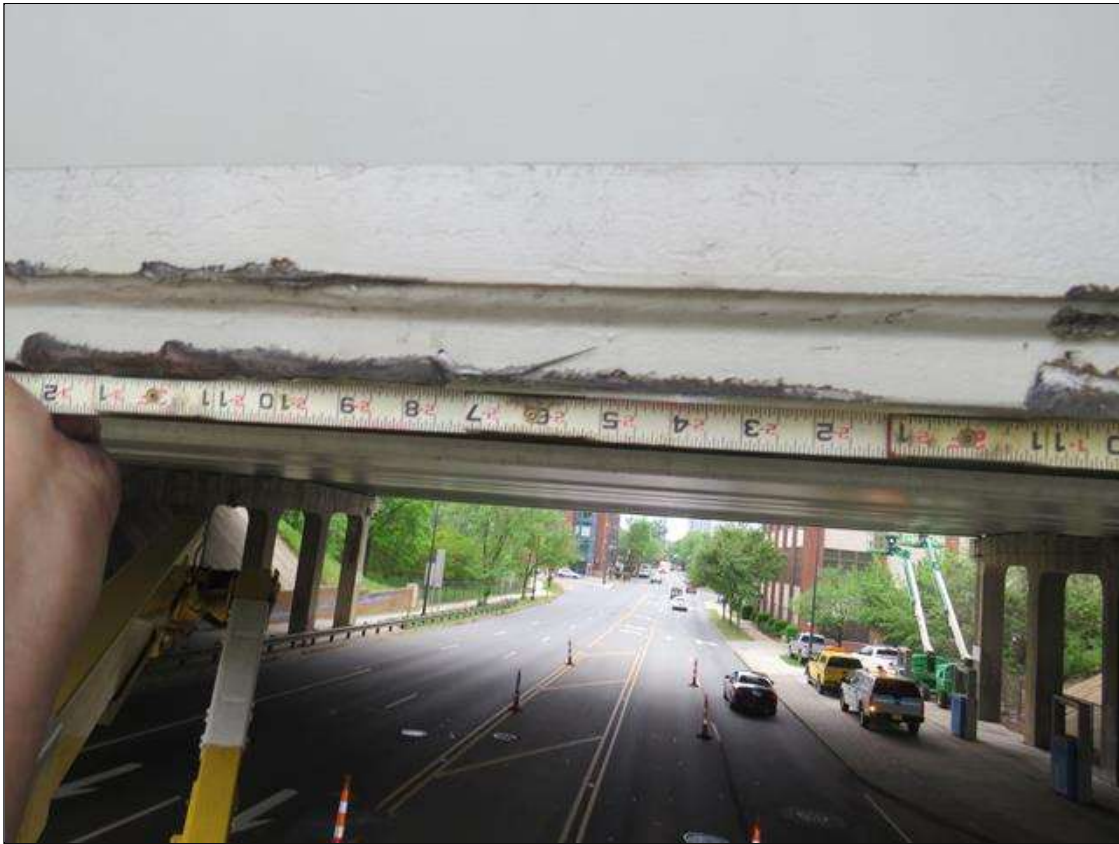
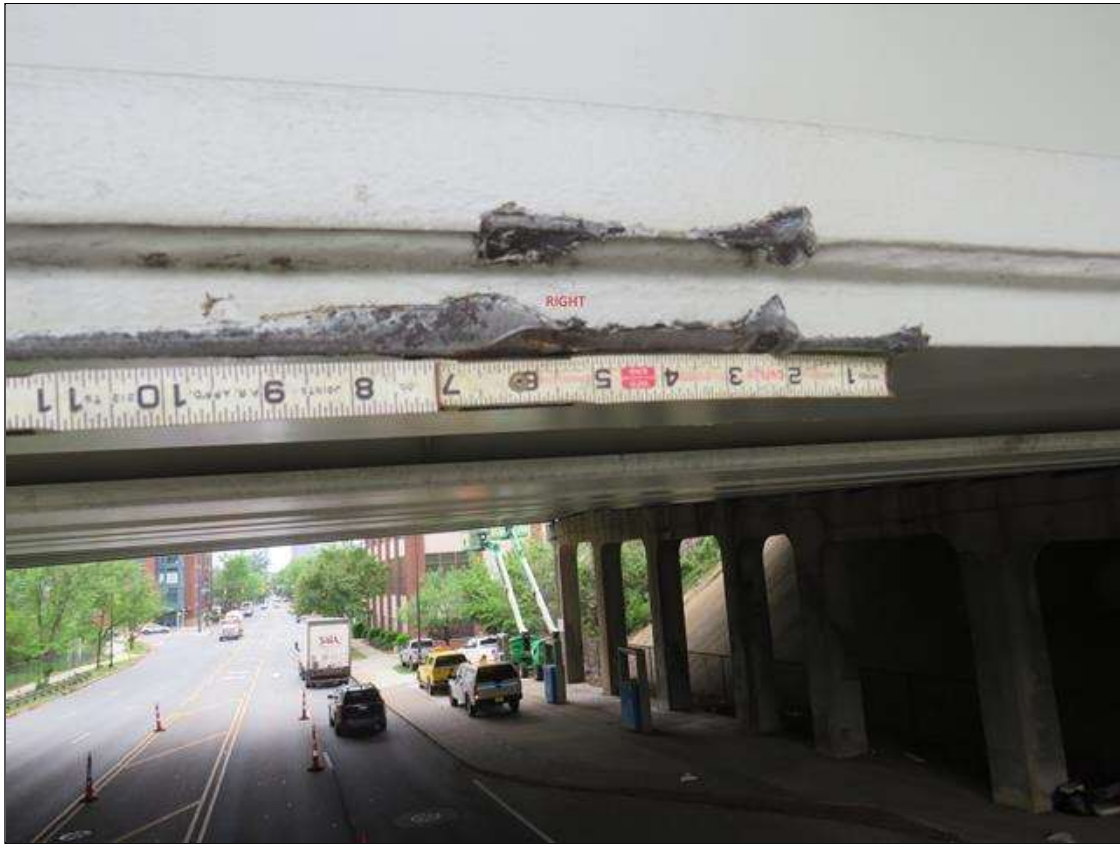
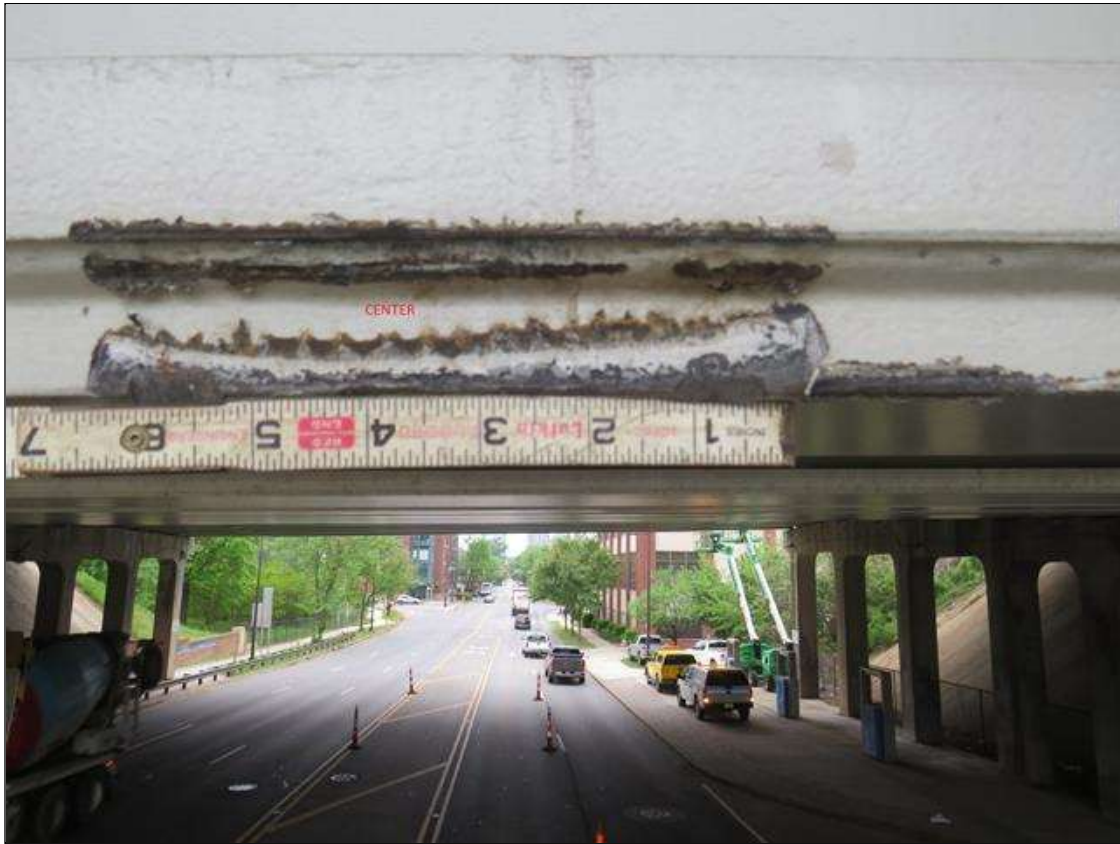
Span 2 Beam 1: Supplemental Inspection Impact Damage, The Bottom of the Beam is bent Northward for the Length of 35 Foot With the Max Distance at the Point of Impact Being 5.5 Inches. The Beam is Out of Plumb By 9 Degrees. The Point of Impact is 3 Foot 3 Inches Long and 2 Inches High and is Located in Span 2, 42 Foot 2 Inches From Bent 2. There are 3 Gouges at the Bottom of the Point of Impact: Left Gouge is 8 Inch X 2 Inch X 1/2 Inch, Center Gouge is 7 Inch X 2 Inch X 1/16 Inch, Right Gouge is 11 Inch X 2 Inch X 1/16 Inch. (PAR)

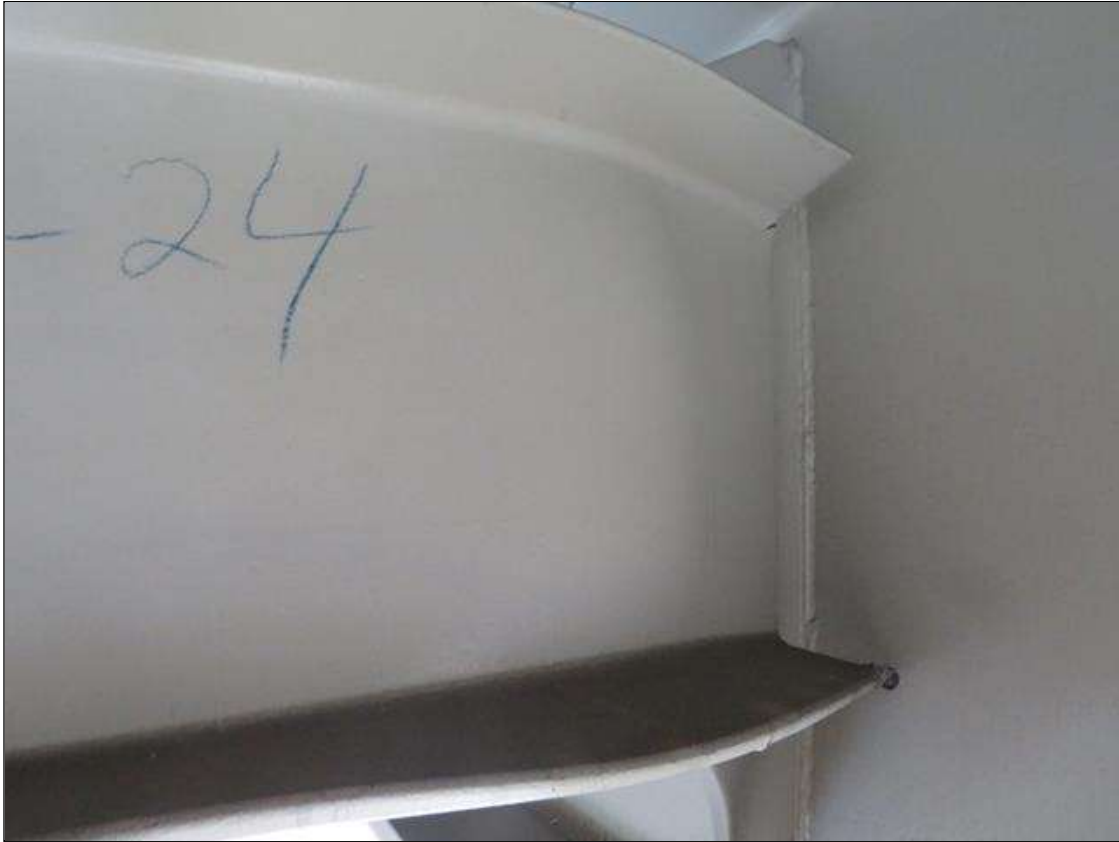
3314	Beam 1	Plate Girder		
Priority Level	Defect Type	Quantity	Defect Description	
?	Connection	1	Span 2 Beam 1: Supplemental Inspection Impact Damage, Span 2 Bay 1, Diaphragm at Point of Impact Located 58 Foot From Bent 1 Has Crumpled. The Web of the Diaphragm is Distorted Up to 1 Foot. The Bay at the Point of Impact Around the Diaphragm has a Spacing of 75.5 Inches at the Top Flange and 67 Inches at the Bottom Flange. Only the Protective Coating Has Chipped and Cracked. (PAR)	
?	Distortion	35	Span 2 Beam 1: Supplemental Inspection Impact Damage, The Bottom of the Beam is bent Northward for the Length of 35 Foot With the Max Distance at the Point of Impact Being 5.5 Inches. The Beam is Out of Plumb By 9 Degrees. The Point of Impact is 3 Foot 3 Inches Long and 2 Inches High and is Located in Span 2, 42 Foot 2 Inches From Bent 2. There are 3 Gouges at the Bottom of the Point of Impact: Left Gouge is 8 Inch X 2 Inch X 1/2 Inch, Center Gouge is 7 Inch X 2 Inch X 1/16 Inch, Right Gouge is 11 Inch X 2 Inch X 1/16 Inch. (PAR)

Span 2 Beam 1: Supplemental Inspection Impact Damage, Span 2 Bay 1, Diaphragm at Point of Impact Located 58 Foot From Bent 1 Has Crumpled. The Web of the Diaphragm is Distorted Up to 1 Foot. The Bay at the Point of Impact Around the Diaphragm has a Spacing of 75.5 Inches at the Top Flange and 67 Inches at the Bottom Flange. Only the Protective Coating Has Chipped and Cracked. (PAR)
