NC DEPARTMENT OF TRANSPORTATION
 DIVISION OF HIGHWAYS
 STRUCTURE MANAGEMENT UNIT

ATTENTION: Supplemental Inspection Impact Damage, Span 2 Bay 1 Diaphragm, Span 2 Beam 1 and Missing Sign PARs. Superstructure Grade Reduced to 4 Due to Supplemental Inspection Impact Damage to Beam 1 and Diaphragm Only.

Supplemental Element Inspection

STRUCTURE NUMBER: 590330 SAP STRUCTURE NO: 0600330 FHWA STRUCTURE NO: 000000001190330

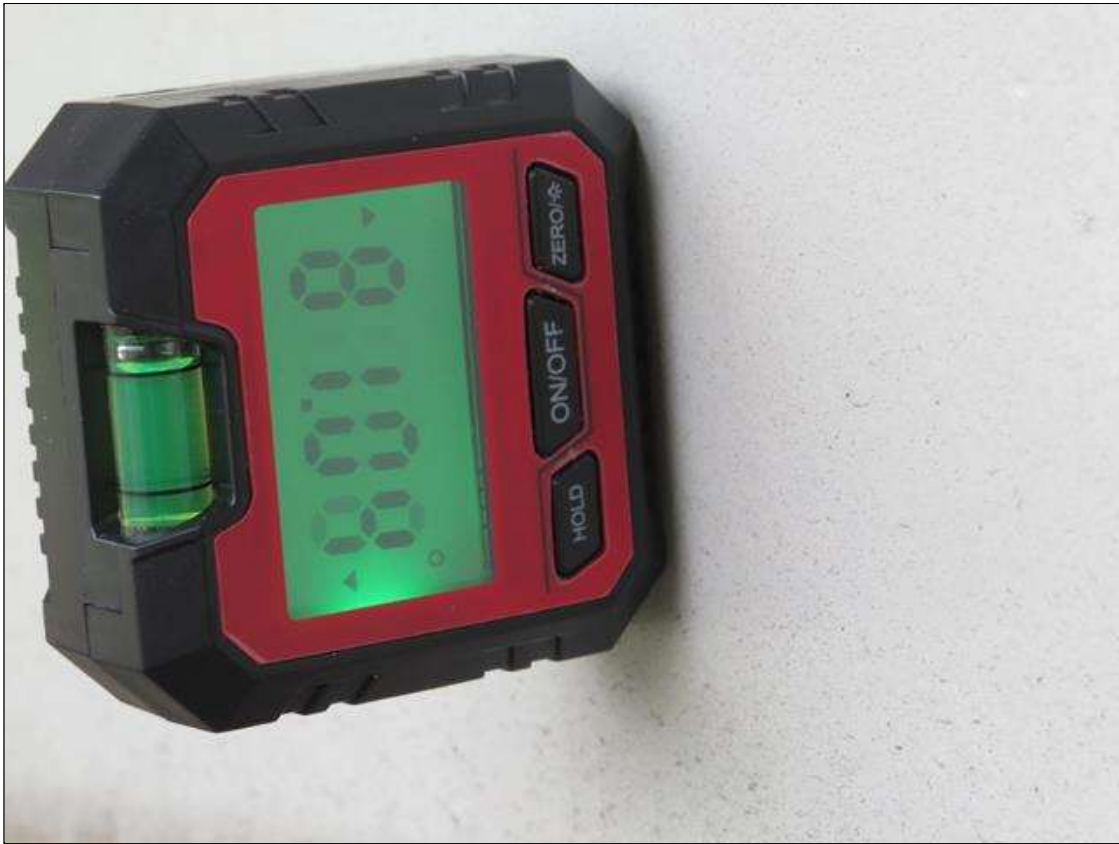
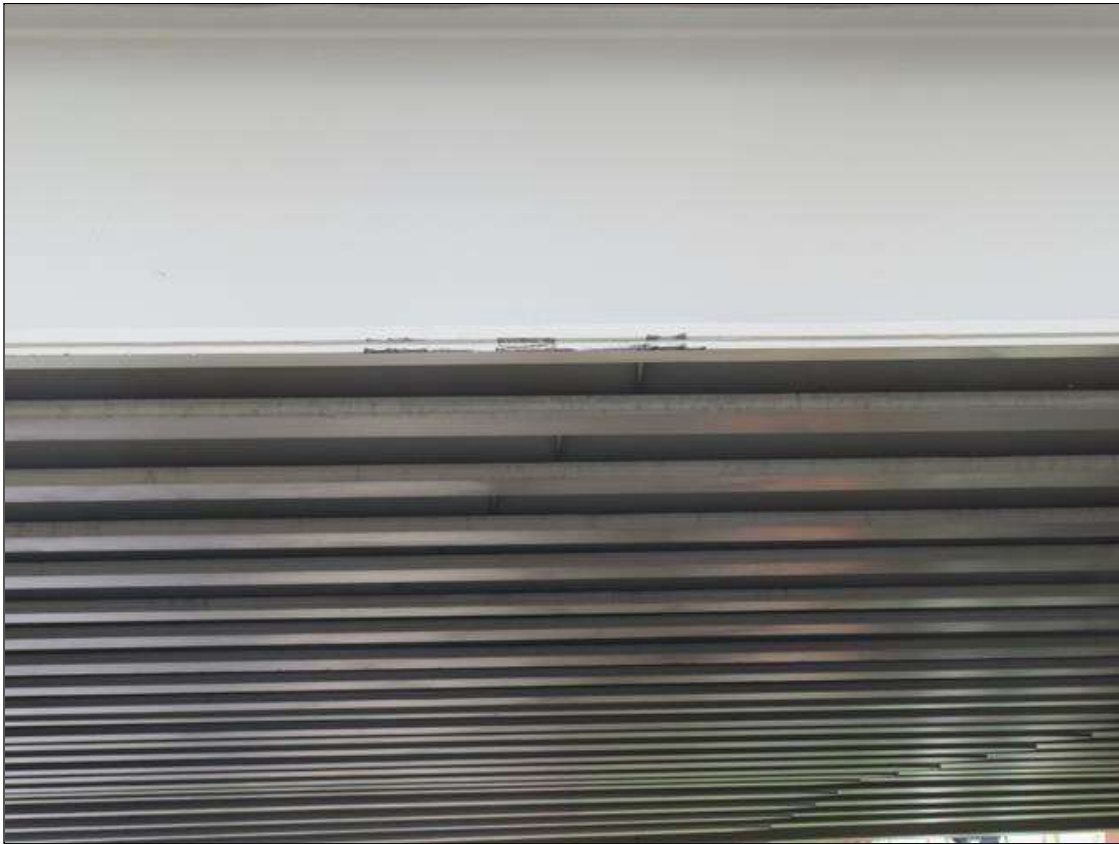
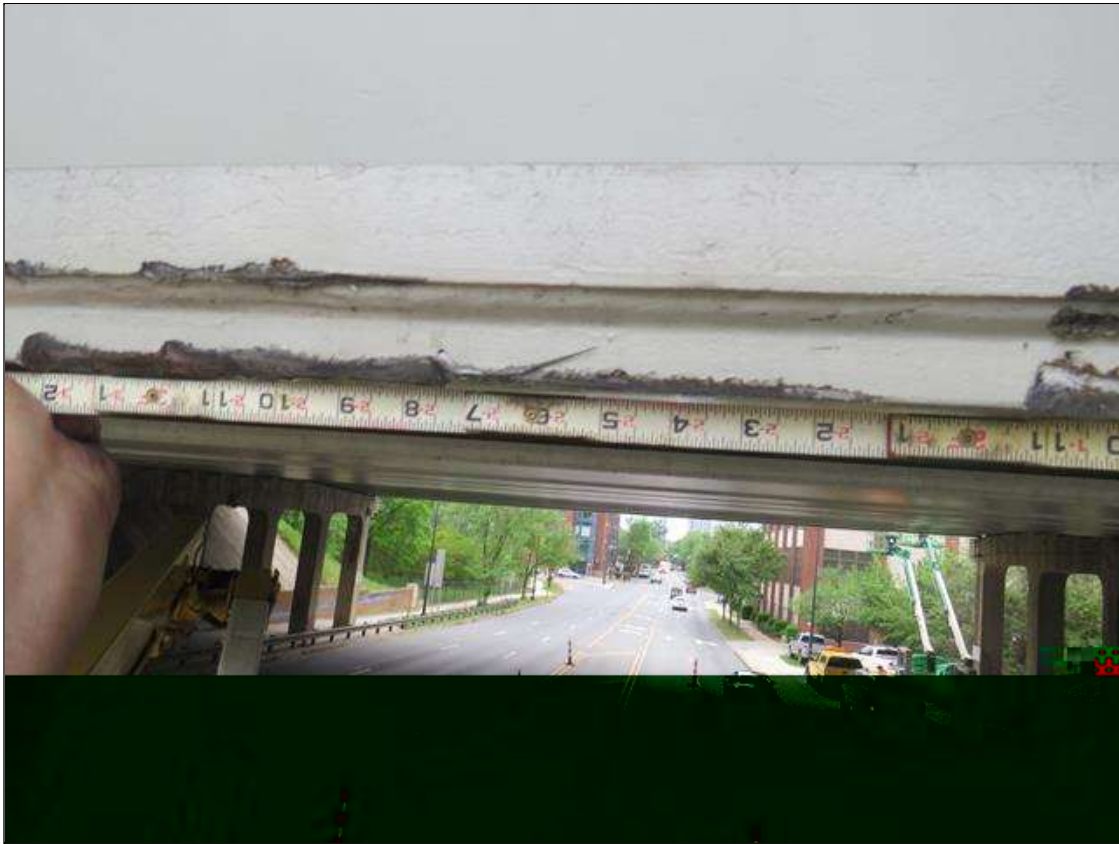
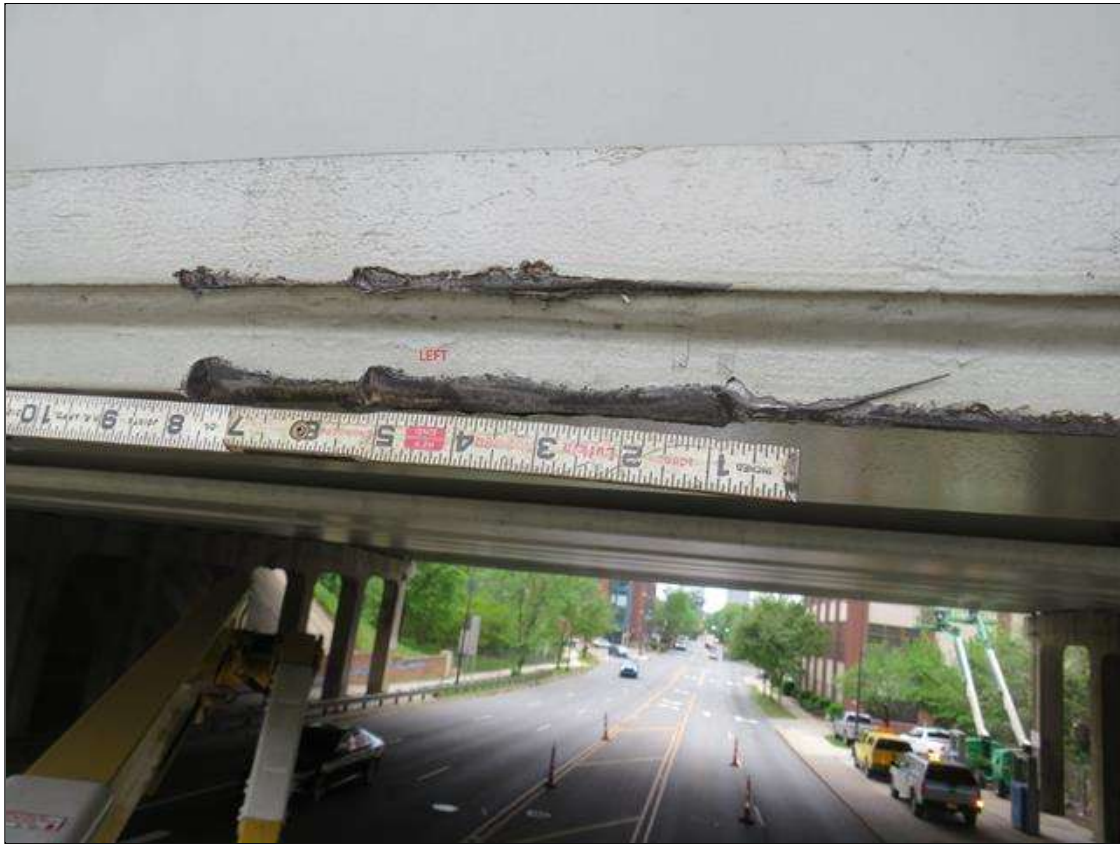
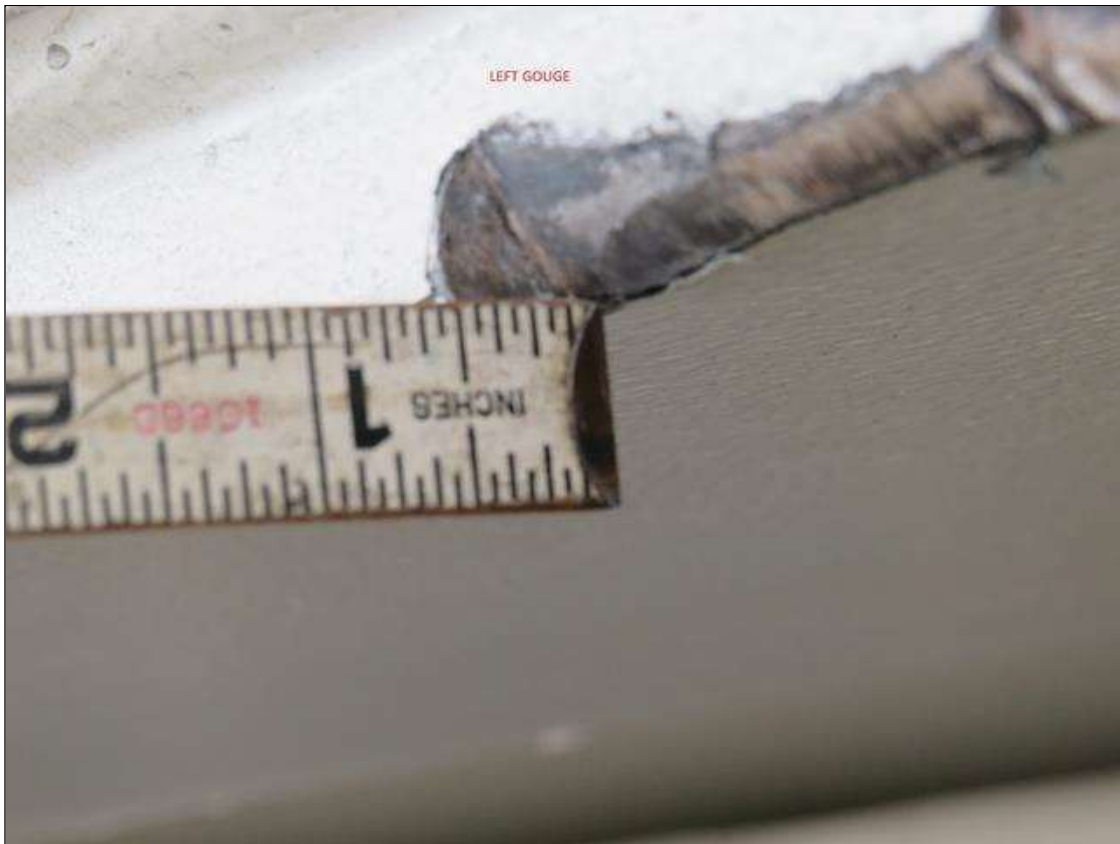
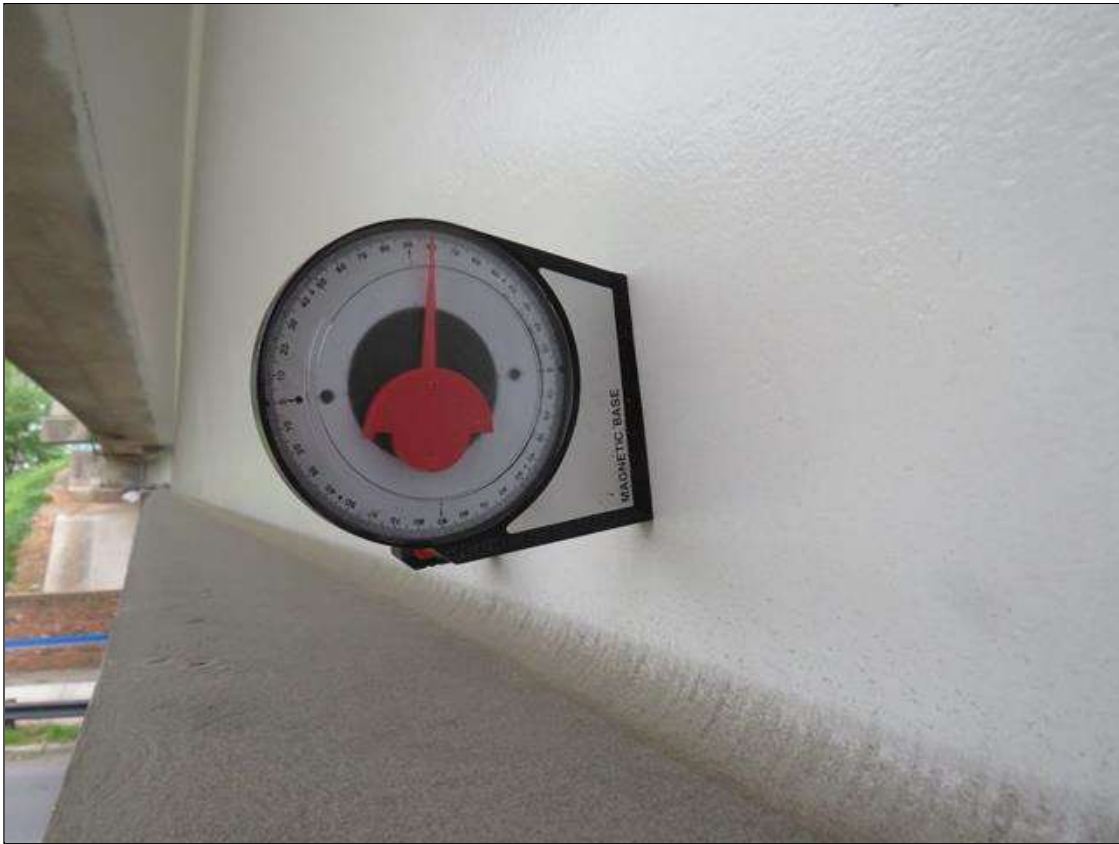
3314	Beam 1	Plate Girder		
Priority Level	Defect Type	Quantity	Defect Description	
?	Connection	1	Span 2 Beam 1: Supplemental Inspection Impact Damage, Span 2 Bay 1, Diaphragm at Point of Impact Located 58 Foot From Bent 1 Has Crumpled. The Web of the Diaphragm is Distorted Up to 1 Foot. The Bay at the Point of Impact Around the Diaphragm has a Spacing of 75.5 Inches at the Top Flange and 67 Inches at the Bottom Flange. Only the Protective Coating Has Chipped and Cracked. (PAR)	
?	Distortion	35	Span 2 Beam 1: Supplemental Inspection Impact Damage, The Bottom of the Beam is bent Northward for the Length of 35 Foot With the Max Distance at the Point of Impact Being 5.5 Inches. The Beam is Out of Plumb By 9 Degrees. The Point of Impact is 3 Foot 3 Inches Long and 2 Inches High and is Located in Span 2, 42 Foot 2 Inches From Bent 2. There are 3 Gouges at the Bottom of the Point of Impact: Left Gouge is 8 Inch X 2 Inch X 1/2 Inch, Center Gouge is 7 Inch X 2 Inch X 1/16 Inch, Right Gouge is 11 Inch X 2 Inch X 1/16 Inch. (PAR)

Span 2 Beam 1: Supplemental Inspection Impact Damage, The Bottom of the Beam is bent Northward for the Length of 35 Foot With the Max Distance at the Point of Impact Being 5.5 Inches. The Beam is Out of Plumb By 9 Degrees. The Point of Impact is 3 Foot 3 Inches Long and 2 Inches High and is Located in Span 2, 42 Foot 2 Inches From Bent 2. There are 3 Gouges at the Bottom of the Point of Impact: Left Gouge is 8 Inch X 2 Inch X 1/2 Inch, Center Gouge is 7 Inch X 2 Inch X 1/16 Inch, Right Gouge is 11 Inch X 2 Inch X 1/16 Inch. (PAR)

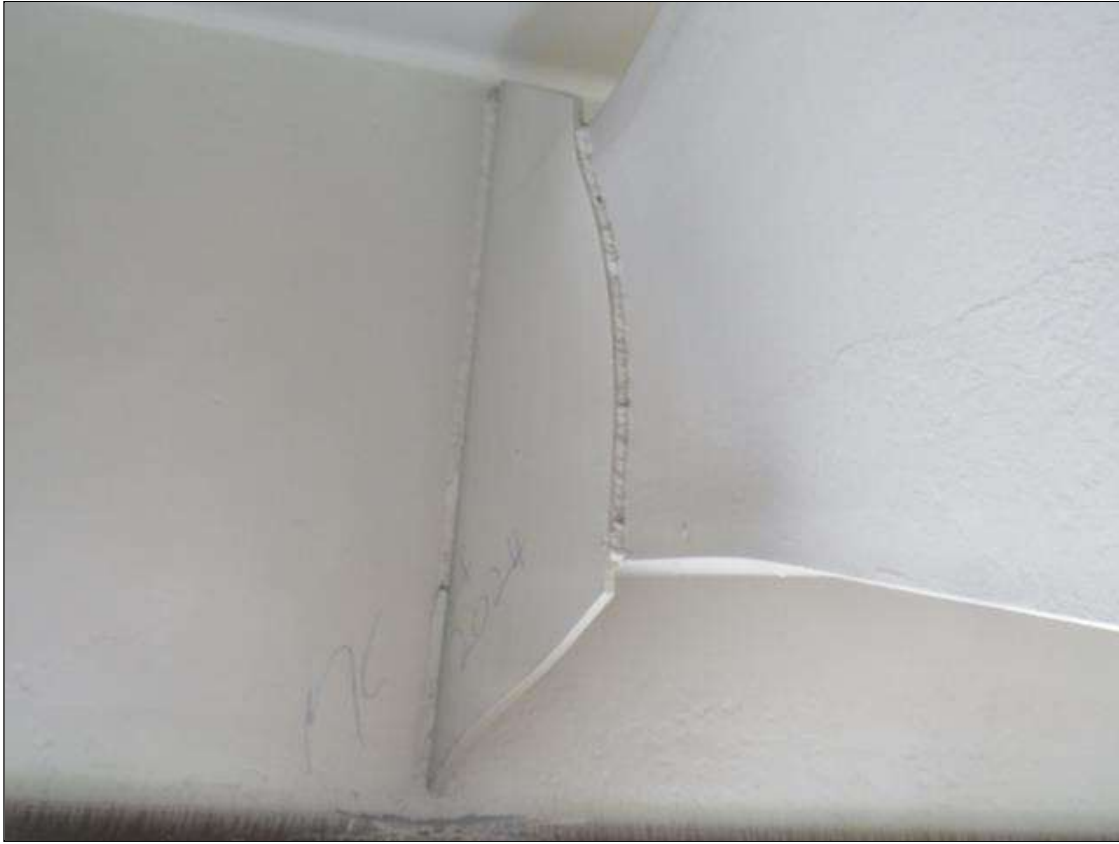
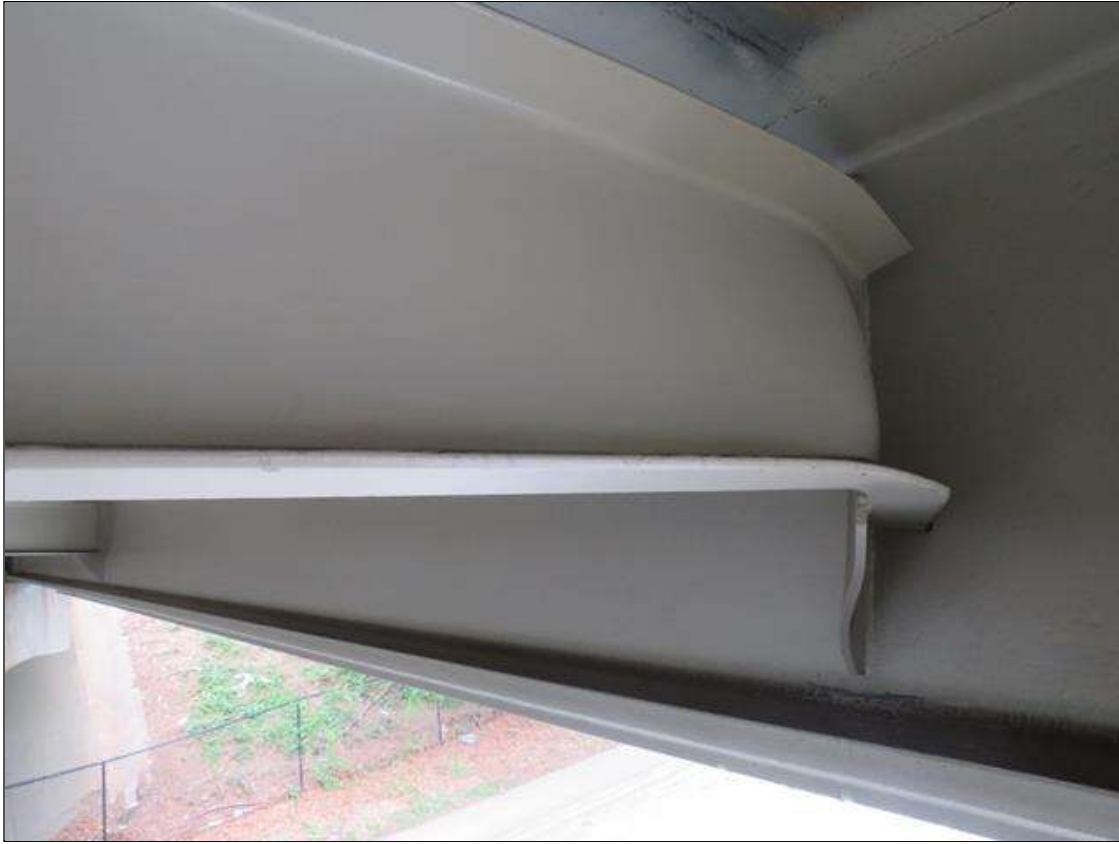
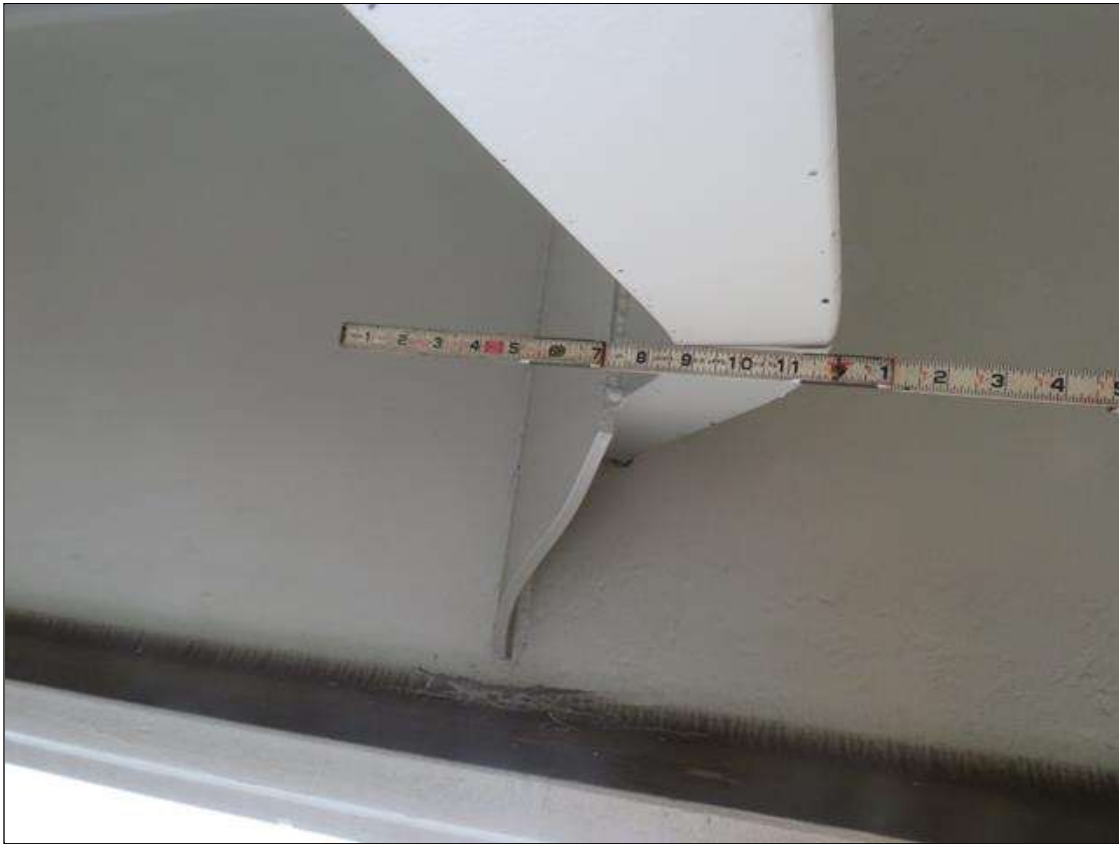
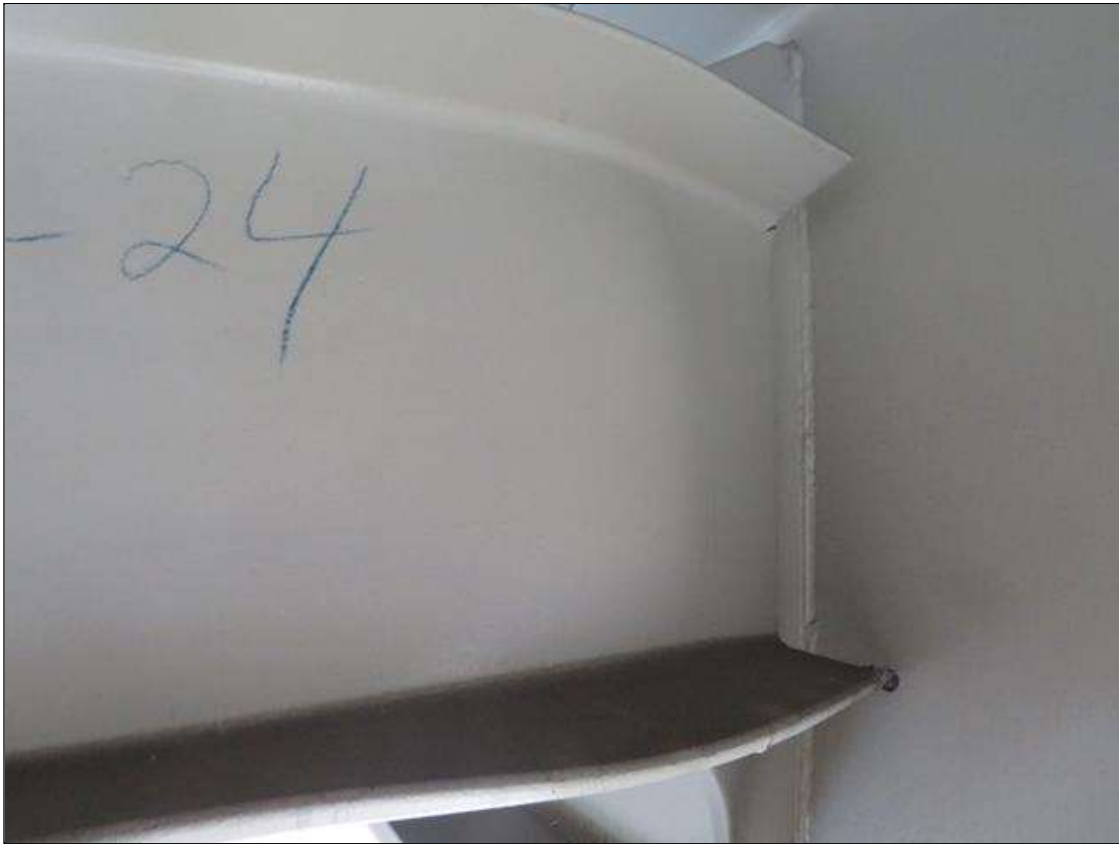
Span 2 Beam 1: Supplemental Inspection Impact Damage, Span 2 Bay 1, Diaphragm at Point of Impact Located 58 Foot From Bent 1 Has Crumpled. The Web of the Diaphragm is Distorted Up to 1 Foot. The Bay at the Point of Impact Around the Diaphragm has a Spacing of 75.5 Inches at the Top Flange and 67 Inches at the Bottom Flange. Only the Protective Coating Has Chipped and Cracked. (PAR)
