NC DEPARTMENT OF TRANSPORTATION  
DIVISION OF HIGHWAYS  
BRIDGE MANAGEMENT UNIT

# BRIDGE INSPECTION REPORT

INSPECTION TYPE: Damage Inspection Report

COUNTY CATAWBA BRIDGE NUMBER 170142 INSPECTION CYCLE 0 YRS  
ROUTE SR1692 ACROSS US321 M.P. 0

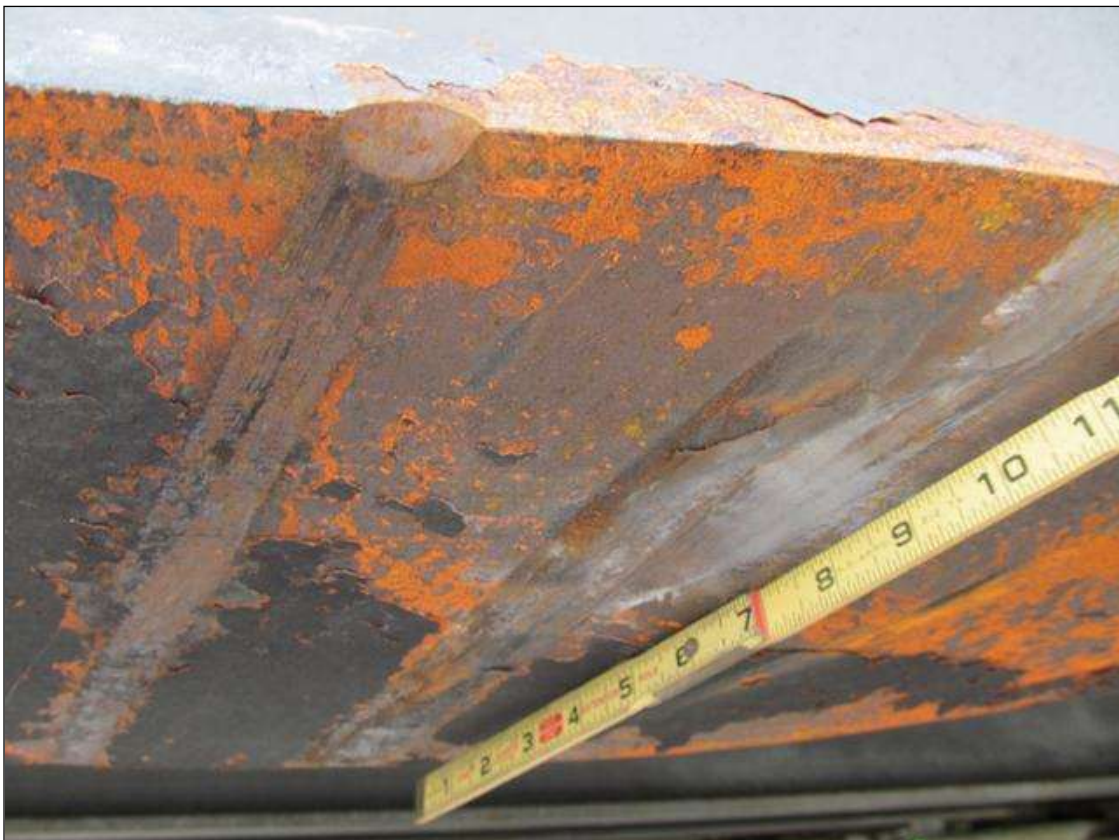
GOUGE IN BEAM 6 AT 14'-1"

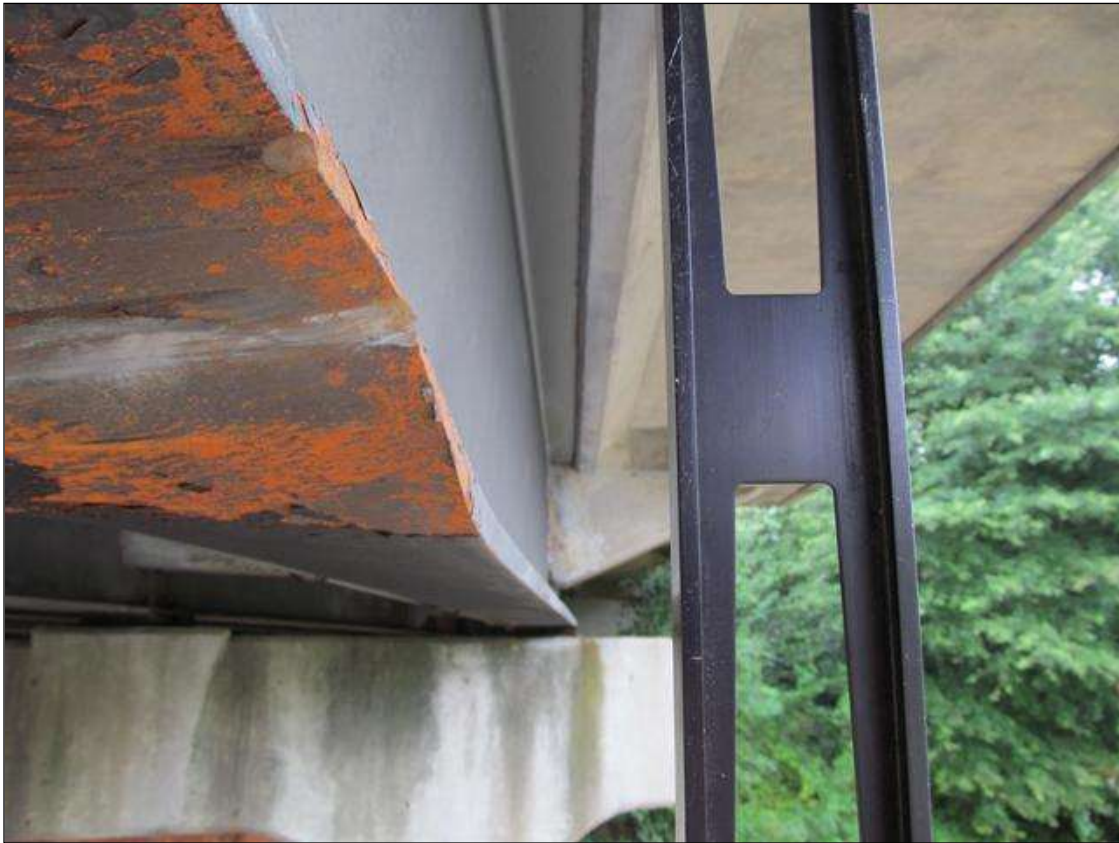
BEAM 6 OUT OF PLUMB

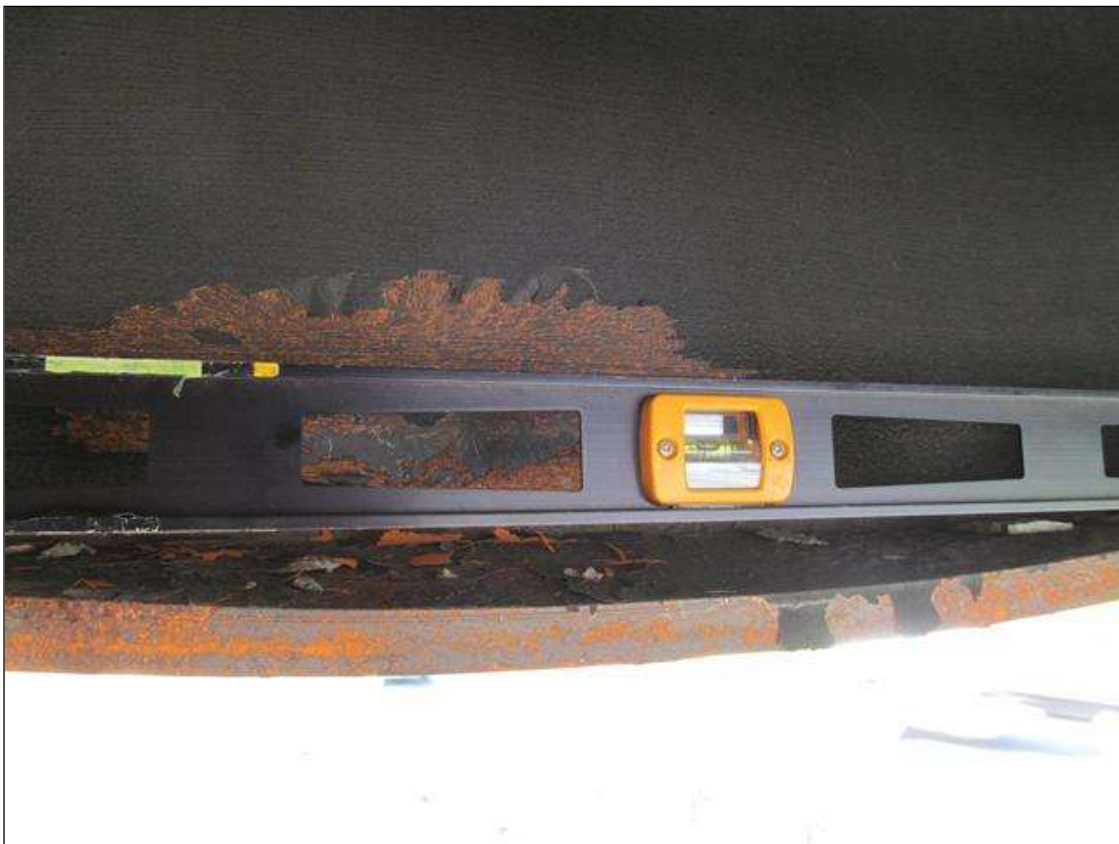
FLANGE ON BEAM 6 BENT DOWN

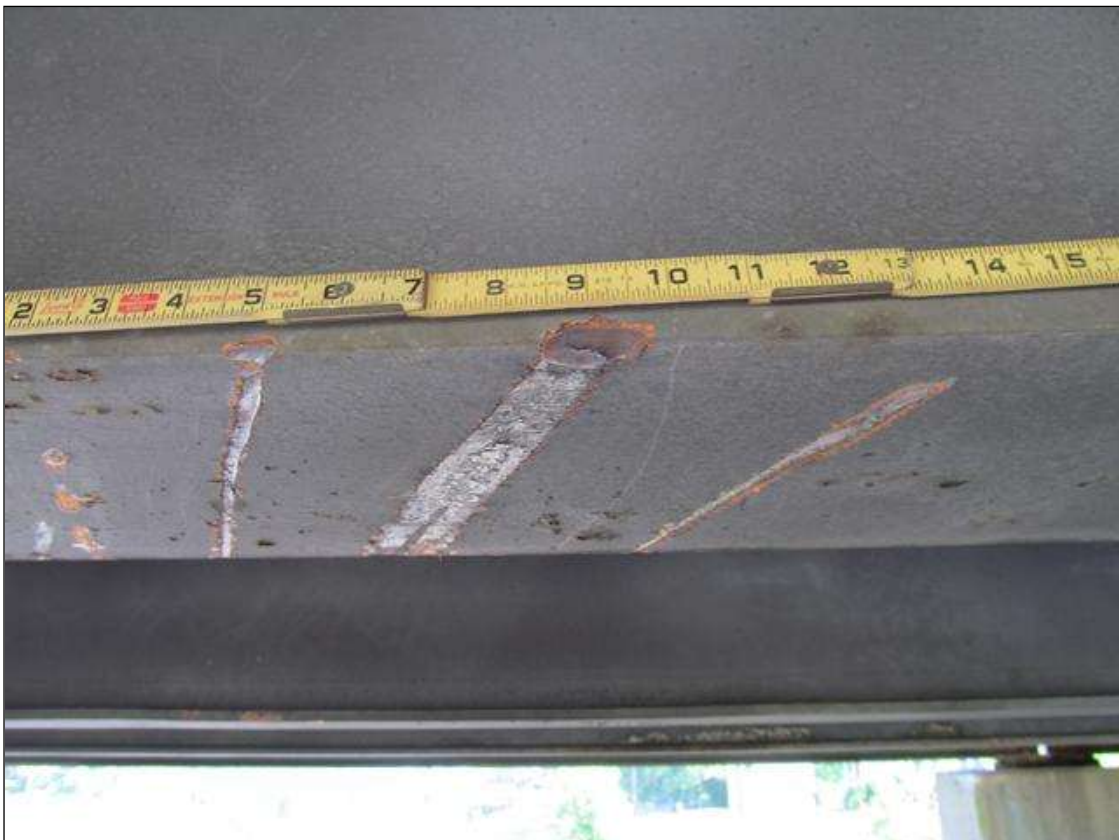
DAMAGE TO BEAM 4 AT 14'-6"

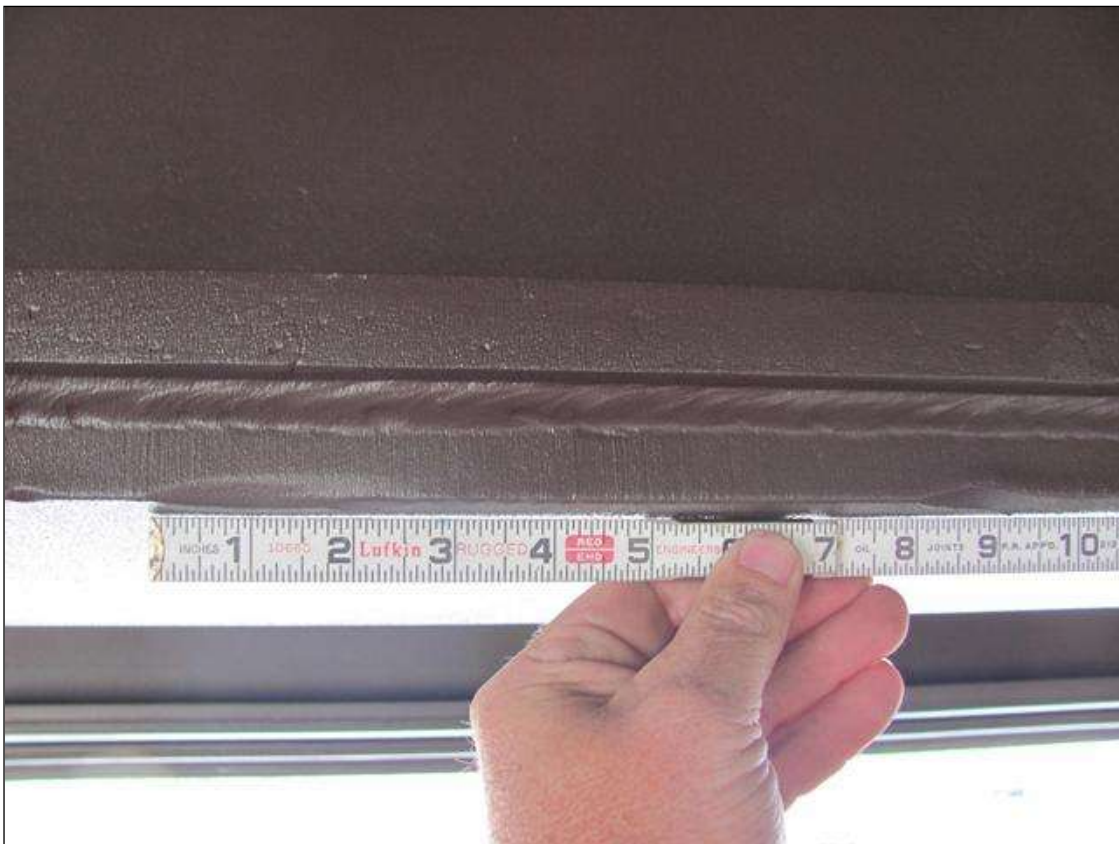
IMPACT ON GIRDER # 6 WAS 23'-6" FROM THE FACE OF BENT 1. INDENTIONS 2 1/2" X 1/16" & 4" X 1/16"

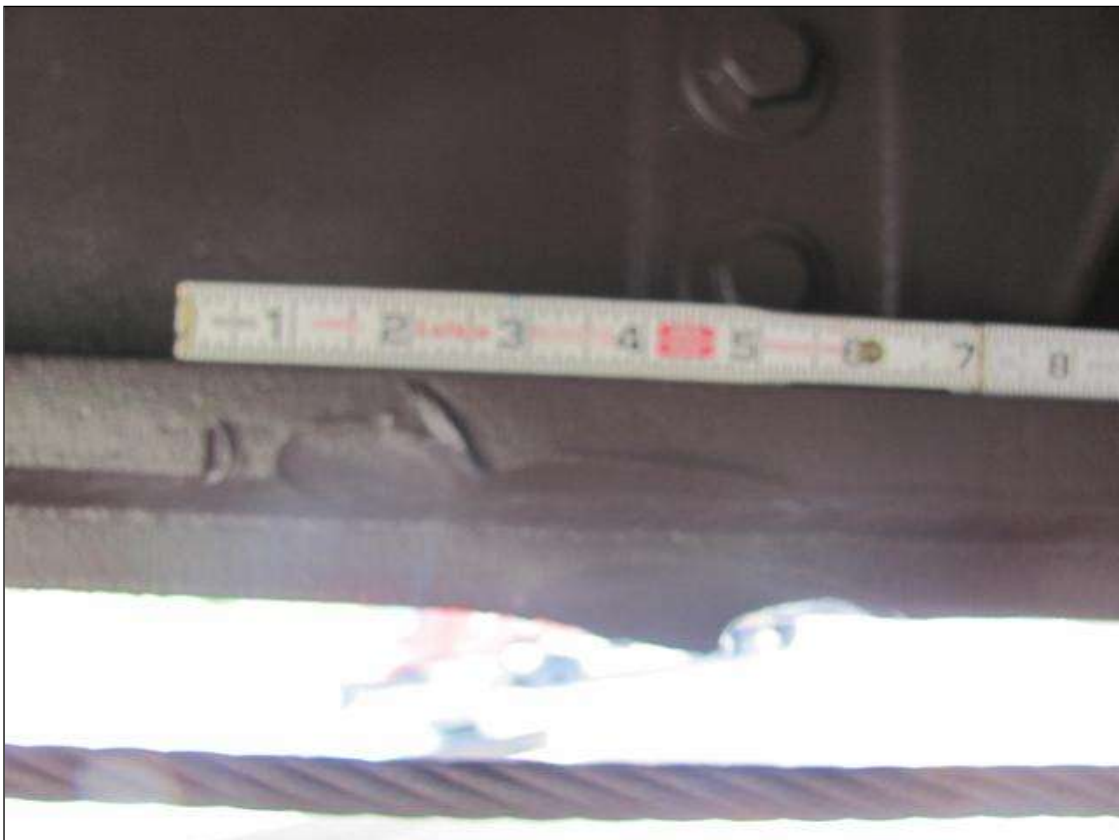
IMPACT ON GIRDER # 7 WAS 23'-11" FROM THE FACE OF BENT 1

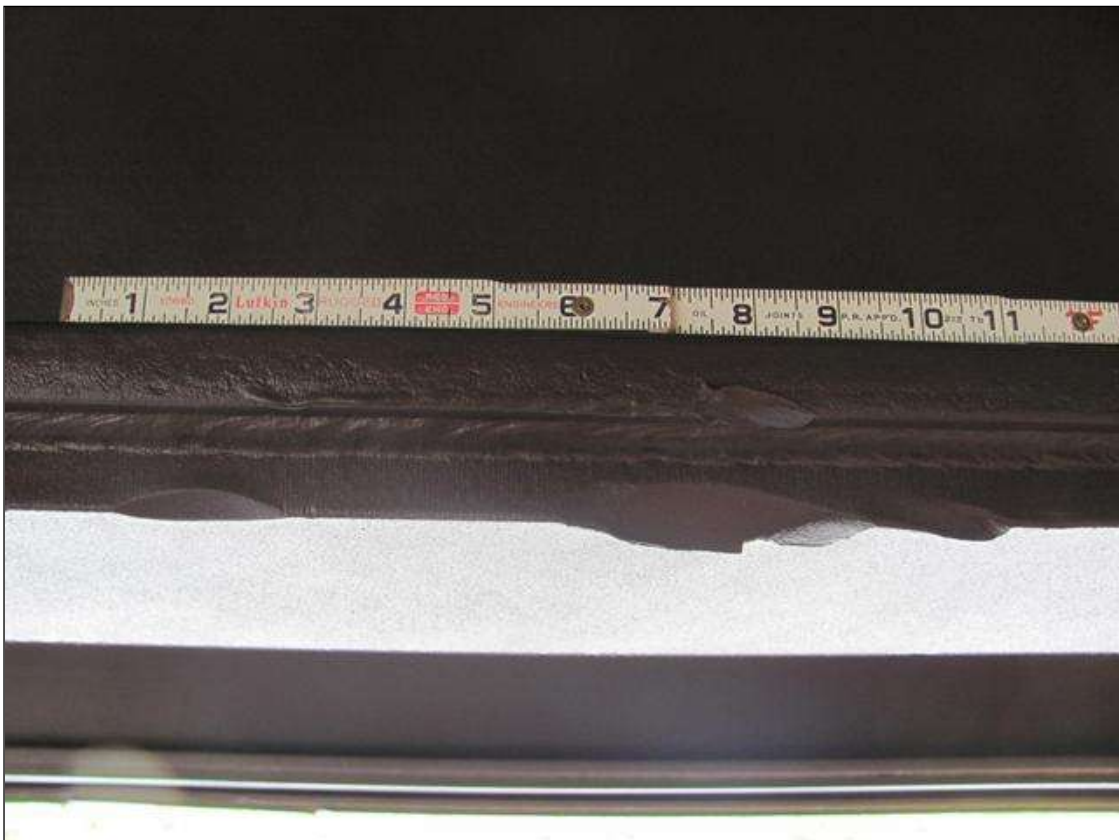
IMPACT ON GIRDER # 8 WAS 21'-6" FROM THE FACE OF BENT 1.

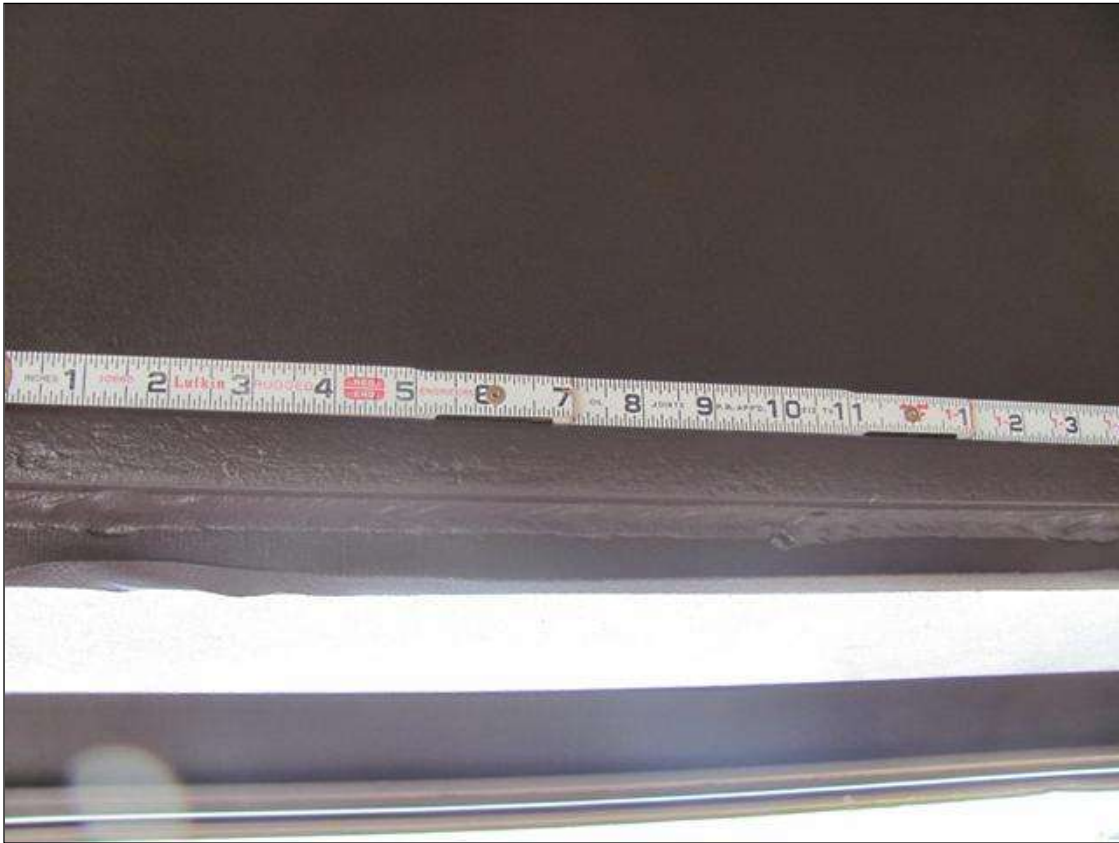
INDENTION ( 1'-7" X 1/16" ) IN COVER PLATE @ 19'-4" FROM THE FACE OF BENT 1. GIRDER 8

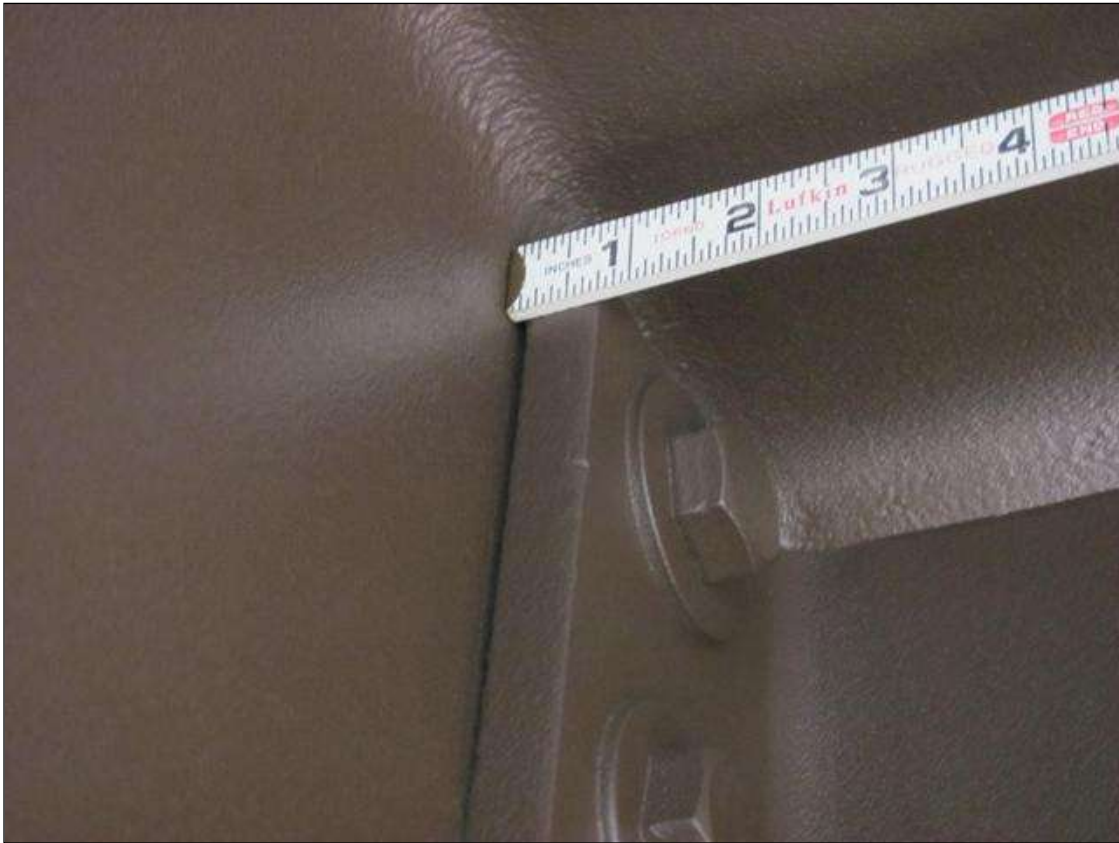
TOP OF DIAPHRAGM @ 13'-11" HAS PULLED AWAY FROM FLANGE 1/8". GIRDER 9

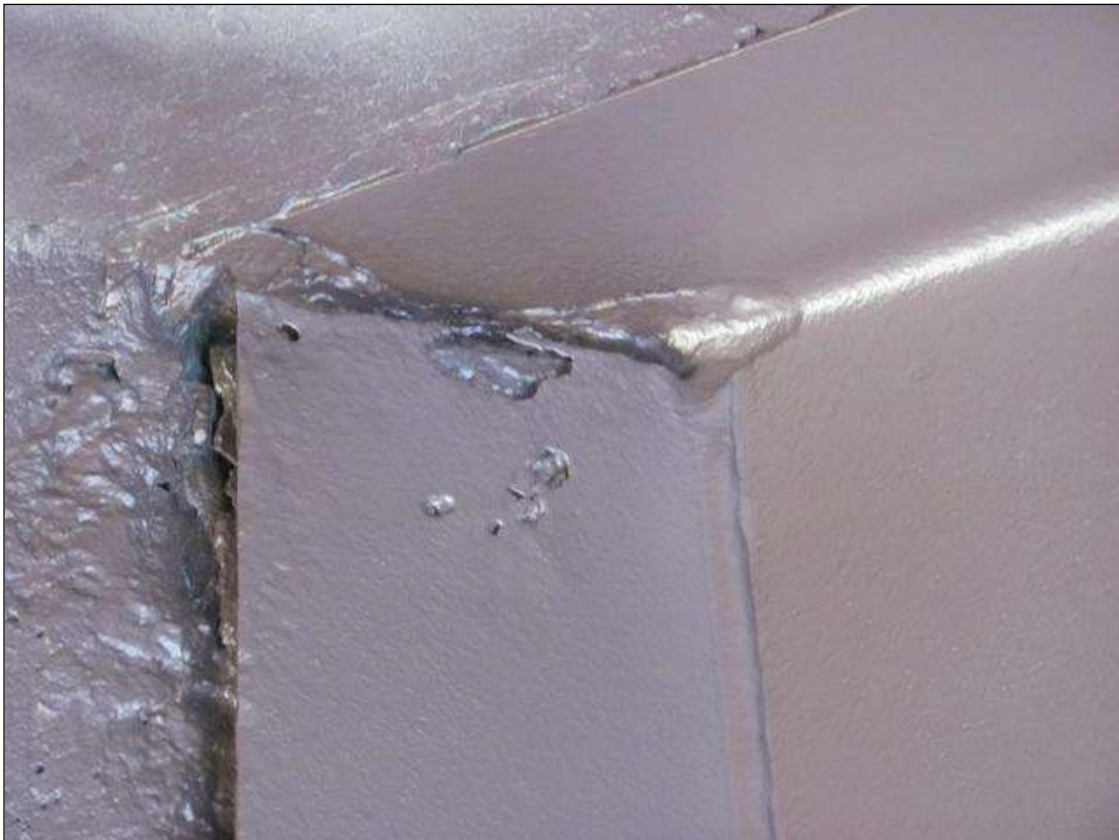
CONDITIONS FOUND IN GIRDER 8

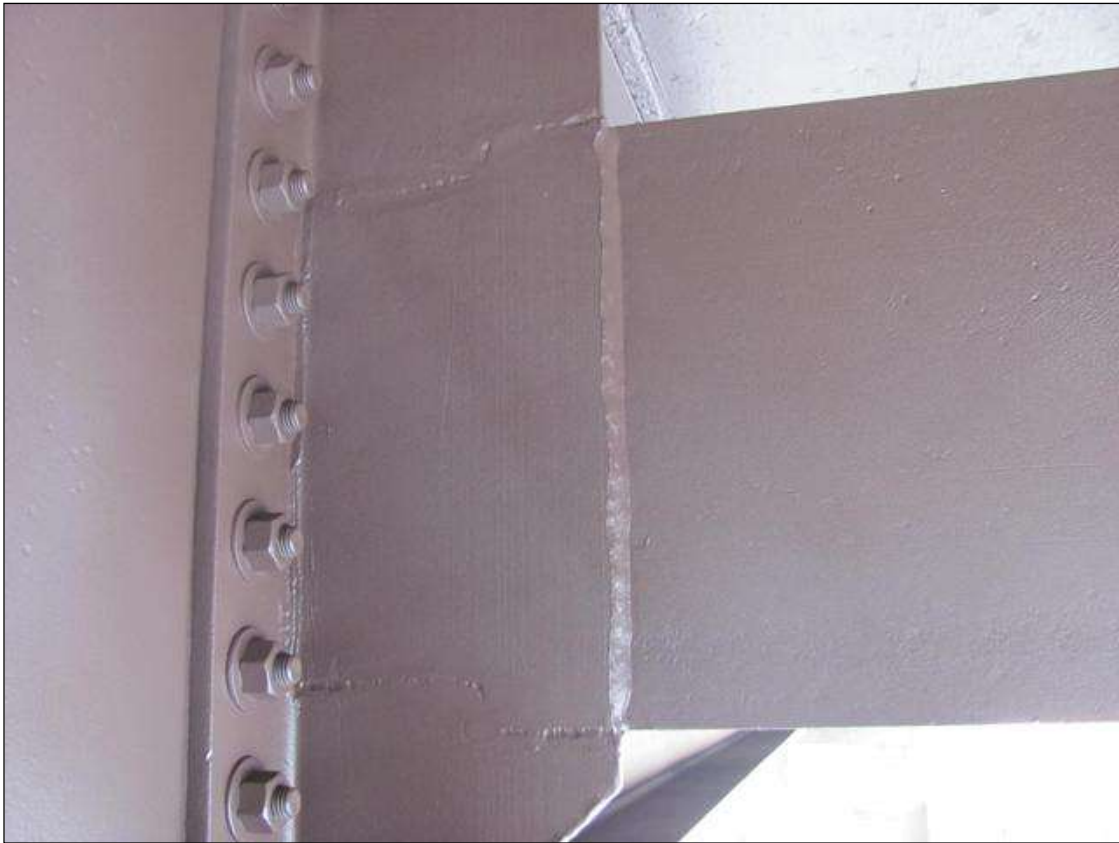
REPAIRS MADE TO DIAPHRAGM @ 16'-6" ON SOUTH SIDE OF GIRDER 9

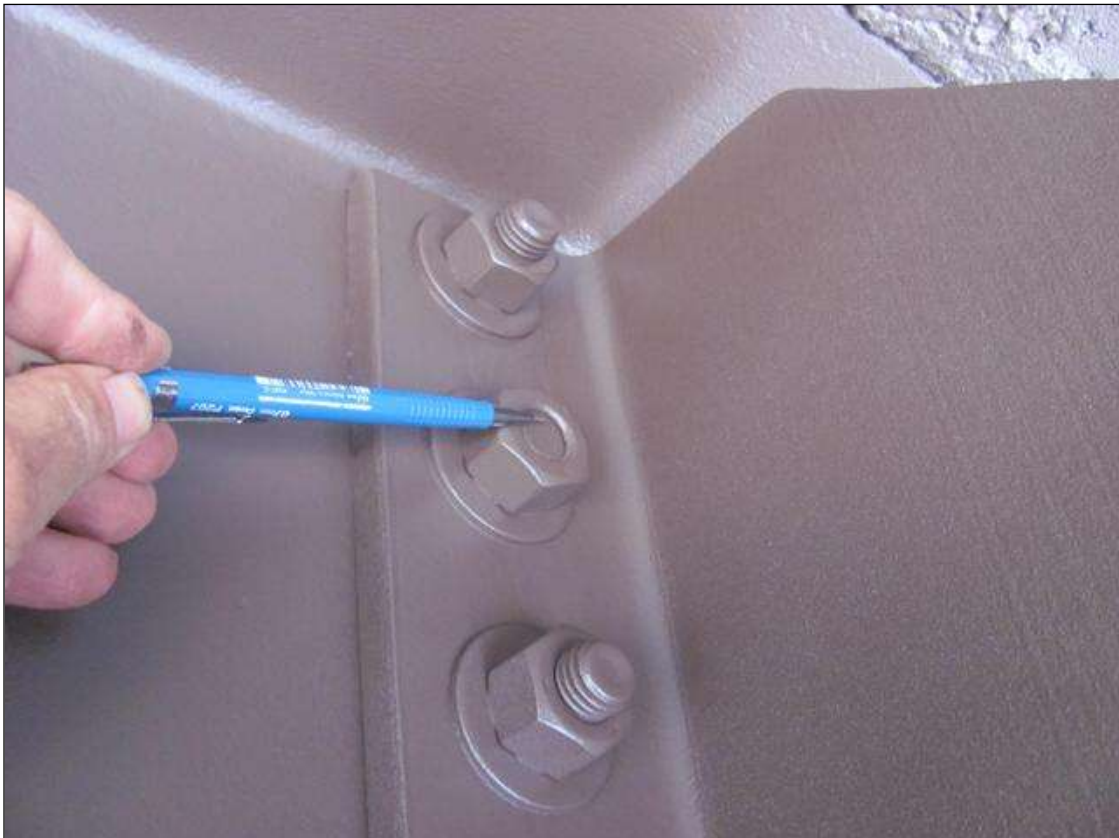
BOLT # 2 ON LEFT SIDE OF DIAPHRAGM @ 16'-6" IS NOT FULLY THREADED. GIRDER 9

MMS Code	MMS Description	Quantity
3314	Maintain Steel Superstructure Components	1 LF
Location:		
Beams and Girders	Bent/Span No. 3	DIAPHRAGM
Priority Level	Status	
Recommended	Routine Maintenance	
Submitted Date:	Submitted By:	Assisted By:
05/08/2012	MD OSBORNE	A KING
Details		
<p>DIAPHRAGM BOLT ON GIRDER NOT FULL THREAD BOLT # 2 ON LEFT SIDE OF DIAPHRAGM @ 16'-6" IS NOT FULLY THREADED. GIRDER # 2, SPAN 3</p>

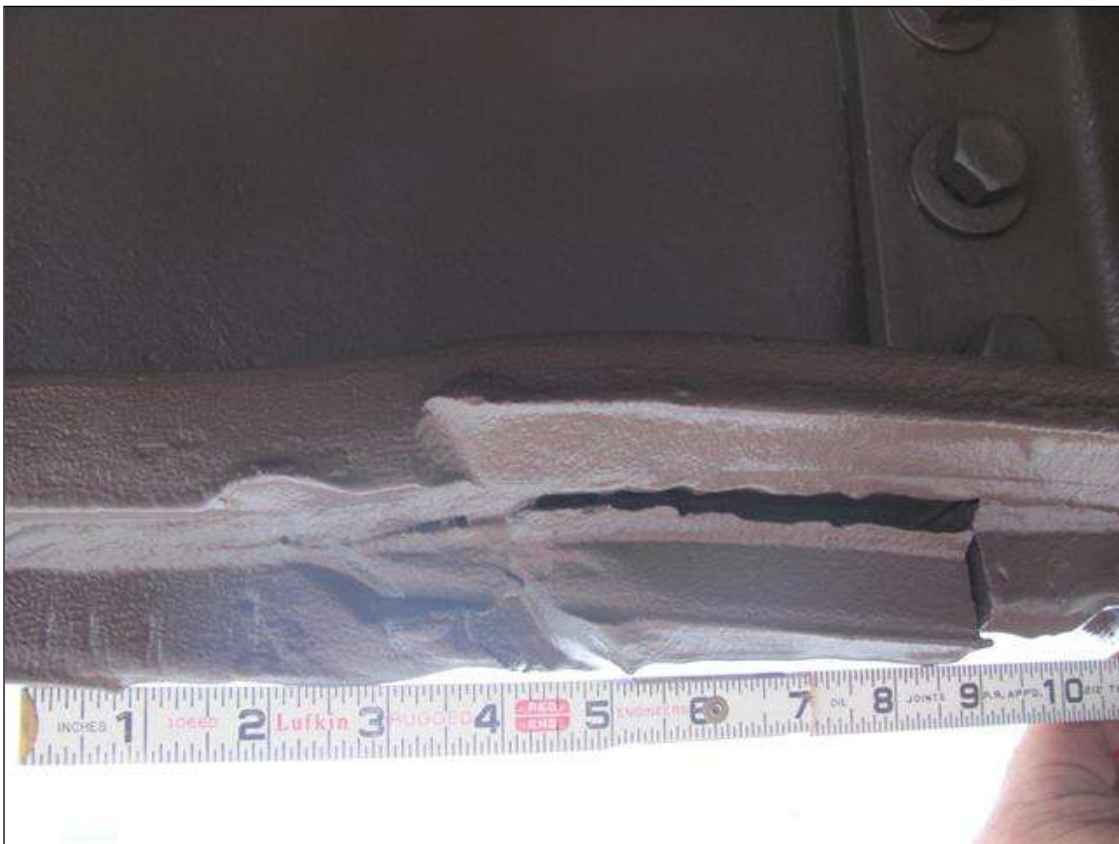
IMPACT ON GIRDER 10 WAS 19'-11" FROM THE FACE OF BENT 1.

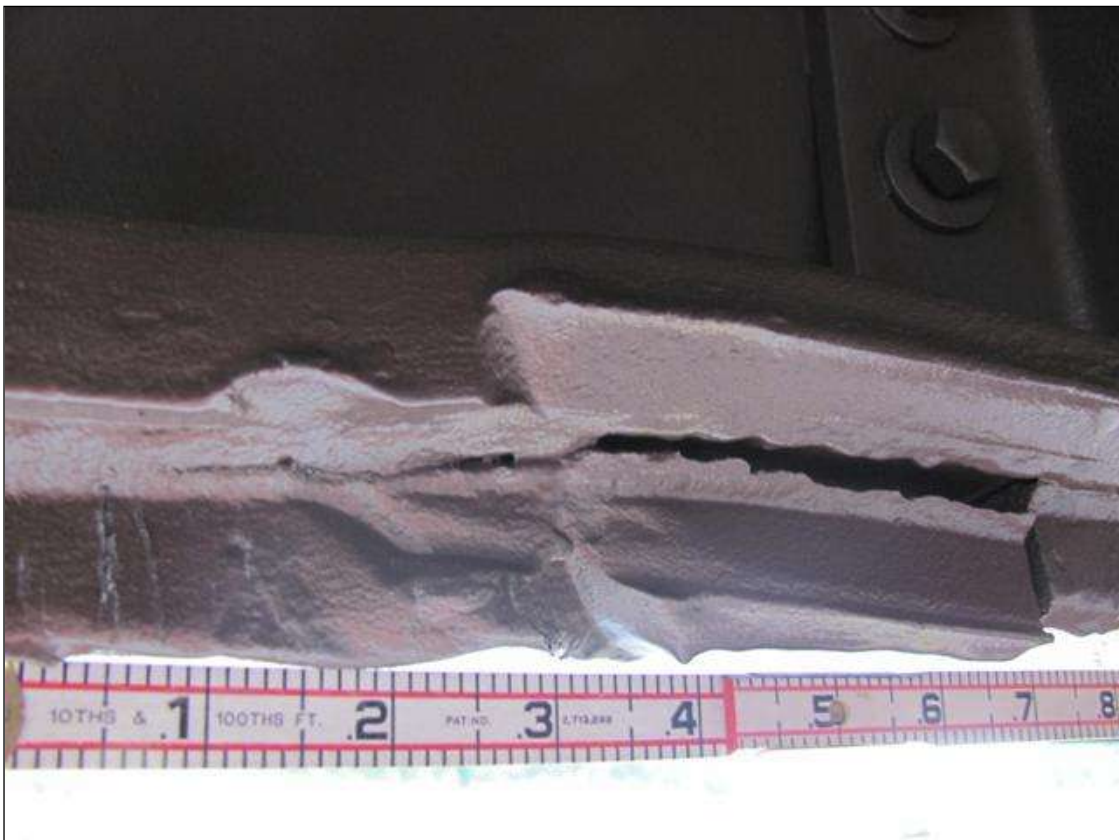
CRACK IN WELD IN COVER PLATE TO FLANGE IS 1 FOOT LONG @ 19'-11" FROM THE FACE OF BENT 1  
GIRDER 10

MMS Code	Description of Function	Unit	Quantity	Remarks	Est. Cost
3314	Maintain Steel Superstructure Components	LF	1	CRACK ( 8" LONG ) IN WELD OF COVER PLATE TO FLANGE @ 21'-2"	
3314	Maintain Steel Superstructure Components	LF	1	CRACK IN BOTTOM OF COVER PLATE IS 7" LONG. 3 3/4" REMAINS NOT CRACKED.	
3314	Maintain Steel Superstructure Components	LF	1	CRACK IN WELD IN COVER PLATE TO FLANGE IS 1 FOOT LONG @ 19'-11" FROM THE FACE OF BENT 3. GIRDER # 1, SPAN 3

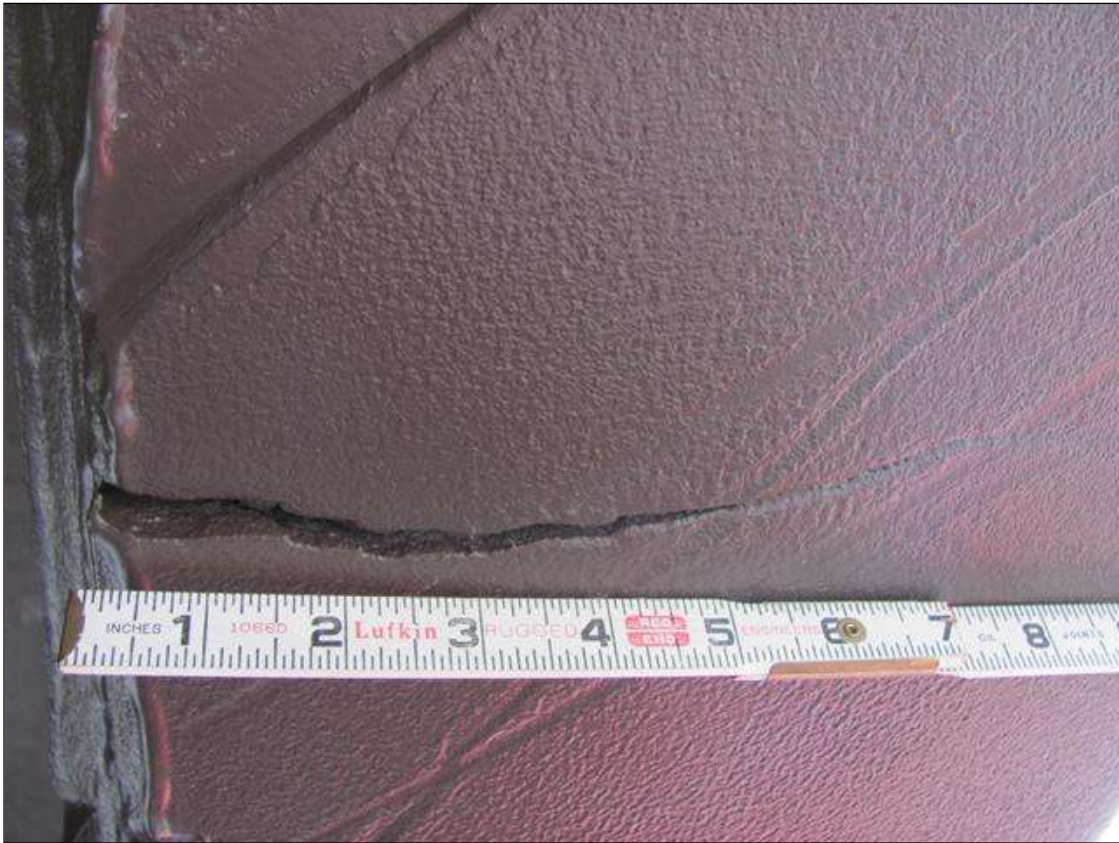
CRACK IN BOTTOM OF COVER PLATE IS 7" LONG. 3 3/4" REMAINS NOT CRACKED. GIRDER 10

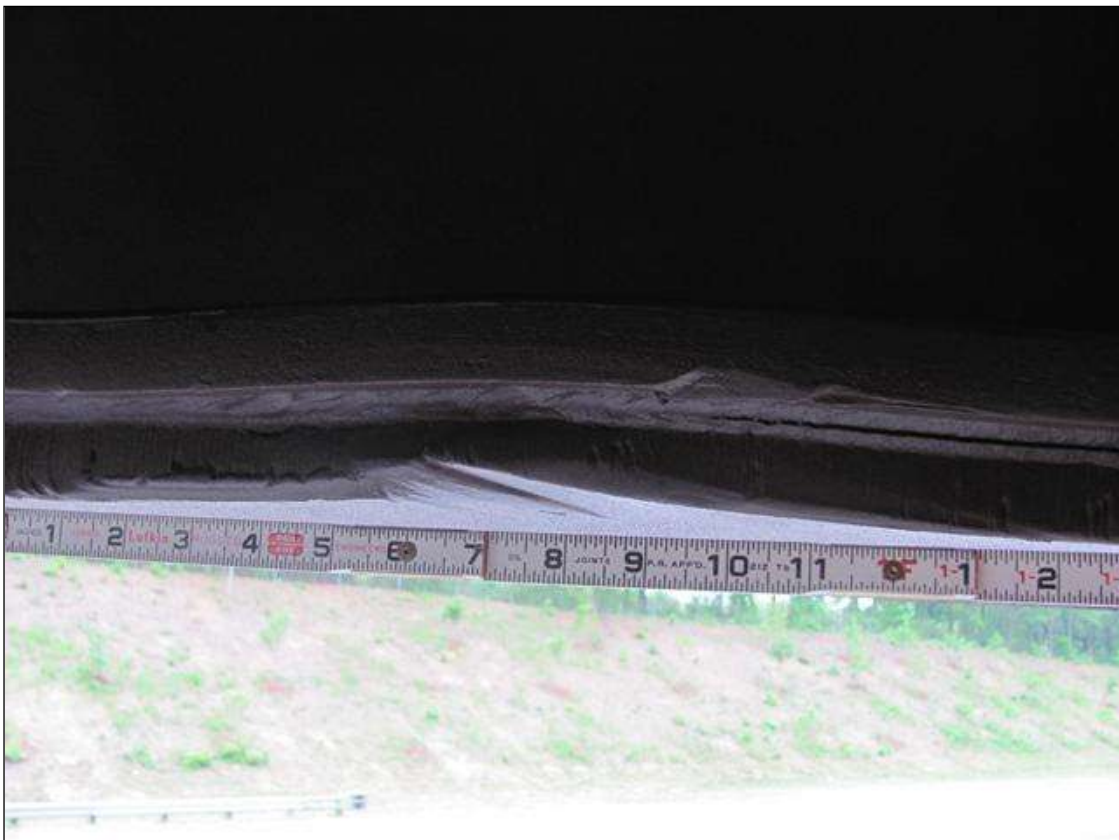
FLANGE AND COVER PLATE IS BENT UPWARD ( 1/2" +/- ) @ 21'-10" INDENTATION IS 12" LONG. GIRDER # 10

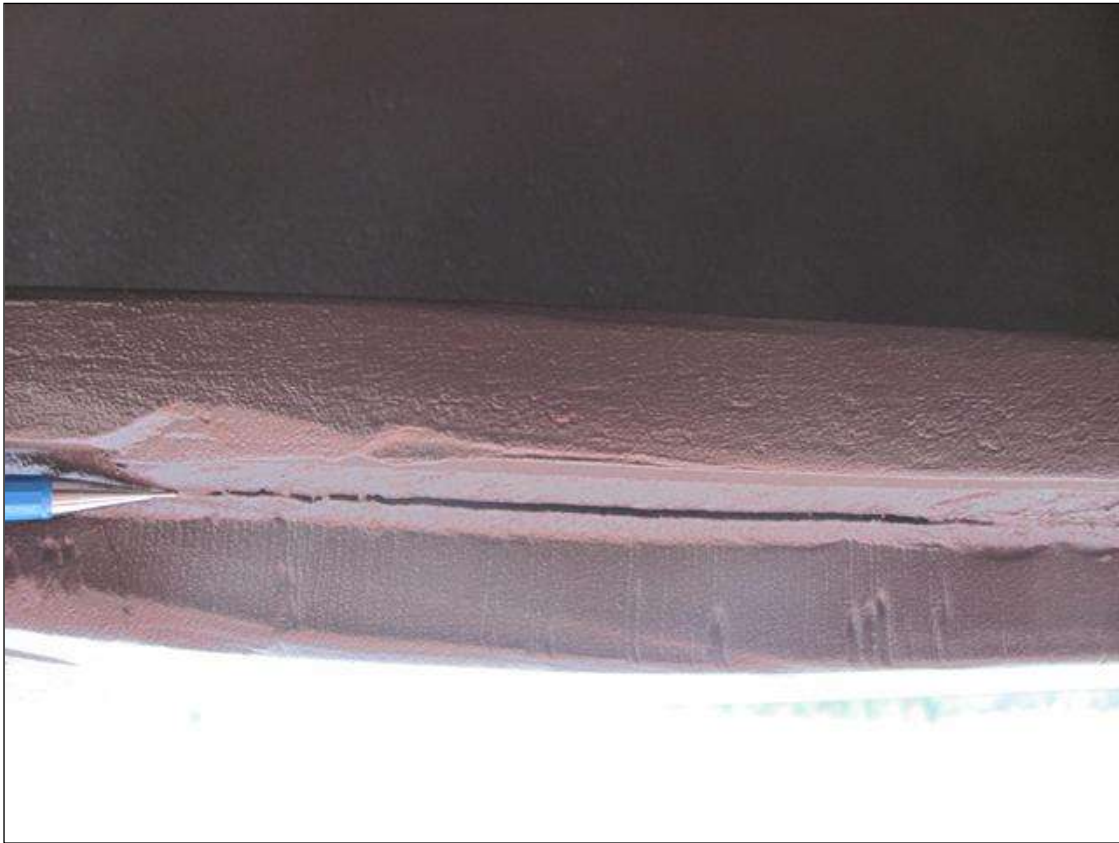
CRACK 8" LONG IN WELD OF COVER PLATE TO FLANGE @ 21'-2" IN GIRDER 10

3314	Maintain Steel Superstructure Components	LF	3	CRACK IN GIRDER #1 COVER PLATE POINT OF IMPACT ON GIRDER # 1 WAS 19'-11" FROM THE FACE OF BENT 3. FLANGE AND COVER PLATE IS OUT OF PLACE. GIRDER # 1, SPAN 3 CRACK IN WELD IN COVER PLATE TO FLANGE IS 1 FOOT LONG @ 19'-11" FROM THE FACE OF BENT 3. GIRDER # 1, SPAN 3 CRACK IN BOTTOM OF COVER PLATE IS 7" LONG. 3 3/4" REMAINS NOT CRACKED. CRACK ( 8" LONG ) IN WELD OF COVER PLATE TO FLANGE @ 21'-2"

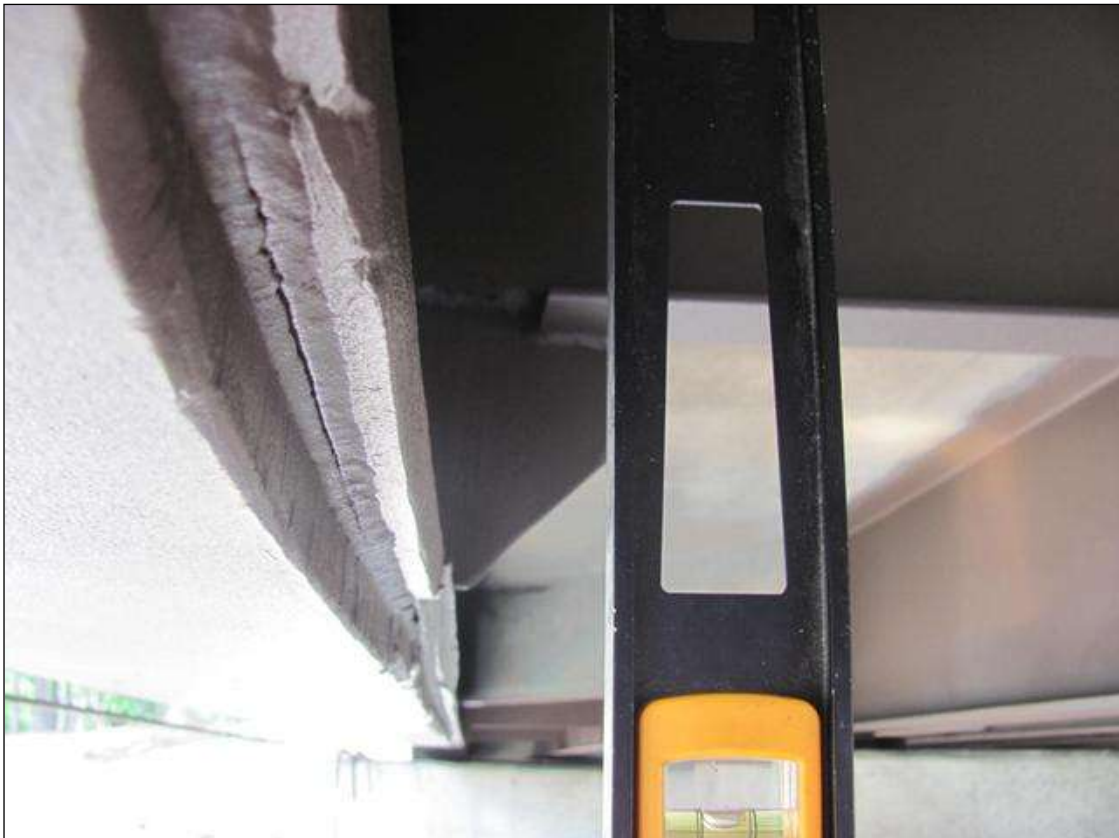
GIRDER 10 IS OUT OF PLUMB  $1\frac{7}{8}$ " IN THE DIRECTION OF TRAFFIC @ 20'-2" FROM THE FACE OF BENT 1.

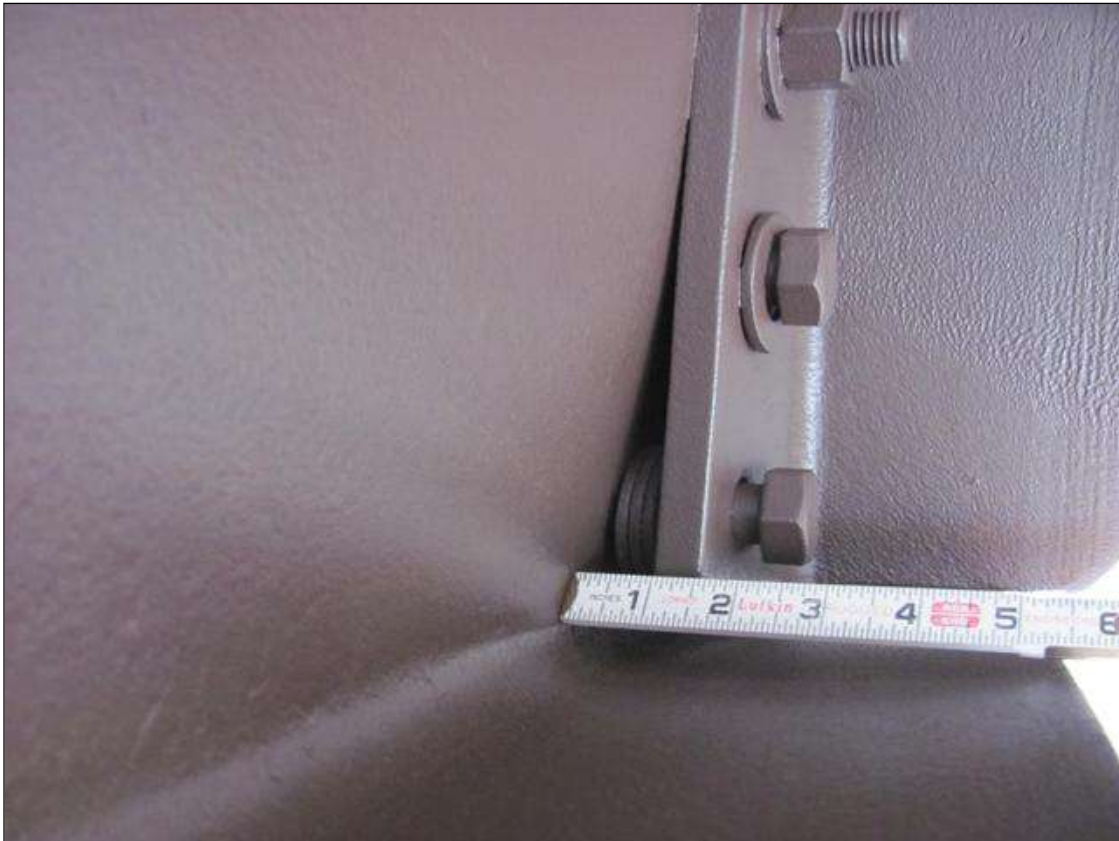
BOTTOM OF WEB IS BENT TO THE SOUTH 7/8" AT DIAPHRAGM @ 19'-4" FROM THE FACE OF BENT 1.  
GIRDER 10

3314	Maintain Steel Superstructure Components	LF	4	DIAPHRAGM BOLTS ON GIRDER #1 ARE LOOSE BOTTOM OF WEB IS BENT TO THE SOUTH ( 7/8" ) AT DIAPHRAGM @ 19'-4" FROM THE FACE OF BENT 3. GIRDER # 1, SPAN 3 FOUR DIAPHRAGM BOLTS ARE NOT TIGHT @ 19'-4" FROM THE FACE OF BENT 3. DIAPHRAGM BOLTS ARE LOOSE. FOUR HAVE NO WASHERS. GIRDER # 1, SPAN 3	
3314	Maintain Steel Superstructure Components	LF	4	FOUR DIAPHRAGM BOLTS ARE NOT TIGHT @ 19'-4" FROM THE FACE OF BENT 3.

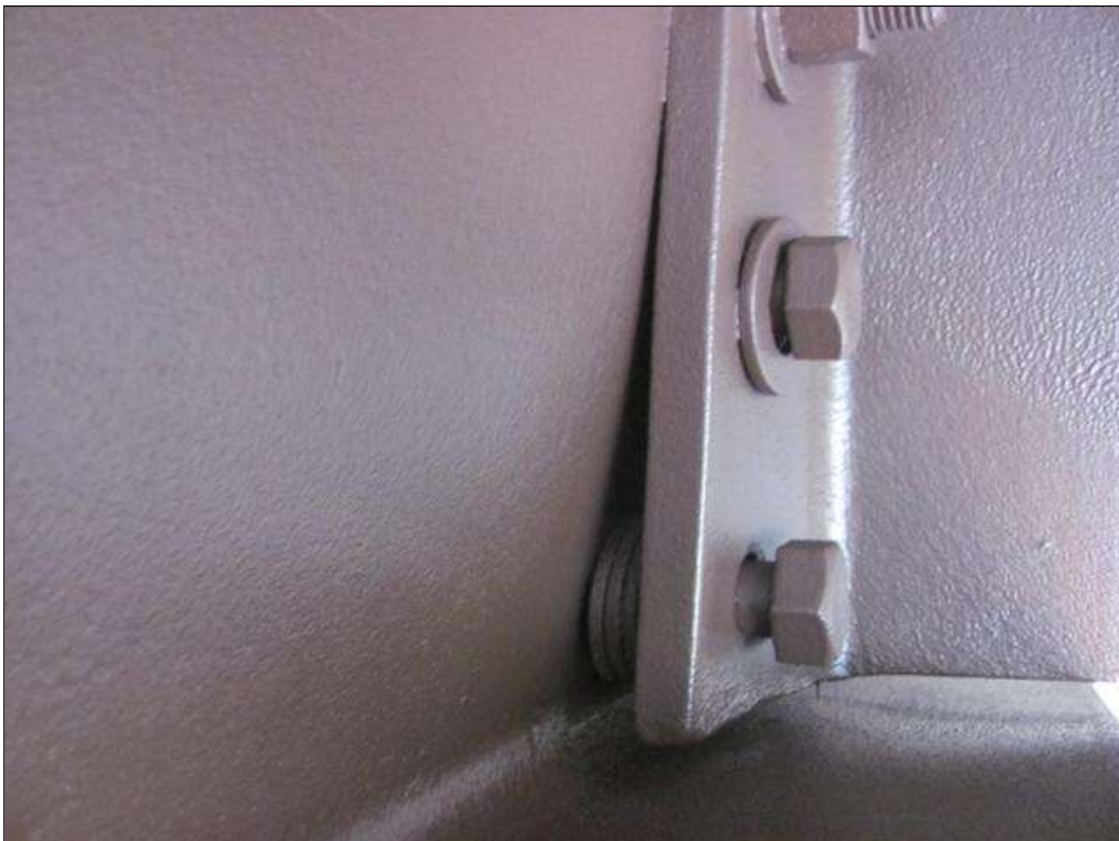
FOUR DIAPHRAGM BOLTS ARE NOT TIGHT @ 19'-4" FROM THE FACE OF BENT 1. GIRDER 10

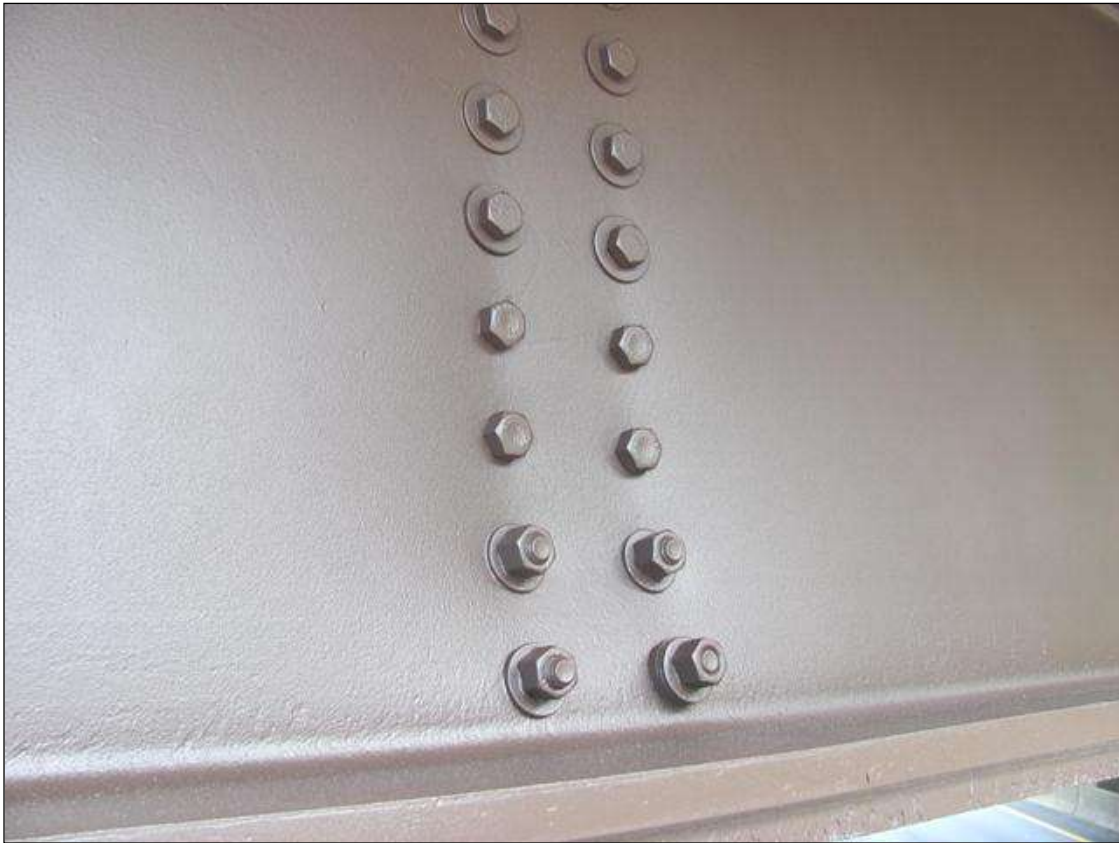
DIAPHRAGM BOLTS ARE LOOSE. FOUR HAVE NO WASHERS. GIRDER 10

MMS Code	MMS Description	Quantity
3314	Maintain Steel Superstructure Components	4 LF
Location:		
Beams and Girders	Bent/Span No. 3	DIAPHRAGM
Priority Level	Status	
Priority Maintenance	Division Bridge Maintenance Notification	
Submitted Date:	Submitted By:	Assisted By:
05/08/2012	MD OSBORNE	A KING
Details		
<p>DIAPHRAGM BOLTS ON GIRDER #1 ARE LOOSE BOTTOM OF WEB IS BENT TO THE SOUTH ( 7/8" ) AT DIAPHRAGM @ 19'-4" FROM THE FACE OF BENT 3. GIRDER # 1, SPAN 3 FOUR DIAPHRAGM BOLTS ARE NOT TIGHT @ 19'-4" FROM THE FACE OF BENT 3. DIAPHRAGM BOLTS ARE LOOSE. FOUR HAVE NO WASHERS. GIRDER # 1, SPAN 3</p>

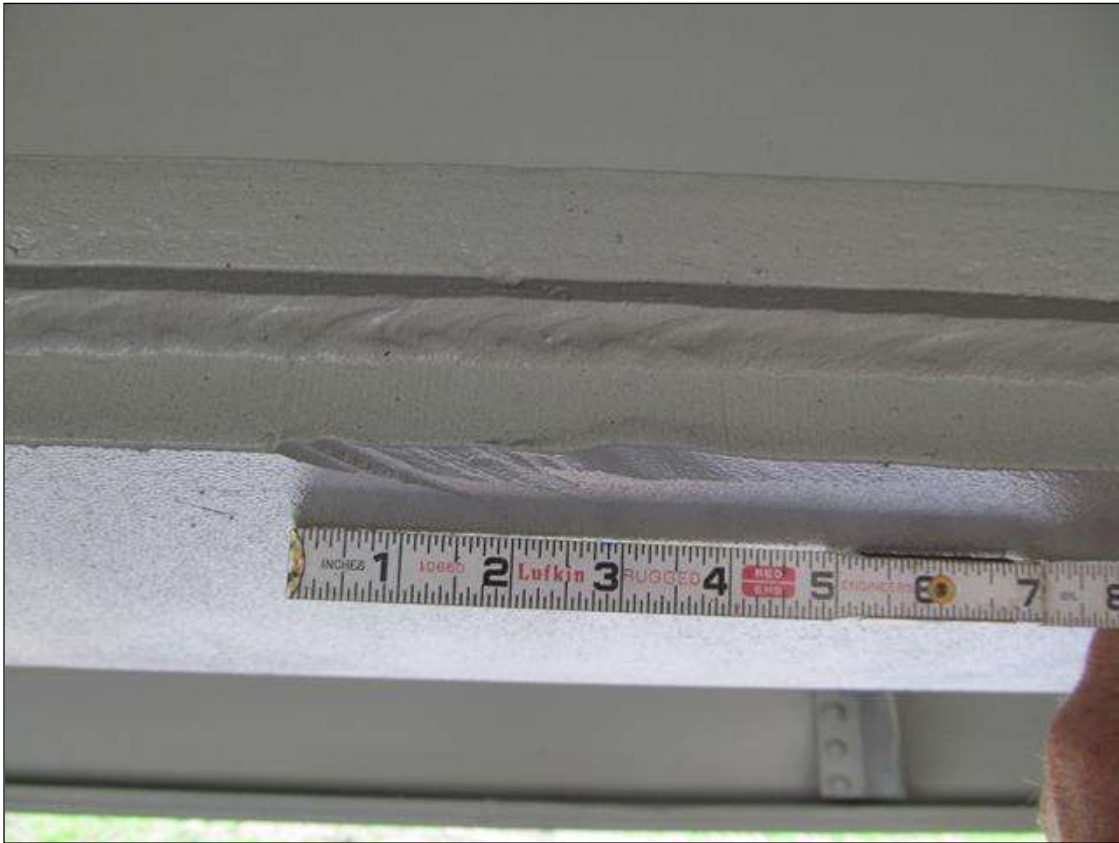
POINT OF IMPACT, IN MIDDLE LANE, ON GIRDER 9 IS 36'-6" FROM THE FACE OF BENT 1. INDENTATION IN COVER PLATE IS 5" X 1/16".

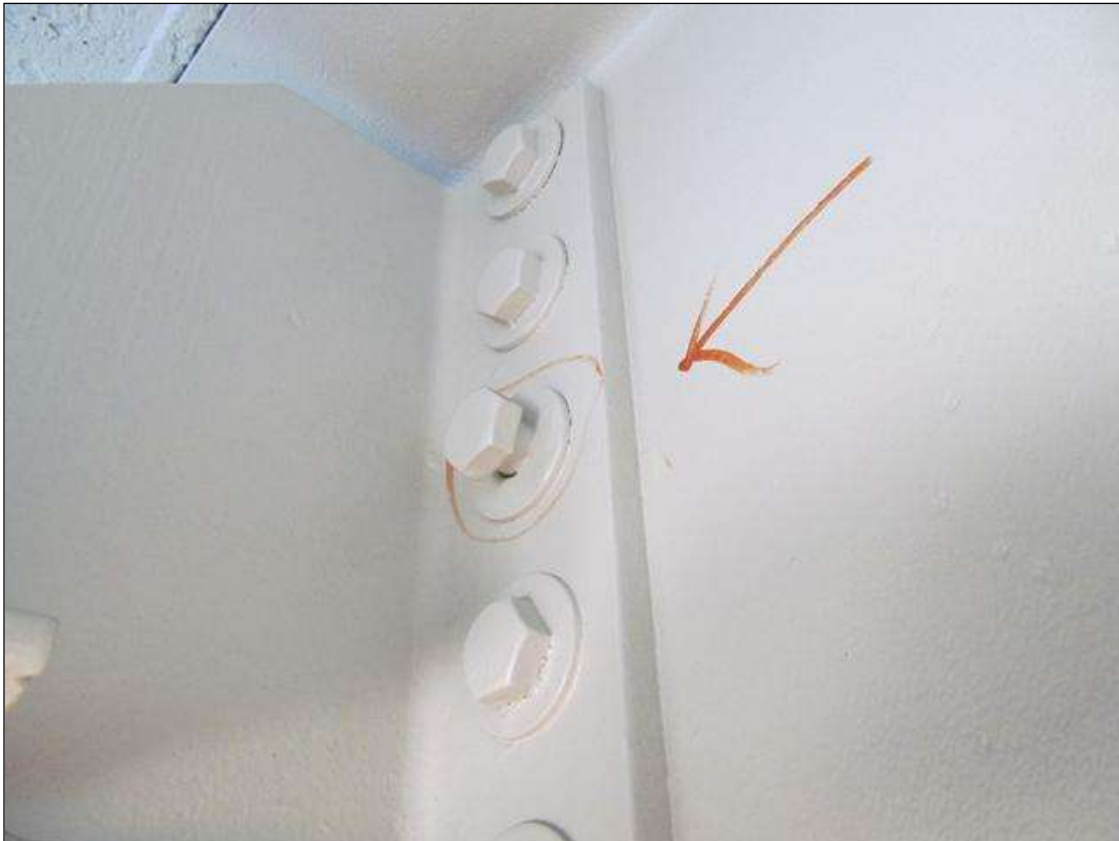
DIAPHRAGM BOLT ON RIGHT SIDE OF GIRDER 9 IS NOT PULLED UP TIGHT @ 34'-7" FROM THE FACE OF BENT 1

MMS Code	MMS Description	Quantity
3314	Maintain Steel Superstructure Components	1 LF
Location:		
Beams and Girders	Bent/Span No. 2	DIAPHRAGM
Priority Level	Status	
Priority Maintenance	Division Bridge Maintenance Notification	
Submitted Date:	Submitted By:	Assisted By:
05/21/2012	MD OSBORNE	A KING
Details		
DIAPHRAGM BOLT OD GIRDER 9 DIAPHRAGM BOLT ON RIGHT SIDE OF GIRDER 9 IS NOT PULLED UP TIGHT @ 34'-7" FROM THE FACE OF BENT 1
