NC DEPARTMENT OF TRANSPORTATION  
DIVISION OF HIGHWAYS  
BRIDGE MANAGEMENT UNIT

# BRIDGE INSPECTION REPORT

INSPECTION TYPE: Damage Inspection Report

COUNTY CATAWBA BRIDGE NUMBER 170142 INSPECTION CYCLE 0 YRS  
ROUTE SR1692 ACROSS US321 M.P. 0

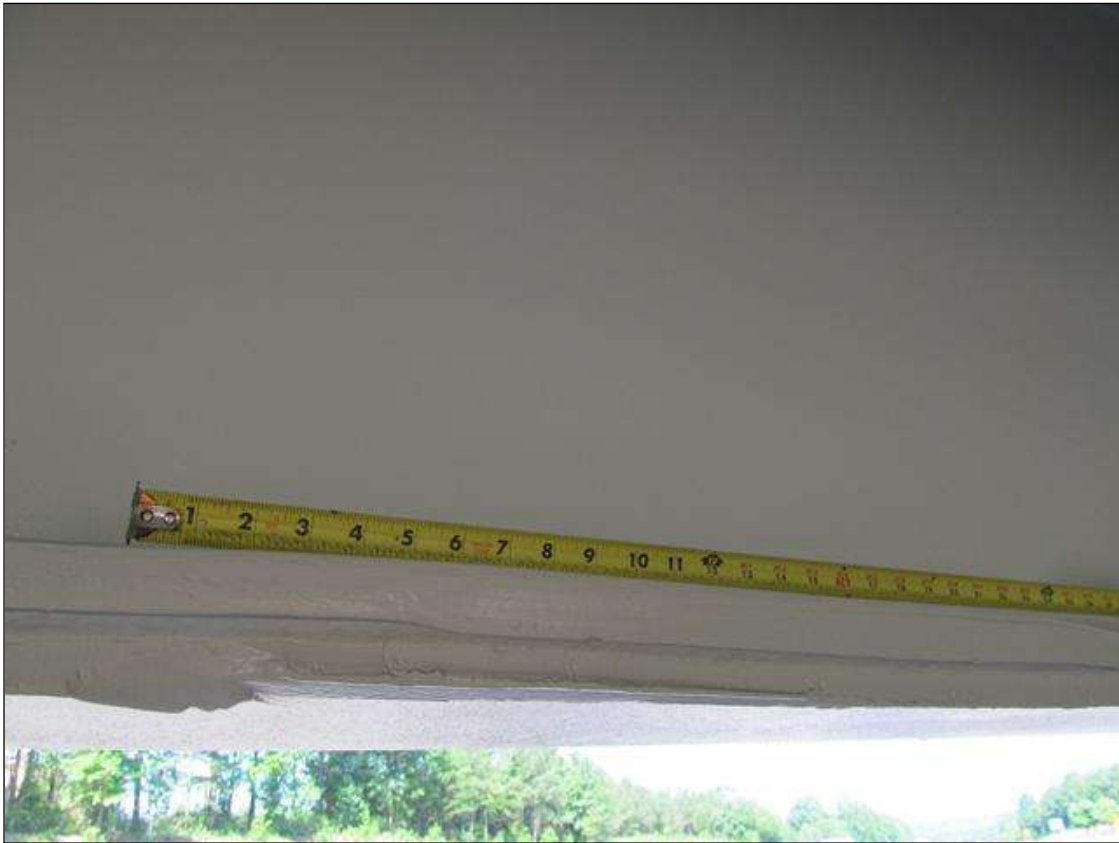
POINT OF IMPACT ON GIRDER 10 IS 38'-2" FROM THE FACE OF BENT 1. INDENTIONS IN COVER PLATE ( 17" X 1/2" ) & FLANGE ( 24" X 5/8" )

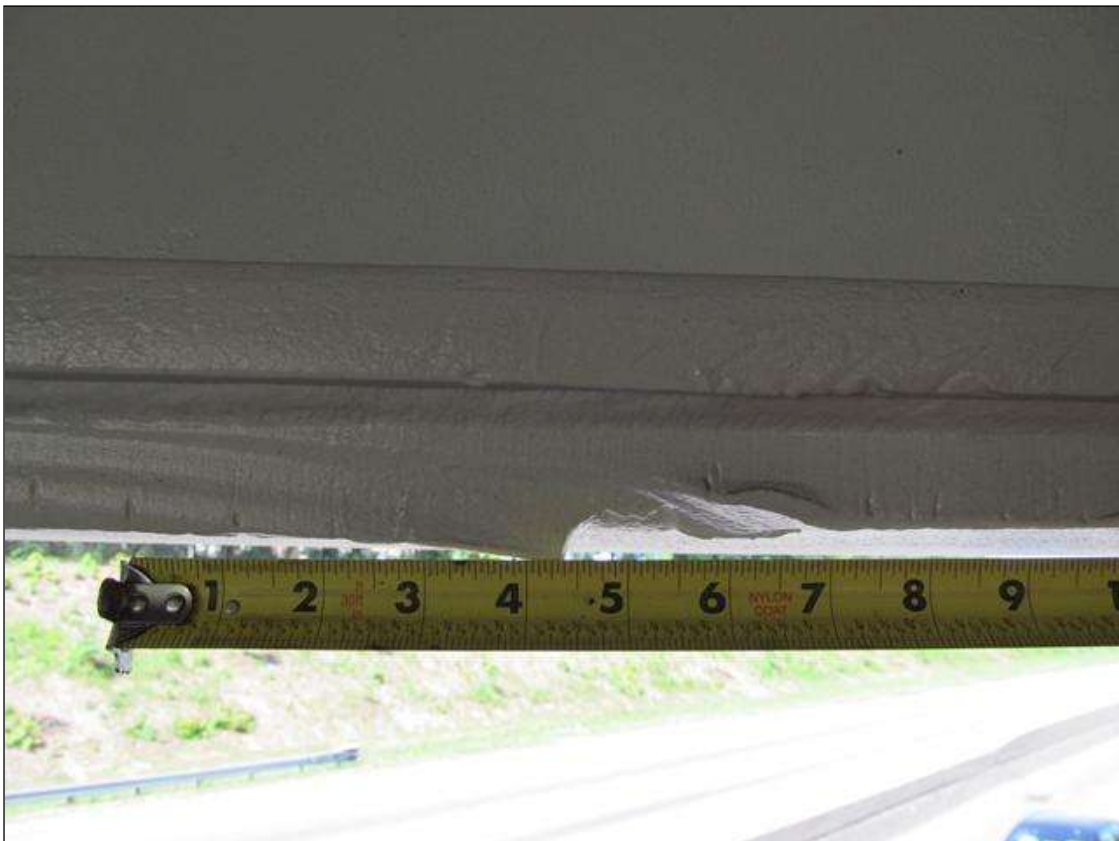
INDENTION ( 7" X 5/8" ) IN COVER PLATE @ 35'-7" FROM THE FACE OF BENT 1. GIRDER 10

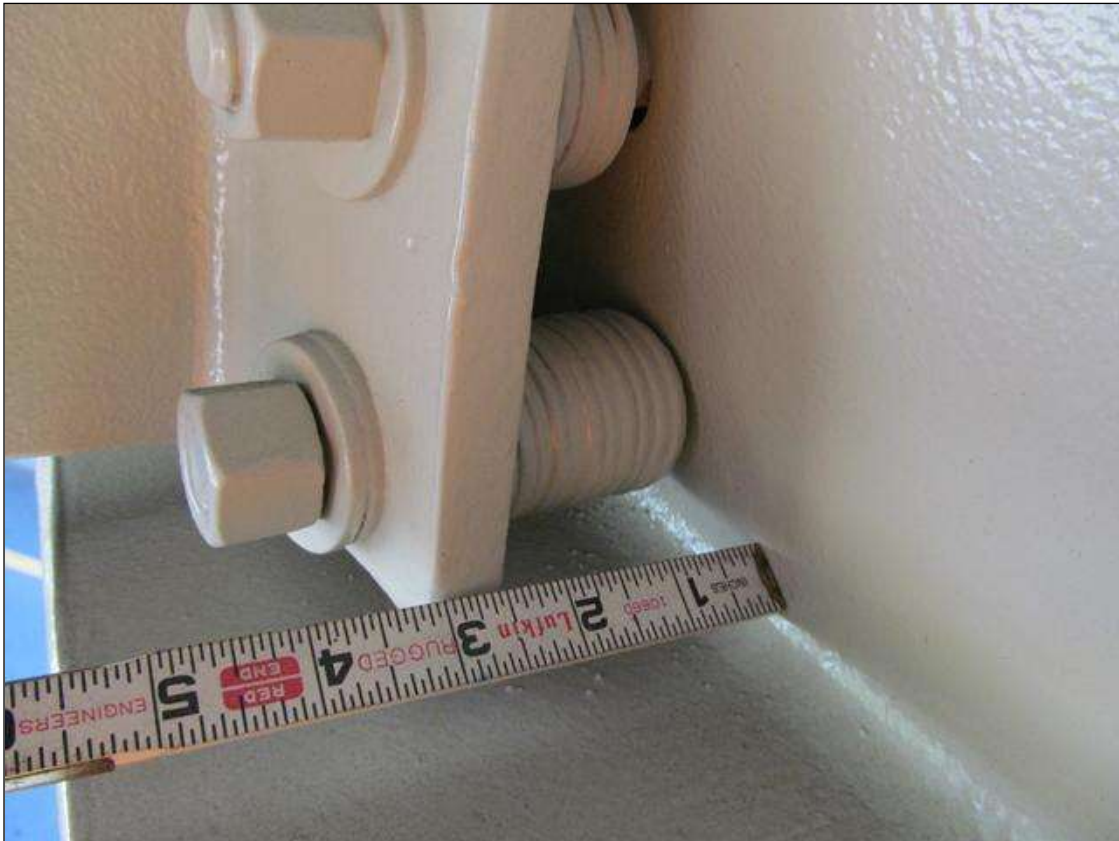
BOTTOM OF DIAPHRAGM ON GIRDER 10 IS 2 1/2" AWAY FROM THE WEB @ 39'-11" FROM THE FACE OF BENT  
1

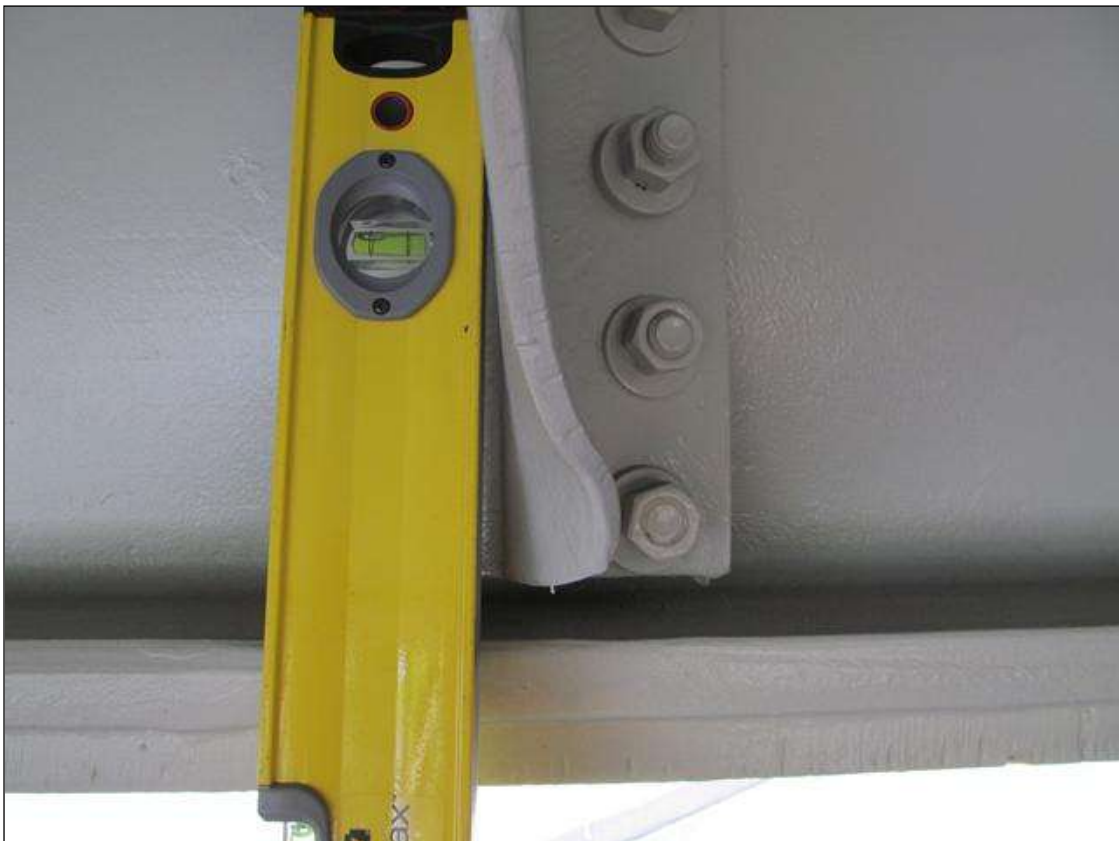
DIAPHRAGM BRACE IS BENT ( 1 1/4" ) TO THE WEST @ 39'-11" FROM THE FACE OF BENT 1. GIRDER 10

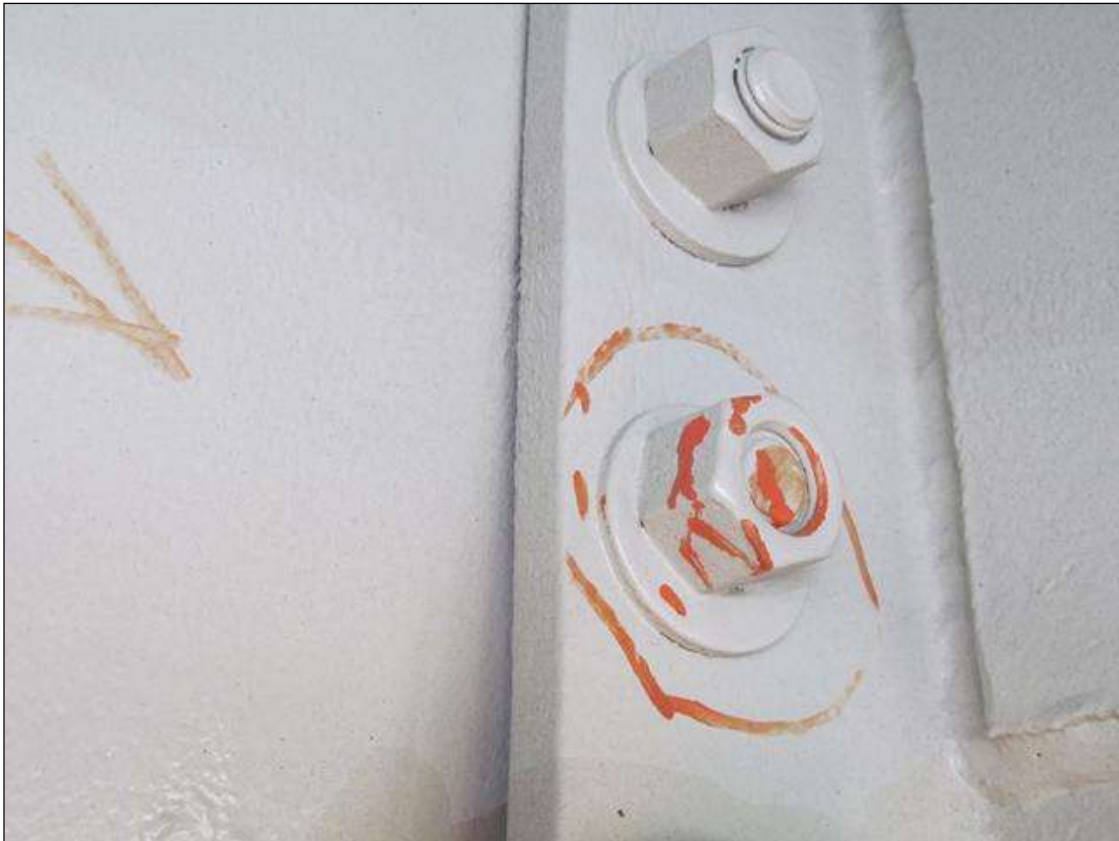
DIAPHRAGM BOLT DOES NOT HAVE A FULL THREAD @ 39'-11" FROM THE FACE OF BENT 1. GIRDER 10

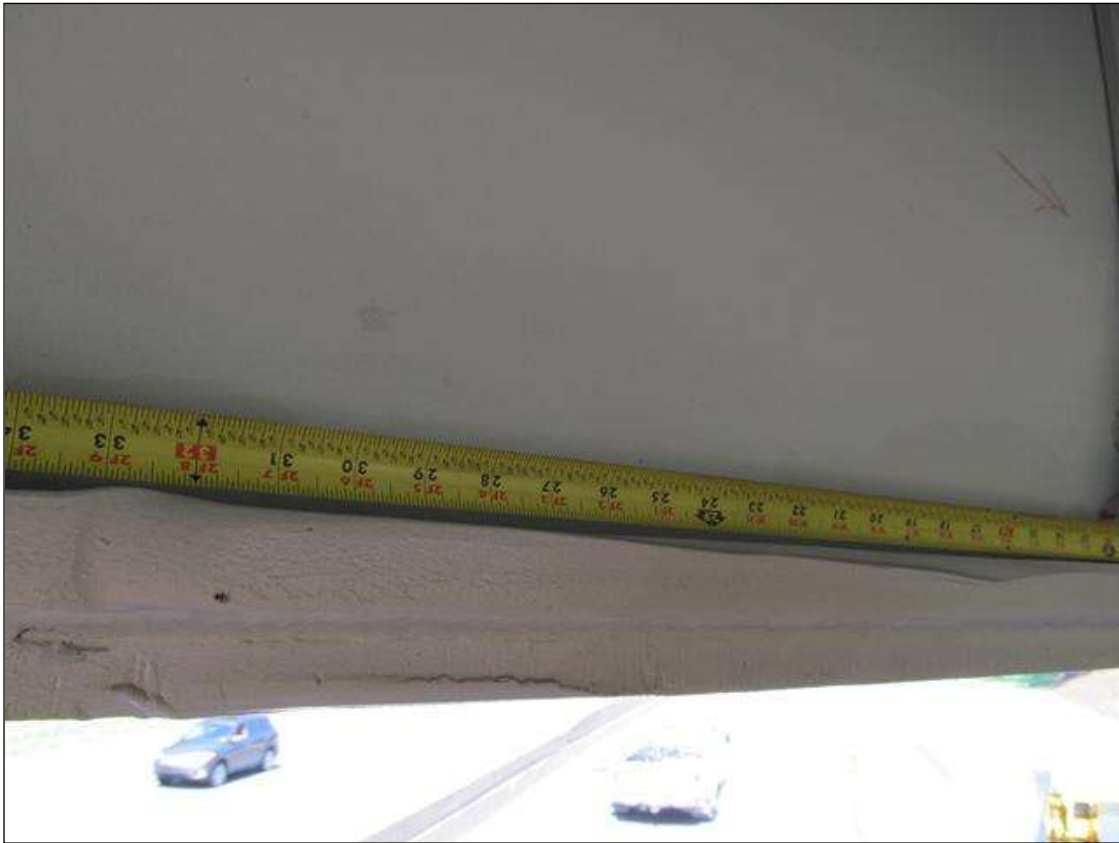
INDENTION ( 2'-10" X 1/4" ) IN FLANGE OF GIRDER 10 @ 43'-1" FROM THE FACE OF BENT 1 AND COVER PLATE ( 7" X 1/16" )

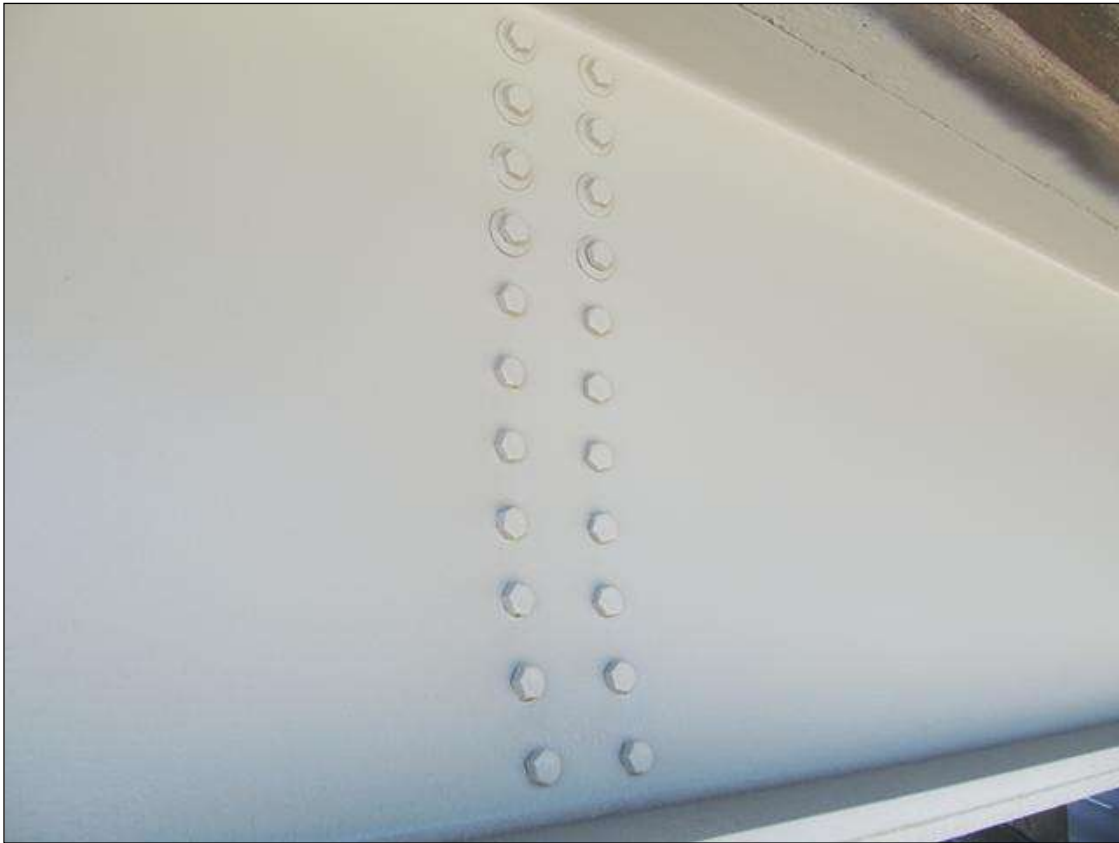
14 DIAPHRAGM BOLTS WITHOUT WASHERS AND 8 WITH WASHERS @ 39'-11" FROM THE FACE OF BENT 1.  
GIRDER 10

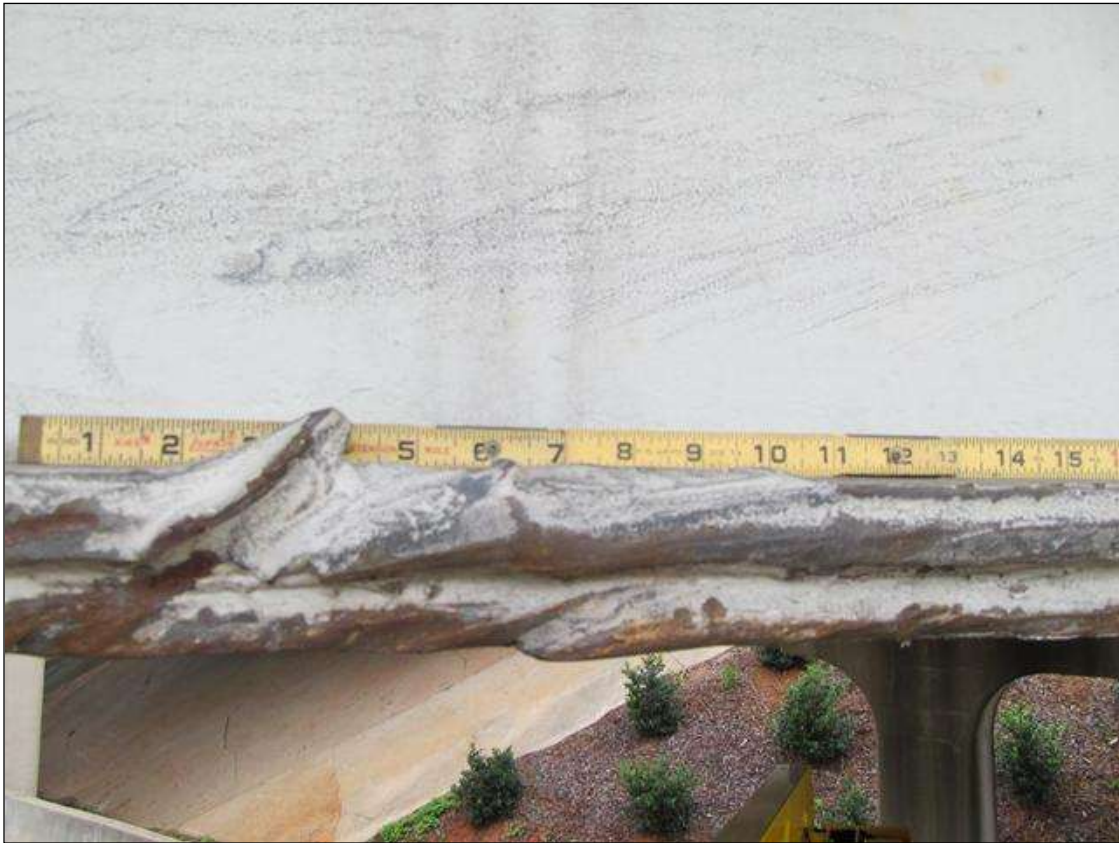
POINT OF IMPACT ON BEAM 4 IS 33'-10" FROM THE FACE OF BENT 3.

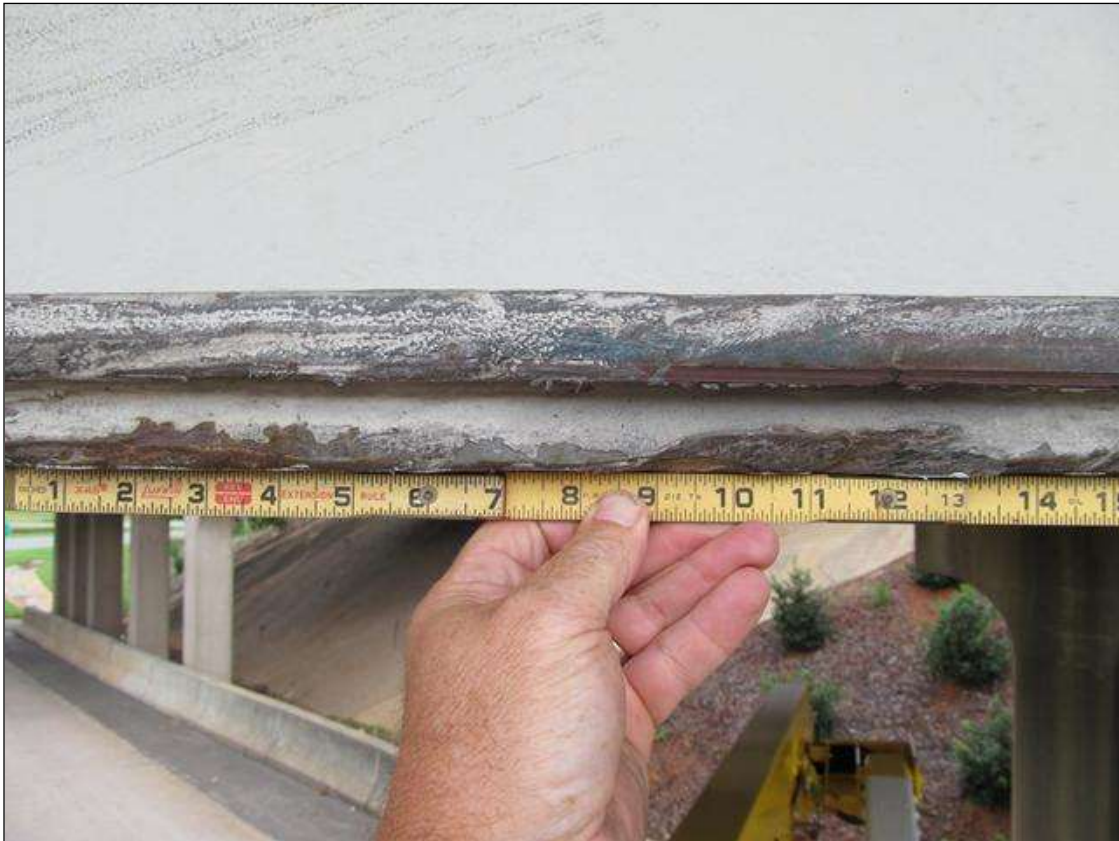
INDENTION ( 16" X 1/2" ) IN COVER PLATE @ 32'-0" FROM THE FACE OF BENT 3. BEAM 4,

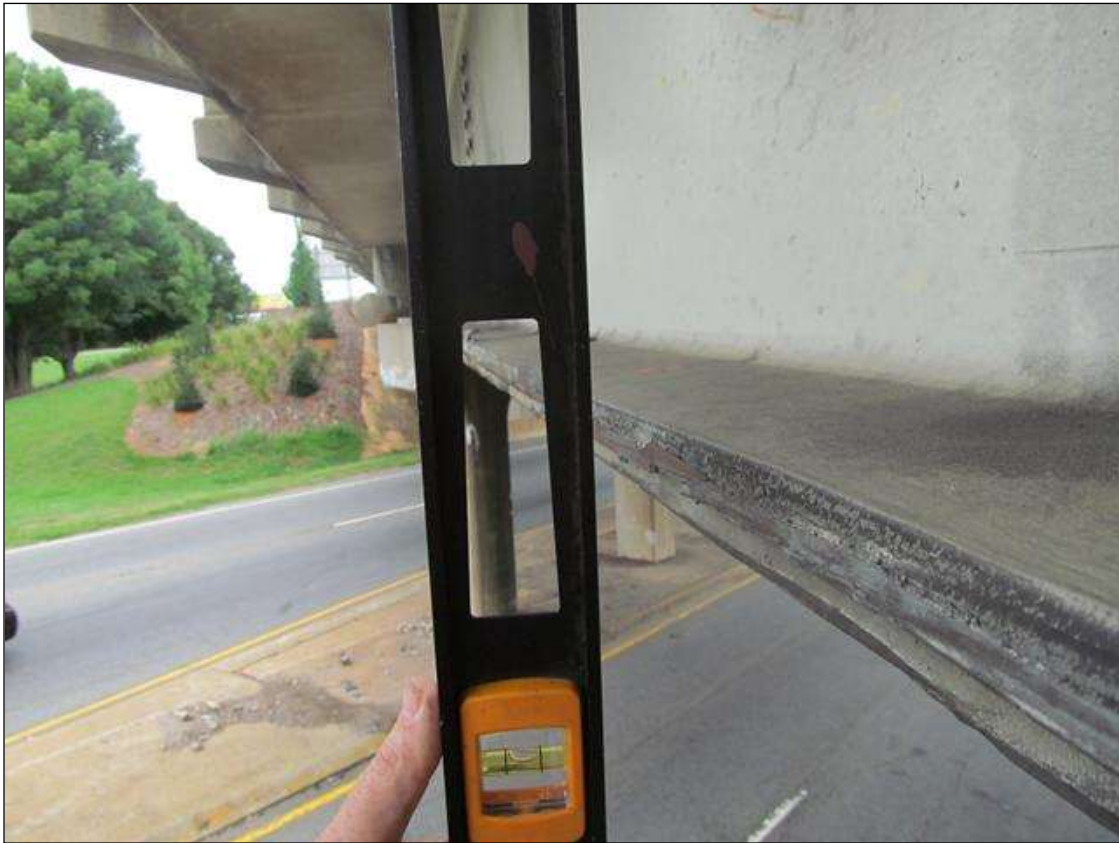
BEAM 4 IS OUT OF PLUMB (  $1 \frac{7}{8}$ " ) TO THE NORTH @ 30'-0" FROM THE FACE OF BENT 3. BEAM 4,

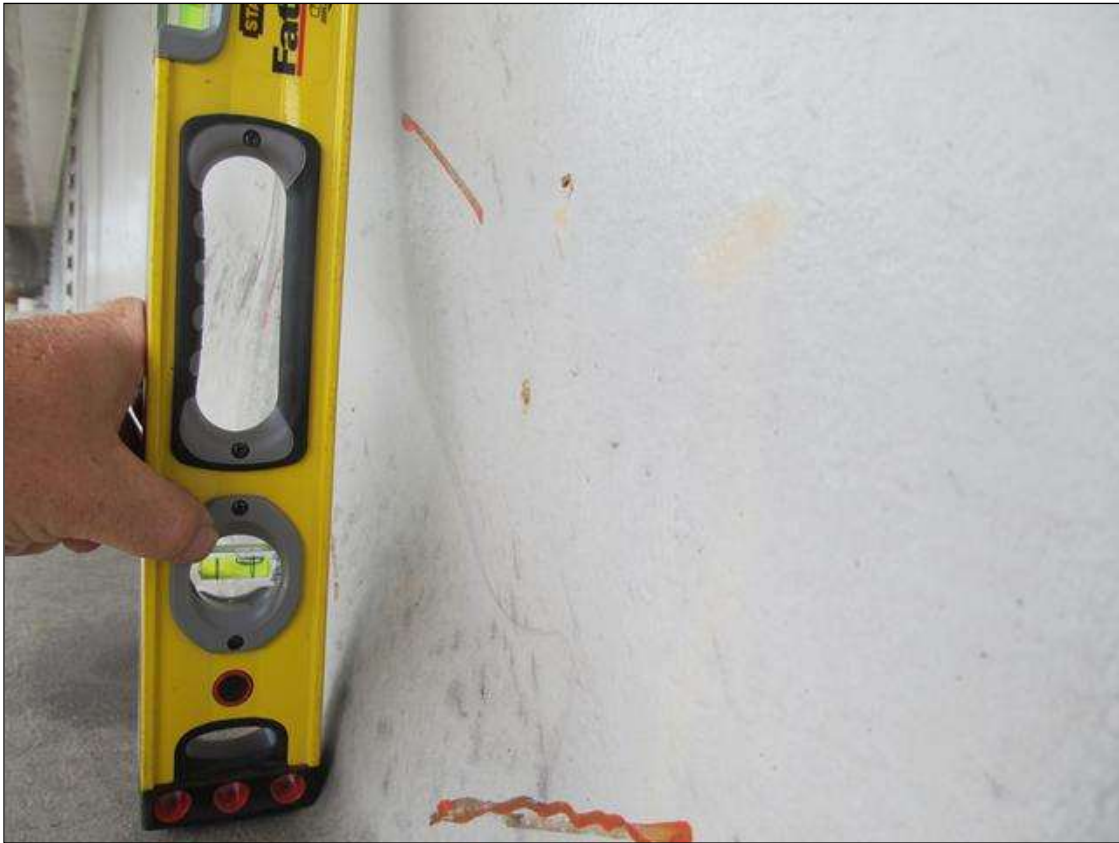
WEB OF BEAM 4 IS BENT ( 1 1/4" ) INWARD @ 28'-6" FROM THE FACE OF BENT 3. BEAM 4, SPAN 3

MMS Code	MMS Description	Quantity
3314	Maintain Steel Superstructure Components	63 LF
Location:		
Beams and Girders	Bent/Span No. 3	BEAM
Priority Level	Status	
Priority Maintenance	Division Bridge Maintenance Notification Received	
Submitted Date:	Submitted By:	Assisted By:
07/25/2012	MD OSBORNE	A KING
Details		
DAMAGE TO BEAM 4 BEAM 4 IS OUT OF PLUMB ( 1 7/8" ) TO THE NORTH @ 30'-0" FROM THE FACE OF BENT 3. BEAM 4, WEB OF BEAM 4 IS BENT ( 1 1/2" ) INWARD @ 30'-4" FROM THE FACE OF BENT 3. BEAM 4, SPAN 3 WEB OF BEAM 4 IS BENT ( 1 1/4" ) INWARD @ 28'-6" FROM THE FACE OF BENT 3. BEAM 4, SPAN 3

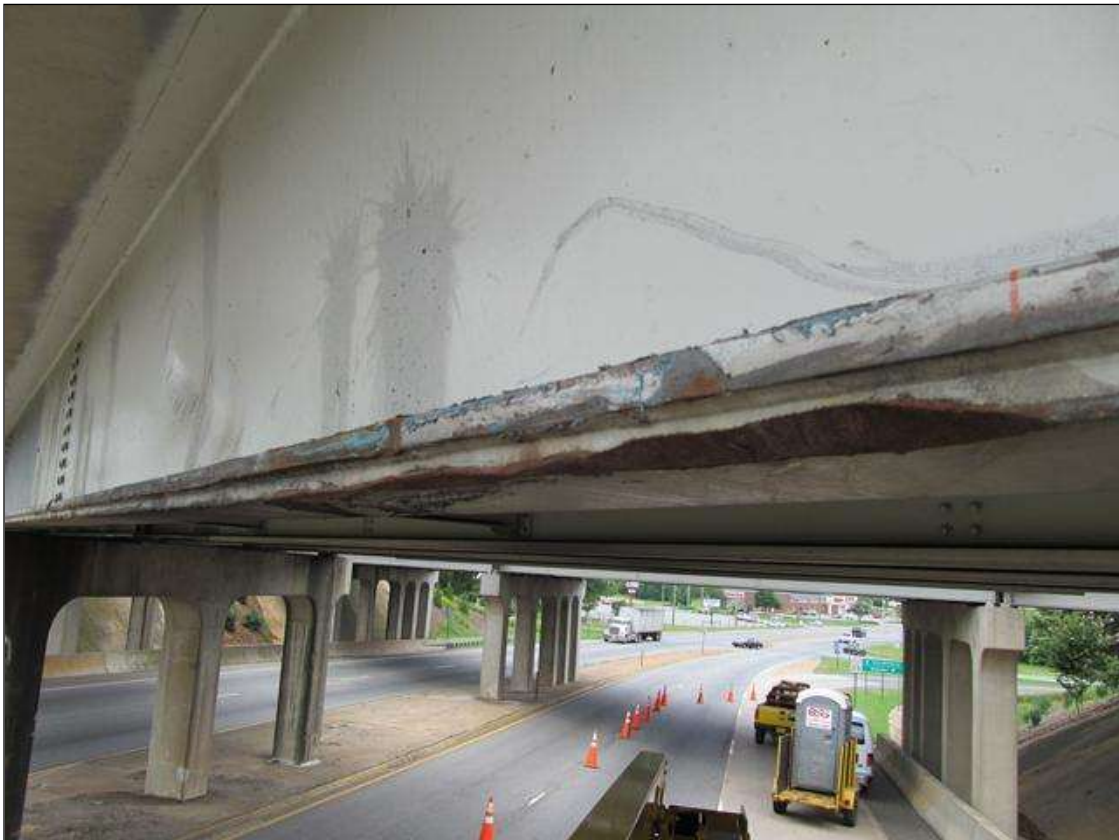
LOOKING AT BEAM 4 FROM BENT 3. BEAM 4 FLANGE AND COVER IS DAMAGED

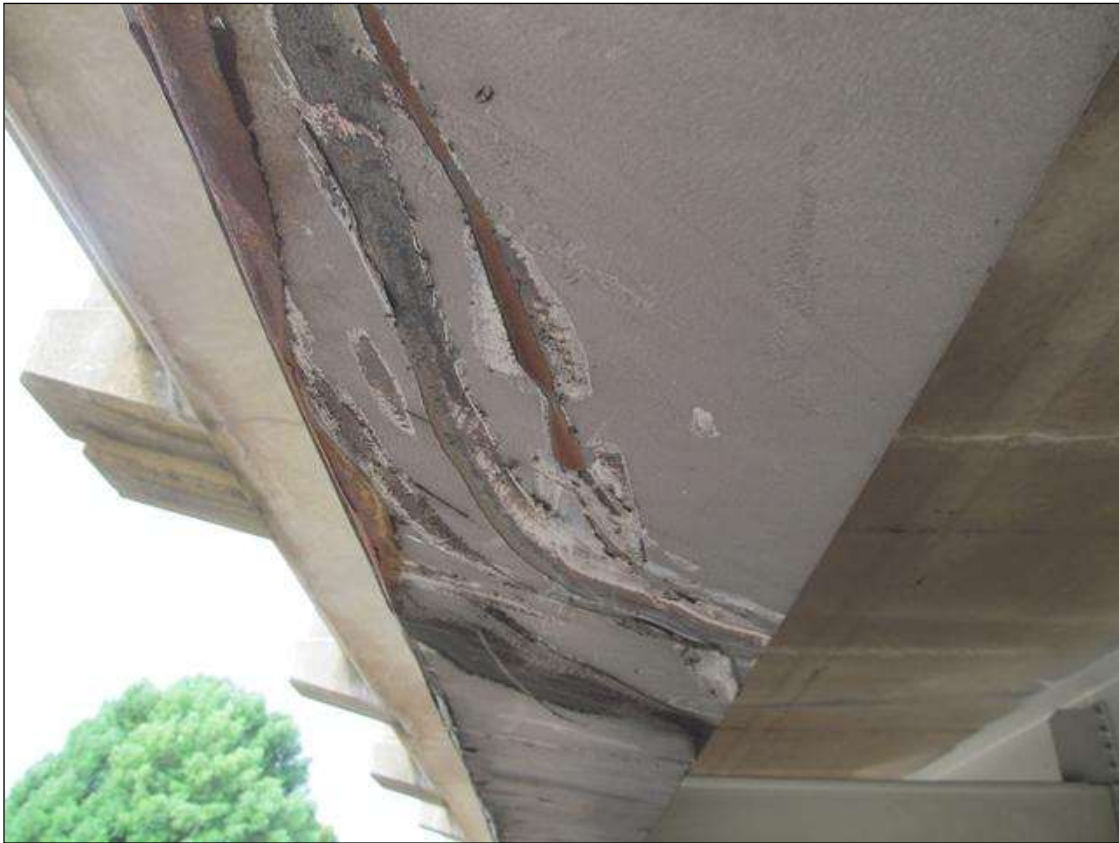
MARKS ON BOTTOM OF COVER PLATE ON BEAM 4 FROM 22'-6" TO 34'-0"

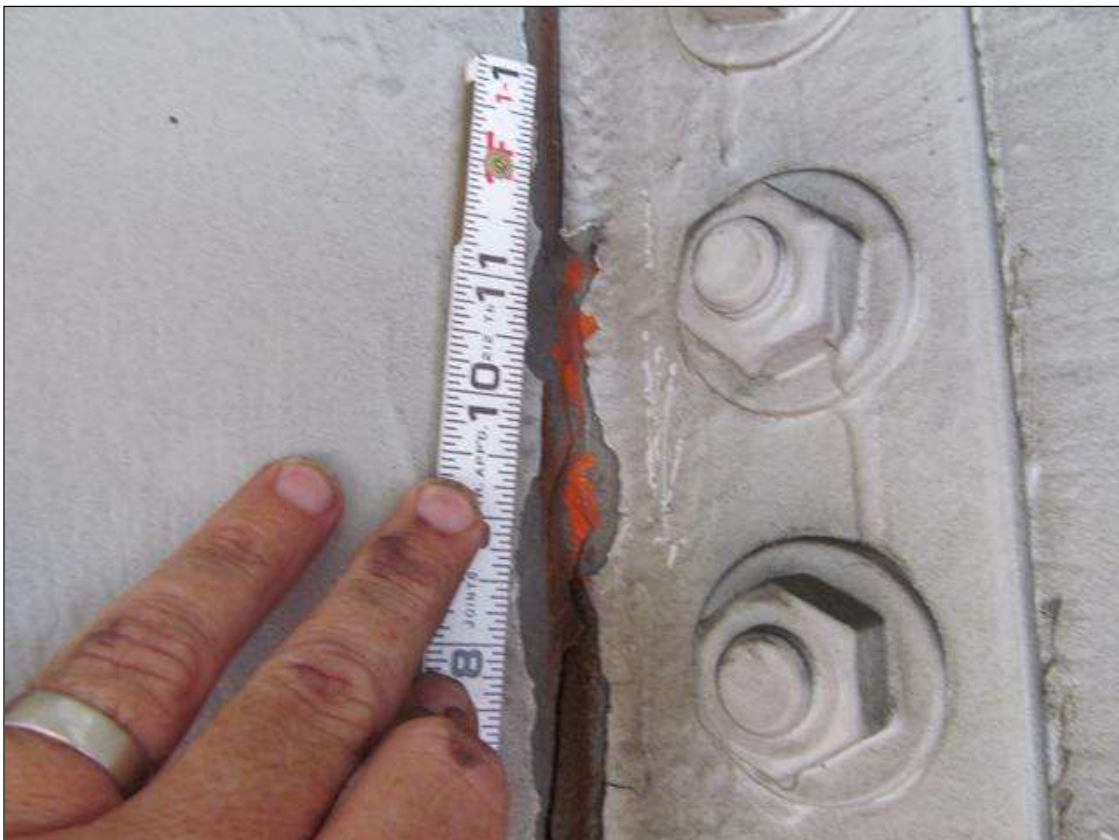
CRACK 11" LONG AT THE BOTTOM OF DIAPHRAGM BRACKET @ 20'-4" FROM THE FACE OF BENT 3. BEAM 4,

3314	Maintain Steel Superstructure Components	LF	8	CRACK IN DIAPHRAGM CRACK 11" LONG AT THE BOTTOM OF DIAPHRAGM BRACKET @ 20'-4" FROM THE FACE OF BENT 3. BEAM 4, CRACK 2 1/2" LONG IN BOTTOM WELD AT DIAPHRAGM TO BRACKET @ 20'-4" FROM THE FACE OF BENT 3. BEAM 4, DIAPHRAGM IS BENT 4 1/2" TO THE EAST @ 20'-4" FROM THE FACE OF BENT 3. BEAM 4, TOP OF DIAPHRAGM @ BEAM 4 HAS A 4" CRACK. BEAM 4, BOTTOM OF DIAPHRAGM @ BEAM 4 HAS A 3 1/2" CRACK. BEAM 4, BOTTOM WELD OF DIAPHRAGM HAS A 3" CRACK. BEAM 4, SPAN 3 CRACK ( 6" ) IN BOTTOM OF DIAPHRAGM @ 37'-4" FROM THE FACE OF BENT 3. BEAM 4, SPAN 3 CRACK ( 3" ) IN TOP OF DIAPHRAGM. BEAM 4, SPAN 3 CRACK ( 2" ) IN BOTTOM OF DIAPHRAGM. BEAM 4, SPAN 3 CRACK ( 6 1/2" ) IN BOTTOM OF DIAPHRAGM BRACKET. BEAM 4, SPAN 3 DIAPHRAGM @ 37'-4" FROM THE FACE OF BENT 3, IS OUT OF PLUMB ( 3/4" ) TO THE EAST. BEAM 4, SPAN 3 CRACK IN BOTTOM WELD OF DIAPHRAGM @ 37'-4" FROM THE FACE OF BENT 3. BEAM 4, SPAN 3 DIAPHRAGM IS BENT ( 3/4" ) UPWARD AT 4'-0" FROM BEAM 4 @ 37'-4" FROM THE FACE OF BENT 3. BEAM 4, SPAN 3 DIAPHRAGM @ 37'-4" FROM THE FACE OF BENT 3, IS OUT OF PLUMB ( 3/4" ) TO THE EAST. BEAM 4, SPAN 3

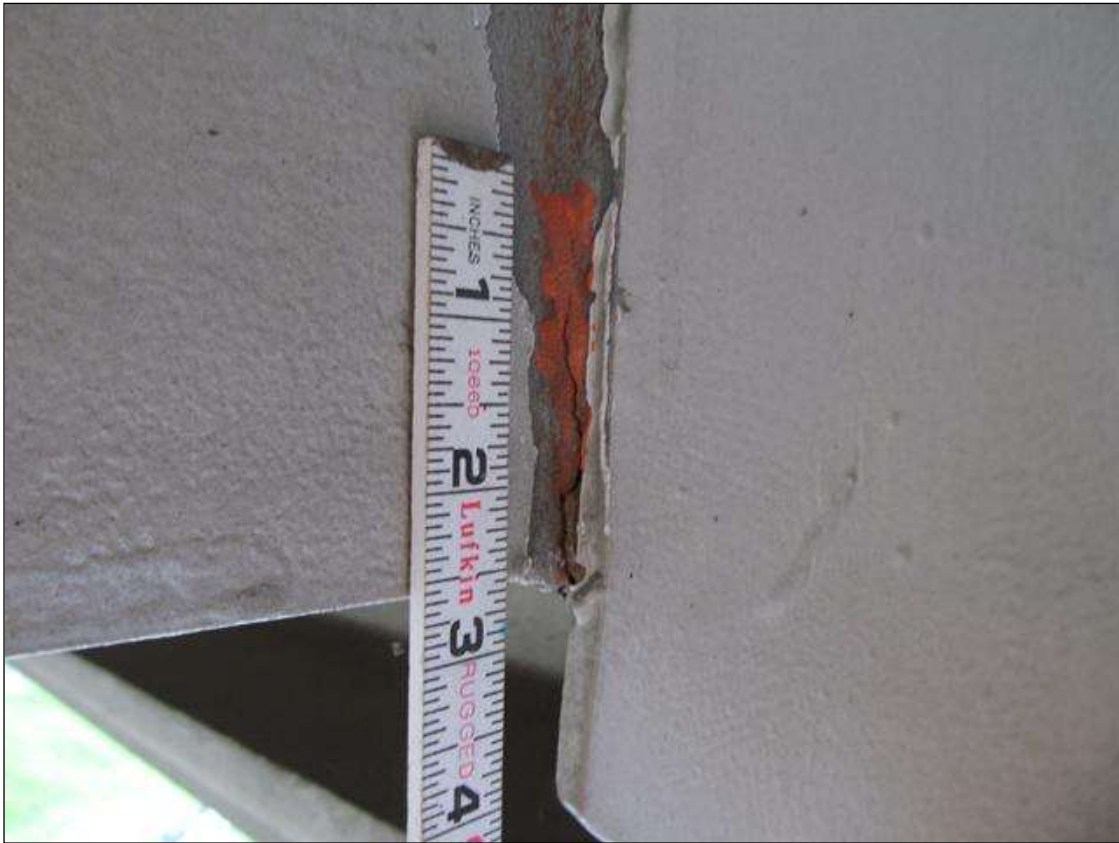
CRACK 2 1/2" LONG IN BOTTOM WELD AT DIAPHRAGM TO BRACKET @ 20'-4" FROM THE FACE OF BENT 3.  
BEAM 4,

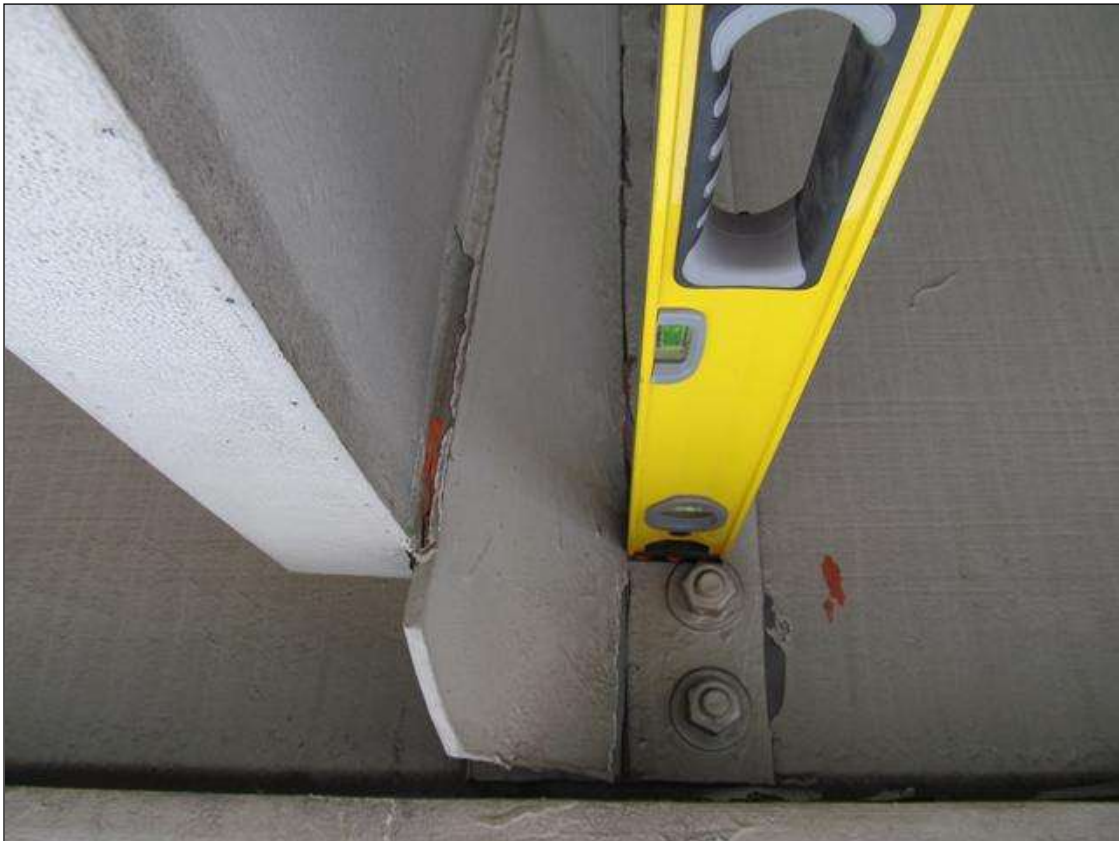
DIAPHRAGM IS BENT 4 1/2" TO THE EAST @ 20'-4" FROM THE FACE OF BENT 3. BEAM 4,

3314	Maintain Steel Superstructure Components	LF	1	CRACK IN BOTTOM WELD OF DIAPHRAGM @ 37'-4" FROM THE FACE OF BENT 3. BEAM 4, SPAN 3	
3314	Maintain Steel Superstructure Components	LF	1	DIAPHRAGM IS BENT 4 1/2" TO THE EAST @ 20'-4" FROM THE FACE OF BENT 3. BEAM 4,	
3314	Maintain Steel Superstructure Components	LF	1	TOP OF DIAPHRAGM @ BEAM 4 HAS A 4" CRACK. BEAM 4,

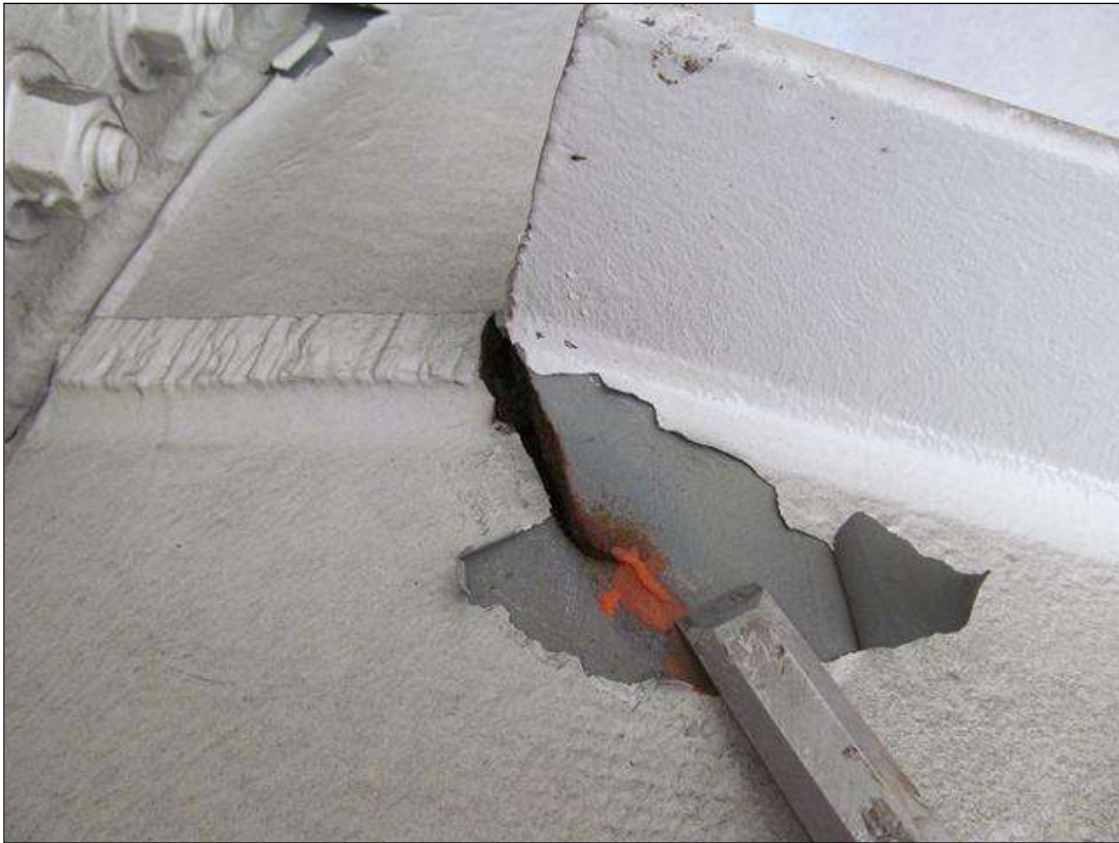
TOP OF DIAPHRAGM @ BEAM 4 HAS A 4" CRACK. BEAM 4,

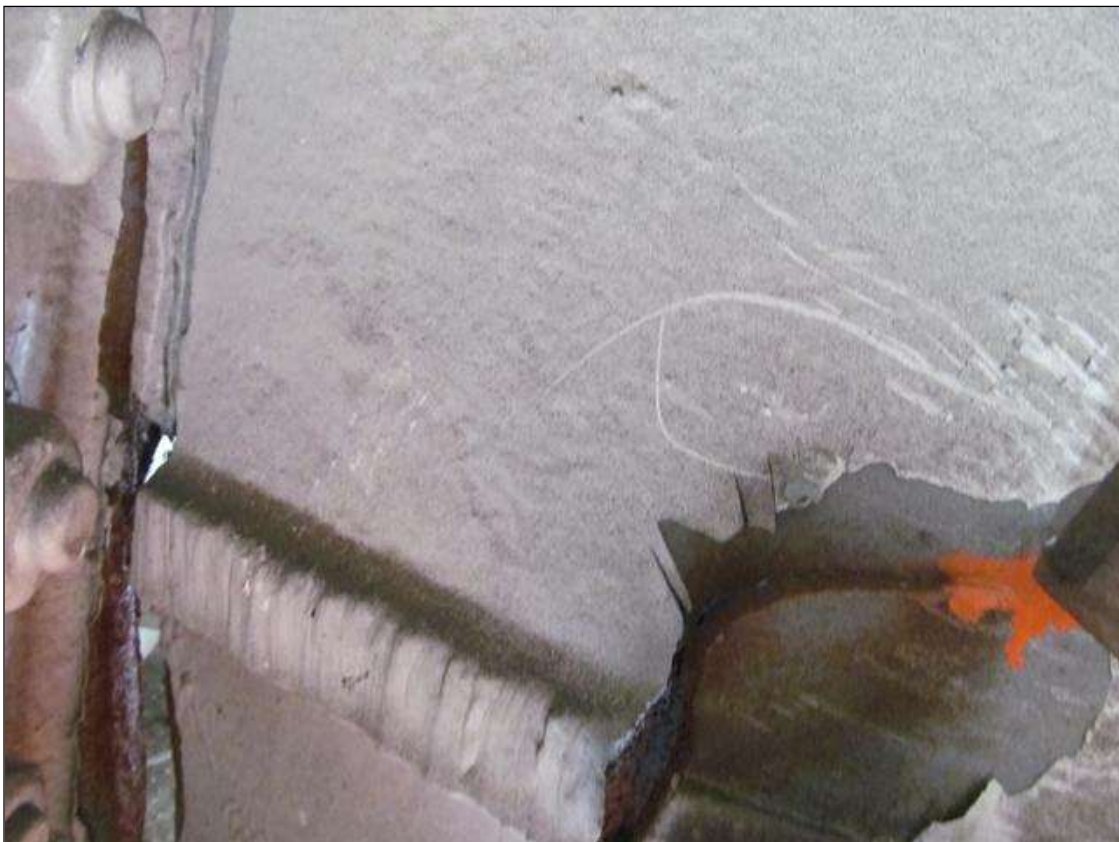
BOTTOM OF DIAPHRAGM @ BEAM 4 HAS A 3 1/2" CRACK. BEAM 4,

MMS Code	Description of Function	Unit	Quantity	Remarks	Est. Cost
3314	Maintain Steel Superstructure Components	LF	1	BOTTOM OF DIAPHRAGM @ BEAM 4 HAS A 3 1/2" CRACK. BEAM 4,	
3314	Maintain Steel Superstructure Components	LF	1	BOTTOM WELD OF DIAPHRAGM HAS A 3" CRACK. BEAM 4, SPAN 3	
3314	Maintain Steel Superstructure Components	LF	1	CRACK 2 1/2" LONG IN BOTTOM WELD AT DIAPHRAGM TO BRACKET @ 20'-4" FROM THE FACE OF BENT 3. BEAM 4,	
3314	Maintain Steel Superstructure Components	LF	1	CRACK ( 2" ) IN BOTTOM OF DIAPHRAGM. BEAM 4, SPAN 3	
3314	Maintain Steel Superstructure Components	LF	1	CRACK ( 3" ) IN TOP OF DIAPHRAGM. BEAM 4, SPAN 3	
3314	Maintain Steel Superstructure Components	LF	1	CRACK ( 6 1/2" ) IN BOTTOM OF DIAPHRAGM BRACKET. BEAM 4, SPAN 3	
3314	Maintain Steel Superstructure Components	LF	1	CRACK ( 6" ) IN BOTTOM OF DIAPHRAGM @ 37'-4" FROM THE FACE OF BENT 3. BEAM 4, SPAN 3	
3314	Maintain Steel Superstructure Components	LF	1	CRACK 11" LONG AT THE BOTTOM OF DIAPHRAGM BRACKET @ 20'-4" FROM THE FACE OF BENT 3. BEAM 4,

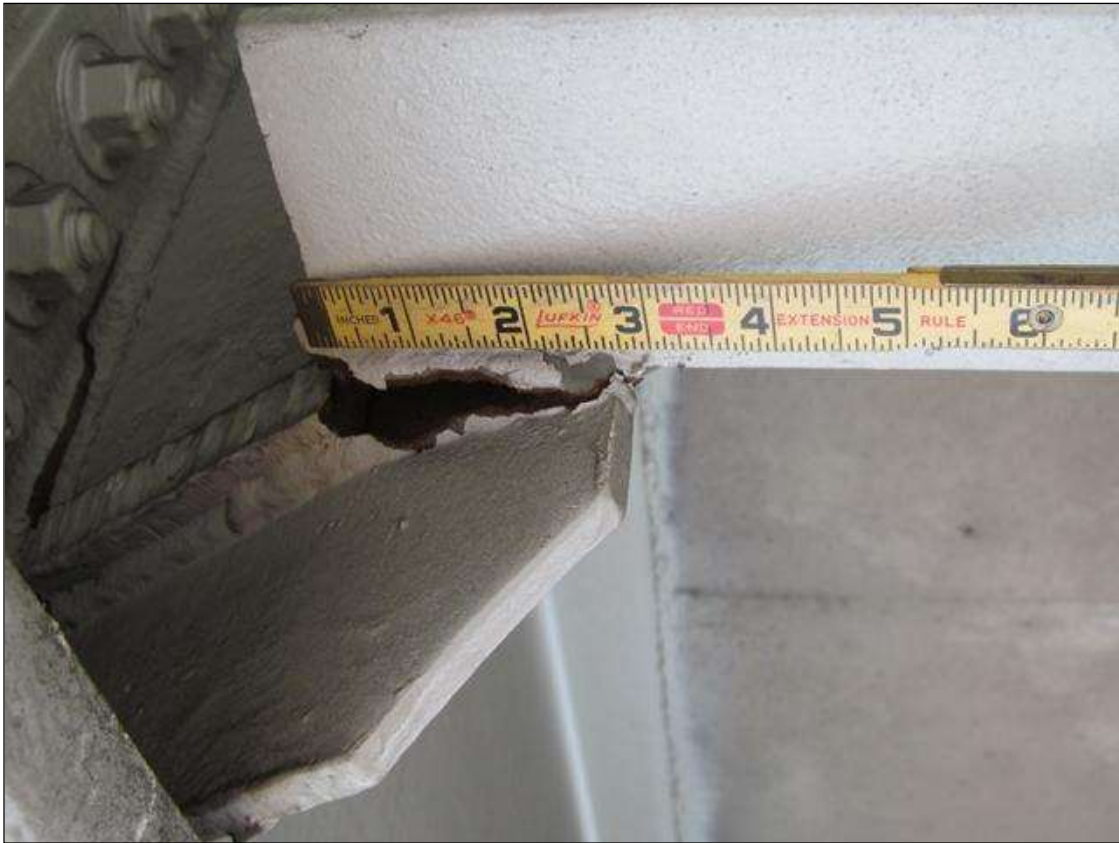
BOTTOM WELD OF DIAPHRAGM HAS A 3" CRACK. BEAM 4, SPAN 3

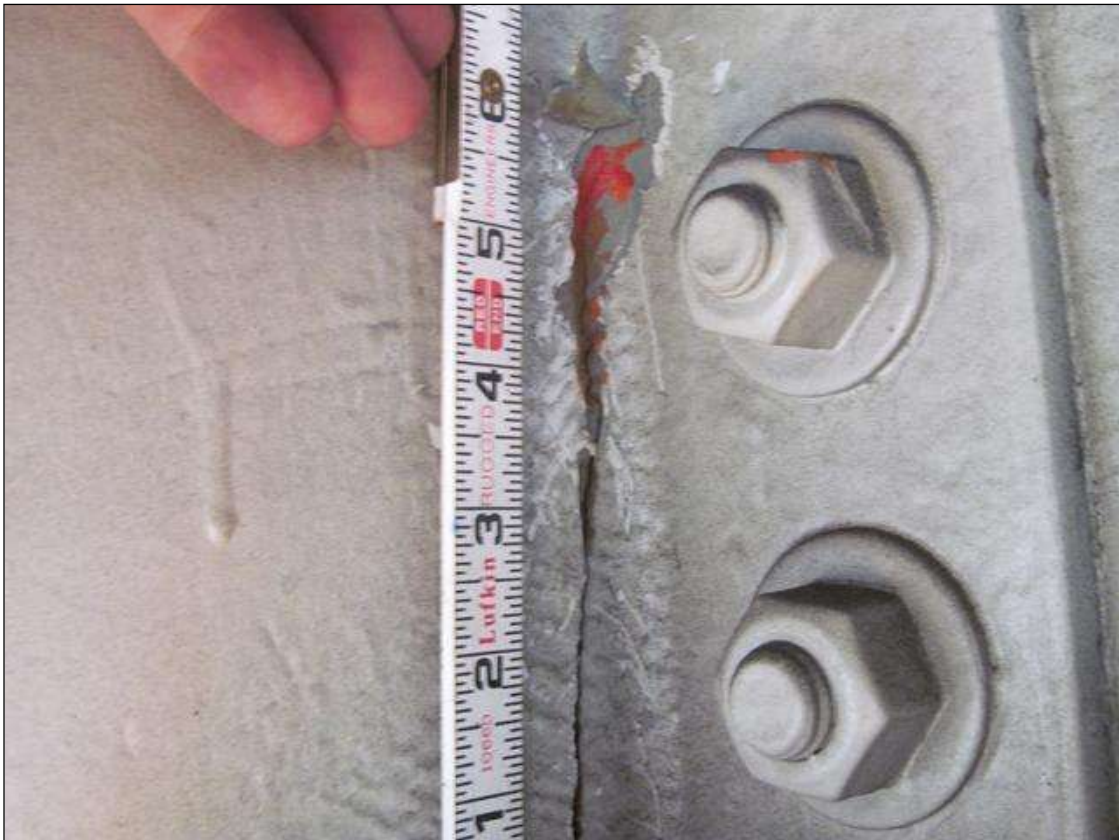
CRACK ( 6" ) IN BOTTOM OF DIAPHRAGM @ 37'-4" FROM THE FACE OF BENT 3. BEAM 4, SPAN 3

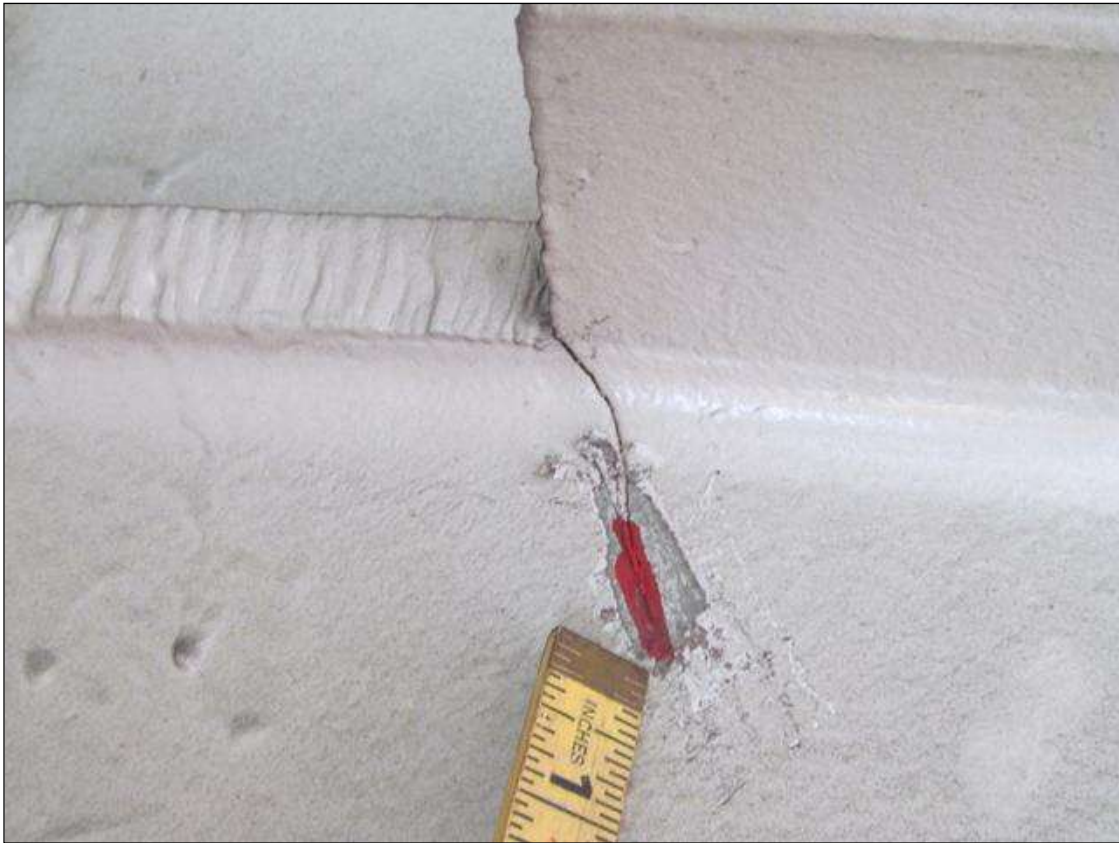
CRACK ( 3" ) IN TOP OF DIAPHRAGM. BEAM 4, SPAN 3

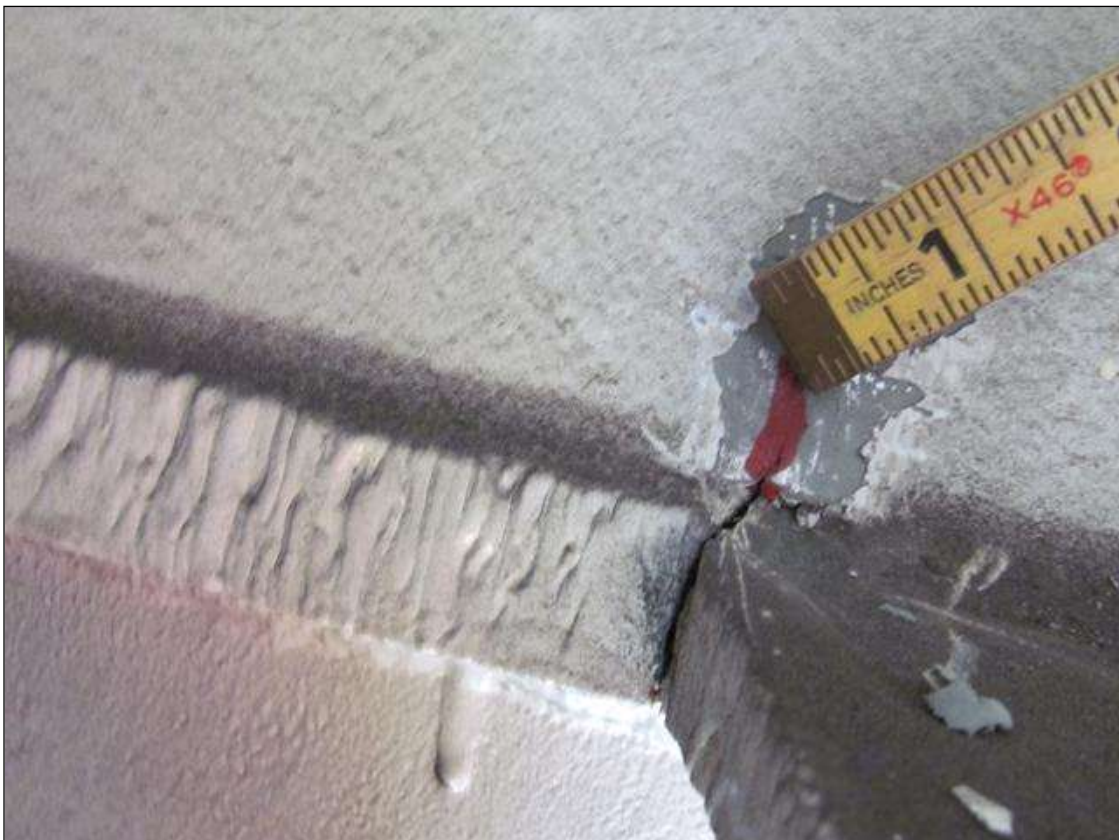
CRACK ( 2" ) IN BOTTOM OF DIAPHRAGM. BEAM 4, SPAN 3

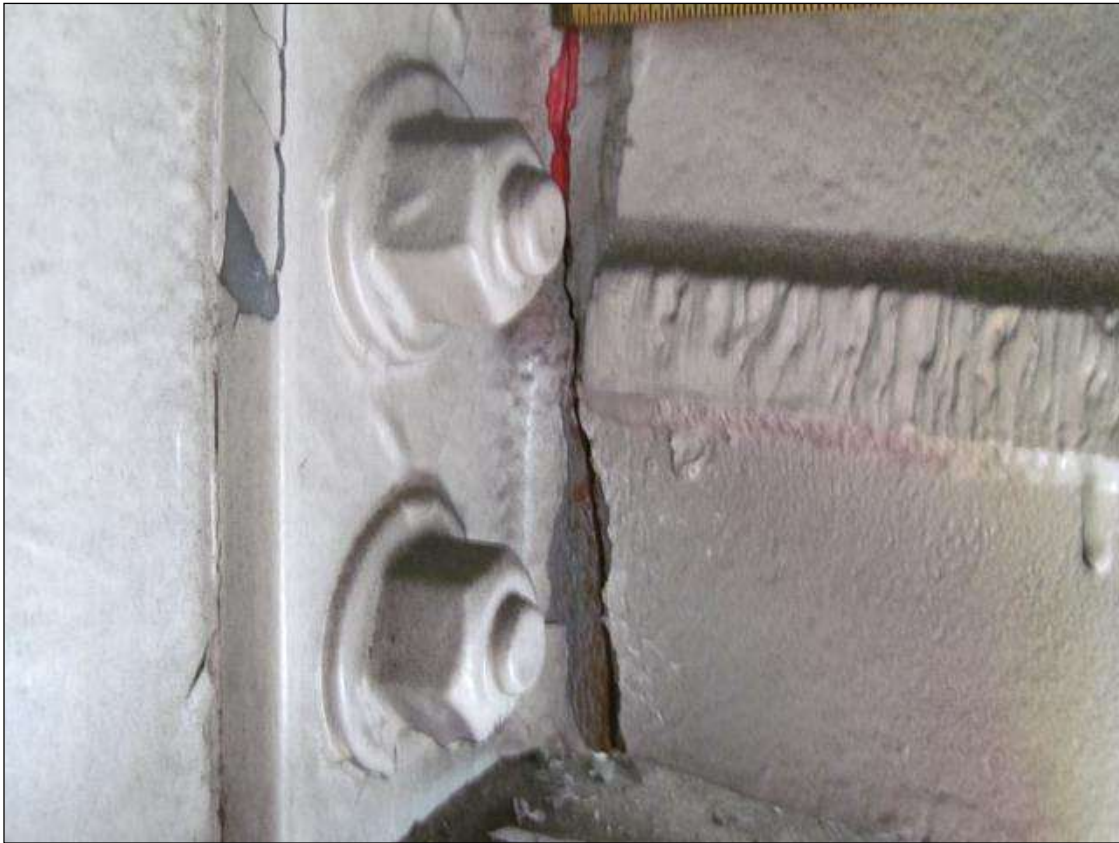
CRACK ( 6 1/2" ) IN BOTTOM OF DIAPHRAGM BRACKET. BEAM 4, SPAN 3
