NC DEPARTMENT OF TRANSPORTATION  
DIVISION OF HIGHWAYS  
BRIDGE MANAGEMENT UNIT

# BRIDGE INSPECTION REPORT

INSPECTION TYPE: Damage Inspection Report

COUNTY CATAWBA BRIDGE NUMBER 170142 INSPECTION CYCLE 0 YRS  
ROUTE SR1692 ACROSS US321 M.P. 0

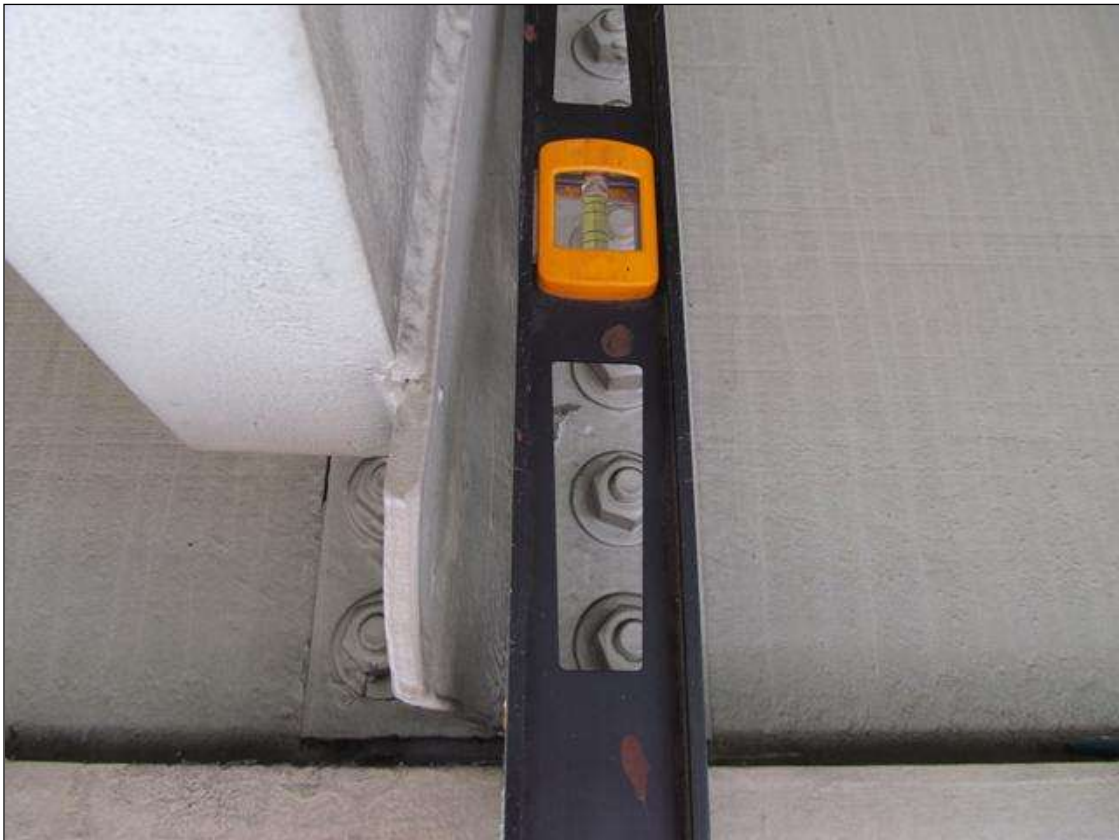
DIAPHRAGM @ 37'-4" FROM THE FACE OF BENT 3, IS OUT OF PLUMB ( 3/4" ) TO THE EAST. BEAM 4, SPAN 3

3314	Maintain Steel Superstructure Components	LF	8	CRACK IN DIAPHRAGM CRACK 11" LONG AT THE BOTTOM OF DIAPHRAGM BRACKET @ 20'-4" FROM THE FACE OF BENT 3. BEAM 4, CRACK 2 1/2" LONG IN BOTTOM WELD AT DIAPHRAGM TO BRACKET @ 20'-4" FROM THE FACE OF BENT 3. BEAM 4, DIAPHRAGM IS BENT 4 1/2" TO THE EAST @ 20'-4" FROM THE FACE OF BENT 3. BEAM 4, TOP OF DIAPHRAGM @ BEAM 4 HAS A 4" CRACK. BEAM 4, BOTTOM OF DIAPHRAGM @ BEAM 4 HAS A 3 1/2" CRACK. BEAM 4, BOTTOM WELD OF DIAPHRAGM HAS A 3" CRACK. BEAM 4, SPAN 3 CRACK ( 6" ) IN BOTTOM OF DIAPHRAGM @ 37'-4" FROM THE FACE OF BENT 3. BEAM 4, SPAN 3 CRACK ( 3" ) IN TOP OF DIAPHRAGM. BEAM 4, SPAN 3 CRACK ( 2" ) IN BOTTOM OF DIAPHRAGM. BEAM 4, SPAN 3 CRACK ( 6 1/2" ) IN BOTTOM OF DIAPHRAGM BRACKET. BEAM 4, SPAN 3 DIAPHRAGM @ 37'-4" FROM THE FACE OF BENT 3, IS OUT OF PLUMB ( 3/4" ) TO THE EAST. BEAM 4, SPAN 3 CRACK IN BOTTOM WELD OF DIAPHRAGM @ 37'-4" FROM THE FACE OF BENT 3. BEAM 4, SPAN 3 DIAPHRAGM IS BENT ( 3/4" ) UPWARD AT 4'-0" FROM BEAM 4 @ 37'-4" FROM THE FACE OF BENT 3. BEAM 4, SPAN 3 DIAPHRAGM @ 37'-4" FROM THE FACE OF BENT 3, IS OUT OF PLUMB ( 3/4" ) TO THE EAST. BEAM 4, SPAN 3

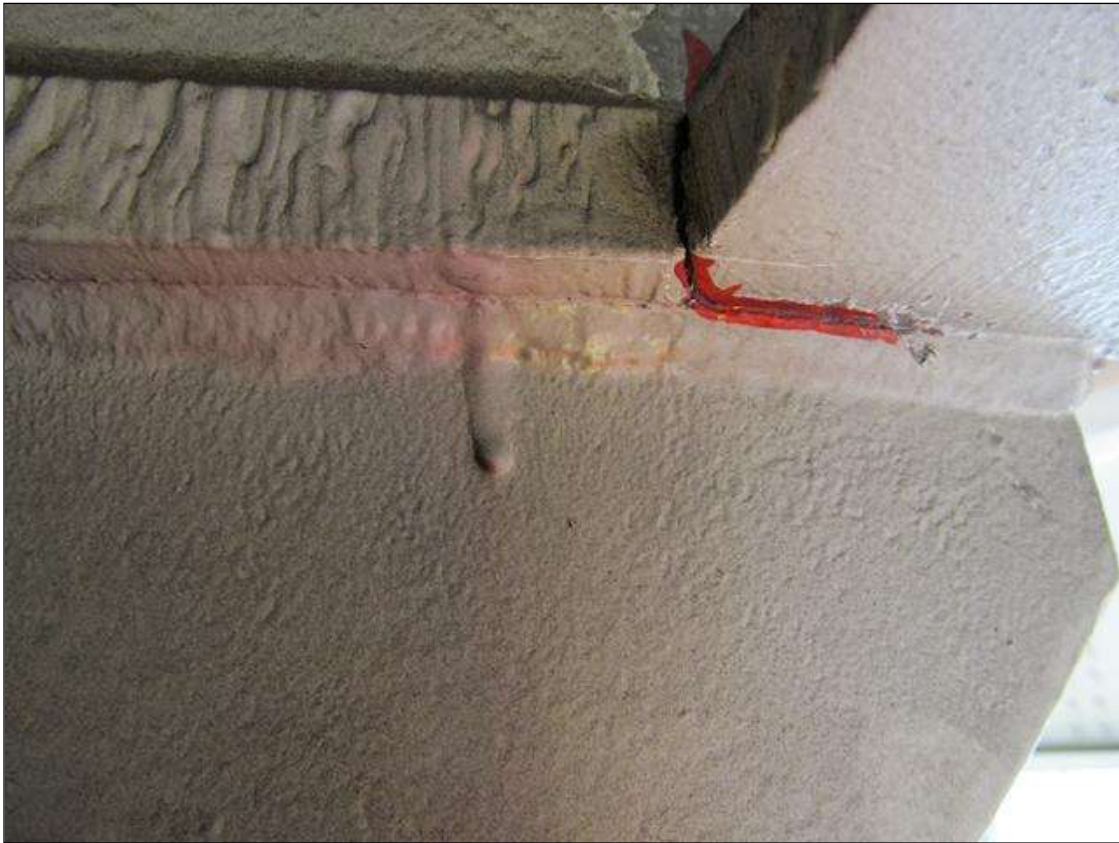
CRACK IN BOTTOM WELD OF DIAPHRAGM @ 37'-4" FROM THE FACE OF BENT 3. BEAM 4, SPAN 3

3314	Maintain Steel Superstructure Components	LF	1	CRACK IN BOTTOM WELD OF DIAPHRAGM @ 37'-4" FROM THE FACE OF BENT 3. BEAM 4, SPAN 3	
3314	Maintain Steel Superstructure Components	LF	1	DIAPHRAGM IS BENT 4 1/2" TO THE EAST @ 20'-4" FROM THE FACE OF BENT 3. BEAM 4,	
3314	Maintain Steel Superstructure Components	LF	1	TOP OF DIAPHRAGM @ BEAM 4 HAS A 4" CRACK. BEAM 4,

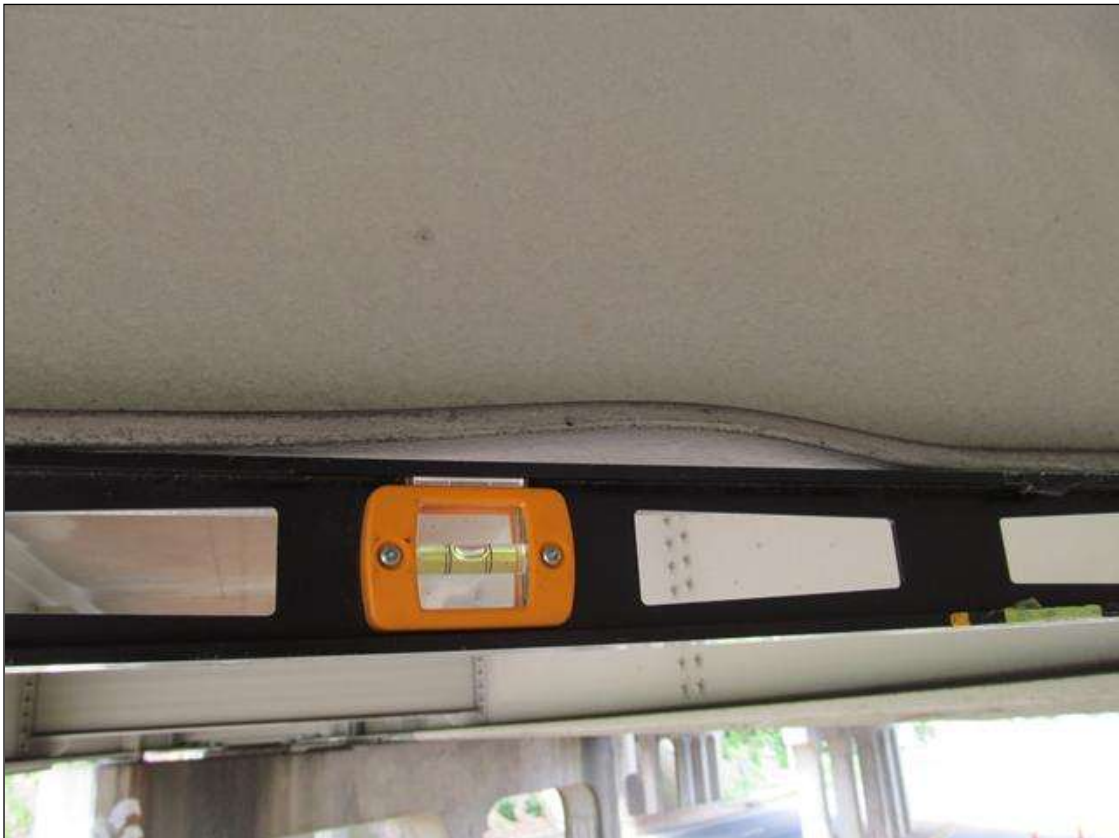
DIAPHRAGM IS BENT (  $\frac{3}{4}$ " ) UPWARD AT 4'-0" FROM BEAM 4 @ 37'-4" FROM THE FACE OF BENT 3. BEAM 4, SPAN 3

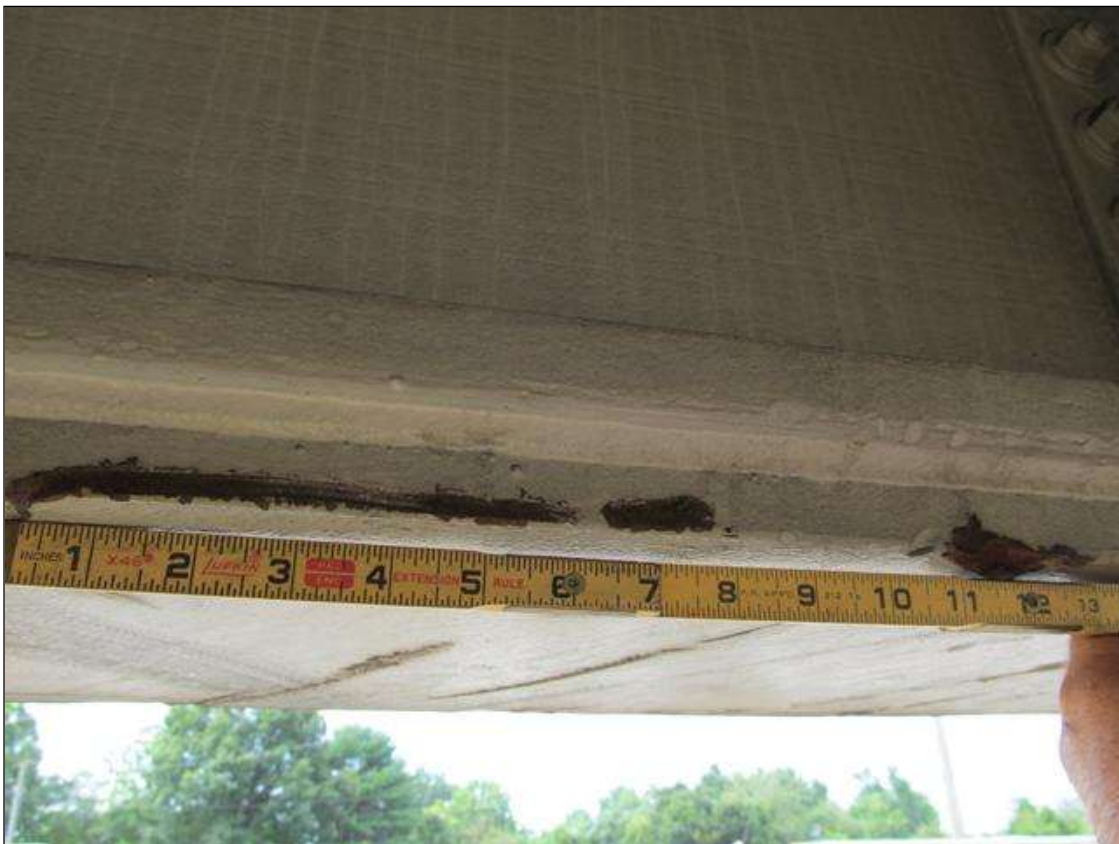
INDENTIONS IN COVER PLATE ON NORTH SIDE OF BEAM 4 @ 36'-3" FROM THE FACE OF BENT 3. BEAM 4, SPAN 3

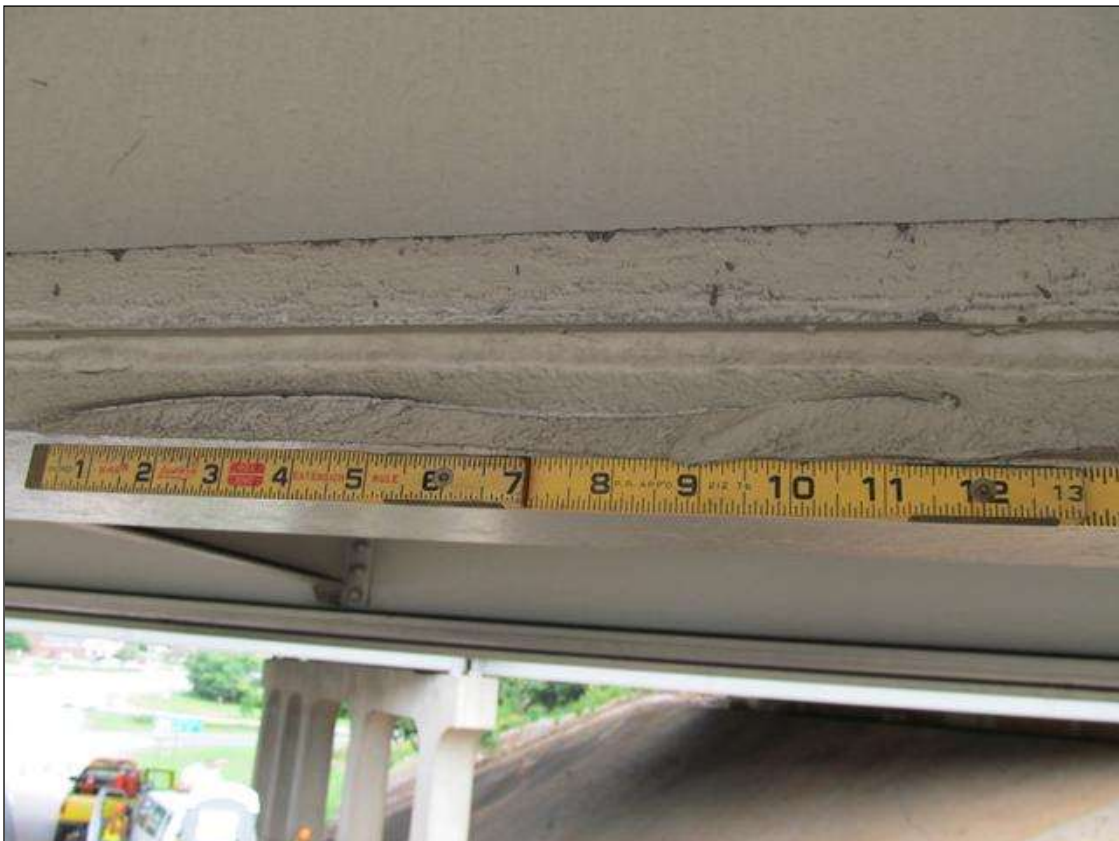
POINT OF IMPACT ON BEAM 3 IS 33'-3" FROM THE FACE OF BENT 3. BEAM 3, SPAN 3

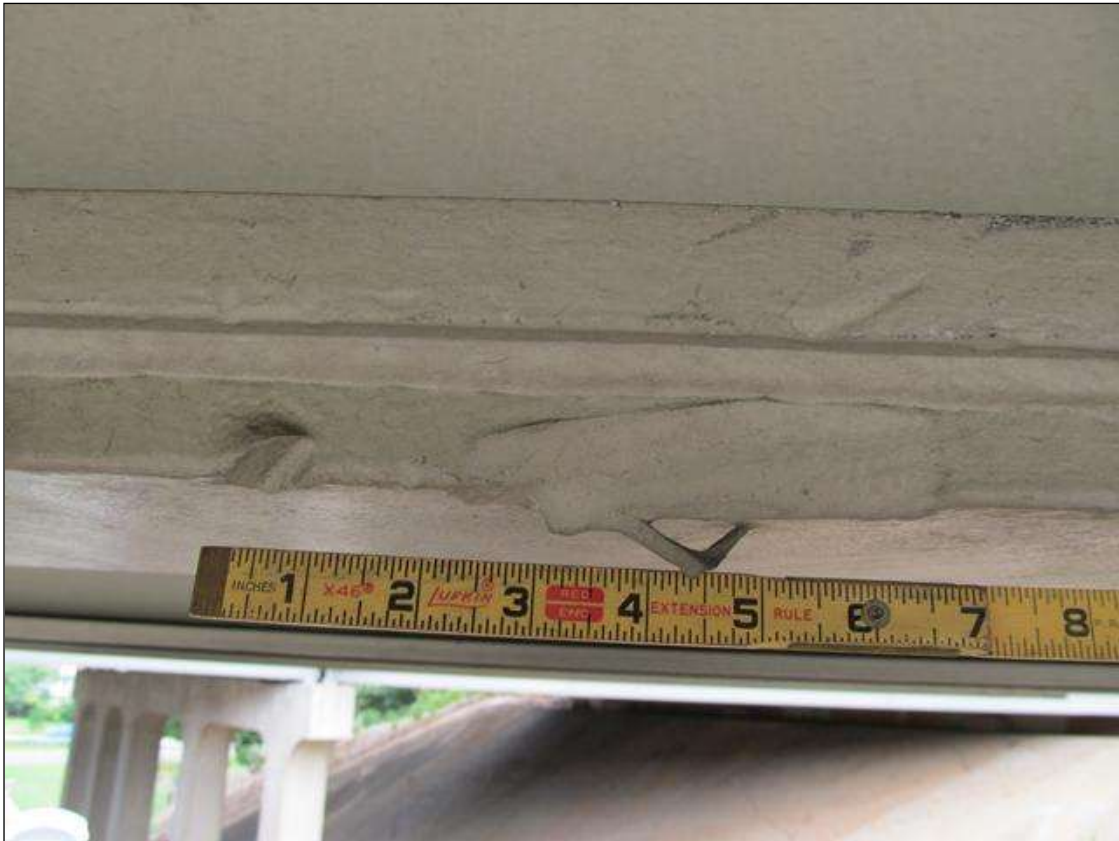
INDENTATION ( 1/2" X 1/4" ) IN COVER PLATE @ 35'-1" FROM THE FACE OF BENT 3. BEAM 3, SPAN 3

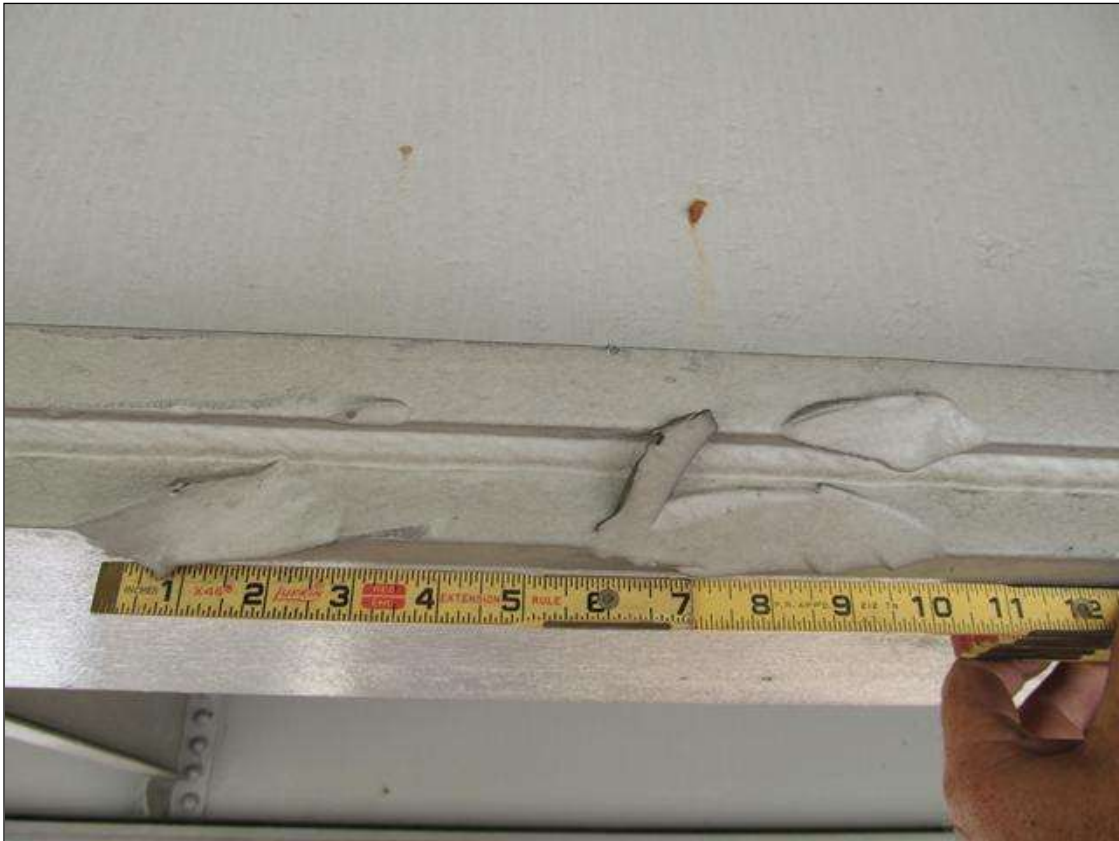
POINT OF IMPACT ON BEAM 2 IS 34'-2" FROM THE FACE OF BENT 3. BEAM 2, SPAN 3

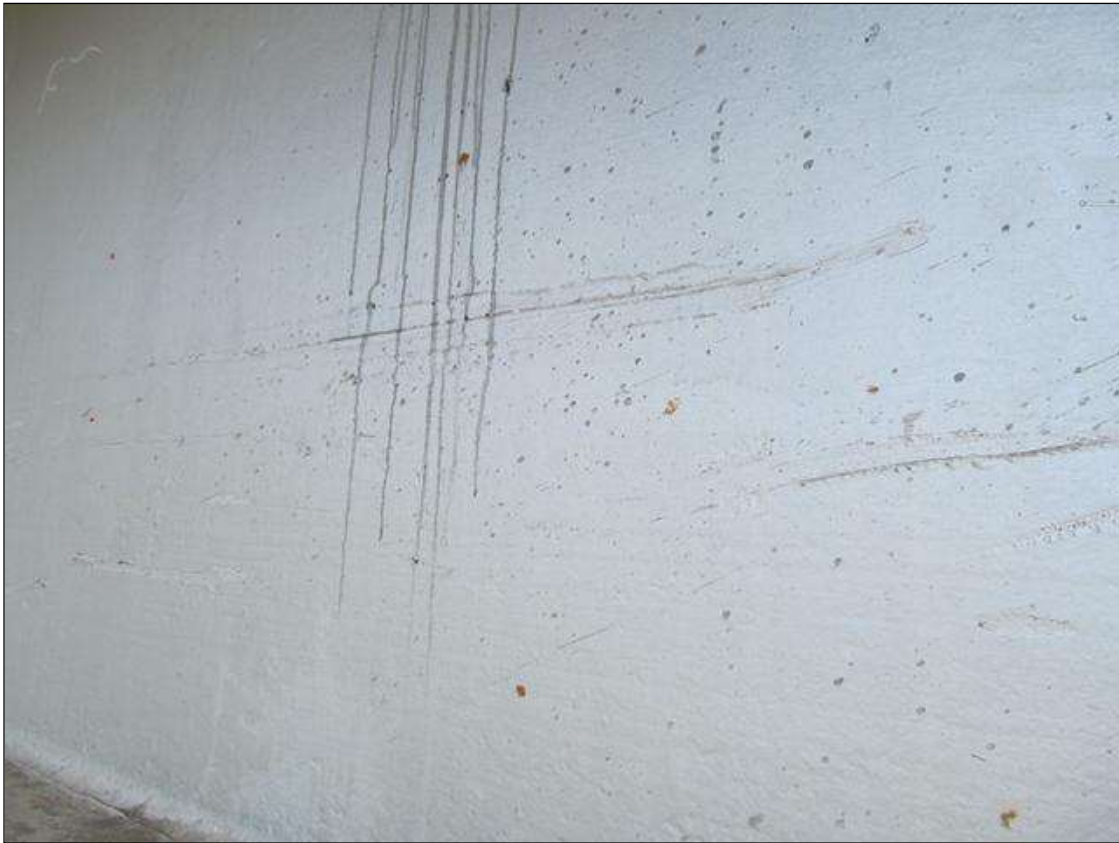
MARKS ON WEB HAVE BEEN PAINTED OVER. BEAM 4, SPAN 3

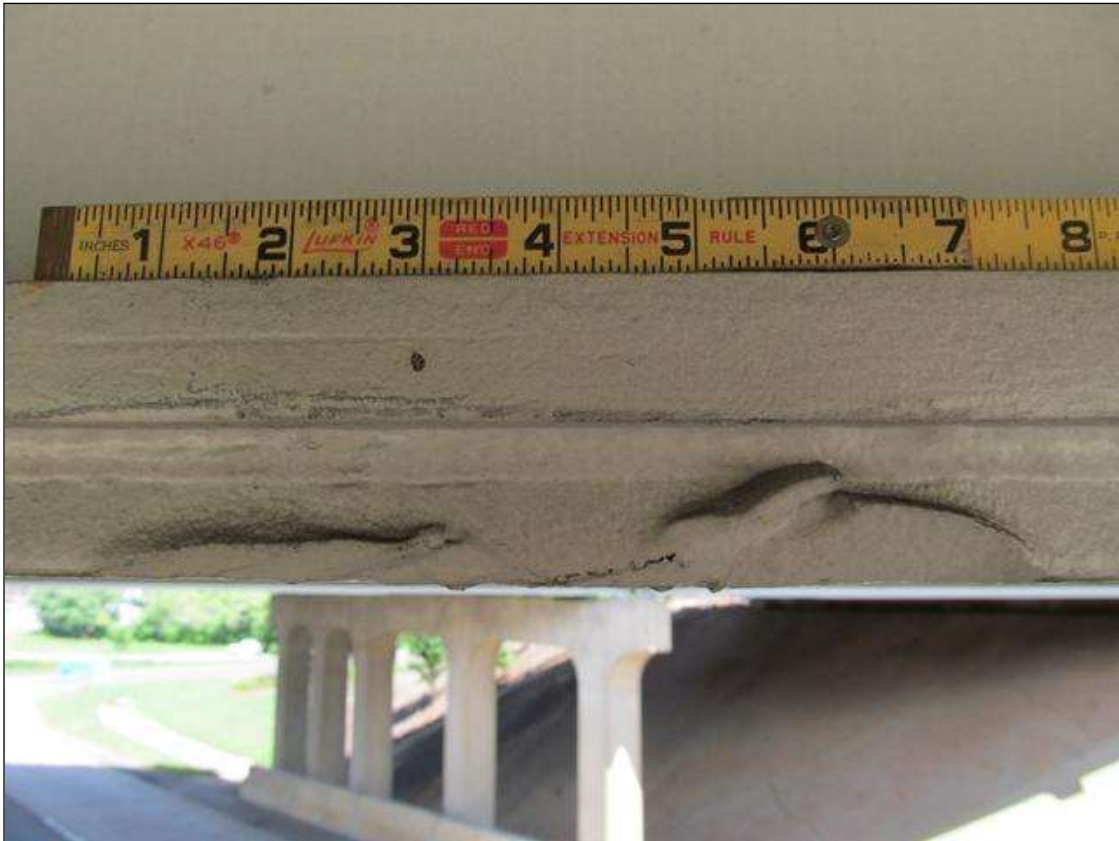
INDENTION ( 8" X 1/4" ) IN COVER PLATE @ 15'-5" FROM THE FACE OF BENT 2. BEAM 3, SPAN 3

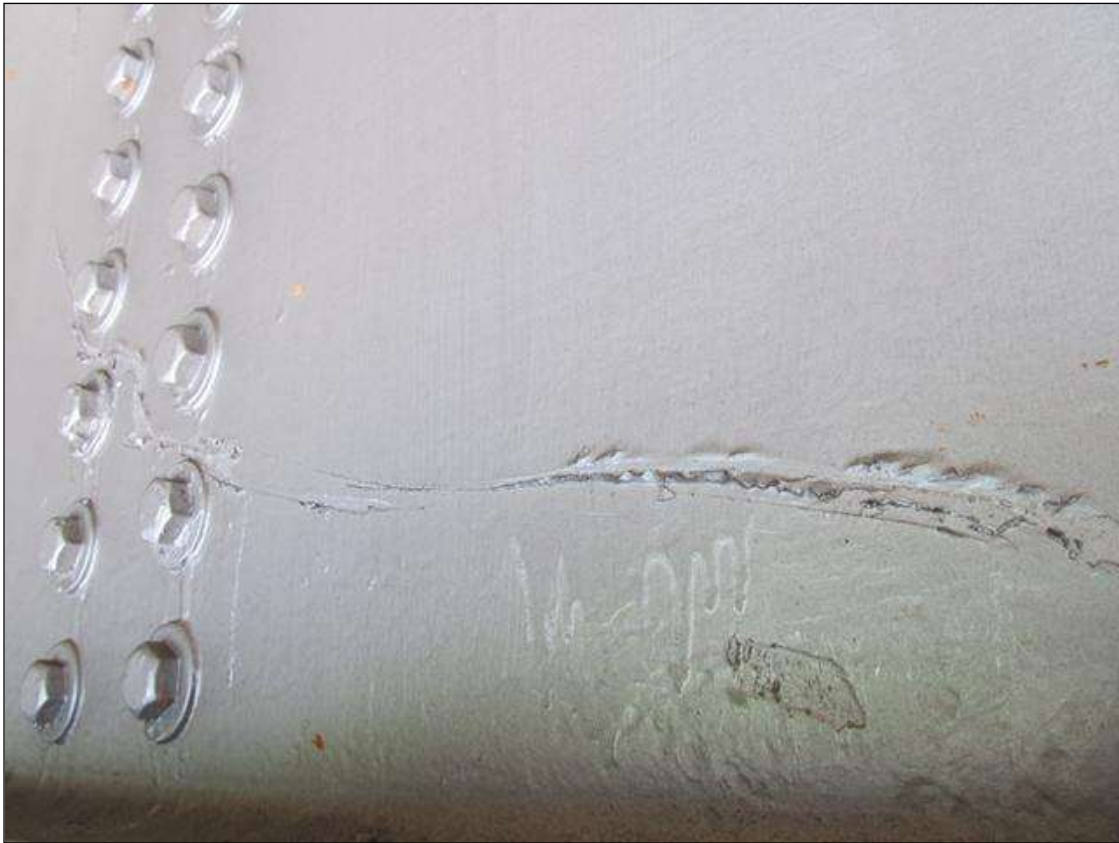
MARKS ON WEB @ 14'-0" FROM THE FACE OF BENT 2. BEAM 3, SPAN 3

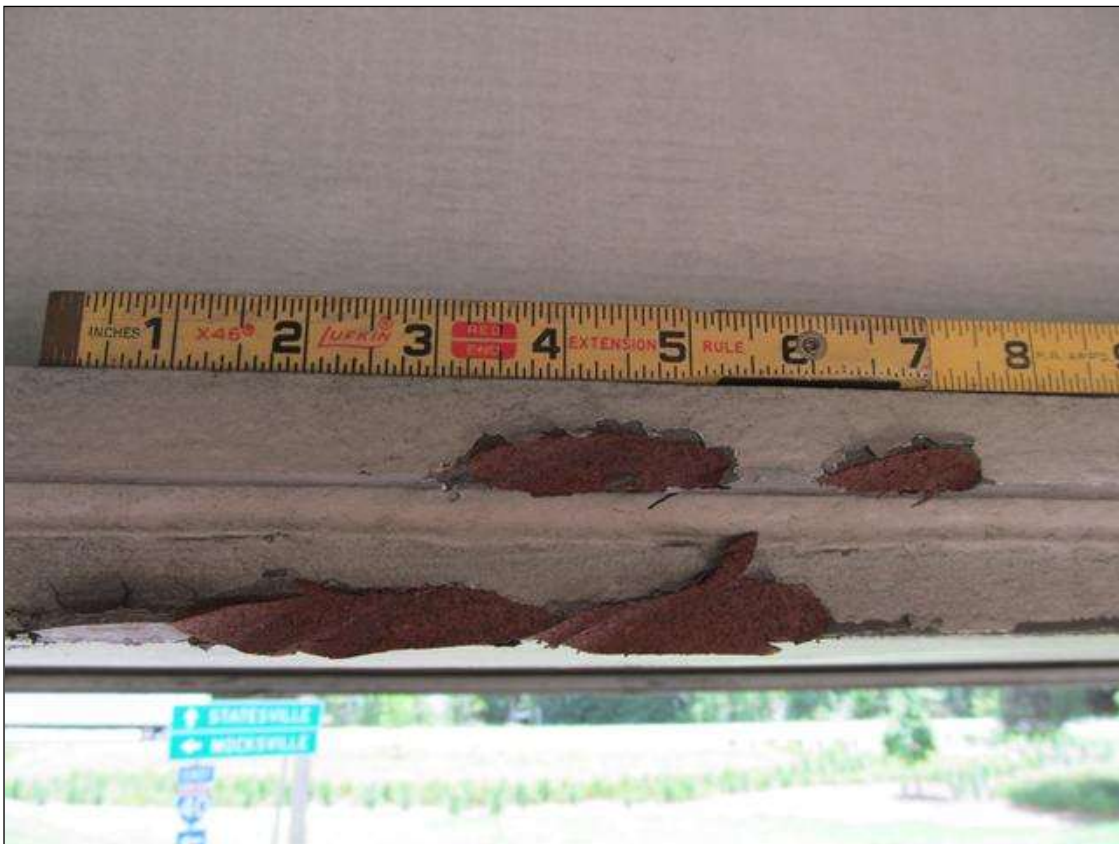
POINT OF IMPACT ON BEAM 3 @ 20'-2" FROM THE FACE OF BENT 2. BEAM 3, SPAN 2

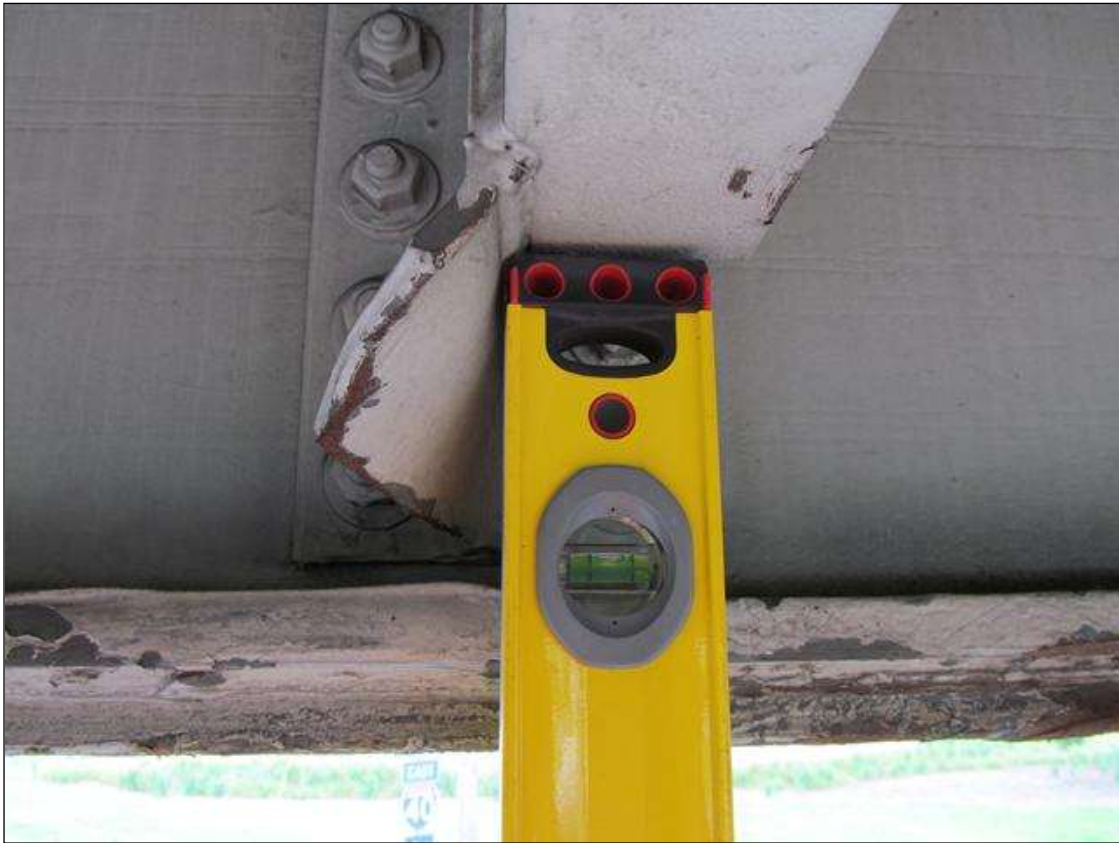
TOP AND BOTTOM OF DIAPHRAGM BRACKET IS BENT UP TO 2" TO THE EAST. OUT OF PLUMB @ 18'-2"  
FROM THE FACE OF BENT 2. BEAM 4, SPAN 2

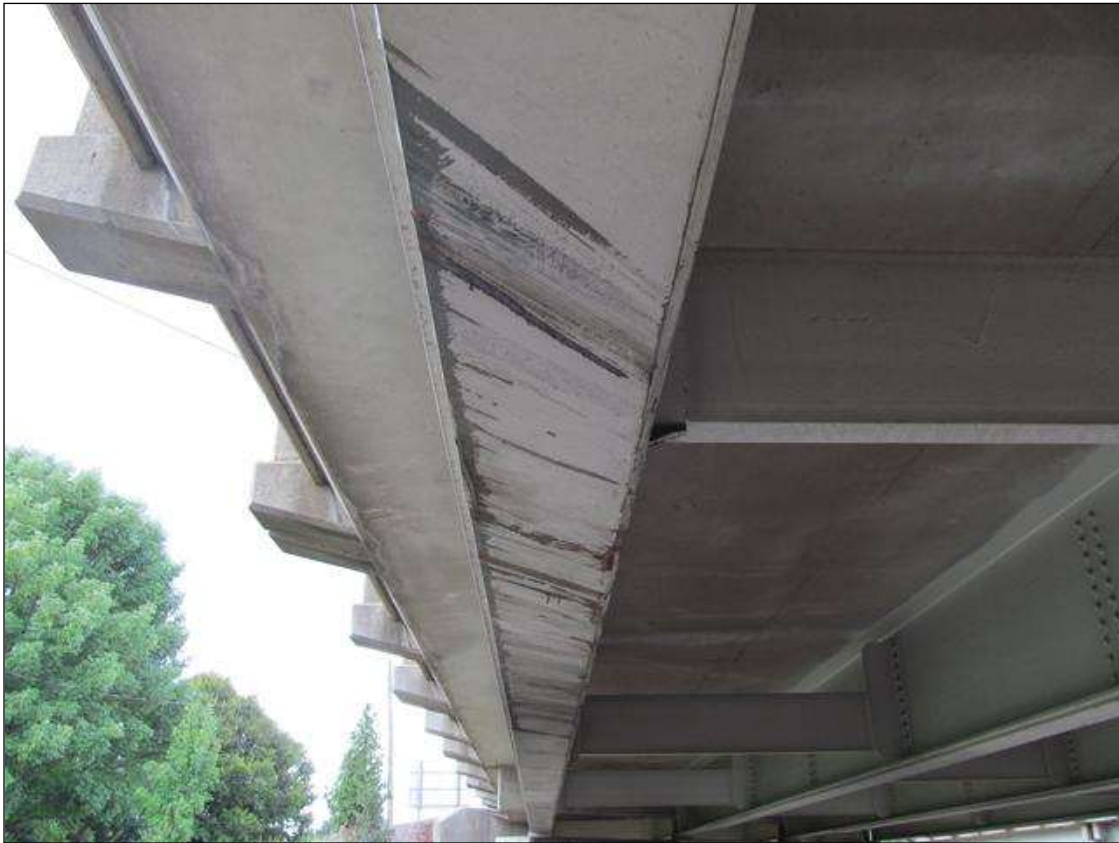
MARKS AND SCRAPES ON COVER PLATE TO BEAM 4, SPAN 2
