NC DEPARTMENT OF TRANSPORTATION
DIVISION OF HIGHWAYS
STRUCTURE MANAGEMENT UNIT

ATTENTION: Supplemental Inspection Impact Damage, Span 2 Beam 6, PAR

Structure Safety Report

STRUCTURE NUMBER: 100392 SAP STRUCTURE NO: 0110392 FHWA STRUCTURE NO: 000000000210392
DIVISION: 13 COUNTY: BUNCOMBE INSPECTION DATE: 08/28/2024 FREQUENCY: None
FACILITY CARRIED: US19,23BUS MILE POST: _____
LOCATION: .05 MI.S.JCT.SR1733
FEATURE INTERSECTED: I-26 & US19,23BYP.
LATITUDE: 35° 42' 48.96" LONGITUDE: 82° 33' 43.72"
SUPERSTRUCTURE: REINFORCED CONCRETE FLOOR ON I-BEAMS
SUBSTRUCTURE: E.BTS:RC CAPS/H-PILES;INT.BTS:RC POST&BEAMS
SPANS: 4 SPANS. SEE SPAN PROFILE SHEET FOR SPAN DETAILS
☐ FRACTURE CRITICAL ☐ TEMPORARY SHORING ☐ SCOUR CRITICAL ☐ SCOUR PLAN OF ACTION
GRADES: (Inspector/NBI Coding) DECK 7 / 7 SUPERSTRUCTURE 4 / 4 SUBSTRUCTURE 4 / 4 CULVERT N / N
POSTED SV: Not Posted POSTED TTST: Not Posted
OTHER SIGNS PRESENT: (4) DELINEATORS, (2) LOW CLEARANCE SIGNS

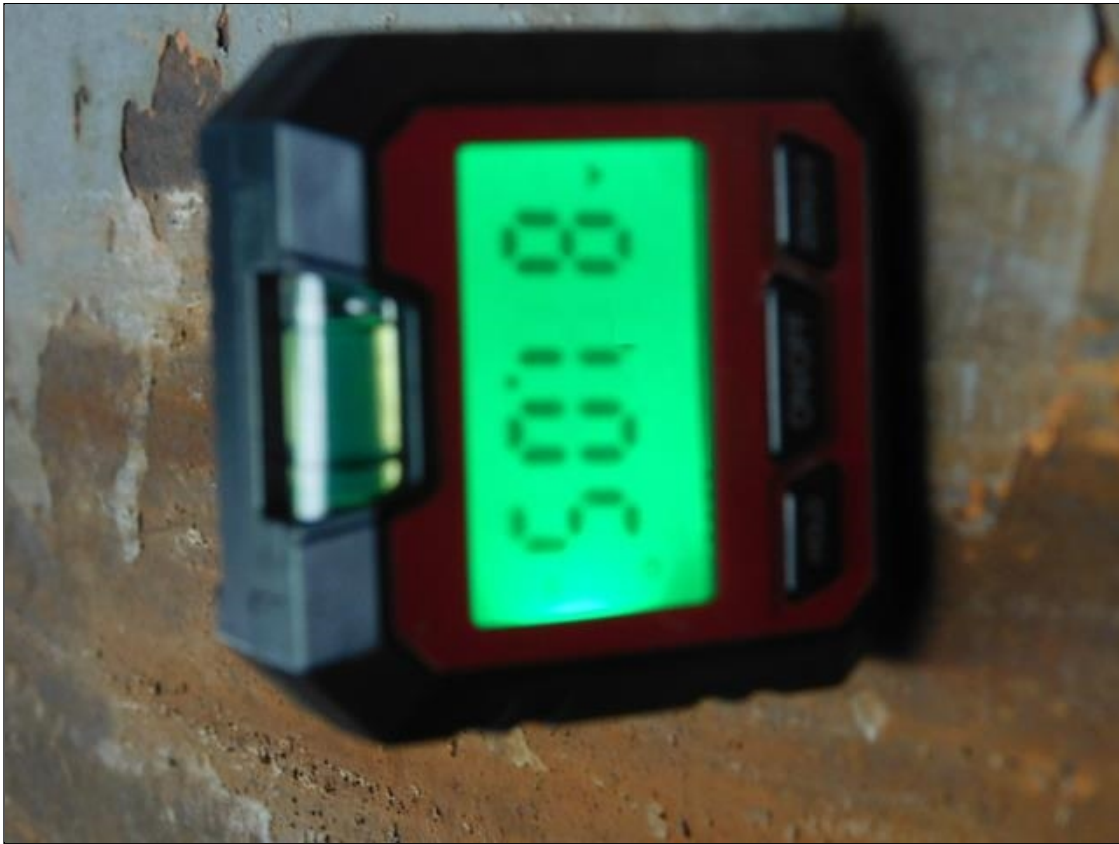
OUT OF PLUMB Span 2 Beam 6: Supplemental Inspection Impact Damage, Span 2 Beam 6 Is Bowed Westward 9 Degrees Out Of Plumb For a Length Of 12 Foot That Begins 11.5 Foot From Bent 1. At The Point of Impact The Weld Connecting The Bottom Flange To The Bottom Stiffener Plate Is Broken For 30 Inches. The Point of Impact (Located 20.5 Foot From Bent 1) Also Has Two Gouges On The Bottom Flange. The First One Is 17 Inches Long X 1 Inch High X 3 Inch Deep. The Second One Is 6 Inch Long X 1/2 Inch High X 2 Inch Deep. (PAR)

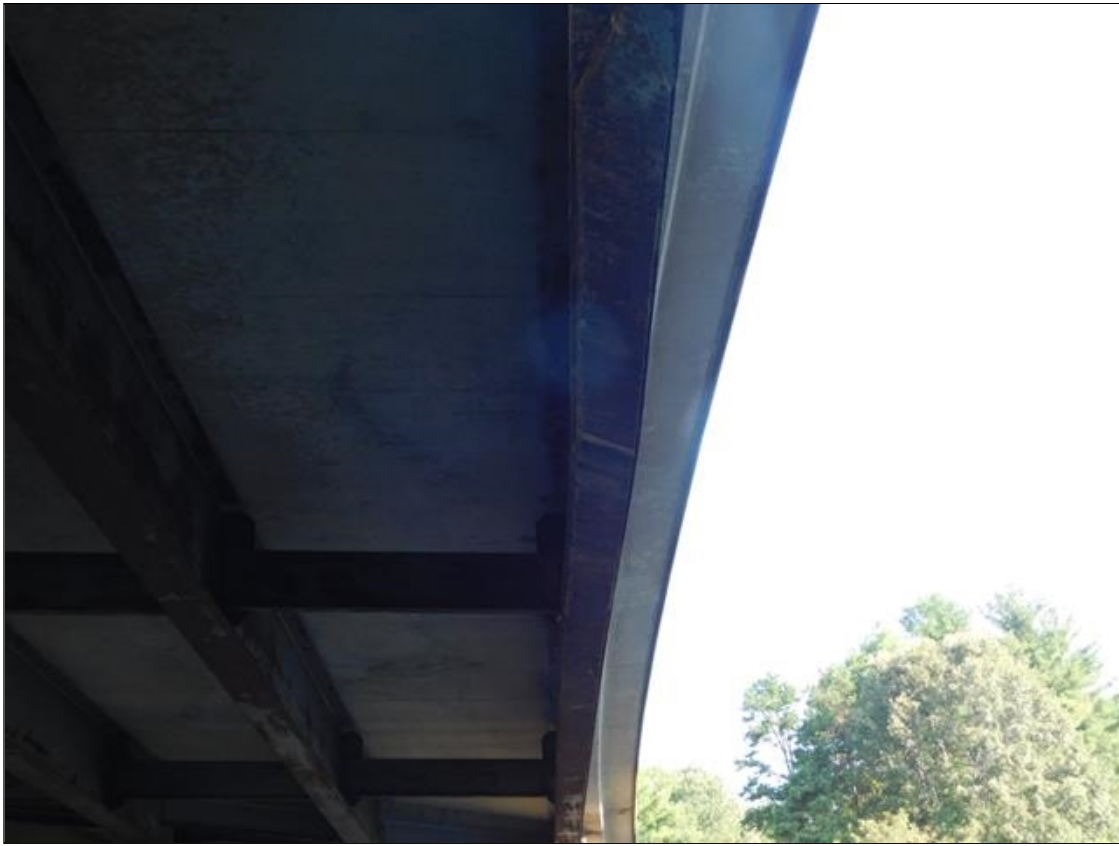
Span 2 Beam 6: Supplemental Inspection Impact Damage, Span 2 Beam 6 Is Bowed Westward 9 Degrees Out Of Plumb For a Length Of 12 Foot That Begins 11.5 Foot From Bent 1. At The Point of Impact The Weld Connecting The Bottom Flange To The Bottom Stiffener Plate Is Broken For 30 Inches. The Point of Impact (Located 20.5 Foot From Bent 1) Also Has Two Gouges On The Bottom Flange. The First One Is 17 Inches Long X 1 Inch High X 3 Inch Deep. The Second One Is 6 Inch Long X 1/2 Inch High X 2 Inch Deep. (PAR)

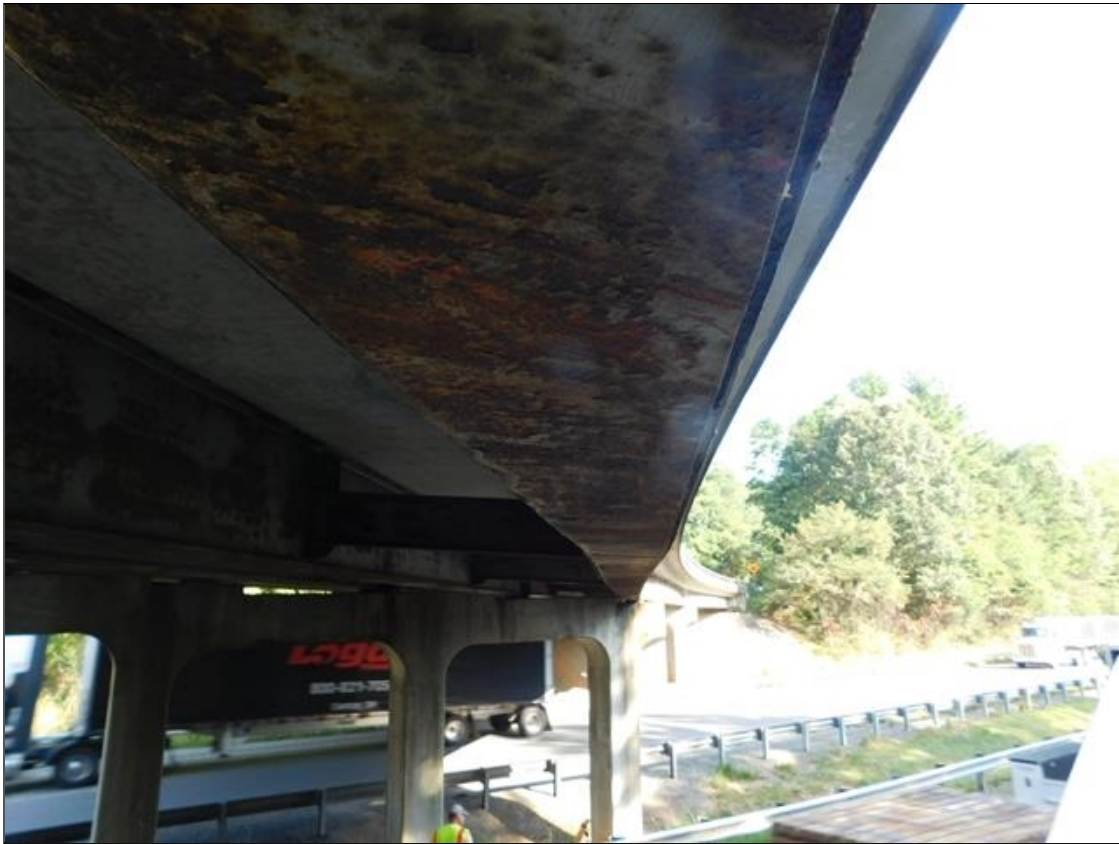
Span 2 Beam 6: Supplemental Inspection Impact Damage, Span 2 Beam 6 Is Bowed Westward 9 Degrees Out Of Plumb For a Length Of 12 Foot That Begins 11.5 Foot From Bent 1. At The Point of Impact The Weld Connecting The Bottom Flange To The Bottom Stiffener Plate Is Broken For 30 Inches. The Point of Impact (Located 20.5 Foot From Bent 1) Also Has Two Gouges On The Bottom Flange. The First One Is 17 Inches Long X 1 Inch High X 3 Inch Deep. The Second One Is 6 Inch Long X 1/2 Inch High X 2 Inch Deep. (PAR)

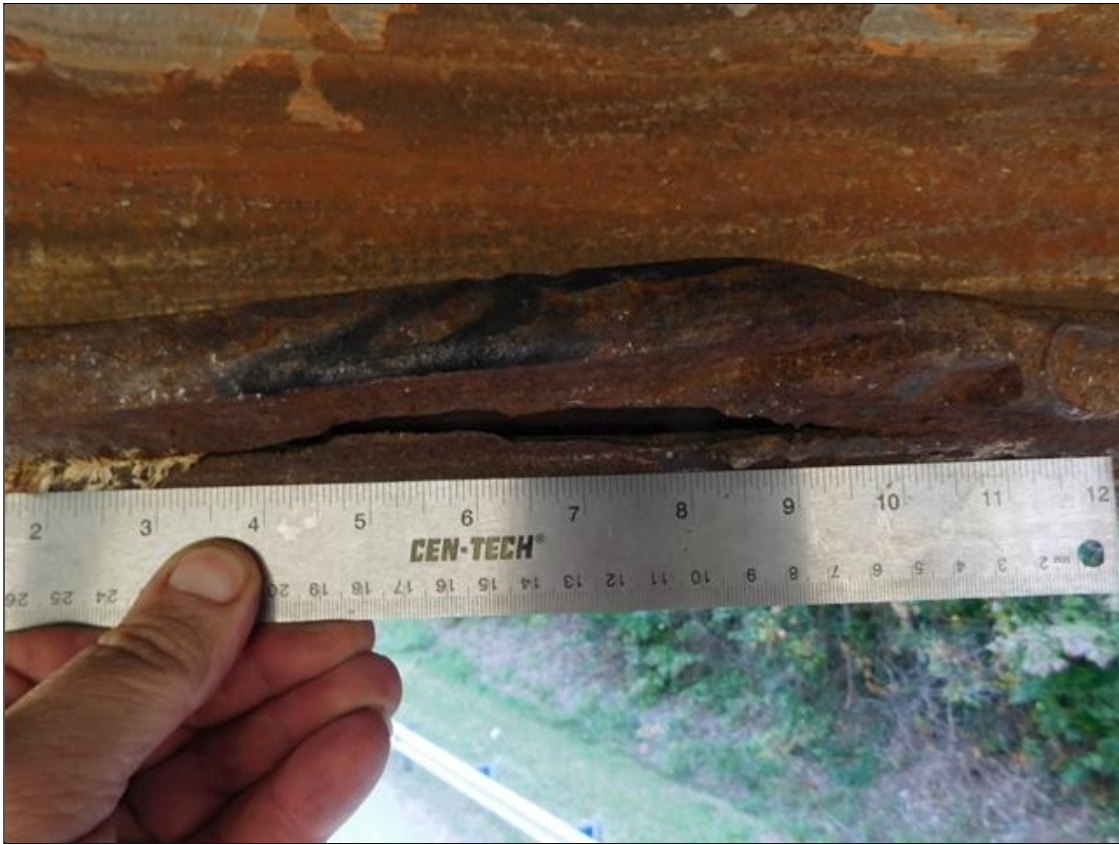
WELD Span 2 Beam 6: Supplemental Inspection Impact Damage, Span 2 Beam 6 Is Bowed Westward 9 Degrees Out Of Plumb For a Length Of 12 Foot That Begins 11.5 Foot From Bent 1. At The Point of Impact The Weld Connecting The Bottom Flange To The Bottom Stiffener Plate Is Broken For 30 Inches. The Point of Impact (Located 20.5 Foot From Bent 1) Also Has Two Gouges On The Bottom Flange. The First One Is 17 Inches Long X 1 Inch High X 3 Inch Deep. The Second One Is 6 Inch Long X 1/2 Inch High X 2 Inch Deep. (PAR)

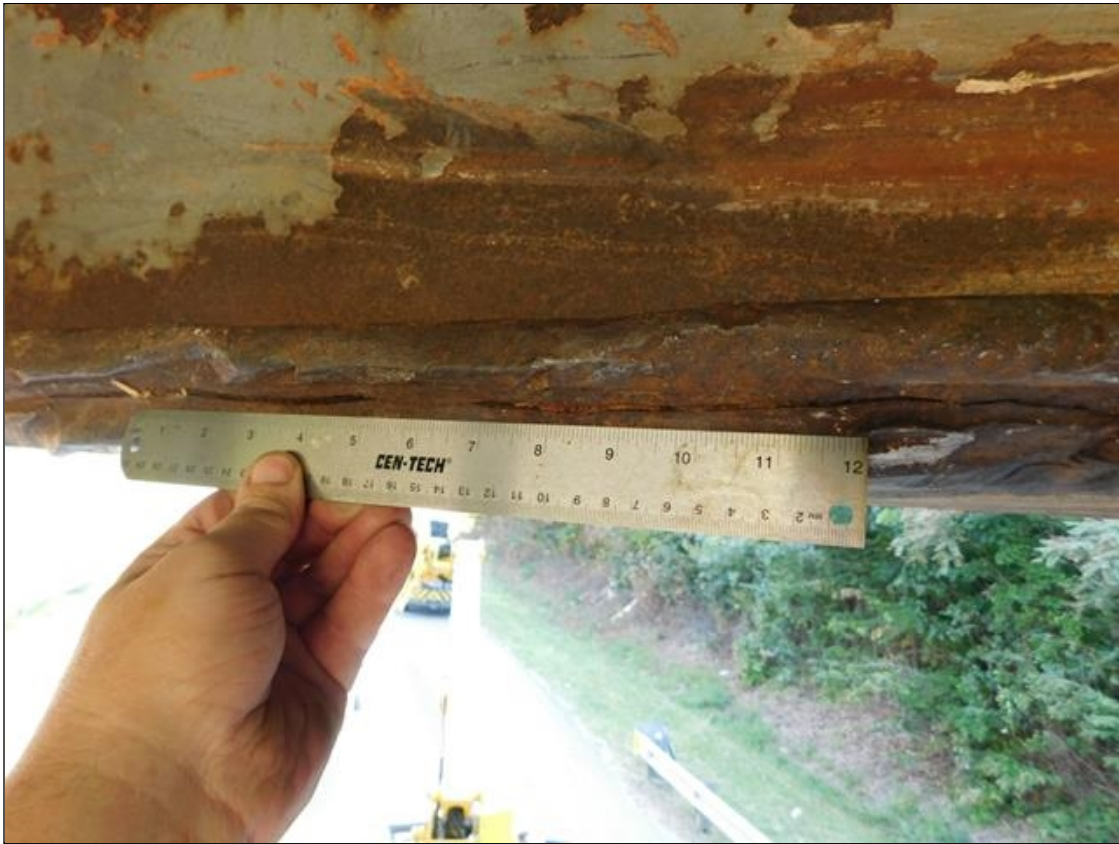
WELD Span 2 Beam 6: Supplemental Inspection Impact Damage, Span 2 Beam 6 Is Bowed Westward 9 Degrees Out Of Plumb For a Length Of 12 Foot That Begins 11.5 Foot From Bent 1. At The Point of Impact The Weld Connecting The Bottom Flange To The Bottom Stiffener Plate Is Broken For 30 Inches. The Point of Impact (Located 20.5 Foot From Bent 1) Also Has Two Gouges On The Bottom Flange. The First One Is 17 Inches Long X 1 Inch High X 3 Inch Deep. The Second One Is 6 Inch Long X 1/2 Inch High X 2 Inch Deep. (PAR)

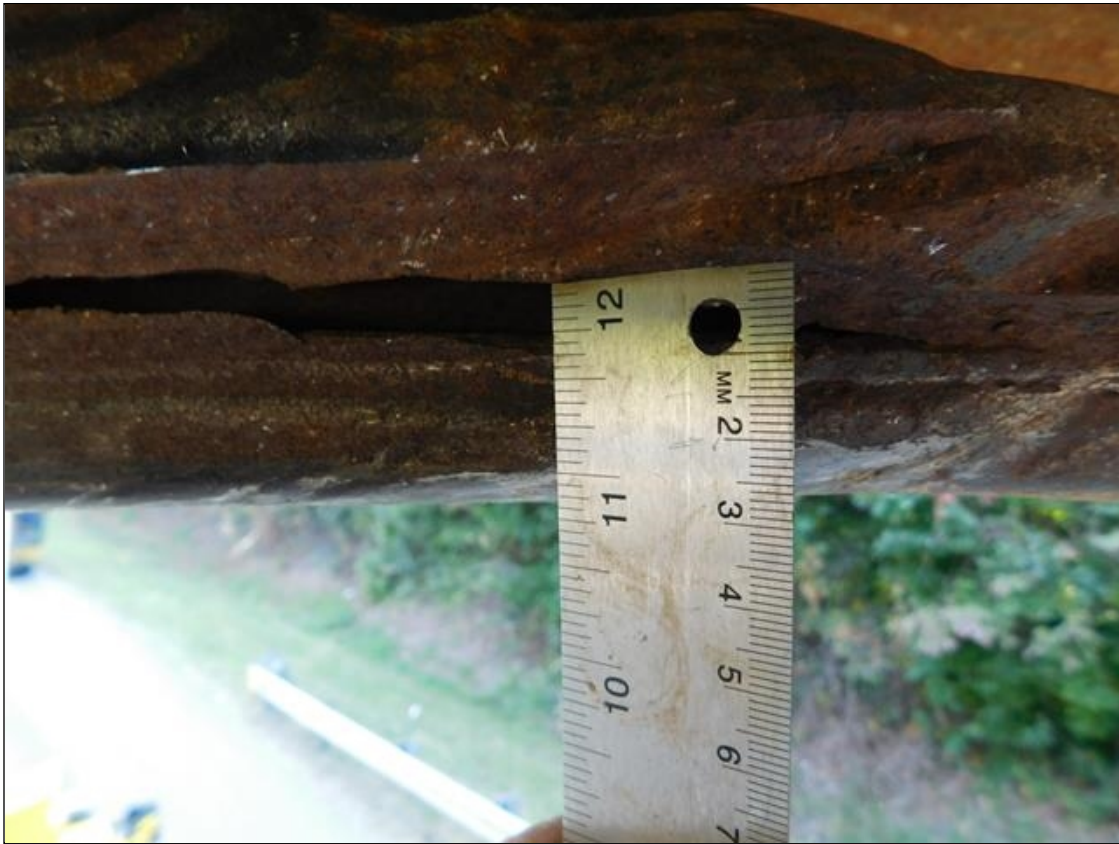
WELD Span 2 Beam 6: Supplemental Inspection Impact Damage, Span 2 Beam 6 Is Bowed Westward 9 Degrees Out Of Plumb For a Length Of 12 Foot That Begins 11.5 Foot From Bent 1. At The Point of Impact The Weld Connecting The Bottom Flange To The Bottom Stiffener Plate Is Broken For 30 Inches. The Point of Impact (Located 20.5 Foot From Bent 1) Also Has Two Gouges On The Bottom Flange. The First One Is 17 Inches Long X 1 Inch High X 3 Inch Deep. The Second One Is 6 Inch Long X 1/2 Inch High X 2 Inch Deep. (PAR)

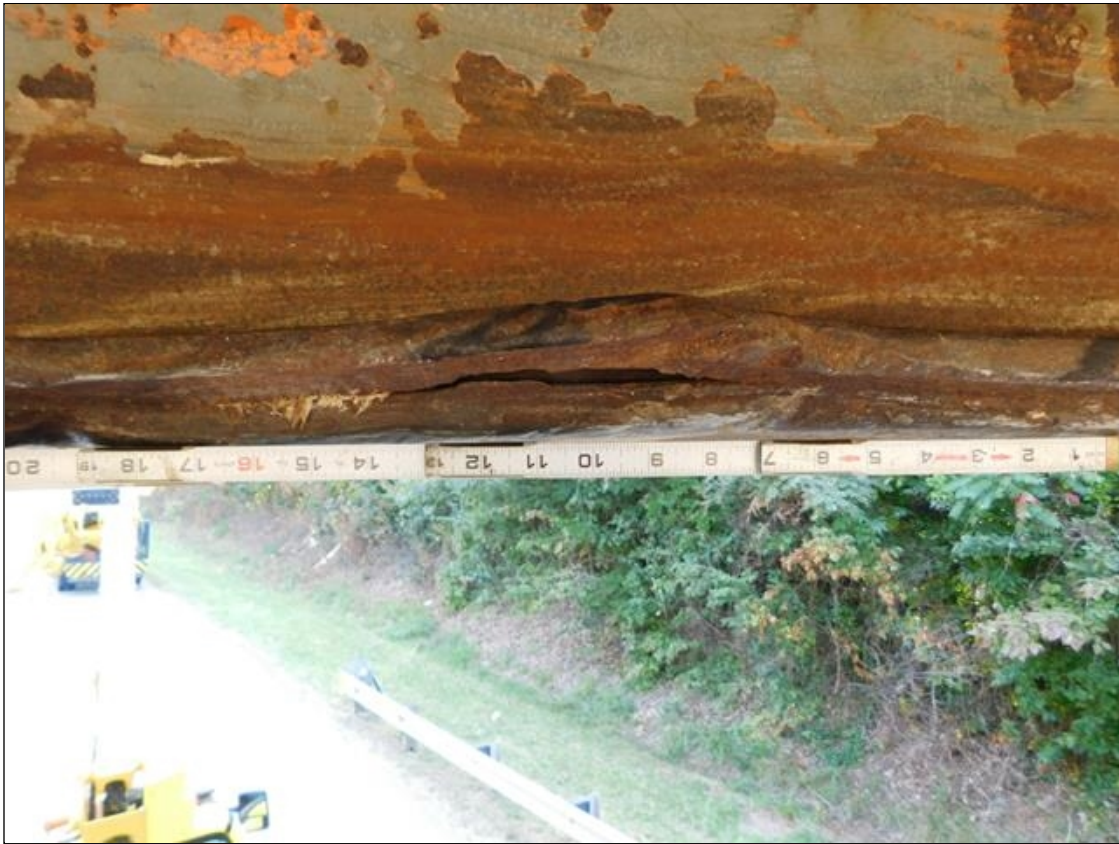
GOUGE ONE Span 2 Beam 6: Supplemental Inspection Impact Damage, Span 2 Beam 6 Is Bowed Westward 9 Degrees Out Of Plumb For a Length Of 12 Foot That Begins 11.5 Foot From Bent 1. At The Point of Impact The Weld Connecting The Bottom Flange To The Bottom Stiffener Plate Is Broken For 30 Inches. The Point of Impact (Located 20.5 Foot From Bent 1) Also Has Two Gouges On The Bottom Flange. The First One Is 17 Inches Long X 1 Inch High X 3 Inch Deep. The Second One Is 6 Inch Long X 1/2 Inch High X 2 Inch Deep. (PAR)

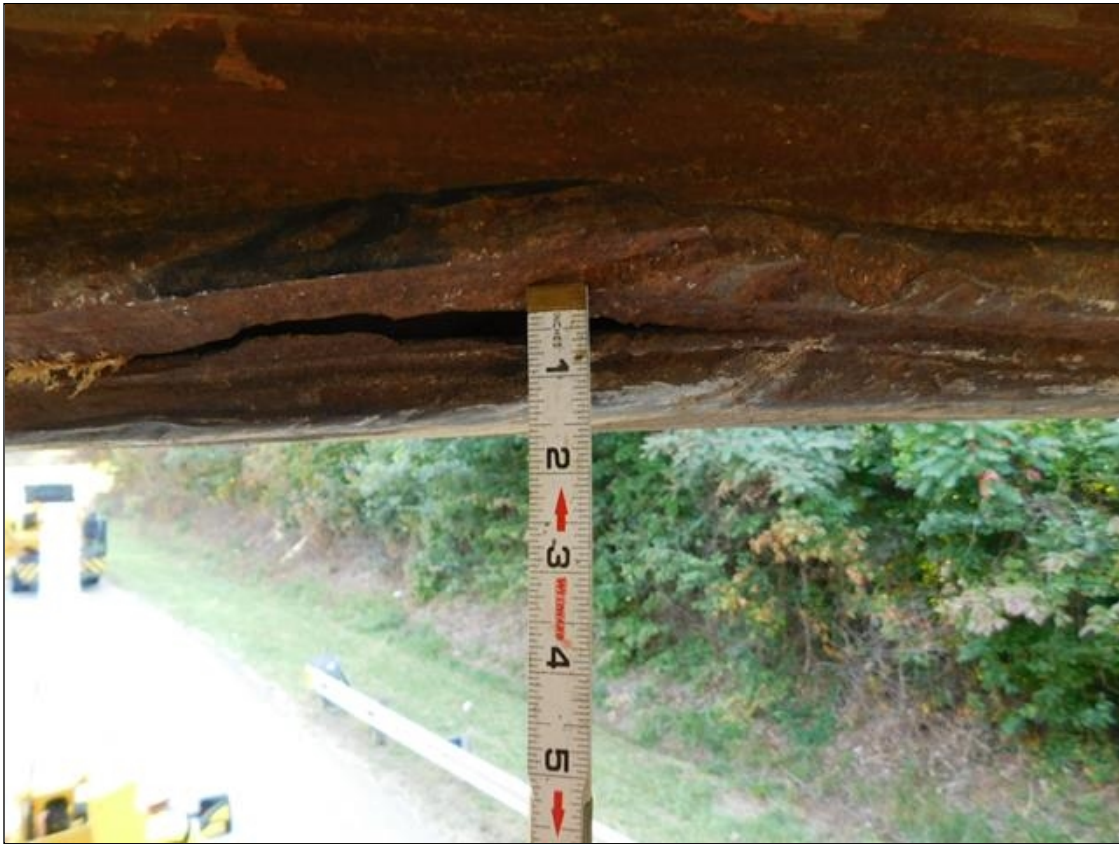
GOUGE ONE Span 2 Beam 6: Supplemental Inspection Impact Damage, Span 2 Beam 6 Is Bowed Westward 9 Degrees Out Of Plumb For a Length Of 12 Foot That Begins 11.5 Foot From Bent 1. At The Point of Impact The Weld Connecting The Bottom Flange To The Bottom Stiffener Plate Is Broken For 30 Inches. The Point of Impact (Located 20.5 Foot From Bent 1) Also Has Two Gouges On The Bottom Flange. The First One Is 17 Inches Long X 1 Inch High X 3 Inch Deep. The Second One Is 6 Inch Long X 1/2 Inch High X 2 Inch Deep. (PAR)

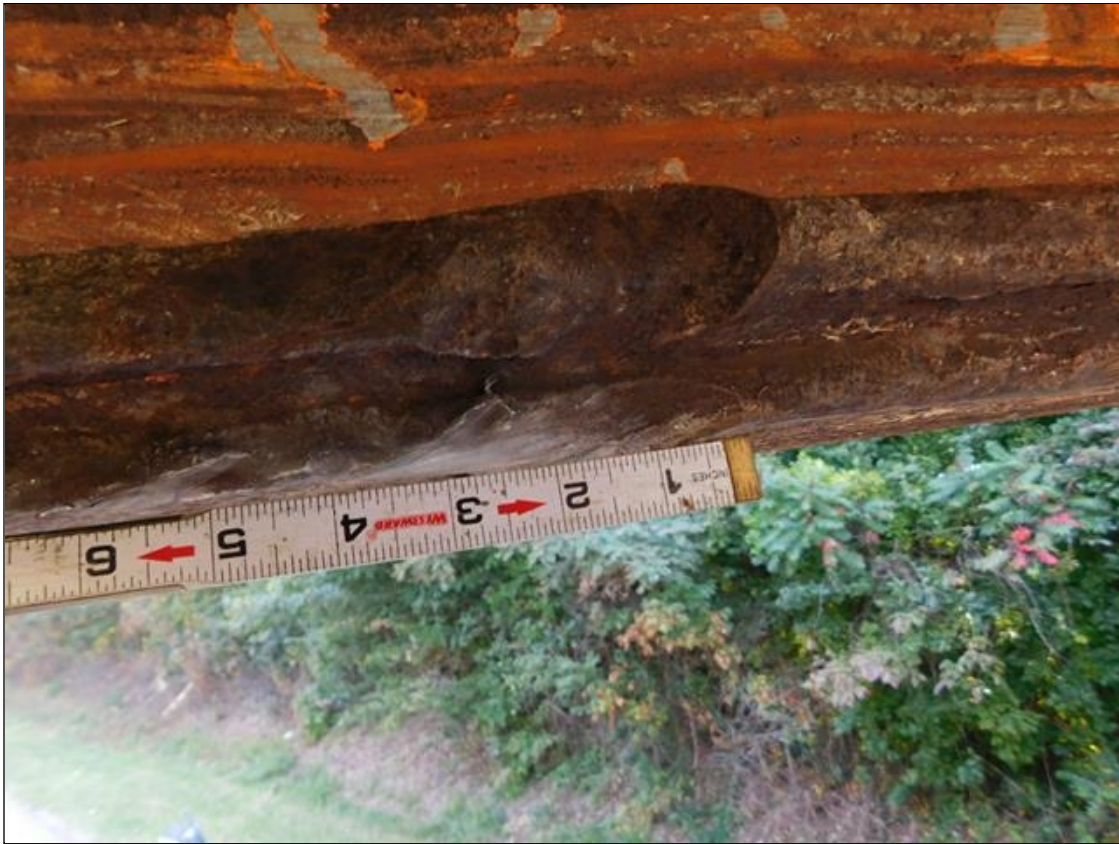
GOUGE TWO Span 2 Beam 6: Supplemental Inspection Impact Damage, Span 2 Beam 6 Is Bowed Westward 9 Degrees Out Of Plumb For a Length Of 12 Foot That Begins 11.5 Foot From Bent 1. At The Point of Impact The Weld Connecting The Bottom Flange To The Bottom Stiffener Plate Is Broken For 30 Inches. The Point of Impact (Located 20.5 Foot From Bent 1) Also Has Two Gouges On The Bottom Flange. The First One Is 17 Inches Long X 1 Inch High X 3 Inch Deep. The Second One Is 6 Inch Long X 1/2 Inch High X 2 Inch Deep. (PAR)

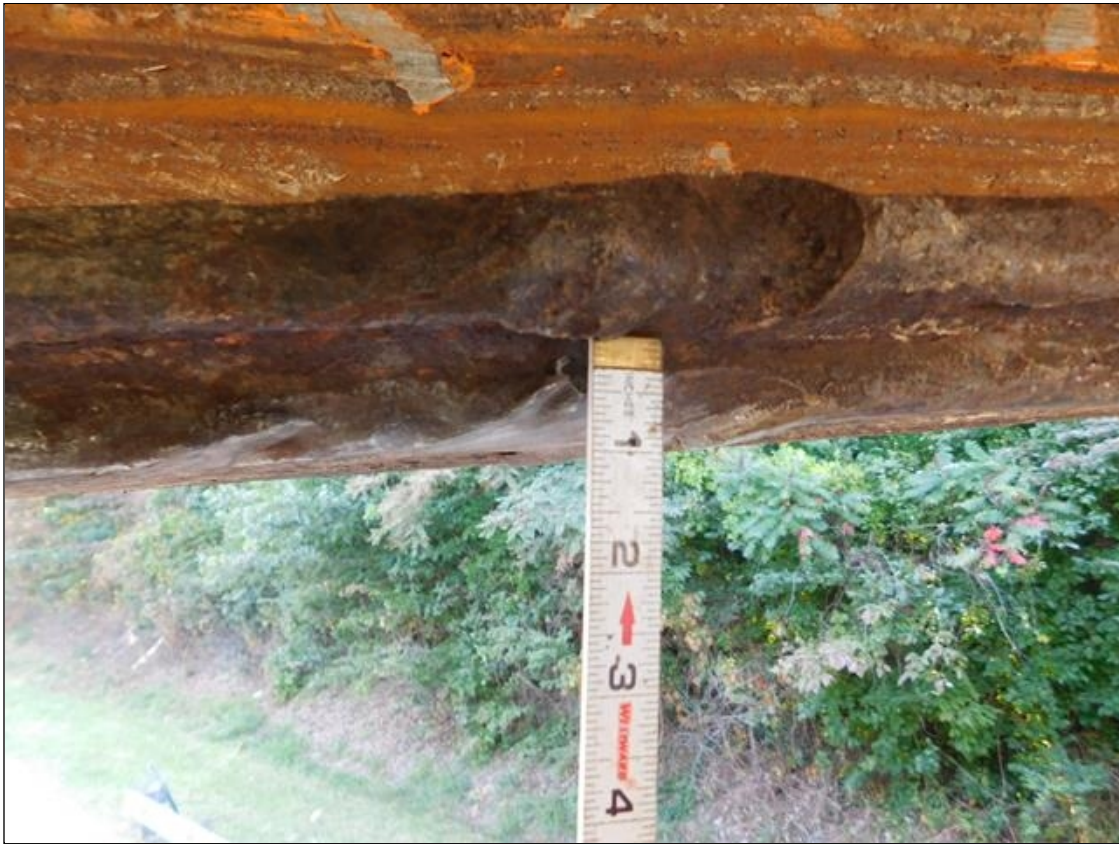
GOUGE TWO Span 2 Beam 6: Supplemental Inspection Impact Damage, Span 2 Beam 6 Is Bowed Westward 9 Degrees Out Of Plumb For a Length Of 12 Foot That Begins 11.5 Foot From Bent 1. At The Point of Impact The Weld Connecting The Bottom Flange To The Bottom Stiffener Plate Is Broken For 30 Inches. The Point of Impact (Located 20.5 Foot From Bent 1) Also Has Two Gouges On The Bottom Flange. The First One Is 17 Inches Long X 1 Inch High X 3 Inch Deep. The Second One Is 6 Inch Long X 1/2 Inch High X 2 Inch Deep. (PAR)

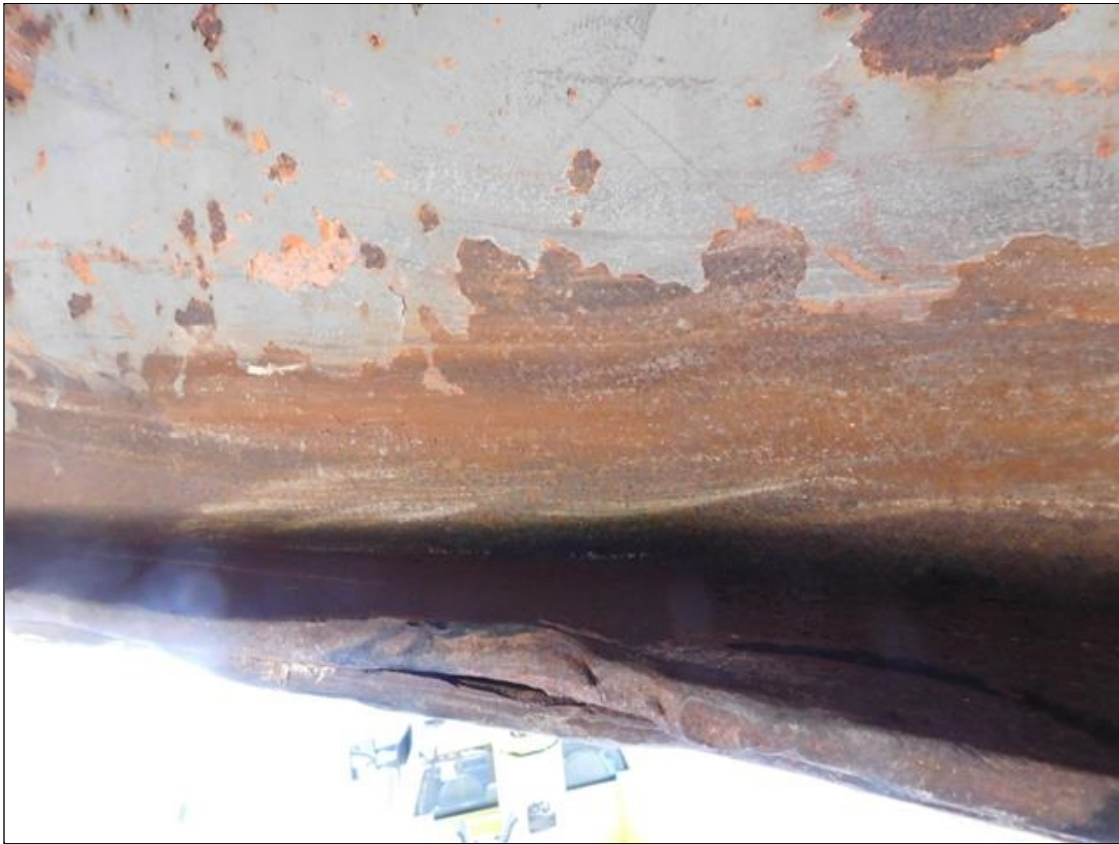
Span 2 Beam 6: Supplemental Inspection Impact Damage 18 Foot Of Scattered Scrapes On Web On The East Side In The Point of Impact Area

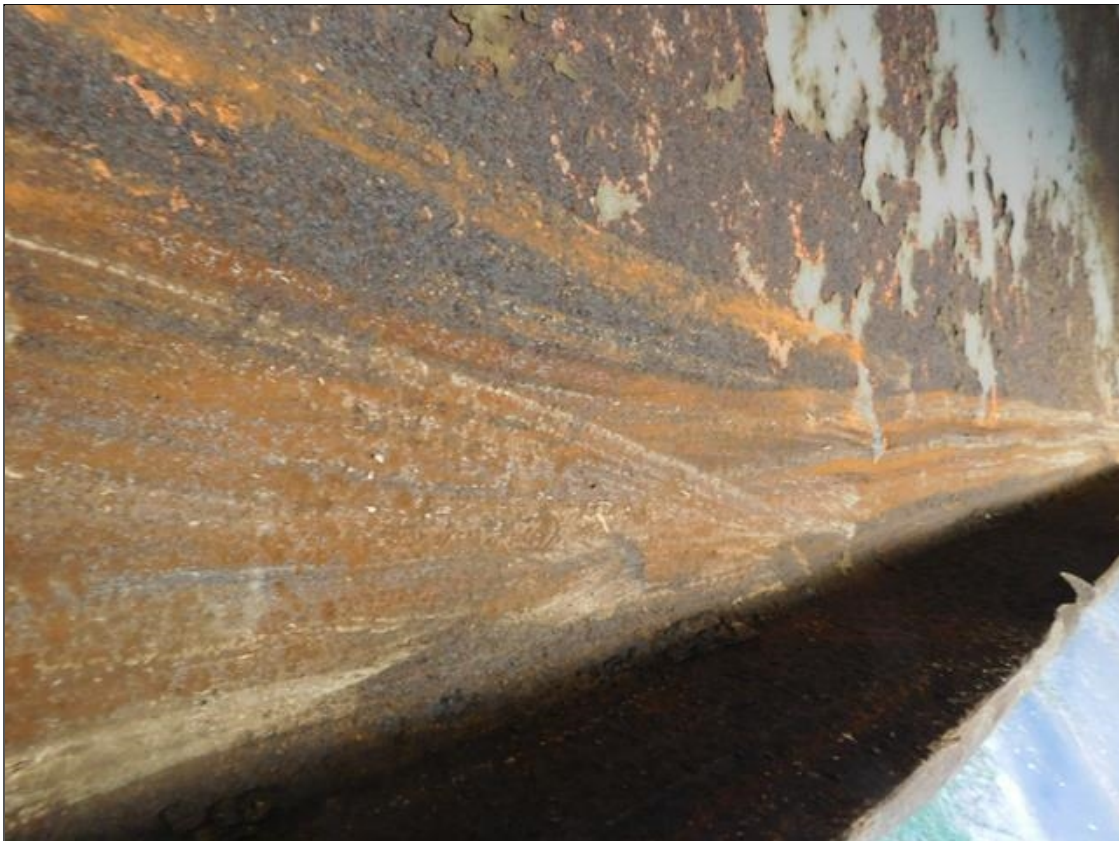
Span 2 Beam 6: Supplemental Inspection Impact Damage 18 Foot Of Scattered Scrapes On Web On The East Side In The Point of Impact Area

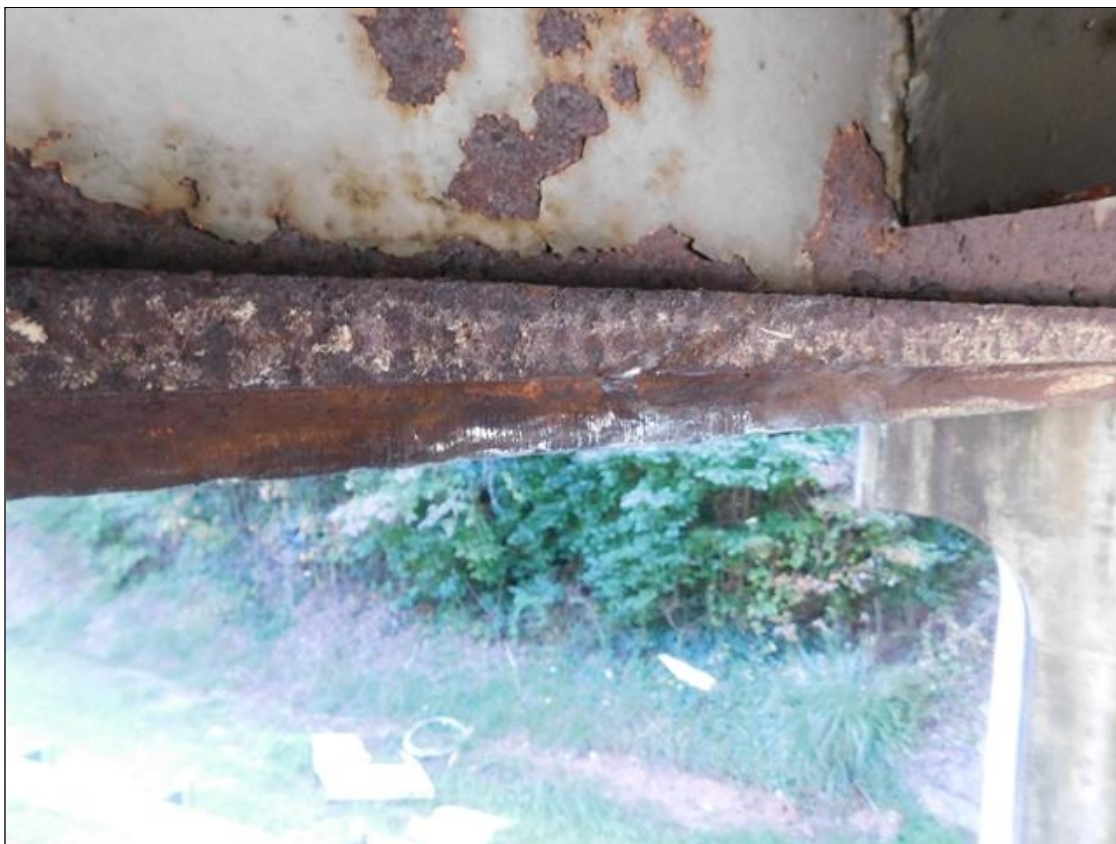
Span 2 Beam 5: Supplemental Inspection Impact Damage Span 2 Beam 5 Has Scattered Scrapes On Bottom Flange
On The East Side For 2 Foot Located 15 Foot From Bent 1
