NC DEPARTMENT OF TRANSPORTATION  
DIVISION OF HIGHWAYS  
STRUCTURE MANAGEMENT UNIT

## Structure Safety Report

### Supplemental Element Inspection

STRUCTURE NUMBER: 110144 SAP STRUCTURE NO: 0120144 FHWA STRUCTURE NO: 000000000230144  
DIVISION: 13 COUNTY: BURKE INSPECTION DATE: 09/19/2024 FREQUENCY: None  
FACILITY CARRIED: SR1704 MILE POST: \_\_\_\_\_  
LOCATION: .2 MI.N.JCT.SR1712  
FEATURE INTERSECTED: I-40  
LATITUDE: 35° 43' 31.7" LONGITUDE: 81° 38' 10.99"  
SUPERSTRUCTURE: REINFORCED CONCRETE FLOOR ON I-BEAMS  
SUBSTRUCTURE: E.BTS:RC CAPS/TIMBER PILES;INT.BTS:RC POST&BEAM  
SPANS: 4 SPANS. SEE SPAN PROFILE SHEET FOR SPAN DETAILS  
☐ FRACTURE CRITICAL ☐ TEMPORARY SHORING ☐ SCOUR CRITICAL ☐ SCOUR PLAN OF ACTION  
GRADES: (Inspector/NBI Coding) DECK 6 / 6 SUPERSTRUCTURE 4 / 5 SUBSTRUCTURE 5 / 5 CULVERT N / N  
POSTED SV: Not Posted POSTED TTST: Not Posted  
OTHER SIGNS PRESENT: NONE

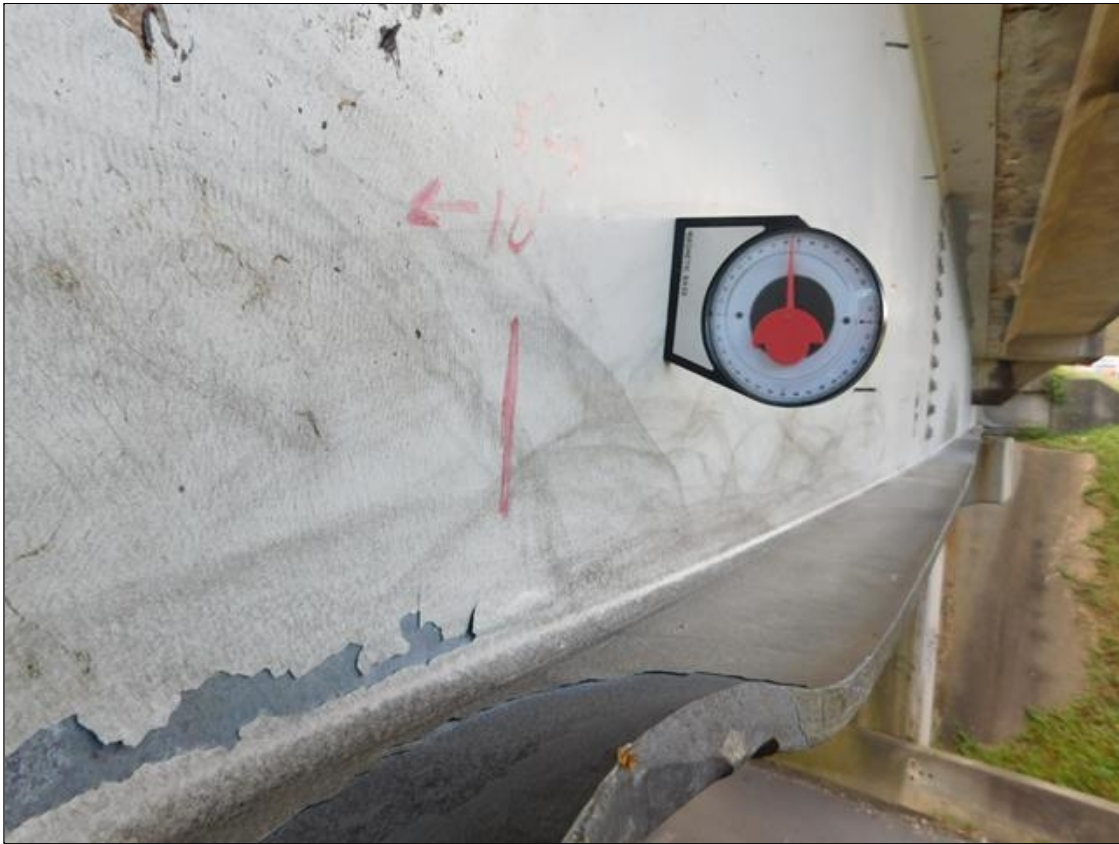
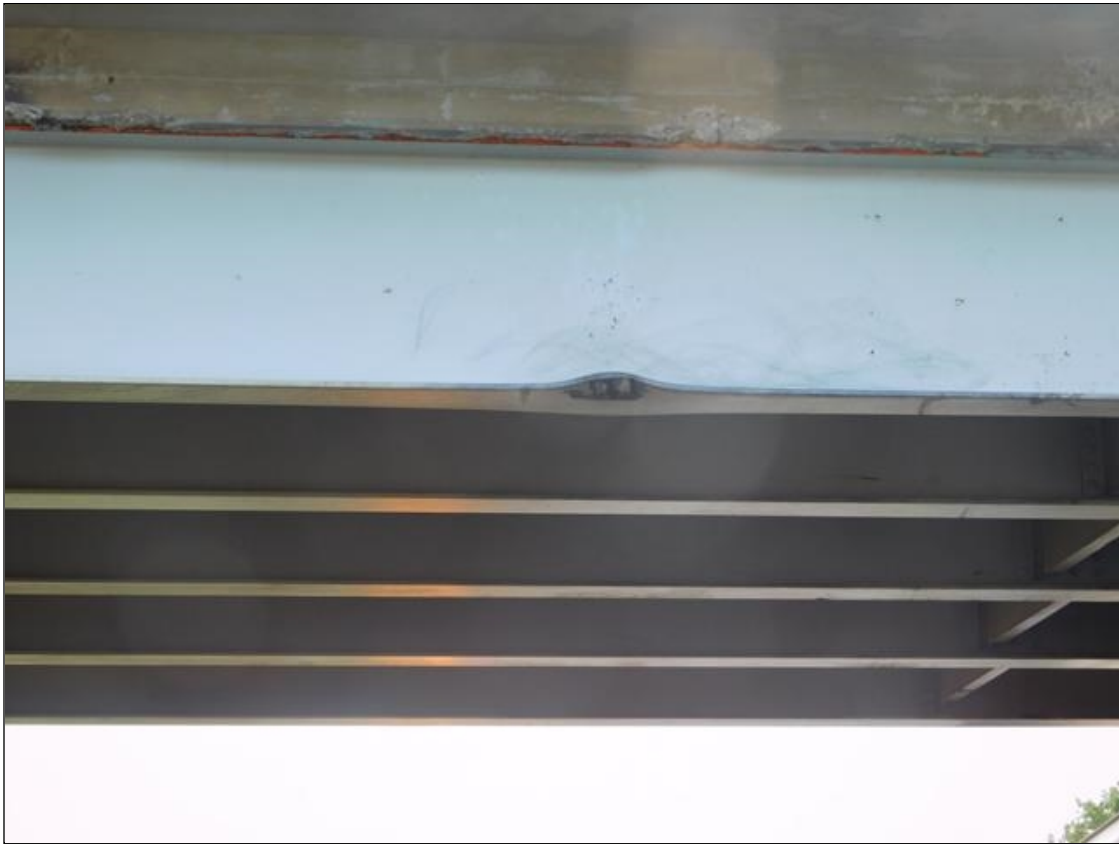
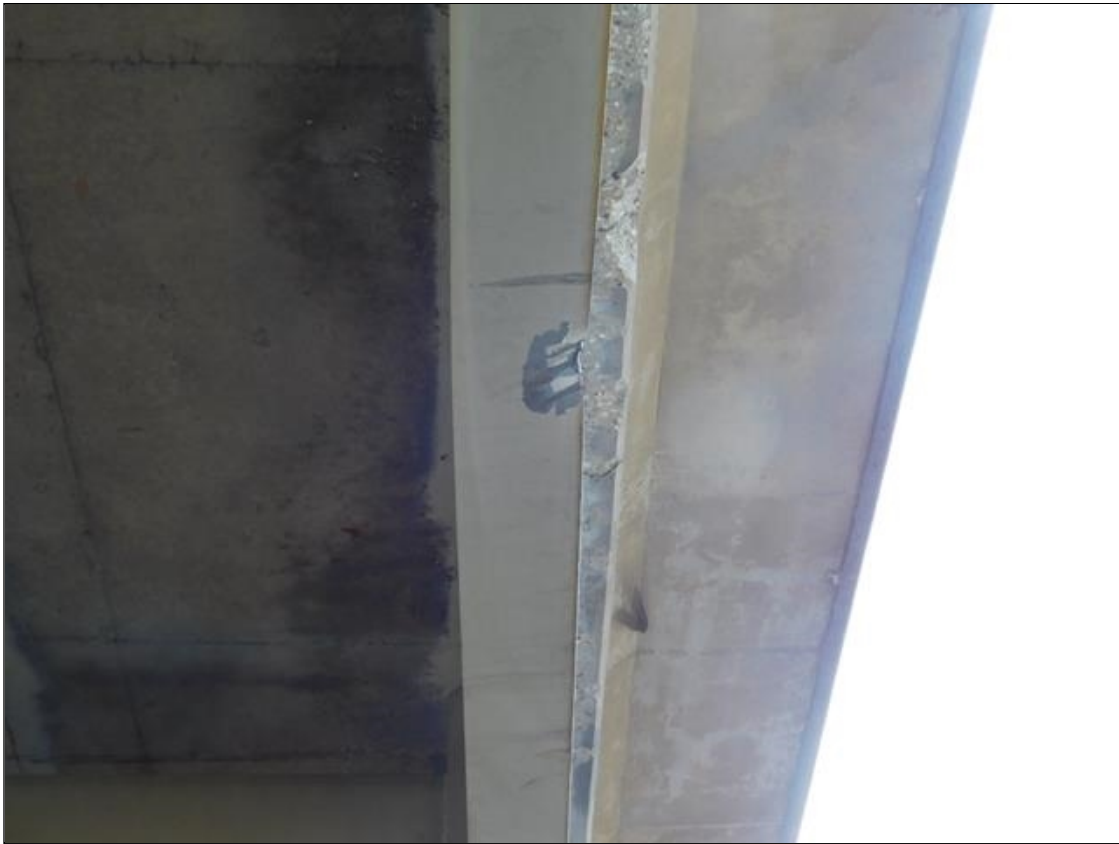
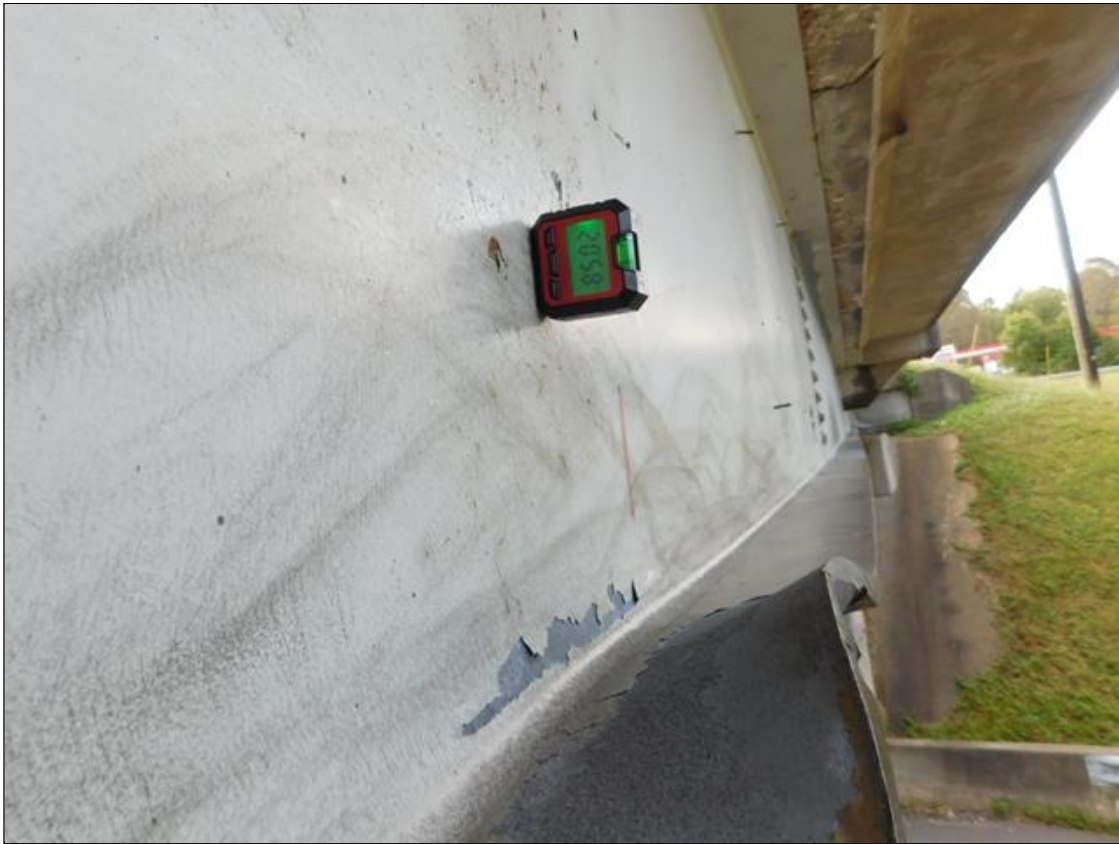
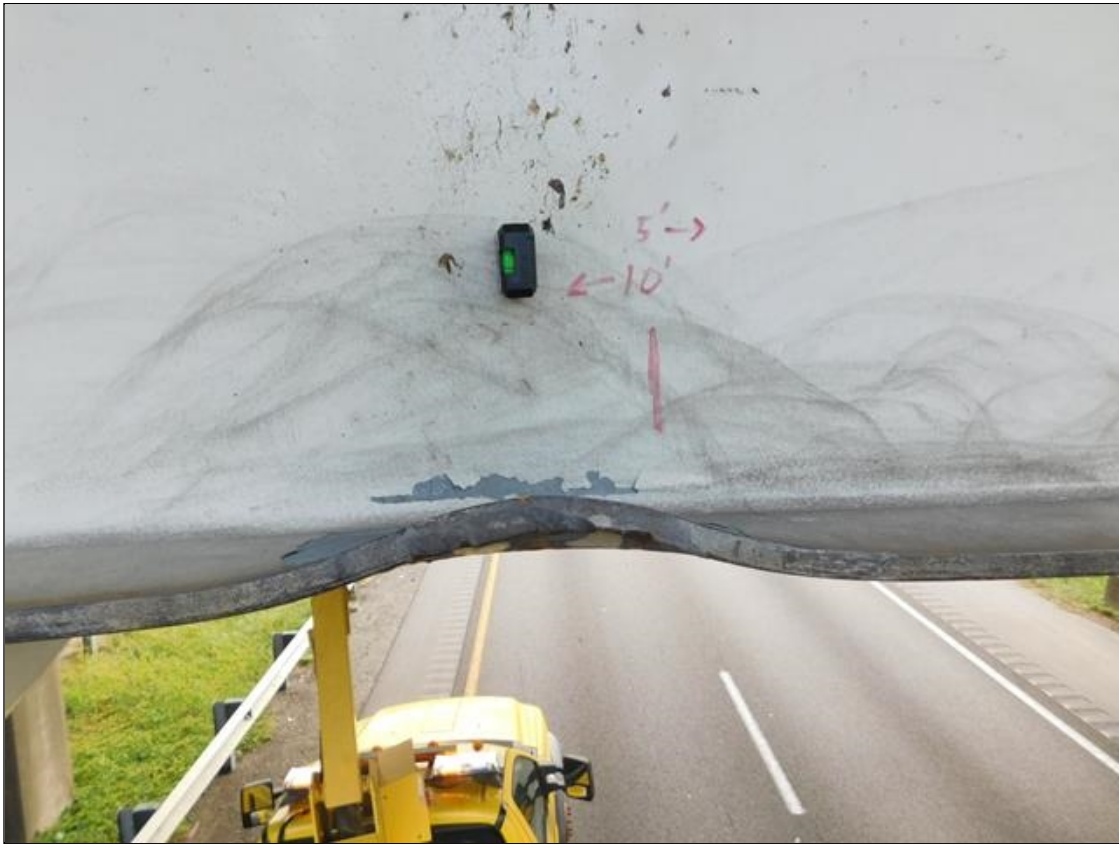
| Priority Level | Defect Type | Quantity | Defect Description |
|---|---|---|---|
| 4 | Distortion | 13 | Span 2 Beam 1: SUPPLEMENTAL INSPECTION IMPACT DAMAGE, SPAN 2 BEAM 1 IS OUT OF PLUMB UP TO 5 DEGREES EASTWARD AT POINT OF IMPACT WHICH IS 17 FOOT 2 INCH FROM BENT 2. IT IS OUT OF PLUMB FOR A TOTAL OF 15 FEET, 10 FOOT NORTH OF THE POINT OF IMPACT AND 5 FOOT TO THE SOUTH. (PAR) |

| <input checked="" type="checkbox"/> | 107 | Distortion | SUPPLEMENTAL INSPECTION IMPACT DAMAGE, SPAN 2 BEAM 1 IS OUT OF PLUMB UP TO 5 DEGREES EASTWARD AT POINT OF IMPACT WHICH IS 17 FOOT 2 INCH FROM BENT 2. IT IS OUT OF PLUMB FOR A TOTAL OF 15 FEET, 10 FOOT NORTH OF THE POINT OF IMPACT AND 5 FOOT TO THE SOUTH. (PAR) | 3 | 13 | 13 Feet |

Span 2 Beam 1: Supplemental Inspection Impact Damage, Span 2 Beam 1 IS OUT OF PLUMB UP TO 5 Degrees EASTWARD AT Point of Impact WHICH IS 17 FOOT 2 INCH FROM Bent 2. IT IS OUT OF PLUMB FOR A TOTAL OF 15 FEET, 10 FOOT NORTH OF THE Point of Impact AND 5 FOOT TO THE SOUTH. (PAR)

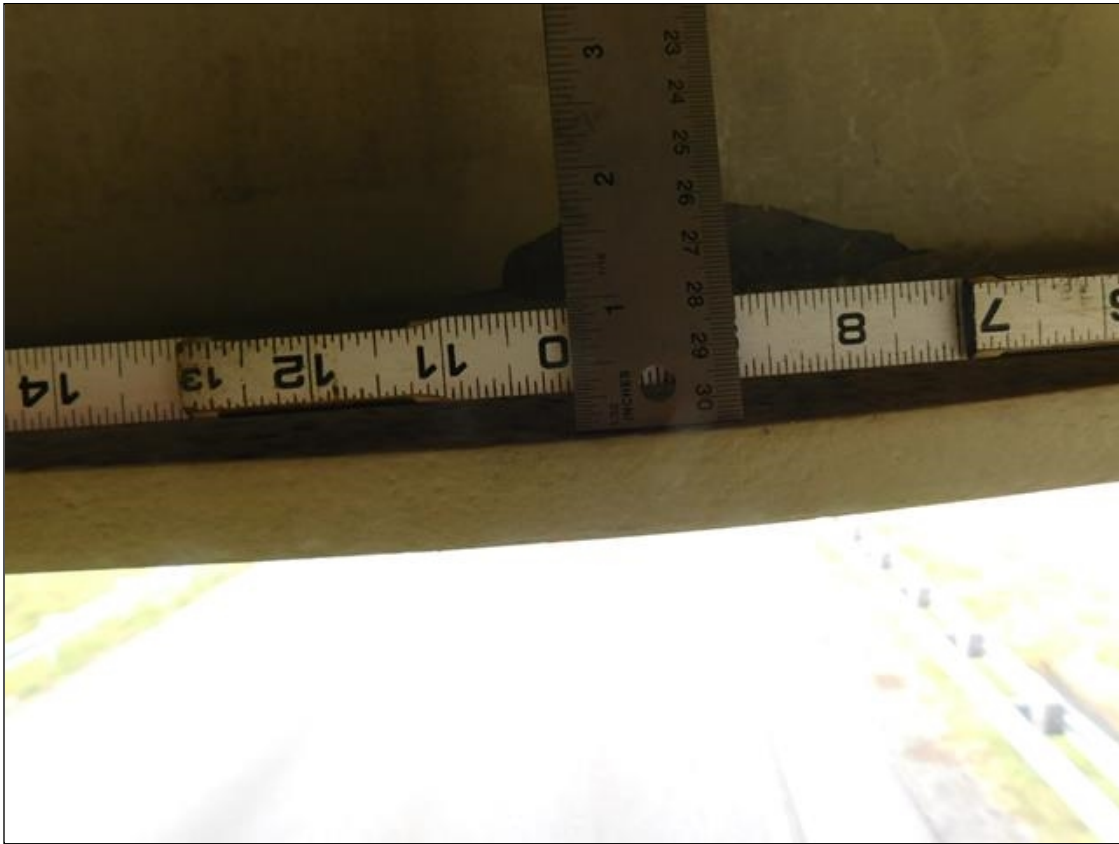
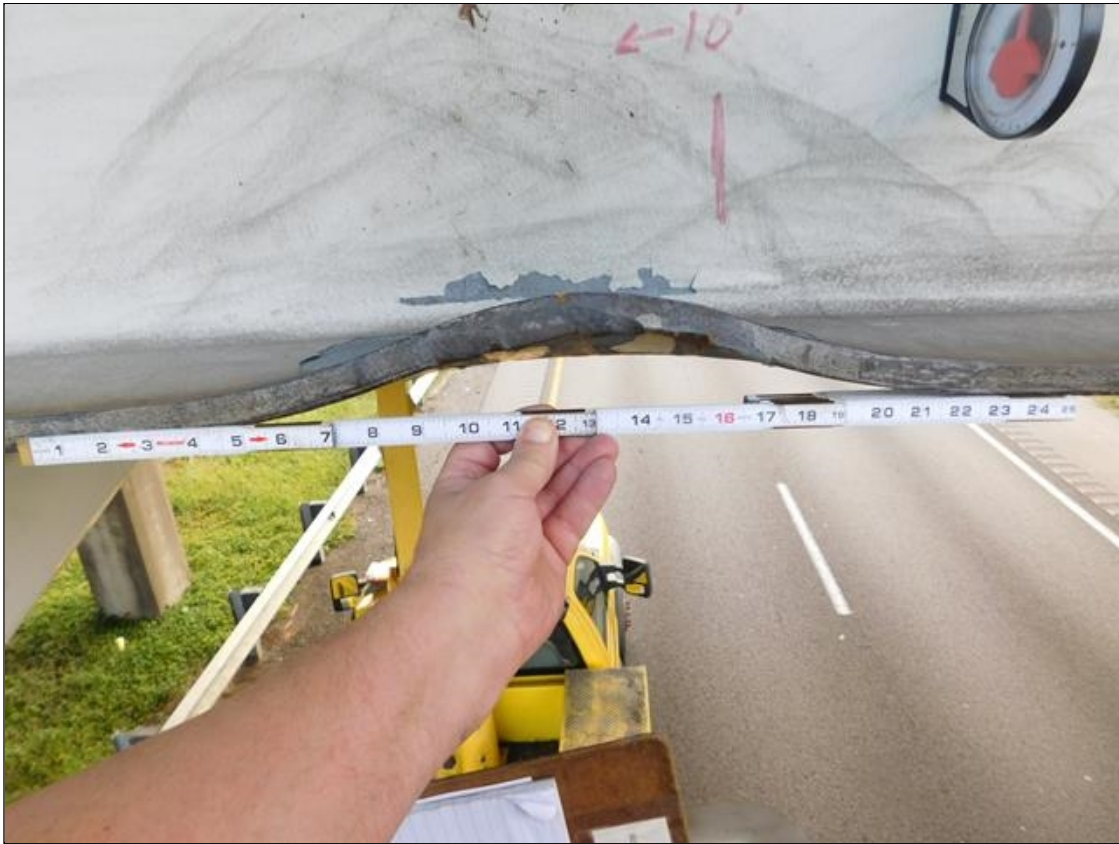
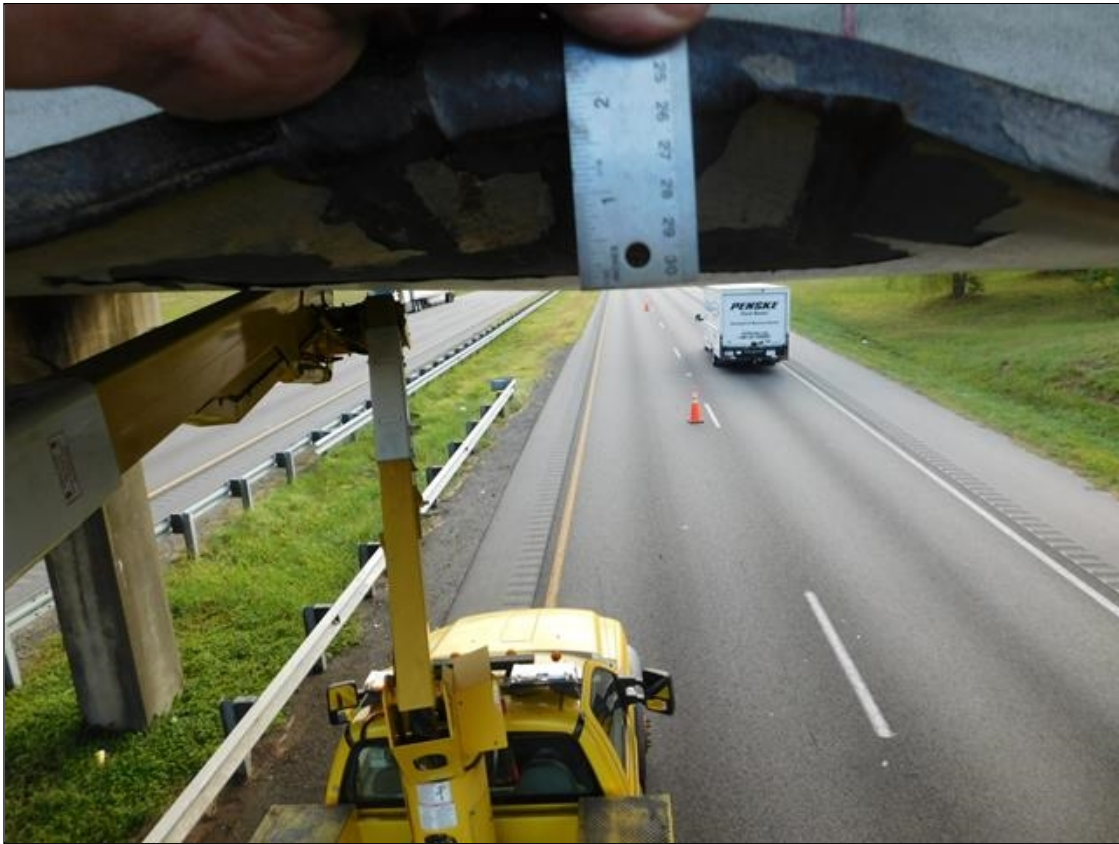
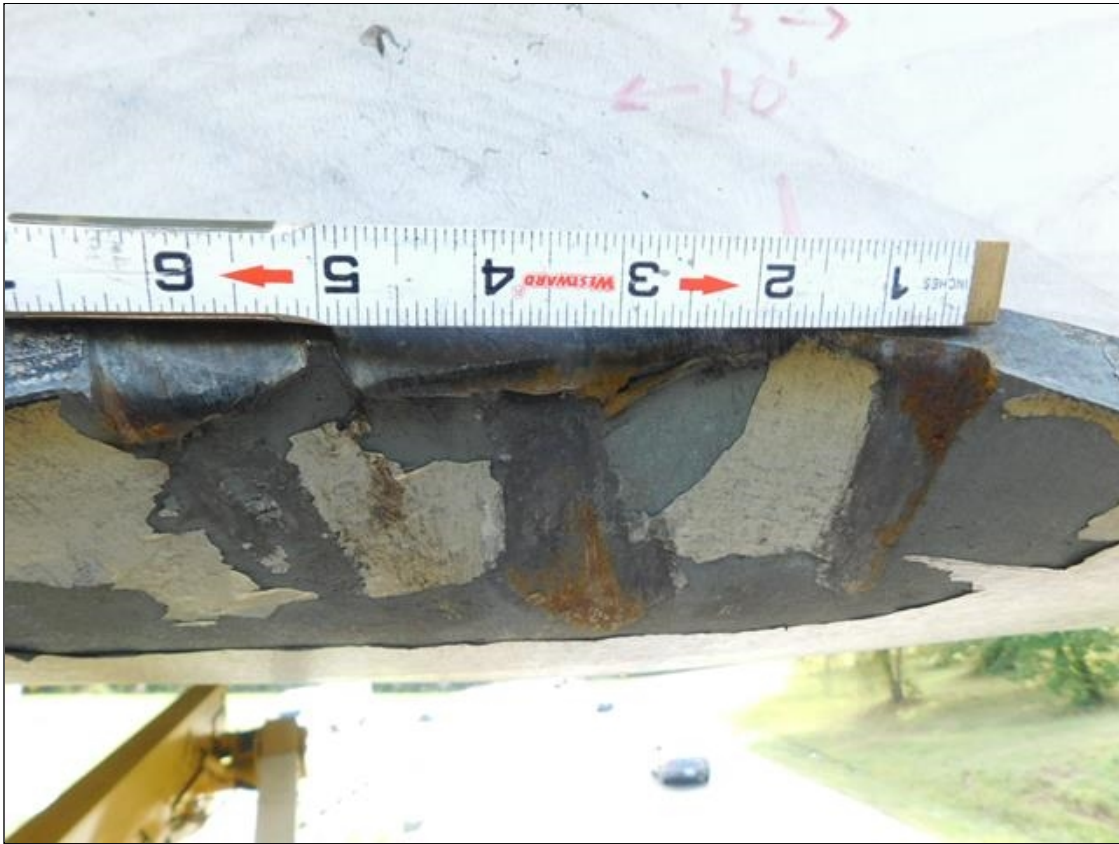
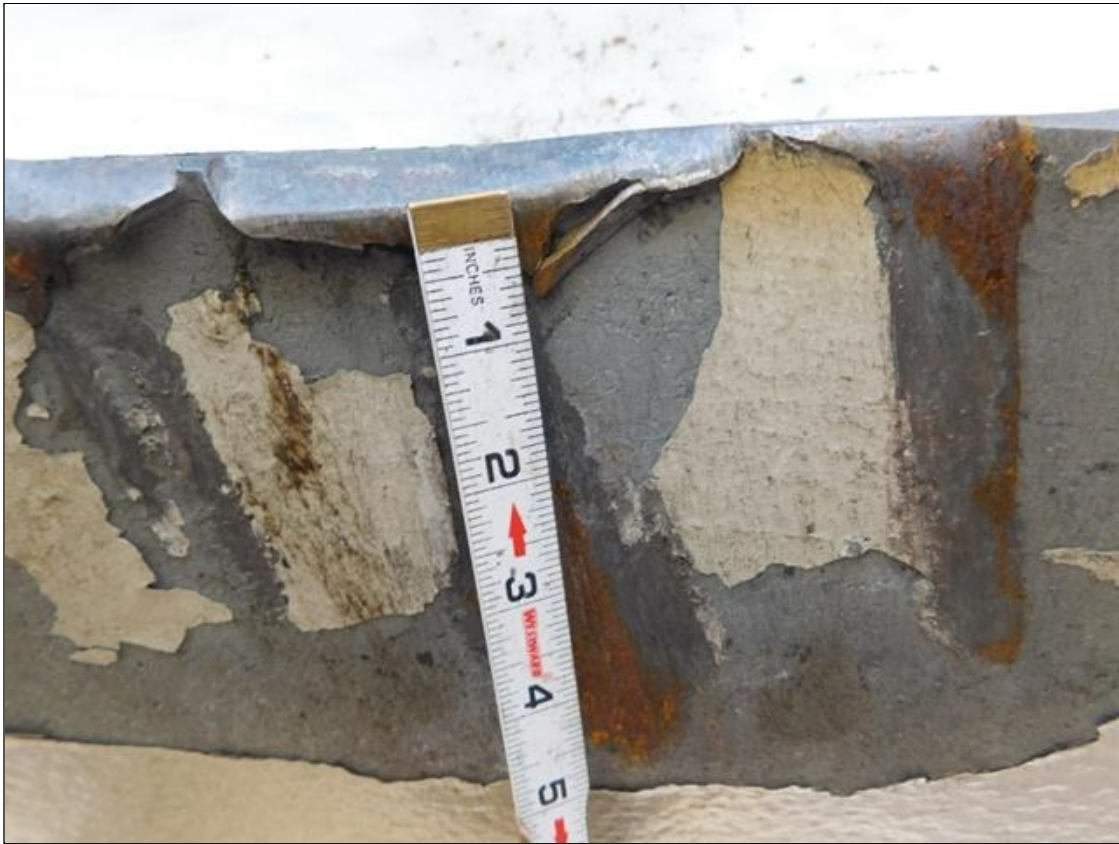
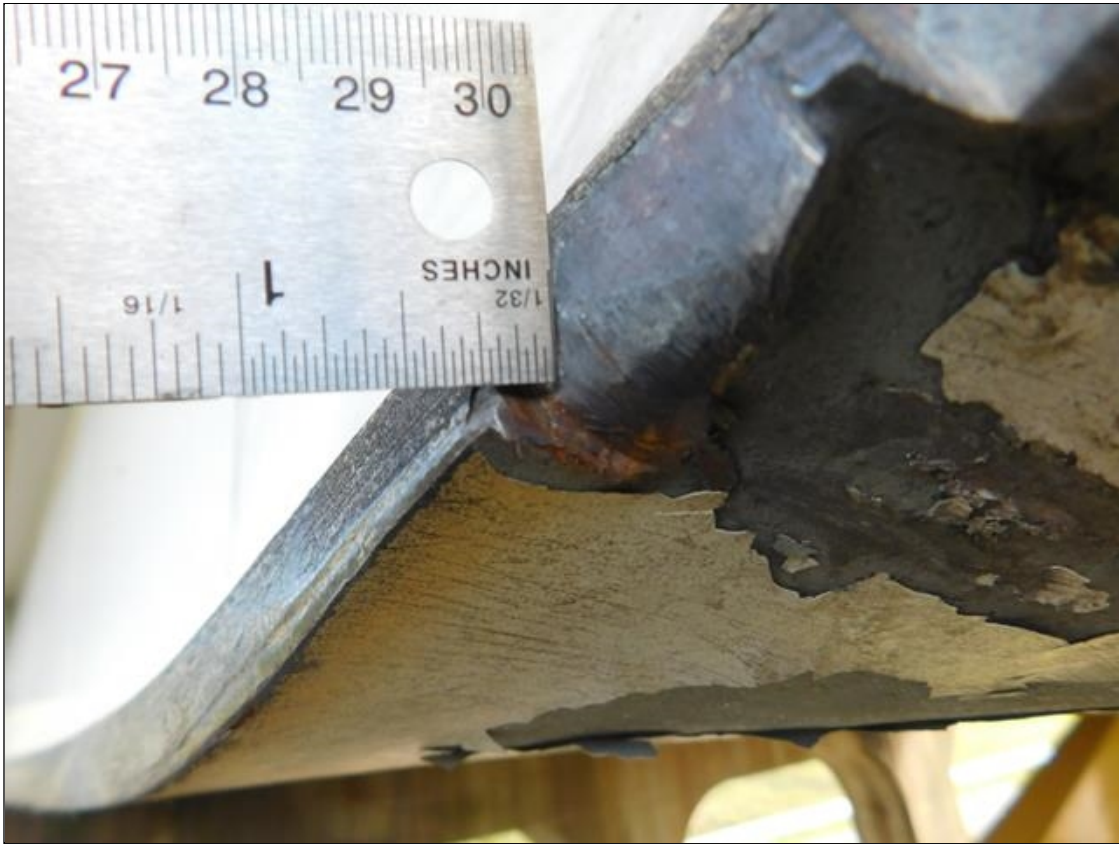
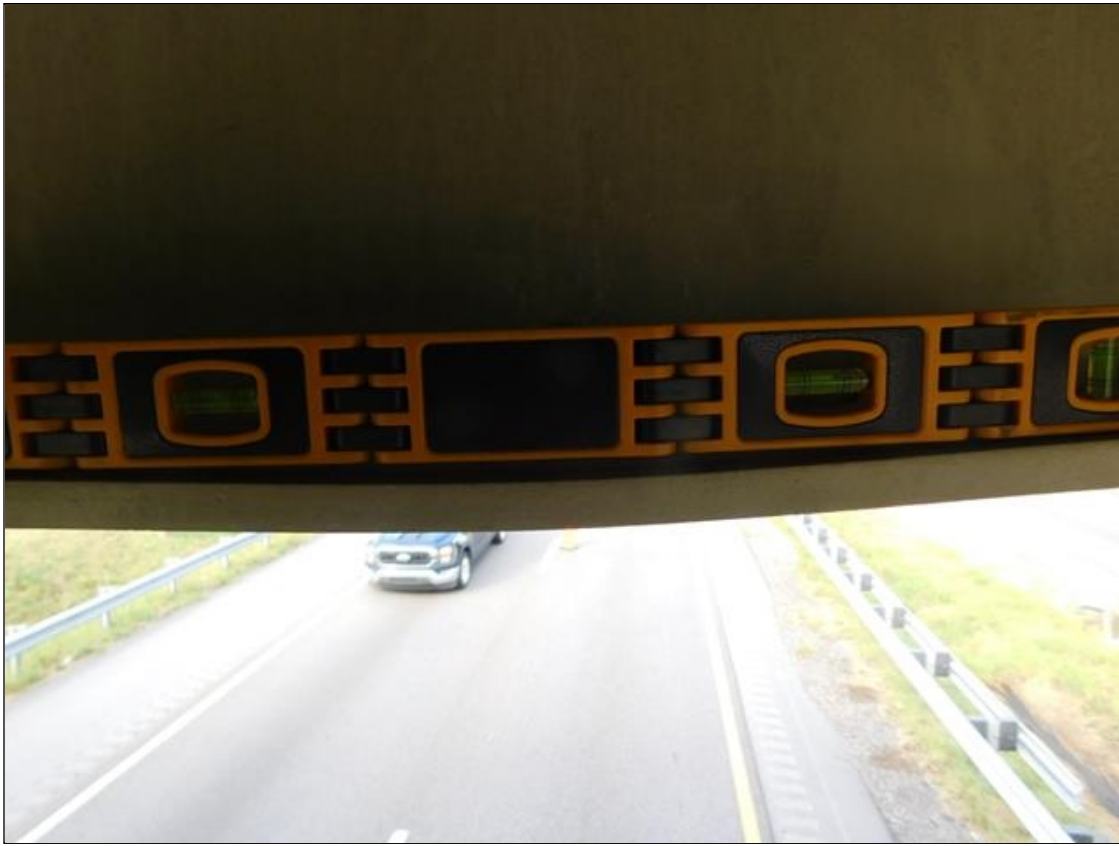
| Priority Level | Defect Type | Quantity | Defect Description |
|---|---|---|---|
| 4 | Distortion | 2 | Span 2 Beam 1: SUPPLEMENTAL INSPECTION IMPACT DAMAGE, SPAN 2 BEAM 1 AT THE POINT OF IMPACT LOCATED 17 FOOT 2 INCH FROM BENT 2 THE BOTTOM FLANGE IS BENT UPWARD ON THE WEST SIDE. THIS IS 2 FOOR LONG X 2 INCH HIGH X 9 INCH ACROSS. THERE IS A 6.5 INCH LONG X UP TO 1/4 INCH DEEP X 5 INCH ACROSS GOUGE IN THE CENTER OF THE BENT BOTTOM FLANGE ON THE WEST SIDE. AT THE SAME LOCATION ON THE EAST SIDE THE BOTTOM FLANGE IS BENT DOWNWARD UP TO A 1/4 INCH OVER A 20 INCH LENGTH. (PAR) |

| <input checked="" type="checkbox"/> | 107 | Distortion | SUPPLEMENTAL INSPECTION IMPACT DAMAGE, SPAN 2 BEAM 1 AT THE POINT OF IMPACT LOCATED 17 FOOT 2 INCH FROM BENT 2 THE BOTTOM FLANGE IS BENT UPWARD ON THE WEST SIDE. THIS IS 2 FOOT LONG X 2 INCH HIGH X 9 INCH ACROSS. THERE IS A 6.5 INCH LONG X UP TO 1/4 INCH DEEP X 5 INCH ACROSS GOUGE IN THE CENTER OF THE BENT BOTTOM FLANGE ON THE WEST SIDE. AT THE SAME LOCATION ON THE EAST SIDE THE BOTTOM FLANGE IS BENT DOWNWARD UP TO A 1/4 INCH OVER A 20 INCH LENGTH. (PAR) | 4 | 2 | 2 Feet |

Span 2 Beam 1: SUPPLEMENTAL INSPECTION IMPACT DAMAGE, SPAN 2 BEAM 1 AT THE POINT OF IMPACT LOCATED 17 FOOT 2 INCH FROM BENT 2 THE BOTTOM FLANGE IS BENT UPWARD ON THE WEST SIDE. THIS IS 2 FOOT LONG X 2 INCH HIGH X 9 INCH ACROSS. THERE IS A 6.5 INCH LONG X UP TO 1/4 INCH DEEP X 5 INCH ACROSS GOUGE IN THE CENTER OF THE BENT BOTTOM FLANGE ON THE WEST SIDE. AT THE SAME LOCATION ON THE EAST SIDE THE BOTTOM FLANGE IS BENT DOWNWARD UP TO A 1/4 INCH OVER A 20 INCH LENGTH. (PAR)
