NC DEPARTMENT OF TRANSPORTATION  
 DIVISION OF HIGHWAYS  
 STRUCTURE MANAGEMENT UNIT

# Structure Safety Report

## Supplemental Element Inspection

DIVISION: 13 COUNTY: BUNCOMBE STRUCTURE NUMBER: 100382 FREQUENCY: None

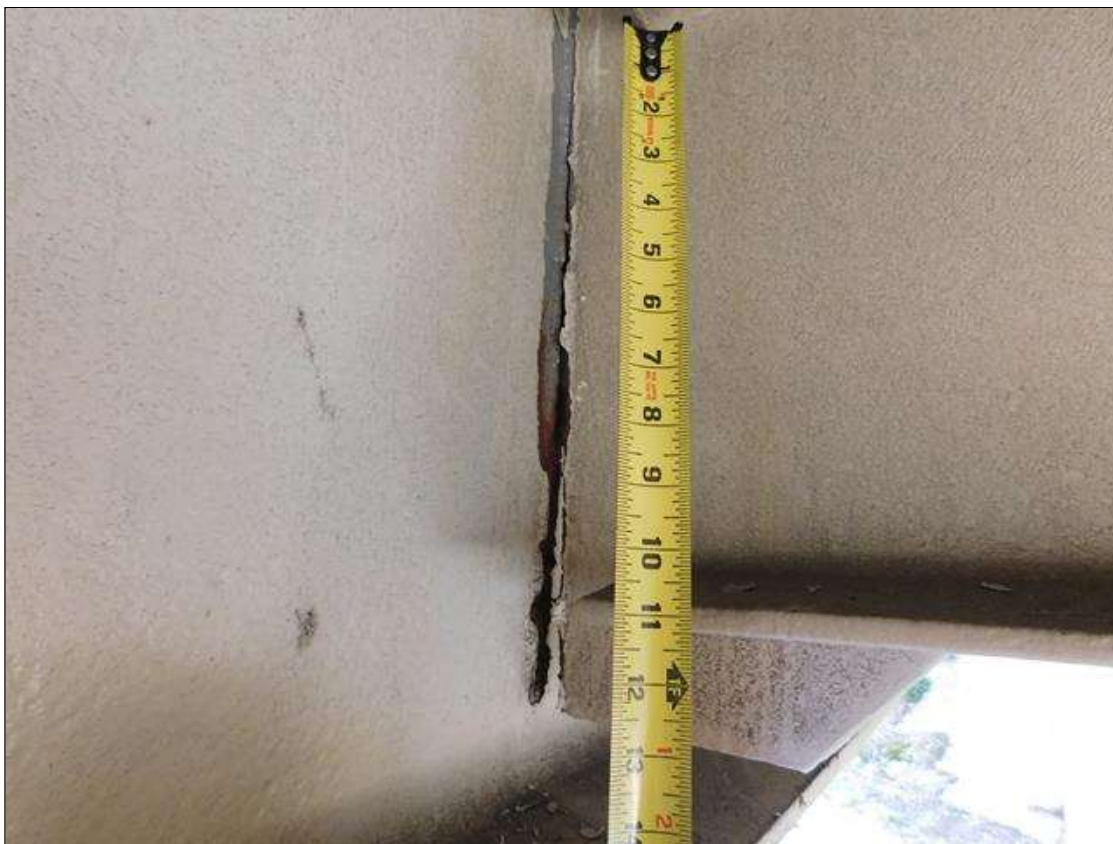
DIAPHRAGM 3 BAY 9 IN SPAN 2 IS CRACKED AND SEPERATED FROM BEAM 10. THE CRACK IS A TOTAL LENGTH OF 20" FROM THE BOTTOM OF THE DIAPHRAGM.

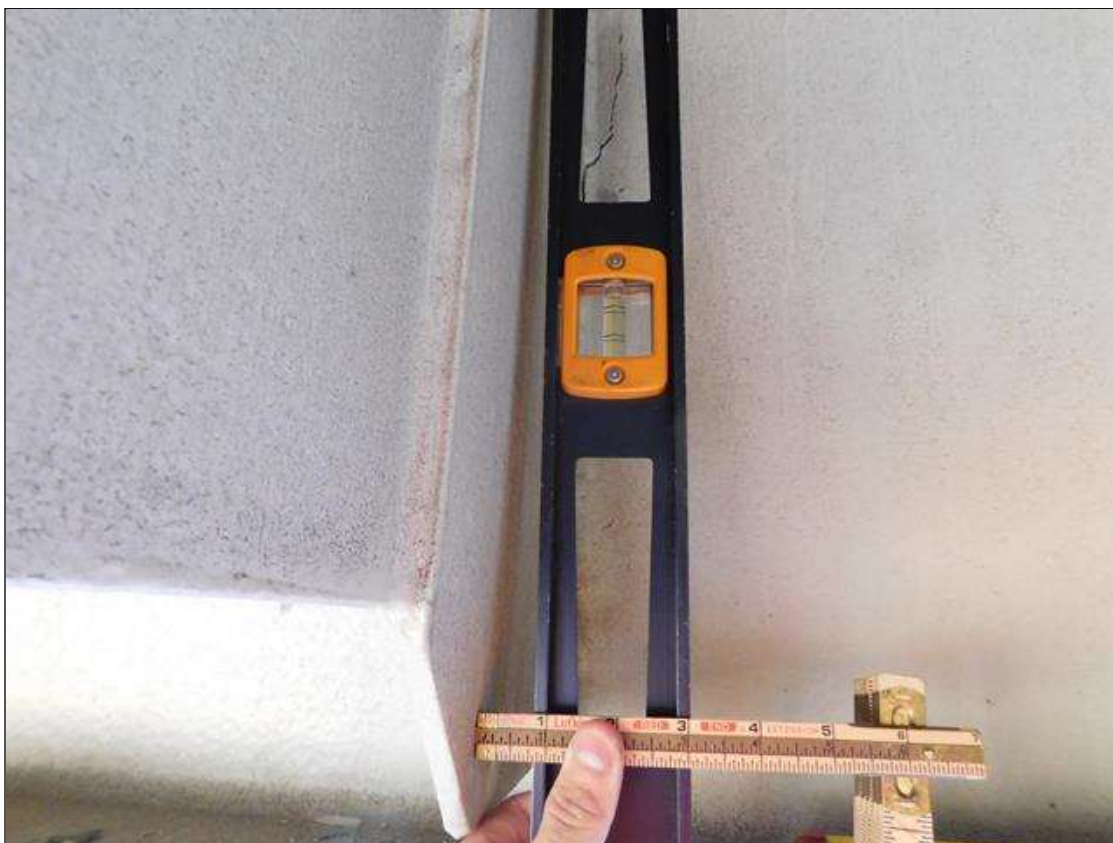
DIAPHRAGM 3 BAY 9 IS OUT OF PLUMB SOUTHWARD FOR 1"

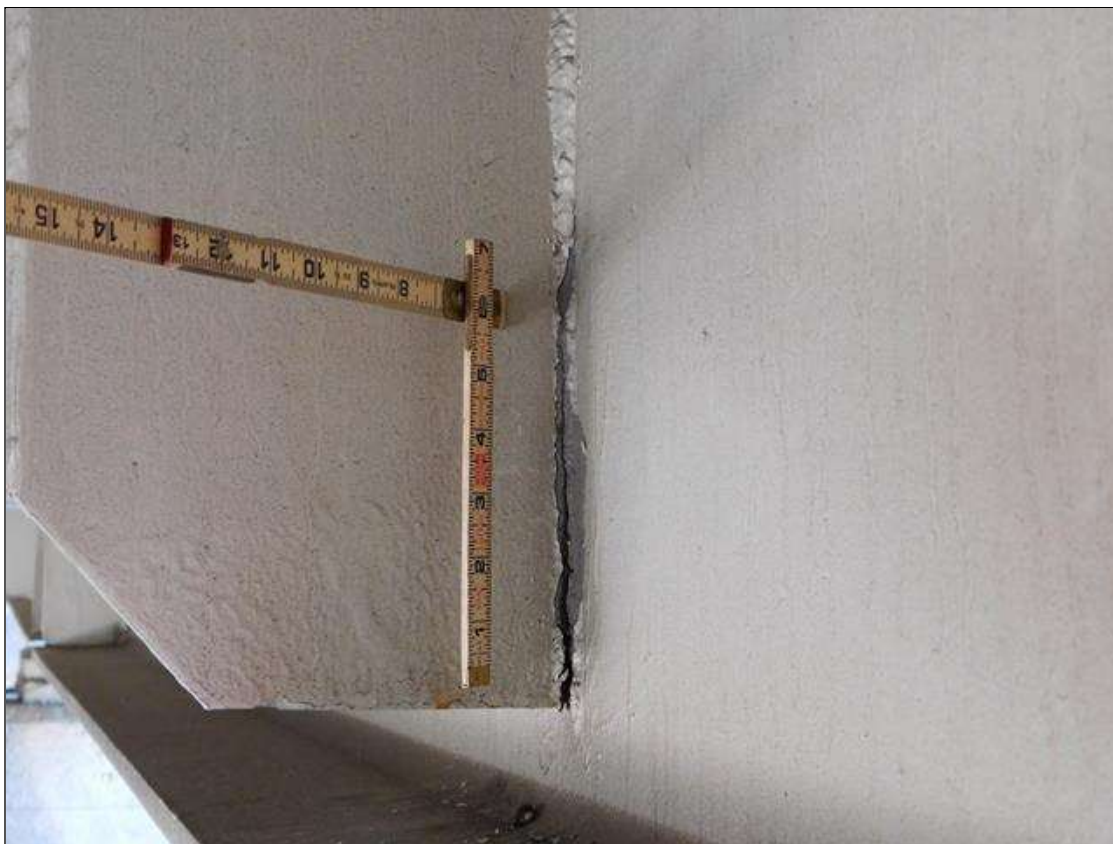
DIAPHRAGM 4 BAY 9 IN SPAN 2 IS CRACKED AND SEPERATED FROM BEAM 10. THE CRACK IS A TOTAL LENGTH OF 8" FROM THE BOTTOM OF THE DIAPHRAGM.

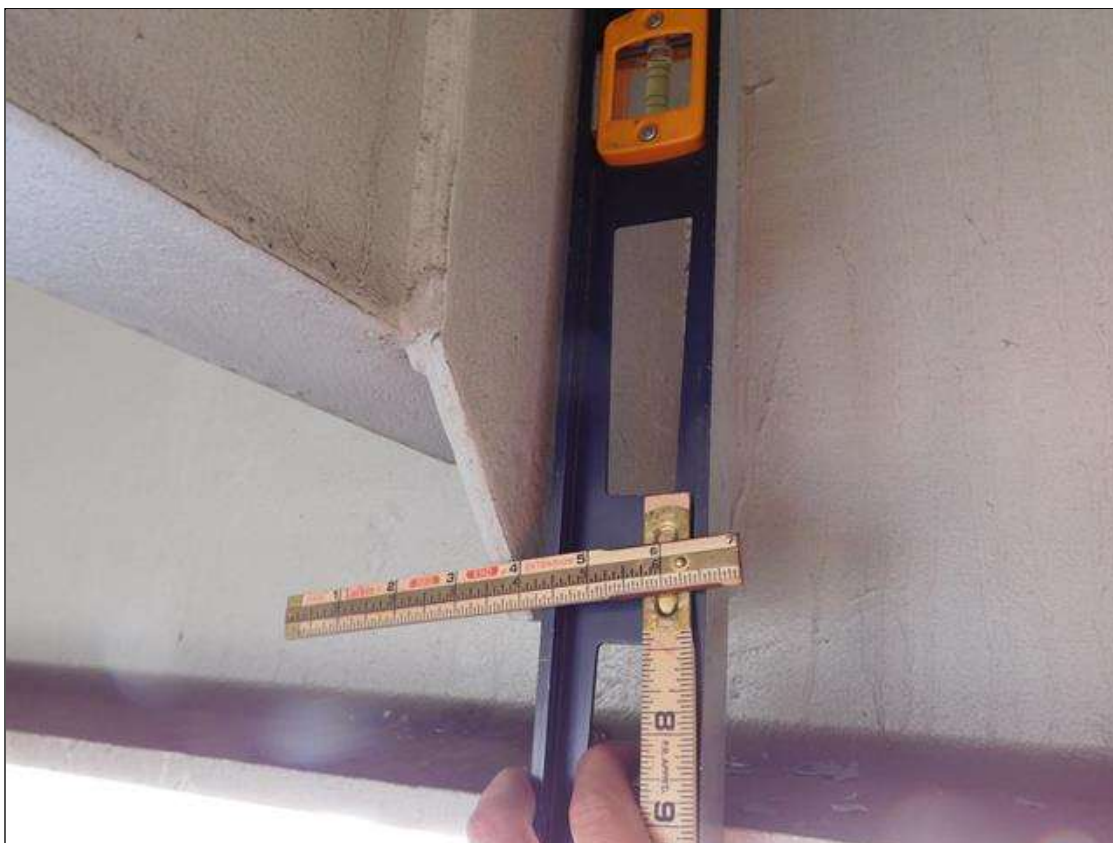
DIAPHRAGM 4 BAY 9 IS OUT OF PLUMB SOUTHWARD FOR 3/4"

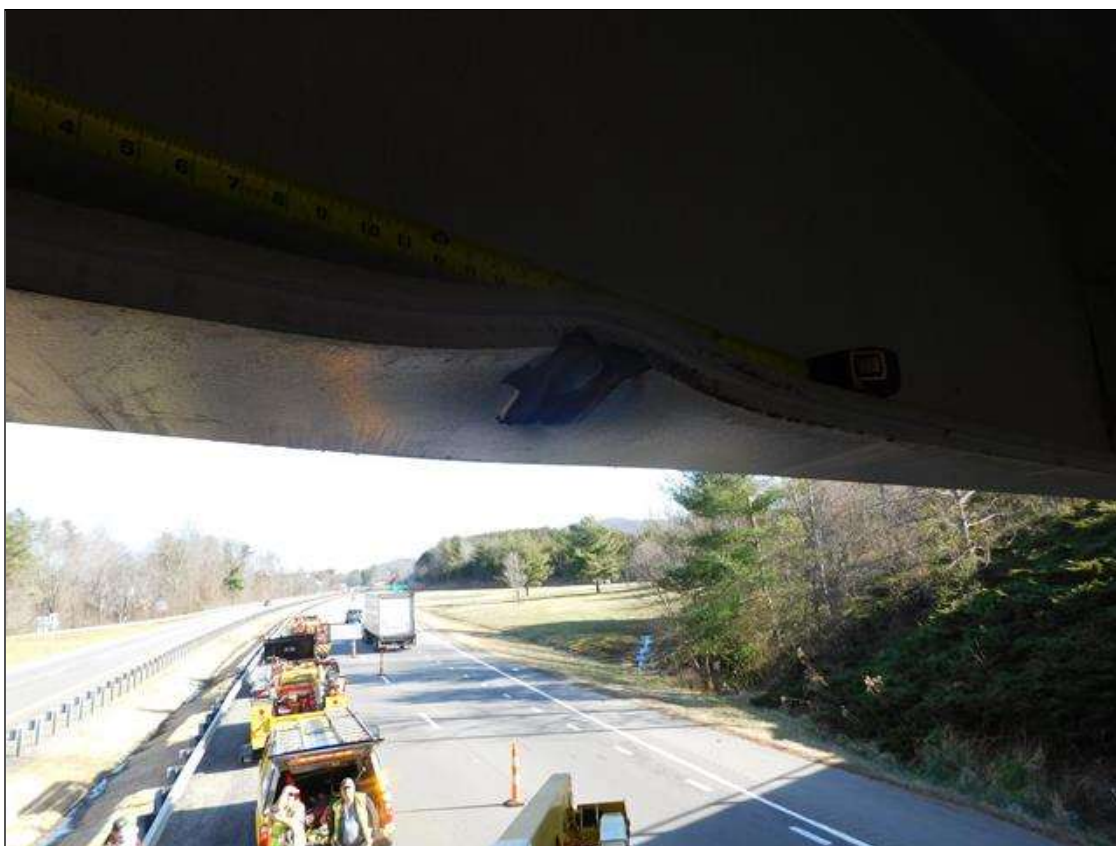
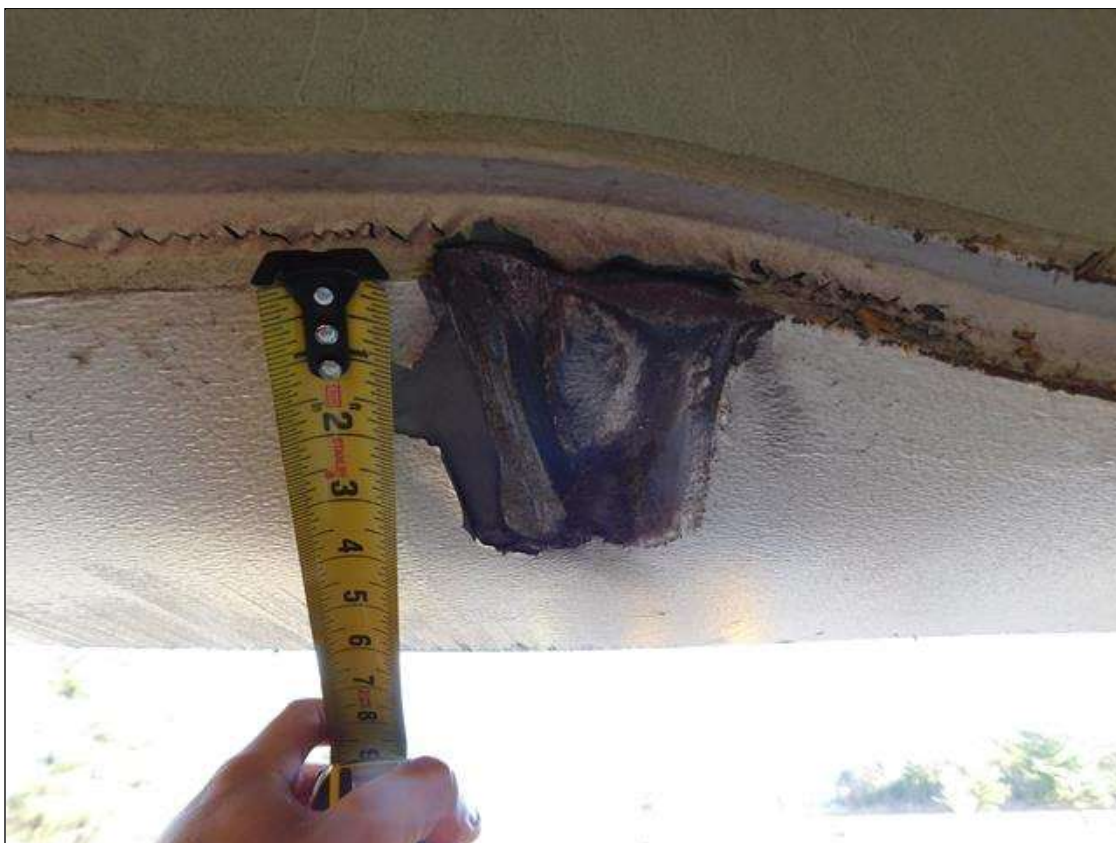
| Element Number | Defect Type | Defect Description | CS | CS Qty | Maint Qty | |
|---|---|--|---|---|---|---|
| 107 | Damage | THREE INDENTIONS IN BEAM 10 AT POINT OF IMPACT. INDENTION 1 IS 4" LONG X 5" WIDE IN BEAM 10 MEASURED 17' FROM INTERIOR BENT 2. INDENTION 2 IS 3" LONG X 1" WIDE MEASURED 23'2" FROM INTERIOR BENT 2. INDENTION 3 IS 3" LONG X 1" WIDE MEASURED 26'4" FROM INTERIOR BENT 2. | 3 | 3 | 3 | Feet |

OVERVIEW OF INDENTATION AT POINT OF IMPACT FOR BEAM 10. INDENTATION IS 4" LONG X 5" WIDE IN BEAM 10 MEASURED 17' FROM INTERIOR BENT 2

CLOSE UP OF INDENTATION AT POINT OF IMPACT FOR BEAM 10. INDENTATION IS 4" LONG X 5" WIDE IN BEAM 10 MEASURED 17' FROM INTERIOR BENT 2

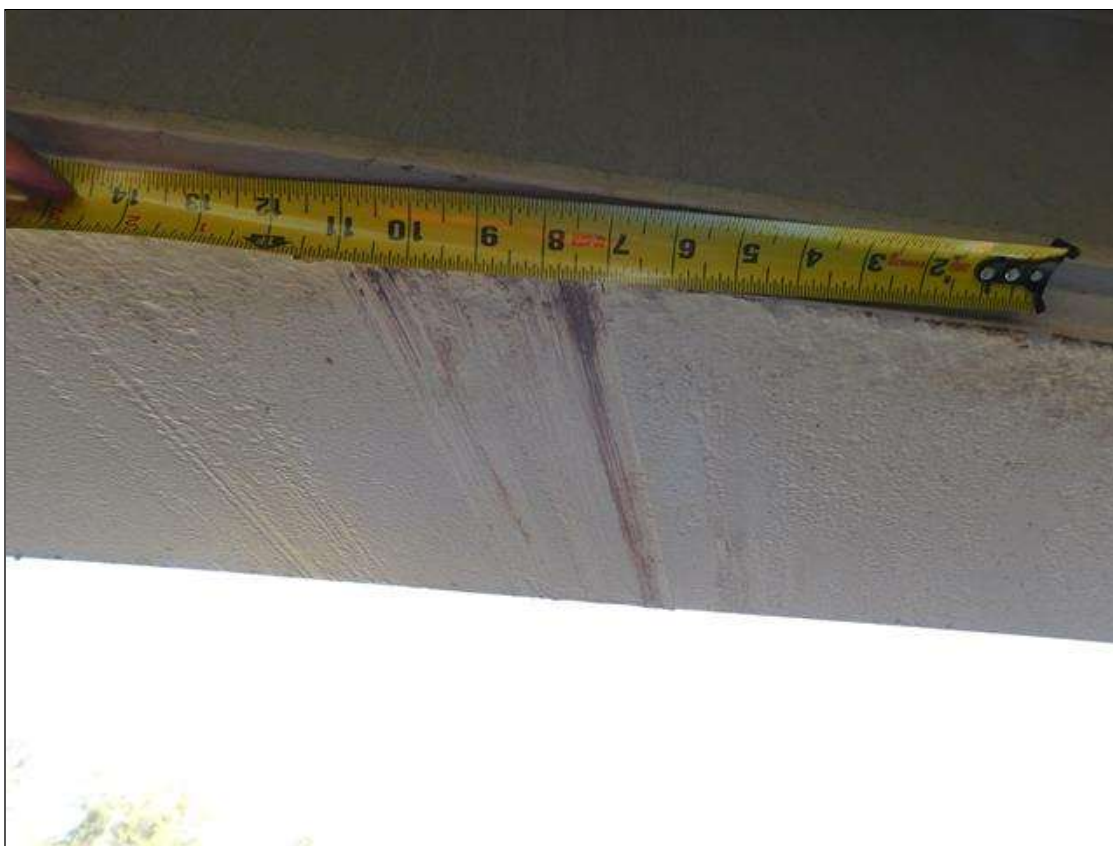
| Element Number | Defect Type | Defect Description | CS | CS Qty | Maint Qty | |
|---|---|--|---|---|---|---|
| 107 | Damage | SCRAPES ON BOTTOM FLANGE OF BEAM 10. MEASURED 20' FROM INERIOR BENT 2 FOR A LENGTH OF 6". SCATTERED SCRAPES ON BOTTOM FLANGE OF BEAM 10 MEASURED 28' FROM INTERIOR BENT 2 AND MEASURED 30' FROM INTERIOR BENT 2 | 2 | 5 | 5 | Feet |

SCRAPES ON BOTTOM FLANGE OF BEAM 10 FOR A TOTAL LENGTH OF 6". MEASURED 20' OUT FROM INTERIOR BENT 2

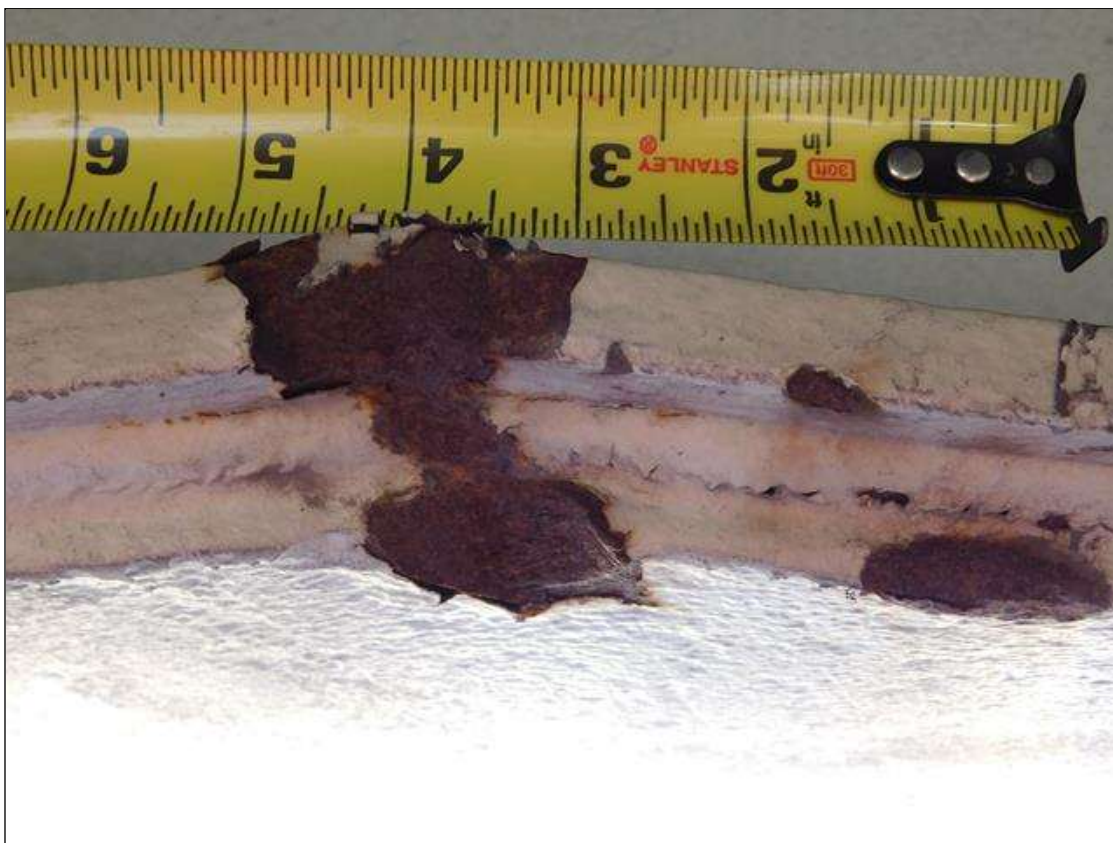
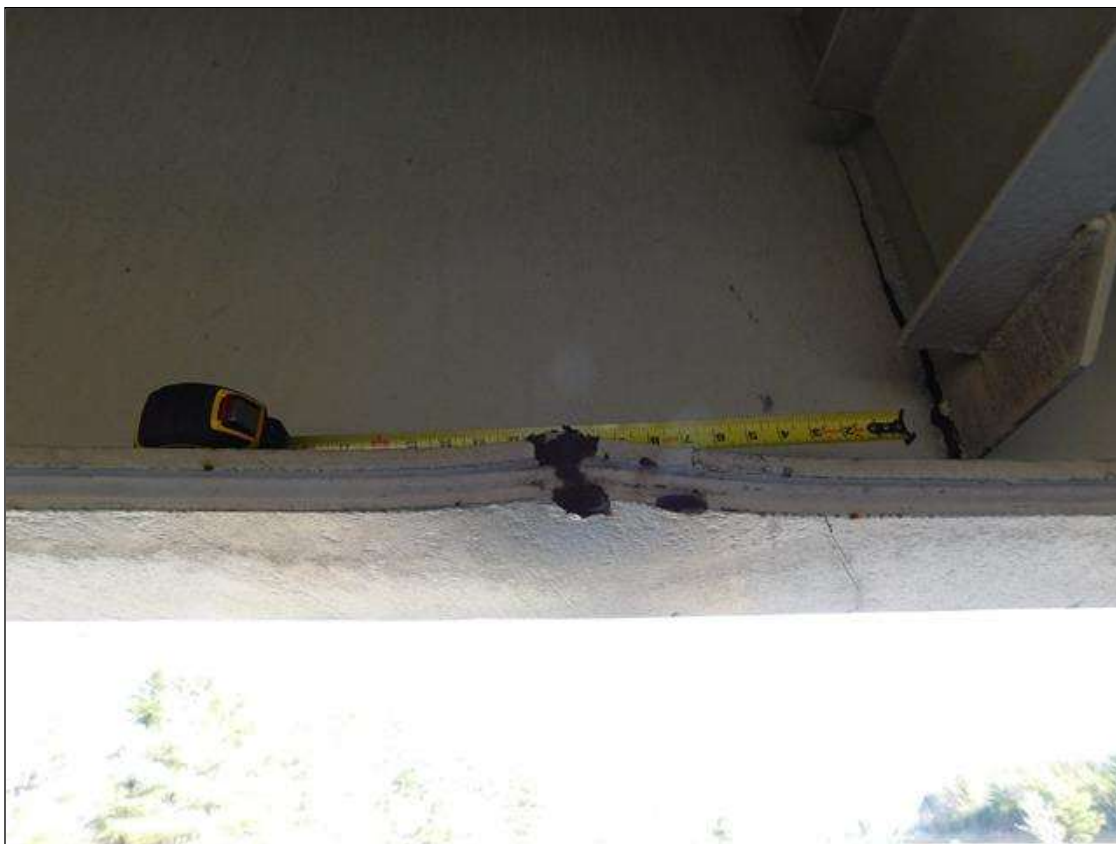
CLOSE UP OF INDENTION AT POINT OF IMPACT FOR BEAM 10. INDENTION IS 3" LONG X 1" WIDE MEASURED 23'2" FROM INTERIOR BENT 2

OVERVIEW OF INDENTATION AT POINT OF IMPACT FOR BEAM 10. INDENTATION IS 3" LONG X 1" WIDE MEASURED 23'2" FROM INTERIOR BENT 2

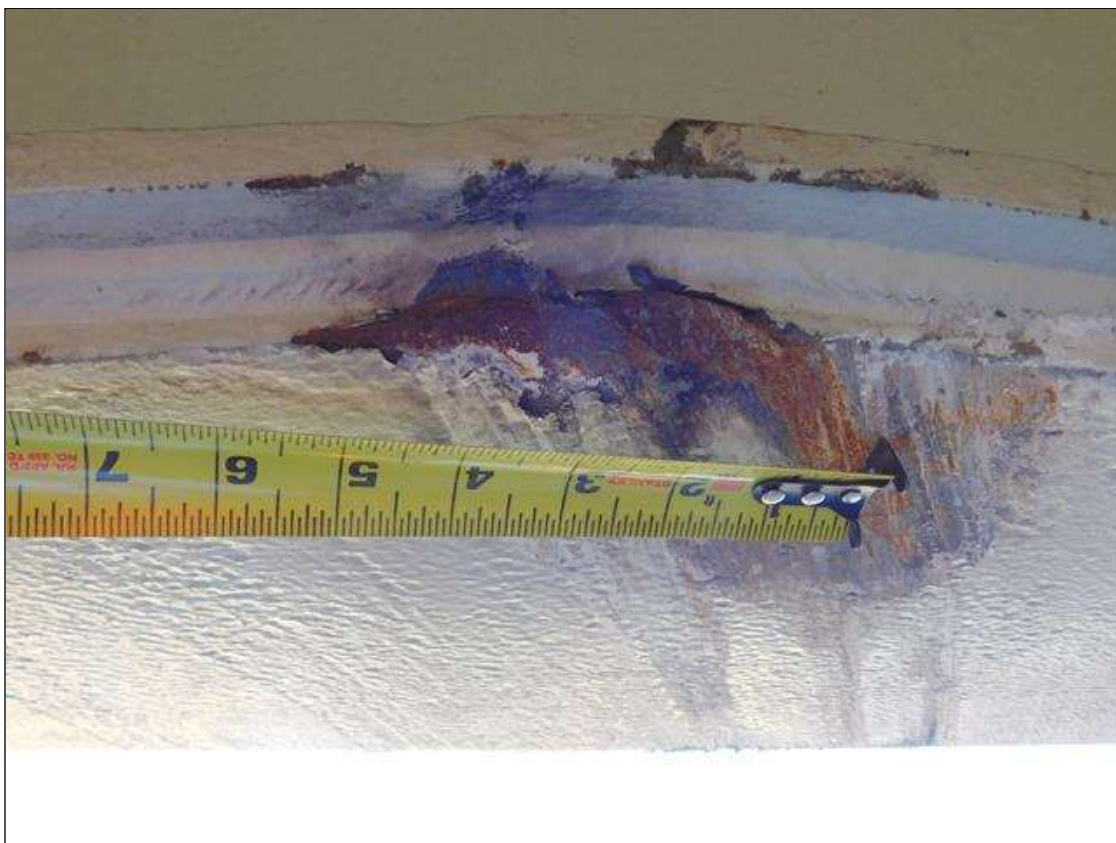
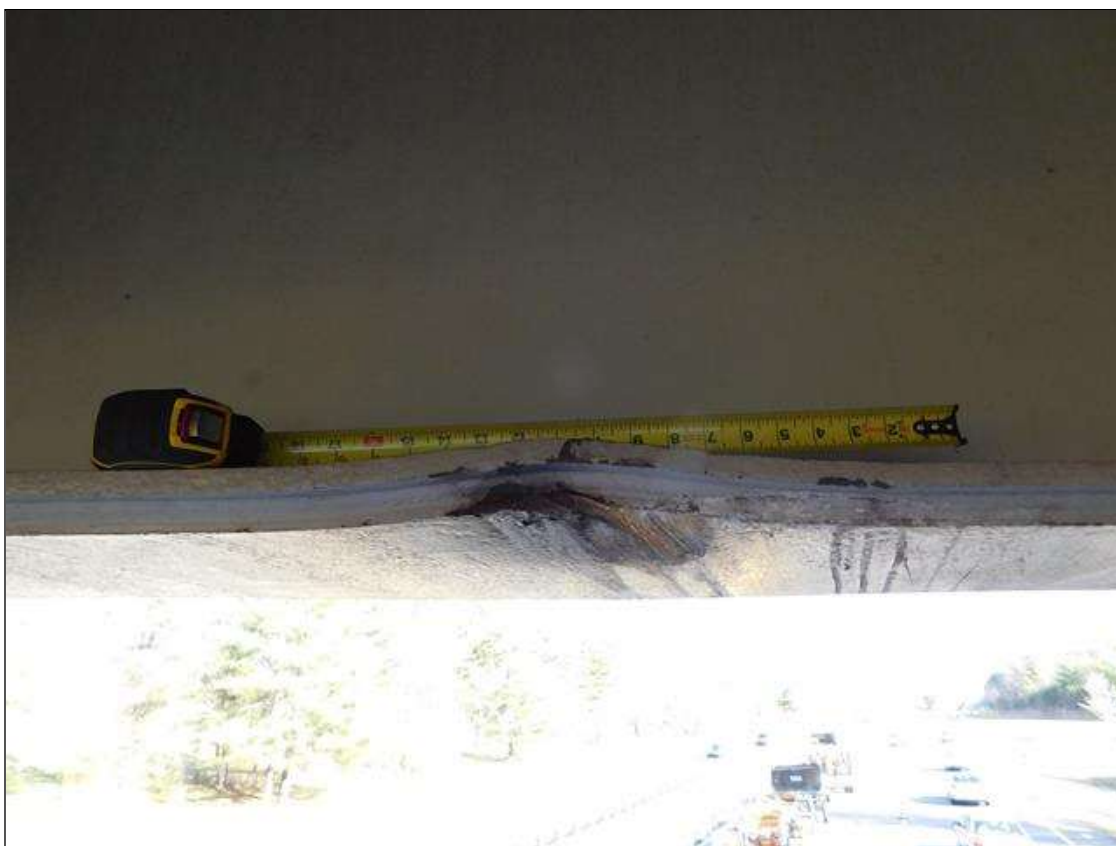
CLOSE UP OF INDENTATION AT POINT OF IMPACT FOR BEAM 10. INDENTATION IS 3" LONG X 1" WIDE MEASURED 26'4" FROM INTERIOR BENT 2.

OVERVIEW OF INDENTION AT POINT OF IMPACT FOR BEAM 10. INDENTION IS 3" LONG X 1" WIDE MEASURED 26'4" FROM INTERIOR BENT 2.

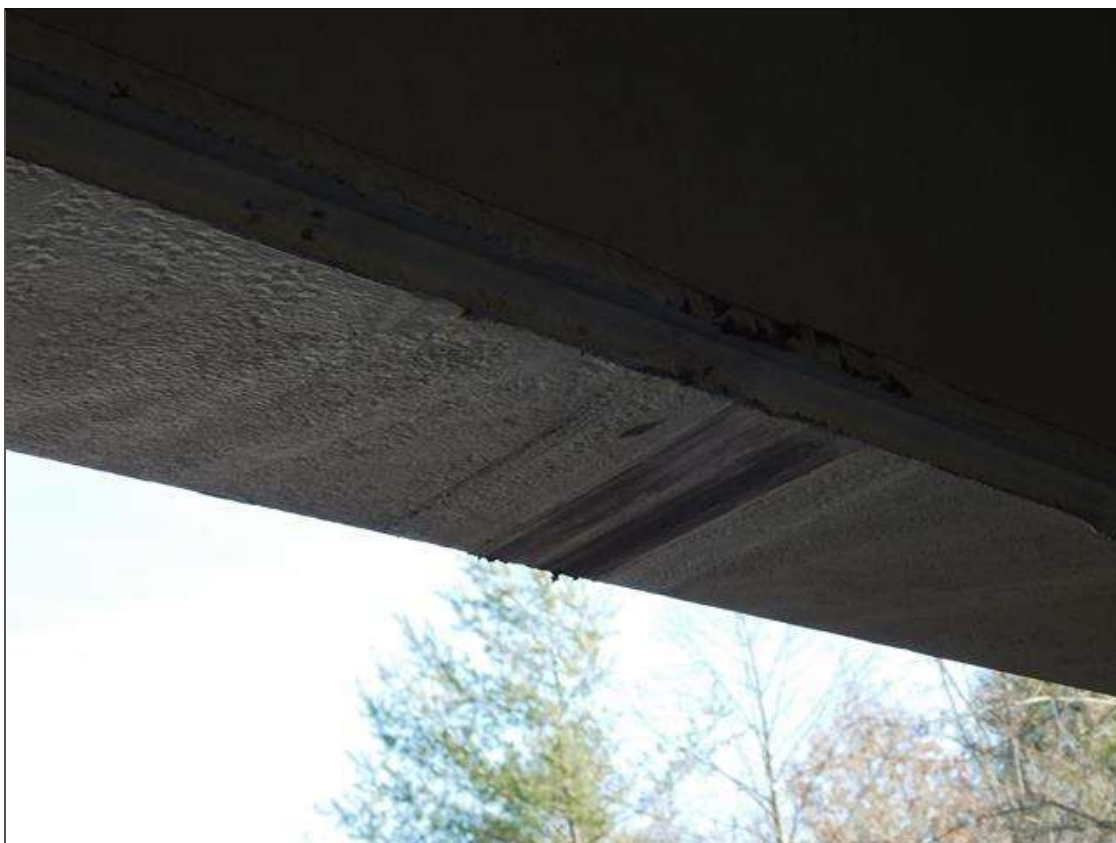
SCATTERED SCRAPES ON BOTTOM FLANGE OF BEAM 10. MEASURED 28' FROM INTERIOR BENT 2

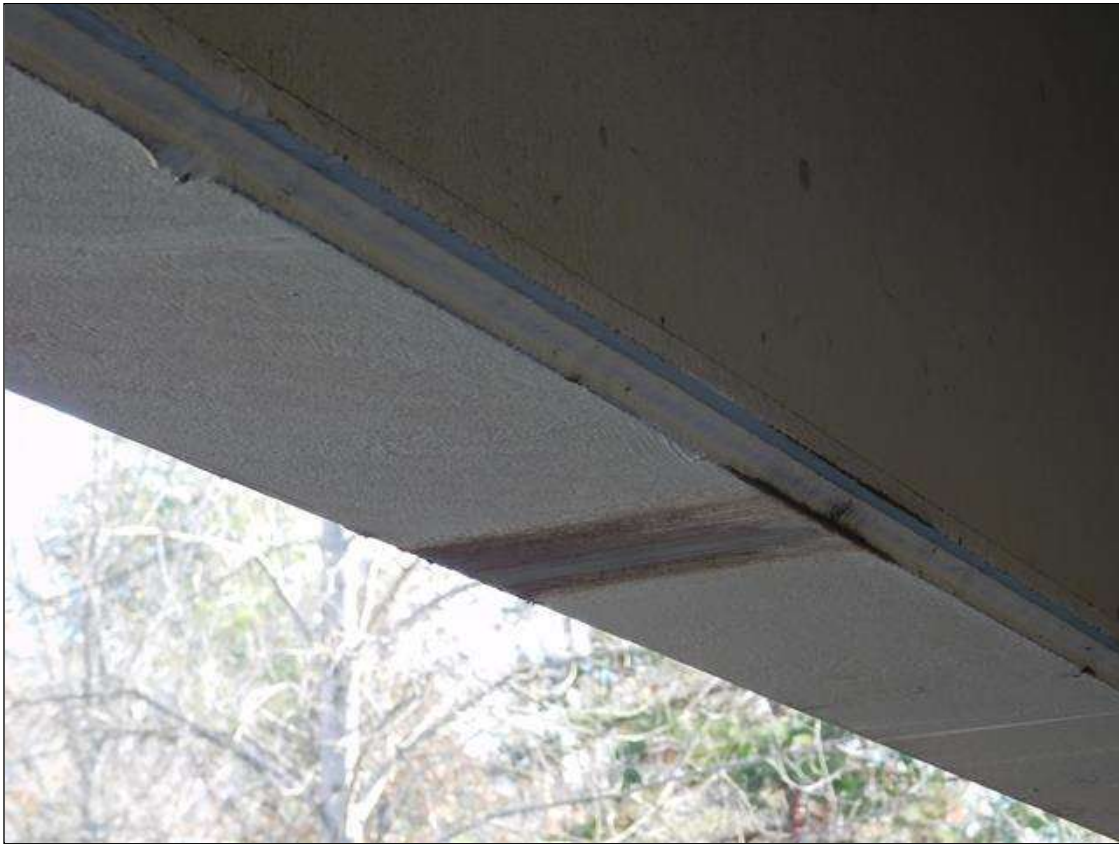
SCATTERED SCRAPES ON BOTTOM FLANGE OF BEAM 10. MEASURED 30' FROM INTERIOR BENT 2

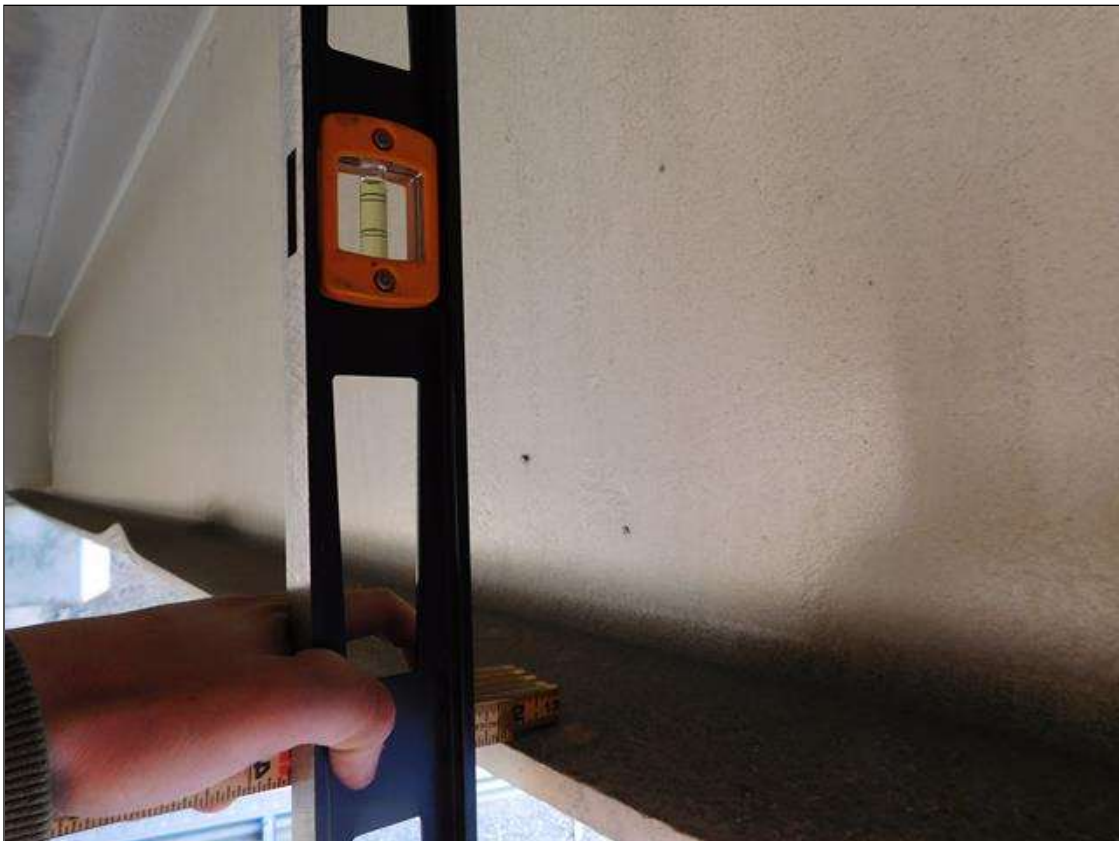
| Element Number | Defect Type | Defect Description | CS | CS Qty | Maint Qty | |
|---|---|--|---|---|---|---|
| 107 | Damage | BEAM 10 IS OUT OF PLUMB FOR A TOTAL LENGTH OF 20 FEET. THE BEAM IS SWEEP WESTWARD AND OUT OF PLUMB 1" | 3 | 20 | 20 | Feet |

BEAM 10 IS OUT OF PLUMB WESTWARD FOR 1" FOR A TOTAL LENGTH OF 20 FEET

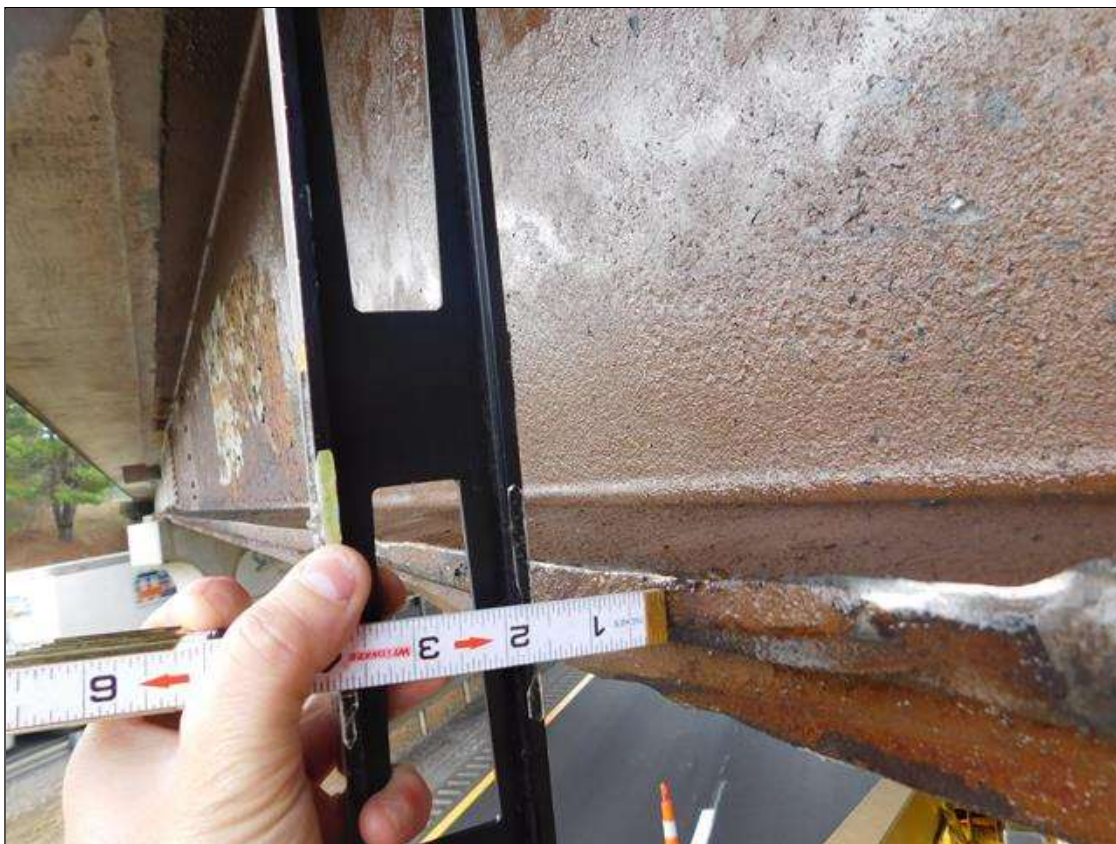
| Element Number | Defect Type | Defect Description | CS | CS Qty | Maint Qty |
|---|---|---|---|---|---|
| 107 | Damage | BEAM SWEEP EASTWARD 1.5" FOR A LENGTH OF 35' AT 29-6" OUT FROM INTERIOR BENT 3. CONFIRMED BY SPECIAL INPSECTION ON 3/5/19 | 3 | 35 | 35 Feet |

Span 3 : BEAM SWEEP EASTWARD 1.5" FOR A LENGTH OF 35' AT 29'-6" OUT FROM INTERIOR BENT 3. CONFIRMED BY SPECIAL INSPECTION ON 3/5/19

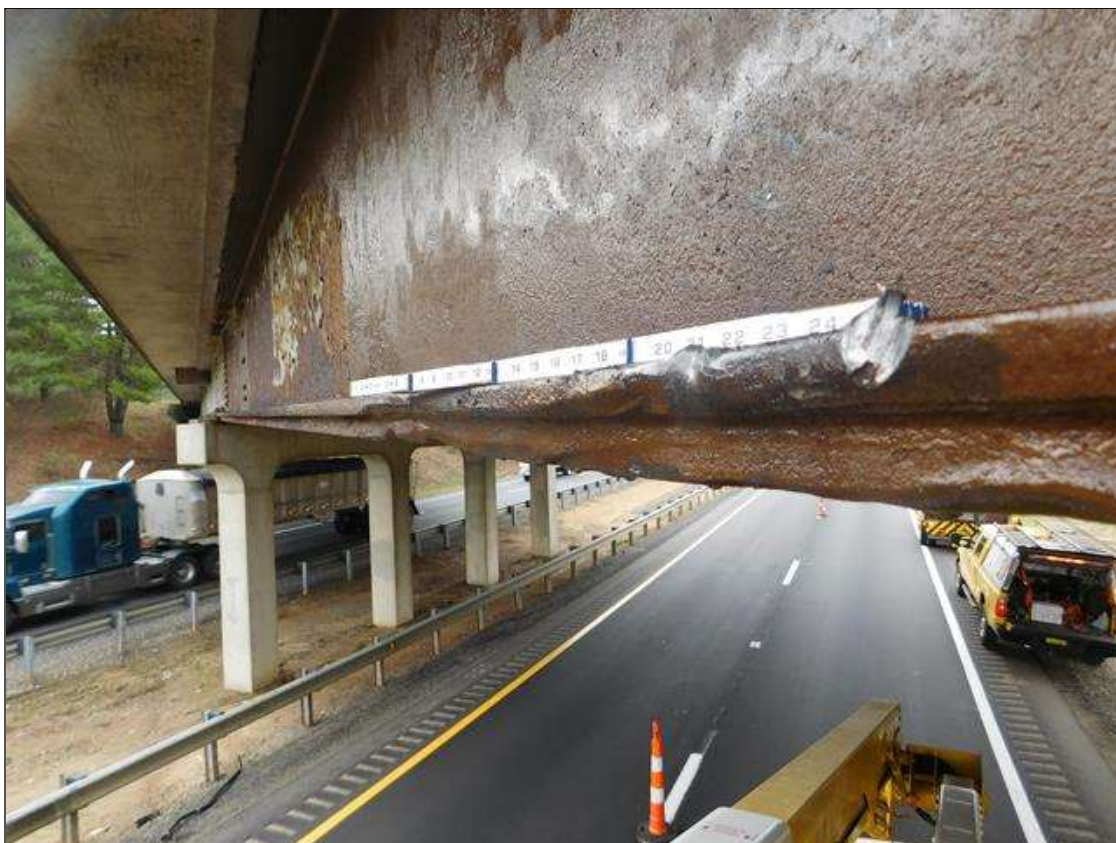
Span 3 : PREVIOUS IMPACT DAMAGE TO BEAM 6

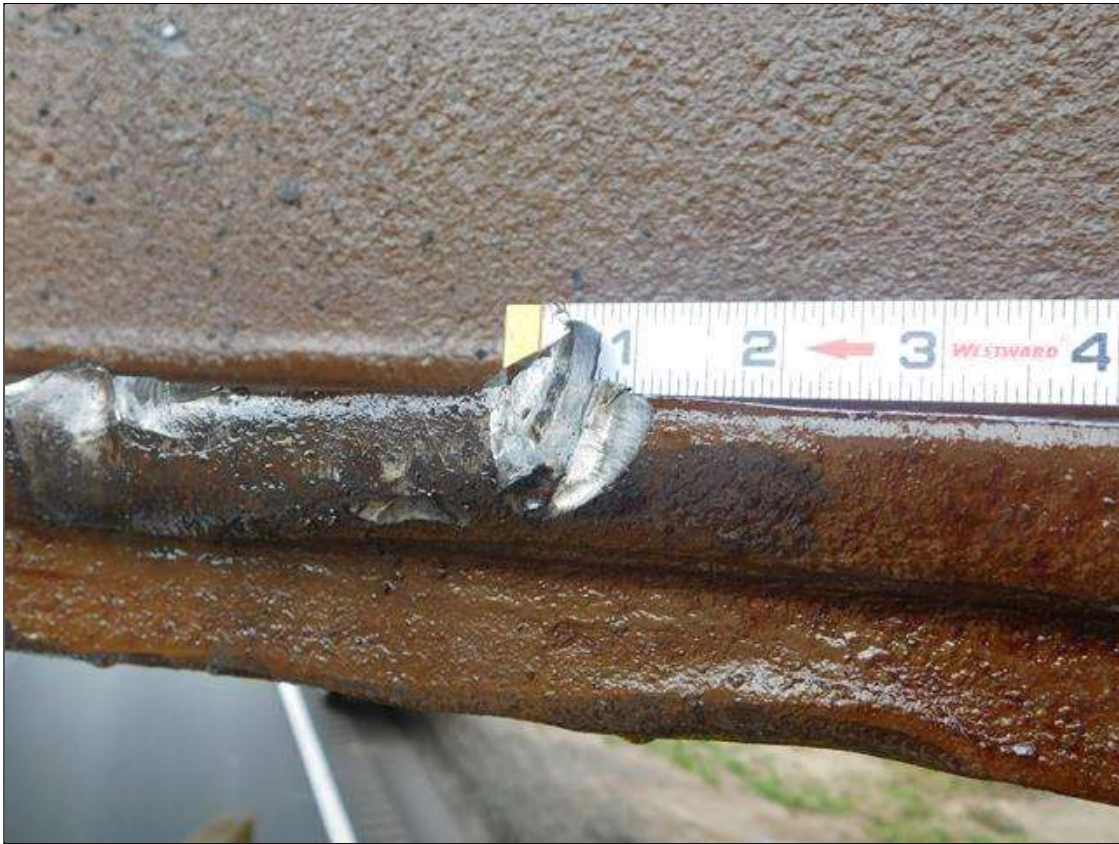
| Element Number | Defect Type | Defect Description | CS | CS Qty | Maint Qty |
|---|---|---|---|---|---|
| 107 | Damage | SPAN 3 INDENTION IN BEAM 6 STARTING AT 44' 4" FROM INTERIOR BENT 3. 1" LONG BY 1/4" DEEP. SCRAPE ON WEB IN BEAM 6 AT 45' FROM INTERIOR BENT 3. 20" LONG WITH 1/4" DEEP INDENTION | 2 | 1 | Feet |

Span 3 : INDENTATION IN BEAM 6 STARTING AT 44' 4" FROM INTERIOR BENT 3. 1" LONG BY 1/4" DEEP

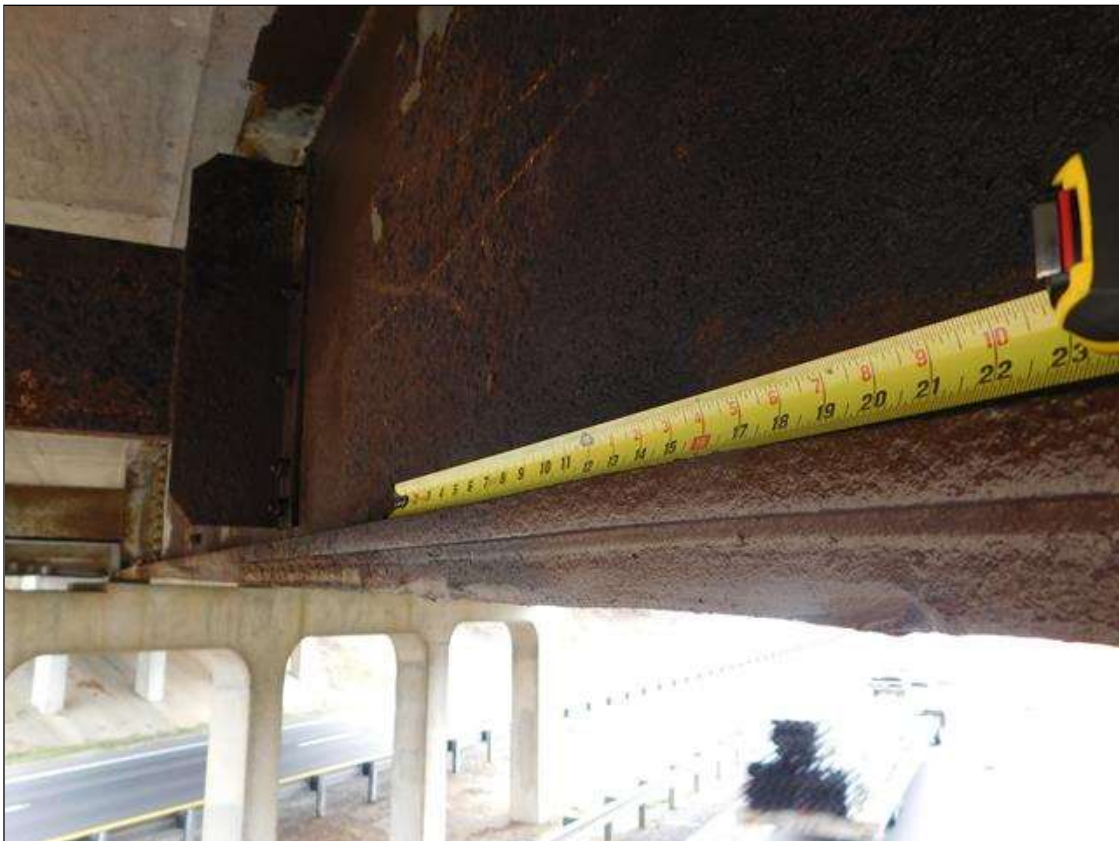
| 107 | Damage | IMPACT DAMAGE TO BEAM 5 AT 49.833' FROM IB 3, 2' LONG BY 1/2" HIGH BY 1" DEEP. CONFIRMED BY SPECIAL INSPECTION ON 3/5/19 | 2 | 2 | 2 | Feet |

Span 3 : PREVIOUS IMPACT DAMAGE TO BEAM 5 AT 49.833' FROM IB 3, 2' LONG BY 1/2" HIGH BY 1" DEEP. CONFIRMED BY SPECIAL INSPECTION ON 3/5/19

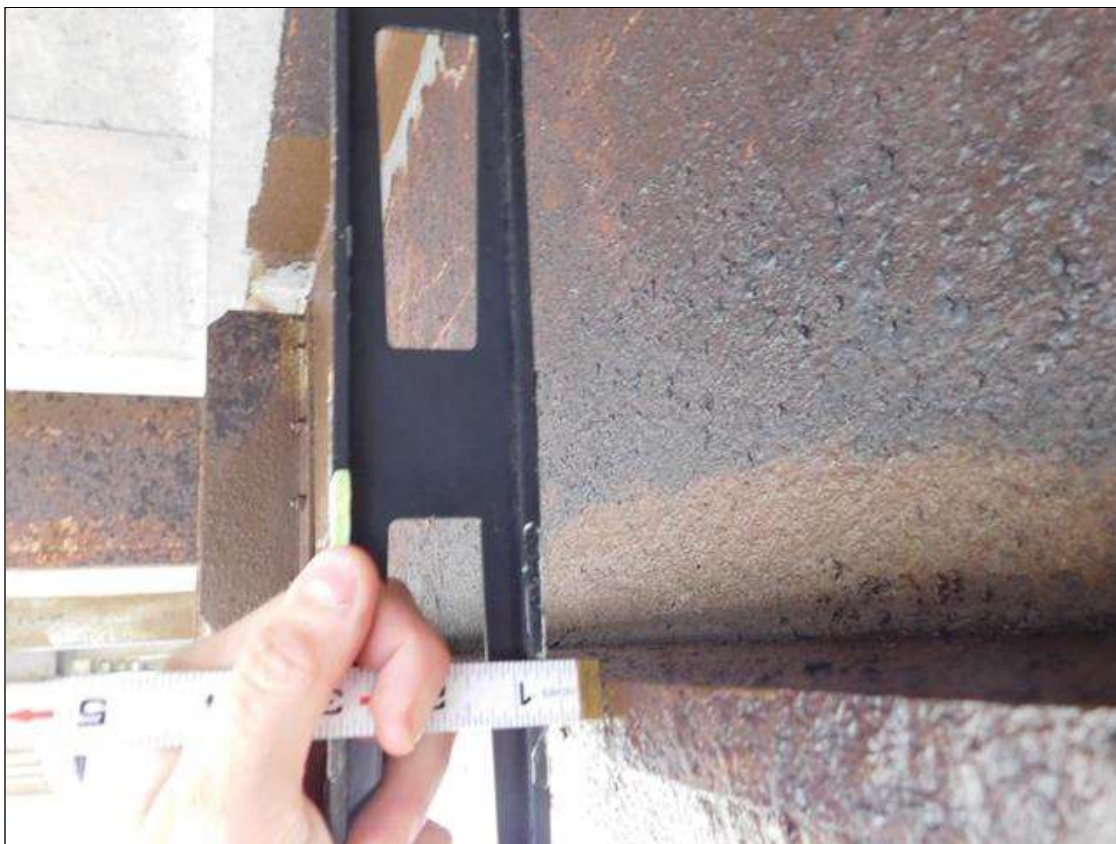
| 107 | Damage | SPAN 3 BEAM 5 SWEEP EASTWARD 1" FOR A LENGTH OF 5' AT 47' -10" OUT FROM IB 3. CONFIRMED BY SPECIAL INSPECTION ON 3/5/19. | 2 | 1 | 1 | Feet |

Span 3 : BEAM 5 SWEEP EASTWARD 1" FOR A LENGTH OF 5' AT 47' -10" OUT FROM IB 3. CONFIRMED BY SPECIAL INSPECTION ON 3/5/19.

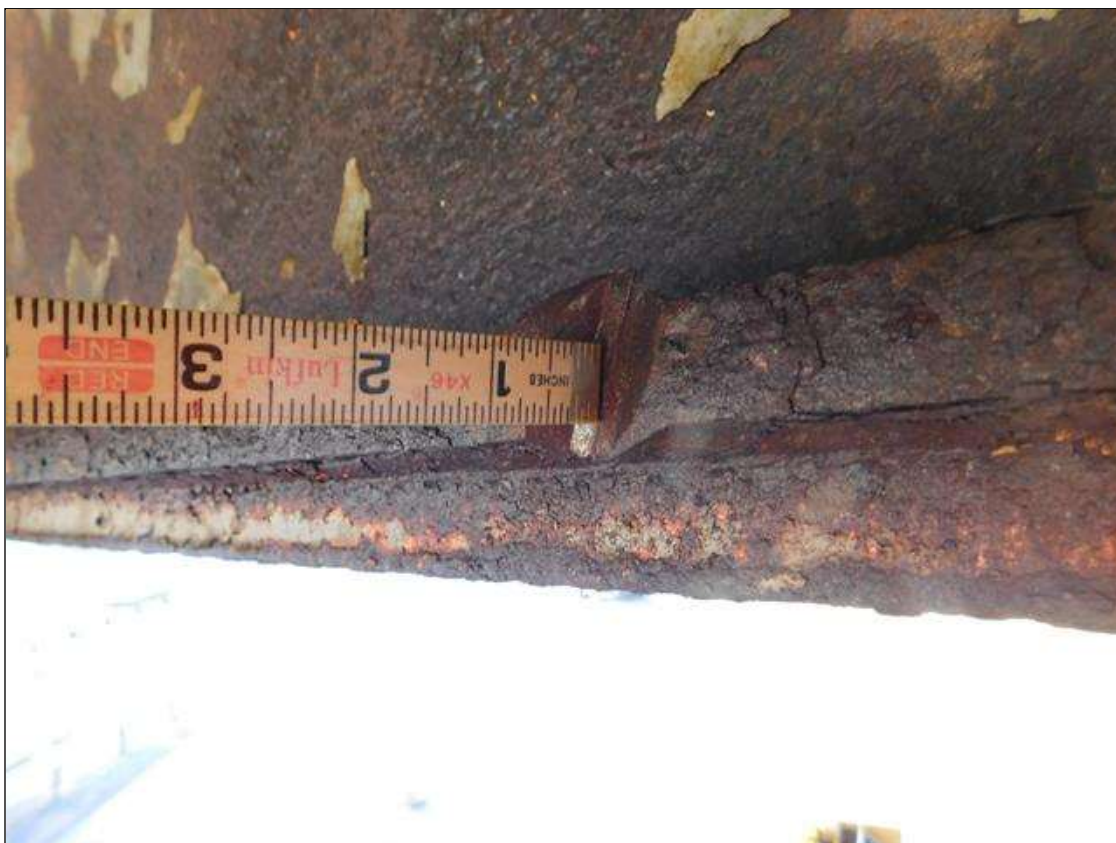
| Element Number | Defect Type | Defect Description | CS | CS Qty | Maint Qty |
|---|---|--|---|---|---|
| 107 | Damage | INDENTION IN BEAM 3 STARTING AT 45' FROM INTERIOR BENT 3. 1" LONG BY 1/4" DEEP | 2 | 1 | Feet |

Span 3 : INDENTION IN BEAM 3 STARTING AT 45' FROM INTERIOR BENT 3. 1" LONG BY 1/4" DEEP

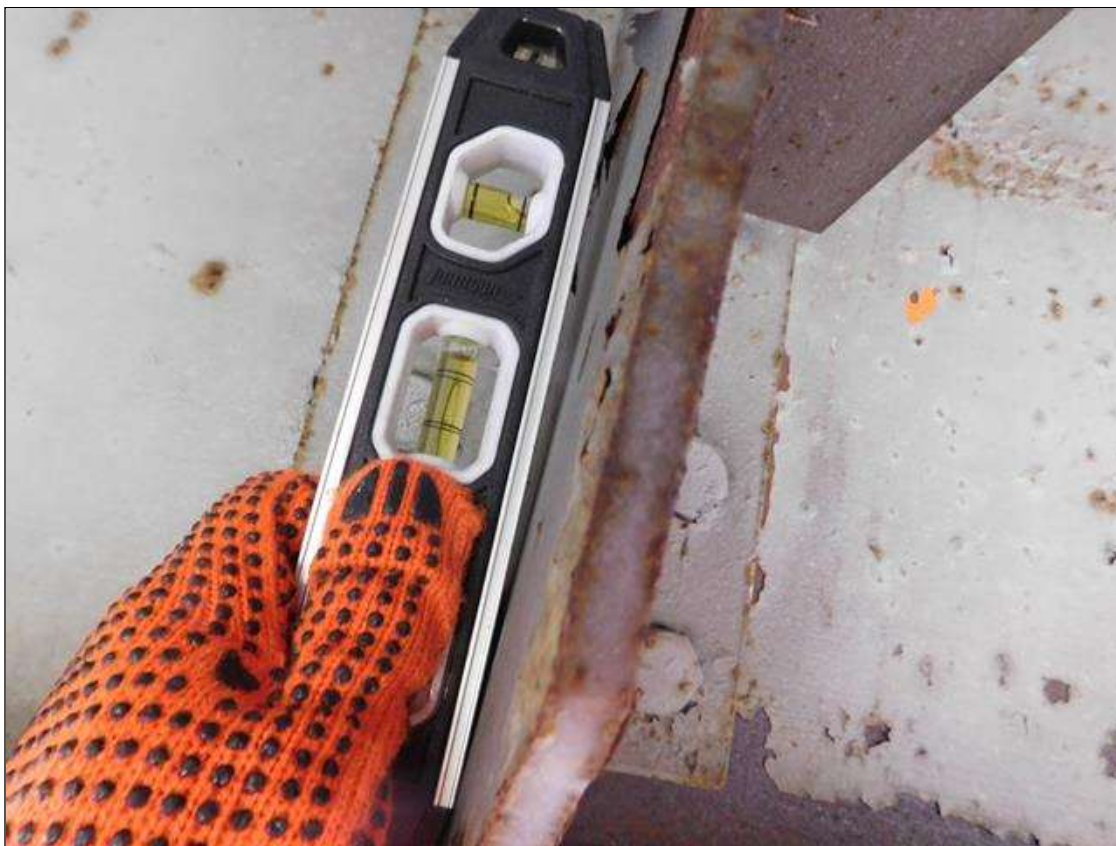
DIAPHRAGM 4 BAY 4 SWEEP NORTHWARD 1/4"

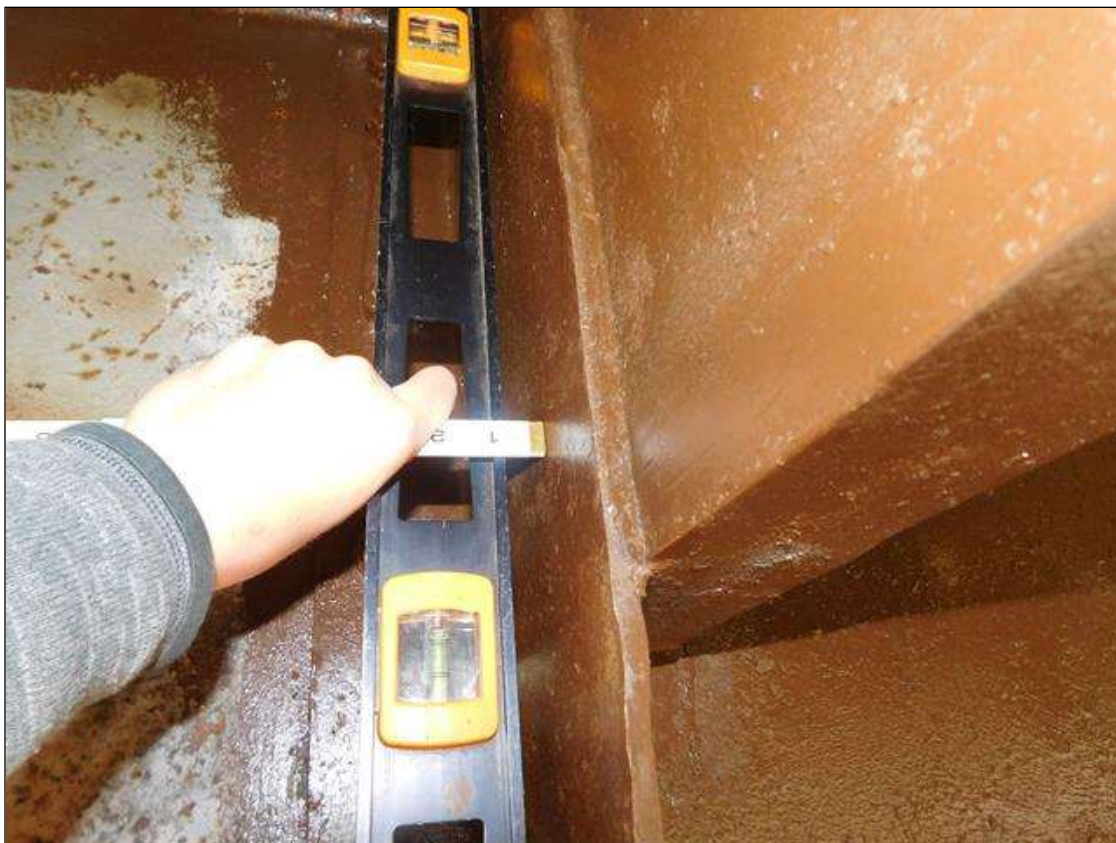
PREVIOUS IMPACT DAMAGE TO DIAPHRAGM 4 BAY 5. SWPET NORTHWARD 1/2"

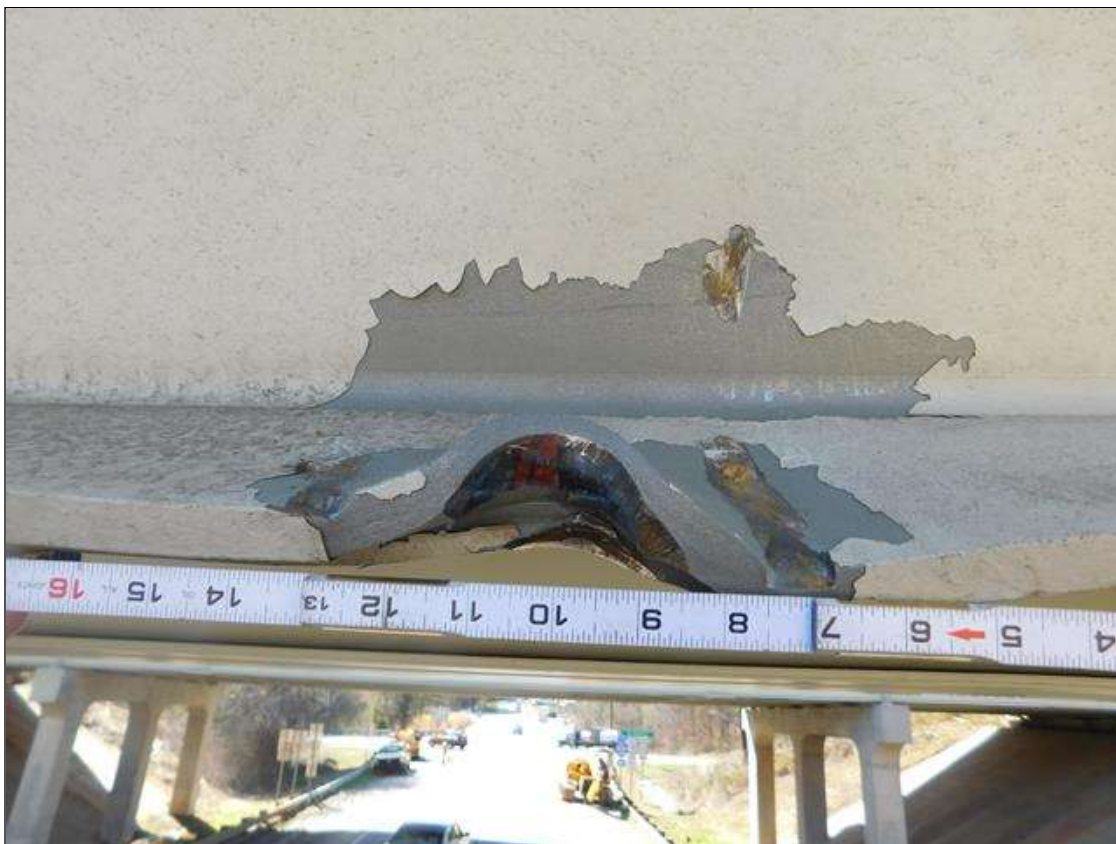
PREVIOUS INPACT DAMGE 3 INDITIONS UP TO 1" LONG AT 43'-11" OUT FROM INT. BENT 1
