NC DEPARTMENT OF TRANSPORTATION  
 DIVISION OF HIGHWAYS  
 STRUCTURE MANAGEMENT UNIT

# Structure Safety Report

## Supplemental Element Inspection

DIVISION: 13 COUNTY: BUNCOMBE STRUCTURE NUMBER: 100382 FREQUENCY: None

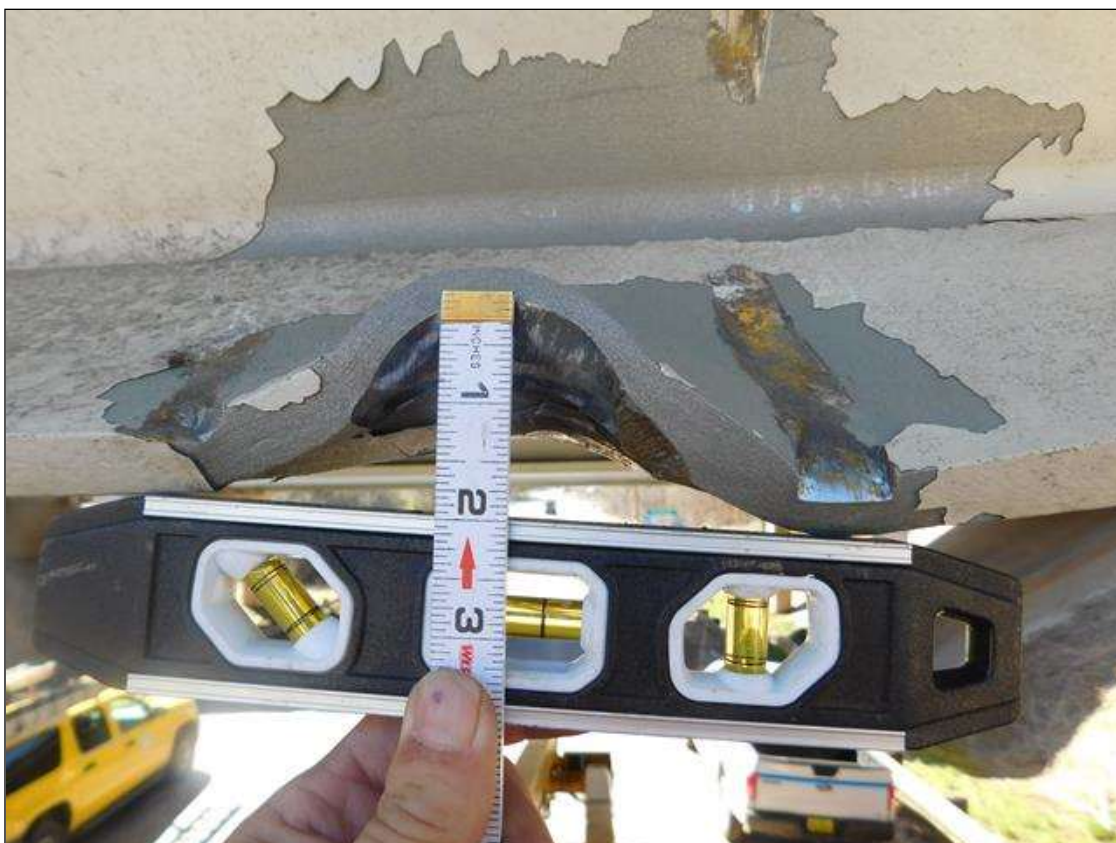
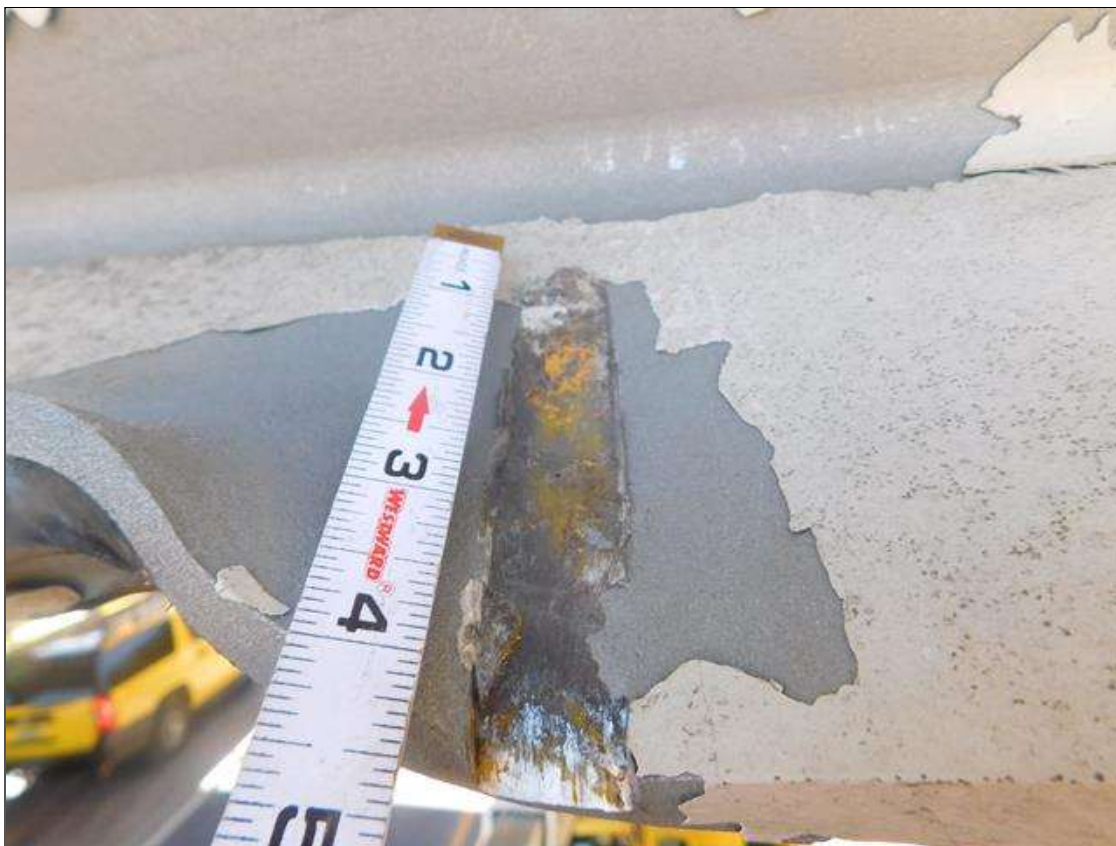
| Element Number | Defect Type | Defect Description | CS | CS Qty | Maint Qty | |
|---|---|---|---|---|---|---|
| 107 | Corrosion | IMPACT DAMAGE : BEAM1 SPAN 2 . BEAM IS DEFLECTED 1'-2" SOUTHWARD . POINT OF IMPACT DAMAGE AT 29'-9" OUT FROM INT. BENT 1 ,1'-0" LONG X 2" HIGH INDINTION WITH A 2" LONG HAIRLINE CRACK BETWEEN THE BOTTOM FLANGE AND COVER PLATE . THERE IS A 1" WIDE X 4" LONG X 1/16" DEEP SCRAPE / INDINTION WEST SIDE OF POINT OF IMPACT. ALSO A 2 1/2" LONG X 3/4" SCRAPE/ INDINTION EAST SIDE OF POINT OF IMPACT. 2" WIDE X 1" HIGH X 1/16" DEEP SCRAPE/INDINTION ON THE WEB AT 2" UP FROM POINT OF IMPACT. SCATTERED SCRAPES AT WEST SIDE OF POINT OF IMPACT . | 3 | 72 | 72 | Feet |

POINT OF IMPACT 1' LONG X 2" HIGH 29'-9" OUT FROM INT. BENT 1 (P/M)

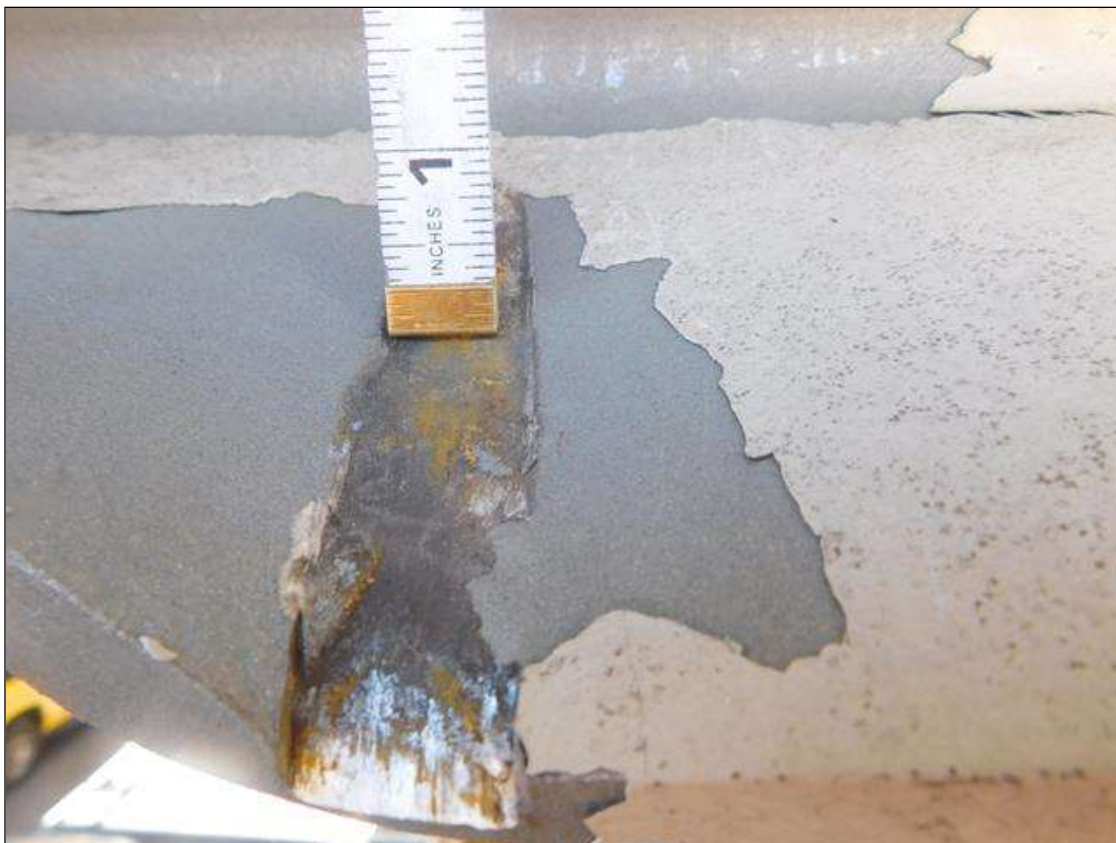
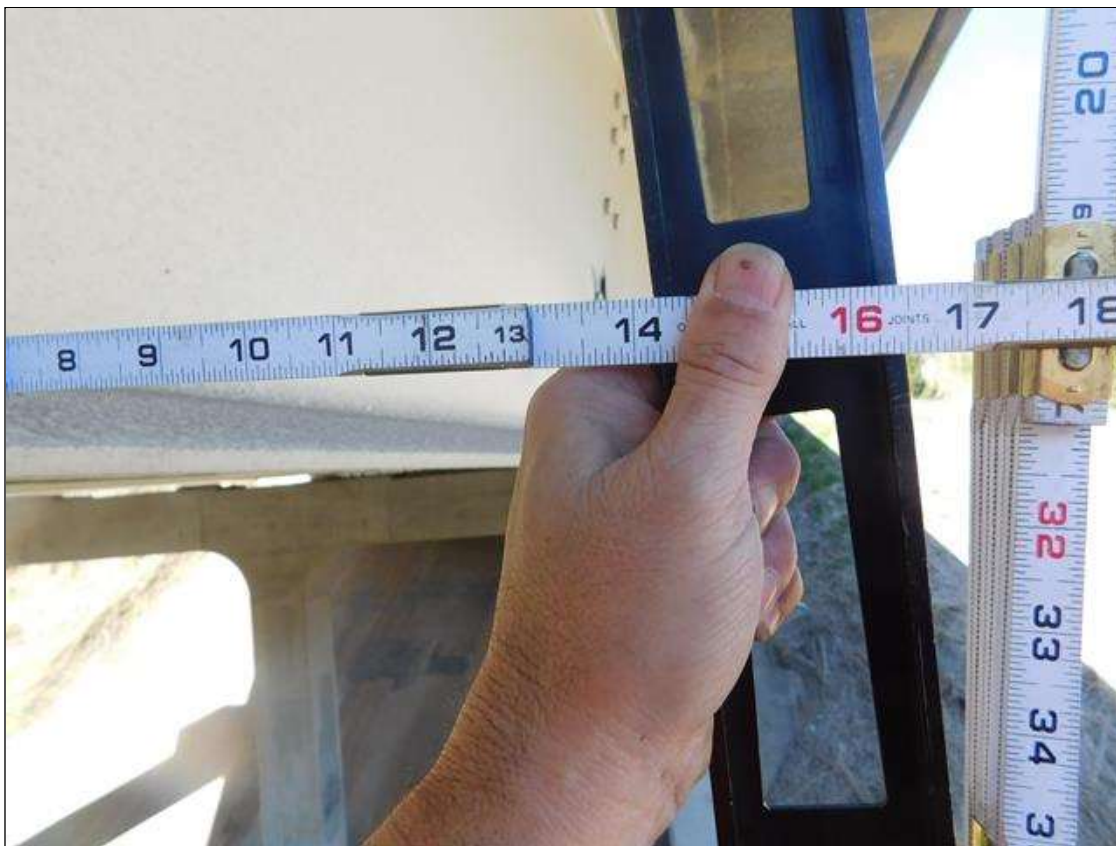
1" WIDE X4" LONG SCRAPE/ INDINTION WEST SIDE OF POINT OF IMPACT

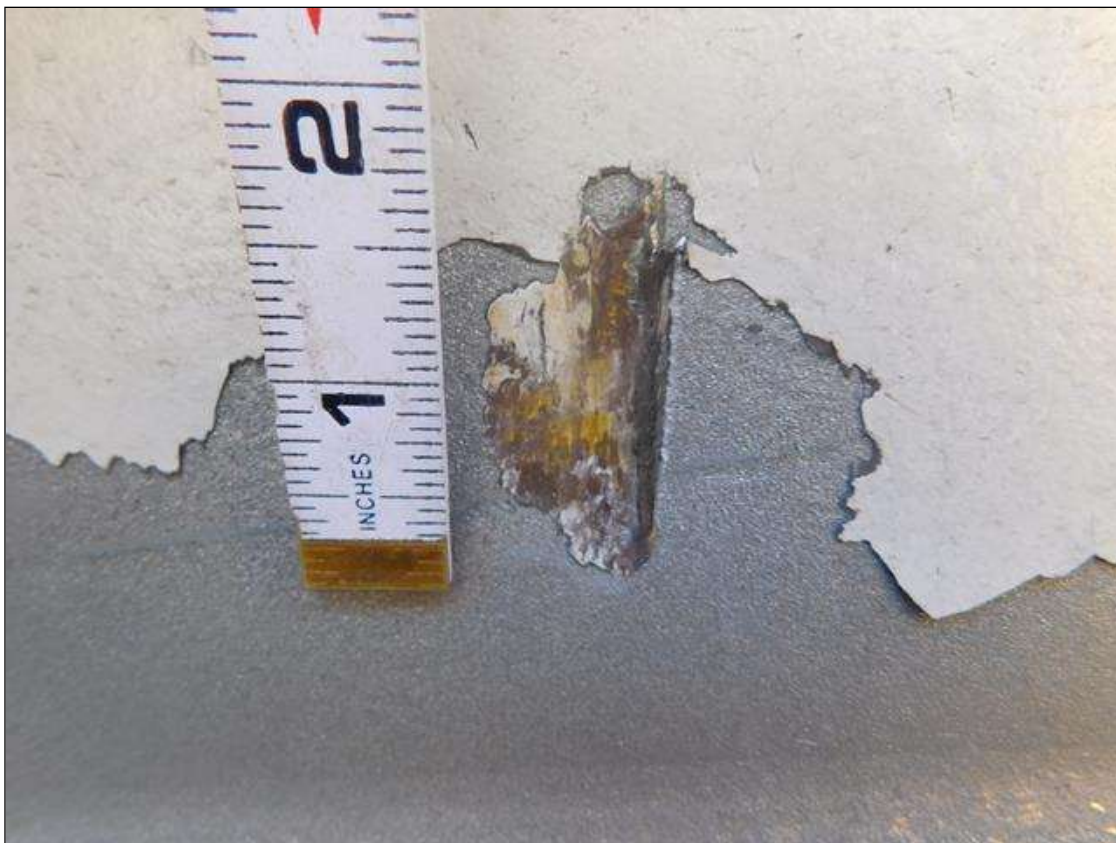
BEAM 1 DEFLECTED 1'-2" SOUTH WARD

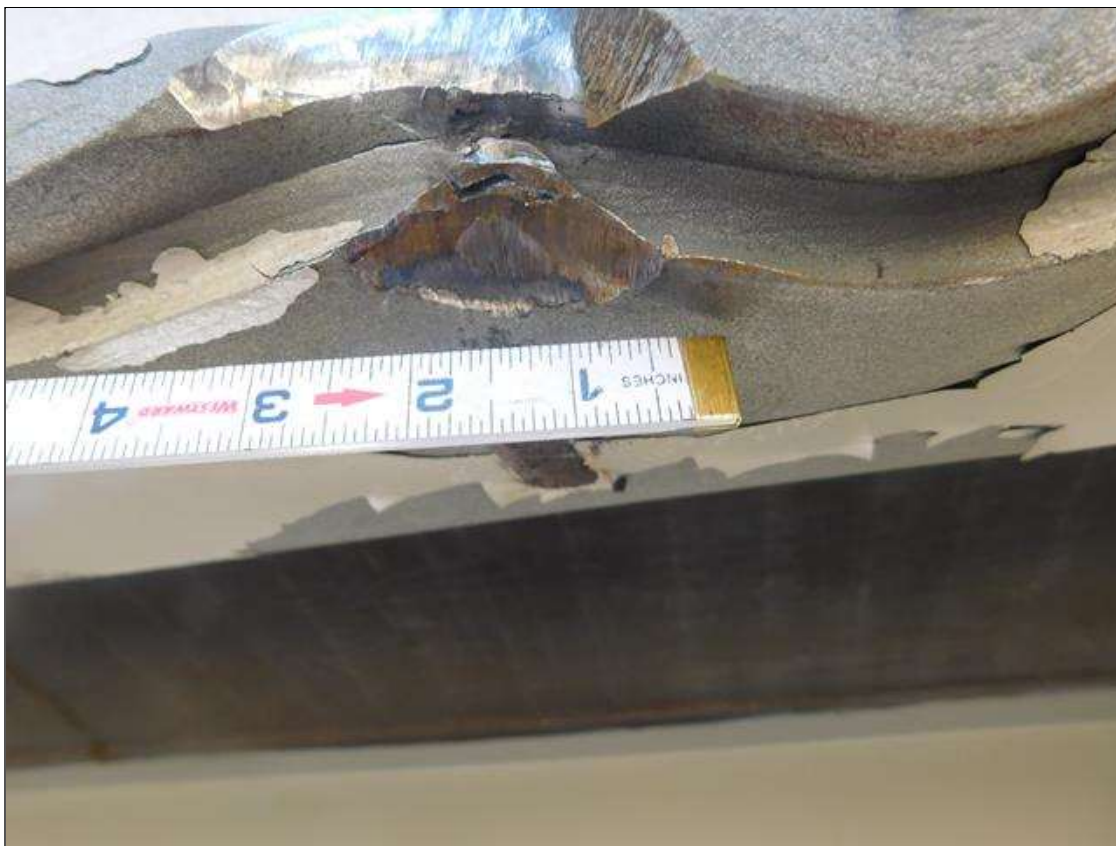
SCRAPE IN BOTTOM OF WEB 2" ABOVE POINT OF IMPACT, 2" WIDE X 1" HIGH X 1/16" DEEP

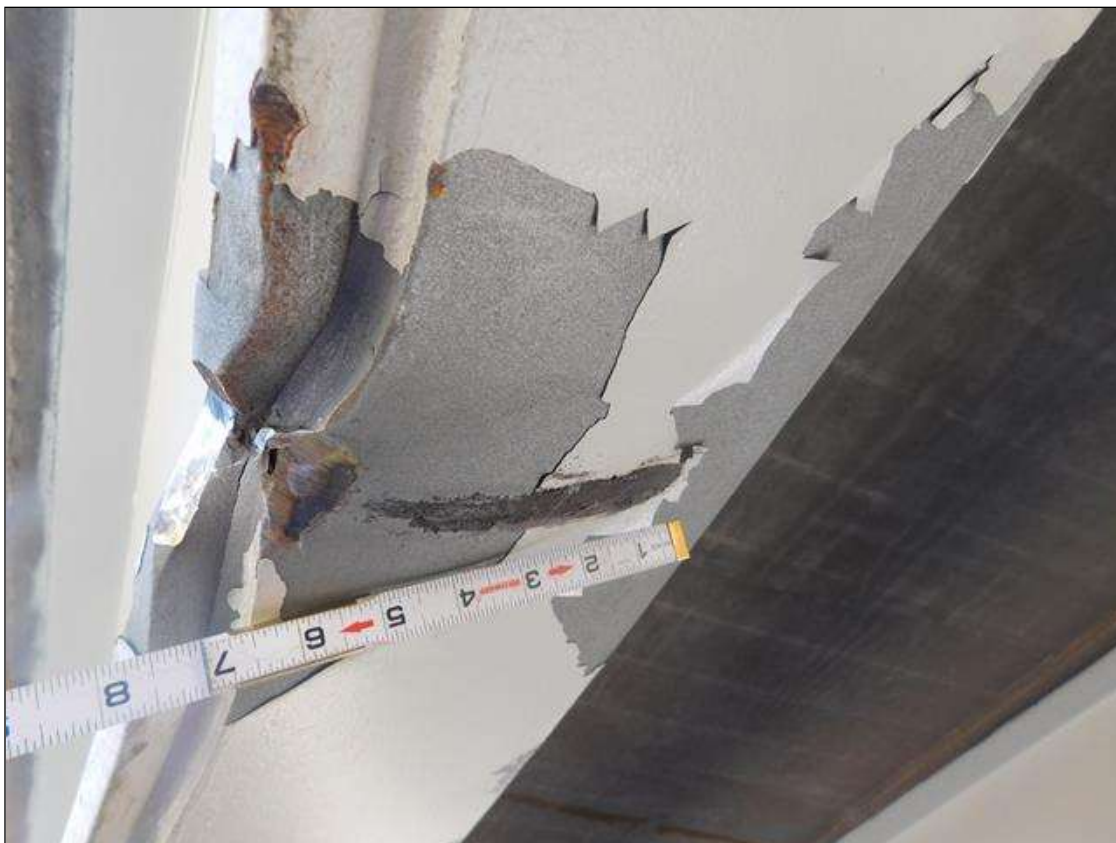
2" WIDE X 1/2" DEEP X 1" LONG INDINTION IN THE BOTTOM COVERPALE AT POINT OF IMPACT.

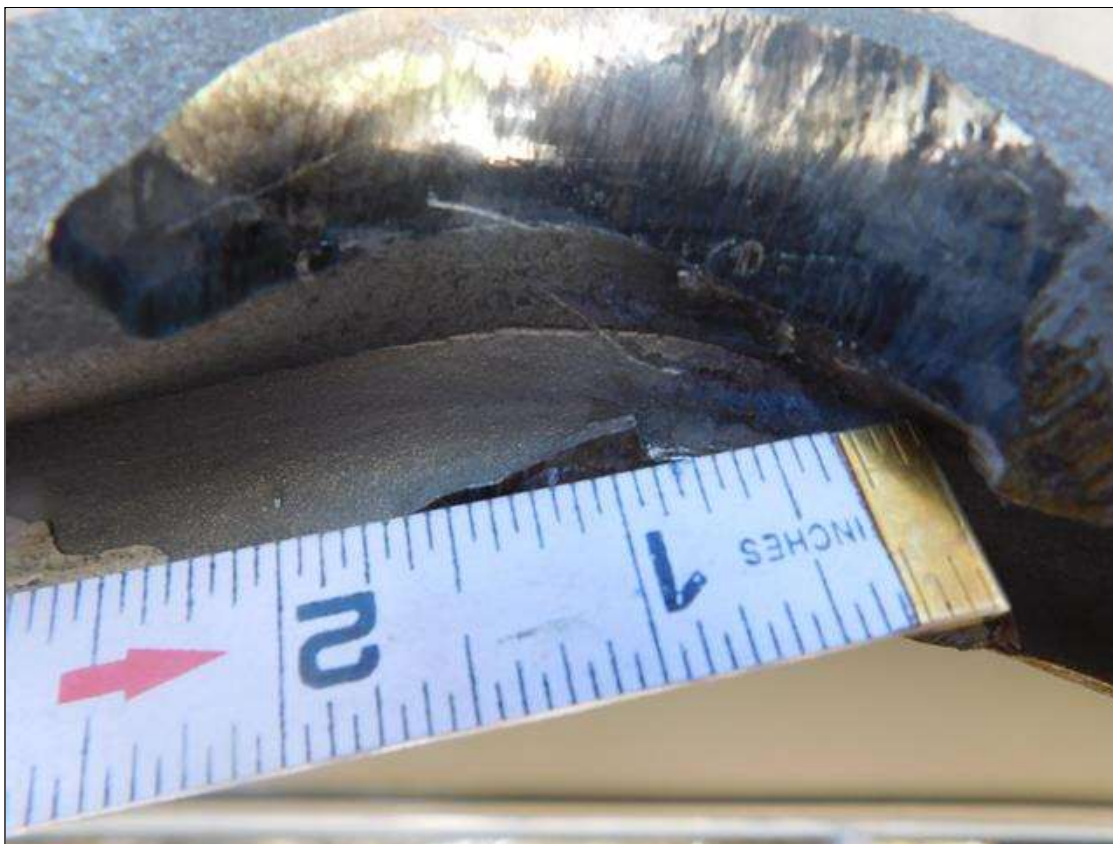
6" LONG SCRAPE ON BOTTOM OF BEAM AT POINT OF IMPACT

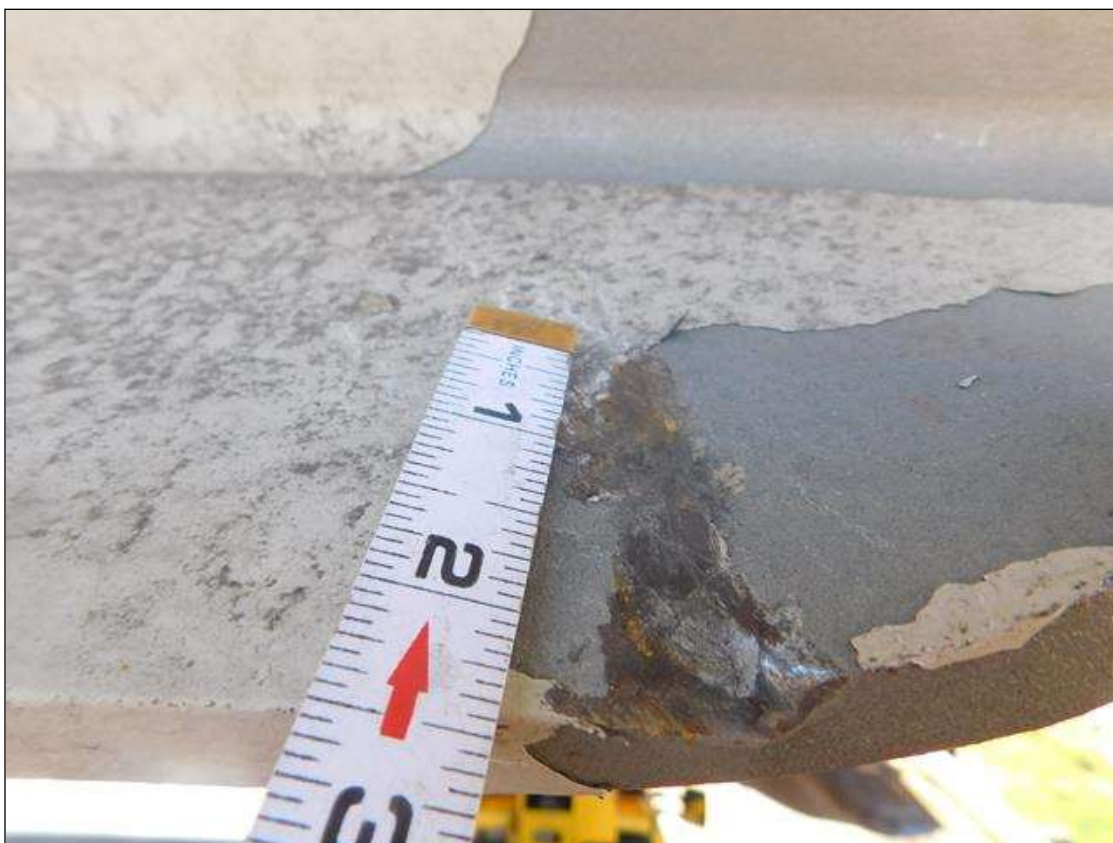
2" LONG HAIRLINE CRACK BETWEEN COVERPLATE AND BOTTOM FLANGE AT POINT OF IMPACT

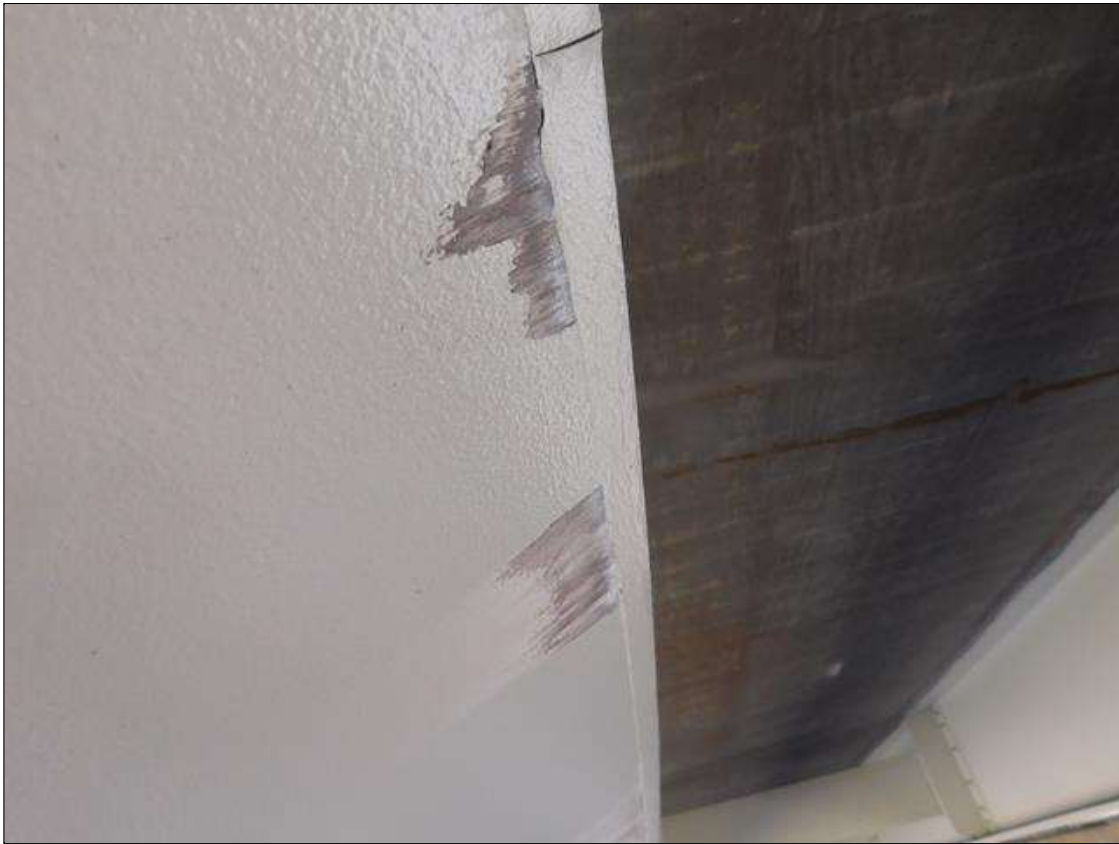
2 1/2" LONG X 3/4" WIDE SCRAPE/INDENTION EAST SIDE OF POINT OF IMPACT.

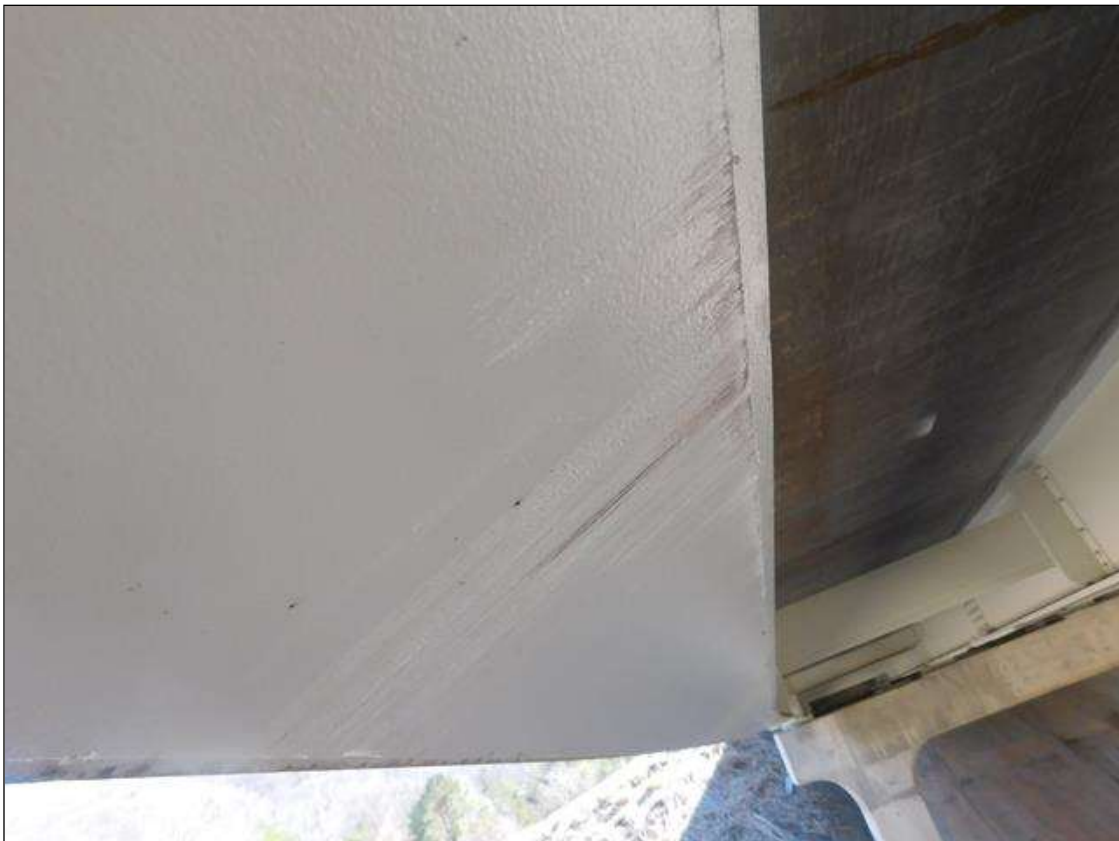
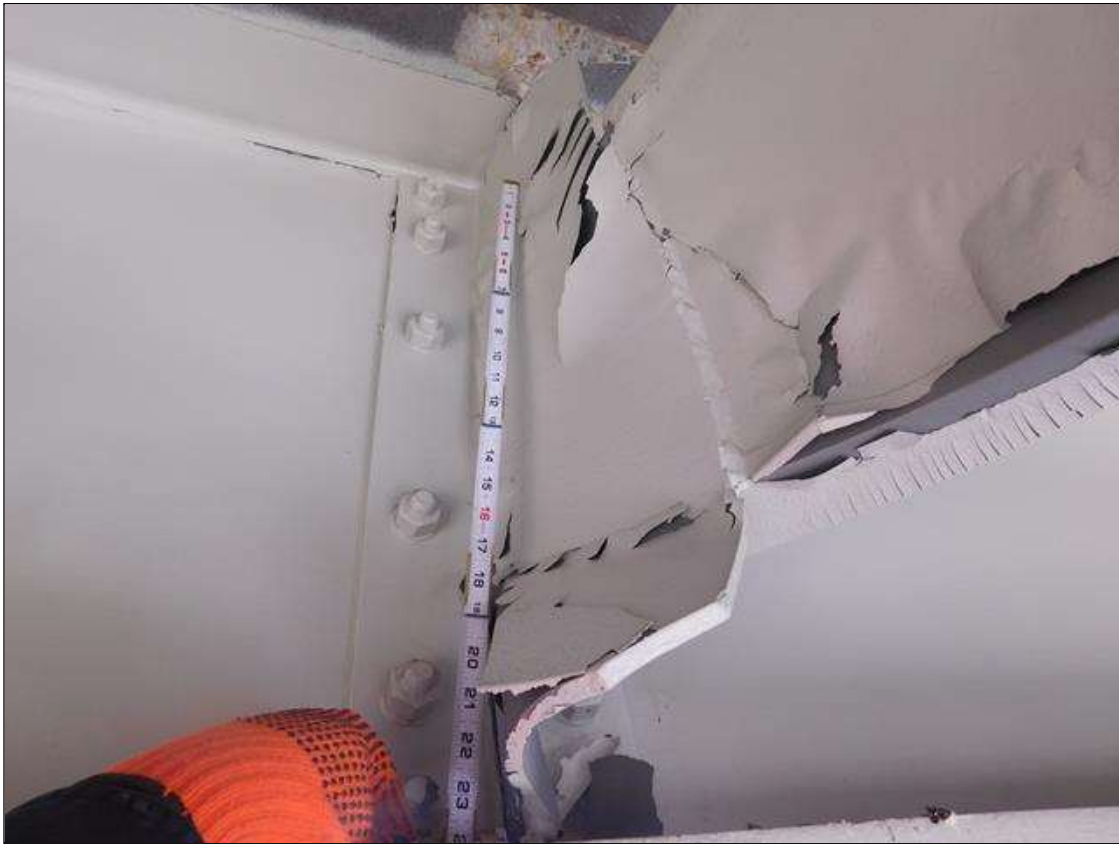
SCATTERED SCRAPES ON BOTTOM OF BEAM 1

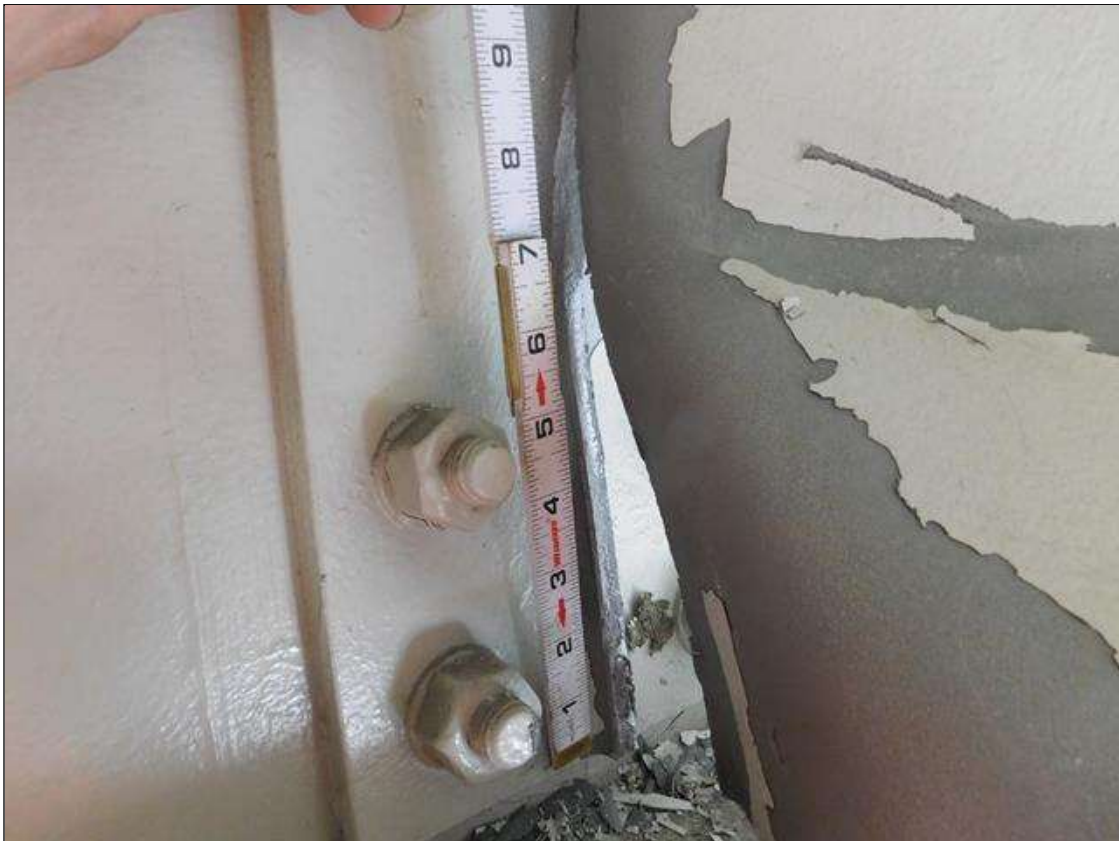
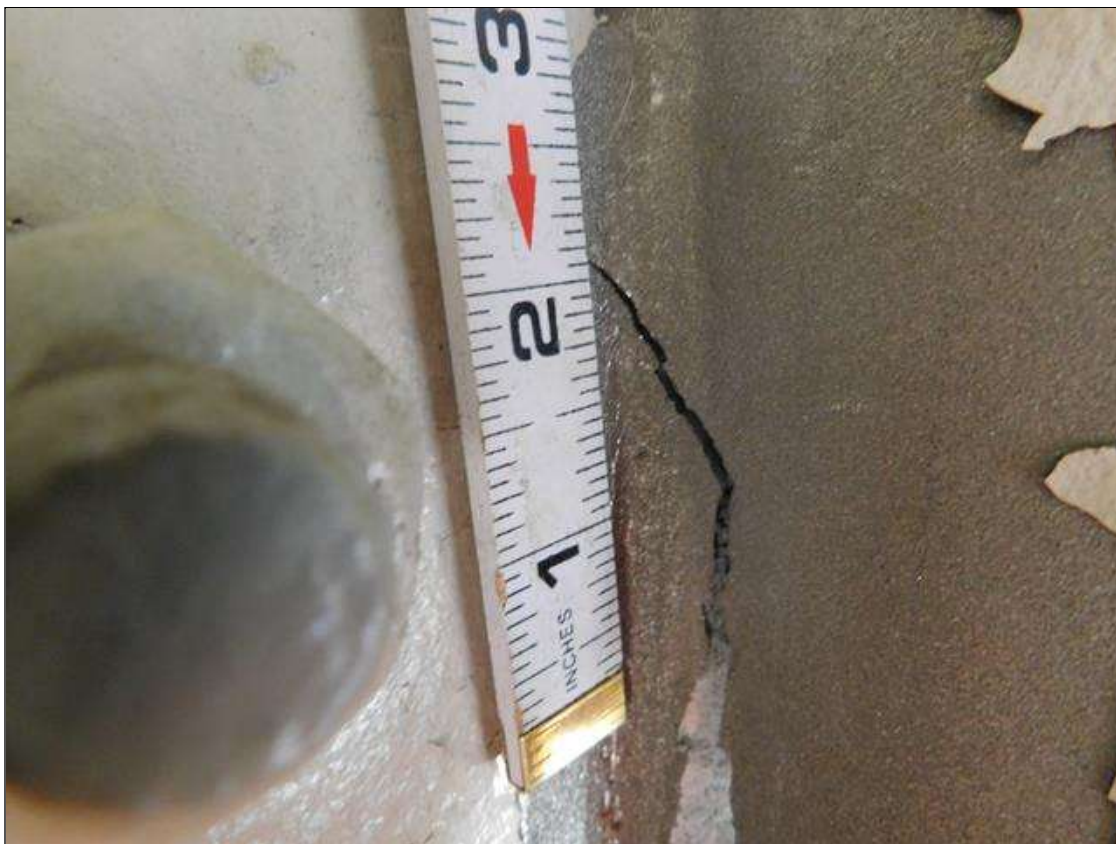
DIAPHRAGM 2 BAY 2 BENT AND TWISTED EAST WARD ON THE NORTH SIDE WITH A 1' HIGH X 2" WIDE RIP IN BOTTOM 1"

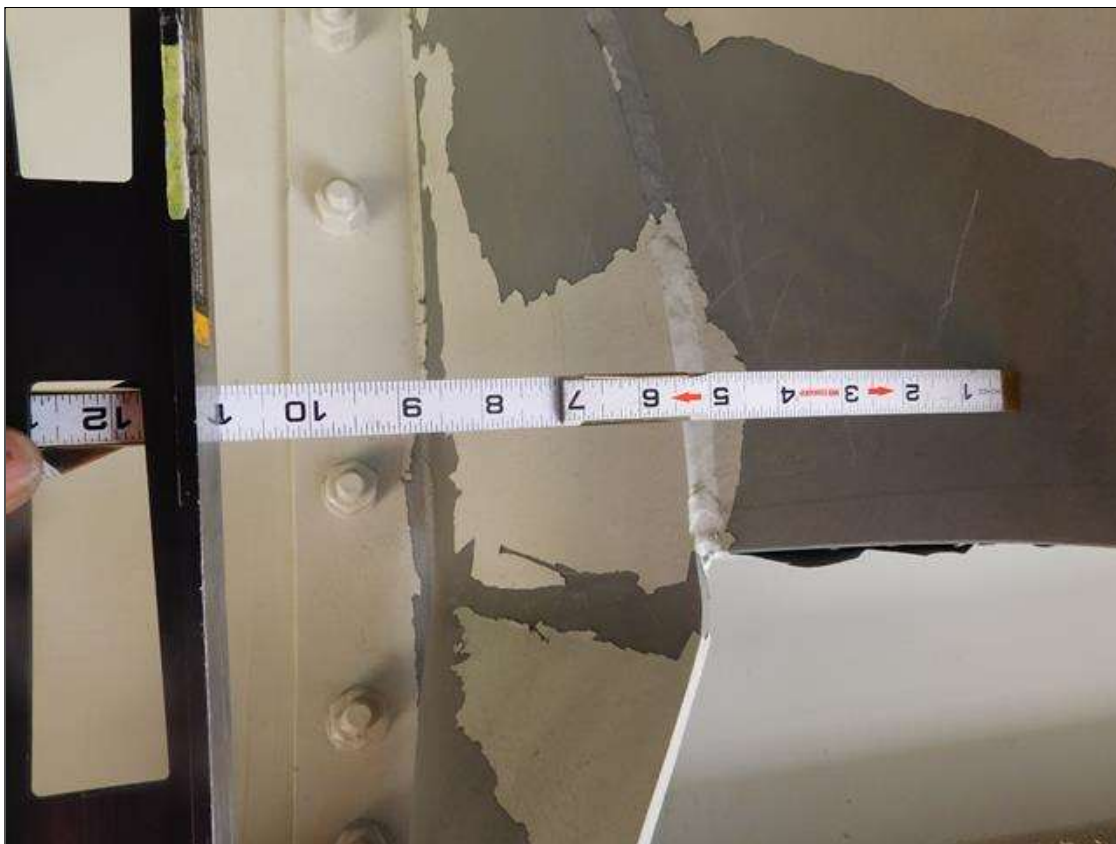
| Element Number | Defect Type | Defect Description | CS | CS Qty | Maint Qty | |
|---|---|---|---|---|---|---|
| 12 | Damage | IMPACT DAMAGE : THERE IS A 7 1/2" LONG X 1" DEEP SPALL ABOVE DIAPHRAGM 2, BAY 1, SPAN 2 . | 2 | 1 | | Square Feet |

SPALLING IN BOTTOM OF DECK, 7 1/2" LONG X 1 1/2" DEEP ABOVE DIAPHRAGM 2 AT POINT OF IMPACT

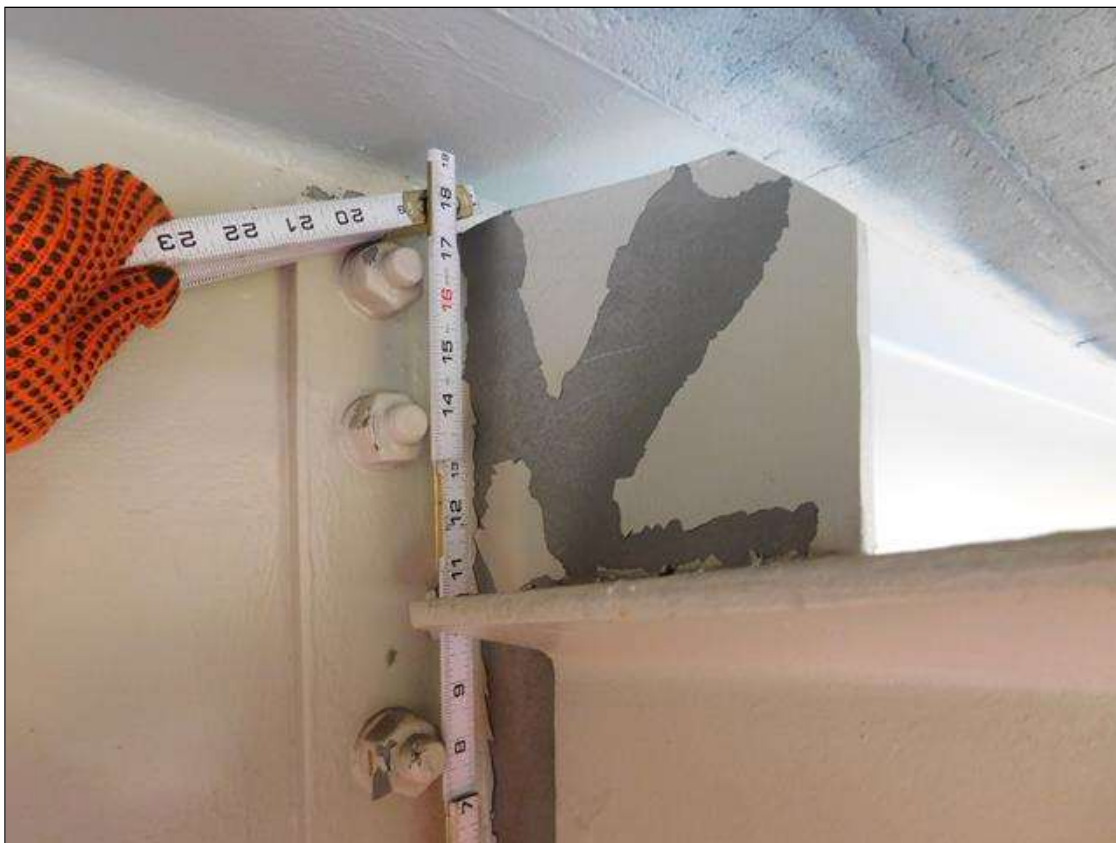
DIAPHRAGM 2 BAY 1 BENT EAST WARD FOR 11" NORTH SIDE

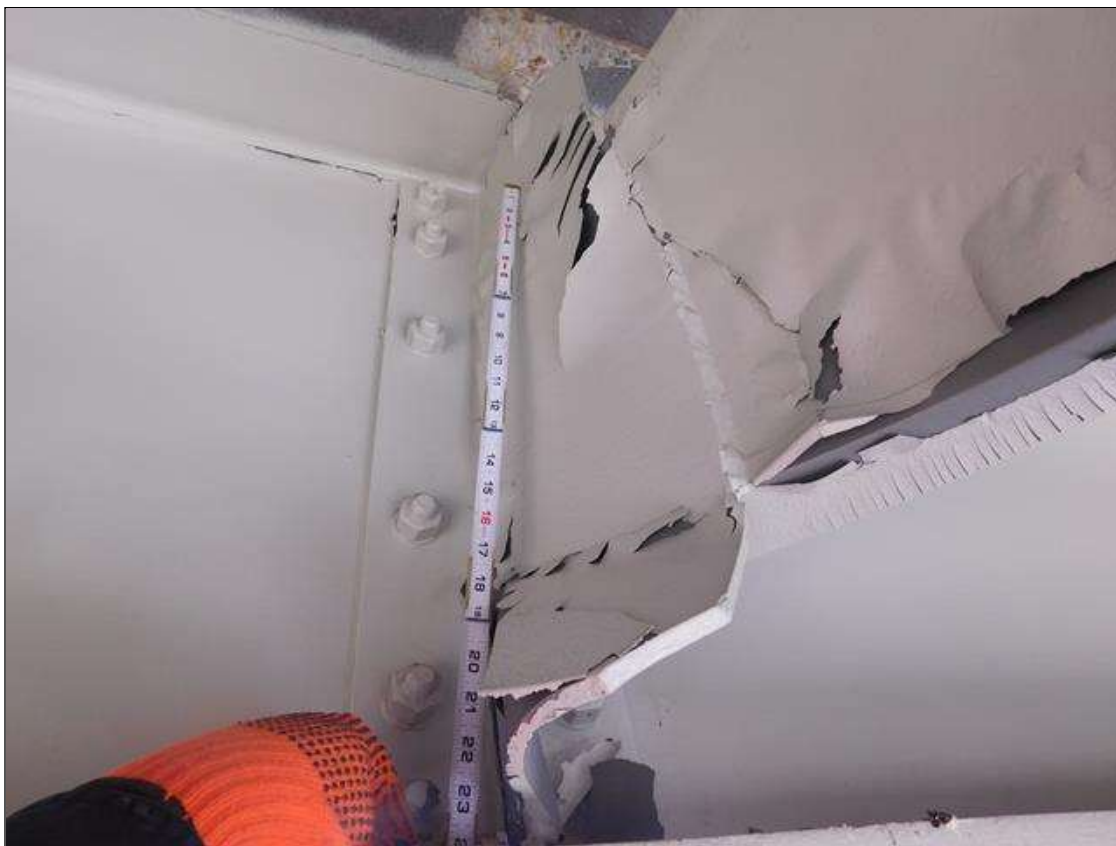
BEAM 1 SPAN 2 IMPACT DAMAGE

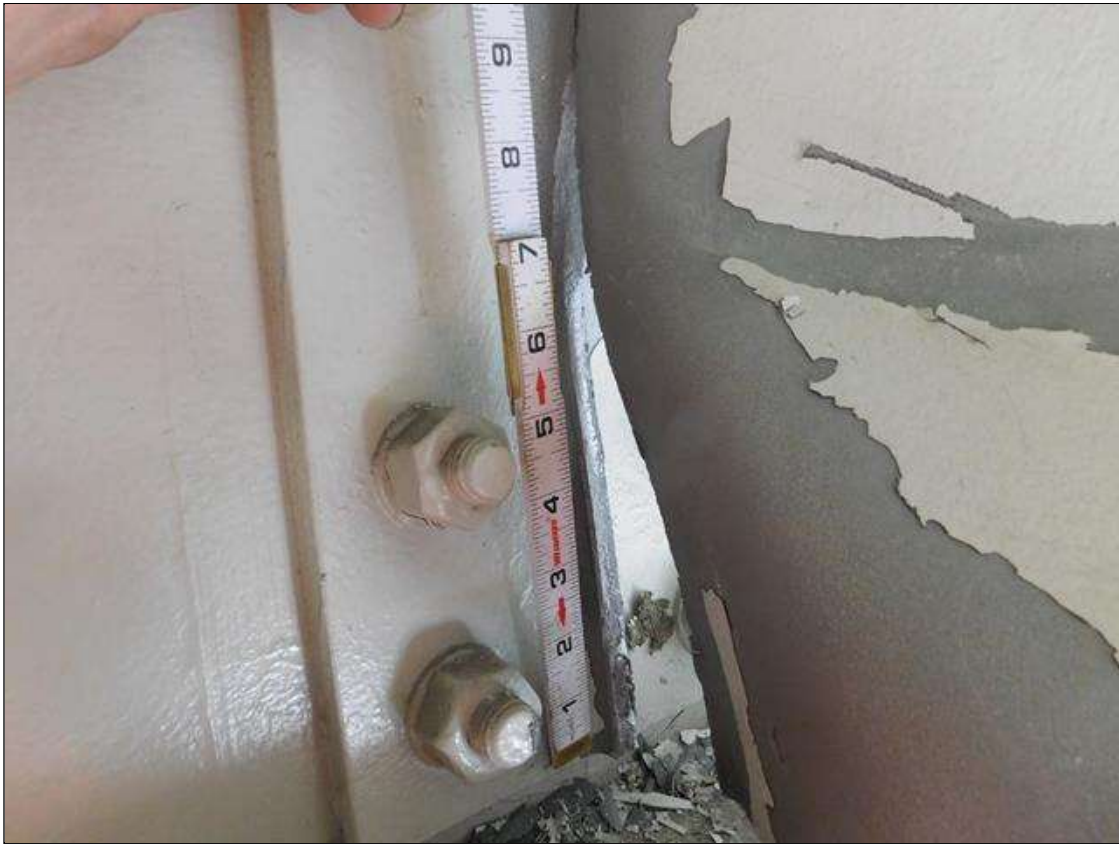
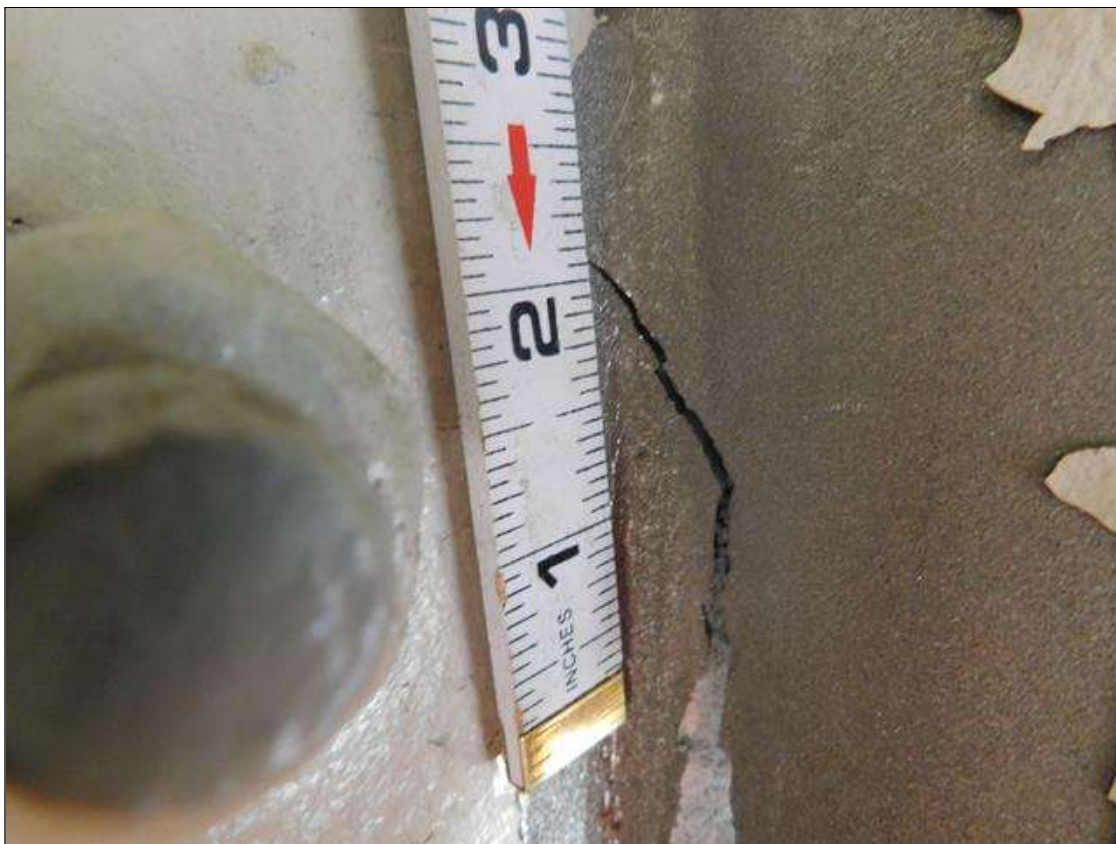
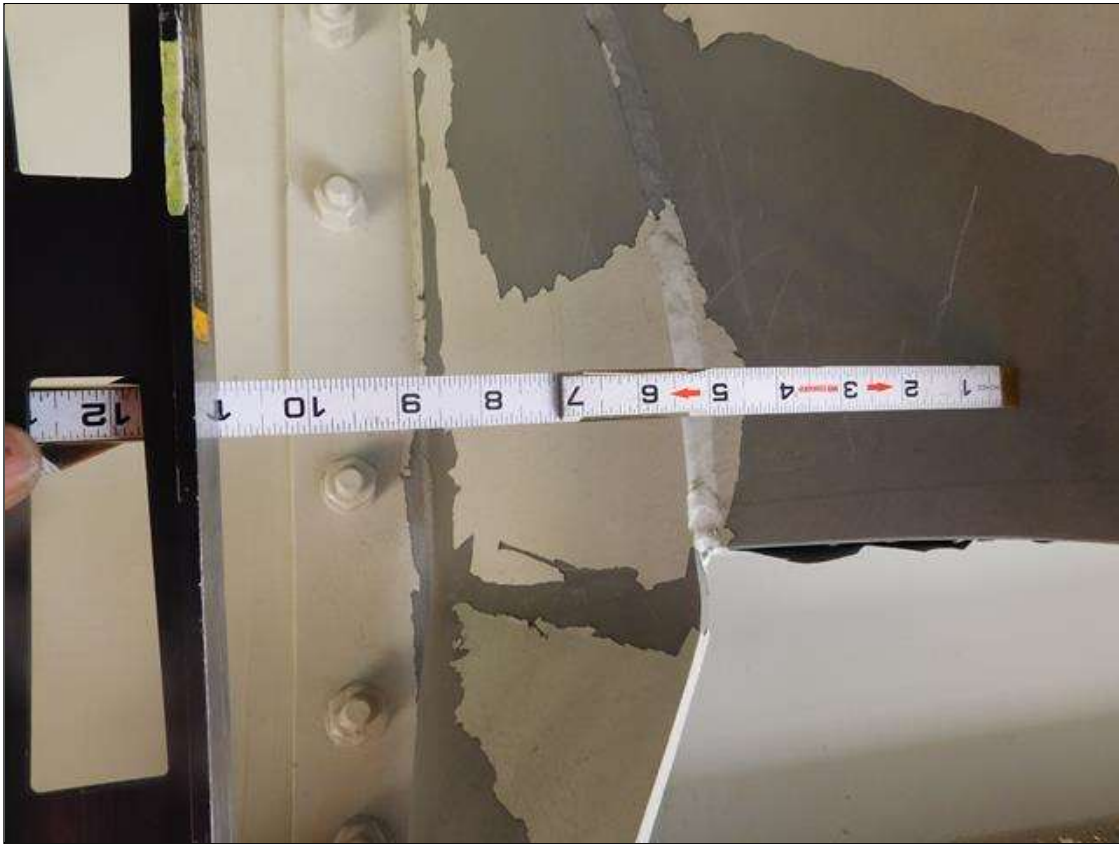
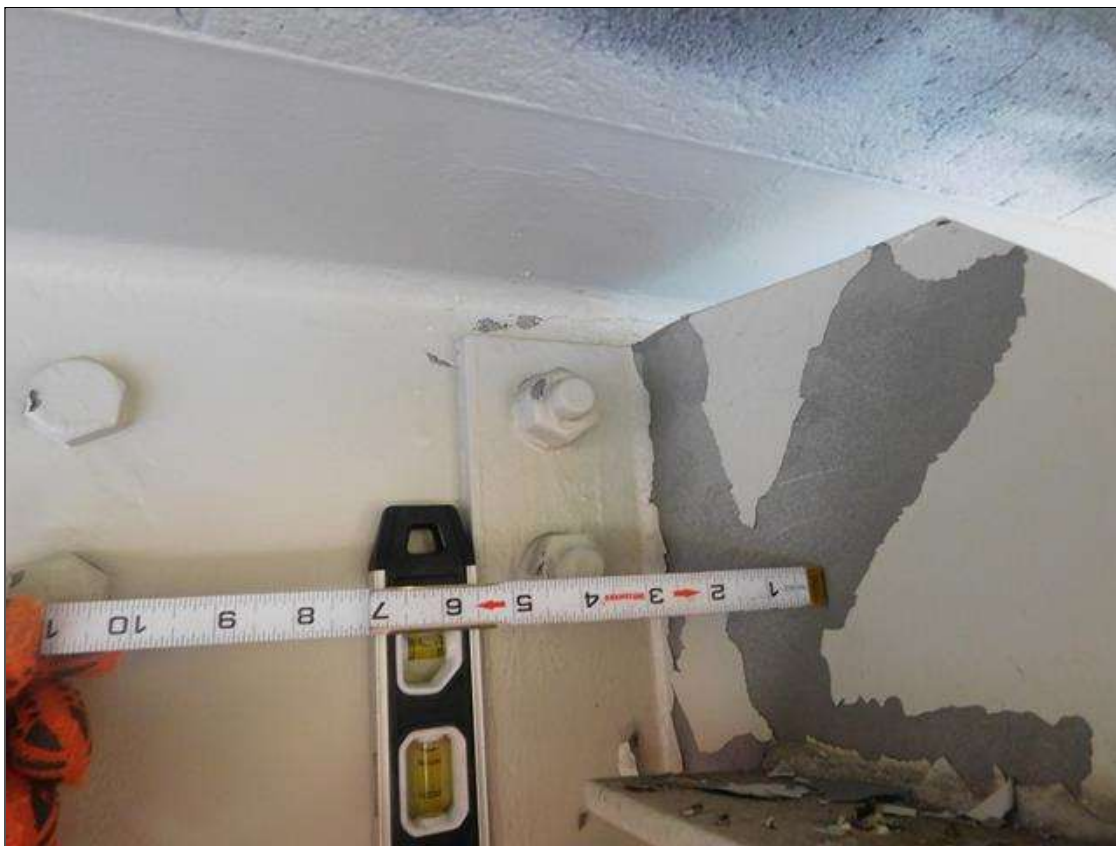
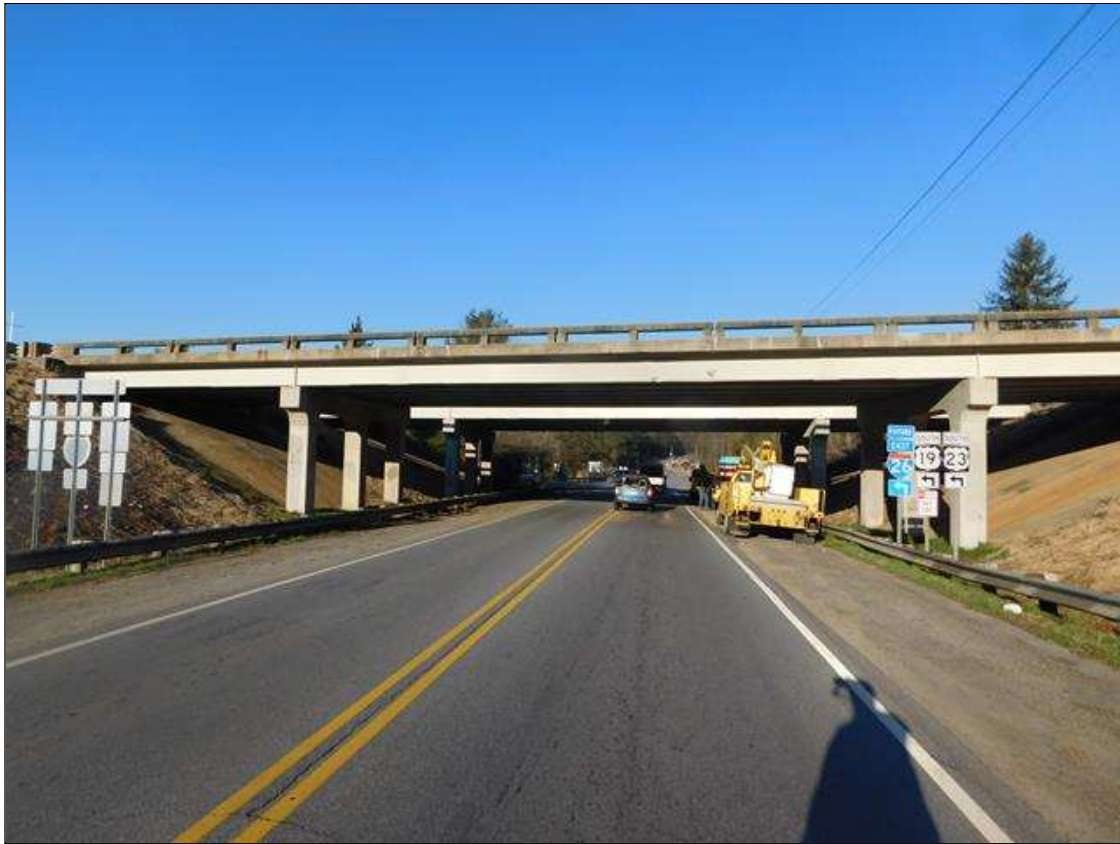
BAY 1 SPAN 2 : DIAPHRAGM 2 BAY 1 SPAN 2 IS BENT AND TWISTED WITH A 1' HIGH X 2" WIDE RIP AT ITS BASE . THERE IS ALSO A 2" LONG CRACK AT THE TOP OF THIS RIP. NORTH SIDE DIAPHRAGM 2 BENT EASTWARD 11". SOUTH SIDE IS BENT WESTWARD UP TO 5". A PRIORITY MAINTENANCE HAS BEE REQUESTED FOR THIS CONDITIONS.
