NC DEPARTMENT OF TRANSPORTATION  
 DIVISION OF HIGHWAYS  
 STRUCTURE MANAGEMENT UNIT

# Structure Safety Report

## Supplemental Element Inspection

DIVISION: 13 COUNTY: BUNCOMBE STRUCTURE NUMBER: 100382 FREQUENCY: None

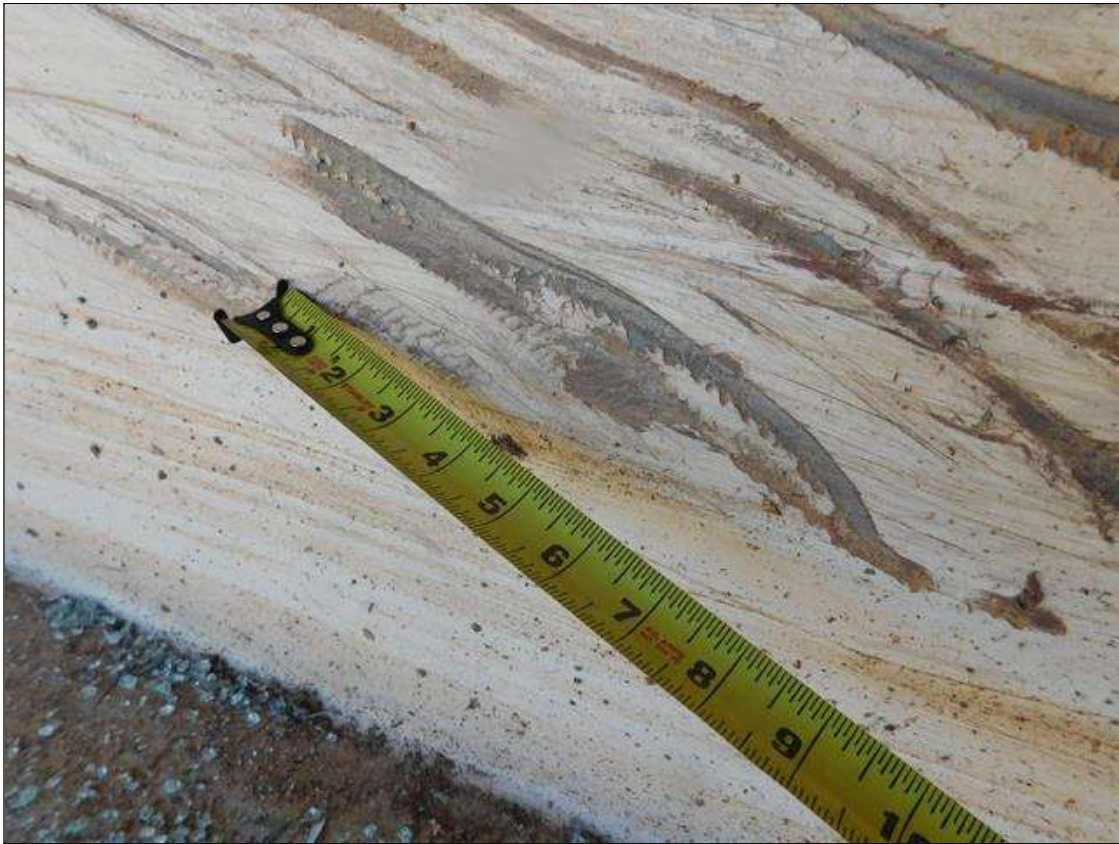
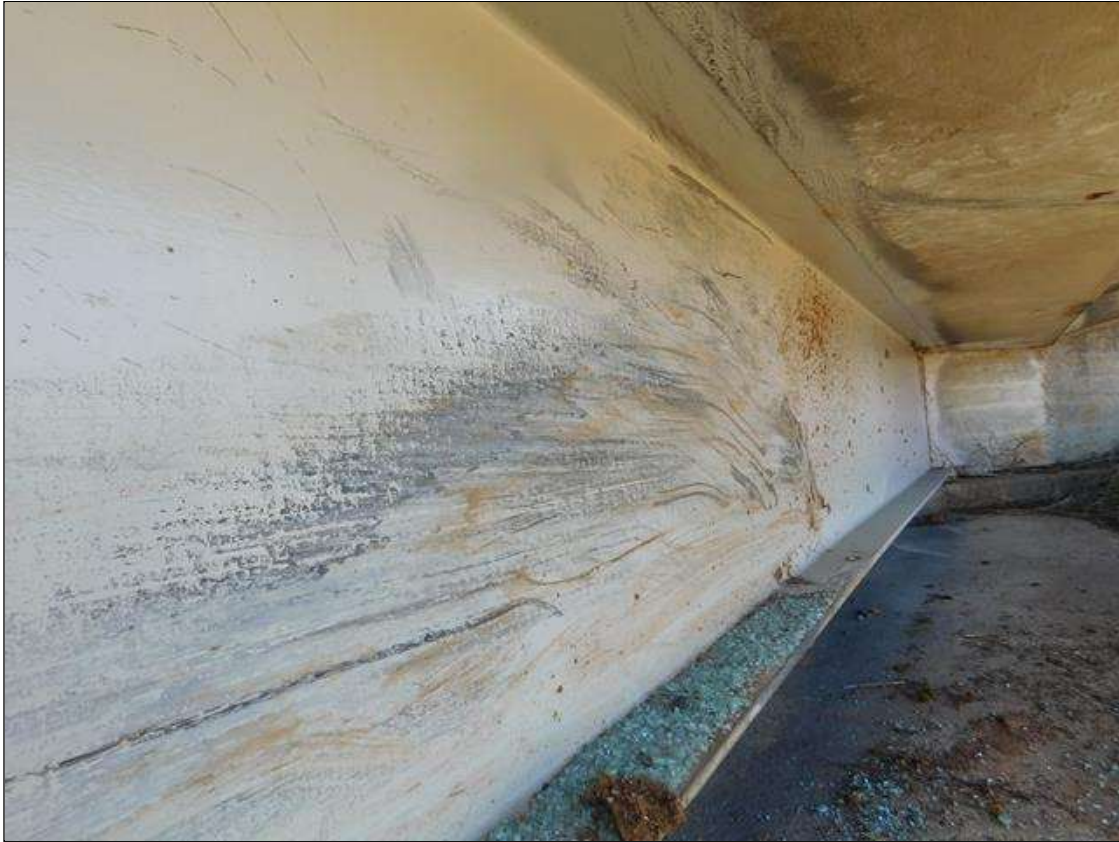
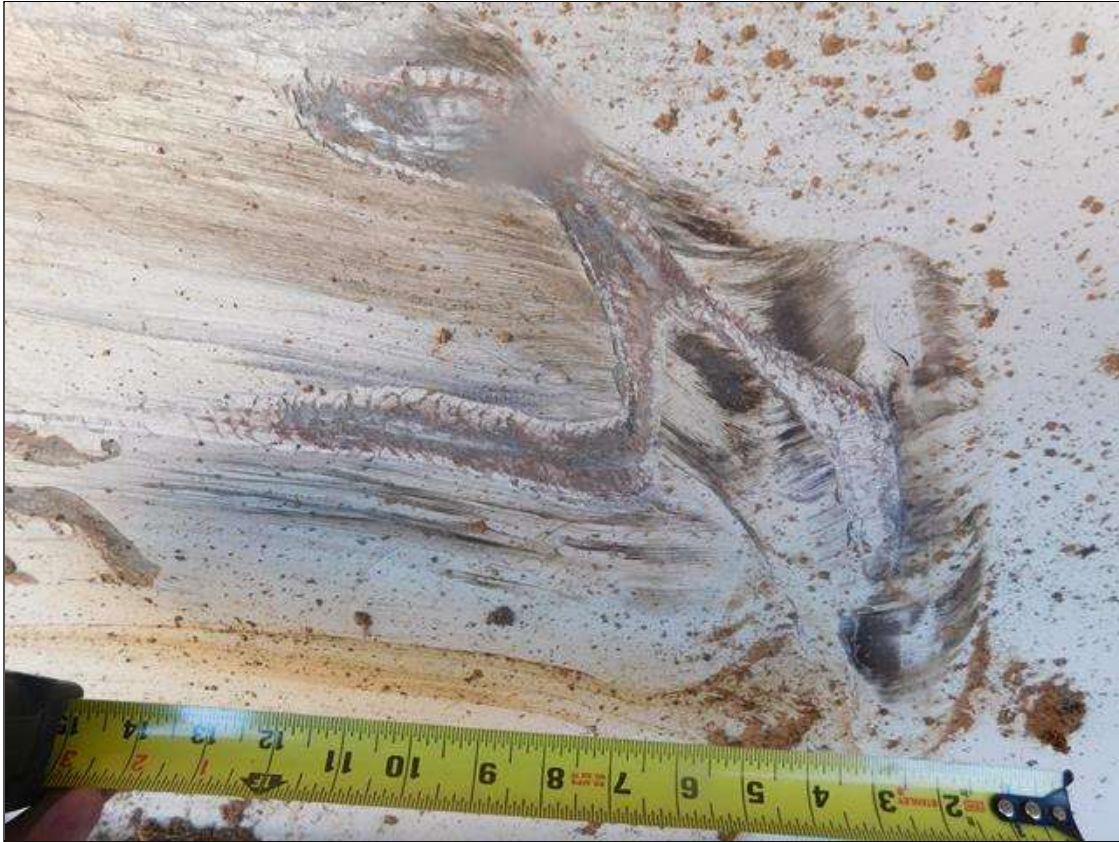
| Element Number | Defect Type | Defect Description | CS | CS Qty | Maint Qty | |
|---|---|--|---|---|---|---|
| 107 | Damage | IMPACT DAMAGE - THE SOUTH MOST 30' DEFLECTED 1" EASTWARD . SCATTERED SCARPS WITH 1/16" INDENTIONS THROUGH OUT A 7' LONG X 2'-7" HIGH AREA AT 12' OUT FROM END BENT 1 (POINT OF IMPACT). THERE IS A 1'-8" LONG X 1/2" WIDE X 1/16" DEEP SCRAP ON THE BOTTOM FLANGE AT 12' OUT FROM END BENT 1 . | 3 | 30 | 30 | Feet |

Span 1 Beam 1: IMPACT DAMAGE - THE SOUTH MOST 30' DEFLECTED 1" EASTWARD . SCATTERED SCARPES WITH 1/6" INDENTIONS THROUGH OUT A 7' LONG X 2'-7" HIGH AREA AT 12' OUT FROM END BENT 1 (POINT OF IMPACT).

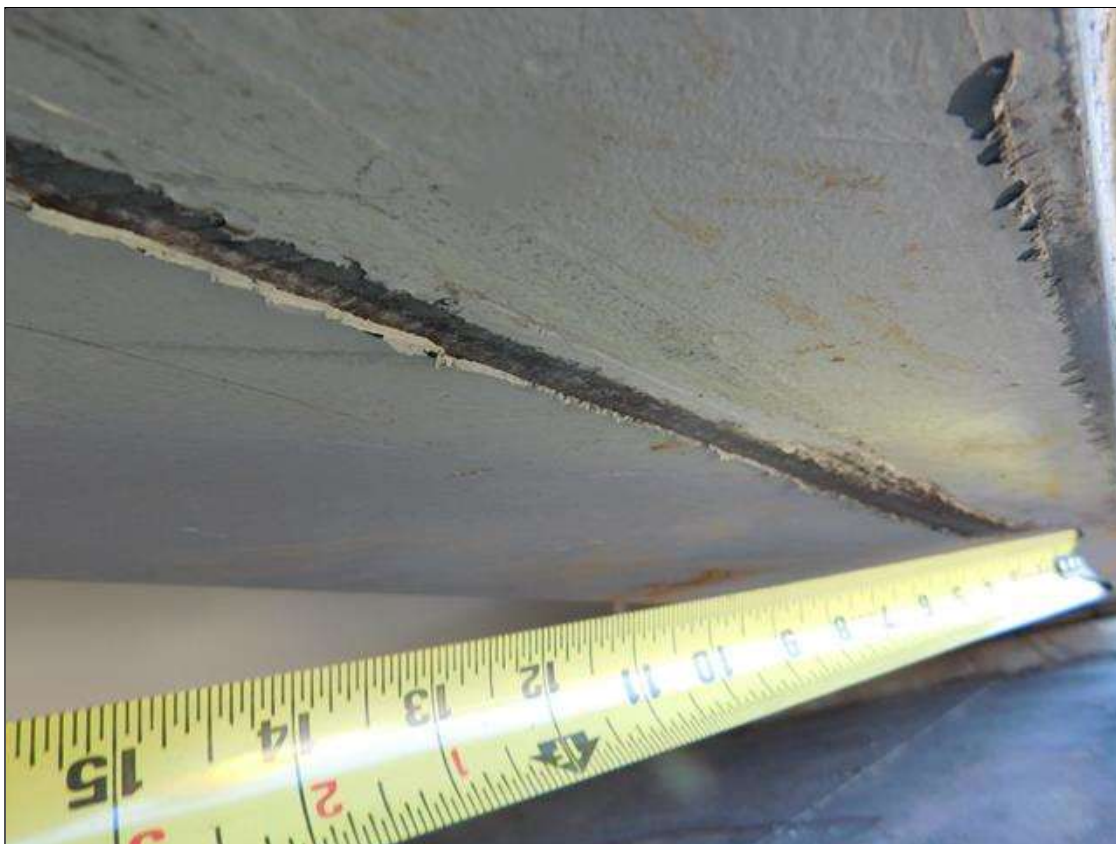
Span 1 Beam 1: IMPACT DAMAGE - THERE IS A 1'-8" LONG X 1/2" WIDE X 1/16" DEEP SCRAP ON THE BOTTOM FLANGE AT 12' OUT FROM END BENT 1 .

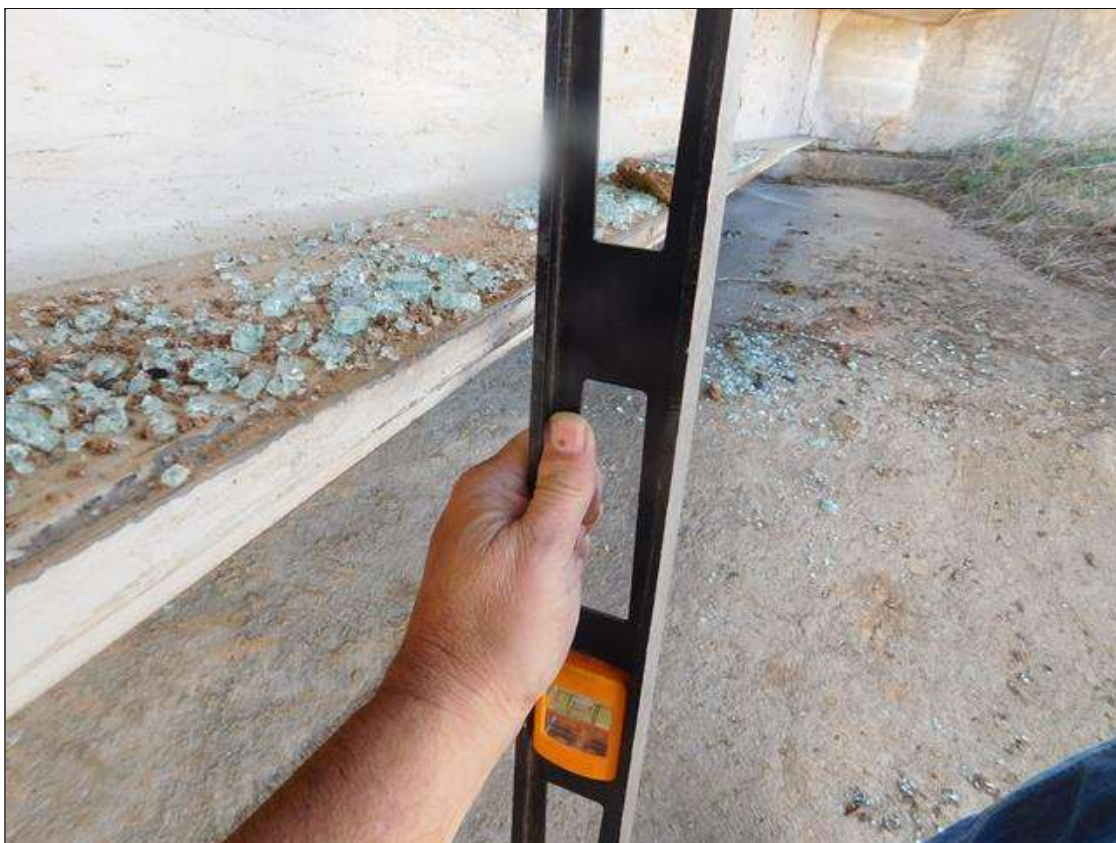
Span 1 Beam 1: IMPACT DAMAGE - THE SOUTH MOST 30' DEFLECTED 1" EASTWARD .

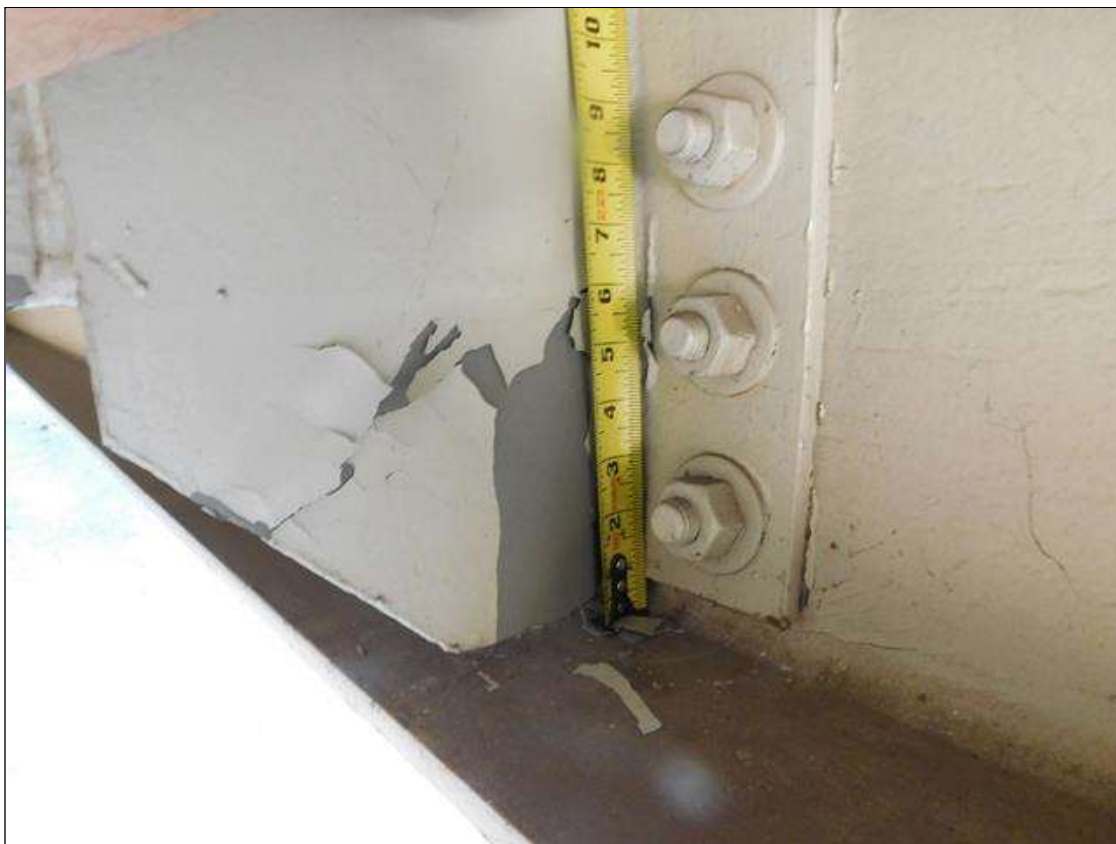
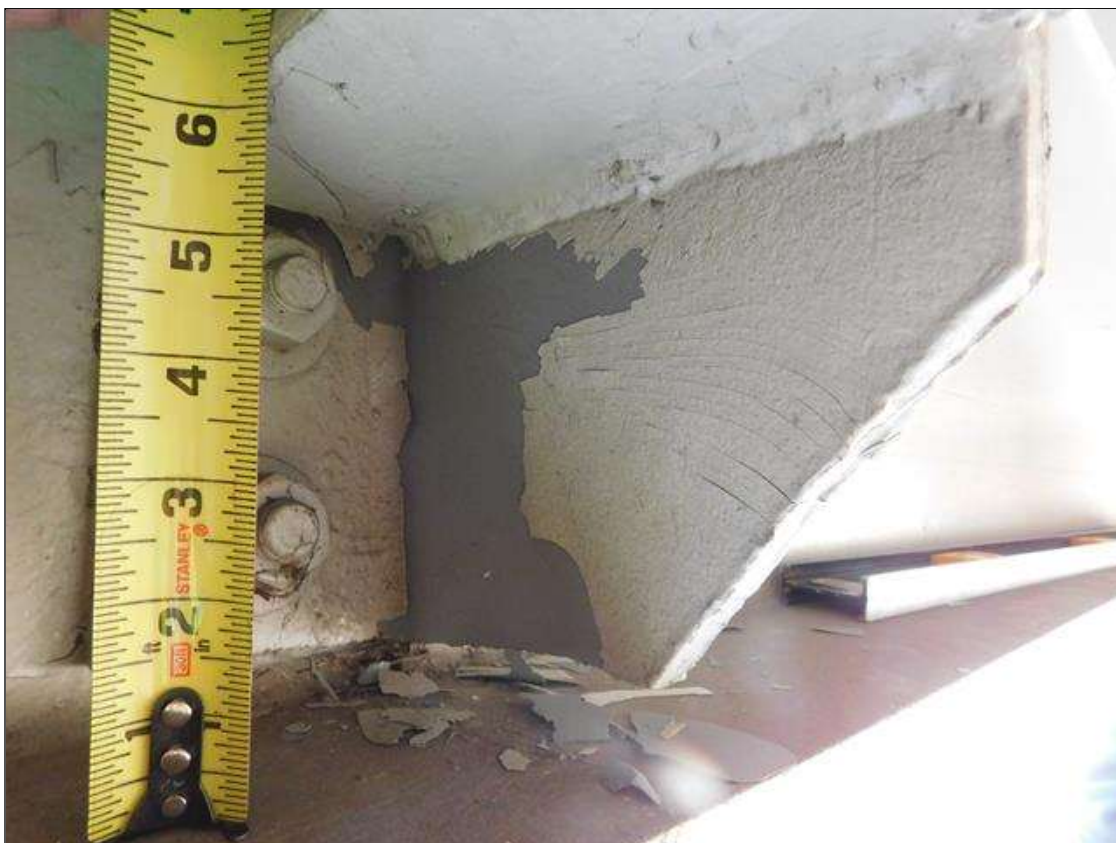
IMPACT DAMAGE - DIAPHRAGM 1 BAY 1 LEFT SIDE THE LOWER 8" OF DIAPHRAGM IS DEFLECTED NORTHWARD UP TO 2"

IMPACT DAMAGE - DIAPHRAGM 1 BAY 1 LEFT SIDE THE LOWER 8" OF DIAPHRAGM DEFLECTED NORTHWARD UP TO 2"

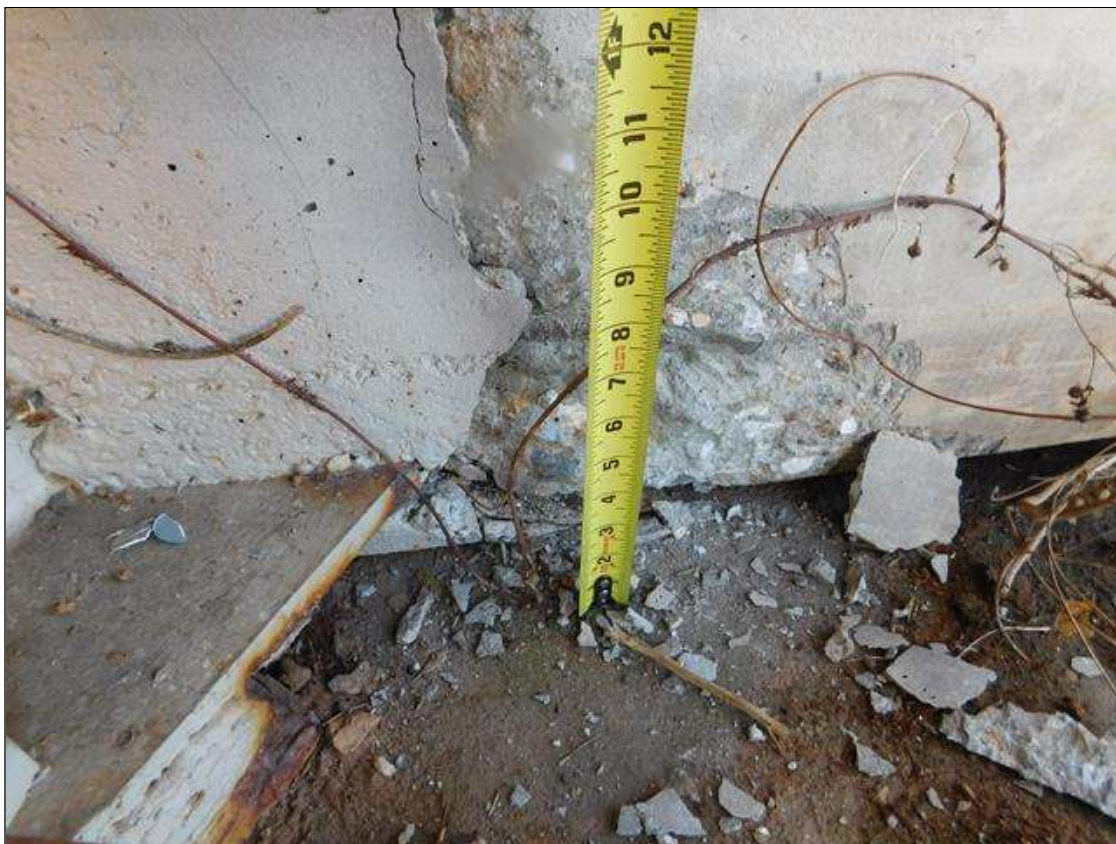
End Bent 1 Abutment/Backwall : 1'3" WIDE X 1' HIGH X 2" DEEP SPALL ON THE LEFT SIDE OF BEAM 1, WITH ONE REBAR EXPOSED .
