NC DEPARTMENT OF TRANSPORTATION
 DIVISION OF HIGHWAYS
 STRUCTURE MANAGEMENT UNIT

Structure Safety Report

Supplemental Element Inspection

DIVISION: 13 COUNTY: BUNCOMBE STRUCTURE NUMBER: 100387 FREQUENCY: None

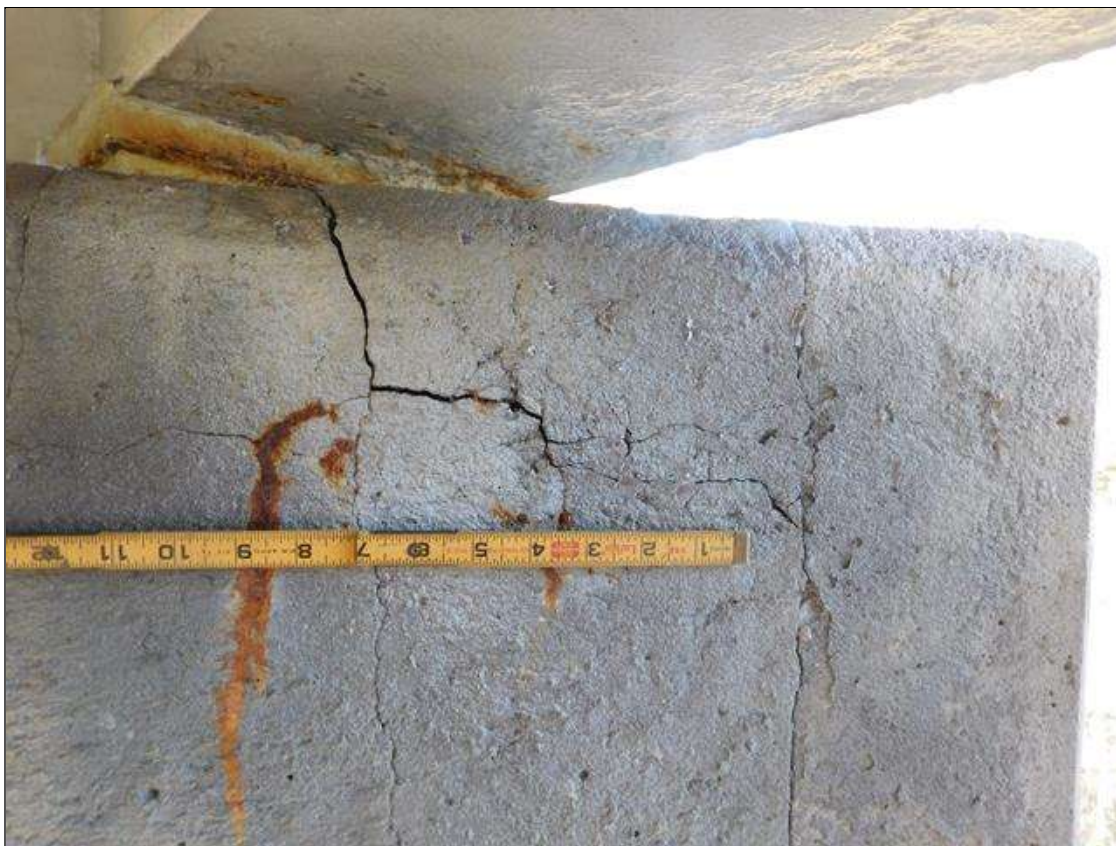
SCATTERED CRACKING IN CAP AT INT BENT 1 BENEATH BEAM 1 SPAN 2

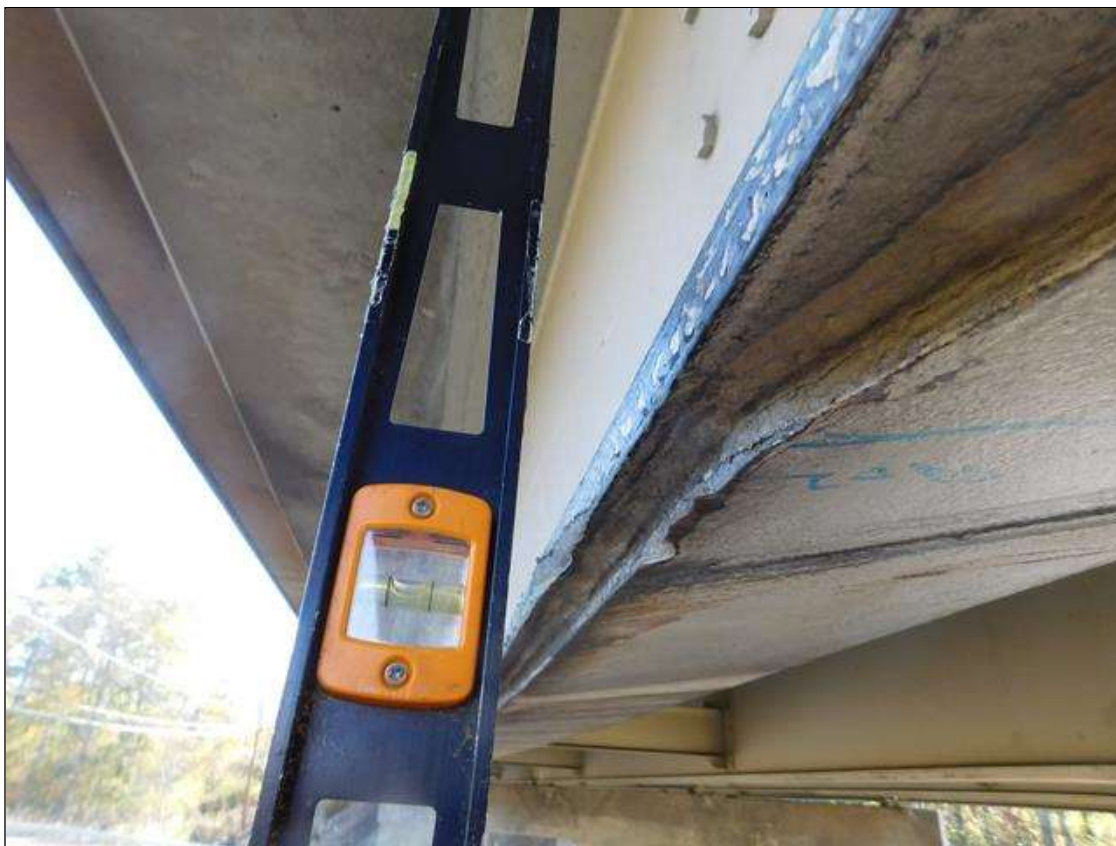
BEAM 1 SPAN 2 BEAM SWEEP EASTWARD 1 1/2" (PAR)

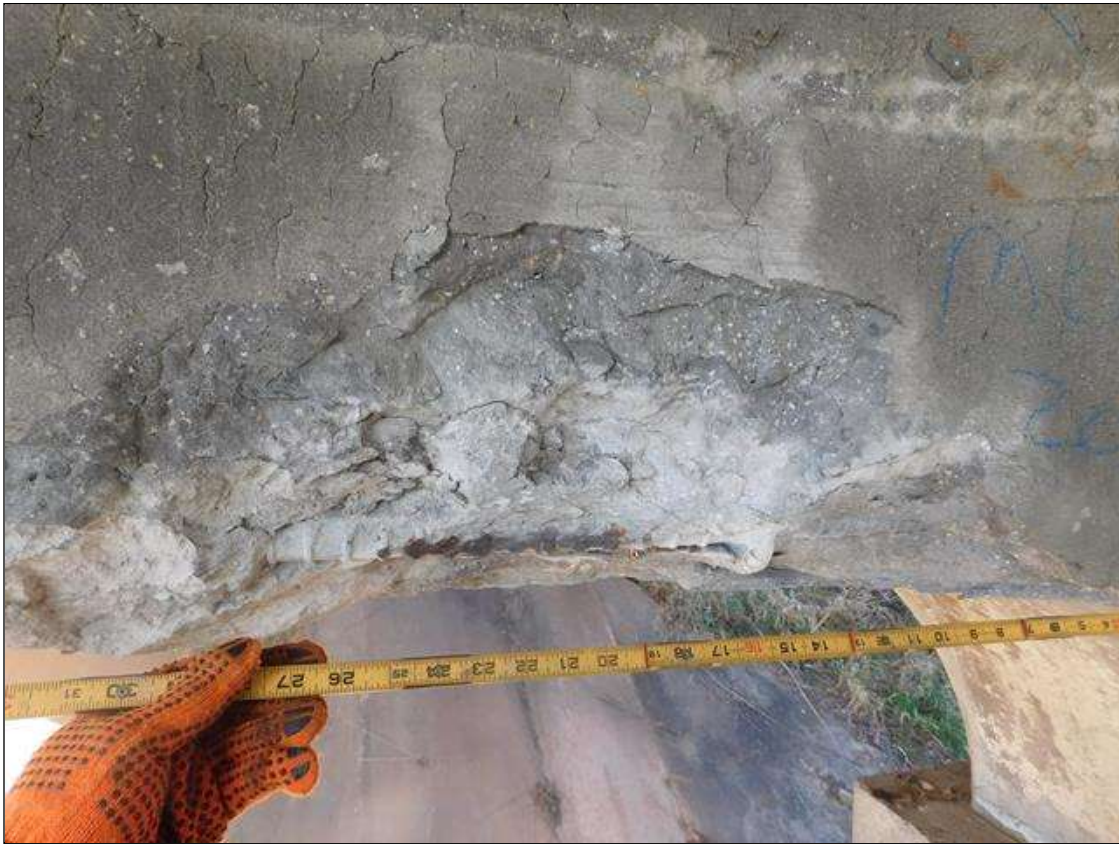
INT. BENT 1 CAP SPALLING BENEATH BEAM 3 AT THE BOTTOM OF CAP 3'-3" LONG X 11" HIGH X 8" DEEP WITH 1 REINFORCING BAR EXPOSED (PAR)

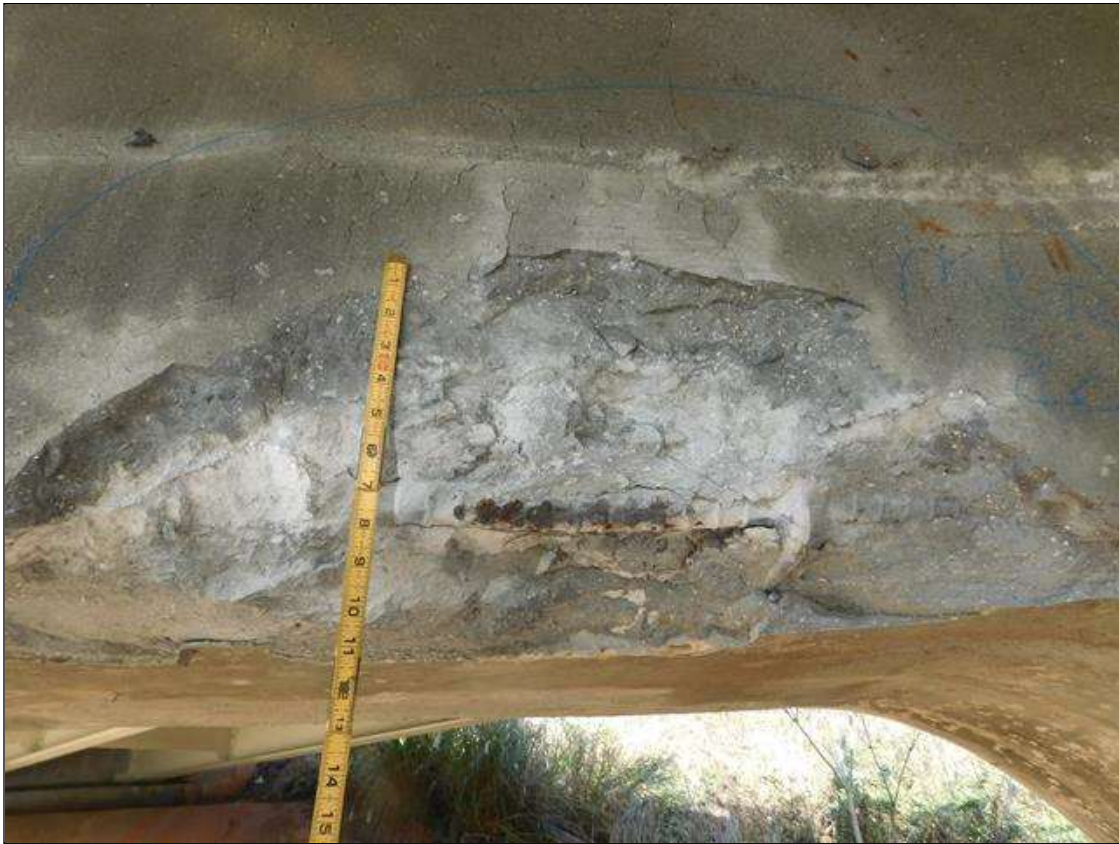
INT. BENT 1 CAP SPALLING BENEATH BEAM 3 AT THE BOTTOM OF CAP 3'-3" LONG X 11" HIGH X 8" DEEP WITH 1 REINFORCING BAR EXPOSED (PAR)

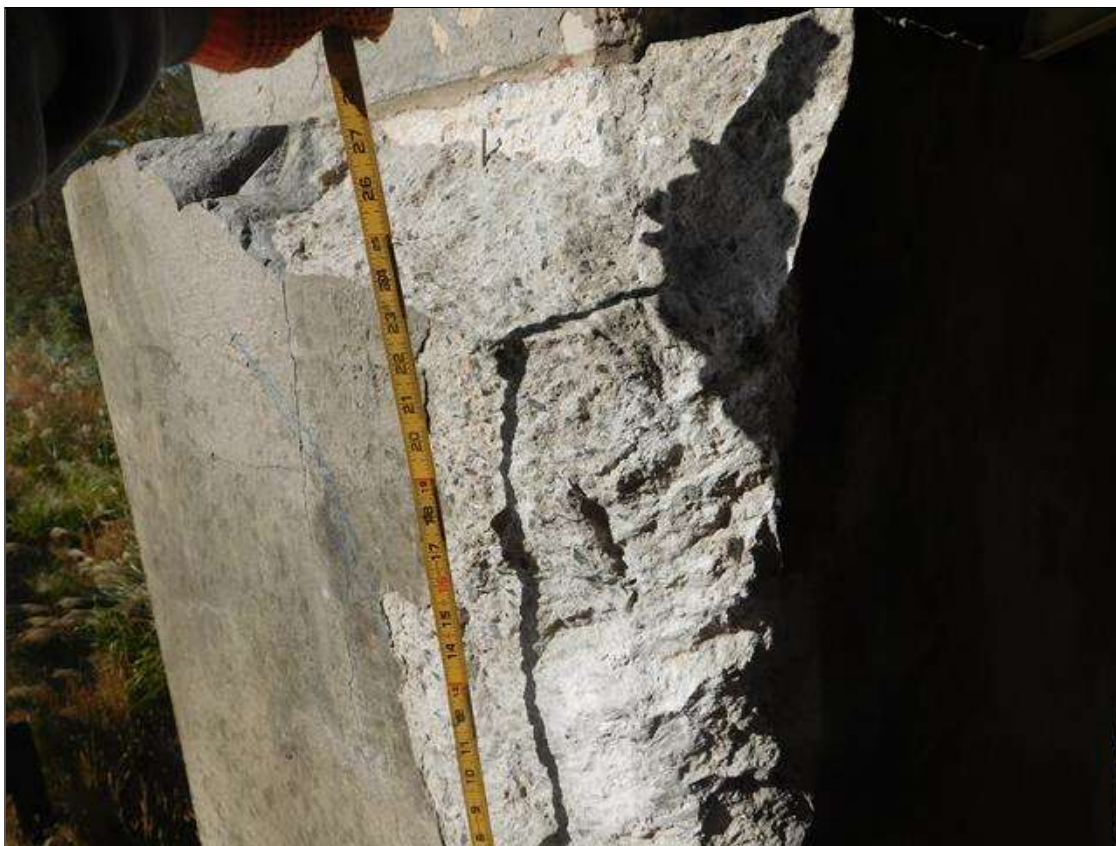
COLUMN 3 INT. BENT 1 SPALL 2'-10" HIGH X 2'88" LONG X 7" DEEP AT THE TOP OF NEW SECTION (PAR)

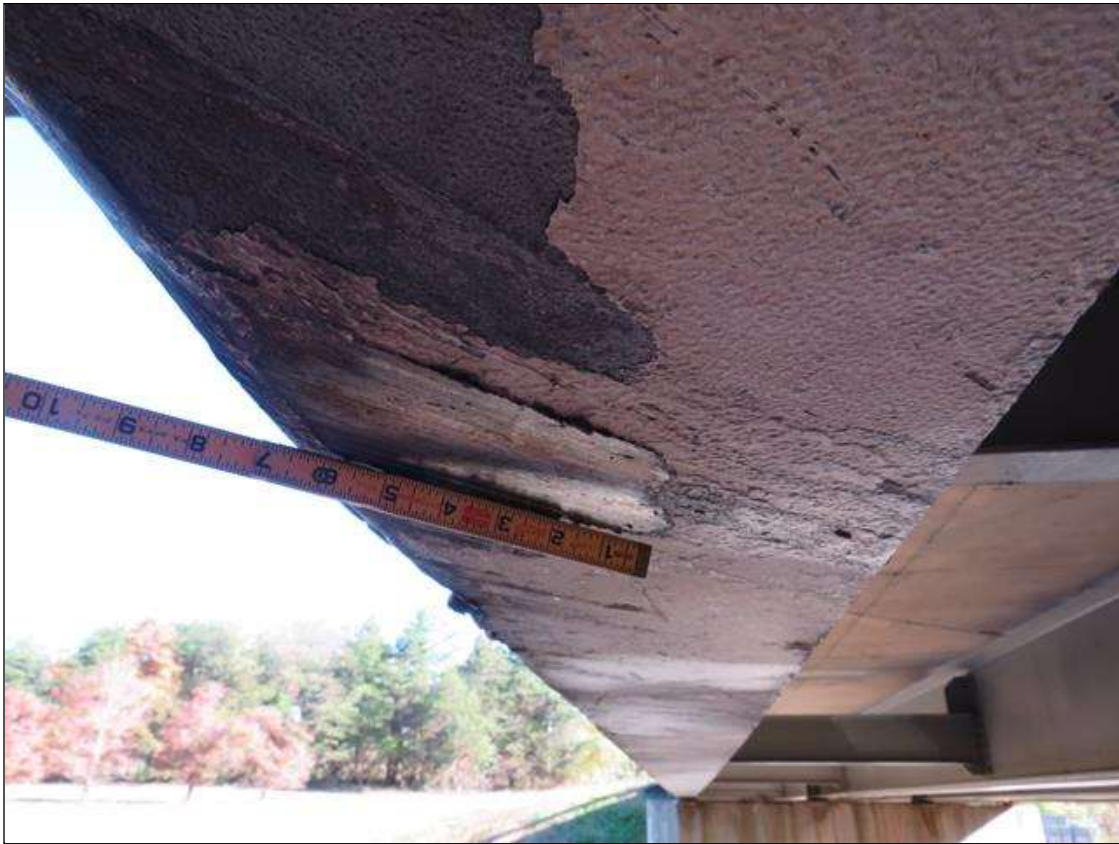
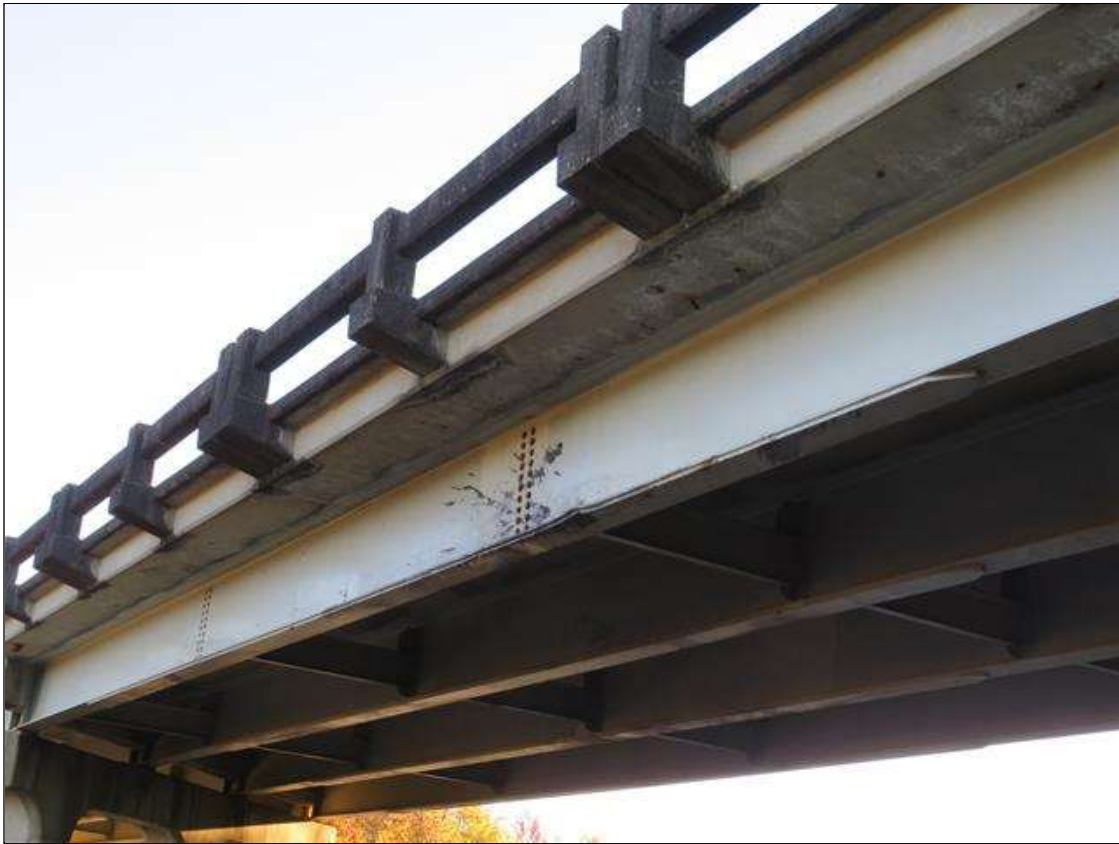
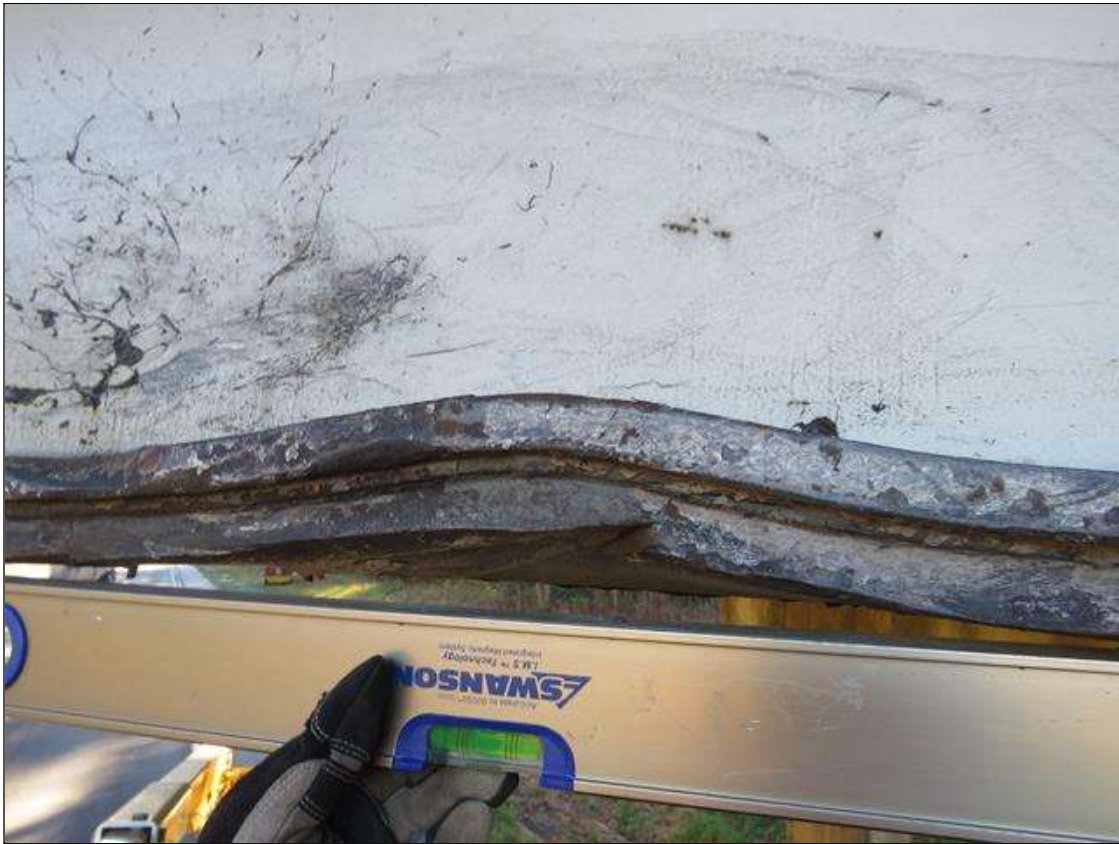
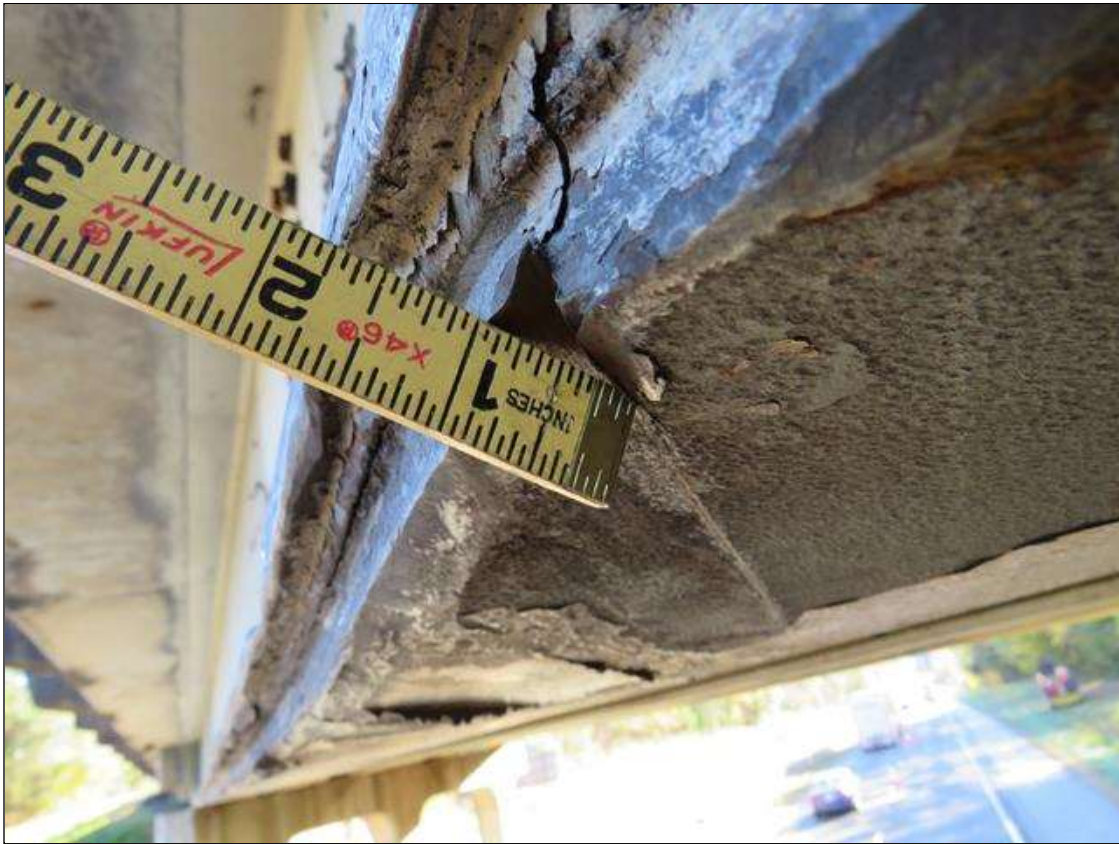
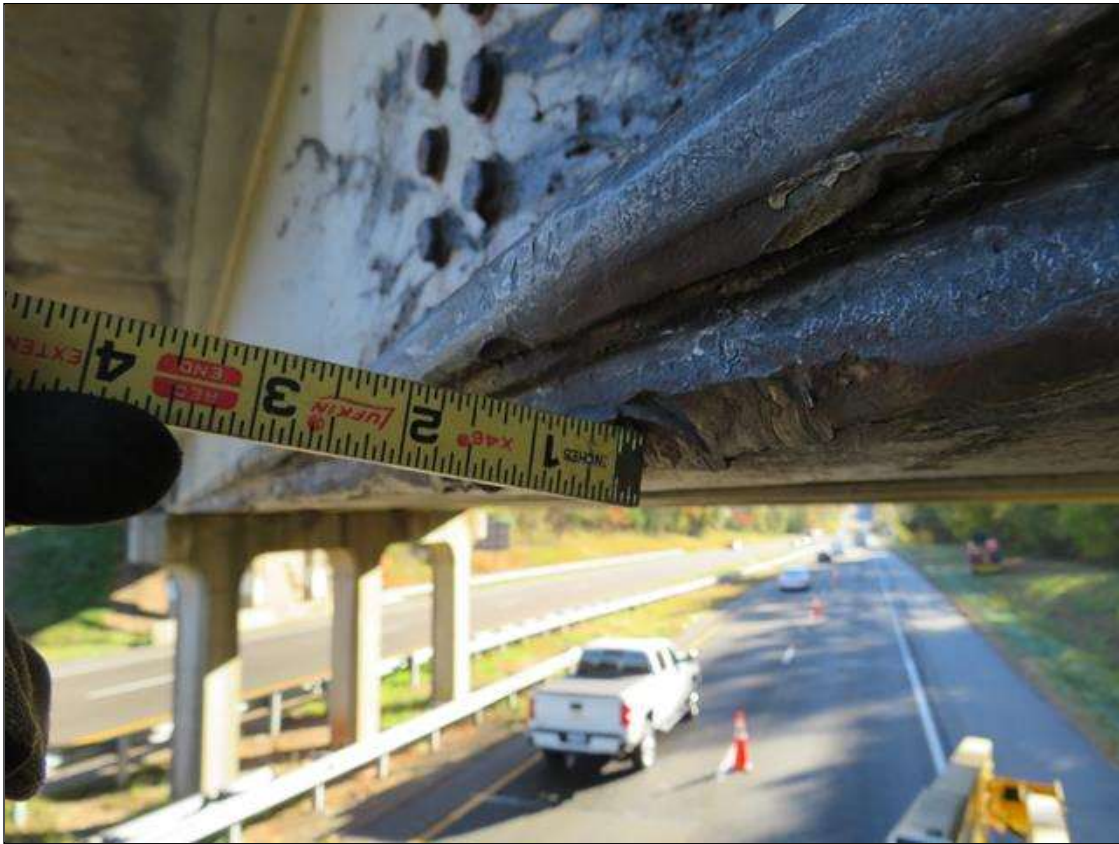
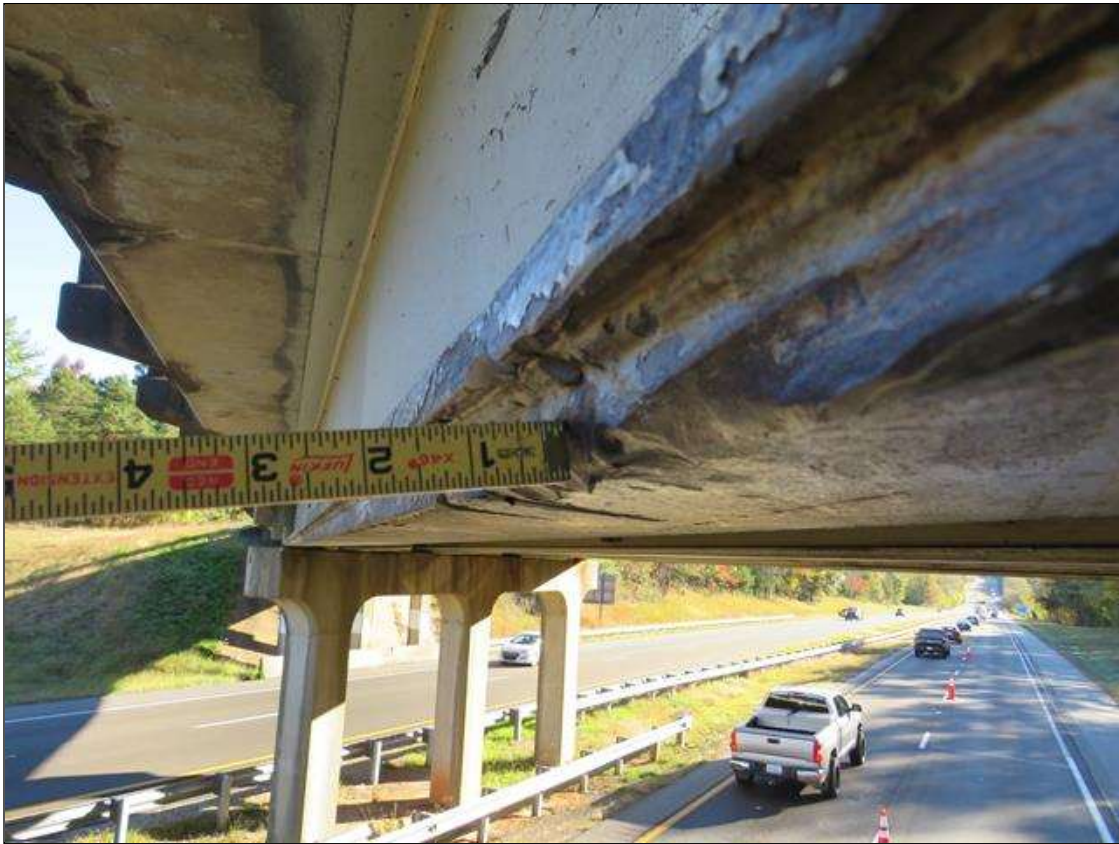
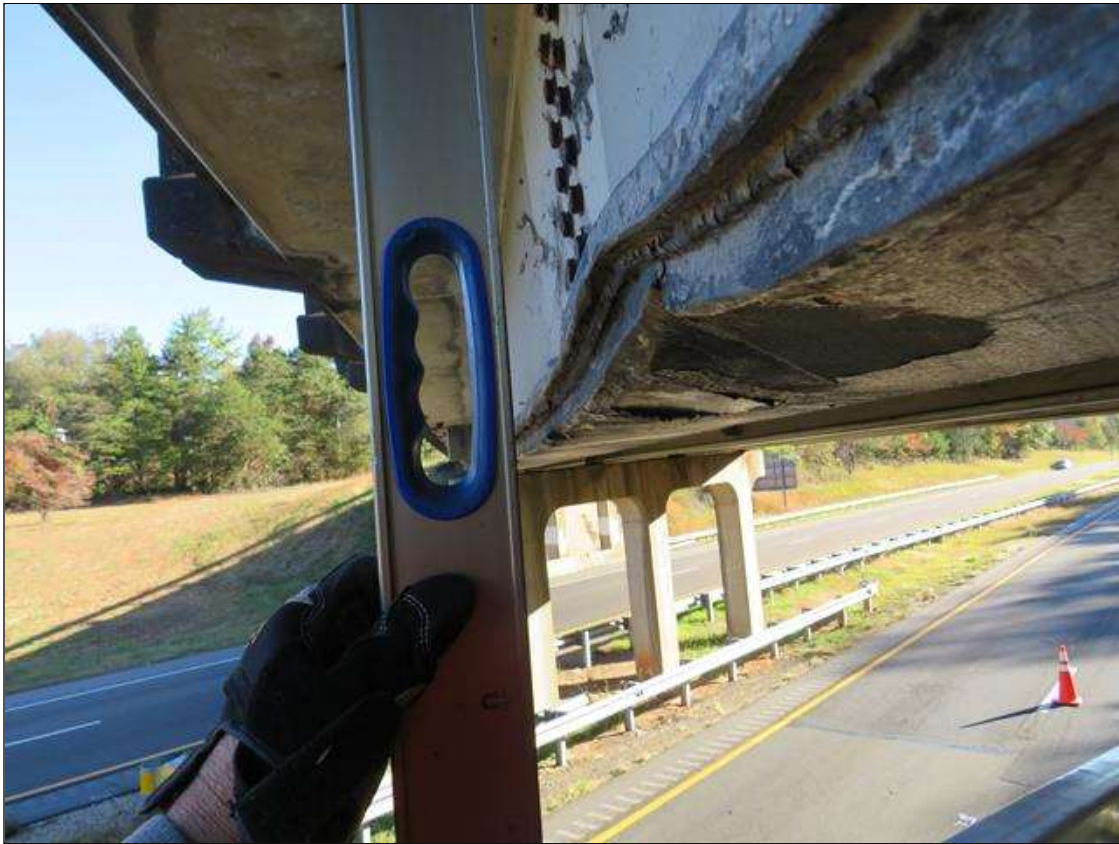
Span 2 Beam 1: SUPPLEMENTAL INSPECTION IMPACT DAMAGE 2021 : Initial point of impact on beam 1 19'-7" from face of bent 1. Beam 1 is out of plumb 2" in the direction of traffic FOR THE LENGTH OF 20' and indentation in cover plate 3' X 2" in the impact area. An indentation in flange 8" X 1/4" at 21'-3", A 8" X 1/4" at 22'-11", a 5" X 1/16" at 17'-4", a 29" X 1/2" at 27'-0" all from face of bent 1. Indentions in flange cover plate 6" X 1/16" at 23'-4", a 6" X 1/16" at 22'-9", a 8" X 1/32" at 21'-6", a 8" X 1/16" at 21'-1", a 8" X 1/16" at 18'-9", a 6" X 1/32" at 16'-4", a 1" X 1/32" at 25'-5" all from face of bent 1. Gouges in flange cover plate 1" X 4" X 1/16" at 21'-1" and 3/4" X 3" X 1/16" at 27'-2" from face of bent 1.

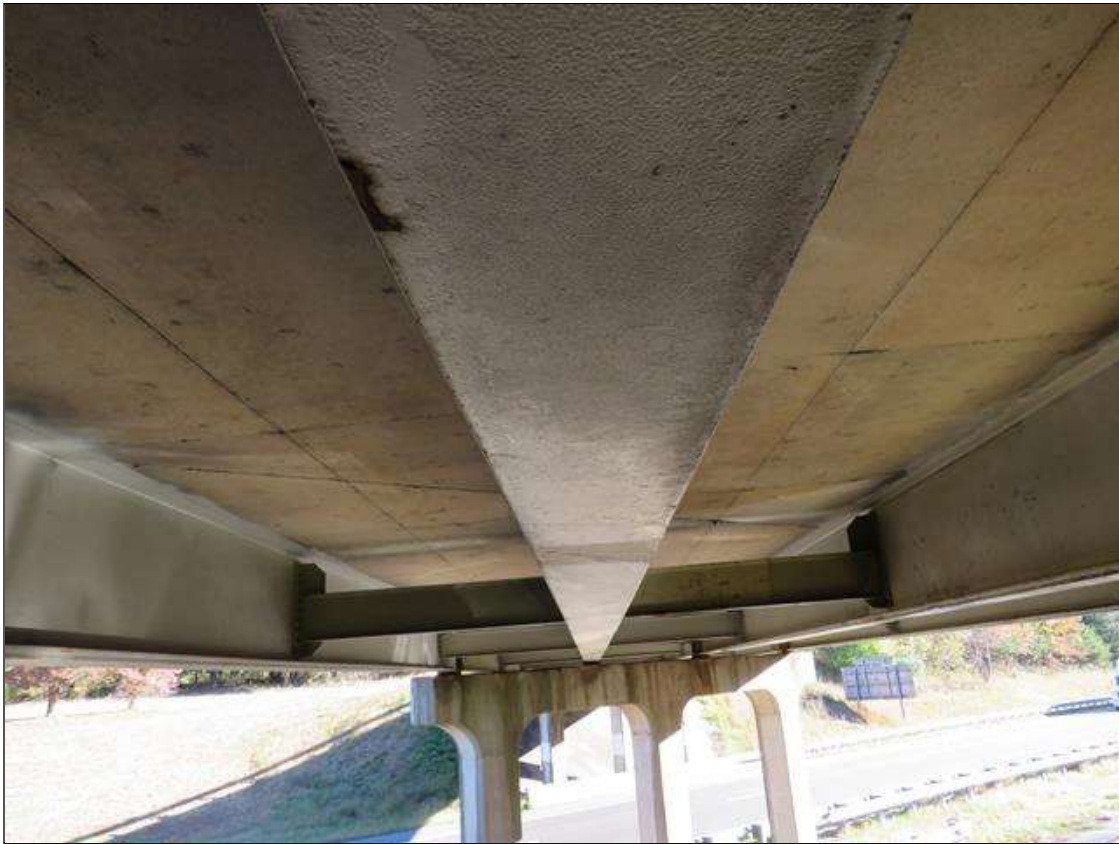
Span 2 Beam 2: SUPPLEMENTAL INSPECTION 2021: Point of impact on beam 2 West approach slab 27'-6" from face of bent 1. Gouges in flange cover plate 1/2" X 14" X 1/16" and a indentation in flange cover plate 6" X 1/32", a indentation in flange 1 1/2" X 1/16" all in the impact area.

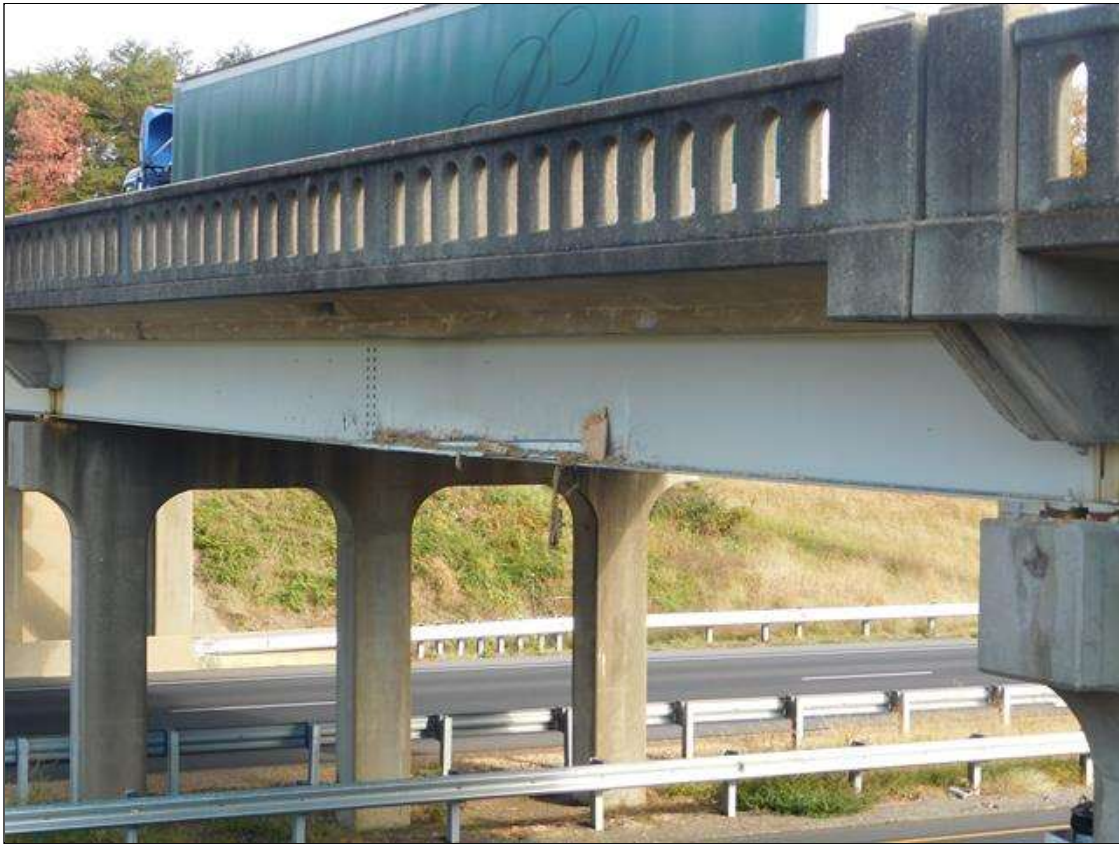
SPAN 2 BEAM 1: OVERVIEW OF IMPACT DAMAGE TO BEAM 1 (PAR)

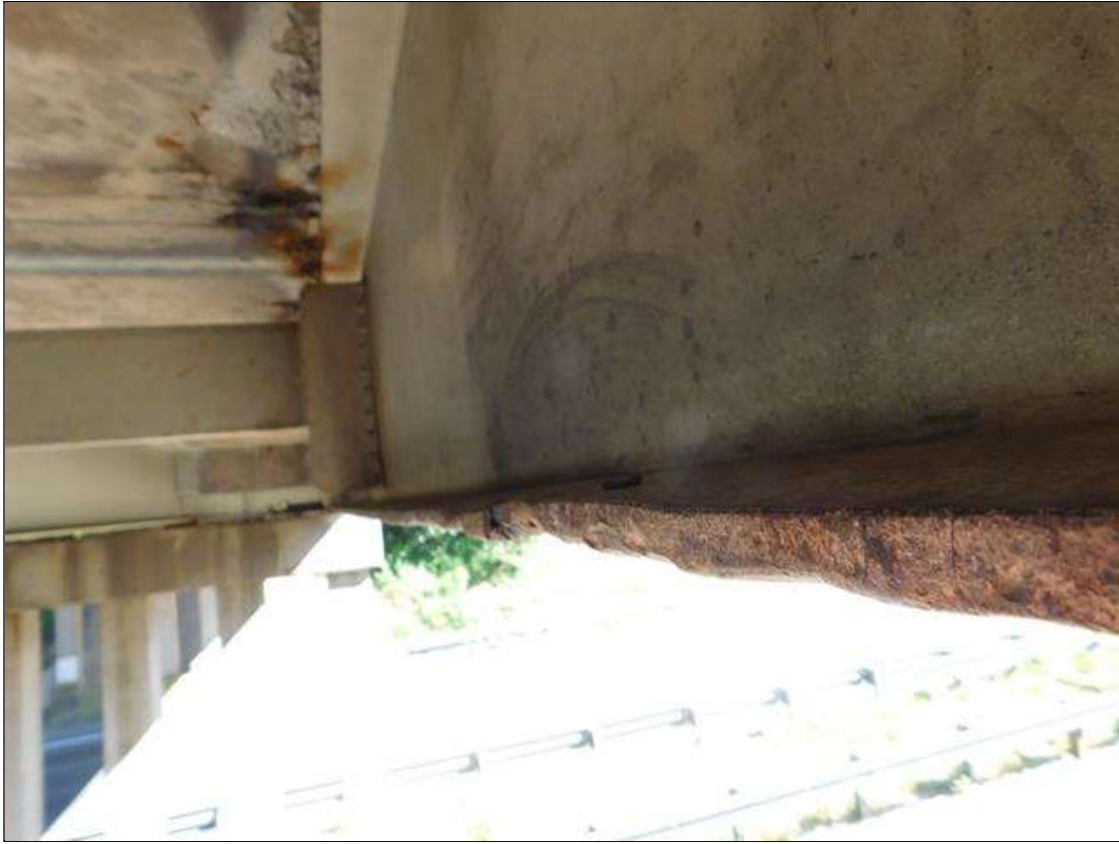
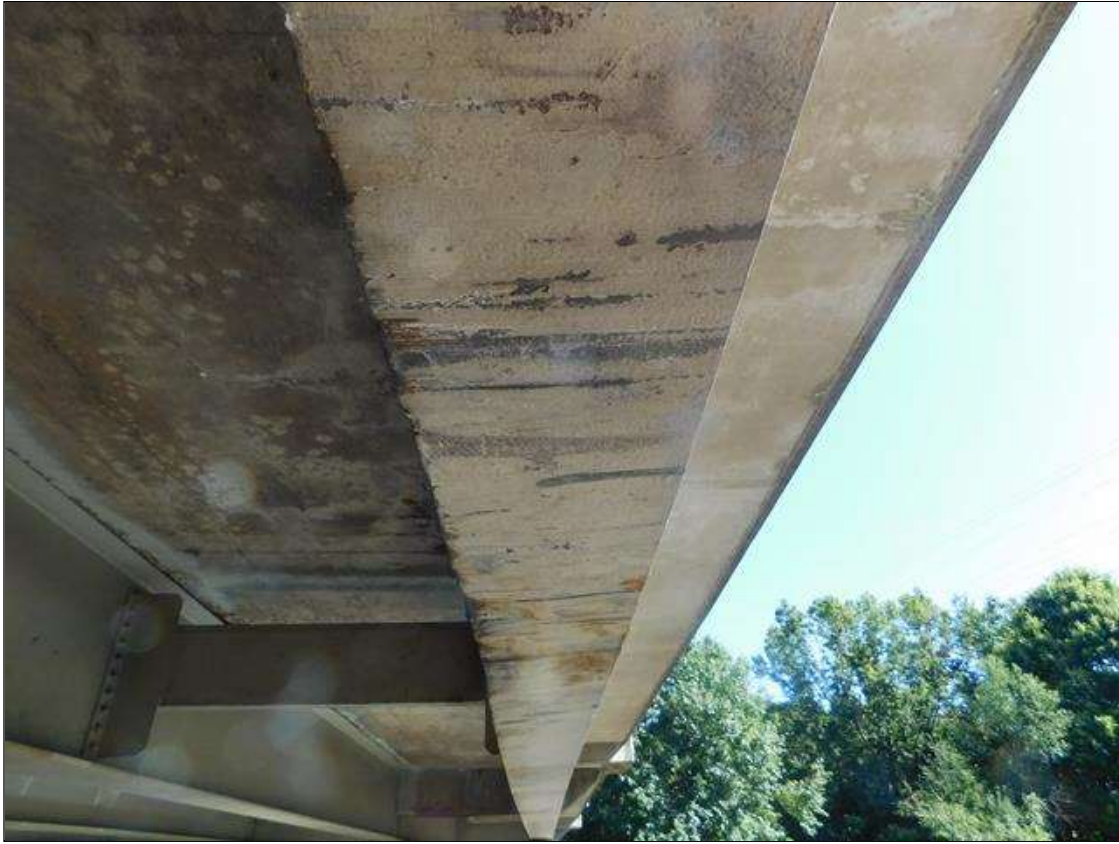
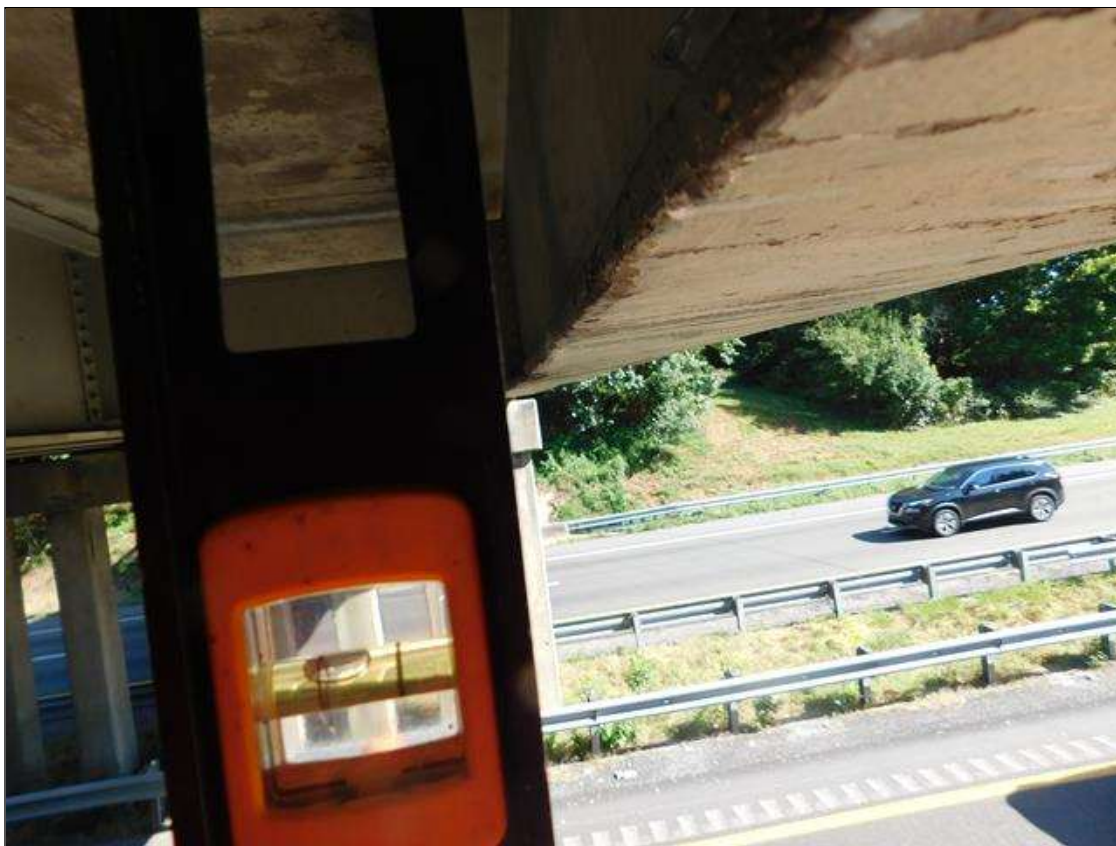
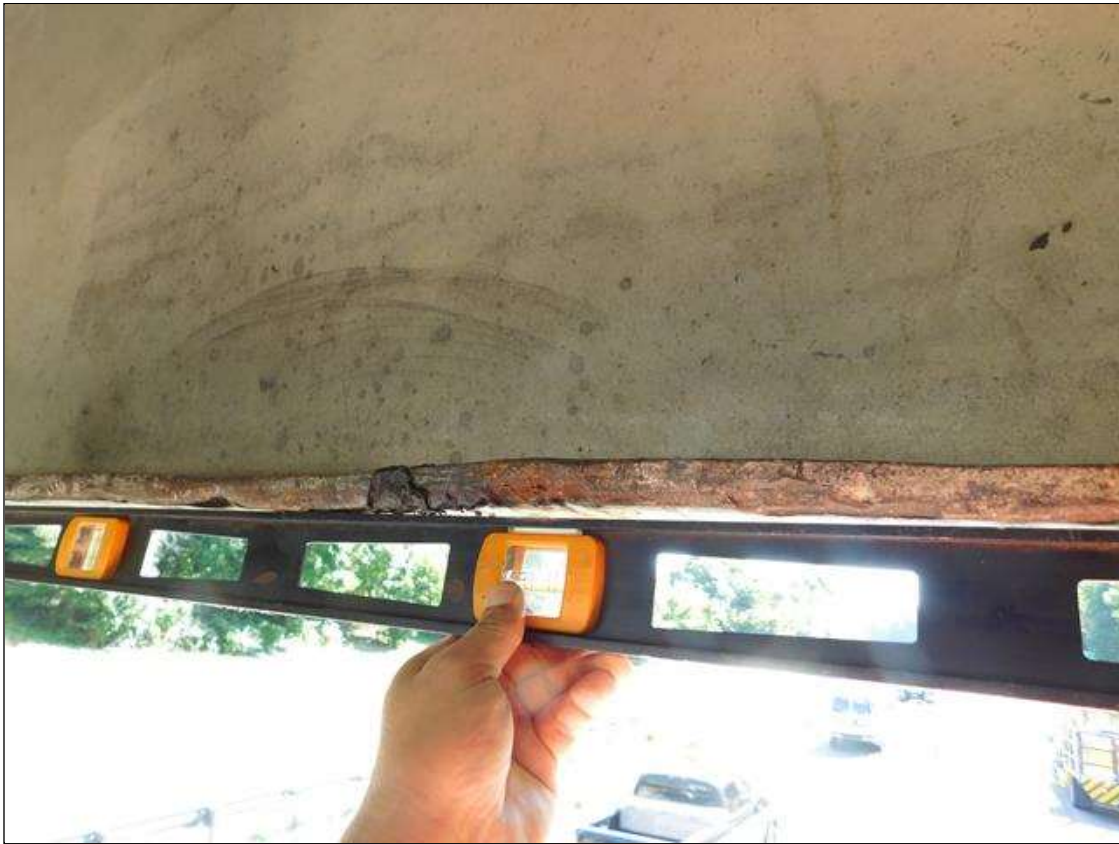
Span 2 Beam 5: 2021 SUPPLEMENTAL INSPECTION 2021 : BEAM 5 SPAN 2 POINT OF IMPACT 10" LONG X 1" HIGH AT 14'10" OUT FROM INT. BENT 2 , WITH THE BEAM BEING SWEEPED EAST WARD UP TO 3" .SCATTERED SCRAPES ALONG THE BOTTOM FLANGE . PREVIOUS IMPACT DAMAGE AS NOTED IN THE ADDITIONAL COMMENTS SECTION. (PAR)

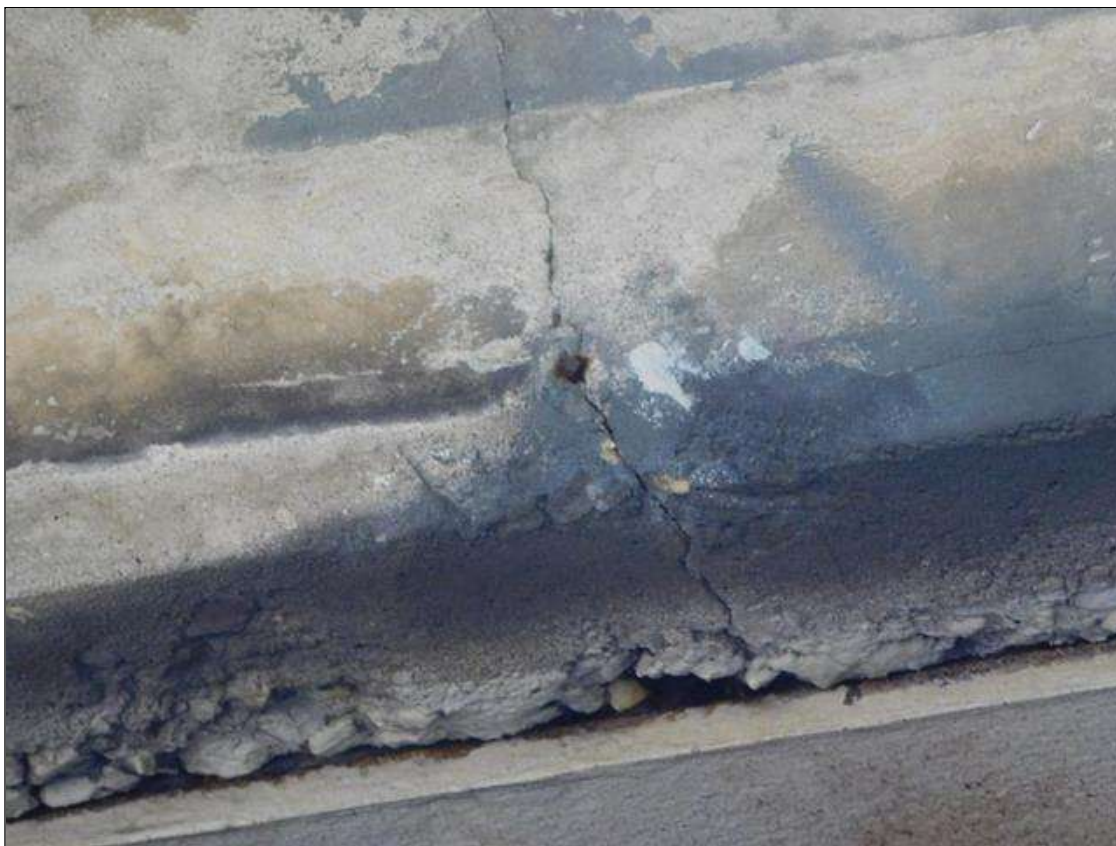
Span 2 Deck: SUPPLEMENTAL INSPECTION 2021 : THERE ARE 2 HAIRLINE CRACK IN THE RIGHT OVERHANG ABOVE POINT OF IMPACT

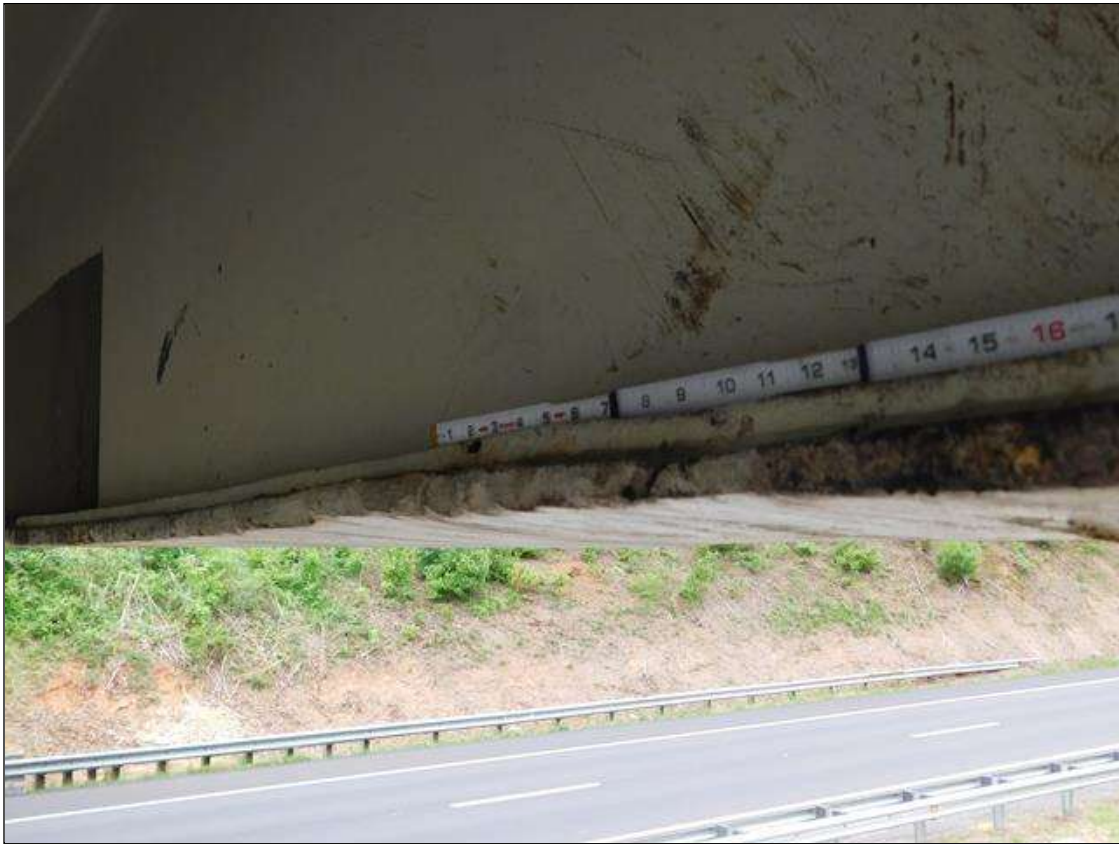
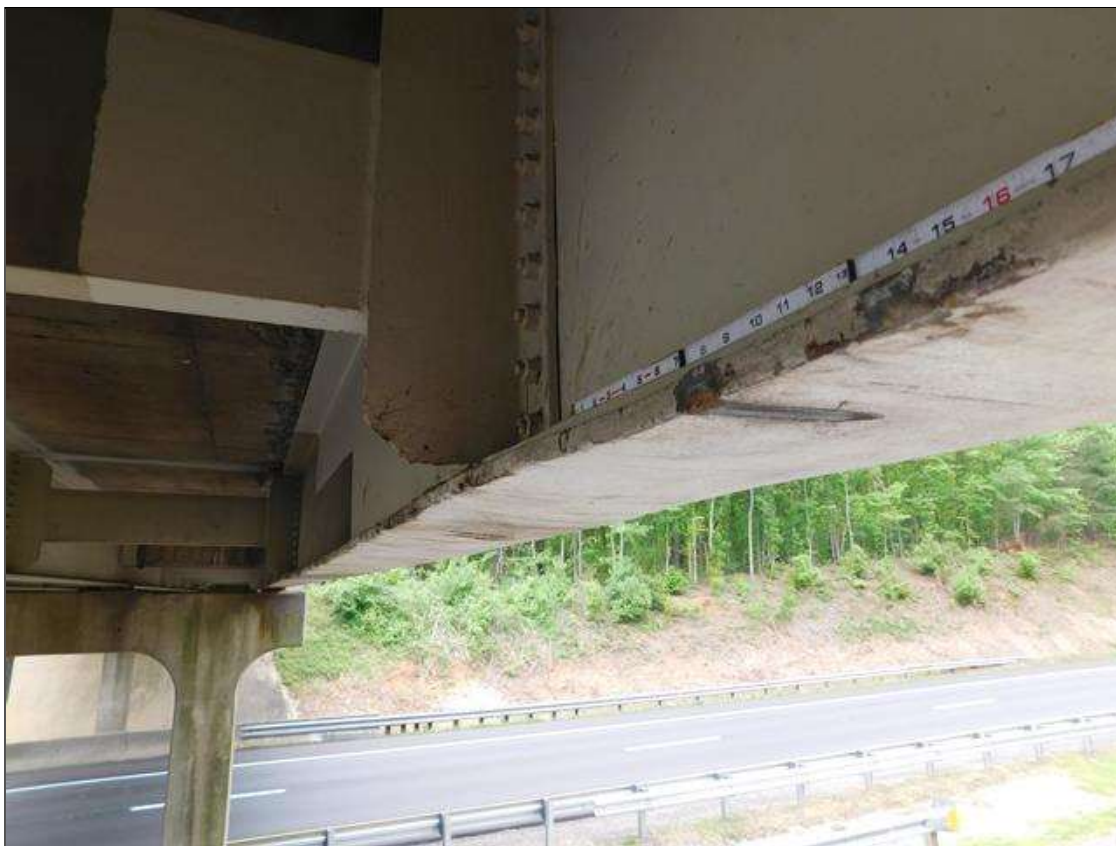
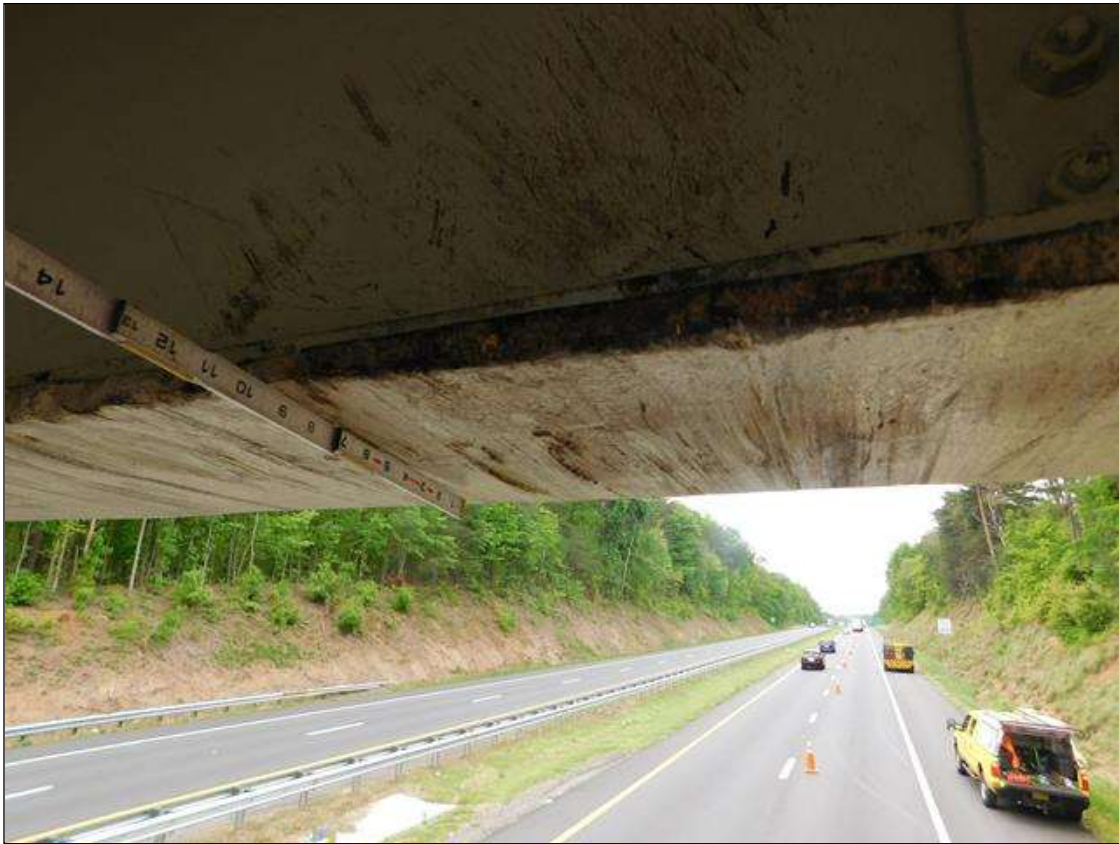
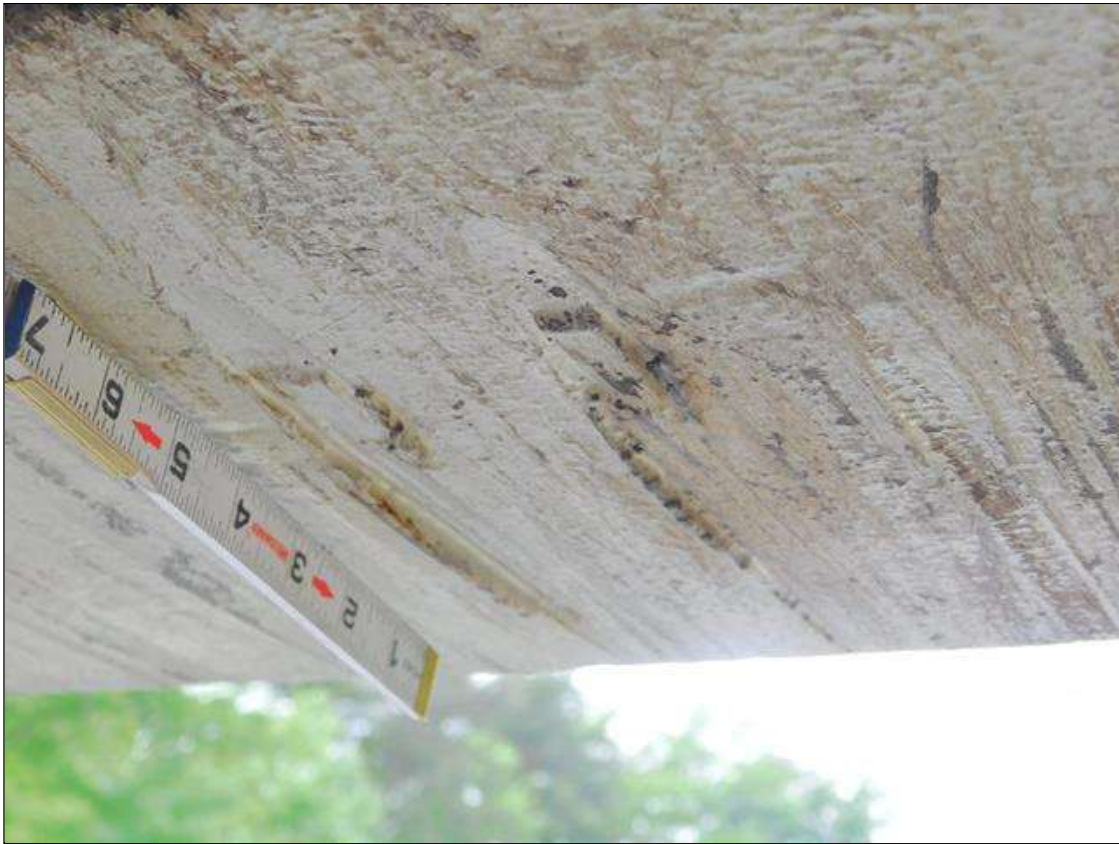
Span 3 Beam 1: DAMAGE TO BEAM 1 SPAN 3 STARTING AT 13.5' FROM INTERIOR BENT 3 FOR A TOTAL LENGTH OF 10'. POINT OF IMPACT MEASURED AT 17.417' FROM INTERIOR BENT 3, WITH SCATTERED SCRAPES AND INDENTIONS THROUGHOUT.
