NC DEPARTMENT OF TRANSPORTATION
 DIVISION OF HIGHWAYS
 STRUCTURE MANAGEMENT UNIT

Structure Safety Report

Supplemental Element Inspection

DIVISION: 13 COUNTY: BUNCOMBE STRUCTURE NUMBER: 100387 FREQUENCY: None

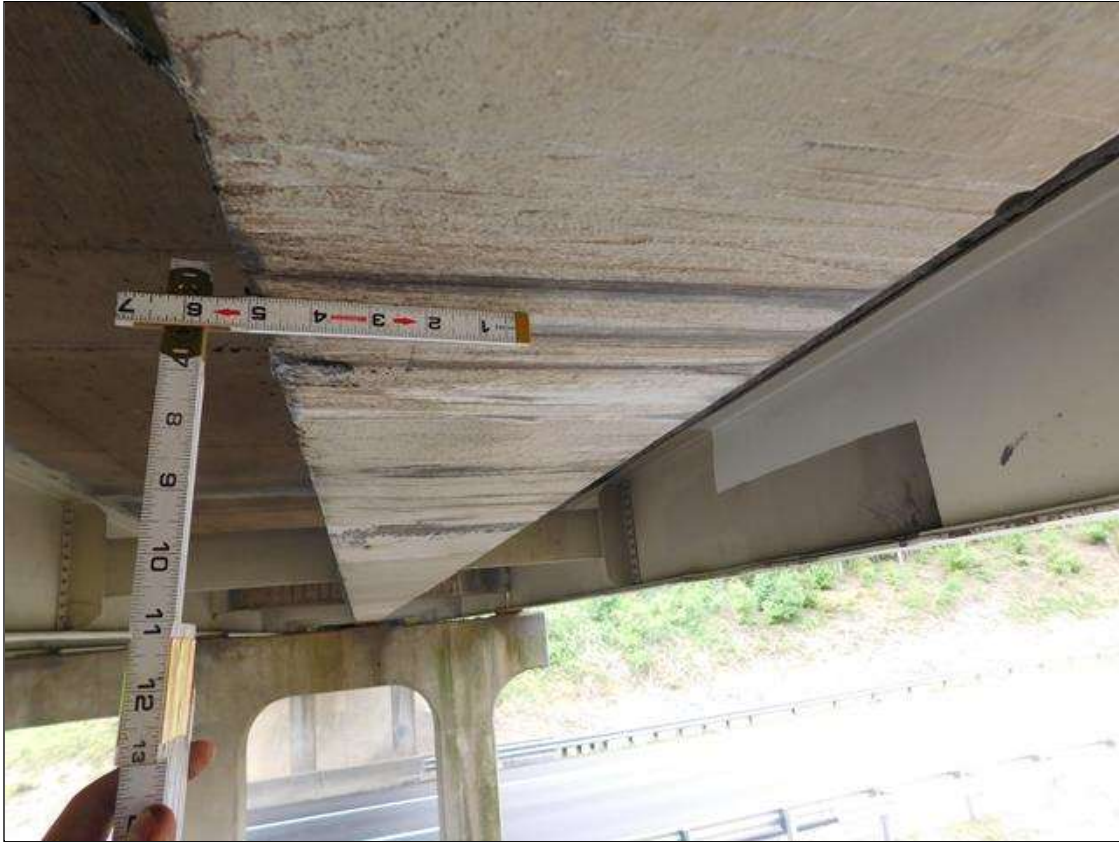
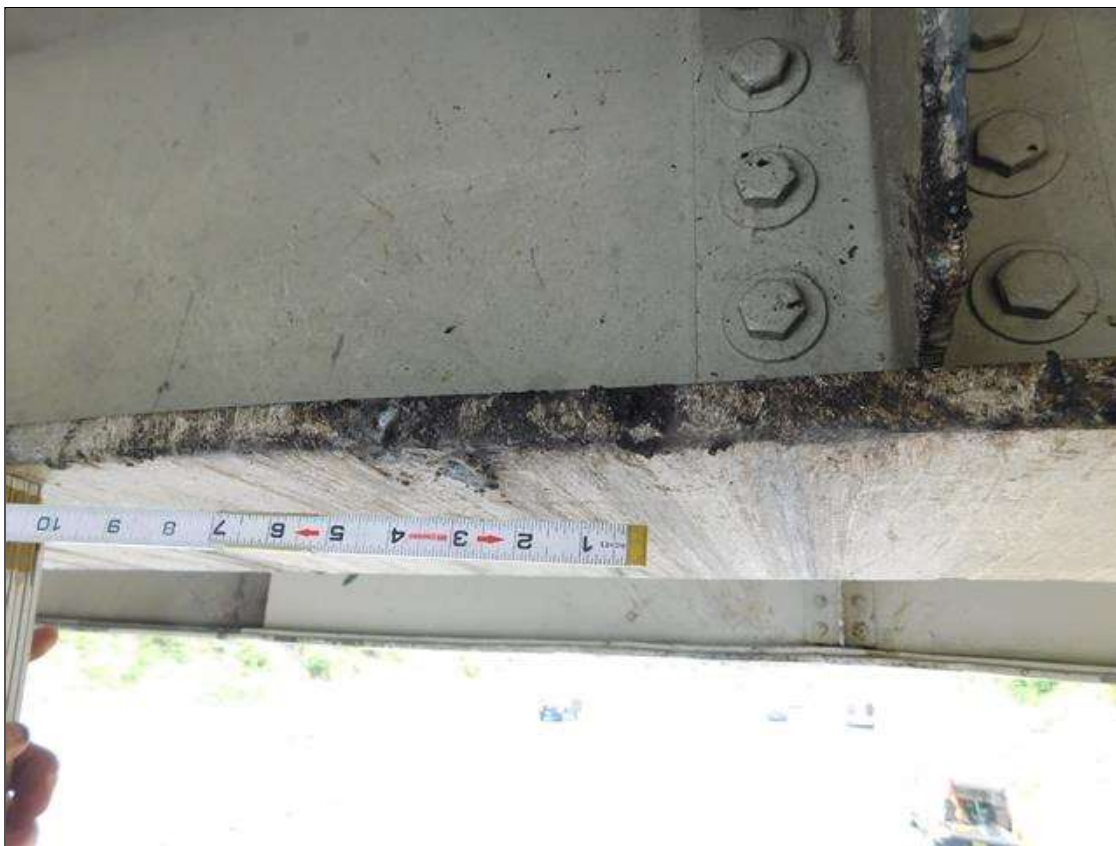
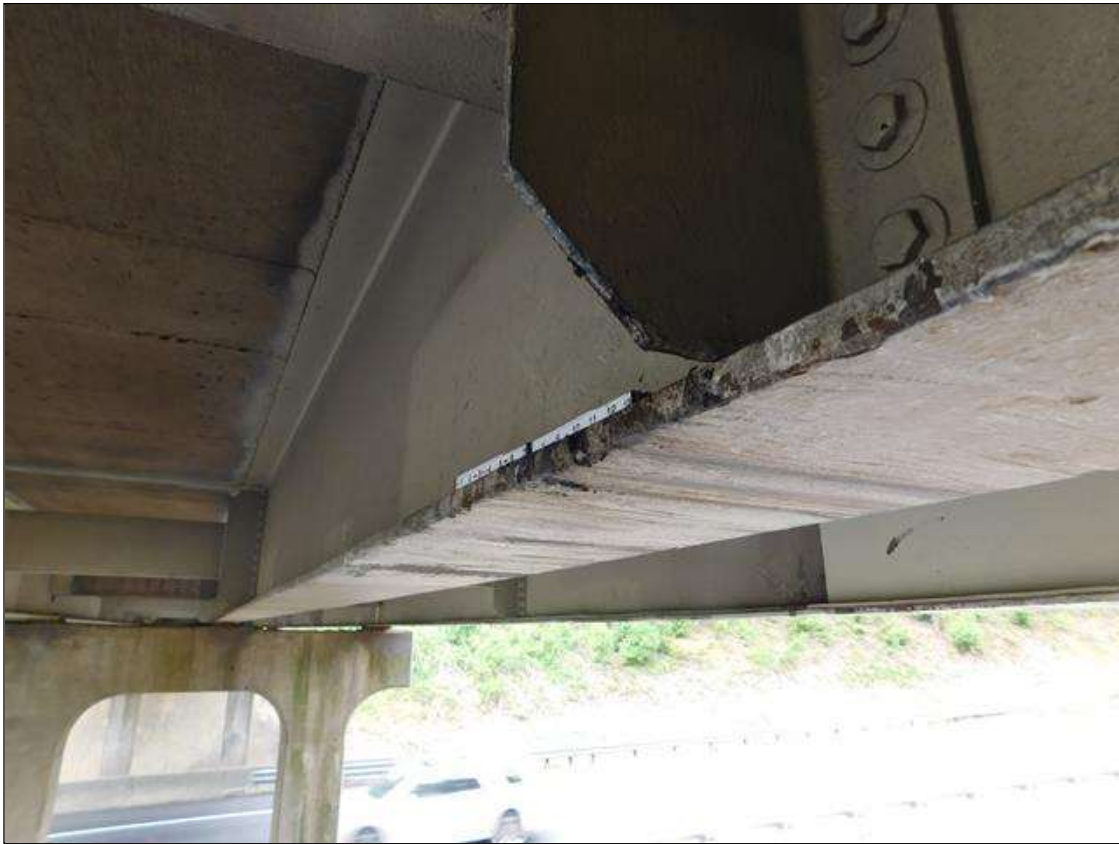
Span 3 Beam 2: DAMAGE TO BEAM 2 SPAN 3 STARTING AT 15.333' FROM INTERIOR BENT 3 FOR A TOTAL LENGTH OF 5', WITH SCRAPES THROUGHOUT BOTTOM FLANGE. POINT OF IMPACT MEASURED AT 16.917' FROM INTERIOR BENT 3

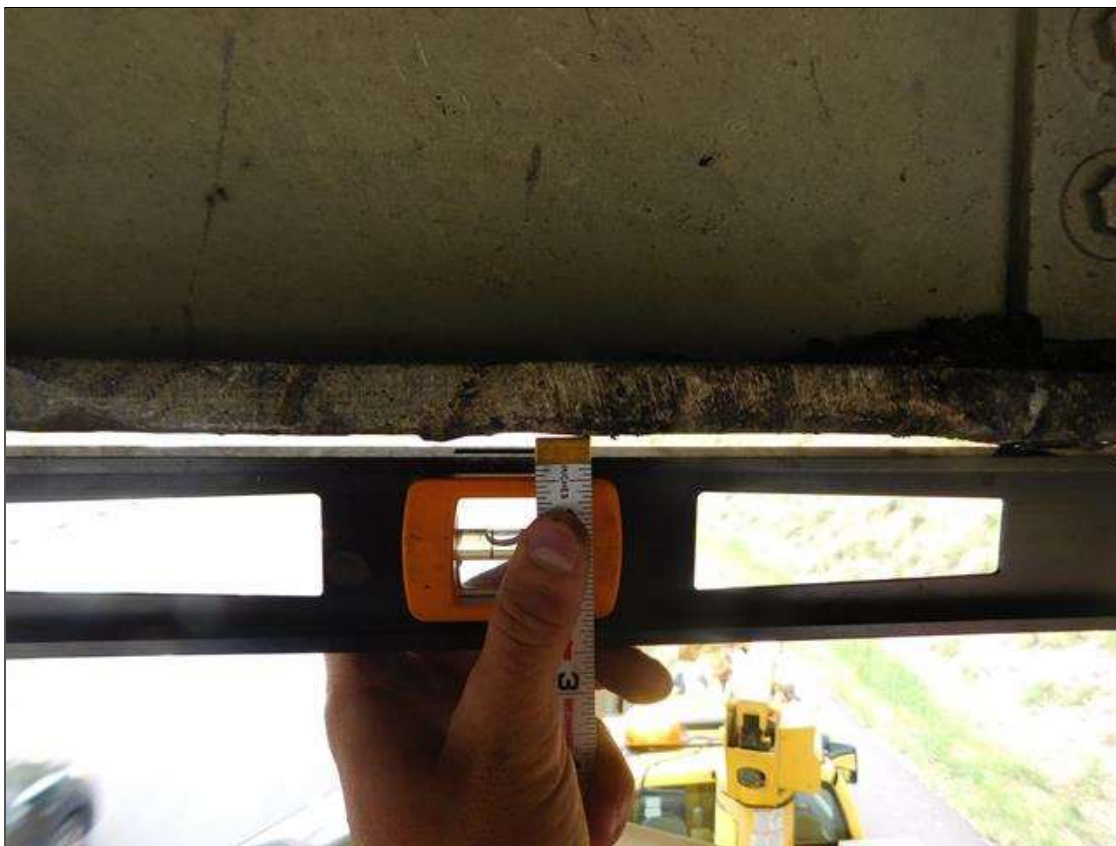
Span 3 Beam 2: BEAM 2 SPAN 3 DEFLECTED UPWARD 1/2" AT POINT OF IMPACT FOR A LENGTH OF 5'

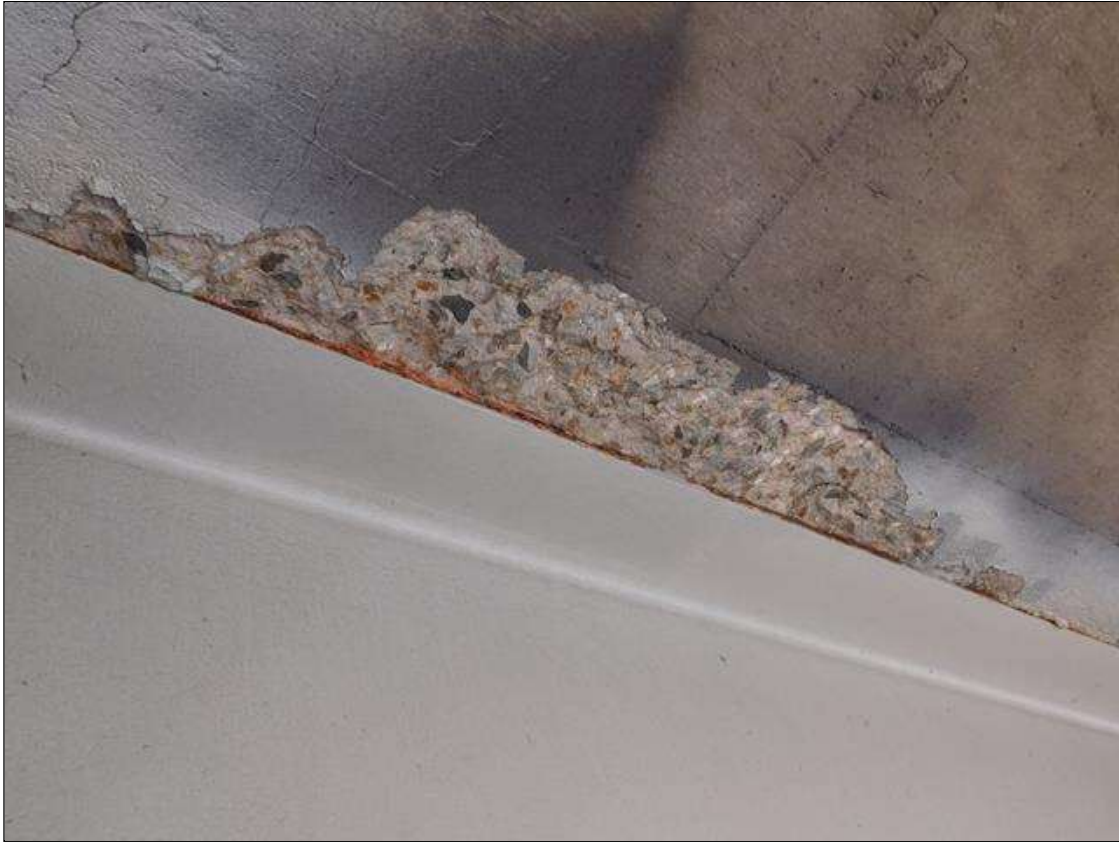
Span 3 Beam 3: SPALL AT EAST SIDE OF TOP FLANGE OF BEAM 3 SPAN 3. 3' LONG AT 12' FROM INTERIOR BENT 2. SPALL. SPALL AT EAST SIDE OF TOP FLANGE OF BEAM 3 SPAN 2. 2' LONG AT 20' FROM INTERIOR BENT 2

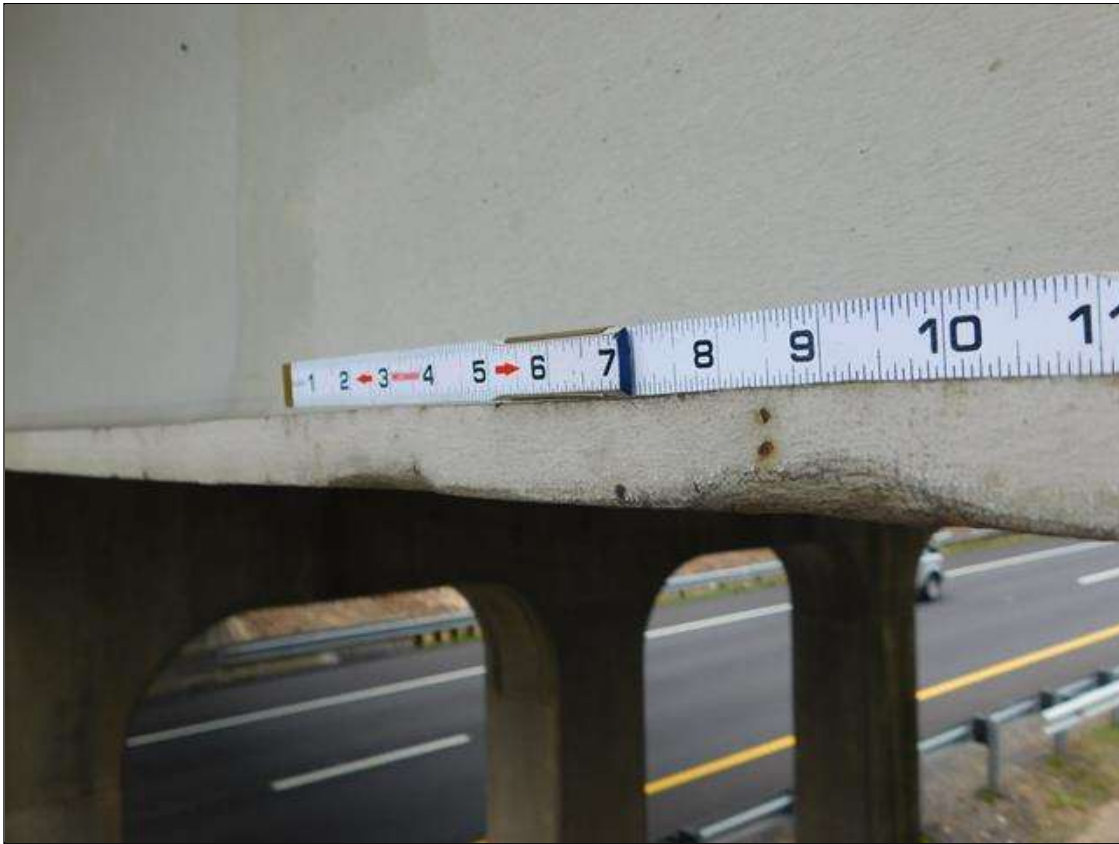
Span 3 Beam 5: TWO 1/4" DEEP INDENTIONS IN BOTTOM FLANGE OF BEAM 5 SPAN 3 AT 16.5' FROM INTERIOR BENT 2 FOR A LENGTH OF 1'

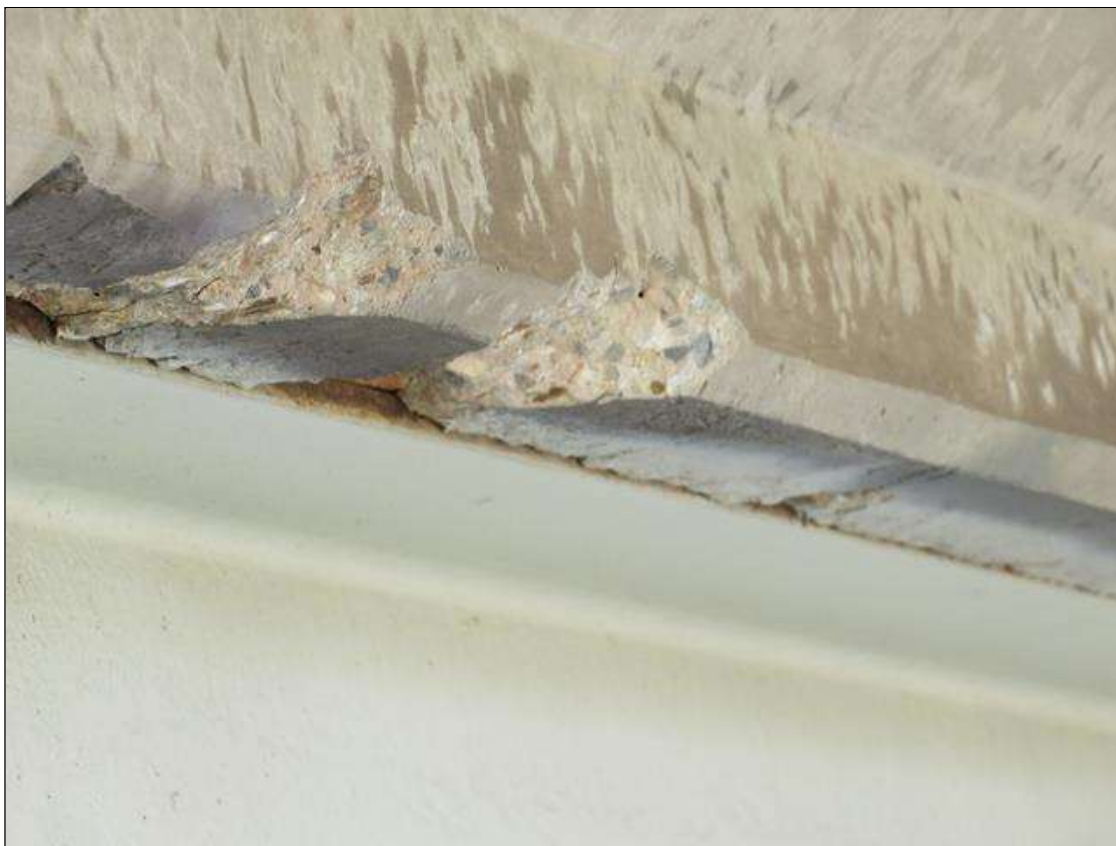
Span 3 Deck: SUPPLEMENTAL INSPECTION IMPACT DAMAGE 2022. spalling up to 12" WIDE X 1" deep, full length, underside of deck along both sides of beam 1.

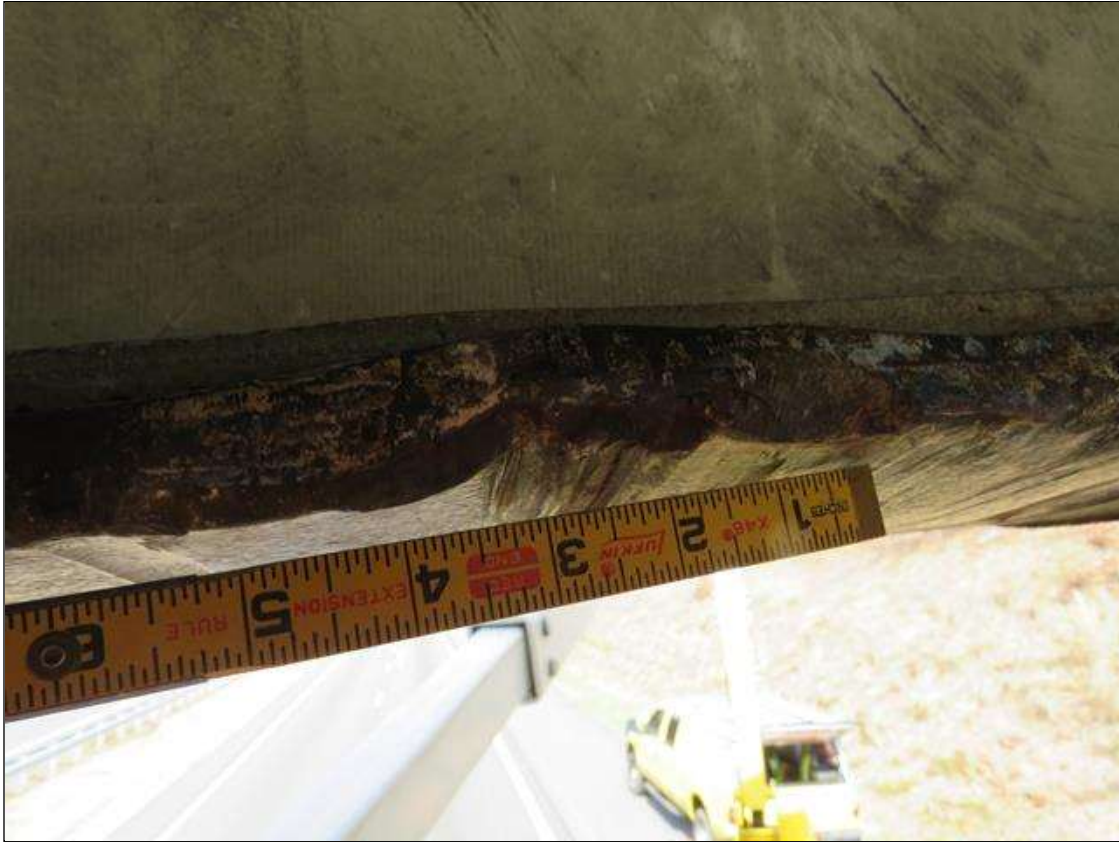
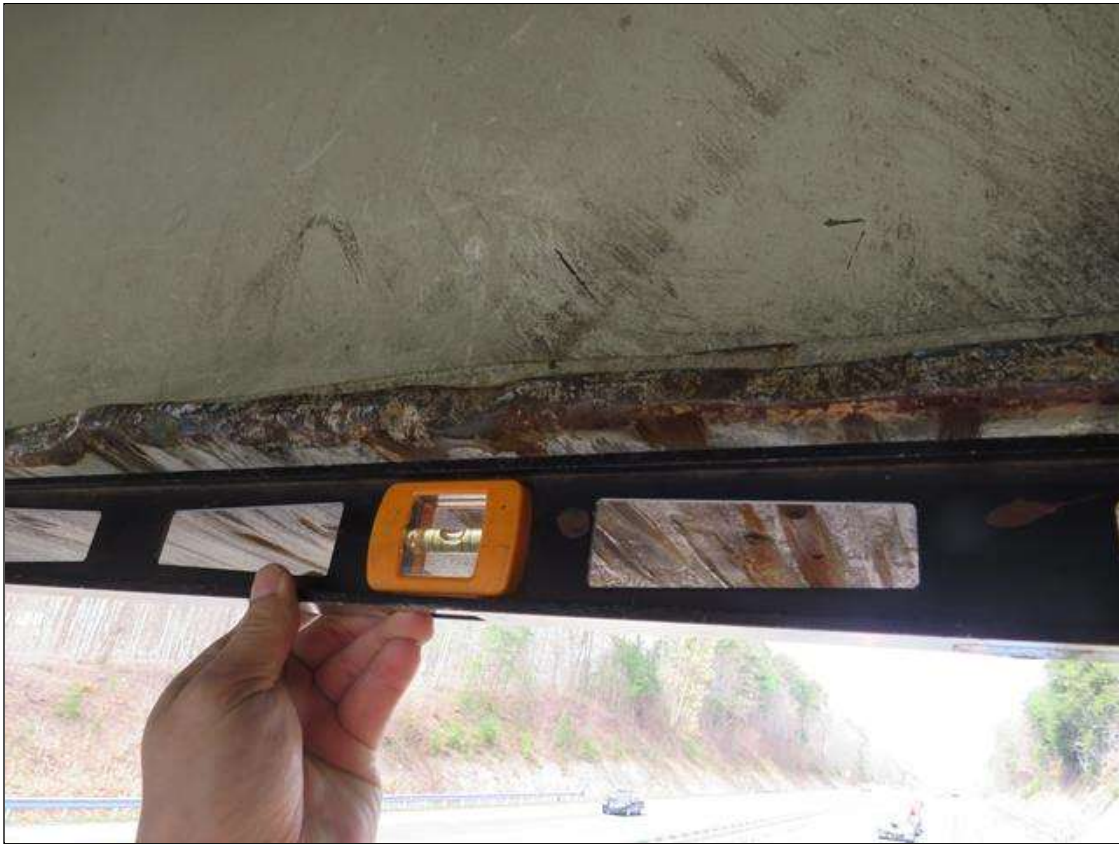
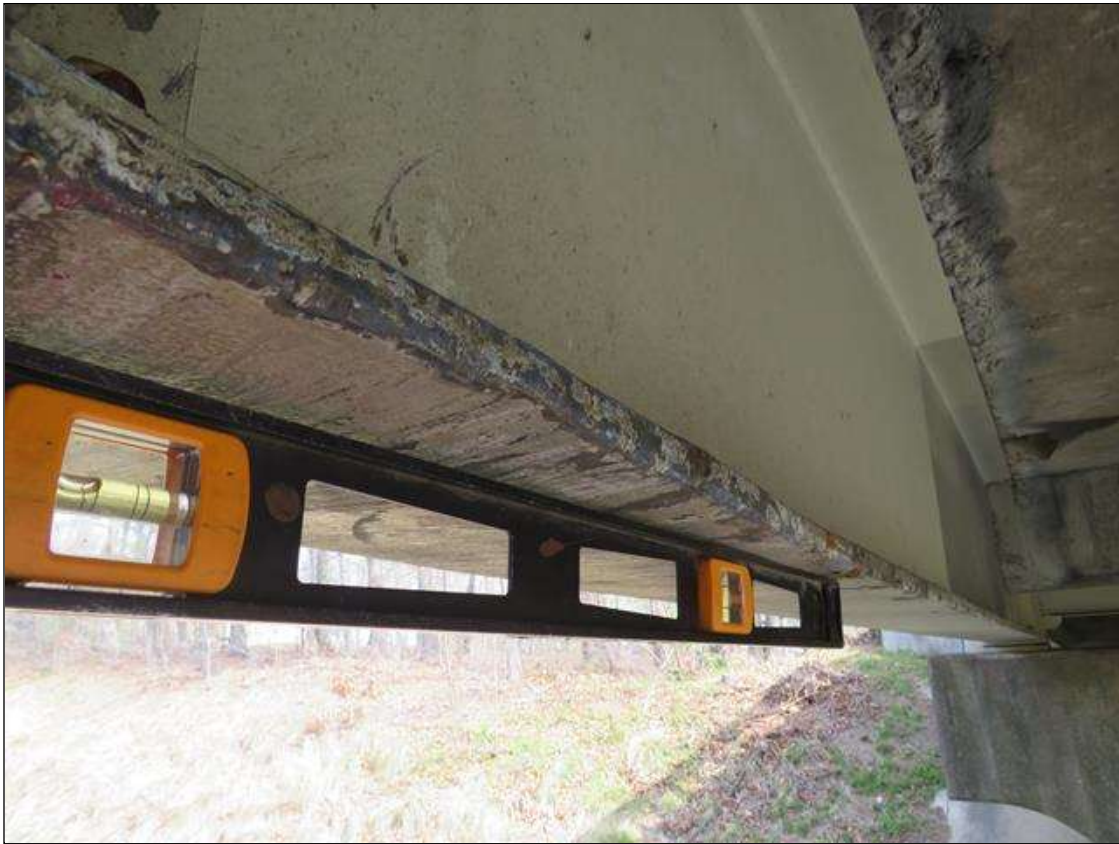
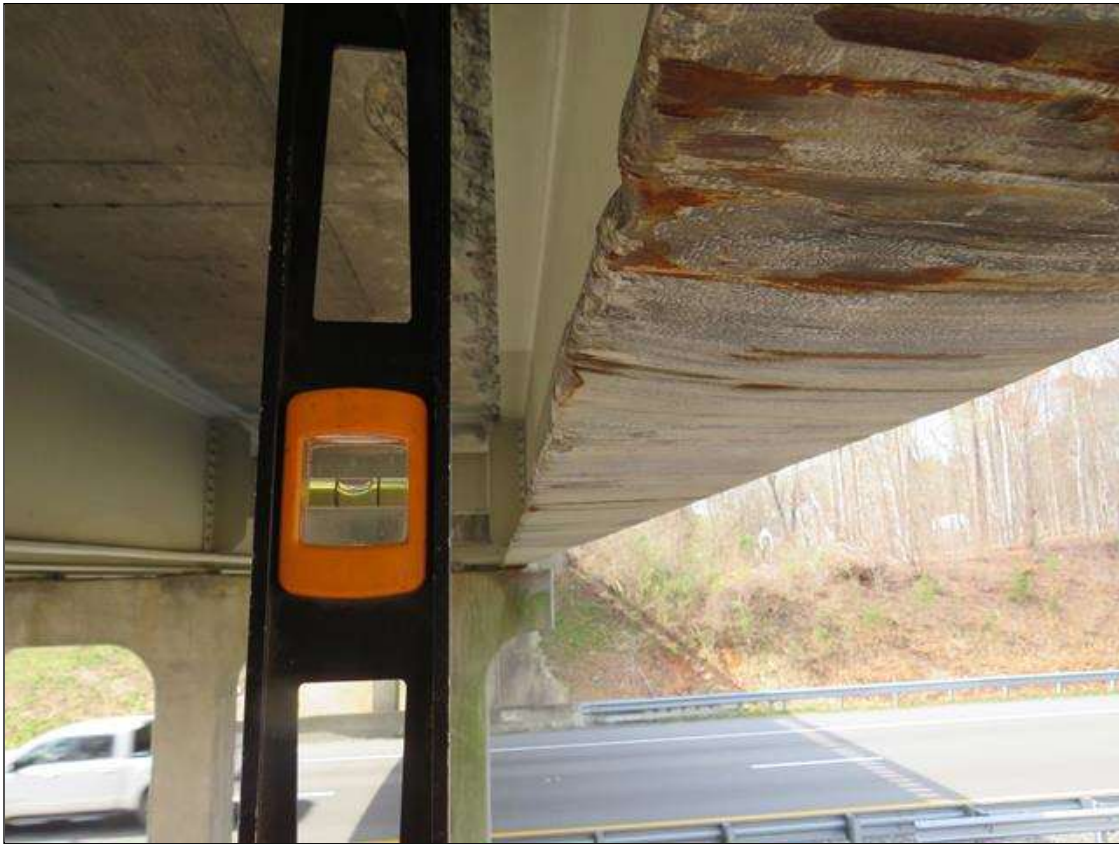
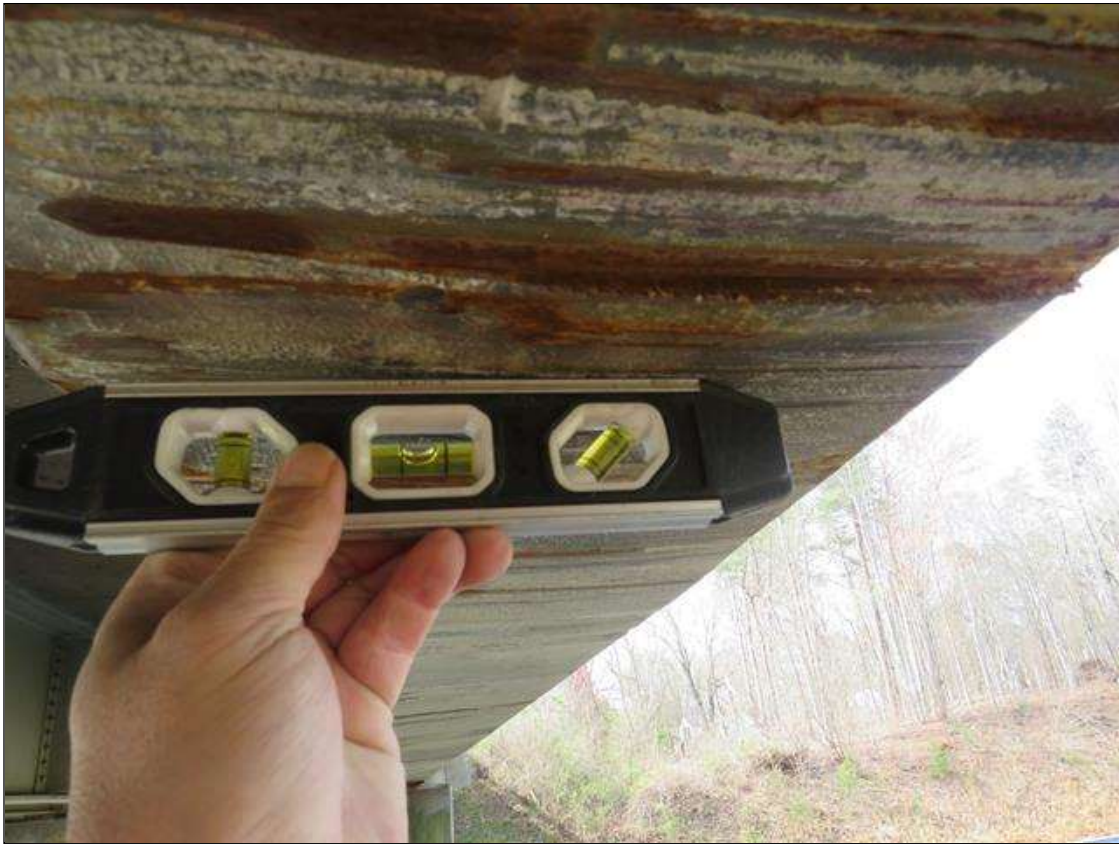
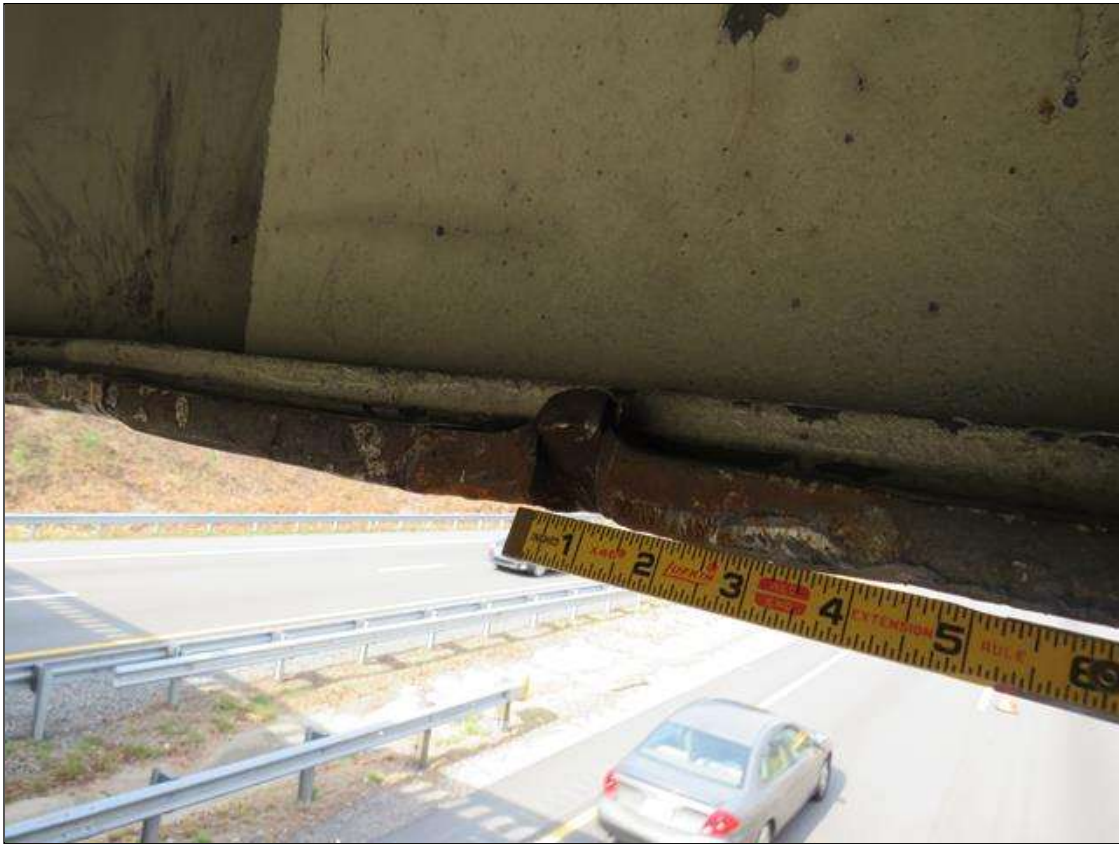
Span 3 Beam 1: SUPPLEMENTAL INSPECTION IMPACT DAMAGE 2022.: POINT OF IMPACT 9' LONG WITH SCATTERED 1" DEEP INDENTIONS THROUGH OUT BOTTOM FLANGE , AT 12'-9" OUT FROM INT. BENT 3 . BEAM 1 DEFLECTION 1/2" TO THE WEST. .,EAST SIDE OF BOTTOM FLANGE BENT UPWARD 1/2in. SCATTERED SCRAPES ALONG BOTTOM FLANGE. (PAR) . SCATTERED OLD SCRAPES AND INDENTIONS ALONG BOTTOM FLANGE .

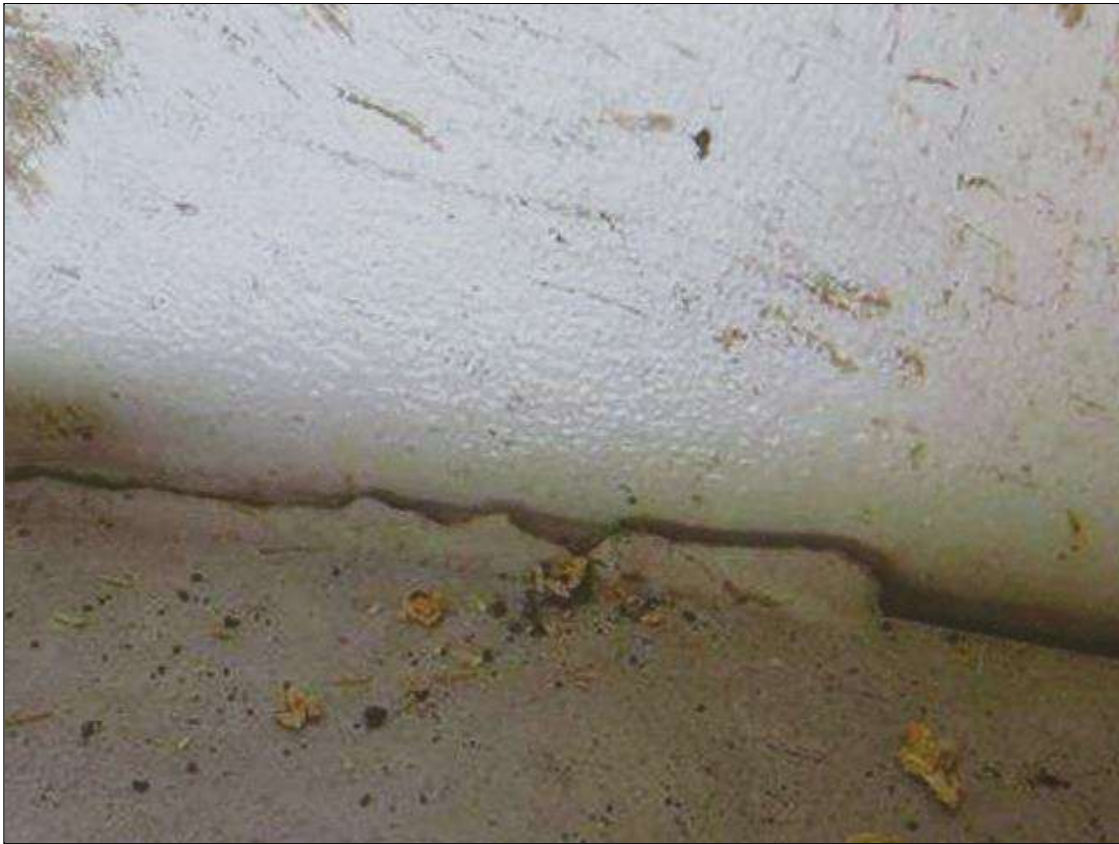
Span 3 Beam 1: SUPPLEMENTAL INSPECTION IMPACT DAMAGE 2022. Crack in weld of plate at bottom flange of beam 1 span 3 measured at 17ft from bent 3 for a length of 1ft

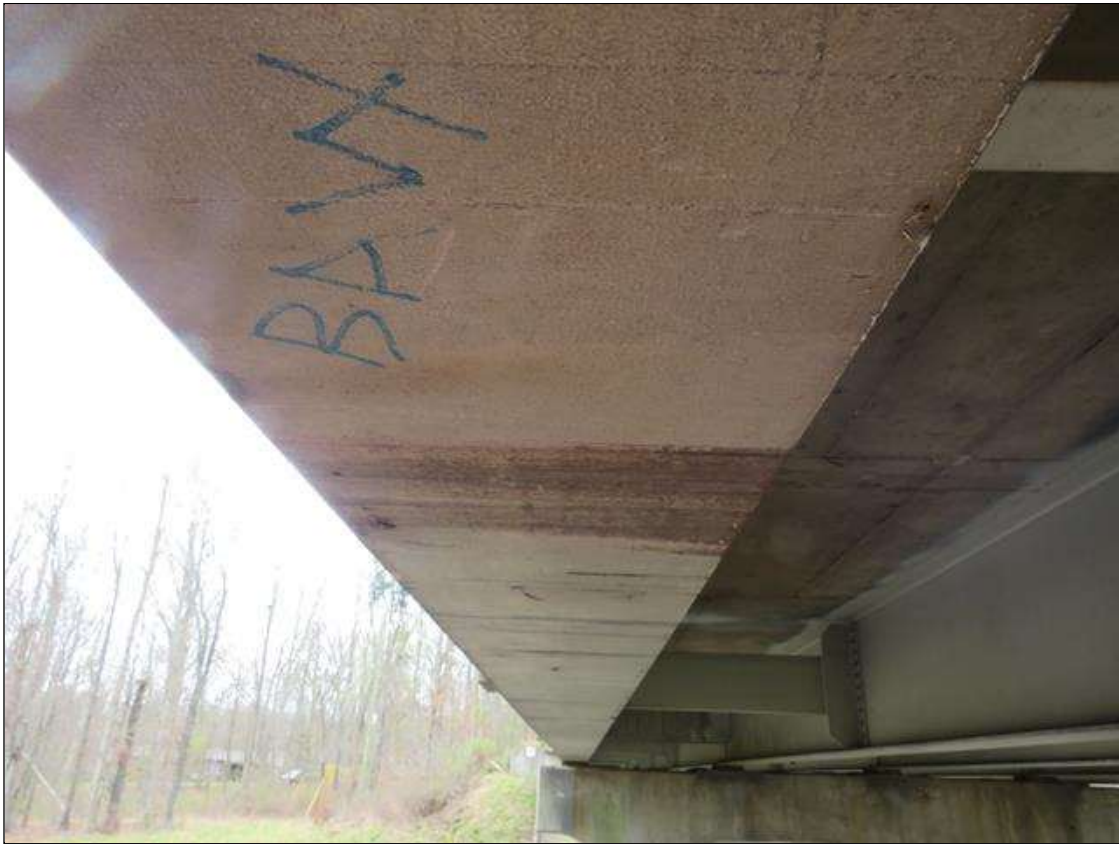
Span 3 Beam 5: beam 5 span 3 has scrapes on bottom flange

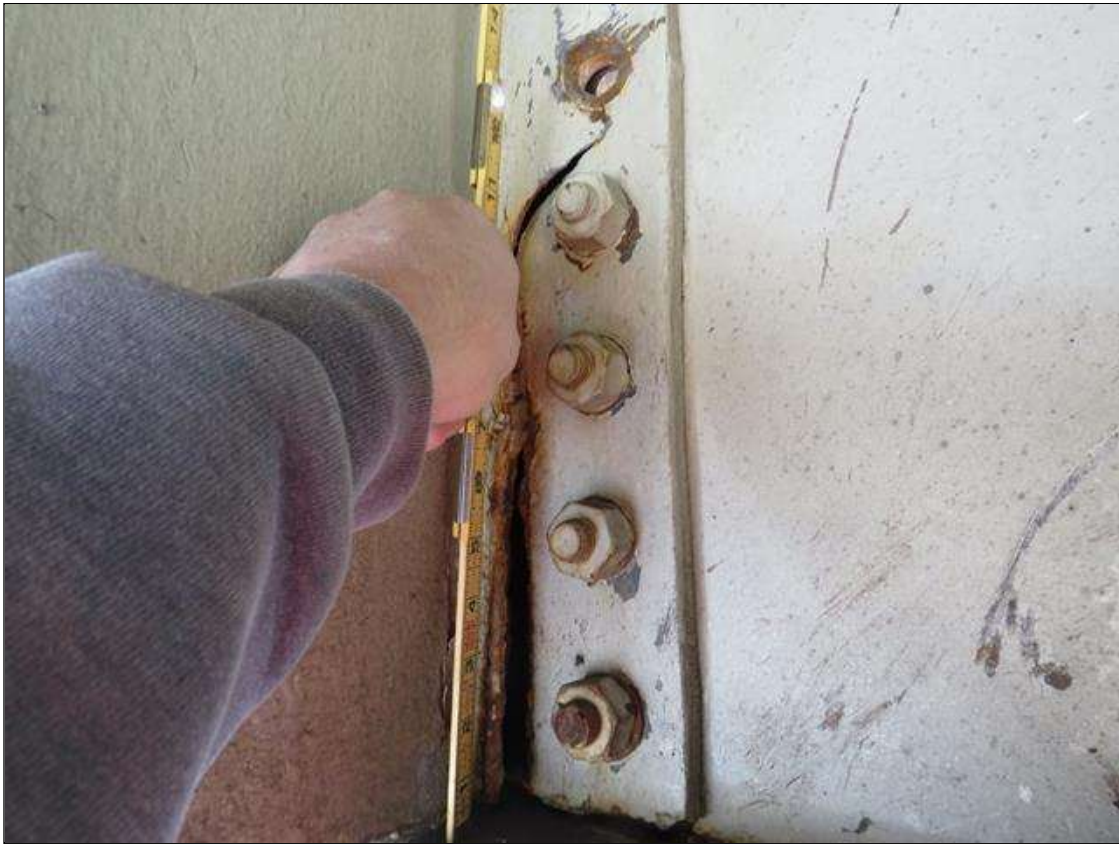
SUPPLEMENTAL INSPECTION IMPACT DAMAGE 2022: SPAN 3 DIAPHRAGM 2 BAY 1: 20 BOLTS WITH 6 MISSING ON BEAM 1, UP TO 1' HIGH CRACKING STRATING AT 1/32" WIDE AT TOP AND UP TO 1 1/8" AT BOTTOM OF DIAPHRAGM (PAR) .

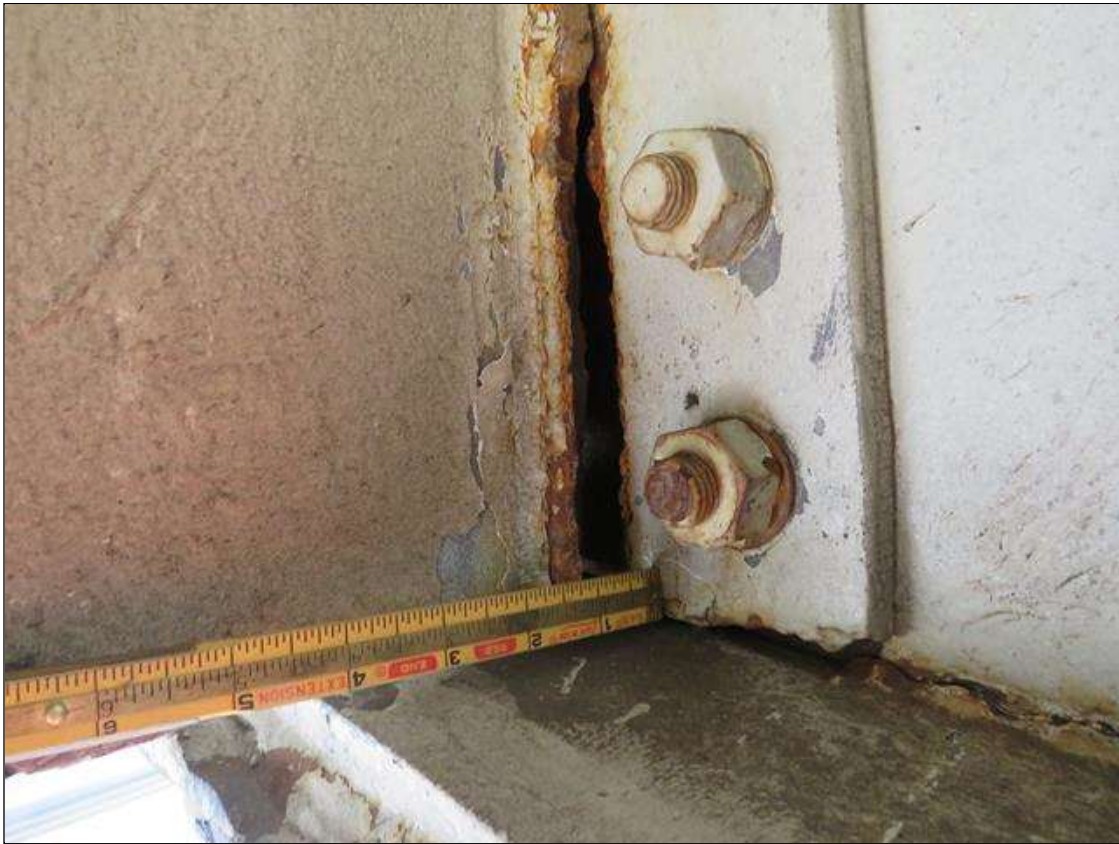
SPAN 3 DIAPHRAGM 2 BAY 1: 20 BOLTS WITH 6 MISSING ON BEAM 1, UP TO 1' HIGH CRACKING STRATING AT 1/32" WIDE AT TOP AND UP TO 1 1/8" AT BOTTOM OF DIAPHRAGM (PAR) .

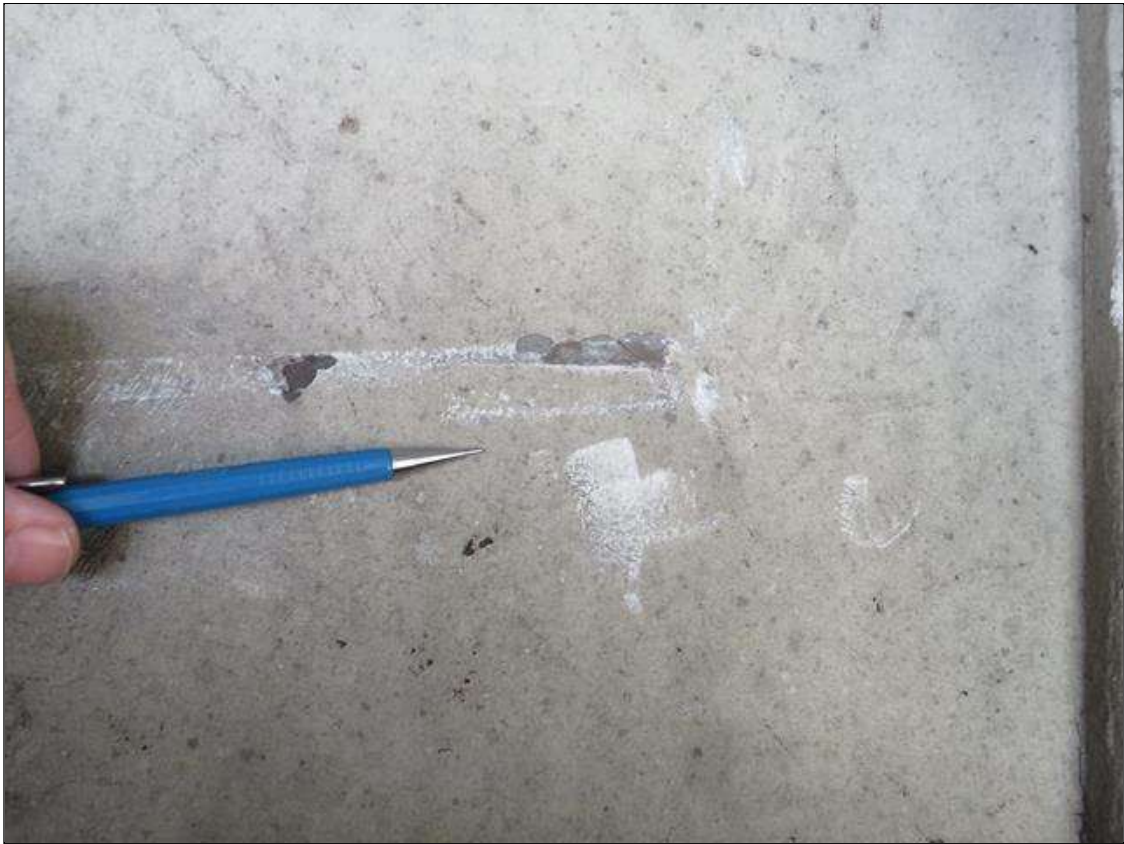
SCATTERED SCRAPES ALONG WEB BEAM 2 SPAN 3

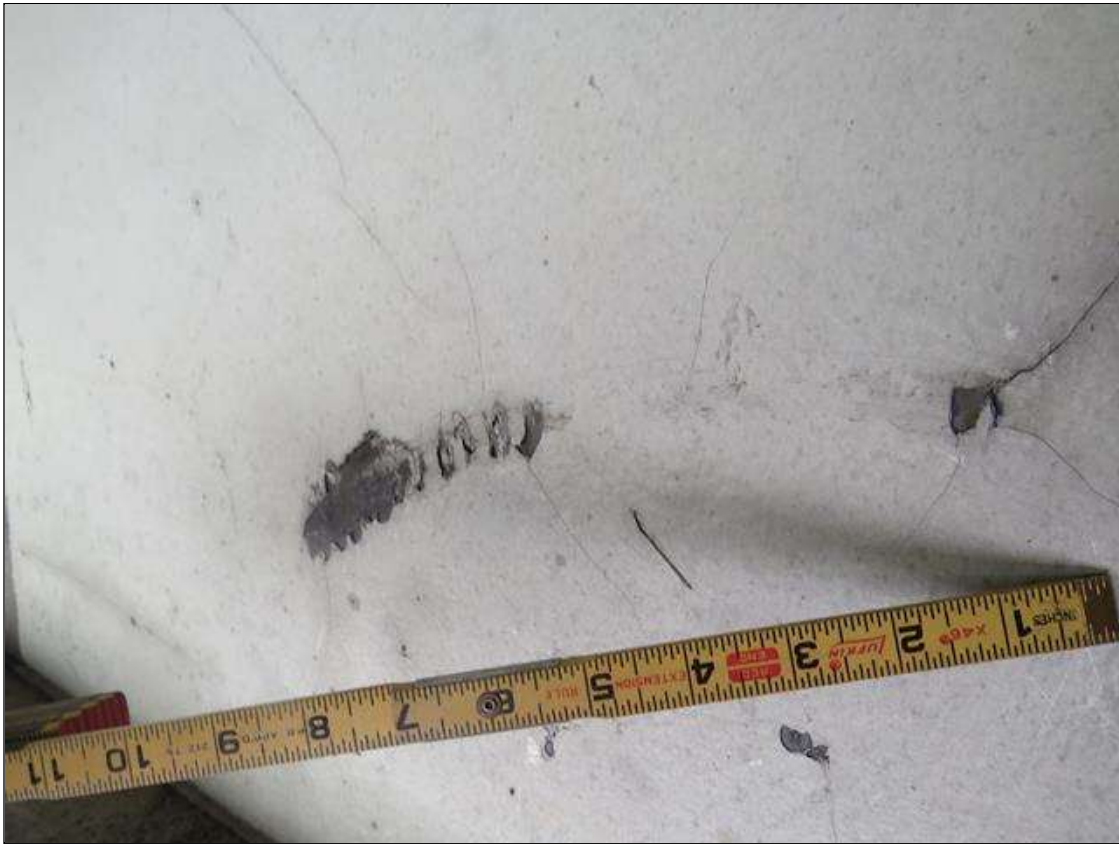
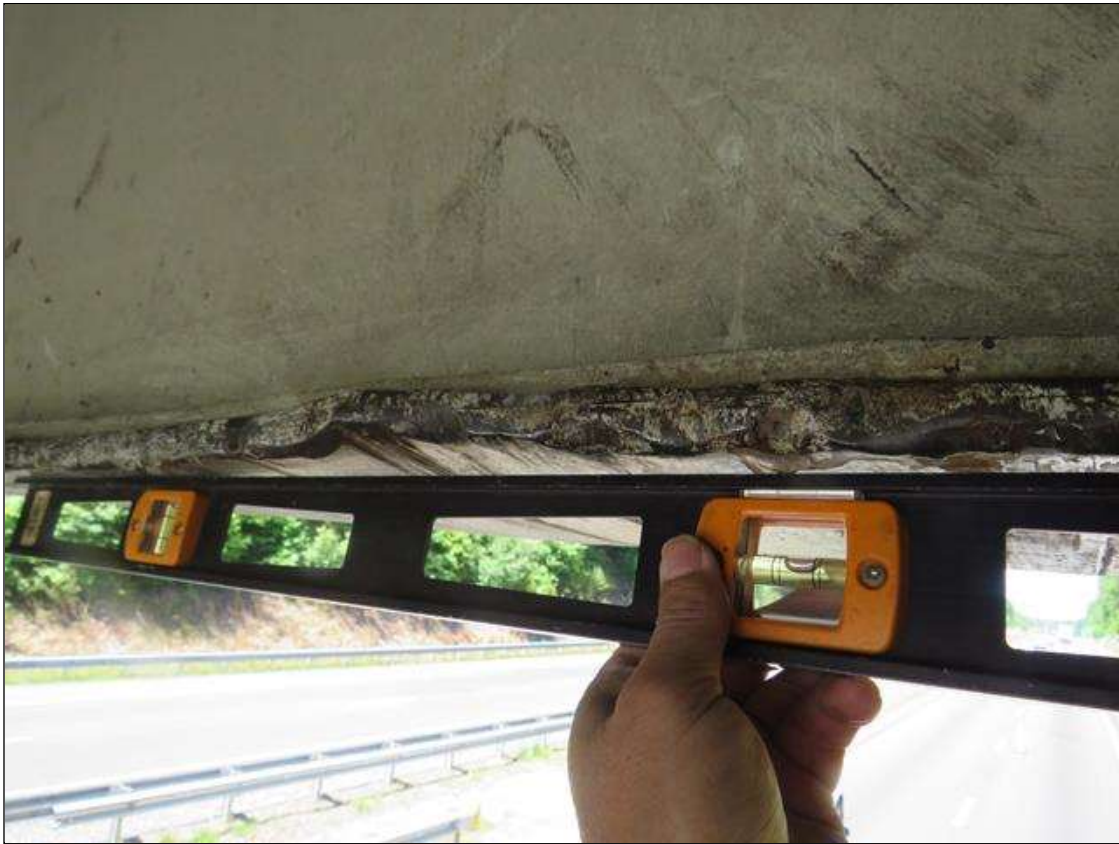
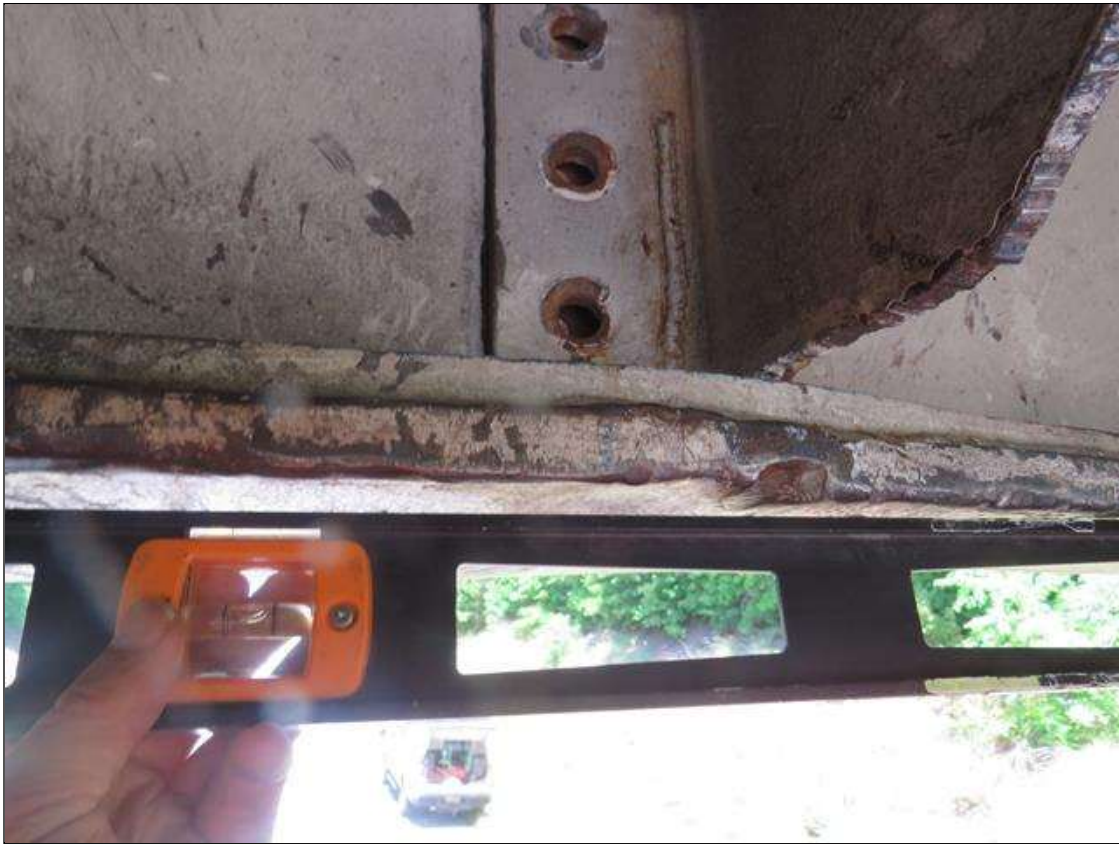
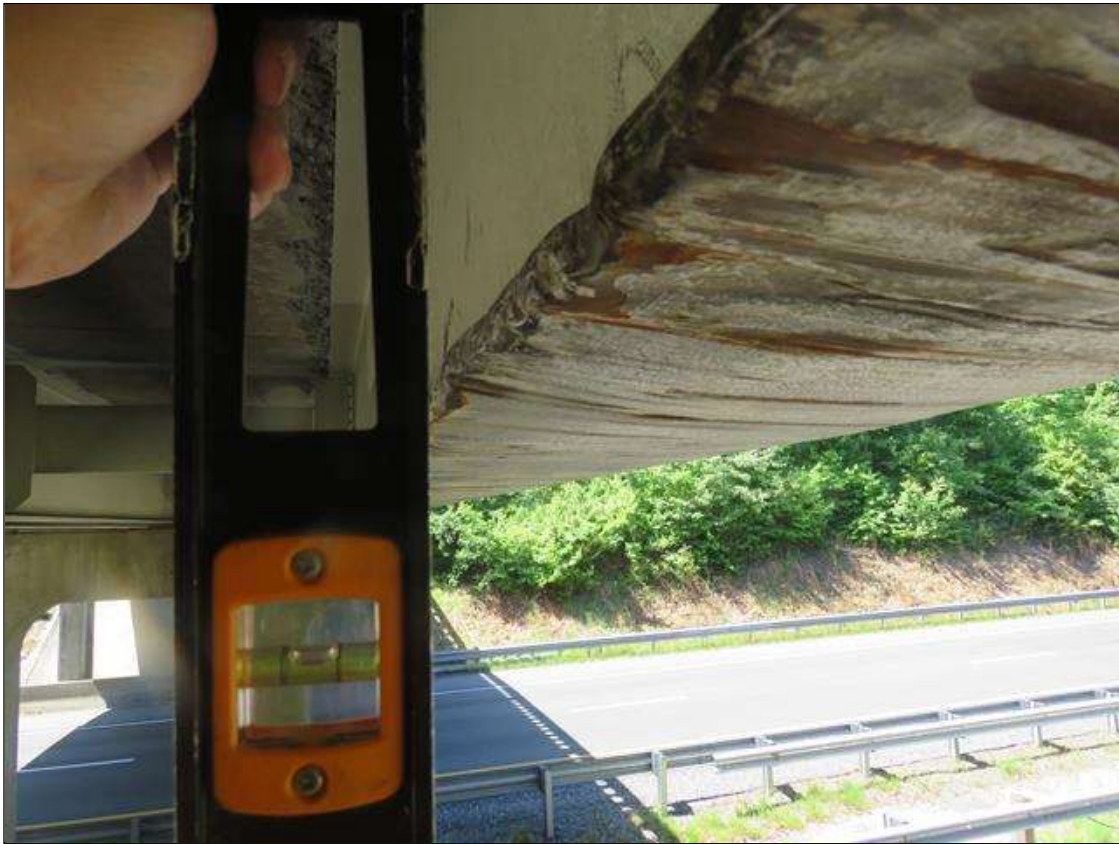
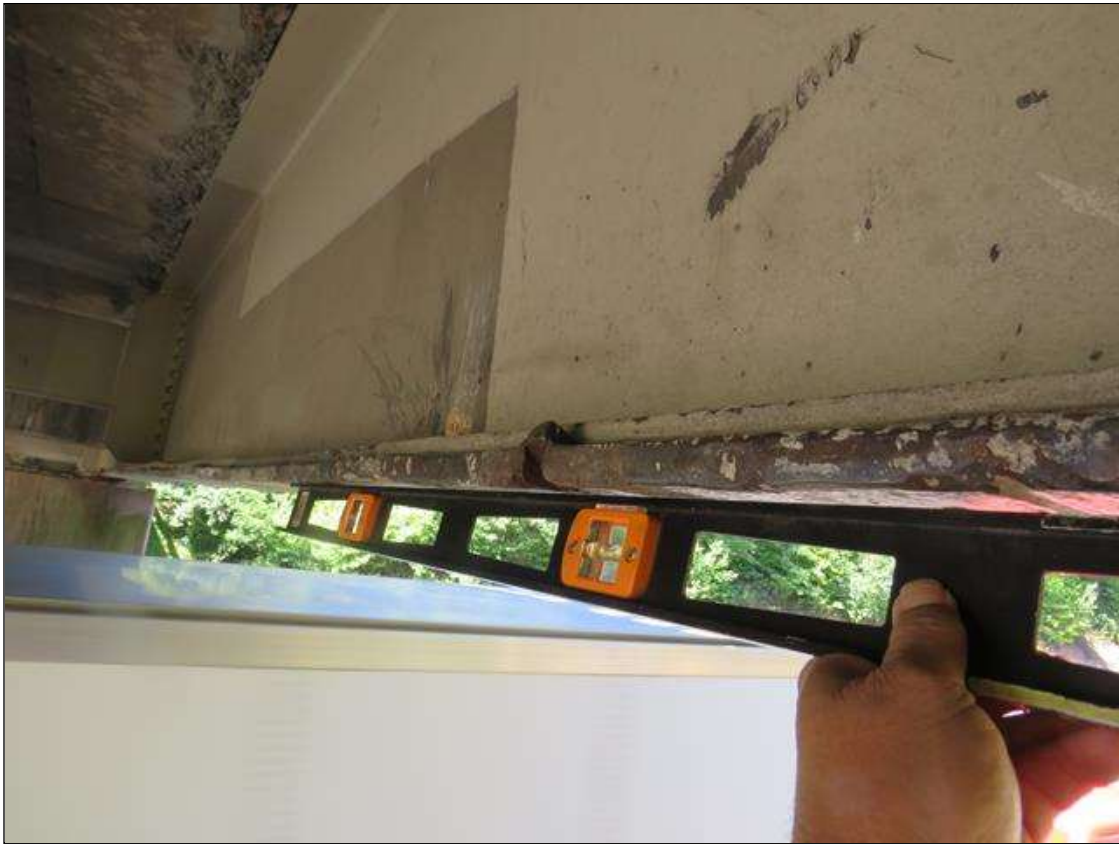
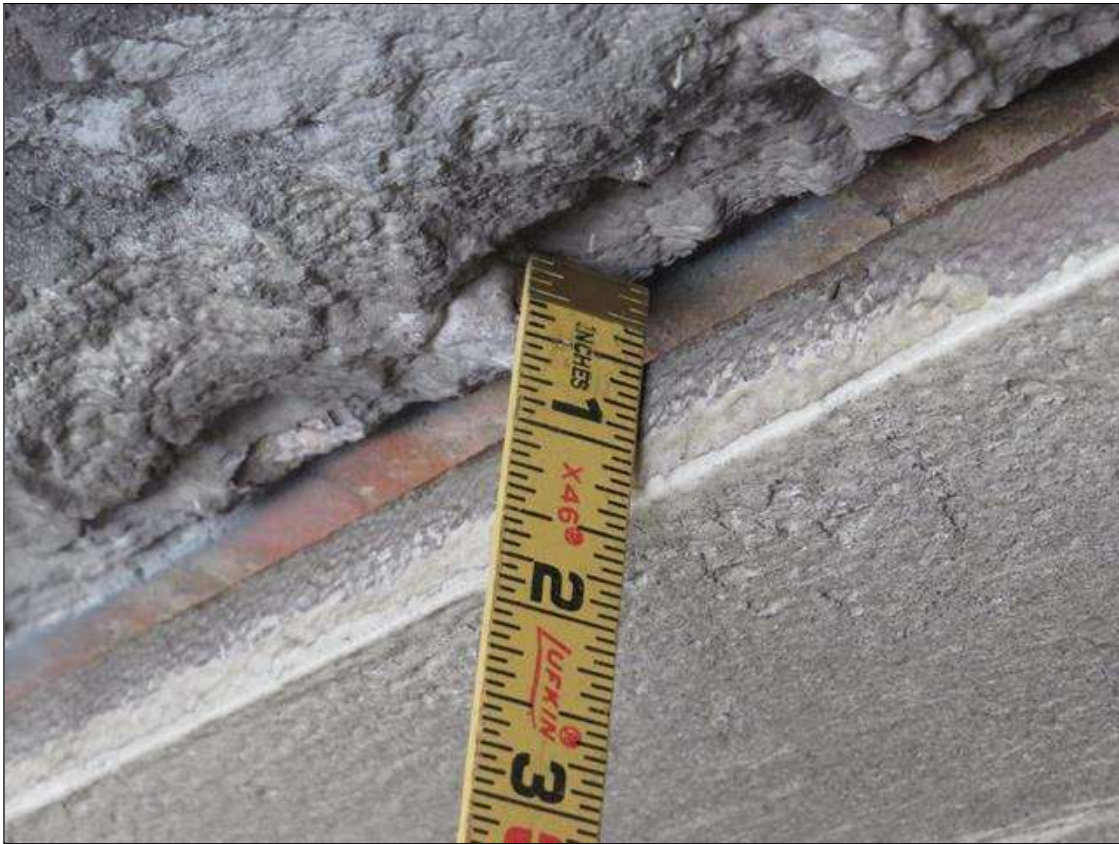
Span 3 Beam 1: SUPPLEMENTAL INSPECTION IMPACT DAMAGE 2022.: POINT OF IMPACT 9' LONG WITH SCATTERED 1" DEEP INDENTIONS THROUGH OUT BOTTOM FLANGE , AT 12'-9" OUT FROM INT. BENT 3 . BEAM 1 DEFLECTION 1" TO THE WEST. TOP FLANGE PULLED LOOSE FROM BEAM EAST SIDE FOR A LENGTH OF 30' X 3/4" .,EAST SIDE OF BOTTOM FLANGE BENT UPWARD 1/2in. SCATTERED SCRAPES ALONG BOTTOM FLANGE AND WEB(PAR) . SCATTERED OLD SCRAPES AND INDENTIONS ALONG BOTTOM FLANGE .
