NC DEPARTMENT OF TRANSPORTATION
 DIVISION OF HIGHWAYS
 STRUCTURE MANAGEMENT UNIT

Structure Safety Report

Supplemental Element Inspection

DIVISION: 13 COUNTY: BUNCOMBE STRUCTURE NUMBER: 100387 FREQUENCY: None

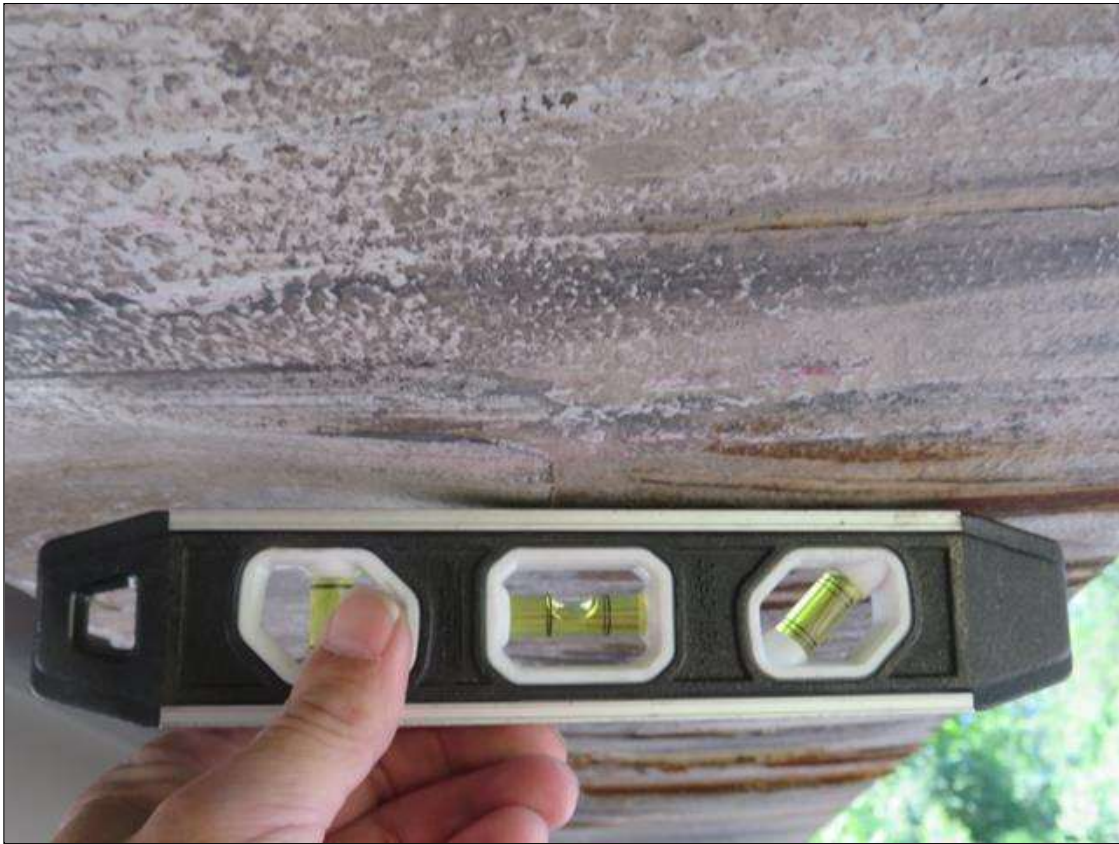
Span 3 Beam 1: SUPPLEMENTAL INSPECTION IMPACT DAMAGE 2022.: POINT OF IMPACT 9' LONG WITH SCATTERED 1" DEEP INDENTIONS THROUGH OUT BOTTOM FLANGE , AT 12'-9" OUT FROM INT. BENT 3 . BEAM 1 DEFLECTION 1" TO THE WEST. TOP FLANGE PULLED LOOSE FROM BEAM EAST SIDE FOR A LENGTH OF 30' X 3/4" .,EAST SIDE OF BOTTOM FLANGE BENT UPWARD 1/2in. SCATTERED SCRAPES ALONG BOTTOM FLANGE AND WEB(PAR) . SCATTERED OLD SCRAPES AND INDENTIONS ALONG BOTTOM FLANGE .

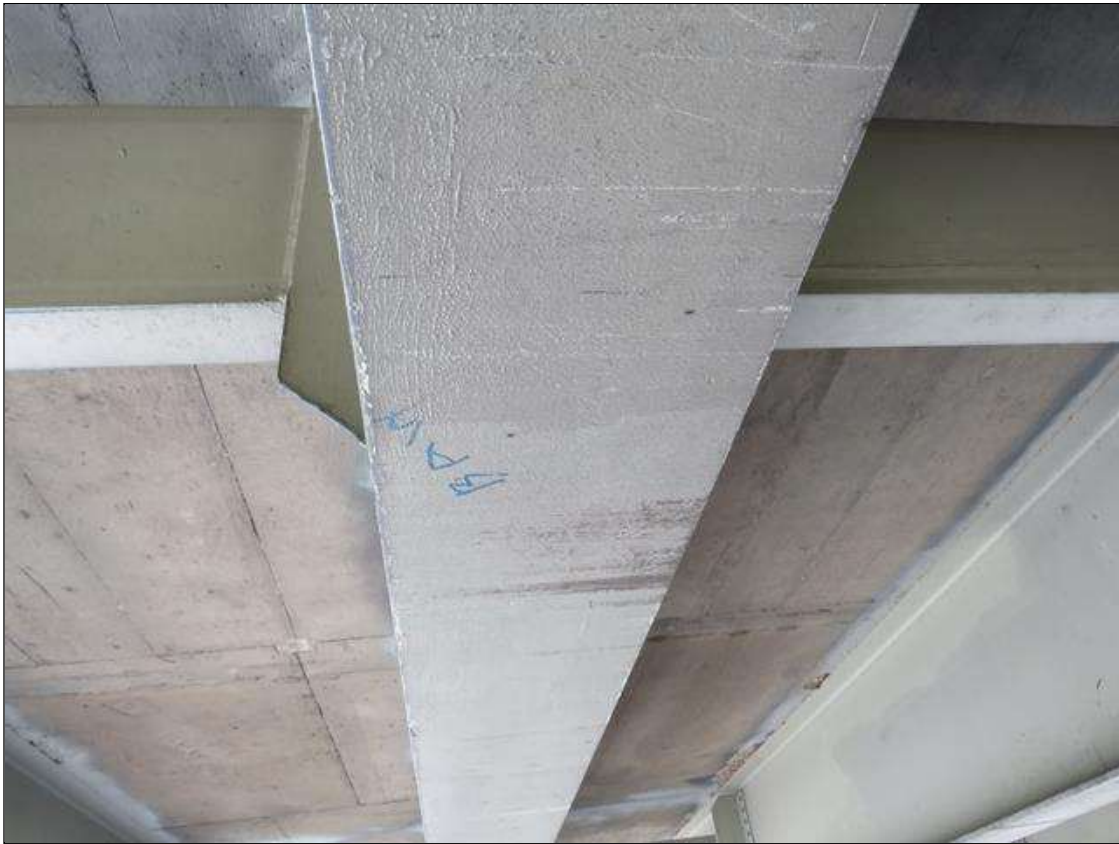
Span 3 Beam 4: SUPPLEMENTAL INSPECTION IMPACT DAMAGE 2022.: Beam 4 Span 3 has scrapes to bottom flange at 16.75ft from bent 3 for a total length of 1ft

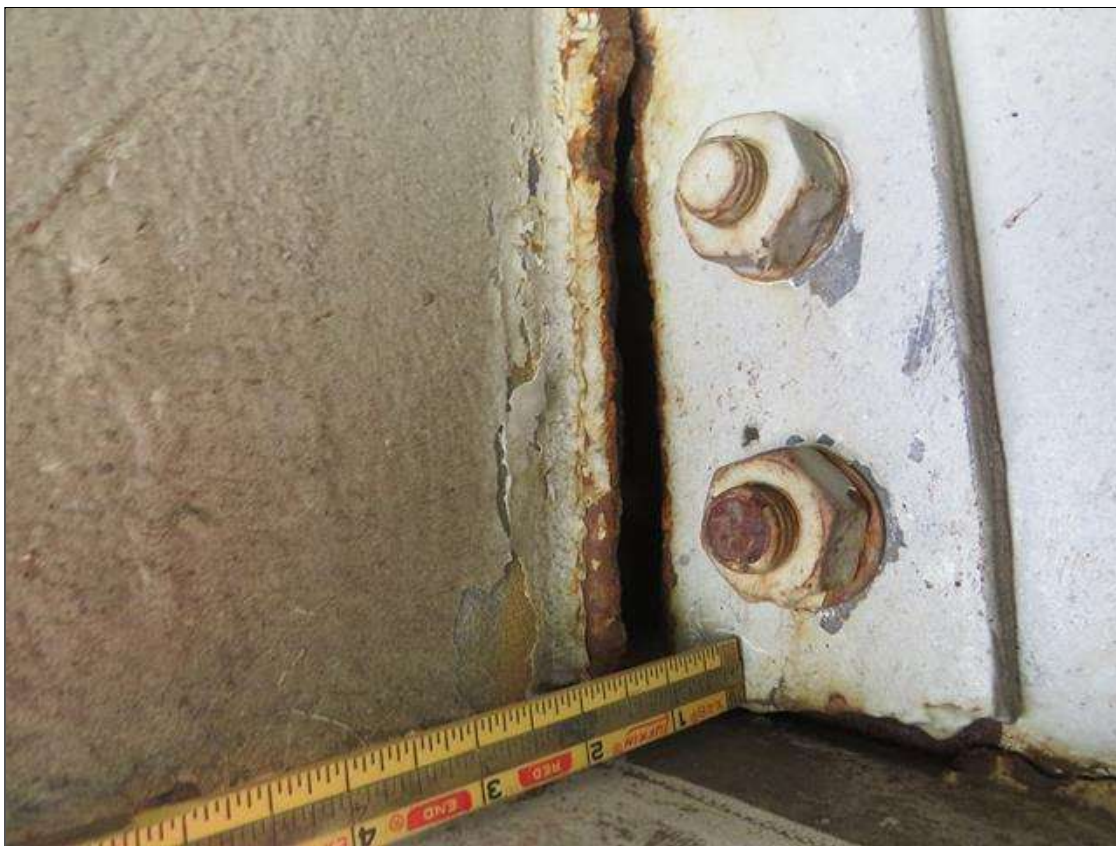
UP TO 1" WIDE CRACKING DIAPHRAGM 2 BAY 1

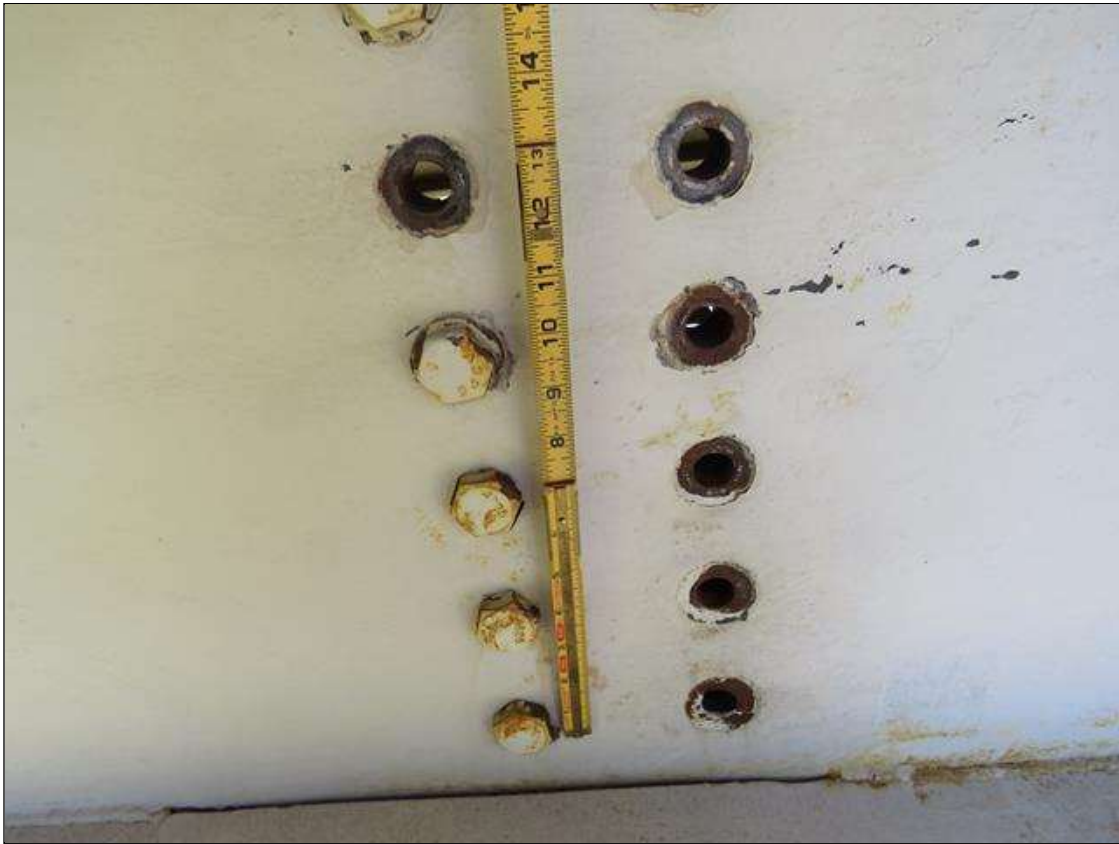
6 DIAPHRAGM BOLTS MISSING BEAM 1

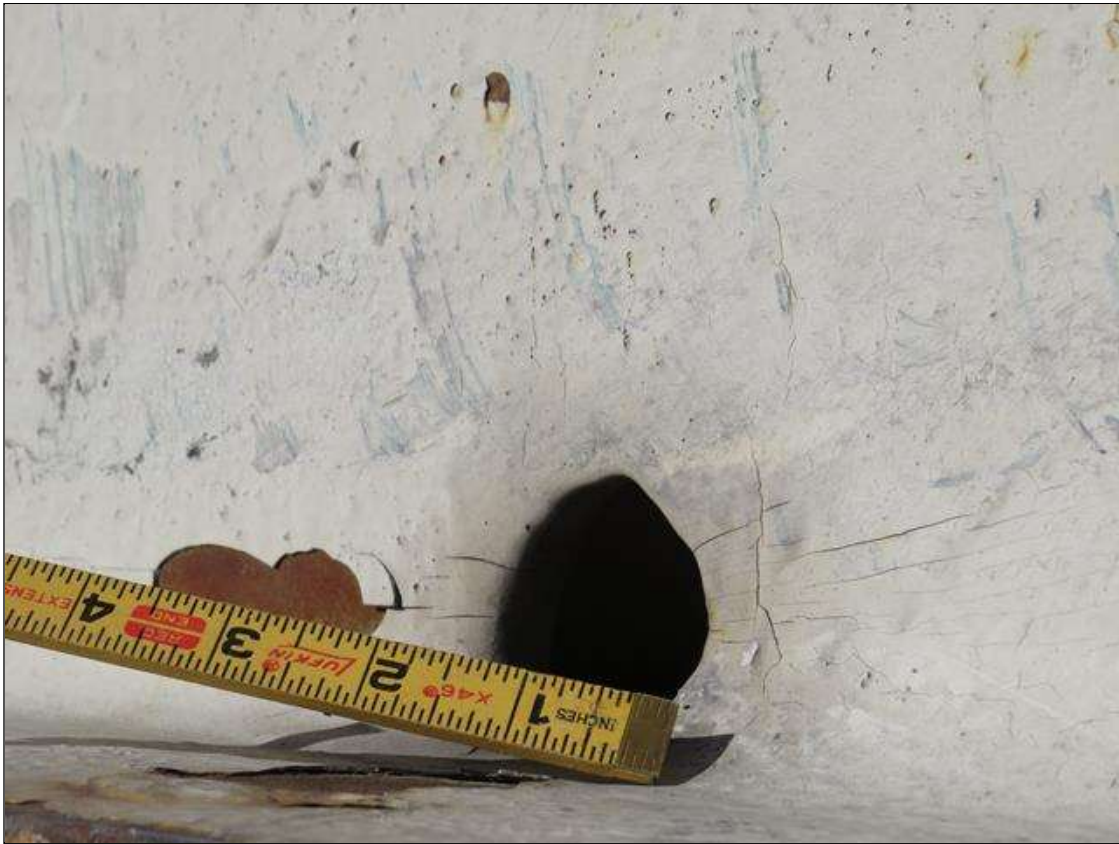
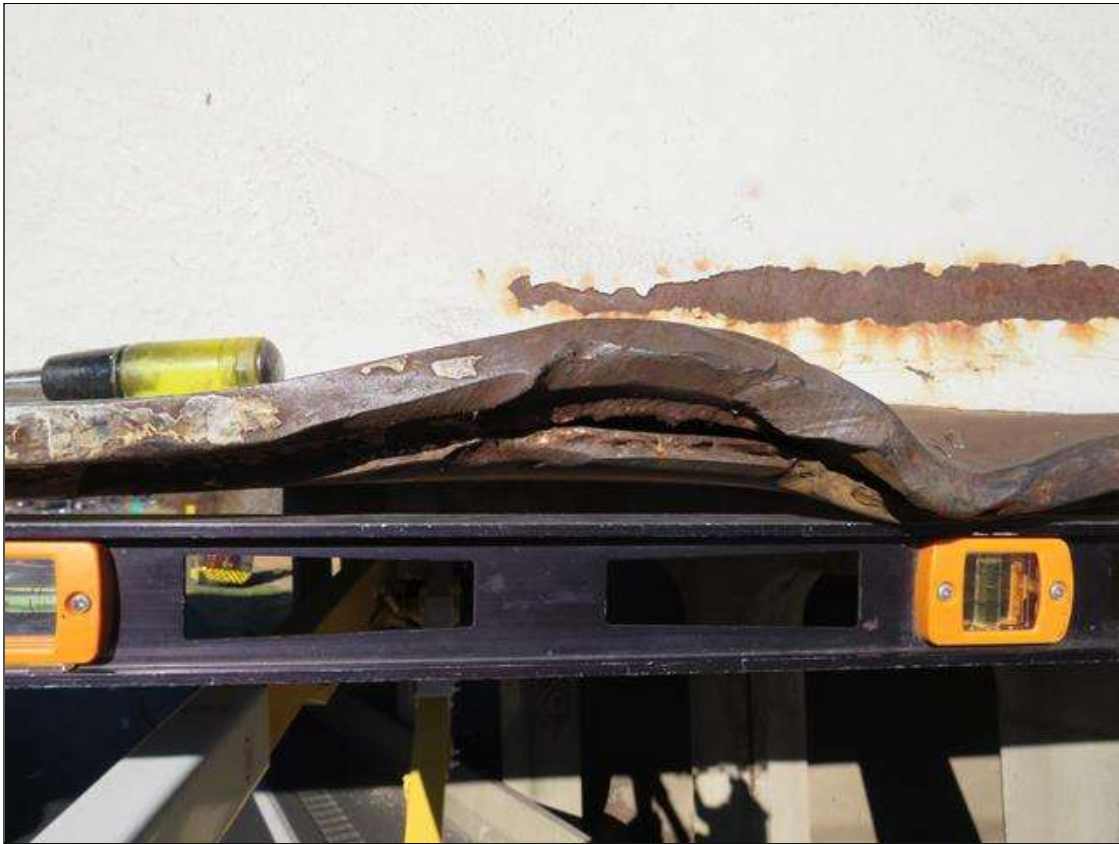
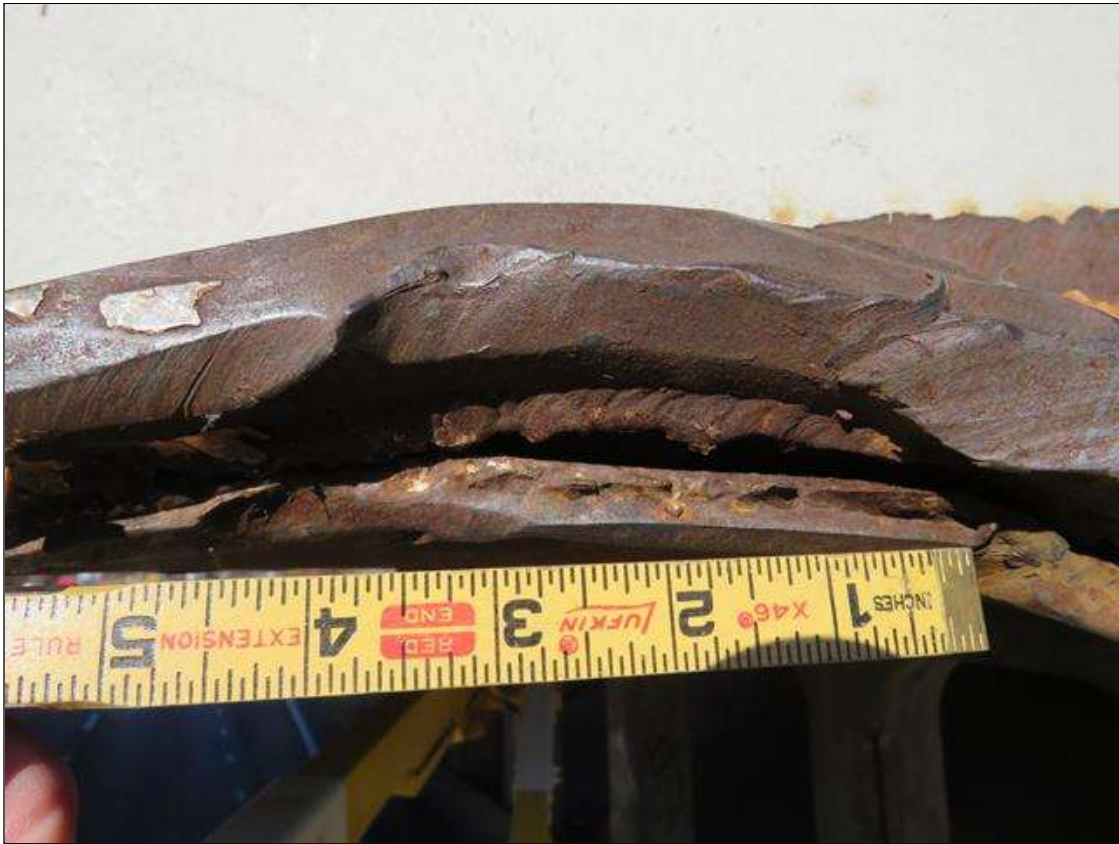
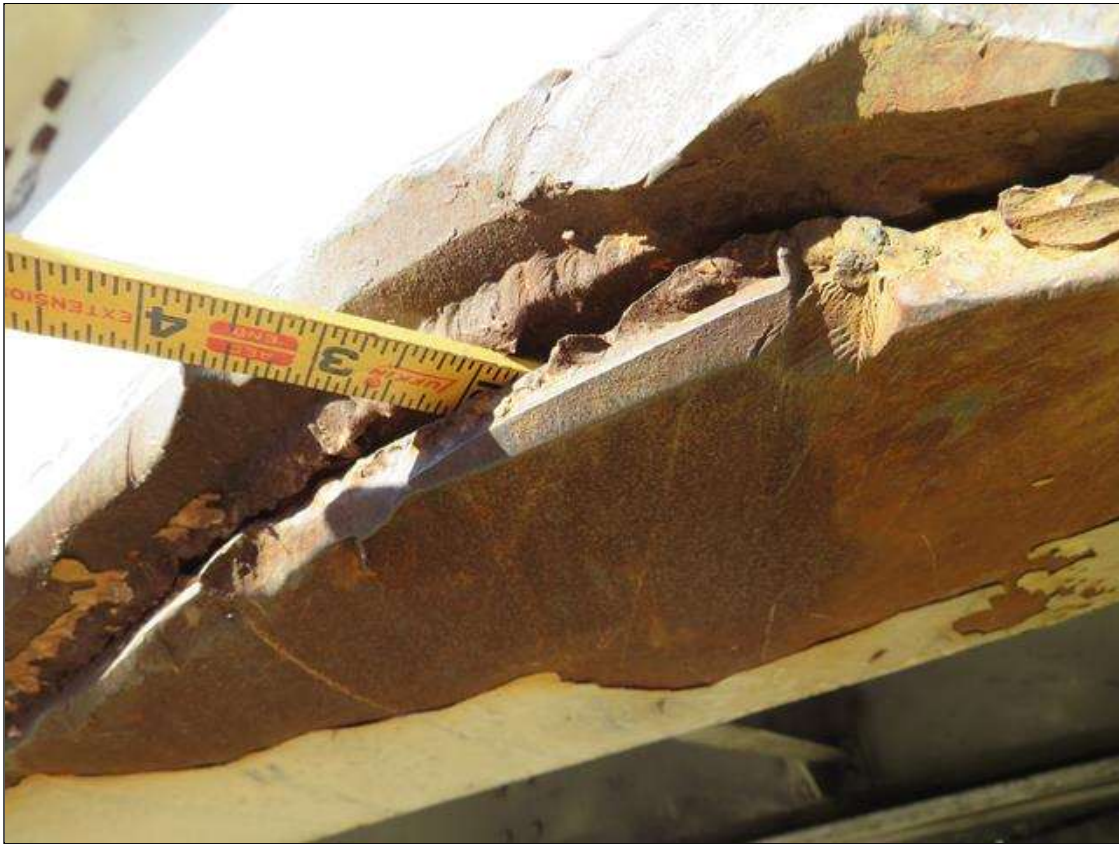
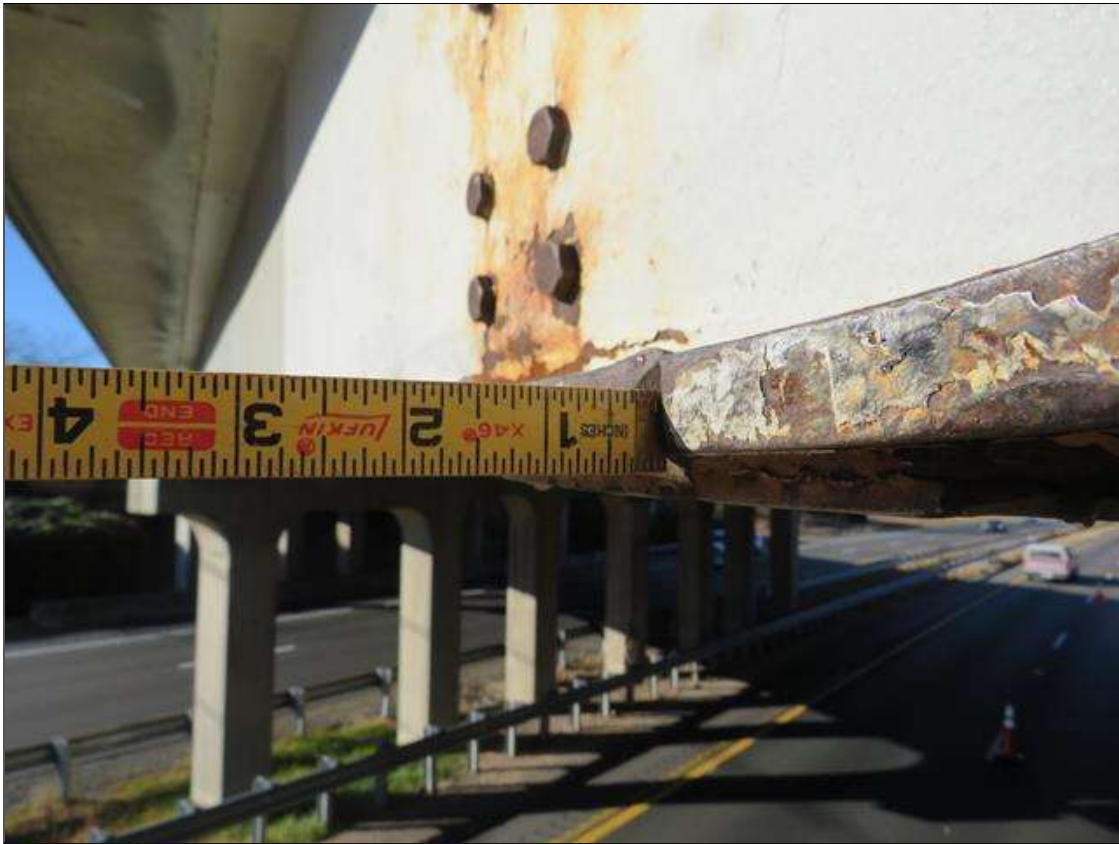
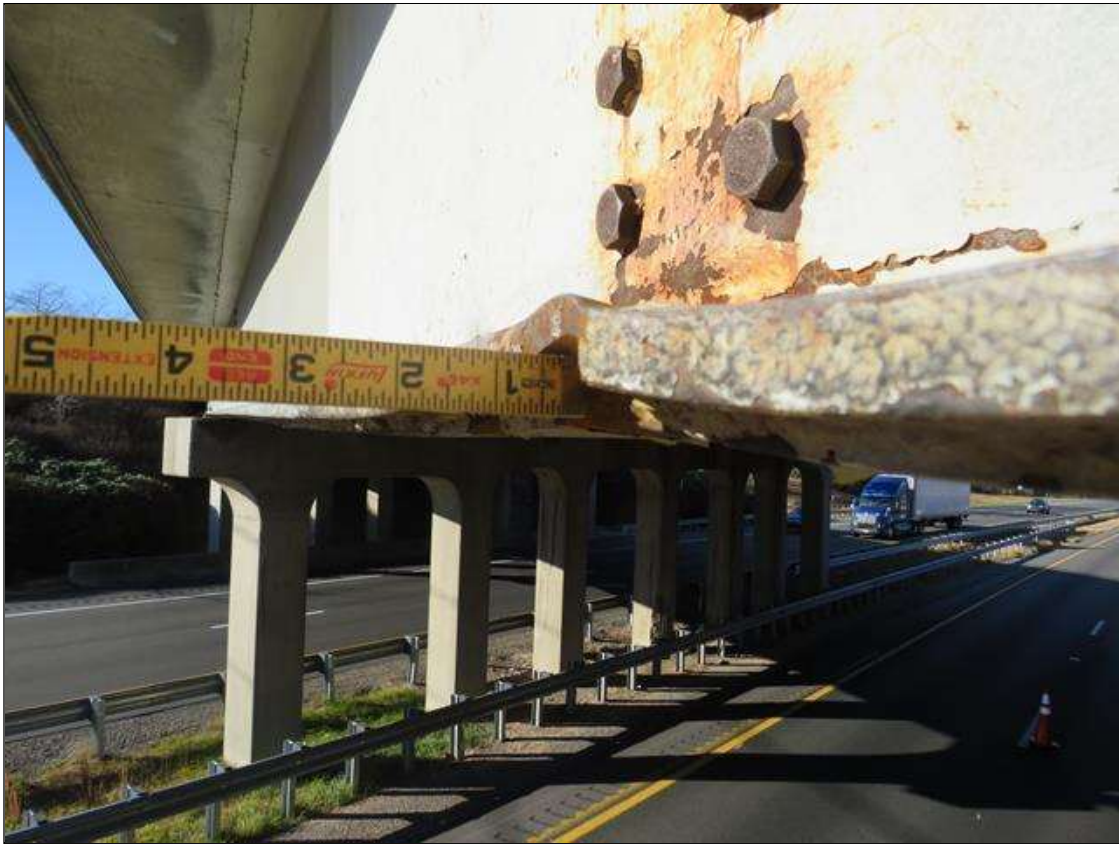
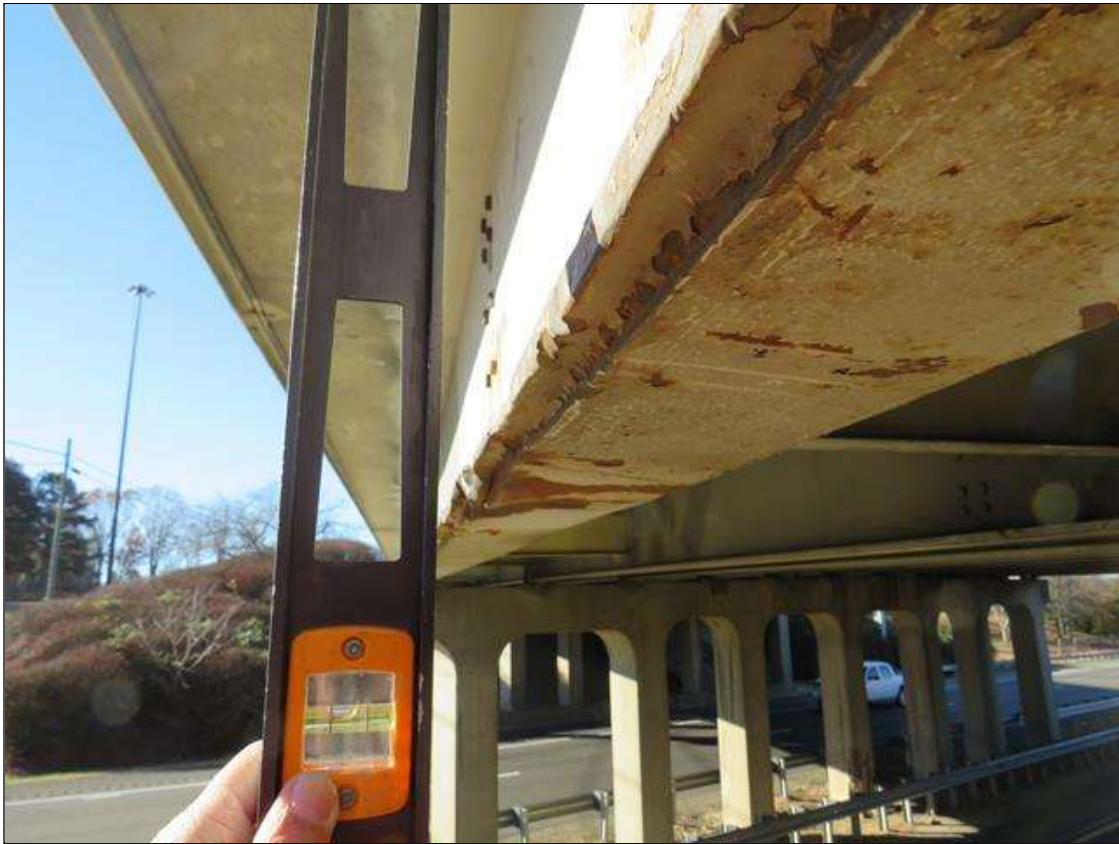
Span 3 Beam 11: SUPPLEMENTAL INSPECTION IMPACT DAMAGE 2021 area of previous impact damage, distortion of bottom flange vertical up to 2" lateral up to 1/2" with broken cover plate weld [10" long]. new area of impact damage 6" long x 2" high at 13'-5" out from int. bent 3 . with the bottom cover plate being broken loose from bottom flange 10" long x 2" deep . there are also two older 1/2" indentions in the same area . Beam 11 is swept westward up to 1 1/2". (par) there is a 2" diameter torch cut hole at both ends of of the 6' length .

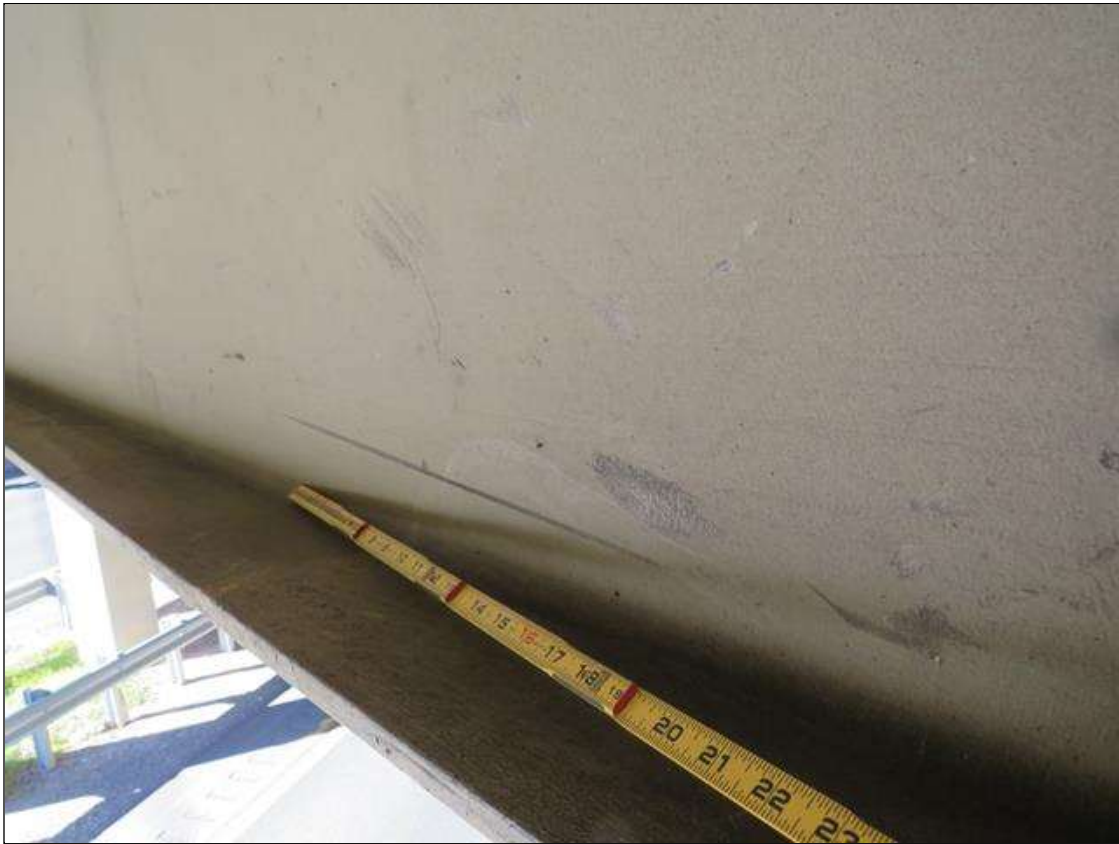
Span 3 Beam 10: SUPPLEMENTAL INSPECTION IMPACT DAMAGE 2021: 1 indentation 1" long x 1/2" deep at 18'-8" from int. bent 3 . scattered scrapes along the web .
