NC DEPARTMENT OF TRANSPORTATION  
DIVISION OF HIGHWAYS  
STRUCTURE MANAGEMENT UNIT  
COUNTY: BUNCOMBE DIV: 13

SUPPLEMENTAL DAMAGE INSPECTION (SPAN 2  
BEAMS 9 AND 10 ONLY)

## Structure Safety Inspection Report

BRIDGE NUMBER: 100382 BRIDGE NAME: \_\_\_\_\_ PREVIOUS BRIDGE NUMBER: \_\_\_\_\_

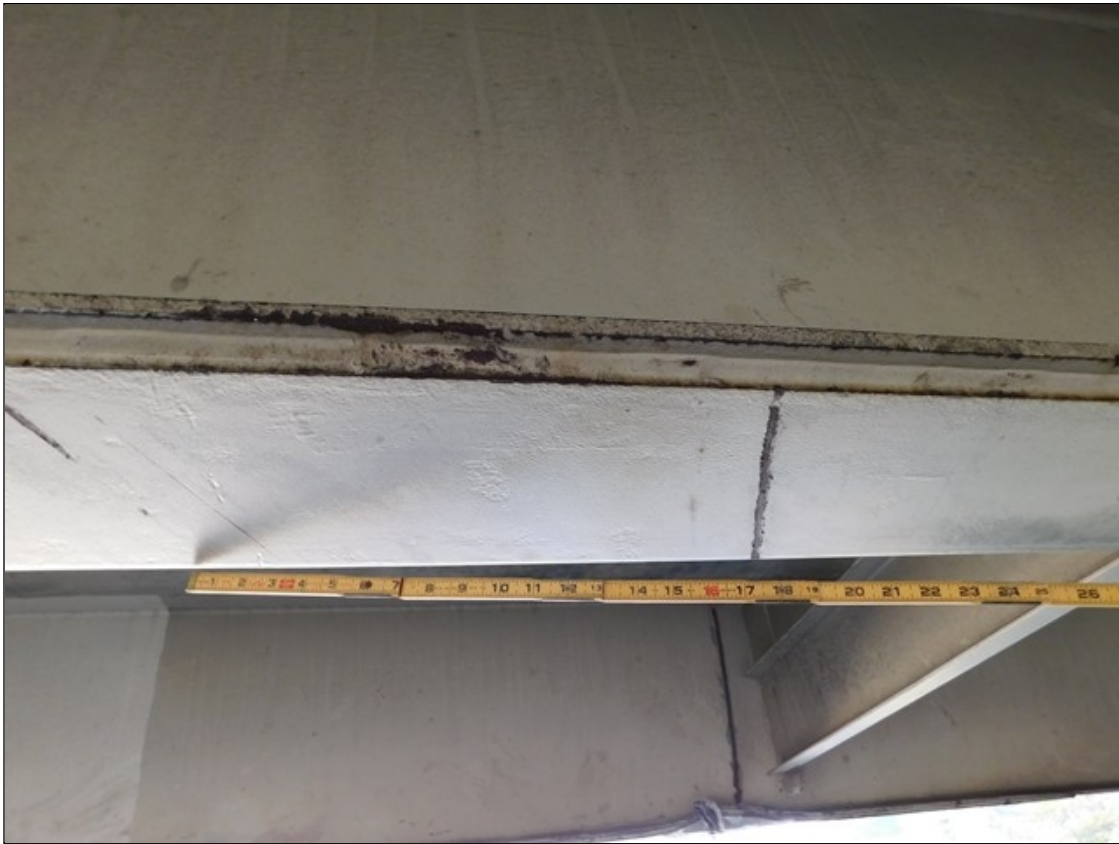
| Element Number | Defect Type | Defect Description | CS | CS Qty | Maint Qty | |
|---|---|---|---|---|---|---|
| <input checked="" type="checkbox"/> 107 | Damage | SCATTERED SCRAPES ON BOTTOM FLANGE AT 16.2 FEET FROM BENT 1 | 2 | 5 | | Feet |

Span 2 Beam 9: SCATTERED SCRAPES ON BOTTOM FLANGE AT 16.2 FEET FROM BENT 1

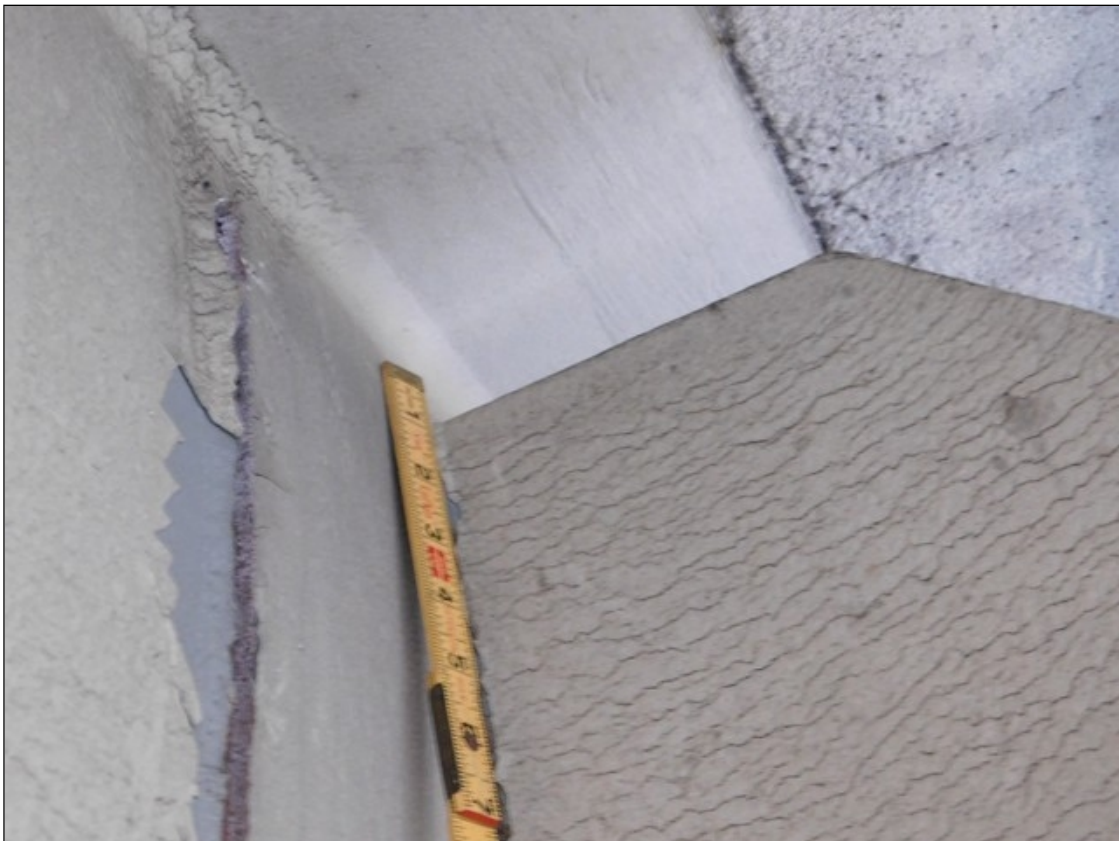
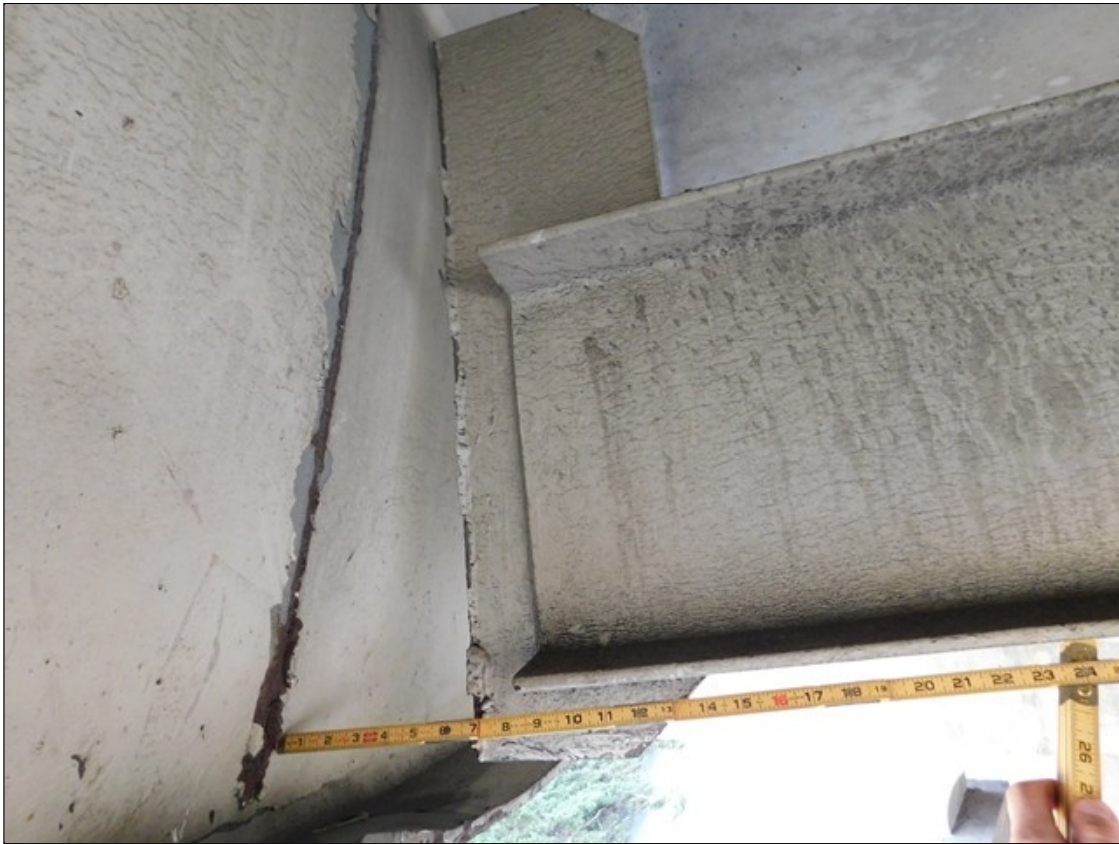
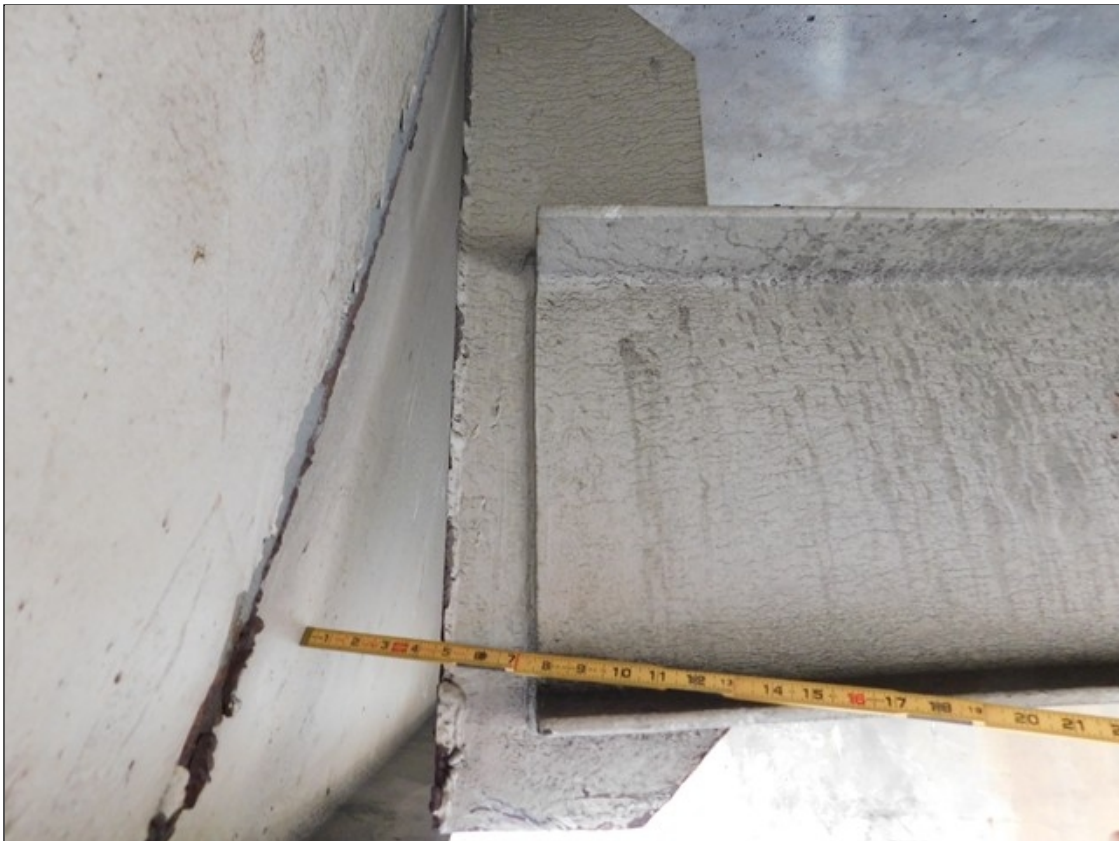
Span 2 Beam 10: SPAN 2, BAY 9, DIAPHRAGM 2 IS COMPLETELY SEPARATED FROM BEAM 10 AND IS SAGGING 1 INCH. A PRIORITY ACTION REQUEST IS BEING ISSUED FOR THIS DIAPHRAGM.

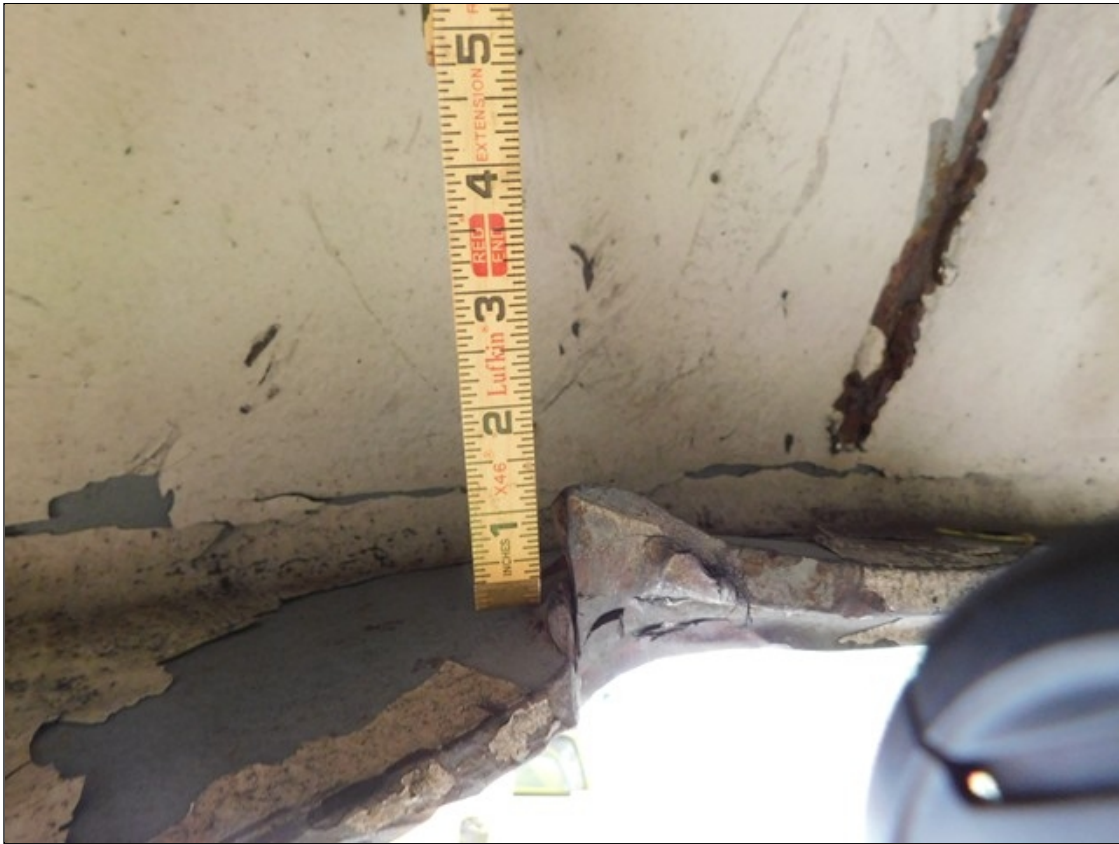
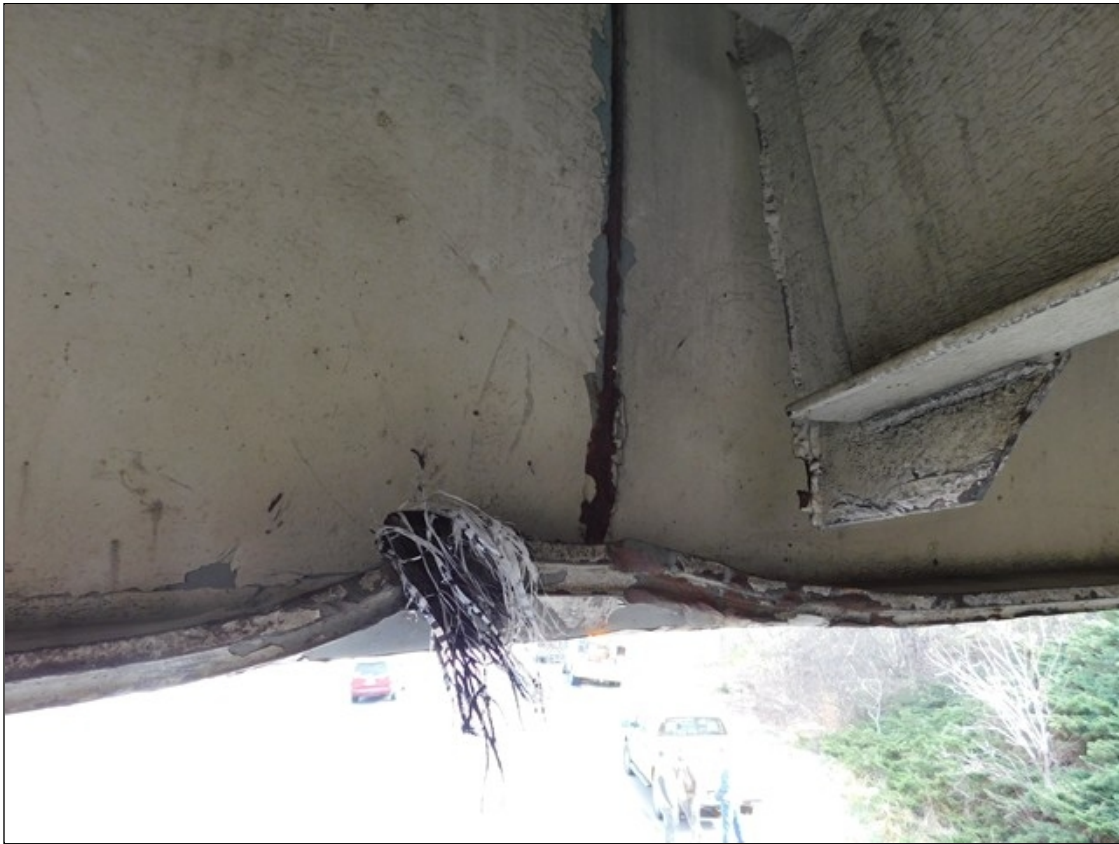
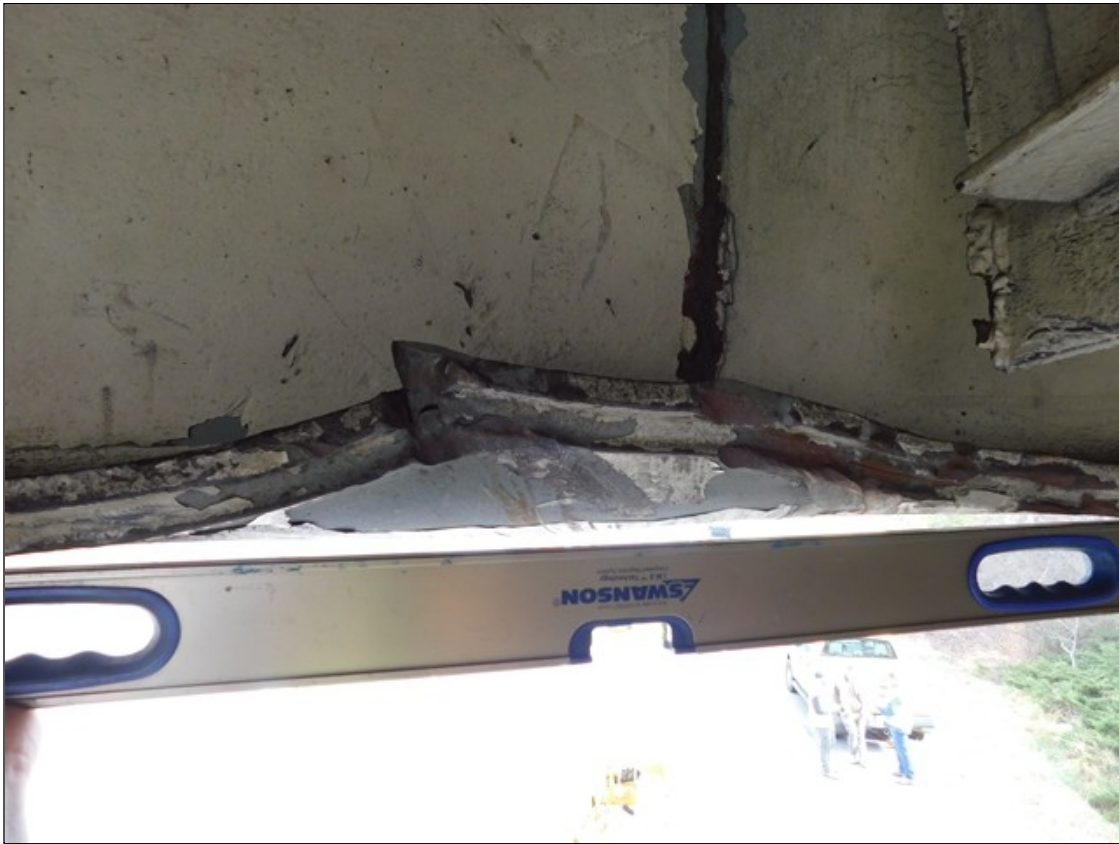
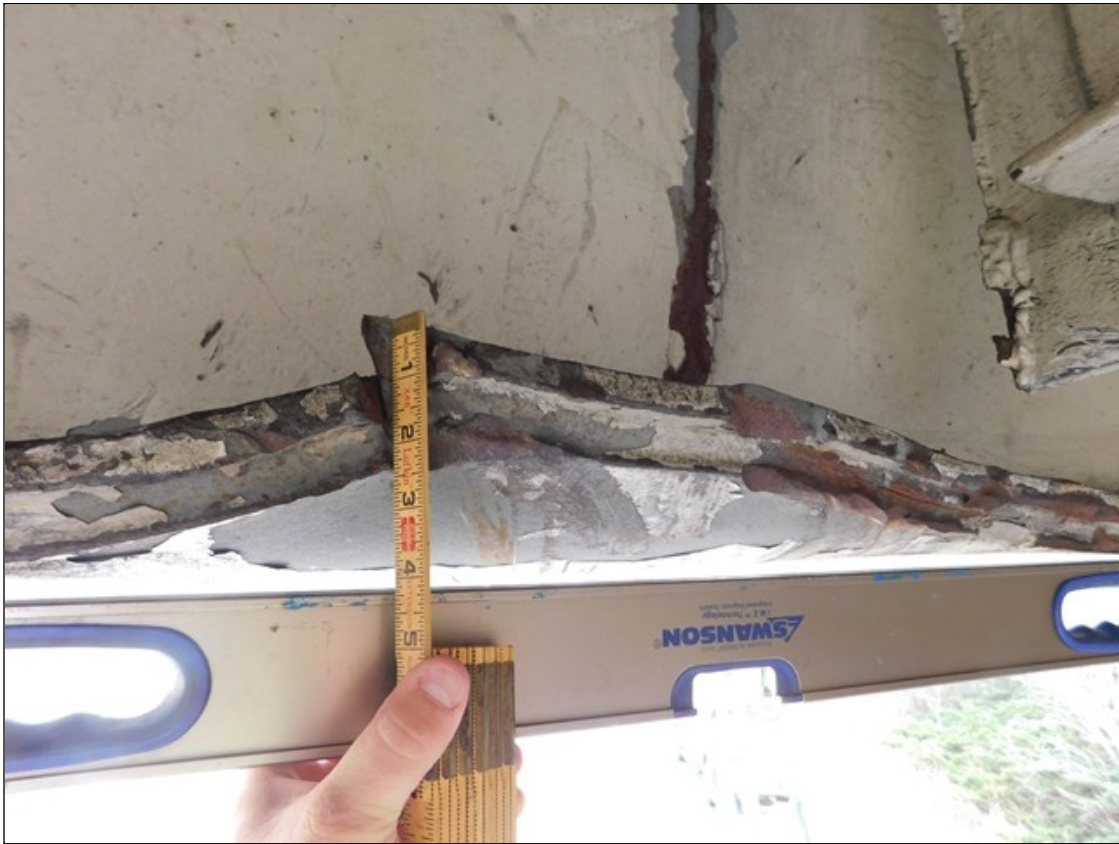
SUPERSTRUCTURE GRADE LOWERED DUE TO DAMAGE TO SPAN 2, BEAM 10

Span 2 Beam 10: BEAM 10 BOTTOM FLANGE IS BENT UPWARDS 4 INCHES x 28 INCHES LONG x 8 INCHES WIDE STARTING AT 15 FEET FROM BENT 1. THERE IS A 1 INCH LONG TEAR IN THE LEFT EDGE OF THE FLANGE. A PRIORITY ACTION REQUEST IS BEING ISSUED FOR THIS BEAM.

Span 2 Beam 10: BEAM 10 BOTTOM FLANGE IS BENT UPWARDS 4 INCHES x 28 INCHES LONG x 8 INCHES WIDE STARTING AT 15 FEET FROM BENT 1. THERE IE A 1 INCH LONG TEAR IN THE LEFT EDGE OF THE FLANGE. A PRIORITY ACTION REQUEST IS BEING ISSUED FOR THIS BEAM.

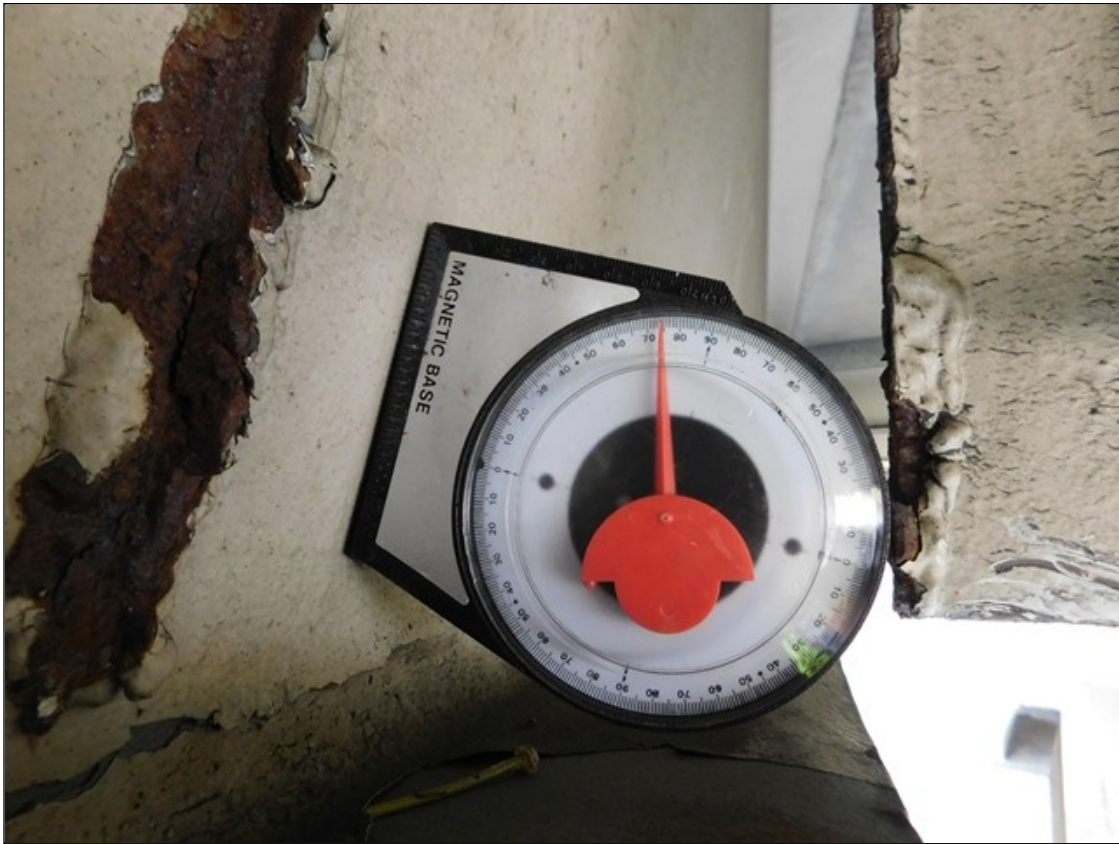
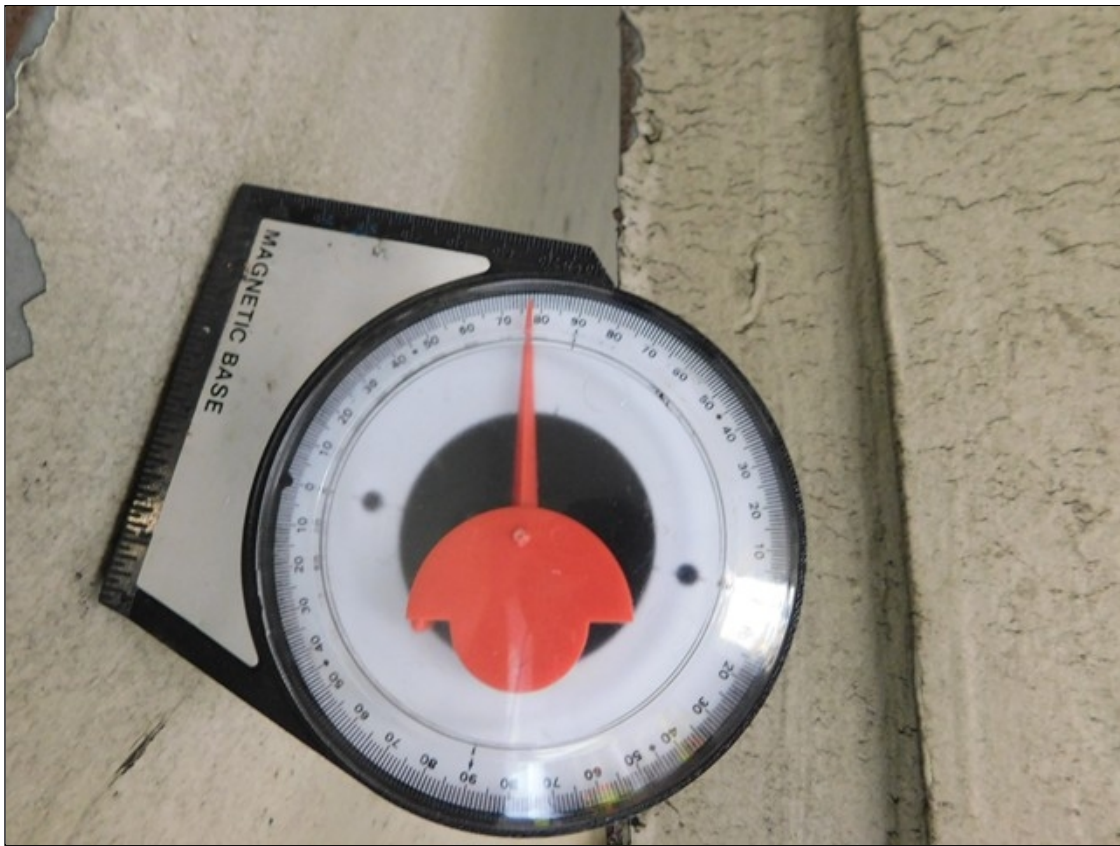
Span 2 Beam 10: BEAM 10 WEB IS OUT OF PLUMB 12 DEGREES AT 15 INCHES FROM THE BOTTOM FLANGE AND 16 DEGREES AT THE BOTTOM FLANGE FOR 25 FEET LONG STARTING AT BENT 1. A PRIORITY ACTION REQUEST IS BEING ISSUED FOR THIS BEAM.

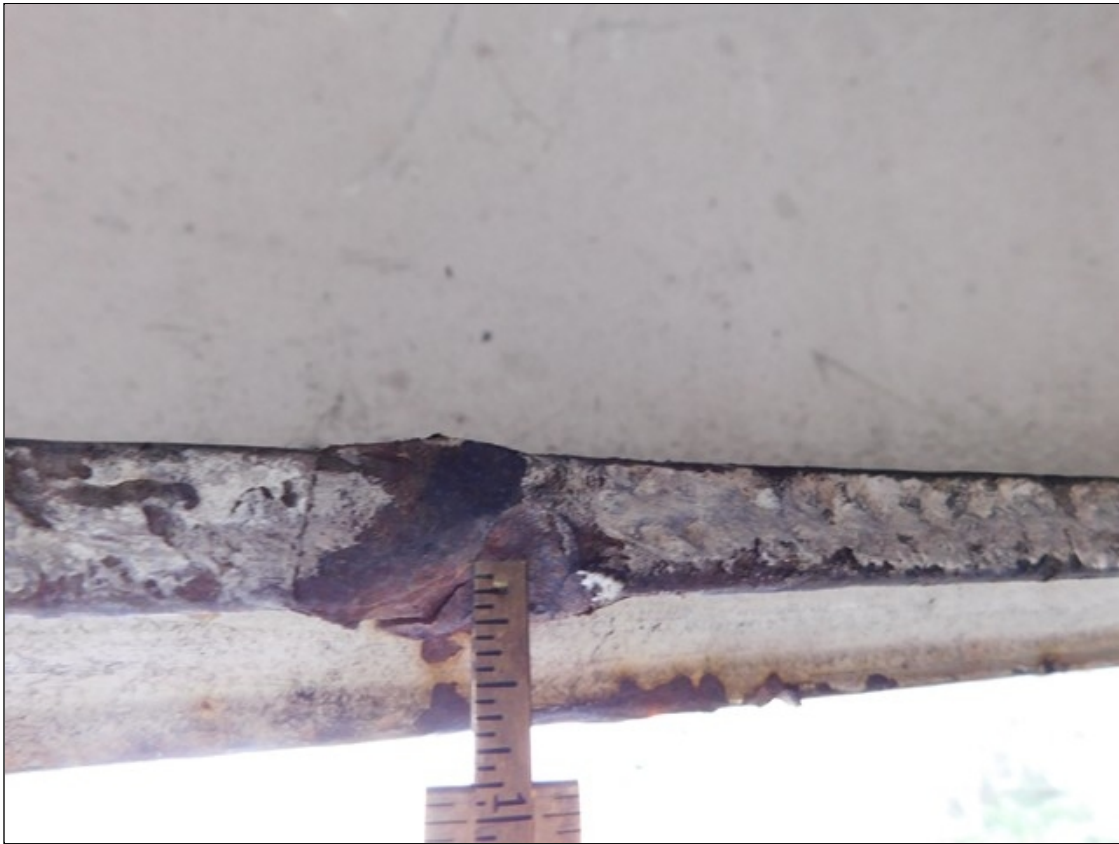
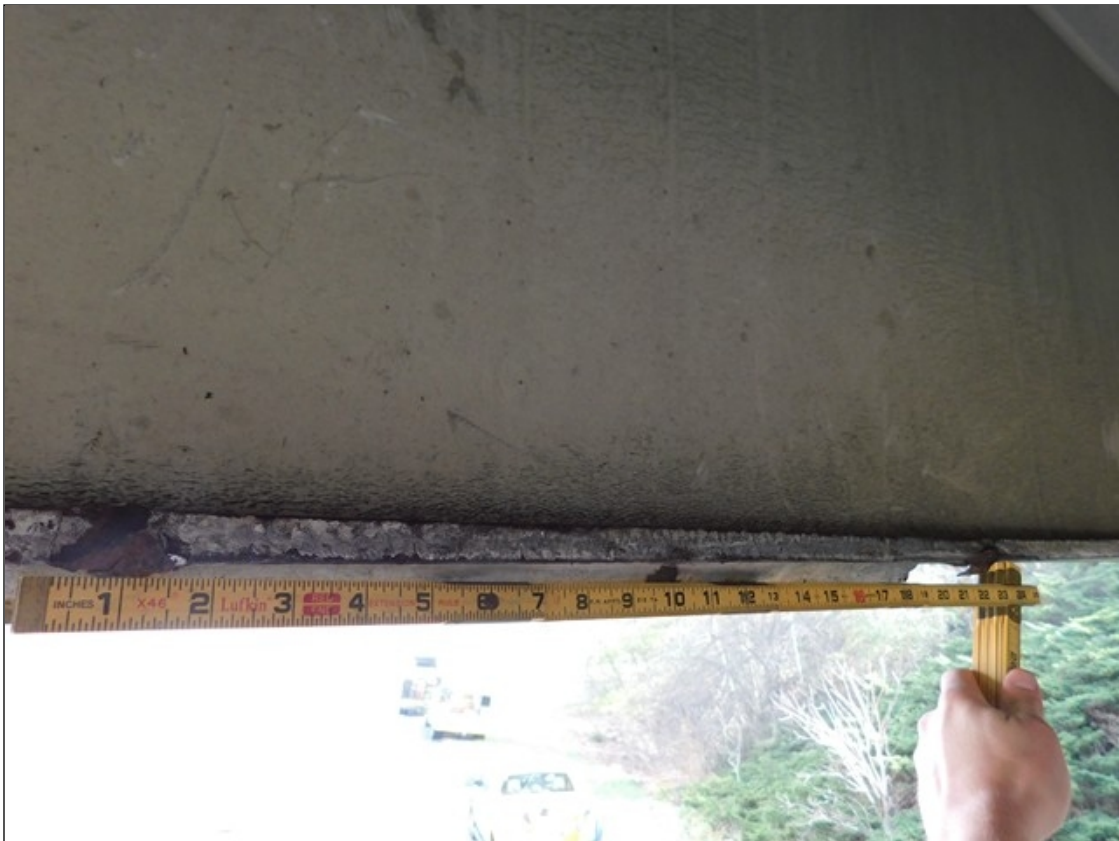
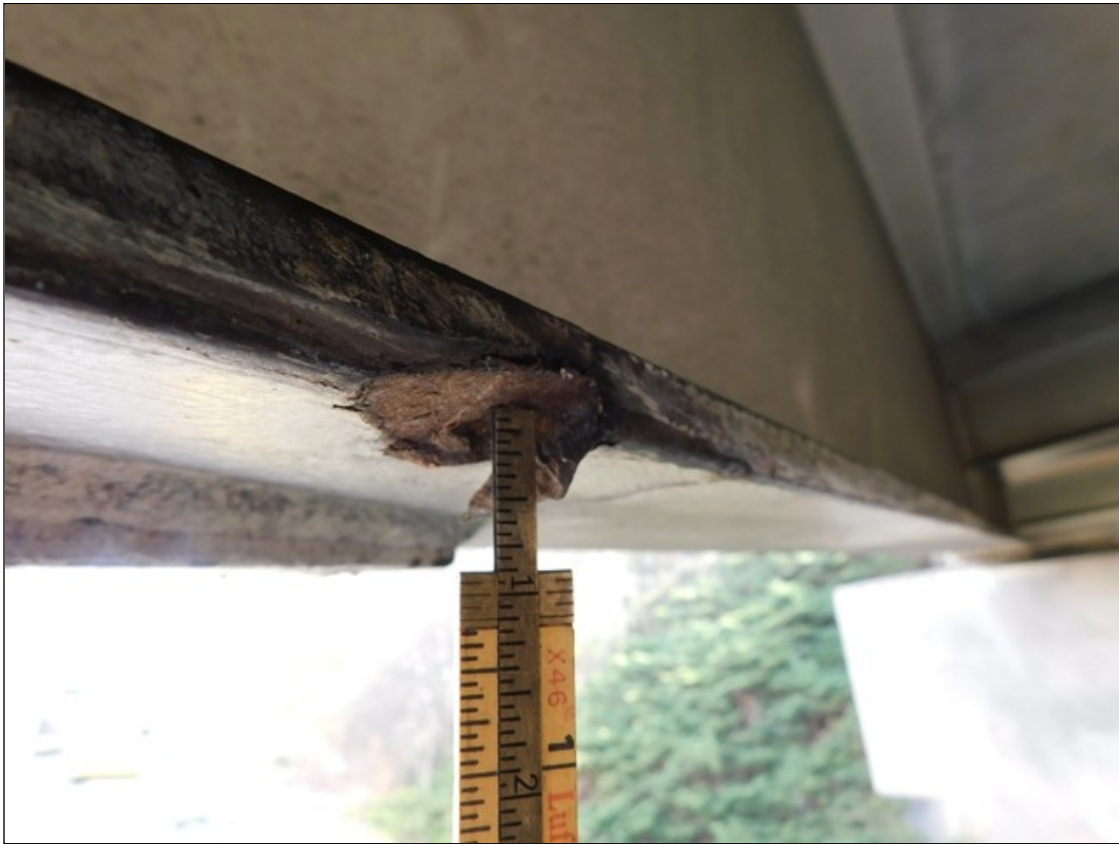
| Element Number | Defect Type | Defect Description | CS | CS Qty | Maint Qty | |
|---|---|---|---|---|---|---|
| <input checked="" type="checkbox"/> 107 | Damage | LEFT EDGE OF THE BOTTOM FLANGE HAS A 1 INCH DIAMETER x 0.25 INCH DEEP GOUGE AT 11.1 FEET FROM BENT 1 AND A 1 INCH DIAMETER x 0.375 DEEP GOUGE AT 12.8 FEET FROM BENT 1. | 3 | 2 | | Feet |

Span 2 Beam 10: LEFT EDGE OF THE BOTTOM FLANGE HAS A 1 INCH DIAMETER x 0.25 INCH DEEP GOUGE AT 11.1 FEET FROM BENT 1 AND A 1 INCH DIAMETER x 0.375 DEEP GOUGE AT 12.8 FEET FROM BENT 1.

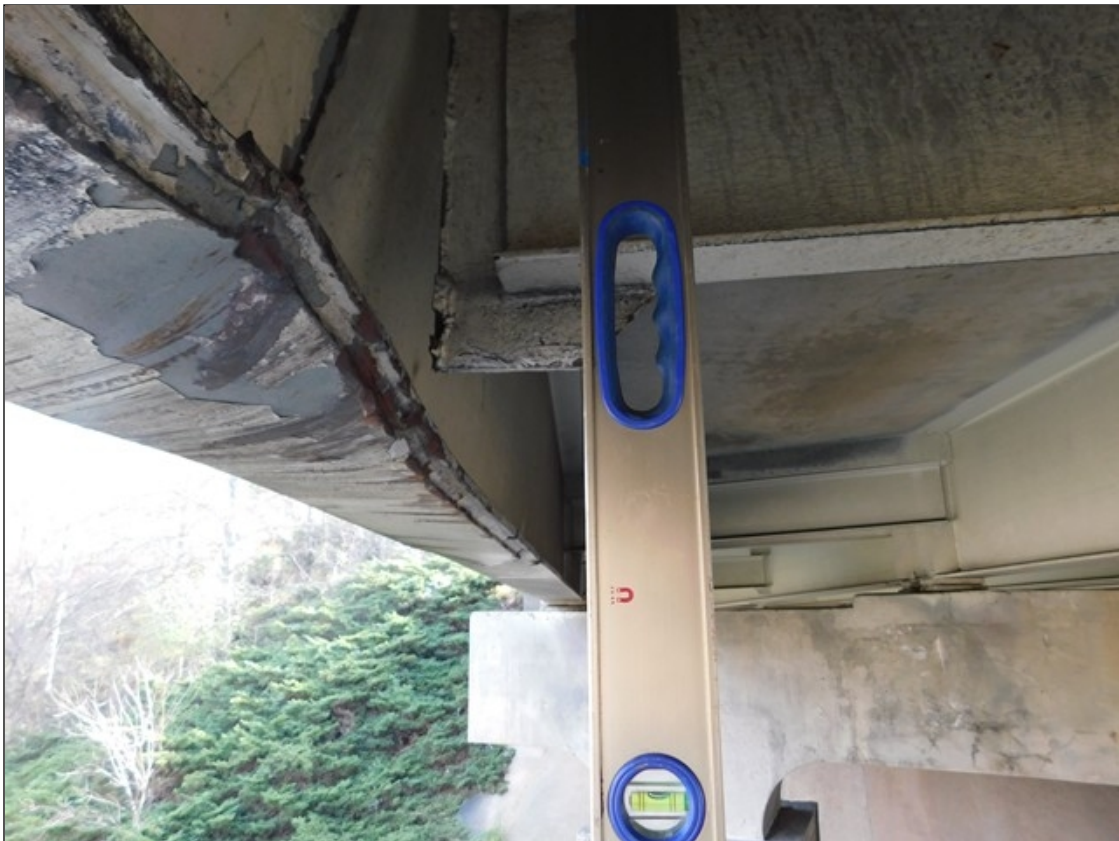
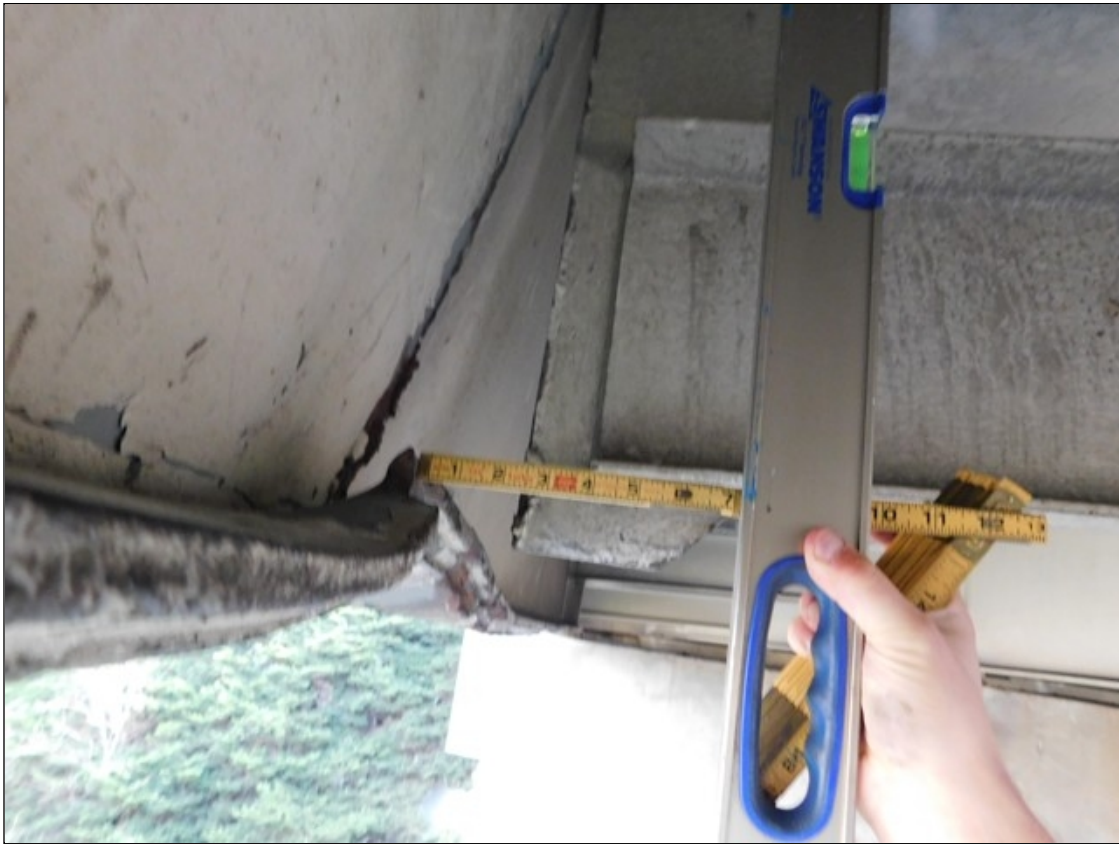
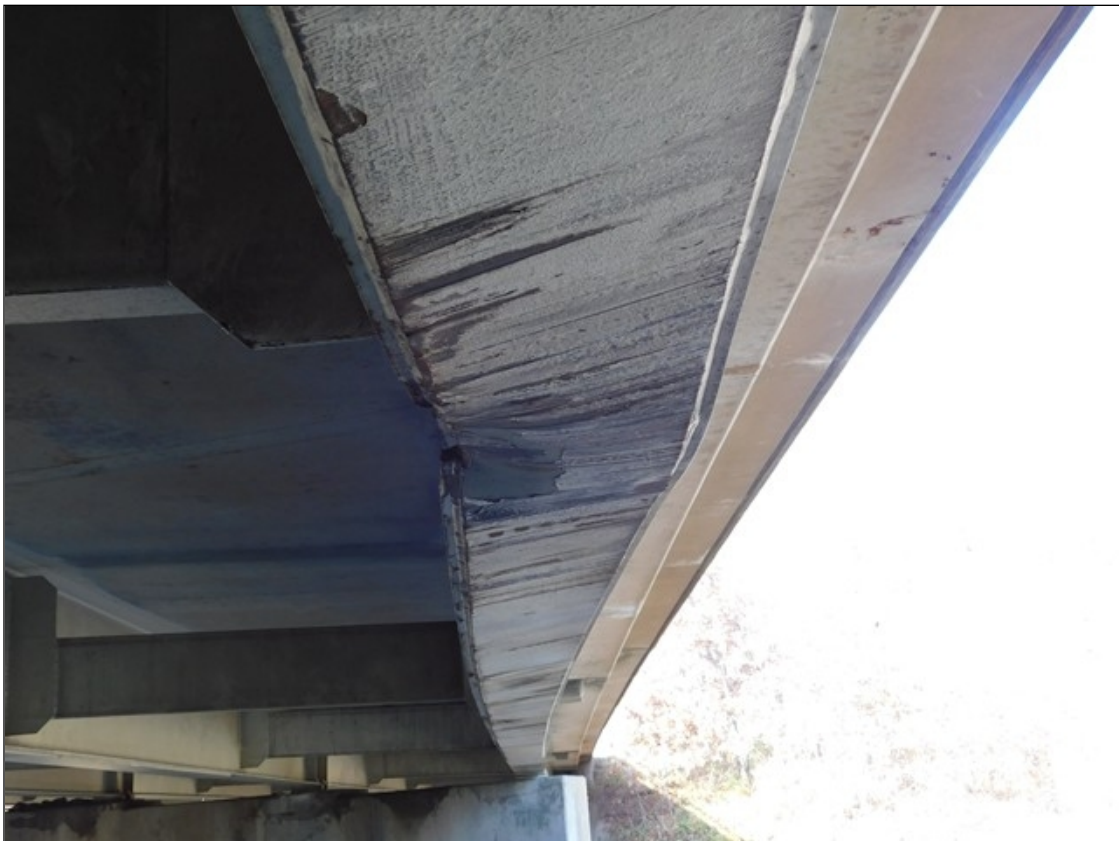
Span 2 Beam 10: BEAM 10 IS BENT WESTWARD FOR UP TO 7 INCHES x 25 FEET LONG STARTING AT BENT 1.

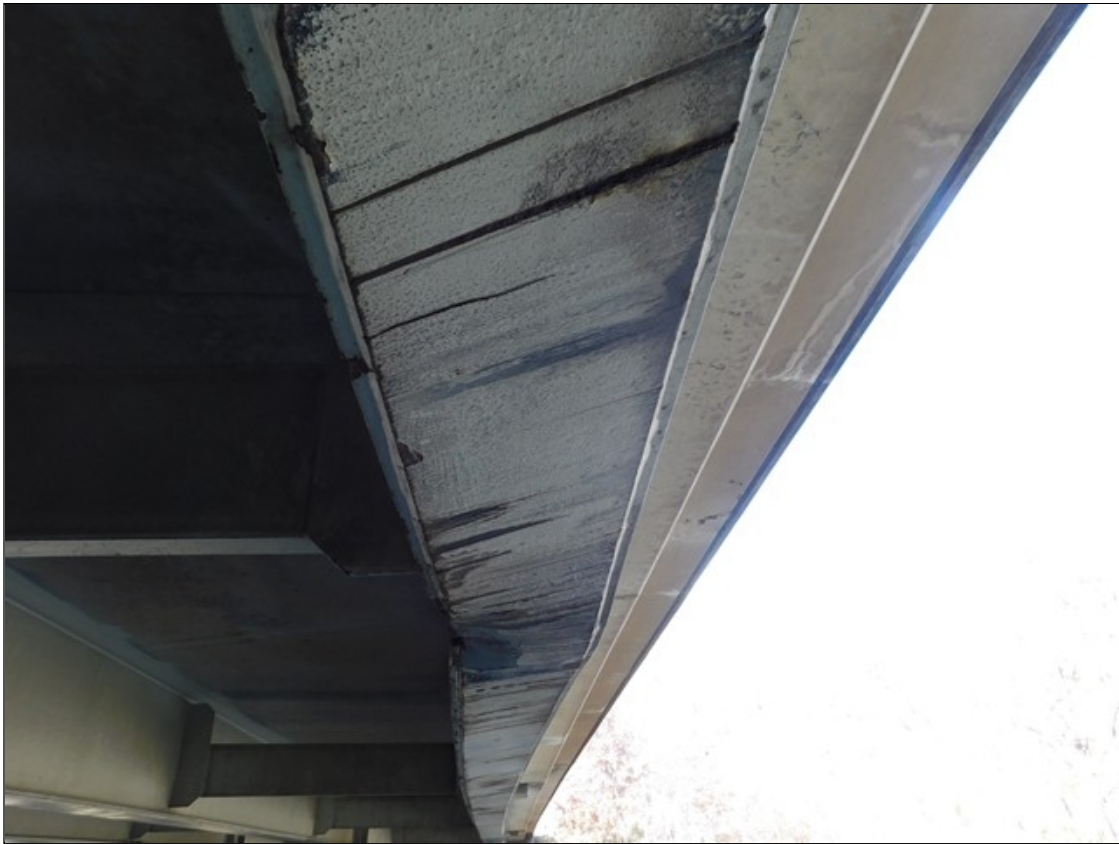
Span 2 Beam 10 - Protective System: BEAM 10 BOTTOM FLANGE HAS NUMEROUS SCRAPES ON THE UNDERSIDE OF THE BOTTOM FLANGE.

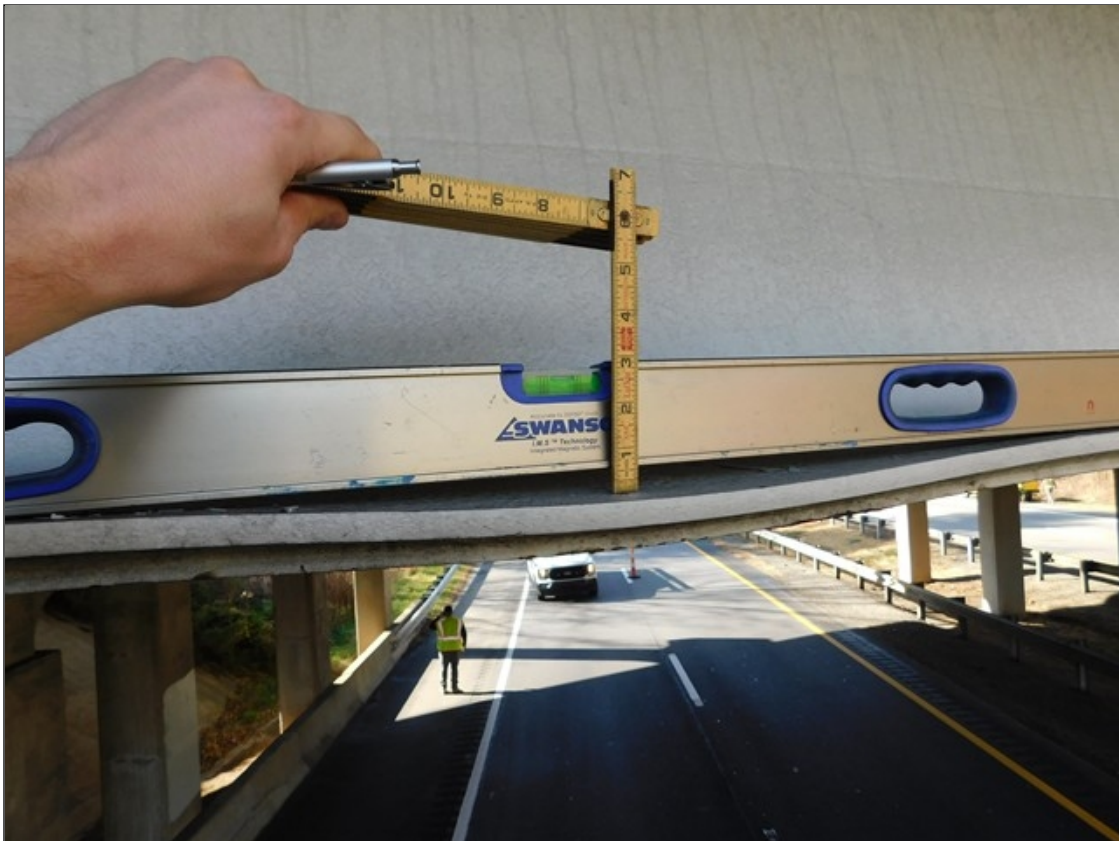
Span 2 Beam 10: BEAM 10 LEFT BOTTOM FLANGE IS BENT DOWNWARD 0.5 INCH FOR 28 INCHES LONG AT 15.2 FEET FROM BENT 1. OVERLAPPING QUANTITY.

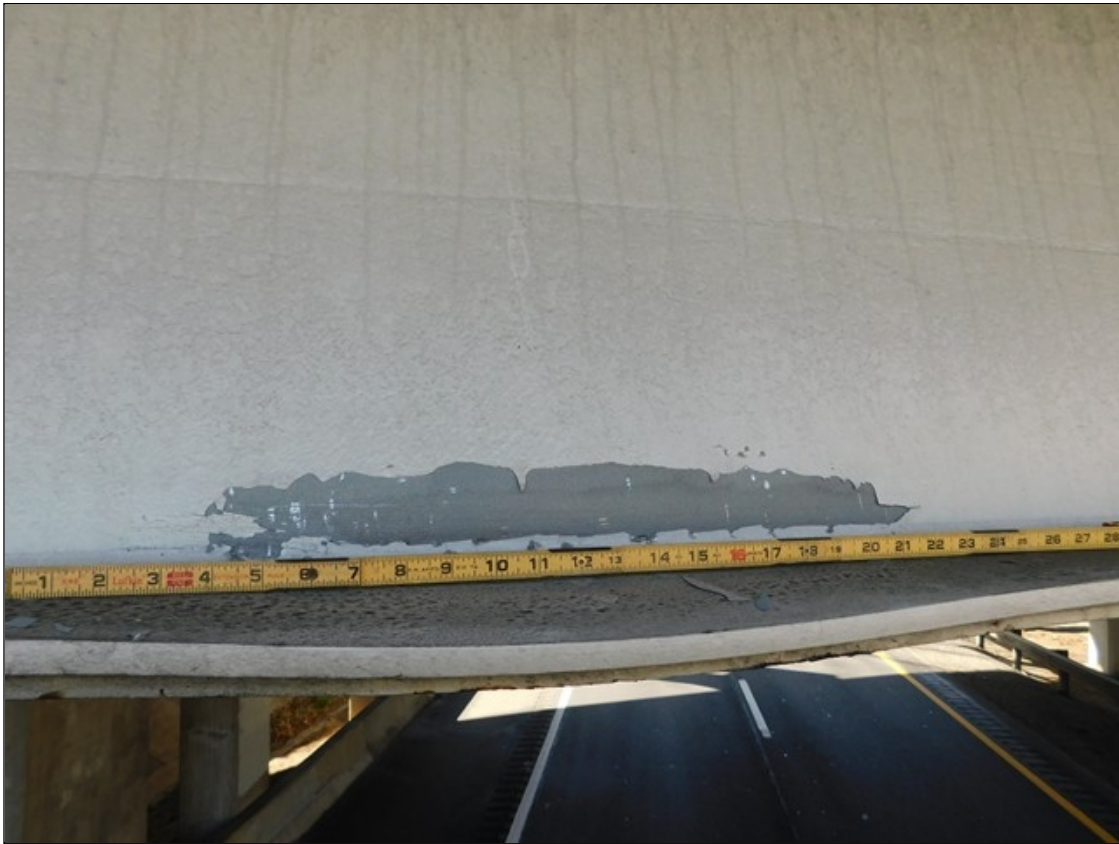
Span 2 Beam 10 - Protective System: PAINT HAS CHIPPED OFF OF THE RIGHT LOWER WEB 2.5 INCHES HIGH x 28 INCHES LONG AT 15 FEET FROM BENT 1.
