NC DEPARTMENT OF TRANSPORTATION
 DIVISION OF HIGHWAYS
 BRIDGE MANAGEMENT UNIT

BRIDGE INSPECTION REPORT

COUNTY SAMPSON BRIDGE NUMBER 810233 INSPECTION CYCLE 2 YRS
 ROUTE SR1742 ACROSS SIX RUN CREEK M.P. 0

INSPECTION DATE 07/22/2010 OPERATING RATING H8-01

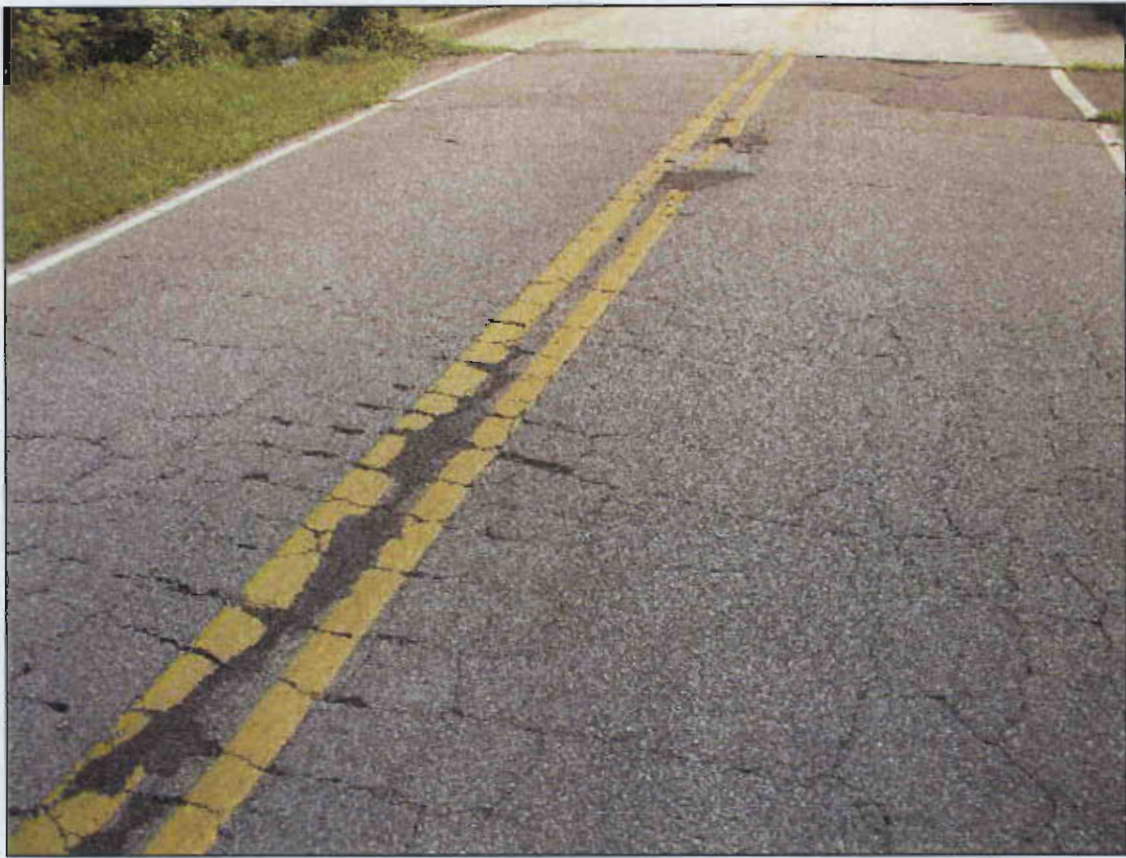
APPROACH 1 MAP CRACKED

MMS Code	Description of Function	Unit	Quantity	Remarks	Est. Cost
2816	Asphalt Surface Repair or Replacement	SY	120	APPROACHES CRACKED, PATCHED, AND SETTLED.	
2910	Manual Brush and Tree Control	LF	80	VEGETATION COVERING WINGWALLS.

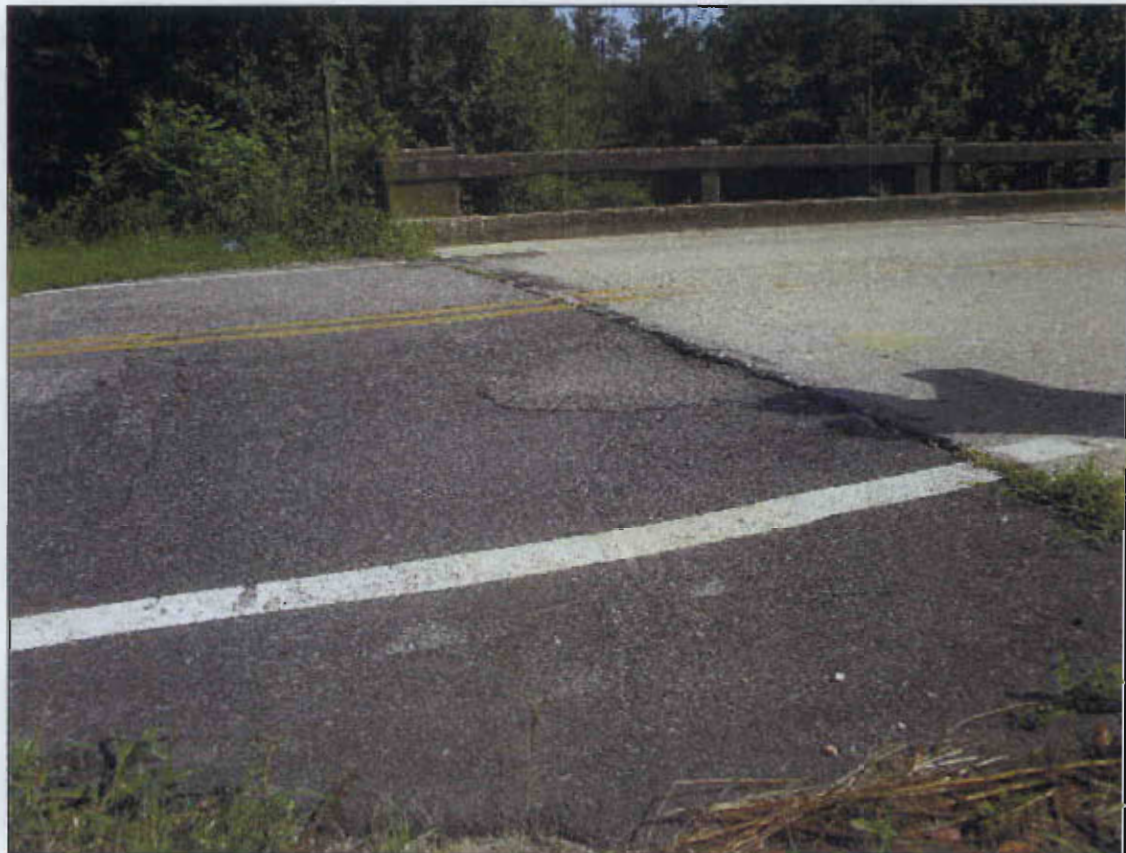
39	5	<p>SLOPE PROTECTION 5 VEGETATION OVERGROWTH AT ENDS OF BRIDGE.</p>	
50	6	<p>APPROACH ROADWAY CONDITION 6 APPROACH 1 TRANSVERSE CRACKS, PATCH, AND 1 1/2 IN. SETTLEMENT AT END BENT 1. APPROACH 2 TRANSVERSE CRACKS, PATCH, AND 1 IN. SETTLEMENT AT END BENT 2.</p>	
61	YES	JOISTS 17 & 18 NOT BEARING AT END BENT 2 CRUTCH.	
62	YES	WEIGHT LIMIT 25 TONS.

APPROACH 1 PATCHED AND SETTLED IN THE RIGHT LANE

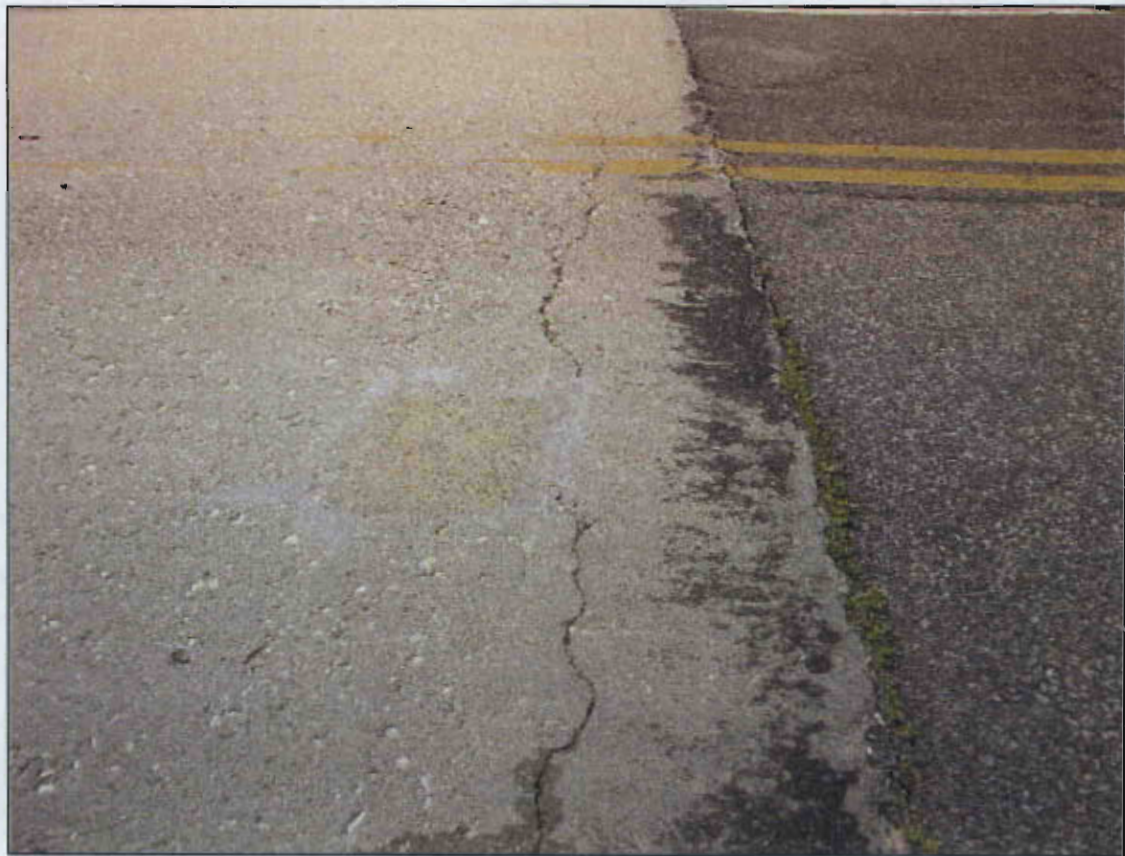
Item No.	Grade		
2a	5	<p>CONCRETE DECK 5 SCALING WITH EXPOSED COARSE AGGREGATE IN BOTH SPANS.</p> <p>SPAN 1 1/8 IN. TRANSVERSE CRACK IN TOP OF DECK SPAN 1 AT END BENT 1. HAIRLINE TO 1/8 LONGITUDINAL CRACK IN TOP OF DECK SPAN 1 SOUTHBOUND LANE. PATCHES IN DECK NEAR END BENT 1 WHERE PILES WERE DRIVEN. SIMILAR IN SPAN 2 AT END BENT 2. 8 IN. DIAMETER SPALL IN BOTTOM OF DECK SPAN 1 BAY 2 AND 9 IN. DIAMETER SPALL IN BOTTOM OF DECK SPAN 1 BAY 18.</p> <p>SPAN 2 1/8 IN. TRANSVERSE CRACK IN TOP OF DECK SPAN 1 AT END BENT 2. HAIRLINE X 8 FT. LONGITUDINAL CRACK IN NORTHBOUND LANE AT BENT 1 AND HAIRLINE X 4 FT. LONGITUDINAL CRACK IN SOUTHBOUND LANE AT BENT 1.</p>	
3a	6	<p>CONCRETE RAILS 6 SCALING WITH EXPOSED COARSE AGGREGATE IN FACES.</p>	
4	6	<p>CURBS 5 SCALING WITH EXPOSED COARSE AGGREGATE IN FACES.</p>	
6d	5	<p>STANDARD JOINTS 5 CRACK IN BENT 1 SEAL NEAR CENTERLINE.</p>	
11	6	<p>LONGITUDINAL JOISTS 6 EXTERIOR JOISTS HAVE LONGITUDINAL CRACKS IN VERTICAL FACES. SPLICE BLOCK IS MISSING AT JOIST 19 OVER BENT 1.</p> <p>SPAN 1 JOIST 5 SPAN 1 AT BENT 1 BOTTOM IS DECAYED 1 IN. DEEP X 3 IN. DIAMETER. JOIST 8 SPAN 1 AT BENT 1 IS DECAYED IN THE END 1 IN. HIGH X 2 IN. WIDE X 4 IN. DEEP.</p> <p>SPAN 2 JOISTS 17 & 18 SPAN 2 HAVE BEEN REPLACED. JOISTS 17 & 18 SPAN 2 ARE NOT BEARING ON END BENT 2 CRUTCH BENT. PRIORITY MAINTENANCE ISSUED</p>

TRANSVERSE CRACK IN TOP OF DECK AT END BENT 1

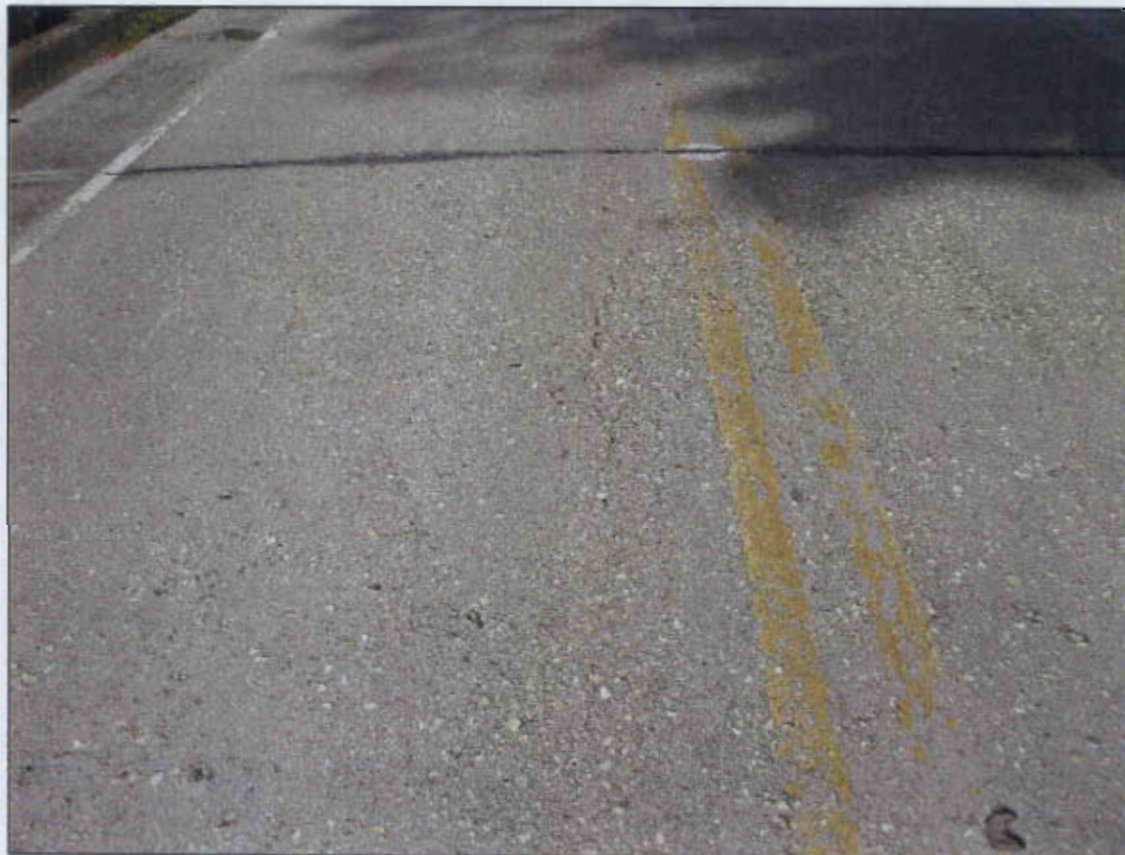
LONGITUDINAL CRACK IN THE LEFT LANE OF SPAN 1

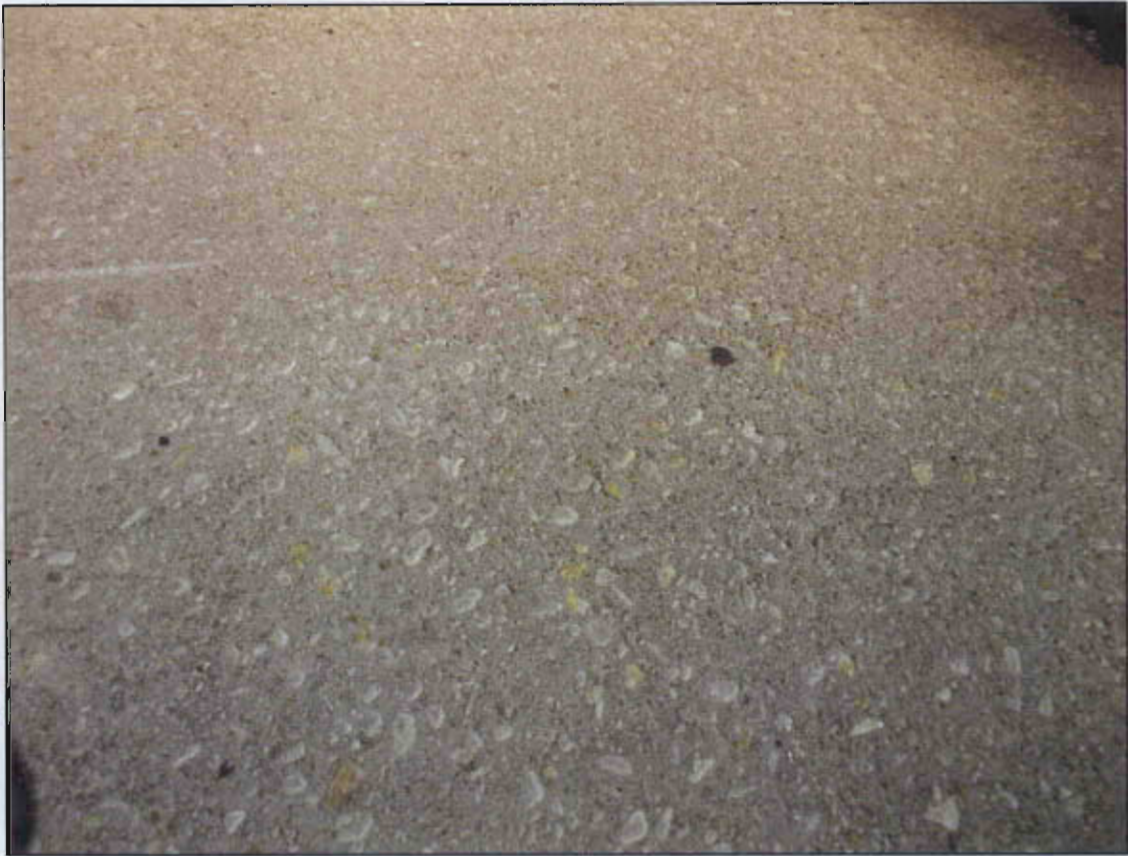
TOP OF DECK SCALED WITH COARSE AGGREGATE EXPOSED

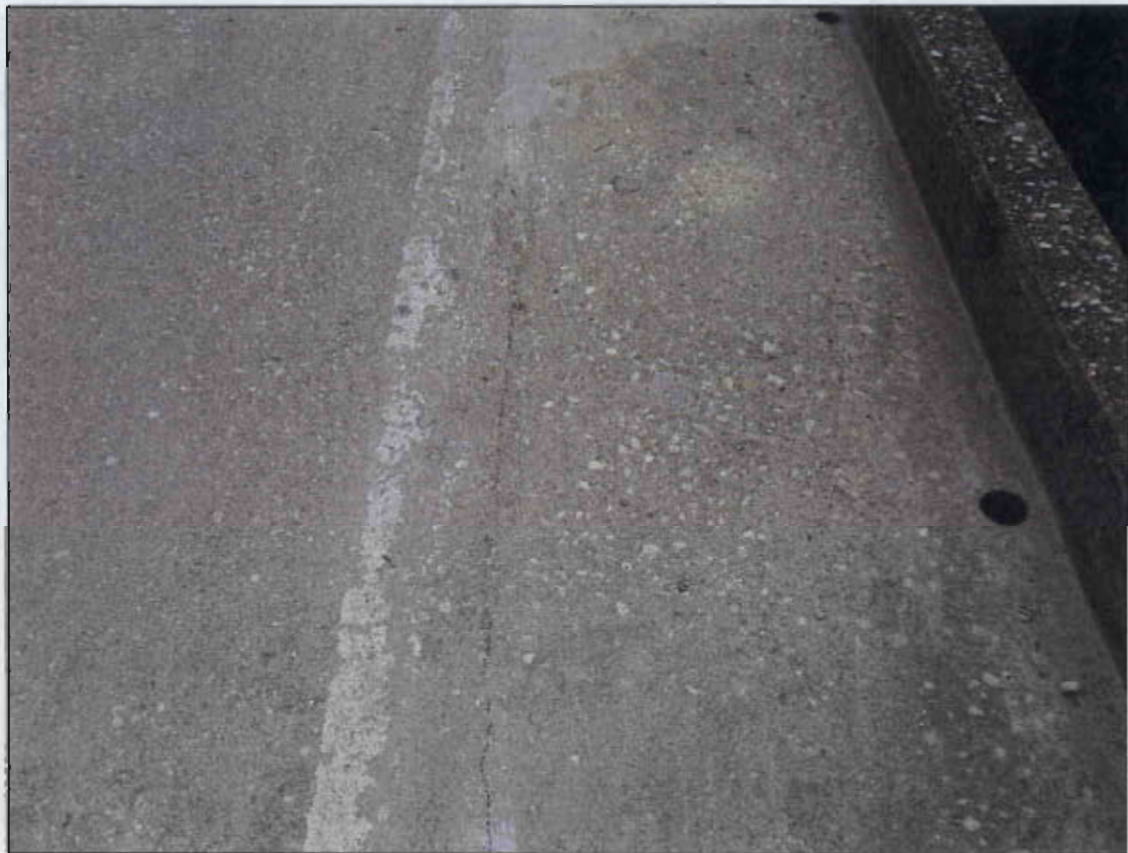
LONGITUDINAL CRACK IN THE RIGHT SIDE SHOULDER OF SPAN 2

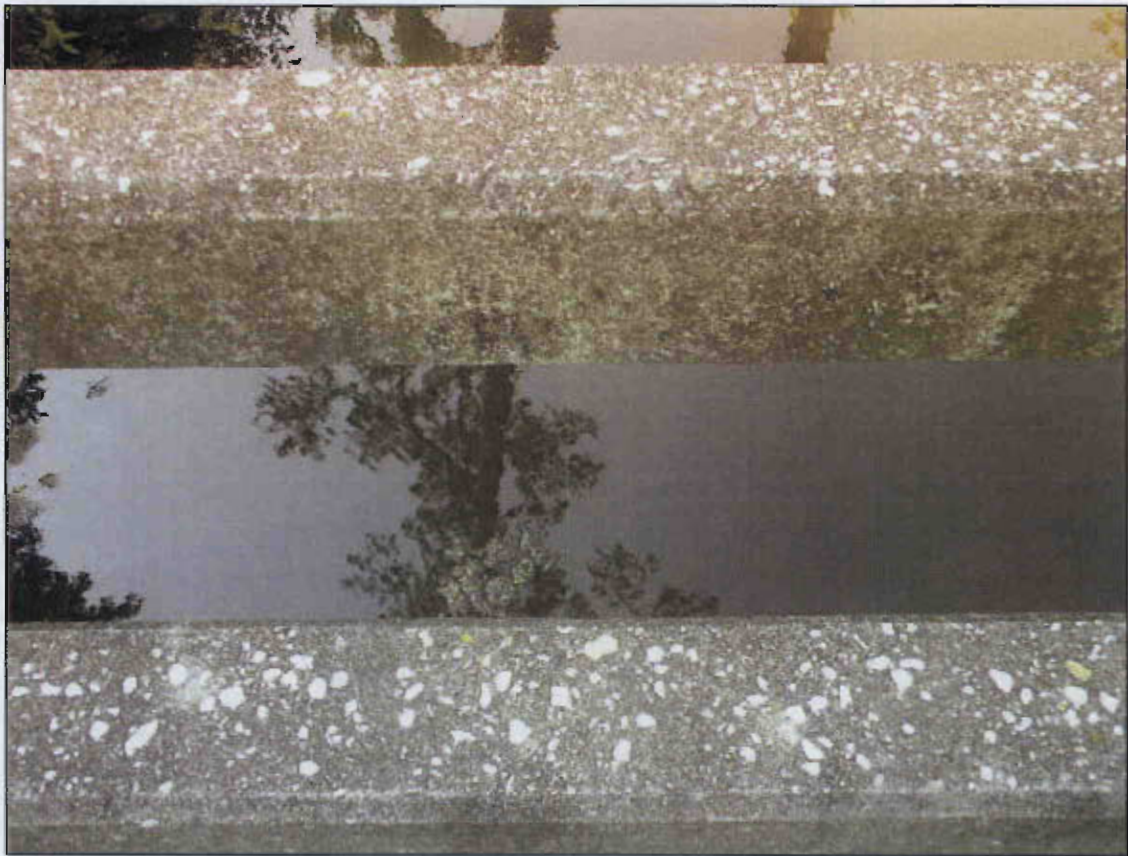
CURBS AND GUARDRAILS SCALED WITH EXPOSED AGGREGATE

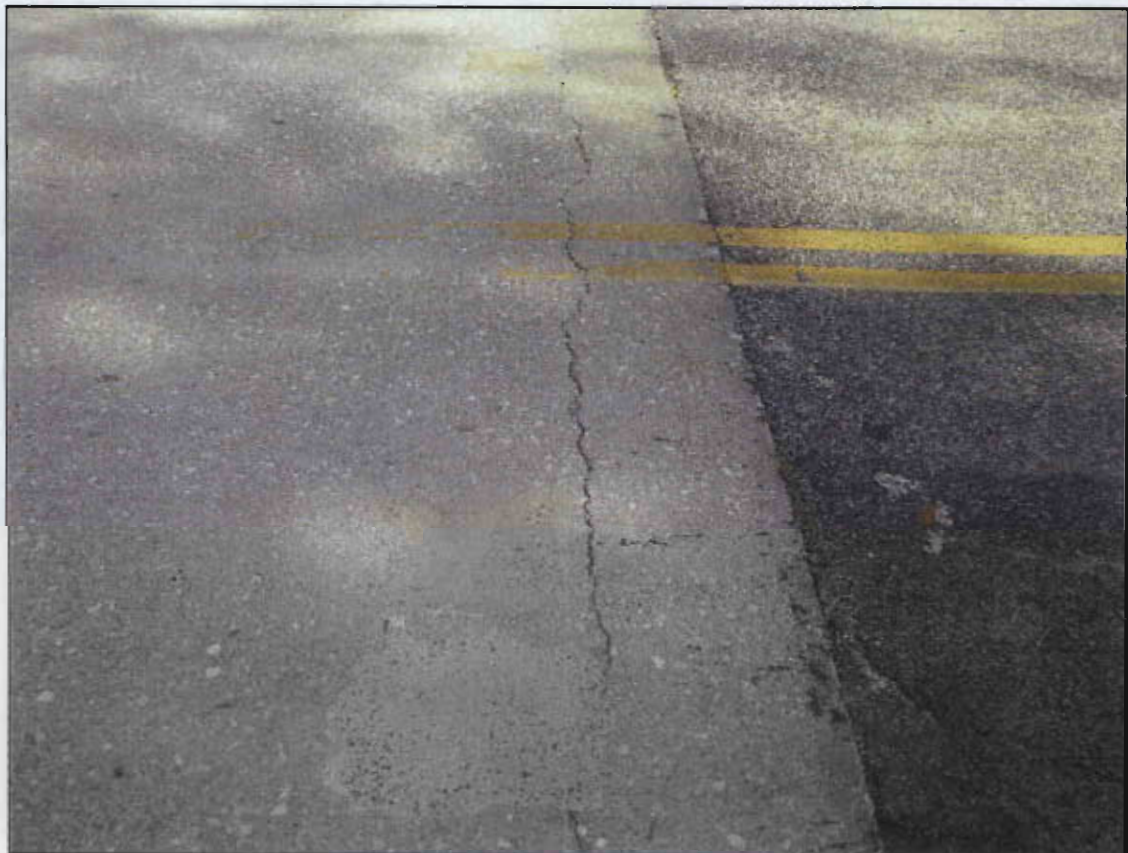
TRANSVERSE CRACK IN SPAN 2 AT END BENT 2

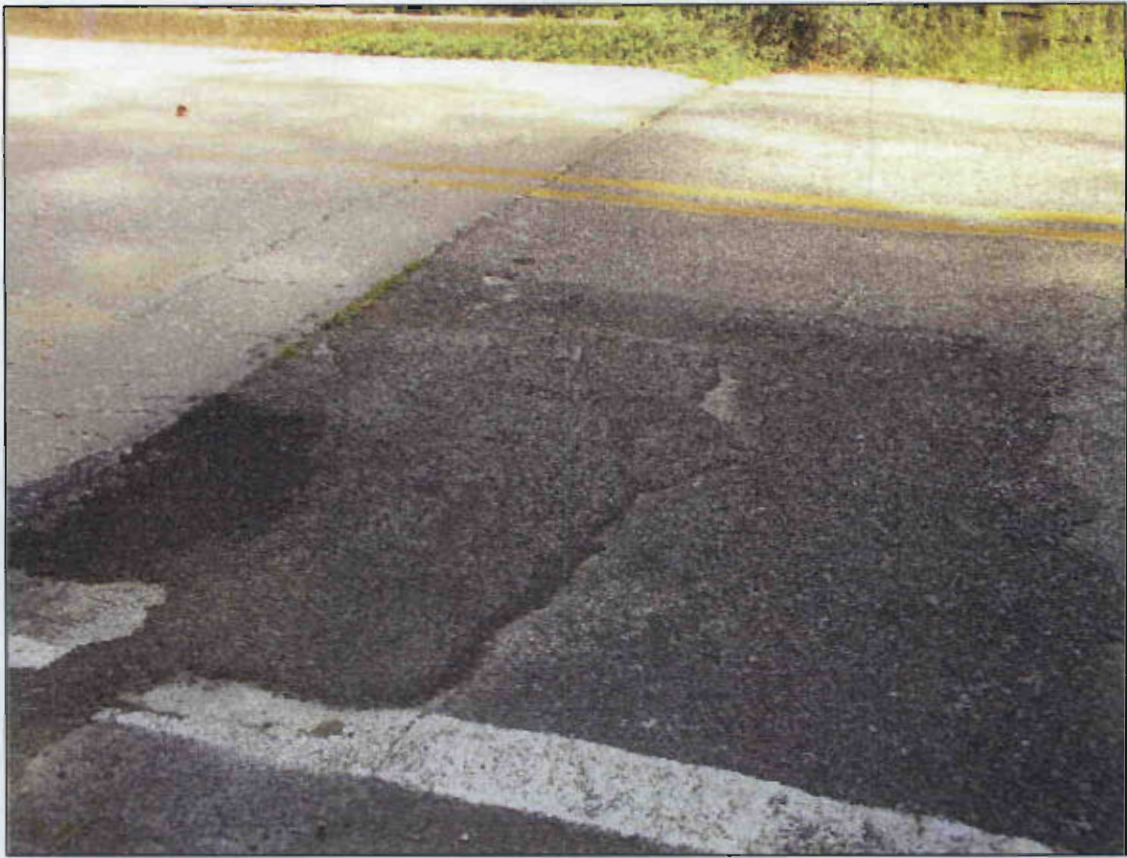
APPROACH 2 PATCHED AND SETTLED IN THE RIGHT LANE AT END BENT 2

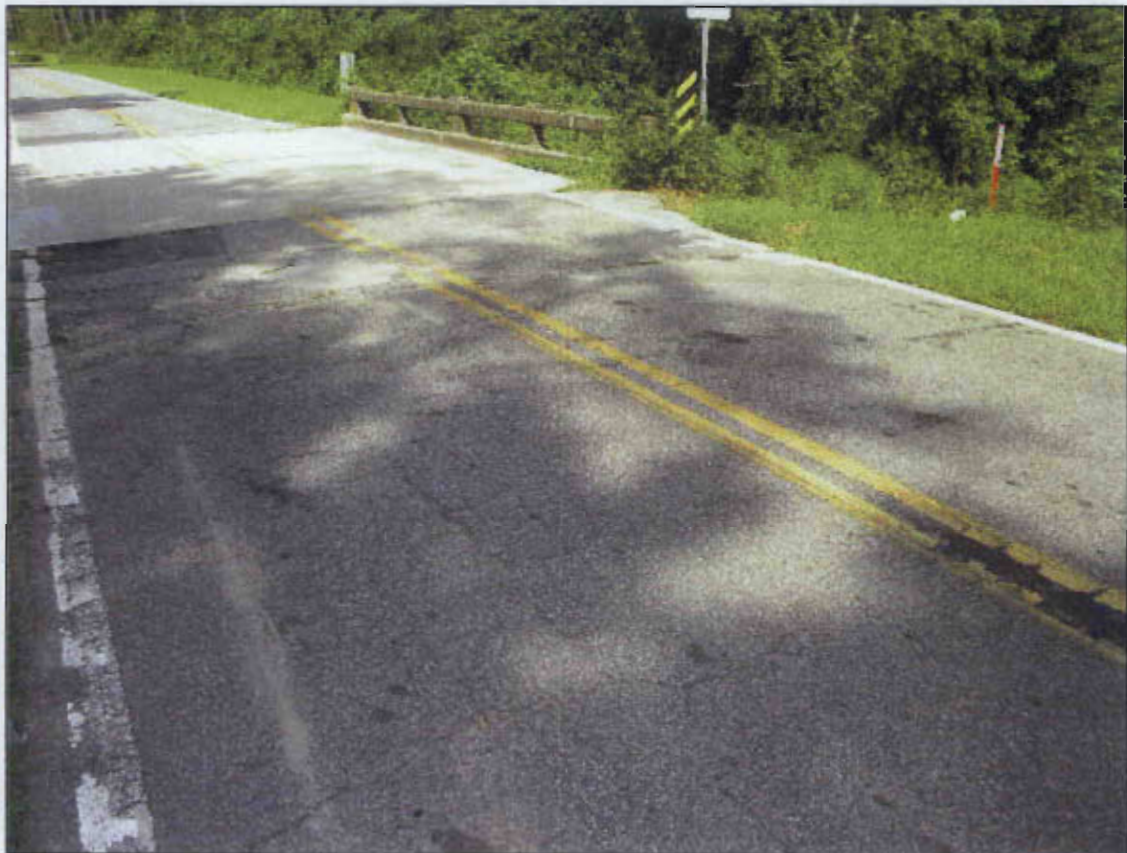
APPROACH 2 MAP CRACKED

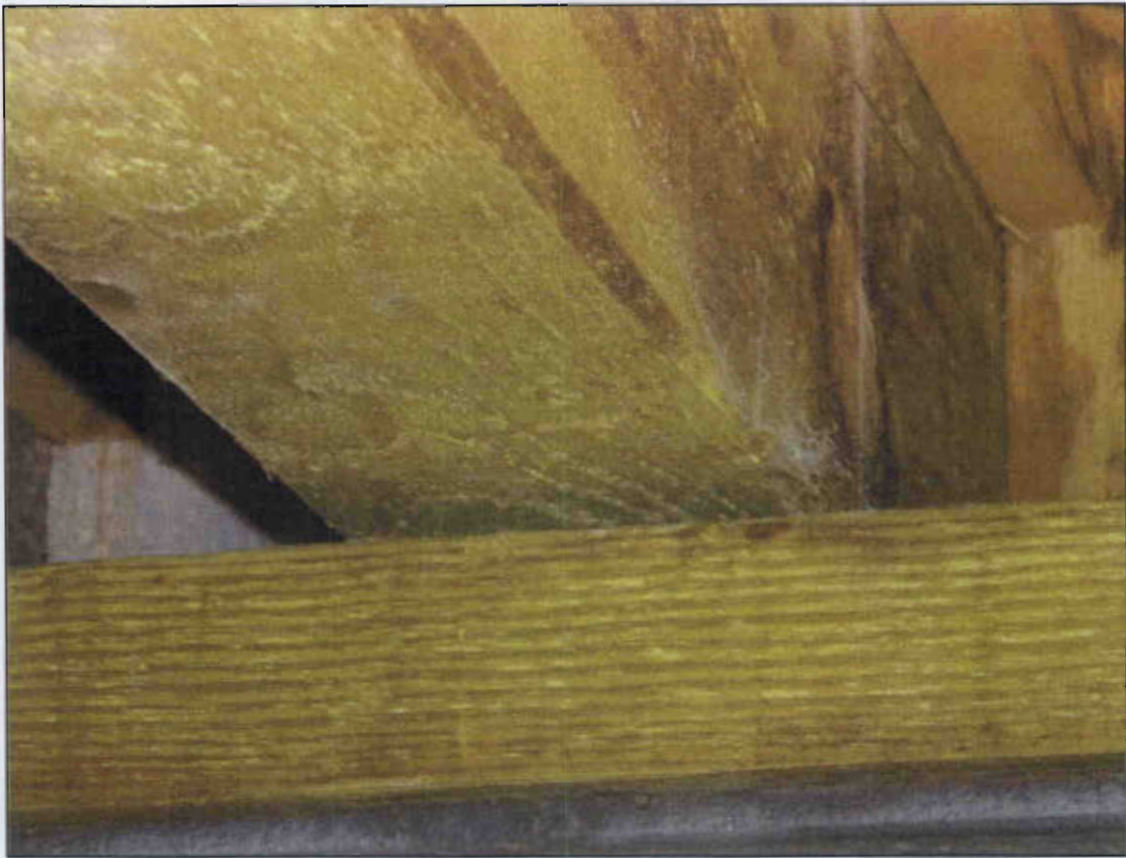
NO BEARING AT JOIST NO.17 OVER END BENT 2 CRUTCH (PRIORITY MAINTENANCE ISSUED)

3304	Maintain/Replace Timber Superstructure Components	LF	2 TSC 8/17/10	JOIST 17 SPAN 2 NOT BEARING ON END BENT 2 CRUTCH BENT. JOIST 18 SPAN 2 NOT BEARING ON END BENT 2 CRUTCH BENT.

MMS Code	MMS Description	Quantity
3304	Maintain/Replace Timber Superstructure Components	2 LF
Location:		
Beams and Girders	Bent/Span No. 2	JOIST 17
Priority Level	Status	
Priority Maintenance	SIA Updates in Process	
Submitted Date:	Submitted By:	Assisted By:
07/22/2010	WILLIS C MAY	WAYNE T WILKINSON
Details		
JOIST 17 SPAN 2 NOT BEARING ON END BENT 2 CRUTCH BENT. JOIST 18 SPAN 2 NOT BEARING ON END BENT 2 CRUTCH BENT.

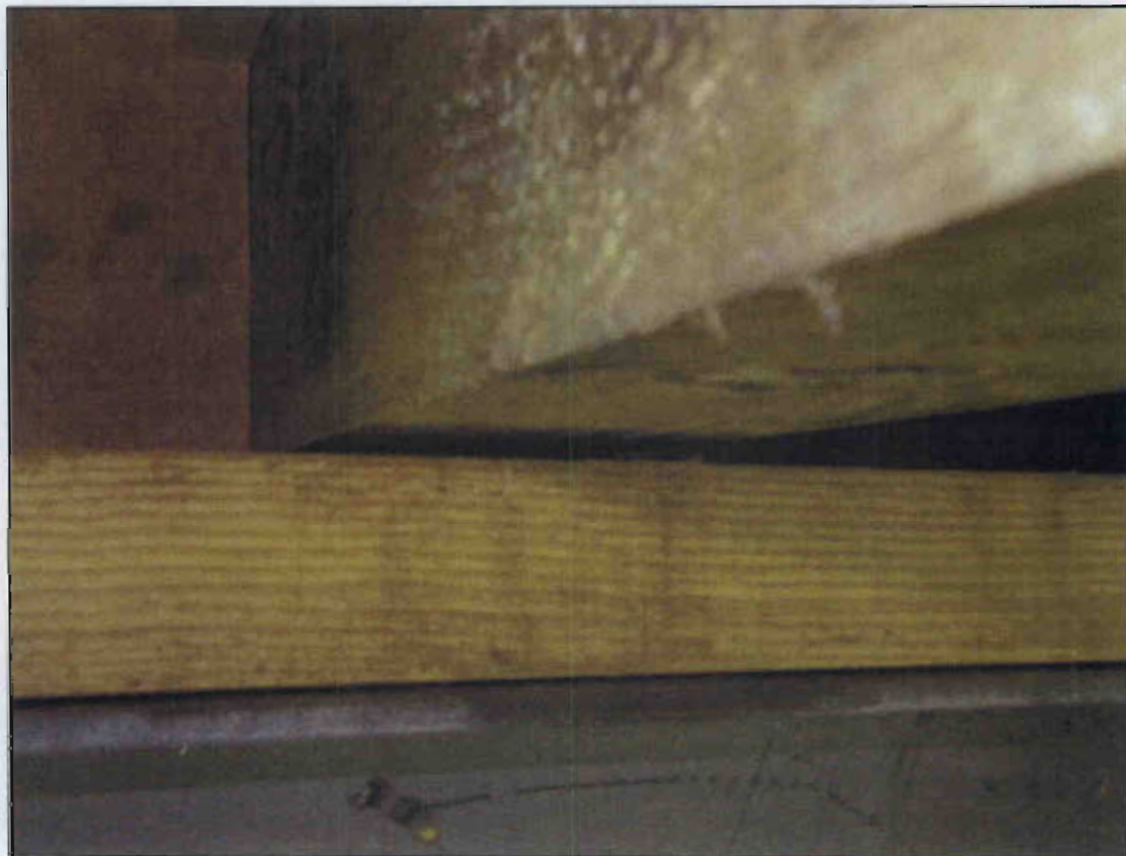
NO BEARING AT JOIST NO.18 OVER END BENT 2 CRUTCH (PRIORITY MAINTENANCE ISSUED)

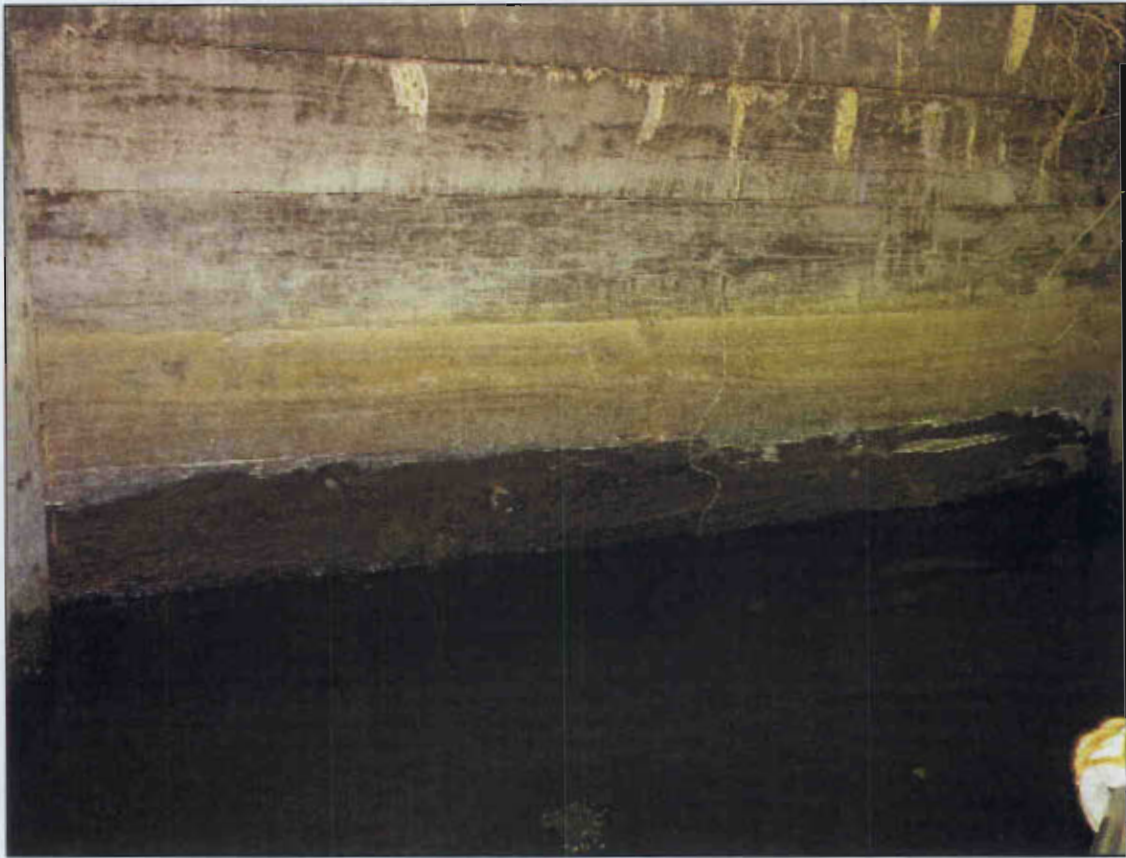
DECAY IN BULKHEAD BOARDS BETWEEN PILE 2 AND 3 AT END BENT 2

3346	Repair / Maintain Timber Wings & Blkhds	SF	225	BULKHEAD AND WINGWALL BOARDS DECAYED AND MISSING WITH EXPOSED FILL.

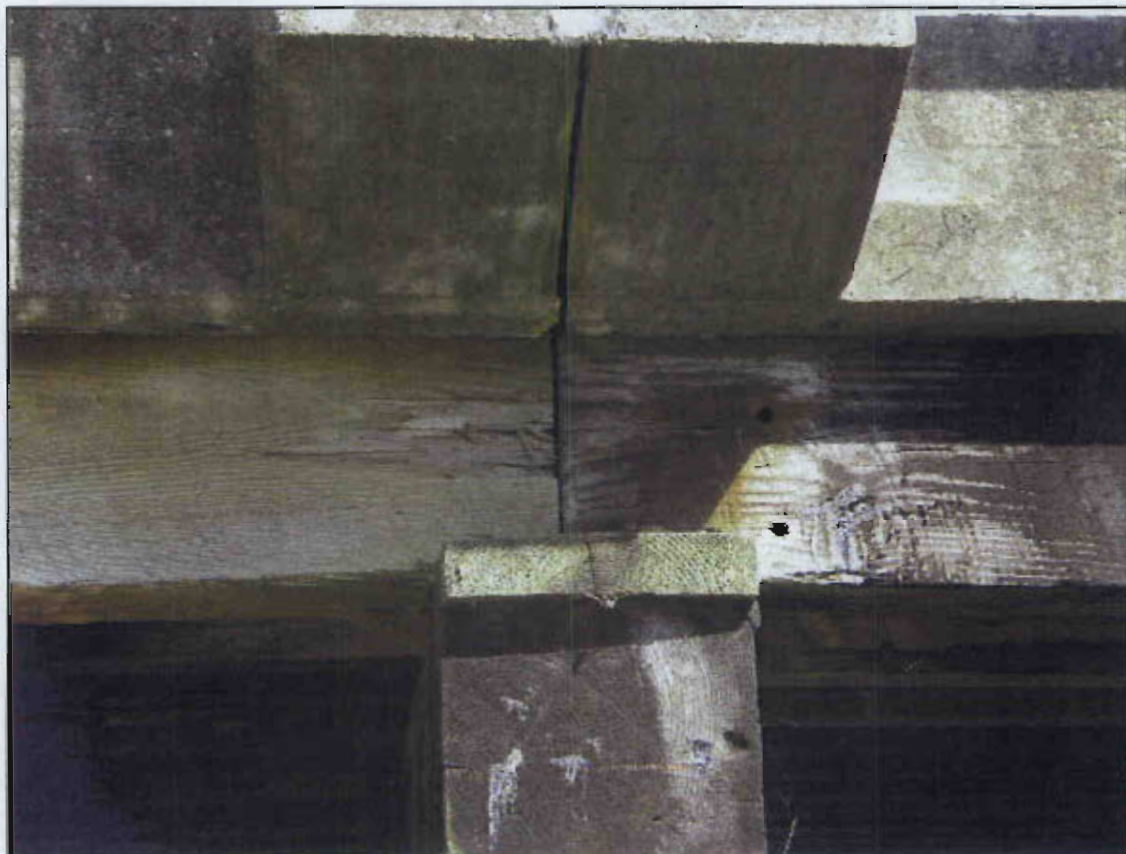
MISSING SPLICE BLOCK AT THE RIGHT SIDE OF INTERIOR BENT

3304	Maintain/Replace Timber Superstructure Components	LF	38	DECAY IN JOIST 5 & 8 SPAN 1 OVER BENT 1. SPLICE BLOCK IS MISSING AT JOIST 19 OVER BENT 1.

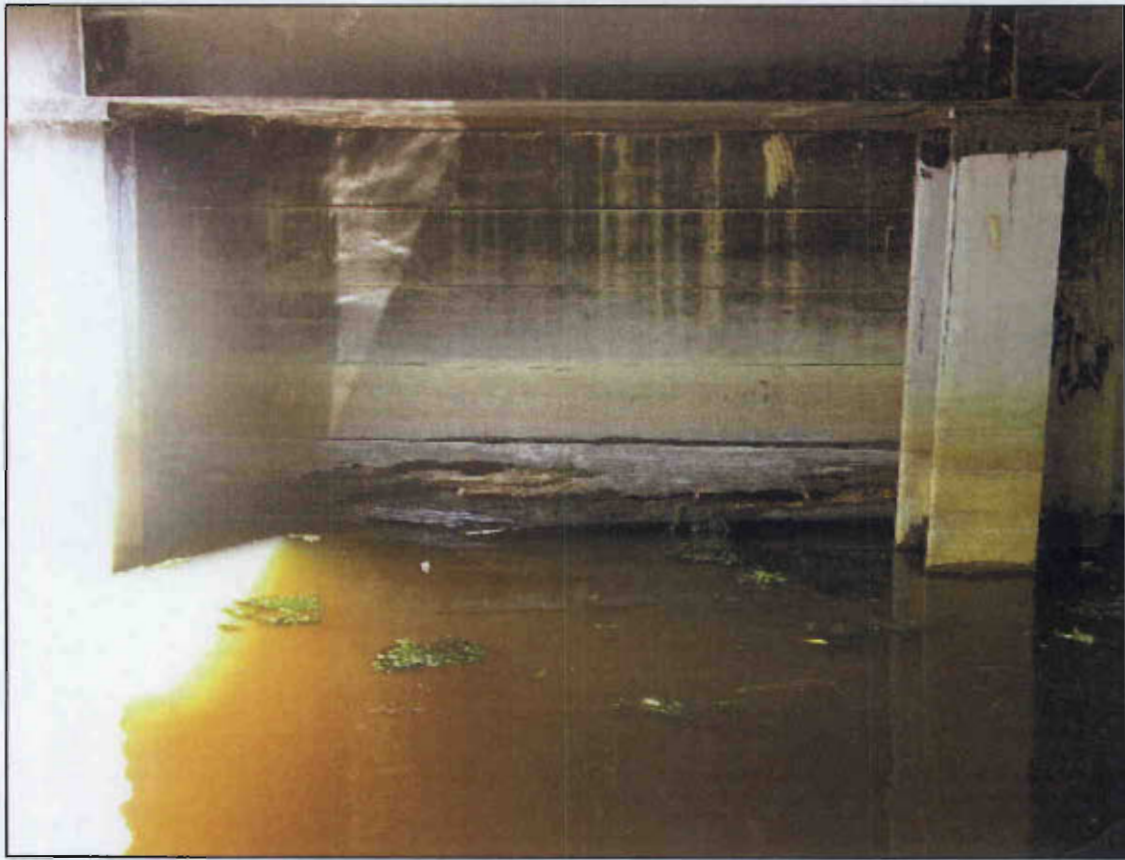
DECAY IN BULKHEAD BOARDS BETWEEN PILE 3 & 4 AT END BENT 1

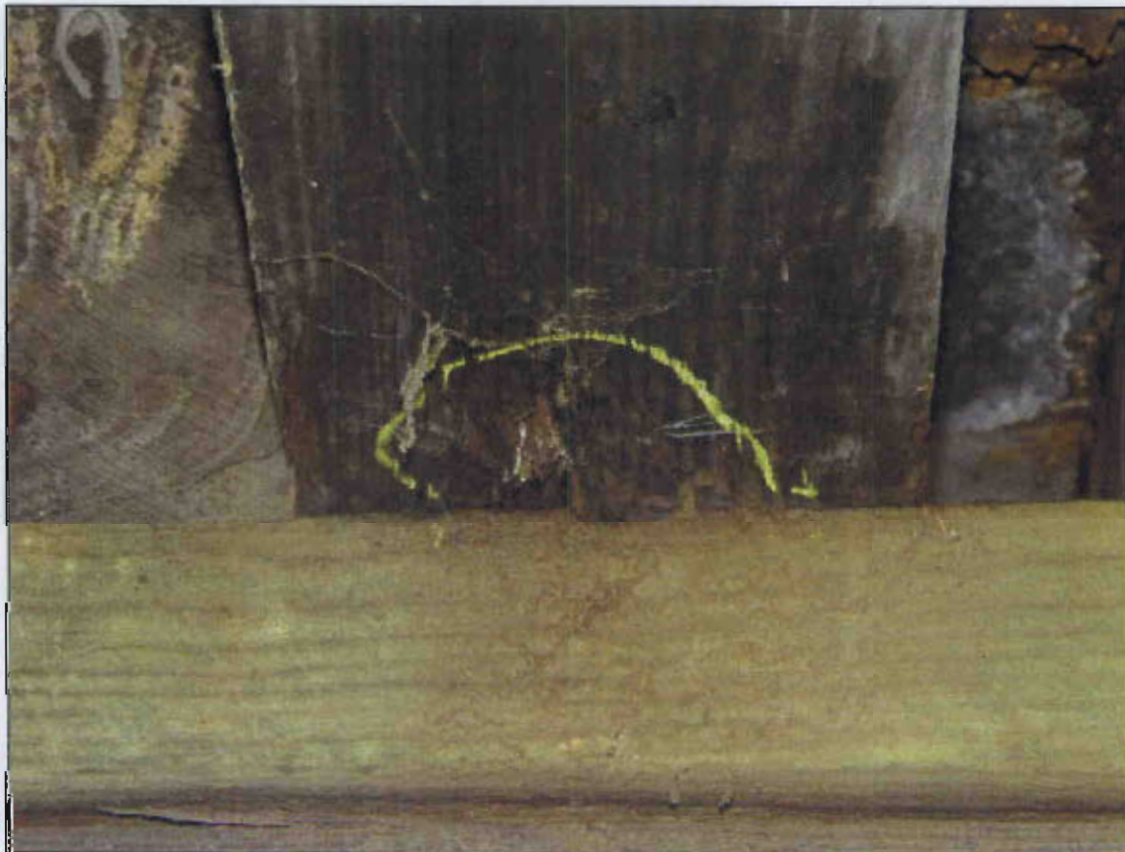
DECAY IN BOTTOM OF JOIST 5 IN SPAN 1 OVER INTERIOR BENT

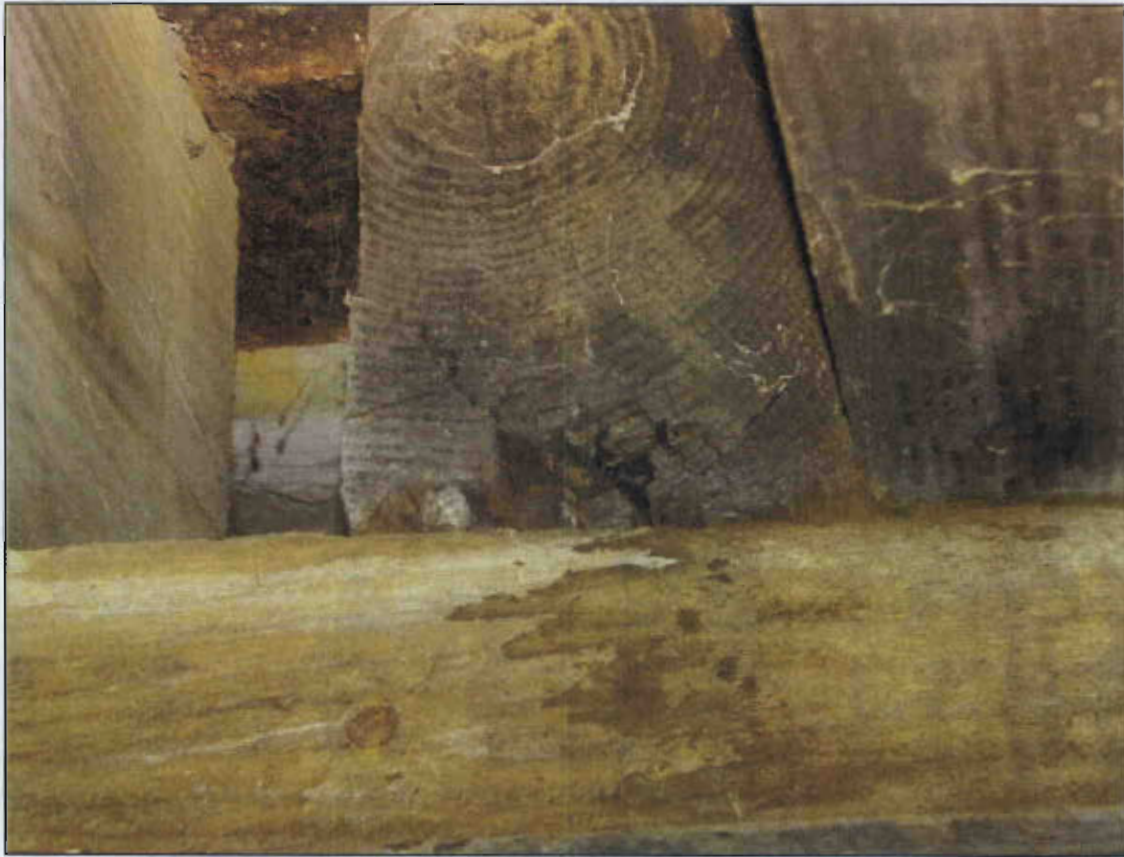
DECAY IN END OF JOIST 8 IN SPAN 1 OVER INTERIOR BENT

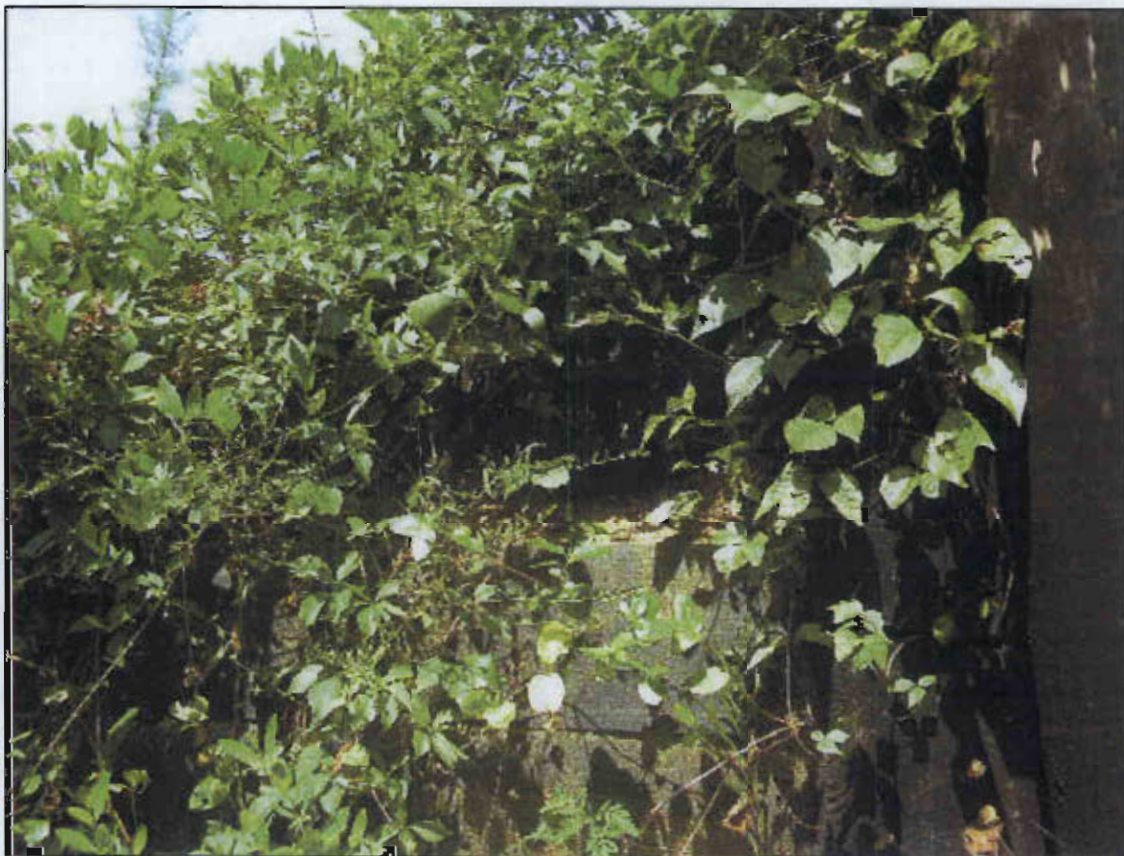
MISSING BOARDS FROM THE RIGHT WINGWALL AT END BENT 1

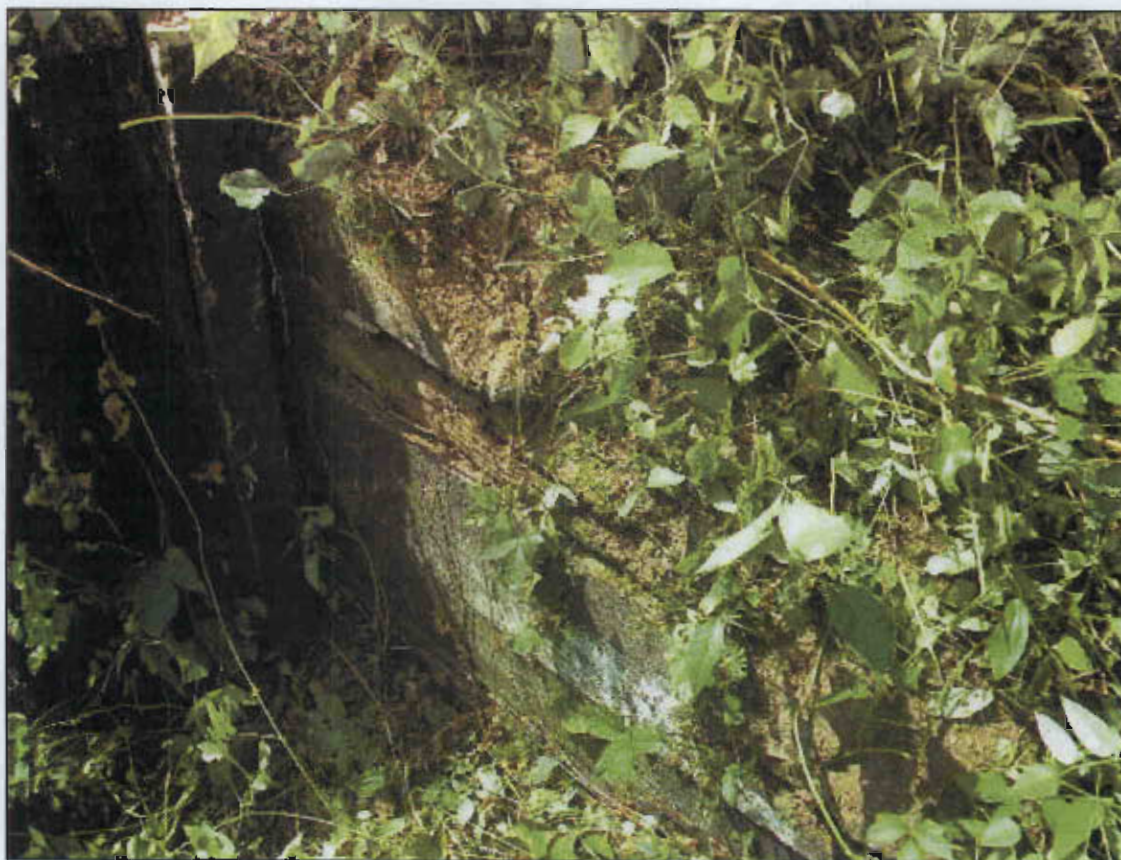
DECAY IN ENDS OF THE LEFT WINGWALL BOARDS AT END BENT 1

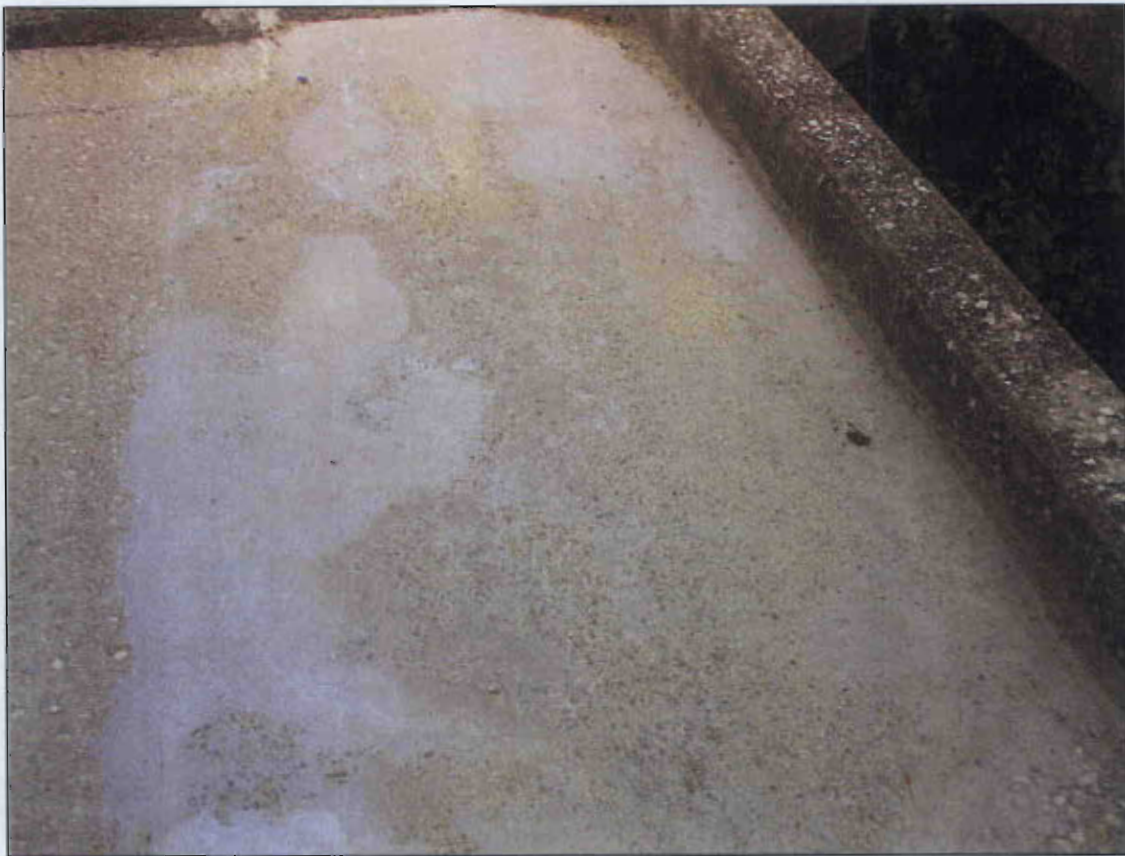
PATCH IN THE RIGHT SIDE OF SPAN 2 AT END BENT 2
