NC DEPARTMENT OF TRANSPORTATION
 DIVISION OF HIGHWAYS
 BRIDGE MANAGEMENT UNIT

BRIDGE INSPECTION REPORT

COUNTY SAMPSON BRIDGE NUMBER 810101 INSPECTION CYCLE 2 YRS
 ROUTE SR1256 ACROSS BIG SWAMP CREEK M.P. 0

INSPECTION DATE 08/25/2010

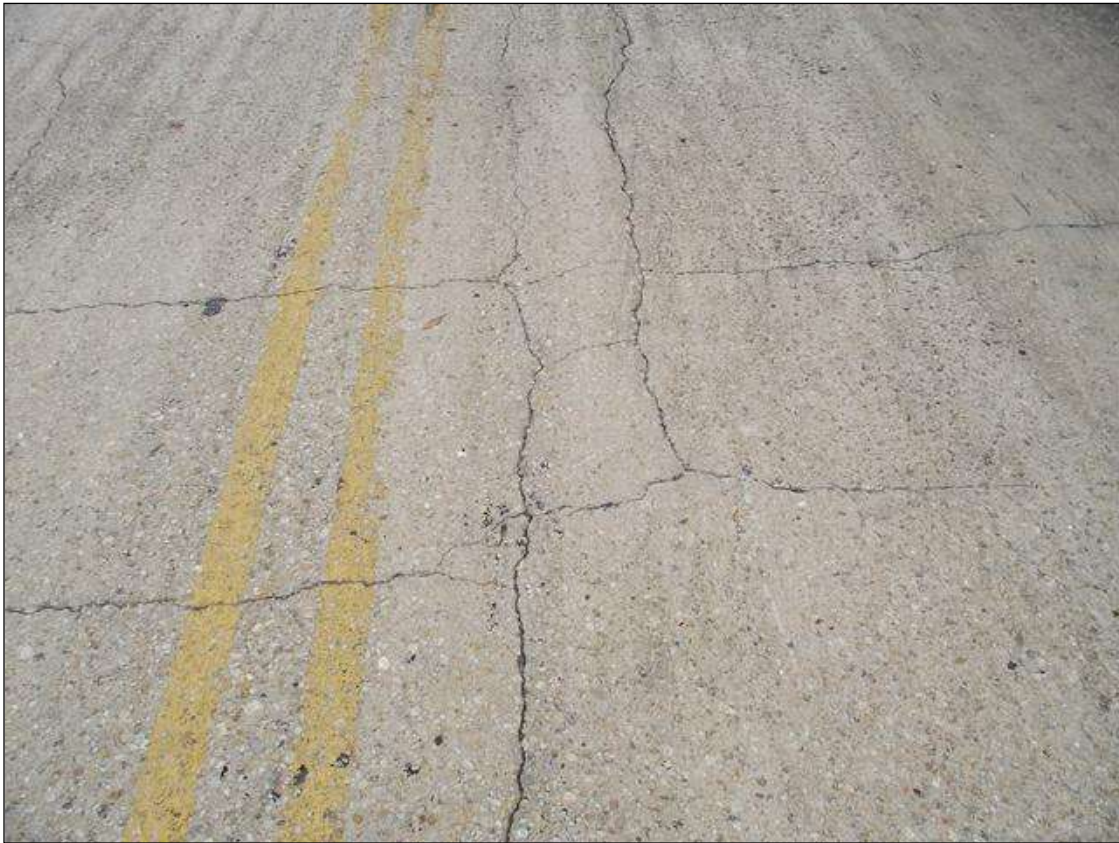
Item No.	Grade		
2a	5	<p>CONCRETE DECK 5 SCALING WITH EXPOSED COARSE AGGREGATE AND POPOUTS 1/2 IN. DEEP IN ALL SPANS.</p> <p>SPAN 1 3 - 1/8 IN. TO 1/4 IN. LONGITUDINAL CRACKS THE FULL LENGTH OF SPAN. 1/16 TO 1/8 IN. TRANSVERSE CRACKS AT 1 FT, 4 FT, 7 FT, AND 11 FT FROM END BENT 1.</p> <p>SPAN 2 3 - HAIRLINE TO 1/8 IN. LONGITUDINAL CRACKS THE FULL LENGTH OF SPAN. 2 - HAIRLINE TO 1/16 IN. TRANSVERSE CRACKS AT 6 FT AND 9 FT FROM BENT 1.</p> <p>SPAN 3 1/8 IN. LONGITUDINAL CRACK NEAR CENTERLINE THE FULL LENGTH OF SPAN.</p> <p>SPAN 4 1 - 1/8 IN. LONGITUDINAL CRACK THE FULL LENGTH OF SPAN. HAIRLINE TO 1/32 IN. WIDE TRANSVERSE CRACKS AT 4 FT, 7 FT, AND 9 FT FROM BENT 3.</p> <p>SPAN 5 2 - 1/16 IN. LONGITUDINAL CRACKS FULL LENGTH OF SPAN. 1/16 IN. TRANSVERSE CRACKS AT 1 FT, 4 FT, AND 8 FT FROM END BENT 2.</p>	
3a	6	<p>CONCRETE RAILS 6 SCALING WITH EXPOSED COARSE AGGREGATE IN FACES. LEFT SIDE RAIL HAS BEEN REPAIRED IN SPAN 1, 2, 3, AND 4.</p>

LONGITUDINAL AND TRANSVERSE CRACKING IN SPAN 1

MMS Code	Description of Function	Unit	Quantity	Remarks	Est. Cost
2816	Asphalt Surface Repair or Replacement	SY	140	APPROACHES ARE SETTLED UP TO 1 IN. AT END BENTS.	
3310	Maintenance/Repair/Replacement of Standard Bridge Expansion Joints	LF	96	JOINTS ARE CRACKED AND LEAKING IN SPOTS.	
3326	Maintain Concrete Deck	SF	200	CRACKS IN TOP OF DECK IN ALL SPANS.

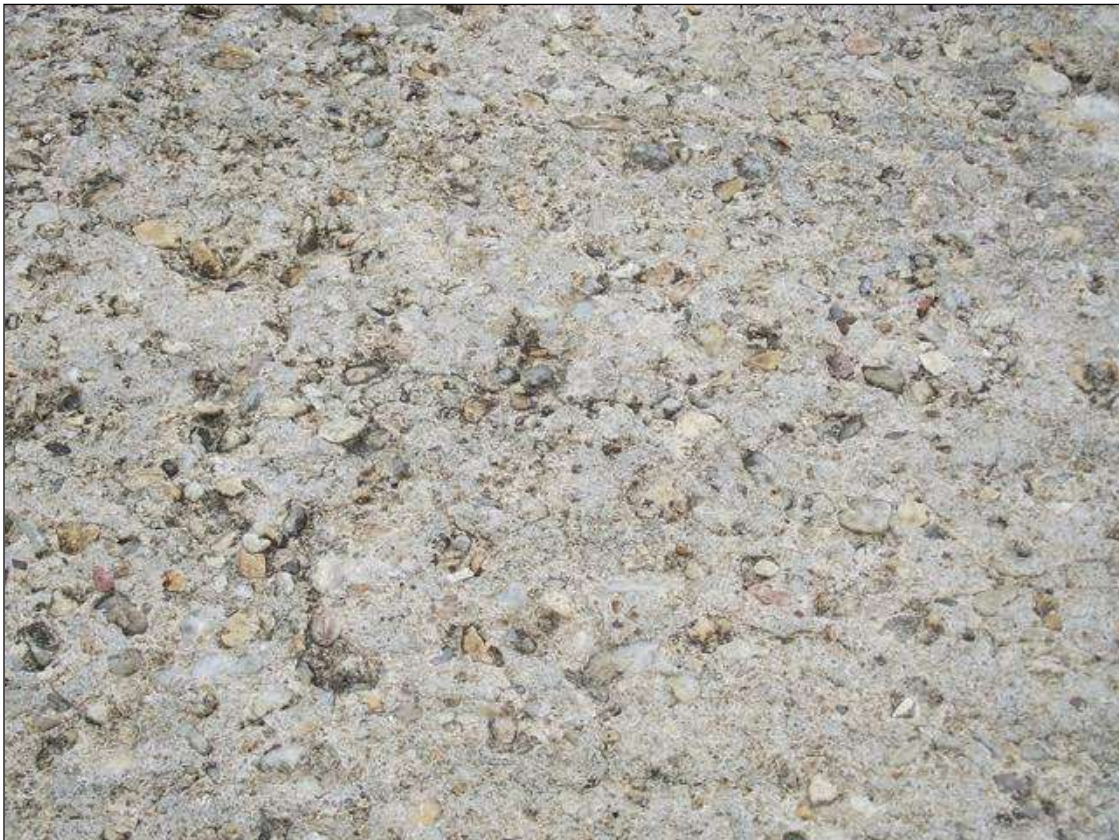
TOP OF DECK SCALED WITH EXPOSED AGGREGATE

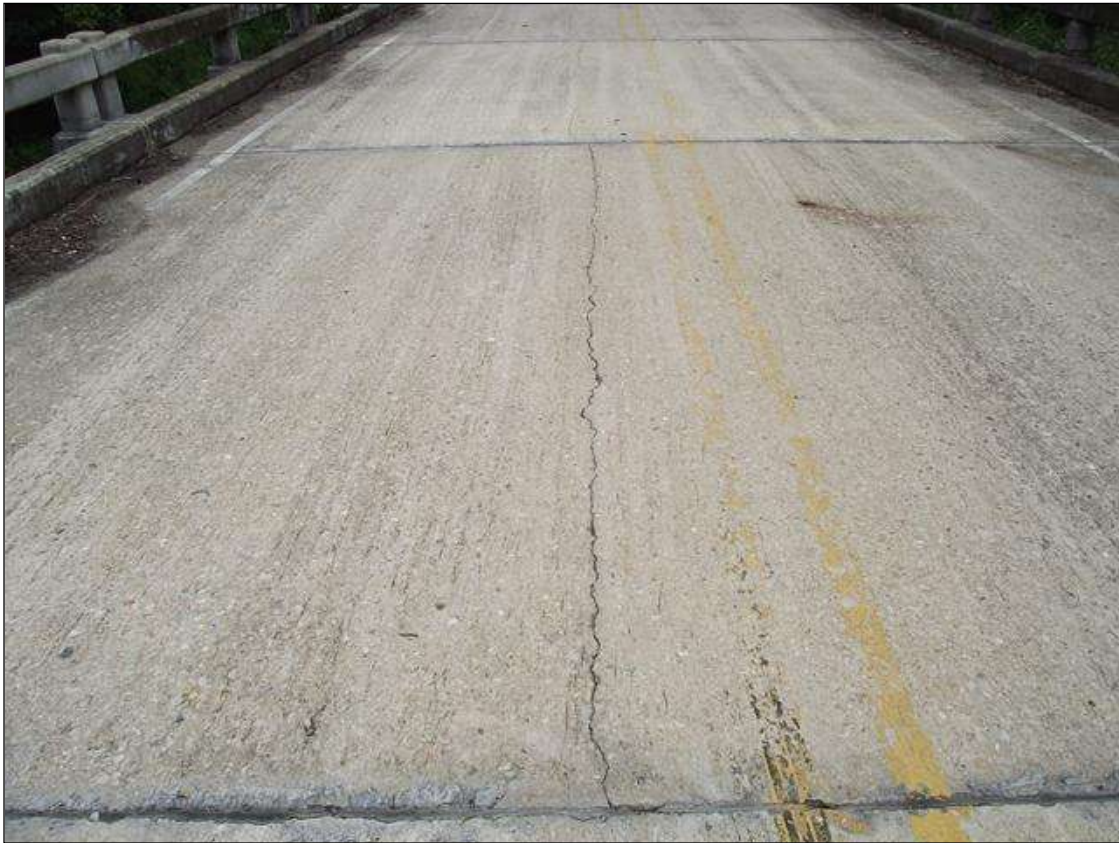
LONGITUDINAL CRACK IN SPAN 3, SIMILAR IN SPAN 2, 4 & 5

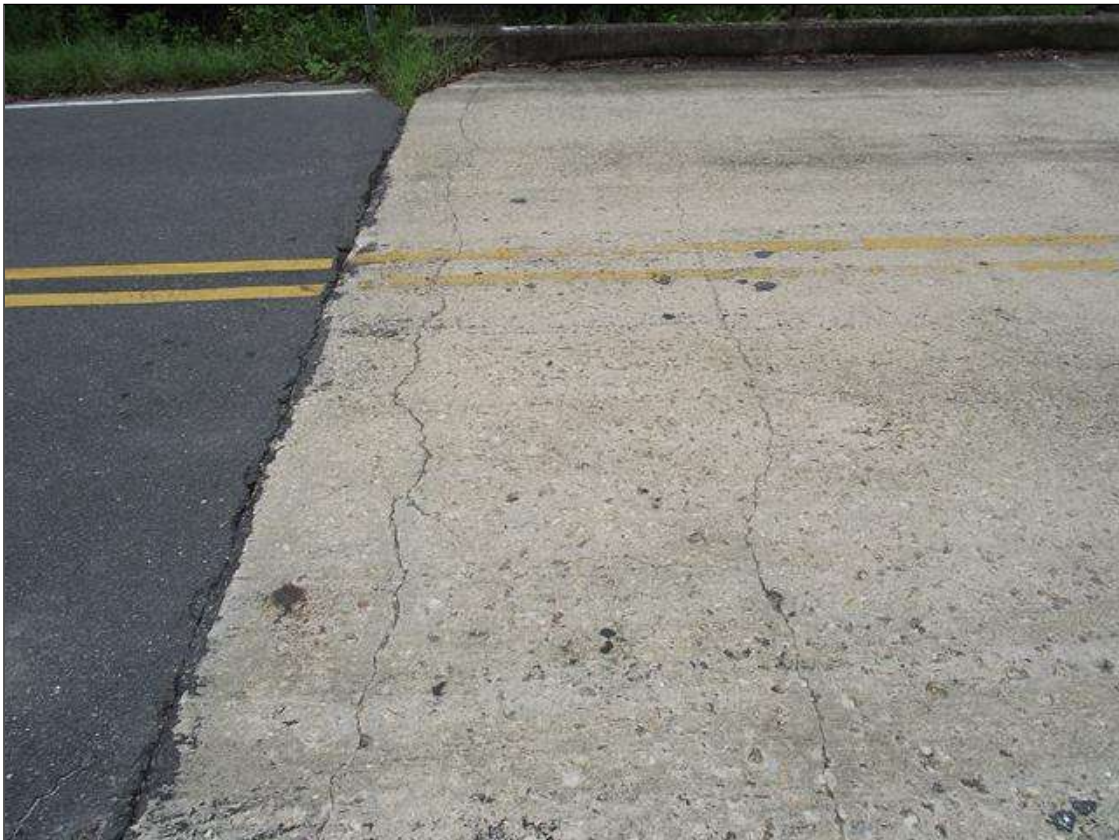
TRANSVERSE CRACKING IN SPAN 5

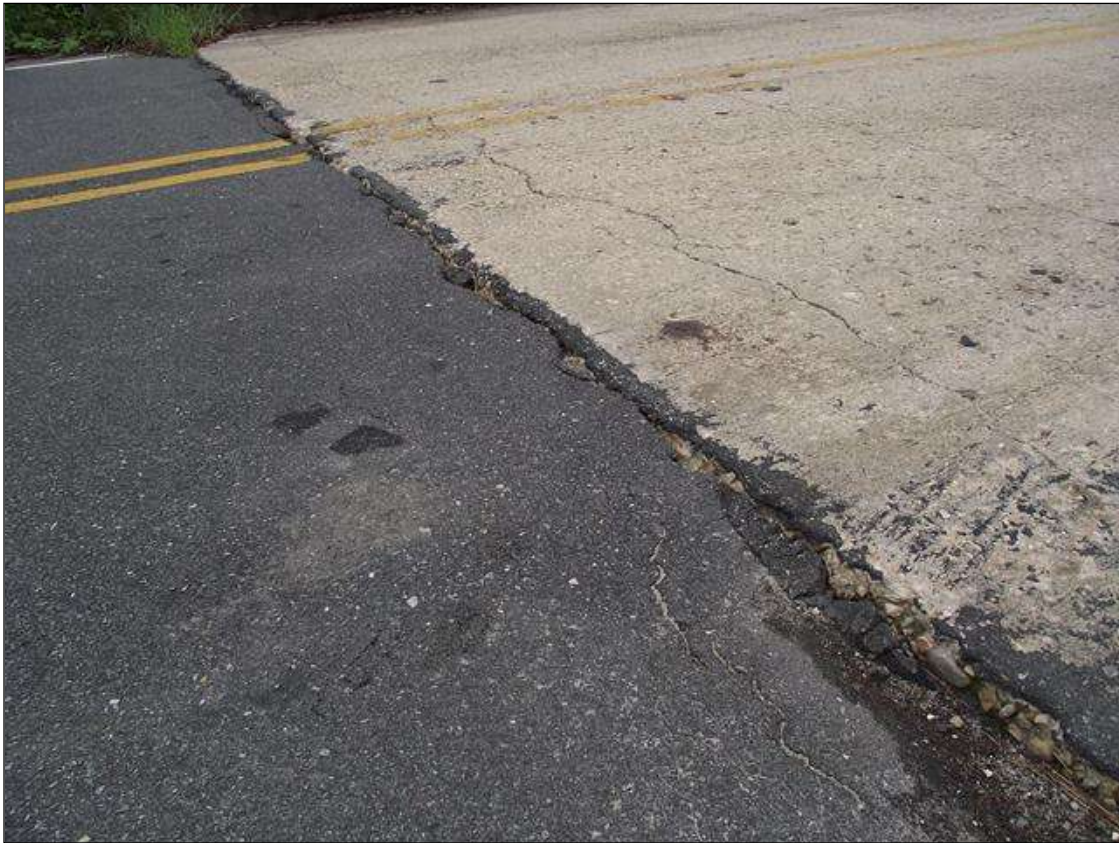
Bridge I&A Form 1(82)H State of North Carolina Dept. of Transportation Division of Highways		FIELD INSPECTION REPORT <u>Bridge Inspection & Analysis</u>	
Team Leader WILLIS C MAY			
Assisted By WTW			
Item No.	Grade		
45b	7	CHANNEL ALIGNMENT 7 SEE UNDERWATER REPORT.	
50	6	APPROACH ROADWAY CONDITION 6 BOTH APPROACHES ARE SETTLED UP TO 1 IN. PATCH IN APPROACH 2 AT END BENT 2.	
62	YES	SV 18 TTST 26

APPROACH 2 SETTLED AT END BENT 2

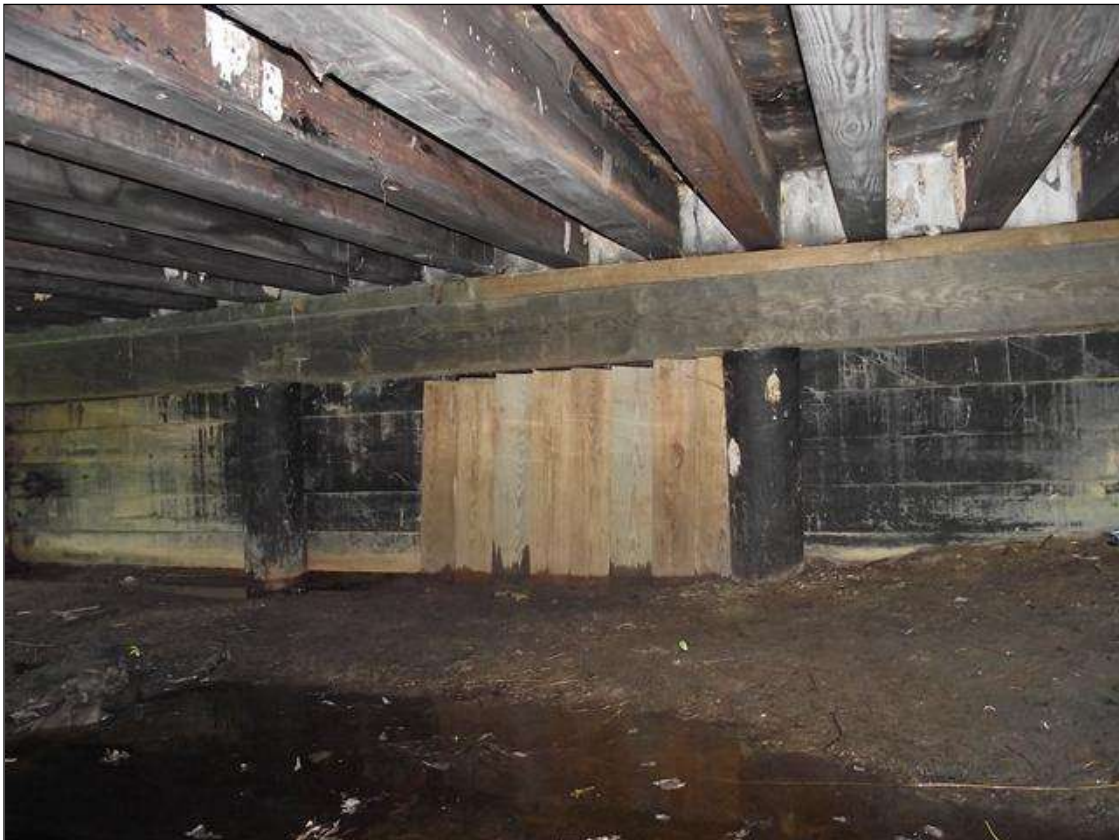
VERTICAL BOARDS FACE NAILED BETWEEN PILE 2 & 3 AT END BENT 1 BULKHEAD

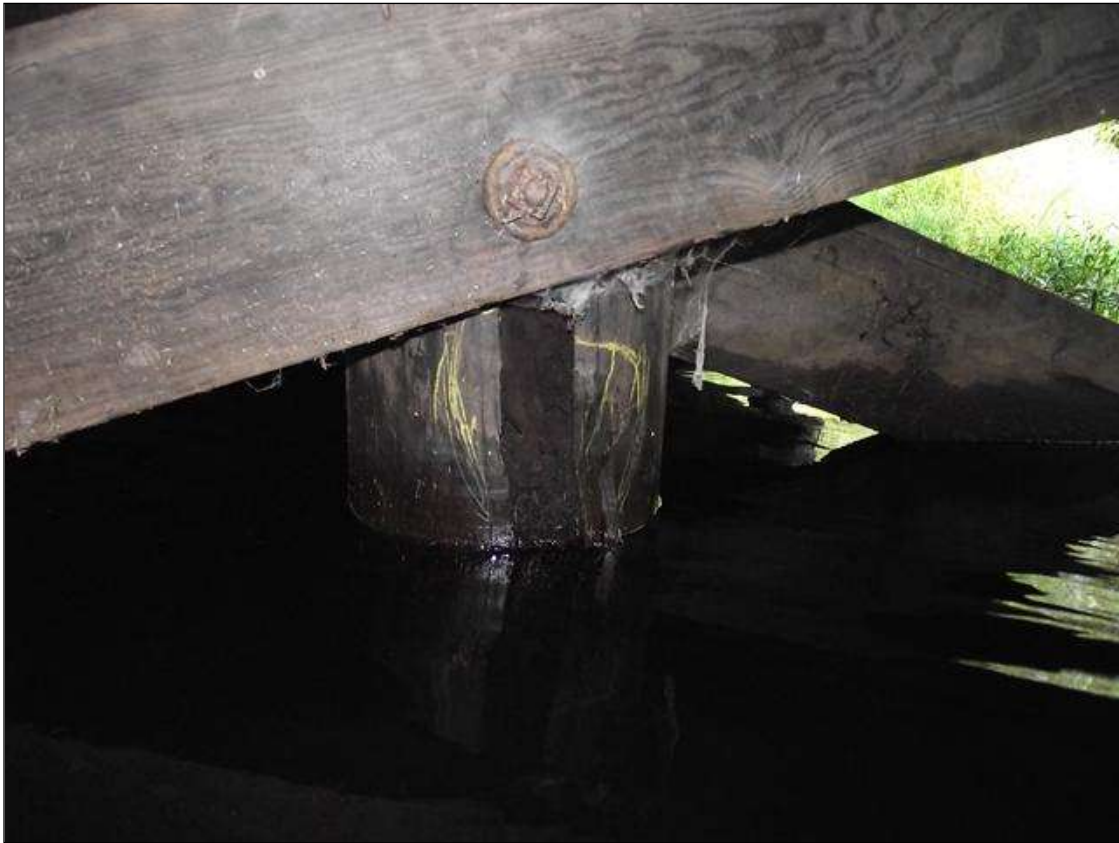
DELAMINATION IN PILE 2 AT BENT 2 SPAN 3 SIDE BELOW CROSSBRACE CONNECTION

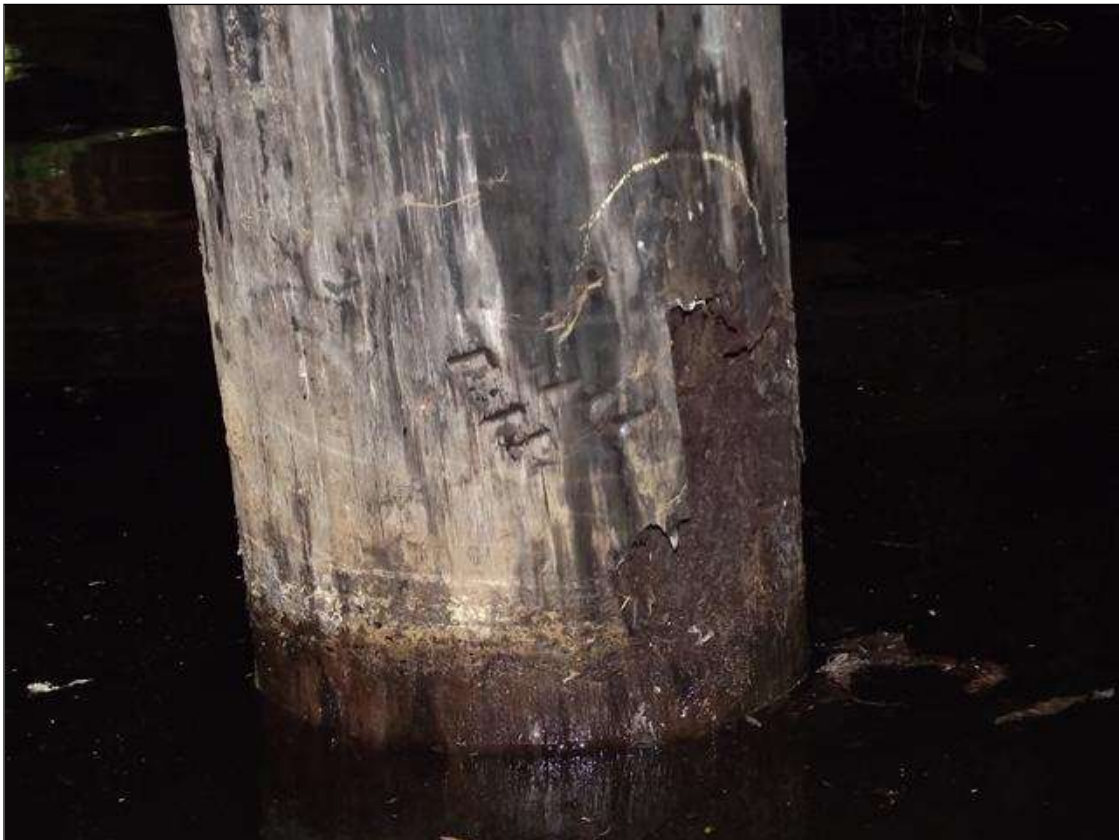
DECAY IN THE LEFT SIDE OF PILE 2 AT BENT 4 (PRIORITY MAINTENANCE ISSUED)

3344	Repair / Replace Timber Substructure Components	LF	5	PILE 2 BENT 4 IS DECAYED IN THE LEFT SIDE NEAR WATERLINE 10 IN. HIGH X 8 IN. WIDE X 2 IN. DEEP. SEE DRAWING

MMS Code	MMS Description	Quantity
3344	Repair / Replace Timber Substructure Components	5 LF
Location:		
Pier Substructure	Bent/Span No. 4	PILE 2 BENT 4
Priority Level	Status	
Priority Maintenance	Division Bridge Maintenance Notification Received	
Submitted Date:	Submitted By:	Assisted By:
08/26/2010	WILLIS C MAY	WAYNE T WILKINSON
Details		
PILE 2 BENT 4 IS DECAYED IN THE LEFT SIDE NEAR WATERLINE 10 IN. HIGH X 8 IN. WIDE X 2 IN. DEEP. SEE DRAWING

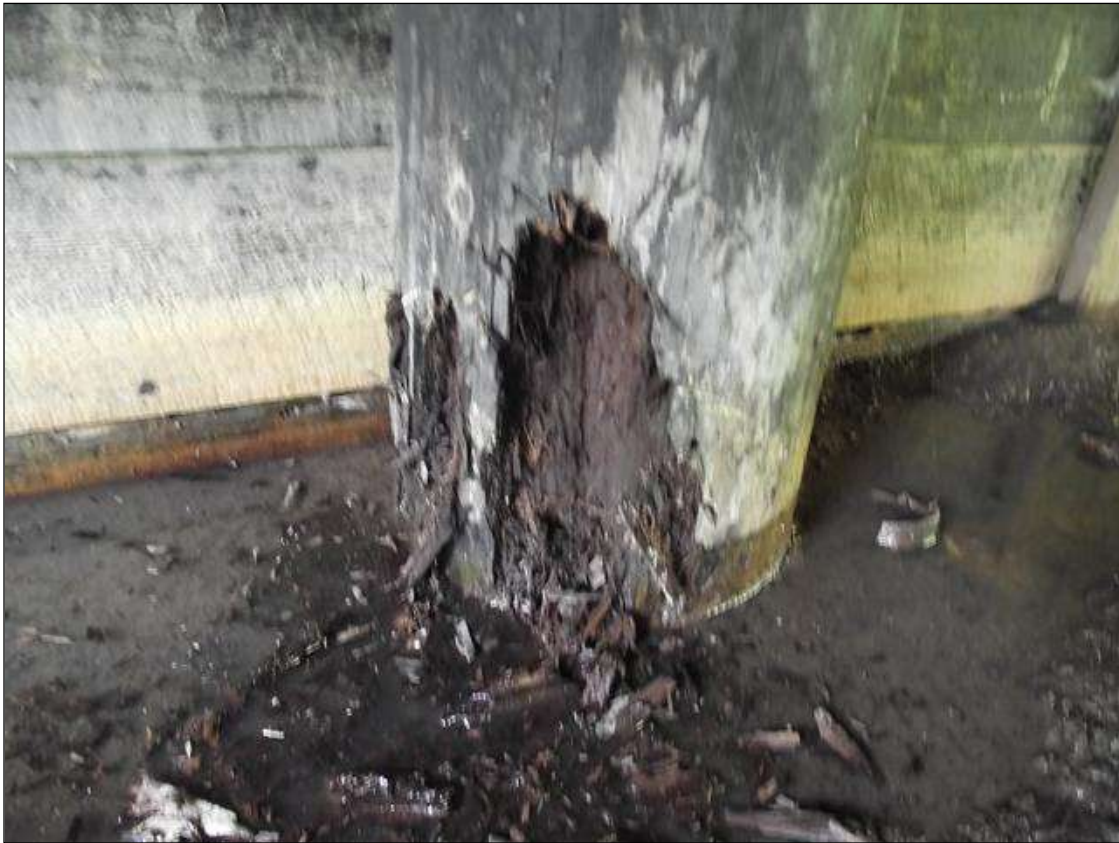
Item No.	Grade	
35b	5	<p>TIMBER PILES 5 PILE 3 END BENT 1 AND PILE 2 BENT 4 GRADE 4 ALL OTHERS GRADE 5. 1/16 IN. VERTICAL CRACKS IN FACES. END BENT 1 PILE 3 END BENT 1 IS DECAYED 12 IN. HIGH X 12 IN. WIDE X 3 IN. DEEP AT THE GROUND LINE . PRIORITY MAINTENANCE ISSUED PILE 4 END BENT 1 HAS BEEN REPAIRED WITH A CONCRETE ENCASEMENT. BENT 1 PILE 2 BENT 1 HAS BEEN SPLICED AND HAS A 2 FT. DIAMETER CONCRETE ENCASEMENT. BENT 2 PILE 2 BENT 2 SPAN 3 SIDE IS DELAMINATED 8 IN. X 8 IN. X 1 IN. DEEP BELOW CROSS BRACE. BENT 3 PILE 1 BENT 3 IS DECAYED AND BROKEN OFF AT WATERLINE. STEEL PILES WITH A CROSS CAP HAS BEEN PLACED 27 IN. FROM LEFT END OF CAP. BENT 4 PILE 2 BENT 4 IS DECAYED IN THE LEFT SIDE NEAR WATERLINE 10 IN. HIGH X 8 IN. WIDE X 2 IN. DEEP. PRIORITY MAINTENANCE ISSUED PILE 3 BENT 4 HAS BEEN REPAIRED AND HAS A CONCRETE ENCASEMENT. PILE 3 BENT 4 HAS A CONCRETE ENCASEMENT AND HAS A 1/4 IN. WIDE VERTICAL CRACK.</p>

DECAY IN THE RIGHT SIDE OF PILE 3 AT END BENT 1 (PRIORITY MAINTENANCE ISSUED)

3344	Repair / Replace Timber Substructure Components	LF	5	PILE 3 END BENT 1 IS DECAYED 12 IN. HIGH X 12 IN. WIDE X 3 IN. DEEP AT THE GROUND LINE . SEE DRAWING	
3346	Repair / Maintain Timber Wings & Blkhds	SF	40	DECAYED BULKHEAD AND WINGWALL BOARDS.

MMS Code	MMS Description	Quantity
3344	Repair / Replace Timber Substructure Components	5 LF
Location:		
Pier Substructure	Bent/Span No. 1	PILE 3 END BENT 1
Priority Level	Status	
Priority Maintenance	Division Bridge Maintenance Notification Received	
Submitted Date:	Submitted By:	Assisted By:
08/26/2010	WILLIS C MAY	WAYNE T WILKINSON
Details		
PILE 3 END BENT 1 IS DECAYED 12 IN. HIGH X 12 IN. WIDE X 3 IN. DEEP AT THE GROUND LINE . SEE DRAWING

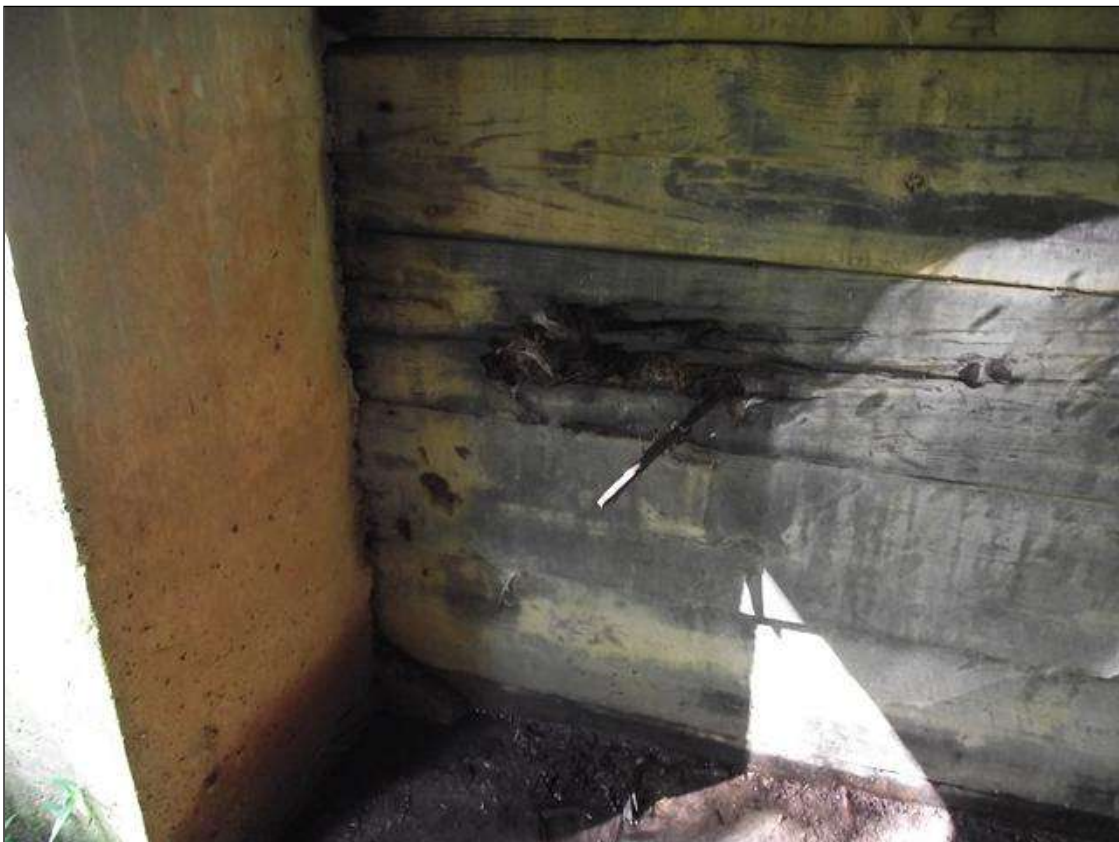
35c	5	<p>TIMBER BULKHEADS, WINGWALLS 5 END BENT 1 VERTICAL BOARDS HAVE BEEN FACE NAILED TO END BENT 1 BULKHEAD BETWEEN PILE 2 & 3. BULKHEAD BOARD # 3 BELOW CAP IS DECAYED THROUGH IN SPOTS WITH EXPOSED FILL FROM PILE 3 TO RIGHT END. ENDS OF RIGHT SIDE WINGWALL BOARDS AT END BENT 1 ARE DECAYED BACK 6 IN. TO 12 IN. END BENT 2 RIGHT SIDE WINGWALL BOARD # 2 AT END BENT 2 IS DECAYED BACK 1 FT.</p>
37a	6	<p>STEEL CAPS 6 THE STEEL CAPS HAVE AREAS OF RUST AND CORROSION AT THE EDGES AND AT THE WELDS.</p>
37b	7	<p>STEEL PILES 7 STEEL PILES HAVE SPOTS OF CORROSION IN THE EDGES.</p>
41	6	<p>DRIFT 6 DRIFT BELOW WATERLINE SEE UNDERWATER REPORT.</p>
45a	6	<p>WATERWAY 6 AQUATIC VEG IN WATERWAY.</p>

DECAY IN THE 3RD BULKHEAD BOARD FROM BOTTOM OF END BENT 1 CAP AND JUST TO THE LEFT OF PILE
