NC DEPARTMENT OF TRANSPORTATION
 DIVISION OF HIGHWAYS
 STRUCTURE MANAGEMENT UNIT

Structure Safety Report

Routine Element Inspection - Contract

COUNTY: HALIFAX STRUCTURE NUMBER: 410198 FREQUENCY: 24 MONTHS

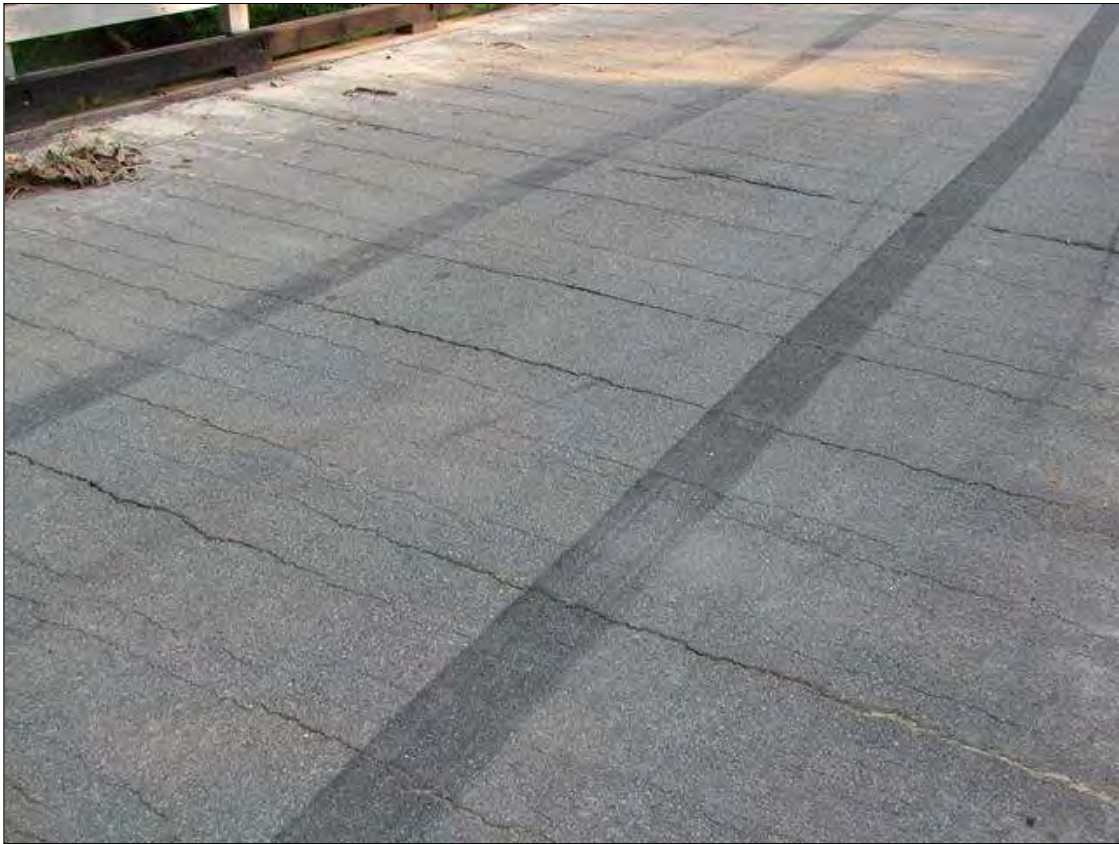
330 Square Feet of Crack (Wearing Surface) (CS3): TRANSVERSE REFLECTIVE CRACKS UP TO 1/4" WIDE THROUGHOUT WEARING SURFACE.

Span 1 Wearing Surface: TRANSVERSE REFLECTIVE CRACKS UP TO 1/4" WIDE THROUGHOUT WEARING SURFACE.

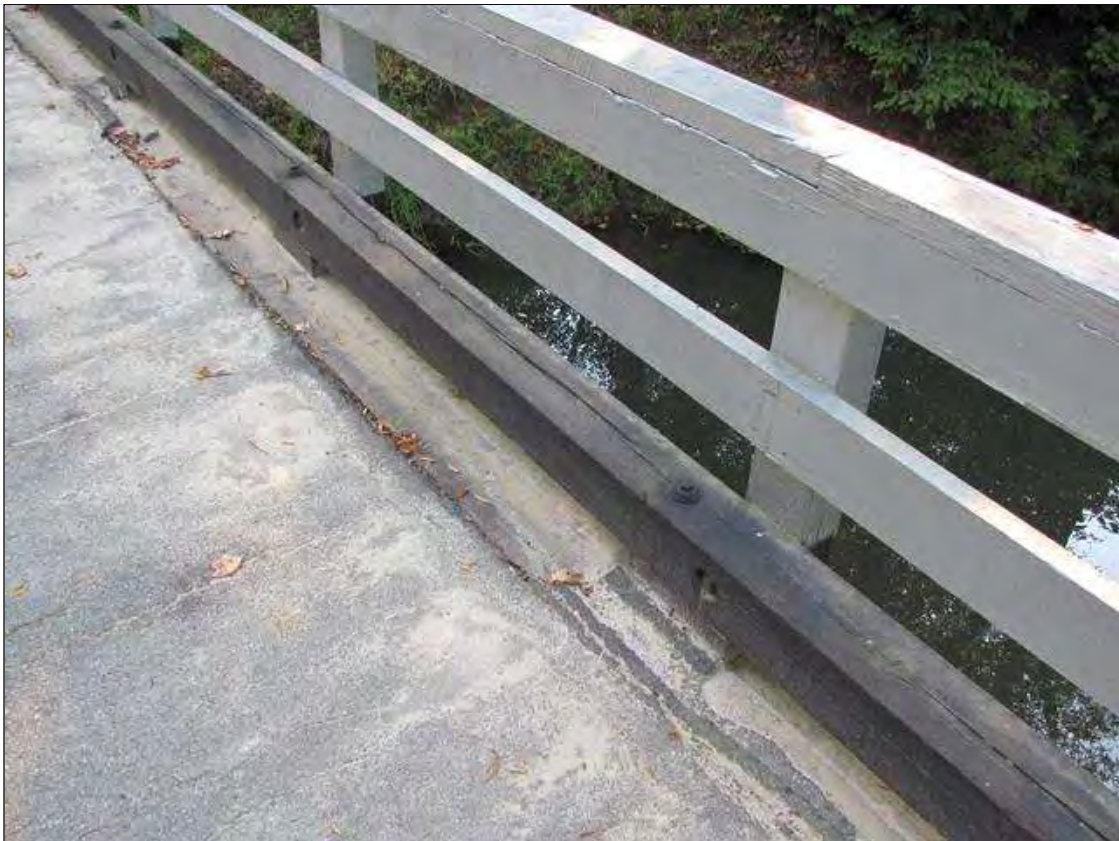
18 Feet of Check/Shake (CS2): FULL LENGTH CHECK IN TIMBER CURB.

Span 1 Right Bridge Rail: FULL LENGTH CHECK IN TIMBER CURB.

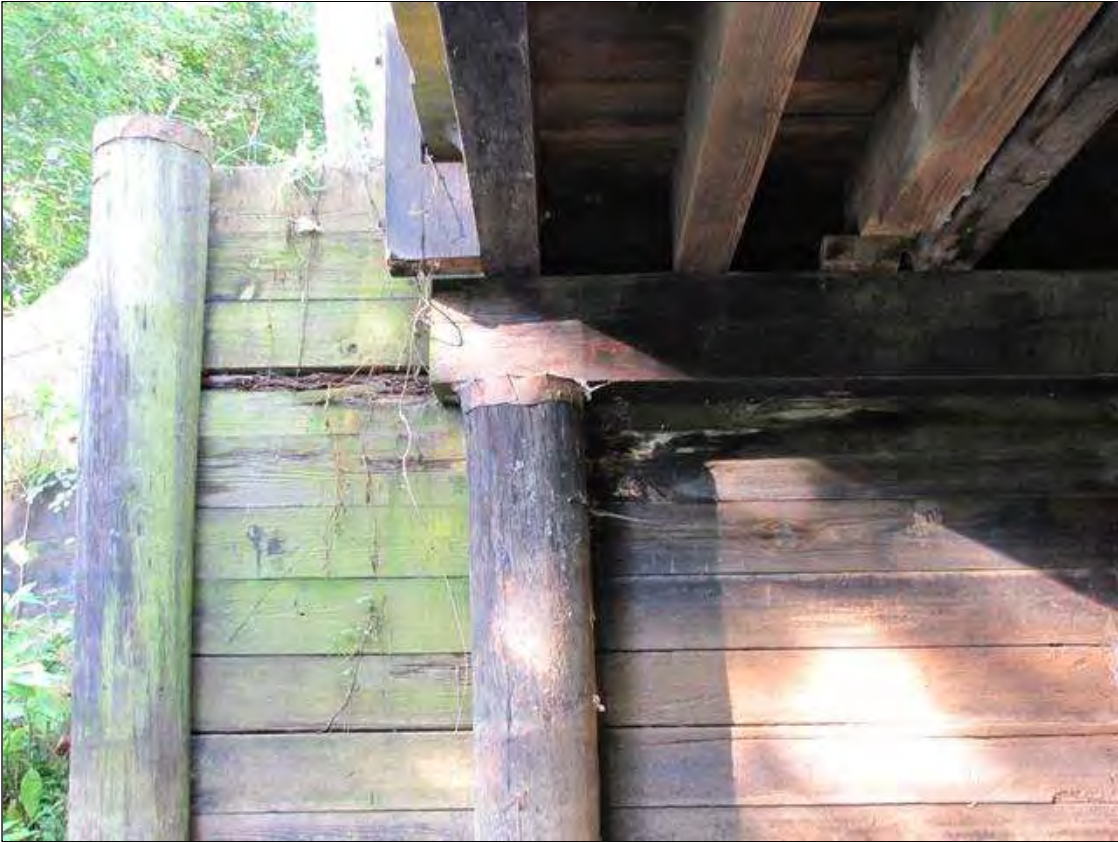
5 Feet of Decay/Section Loss (CS3): 5 FT X 1 FT AREA OF DECAY IN RIGHT END.
8 Feet of Scour (CS2): 8 FT OF UNDERMINING AT RIGHT SIDE.

End Bent 1 Abutment/Backwall : 5 FT X 1 FT AREA OF DECAY IN RIGHT END.

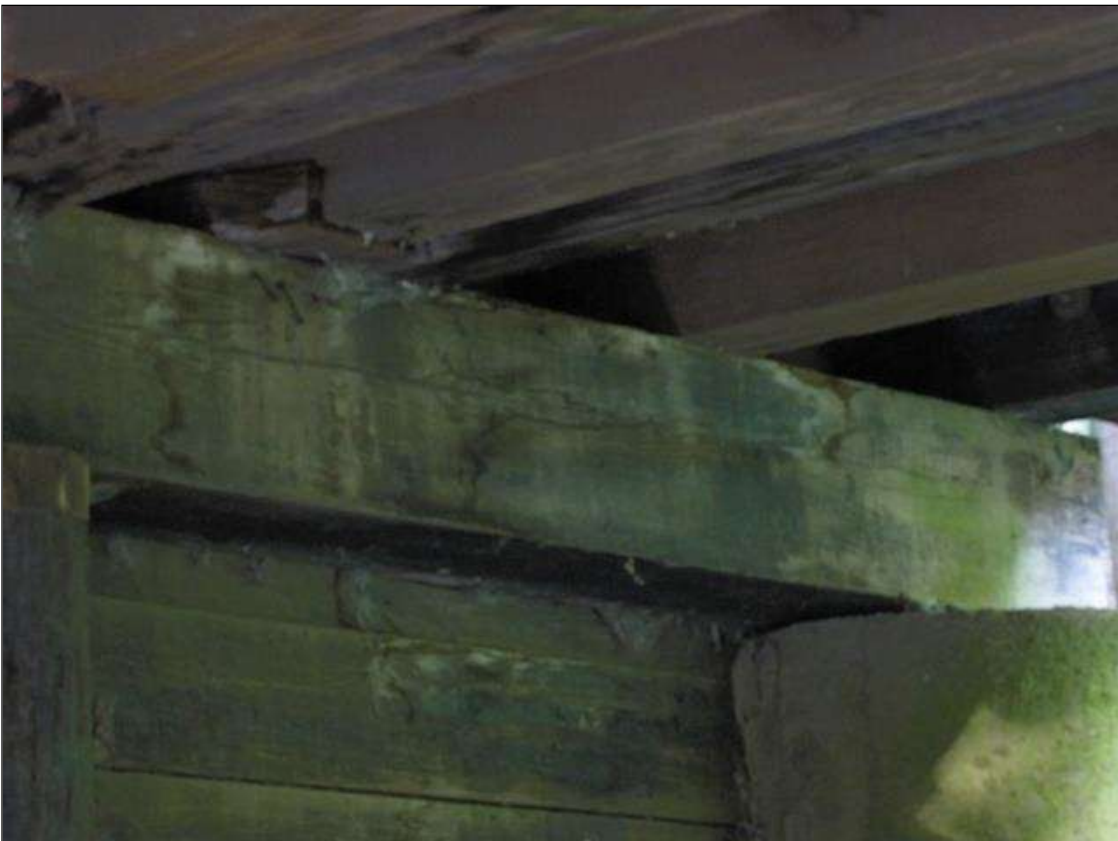
RANDOM HORIZONTAL CHECKS THROUGHOUT CAP.

End Bent 1 Cap : RANDOM HORIZONTAL CHECKS THROUGHOUT CAP.

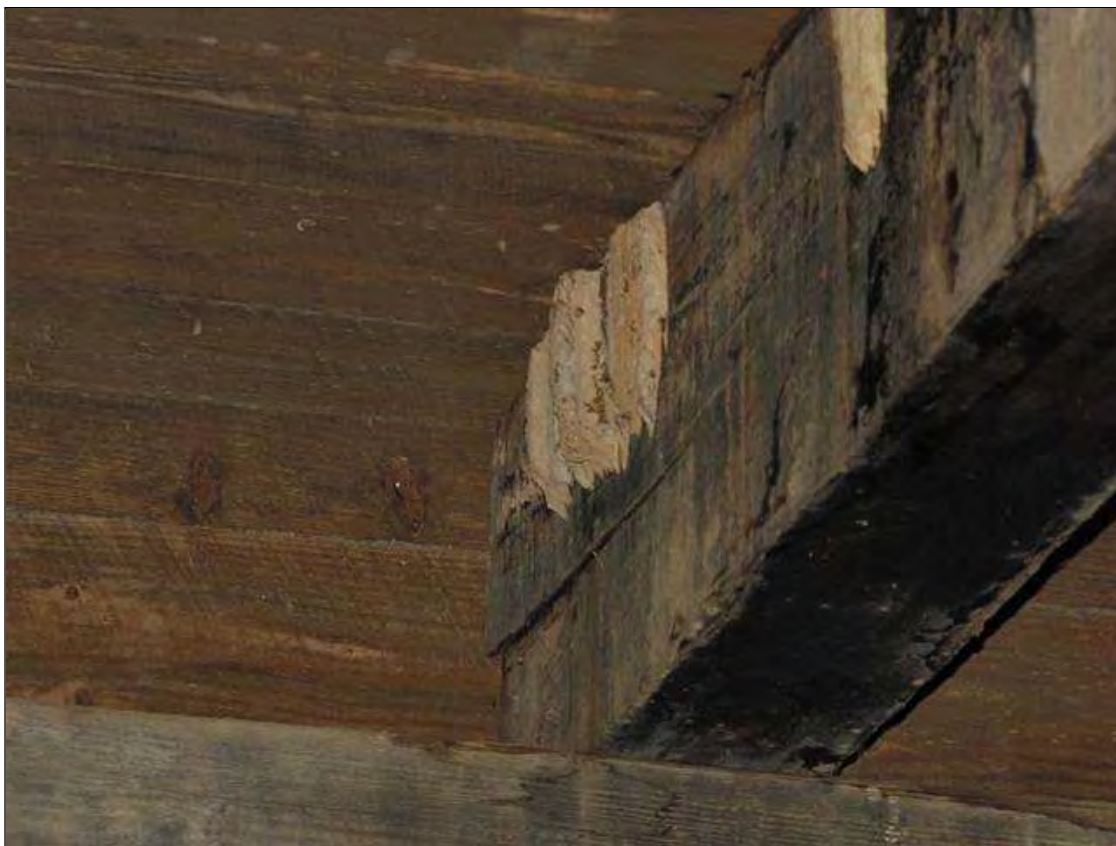
2 Feet of Decay/Section Loss (CS2): 14 IN OF END DECAY WITH CRUSHING UP TO 1 1/2" AT END BENT 1 CAP.

Span 1 Beam 8: 14 IN OF END DECAY WITH CRUSHING UP TO 1 1/2" AT END BENT 1 CAP.

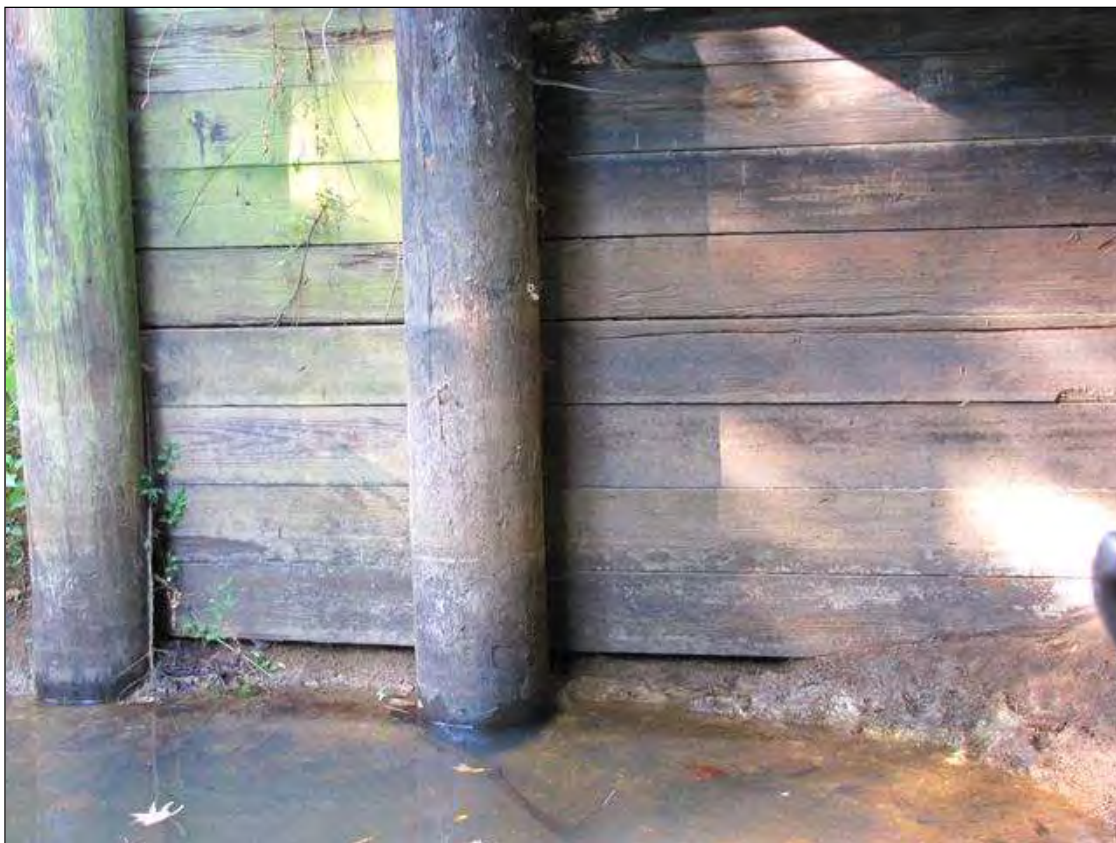
End Bent 1 Abutment/Backwall : 8 FT OF UNDERMINING AT RIGHT SIDE.

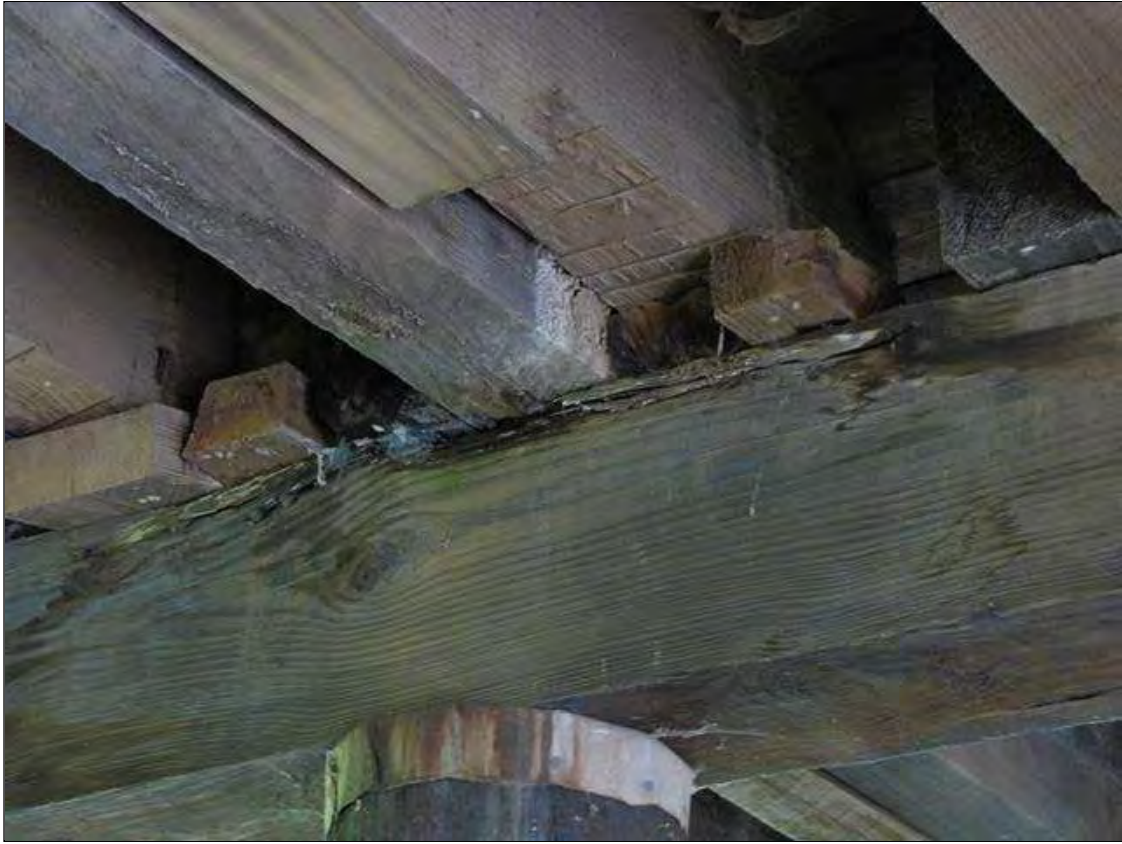
3 Feet of Decay/Section Loss (CS2): 3 FT OF CRUSHING AT TOP OF CAP AT BEAMS 4 AND 5 ON SPAN 1 SIDE.

Bent 1 Cap : 3 FT OF CRUSHING AT TOP OF CAP AT BEAMS 4 AND 5 ON SPAN 1 SIDE.

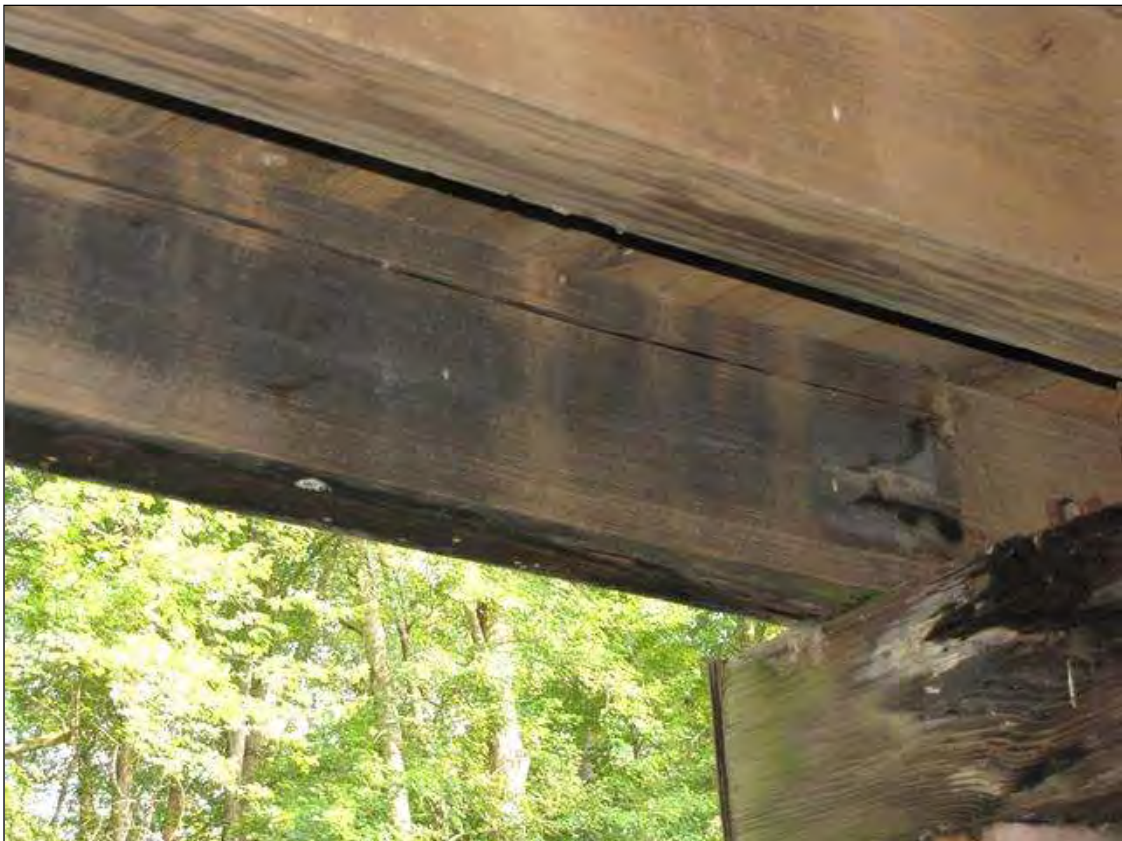
10 Feet of Split/Delamination (Timber) (CS3): SPLIT IN EAST FACE 3 IN FROM TOP, BEGINNING AT MIDSPAN TO BENT 1.

Span 1 Beam 1: SPLIT IN EAST FACE 3 IN FROM TOP, BEGINNING AT MIDSPAN TO BENT 1.

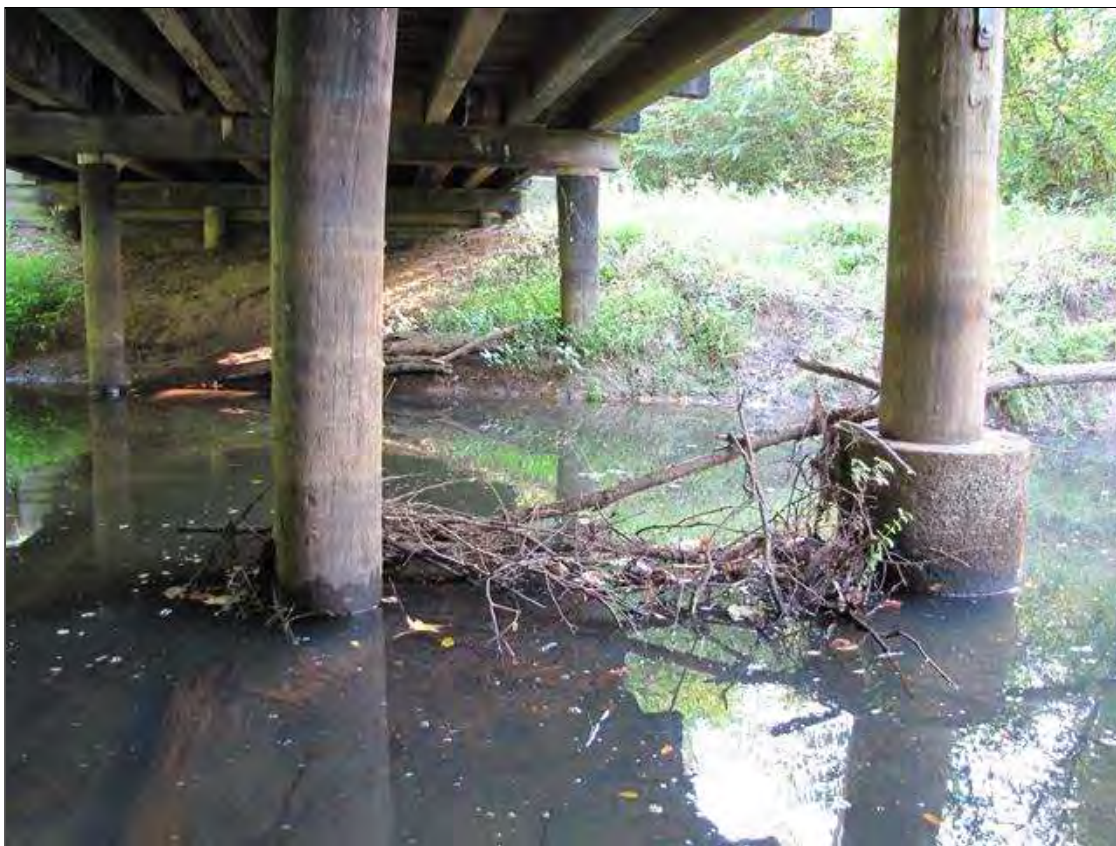
DRIFT ACCUMULATION AT BENT 1 BETWEEN PILES 3 AND 4

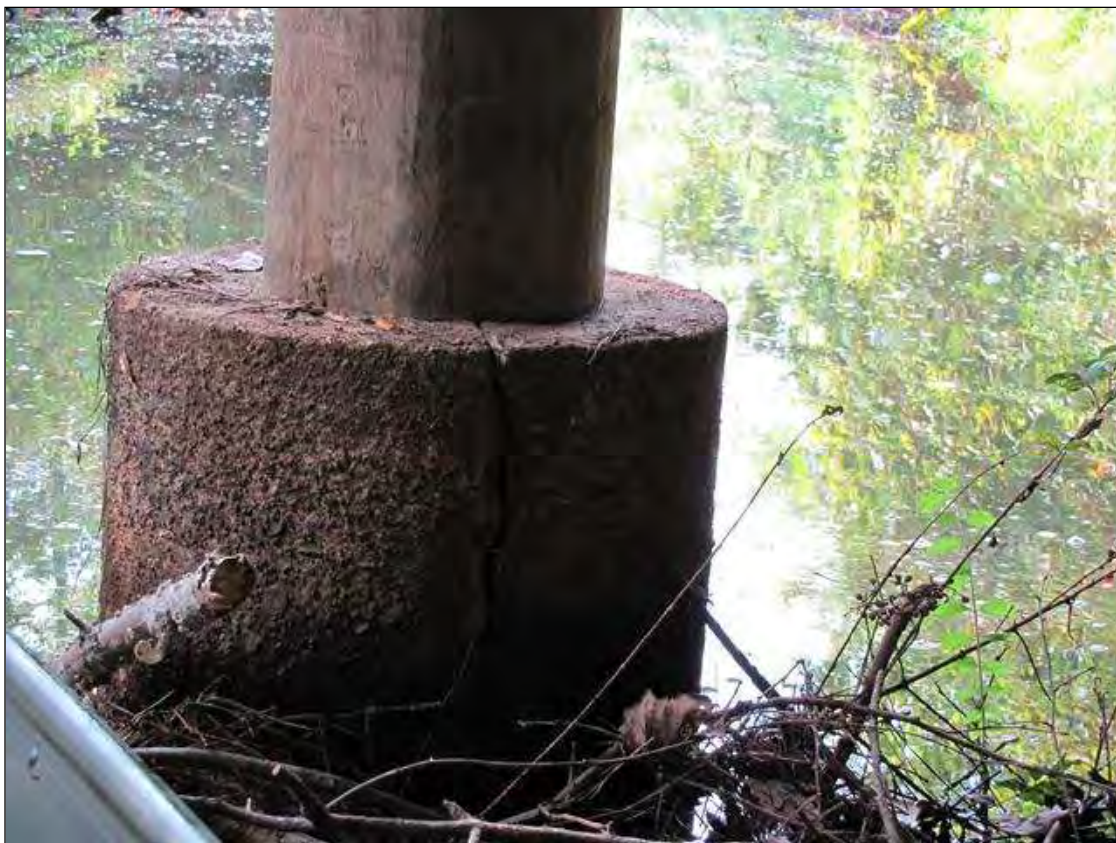
CONCRETE COLLAR AT PILE 4 BENT 1. COLLAR HAS CRACK ON WEST FACE.

Bent 1 Pile 4: CONCRETE COLLAR IS CRACKED ON WEST FACE.

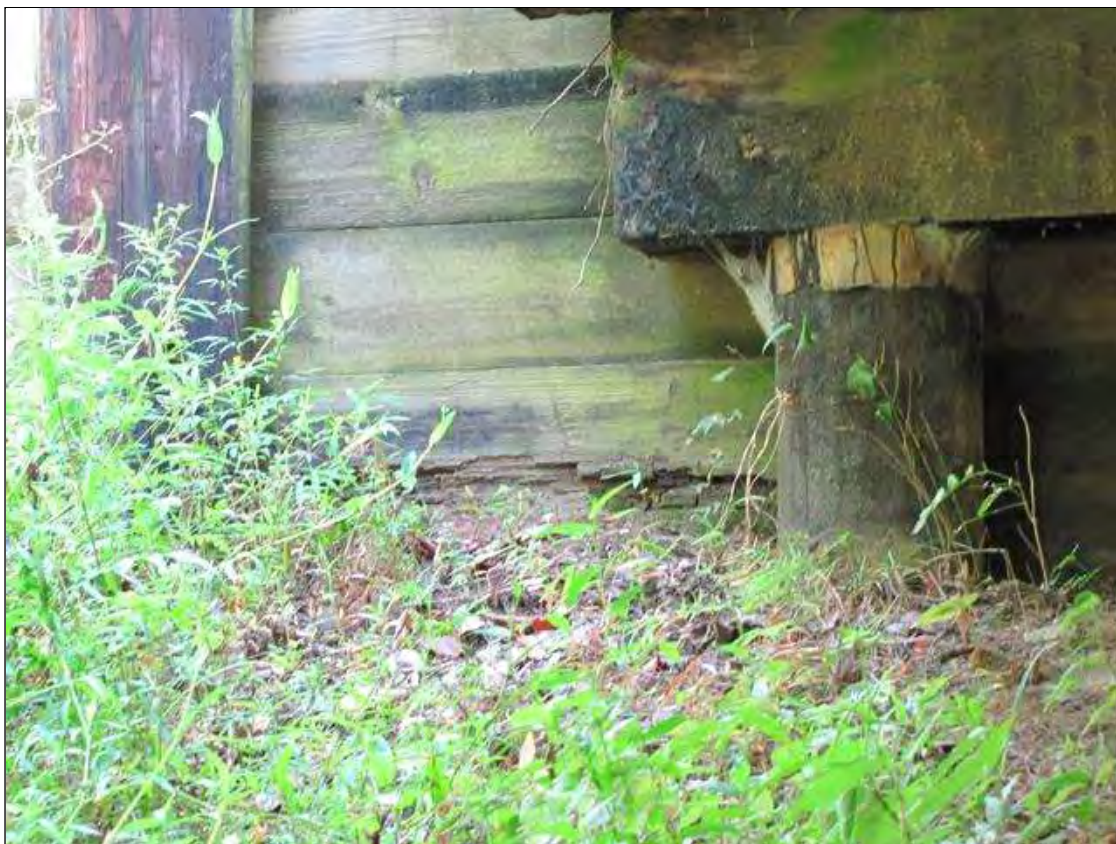
6 Feet of Decay/Section Loss (CS3): 6 FT X 2 FT AREA OF DECAY AT LEFT SIDE AT PILE 1.

End Bent 2 Abutment/Backwall : 6 FT X 2 FT AREA OF DECAY AT LEFT SIDE AT PILE 1.

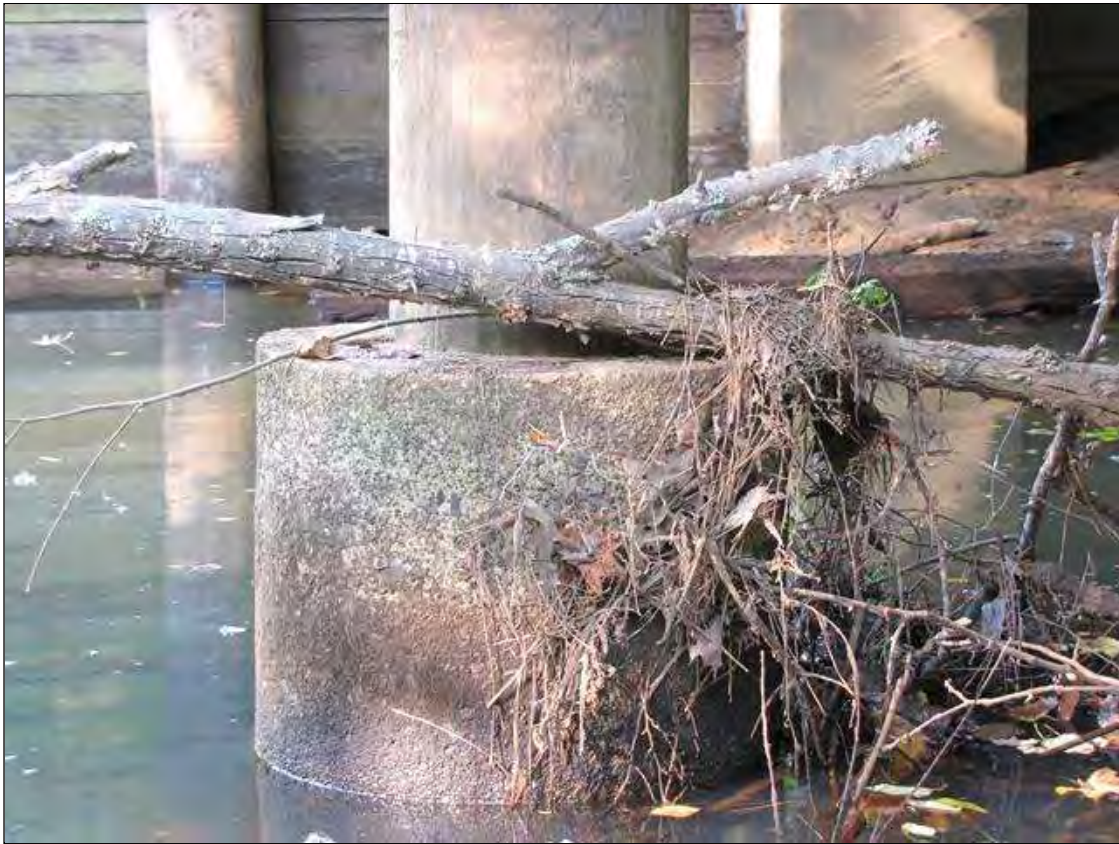
CONCRETE COLLAR AT PILE 4 BENT 1

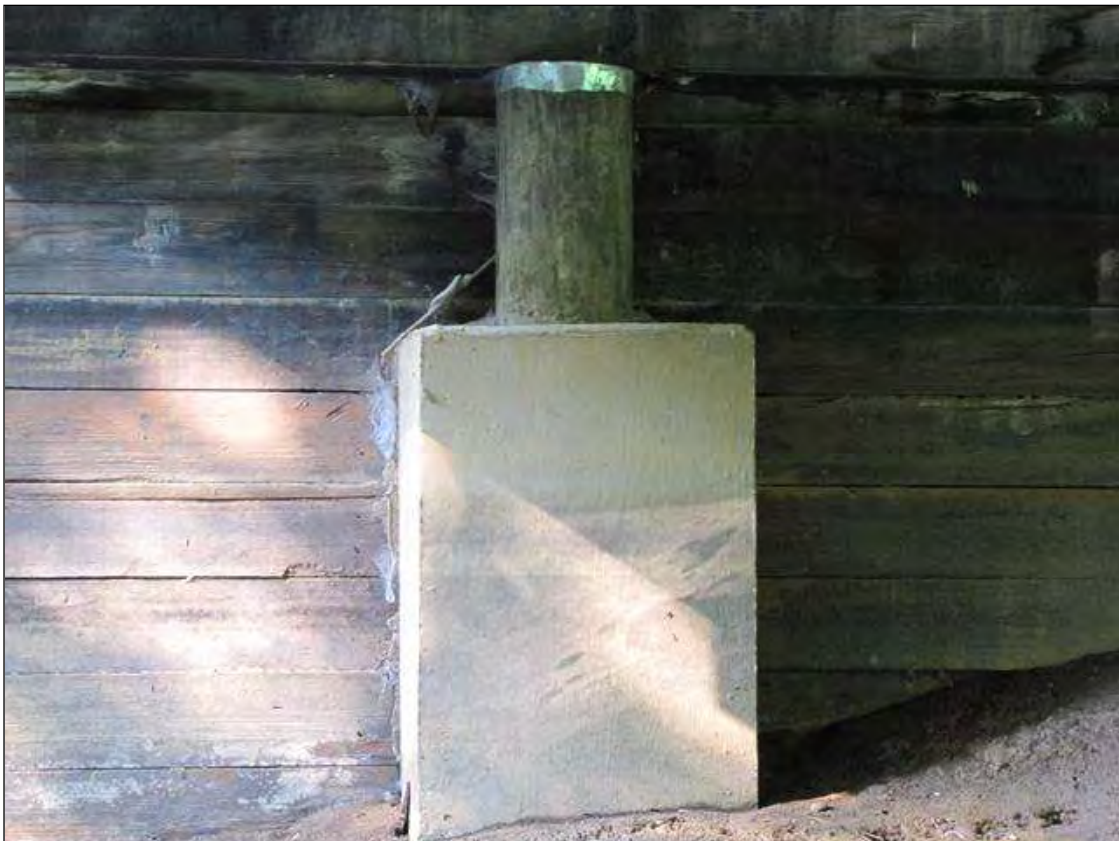
CONCRETE COLLAR AT PILE 3 END BENT 1.

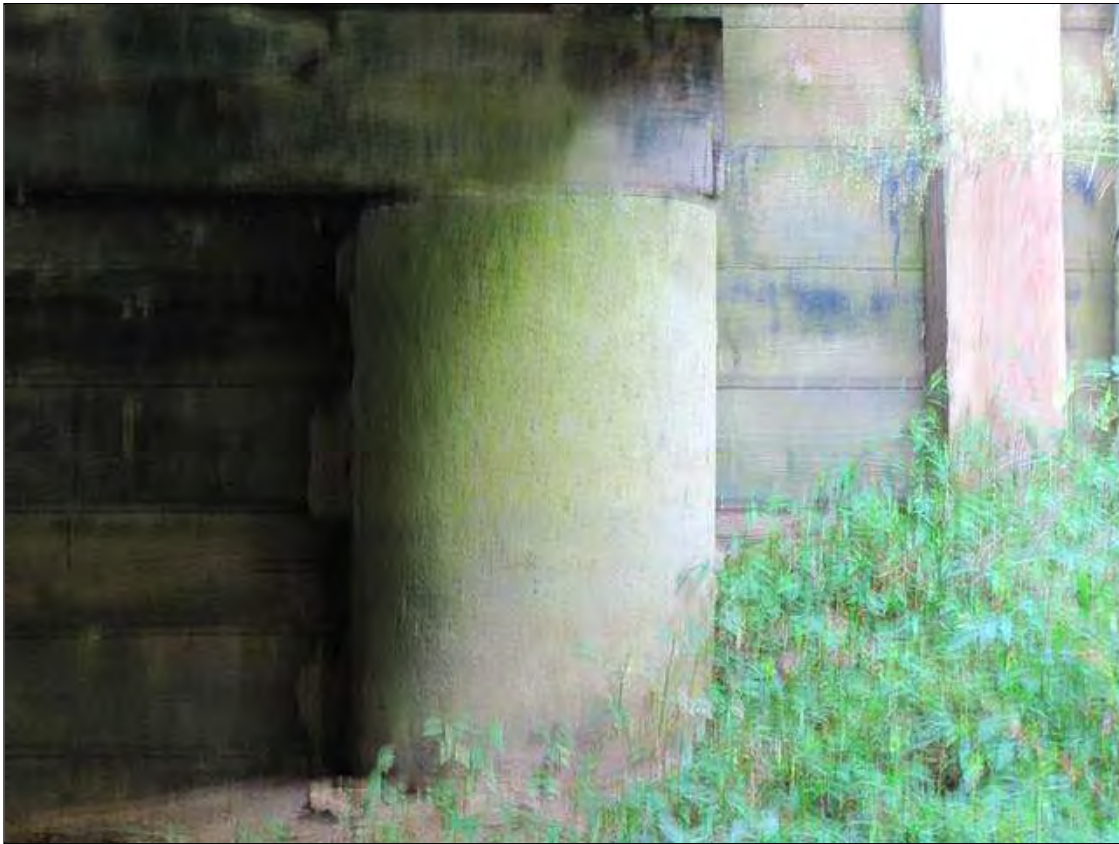
CONCRETE COLLAR AT PILE 1 END BENT 1.
