NC DEPARTMENT OF TRANSPORTATION
 DIVISION OF HIGHWAYS
 BRIDGE MANAGEMENT UNIT

PRIORITY MAINTENANCE - RUST AND CORROSION
 WITH SECTION LOSS ON BEAMS 1, 2, 9 AND 10

BRIDGE INSPECTION REPORT

COUNTY EDGEcombe BRIDGE NUMBER 320076 INSPECTION CYCLE 0 YRS
 ROUTE SR1527 ACROSS CONETOE CRK. OVERFLOW M.P. 0

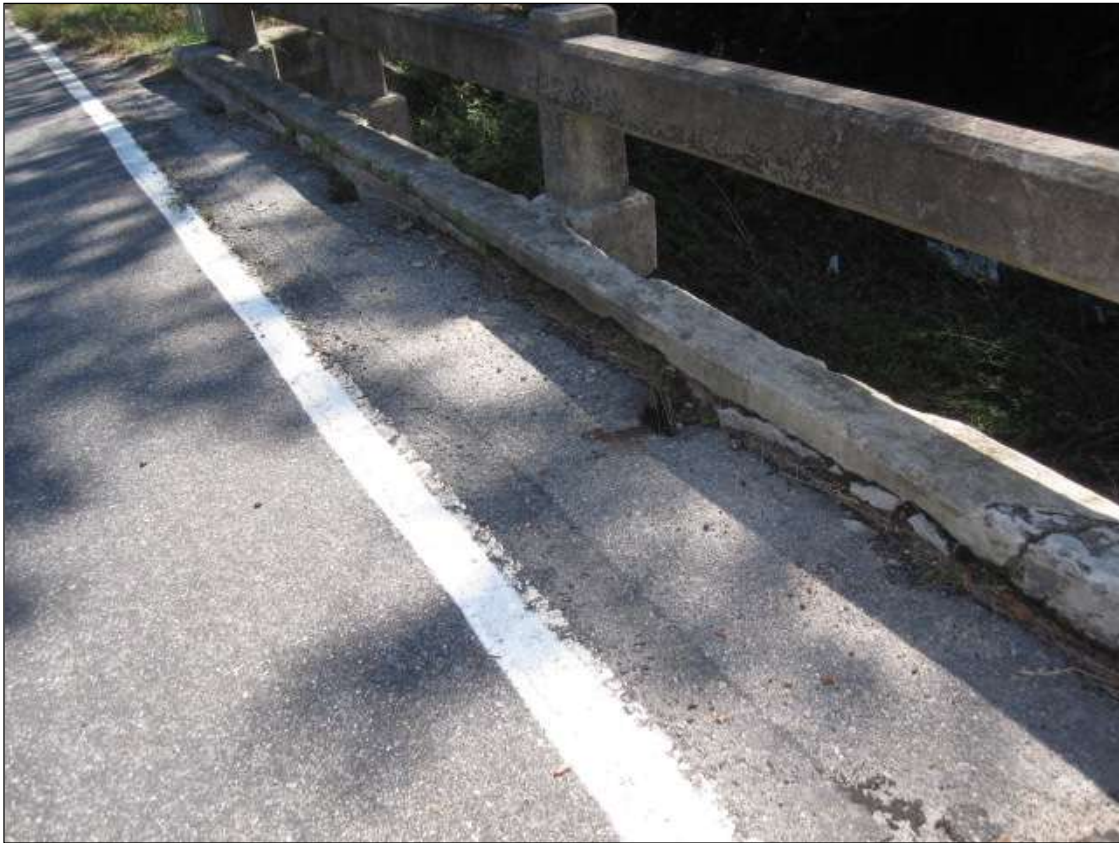
20 FT X 3" X 1" DEEP SPALL IN FACE OF SOUTH CURB

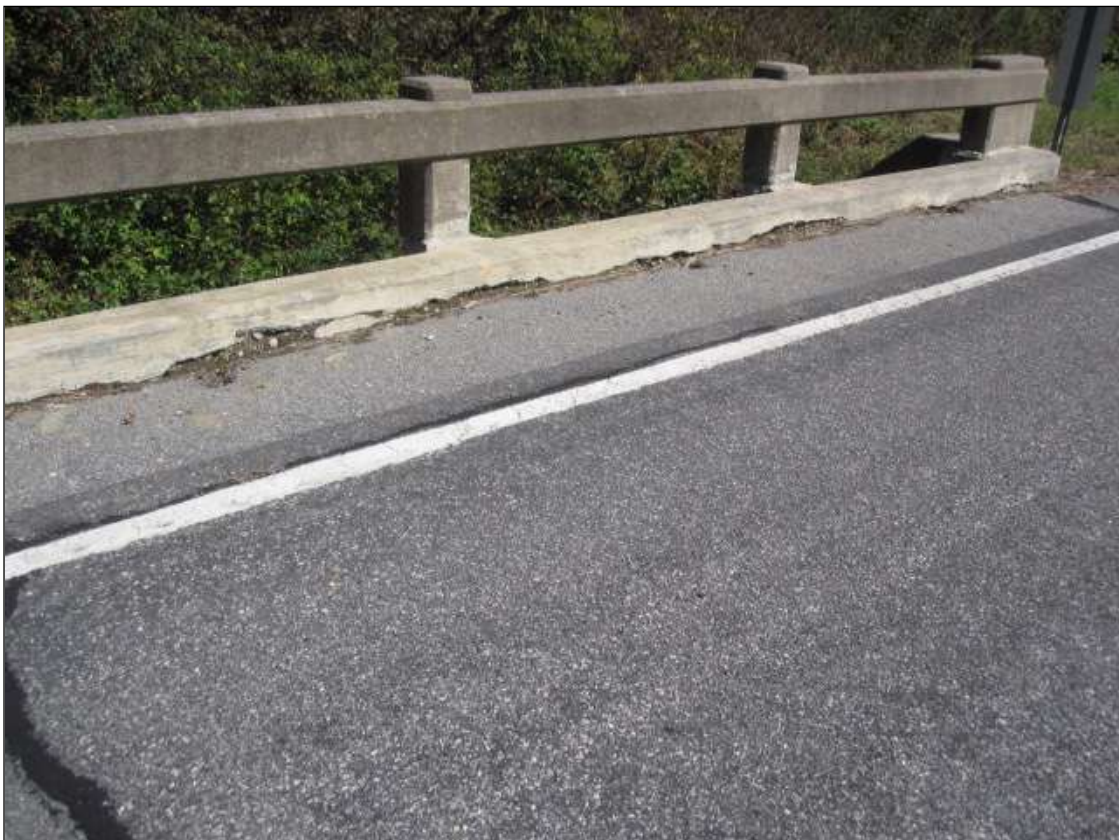
20 FT X 3" X 1" DEEP SPALL IN FACE OF NORTH CURB

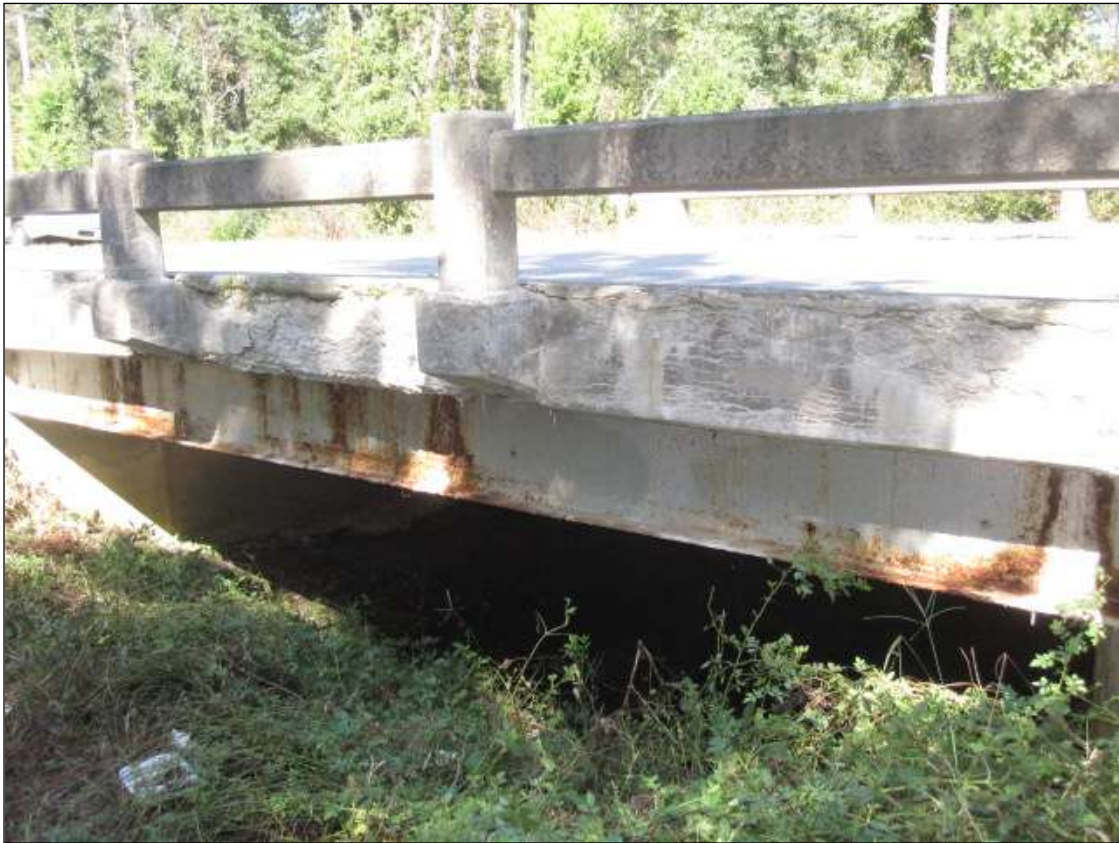
FULL WIDTH X FULL LENGTH SPALLING ALONG EXTERIOR FACE OF SOUTH CURB

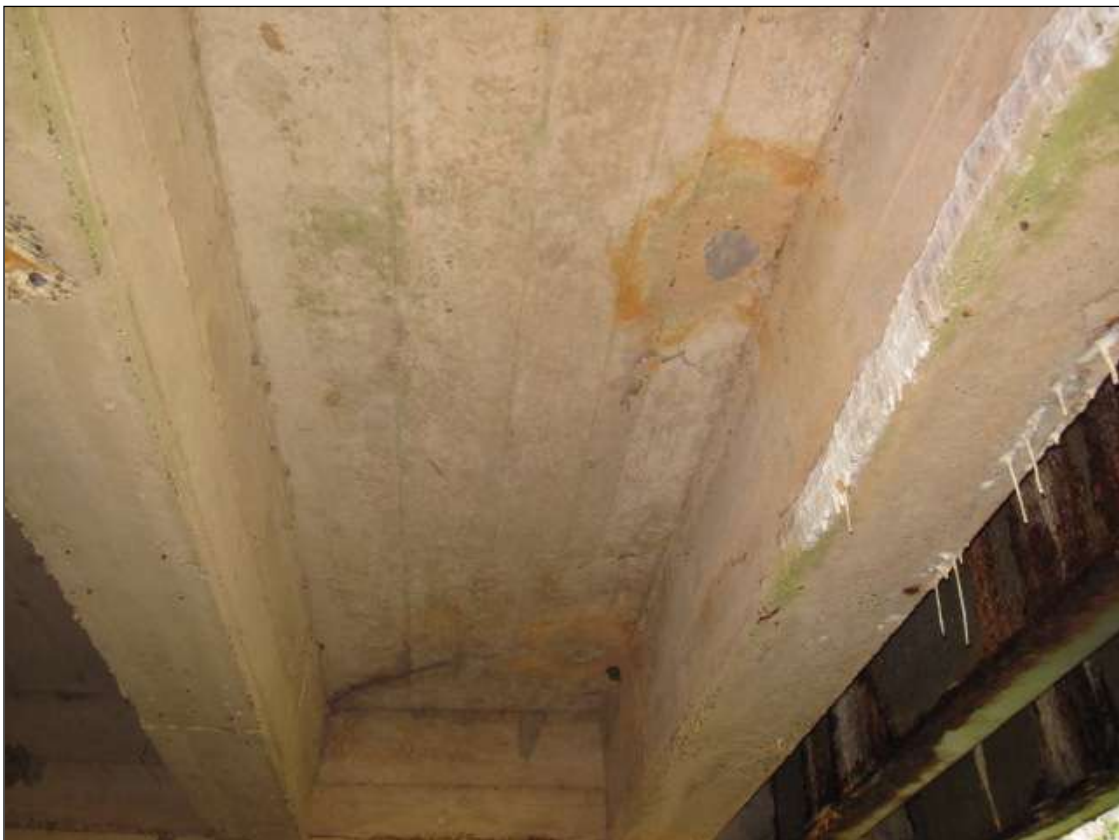
DELAMINATIONS IN BOTTOM OF DECK BAY 7

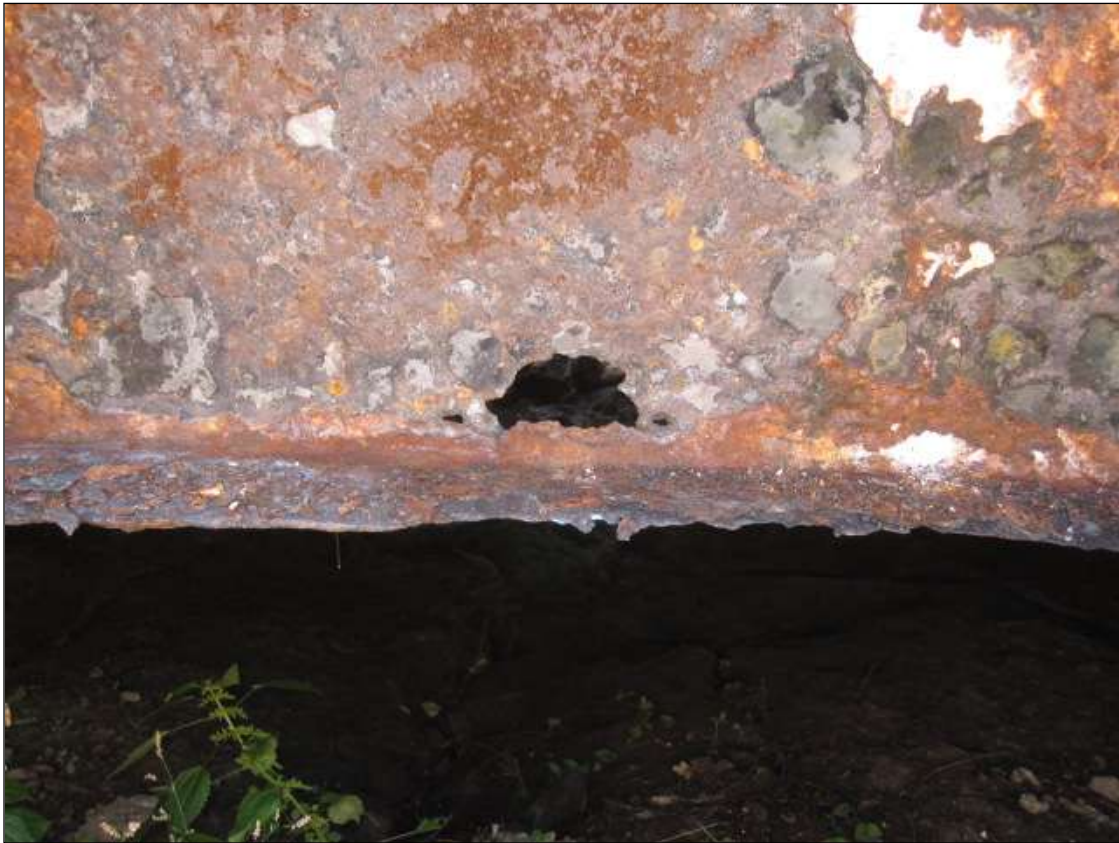
RUST AND CORROSION WITH 5" X 2" HOLE IN WEB OF BEAM 1 AT MIDSPAN

3314	Maintain Steel Superstructure Components	LF	20	RUST AND CORROSION WITH 5" X 2" HOLE IN WEB OF BEAM 1 AT MIDSPAN

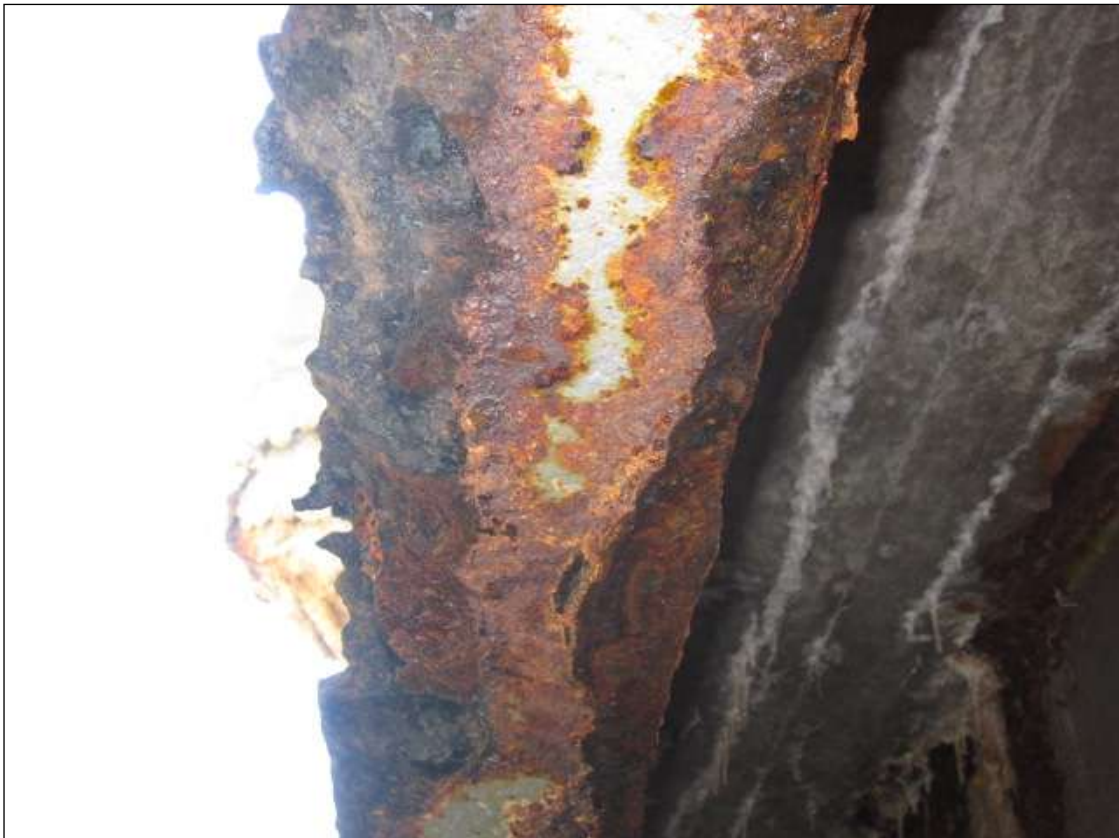
RUST AND CORROSION WITH UP TO 50% SECTION LOSS OF BOTTOM FLANGE BEAM 1 AT MIDSPAN

3314	Maintain Steel Superstructure Components	LF	20	RUST AND CORROSION WITH UP TO 50% SECTION LOSS OF BOTTOM FLANGE BEAM 1 AT MIDSPAN

MMS Code	MMS Description	Quantity
3314	Maintain Steel Superstructure Components	20 LF
Location:		
Beams and Girders		Bent/Span No. 1 BEAM
Priority Level	Status	
Priority Maintenance	Division Bridge Maintenance Notification	
Submitted Date:	Submitted By:	Assisted By:
10/15/2012	MATTHEW MOYER	DAVID WAGNER
Details		
<p>RUST AND CORROSION WITH 5" X 2" HOLE IN WEB OF BEAM 1 AT MIDSPAN</p> <p>RUST AND CORROSION WITH UP TO 50% SECTION LOSS OF BOTTOM FLANGE BEAM 1 AT MIDSPAN</p>

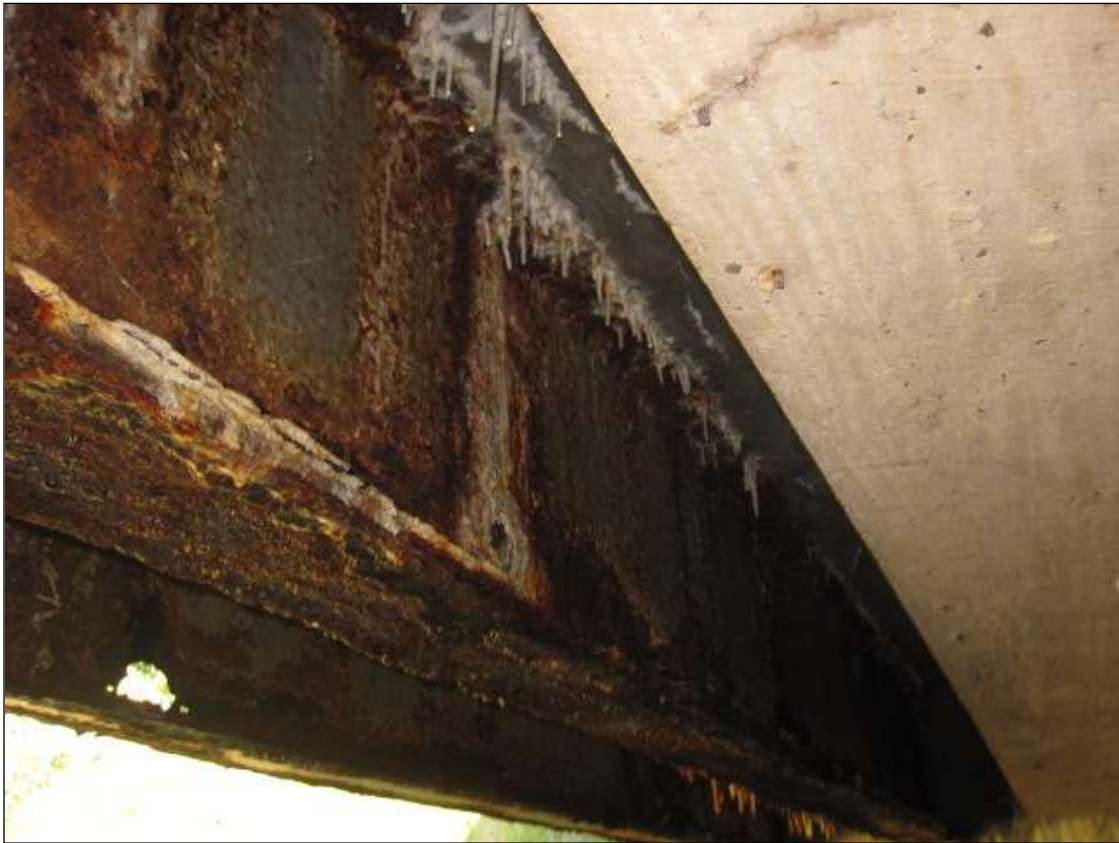
RUST AND CORROSION WITH UP TO 50% SECTION LOSS OF BOTTOM FLANGE BEAM 2 AT MIDSPAN

3314	Maintain Steel Superstructure Components	LF	20	RUST AND CORROSION WITH UP TO 50% SECTION LOSS OF BOTTOM FLANGE BEAM 2 AT MIDSPAN

MMS Code	MMS Description	Quantity
3314	Maintain Steel Superstructure Components	20 LF
Location:		
Beams and Girders		Bent/Span No. 2 BEAM
Priority Level	Status	
Priority Maintenance	Division Bridge Maintenance Notification	
Submitted Date:	Submitted By:	Assisted By:
10/15/2012	MATTHEW MOYER	DAVID WAGNER
Details		
<p>RUST AND CORROSION WITH UP TO 50% SECTION LOSS OF BOTTOM FLANGE BEAM 2 AT MIDSPAN</p>

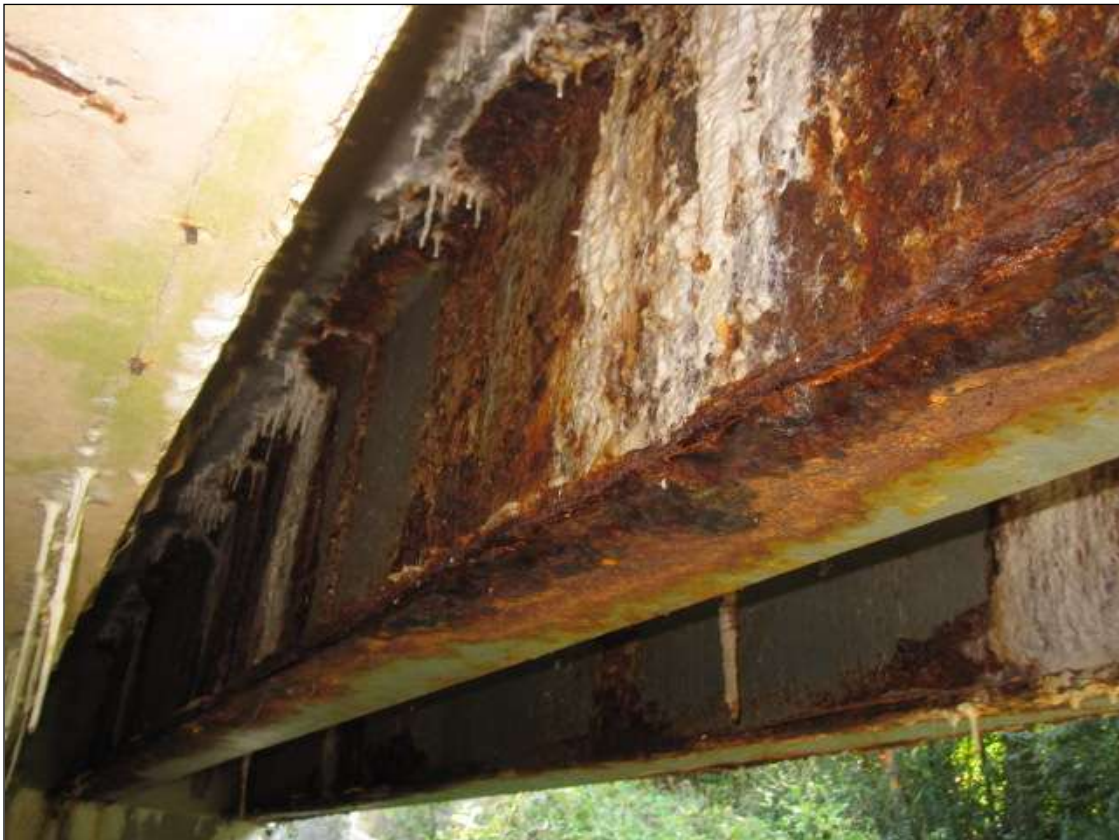
RUST AND CORROSION WITH UP TO 50% SECTION LOSS OF BOTTOM FLANGE BEAM 9 AT MIDSPAN

MMS Code	MMS Description	Quantity
3314	Maintain Steel Superstructure Components	20 LF
Location:		
Beams and Girders		Bent/Span No. 9 BEAM
Priority Level	Status	
Priority Maintenance	Division Bridge Maintenance Notification	
Submitted Date:	Submitted By:	Assisted By:
10/15/2012	MATTHEW MOYER	DAVID WAGNER
Details		
RUST AND CORROSION WITH UP TO 50% SECTION LOSS OF BOTTOM FLANGE BEAM 9 AT MIDSPAN

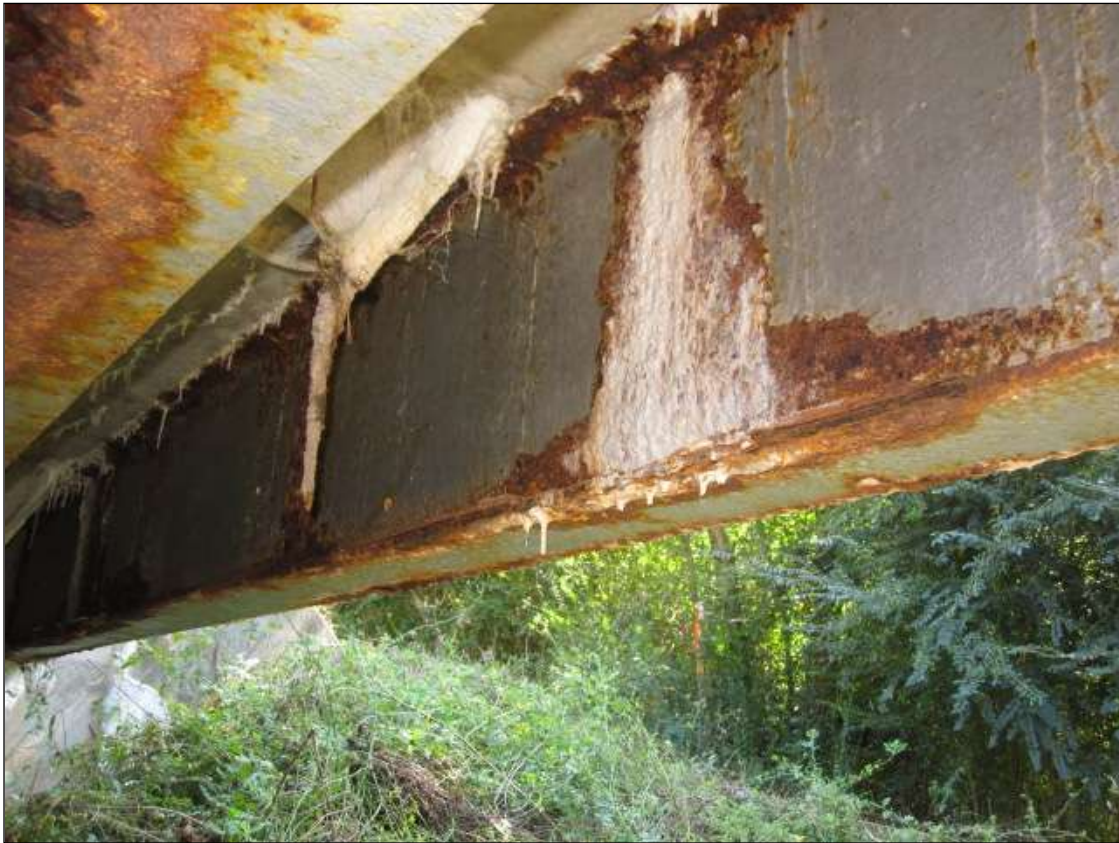
RUST AND CORROSION WITH UP TO 35% SECTION LOSS OF BOTTOM FLANGE BEAM 10 AT MIDSPAN

MMS Code	MMS Description	Quantity
3314	Maintain Steel Superstructure Components	20 LF
Location:		
Beams and Girders		Bent/Span No. 10 BEAM
Priority Level	Status	
Priority Maintenance	Division Bridge Maintenance Notification	
Submitted Date:	Submitted By:	Assisted By:
10/15/2012	MATTHEW MOYER	DAVID WAGNER
Details		
RUST AND CORROSION WITH UP TO 35% SECTION LOSS OF BOTTOM FLANGE BEAM 10 AT MIDSPAN

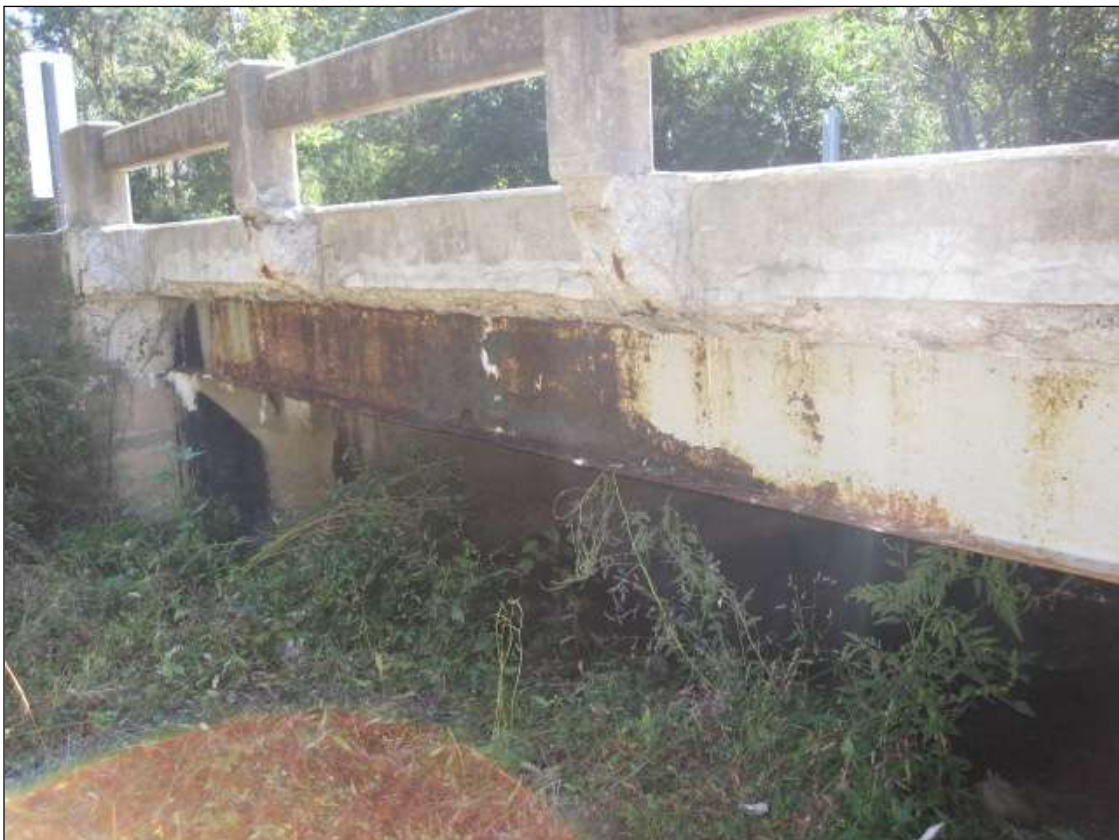
FULL WIDTH X FULL LENGTH SPALLING ALONG NORTH EXTERIOR FACE OF DECK

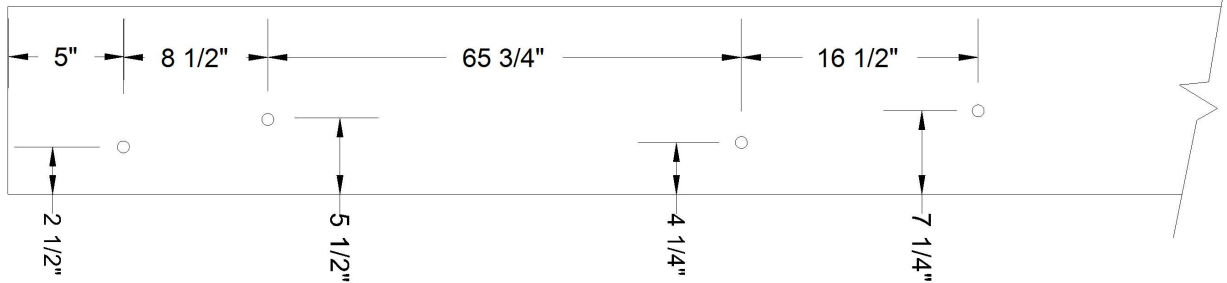
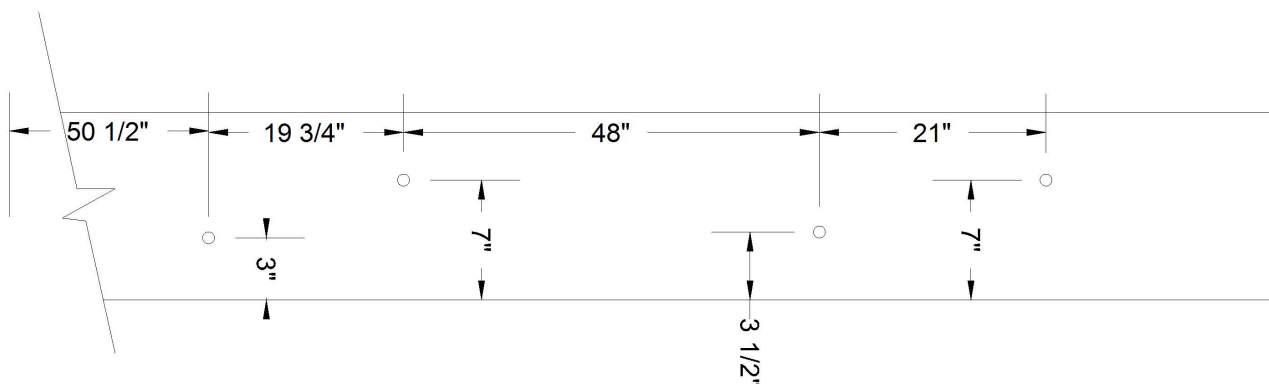
5/8" HOLES IN SALVAGE BEAM

5/8" HOLES IN BOTTOM FLANGE

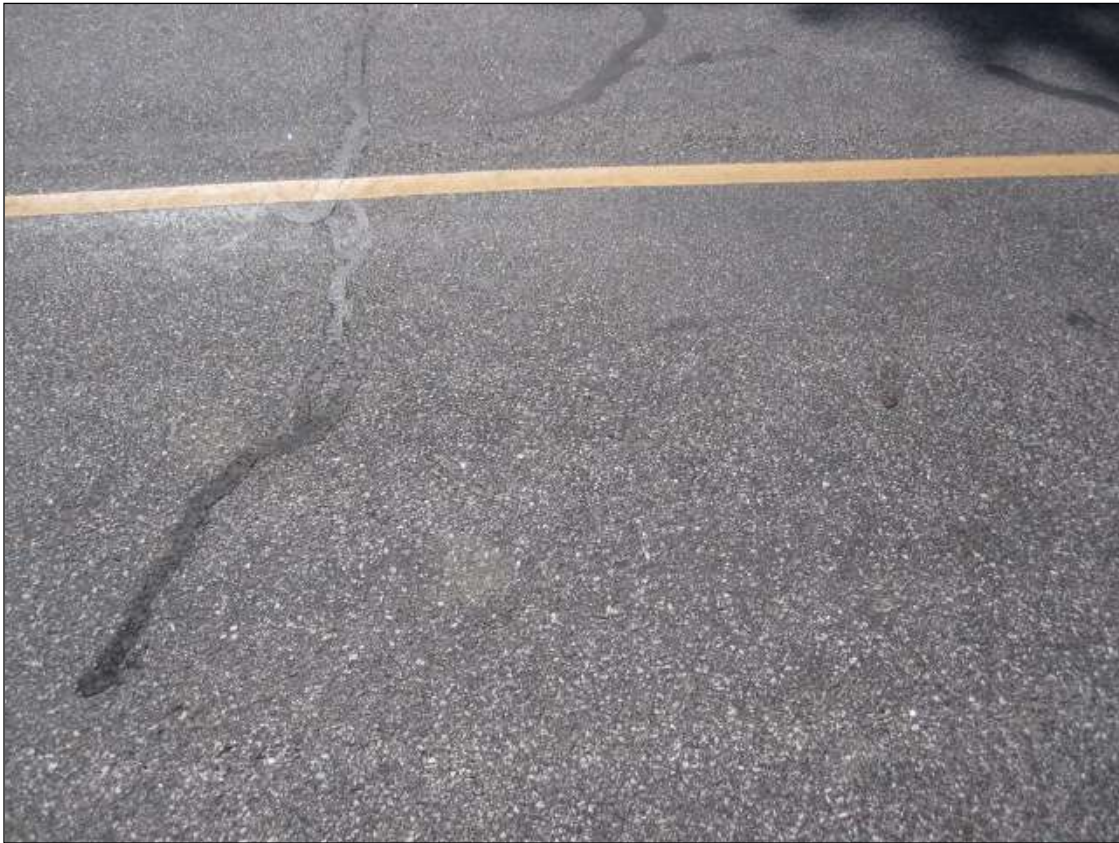
SEALED CRACKS IN APPROACH ROADWAY

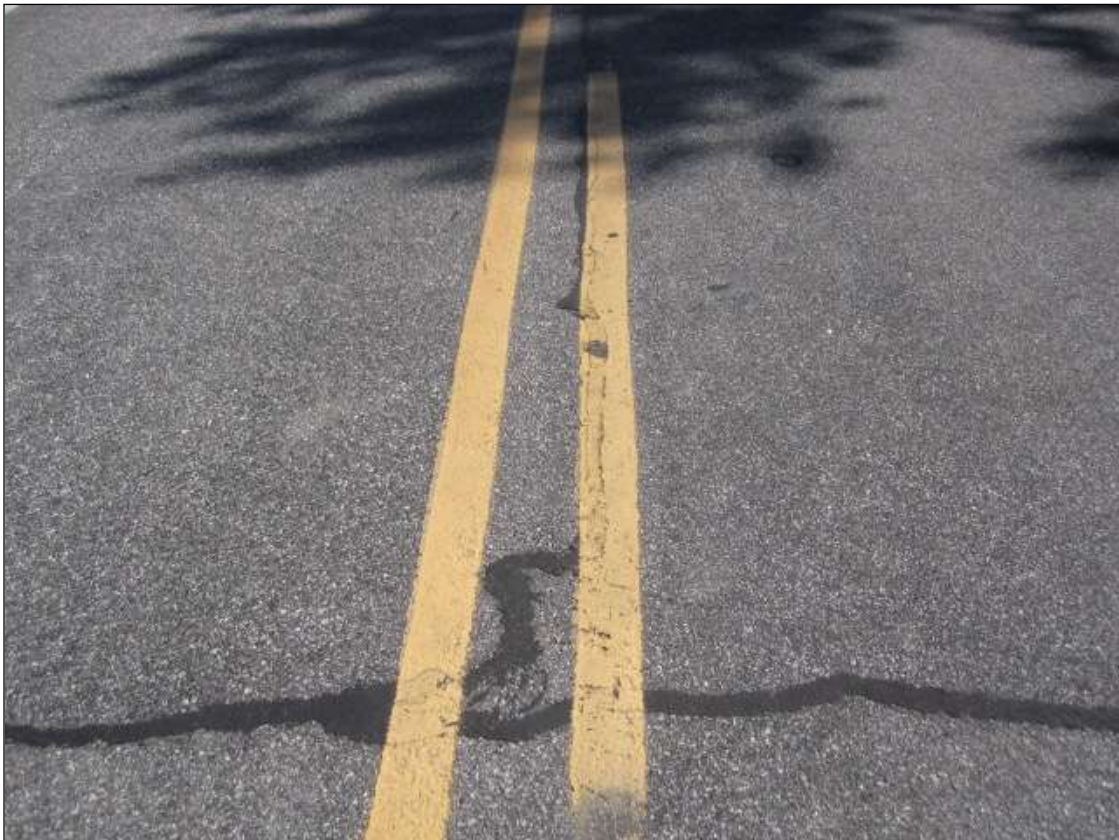
SEALED CRACKS IN ASPHALT WEARING SURFACE
