NC DEPARTMENT OF TRANSPORTATION
 DIVISION OF HIGHWAYS
 STRUCTURE MANAGEMENT UNIT

Structure Safety Report

Routine Element Inspection

COUNTY: JOHNSTON STRUCTURE NUMBER: 500232 FREQUENCY: 24 MONTHS

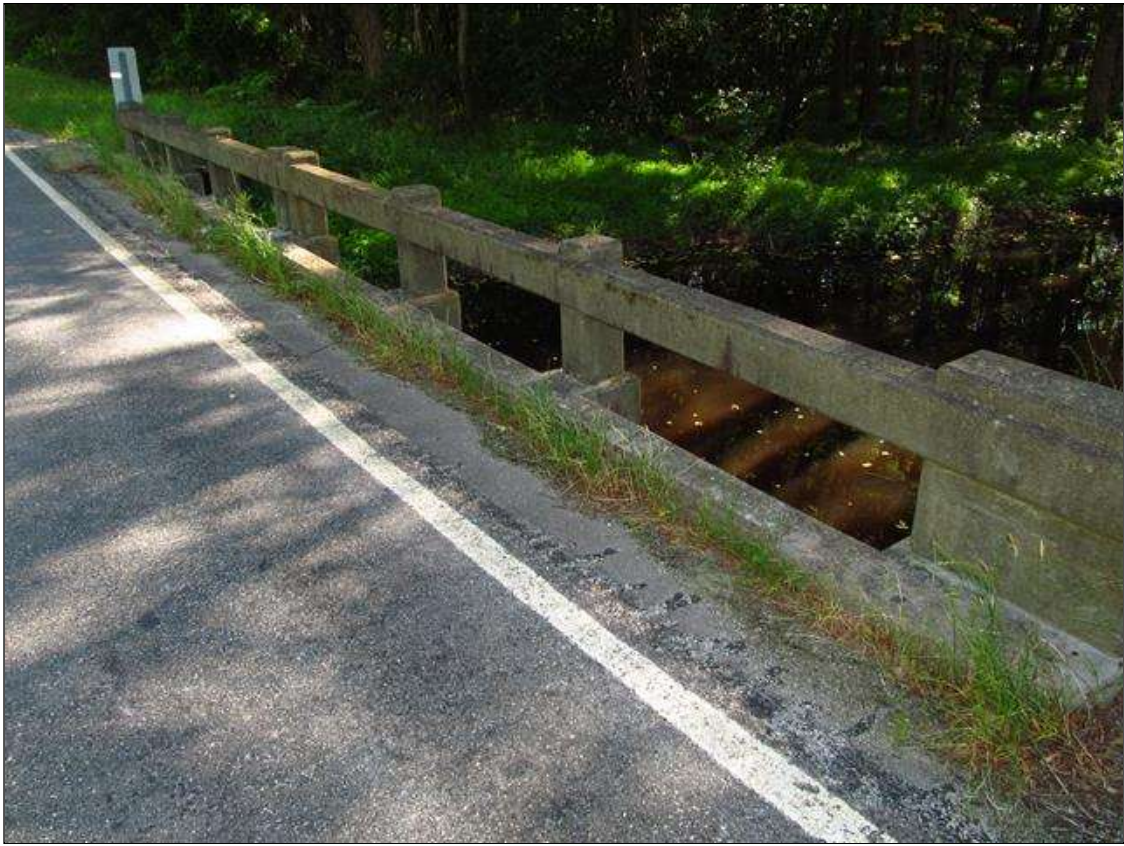
Dirt and Vegetation along curblines

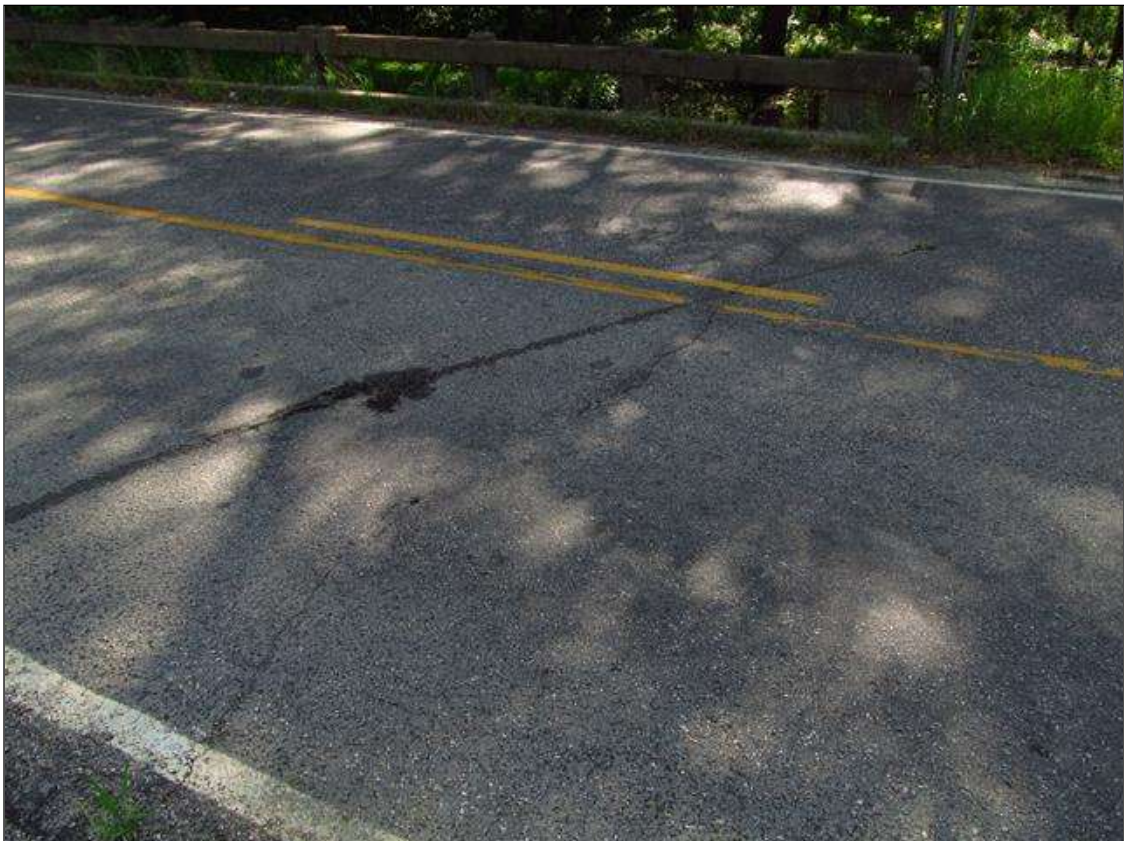
24 Square Feet of Cracking over End Bent 1. Width 0.012-0.05 in. or spacing of 1.0-3.0 ft.

Transverse crack in Wearing surface over End Bent 1

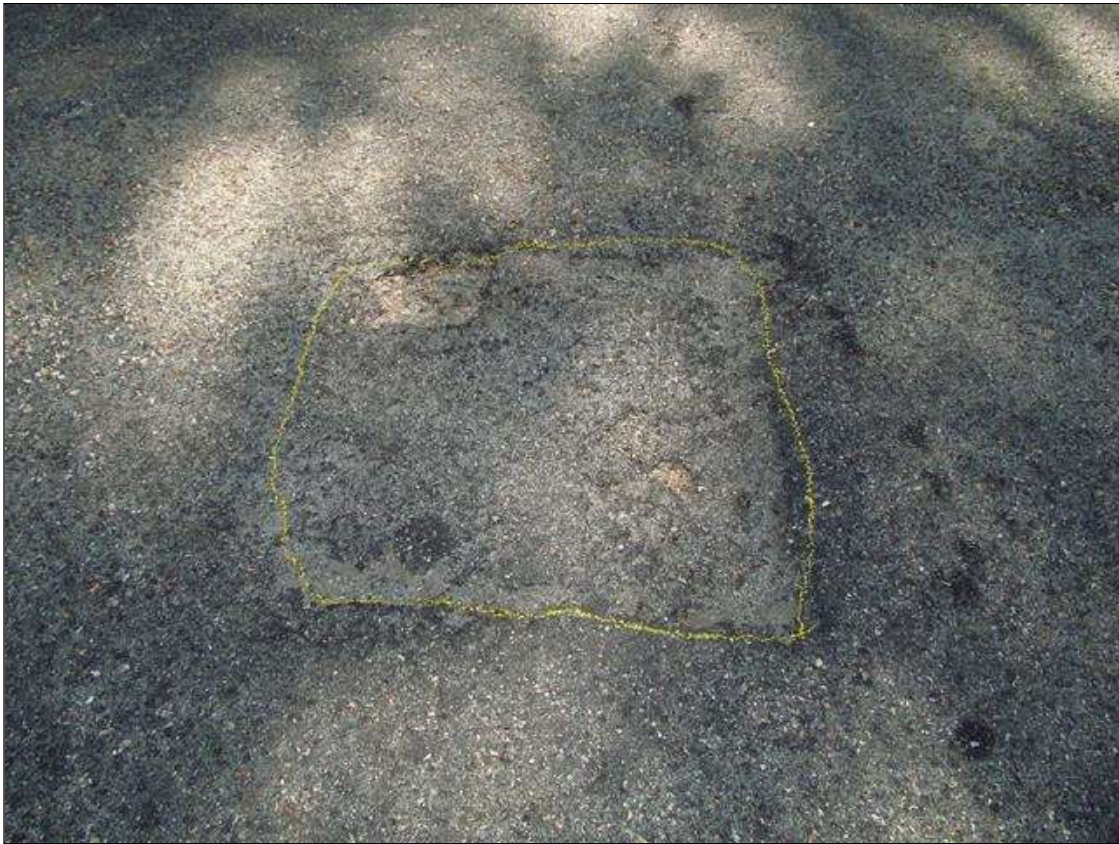
4 Square Feet of Effectiveness. Area in the Southbound lane is uneven and worn.

4 square feet of asphalt settled in the Southbound lane of Span 2

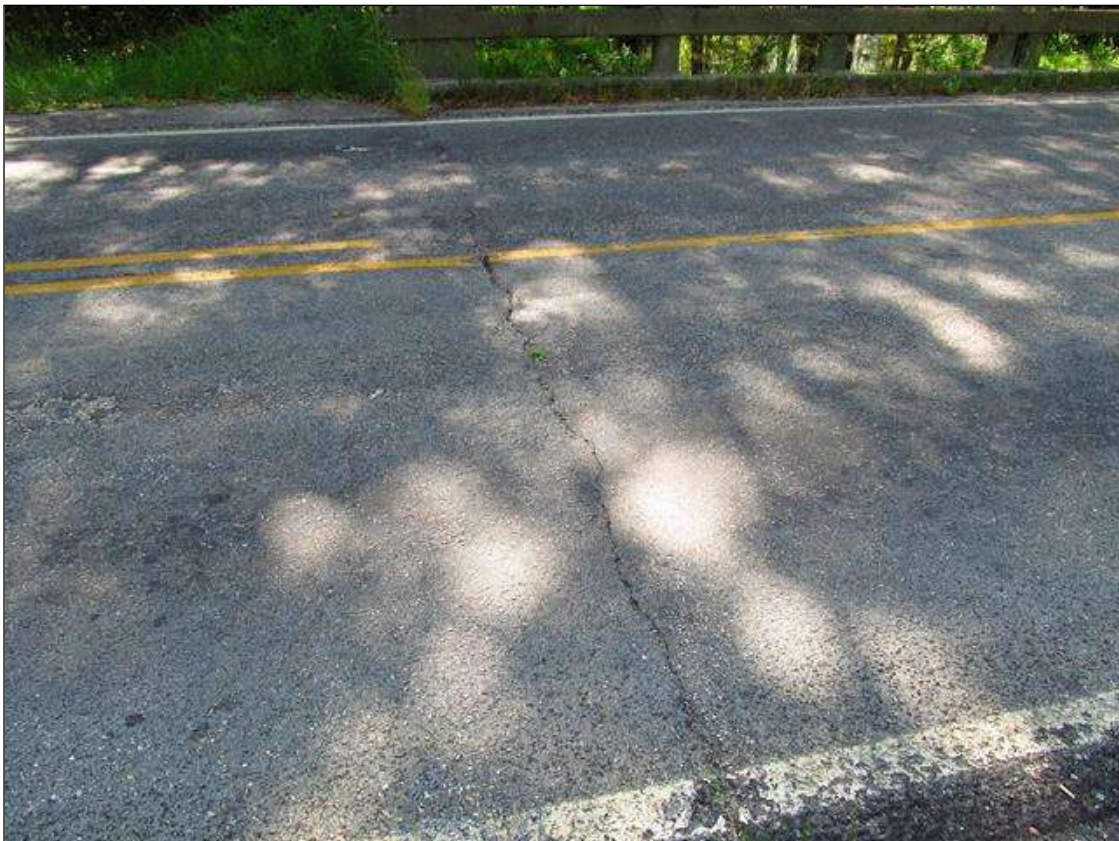
Transverse crack in Wearing surface over End Bent 2

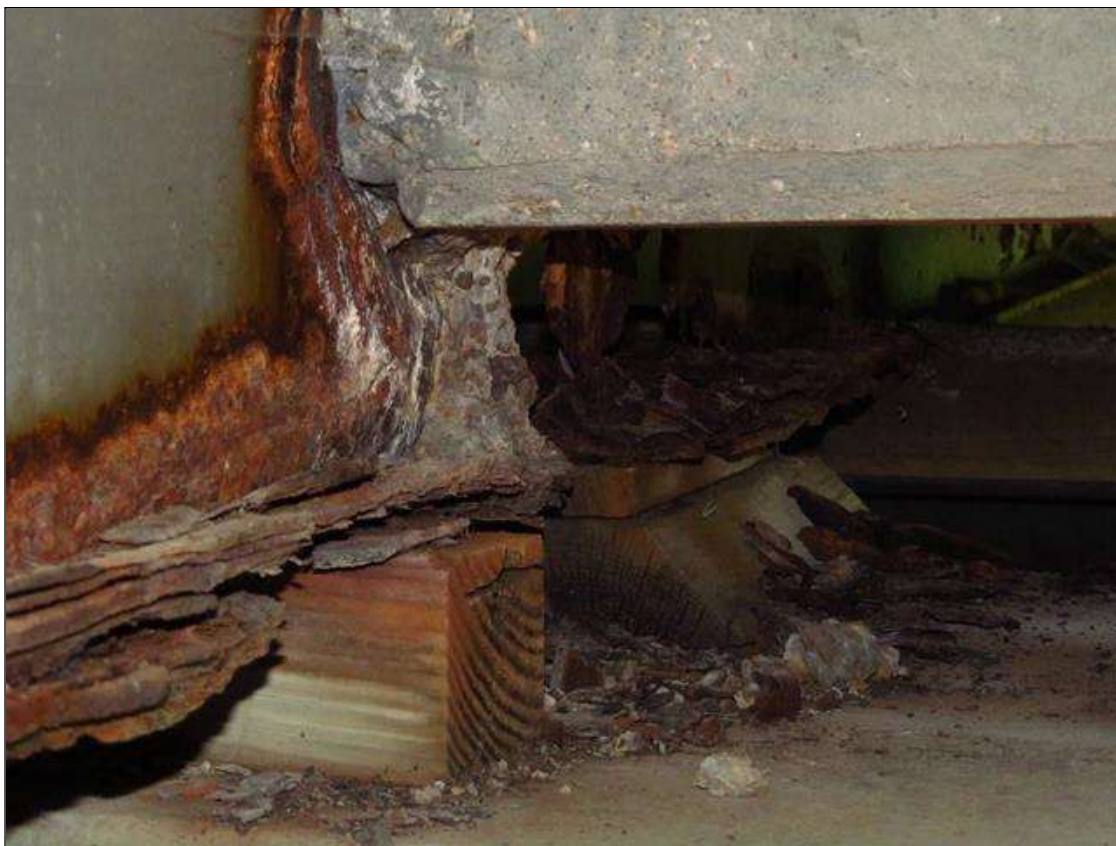
1 Feet of 100 % section loss in bottom flange and web 4 in high over bent 1.
6 Feet of Corrosion: Section loss in top flange with 3/16 in remaining.
11 Feet of Corrosion: Freckled Rust. Corrosion of the steel has initiated.
30 Square Feet of Effectiveness (Steel Protective Coatings): Failed; no protection of the underlying metal.

Section loss in the end of Beam 2 in Span 1 over Bent 1 - other beams similar throughout structure

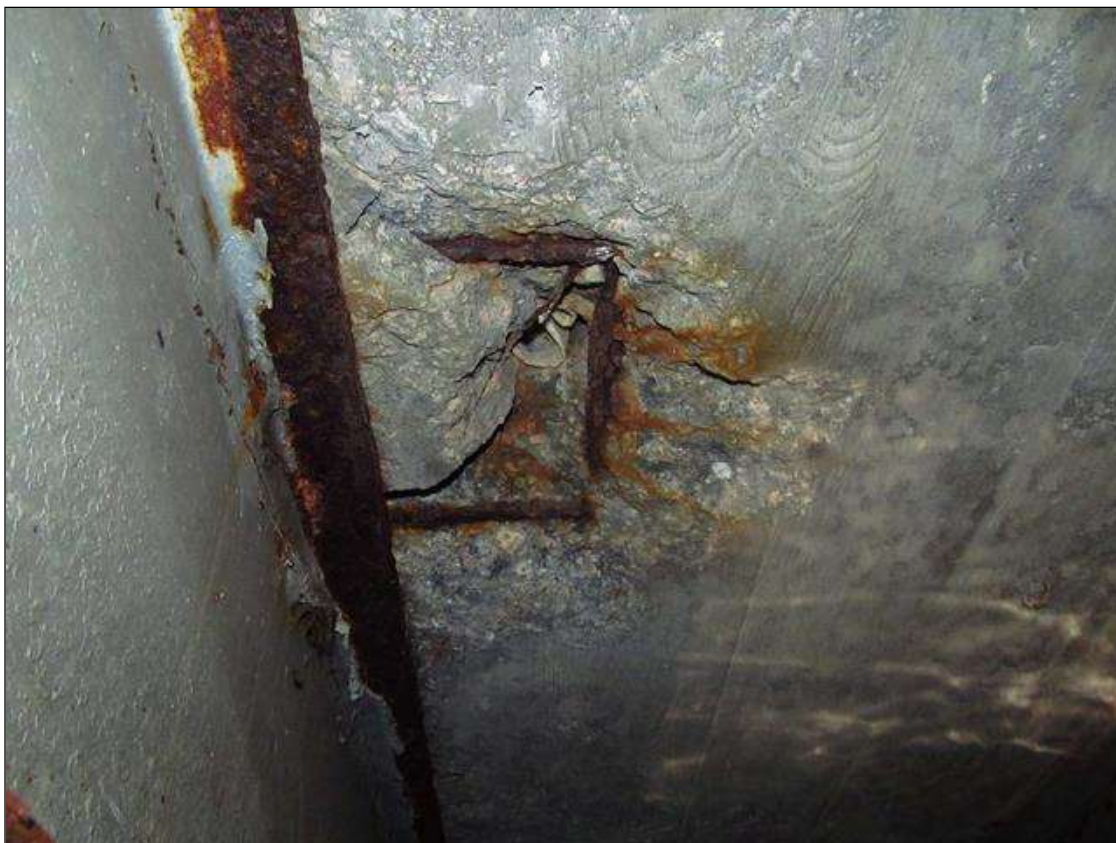
3 Square Feet of spall with exposed rebar in bottom of deck in bays 6 ,10 , 11 where holes were drilled for temporary supports. Spalls are up to 12 in diameter x 3 in deep.
19 Square Feet of Abrasion/Wear along deck curbs. Abrasion or wearing has exposed coarse aggregate but the aggregate remains secure in the concrete.

4 Square Feet of spall with exposed rebar in bottom of deck in bays 6 ,10 , 11 where holes were drilled for temporary supports. Spalls are up to 12 in diameter x 3 in deep.

Spalling with Exposed rebar in Bottom of deck where crutch bents were added

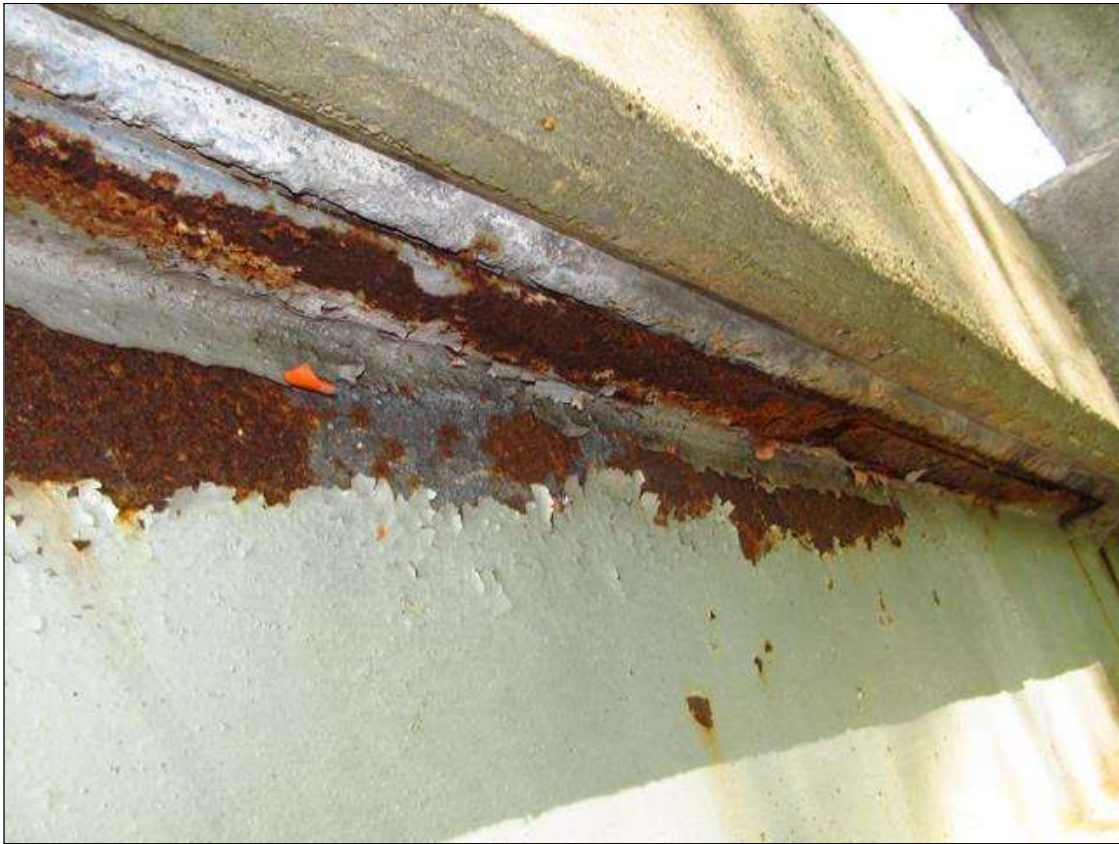
Corrosion along beam flanges and webs throughout structure

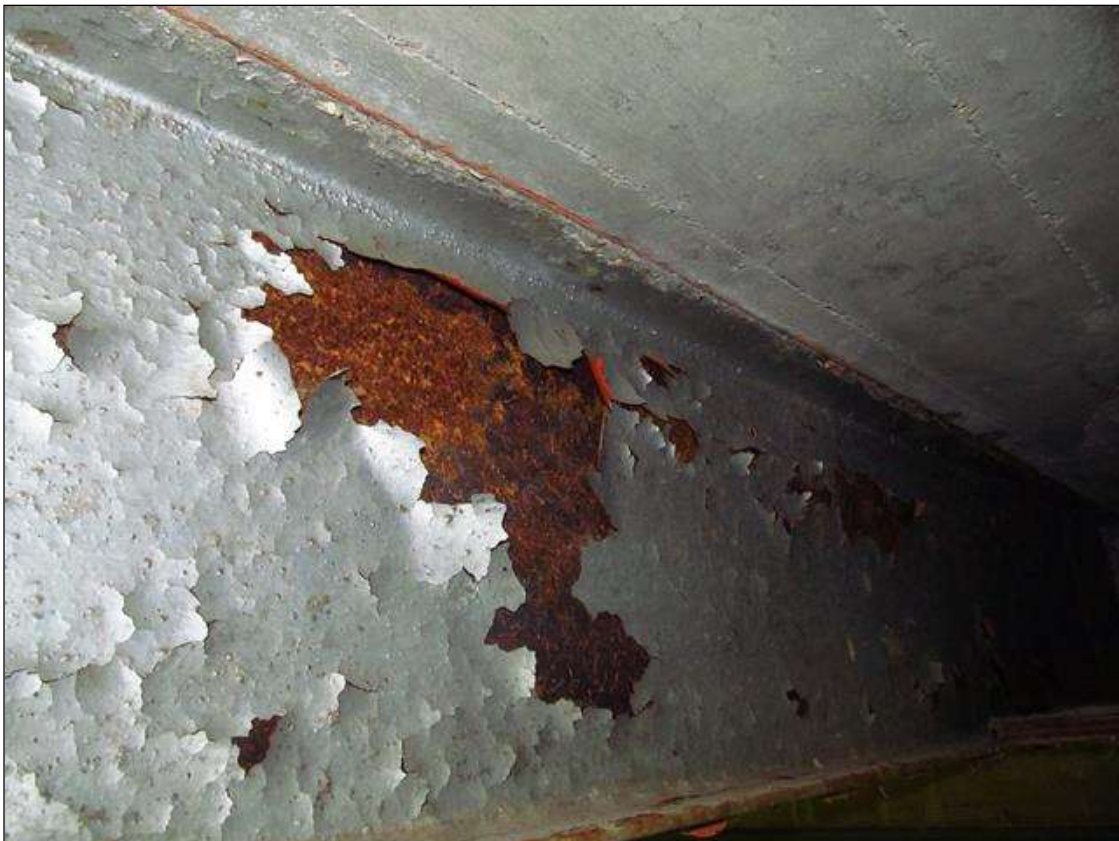
Areas of failed protective coating throughout structure

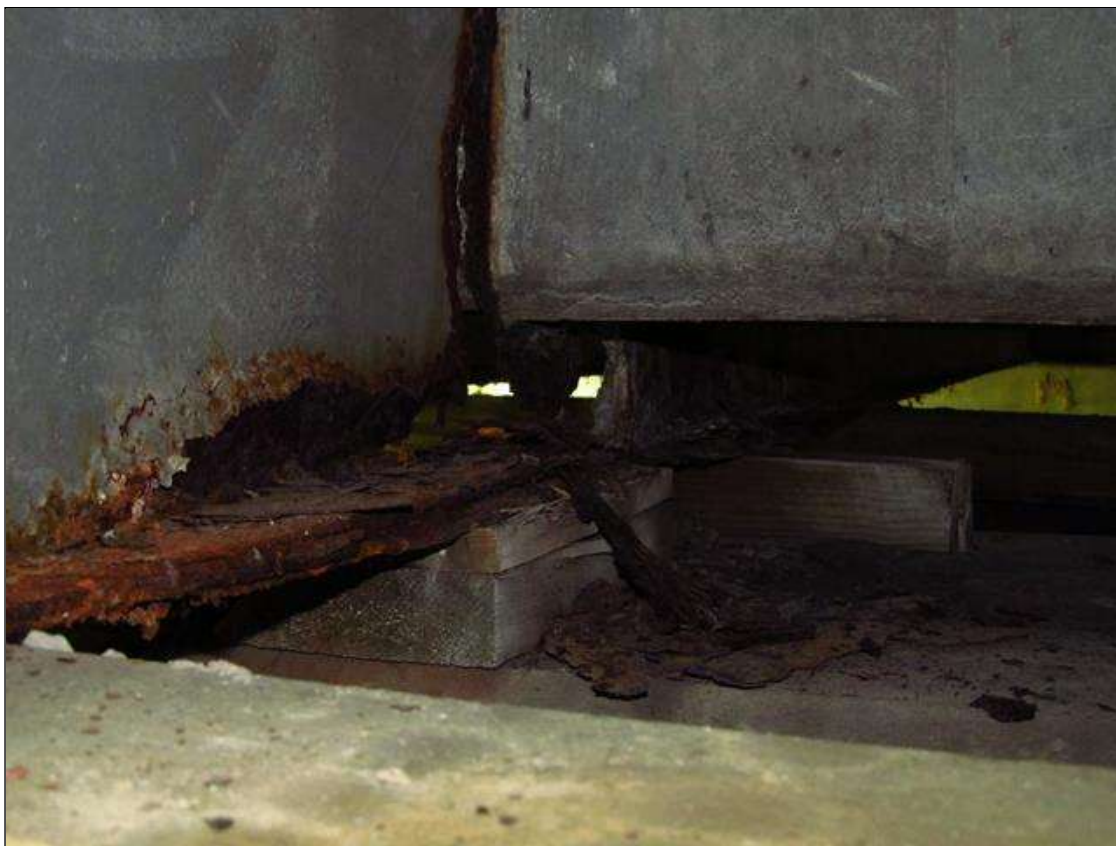
Section loss in the end of Beam 2 in Span 1 over Bent 1 - other beams similar throughout structure

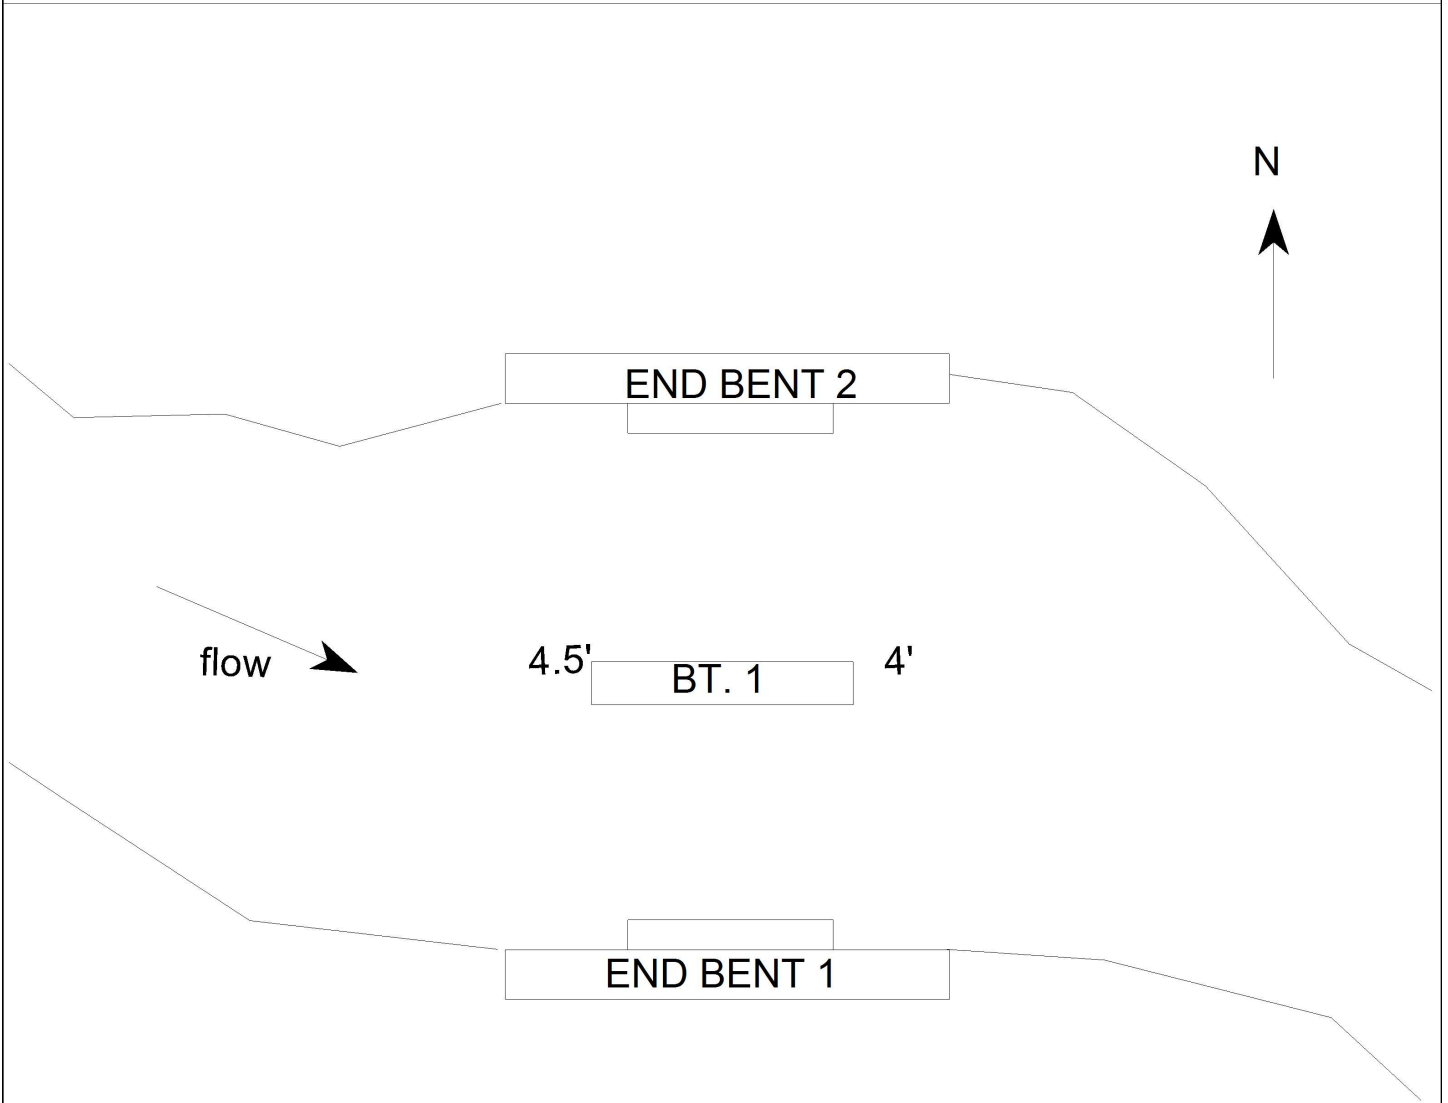
Title PLAN VIEW		Description STEEL H-PILE CRUTCH BENT	
Bridge No: 500232	Drawn By: JCB	Date: 12/16/2008	File Name: S0158000658

W/S EAST SIDE BENT 1: 7.3'
BOTTOM COMP: SILT, CLAY
PROBE: +/- 1FT
