NC DEPARTMENT OF TRANSPORTATION
 DIVISION OF HIGHWAYS
 STRUCTURE MANAGEMENT UNIT

ATTENTION: **IMPACT DAMAGE: SPAN 1, BEAMS 1, 4, AND 5 - PROMPT ACTION REQUESTED**

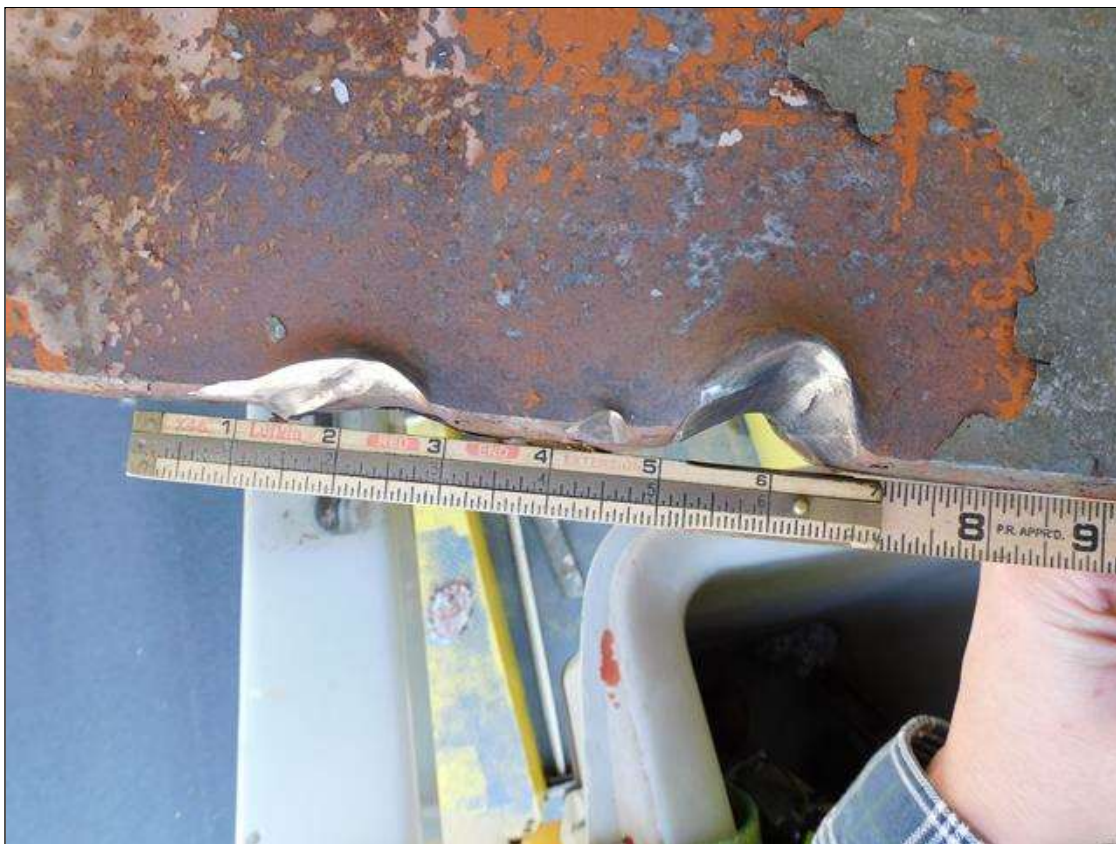
Span 1 Beam 1: IMPACT DAMAGE 4/2022: (2) INDENTIONS UP TO 1-1/2"W x 5/8"D ON NORTH EDGE OF BOTTOM FLANGE AT 55' FROM END BENT 1 BEARING (PAR)

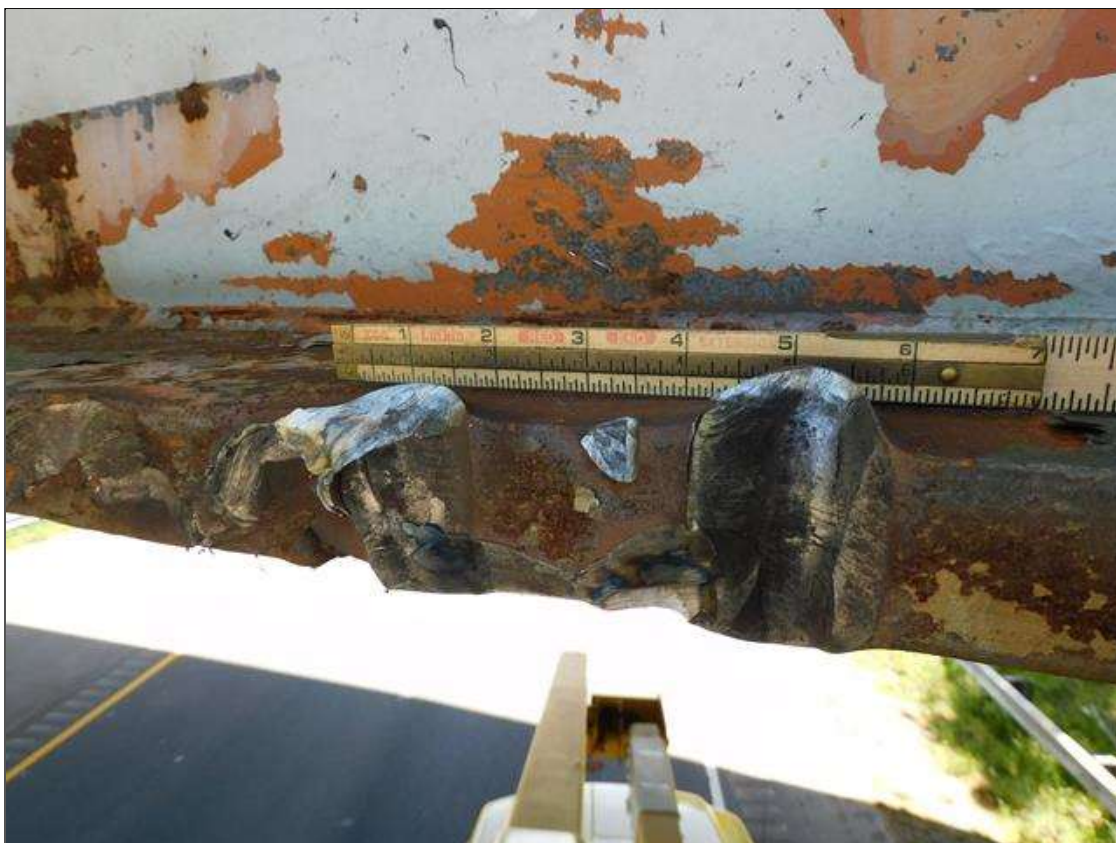
Span 1 Beam 1: IMPACT DAMAGE 4/2022: (2) INDENTIONS UP TO 1-1/2"W x 5/8"D ON NORTH EDGE OF BOTTOM FLANGE AT 55' FROM END BENT 1 BEARING (PAR)

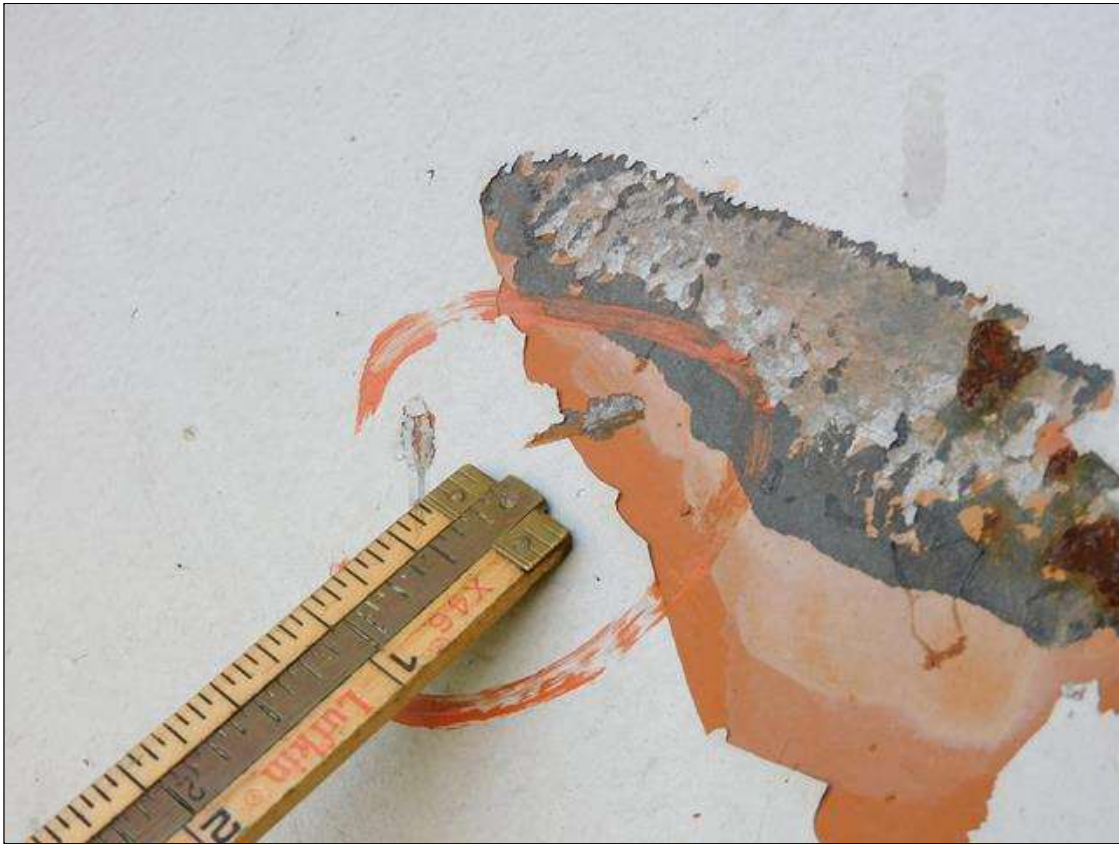
Span 1 Beam 1: IMPACT DAMAGE 4/2022: (3) GOUGES UP TO 2"L x 1/16"D SCATTERED ON BOTTOM 18" OF WEB - LOCATED 55' FROM END BENT 1 BEARING

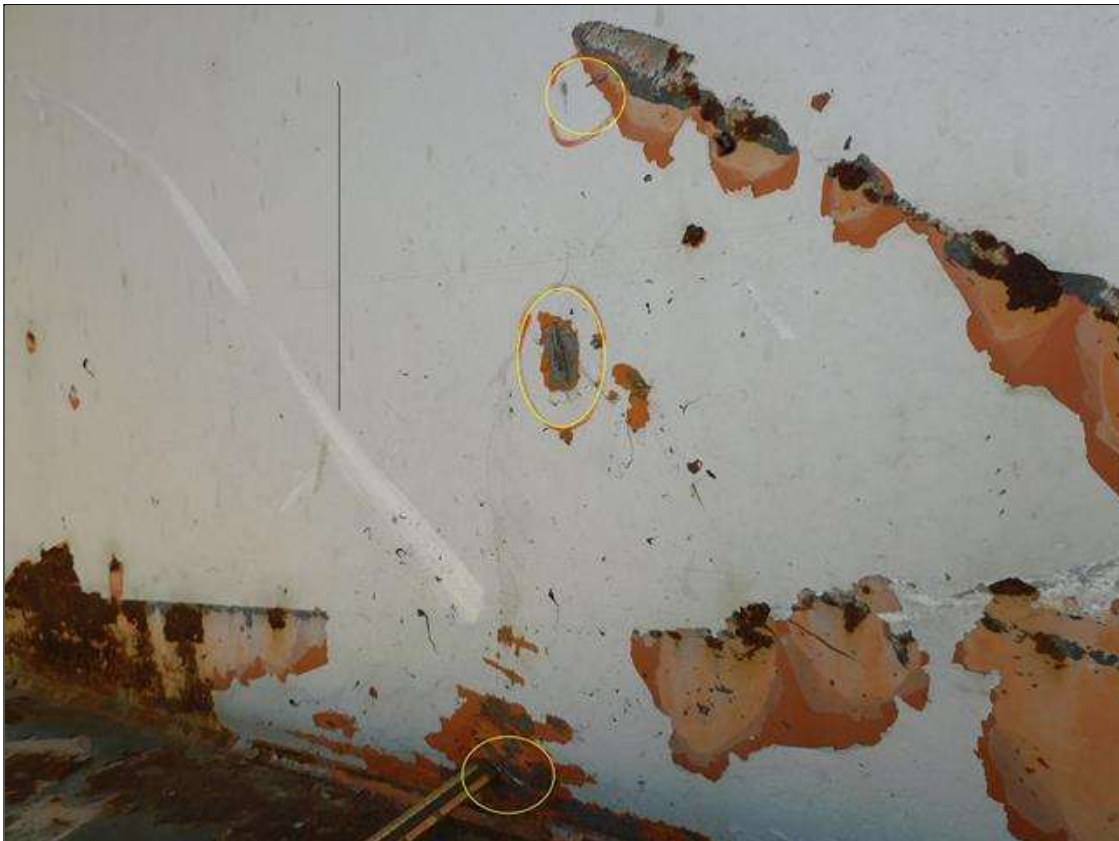
Span 1 Beam 1: IMPACT DAMAGE 4/2022: (3) GOUGES UP TO 2"L x 1/16"D SCATTERED ON BOTTOM 18" OF WEB - LOCATED 55' FROM END BENT 1 BEARING

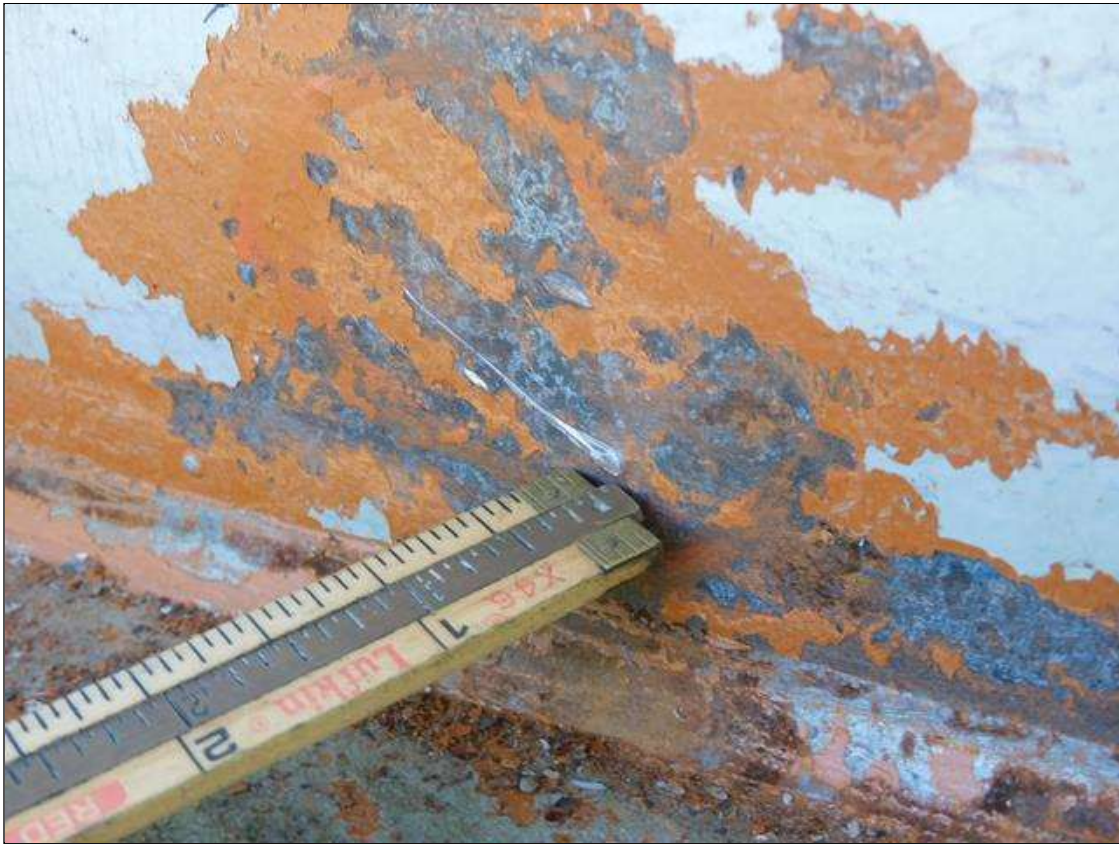
Span 1 Beam 1: IMPACT DAMAGE 4/2022: (3) GOUGES UP TO 2"L x 1/16"D SCATTERED ON BOTTOM 18" OF WEB - LOCATED 55' FROM END BENT 1 BEARING

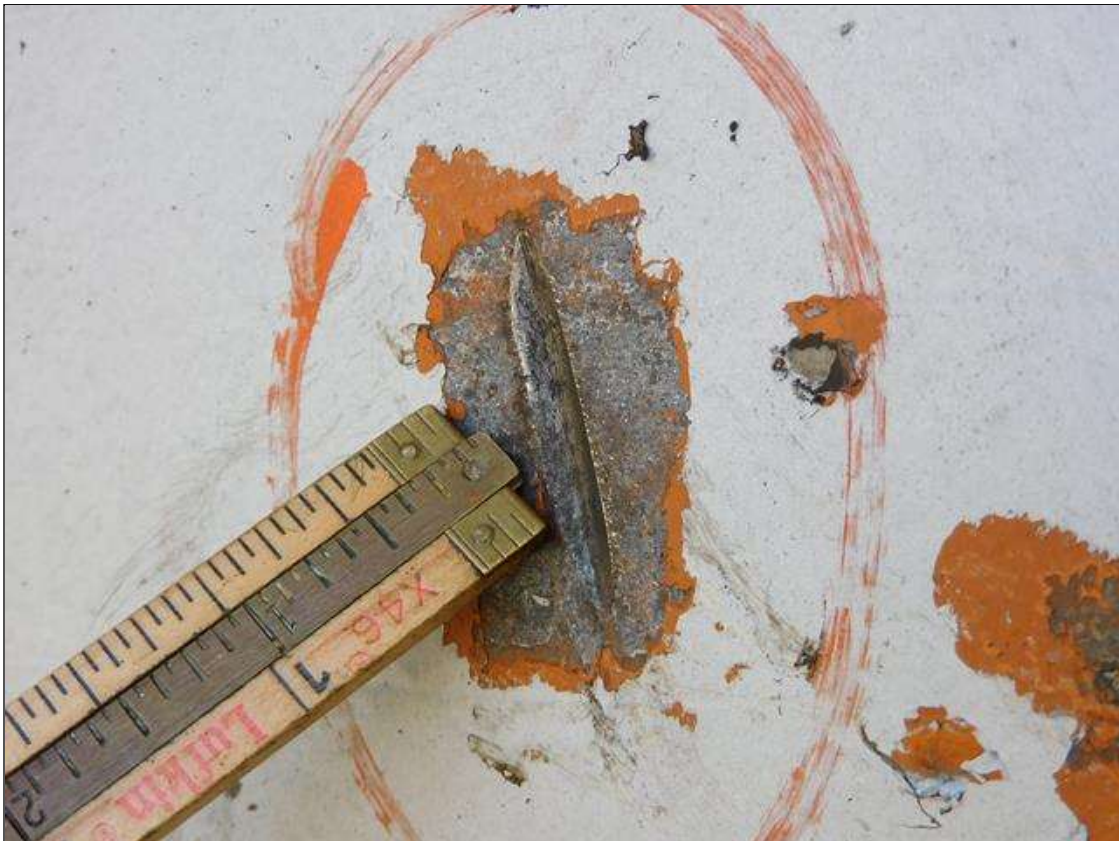
Span 1 Beam 1: IMPACT DAMAGE 4/2022: (3) GOUGES UP TO 2"L x 1/16"D SCATTERED ON BOTTOM 18" OF WEB - LOCATED 55' FROM END BENT 1 BEARING

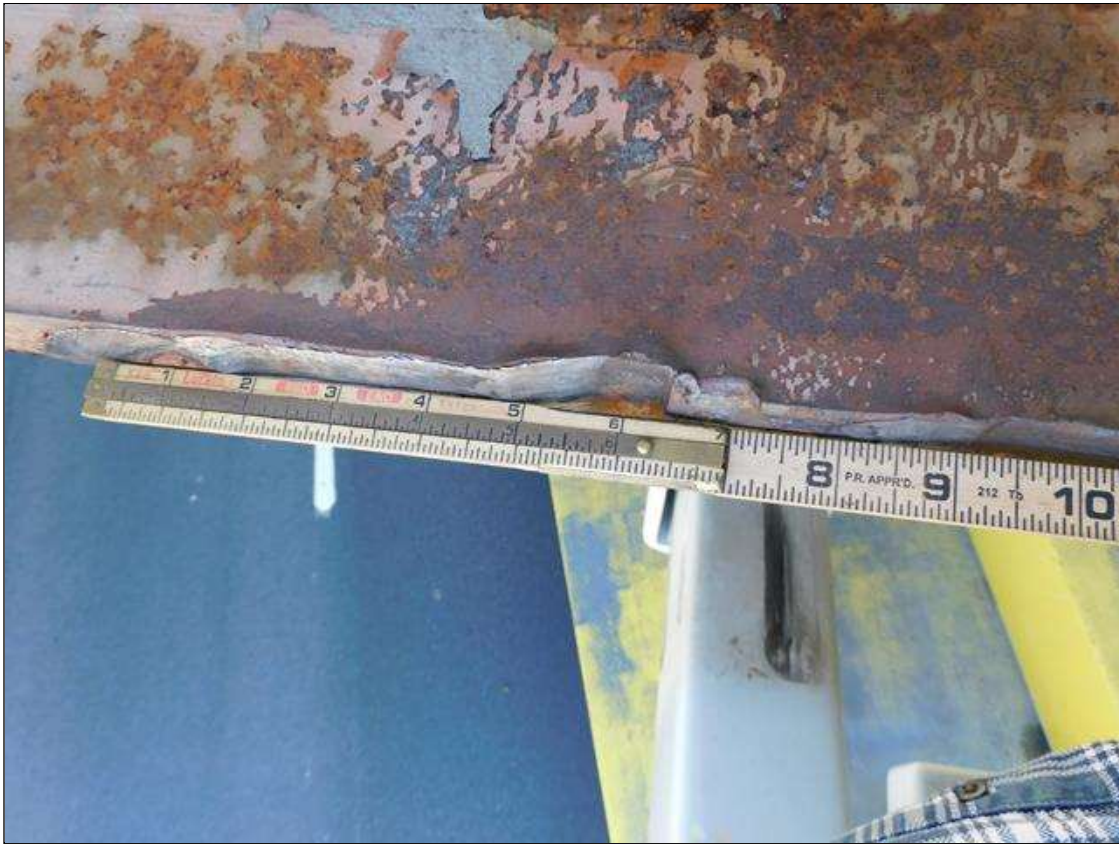
Span 1 Beam 1: IMPACT DAMAGE 4/2022: INDENTIONS UP TO 1-1/2"W x 1/4"D SCATTERED ALONG 10" SECTION OF BOTTOM FLANGE ON NORTH SIDE - LOCATED 56' FROM END BENT 1 BEARING (PAR)

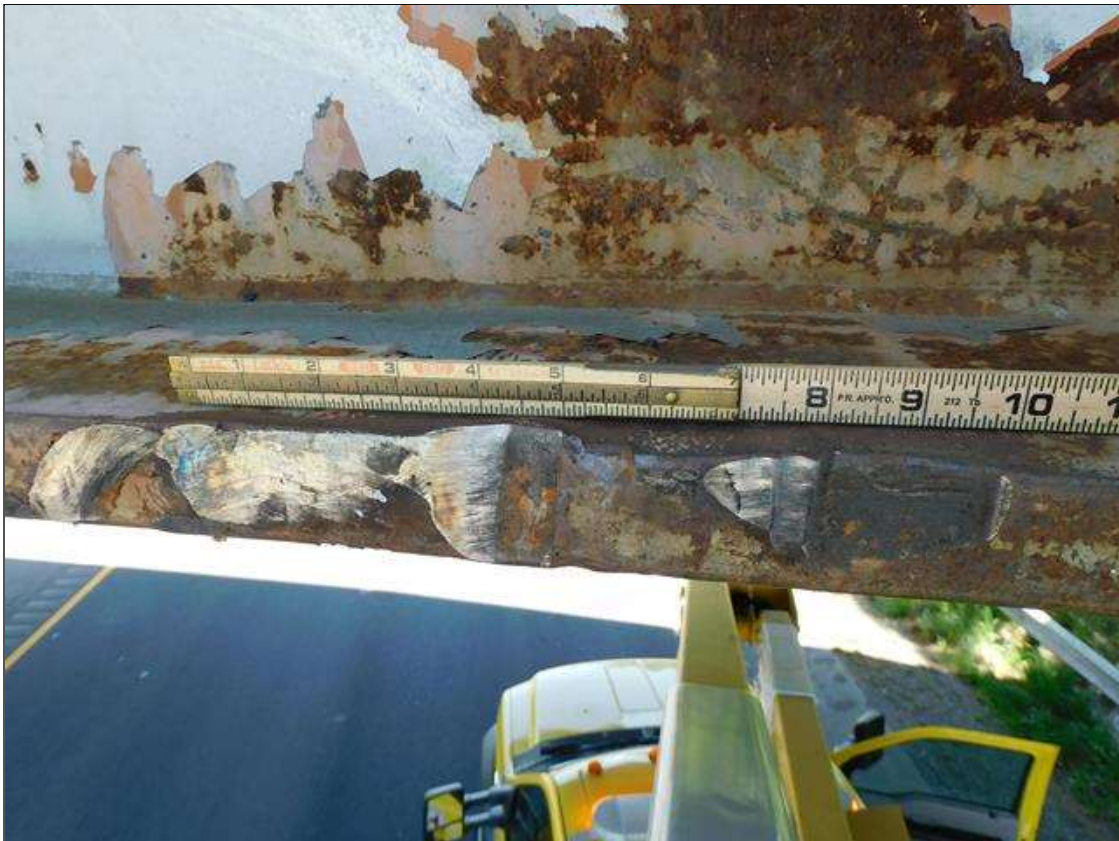
Span 1 Beam 1: IMPACT DAMAGE 4/2022: INDENTIONS UP TO 1-1/2"W x 1/4"D SCATTERED ALONG 10" SECTION OF BOTTOM FLANGE ON NORTH SIDE - LOCATED 56' FROM END BENT 1 BEARING (PAR)

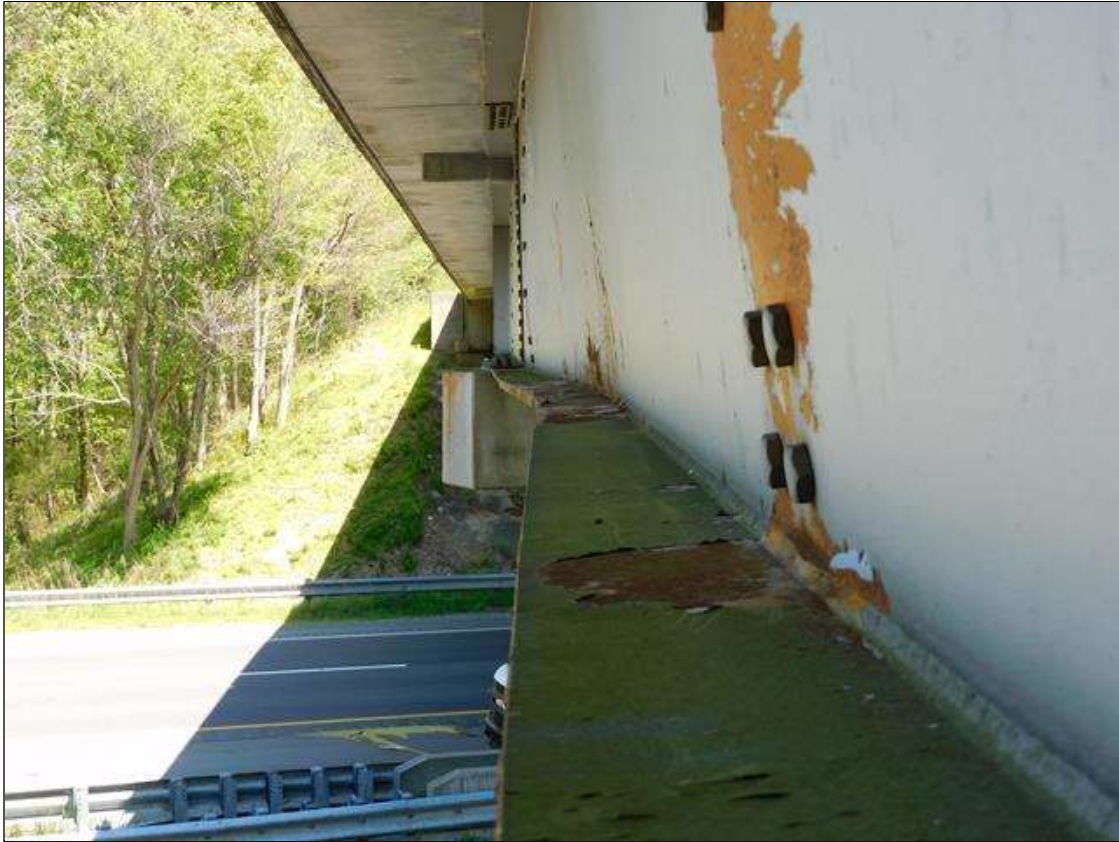
Span 1 Beam 1: IMPACT DAMAGE 4/2022: 23LF OF BEAM OUT OF PLUMB TO THE SOUTH UP TO 4-3/4" - MAX DEFLECTION AT 55' FROM END BENT 1 BEARING - SECTION LOCATED BETWEEN INT. DIAPHRAGMS 2 AND 3 (PAR)

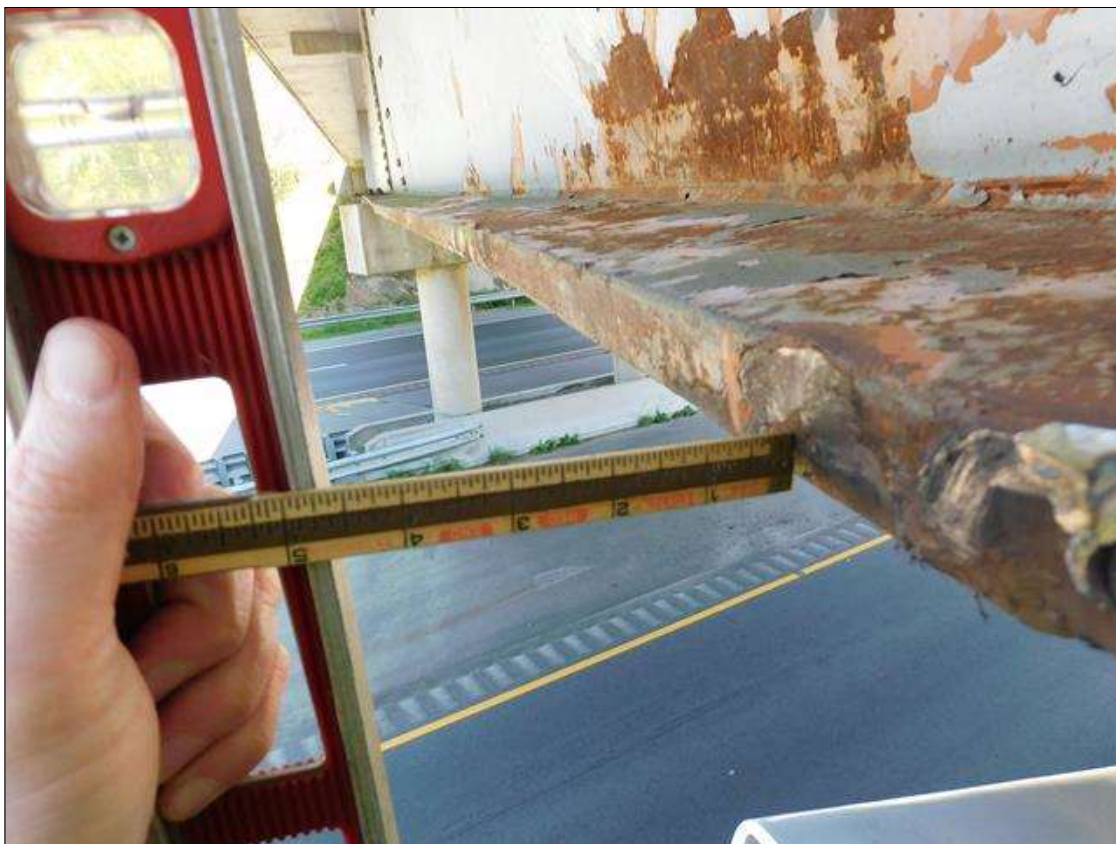
Span 1 Beam 1: IMPACT DAMAGE 4/2022: 23LF OF BEAM OUT OF PLUMB TO THE SOUTH UP TO 4-3/4" - MAX DEFLECTION AT 55' FROM END BENT 1 BEARING - SECTION LOCATED BETWEEN INT. DIAPHRAGMS 2 AND 3 (PAR)

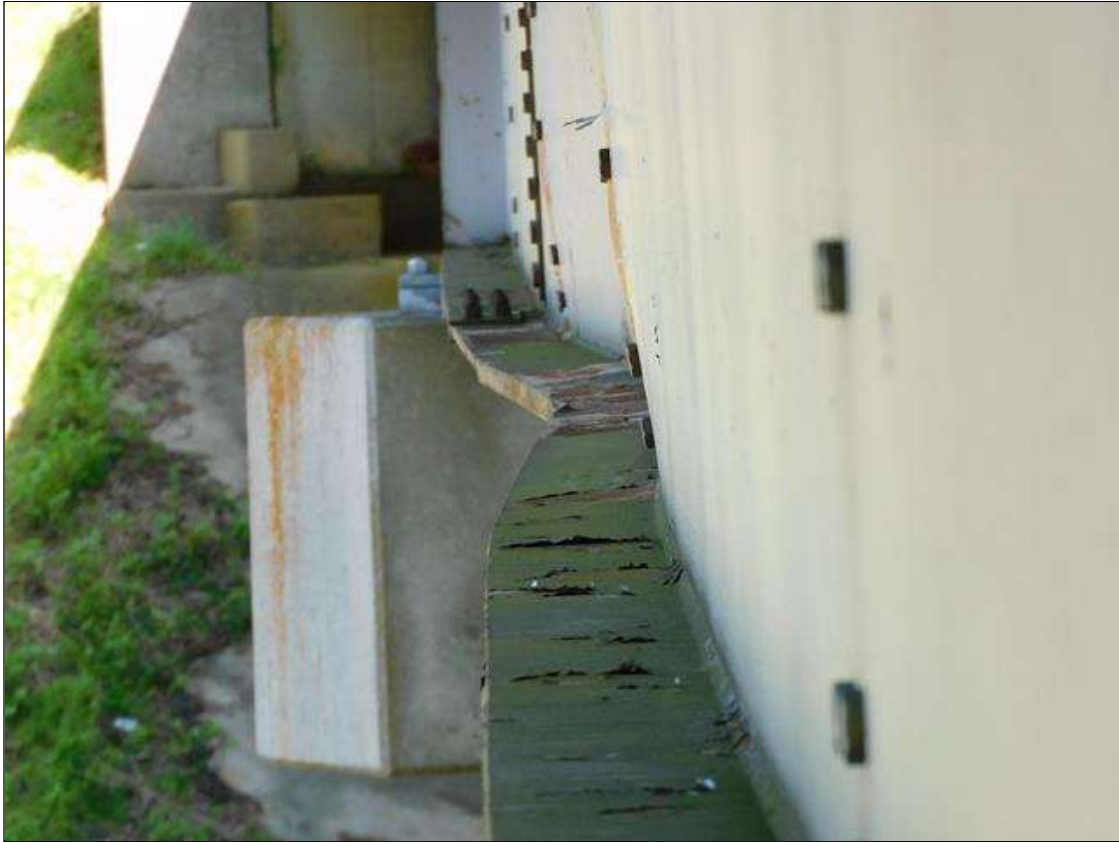
Span 1 Beam 1: IMPACT DAMAGE 4/2022: 23LF OF BEAM OUT OF PLUMB TO THE SOUTH UP TO 4-3/4" - MAX DEFLECTION AT 55' FROM END BENT 1 BEARING - SECTION LOCATED BETWEEN INT. DIAPHRAGMS 2 AND 3 (PAR)

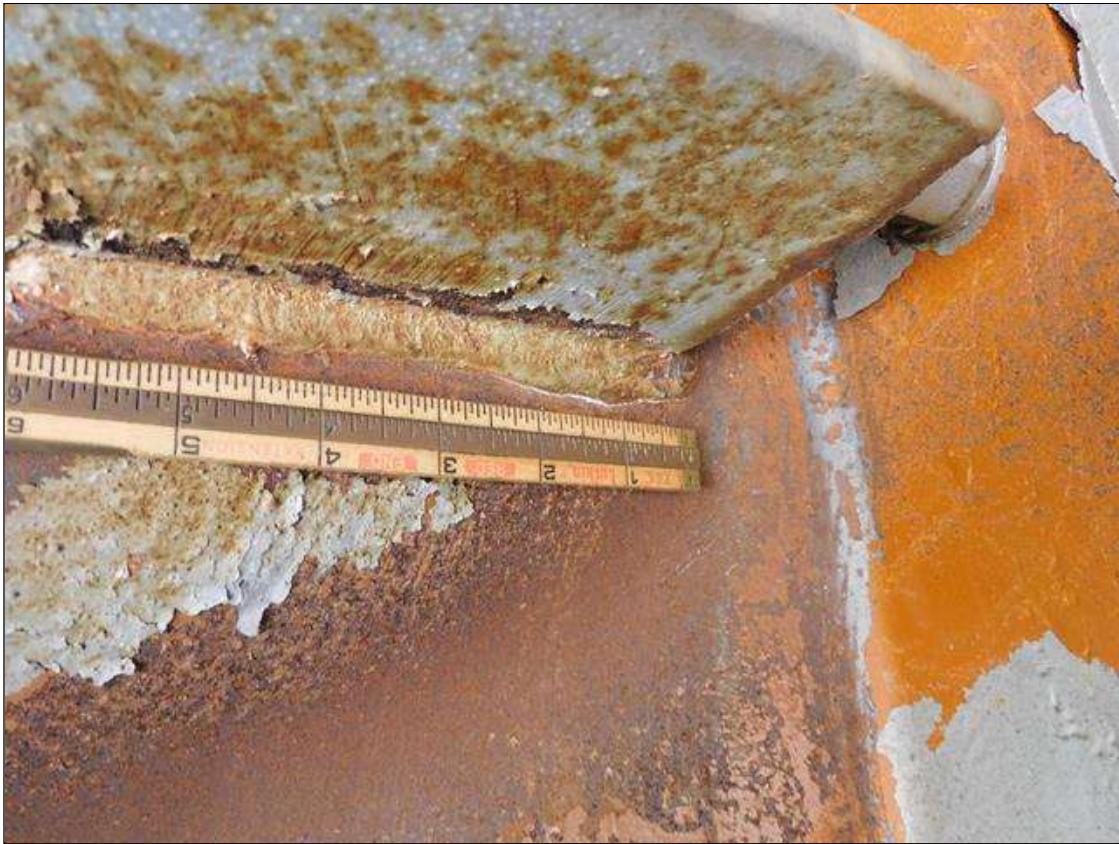
Span 1 Bay 1: IMPACT DAMAGE 4/2022 - INT. DIAPHRAGM 2, BEAM 1 CONNECTION, BOTTOM WELD - 4"L CRACK AT TOE OF WELD (PAR)

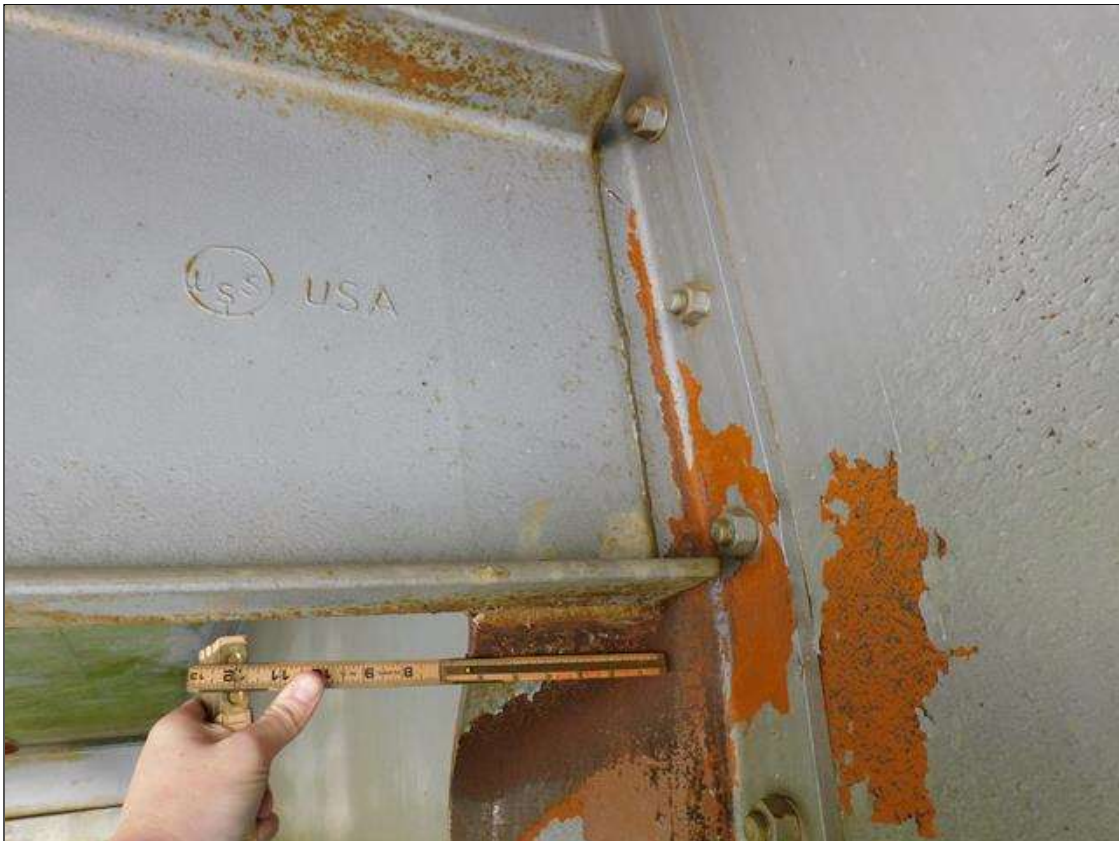
ALT VIEW - Span 1 Bay 1: IMPACT DAMAGE 4/2022 - INT. DIAPHRAGM 2, BEAM 1 CONNECTION, BOTTOM WELD - 4"L CRACK AT TOE OF WELD (PAR)

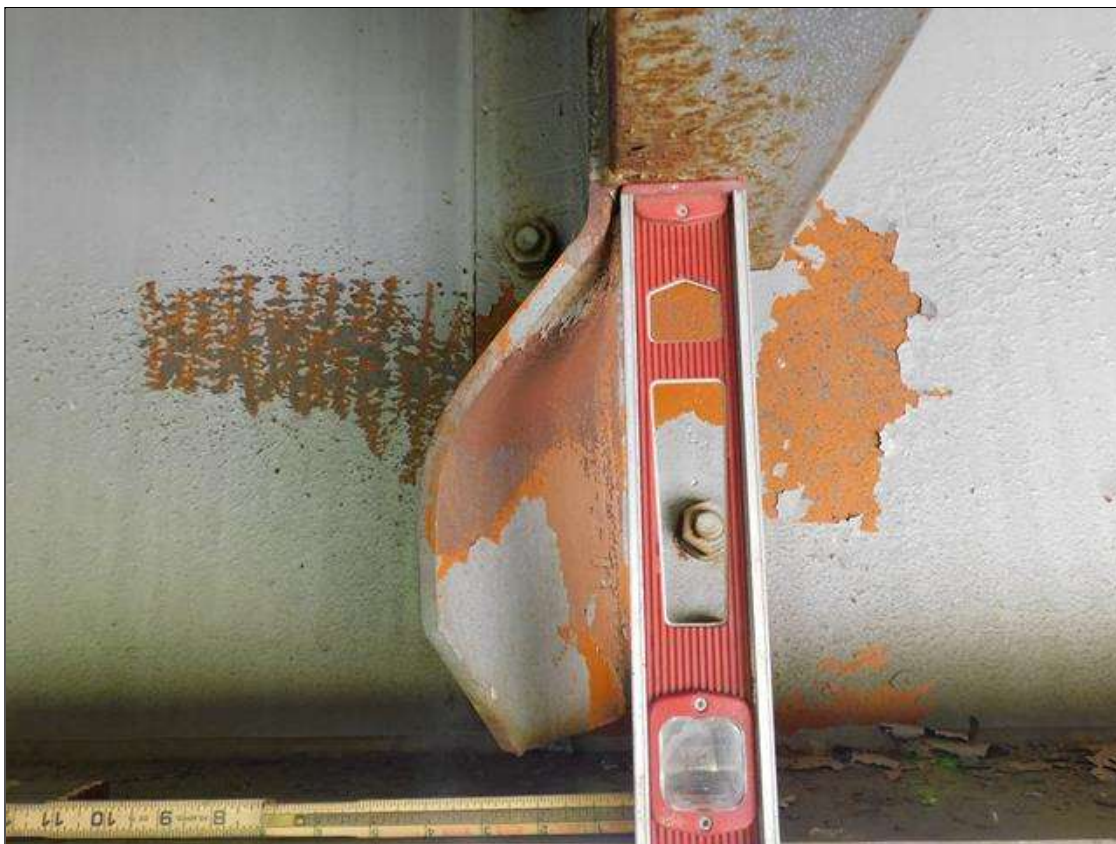
Span 1 Bay 1: IMPACT DAMAGE 4/2022 - INT. DIAPHRAGM 2, BEAM 1 CONNECTION BRACKET - BOTTOM 10" BENT 4" TO THE WEST (PAR)

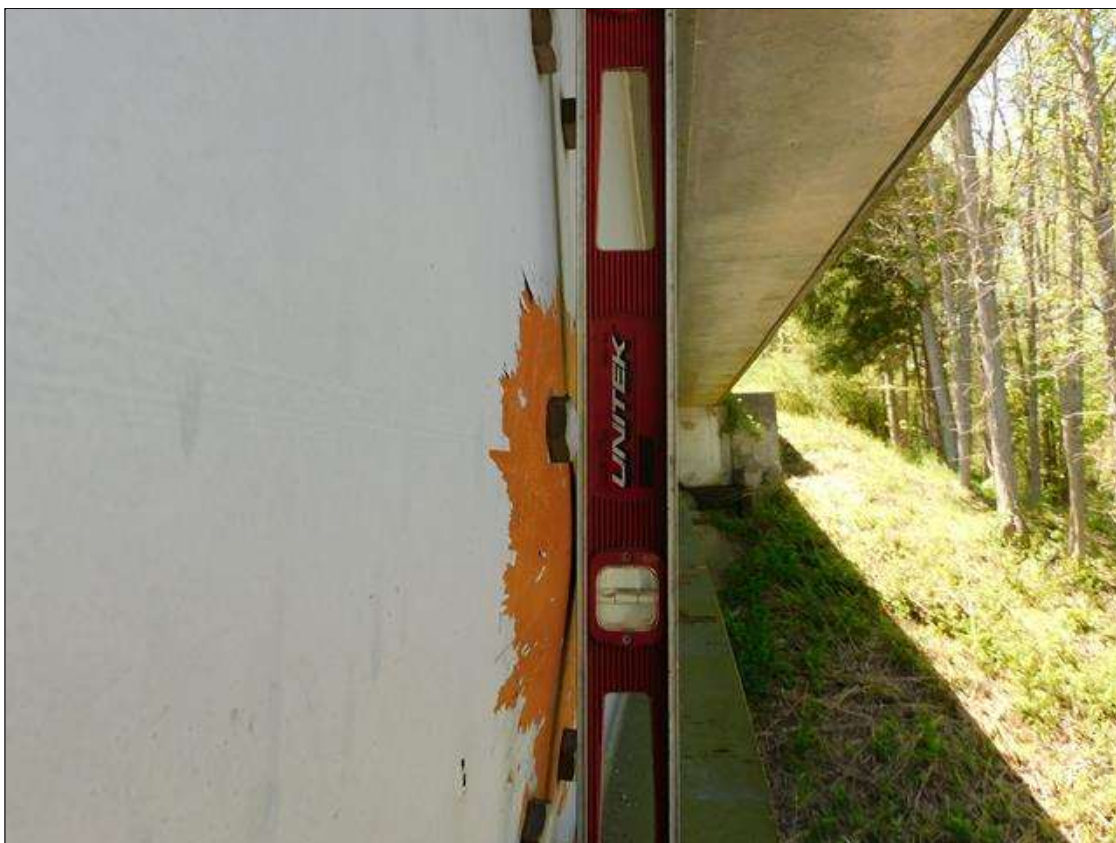
Span 1 Beam 1: IMPACT DAMAGE 4/2022 - 24" DIAMETER SECTION OF WEB DEFLECTED 1-1/4" TO THE NORTH AT INT. DIAPHRAGM 2 CONNECTION (PAR)

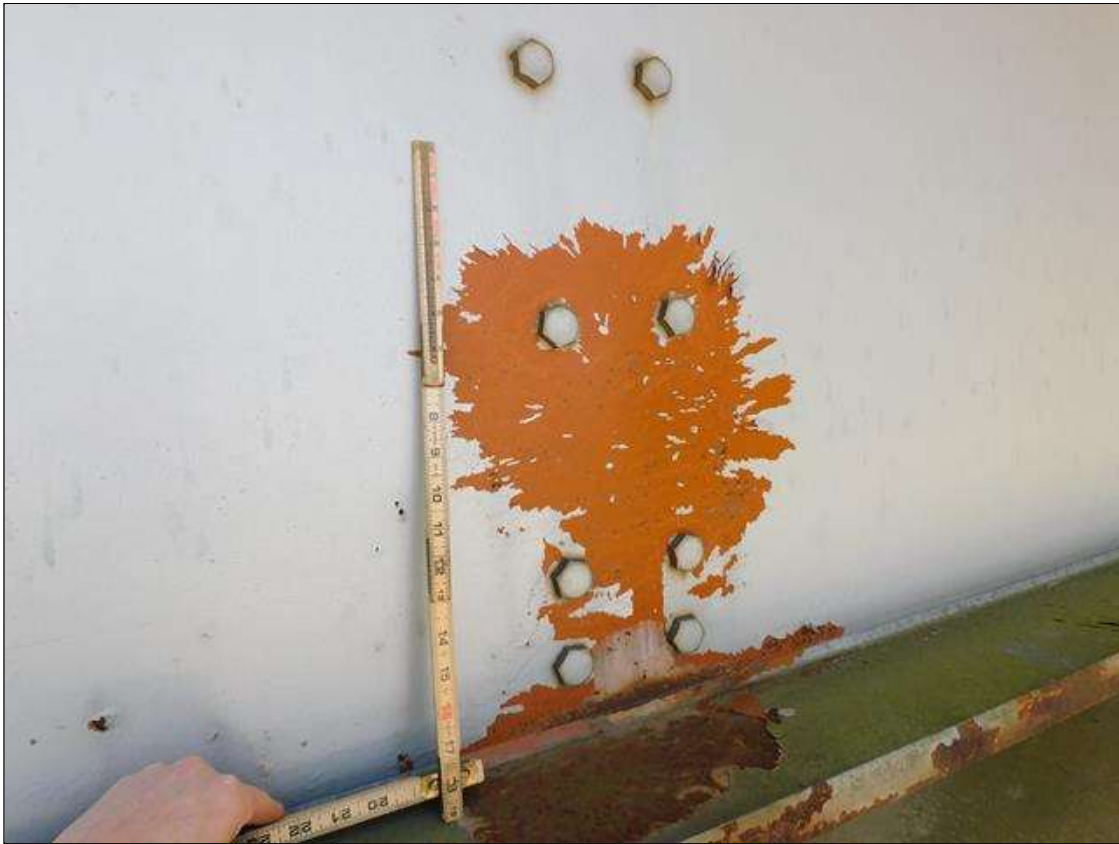
Span 1 Beam 1: IMPACT DAMAGE 4/2022 - 24" DIAMETER SECTION OF WEB DEFLECTED 1-1/4" TO THE NORTH AT INT. DIAPHRAGM 2 CONNECTION (PAR)

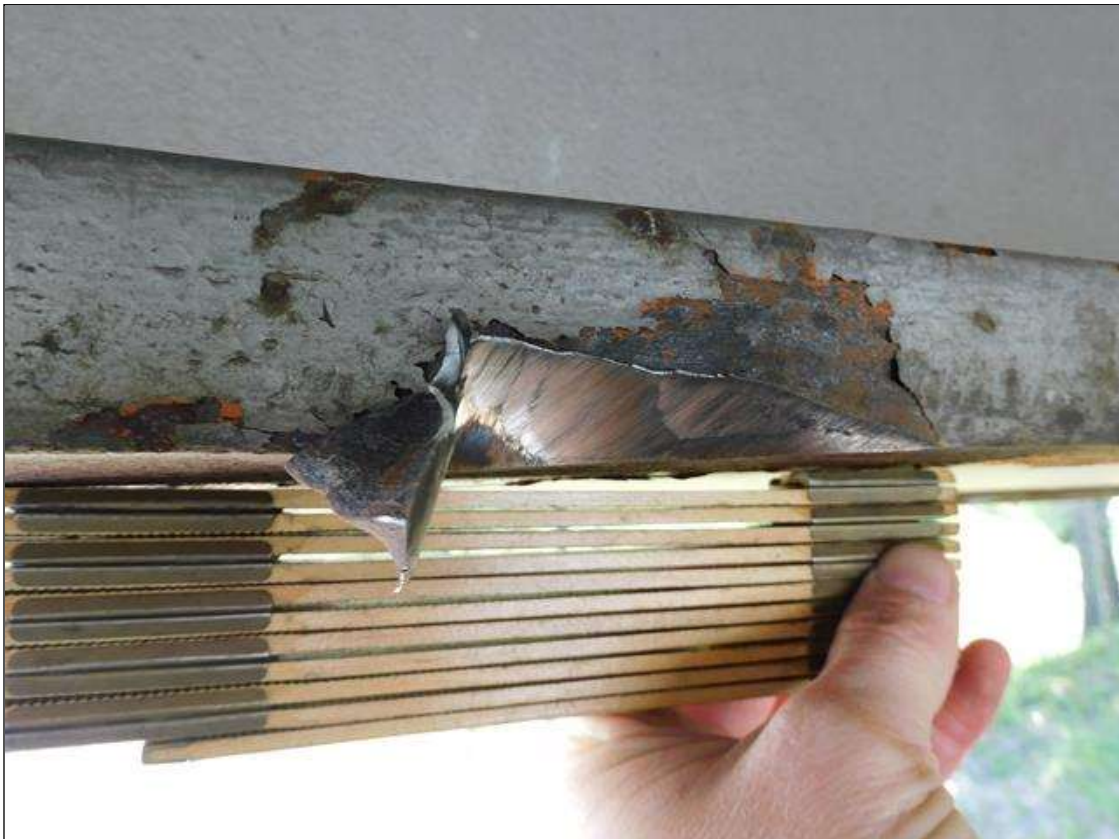
Span 1 Beam 4: IMPACT DAMAGE 4/2022: 3-1/2"L GOUGE UP TO 5/8"D ON NORTH EDGE OF BOTTOM FLANGE - LOCATED 56' FROM END BENT 1 BEARING (PAR)

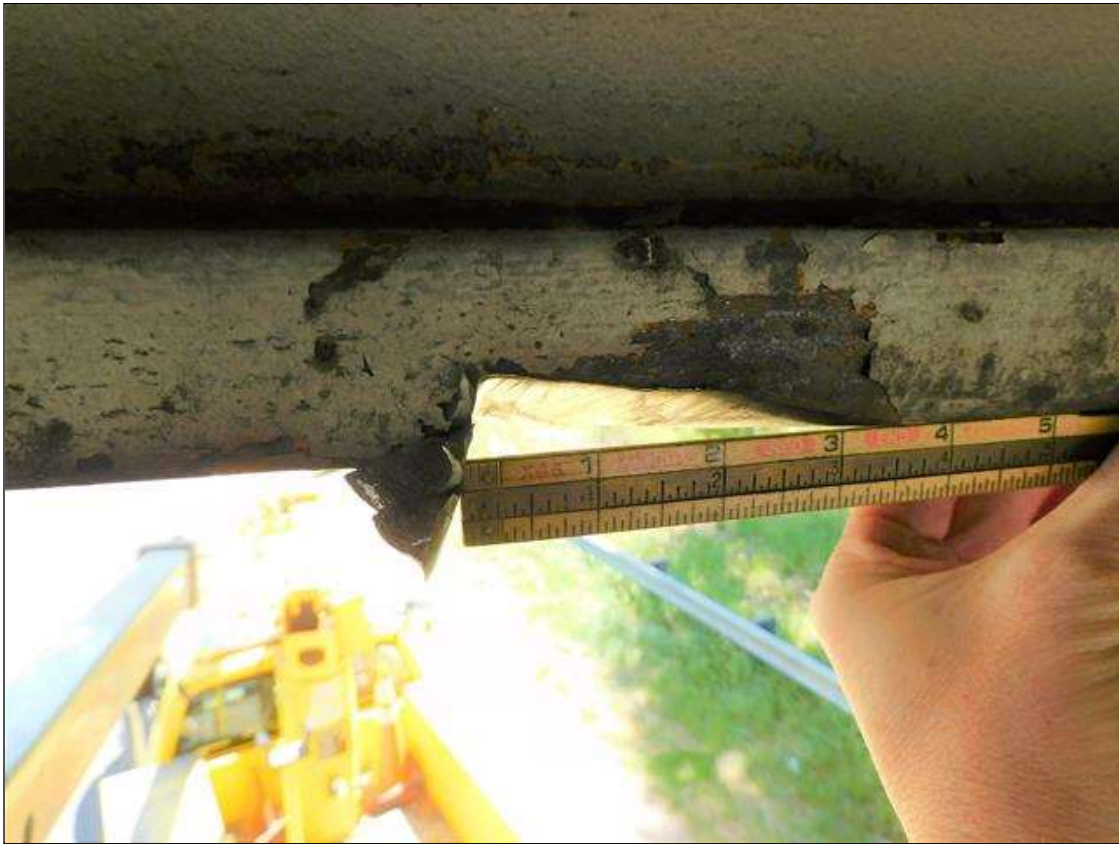
Span 1 Beam 4: IMPACT DAMAGE 4/2022: 3-1/2"L GOUGE UP TO 5/8"D ON NORTH EDGE OF BOTTOM FLANGE - LOCATED 56' FROM END BENT 1 BEARING (PAR)

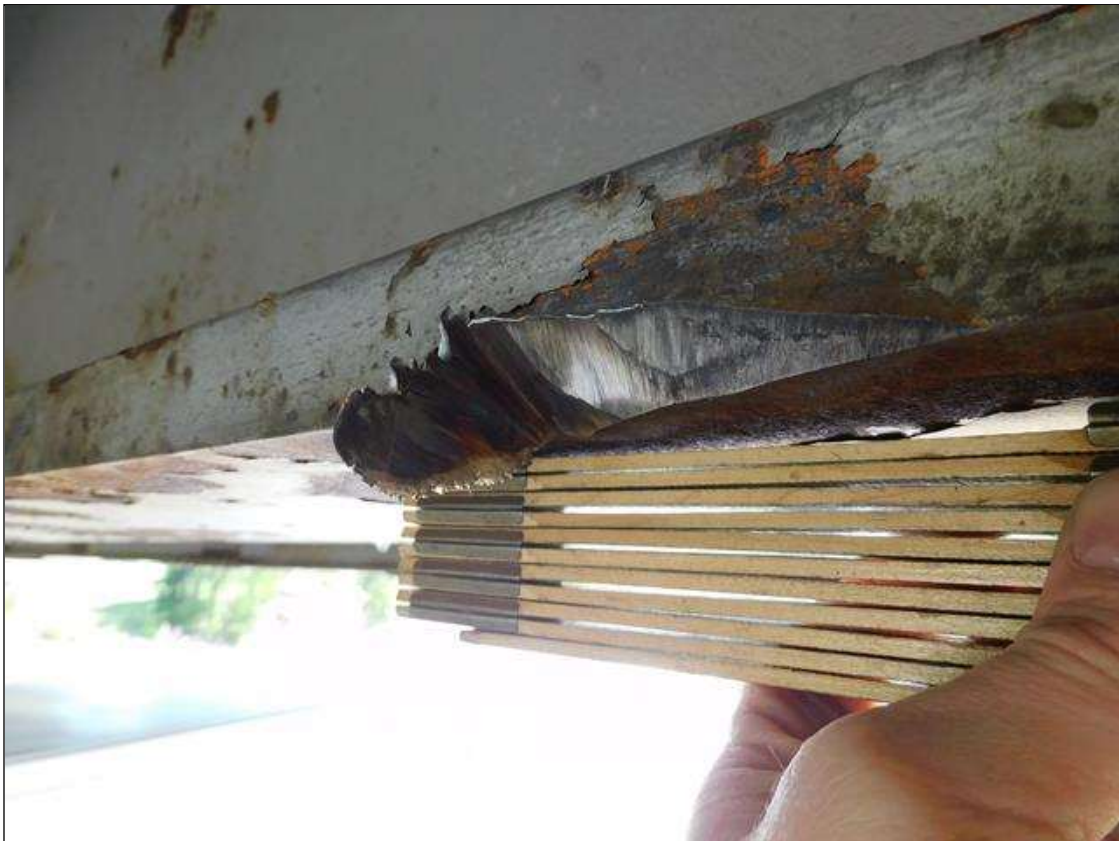
Span 1 Beam 4: IMPACT DAMAGE 4/2022: 3-1/2"L GOUGE UP TO 5/8"D ON NORTH EDGE OF BOTTOM FLANGE - LOCATED 56' FROM END BENT 1 BEARING (PAR)

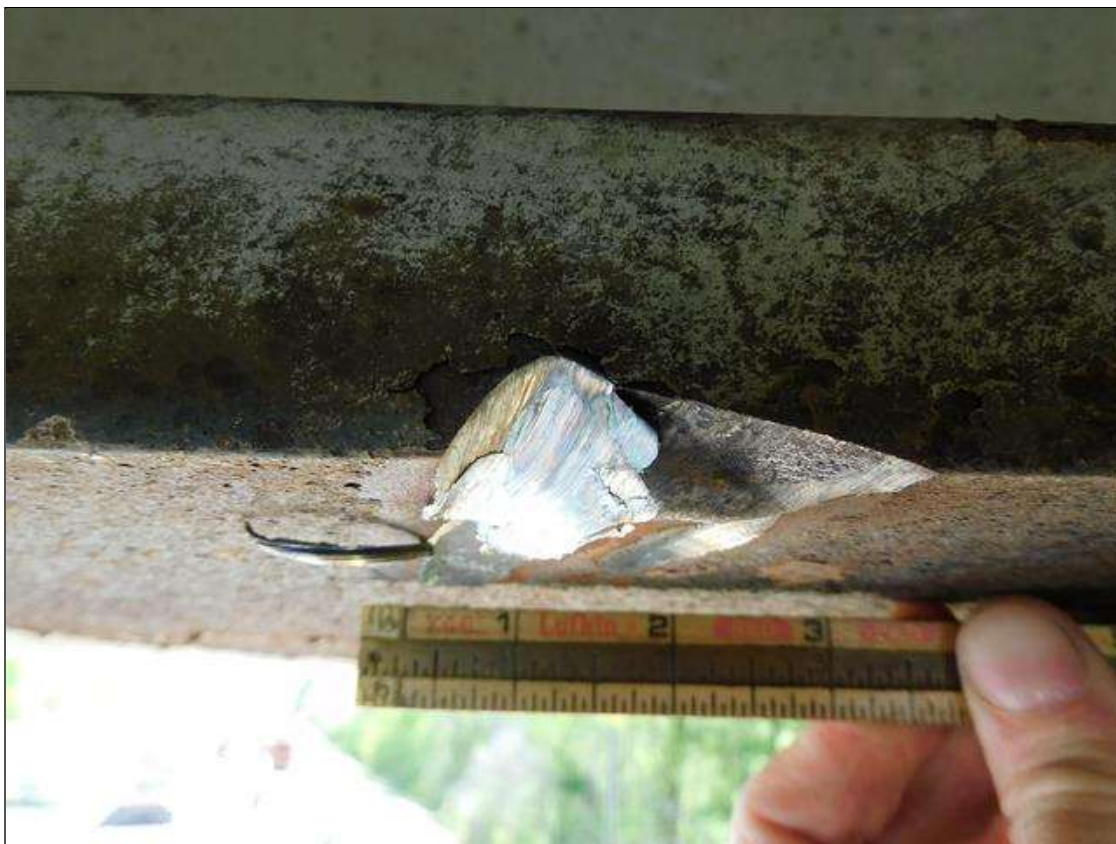
Span 1 Beam 5: IMPACT DAMAGE 4/2022: 2"W x 3"L x 3/8"D GOUGE ON NORTH EDGE OF BOTTOM FLANGE AT 56' FROM END BENT 1 BEARING (PAR)

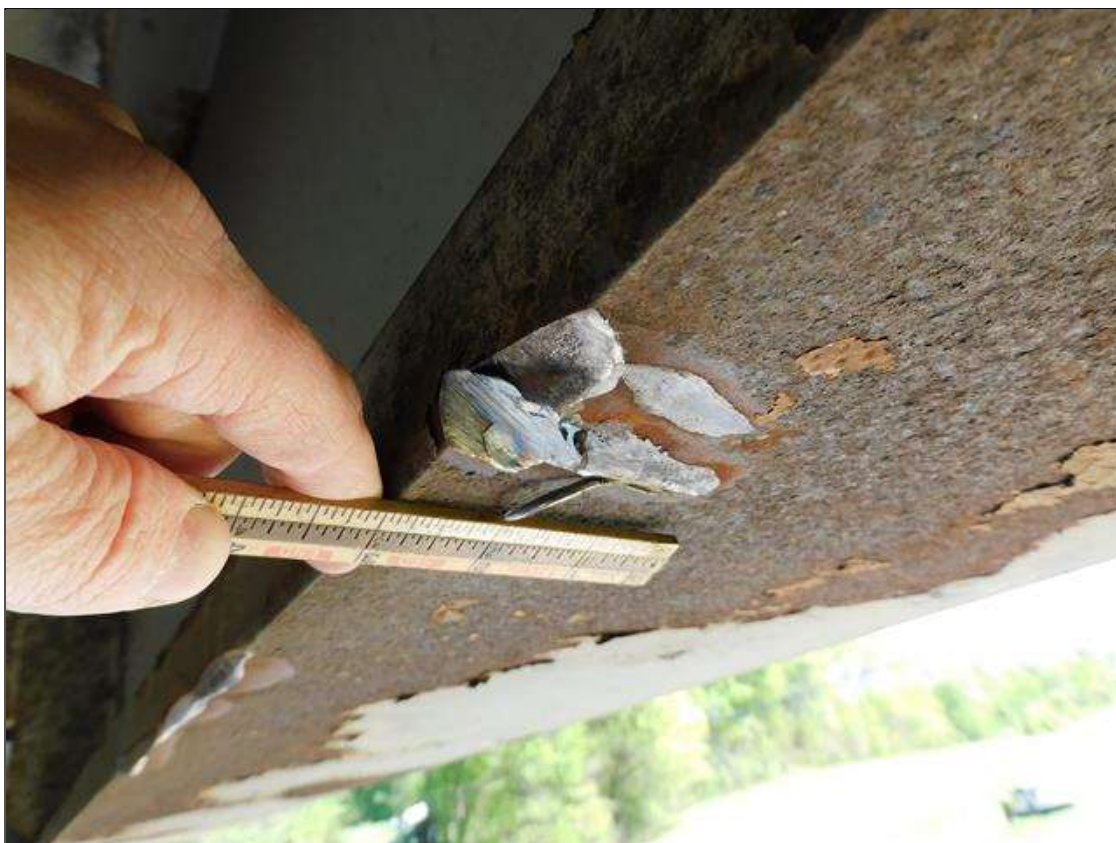
Span 1 Beam 5: IMPACT DAMAGE 4/2022: 2"W x 3"L x 3/8"D GOUGE ON NORTH EDGE OF BOTTOM FLANGE AT 56' FROM END BENT 1 BEARING (PAR)

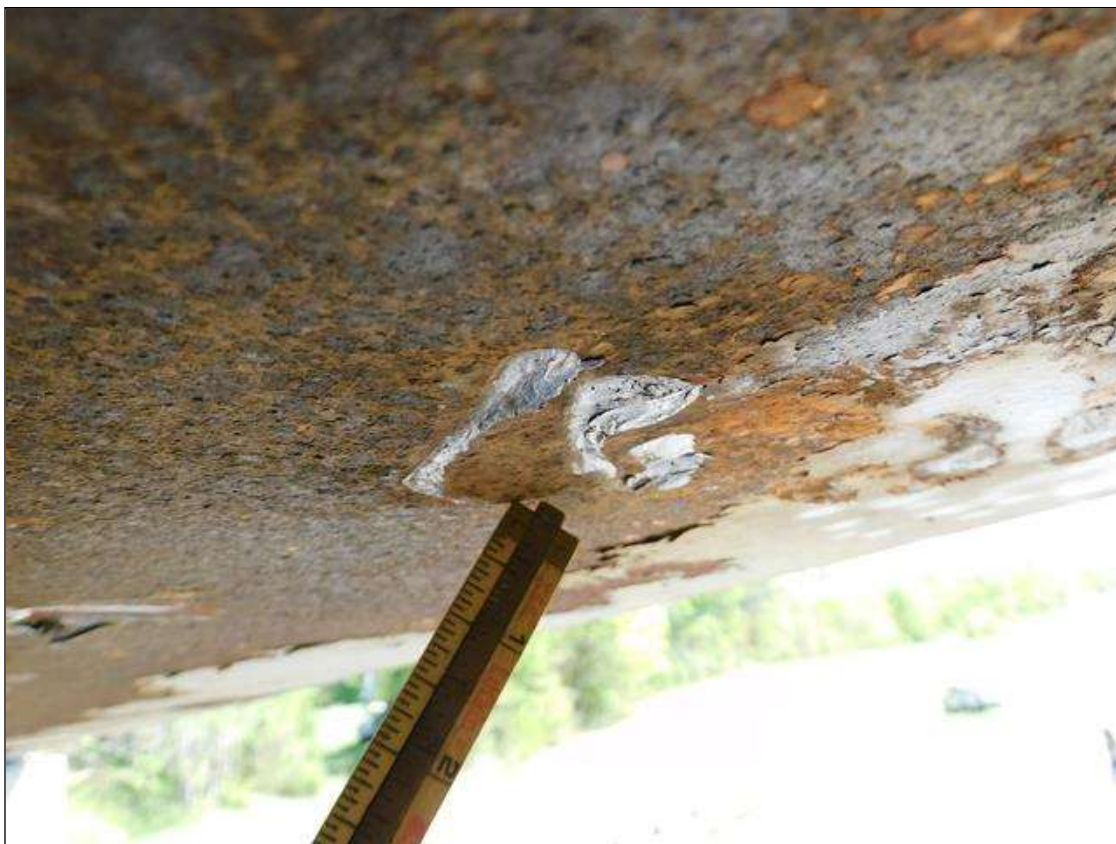
Span 1 Beam 5: IMPACT DAMAGE 4/2022: (3) GOUGES UP TO 2"L x 1/2"W x 1/16"D ON BOTTOM SIDE OF BOTTOM FLANGE - LOCATED 55'-6" FROM END BENT 1 BEARING

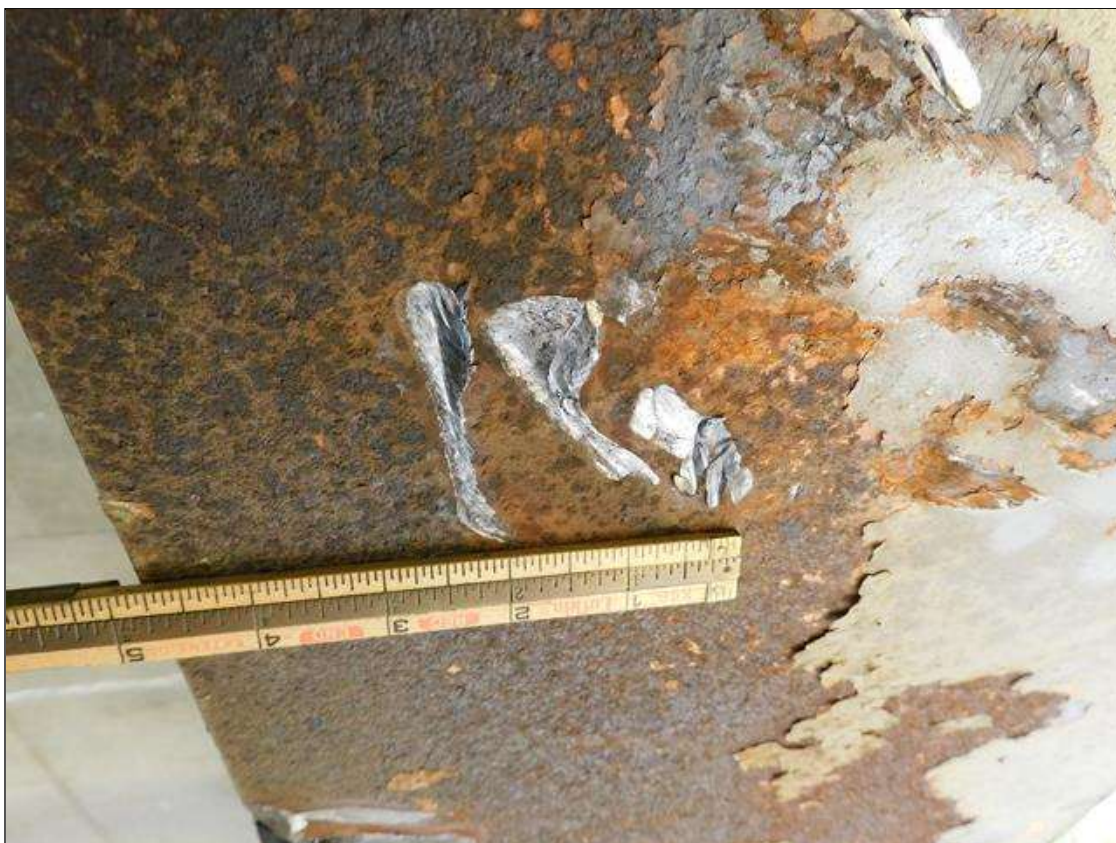
Span 1 Beam 5: IMPACT DAMAGE 4/2022: (3) GOUGES UP TO 2"L x 1/2"W x 1/16"D ON BOTTOM SIDE OF BOTTOM FLANGE - LOCATED 55'-6" FROM END BENT 1 BEARING
