NC DEPARTMENT OF TRANSPORTATION
 DIVISION OF HIGHWAYS
 STRUCTURE MANAGEMENT UNIT

ATTENTION: **IMPACT DAMAGE: SPAN 1, BEAMS 1, 4, AND 5 - PROMPT ACTION REQUESTED**

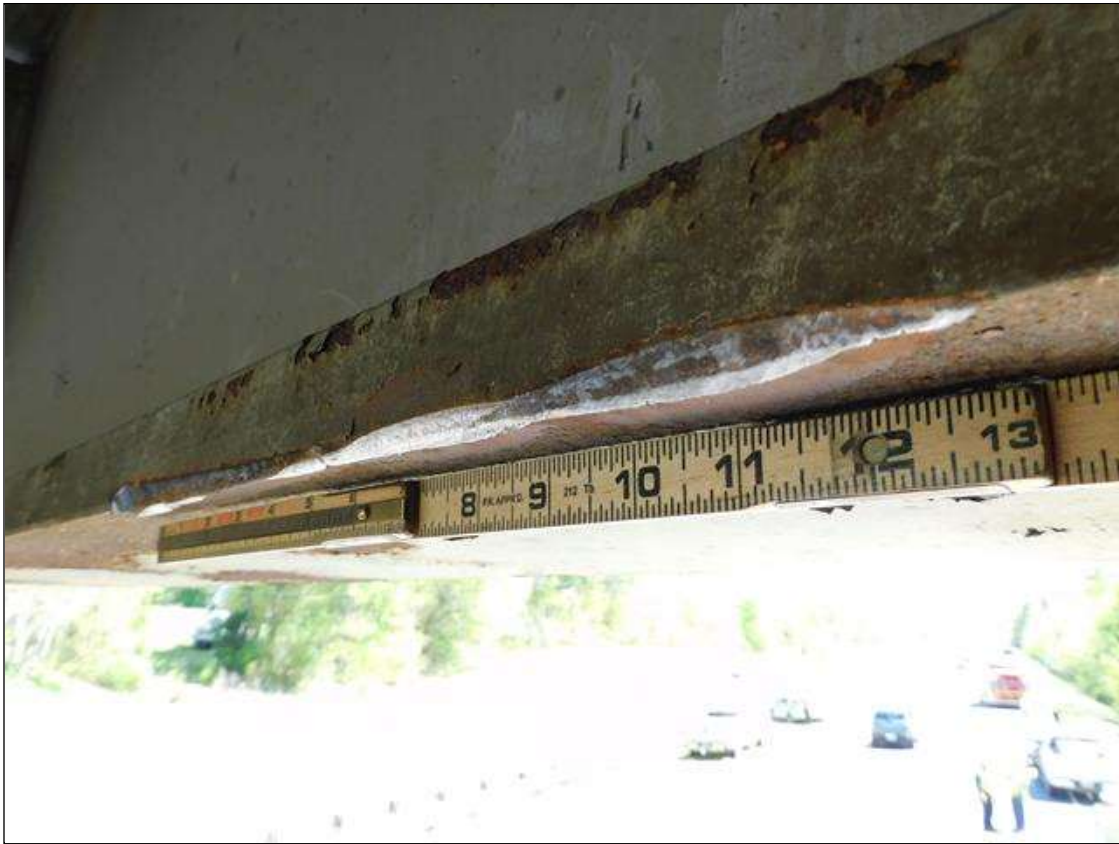
Span 1 Beam 5: IMPACT DAMAGE 4/2022: 13"L x 1/2"W x 1/4"D INDENTION ON NORTH EDGE OF BOTTOM FLANGE AT 57' FROM END BENT 1 BEARING

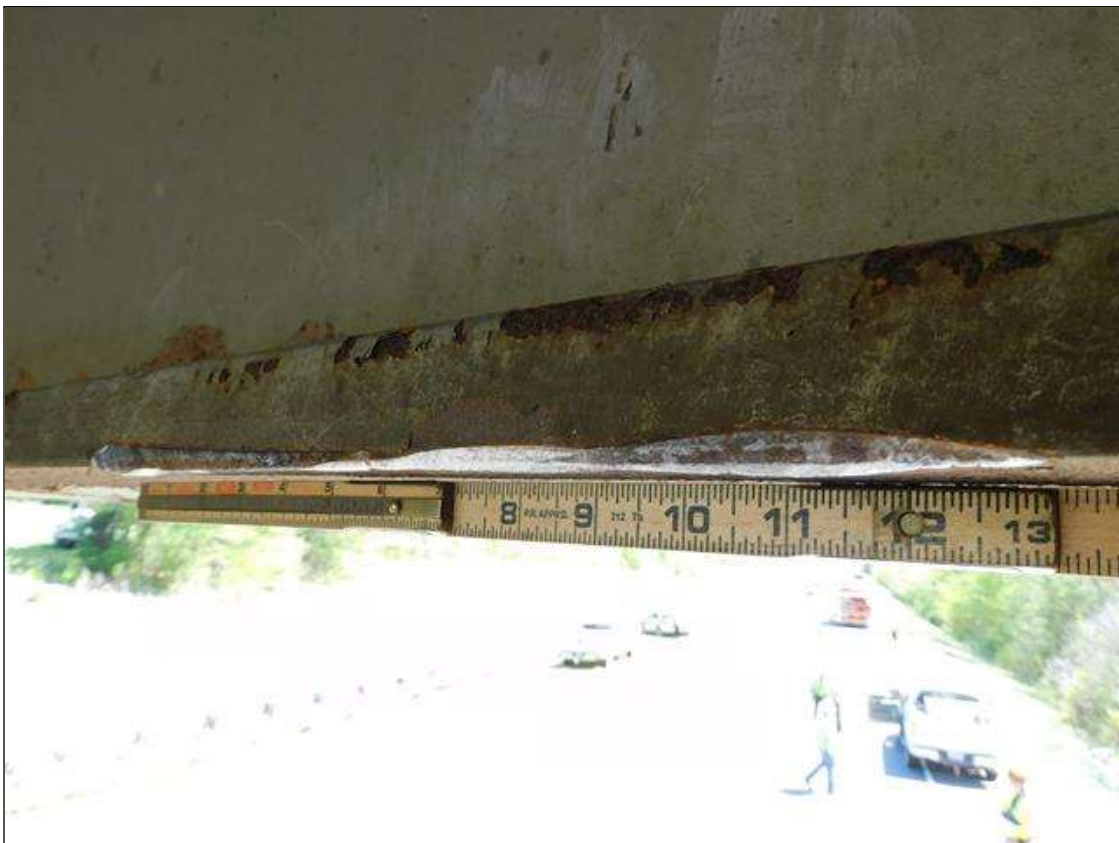
Span 1 Beam 5: IMPACT DAMAGE 4/2022: 13"L x 1/2"W x 1/4"D INDENTION ON NORTH EDGE OF BOTTOM FLANGE AT 57' FROM END BENT 1 BEARING

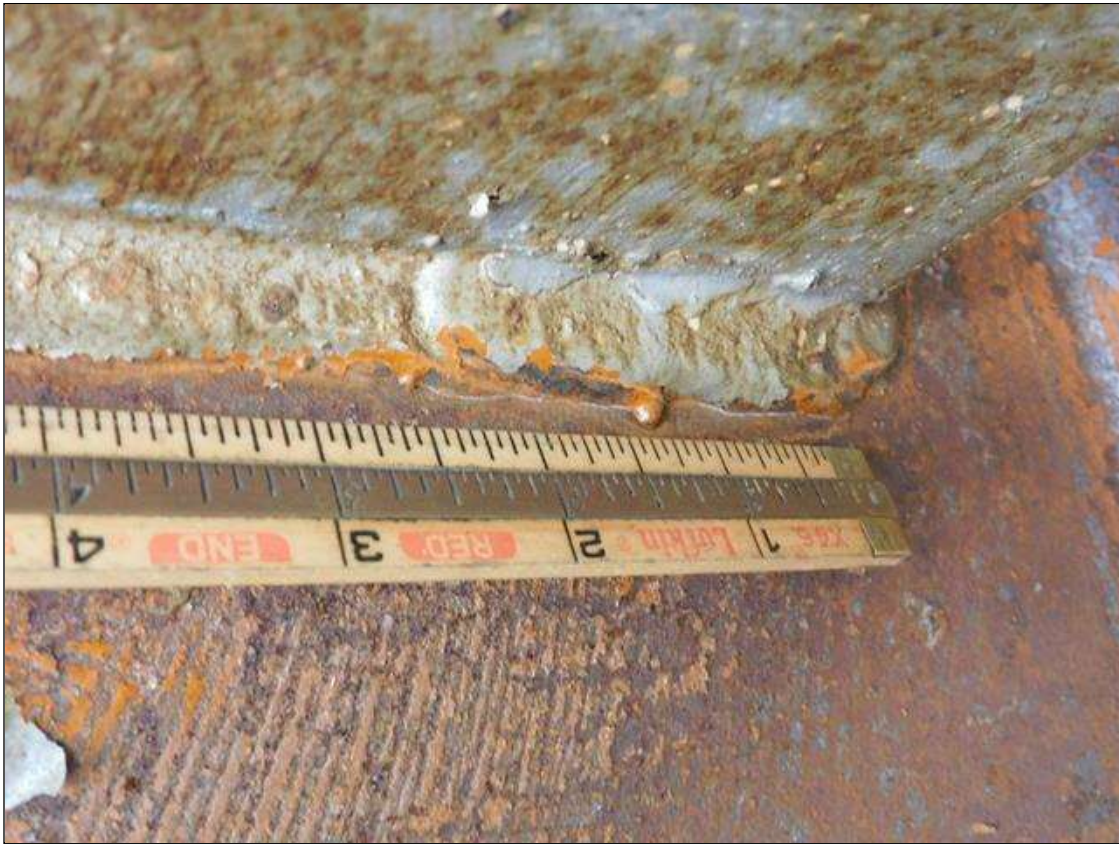
Span 1 Bay 1: IMPACT DAMAGE 4/2022 - INT. DIAPHRAGM 3, BEAM 1 CONNECTION, BOTTOM WELD - 3"L CRACK AT TOE OF WELD (PAR)

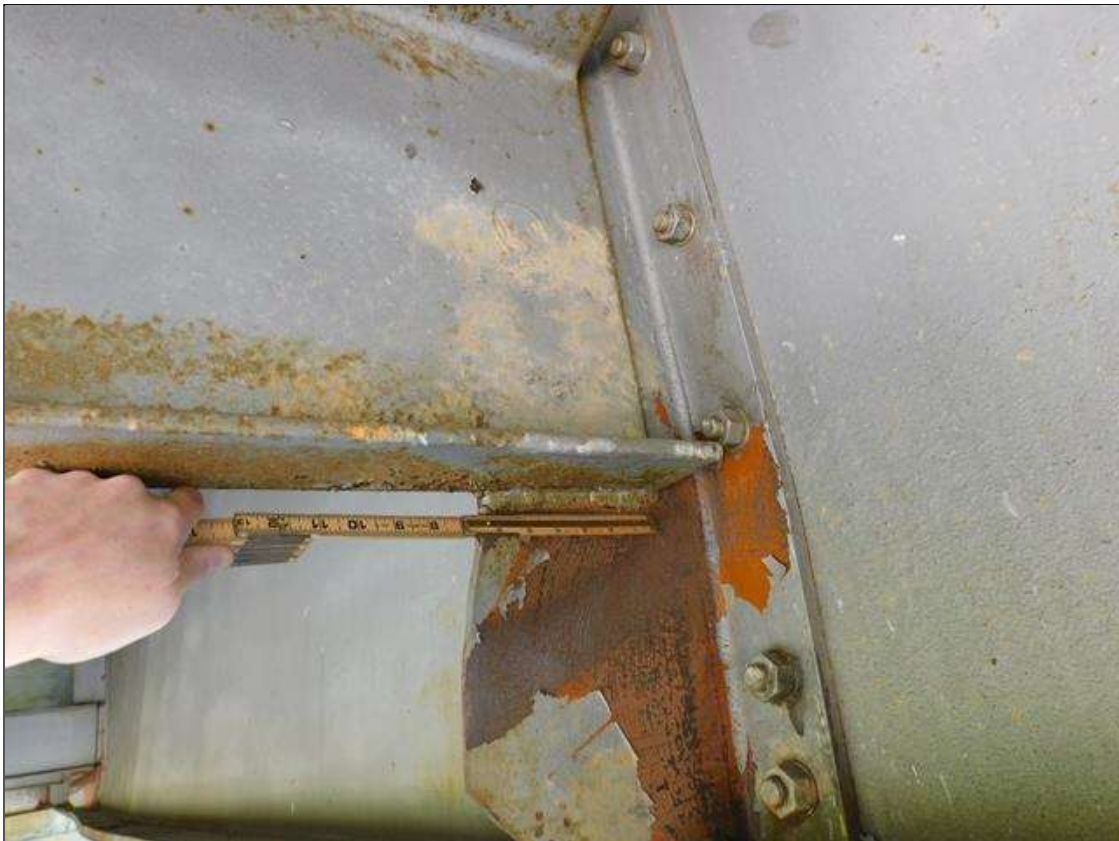
ALT VIEW - Span 1 Bay 1: IMPACT DAMAGE 4/2022 - INT. DIAPHRAGM 3, BEAM 1 CONNECTION, BOTTOM WELD - 3"L CRACK AT TOE OF WELD (PAR)

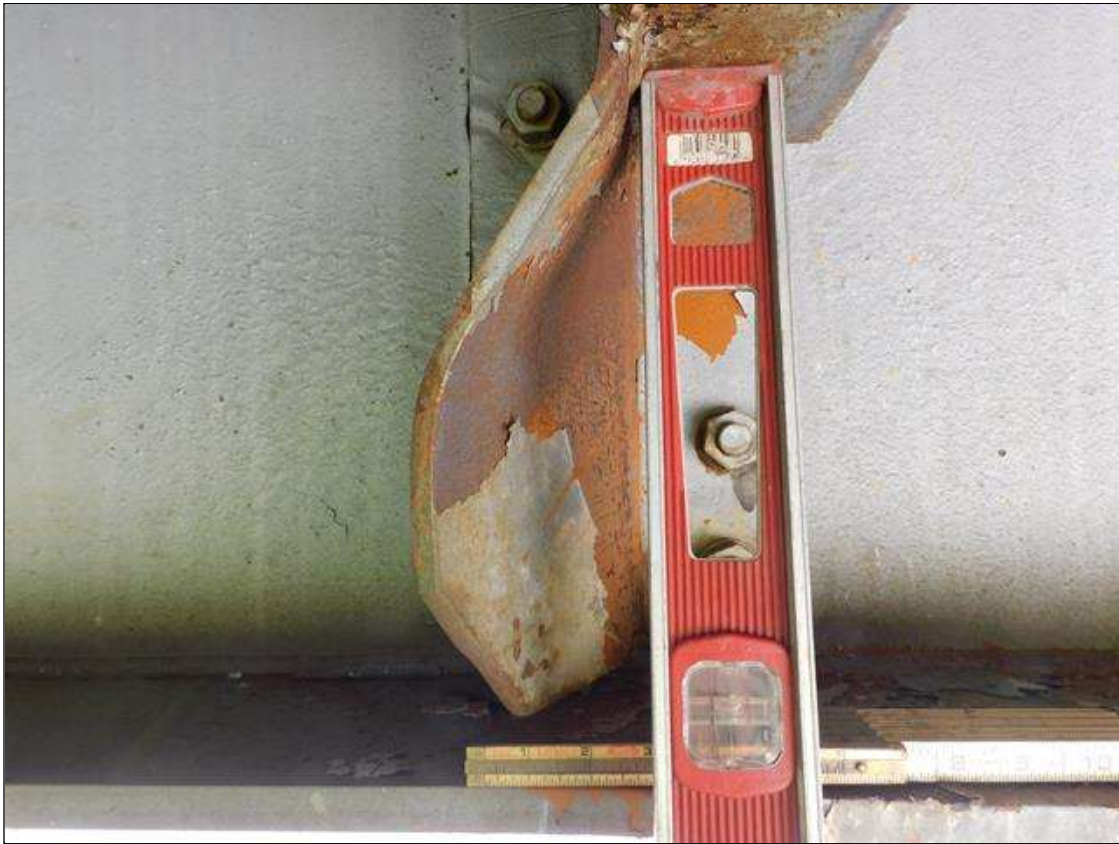
Span 1 Bay 1: IMPACT DAMAGE 4/2022 - INT. DIAPHRAGM 3, BEAM 1 CONNECTION BRACKET - BOTTOM 10" BENT 3-1/2" TO THE WEST (PAR)

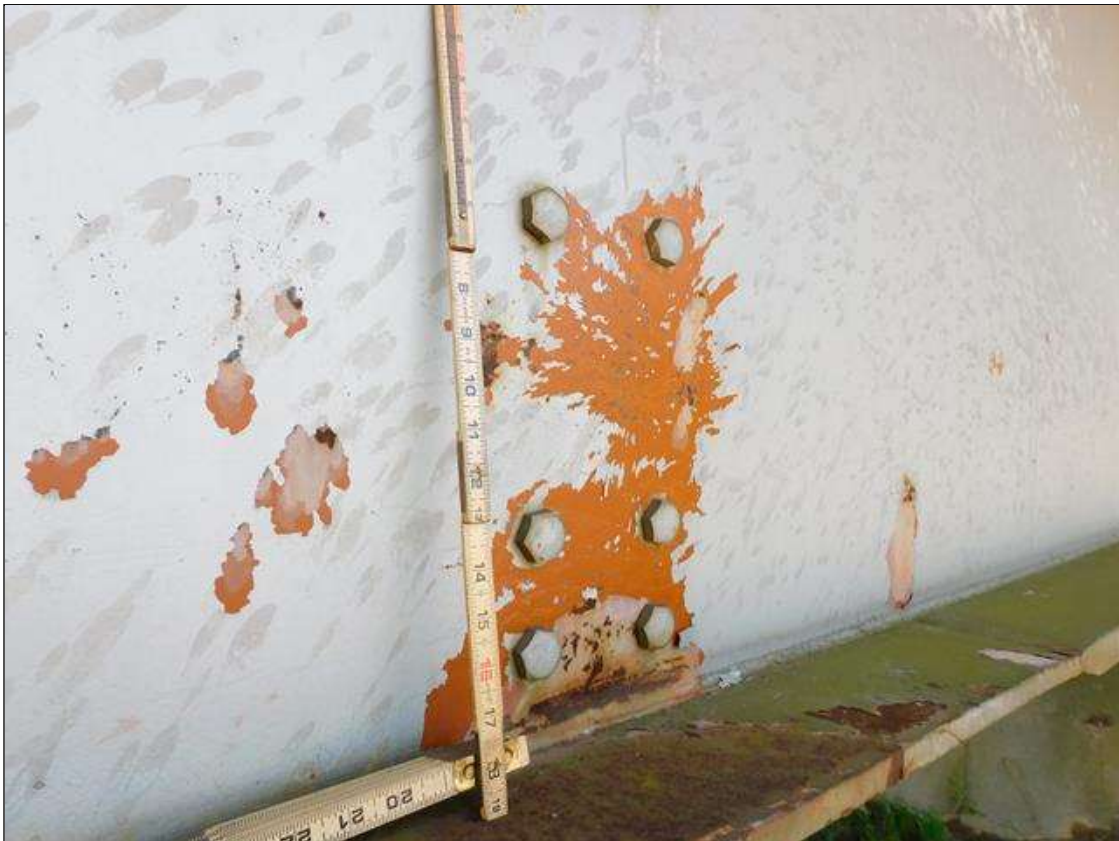
Span 1 Beam 1: IMPACT DAMAGE 4/2022 - 24" DIAMETER SECTION OF WEB DEFLECTED 1-1/4" TO THE NORTH AT INT. DIAPHRAGM 3 CONNECTION (PAR)

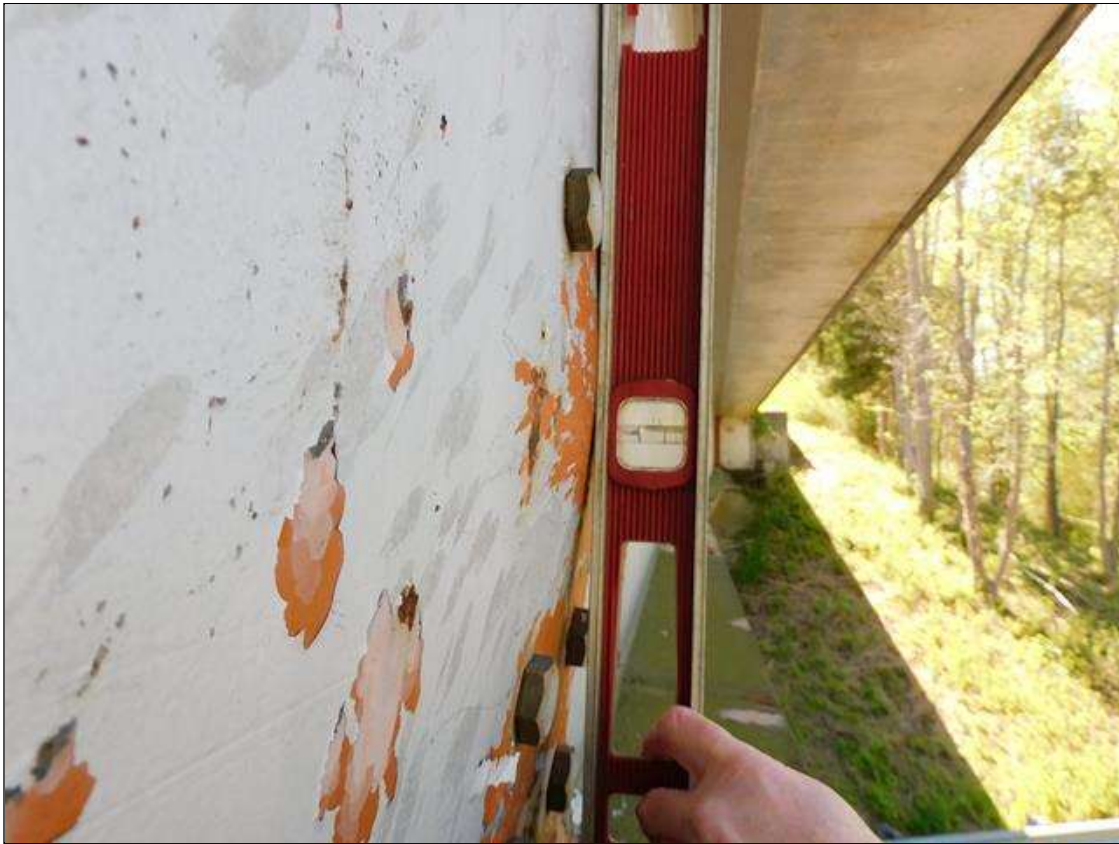
Span 1 Beam 1: IMPACT DAMAGE 4/2022 - 24" DIAMETER SECTION OF WEB DEFLECTED 1-1/4" TO THE NORTH AT INT. DIAPHRAGM 3 CONNECTION (PAR)

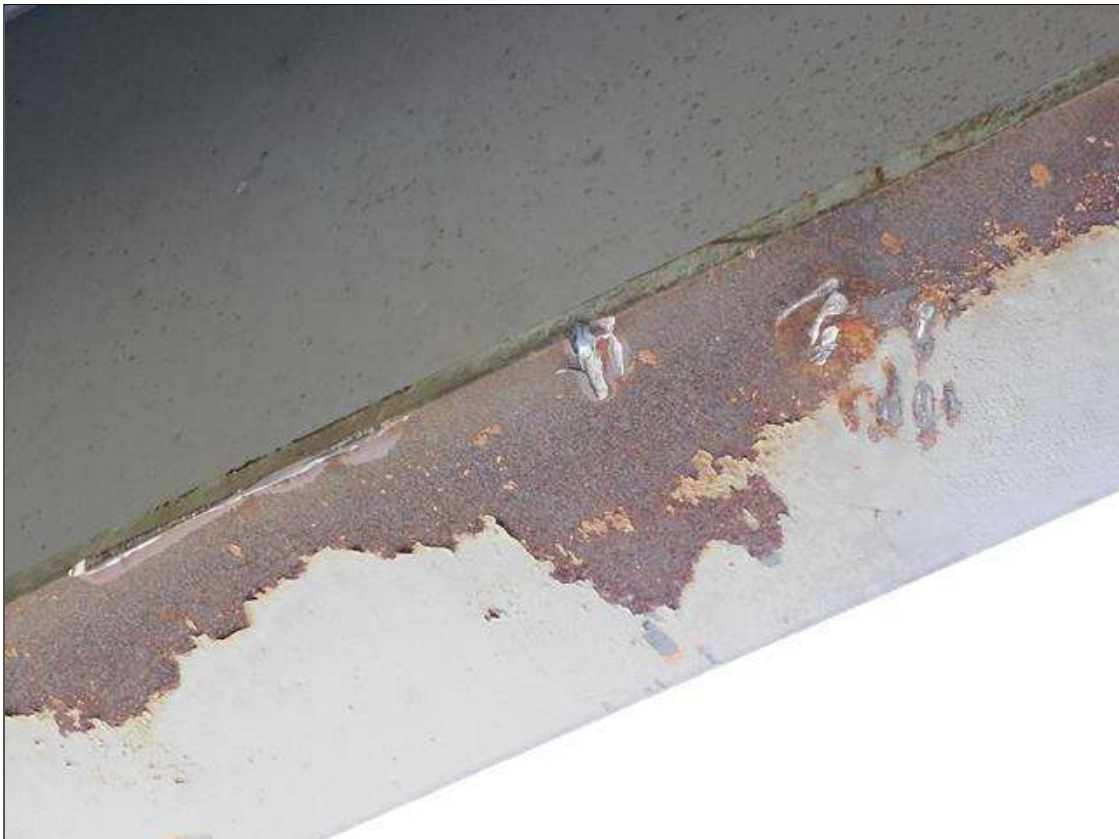
SPAN 1 BEAM 5 - IMPACT DAMAGE OVERVIEW

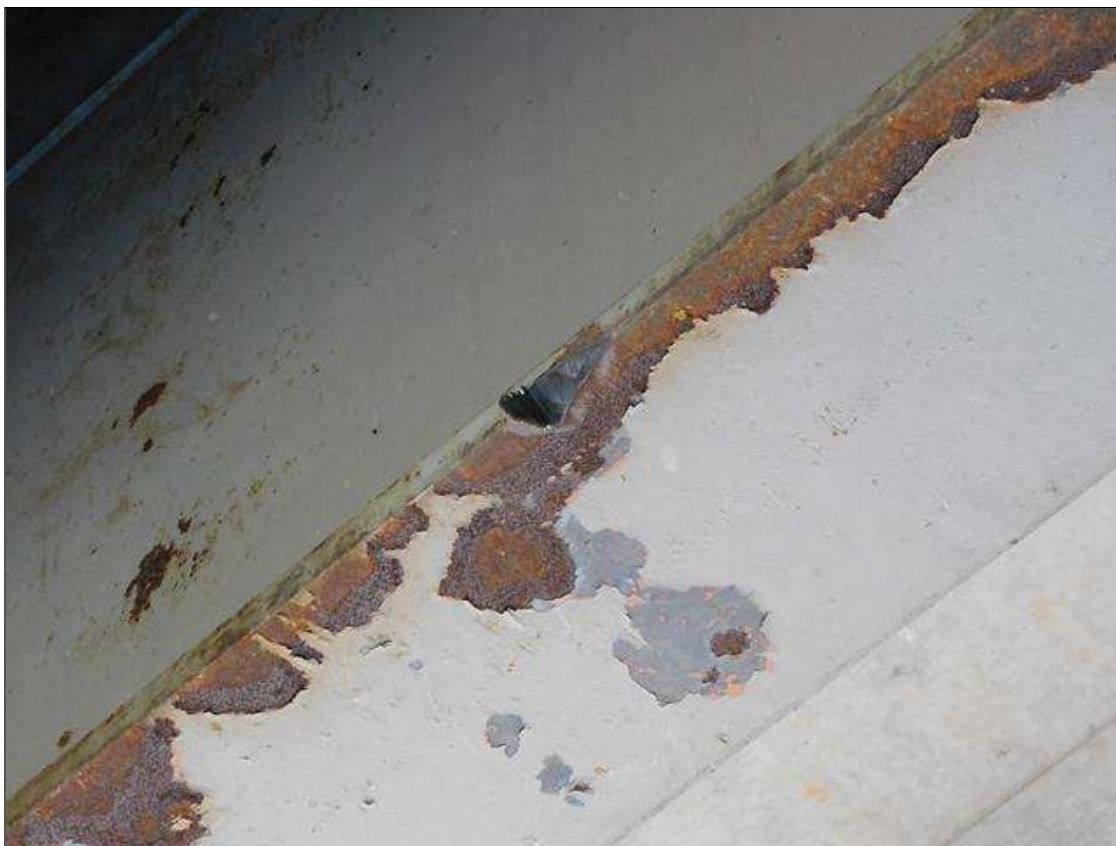
SPAN 1 BEAM 4 - IMPACT DAMAGE OVERVIEW

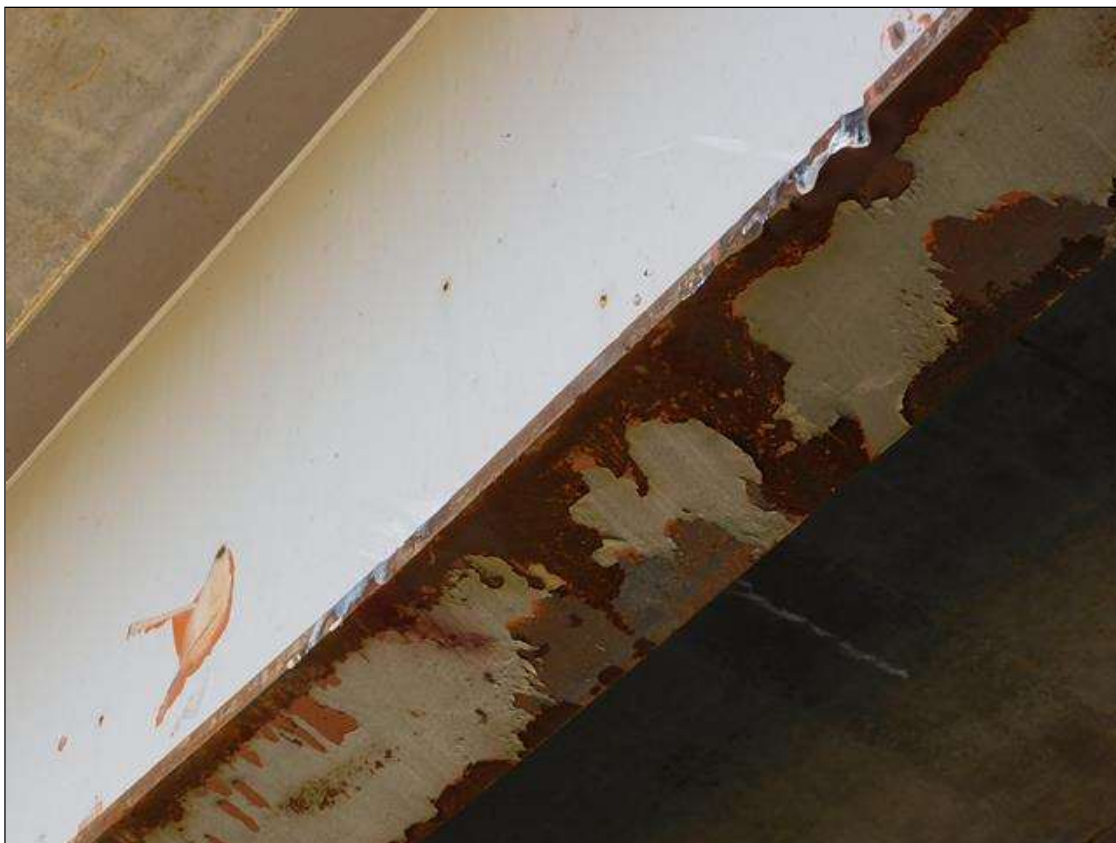
SPAN 1 BEAM 1 - IMPACT DAMAGE OVERVIEW
