NC DEPARTMENT OF TRANSPORTATION
 DIVISION OF HIGHWAYS
 STRUCTURE MANAGEMENT UNIT

ATTENTION: **IMPACT DAMAGE IN SPAN 4 TO BEAMS 3, 4, 5, AND DIAPH. 2 IN BAY 4. INSPECTON REQUESTED BY DIVISION. SEVERE DAMAGE TO BEAM 5. PM ISSUED.**

Structure Safety Report Supplemental Element Inspection

COUNTY: RANDOLPH STRUCTURE NUMBER: 750205 FREQUENCY: None

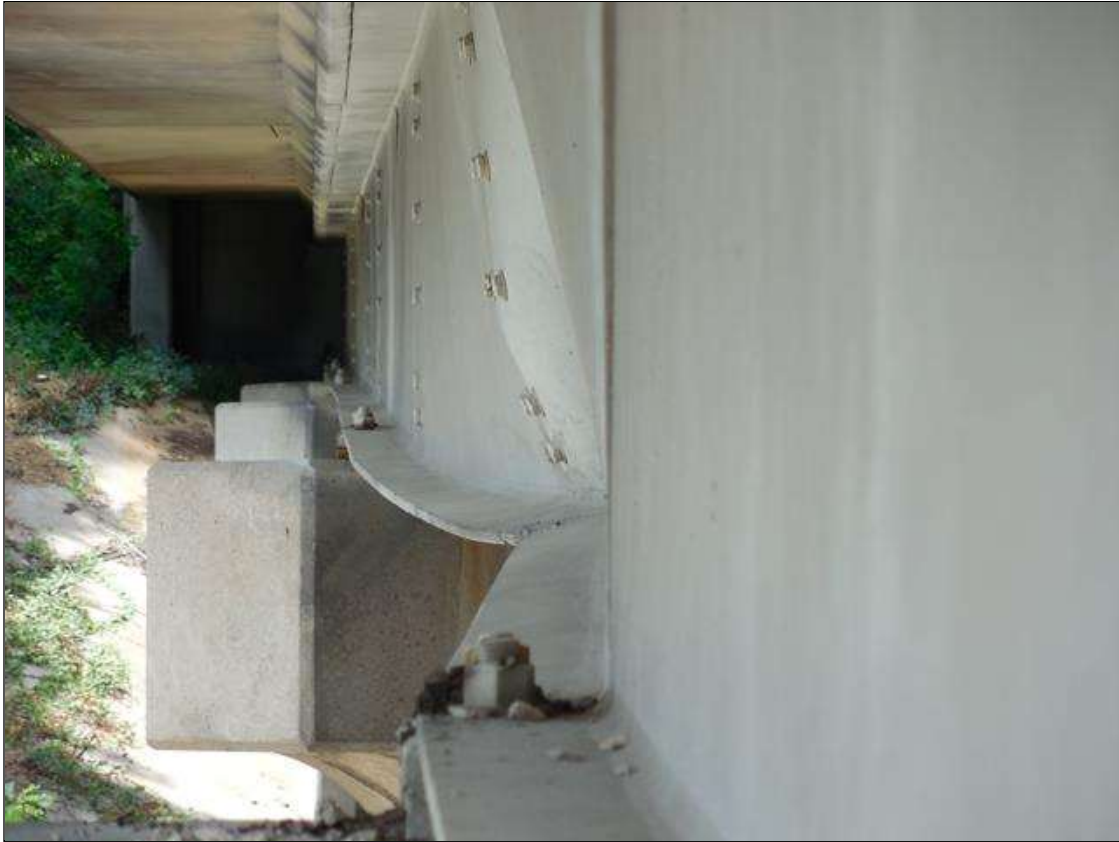
Span 4 Beam 5: LOOKING WEST ALONG SOUTH SIDE - INITIAL POINT OF IMPACT (POI) AT 17'-6" FROM BENT 4 BEARING. BEAM OUT OF PLUMB 9" TO THE NORTH AT POI - TOTAL OF ~30LF OF BEAM DEFLECTED FROM DIAPHRAGM #1 IN BAY 4 TO BENT 4 BEARING.

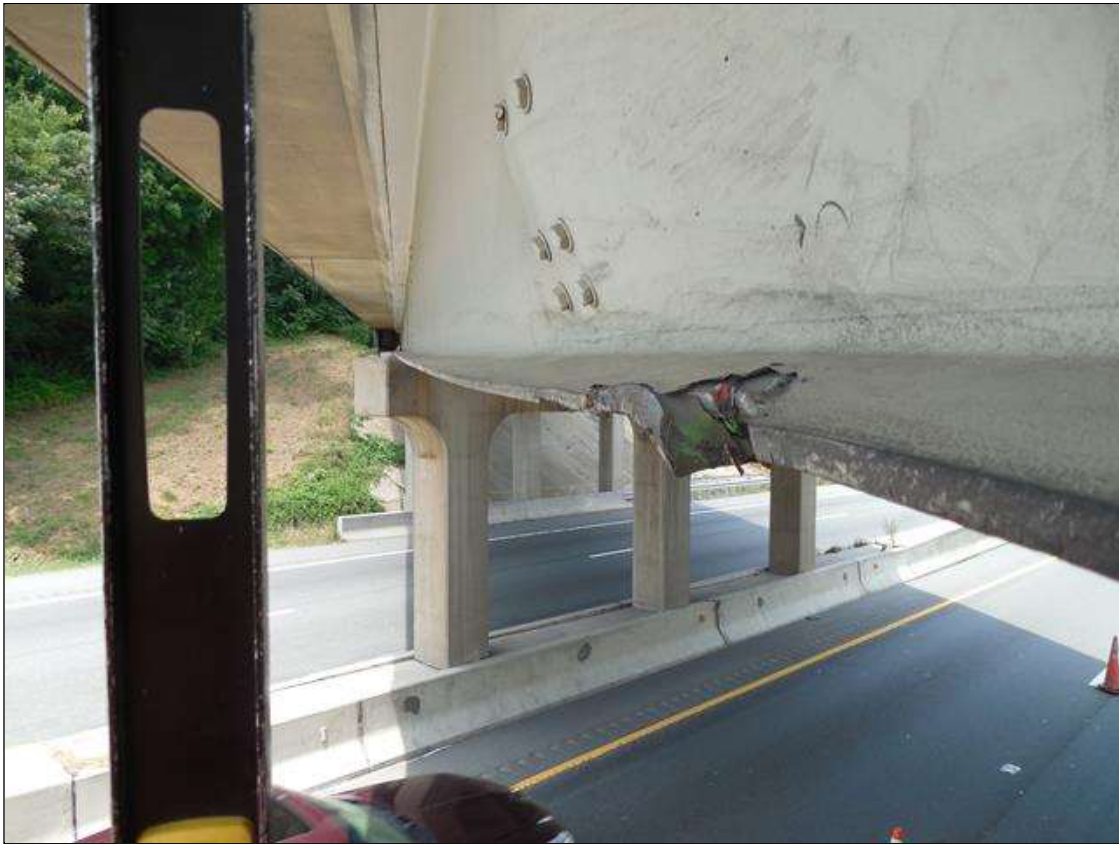
Element Number	Defect Type	Defect Description	CS	CS Qty	Maint Qty
107	Damage	INITIAL POINT OF IMPACT (POI) AT 17'-6" FROM BENT 4 BEARING. BEAM OUT OF PLUMB 9" TO THE NORTH AT POI - TOTAL OF 30LF OF BEAM DEFLECTED FROM INT. DIAPHRAGM #1 IN BAY 4 TO BENT 4 BEARING. --- 7"L x 2-3/4"W TEAR IN SOUTH HALF OF BOTTOM FLANGE AT POI - 9" OF BOTTOM FLANGE REMAINING. --- OUTSIDE EDGE OF BOTTOM FLANGE SCRAPED AND GOUGED UP TO 1/4"D ACROSS 11" AREA ADJACENT TO POI. --- 17"H x 36"W x 3"D DEFORMATION IN WEB AT POI, BEGINNING 3" FROM TOP FLANGE. --- BOTTOM HALF OF DIAPHRAGM #2 BENT TO THE WEST APROX. 8" AT BEAM 5 CONNECTION, w/ DAMAGE TO ENTIRE LENGTH OF DIAPHRAGM CONNECTION BRACKET - MAX DEFLECTION OF 6" TO THE WEST.	4	30	30 Feet
515	Damage	EXPOSED STEEL AT IMPACT AREAS	4	8	Square Feet

Span 4 Beam 5: INITIAL POINT OF IMPACT (POI) AT 17'-6" FROM BENT 4 BEARING. BEAM OUT OF PLUMB 9" TO THE NORTH AT POI - TOTAL OF 30LF OF BEAM DEFLECTED FROM INT. DIAPHRAGM #1 IN BAY 4 TO BENT 4 BEARING.

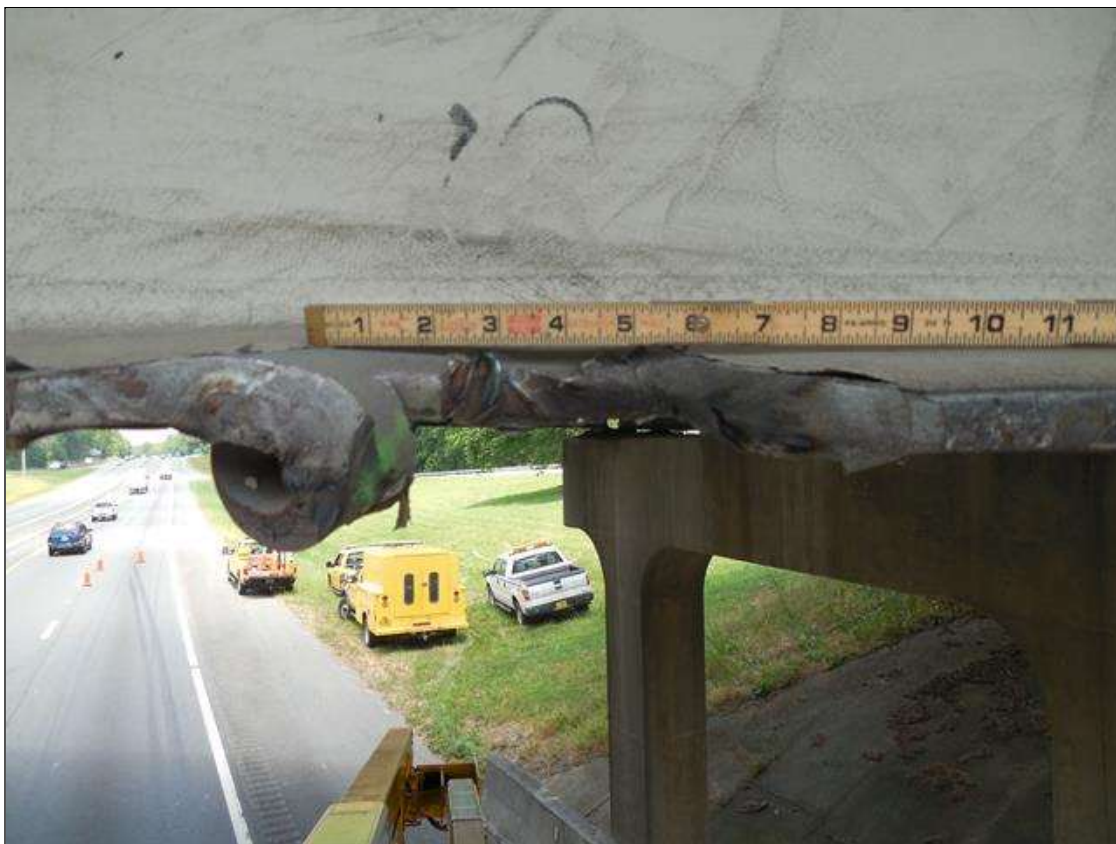
SPAN 4 BEAM 5: 7"L x 2-3/4"W TEAR IN SOUTH HALF OF BOTTOM FLANGE AT POI.

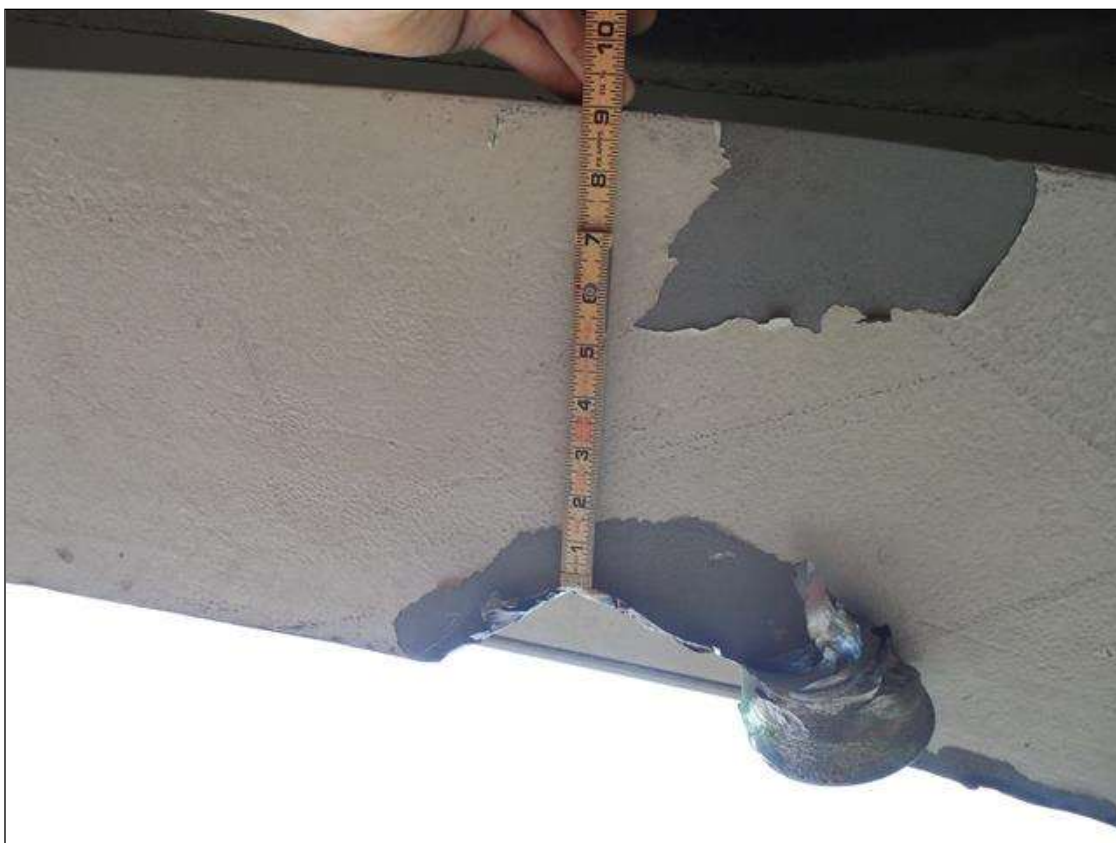
SPAN 4 BEAM 5: BOTTOM VIEW OF 7"L x 2-3/4"W TEAR IN SOUTH HALF OF BOTTOM FLANGE AT POI - 9" OF BOTTOM FLANGE REMAINING.

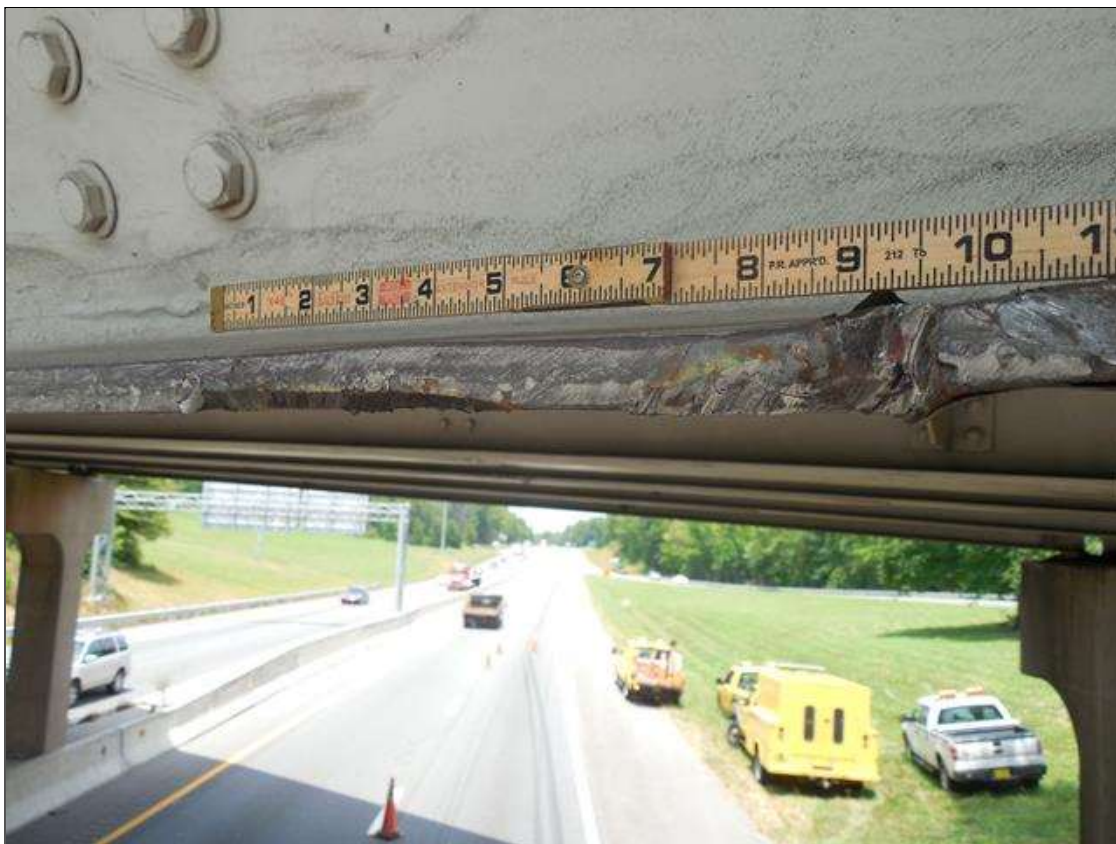
SPAN 4 BEAM 5: OUTSIDE EDGE OF BOTTOM FLANGE SCRAPED AND GOUGED UP TO 1/4"D ACROSS 11" AREA ADJACENT TO POI

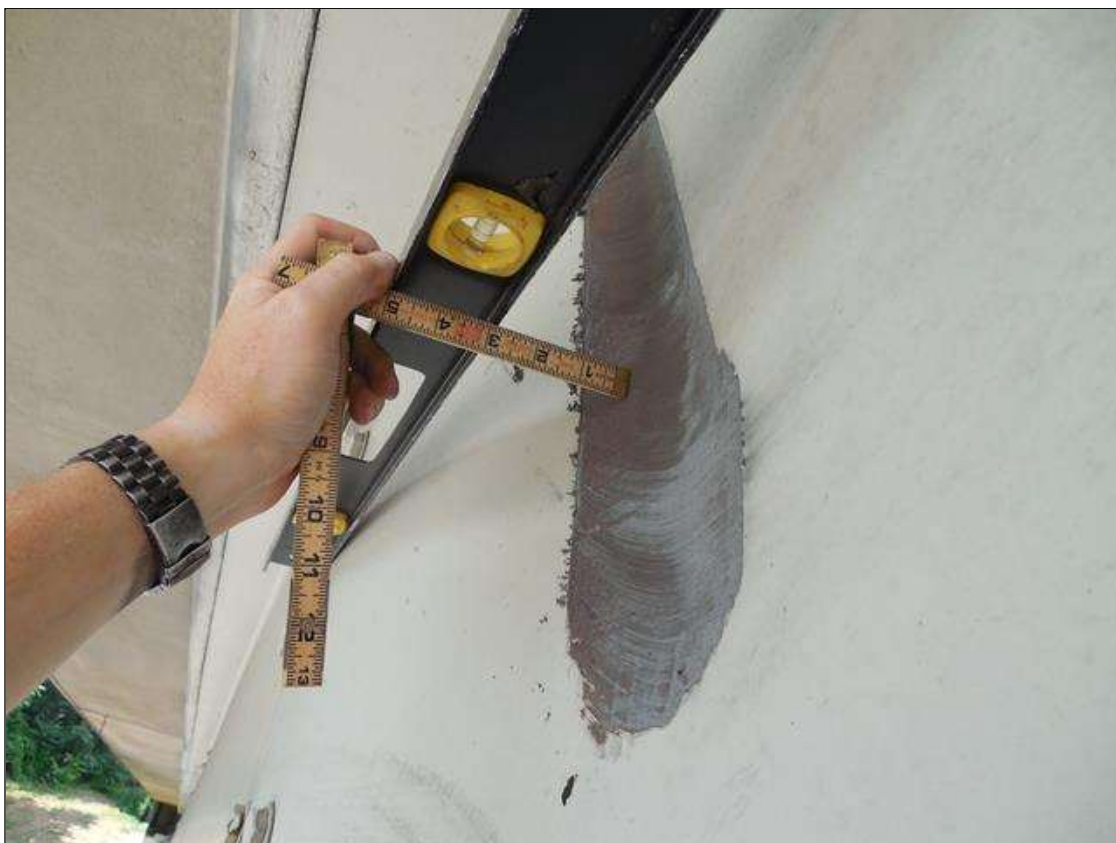
SPAN 4 BEAM 5: 17"H x 36"W x 3"D DEFORMATION IN WEB AT POI, BEGINNING 3" FROM TOP FLANGE

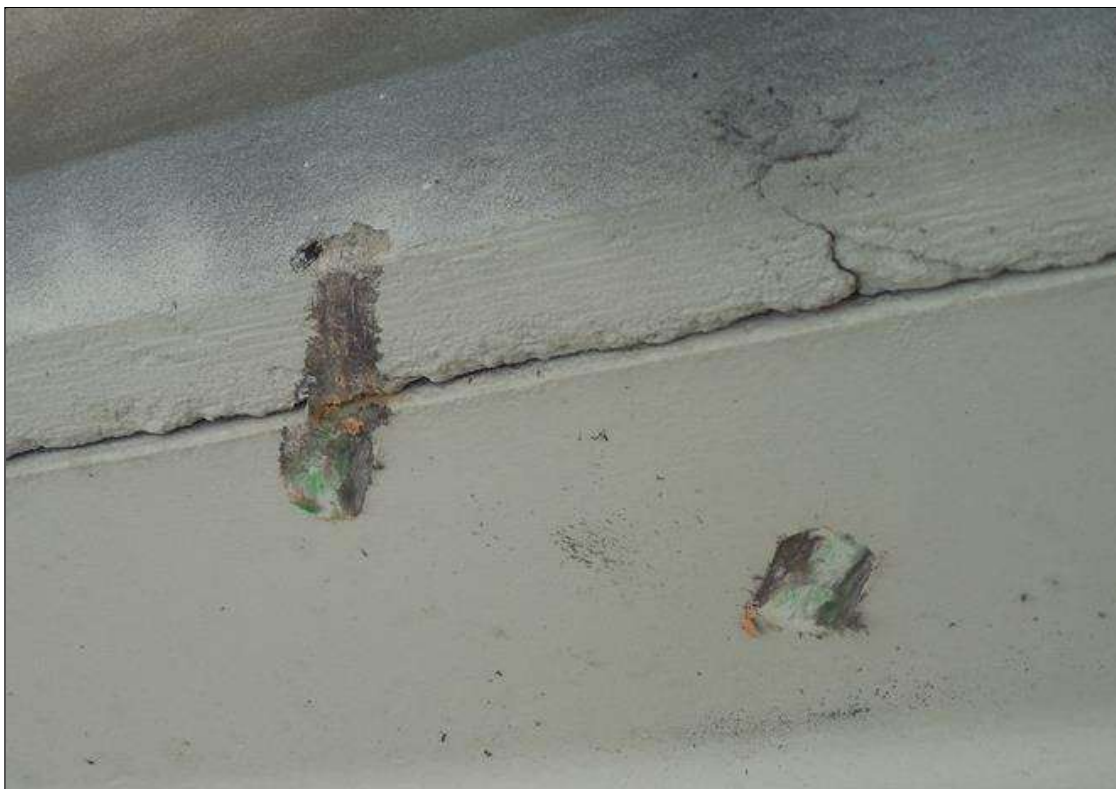
SPAN 4 BEAM 5: (2) 1" DIAMETER SCRAPES IN TOP FLANGE AT POI

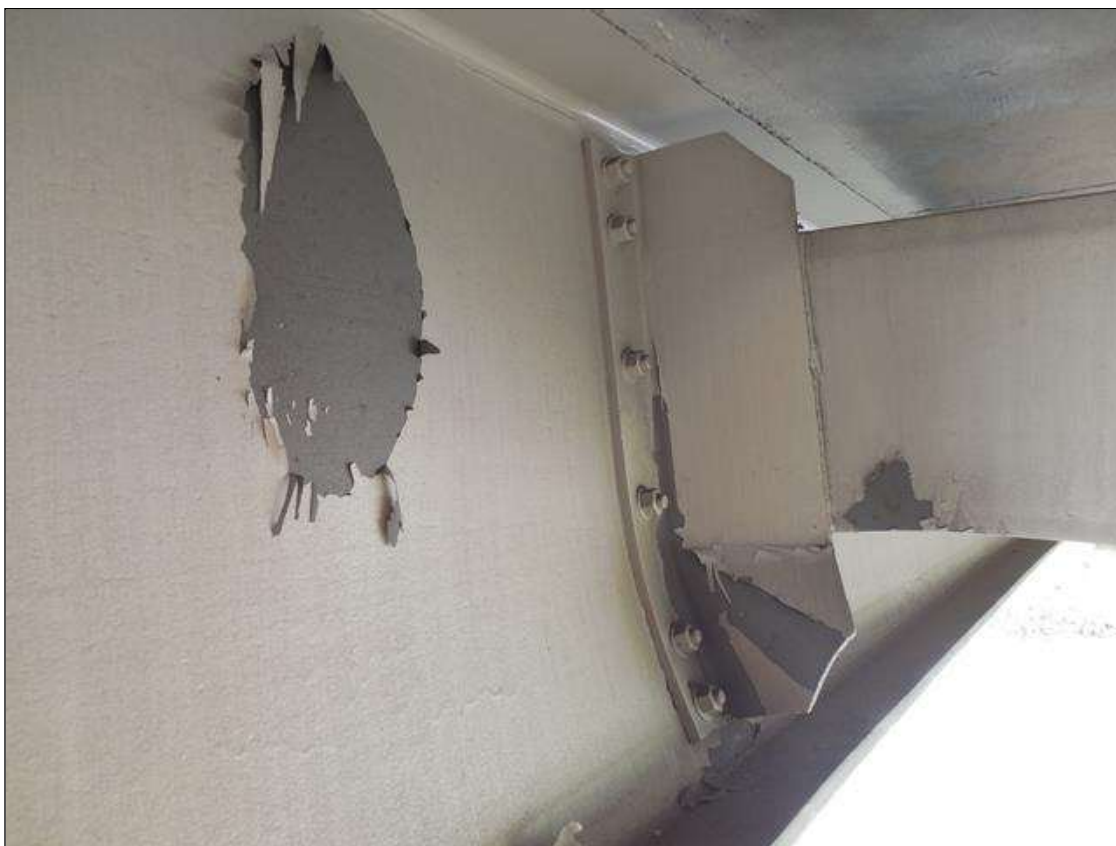
SPAN 4 BEAM 5: OVERVIEW OF NORTH SIDE OF DAMAGE TO BEAM WEB AND DIAPHRAGM #2 AT POI

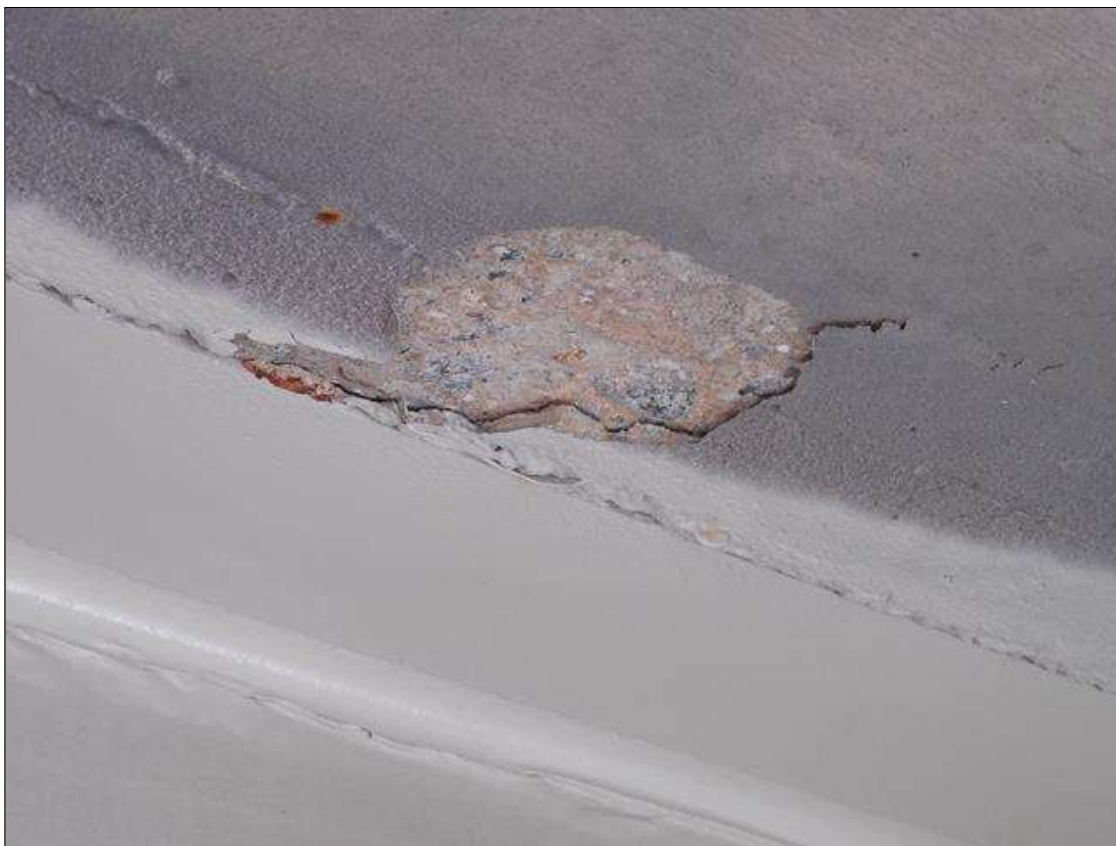
Element Number	Defect Type	Defect Description	CS	CS Qty	Maint Qty
12	Damage	1/4"D x 6" DIAMETER SPALL AT TOP FLANGE OF BEAM 5 IN BAY 4 LOCATED 20' FROM BENT 4	2	1	Square Feet

Span 4 Deck: 1/4"D x 6" DIAMETER SPALL IN BOTTOM OF DECK AT TOP FLANGE OF BEAM 5 IN BAY 4 LOCATED 20' FROM BENT 4

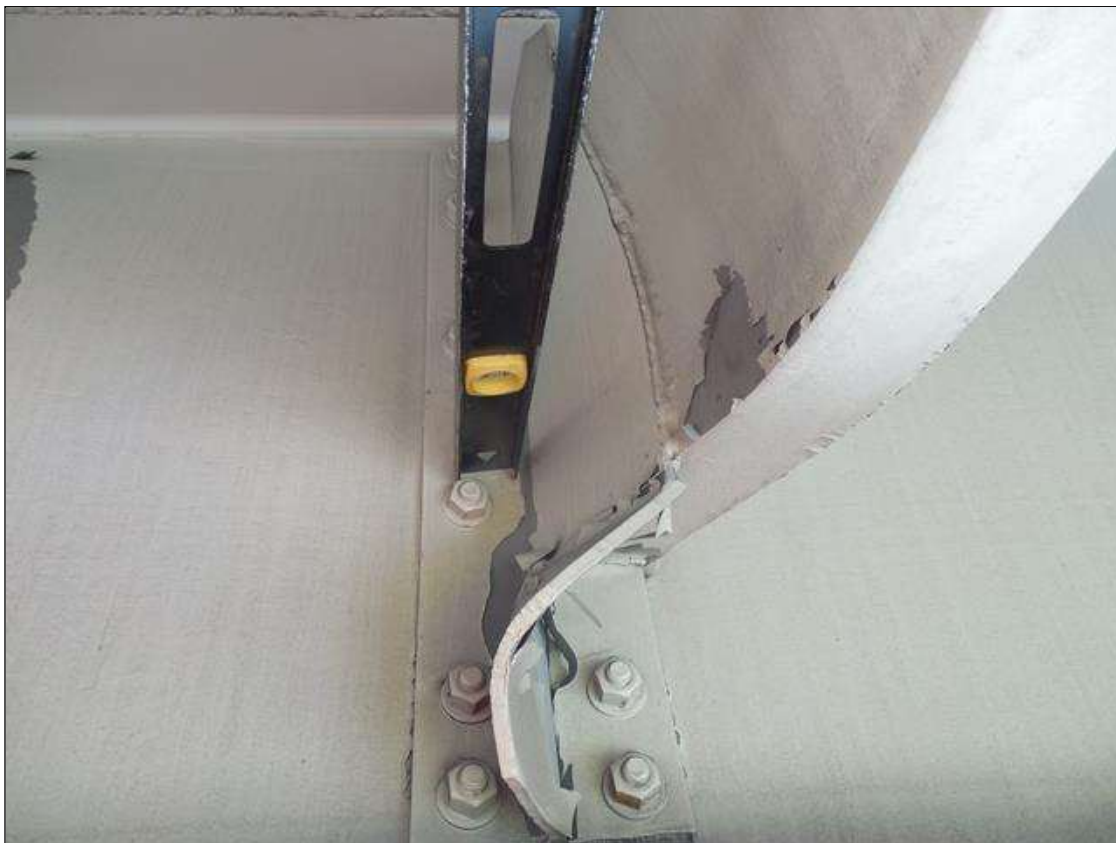
SPAN 4 BAY 4: BOTTOM HALF OF DIAPHRAGM #2 BENT TO THE WEST APROX. 8" AT BEAM 5 CONNECTION.

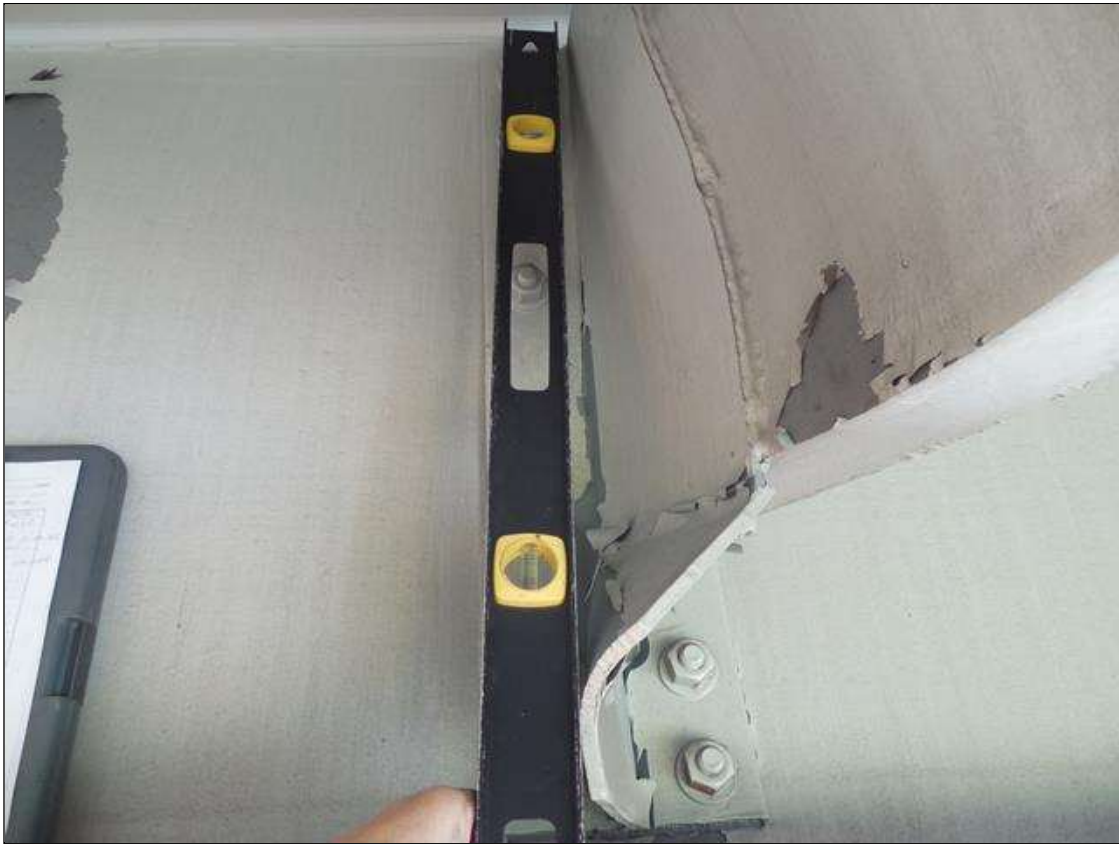
SPAN 4 BAY 4: DAMAGE TO ENTIRE LENGTH OF DIAPHRAGM #2 BEAM 5 CONNECTION BRACKET - MAX DEFLECTION OF 6" TO THE WEST.

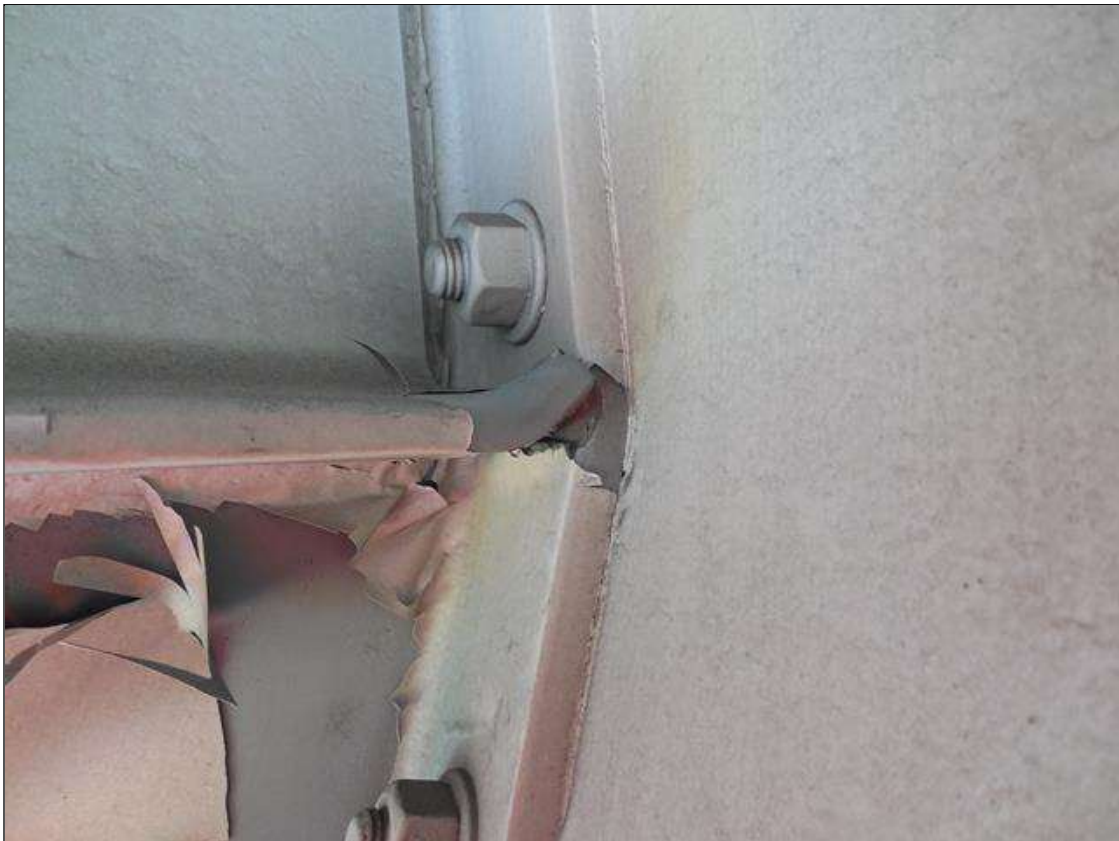
SPAN 4 BAY 4: 2"L x 1/2"H x 1/8"D INDENTION IN DIAPHRAGM #2 BEAM 5 CONNECTION BRACKET DUE TO CONTACT WITH DIAPHRAGM BOTTOM FLANGE

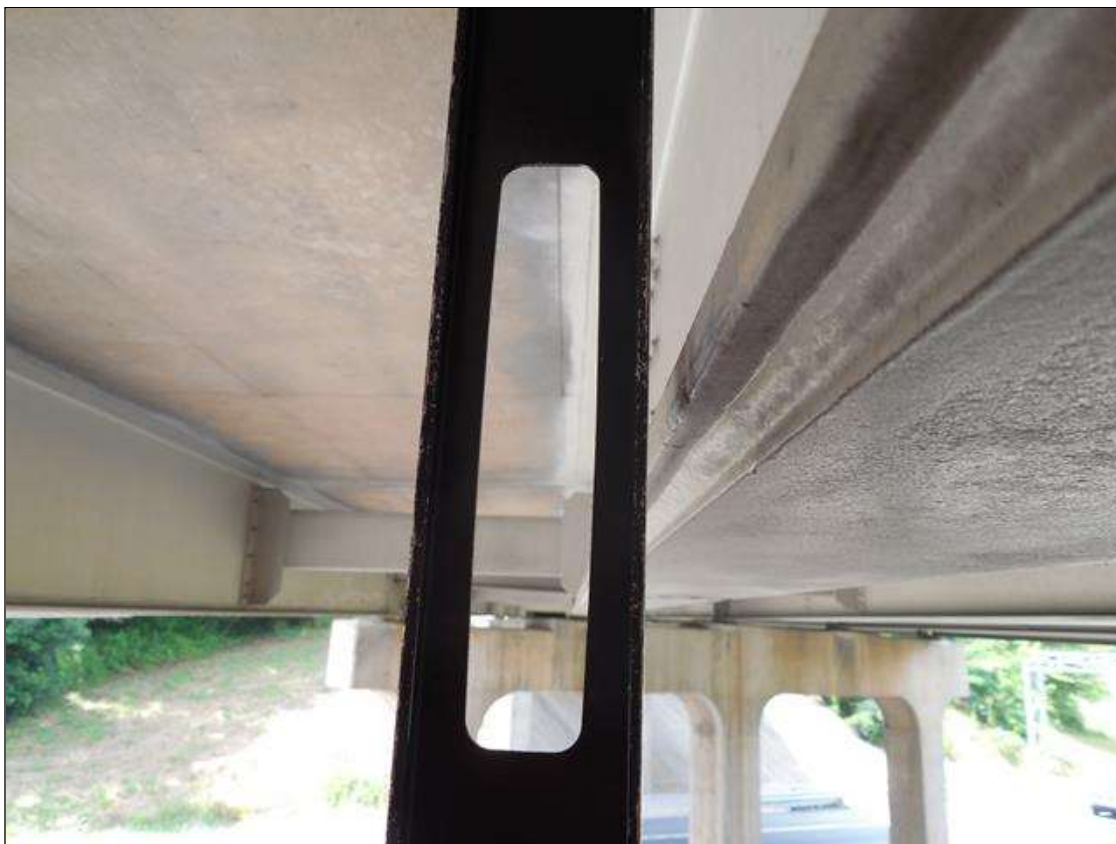
Span 4 Beam 4: 10LF OF BEAM OUT OF PLUMB 1/4" TO THE NORTH - CENTER POINT AT DIAPHRAGM #2 CONNECTION

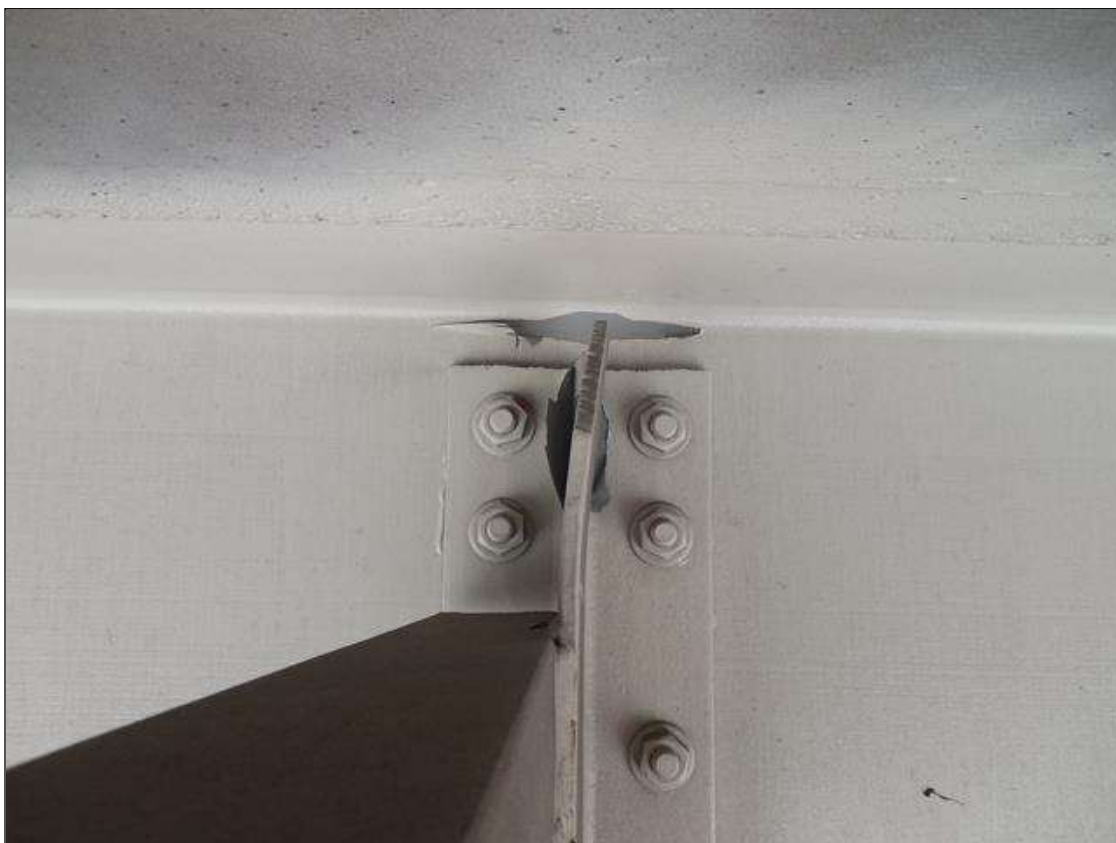
SPAN 4 BAY 4: TOP 4" OF DIAPHRAGM #2 CONNECTION TO BEAM 4 BENT 2" TO THE EAST

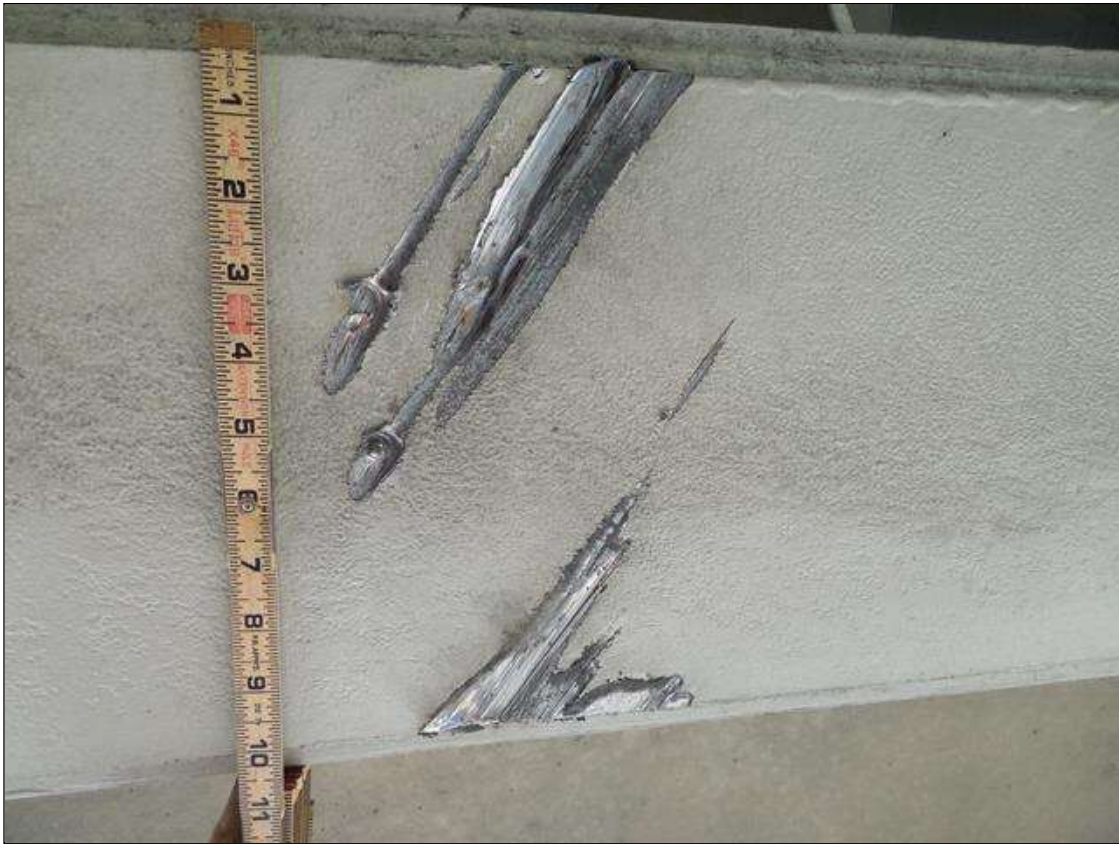
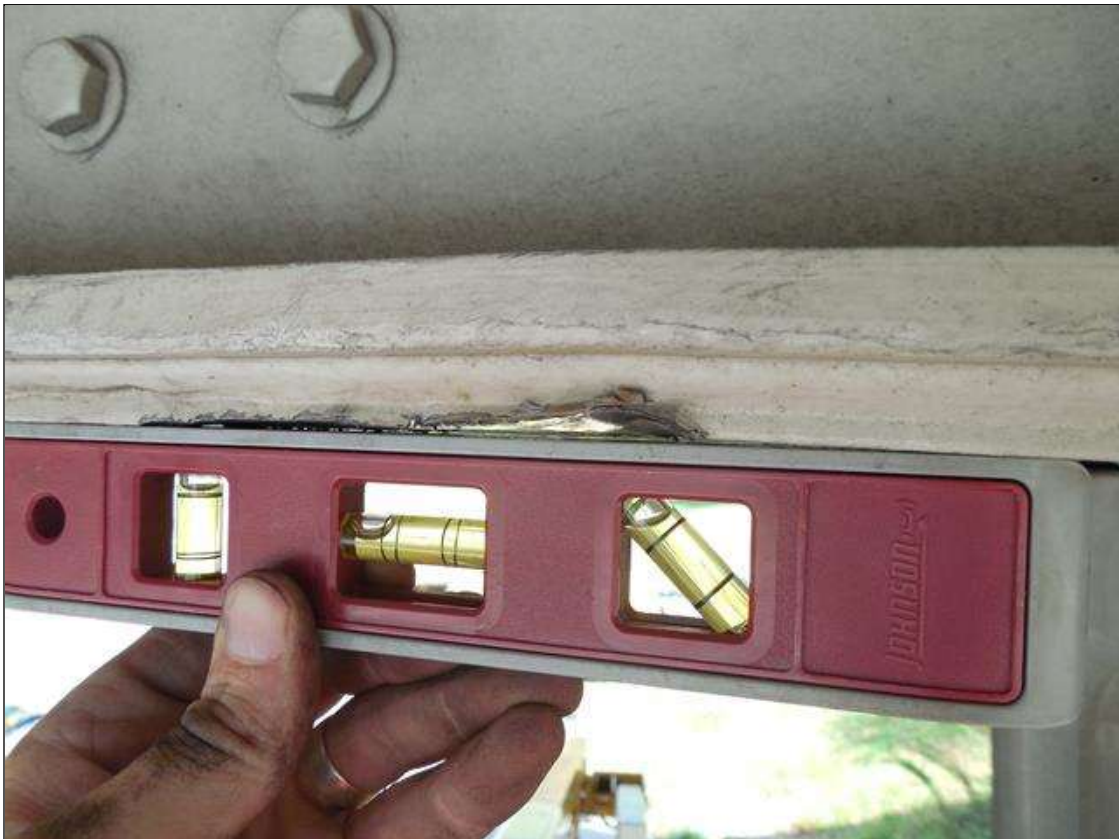
Span 4 Beam 4: (2) 3"L x 6"W AREAS OF 1/8"D SCRAPES ON BOTTOM COVER PLATE, LOCATED 19'-6" FROM BENT 4 BEARING

Span 4 Beam 4 : ALT. VIEW - (2) 3"L x 6"W AREAS OF 1/8"D SCRAPES ON BOTTOM COVER PLATE, LOCATED 19'-6" FROM BENT 4 BEARING

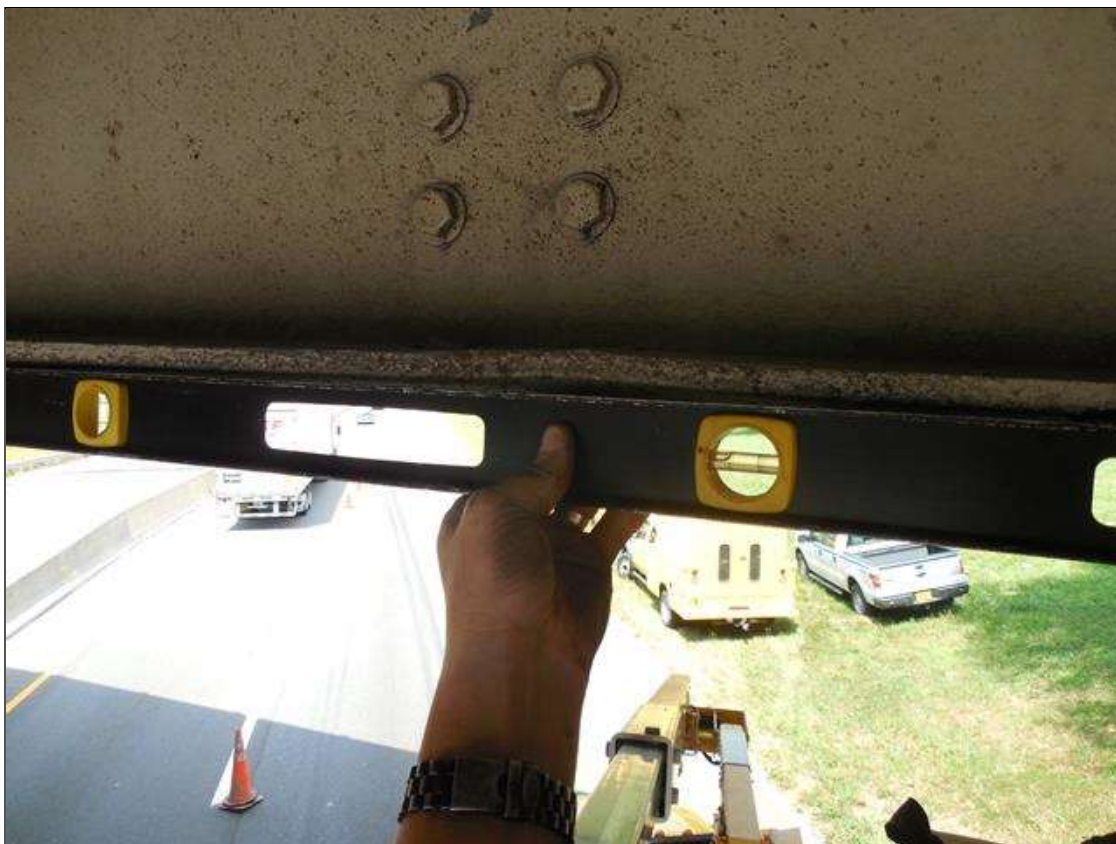
Span 4 Beam 3: 4"L SECTION ALONG SOUTH EDGE OF BOTTOM FLANGE AND COVER PLATE BENT UP 3/16", LOCATED 19'-6" FROM BENT 4 BEARING

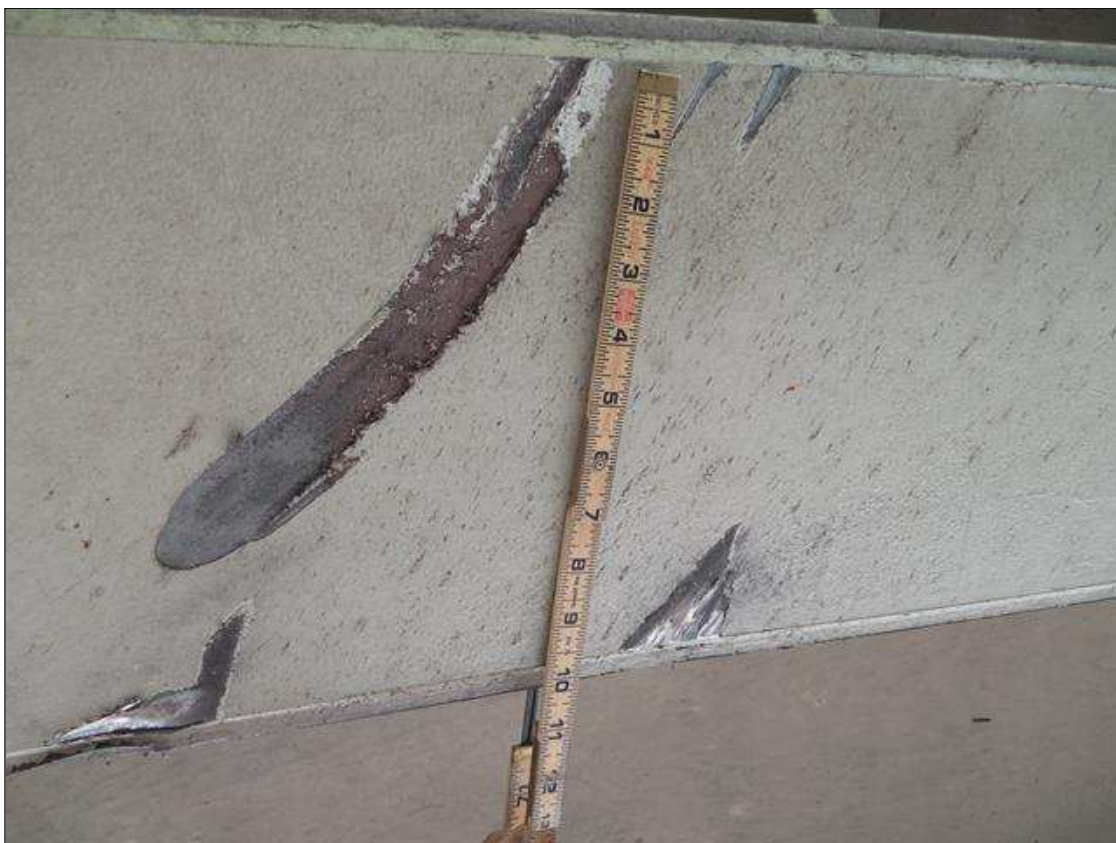
Span 4 Beam 3: 9"L x 2"W SCRAPE ON BOTTOM COVER PLATE APPROX. 1/32"D, LOCATED 19' FROM BENT 4 BEARING

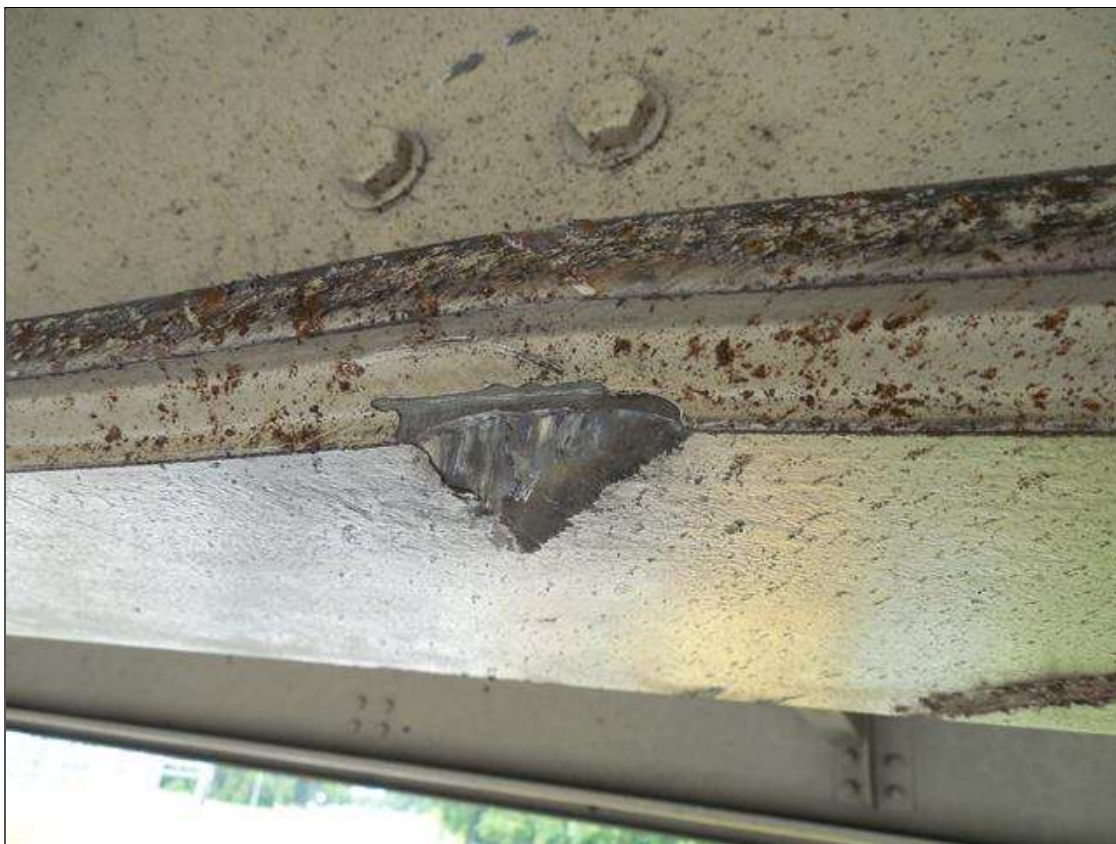
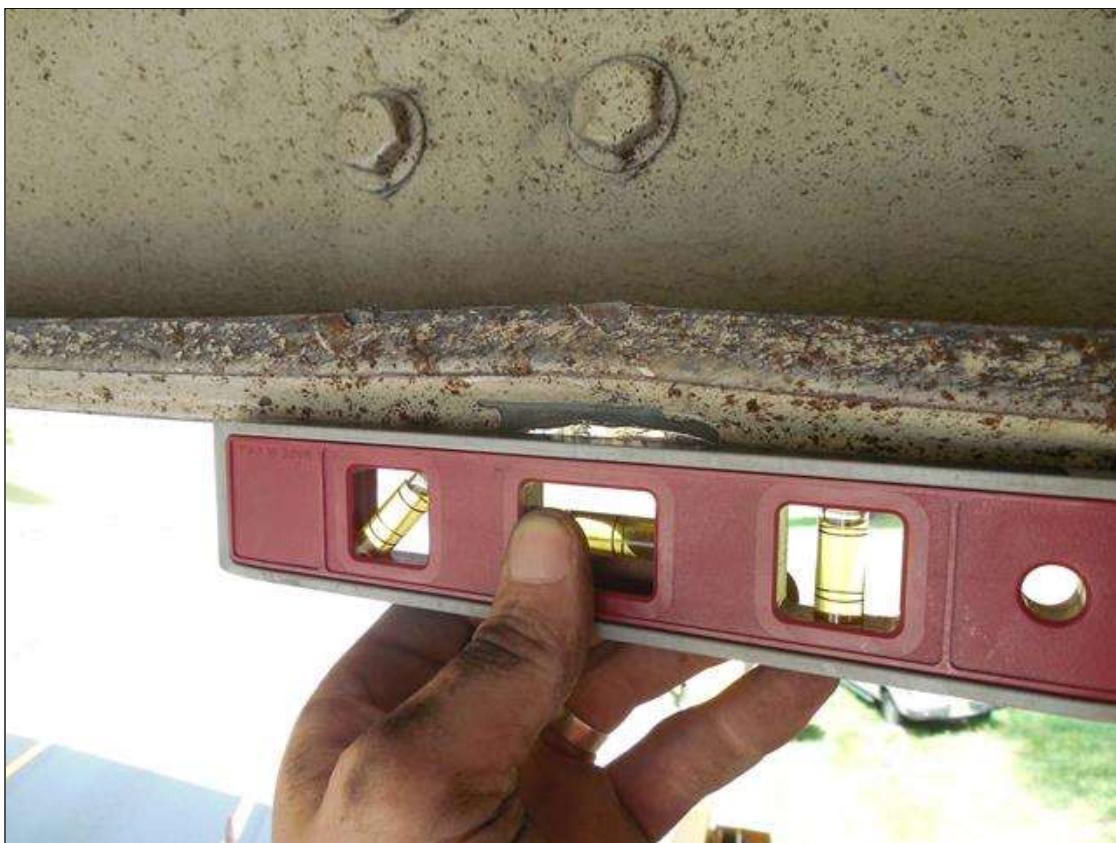
Span 4 Beam 3: ALT. VIEW - 2"L x 2"W x 1/8"D GOUGE IN SOUTH EDGE OF COVER PLATE, LOCATED 19'-6" FROM BENT 4

Span 4 Beam 3: 2"L x 2"W x 1/8"D GOUGE IN SOUTH EDGE OF COVER PLATE, LOCATED 19'-6" FROM BENT 4

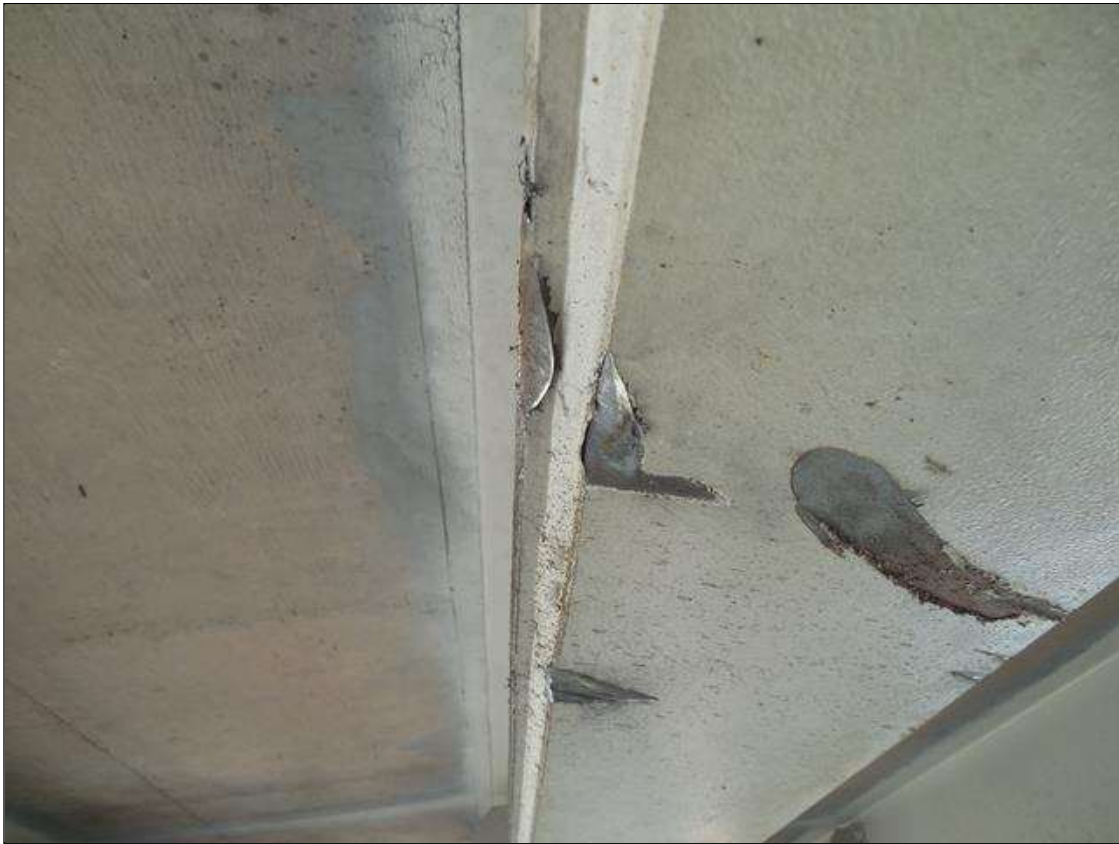
Span 4 Beam 3: (2) 2"L x 1/2"W x 3/16" INDENTIONS IN SOUTH EDGE OF BOTTOM COVER PLATE AND BOTTOM FLANGE LOCATED 19' FROM BENT 4

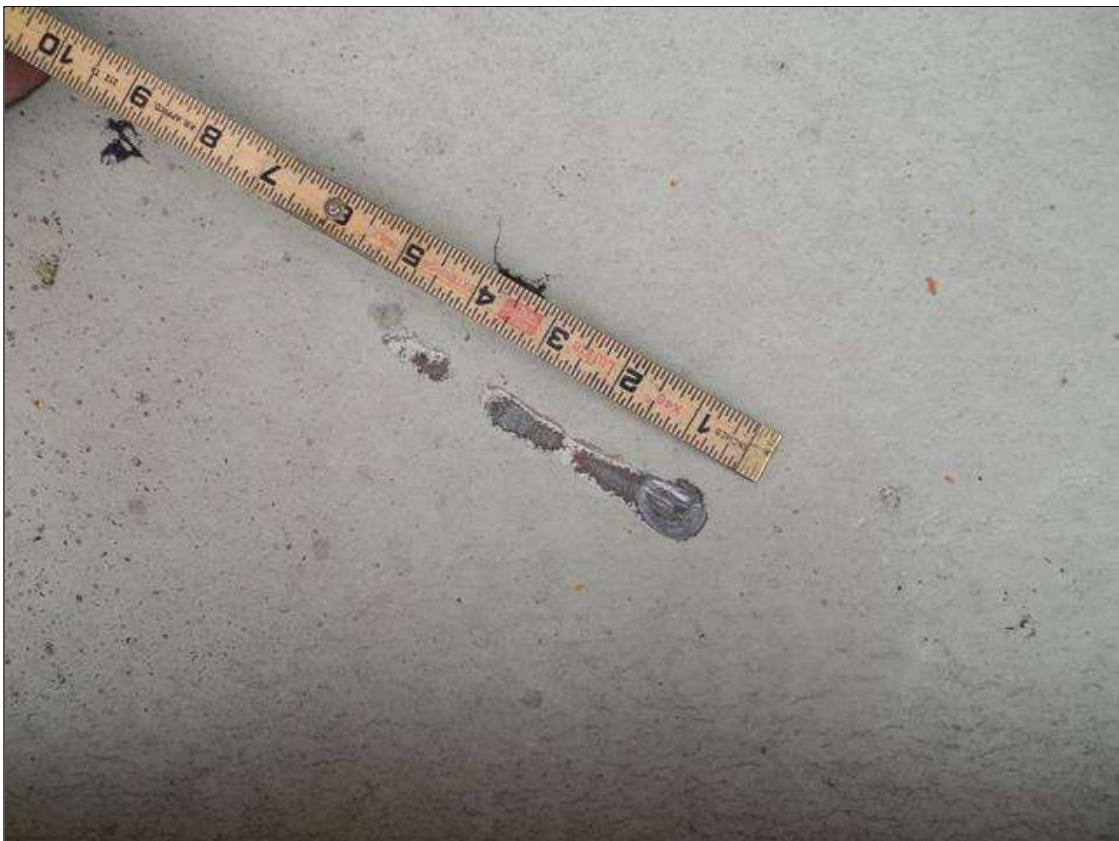
Span 4 Beam 3: APPROX 4"L x 1/2"W SCRAPE ON SOUTH FACE OF WEB, LOCATED 4-1/2" UP FROM BOTTOM FLANGE AND 19' FROM BENT 4 BEARING

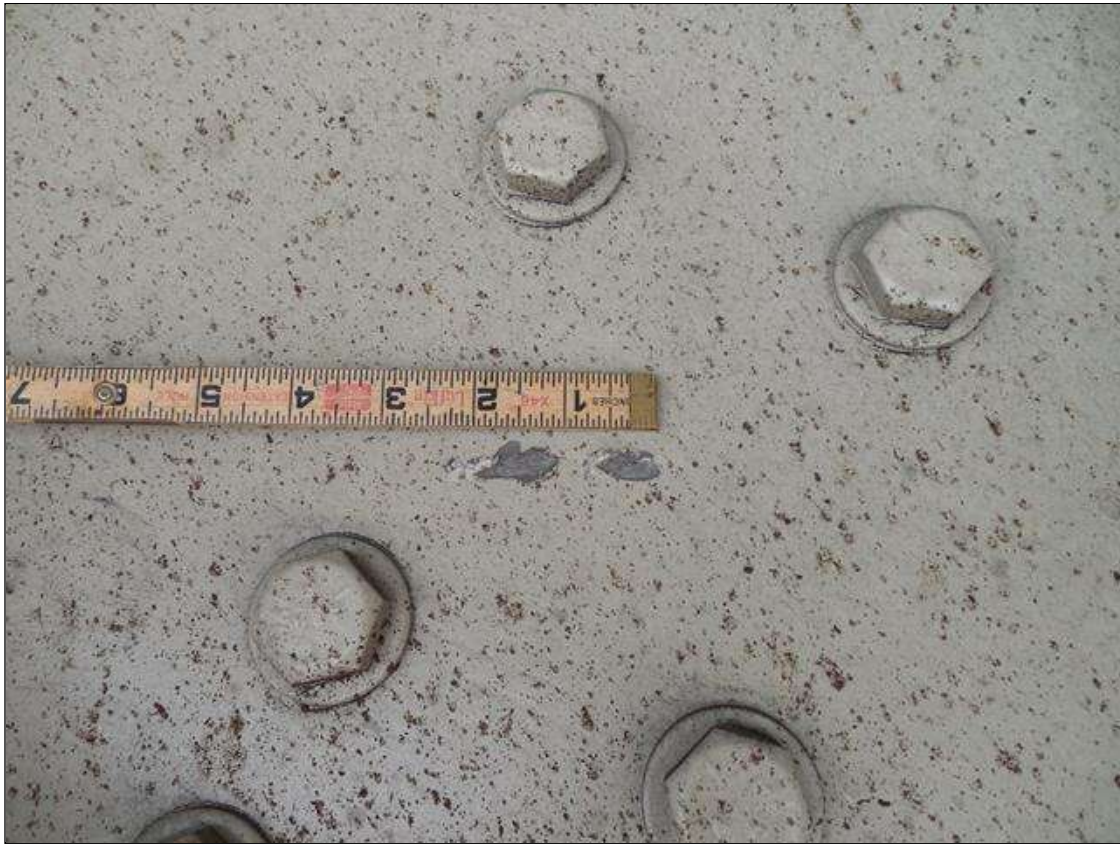
Span 4 Beam 3: APPROX. 2"L x 1/2" SCRAPE ON SOUTH FACE OF WEB, LOCATED 9" UP FROM BOTTOM FLANGE AT BAY 2 DIAPHRAGM #2 CONNECTION
