NC DEPARTMENT OF TRANSPORTATION
 DIVISION OF HIGHWAYS
 STRUCTURE MANAGEMENT UNIT

ATTENTION: **IMPACT DAMAGE IN SPAN 4 TO BEAMS 3, 4, 5, AND DIAPH. 2 IN BAY 4. INSPECTON REQUESTED BY DIVISION. SEVERE DAMAGE TO BEAM 5. PM ISSUED.**

Structure Safety Report Supplemental Element Inspection

COUNTY: RANDOLPH STRUCTURE NUMBER: 750205 FREQUENCY: None

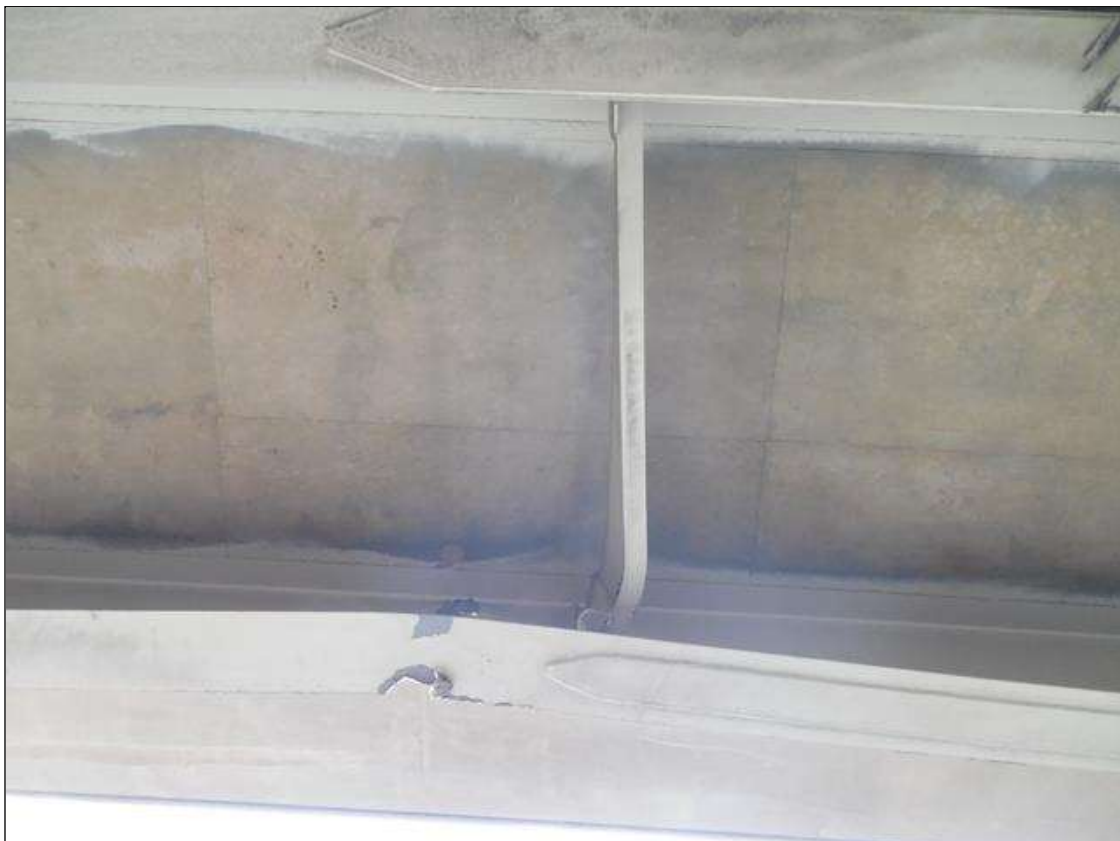
SPAN 4 BAY 4: LOOKING UP AT POI - BEAM 5, DIAPHRAGM #2, BEAM 4 SHOWN
