Structure: 750017

# Priority Action Repair Report

## Priority Action Request

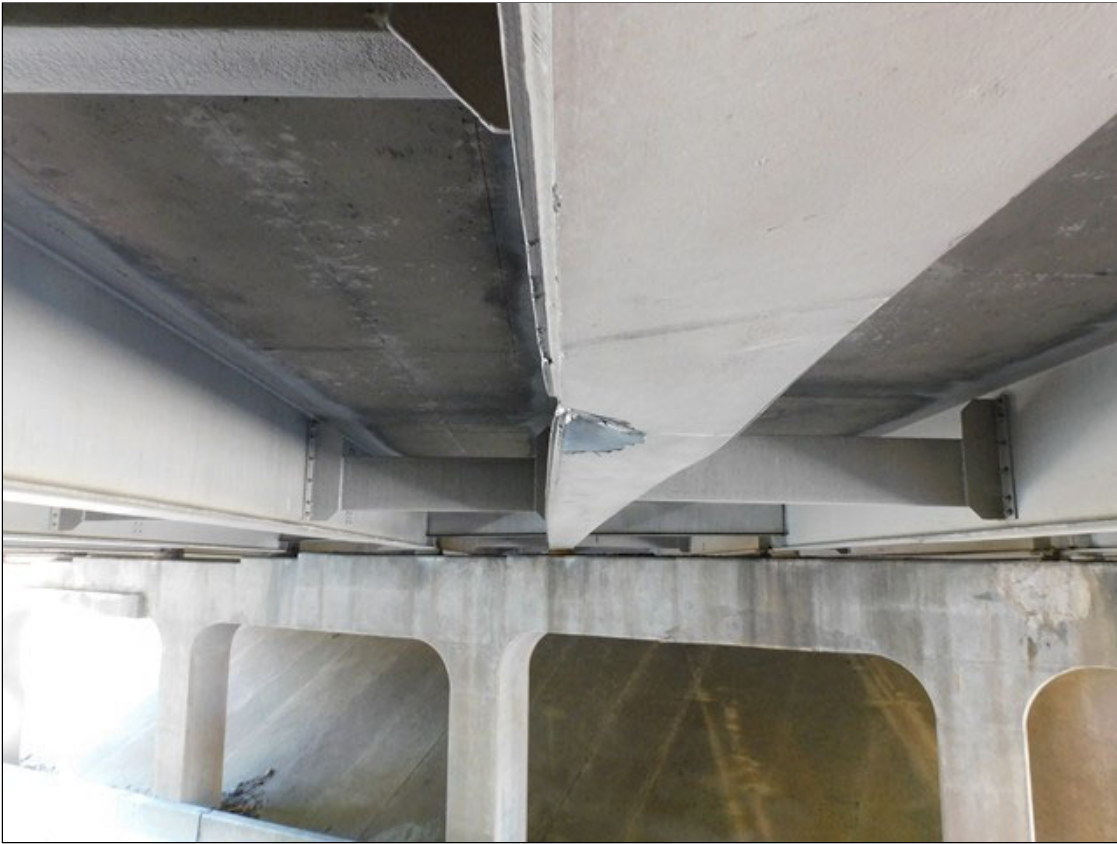
Span 2 Beam 5: IMPACT- LOCATED 20.15 FEET FROM INTERIOR BENT 2; SOUTH EDGE OF BOTTOM FLANGE AREA 27 INCHES LONG DEFLECTED UPWARDS APPROXIMATELY 3 INCHES WITH SEGMENT OF BEAM 15 FEET LONG DEFLECTED TOWARDS NORTH APPROXIMATELY 3 INCHES; GOUGE PRESENT AT IMPACT LOCATION UP TO 0.25 INCH DEEP - PAR

Request down grade to a 12 month PM. Making plans to be repaired by heat straightening contractor.

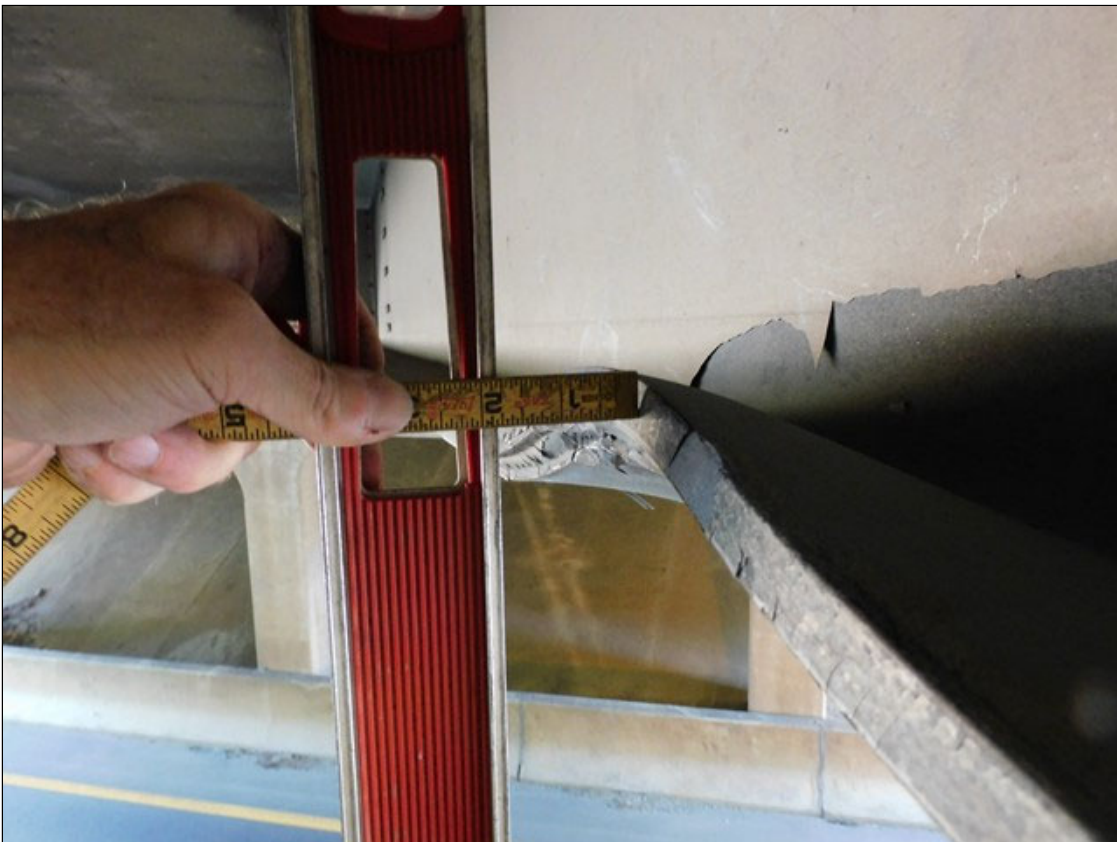
Span 2 Beam 5: IMPACT- LOCATED 20.15 FEET FROM INTERIOR BENT 2; SOUTH EDGE OF BOTTOM FLANGE AREA 27 INCHES LONG DEFLECTED UPWARDS APPROXIMATELY 3 INCHES WITH SEGMENT OF BEAM 15 FEET LONG DEFLECTED TOWARDS NORTH APPROXIMATELY 3 INCHES; GOUGE PRESENT AT IMPACT LOCATION UP TO 0.25 INCH DEEP - PAR

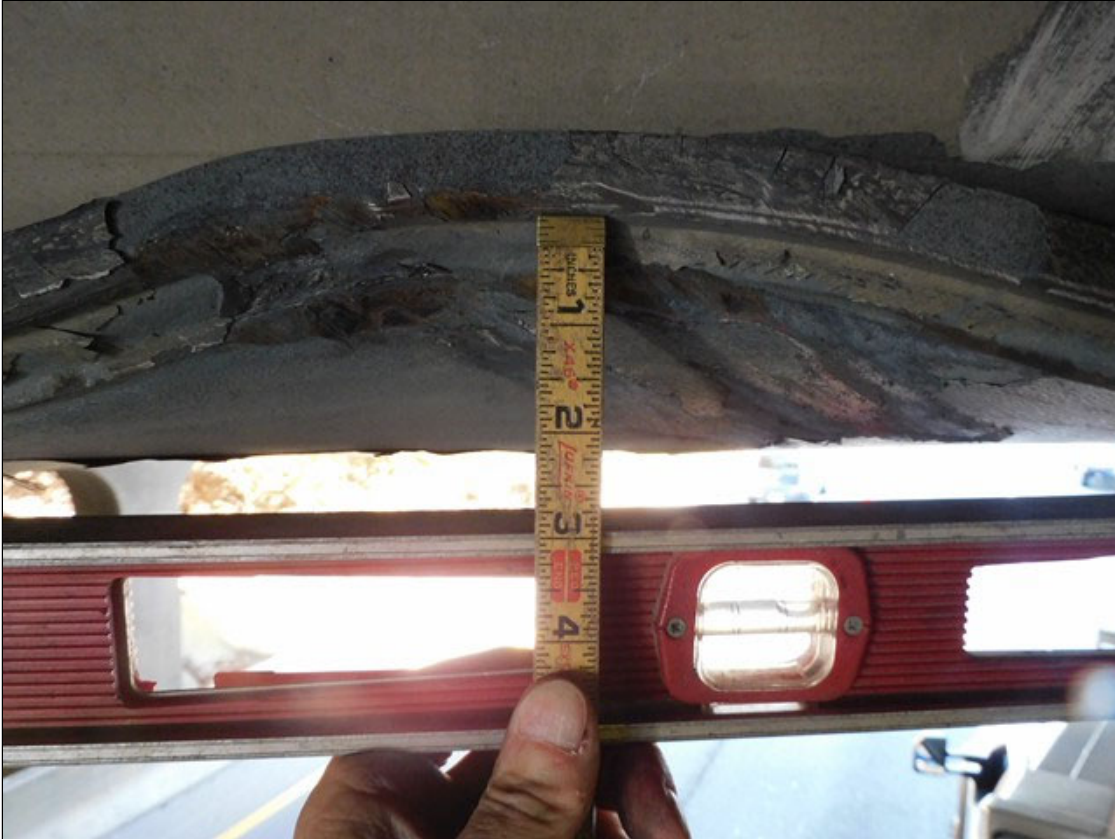
Span 2 Beam 5: IMPACT- LOCATED 20.15 FEET FROM INTERIOR BENT 2; SOUTH EDGE OF BOTTOM FLANGE AREA 27 INCHES LONG DEFLECTED UPWARDS APPROXIMATELY 3 INCHES WITH SEGMENT OF BEAM 15 FEET LONG DEFLECTED TOWARDS NORTH APPROXIMATELY 3 INCHES; GOUGE PRESENT AT IMPACT LOCATION UP TO 0.25 INCH DEEP - PAR

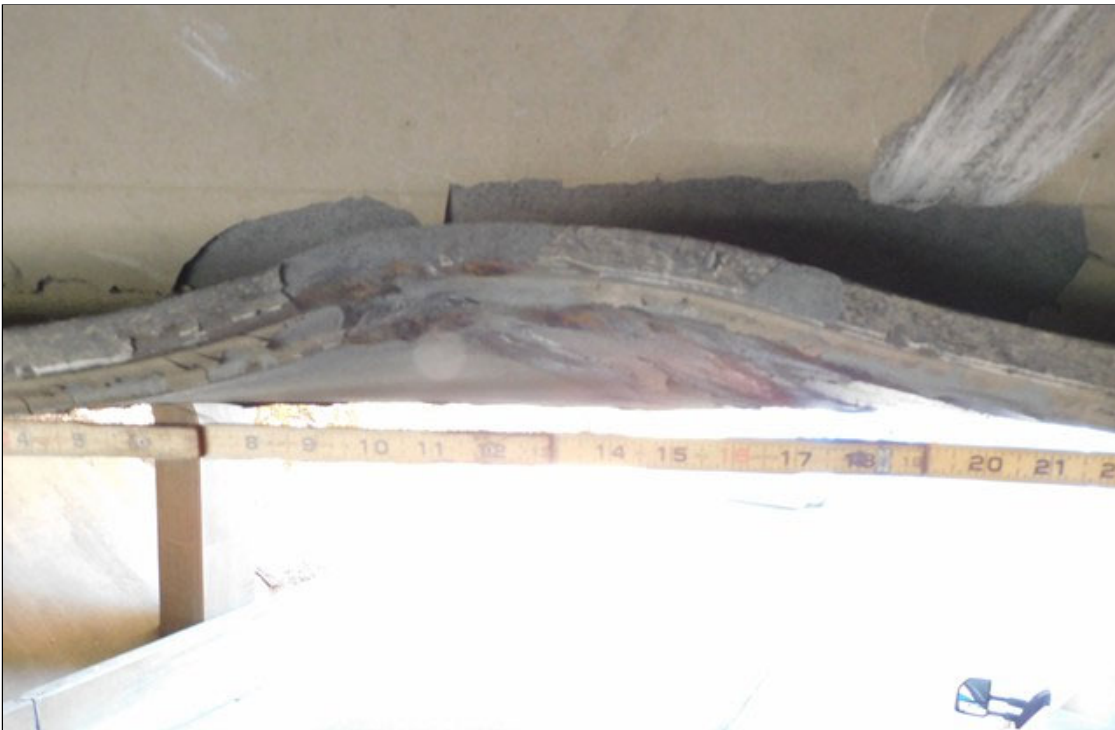
Span 2 Beam 5: IMPACT- LOCATED 20.15 FEET FROM INTERIOR BENT 2; SOUTH EDGE OF BOTTOM FLANGE AREA 27 INCHES LONG DEFLECTED UPWARDS APPROXIMATELY 3 INCHES WITH SEGMENT OF BEAM 15 FEET LONG DEFLECTED TOWARDS NORTH APPROXIMATELY 3 INCHES; GOUGE PRESENT AT IMPACT LOCATION UP TO 0.25 INCH DEEP - PAR

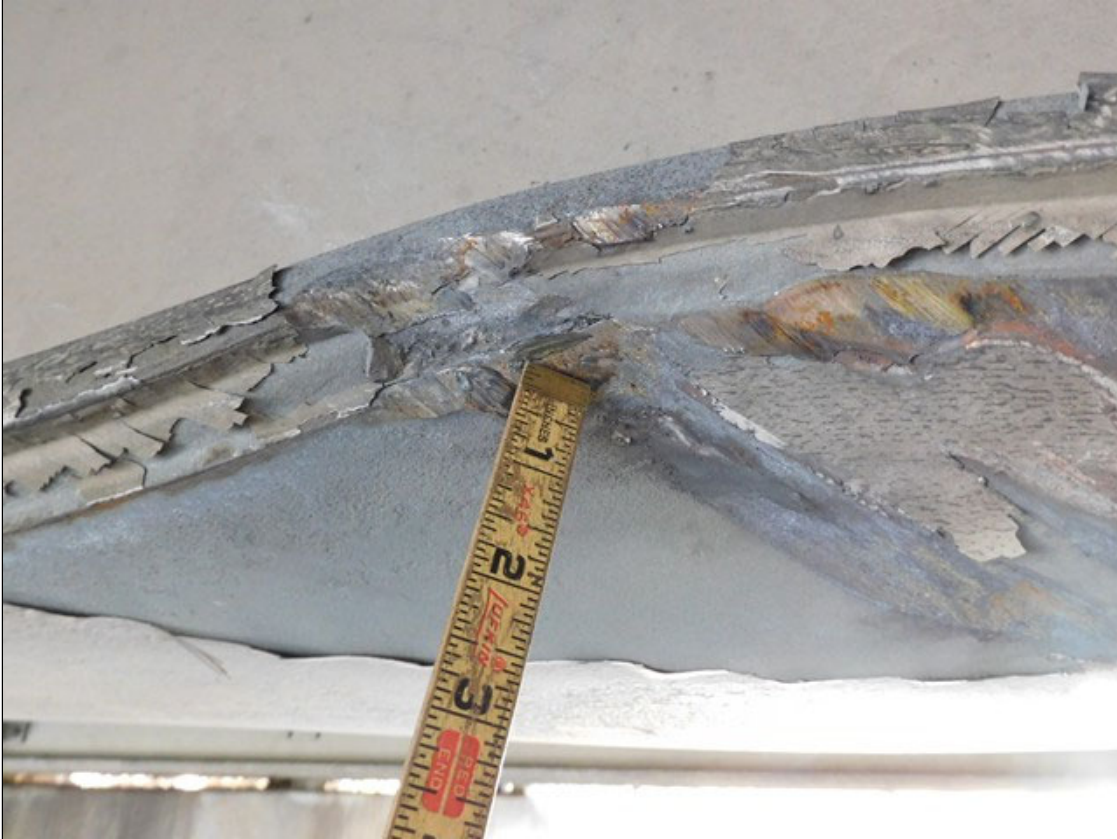
Span 2 Beam 5: IMPACT- LOCATED 20.15 FEET FROM INTERIOR BENT 2; SOUTH EDGE OF BOTTOM FLANGE AREA 27 INCHES LONG DEFLECTED UPWARDS APPROXIMATELY 3 INCHES WITH SEGMENT OF BEAM 15 FEET LONG DEFLECTED TOWARDS NORTH APPROXIMATELY 3 INCHES; GOUGE PRESENT AT IMPACT LOCATION UP TO 0.25 INCH DEEP - PAR

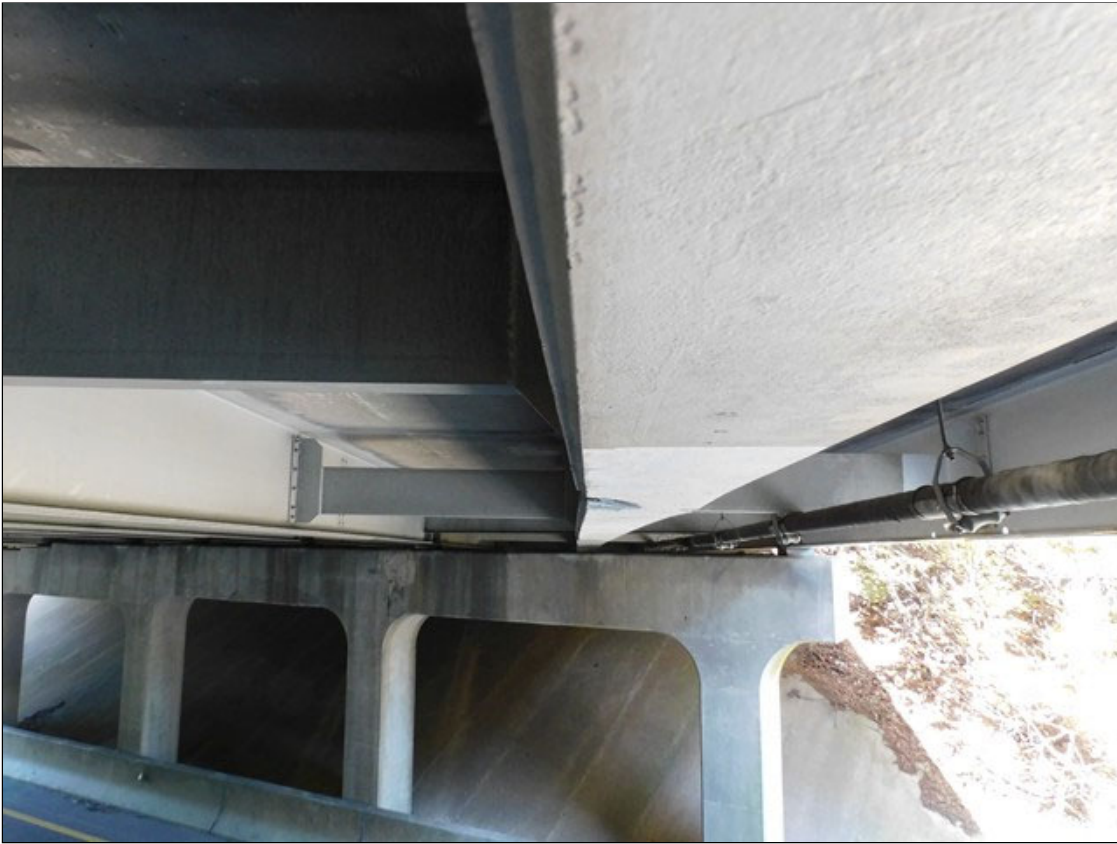
Span 2 Beam 2: IMPACT- LOCATED 18.74 FEET FROM INTERIOR BENT 2 - SOUTH EDGE OF BOTTOM FLANGE AREA 20 INCHES LONG DEFLECTED UPWARDS APPROXIMATLY 3 INCHES WITH CRACK PRESENT IN WELD BETWEEN BOTTOM FLANGE AND COVER PLATE; CRACK APPROXIMATELY 12 INCHES LONG X 0.22 INCH WIDE. SEGMENT OF BEAM APPROXIMATELY 12 FEET LONG DEFLECTED TOWARDS NORTH 1.75 INCHES - GOUGES PRESENT IN IMPACT LOCATION UP TO 0.25 INCH DEEP - PAR

Making plans to be repaired by heat straightening contractor. NCDOT will repair crack in weld between bottom flange and cover plate.

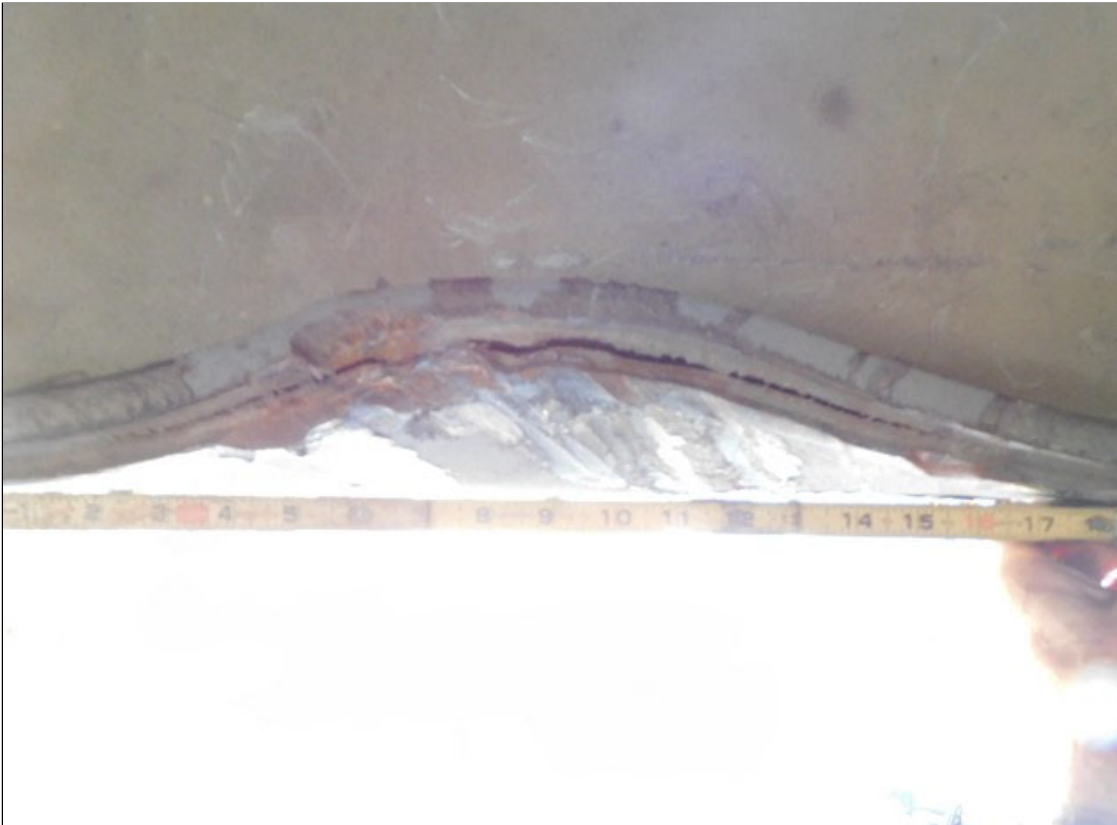
Span 2 Beam 2: IMPACT- LOCATED 18.74 FEET FROM INTERIOR BENT 2 - SOUTH EDGE OF BOTTOM FLANGE AREA 20 INCHES LONG DEFLECTED UPWARDS APPROXIMATELY 3 INCHES WITH CRACK PRESENT IN WELD BETWEEN BOTTOM FLANGE AND COVER PLATE; CRACK APPROXIMATELY 12 INCHES LONG X 0.22 INCH WIDE. SEGMENT OF BEAM APPROXIMATELY 12 FEET LONG DEFLECTED TOWARDS NORTH 1.75 INCHES - GOUGES PRESENT IN IMPACT LOCATION UP TO 0.25 INCH DEEP - PAR

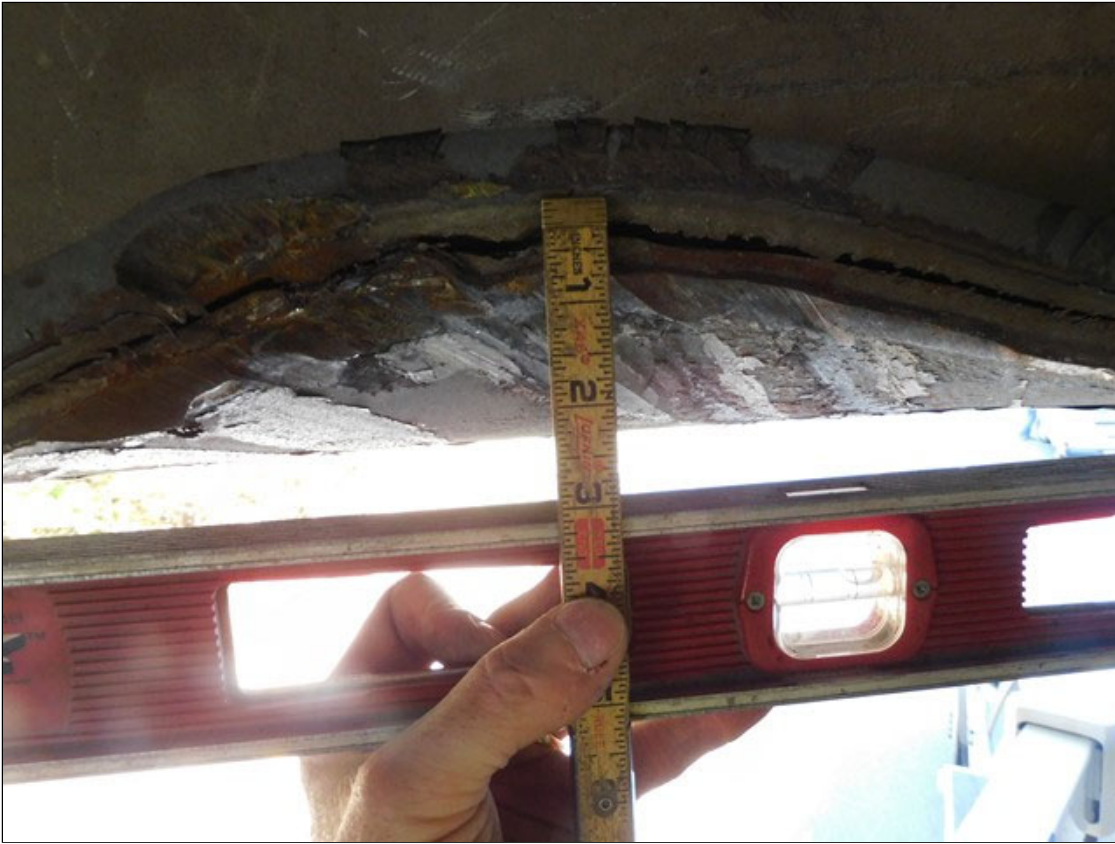
Span 2 Beam 2: IMPACT- LOCATED 18.74 FEET FROM INTERIOR BENT 2 - SOUTH EDGE OF BOTTOM FLANGE AREA 20 INCHES LONG DEFLECTED UPWARDS APPROXIMATELY 3 INCHES WITH CRACK PRESENT IN WELD BETWEEN BOTTOM FLANGE AND COVER PLATE; CRACK APPROXIMATELY 12 INCHES LONG X 0.22 INCH WIDE. SEGMENT OF BEAM APPROXIMATELY 12 FEET LONG DEFLECTED TOWARDS NORTH 1.75 INCHES - GOUGES PRESENT IN IMPACT LOCATION UP TO 0.25 INCH DEEP - PAR

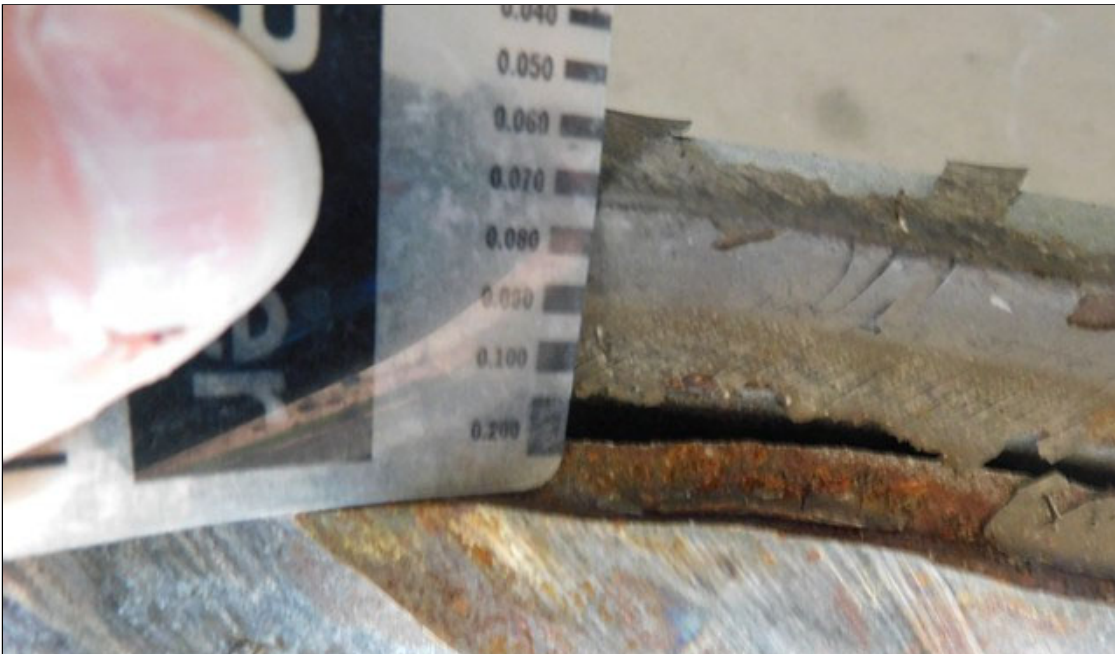
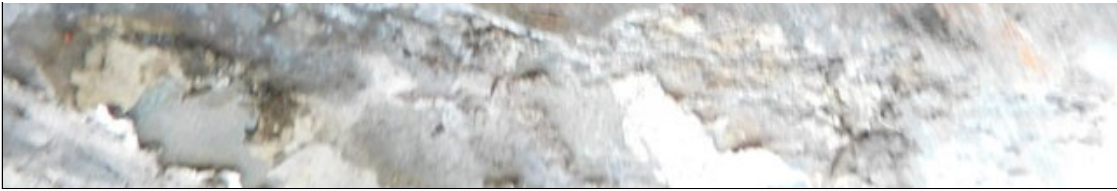
Span 2 Beam 2: IMPACT- LOCATED 18.74 FEET FROM INTERIOR BENT 2 - SOUTH EDGE OF BOTTOM FLANGE AREA 20 INCHES LONG DEFLECTED UPWARDS APPROXIMATELY 3 INCHES WITH CRACK PRESENT IN WELD BETWEEN BOTTOM FLANGE AND COVER PLATE; CRACK APPROXIMATELY 12 INCHES LONG X 0.22 INCH WIDE. SEGMENT OF BEAM APPROXIMATELY 12 FEET LONG DEFLECTED TOWARDS NORTH 1.75 INCHES - GOUGES PRESENT IN IMPACT LOCATION UP TO 0.25 INCH DEEP - PAR

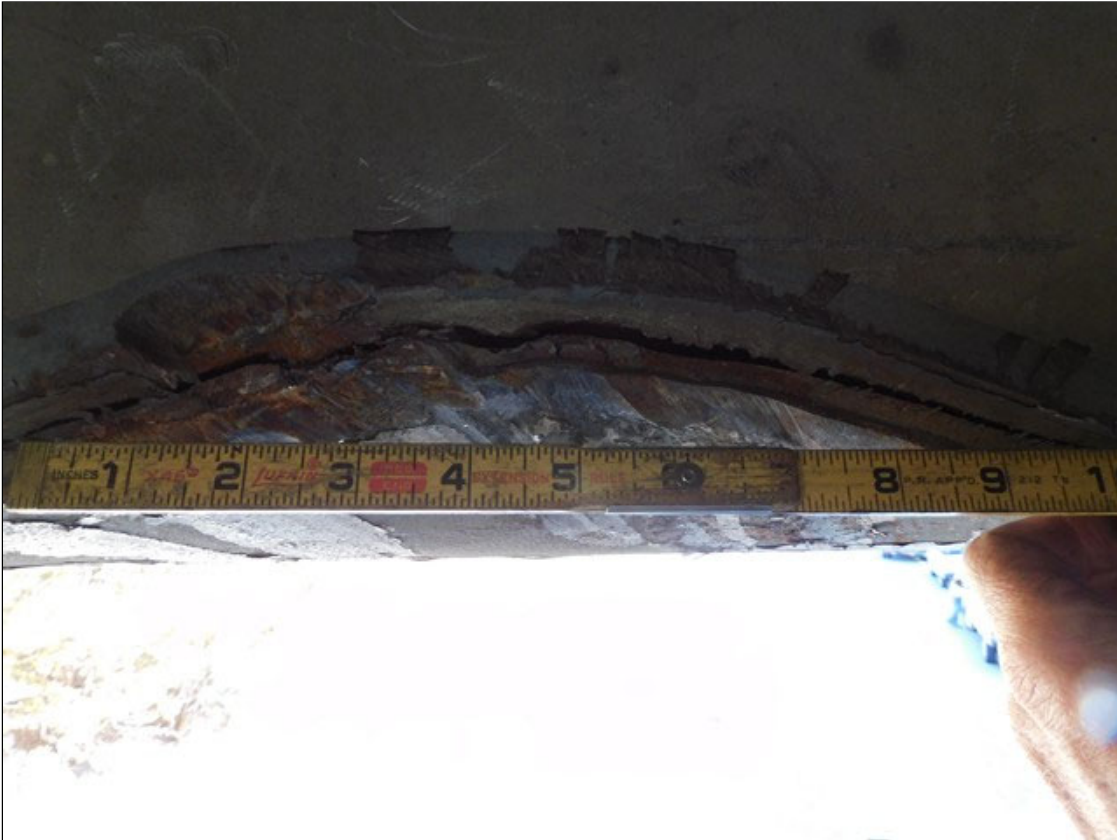
Span 2 Beam 2: IMPACT- LOCATED 18.74 FEET FROM INTERIOR BENT 2 - SOUTH EDGE OF BOTTOM FLANGE AREA 20 INCHES LONG DEFLECTED UPWARDS APPROXIMATELY 3 INCHES WITH CRACK PRESENT IN WELD BETWEEN BOTTOM FLANGE AND COVER PLATE; CRACK APPROXIMATELY 12 INCHES LONG X 0.22 INCH WIDE. SEGMENT OF BEAM APPROXIMATELY 12 FEET LONG DEFLECTED TOWARDS NORTH 1.75 INCHES - GOUGES PRESENT IN IMPACT LOCATION UP TO 0.25 INCH DEEP - PAR

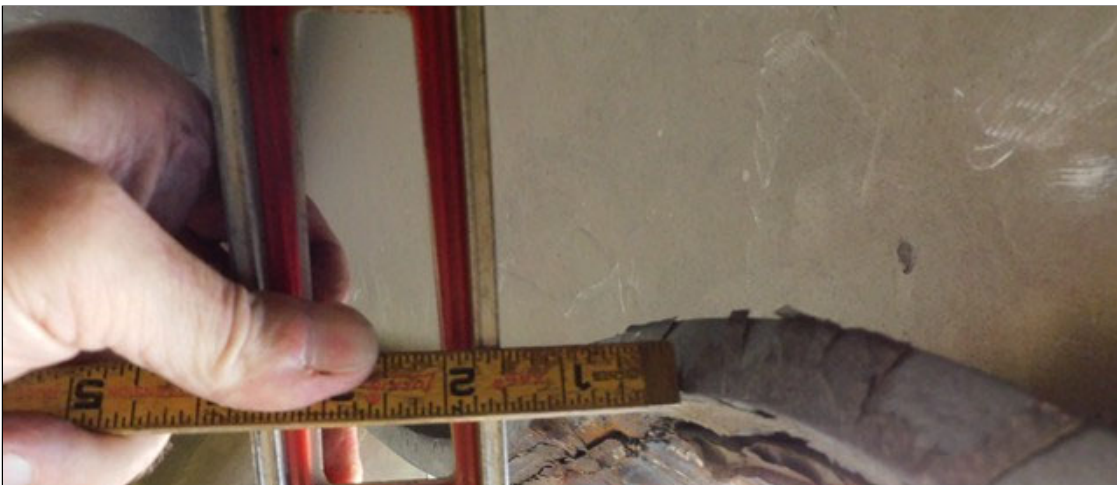
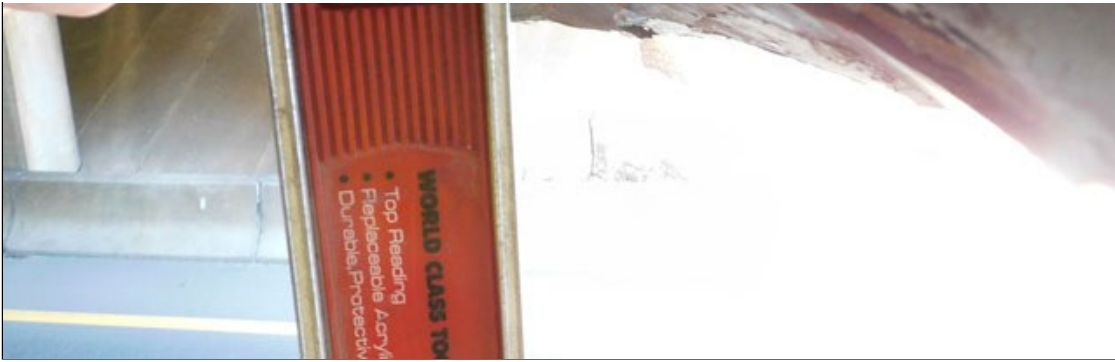
Span 2 Beam 2: IMPACT- LOCATED 18.74 FEET FROM INTERIOR BENT 2 - SOUTH EDGE OF BOTTOM FLANGE AREA 20 INCHES LONG DEFLECTED UPWARDS APPROXIMATELY 3 INCHES WITH CRACK PRESENT IN WELD BETWEEN BOTTOM FLANGE AND COVER PLATE; CRACK APPROXIMATELY 12 INCHES LONG X 0.22 INCH WIDE. SEGMENT OF BEAM APPROXIMATELY 12 FEET LONG DEFLECTED TOWARDS NORTH 1.75 INCHES - GOUGES PRESENT IN IMPACT LOCATION UP TO 0.25 INCH DEEP - PAR

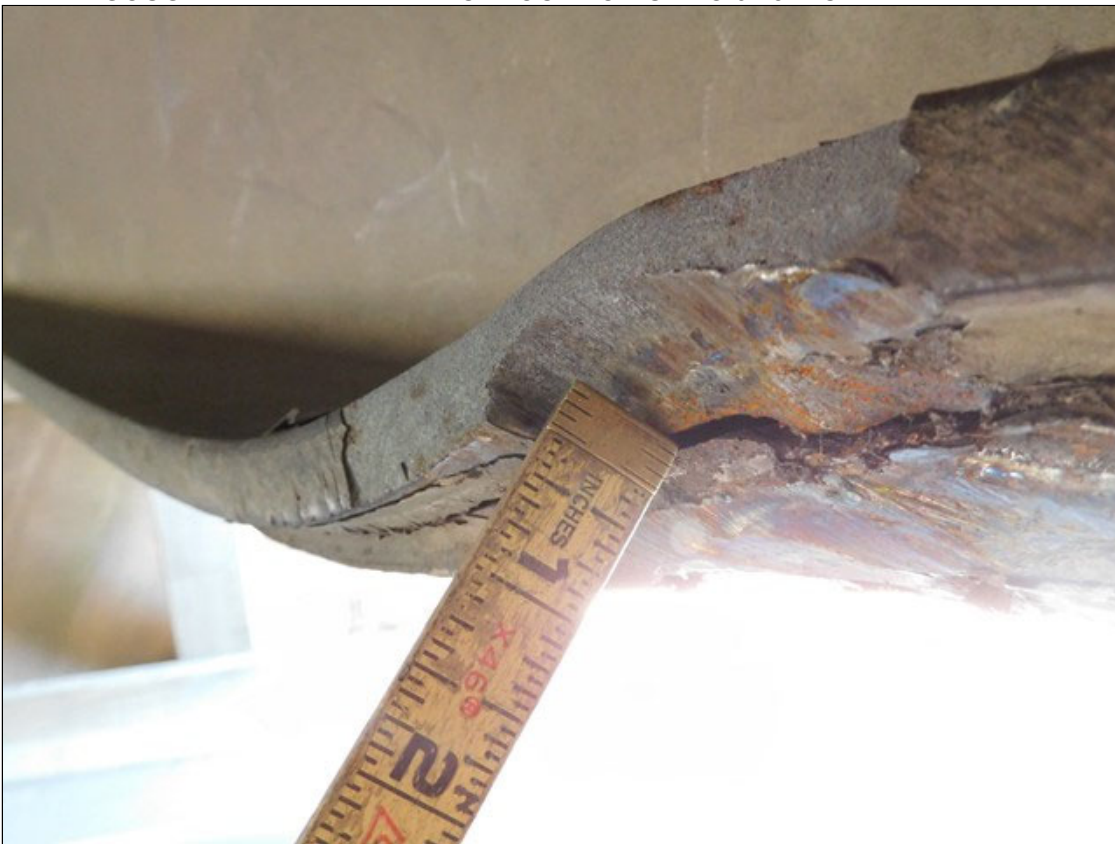
Span 2 Beam 2: IMPACT- LOCATED 18.74 FEET FROM INTERIOR BENT 2 - SOUTH EDGE OF BOTTOM FLANGE AREA 20 INCHES LONG DEFLECTED UPWARDS APPROXIMATELY 3 INCHES WITH CRACK PRESENT IN WELD BETWEEN BOTTOM FLANGE AND COVER PLATE; CRACK APPROXIMATELY 12 INCHES LONG X 0.22 INCH WIDE. SEGMENT OF BEAM APPROXIMATELY 12 FEET LONG DEFLECTED TOWARDS NORTH 1.75 INCHES - GOUGES PRESENT IN IMPACT LOCATION UP TO 0.25 INCH DEEP - PAR

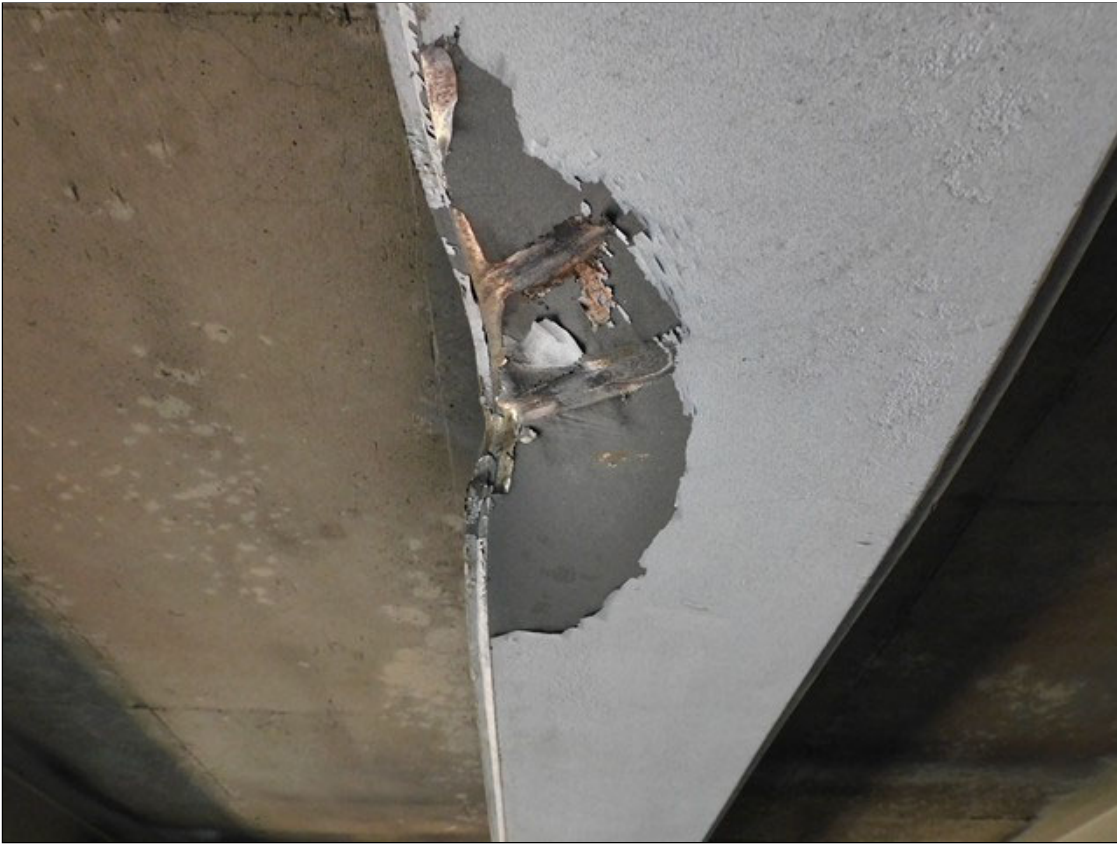
Span 2 Beam 8: IMPACT - LOCATED 22.71 FEET FROM INTERIOR BENT 2- SOUTH EDGE OF BOTTOM FLANGE; AREA 24 INCHES LONG DEFLECTED UPWARDS APPROXIMATELY 3 INCHES; BEAM DEFLECTED TOWARDS NORTH APPROXIMATELY 2 INCHES OVER LENGTH OF 20 FEET - LONGITUDINAL CRACK IN COVER PLATE AT IMPACT LOCATION APPROXIMATELY 7 INCHES LONG X 0.200 INCHES WIDE - PAR

Making plans to be repaired by heat straightening contractor. NCDOT will repair crack in weld between bottom flange and cover plate.

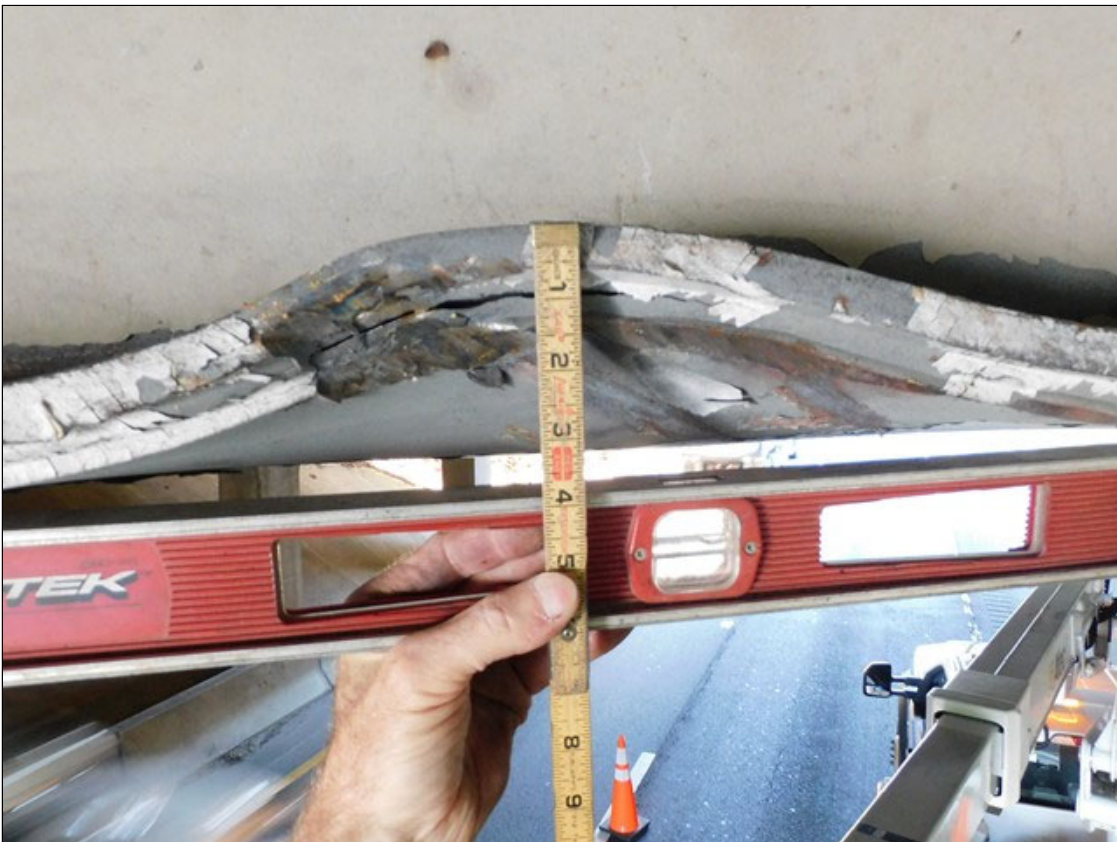
Span 2 Beam 8: IMPACT - LOCATED 22.71 FEET FROM INTERIOR BENT 2- SOUTH EDGE OF BOTTOM FLANGE;  
AREA 24 INCHES LONG DEFLECTED UPWARDS APPROXIMATELY 3 INCHES; BEAM DEFLECTED TOWARDS  
NORTH APPROXIMATELY 2 INCHES OVER LENGTH OF 20 FEET - LONGITUDINAL CRACK IN COVER PLATE AT  
IMPACT LOCATION APPROXIMATELY 7 INCHES LONG X 0.200 INCHES WIDE - PAR

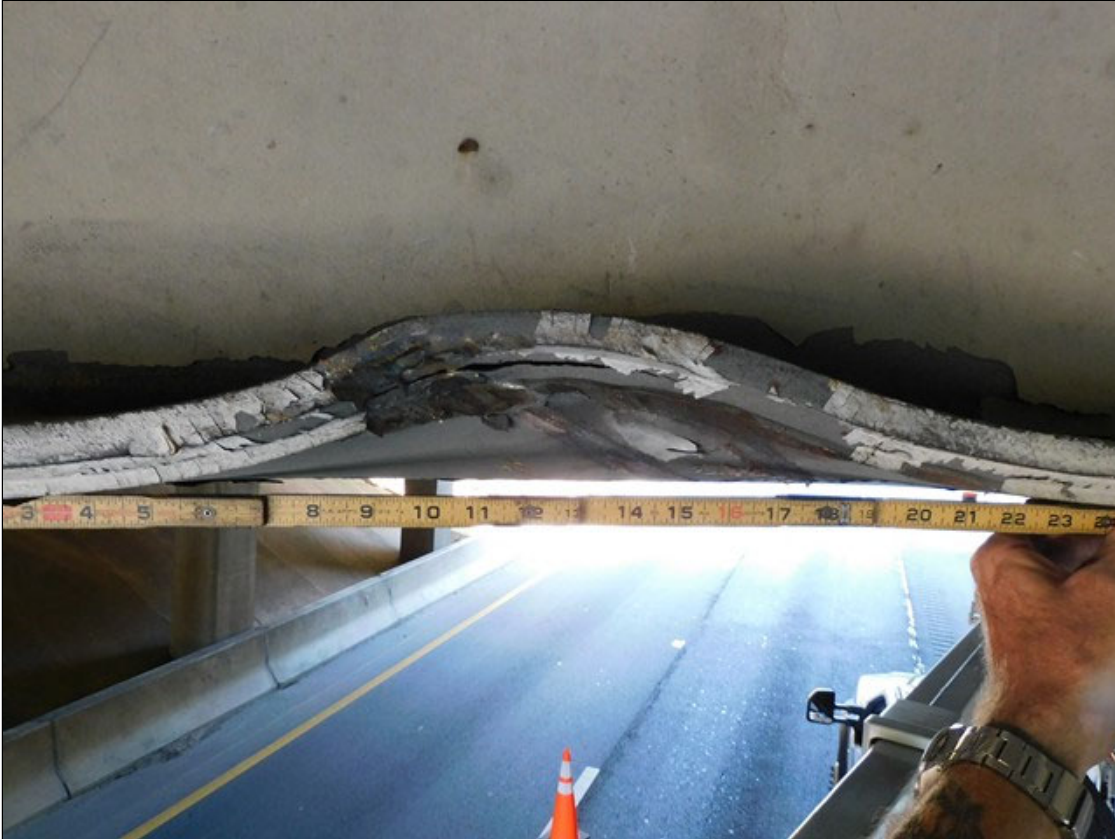
Span 2 Beam 8: IMPACT - LOCATED 22.71 FEET FROM INTERIOR BENT 2- SOUTH EDGE OF BOTTOM FLANGE;  
AREA 24 INCHES LONG DEFLECTED UPWARDS APPROXIMATELY 3 INCHES; BEAM DEFLECTED TOWARDS  
NORTH APPROXIMATELY 2 INCHES OVER LENGTH OF 20 FEET - LONGITUDINAL CRACK IN COVER PLATE AT  
IMPACT LOCATION APPROXIMATELY 7 INCHES LONG X 0.200 INCHES WIDE - PAR

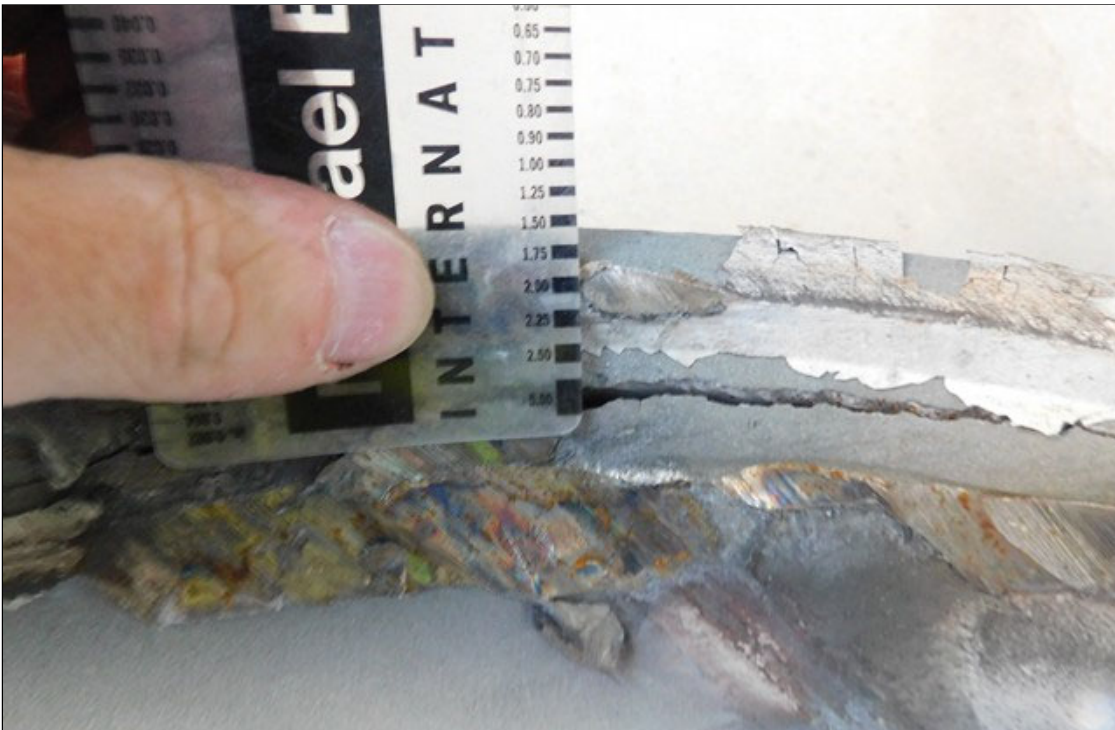
Span 2 Beam 8: IMPACT - LOCATED 22.71 FEET FROM INTERIOR BENT 2- SOUTH EDGE OF BOTTOM FLANGE; AREA 24 INCHES LONG DEFLECTED UPWARDS APPROXIMATELY 3 INCHES; BEAM DEFLECTED TOWARDS NORTH APPROXIMATELY 2 INCHES OVER LENGTH OF 20 FEET - LONGITUDINAL CRACK IN COVER PLATE AT IMPACT LOCATION APPROXIMATELY 7 INCHES LONG X 0.200 INCHES WIDE - PAR

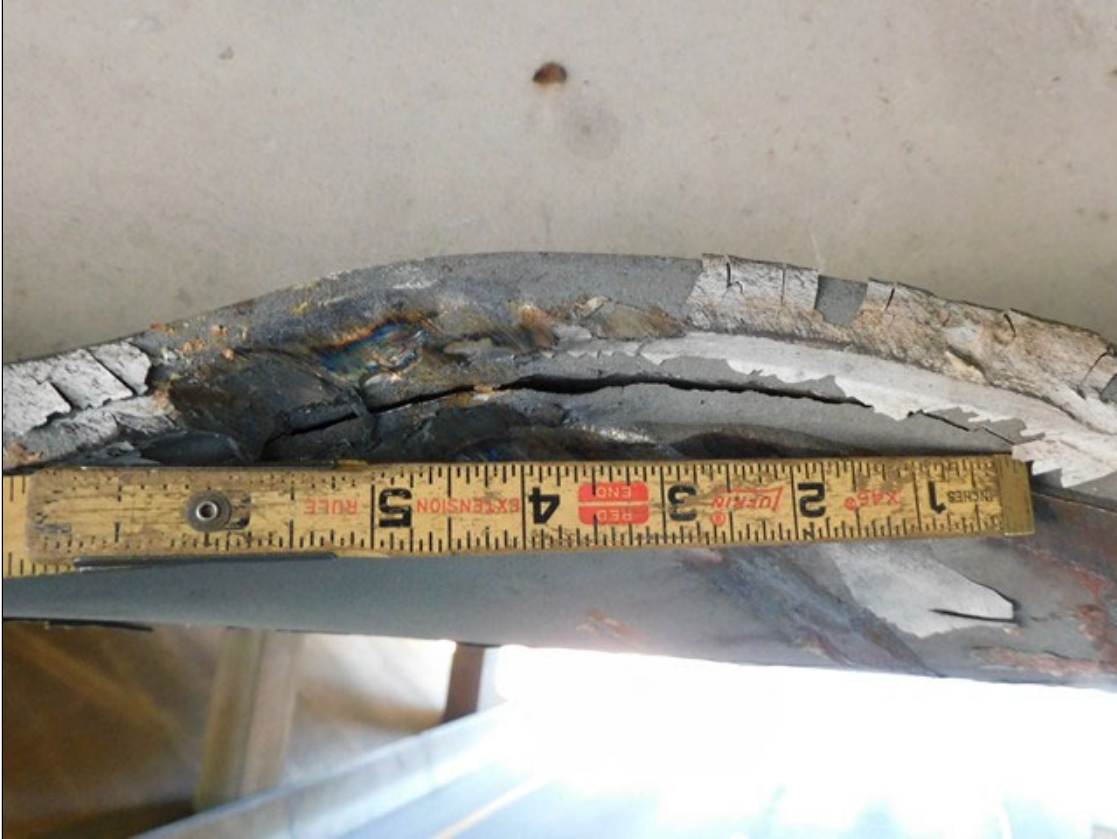
Span 2 Beam 8: IMPACT - LOCATED 22.71 FEET FROM INTERIOR BENT 2- SOUTH EDGE OF BOTTOM FLANGE; AREA 24 INCHES LONG DEFLECTED UPWARDS APPROXIMATELY 3 INCHES; BEAM DEFLECTED TOWARDS NORTH APPROXIMATELY 2 INCHES OVER LENGTH OF 20 FEET - LONGITUDINAL CRACK IN COVER PLATE AT IMPACT LOCATION APPROXIMATELY 7 INCHES LONG X 0.200 INCHES WIDE - PAR

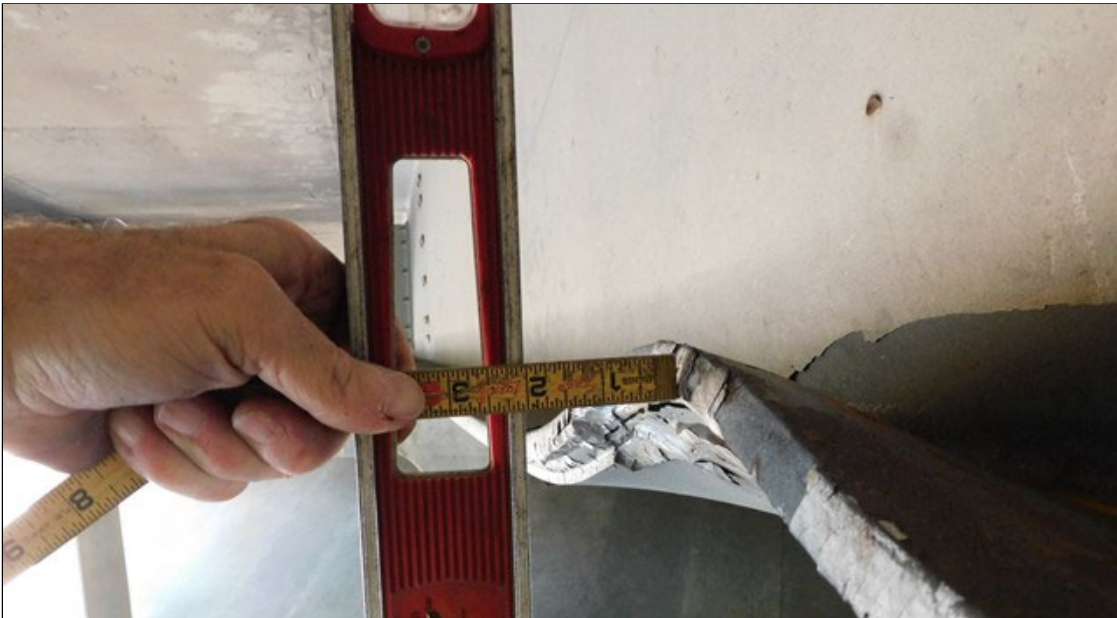
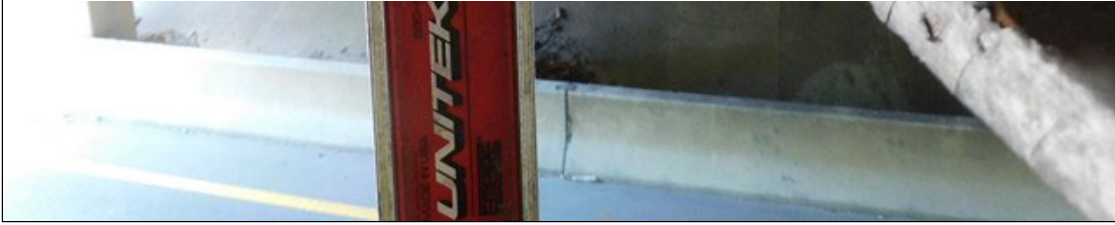
Span 2 Beam 8: IMPACT - LOCATED 22.71 FEET FROM INTERIOR BENT 2- SOUTH EDGE OF BOTTOM FLANGE; AREA 24 INCHES LONG DEFLECTED UPWARDS APPROXIMATELY 3 INCHES; BEAM DEFLECTED TOWARDS NORTH APPROXIMATELY 2 INCHES OVER LENGTH OF 20 FEET - LONGITUDINAL CRACK IN COVER PLATE AT IMPACT LOCATION APPROXIMATELY 7 INCHES LONG X 0.200 INCHES WIDE - PAR

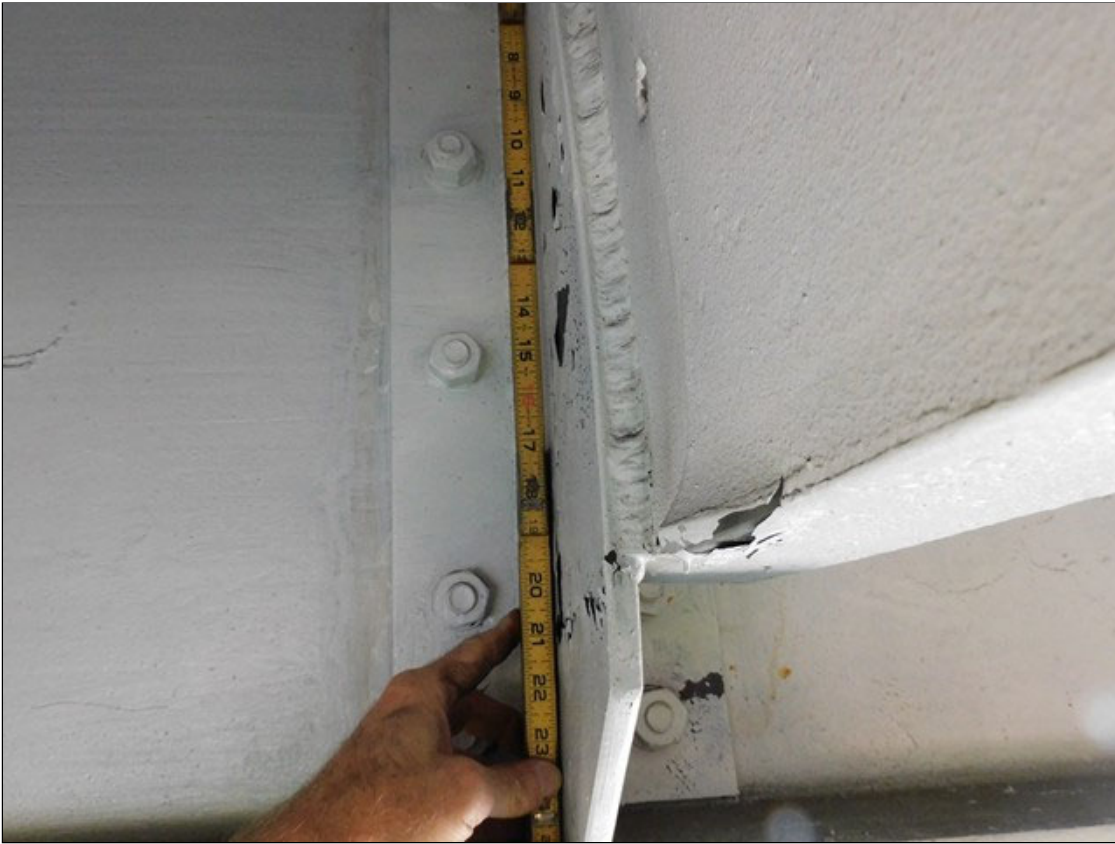
Span 2 Beam 10: IMPACT- LOCATED 22.41 FEET FROM INTERIOR BENT 2; SOUTH EDGE BOTTOM FLANGE- AREA 9 INCHES LONG X FULL BOTTOM FLANGE/COVER PLATE WIDTH WITH GOUGES UP TO 0.25 OF AN INCH DEEP. BEAM DEFLECTED TOWARDS NORTH APPROXIMATELY 2.25 INCHES OVER LINEAR SEGMENT 20 FEET LONG. DIAPHRAGM BRACKET LOCATED 13.5 FEET FROM INTERIOR BENT 2 BENT TOWARDS SOUTH APPROXIMATELY 1.5 INCHES OVER 24 INCHES LONG SECTION - PAR

Request down grade to a 12 month PM. Making plans to be repaired by heat straightening contractor.

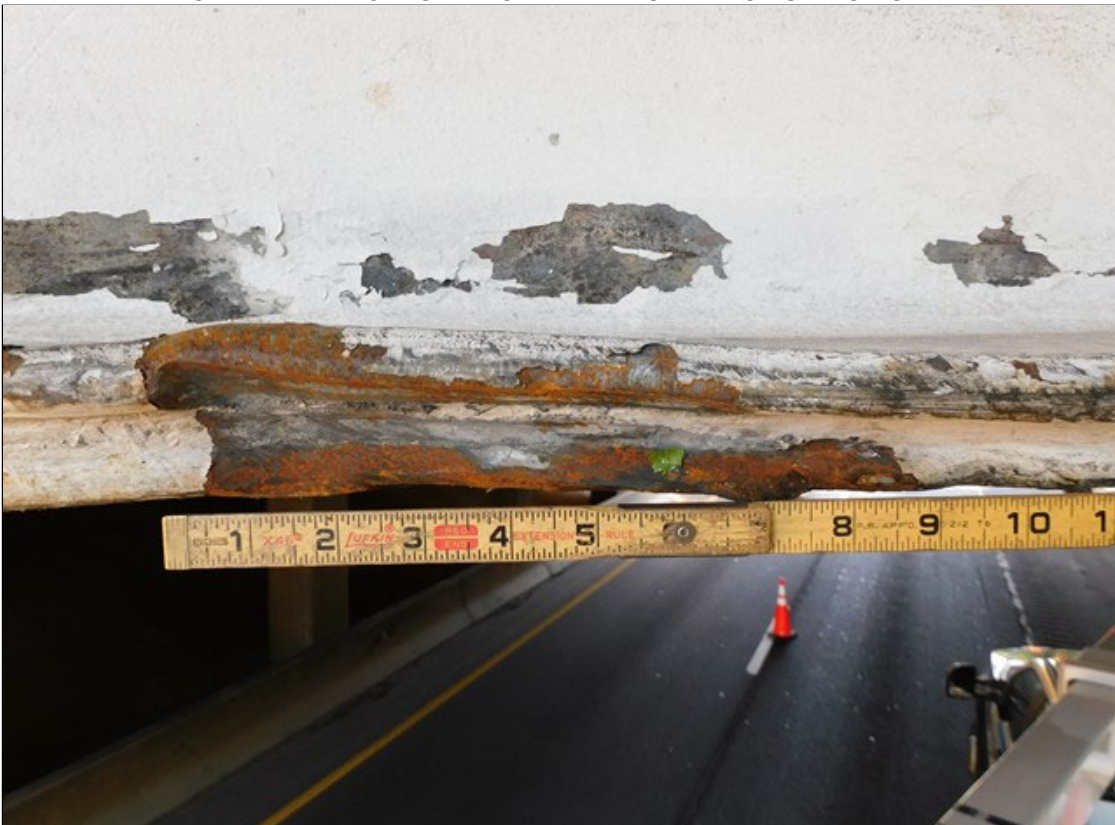
Span 2 Beam 10: IMPACT- LOCATED 22.41 FEET FROM INTERIOR BENT 2; SOUTH EDGE BOTTOM FLANGE- AREA 9 INCHES LONG X FULL BOTTOM FLANGE/COVER PLATE WIDTH WITH GOUGES UP TO 0.25 OF AN INCH DEEP. BEAM DEFLECTED TOWARDS NORTH APPROXIMATELY 2.25 INCHES OVER LINEAR SEGMENT 20 FEET LONG. DIAPHRAGM BRACKET LOCATED 13.5 FEET FROM INTERIOR BENT 2 BENT TOWARDS SOUTH APPROXIMATELY 1.5 INCHES OVER 24 INCHES LONG SECTION - PAR

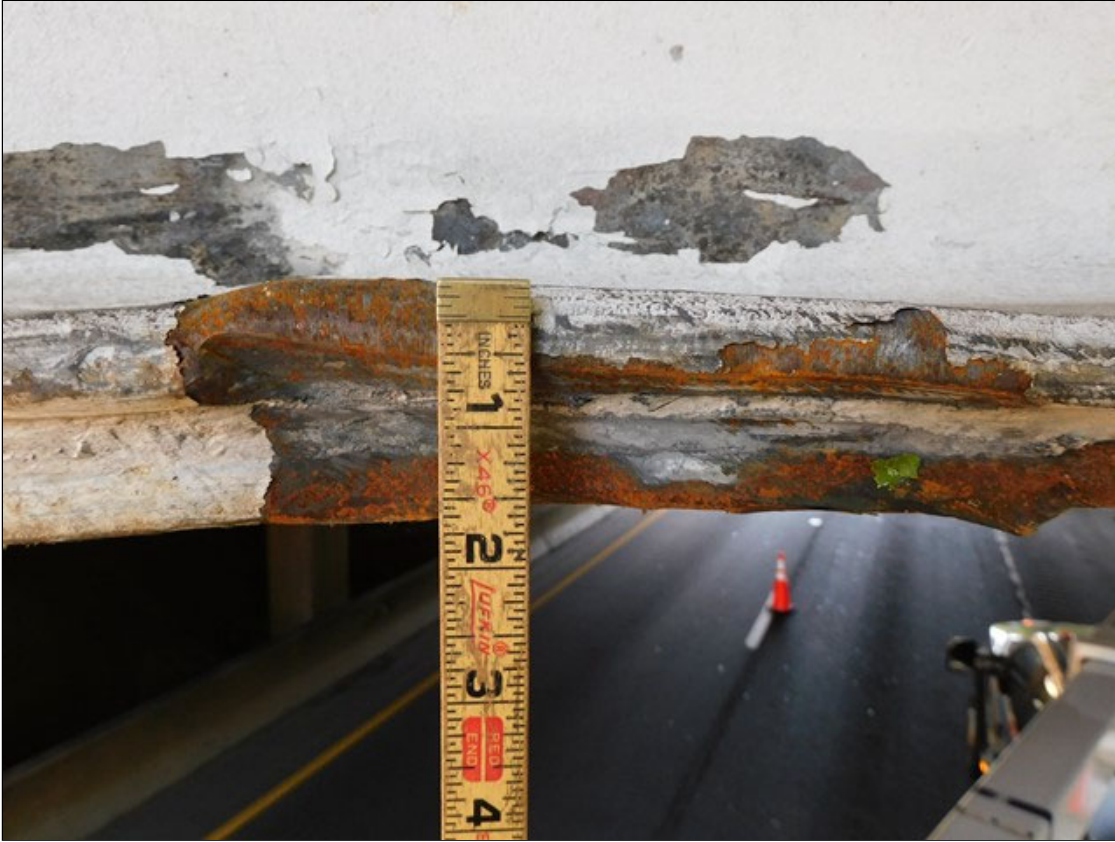
Span 2 Beam 10: IMPACT- LOCATED 22.41 FEET FROM INTERIOR BENT 2; SOUTH EDGE BOTTOM FLANGE- AREA 9 INCHES LONG X FULL BOTTOM FLANGE/COVER PLATE WIDTH WITH GOUGES UP TO 0.25 OF AN INCH DEEP. BEAM DEFLECTED TOWARDS NORTH APPROXIMATELY 2.25 INCHES OVER LINEAR SEGMENT 20 FEET LONG. DIAPHRAGM BRACKET LOCATED 13.5 FEET FROM INTERIOR BENT 2 BENT TOWARDS SOUTH APPROXIMATELY 1.5 INCHES OVER 24 INCHES LONG SECTION - PAR

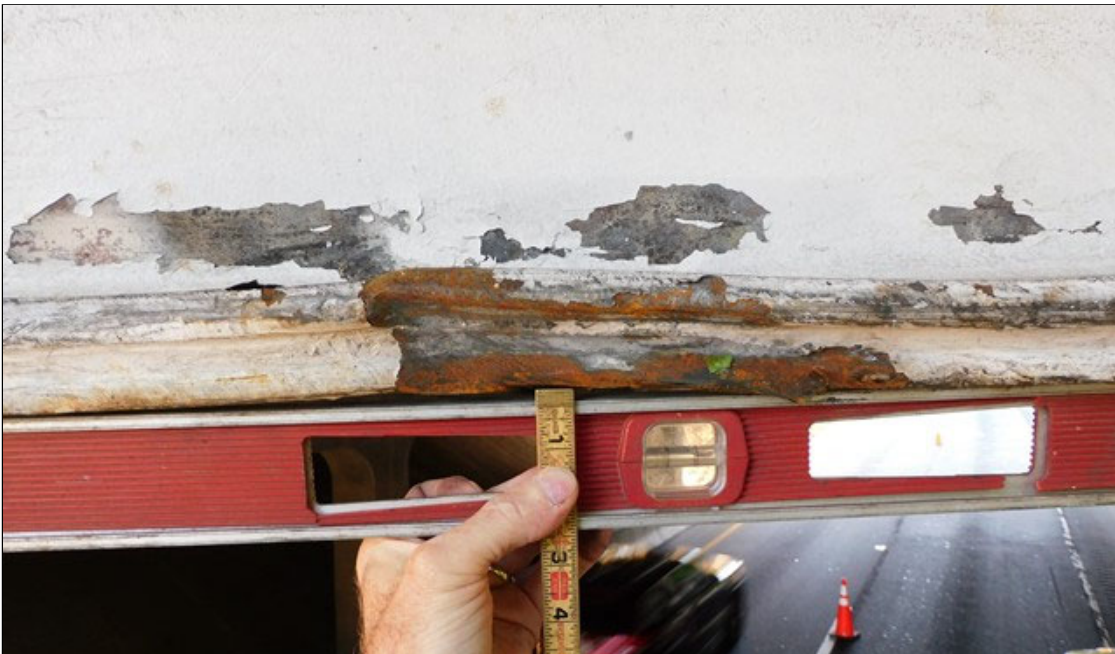
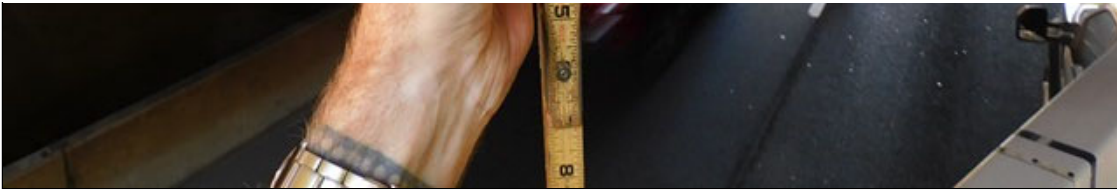
Span 2 Beam 10: IMPACT- LOCATED 22.41 FEET FROM INTERIOR BENT 2; SOUTH EDGE BOTTOM FLANGE- AREA 9 INCHES LONG X FULL BOTTOM FLANGE/COVER PLATE WIDTH WITH GOUGES UP TO 0.25 OF AN INCH DEEP. BEAM DEFLECTED TOWARDS NORTH APPROXIMATELY 2.25 INCHES OVER LINEAR SEGMENT 20 FEET LONG. DIAPHRAGM BRACKET LOCATED 13.5 FEET FROM INTERIOR BENT 2 BENT TOWARDS SOUTH APPROXIMATELY 1.5 INCHES OVER 24 INCHES LONG SECTION - PAR
