Structure: 750017

# Priority Action Repair Report

## Priority Action Request

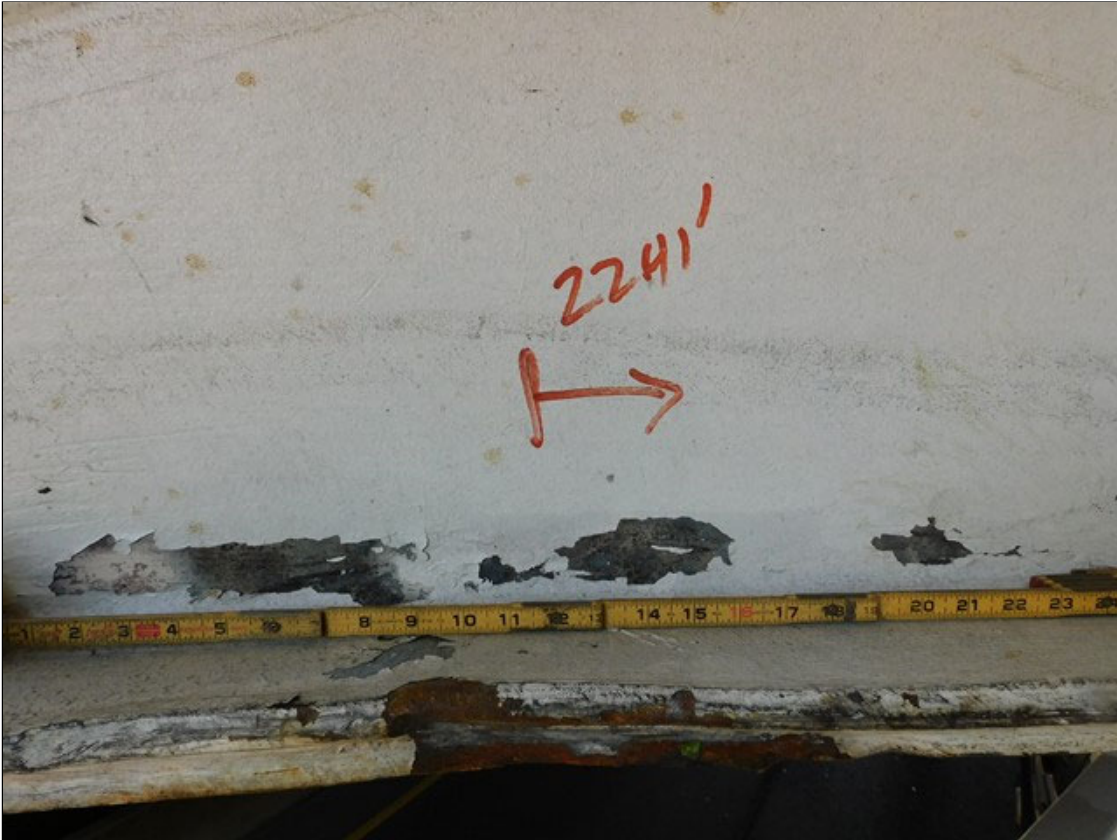
Span 2 Beam 10: IMPACT- LOCATED 22.41 FEET FROM INTERIOR BENT 2; SOUTH EDGE BOTTOM FLANGE- AREA 9 INCHES LONG X FULL BOTTOM FLANGE/COVER PLATE WIDTH WITH GOUGES UP TO 0.25 OF AN INCH DEEP. BEAM DEFLECTED TOWARDS NORTH APPROXIMATELY 2.25 INCHES OVER LINEAR SEGMENT 20 FEET LONG. DIAPHRAGM BRACKET LOCATED 13.5 FEET FROM INTERIOR BENT 2 BENT TOWARDS SOUTH APPROXIMATELY 1.5 INCHES OVER 24 INCHES LONG SECTION - PAR

Request down grade to a 12 month PM. Making plans to be repaired by heat straightening contractor.

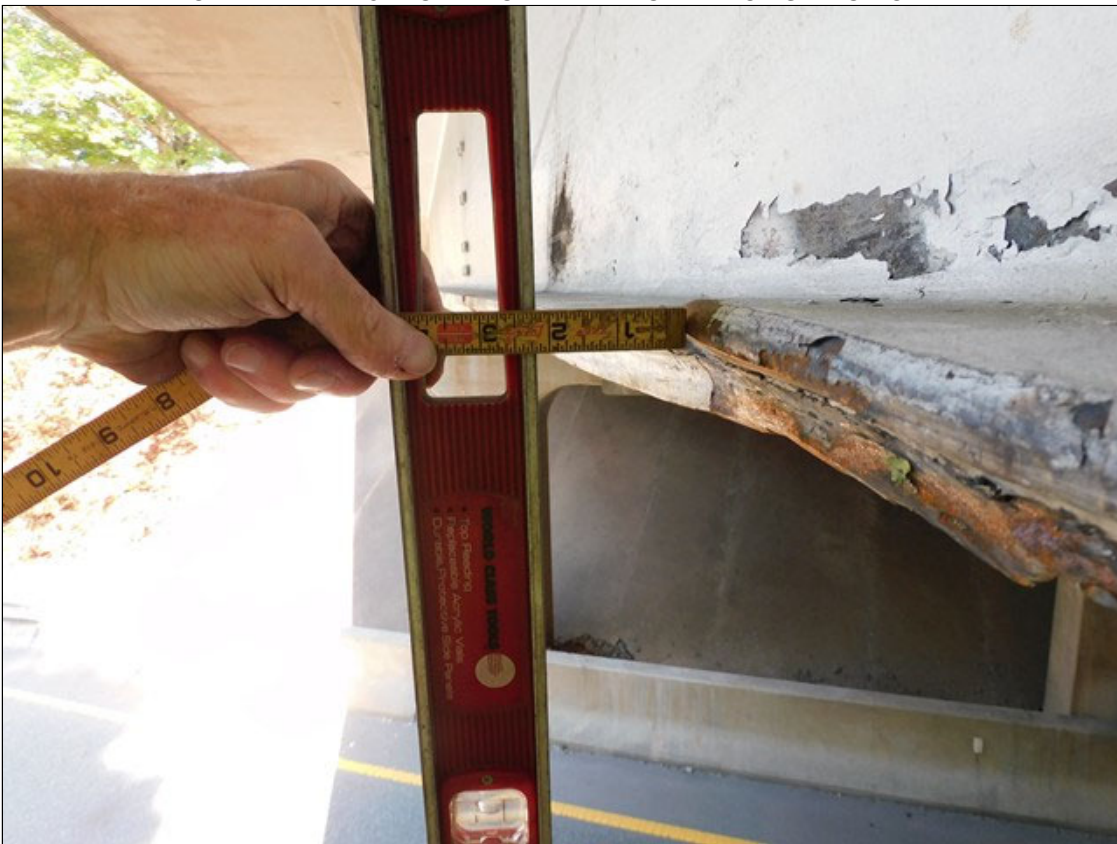
Span 2 Beam 10: IMPACT- LOCATED 22.41 FEET FROM INTERIOR BENT 2; SOUTH EDGE BOTTOM FLANGE- AREA 9 INCHES LONG X FULL BOTTOM FLANGE/COVER PLATE WIDTH WITH GOUGES UP TO 0.25 OF AN INCH DEEP. BEAM DEFLECTED TOWARDS NORTH APPROXIMATELY 2.25 INCHES OVER LINEAR SEGMENT 20 FEET LONG. DIAPHRAGM BRACKET LOCATED 13.5 FEET FROM INTERIOR BENT 2 BENT TOWARDS SOUTH APPROXIMATELY 1.5 INCHES OVER 24 INCHES LONG SECTION - PAR

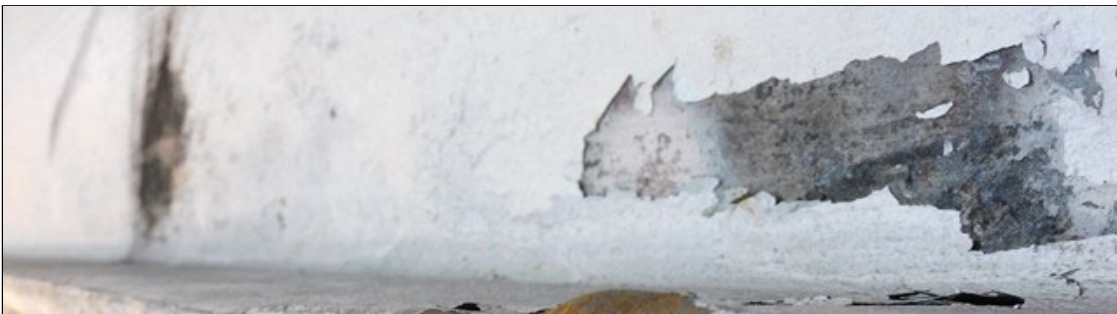
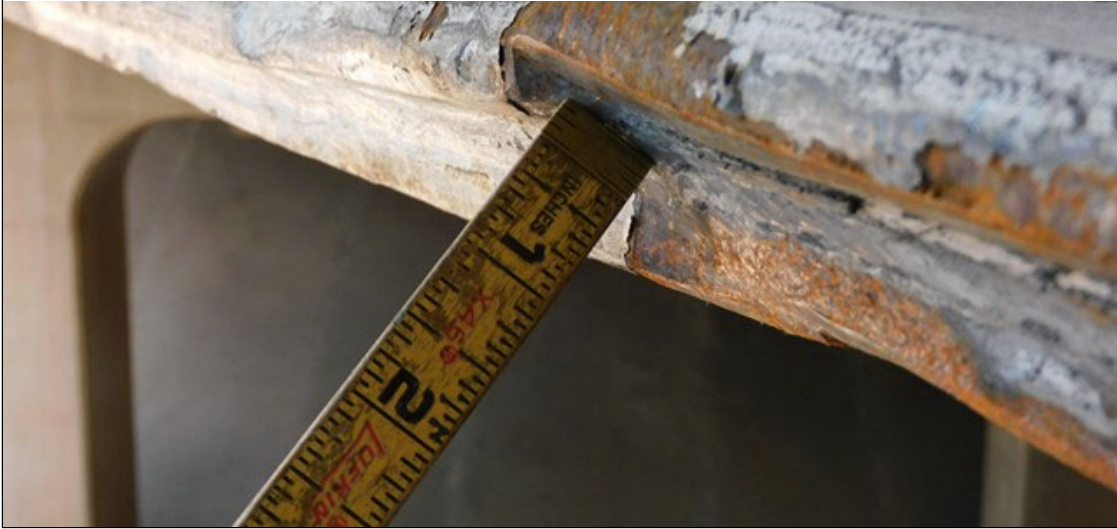
Span 2 Beam 10: IMPACT- LOCATED 22.41 FEET FROM INTERIOR BENT 2; SOUTH EDGE BOTTOM FLANGE- AREA 9 INCHES LONG X FULL BOTTOM FLANGE/COVER PLATE WIDTH WITH GOUGES UP TO 0.25 OF AN INCH DEEP. BEAM DEFLECTED TOWARDS NORTH APPROXIMATELY 2.25 INCHES OVER LINEAR SEGMENT 20 FEET LONG. DIAPHRAGM BRACKET LOCATED 13.5 FEET FROM INTERIOR BENT 2 BENT TOWARDS SOUTH APPROXIMATELY 1.5 INCHES OVER 24 INCHES LONG SECTION - PAR
