Structure: 750009

# Priority Action Repair Report

PM 24 Month

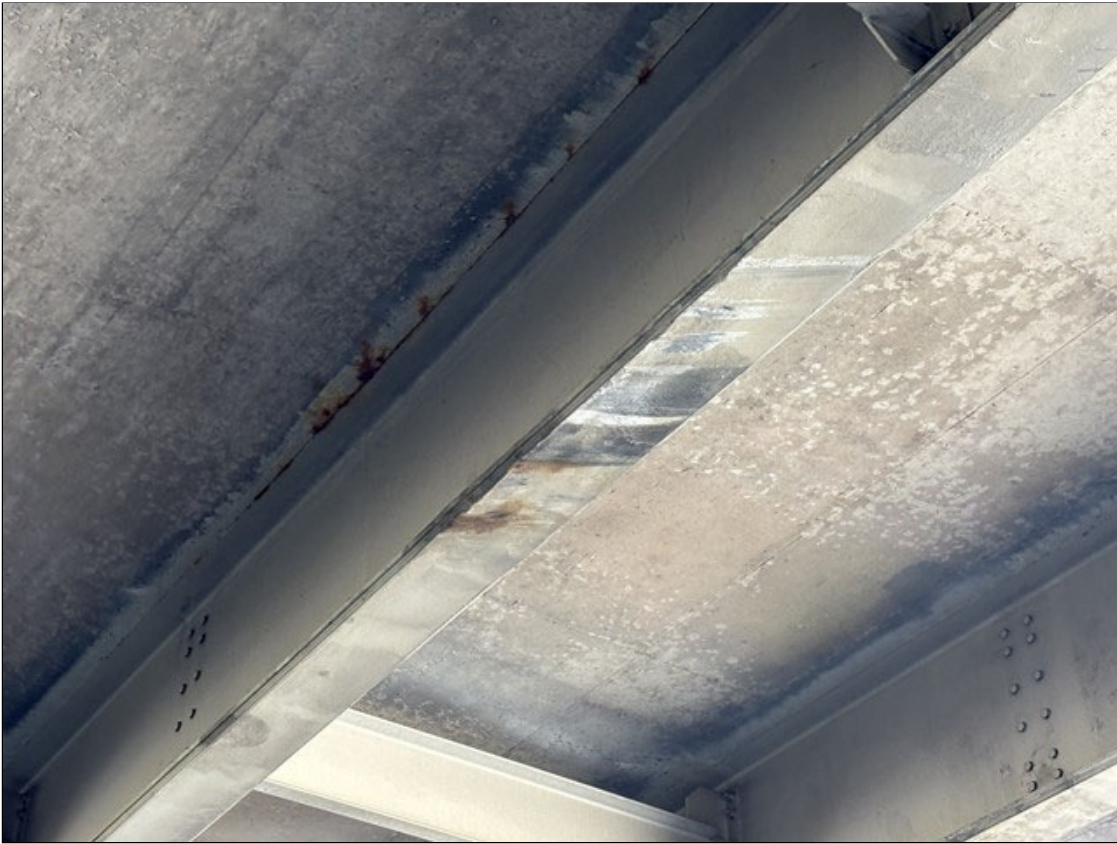
Span 2 Beam 8: (2) AREAS OF IMPACT DAMAGE UP TO 4 FOOT LONG WITH UP TO 1 INCH DEFLECTION IN LEFT EDGE OF BOTTOM FLANGE AND COVER PLATE, AT 17 FOOT AND 18 1/2 FOOT FROM BENT 1.

Span 2 Beam 8: (2) AREAS OF IMPACT DAMAGE UP TO 4 FOOT LONG WITH UP TO 1 INCH DEFLECTION IN LEFT EDGE OF BOTTOM FLANGE AND COVER PLATE, AT 17 FOOT AND 18 1/2 FOOT FROM BENT 1

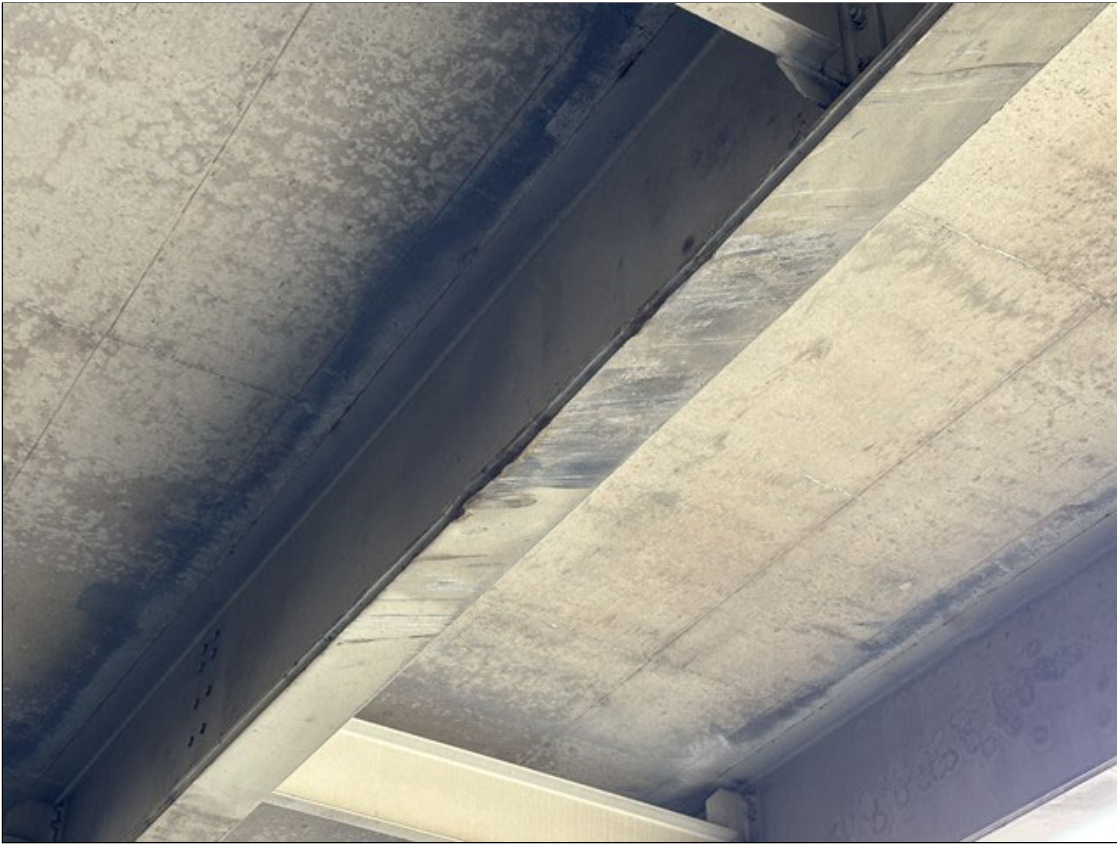
Span 2 Beam 9: (2) AREAS OF IMPACT DAMAGE UP TO 30 INCH LONG WITH UP TO 1 INCH DEFLECTION IN LEFT EDGE OF BOTTOM FLANGE AND COVER PLATE, AT 22 FOOT 11 INCH AND 17 FOOT 4 INCH FROM BENT 1.

Span 2 Beam 9: (2) AREAS OF IMPACT DAMAGE UP TO 30 INCH LONG WITH UP TO 1 INCH DEFLECTION IN LEFT EDGE OF BOTTOM FLANGE AND COVER PLATE, AT 22 FOOT 11 INCH AND 17 FOOT 4 INCH FROM BENT

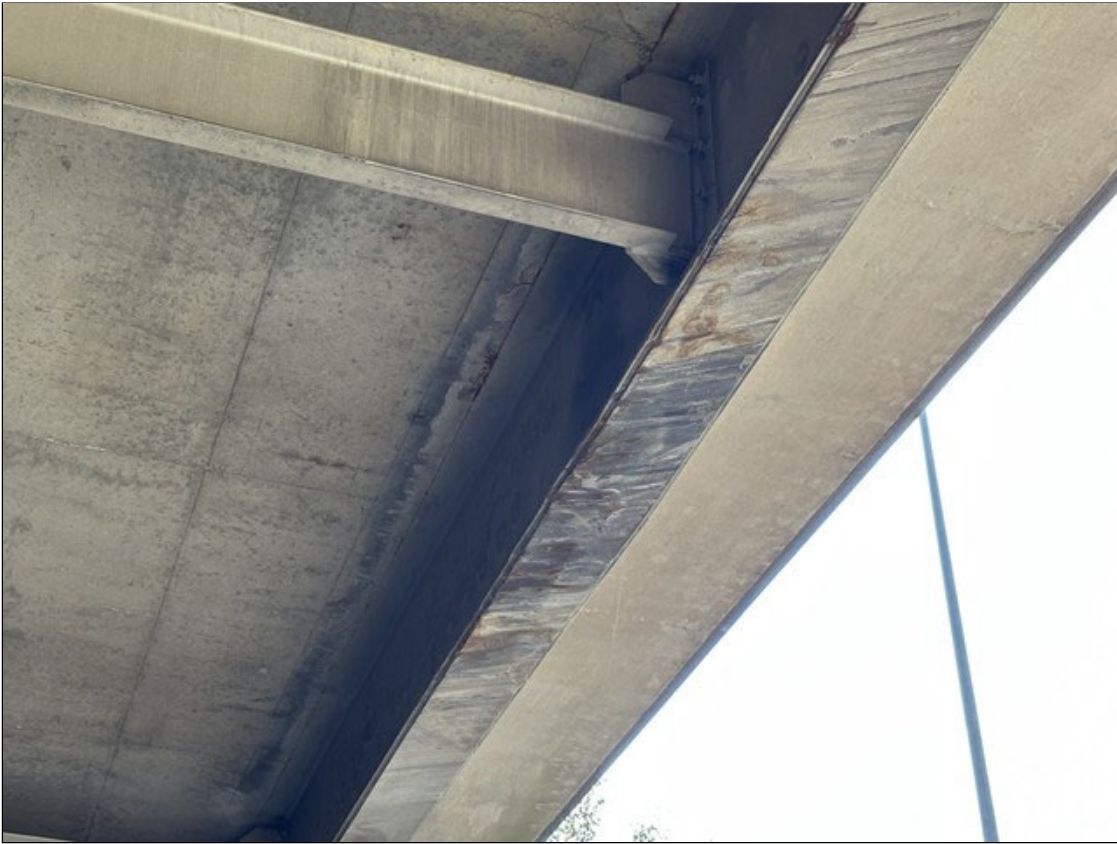
Span 2 Beam 10: IMPACT-11/19/2025- PRIOR DAMAGE; LOCATED 21.2 FEET FROM INTERIOR BENT 1 - AREA 8 FEET LONG DEFLECTED TOWARDS SOUTH 1.25 INCHES WITH SEGMENT OF BOTTOM FLANGE DEFLECTED UPWARDS 1.5 INCHES - ALONG BOTTOM FLANGE AT MID SPAN, AREA OF IMPACT DAMAGE [8 FOOT LONG] WITH AREA OF DELECTION [1/4 INCH X 3 FOOT LONG] ON SOUTH FACE AND DEFLECTED UP [1.25 INCH X 4 FOOT LONG] ON NORTH FACE.

Span 2 Beam 10: IMPACT-11/19/2025- PRIOR DAMAGE; LOCATED 21.2 FEET FROM INTERIOR BENT 1 - AREA 8 FEET LONG DEFLECTED TOWARDS SOUTH 1.25 INCHES WITH SEGMENT OF BOTTOM FLANGE DEFLECTED UPWARDS 1.5 INCHES - ALONG BOTTOM FLANGE AT MID SPAN, AREA OF IMPACT DAMAGE [8 FOOT LONG] WITH AREA OF DEFECTION [1/4 INCH X 3 FOOT LONG] ON SOUTH FACE AND DEFLECTED UP [1.25 INCH X 4 FOOT LONG] ON NORTH FACE

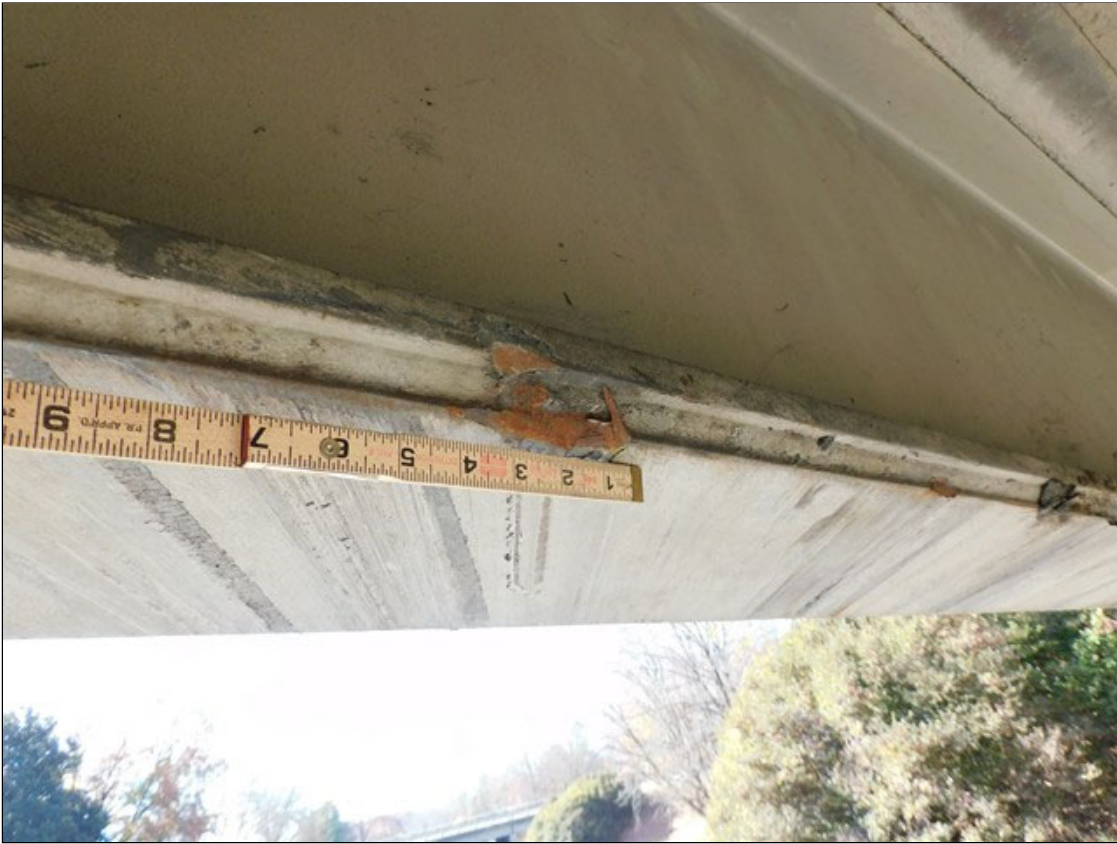
Span 2 Beam 10: IMPACT-11/19/2025- PRIOR DAMAGE; LOCATED 21.2 FEET FROM INTERIOR BENT 1 - AREA 8 FEET LONG DEFLECTED TOWARDS SOUTH 1.25 INCHES WITH SEGMENT OF BOTTOM FLANGE DEFLECTED UPWARDS 1.5 INCHES - ALONG BOTTOM FLANGE AT MID SPAN, AREA OF IMPACT DAMAGE [8 FOOT LONG] WITH AREA OF DELECTION [1/4 INCH X 3 FOOT LONG] ON SOUTH FACE AND DEFLECTED UP [1.25 INCH X 4 FOOT LONG] ON NORTH FACE. -PAR

Span 2 Beam 10: IMPACT-11/19/2025- PRIOR DAMAGE; LOCATED 21.2 FEET FROM INTERIOR BENT 1 - AREA 8 FEET LONG DEFLECTED TOWARDS SOUTH 1.25 INCHES WITH SEGMENT OF BOTTOM FLANGE DEFLECTED UPWARDS 1.5 INCHES - ALONG BOTTOM FLANGE AT MID SPAN, AREA OF IMPACT DAMAGE [8 FOOT LONG] WITH AREA OF DELECTION [1/4 INCH X 3 FOOT LONG] ON SOUTH FACE AND DEFLECTED UP [1.25 INCH X 4 FOOT LONG] ON NORTH FACE.

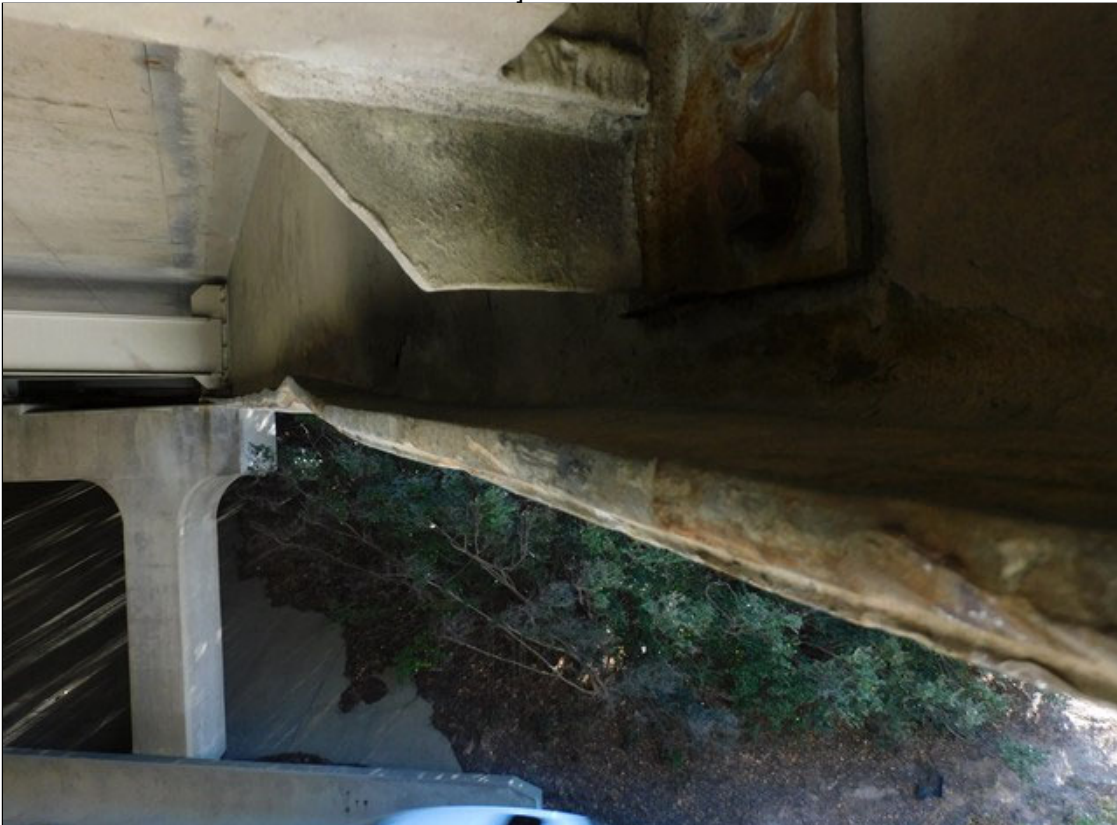
Span 2 Beam 10: IMPACT-11/19/2025- PRIOR DAMAGE; LOCATED 21.2 FEET FROM INTERIOR BENT 1 - AREA 8 FEET LONG DEFLECTED TOWARDS SOUTH 1.25 INCHES WITH SEGMENT OF BOTTOM FLANGE DEFLECTED UPWARDS 1.5 INCHES - ALONG BOTTOM FLANGE AT MID SPAN, AREA OF IMPACT DAMAGE [8 FOOT LONG] WITH AREA OF DELECTION [1/4 INCH X 3 FOOT LONG] ON SOUTH FACE AND DEFLECTED UP [1.25 INCH X 4 FOOT LONG] ON NORTH FACE.

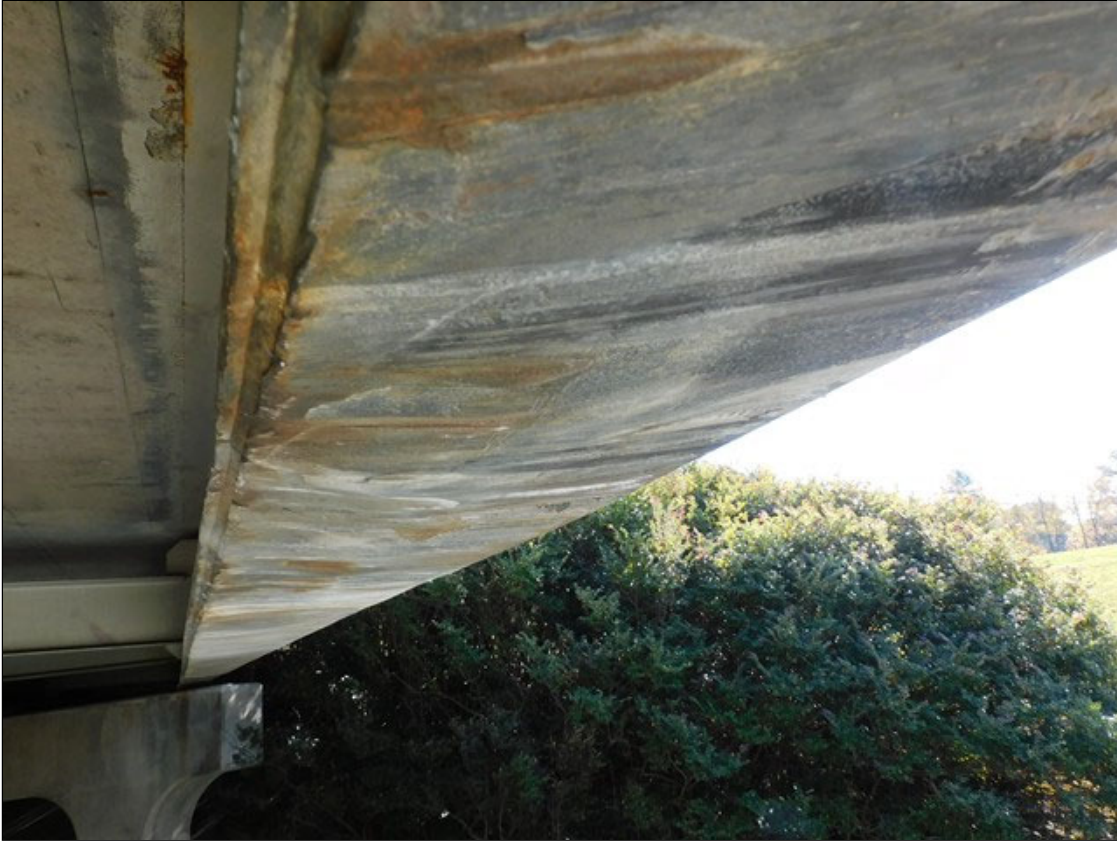
Span 2 Beam 10: IMPACT-11/19/2025- PRIOR DAMAGE; LOCATED 21.2 FEET FROM INTERIOR BENT 1 - AREA 8 FEET LONG DEFLECTED TOWARDS SOUTH 1.25 INCHES WITH SEGMENT OF BOTTOM FLANGE DEFLECTED UPWARDS 1.5 INCHES - ALONG BOTTOM FLANGE AT MID SPAN, AREA OF IMPACT DAMAGE [8 FOOT LONG] WITH AREA OF DELECTION [1/4 INCH X 3 FOOT LONG] ON SOUTH FACE AND DEFLECTED UP [1.25 INCH X 4 FOOT LONG] ON NORTH FACE.

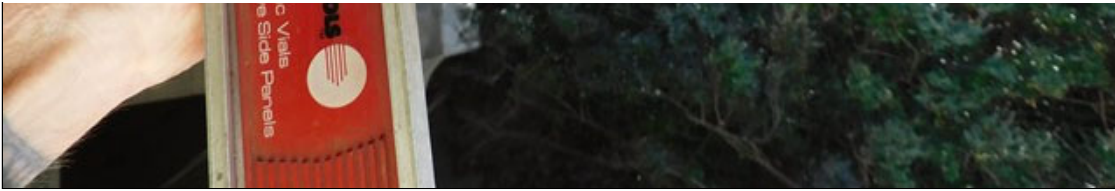
Span 2 Beam 10: IMPACT-11/19/2025- PRIOR DAMAGE; LOCATED 21.2 FEET FROM INTERIOR BENT 1 - AREA 8 FEET LONG DEFLECTED TOWARDS SOUTH 1.25 INCHES WITH SEGMENT OF BOTTOM FLANGE DEFLECTED UPWARDS 1.5 INCHES - ALONG BOTTOM FLANGE AT MID SPAN, AREA OF IMPACT DAMAGE [8 FOOT LONG] WITH AREA OF DEFECTION [1/4 INCH X 3 FOOT LONG] ON SOUTH FACE AND DEFLECTED UP [1.25 INCH X 4 FOOT LONG] ON NORTH FACE.

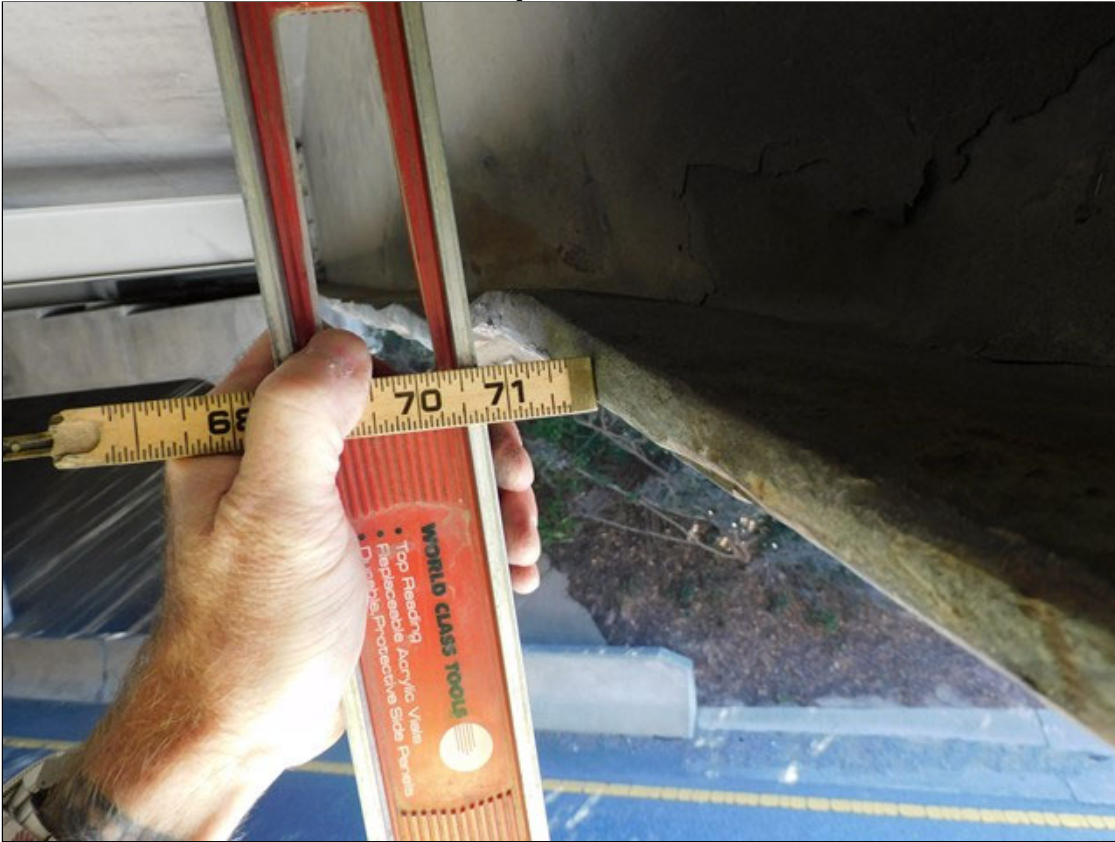
Span 2 Beam 10: IMPACT-11/19/2025- PRIOR DAMAGE; LOCATED 21.2 FEET FROM INTERIOR BENT 1 - AREA 8 FEET LONG DEFLECTED TOWARDS SOUTH 1.25 INCHES WITH SEGMENT OF BOTTOM FLANGE DEFLECTED UPWARDS 1.5 INCHES - ALONG BOTTOM FLANGE AT MID SPAN, AREA OF IMPACT DAMAGE [8 FOOT LONG] WITH AREA OF DEFECTION [1/4 INCH X 3 FOOT LONG] ON SOUTH FACE AND DEFLECTED UP [1.25 INCH X 4 FOOT LONG] ON NORTH FACE.

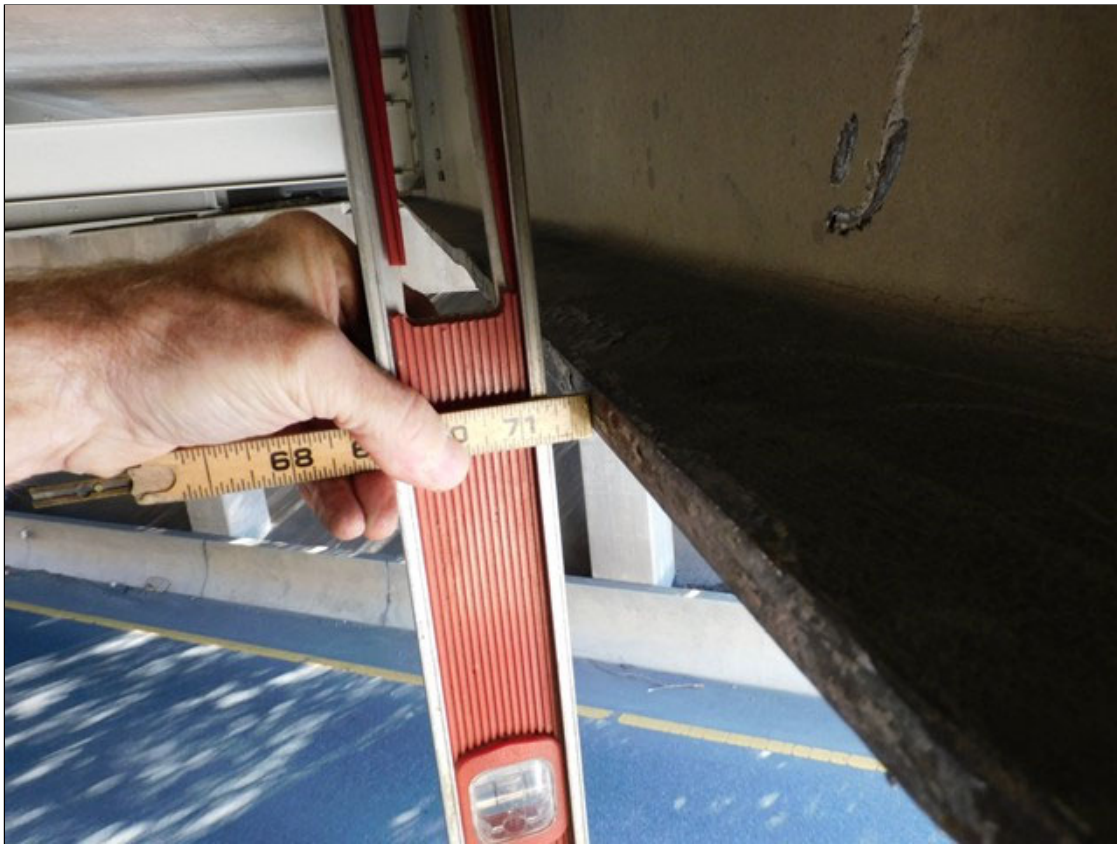
Span 2 Beam 9: ALONG BOTTOM FLANGE AT MID SPAN, AREA OF IMPACT DAMAGE [6 FOOT LONG] WITH DEFLECTION [UP TO 1/2 INCH].

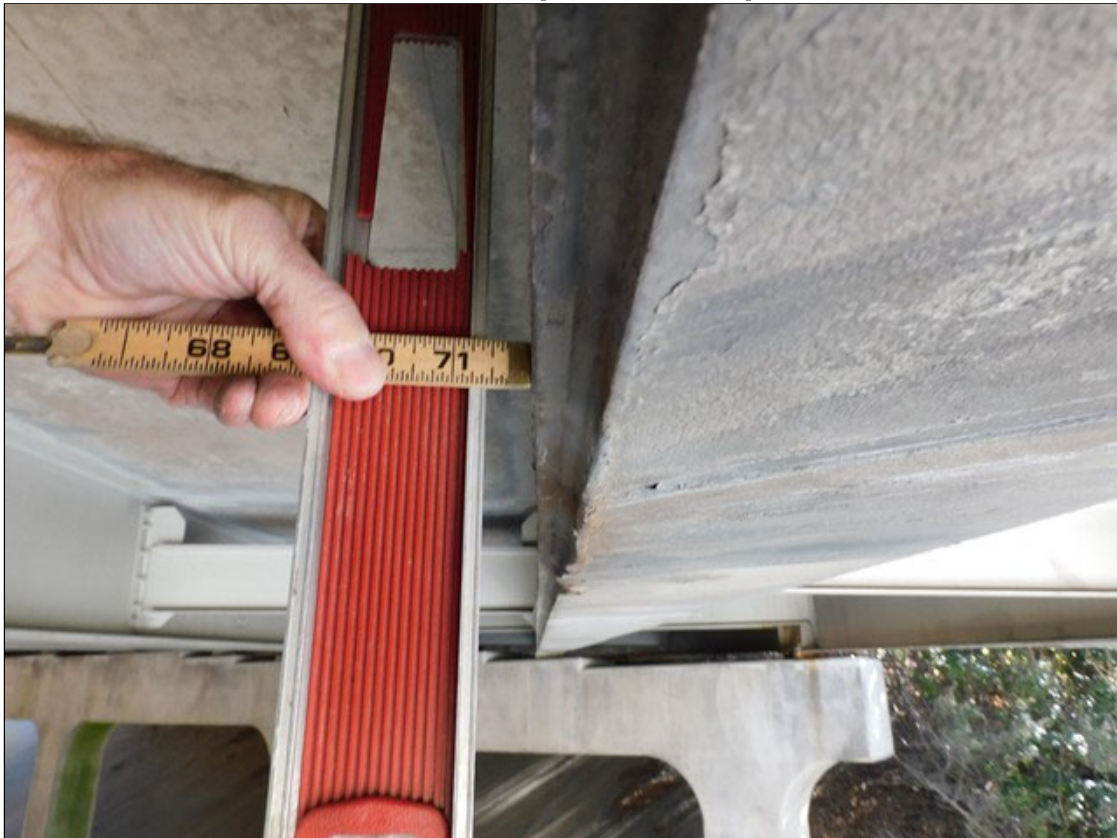
Span 2 Beam 9: ALONG BOTTOM FLANGE AT MID SPAN, AREA OF IMPACT DAMAGE [6 FOOT LONG] WITH DEFLECTION [UP TO 1/2 INCH].

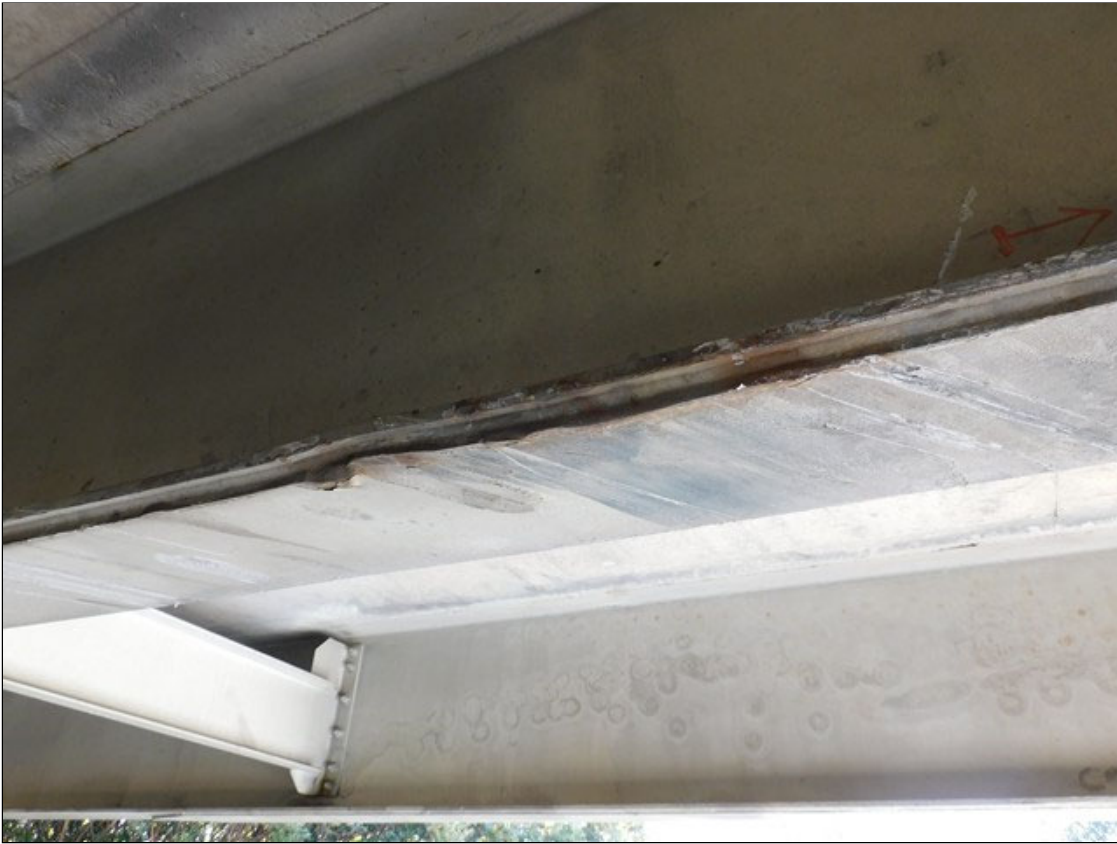
Span 2 Beam 9: ALONG BOTTOM FLANGE AT MID SPAN, AREA OF IMPACT DAMAGE [6 FOOT LONG] WITH DEFLECTION [UP TO 1/2 INCH].

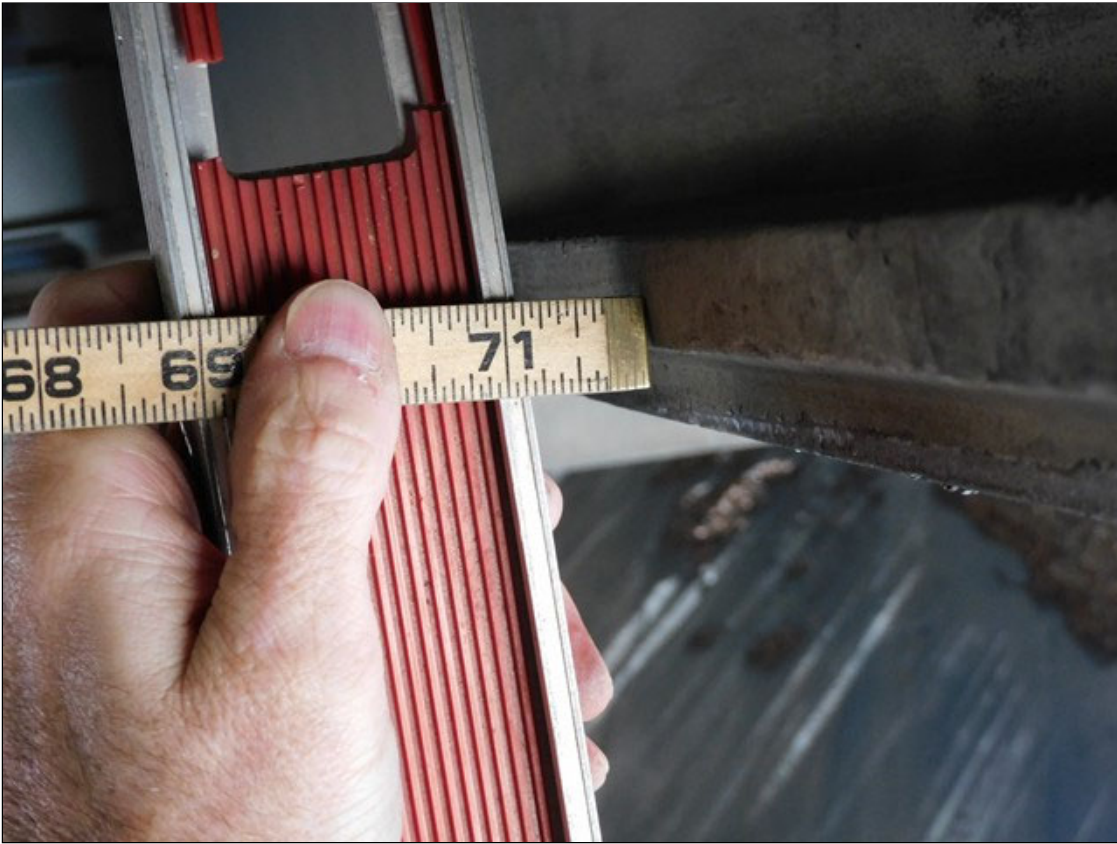
Span 2 Beam 8: LOCATED 18.5 FEET FROM INTERIOR BENT 1 - ALONG MIDSPAN OF BOTTOM FLANGE AND COVER PLATE, AREAS OF IMPACT DAMAGE [4 FOOT X UP TO 1 INCH DEFLECTION] -PAR

Span 2 Beam 8: LOCATED 18.5 FEET FROM INTERIOR BENT 1 - ALONG MIDSPAN OF BOTTOM FLANGE AND COVER PLATE, AREAS OF IMPACT DAMAGE [4 FOOT X UP TO 1 INCH DEFLECTION]

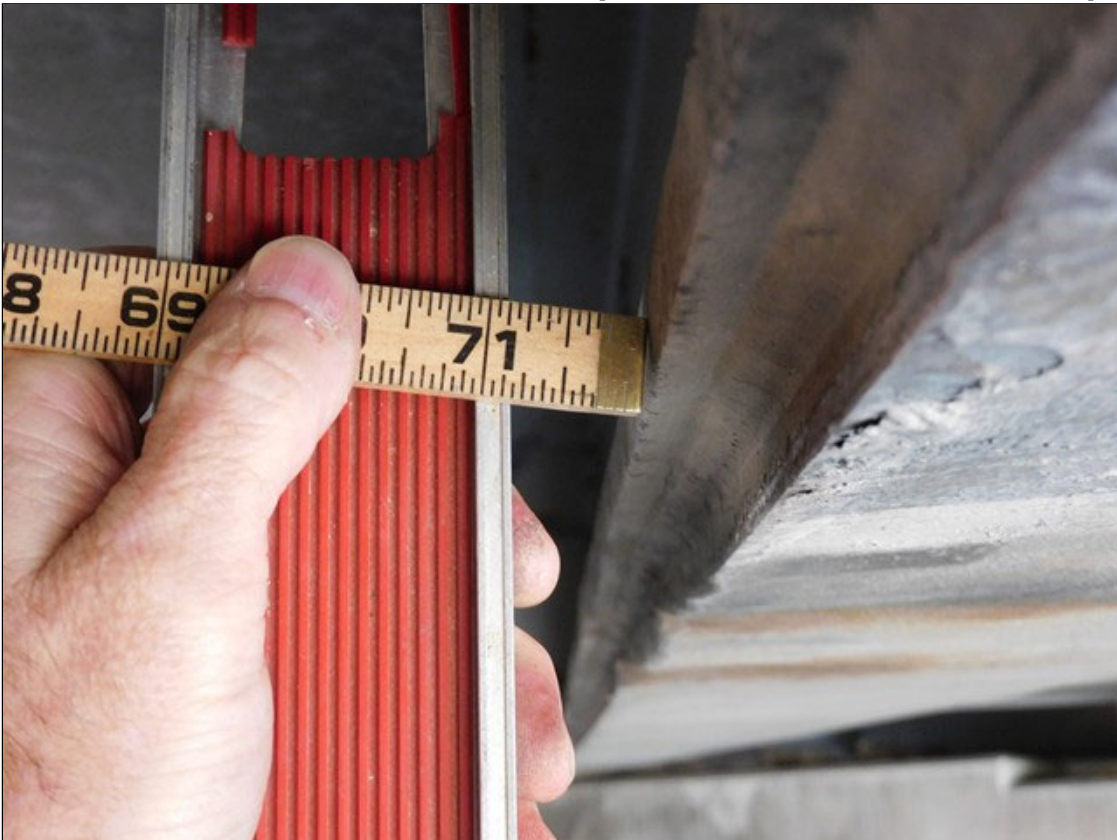
Span 2 Beam 8: LOCATED 18.5 FEET FROM INTERIOR BENT 1 - ALONG MIDSPAN OF BOTTOM FLANGE AND COVER PLATE, AREAS OF IMPACT DAMAGE [4 FOOT X UP TO 1 INCH DEFLECTION]
