Structure: 760011

# Priority Action Repair Report

PM 12 Month

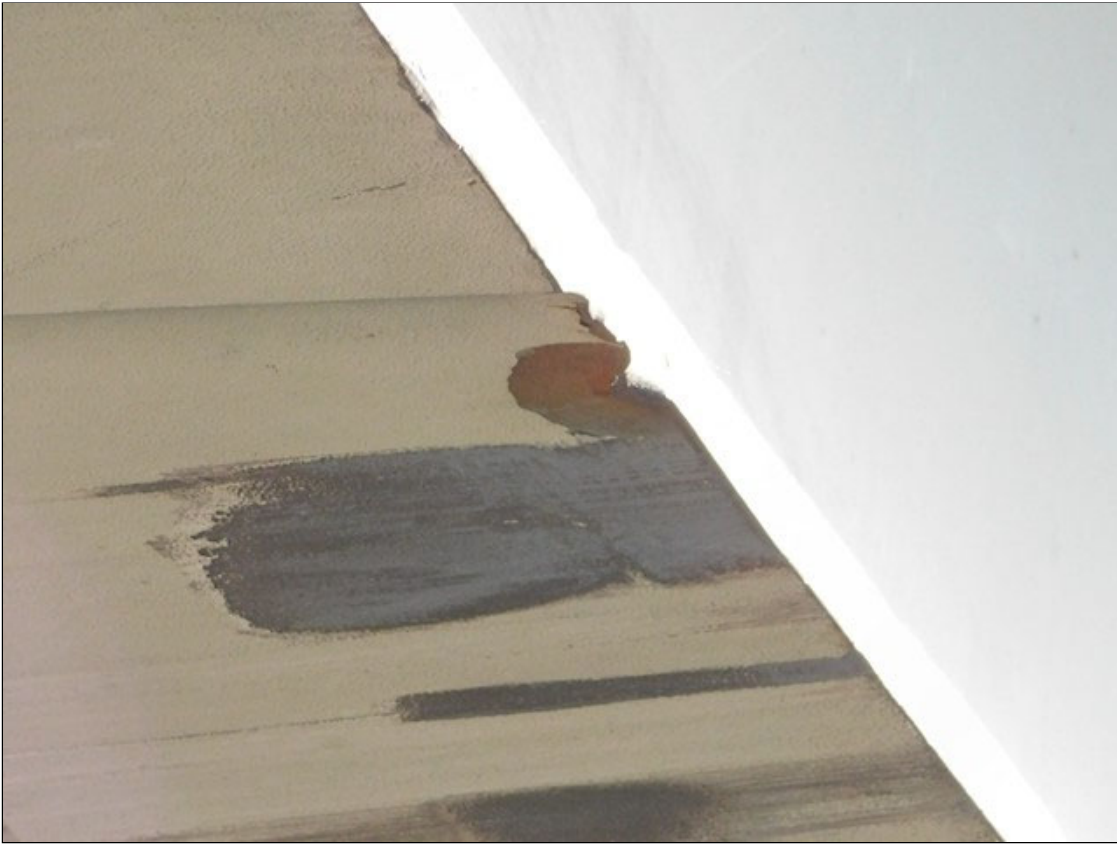
SPAN 2 Beam 5: (PAR) DAMAGE TO BOTTOM FLANGE APPROXIMATELY 25 FEET FROM BENT 2, UP TO 2 INCH DIAMETER GOUGE ON SOUTH EDGE AND UP TO 1/2 INCH DISTORTION TO BOTTOM WEB

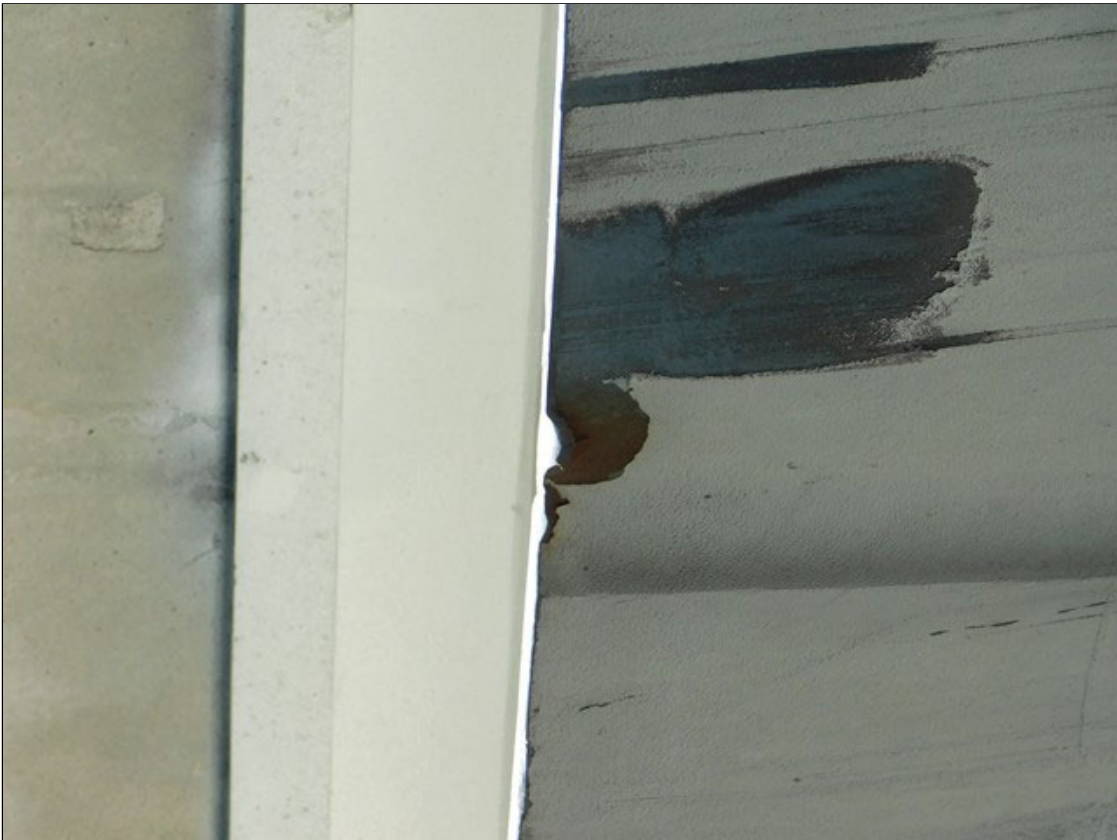
SPAN 2 Beam 5: (PAR) DAMAGE TO BOTTOM FLANGE APPROXIMATELY 25 FEET FROM BENT 2, UP TO 2 INCH DIAMETER GOUGE ON SOUTH EDGE AND UP TO 1/2 INCH DISTORTION TO BOTTOM WEB

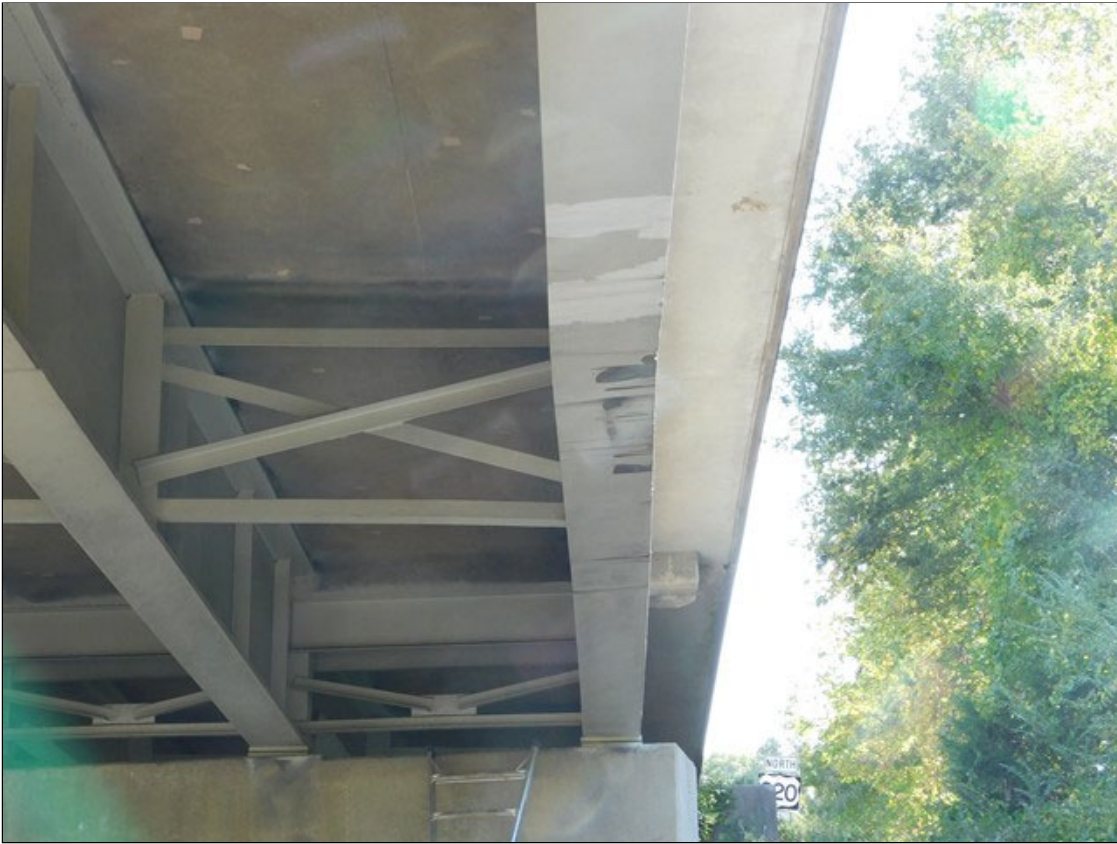
SPAN 2 Beam 5: 12 FEET X 1/2 INCH DISTORTION FROM IMPACT DAMAGE ON BOTTOM FLANGE AND WEB  
STARTING 25 FEET FROM BENT 2 (PAR)

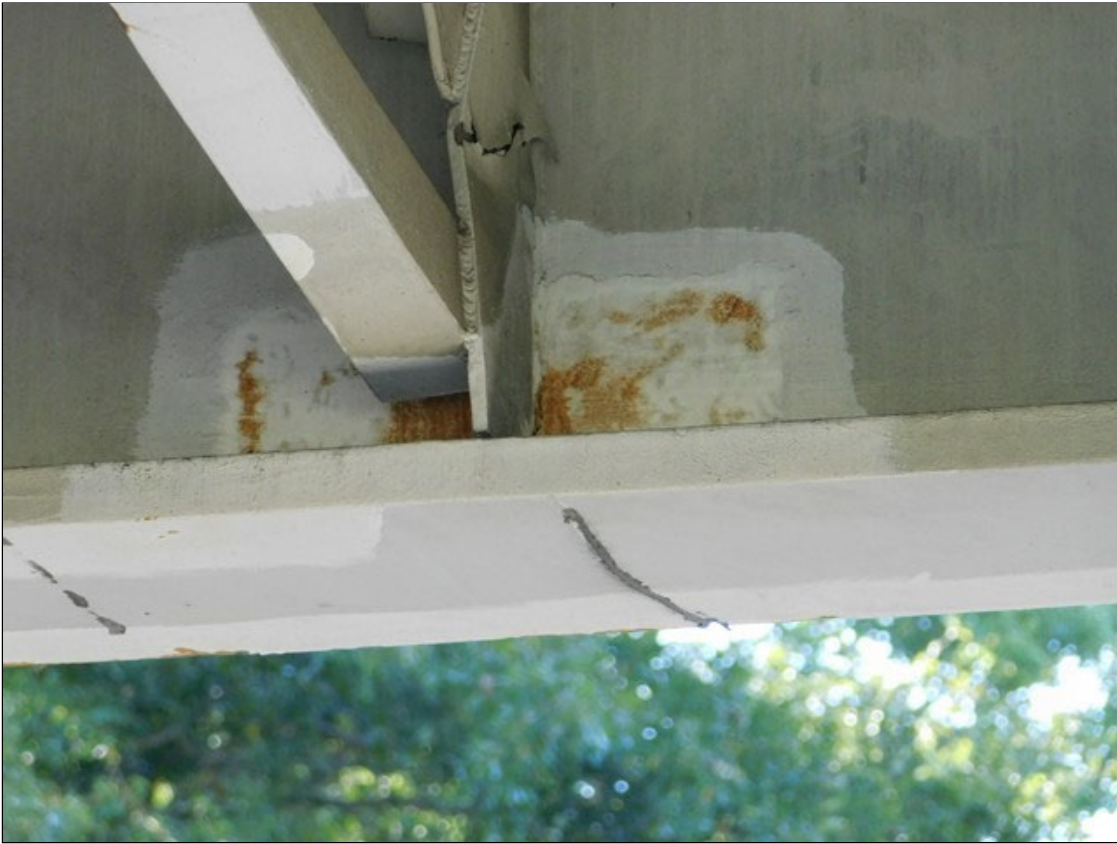
SPAN 2 Beam 5: (2025 NO HANDS-ON ACCESS) 5-1/4 INCHES LONG HORIZONTAL CRACK IN WEB ABOVE BOTTOM FLANGE AT 37 FEET FROM BENT 2 BEARING (PAINT APPLIED) (PAR)
