DAMAGE REPORTS

NC DEPARTMENT OF TRANSPORTATION
DIVISION OF HIGHWAYS
BRIDGE MANAGEMENT UNIT

BRIDGE INSPECTION REPORT

INSPECTION TYPE: Damage Inspection Report

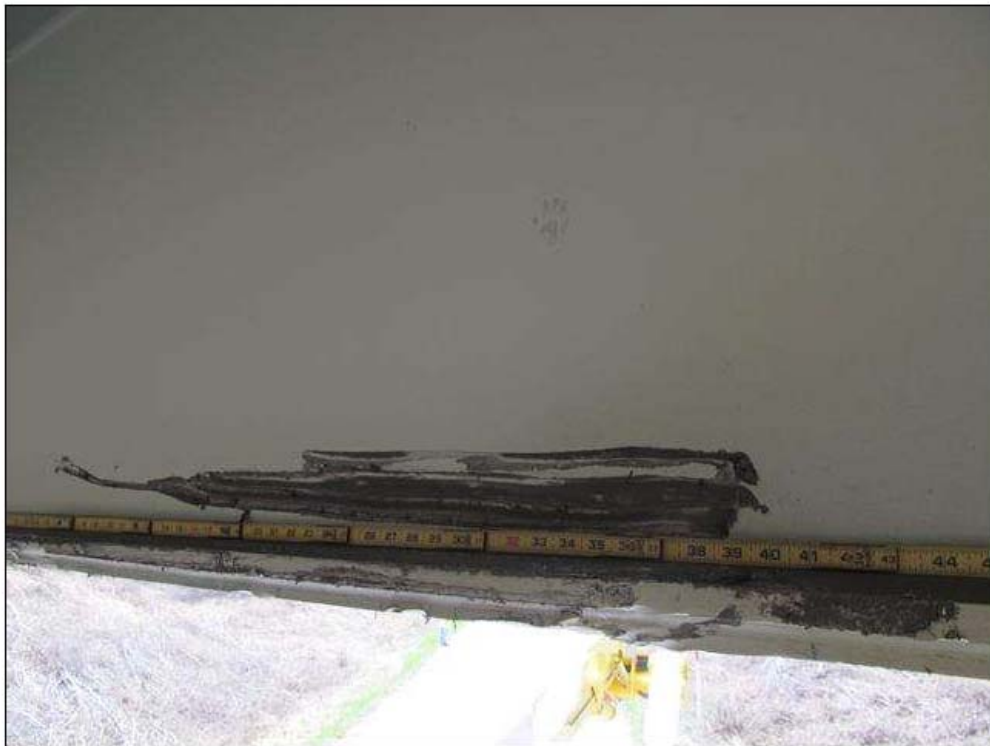
SCRAPES ON BEAM 5 FROM 17'-8" FROM BENT 1 TO 24'-9" FROM FACE OF BENT 2

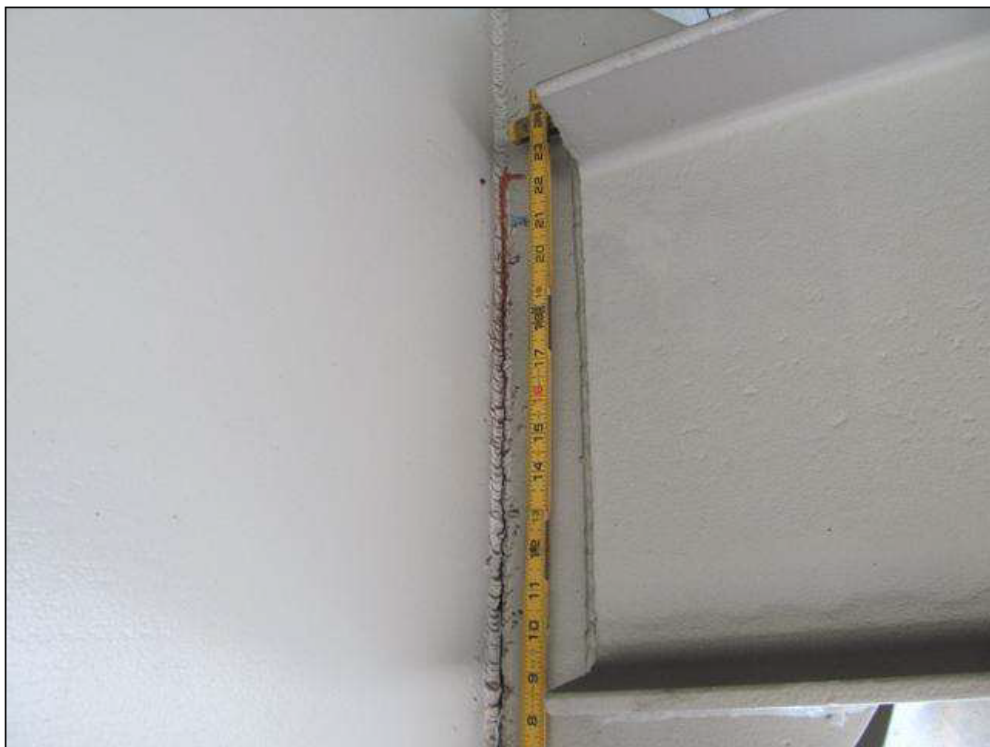
3314	Maintain Steel Superstructure Components	LF	2	CRACK IN DIAPHRAGM A 23" CRACK IN DIAPHRAGM WELD AT DIAPHRAGM ON BEAM 5 AT 14'-2" FROM BENT 1

A 23" CRACK IN DIAPHRAGM WELD AT DIAPHRAGM ON BEAM 5 AT 14'-2" FROM BENT 1

MMS Code	MMS Description	Quantity
3314	Maintain Steel Superstructure Components	2 LF
Location:		
Beams and Girders	Bent/Span No. 2	DIAPHRAGM
Priority Level	Status	
Priority Maintenance	Division Bridge Maintenance Notification Received	
Submitted Date:	Submitted By:	Assisted By:
04/04/2013	MD OSBORNE	A KING
Details		
CRACK IN DIAPHRAGM A 23" CRACK IN DIAPHRAGM WELD AT DIAPHRAGM ON BEAM 5 AT 14'-2" FROM BENT 1

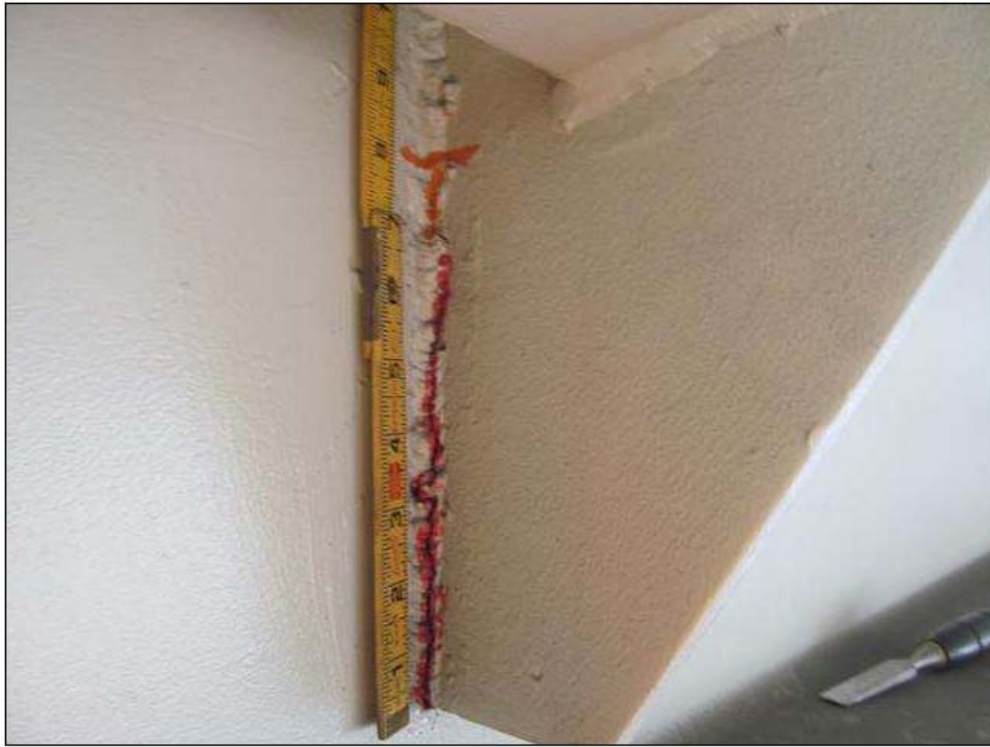
3314	Maintain Steel Superstructure Components	LF	1	CRACK IN DIAPHRAGM A 8" LONG CRACK IN DIAPHRAGM WELD AT DIAPHRAGM ON BEAM 5 AT 20'-00 FROM FACE OF BENT 2

A 8" LONG CRACK IN DIAPHRAGM WELD AT DIAPHRAGM ON BEAM 5 AT 20'-00" FROM FACE OF BENT 2

MMS Code	MMS Description	Quantity
3314	Maintain Steel Superstructure Components	1 LF
Location:		
Beams and Girders	Bent/Span No. 2	DIAPHRAGM
Priority Level	Status	
Priority Maintenance	Division Bridge Maintenance Notification Received	
Submitted Date:	Submitted By:	Assisted By:
04/04/2013	MD OSBORNE	A KING
Details		
CRACK IN DIAPHRAGM A 8" LONG CRACK IN DIAPHRAGM WELD AT DIAPHRAGM ON BEAM 5 AT 20'-00 FROM FACE OF BENT 2

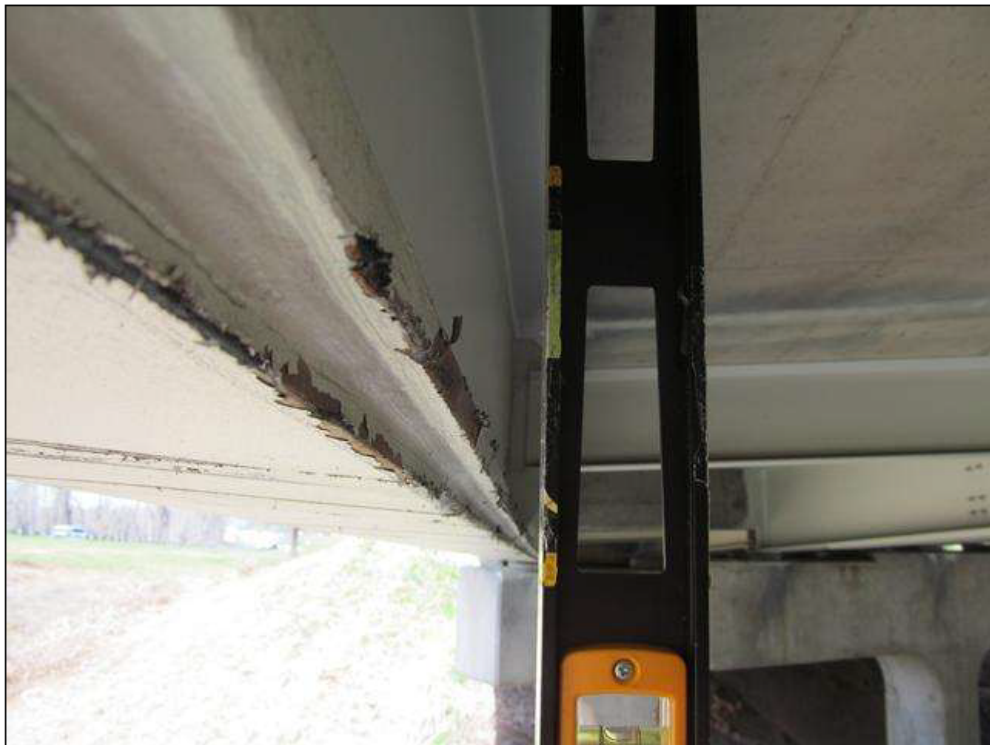
3314	Maintain Steel Superstructure Components	LF	55	BEAM 5 BEAM 5 IS 1 1/2" OUT OF PLUM AT 24'-9" FROM FACE OF BENT 1	
3314	Maintain Steel Superstructure Components	LF	55	BEAM 5 IS 1 1/2" OUT OF PLUM AT 24'-9" FROM FACE OF BENT 1	
3314	Maintain Steel Superstructure Components	LF	1	A 8" LONG CRACK IN DIAPHRAGM WELD AT DIAPHRAGM ON BEAM 5 AT 20'-00 FROM FACE OF BENT 2	
3314	Maintain Steel Superstructure Components	LF	2	A 23" CRACK IN DIAPHRAGM WELD AT DIAPHRAGM ON BEAM 5 AT 14'-2" FROM BENT 1

BEAM 5 IS 1 1/2" OUT OF PLUM AT 24'-9" FROM FACE OF BENT 1

MMS Code	MMS Description	Quantity
3314	Maintain Steel Superstructure Components	55 LF
Location:		
Beams and Girders Bent/Span No. 2 BEAM		
Priority Level	Status	
Priority Maintenance	Division Bridge Maintenance Notification Received	
Submitted Date:	Submitted By:	Assisted By:
04/04/2013	MD OSBORNE	A KING
Details		
BEAM 5 BEAM 5 IS 1 1/2" OUT OF PLUM AT 24'-9" FROM FACE OF BENT 1

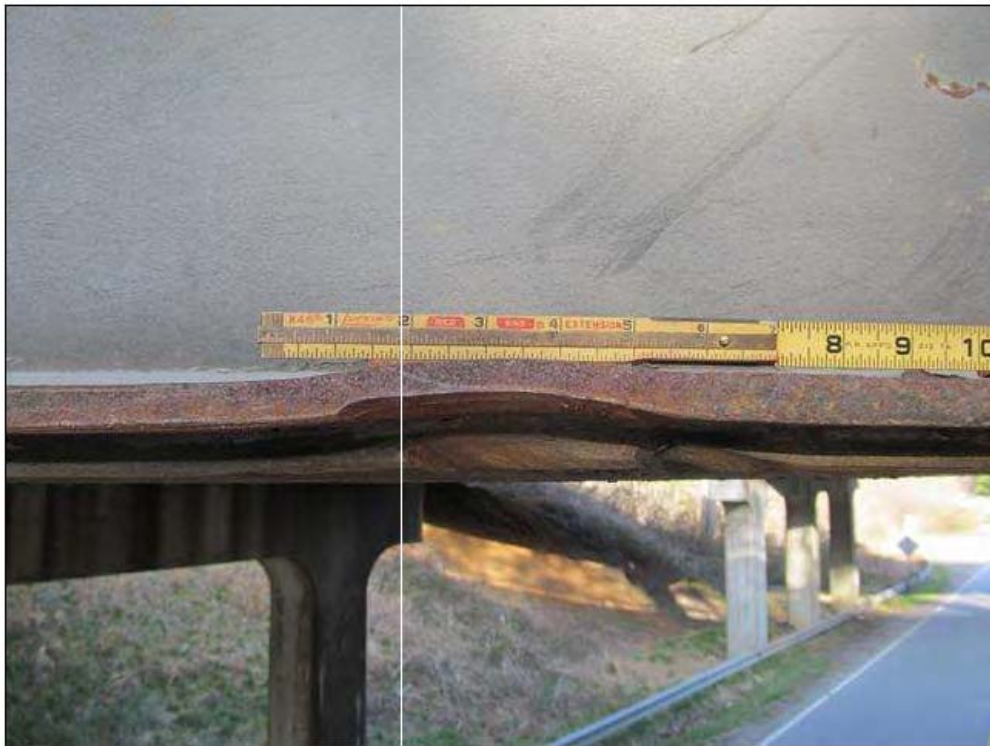
Item No.	Grade		
10	F	IMPACT DAMAGE INSPECTION WAS REQUESTED BY DIVISION BRIDGE MAINTENANCE FOR SPAN 2 OVER SR 1882 BEAM 1: INITIAL POINT OF IMPACT ON BEAM 1 IN SBL WAS 26'-3" FROM FACE OF BENT 1, INDENTION IN FLANGE 5" X 1/8" AND IN COVER PLATE 5" X 1/4" THE FLANGE IS BENT UPWARD 1/2" AT POINT OF IMPACT. BEAM 1 IS OUT OF PLUM 1/2" TO THE SOUTH AT 26'-3" FROM FACE OF BENT 1. INDENTION IN FLANGE COVER PLATE 3" X 1/4" AT 24'-2" FROM FACE OF BENT 1. GOUGES IN FLANGE COVER PLATE 4" X 2" X 1/16" AT 23'-0" FROM FACE OF BENT 1. SCRAPES ON BOTTOM OF BEAM 1 FROM 12'-4" FROM FACE OF BENT 1 TO 8'-10" FROM FACE OF BENT 2. POINT OF IMPACT ON BEAM 1 IN NBL WAS 18'-9" FROM FACE OF BENT 2, INDENTION IN FLANGE 2" X 1/2" AND IN COVER PLATE 2" X 1/16". INDENTIONS IN FLANGE COVER PLATE 10" X 1/8" AT 20'-7", A 2" X 1/4" AT 19'-8", A 2 1/2" X 1/16" AT 17'-7", ALL FROM FACE OF BENT 2. INDENTIONS IN FLANGE 10" X 1/8" AT 20'-7", A 2 1/2" X 1/16" AT 17'-7" ALL FROM FACE OF BENT 2. A 12" X 3/4" X 1/16" GOUGE IN FLANGE COVER PLATE AT 20'-7" FROM FACE OF BENT 2. BEAM IS OUT OF PLUM 5/8" TO THE NORTH AT 21'-4" FROM FACE OF BENT 2. A 3/8" BOW IN WEB OF BEAM 1 AT 21'-4" (SEE PHOTOS) BEAM 2 : BEAM 2 HAS SCRAPES ON THE BOTTOM ABOVE THE SOUTH AND NORTH BOUND LANES. (SEE PHOTO)

POINT OF IMPACT ON BEAM 1 IS 28'-3" FROM THE FACE OF BENT 1. INDENTION IN FLANGE (5" X 1/8") & COVER PLATE (5" X 1/4"). BEAM 1, SPAN 2

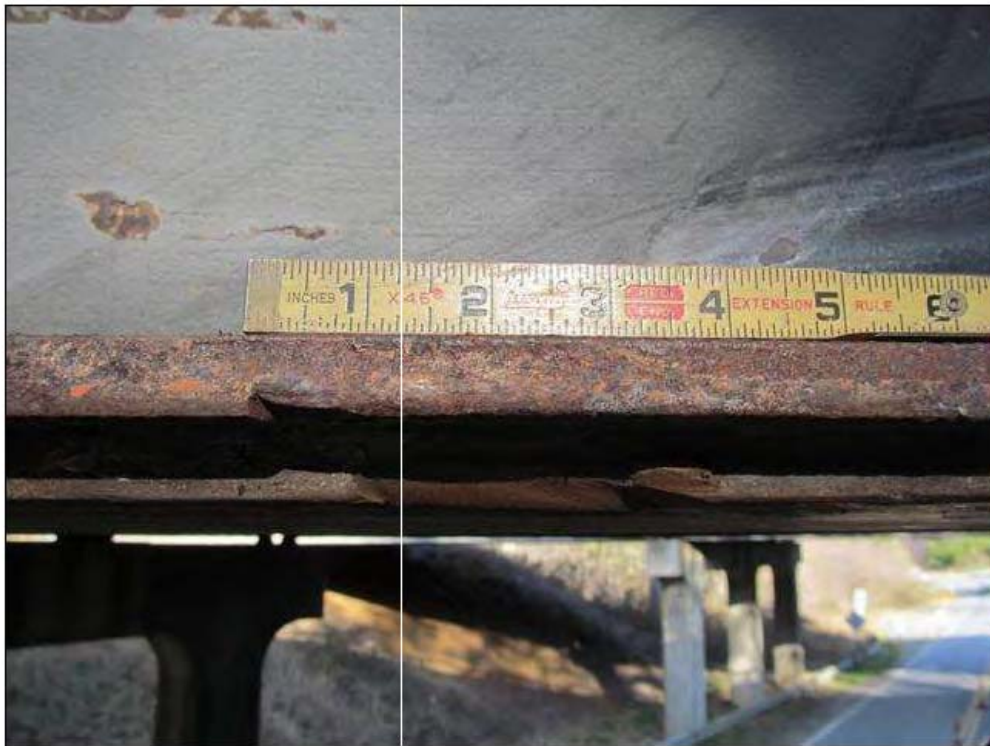
INDENTATION IN COVER PLATE (3" X 1/4") AND FLANGE (1" X 1/4") @ 24'-2" FROM THE FACE OF BENT 1.
BEAM 1, SPAN 2

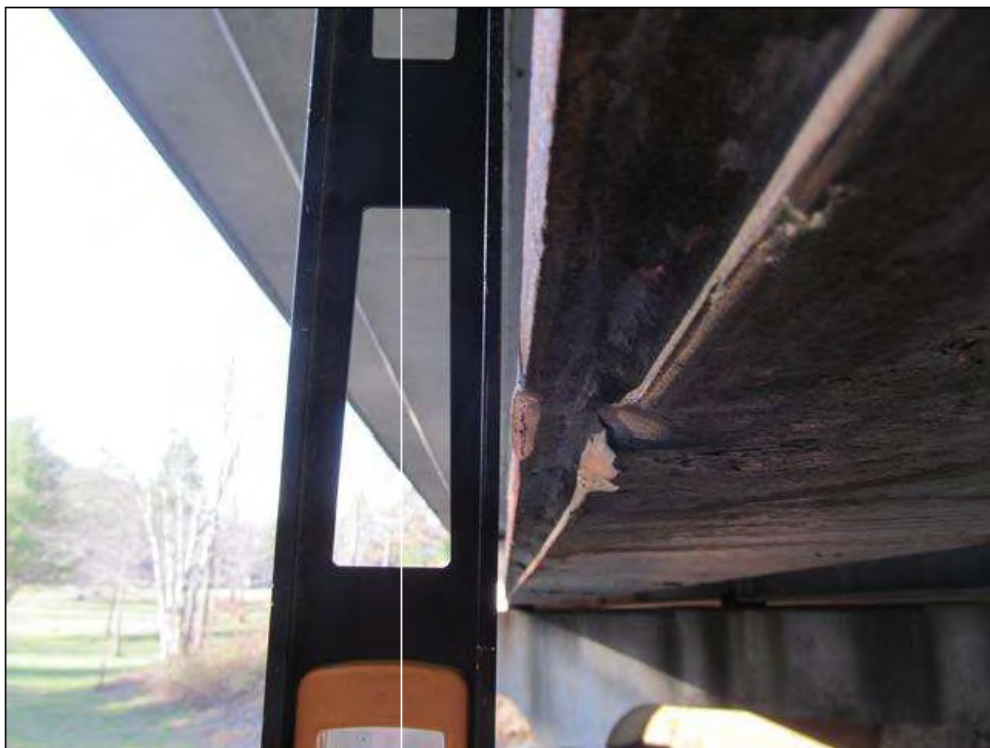
BEAM 1 IS OUT OF PLUMB (1/2") TO THE SOUTH @ 26'-3" FROM THE FACE OF BENT 1. BEAM 1, SPAN 2

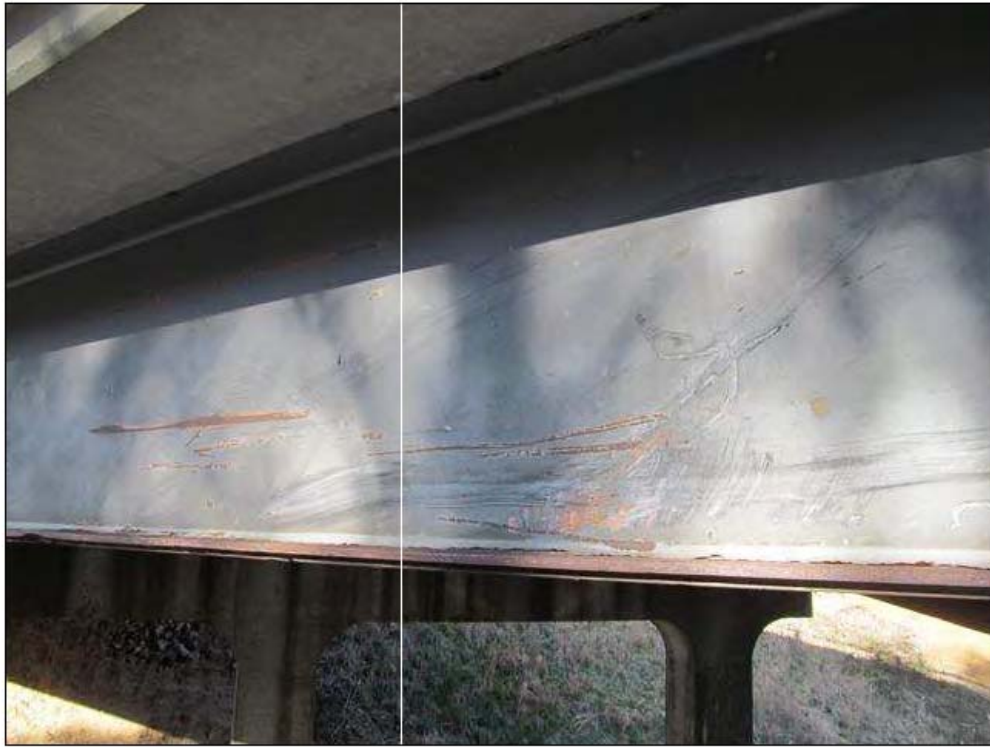
SCRAPES ON THE OUTSIDE OF BEAM 1, SPAN 2

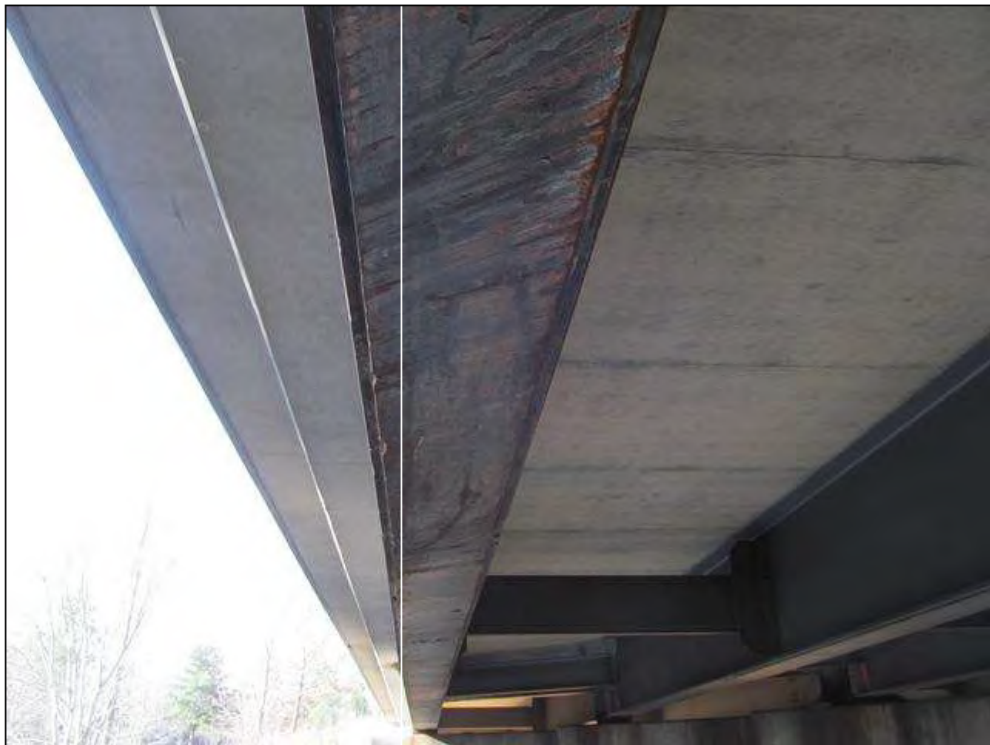
SCRAPES ON THE BOTTOM OF BEAM 1 IN FLANGE & COVER PLATE. FROM 12'-4" OF BENT 1 TO 8'-10" OF BENT 2. BEAM 1, SPAN 2

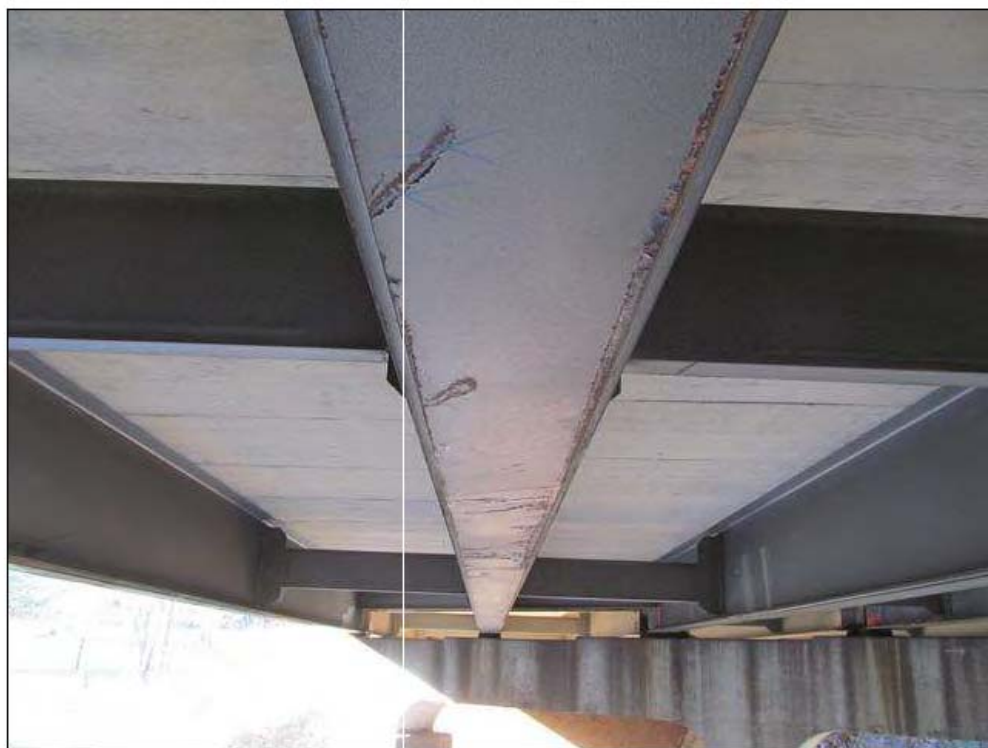
SCRAPES ON BOTTOM OF COVER PLATE OF BEAM 2 IN SOUTH BOUND LANE. BEAM 2, SPAN 2. (SAME IN NORTH BOUND LANE)

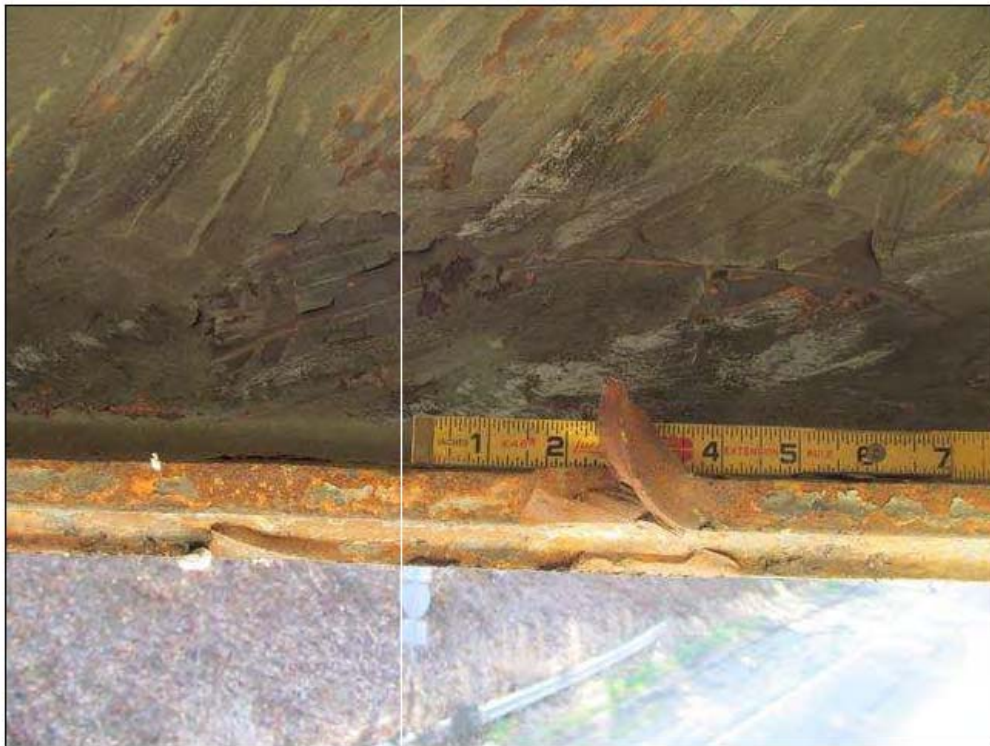
POINT OF IMPACT ON BEAM 1 IS 18'-9" FROM THE FACE OF BENT 2. INDENTION IN FLANGE (2" X 1/2") & COVER PLATE (2" X 1/16"). BEAM 1, SPAN 2. NBL

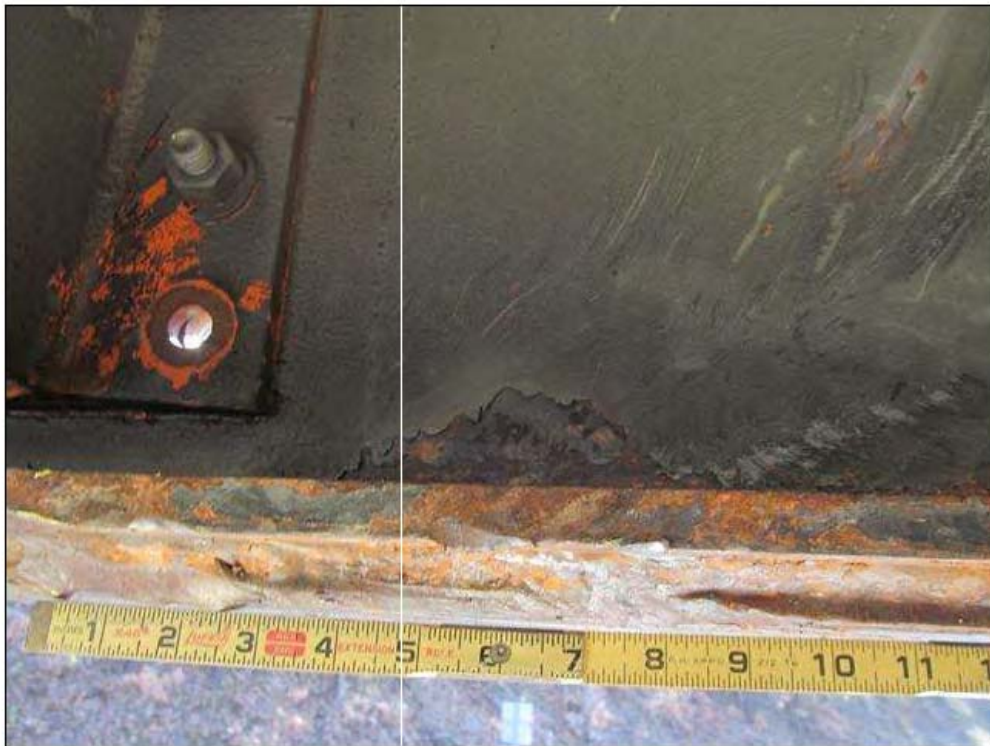
INDENTATION IN COVER PLATE (8" X 1/16") & FLANGE (10" X 1/8") AT 20'-7" FROM THE FACE OF BENT 2.
BEAM 1, SPAN 2. (NBL)

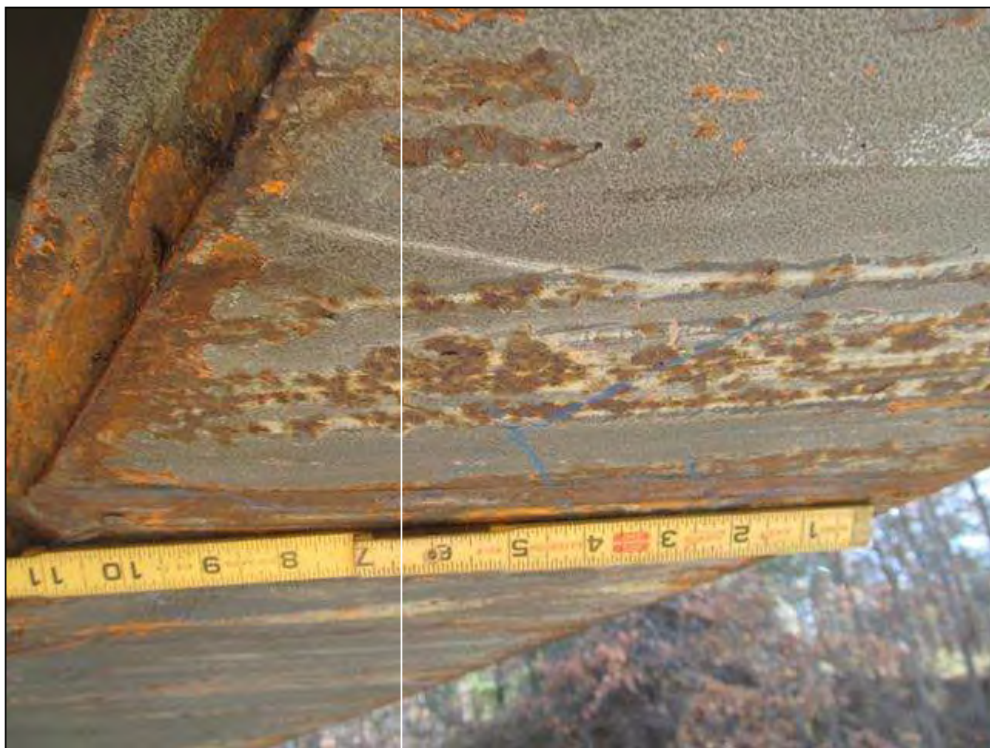
GOUGE IN COVER PLATE (12" X 3/4" X 1/16") @ 20'-7" FROM THE FACE OF BENT 2. BEAM 1, SPAN 2. (NBL)

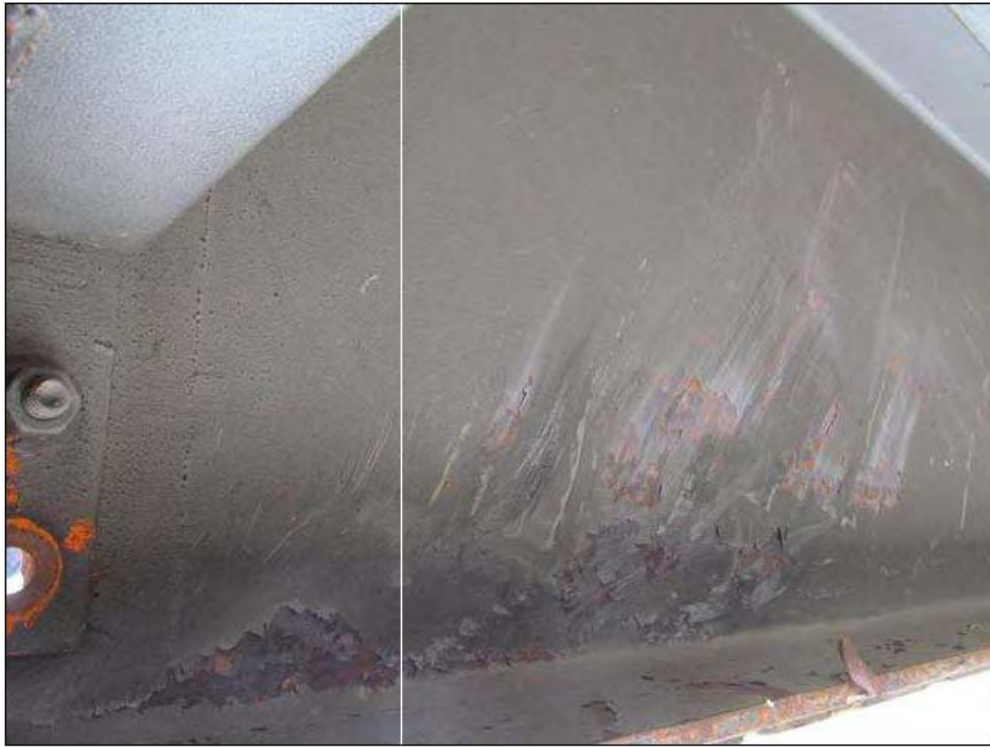
SCRAPES ON INSIDE OF WEB ON BEAM 1, SPAN 2 ABOVE NBL

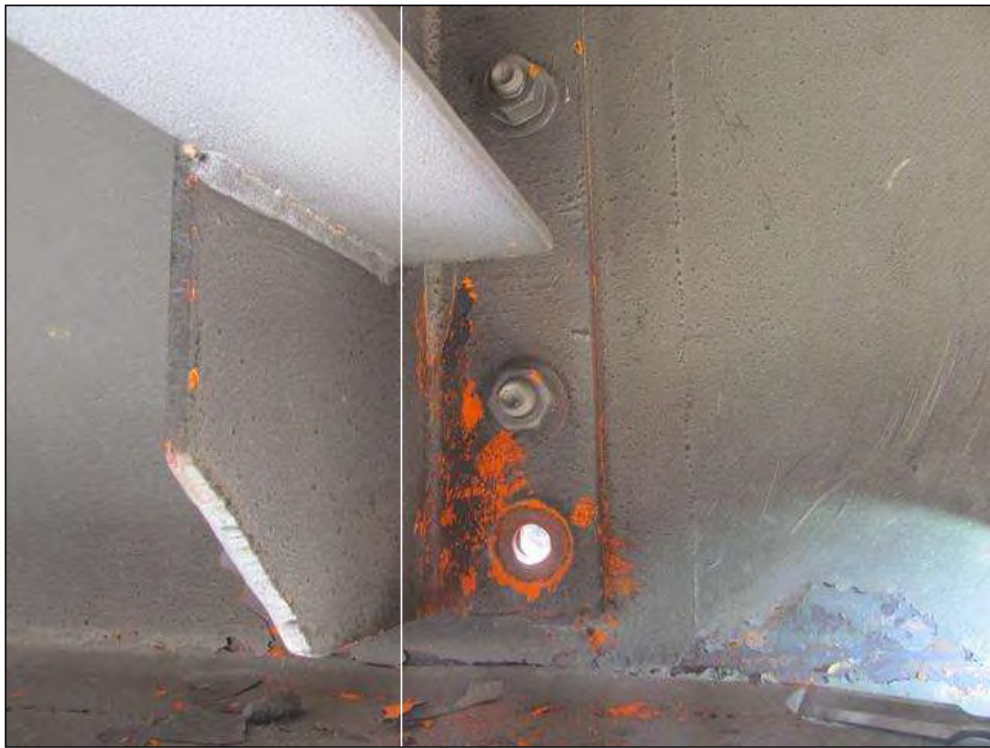
12	P	CONNECTION PLATE OF INTERMEDIATE DIAPHRAGMS: DIAPHRAGM AT 21'-4" FROM BENT 2 IS MISSING ONE OF TWELVE DIAPHRAGM BOLTS, BOTTOM OF DIAPHRAGM HAS PULLED AWAY FROM WEB 1/16" AT 21'-4" FROM FACE OF BENT 2. (SEE PHOTOS)	
15	F	BEARINGS AND ANCHOR BOLTS IN SPAN 2 DID NOT SHOW ANY INDICATION OF DAMAGE DUE TO THE IMPACT.	
61	YES	DIAPHRAGM	
73f	YES	UT MACHINE

3314	Maintain Steel Superstructure Components	LF	1	DIAPHRAGM ONE OF TWELVE DIAPHRAGM BOLTS IS MISSING ON BEAM 1 @ 21'-4" FROM THE FACE OF BENT 2. SPAN 2 BOTTOM OF DIAPHRAGM PLATE HAS PULLED AWAY FROM THE WEB (1/16" +/-) @ 21'-4" FROM THE FACE OF BENT 2. BEAM 1, SPAN 2

ONE OF TWELVE DIAPHRAGM BOLTS IS MISSING ON BEAM 1 @ 21'-4" FROM THE FACE OF BENT 2. SPAN 2

MMS Code	MMS Description	Quantity
3314	Maintain Steel Superstructure Components	1 LF
Location:		
Beams and Girders	Bent/Span No. 2	DIAPHRAGM
Priority Level	Status	
Priority Maintenance	Division Bridge Maintenance Notification Received	
Submitted Date:	Submitted By:	Assisted By:
04/04/2013	MD OSBORNE	A KING
Details		
DIAPHRAGM ONE OF TWELVE DIAPHRAGM BOLTS IS MISSING ON BEAM 1 @ 21'-4" FROM THE FACE OF BENT 2. SPAN 2 BOTTOM OF DIAPHRAGM PLATE HAS PULLED AWAY FROM THE WEB (1/16" +/-) @ 21'-4" FROM THE FACE OF BENT 2. BEAM 1, SPAN 2

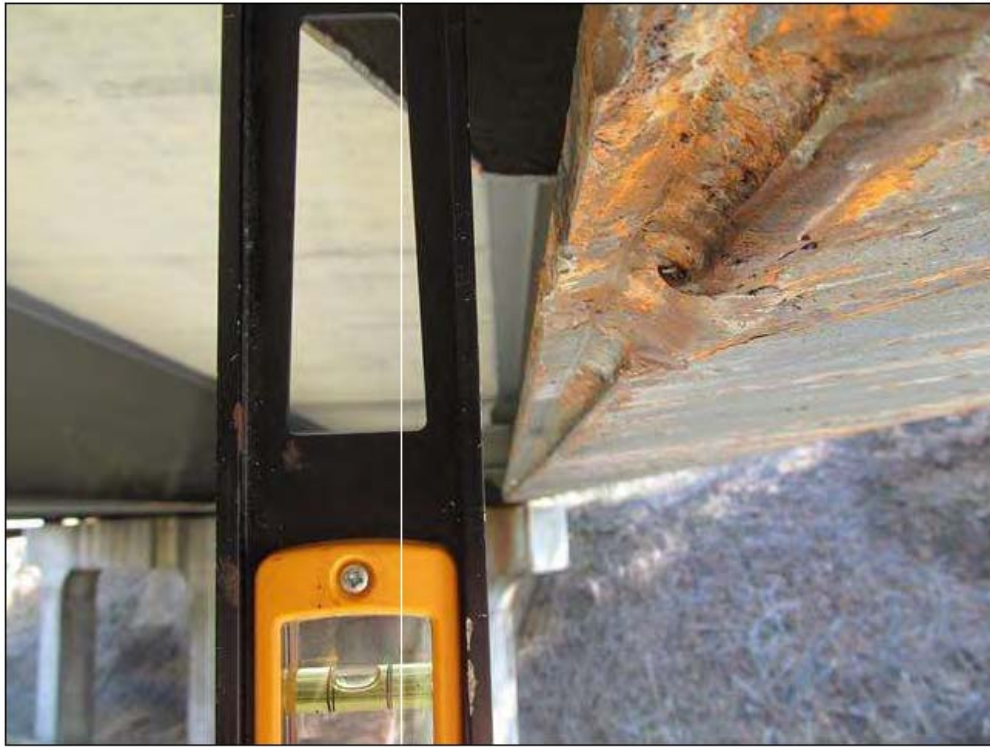
BEAM 1 IS OUT OF PLUMB ($5/8"$ +/-) TO THE NORTH @ $21'-4"$ FROM THE FACE OF BENT 2. BEAM 1, SPAN 2

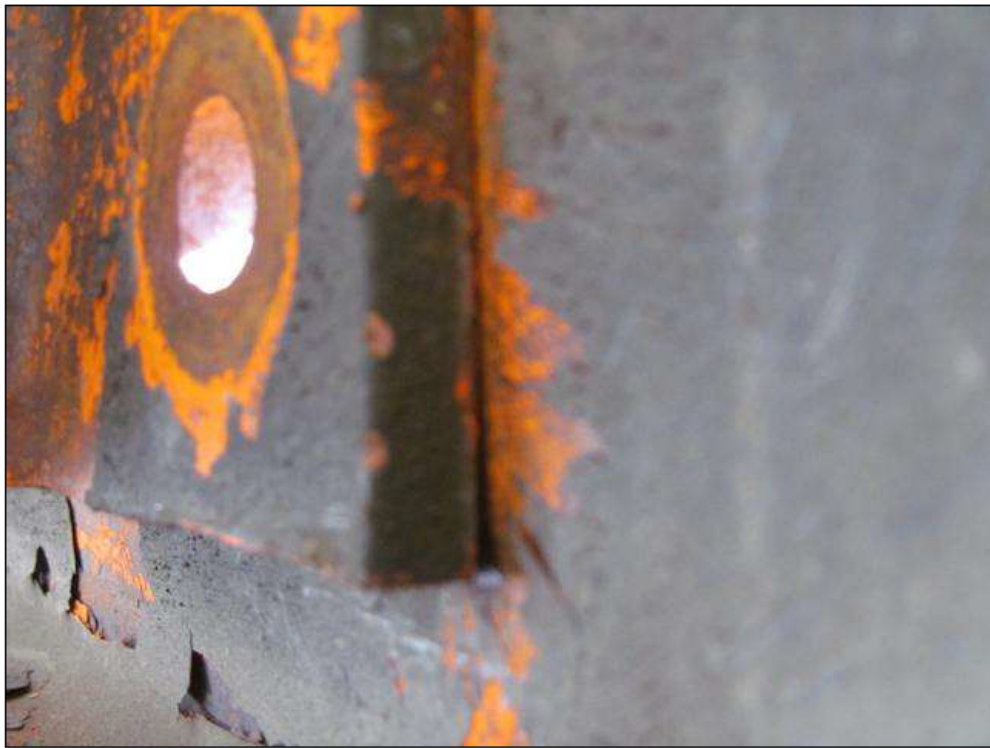
BOTTOM OF DIAPHRAGM PLATE HAS PULLED AWAY FROM THE WEB ($1/16"$ +/-) @ $21'-4"$ FROM THE FACE OF BENT 2. BEAM 1, SPAN 2

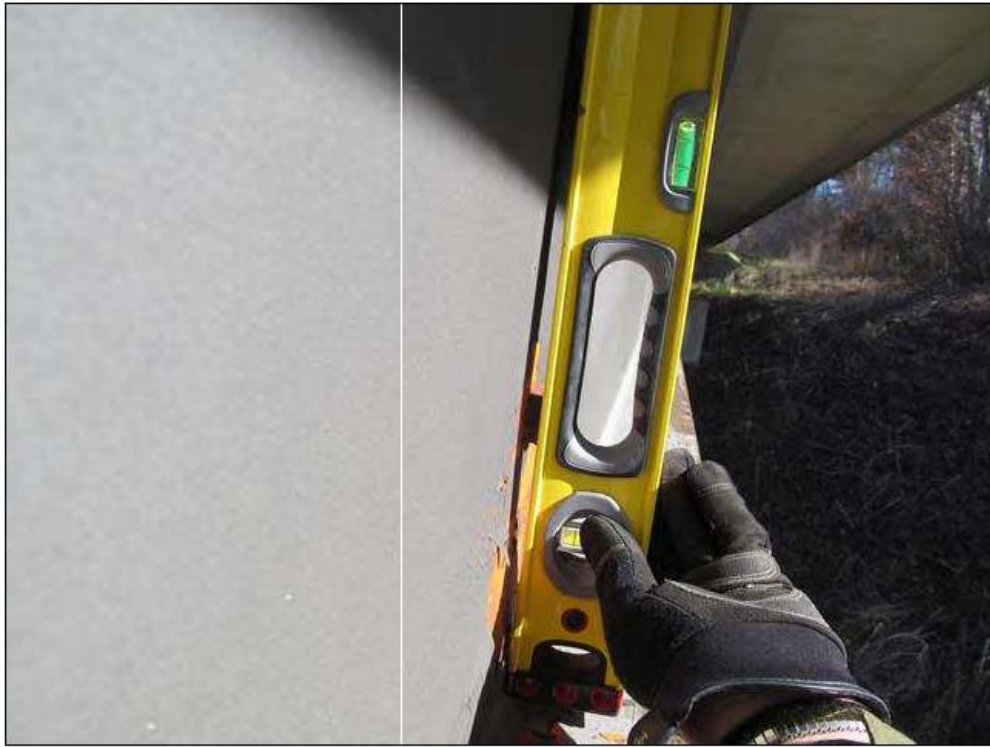
BOW IN BEAM 1 (3/8") @ 21'-4" FROM THE FACE OF BENT 2. BEAM 1, SPAN 2

MMS Code	MMS Description	Quantity
3314	Maintain Steel Superstructure Components	58 LF
Location:		
Beams and Girders	Bent/Span No. 2	BEAM
Priority Level	Status	
Priority Maintenance	Division Bridge Maintenance Notification Received	
Submitted Date:	Submitted By:	Assisted By:
04/04/2013	MD OSBORNE	A KING
Details		
BEAM 1 BEAM 1 IS OUT OF PLUMB (5/8" +/-) TO THE NORTH @ 21'-4" FROM THE FACE OF BENT 2. BEAM 1, SPAN 2 BOW IN BEAM 1 (3/8") @ 21'-4" FROM THE FACE OF BENT 2. BEAM 1, SPAN 2

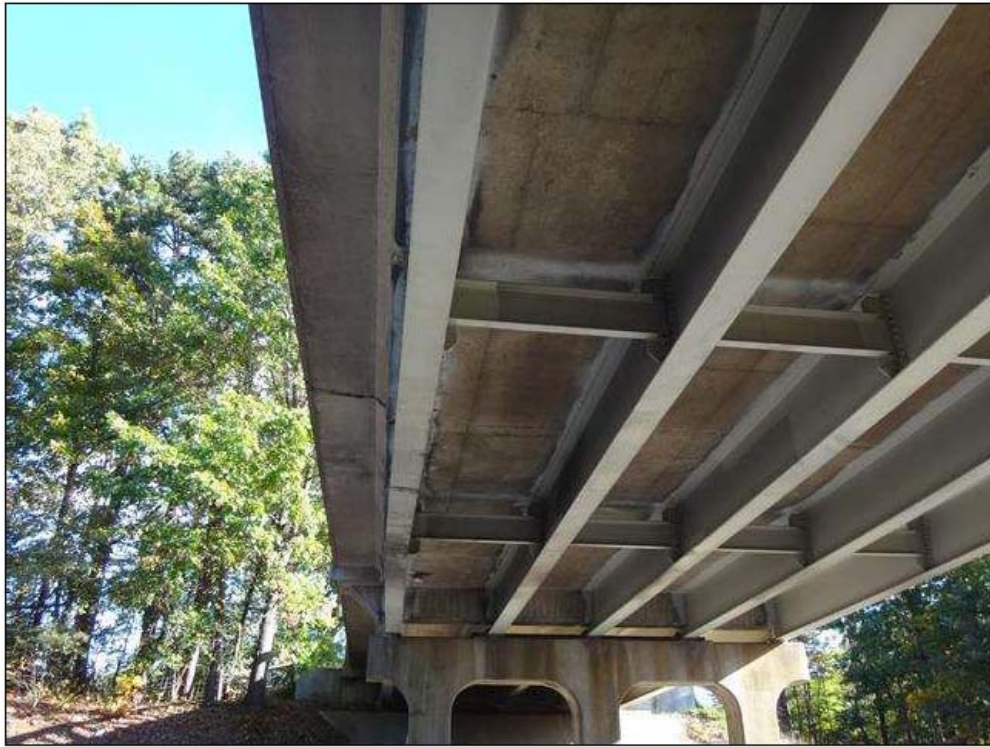
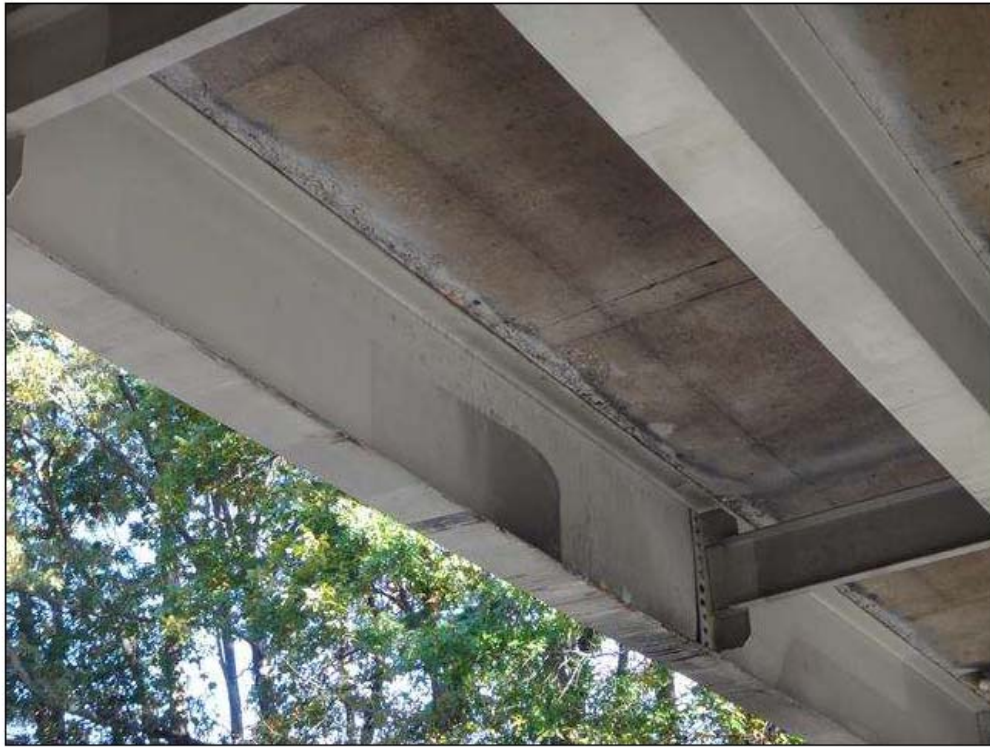
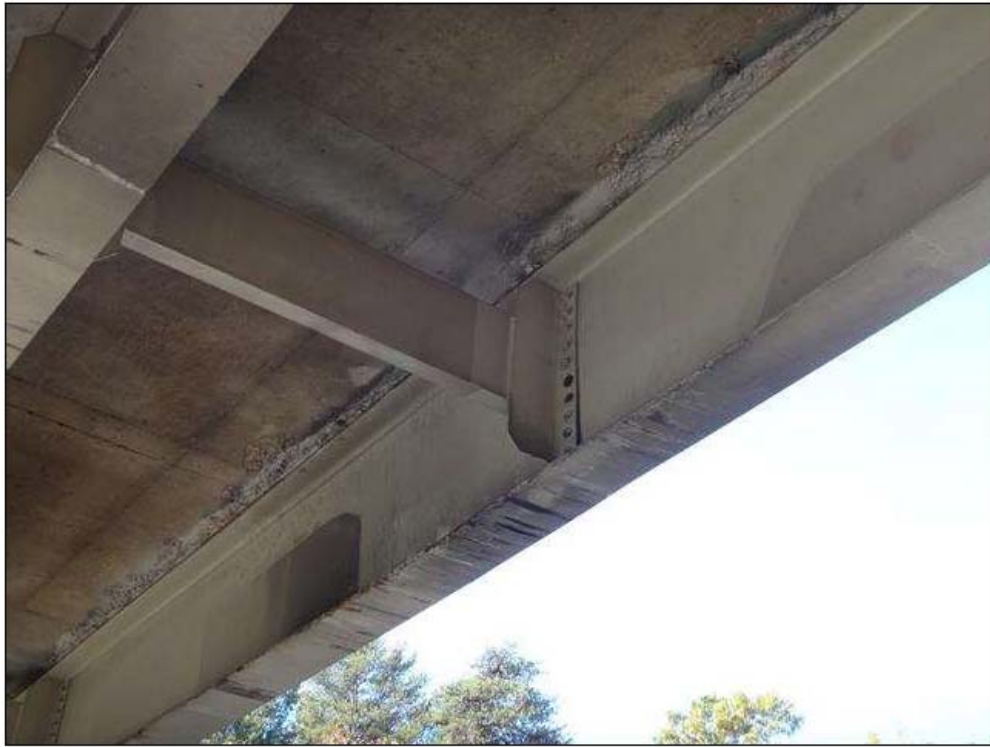
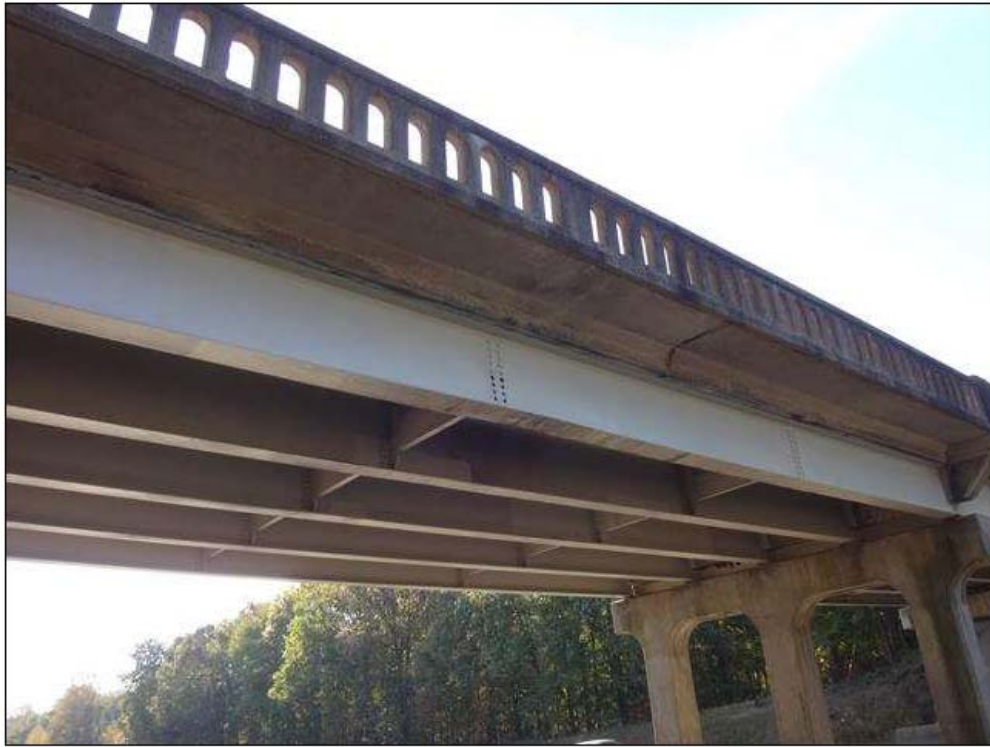
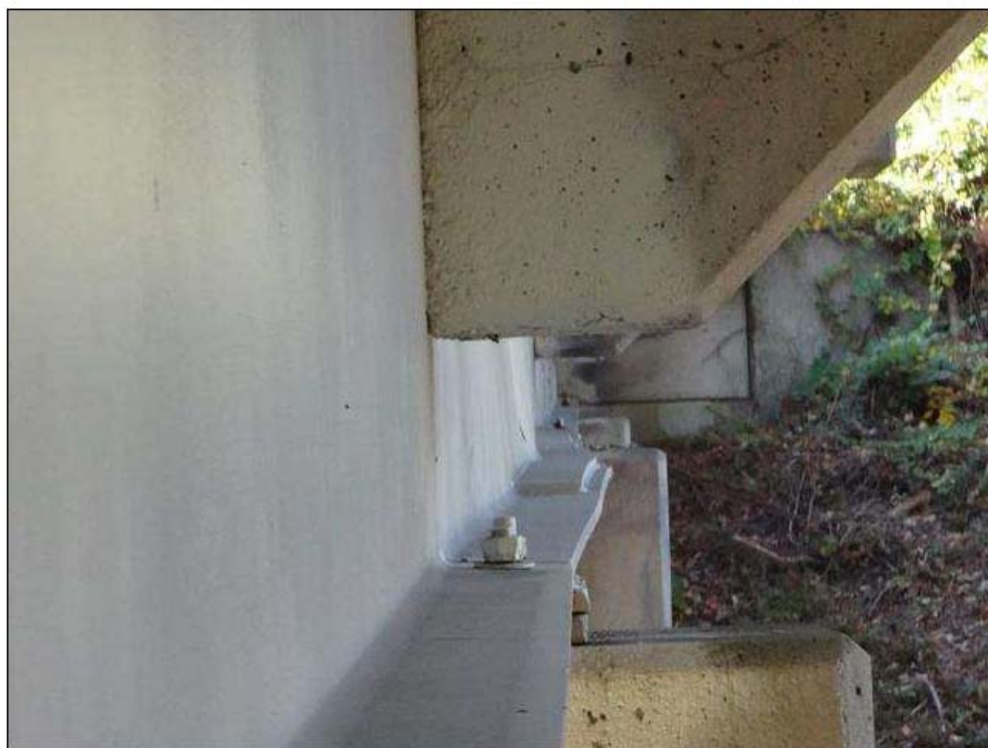
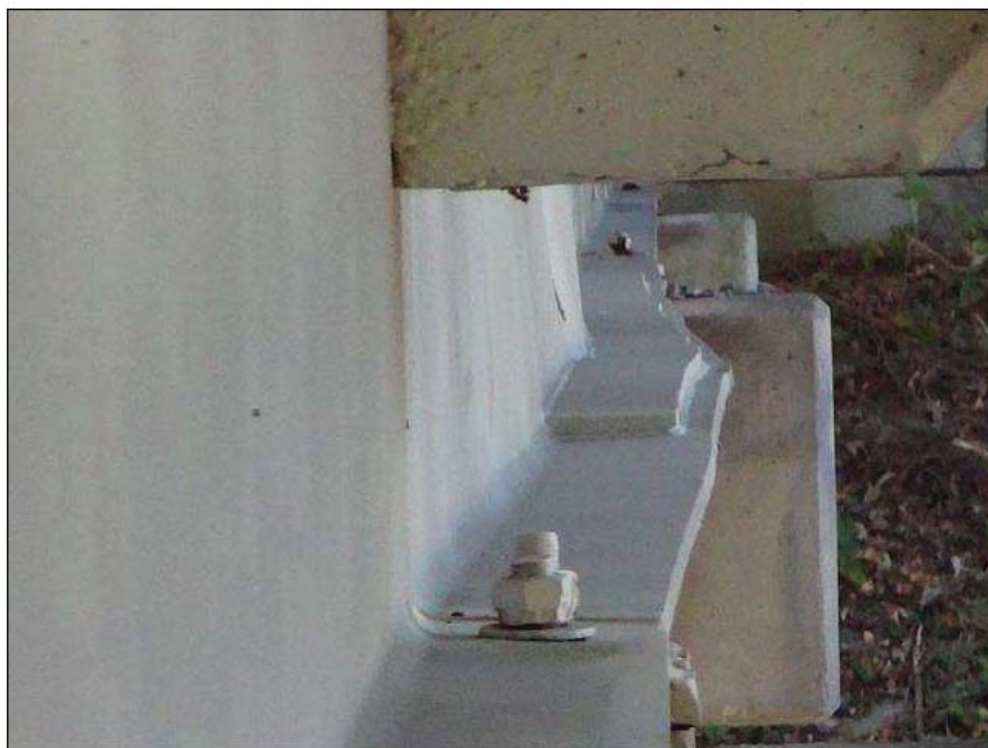
SPAN 3 BEAM 1 WEB AND BOTTOM FLANGE AT 20FT FROM BENT 3, IMPACT DAMAGE (12LF), OUT OF PLUMB
(UP TO +/- 3IN)

SPAN 3 BEAM 1 WEB AND BOTTOM FLANGE AT 20FT FROM BENT 3, IMPACT DAMAGE (12LF), OUT OF PLUMB (UP TO +/- 3IN)

MMS Code	MMS Description	Quantity
3314	Maintain Steel Superstructure Components	12 LF
Location:		
Beams and Girders Bent/Span No. 3 BEAM 1		
Priority Level	Status	
Priority Maintenance	Division Bridge Maintenance Notification Received	
Submitted Date:	Submitted By:	Assisted By:
10/23/2015	MONTY HOBBS	RICARDO CORNEJO
Details		
<p>SPAN 3 BEAM 1 WEB AND BOTTOM FLANGE AT 20FT FROM BENT 3, IMPACT DAMAGE (12LF), OUT OF PLUMB (UP TO +/- 3IN)</p> <p>SPAN 3 BEAM 1 AT 20FT FROM BENT 3, TWO ROWS OF FIVE BOLTS SHEARED AND MISSING FROM IMPACT DAMAGE</p> <p>SPAN 3 BEAM 1 AT 20FT FROM BENT 3, BROKEN WELD BETWEEN COVER PLATE AND BOTTOM FLANGE (UP TO 4IN)</p>

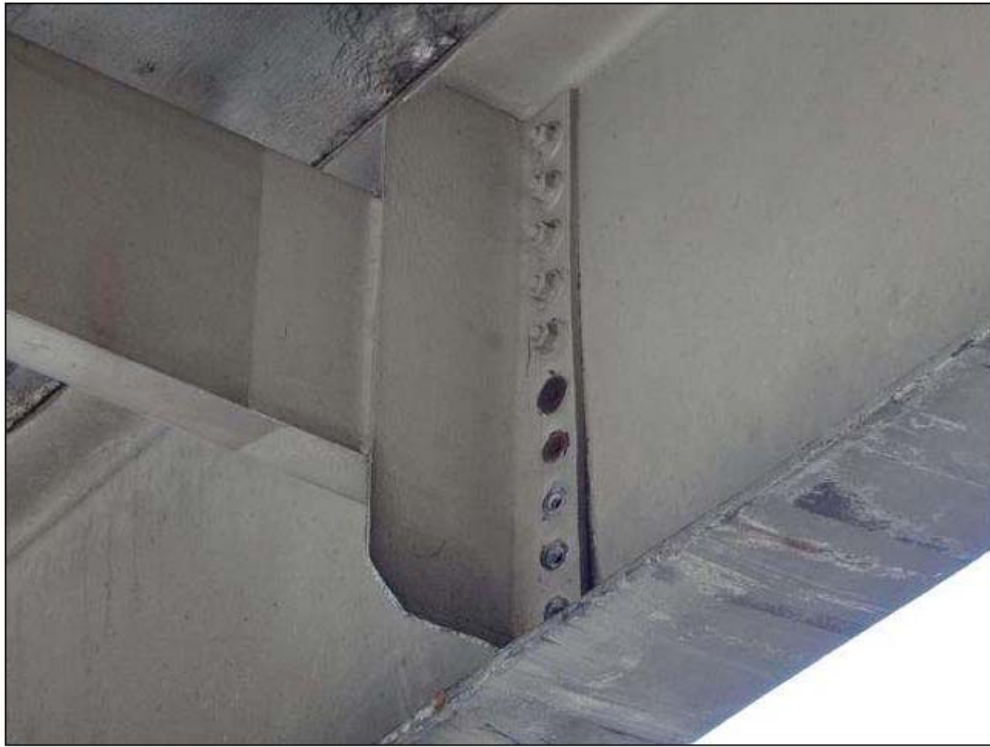
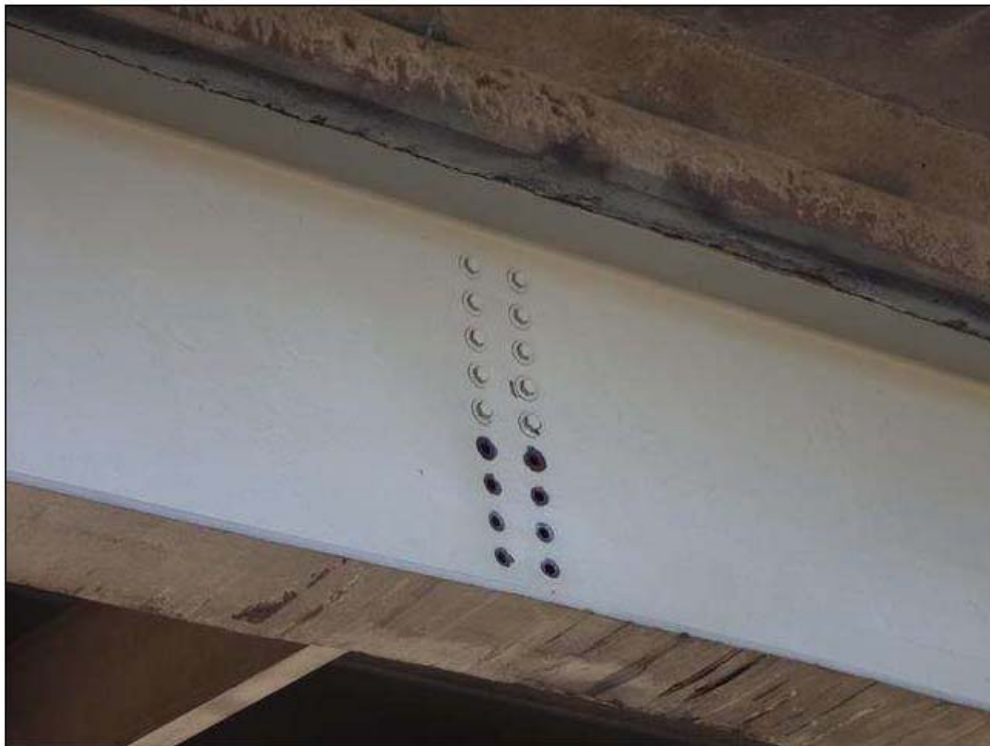
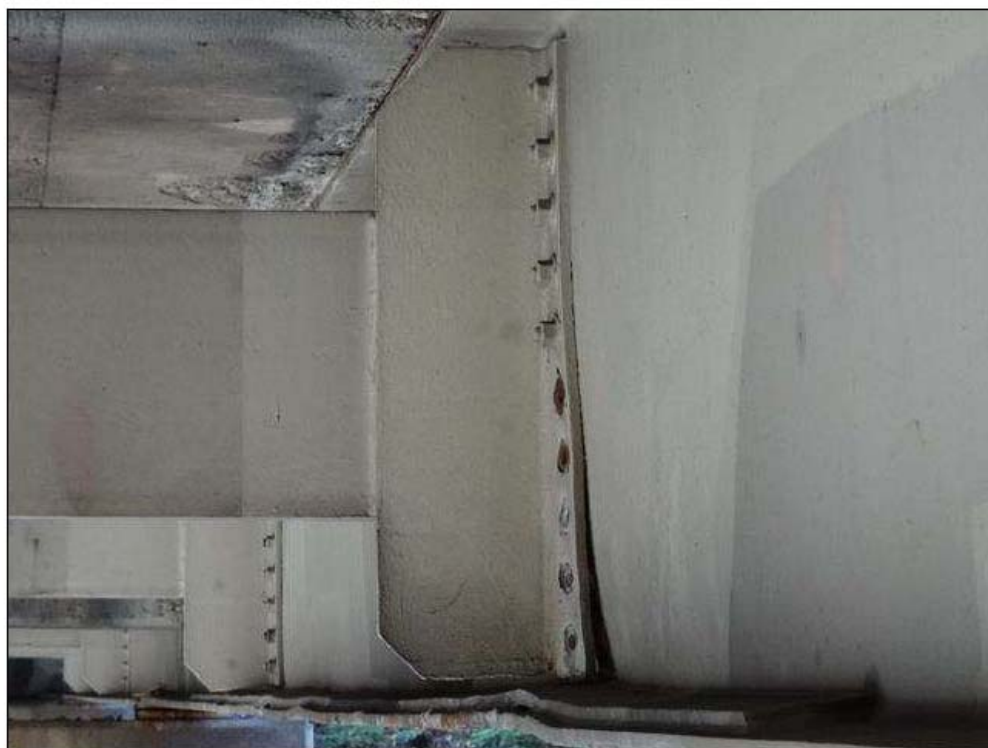
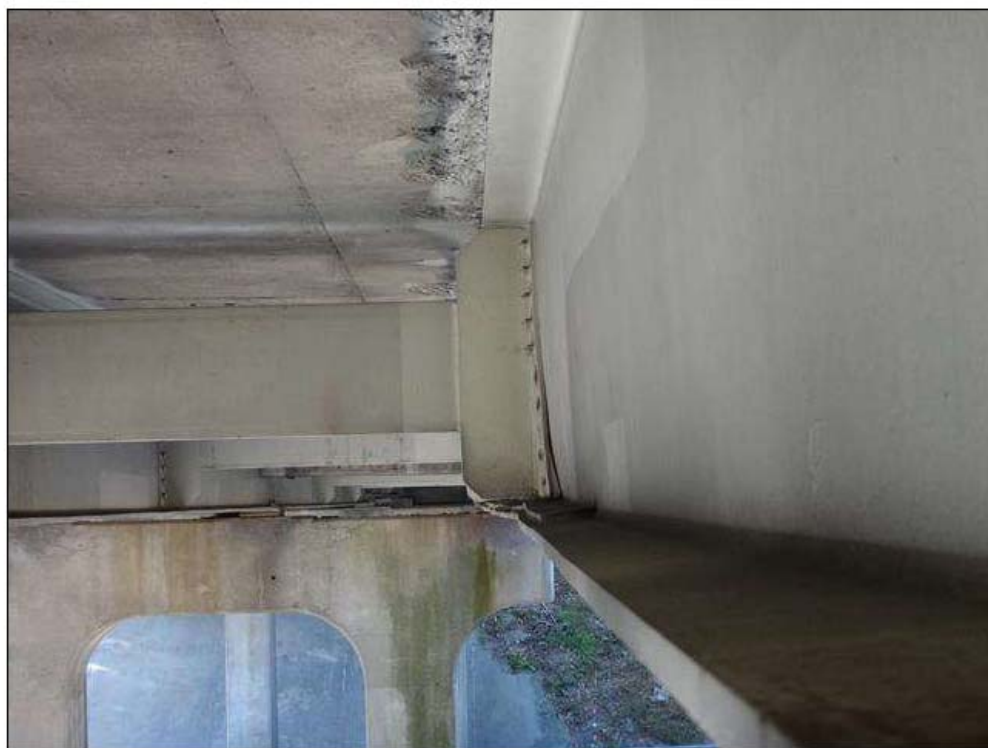
SPAN 3 BEAM 1 AT 20FT FROM BENT 3, TWO ROWS OF FIVE BOLTS SHEARED AND MISSING FROM IMPACT DAMAGE
