DAMAGE REPORTS

NC DEPARTMENT OF TRANSPORTATION
DIVISION OF HIGHWAYS
BRIDGE MANAGEMENT UNIT

BRIDGE INSPECTION REPORT

INSPECTION TYPE: Damage Inspection Report

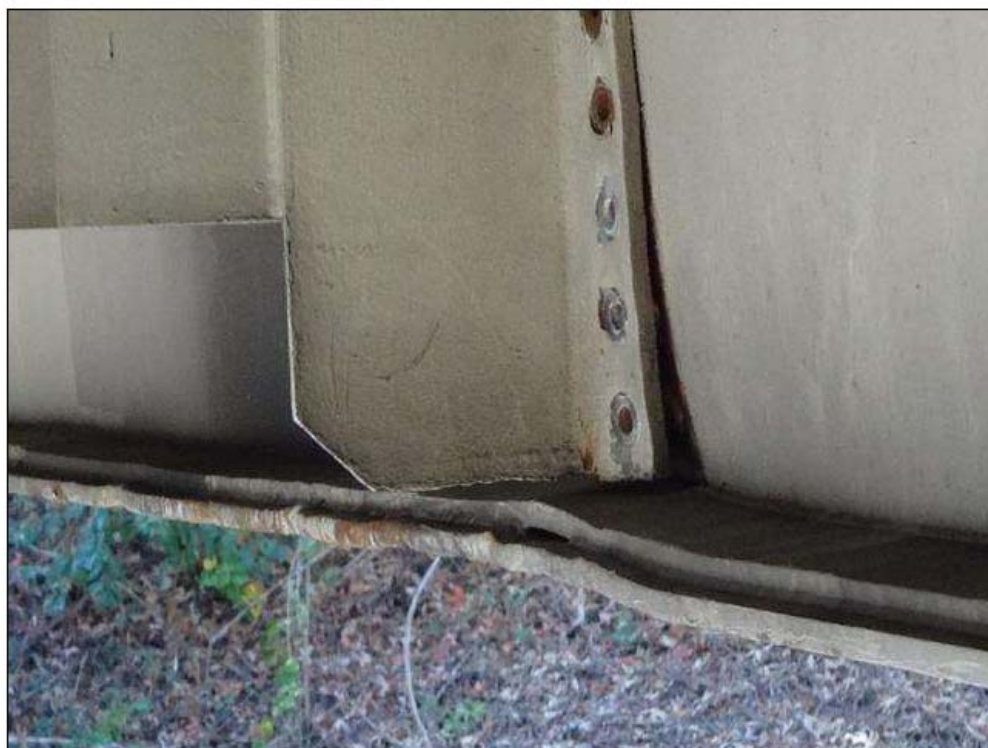
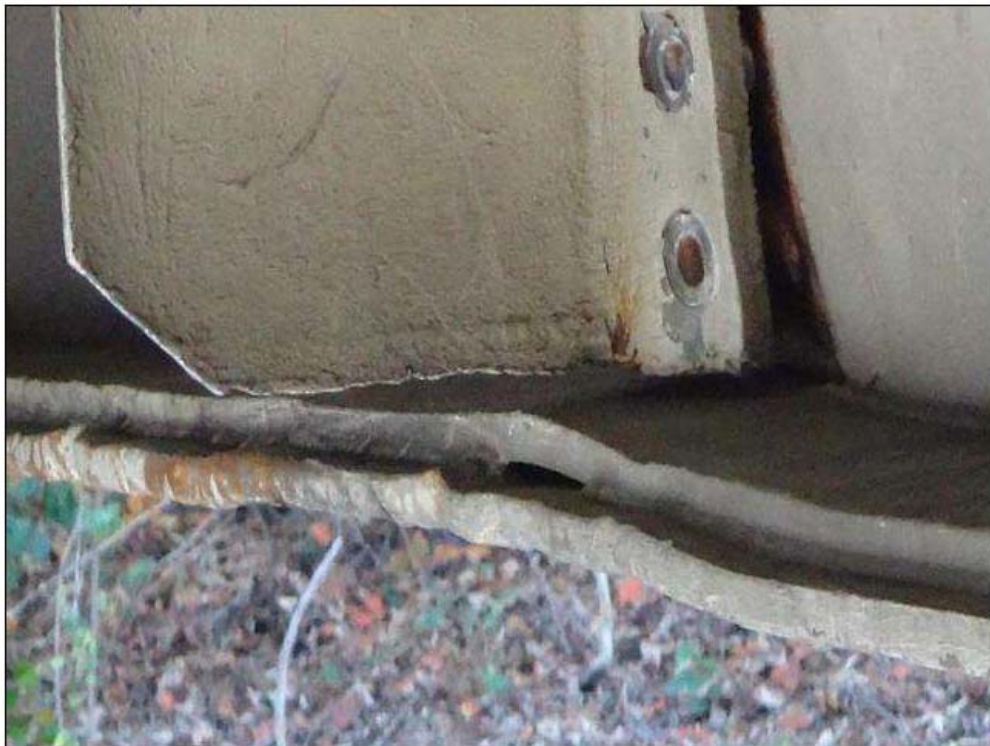
SPAN 3 BEAM 1 AT 20FT FROM BENT 3, BROKEN WELD BETWEEN COVER PLATE AND BOTTOM FLANGE (UP TO 4IN)

MMS Code	MMS Description	Quantity
3314	Maintain Steel Superstructure Components	12 LF
Location:		
Beams and Girders Bent/Span No. 3 BEAM 1		
Priority Level	Status	
Priority Maintenance	Division Bridge Maintenance Notification Received	
Submitted Date:	Submitted By:	Assisted By:
10/23/2015	MONTY HOBBS	RICARDO CORNEJO
Details		
<p>SPAN 3 BEAM 1 WEB AND BOTTOM FLANGE AT 20FT FROM BENT 3, IMPACT DAMAGE (12LF), OUT OF PLUMB (UP TO +/- 3IN)</p> <p>SPAN 3 BEAM 1 AT 20FT FROM BENT 3, TWO ROWS OF FIVE BOLTS SHEARED AND MISSING FROM IMPACT DAMAGE</p> <p>SPAN 3 BEAM 1 AT 20FT FROM BENT 3, BROKEN WELD BETWEEN COVER PLATE AND BOTTOM FLANGE (UP TO 4IN)</p>

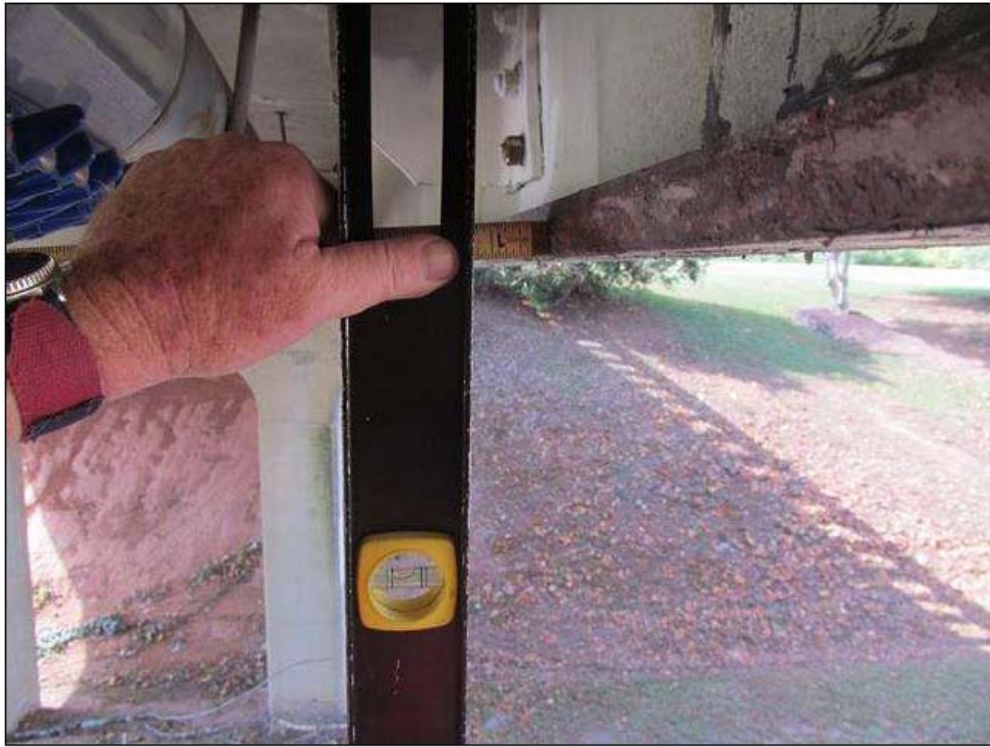
BEAM 1, BENT OUT OF PLUMB 1.5"

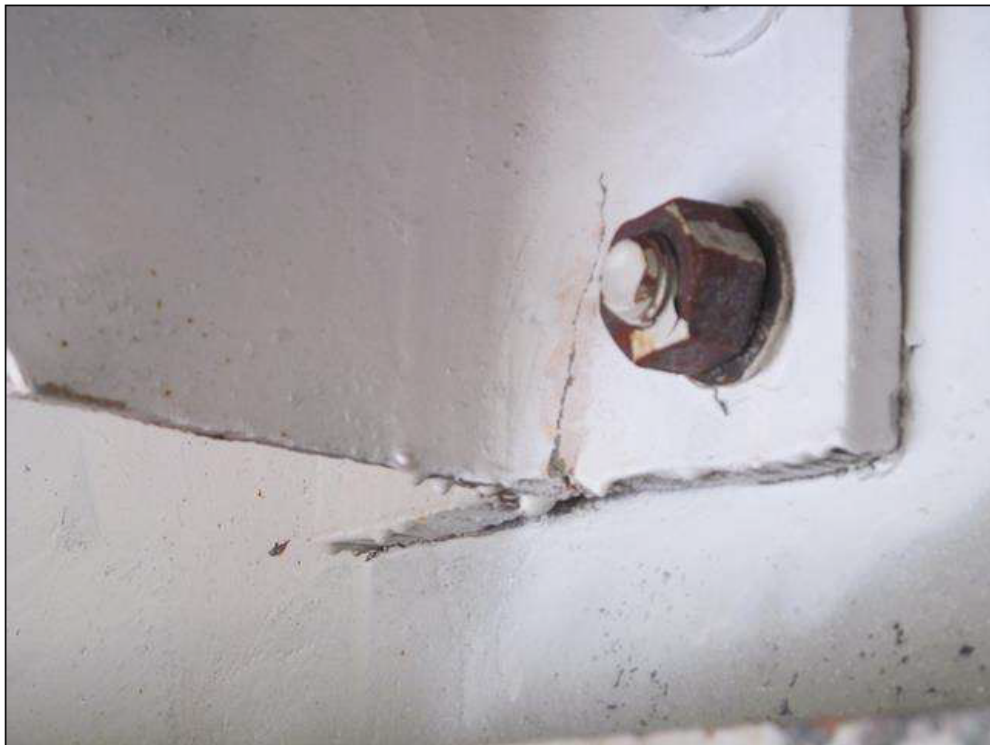
CRACK ON DIAPHRAGM CONNECTION BRACKET HAS NOT CHANGED FROM PREVIOUS HIT.

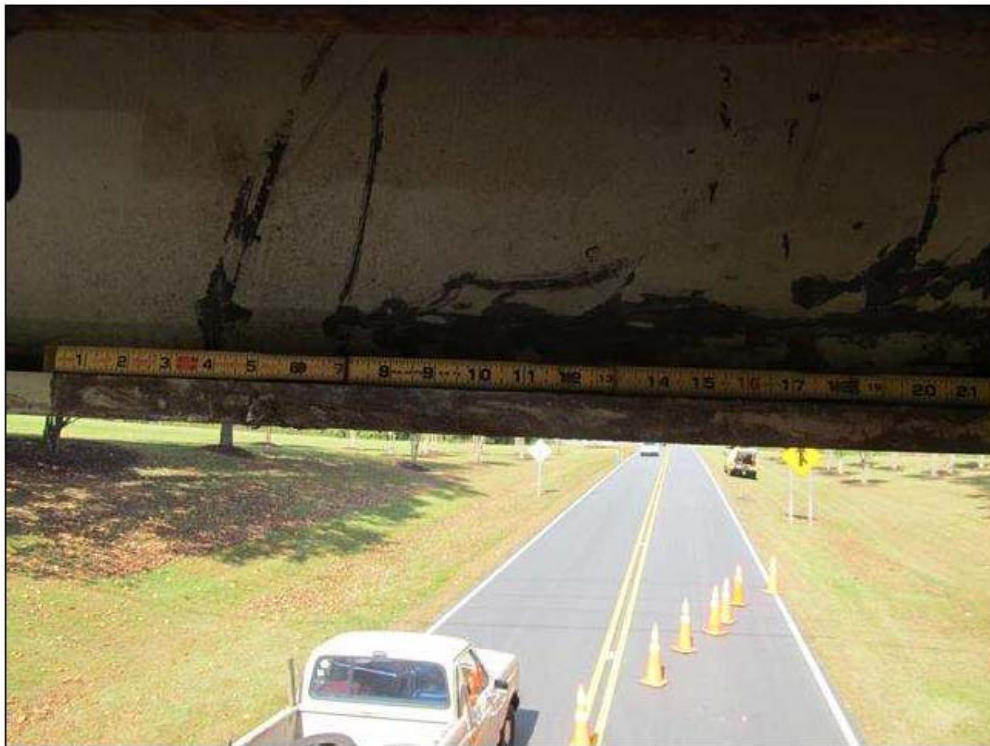
IMPACT AREA @ 20.167' OUT FROM BEARING AT BENT 2, AREA IS 2' LONG

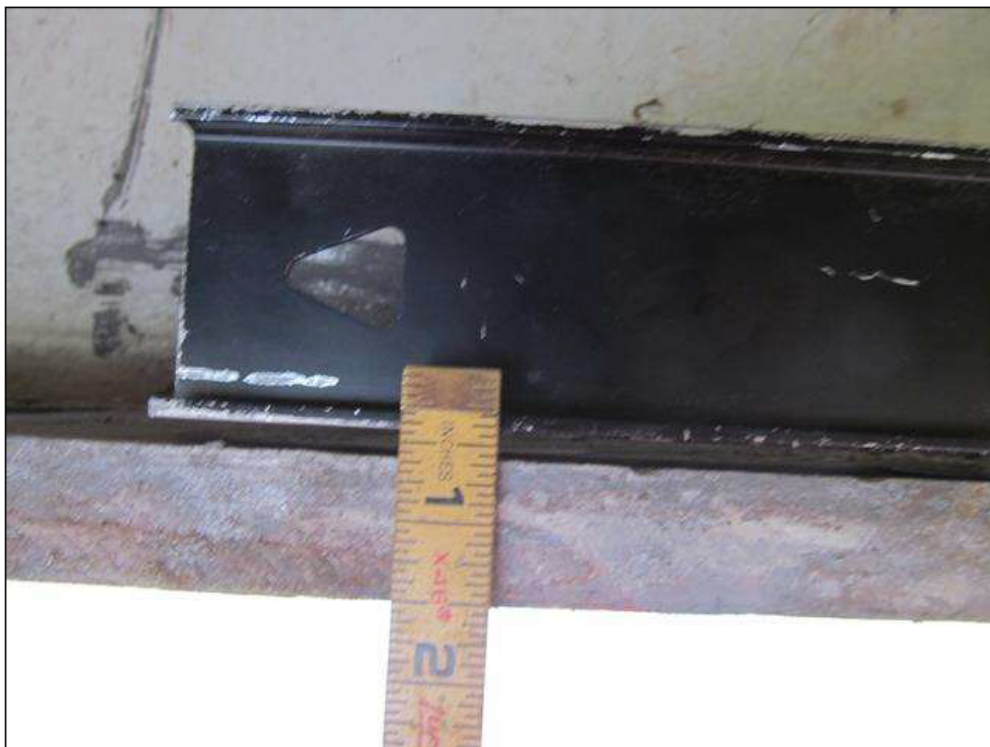
BEAM 1, BOTTOM FLANGE BENT DOWNWARD, UP TO A 1/4"

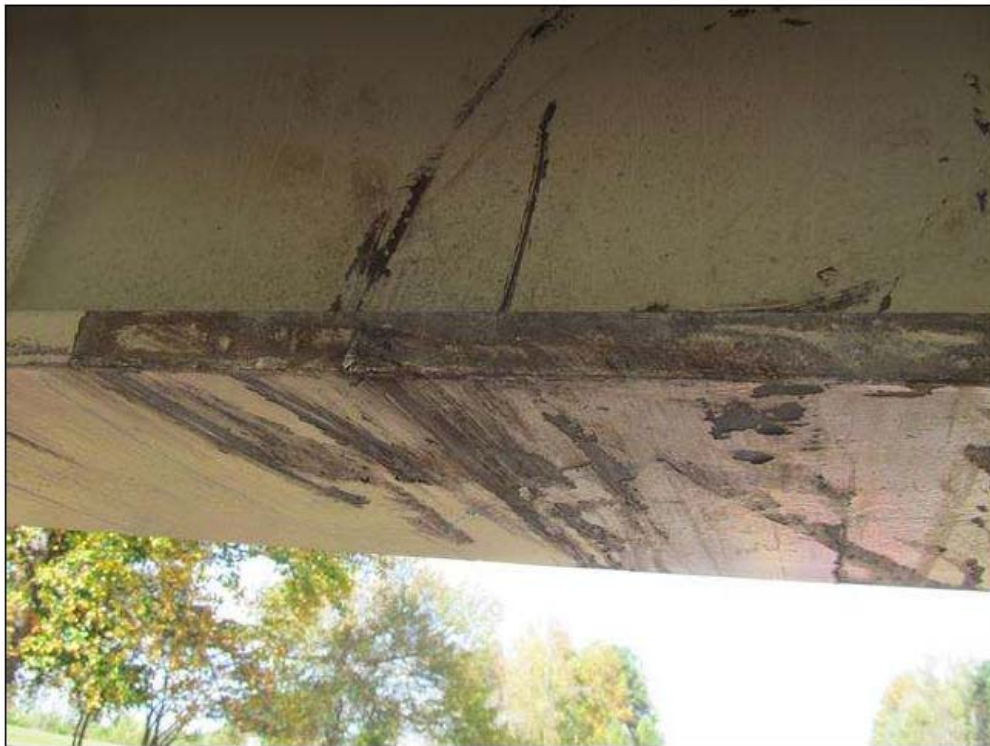
ANOTHER VIEW OF IMPACT AREA

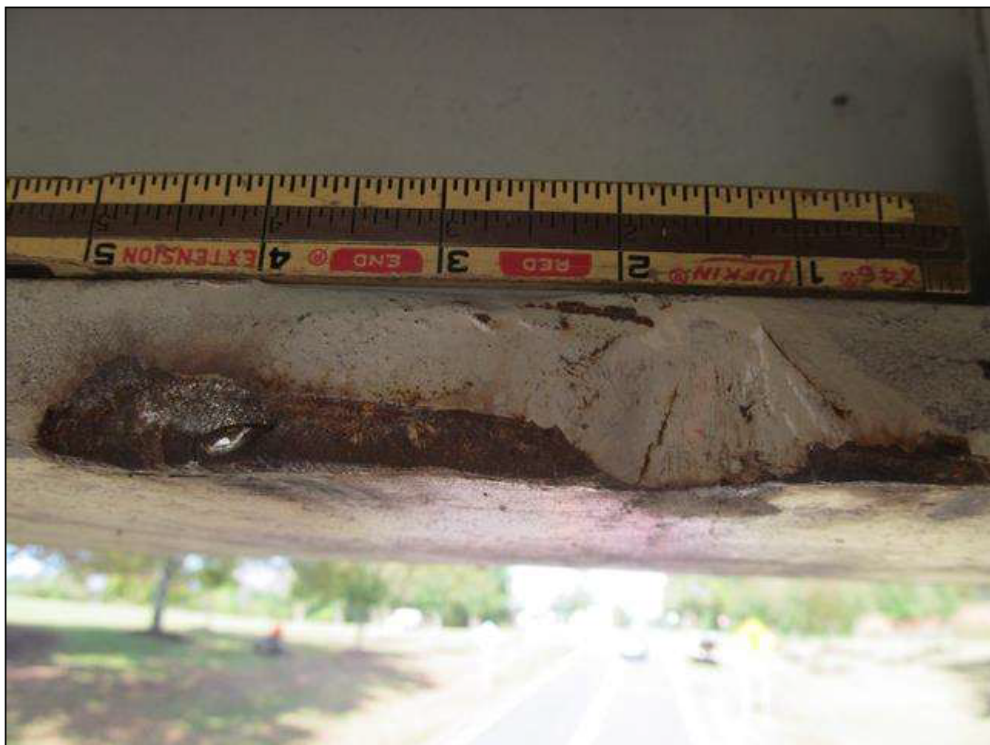
OLD IMPACT AREA @ 16.417' OUT FROM BENT 2 BEARING, DIVOT IS 1"WIDE X 1/2"DEEP IN BOTTOM FLANGE.

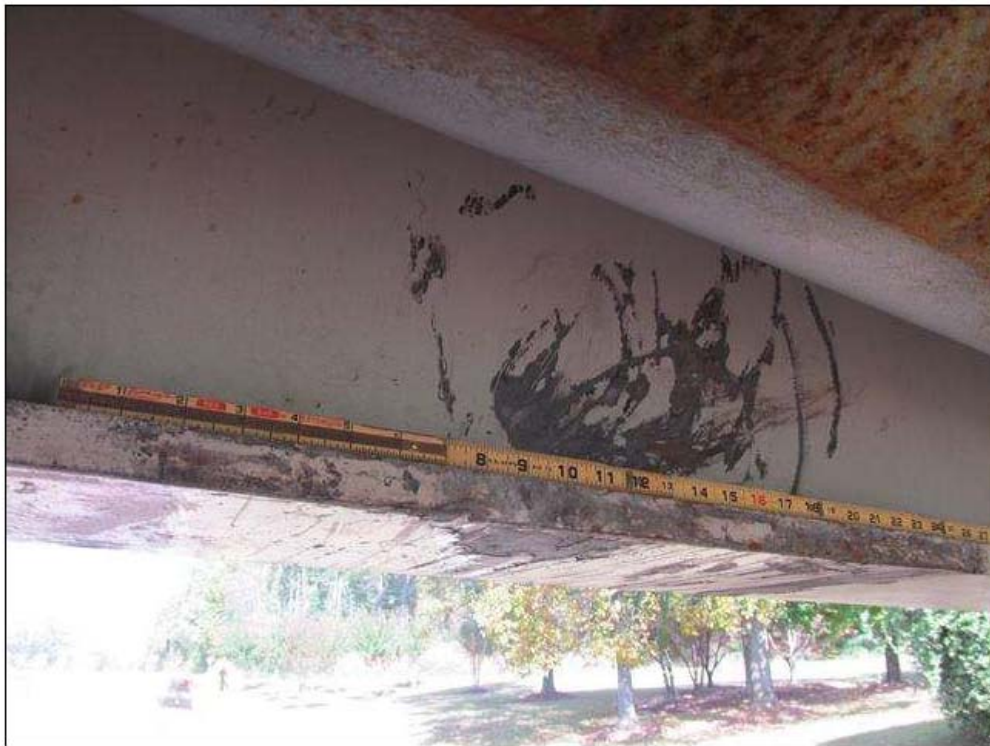
IMPACT ZONE 2, @ 13.083' OUT FROM BENT 2 BEARING, AREA IS 2' LONG

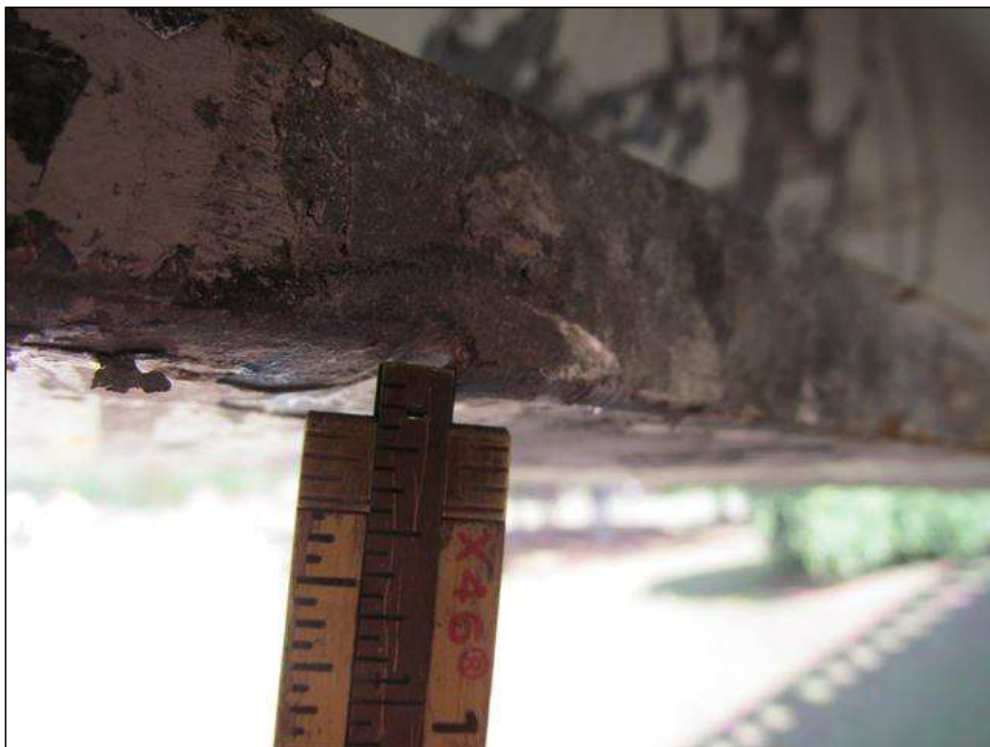
VIEW OF 1/8" DEEP OF SCRAPE TO BOTTOM FLANGE ON BEAM 1

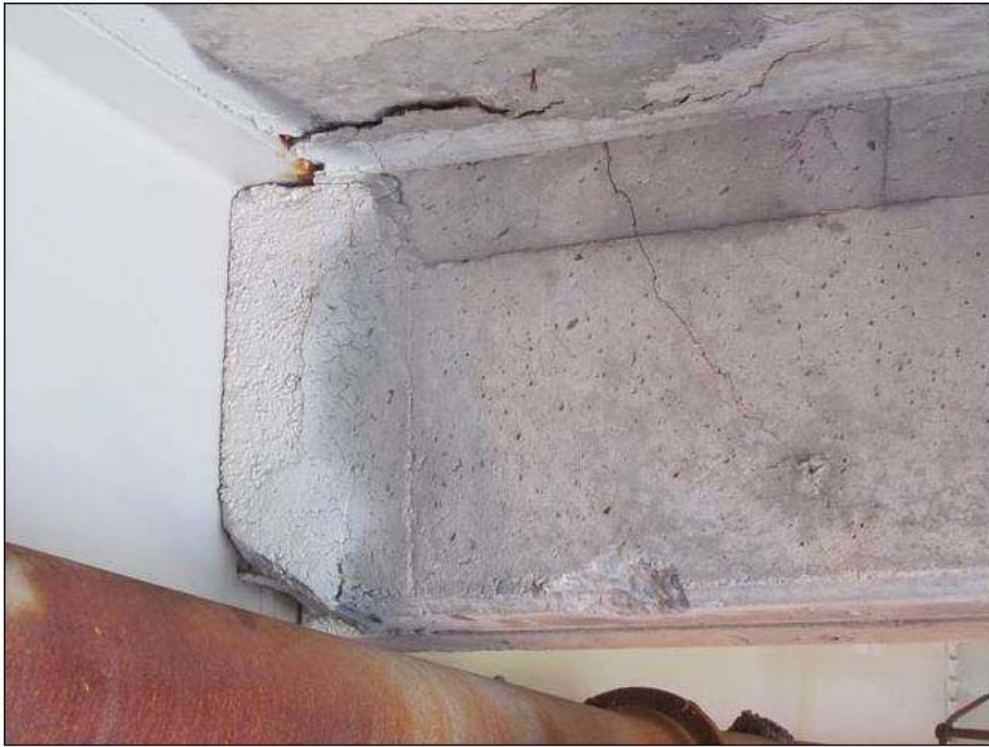
13	F	END DIAPHRAGMS AT BENT 2 HAVE CRACKING IN BAY1 AND EXTERIOR END DIAPHRAGM.	
15	F	BEARINGS & ANCHOR BOLTS ON BEAM 1 IN SPAN 2 DID NOT SHOW ANY INDICATION OF DAMAGE DUE TO THE IMPACT

END DIAPHRAGM IN BAY 1, AT BENT 2. CRACKED.

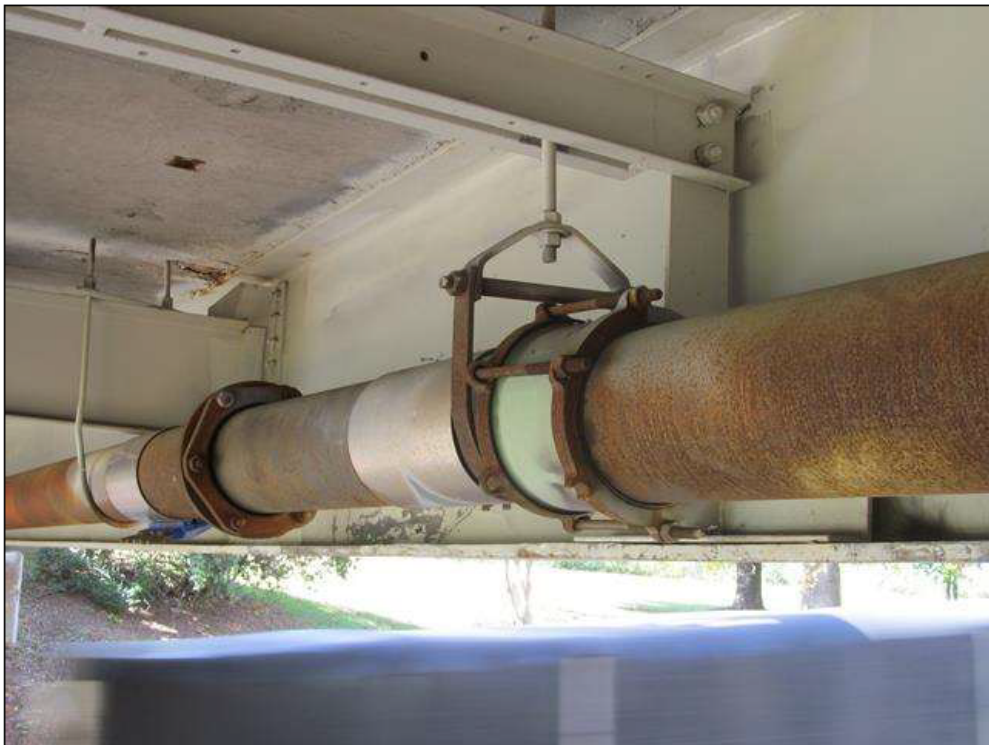
WATER LINE IN BAY 1

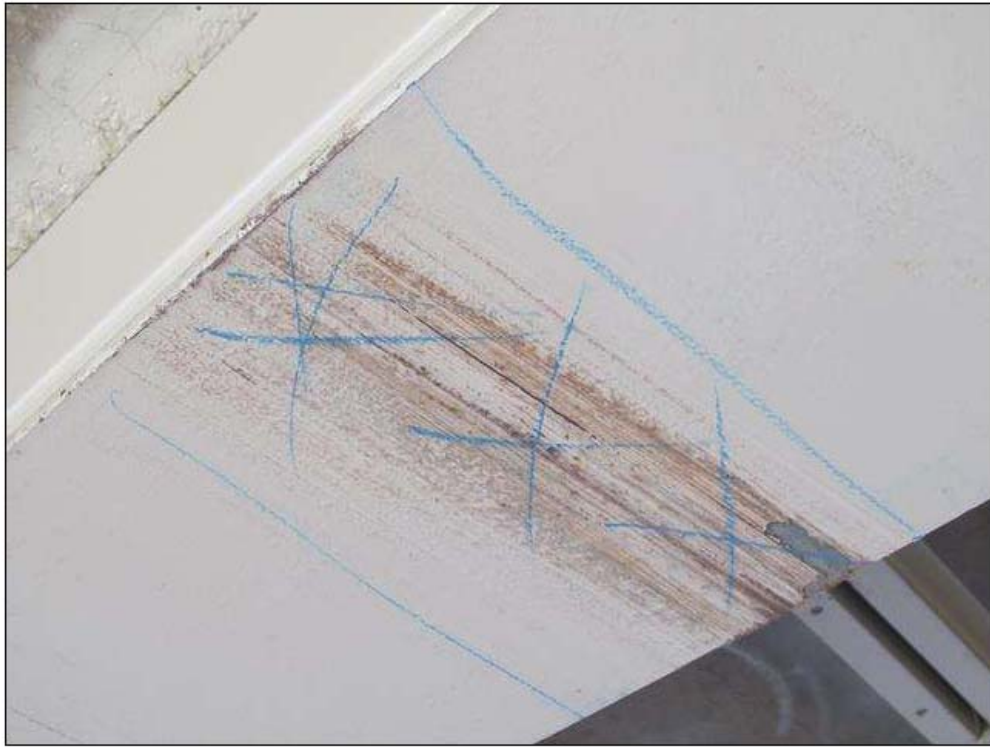
BEAM 2, @ 13.583' OUT FROM BENT 2 BEARING, SCRAPE MARKS.

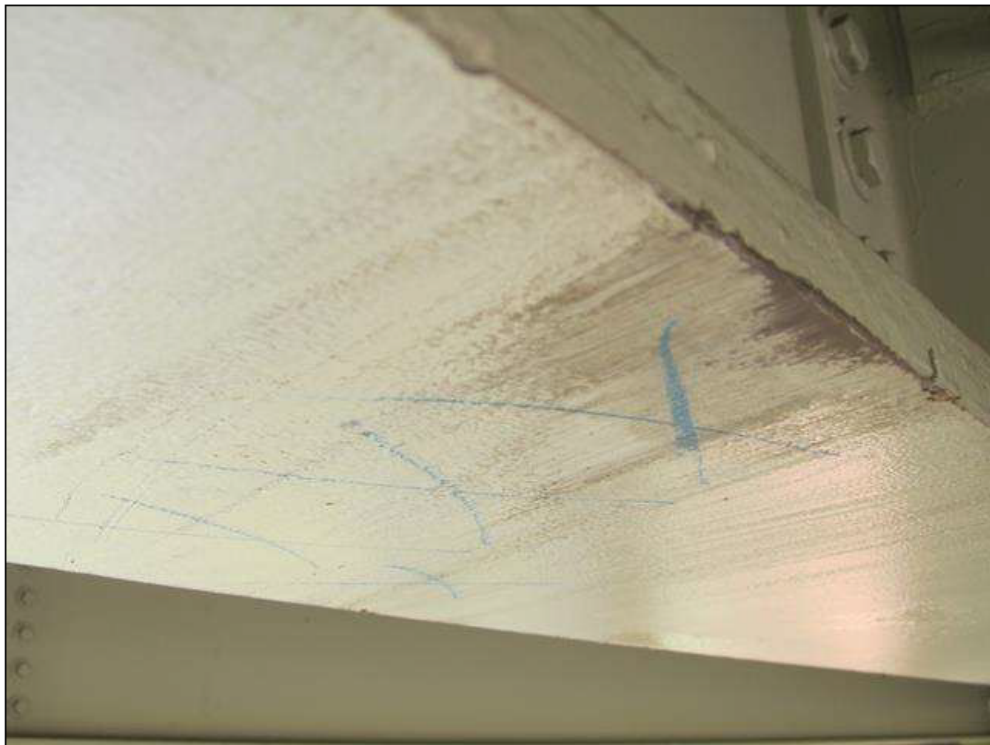
BEAM 2, @ 19.75 FROM BENT 2 BEARING, SCRAPE MARKS

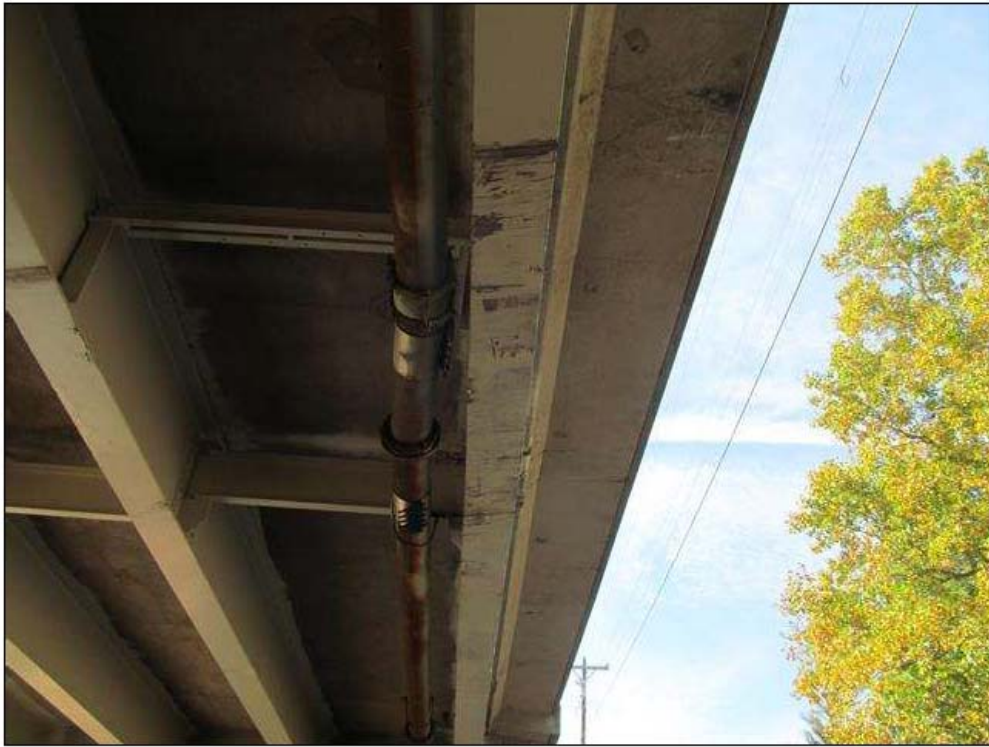
LOOKING UP AT BEAM 1 IMPACT AREA

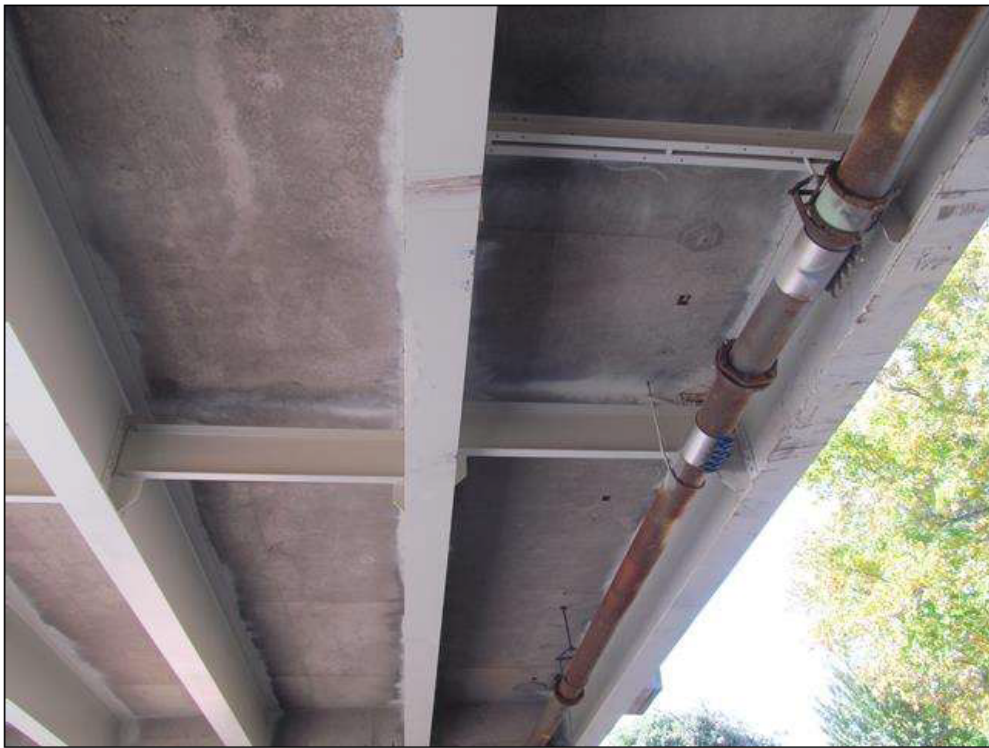
LOOKING UP AT BEAM 2 IMPACT AREA

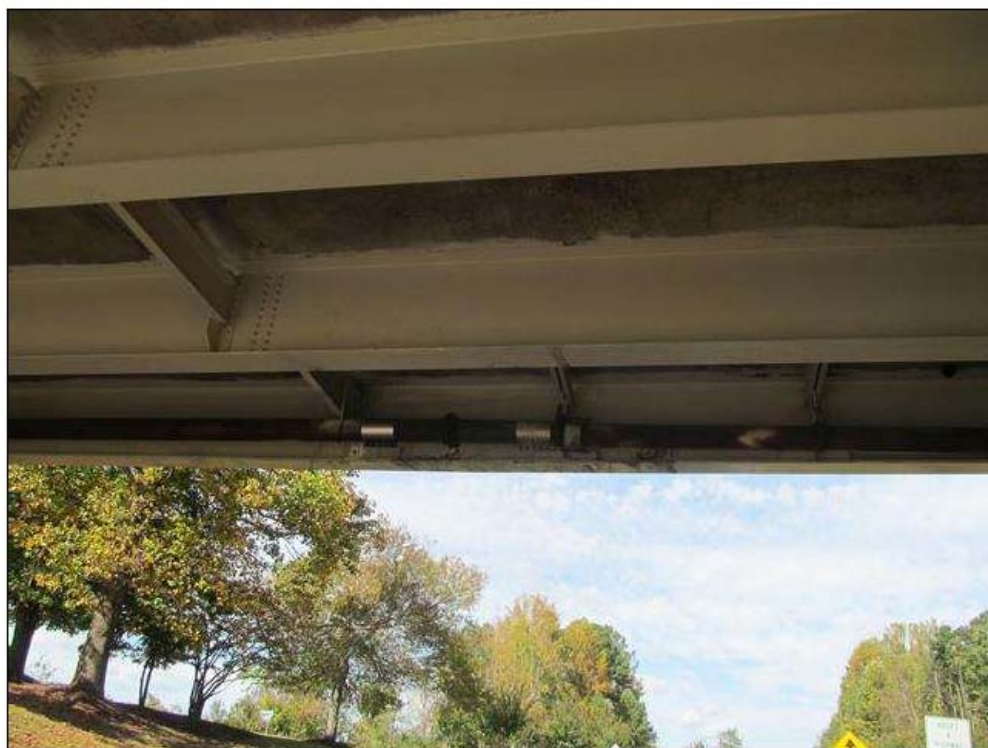
OVERVIEW OF IMPACT AREA
