NC DEPARTMENT OF TRANSPORTATION
 DIVISION OF HIGHWAYS
 BRIDGE MANAGEMENT UNIT

IMPACT DAMAGE REPORT ON SPAN 2
 RATINGS FOR SPAN 2 ITEMS ONLY
 PRIORITY MAINTENANCE REQUESTED

INSPECTION TYPE: Damage Inspection Report

COUNTY BUNCOMBE BRIDGE NUMBER 100369 INSPECTION CYCLE 0 YRS
 ROUTE I-40 EBL ACROSS BILTMORE ESTATE ROAD M.P. 49500

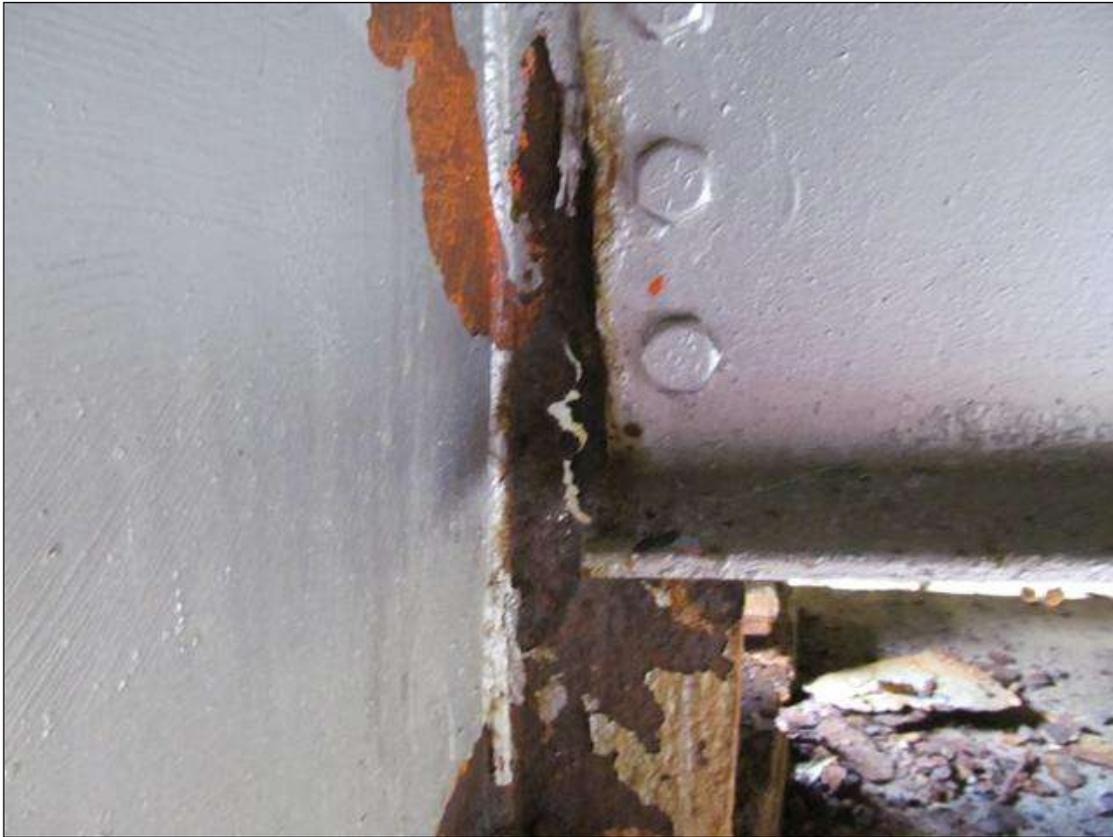
CONDITIONS FOUND IN WEB STIFFNER ON BEAM 6 AT BENT 1

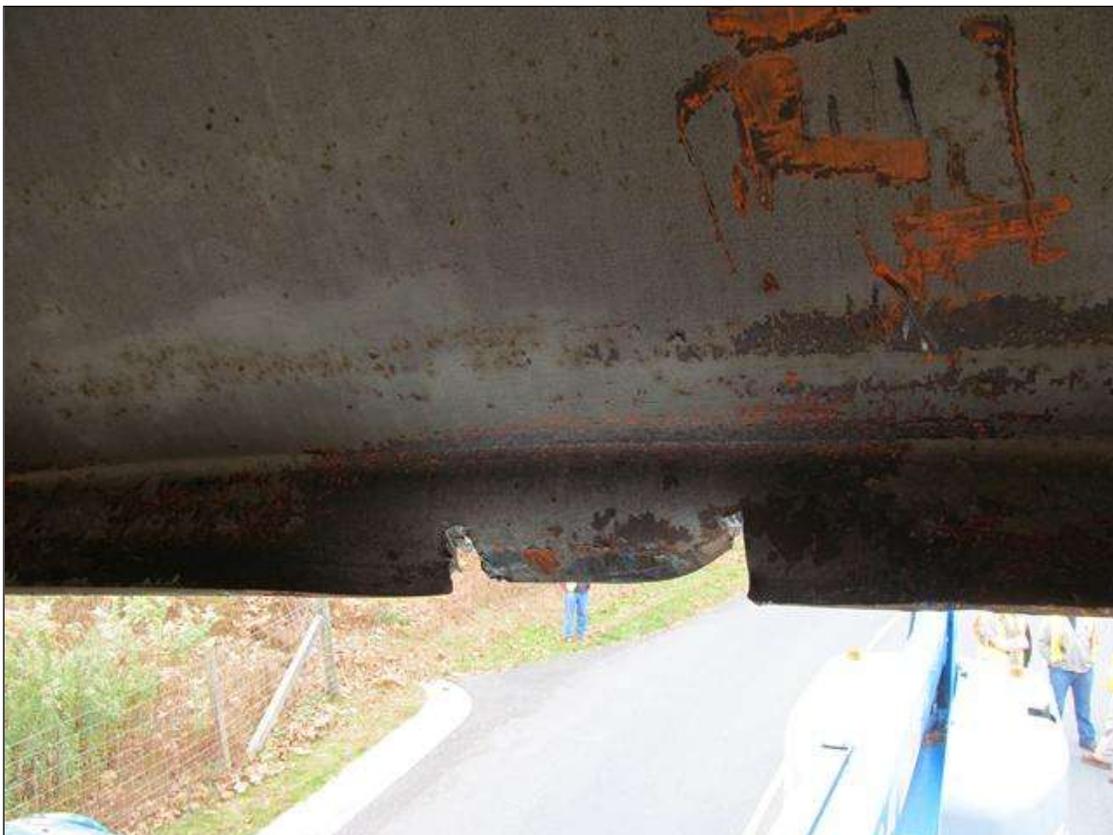
Item No.	Grade		
10	P	<p>IMPACT DAMAGE INSPECTION WAS REQUESTED BY TOPSIDE BRIDGE INSPECTION FOR SPAN 2 ON BILTMORE ESTATE ROAD</p> <p>BEAM 6: POINT OF IMPACT ON BEAM 6 IN SPAN 2 WAS 18'-5" FROM FACE OF BENT 1. 2 GOUGES IN FLANGE 1" X 3" AND 1" X 2 1/2" COMPLETEY THROUGH FLANGE. BEAM IS OUT OF PLUMB 24 3/4" +/- AT 18'-5" FROM FACE OF BENT 1. TOP OF FLANGE HAS PULLED AWAY FROM DECK 2" +/- . A 4" +/- CRACK IS RUNNING TOWARD BENT #2 FROM GOUGE AT 18'-5" FROM FACE OF BENT #1. A GOUGE 3/4" X 5 1/2" X 1/8" IN FLANGE AT 18'- 10" FROM FACE OF BENT 1. A GOUGE 1/2" X 3" X 1/16" IN FLANGE AT 17'- 11", ONE 1/4" X 10" X 1/32" AT 14'-10" ALL FROM FACE OF BENT 1. A INDENTION 1" X 1/32" AT 17'-0" FROM FACE OF BENT 1. WEB STIFFNER ON INSIDE OF BEAM 6 AT BENT 1 HAS TORE OPEN, AND BENT OUT OF PLUMB 1" +/- . WEB STIFFNER AT BENT 2 IS BOWED TO THE EAST 2" +/- . THE TOP OF FLANGE OF BEAM 6 AND THE SIP FORMING HAS SEPRATED 1/2". BEAM 6 STARTS TO BOW AT 22" FROM BENT 1 AND 21" FROM BENT 2. THE J CHANNEL HOLDING THE SIP FORMING IN PLACE HAS BROKE THE SPOT WELDS AND DROPED 2" +/- AT BEAM 6. (SEE PHOTOS)</p> <p>BEAM 5: INITINAL POINT OF IMPACT ON BEAM 5 IN SPAN 2 WAS 18'-11" FROM FACE OF BENT 1. THERE ARE 2 GOUGES IN FLANGE 3/4" X 5 1/2" X 1/4" AND 3/4" X 5 1/2" X 1/4" THE FLANGE IS BENT UPWARD 2" AT POINT OF IMPACTAND 3/4" X 2 1/2". (SEE PHOTOS)</p>

POINT OF IMPACT ON BEAM 6

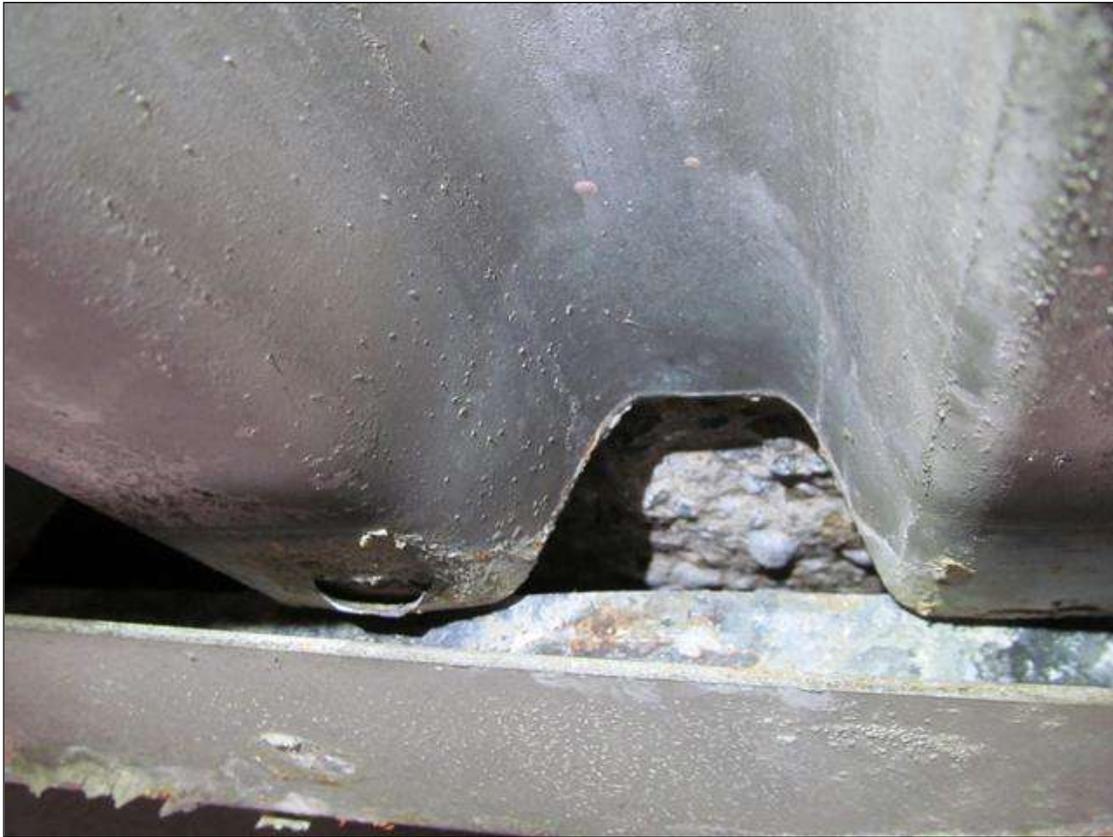
TOP OF BEAM 6 PULLED AWAY FROM DECK 2" +/-

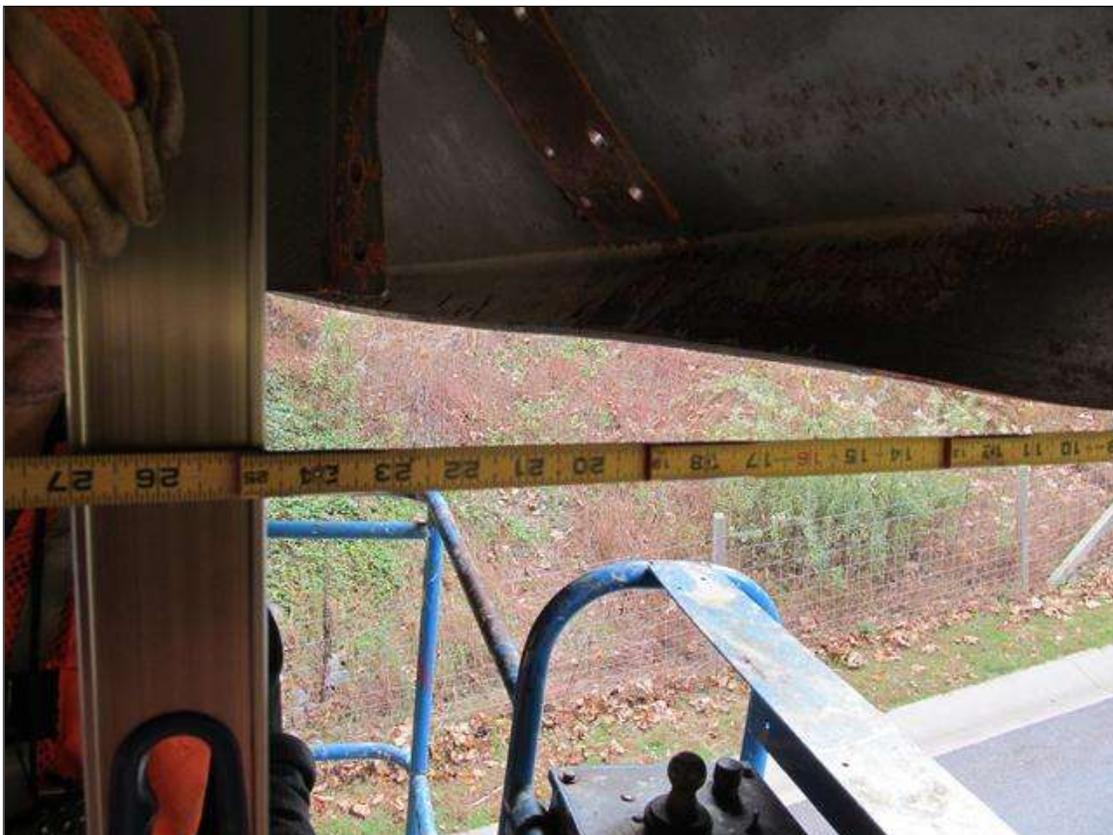
3314	Maintain Steel Superstructure Components	LF	45	BEAM 6 IS OUT OF PLUMB 24 3/4" POINT OF IMPACT ON BEAM 6 BEAM 6 OUT OF PLUMB 24 3/4" AT 18'-5" FROM BENT 1 LOOKING AT BEAM 6 FROM BENT 1 LOOKING AT BEAM 6 FROM BENT 2 LOOKING AT THE INSIDE OF BEAM 6 FROM BENT 2

BEAM 6 OUT OF PLUMB 24 3/4" AT 18'-5" FROM BENT 1

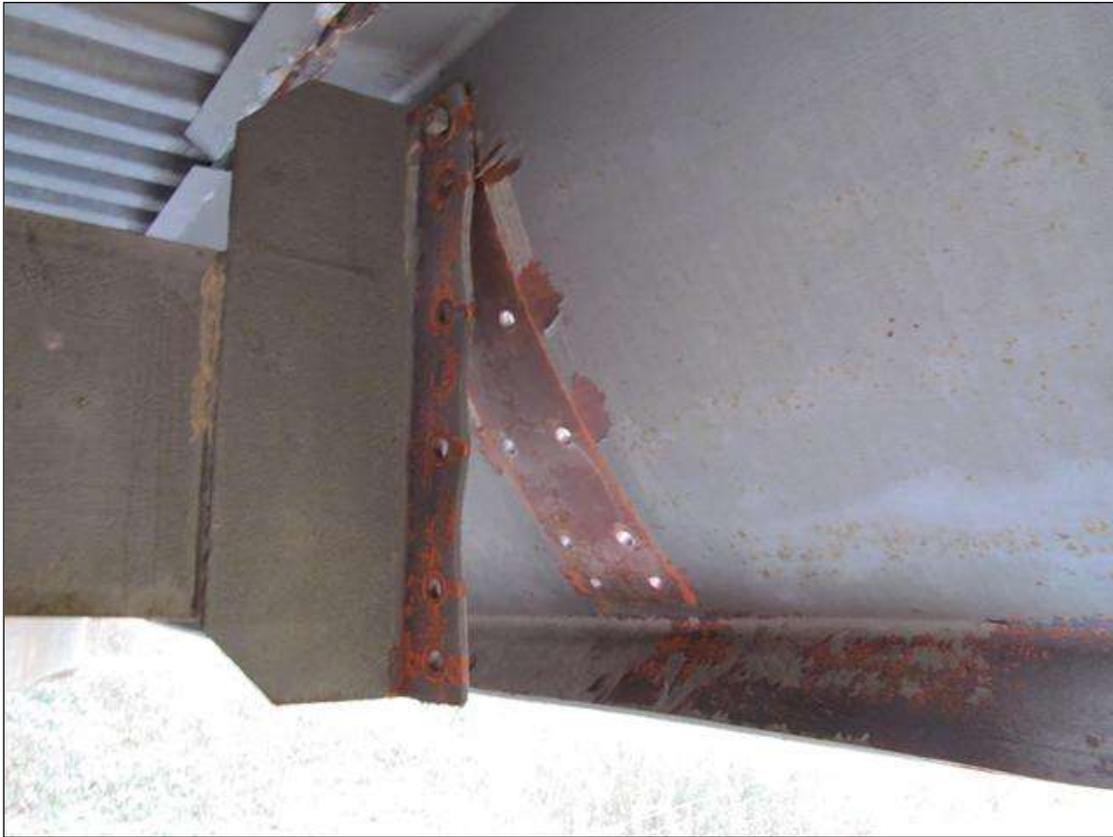
12	P	CONNECTION PLATE OF INTERMEDIATE DIAPHRAGM AT 21'-5" ON BEAM 6 IS MISSING 10 OF 12 DIAPHRAGM BOLTS, THE TWO THAT REMAINS ARE NOT FULLY THREADED. THE WEB OF THE DIAPHRAGM WHERE THE DIAPHRAGM BOLT HOLES ARE IS BENT OUT OF SHAPE (SEE PHOTOS)	
15	P	BEARINGS & ANCHOR BOLTS IN SPAN 3 HAD DAMAGE DUE TO IMPACT: TWO OF THE ANCHOR BOLTS AT BENT 2 ARE BROKE AT 3.9" +/- AND THE INSIDE ANCHOR BOLT AT BENT 1 IS BROKE AT 3.9" +/-	
61	YES	THREE OF THE FOUR ANCHOR BOLTS ARE BROKE, BEAM 6 IS BENT 24 3/4" OUT OF PLUMB, 10 OF THE 12 DIAPHRAGM BOLTS ARE MISSING, CONCRETE DIAPHRAGMS AT BENT #1 AND #2 ARE DAMAGED, TOP OF BEAM 6 IS PULLED AWAT FROM DECK 2"	
73f	YES	UT MACHINE / JIG LIFT/ CLIMBING VEST / MT MACHINE

10 OF 12 DIAPHRAGM BOLTS MISSING

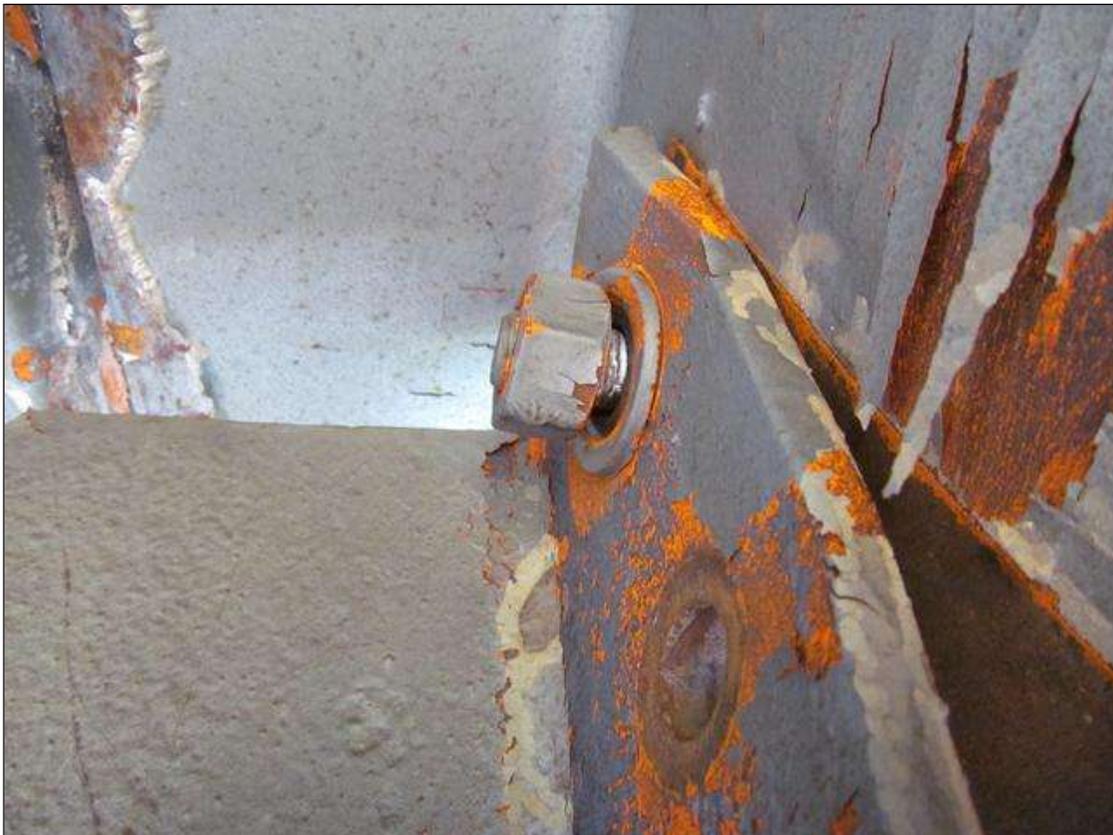
THE TWO REMAINING DIAPHRAGM BOLTS ARE NOT FULLY THREADED

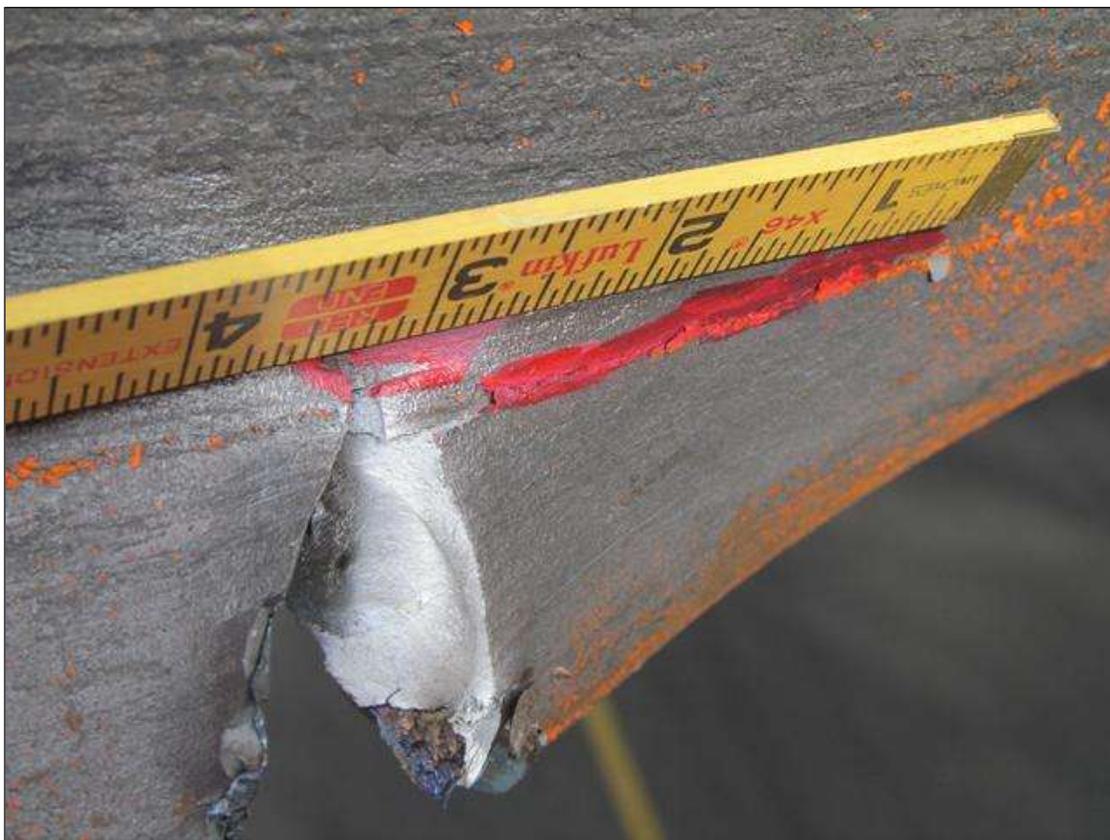
A 4"+/- CRACK RUNNING OUT FLANGE FROM GOUGE IN BEAM 6

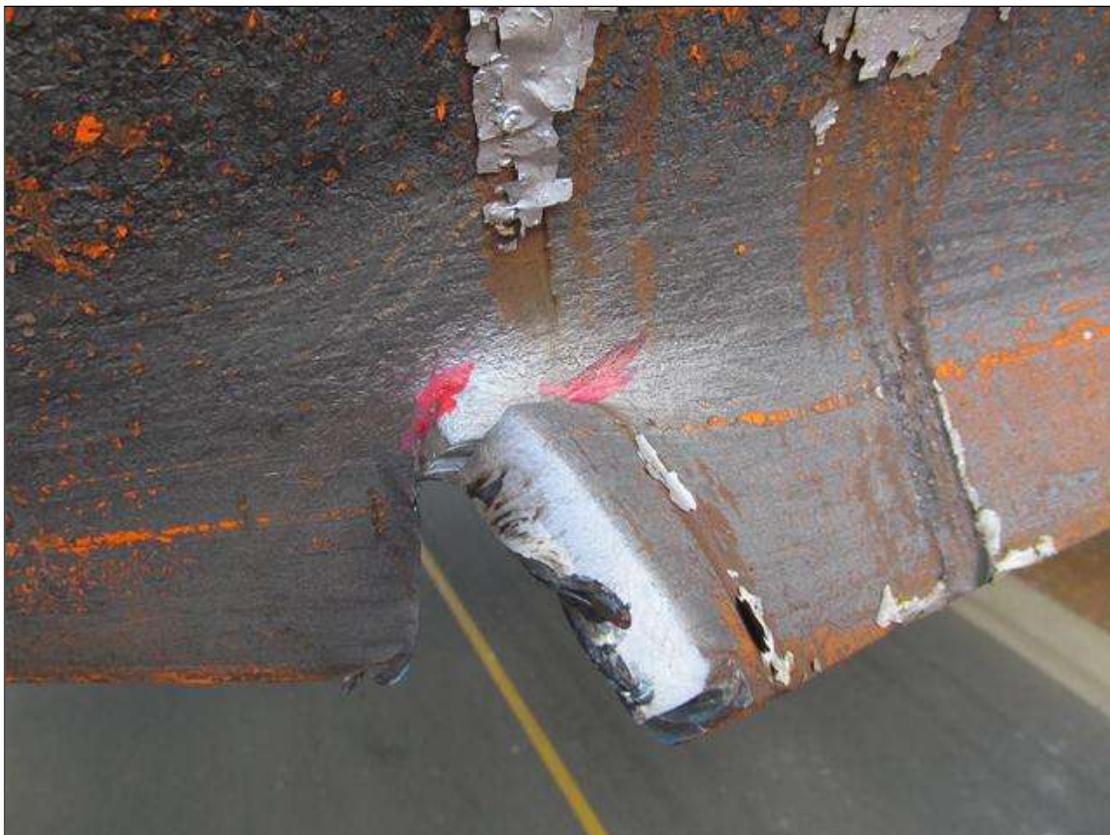
GOUGE IN FLANGE OF BEAM 6 AT 18'-5" FROM BENT 1

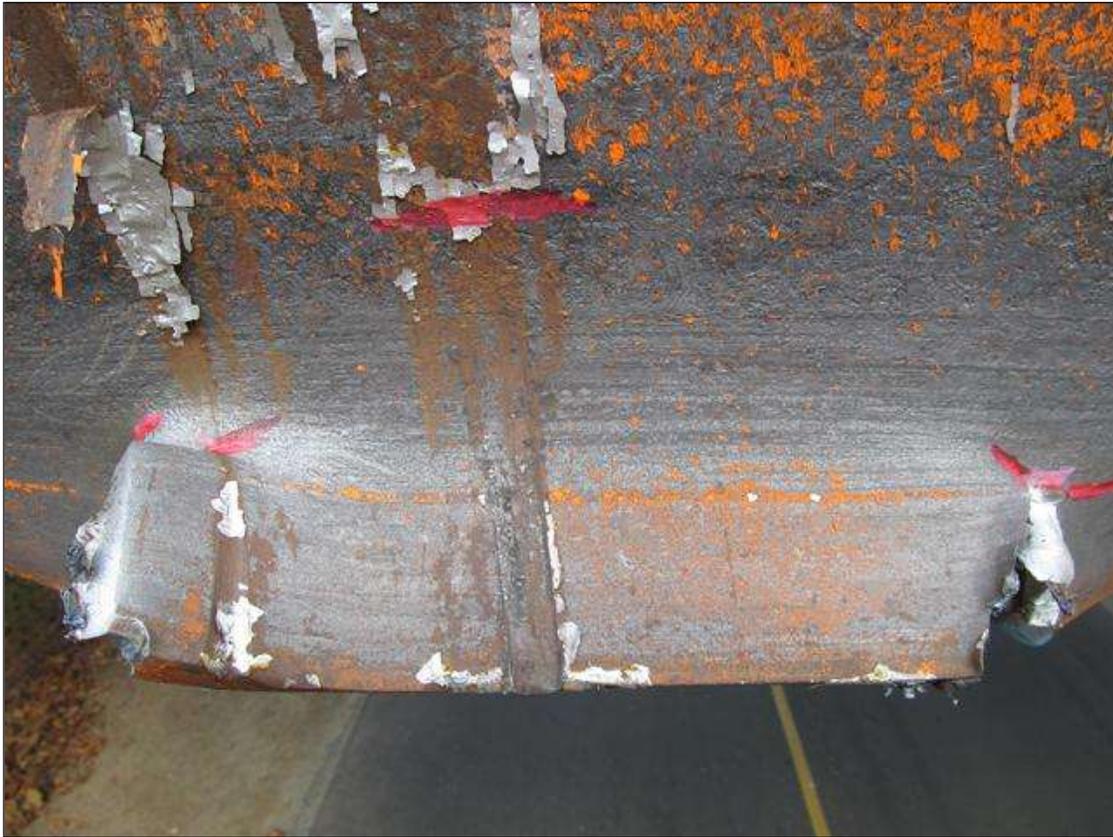
GOUGE IN FLANGE OF BEAM 6 AT 18'-10" FROM BENT 1

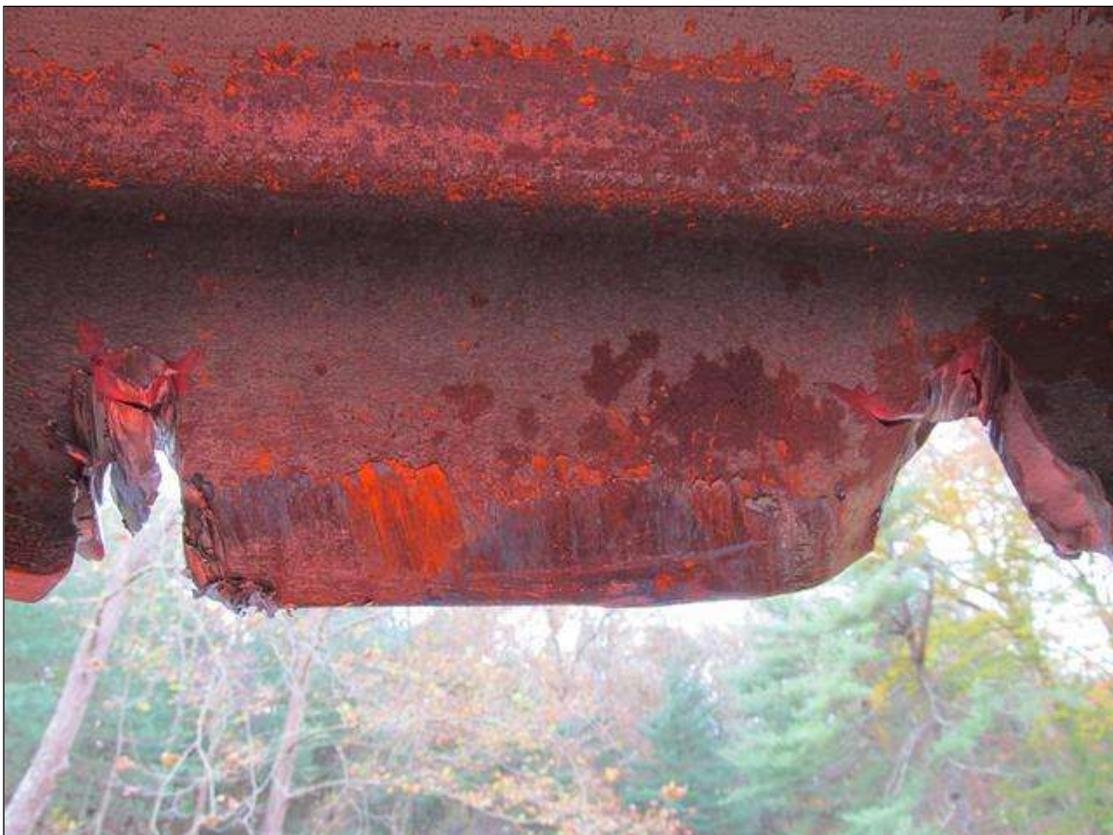
LOOKING AT GOUGE ON BEAM 6

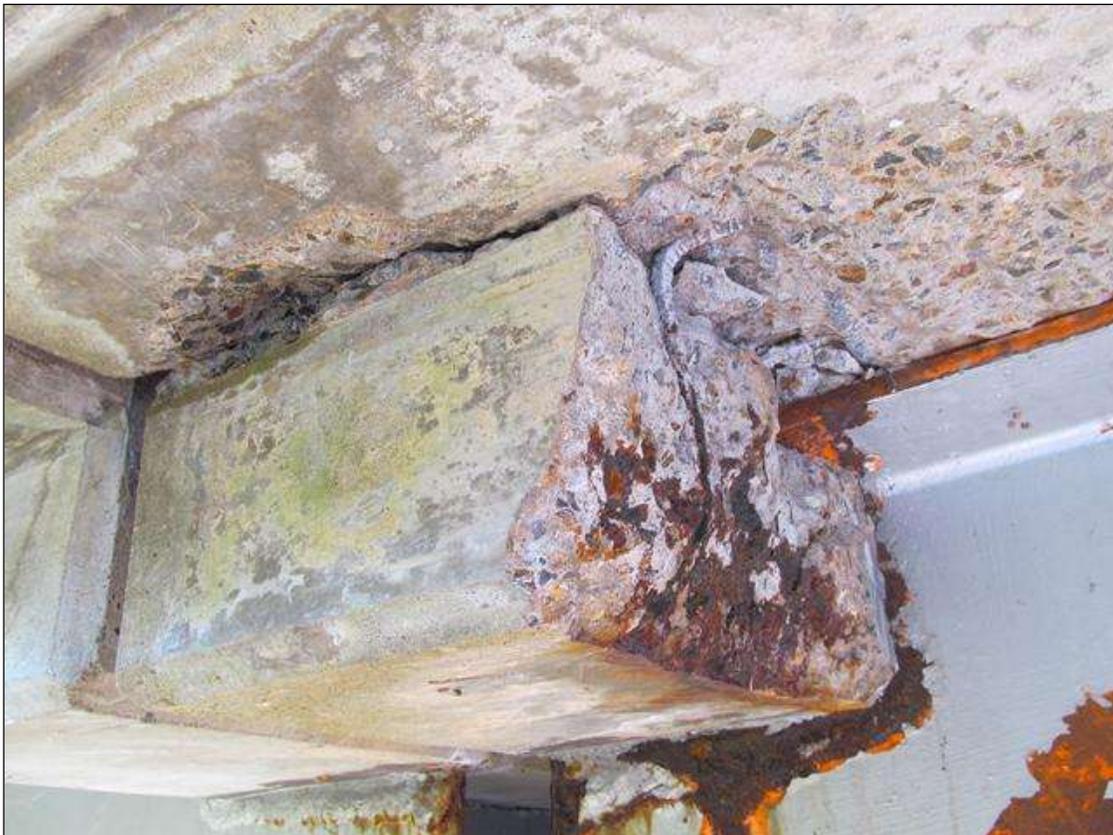
CONCRETE DIAPHRAGM ON THE OUTSIDE BEAM 6 AT BENT 1

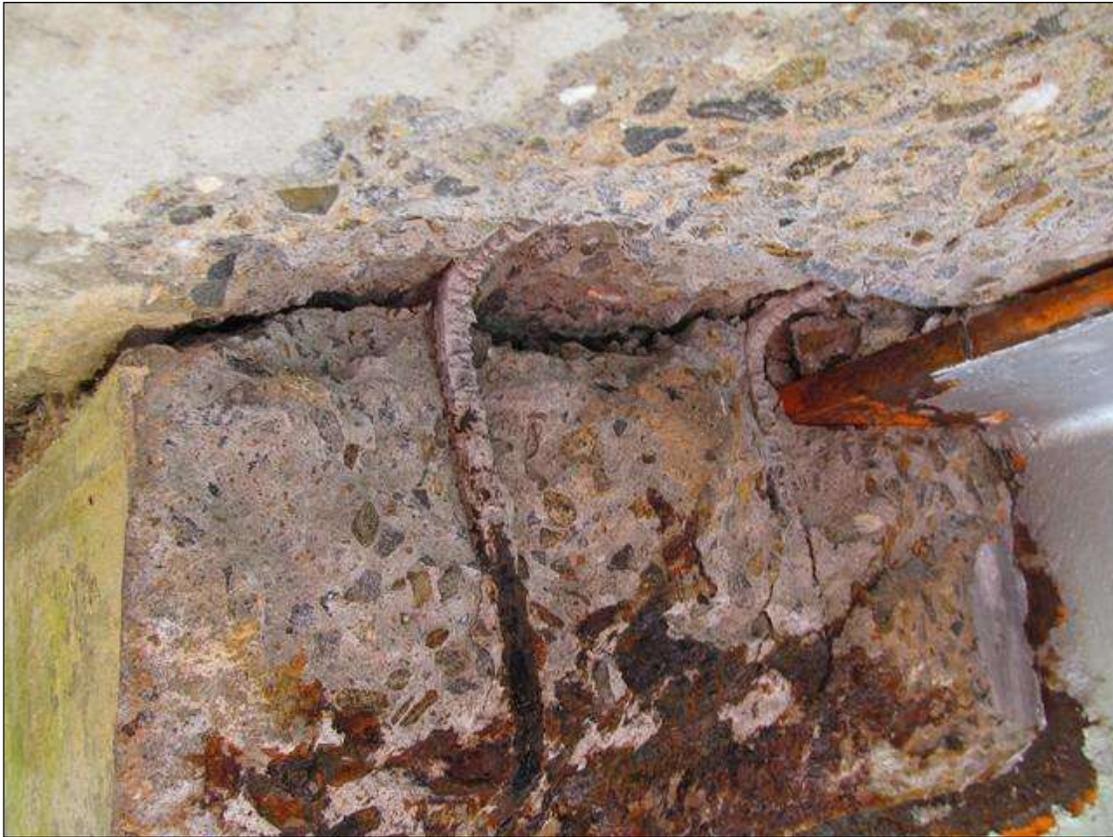
CONCRETE DIAPHRAGM AT BENT 1

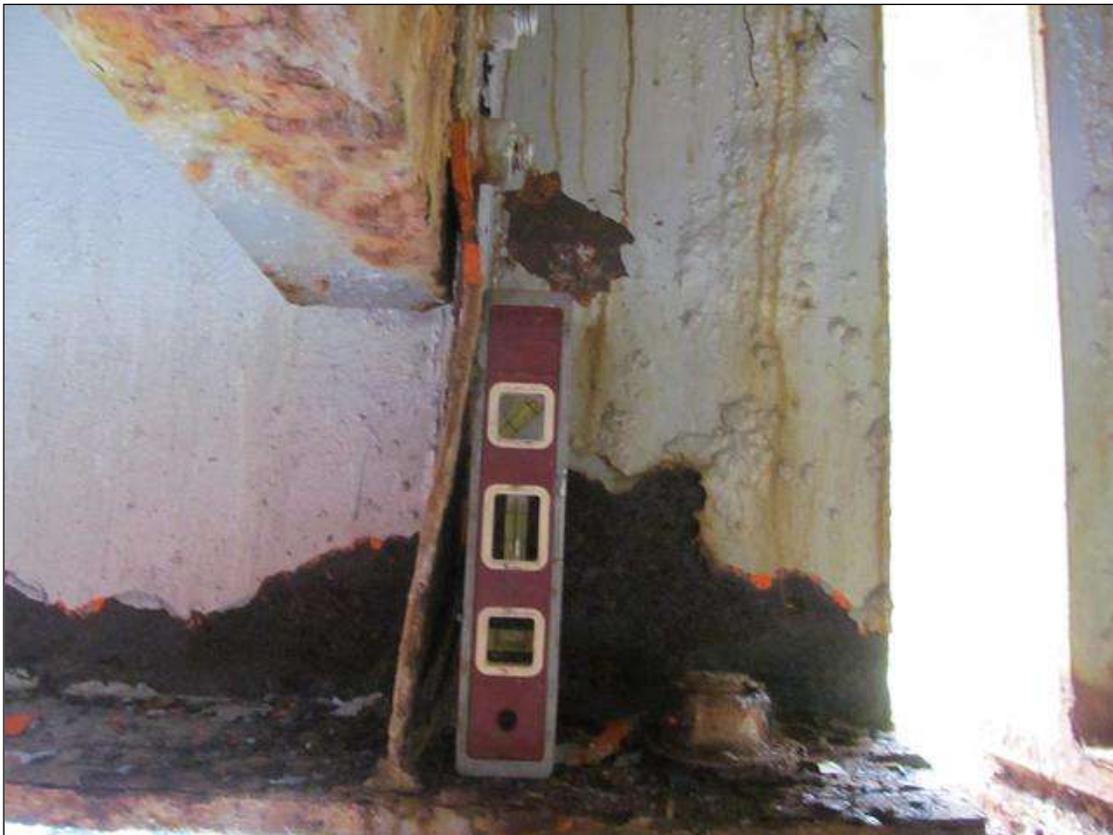
WEB STIFFNER AT BENT 1 ON BEAM 6 OUT OF PLUMB

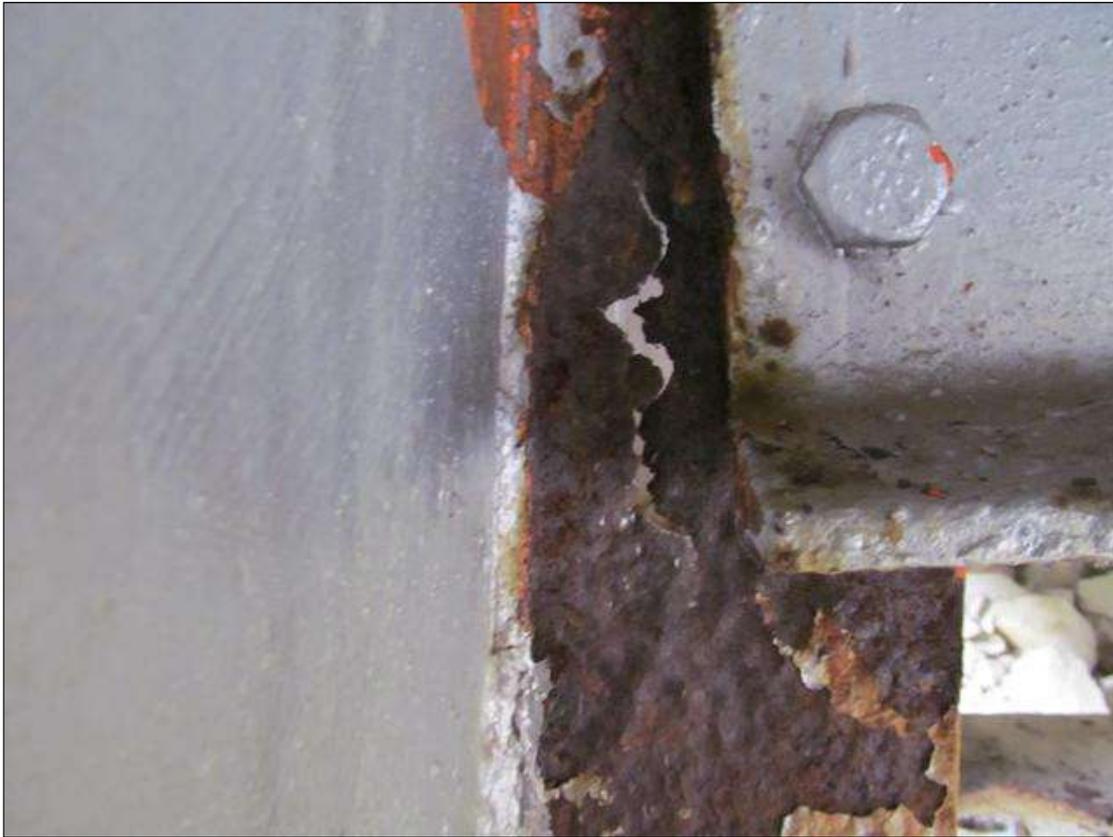
CONDITIONS FOUND IN WEB STIFFNER AT BEAM 6 BENT 1

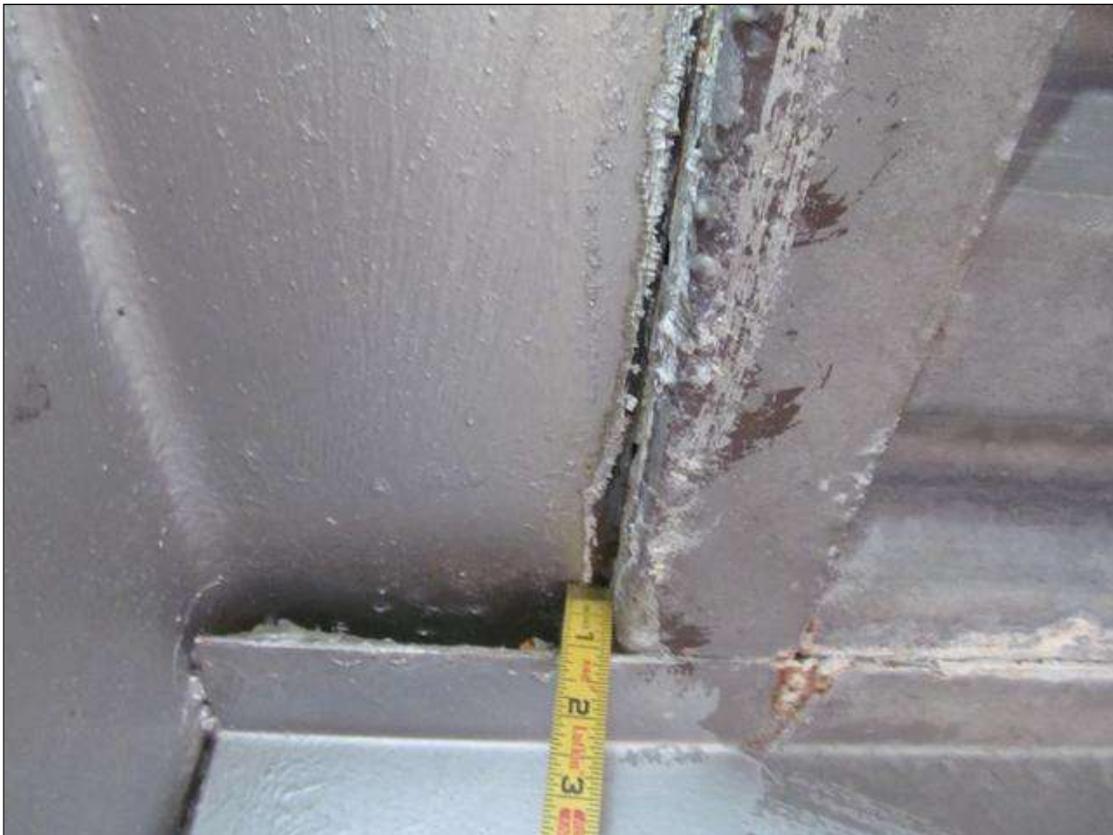
TOP OF BEAM 6 HAS MOVED TO THE SOUTH 1/2" +/-

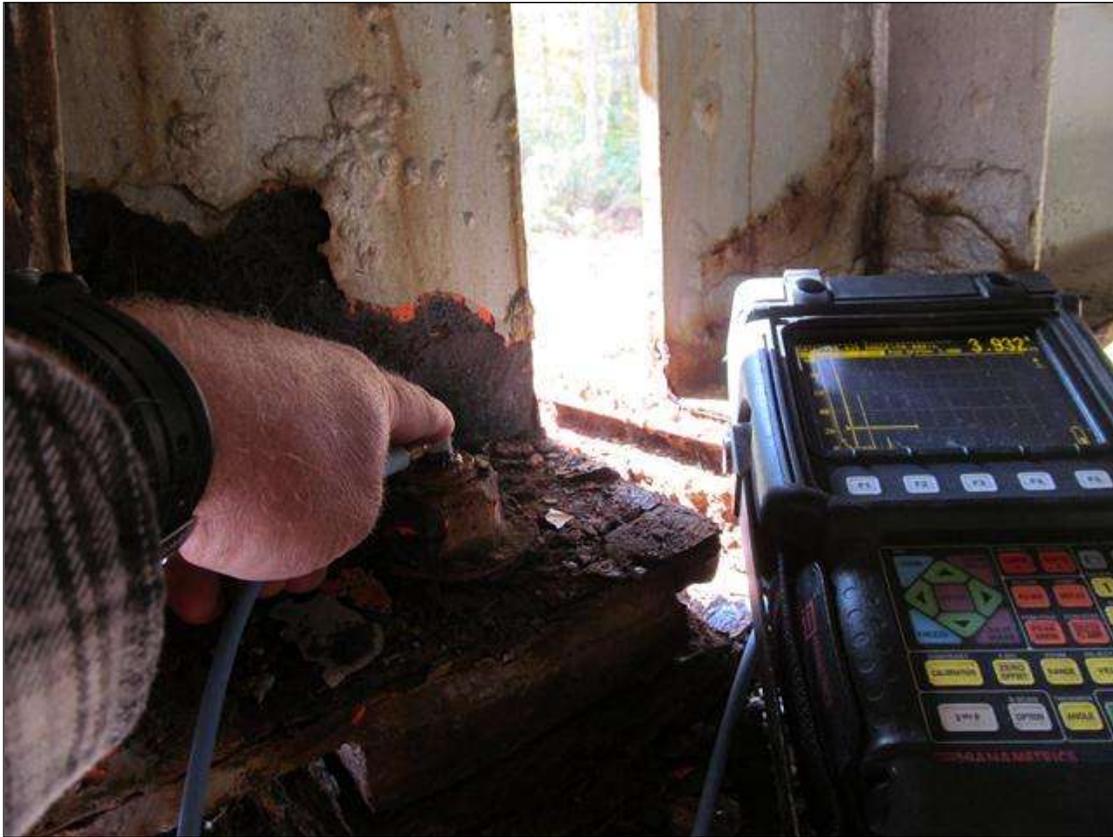
ANCHOR BOLT AT BENT 1 ON BEAM 6 IS BROKE AT 3.9"

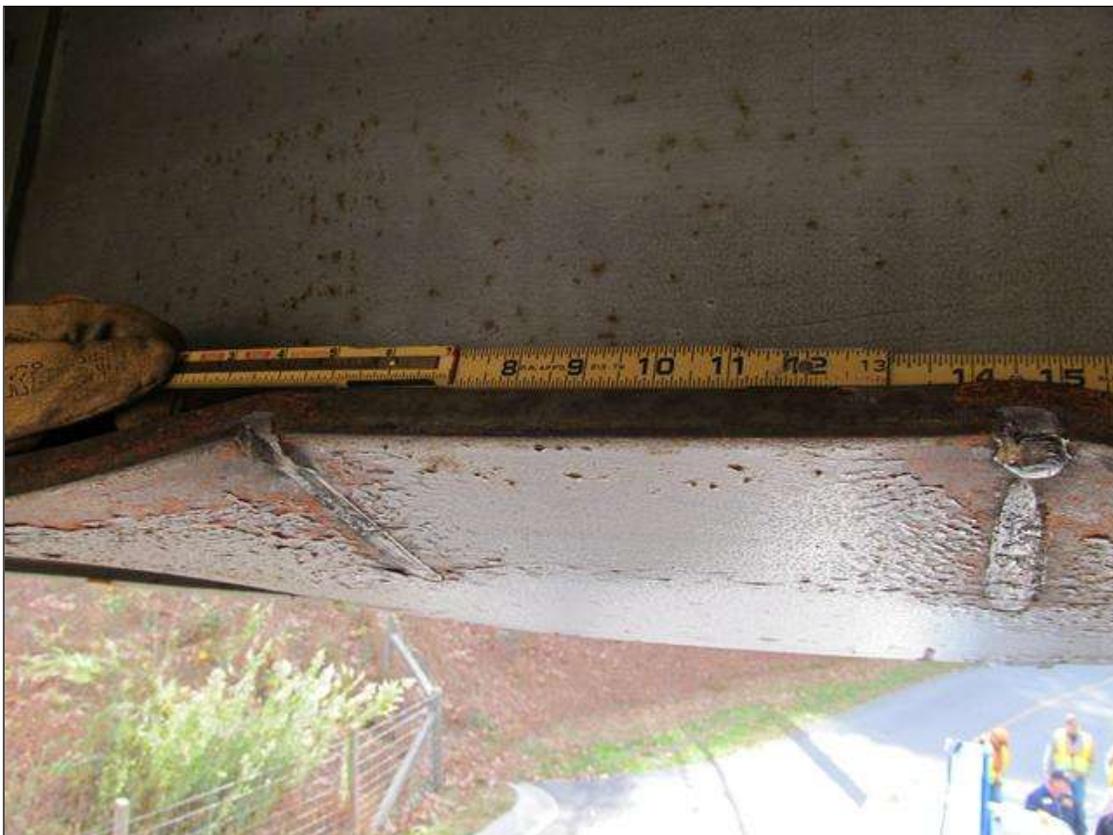
CODITIONS FOUND IN BEAM 5 AT 18'-11" FROM BENT 1

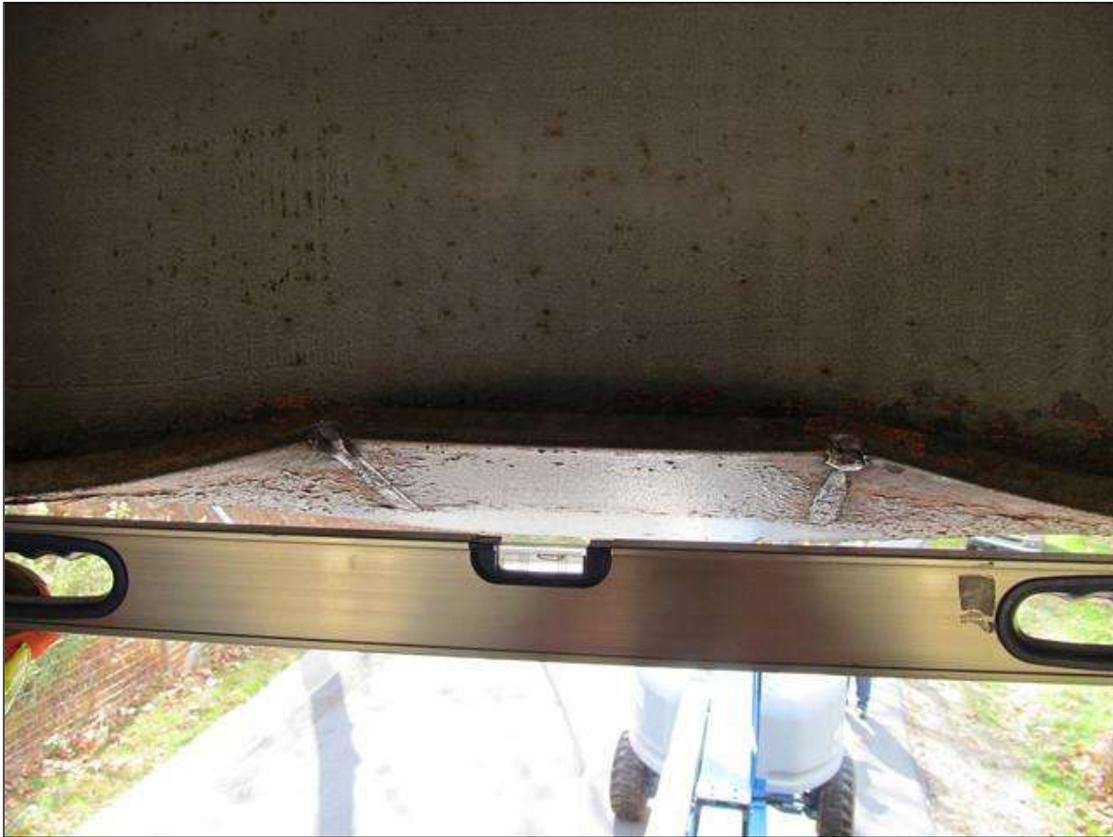
FLANGE IS BENT UPWARD 2" AT 18'-11" FROM BENT 1

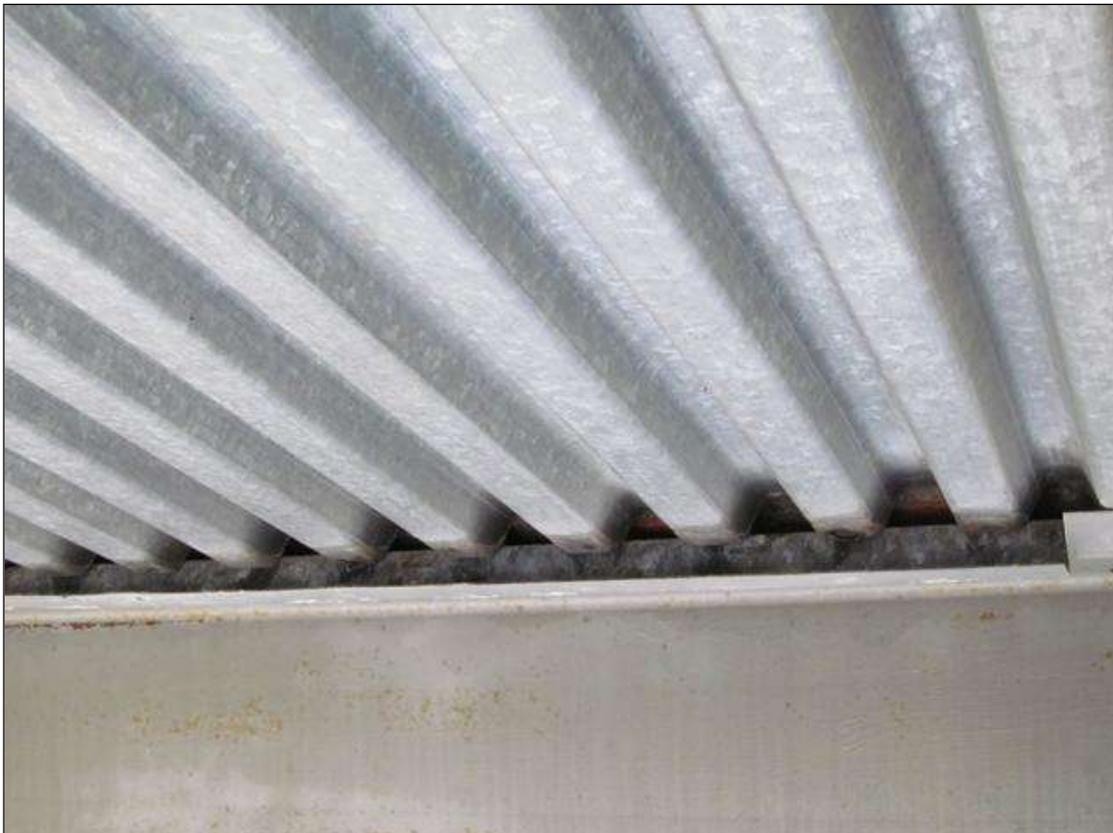
J CHANNEL HOLDING SIP FORMING INPLACE HAS BROKE LOOSE AND DROPE 2"+/-

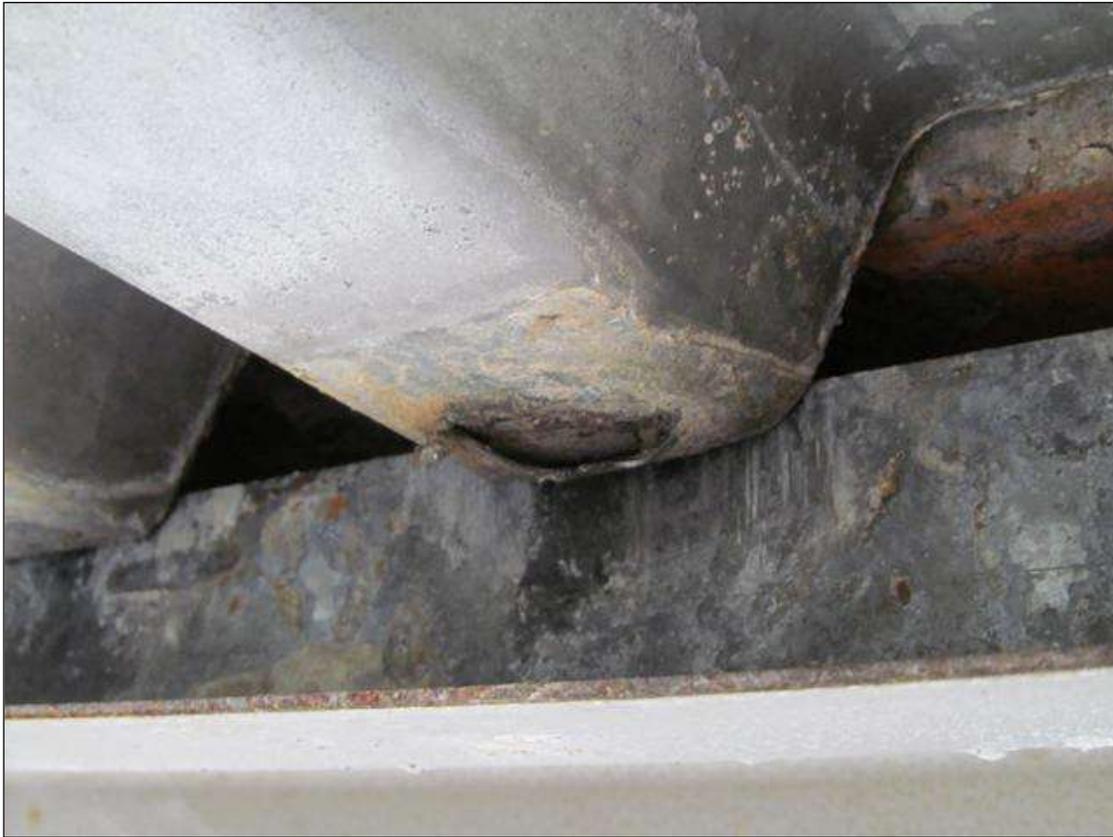
TAC WELD BROKE LOOSE ON J CHANNEL ON SIP FORMING

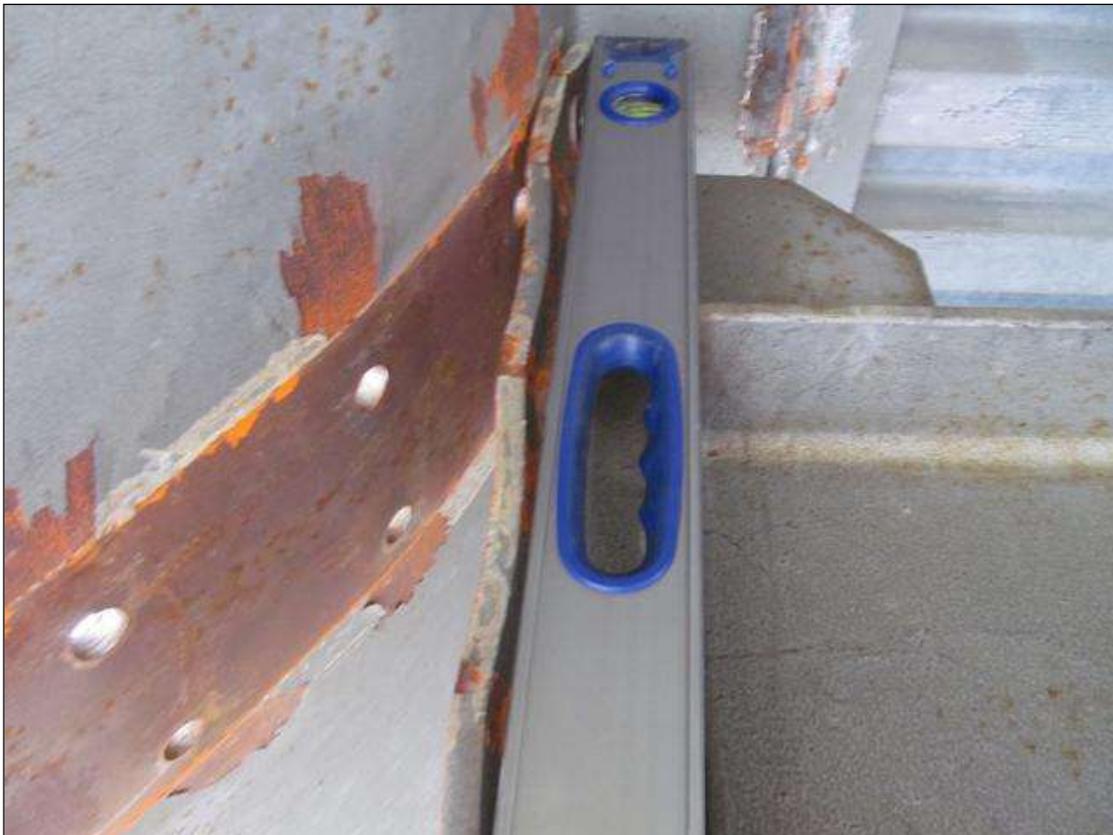
DIAPHRAGM BRACKET BENT OUT OF PLUMB AT BEAM 6

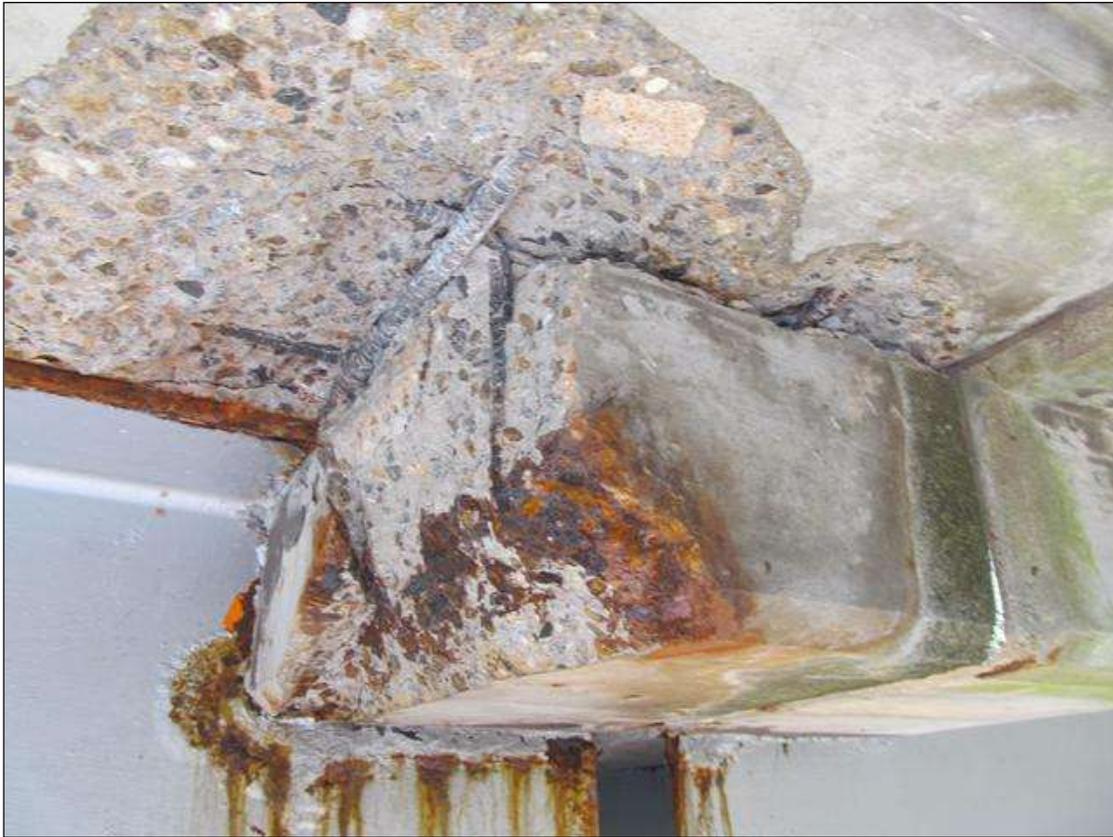
CONDITIONS FOUND IN CONCRETE DIAPHRAGM ON OUTSIDE OF BEAM AT 6 BENT 2

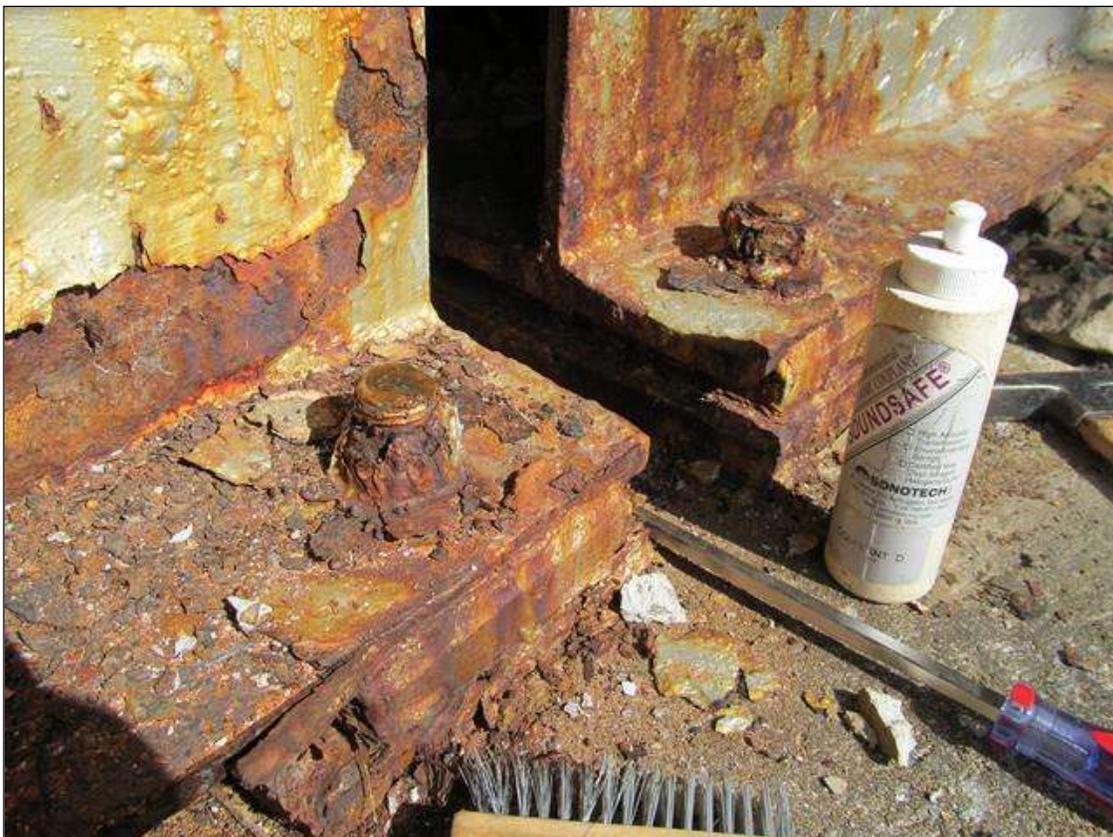
ANCHOR BOLT AT BENT 2 ON BEAM 6 IS BROKE AT 3.9'+/-
