NC DEPARTMENT OF TRANSPORTATION
 DIVISION OF HIGHWAYS
 BRIDGE MANAGEMENT UNIT

IMPACT DAMAGE REPORT ON SPAN 2
 RATINGS FOR SPAN 2 ITEMS ONLY
 PRIORITY MAINTENANCE REQUESTED

INSPECTION TYPE: Damage Inspection Report

COUNTY BUNCOMBE BRIDGE NUMBER 100369 INSPECTION CYCLE 0 YRS
 ROUTE I-40 EBL ACROSS BILTMORE ESTATE ROAD M.P. 49500

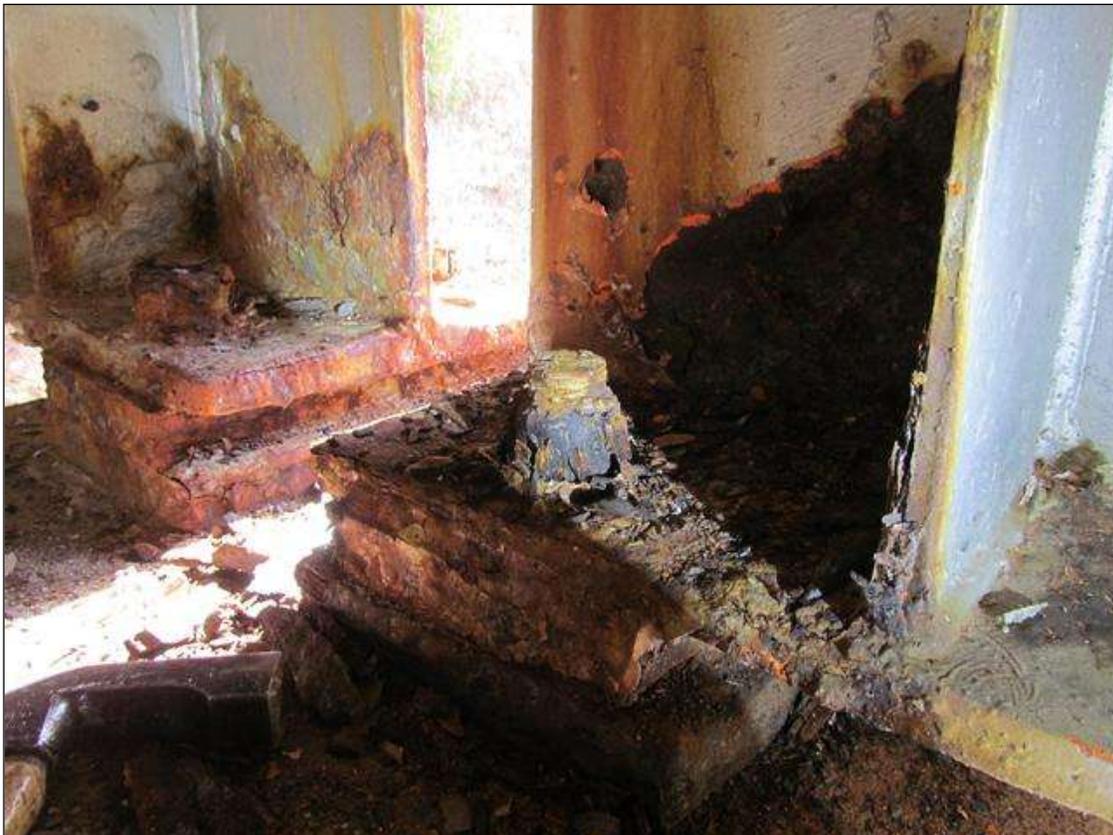
ANCHOR BOLT ON INSIDE OF BEAM 6 AT BENT 2 IS BROKE AT 3.9" +/-

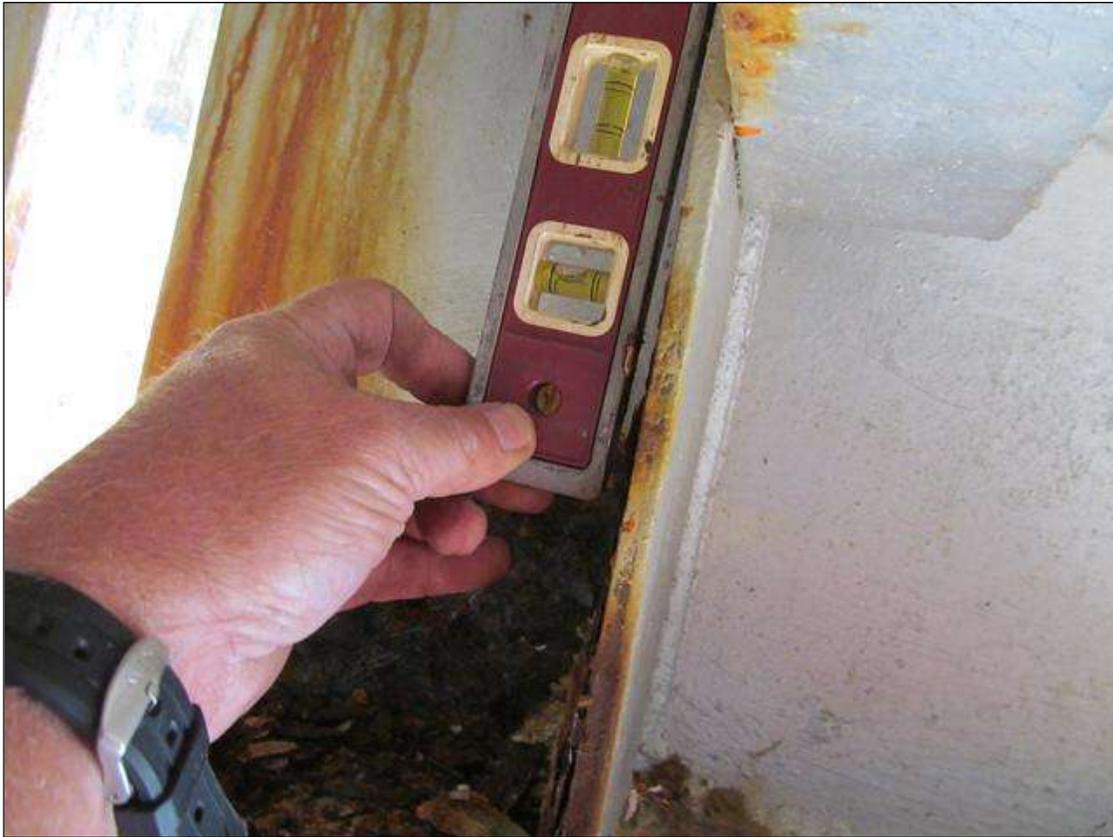
WEB STIFFNER ON BEAM 6 AT BENT 2 IS OUT OF PLUMB 1" +/-

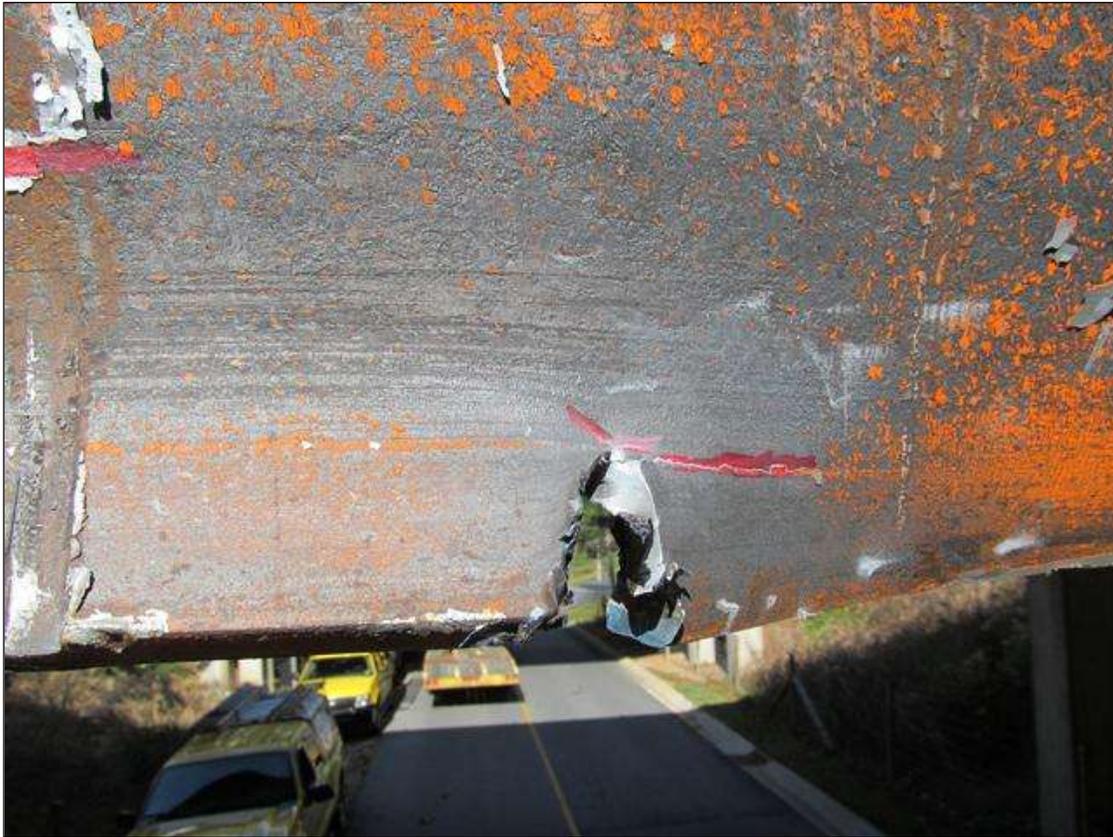
LOOKING AT CRACK AFTER MT TESTED
