STATE OF NORTH CAROLINA
DEPARTMENT OF TRANSPORTATION

ROY COOPER
GOVERNOR

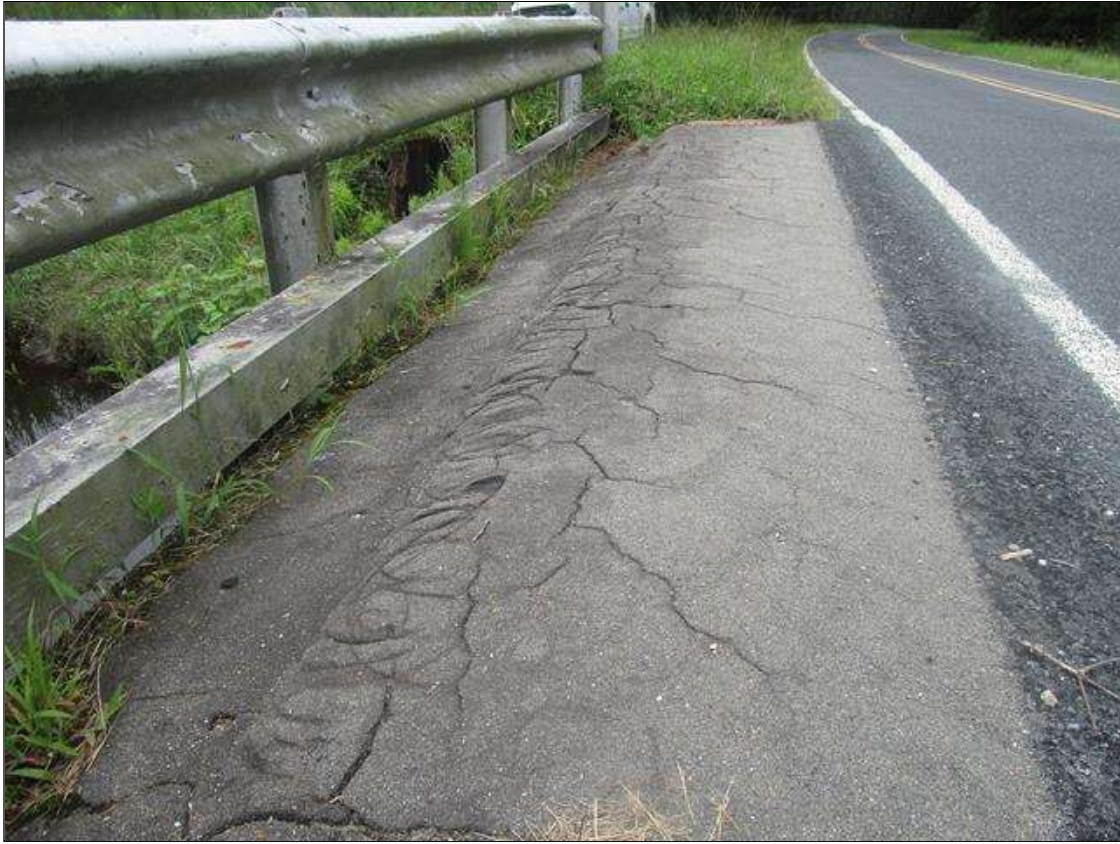
Span 1 Wearing Surface: FULL LENGTH X 4FT WIDE MAP CRACKING UP TO 1/4IN WIDE ALONG THE RIGHT SHOULDER

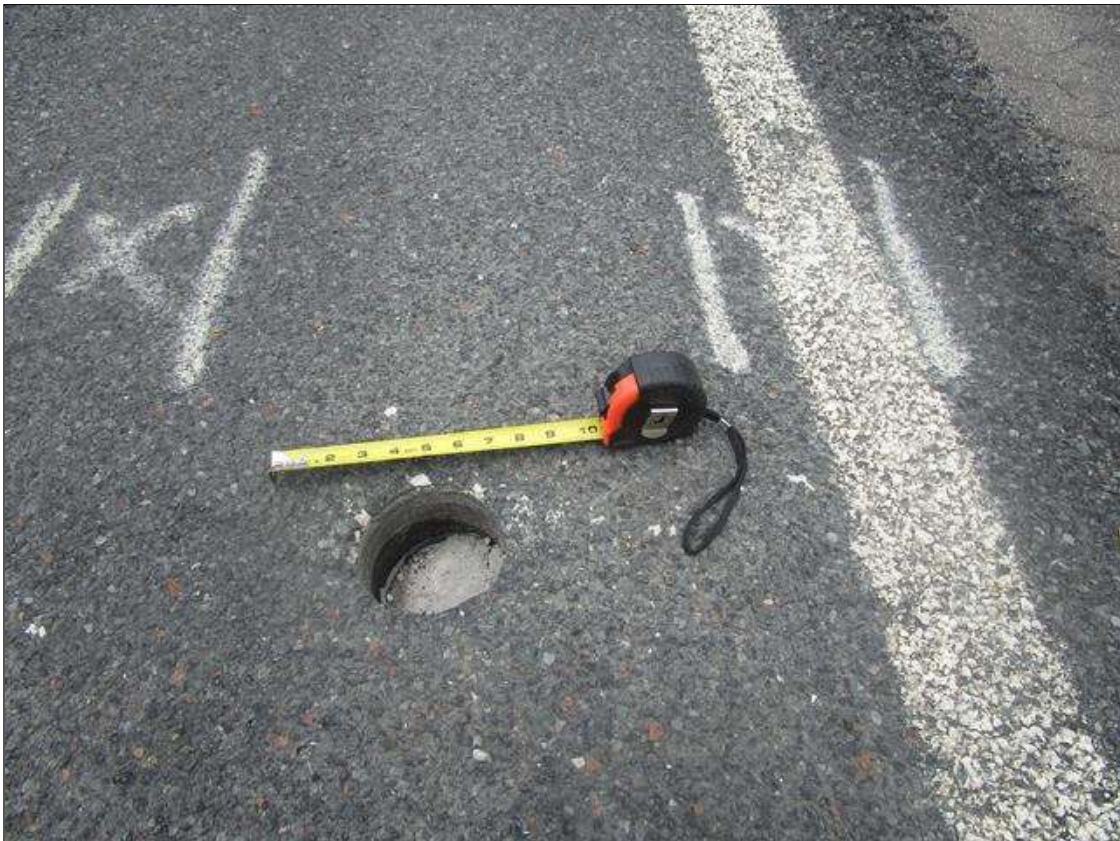
Span 2 Wearing Surface: 5FT FROM BENT 2 IN WESTBOUND LANE, 4IN DIAMETER X 4IN DEEP DIAMETER POTHOLE, PAR

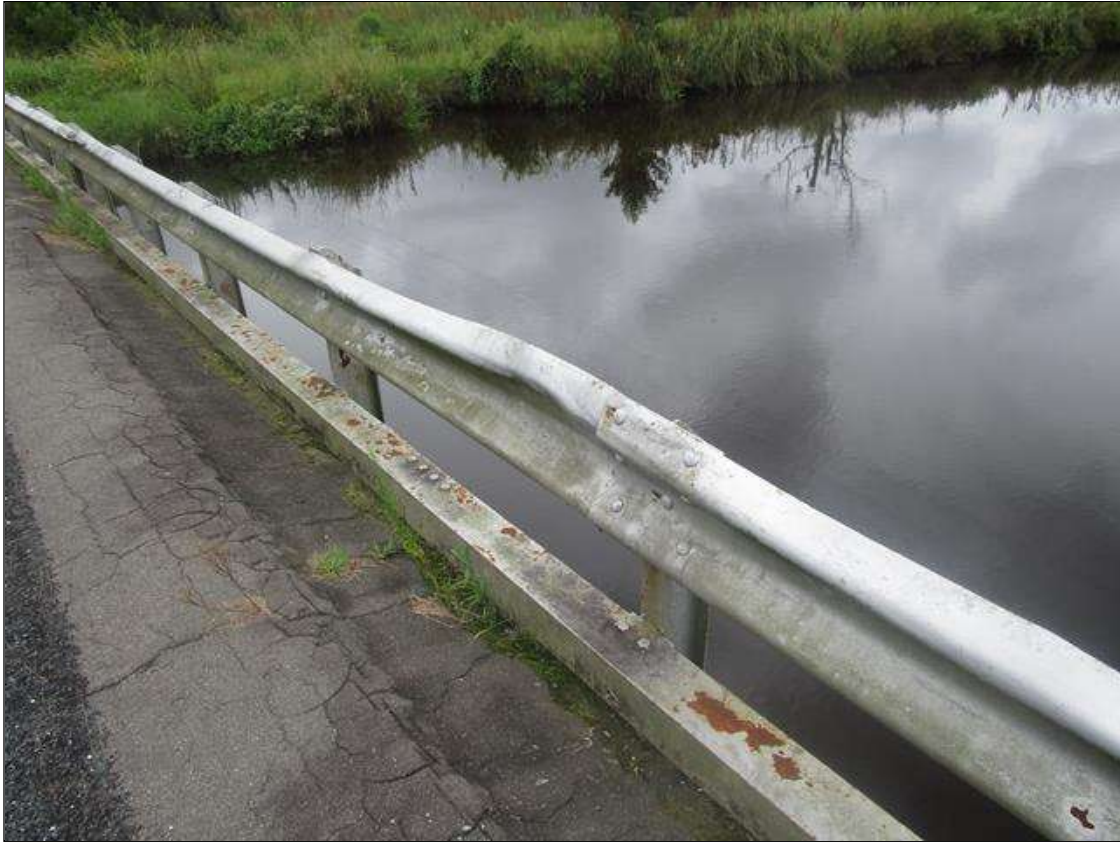
Span 2 Right Bridge Rail: AT BENT 2, 8FT LONG X 3IN DEEP IMPACT DAMAGE TO BRIDGE RAIL

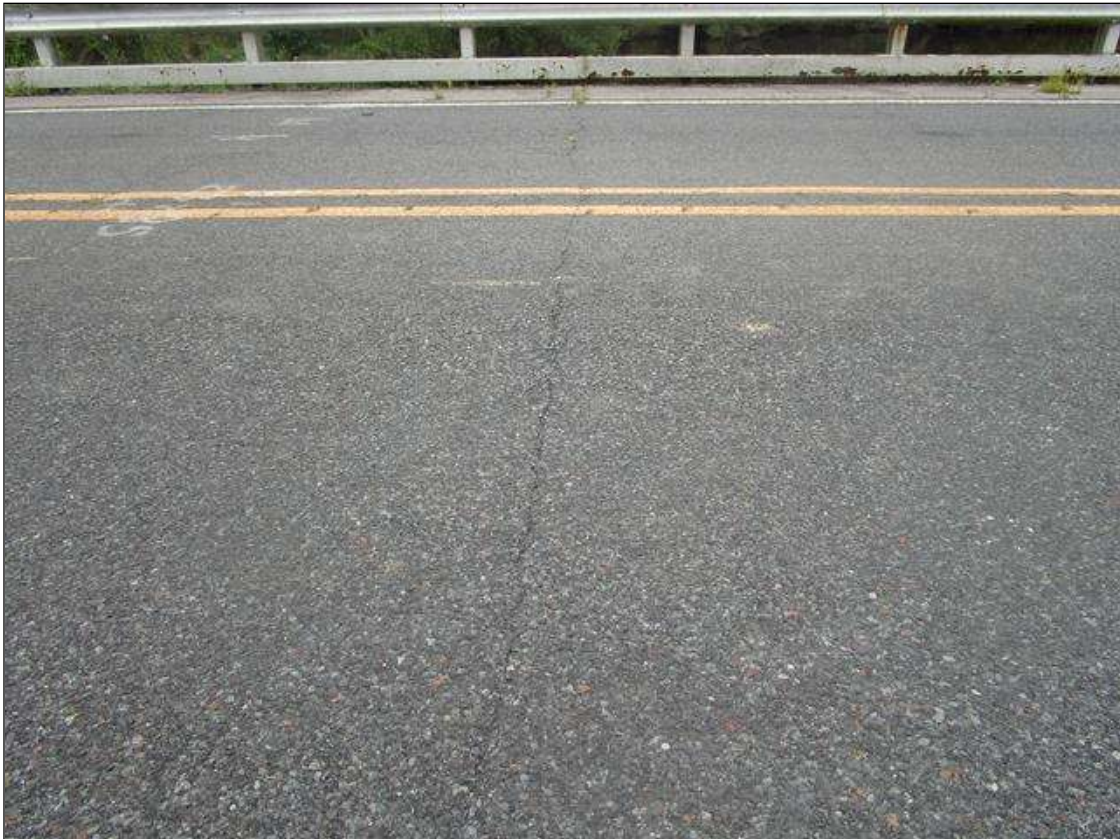
Span 3 Wearing Surface: ALONG BENT 2, FULL WIDTH X UP TO 1/16IN WIDE TRANSVERSE CRACK IN THE ASPHALT WEARING SURFACE

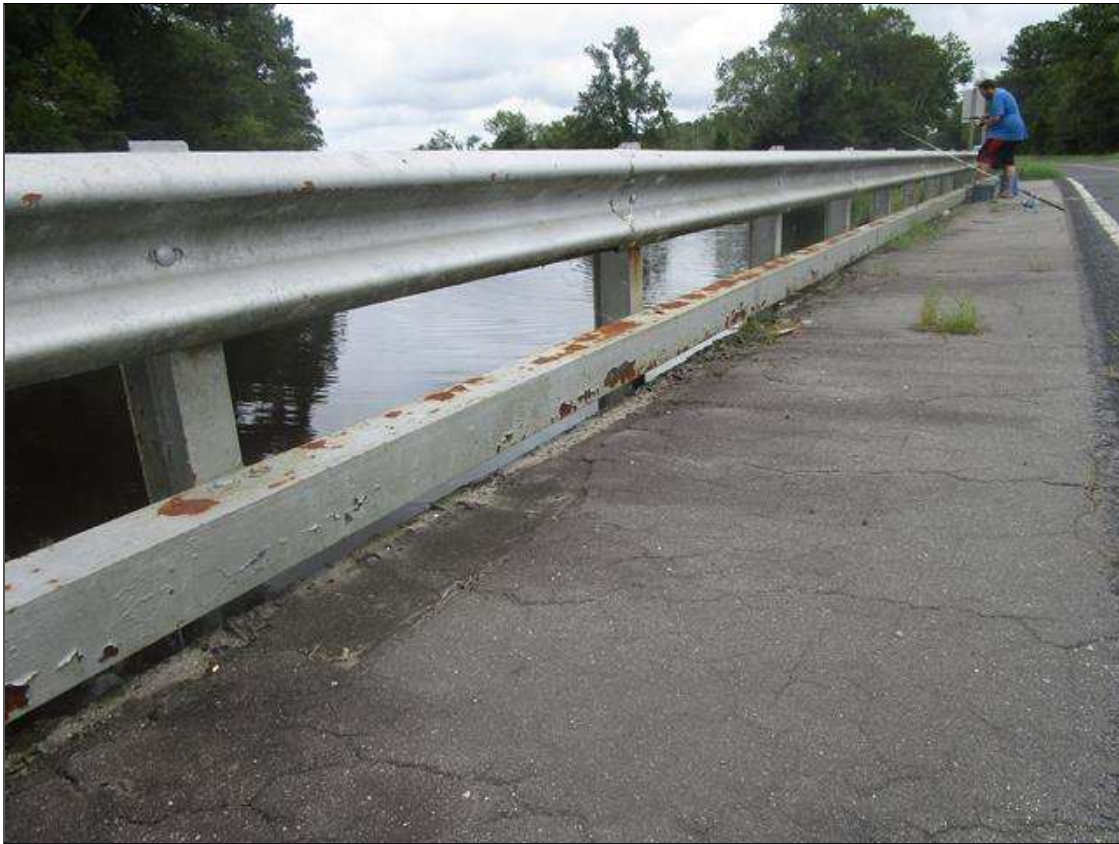
Span 3 Left Bridge Rail: INTERMITTENT FULL LENGTH X 4IN WIDE SURFACE RUST ON THE NORTH CURB

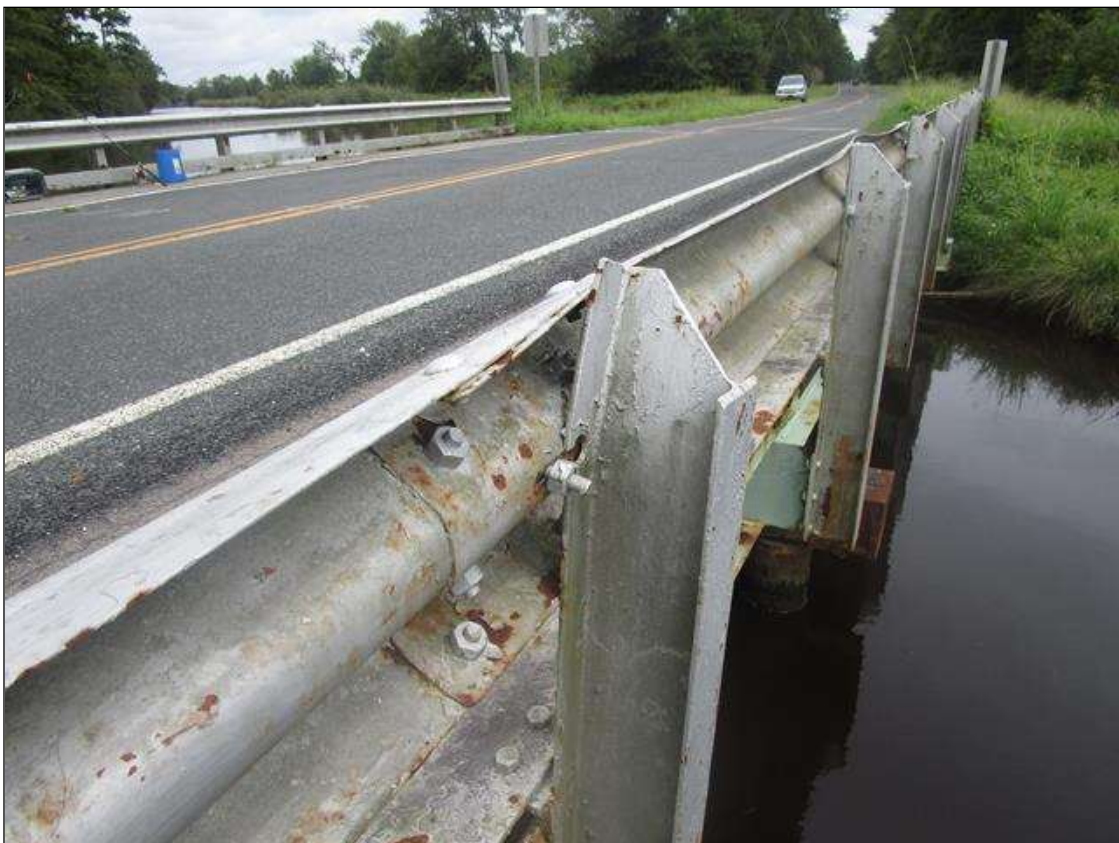
Span 4 Right Bridge Rail: BENT POST 2 WITH LOSS OF CONNECTION TO GUARD RAIL, PAR

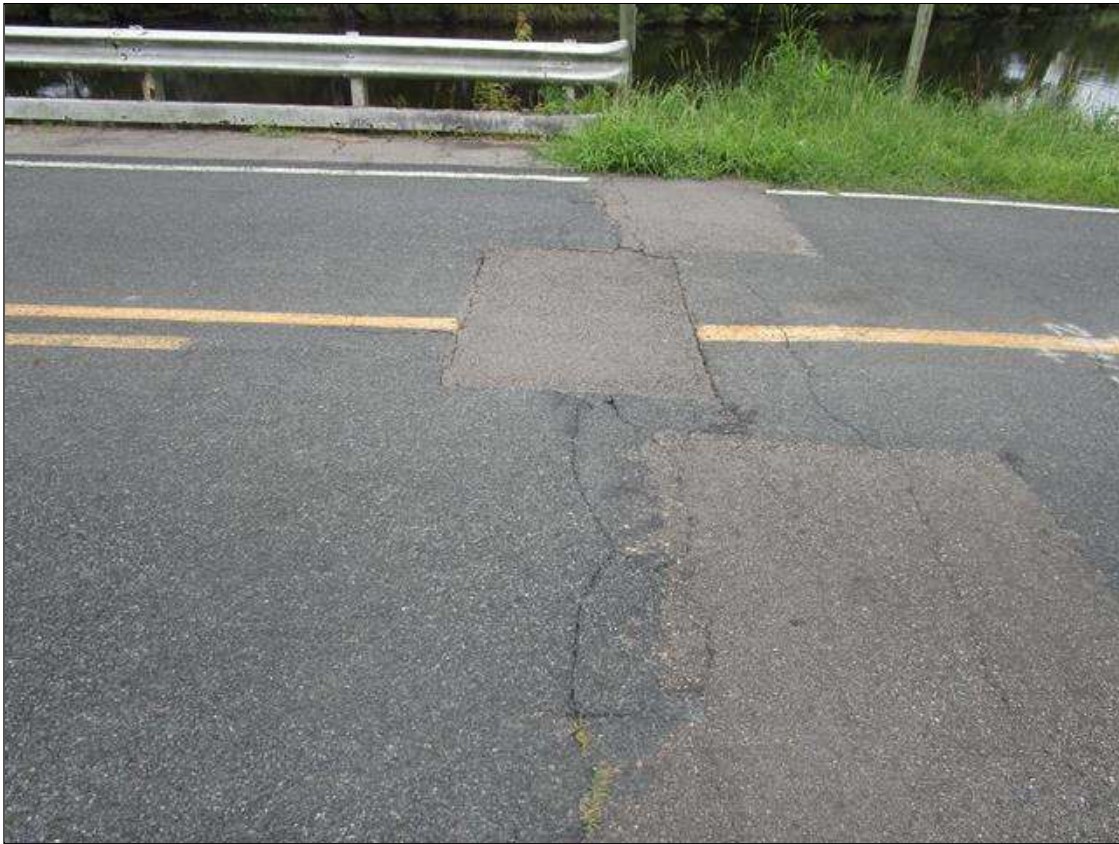
Span 6 Wearing Surface: 4' X 2' PATCHED AREA IN THE ASPHALT WEARING SURFACE AT THE CENTERLINE AT END BENT 2

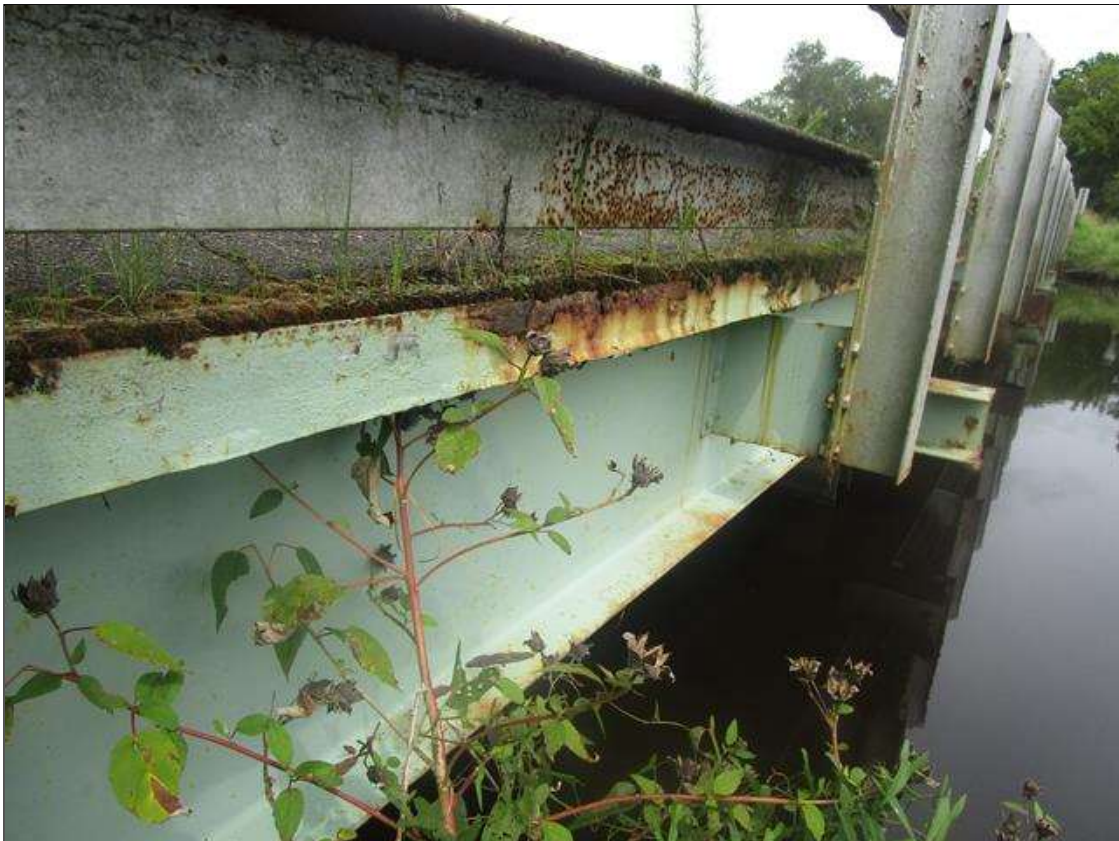
Span 1 Deck: NORTH AND SOUTH DECK FASCIA ANGLES, FULL LENGTH X FULL WIDTH X FULL HEIGHT AREA OF DELAMINATED STEEL ONSET OF SECTION LOSS

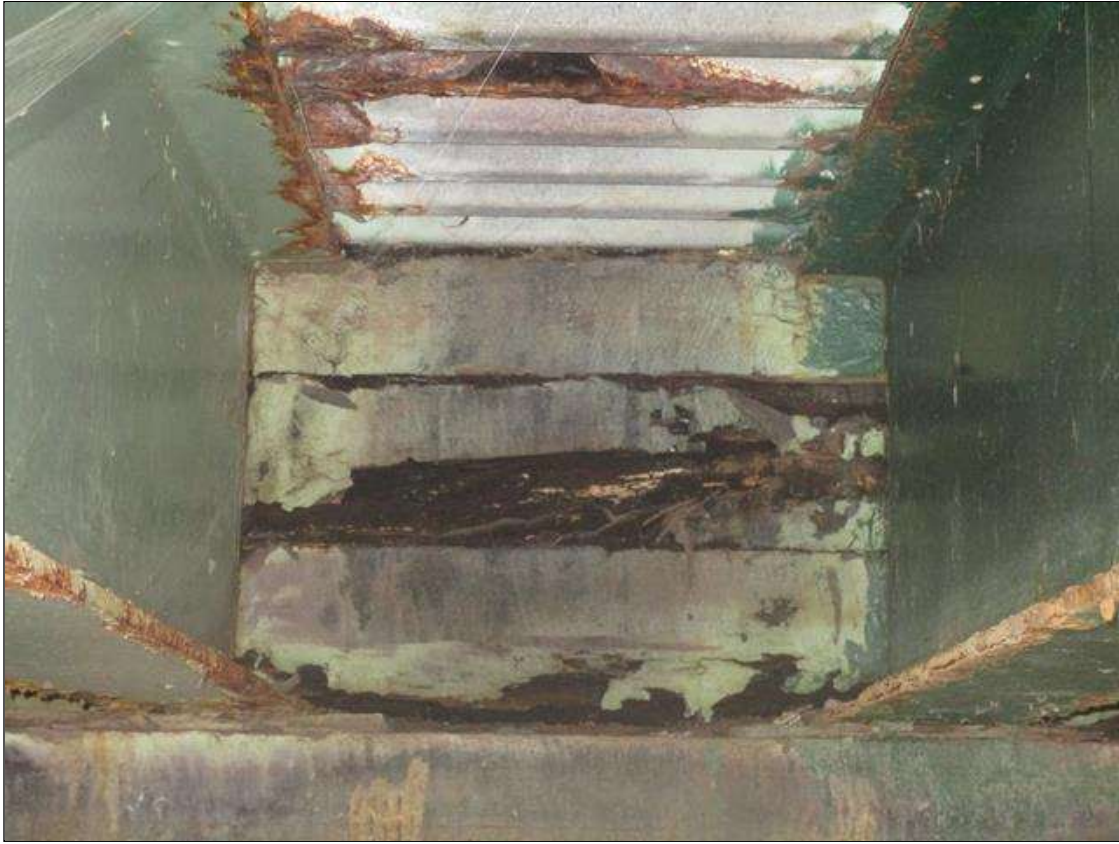
End Bent 1 Abutment: 5'-0" LONG X 8" HIGH X 1" DEEP AREA OF DECAY IN THE BULKHEAD IN BAYS 1 TO 3.
(BAY 2 SHOWN)

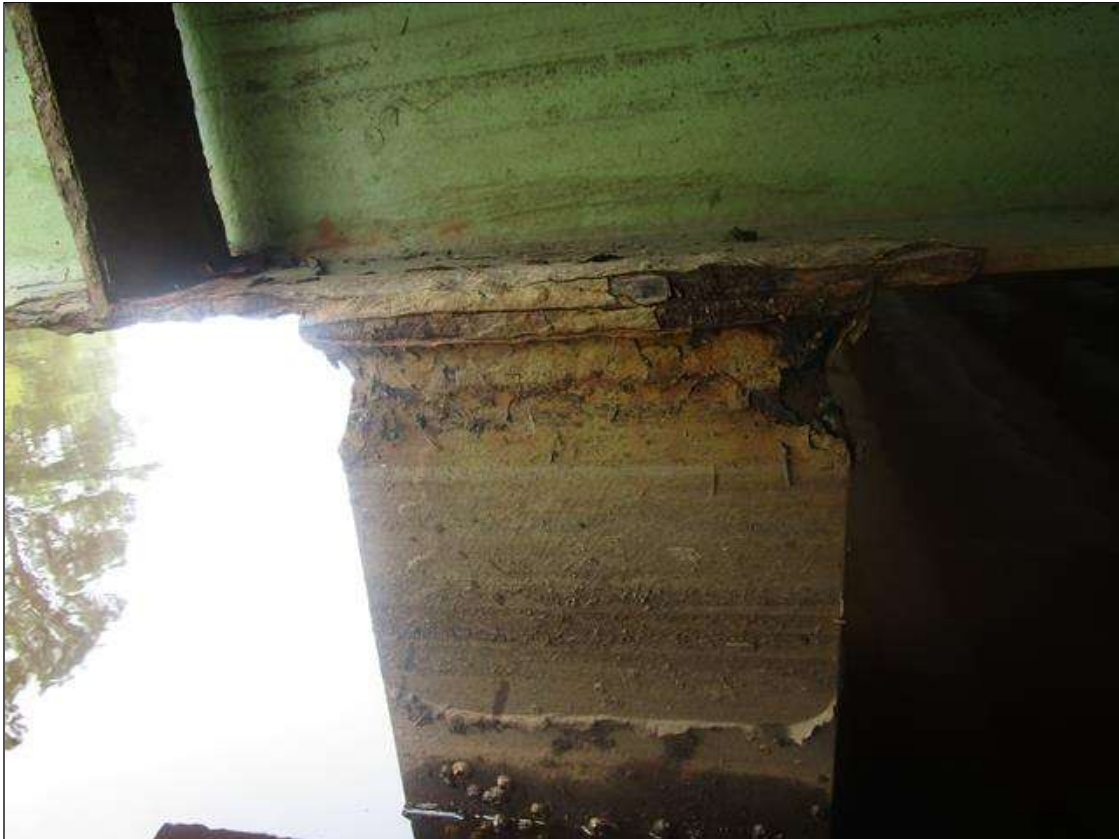
Bent 1 Pile 1: 2IN LONG X 1IN WIDE X 100% SECTION LOSS OF BOTH EDGES AT BOTH FLANGES AT TOP OF PILE. 1/8IN SECTION LOSS IN TOP PLATE, PAR

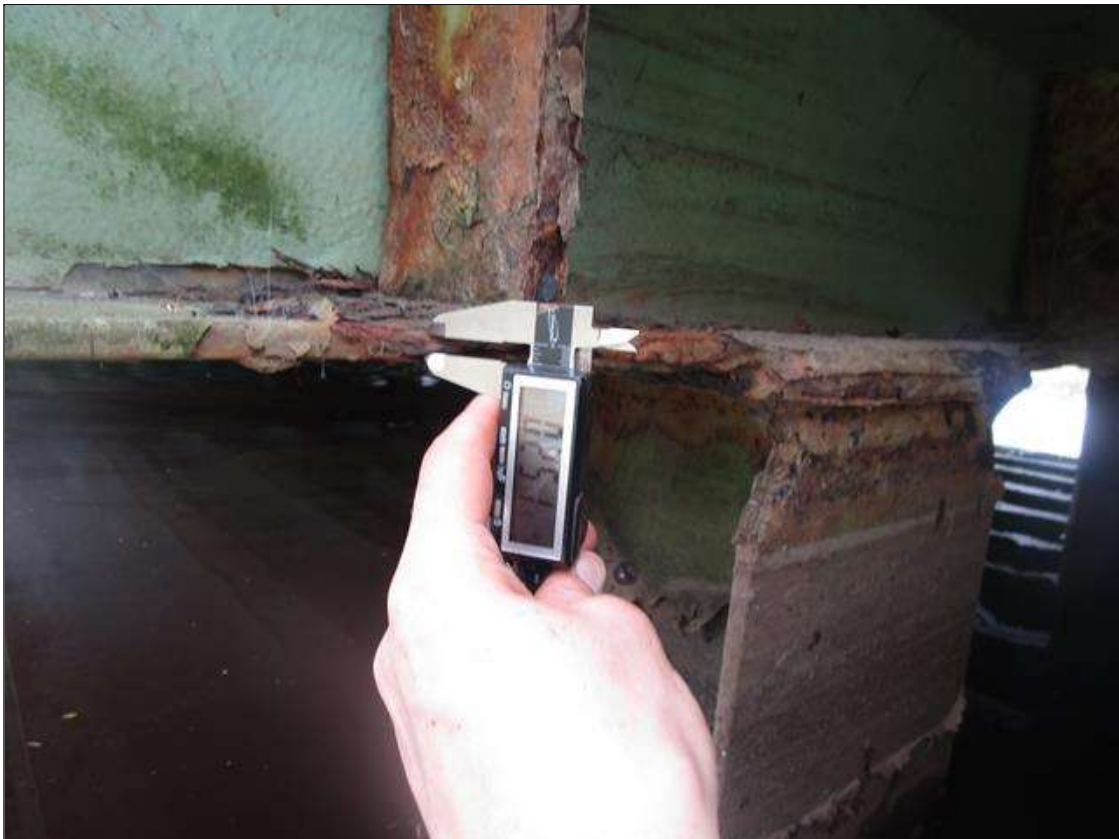
Bent 1 Cap 1: 3FT OF CORROSION IN BOTTOM FLANGE AT BEAM 1, BEAM 2 AND PILE 1. 0.251IN REMAINING, PAR

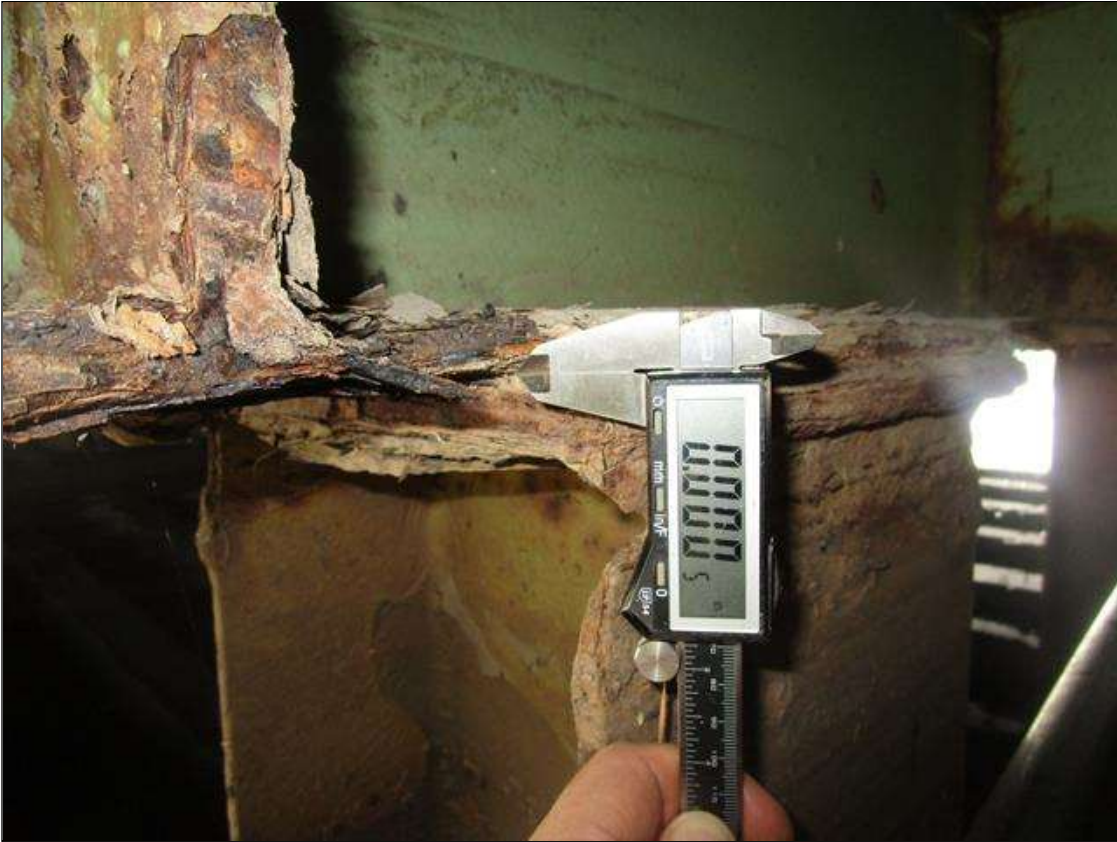
Bent 1 Cap 1: 3FT OF CORROSION IN BOTTOM FLANGE AT BEAM 3 AND PILE 2, 1IN WIDE X 1FT LONG X 100% SECTION LOSS IN EDGE OF BOTTOM FLANGE, PAR

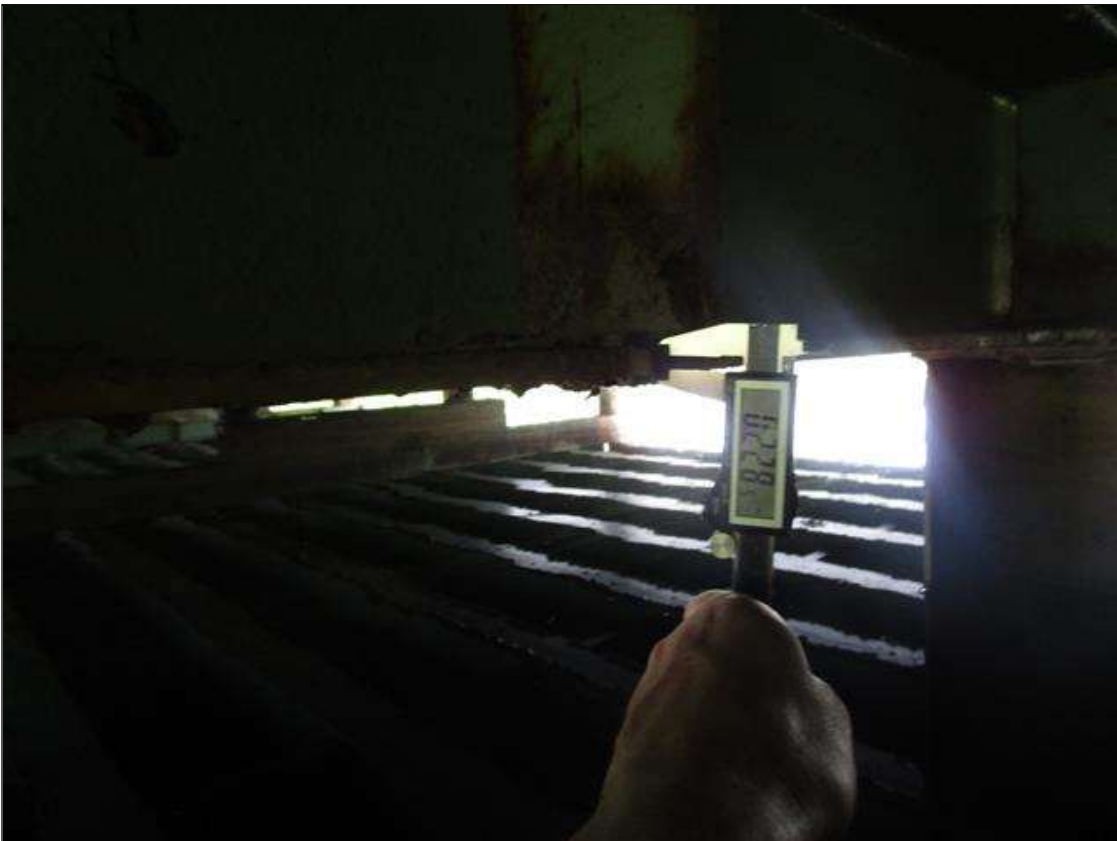
Bent 1 Cap 1: 1FT OF CORROSION IN BOTTOM FLANGE AT BEAM 4, 1IN WIDE X 1FT LONG AREA OF SECTION LOSS DOWN TO 0.228IN REMAINING IN BOTTOM FLANGE, PAR

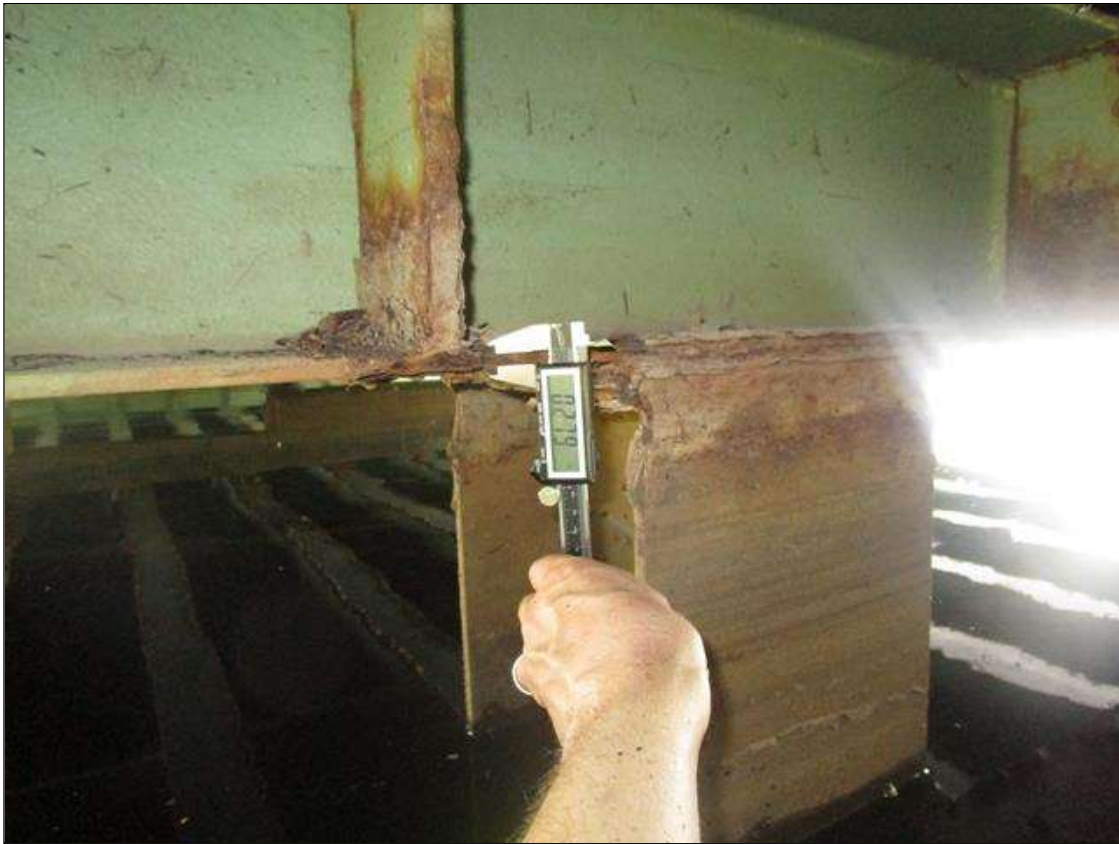
Bent 1 Cap 1: AT BEAM 5, AT PILE 3, 0.279IN REMAINING IN BOTTOM FLANGE, PAR

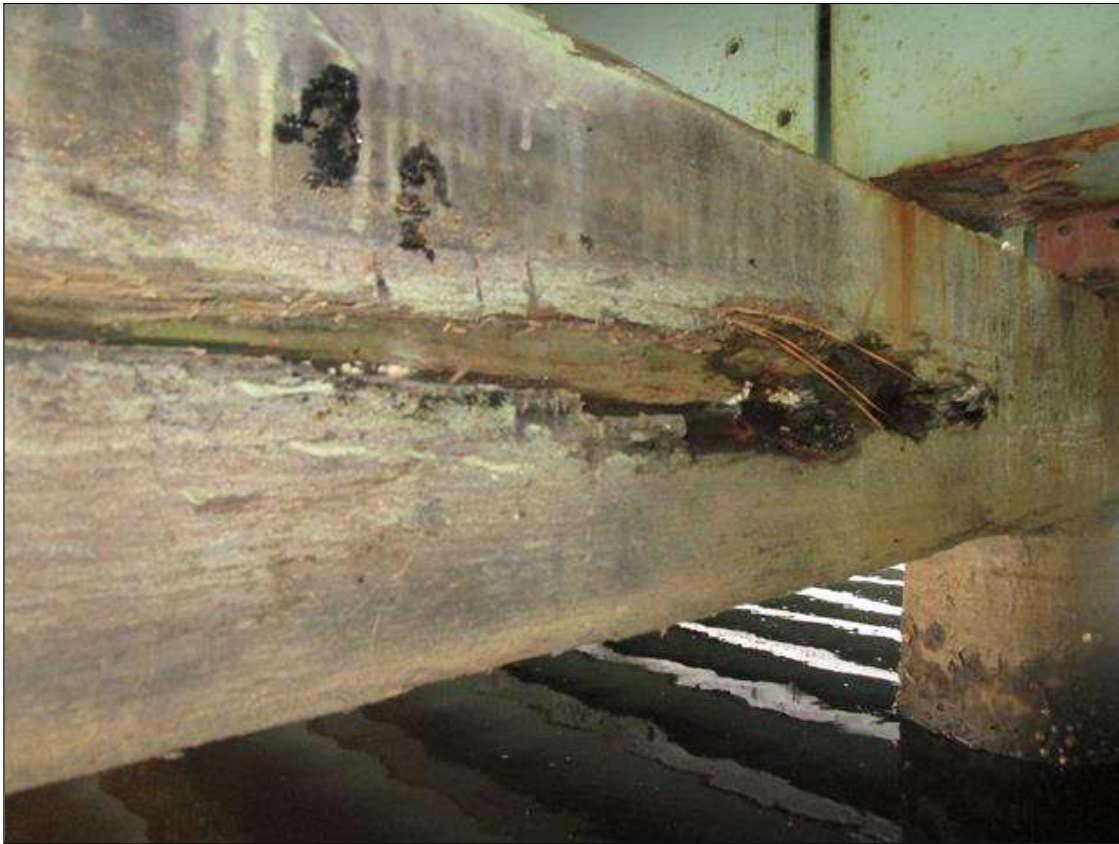
Bent 2 Cap 2: WEST FACE OF CAP BELOW BAYS 1 AND 2, 3FT LONG X 6IN HIGH X 2IN DEEP DECAYED AREA, PAR

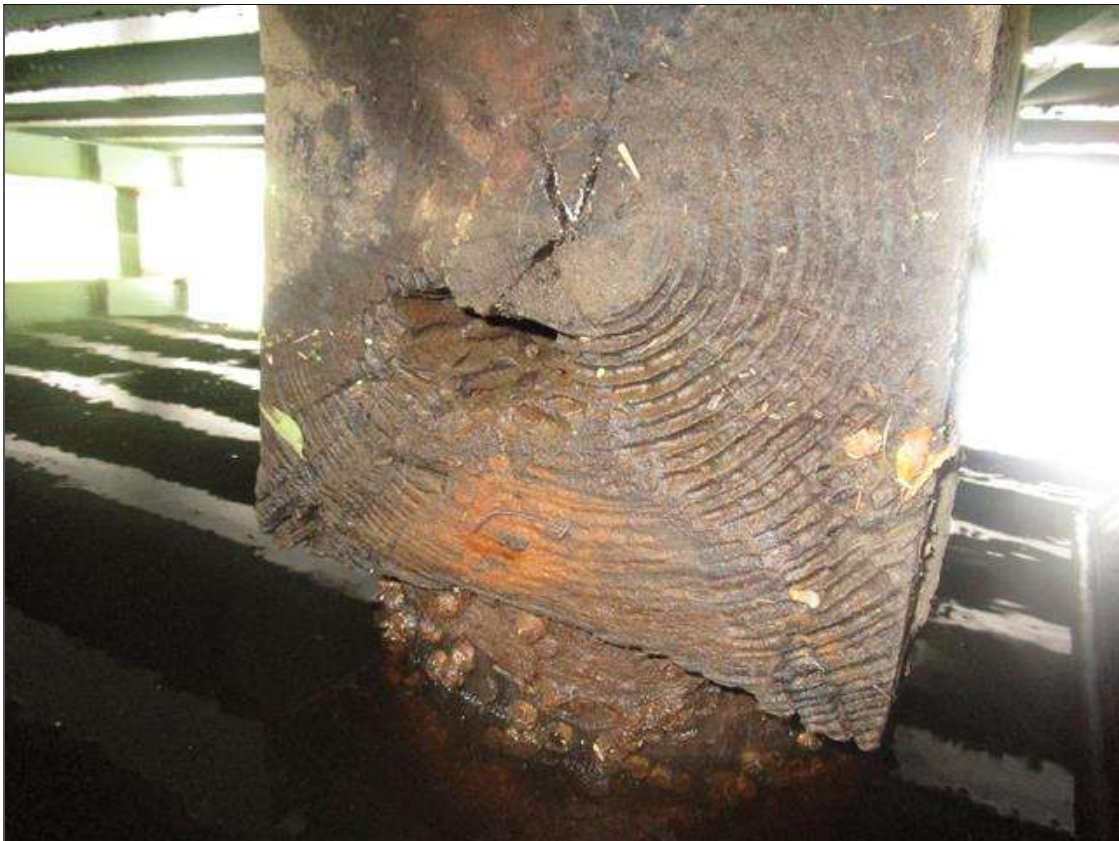
Bent 2 Cap 2: NORTH END OF THE SUB CAP AT PILE 3 WATERLINE, 3IN DIAMETER X 4IN DEEP DECAYED AREA, PAR

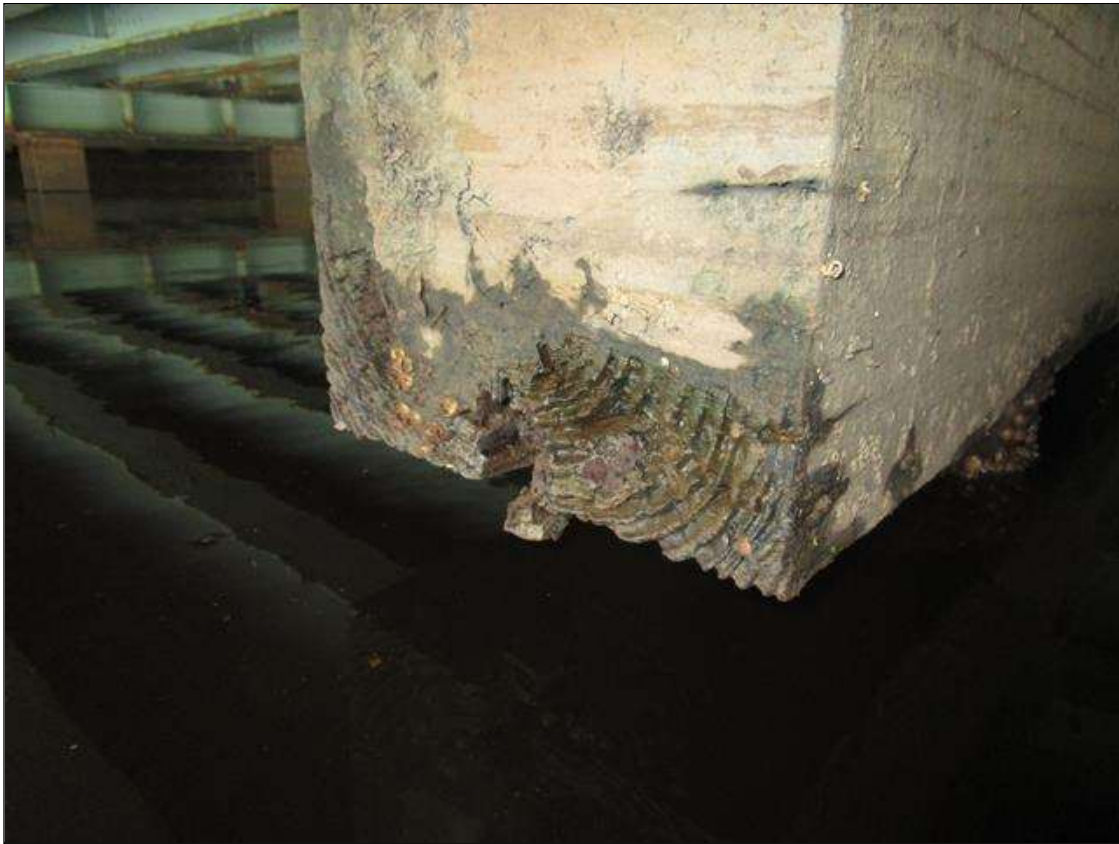
Bent 2 Cap 2: SUBCAP AT PILE 4, 3IN X 3IN X 3IN DEEP DECAY, PAR

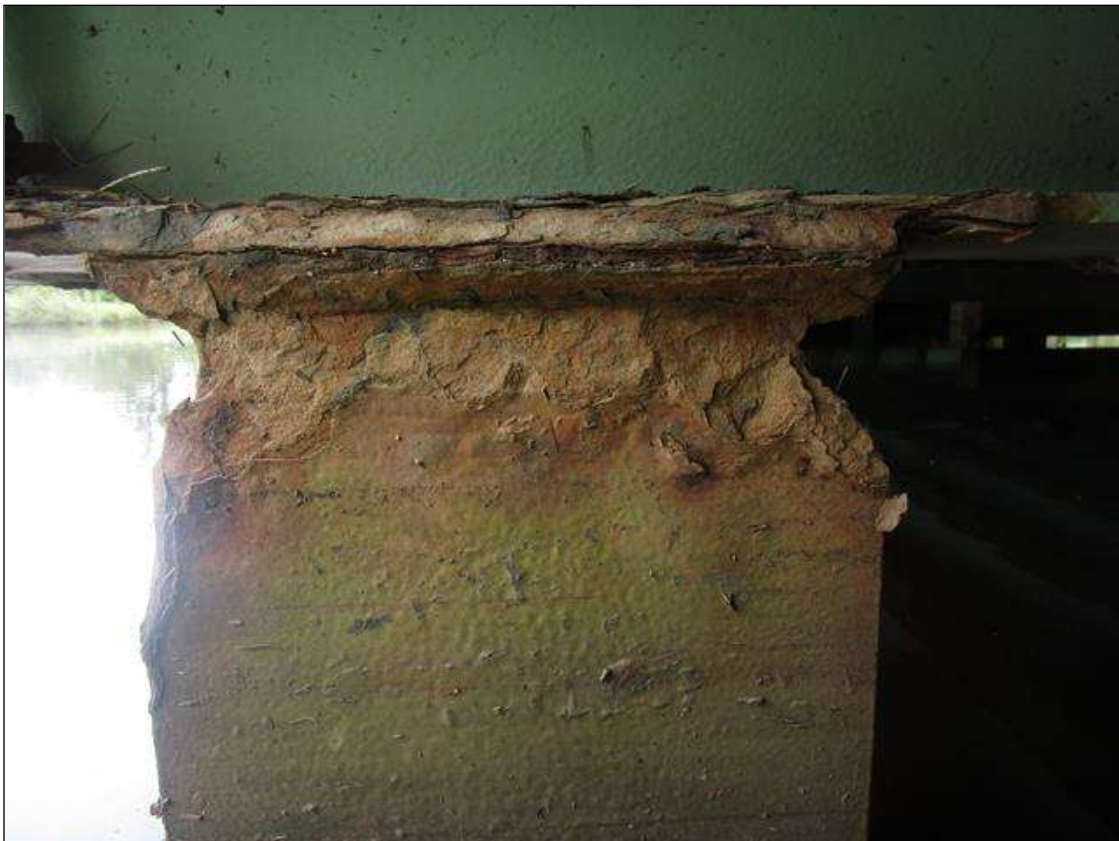
Bent 3 Pile 1: 2IN LONG X 1IN WIDE X 100% SECTION LOSS OF BOTH EDGES AT BOTH FLANGES AT TOP OF PILE. 1/8IN SECTION LOSS IN TOP PLATE, PAR

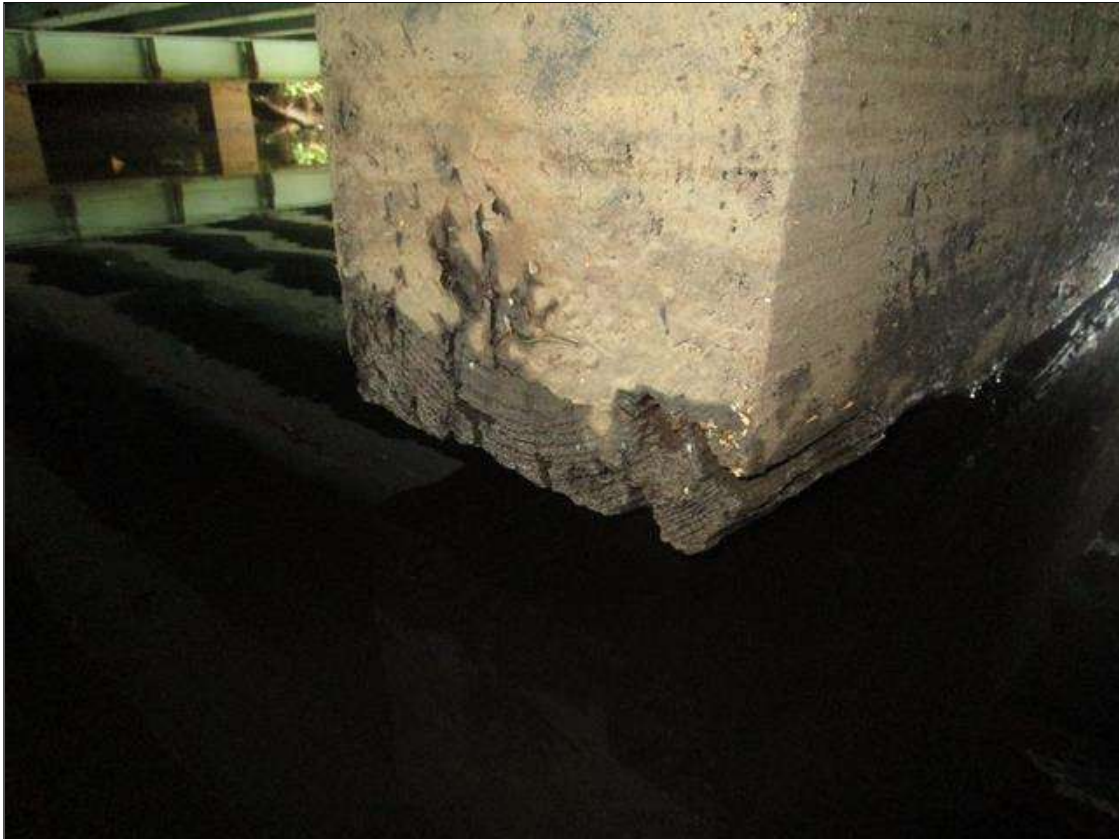
Bent 4 Cap 2: NORTH END OF SUBCAP AT PILE 3, 3IN HIGH X 12IN WIDE X 12IN DEEP DECAY, PAR

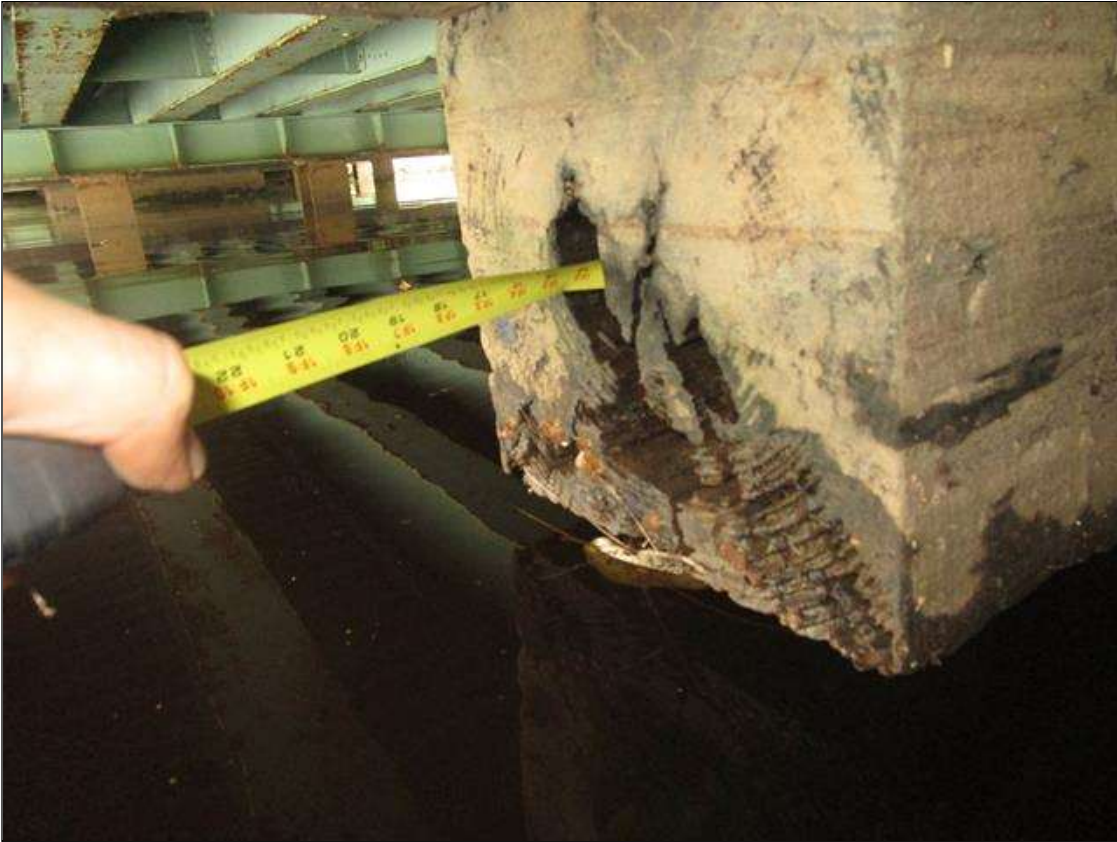
Bent 4 Cap 2: SOUTH END OF THE SUB CAP, 10IN HIGH X 12IN WIDE X 14IN DEEP DECAY IN PILE 4, PAR

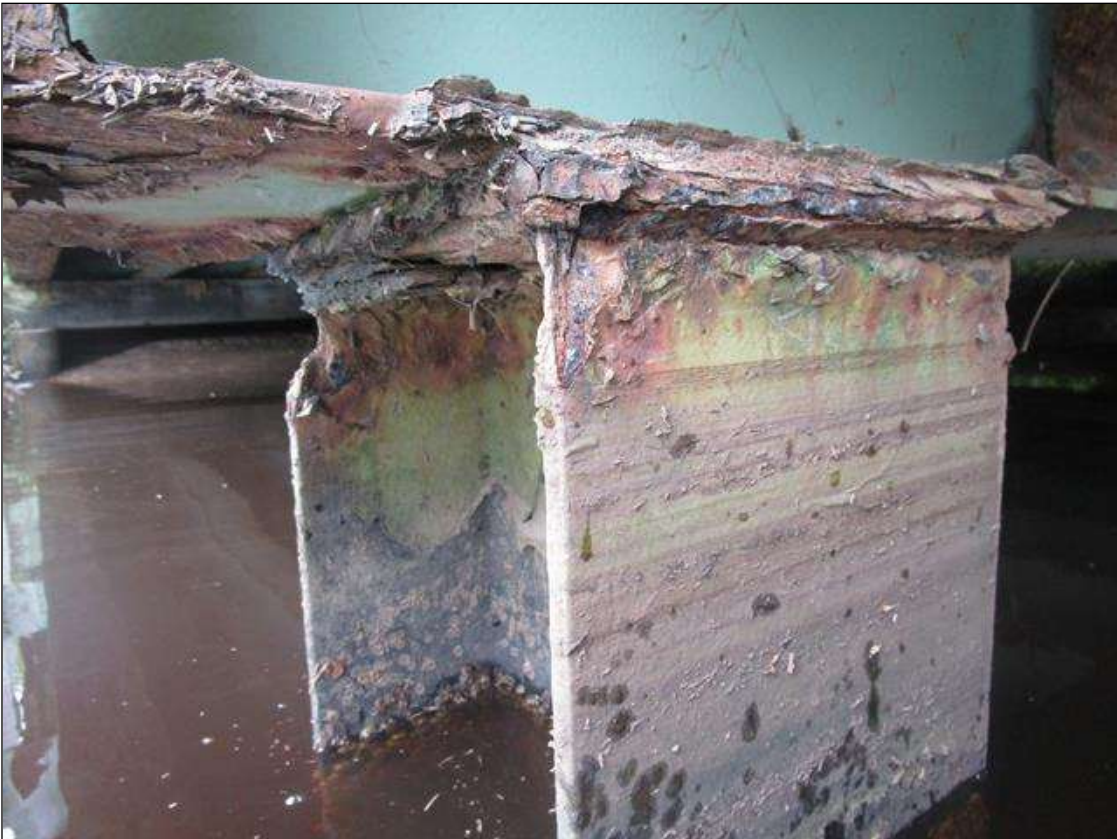
Bent 5 Pile 1: 2IN LONG X 1IN WIDE X 100% SECTION LOSS OF BOTH EDGES AT BOTH FLANGES AT TOP OF PILE. 1/8IN SECTION LOSS IN TOP PLATE, PAR

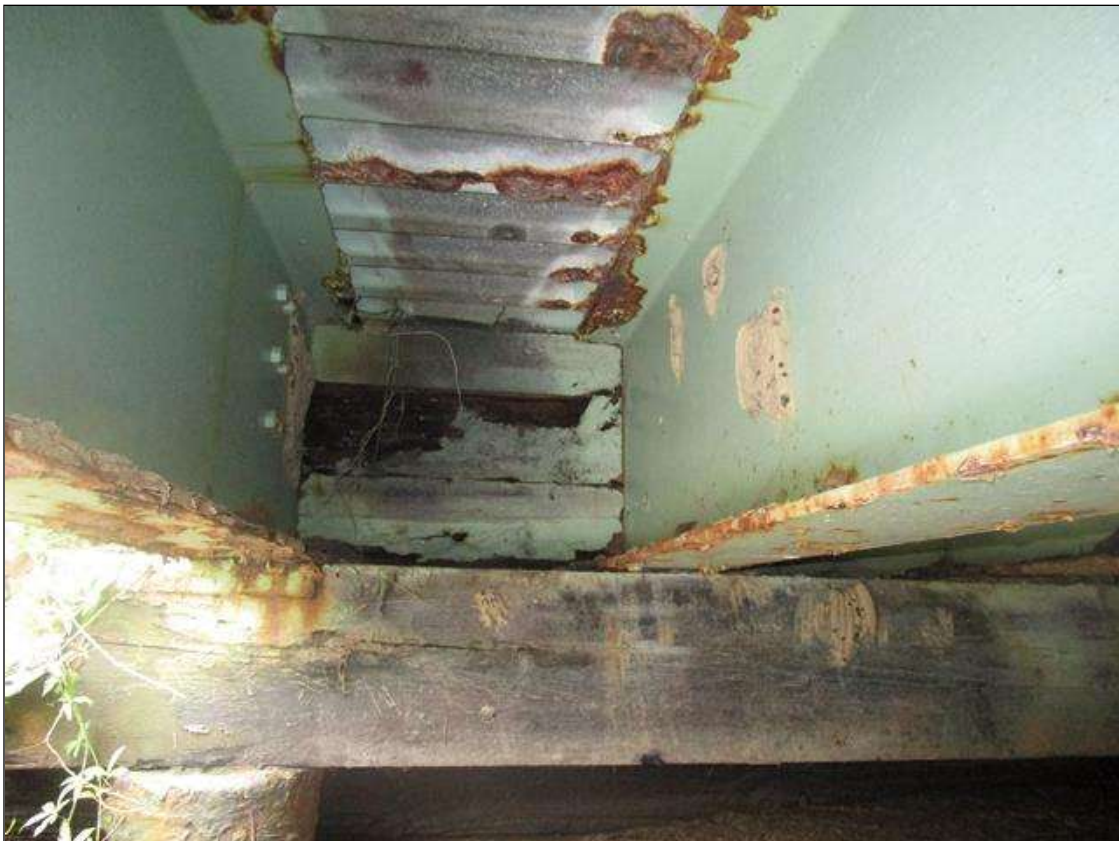
End Bent 2 Abutment: BULKHEAD IN BAY 1, 2'-0" LONG X 8" HIGH X 1" DEEP AREA OF DECAY

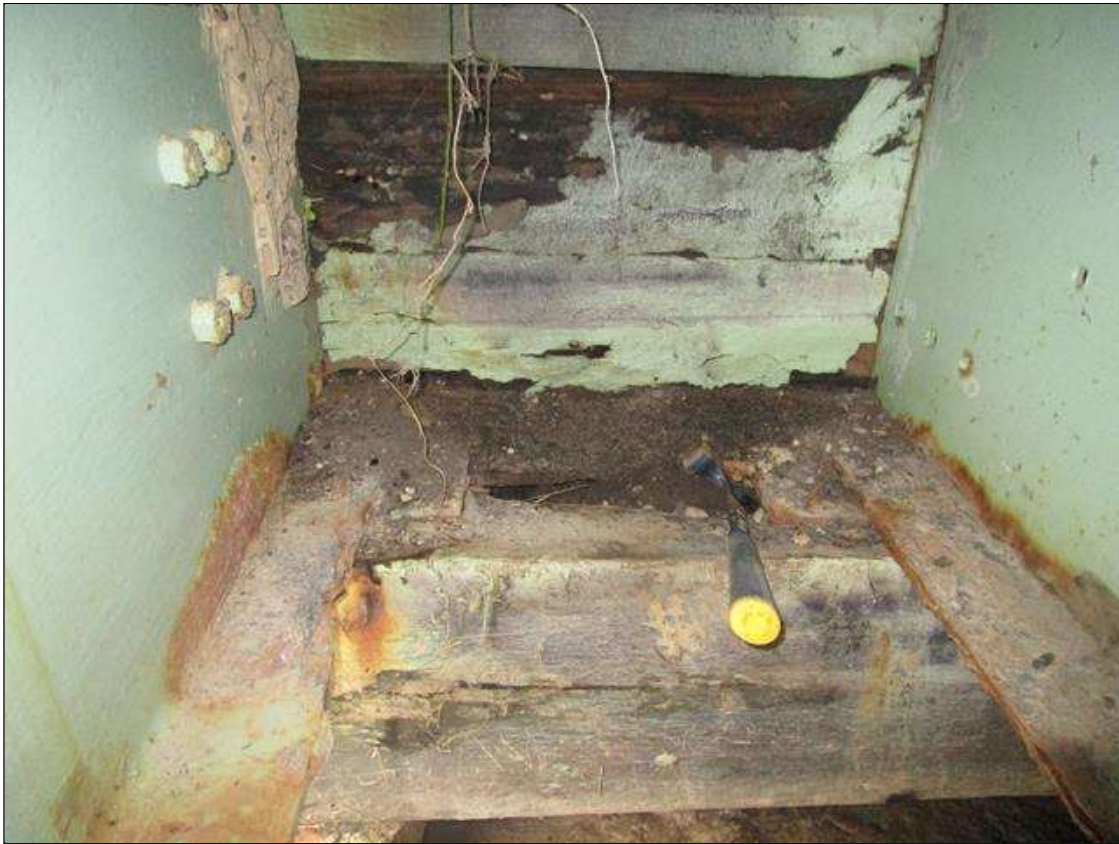
End Bent 2 Cap 1: TOP OF CAP BELOW BAYS 1-3, 6FT LONG X 8IN WIDE X 5IN DEEP DECAYED AREA. 60% LOSS OF BEARING AREA AT BEARINGS 1-3, PAR

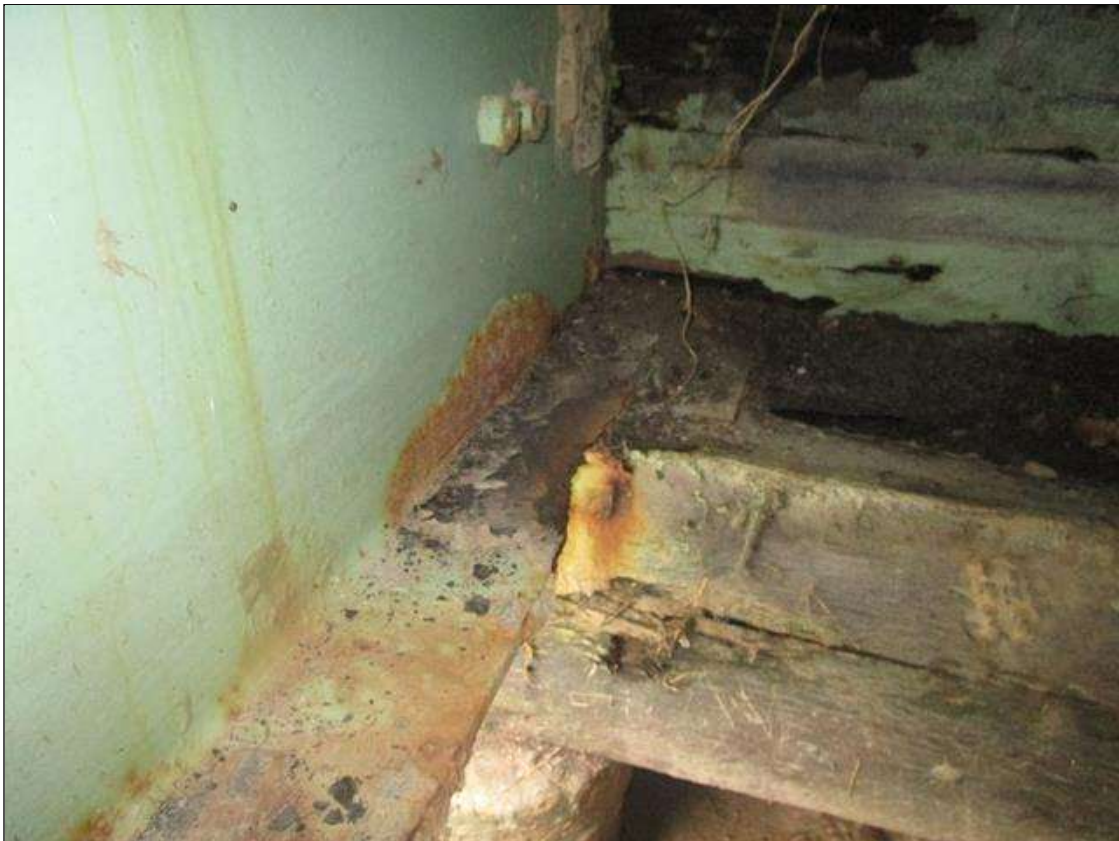
Span 5 Beam 1: SPAN 6 AT END BENT 2, 3FT X 1IN WIDE AREA OF 100% SECTION LOSS IN BOTTOM FLANGE, PAR
