STATE OF NORTH CAROLINA
DEPARTMENT OF TRANSPORTATION

ROY COOPER
GOVERNOR

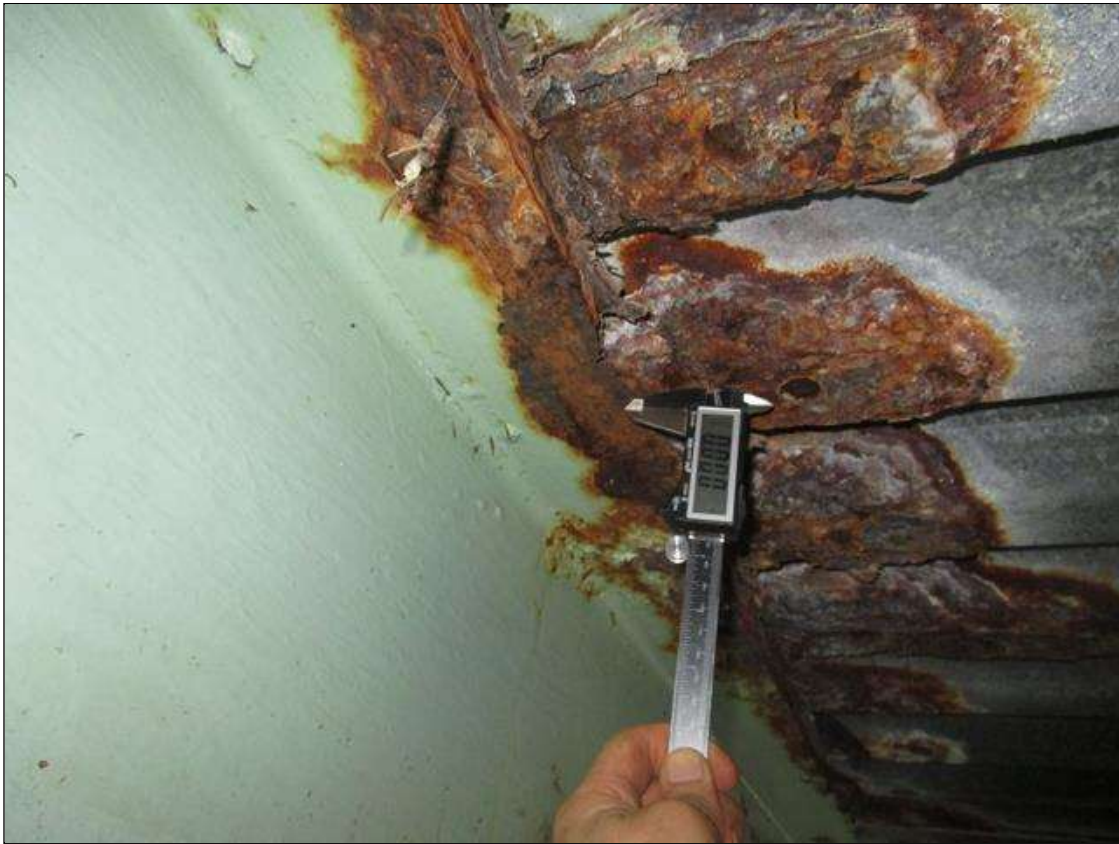
Span 5 Beam 3: SPAN 6, INTERMITTENT FULL LENGTH X 1/2IN WIDE AREA OF CORROSION WITH 100% SECTION LOSS IN BOTTOM AND TOP FLANGE, PAR

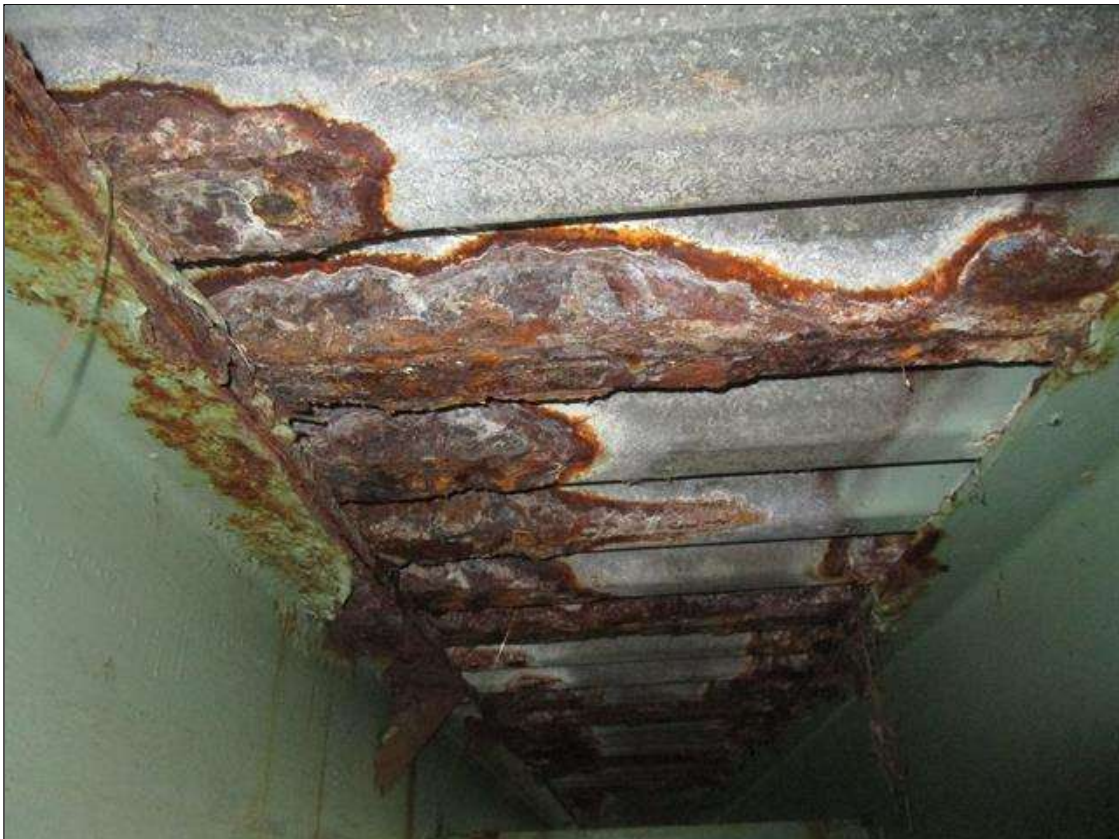
Span 6 Deck: UNDERSIDE OF PLANK DECK, BAYS 3-4, 20SF OF DELAMINATED STEEL WITH 25% SECTION LOSS, PAR

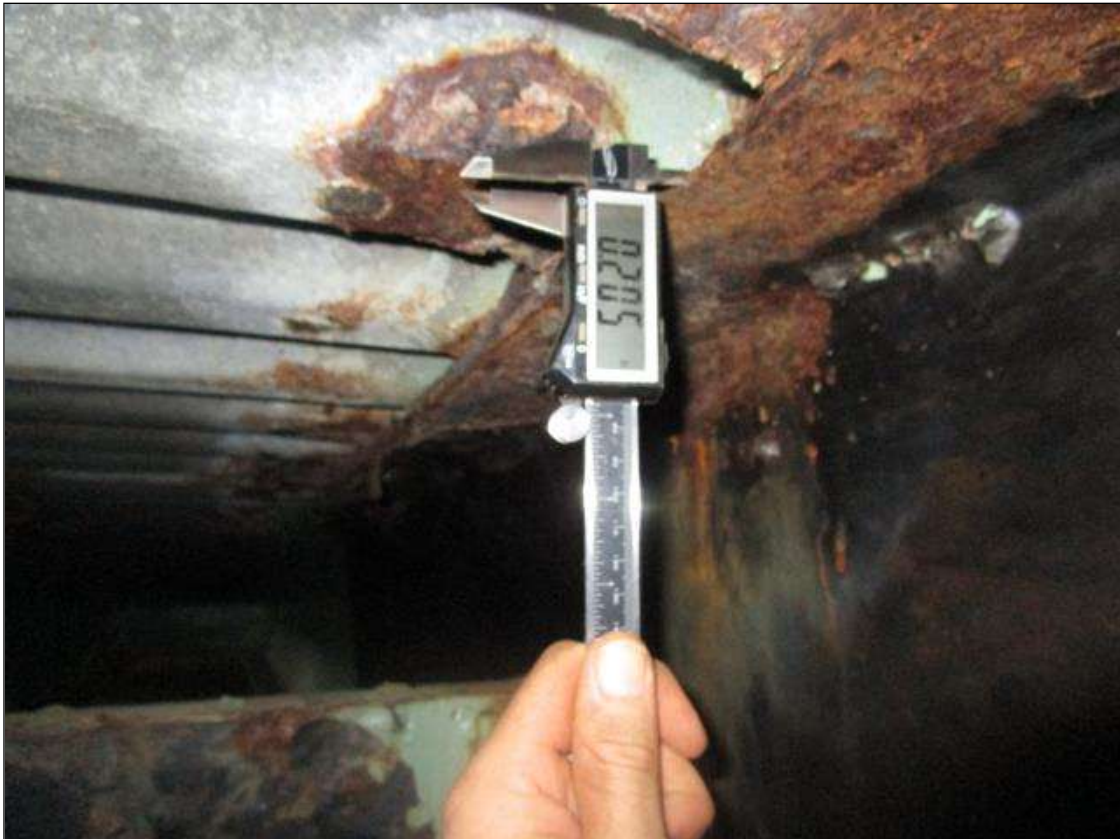
Span 5 Beam 6: SPAN 5, INTERMITTENT FULL LENGTH CORROSION WITH SECTION LOSS DOWN TO 0.205IN REMAINING IN TOP FLANGE, PAR

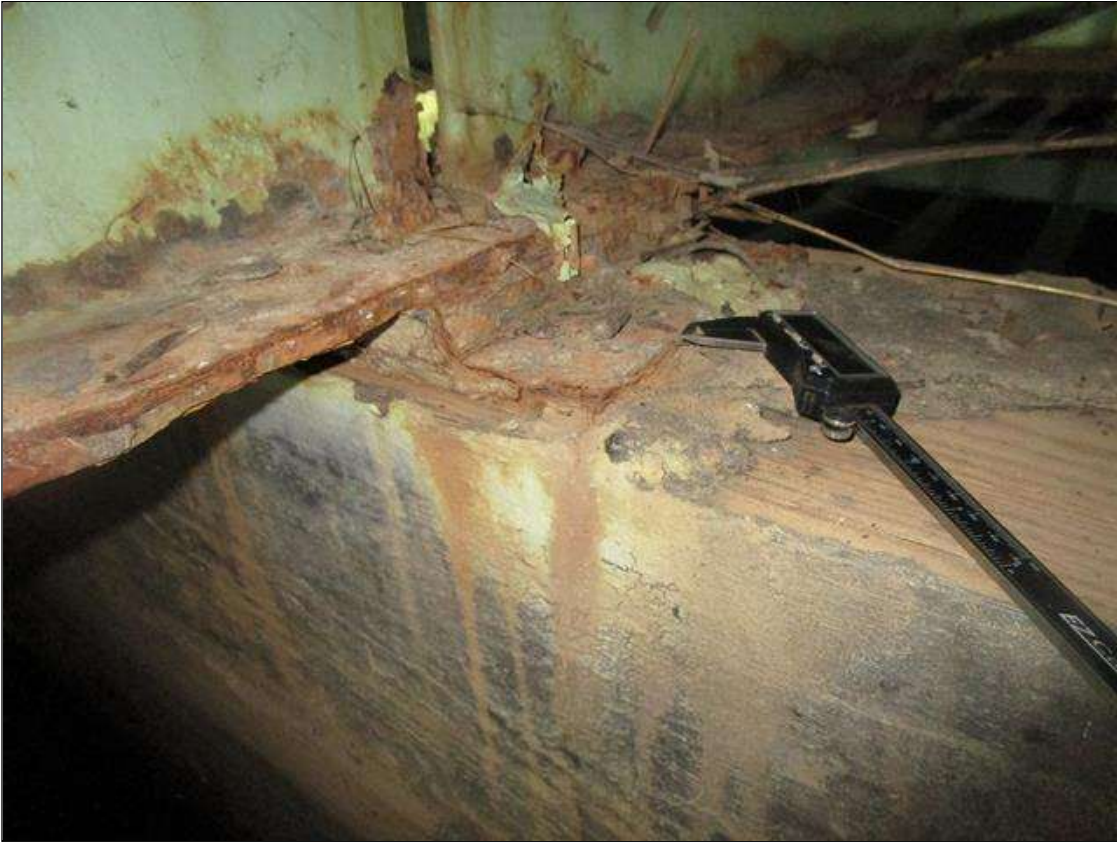
Span 5 Beam 6 - Near Bearing: FULL LENGTH X FULL WIDTH AREA OF DELAMINATED STEEL WITH 1/8IN SECTION LOSS. DOWN TO 3/8IN REMAINING, PAR

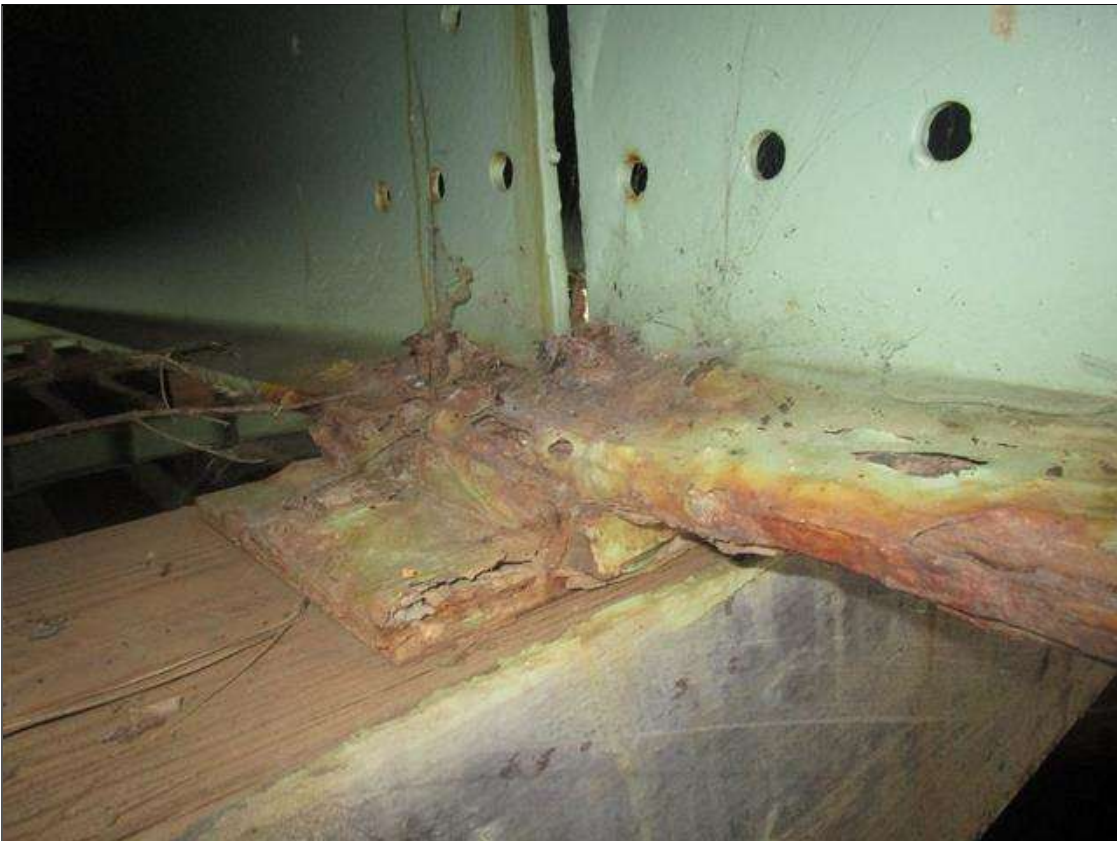
Span 5 Beam 5 - Near Bearing: ANCHOR BOLT COMPLETELY CORRODED, PAR

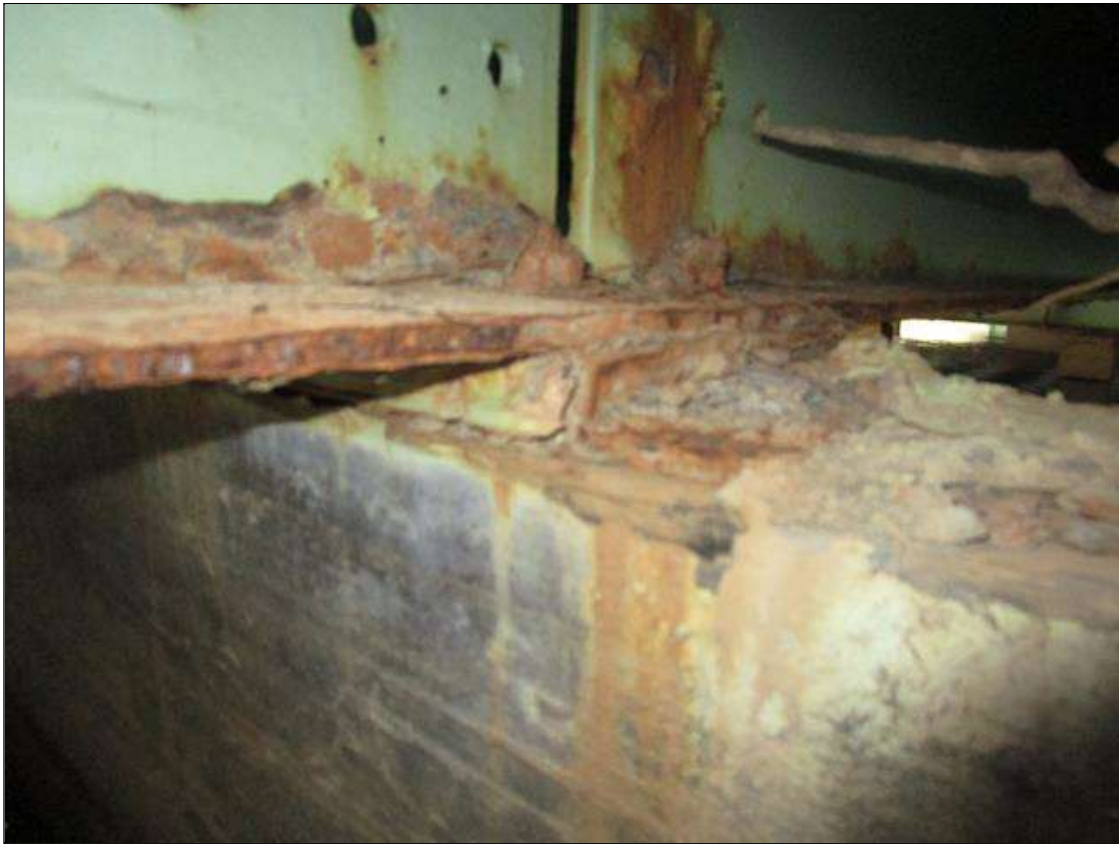
Span 5 Beam 7 - Near Bearing: 1/4IN SECTION LOSS. 3/8IN REMAINING, PAR

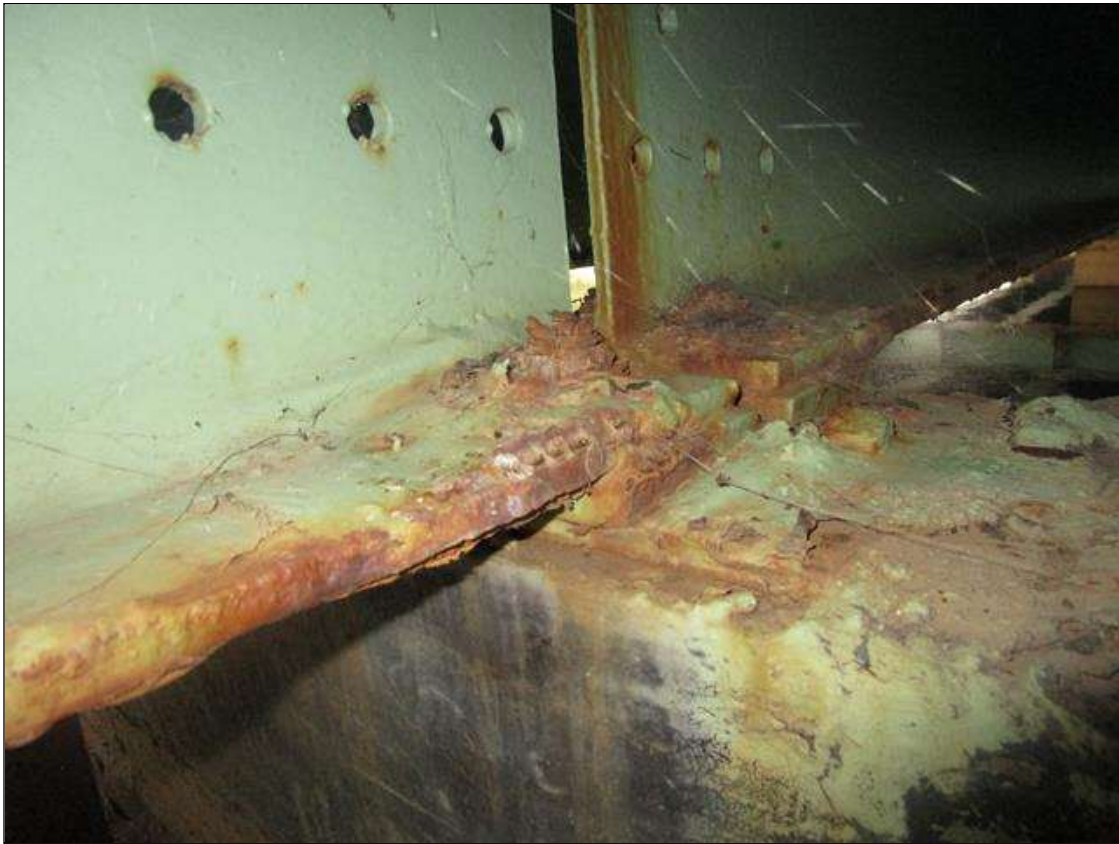
Span 5 Beam 9 - Near Bearing: ANCHOR BOLT COMPLETELY CORRODED, PAR

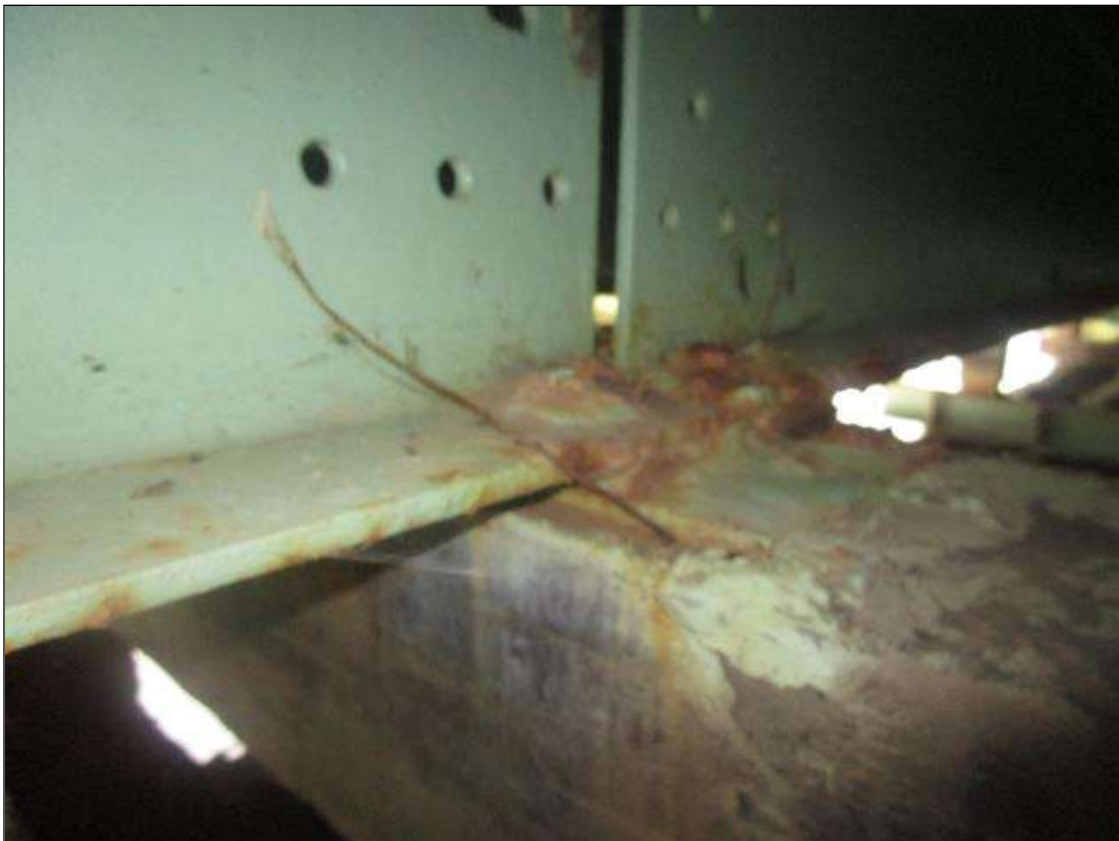
Span 5 Beam 10 - Near Bearing: ANCHOR BOLT COMPLETELY CORRODED, PAR

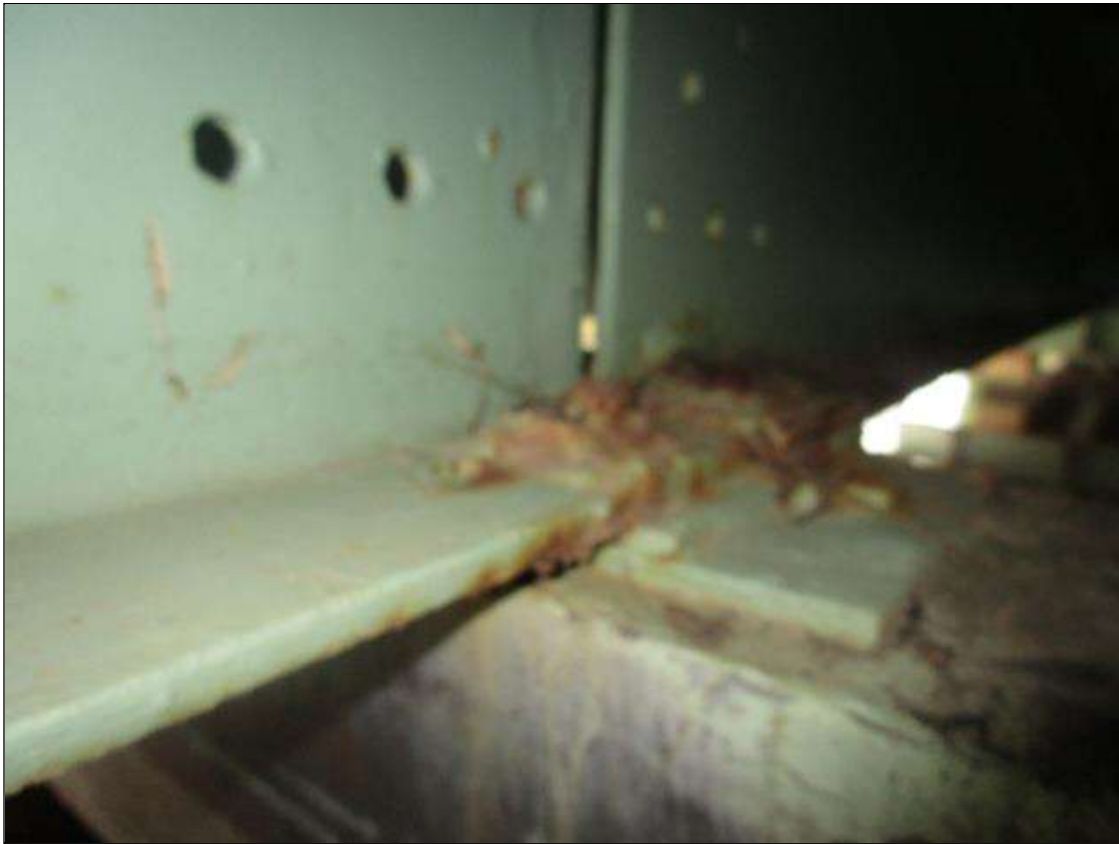
Span 5 Beam 11 - Near Bearing: ANCHOR BOLT COMPLETELY CORRODED, PAR

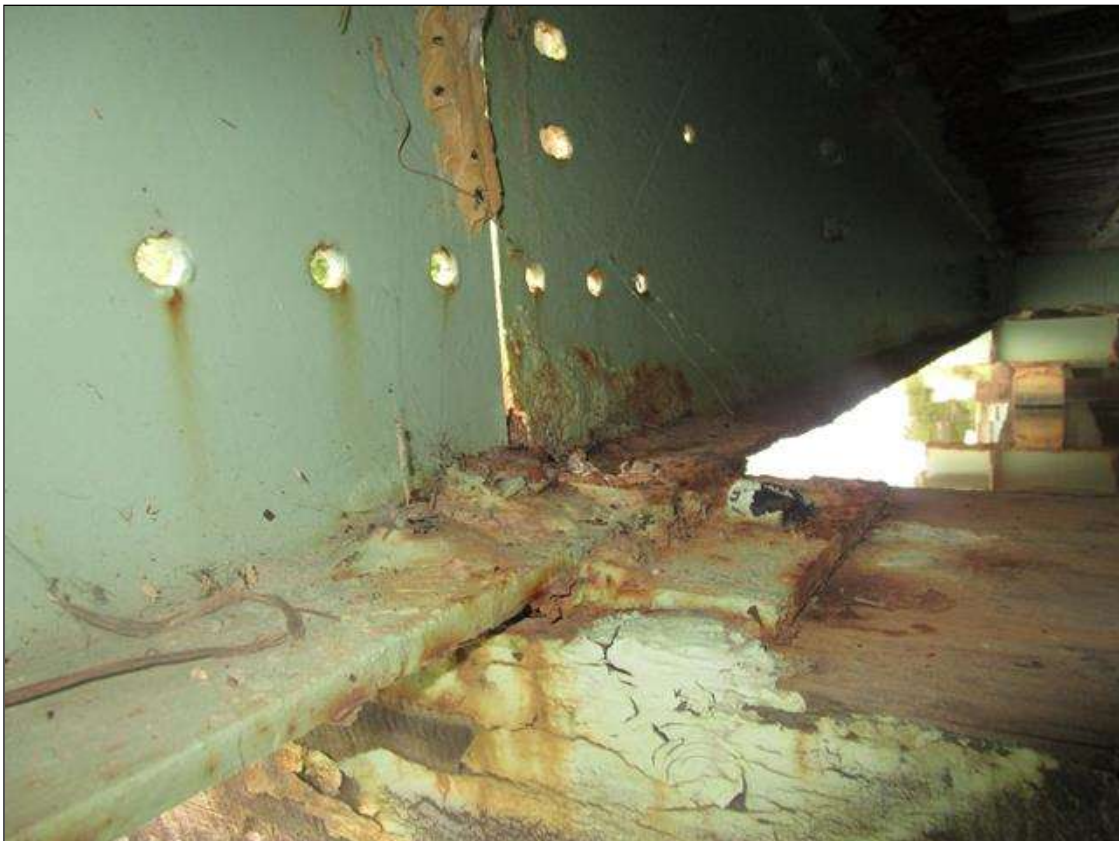
Span 5 Beam 12 - Near Bearing: ANCHOR BOLT COMPLETELY CORRODED, PAR

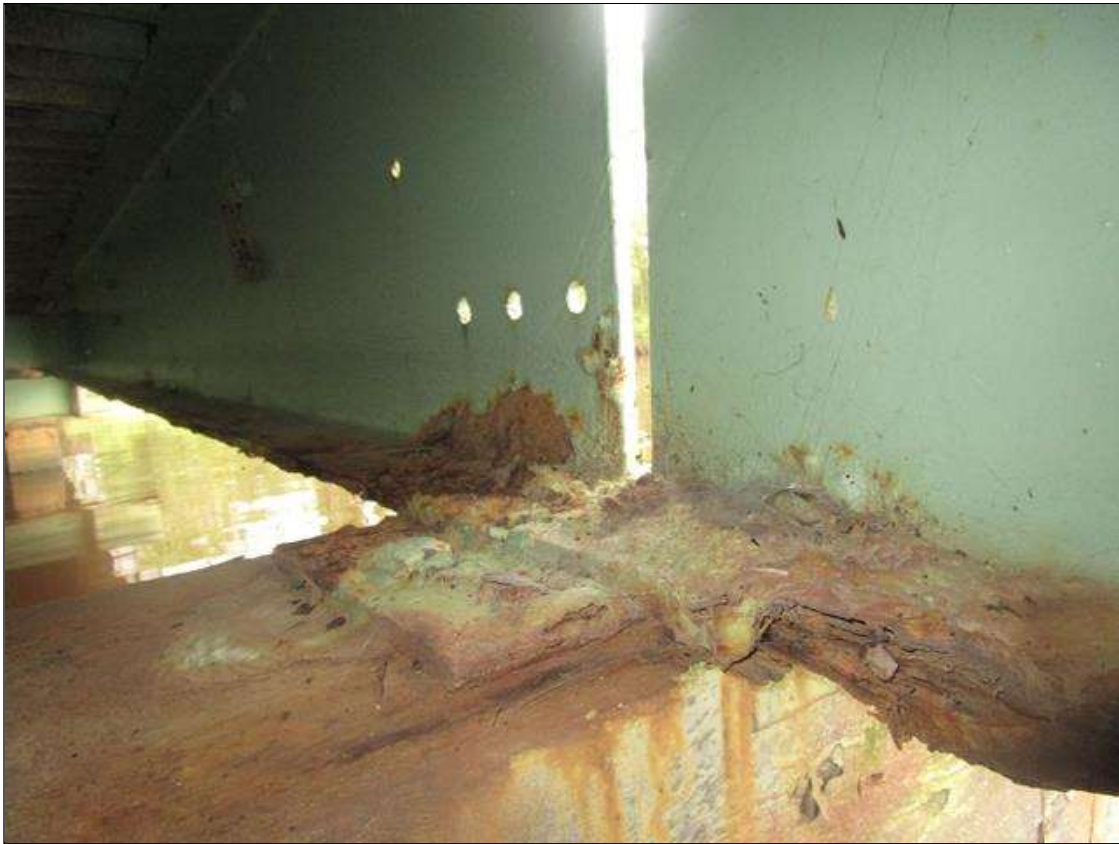
Span 5 Beam 1 - Near Bearing: ANCHOR BOLT COMPLETELY CORRODED, PAR

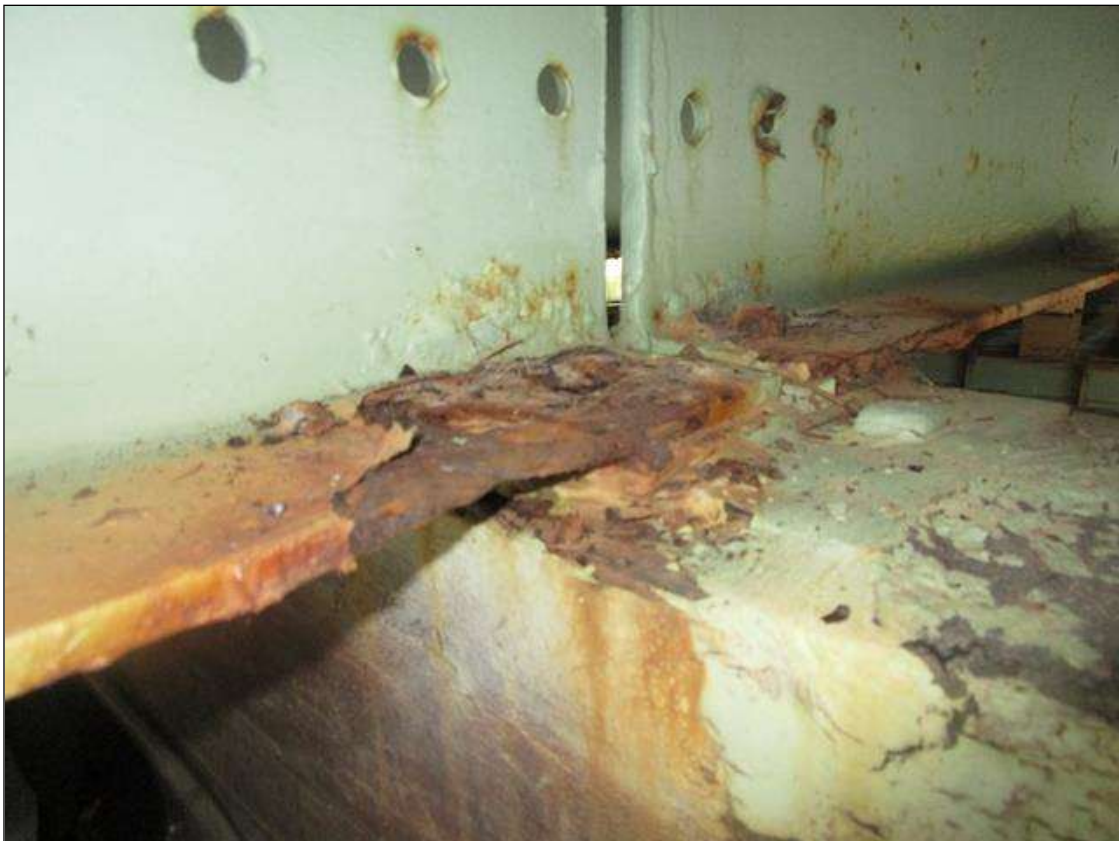
Span 5 Beam 2 - Near Bearing: ANCHOR BOLT COMPLETELY CORRODED, PAR

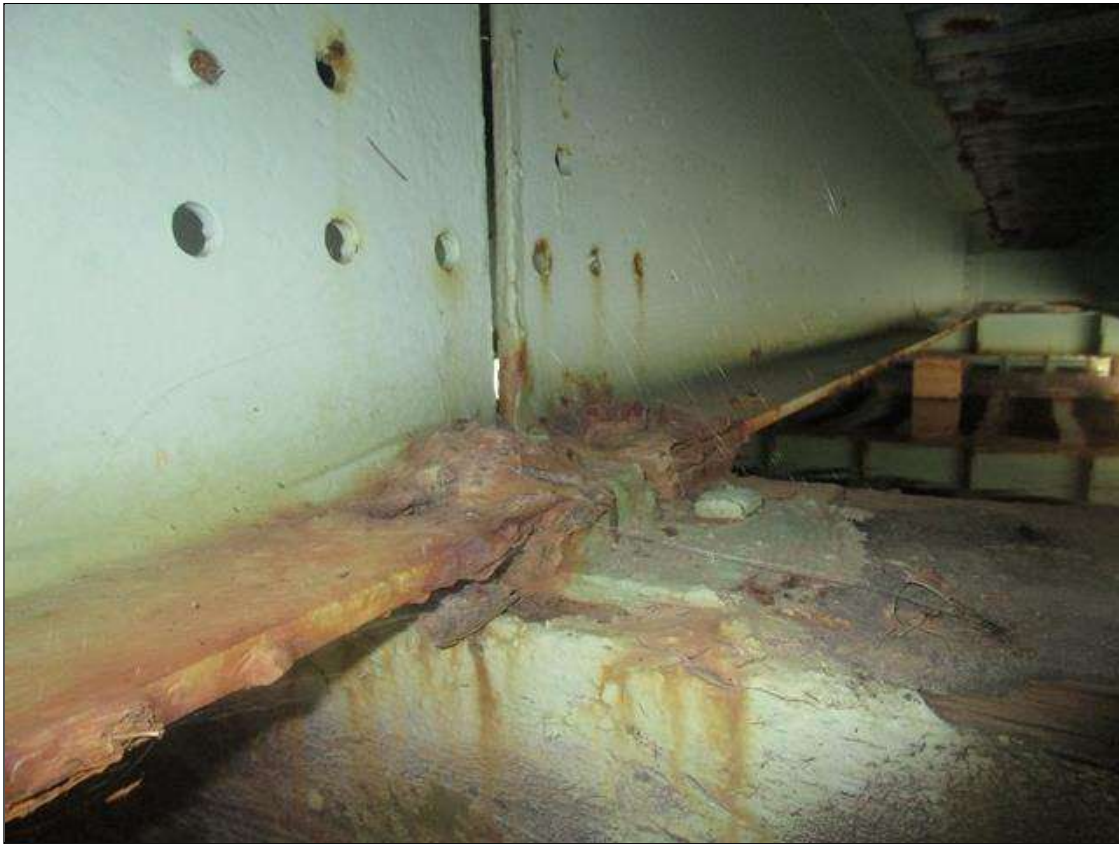
Span 5 Beam 3 - Near Bearing: ANCHOR BOLT COMPLETELY CORRODED, PAR

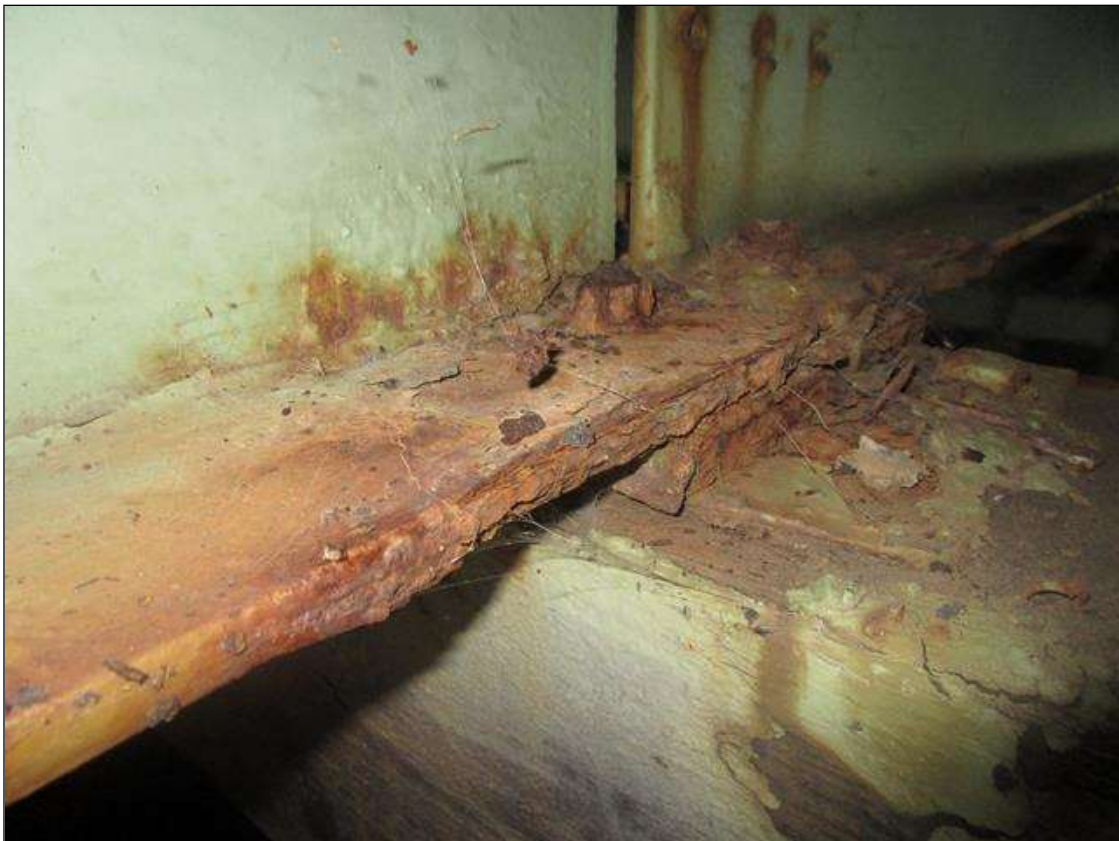
Span 5 Beam 4 - Near Bearing: ANCHOR BOLT COMPLETELY CORRODED, PAR

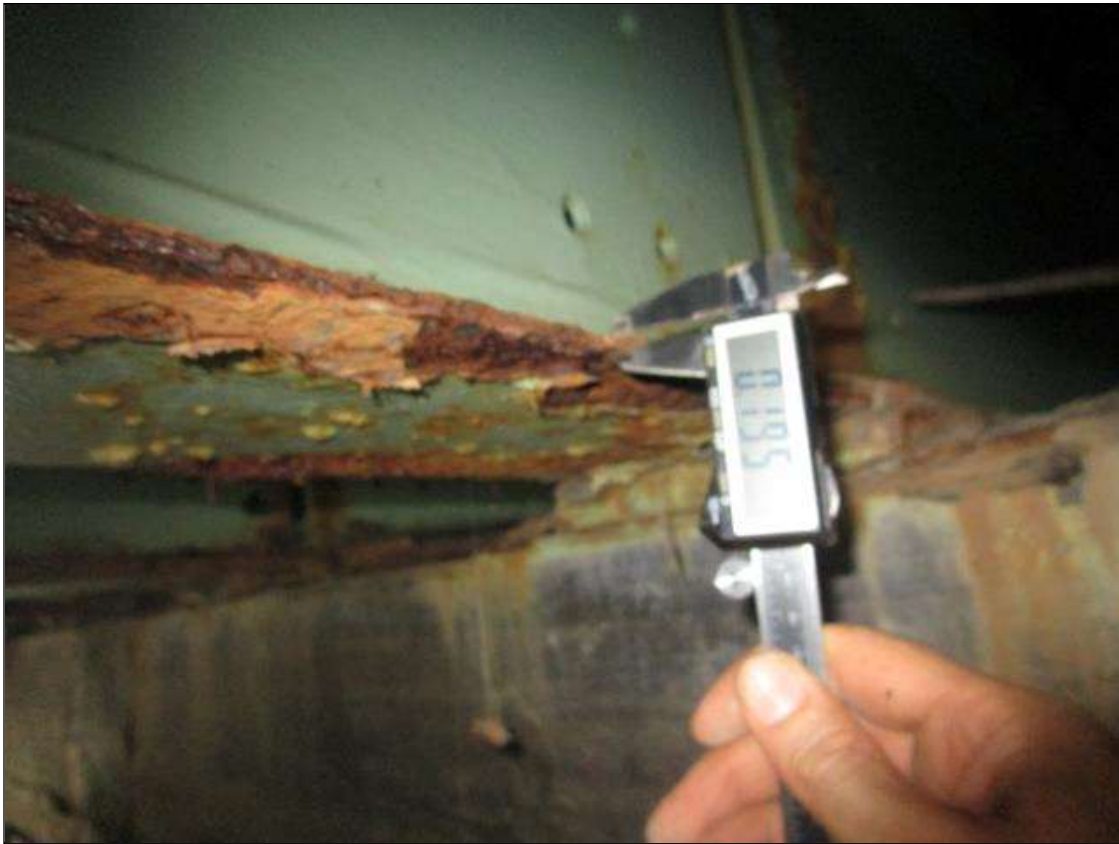
Span 5 Beam 7: SPAN 5, INTERMITTENT FULL LENGTH AREA OF CORROSION DOWN TO 0.195IN REMAINING, PAR

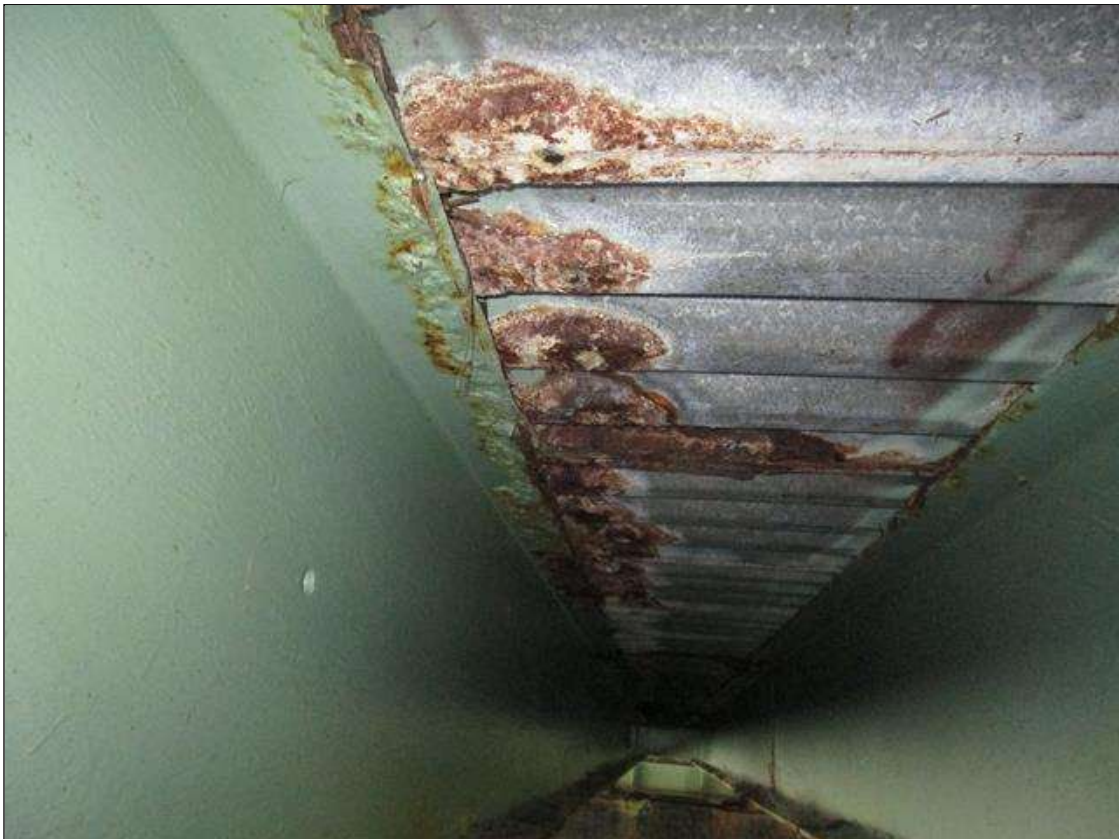
Span 5 Deck: BAY 8, 12FT X 1FT AREA WITH 25% SECTION LOSS, PAR

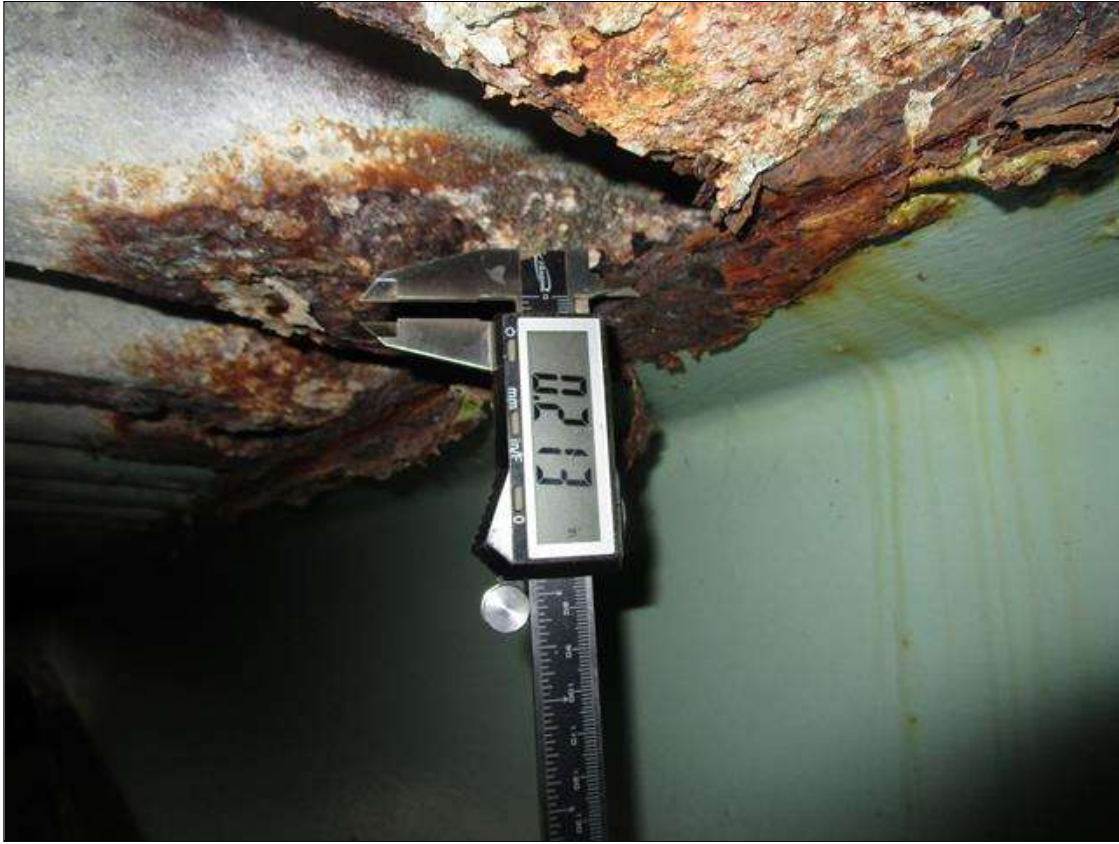
Span 3 Beam 4: SPAN 4, MIDSPAN, 3FT OF CORROSION WITH SECTION LOSS IN TOP FLANGE DOWN TO 0.213IN REMAINING, PAR

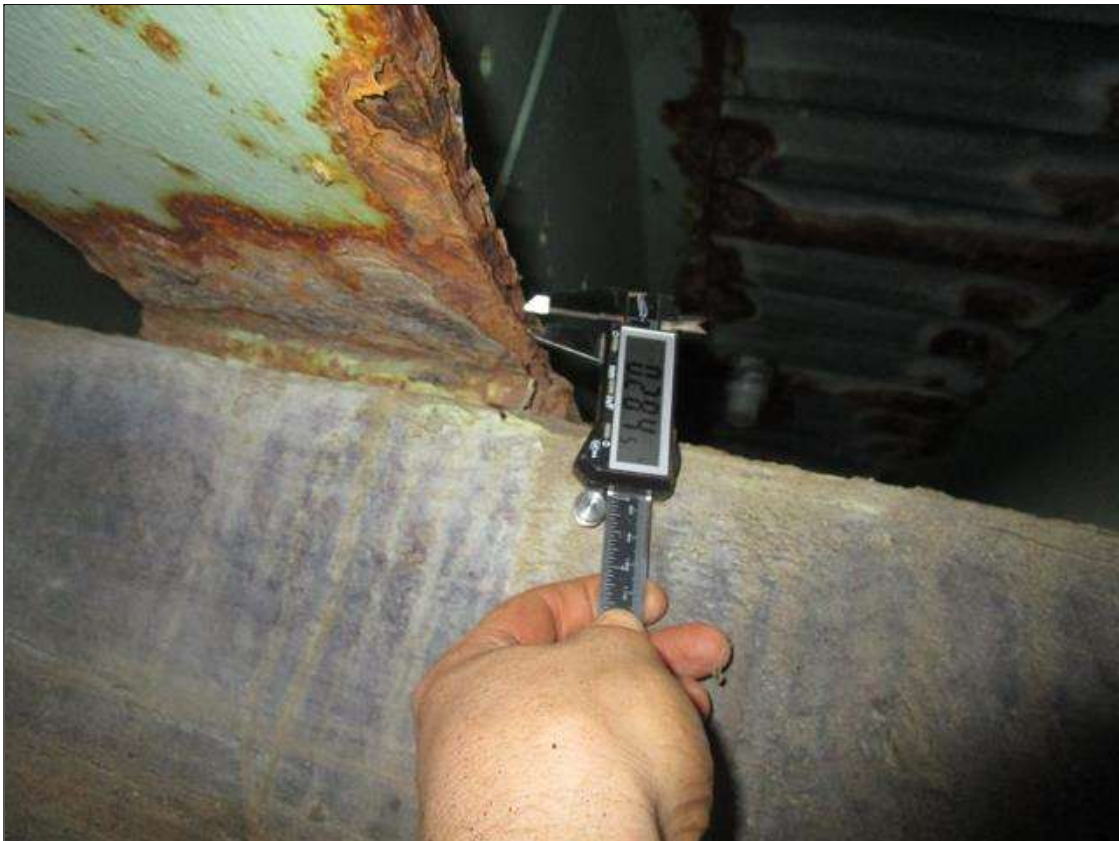
Span 3 Beam 3: SPAN 4, AT BENT 4, 1FT AREA OF SECTION LOSS DOWN TO 0.284IN REMAINING IN BOTTOM FLANGE, PAR

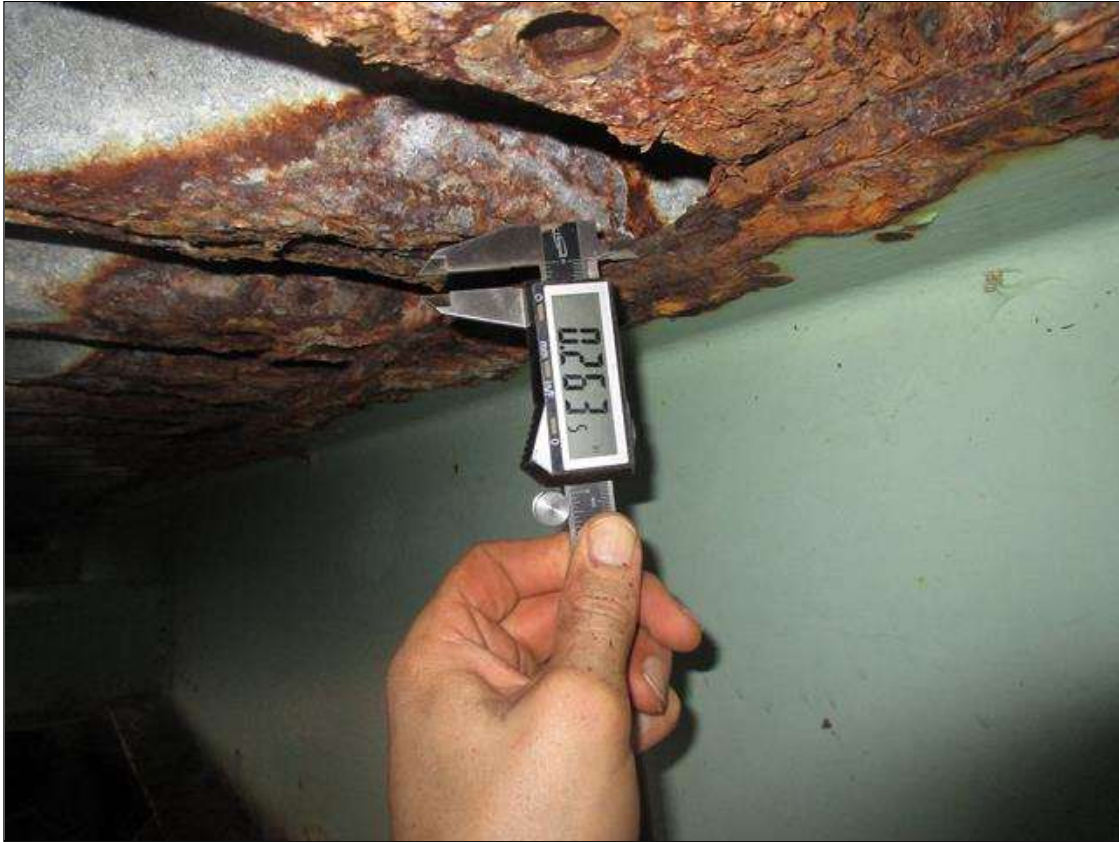
Span 3 Beam 3: SPAN 3, INTERMITTENT FULL LENGTH CORROSION WITH SECTION LOSS DOWN TO 0.263IN REMAINING IN THE TOP FLANGE, PAR

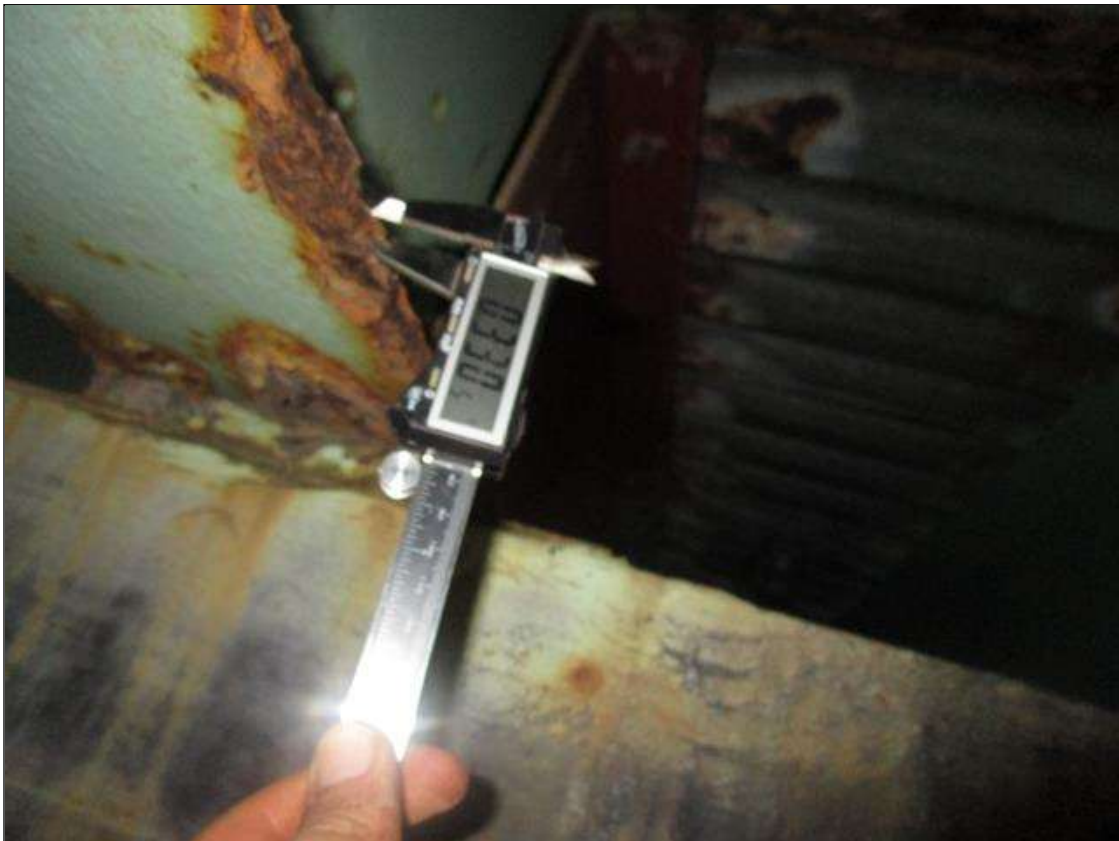
Span 3 Beam 4: SPAN 3, AT BENT 2, 4FT AREA OF SECTION LOSS DOWN TO 0.33IN REMAINING IN THE BOTTOM FLANGE, PAR

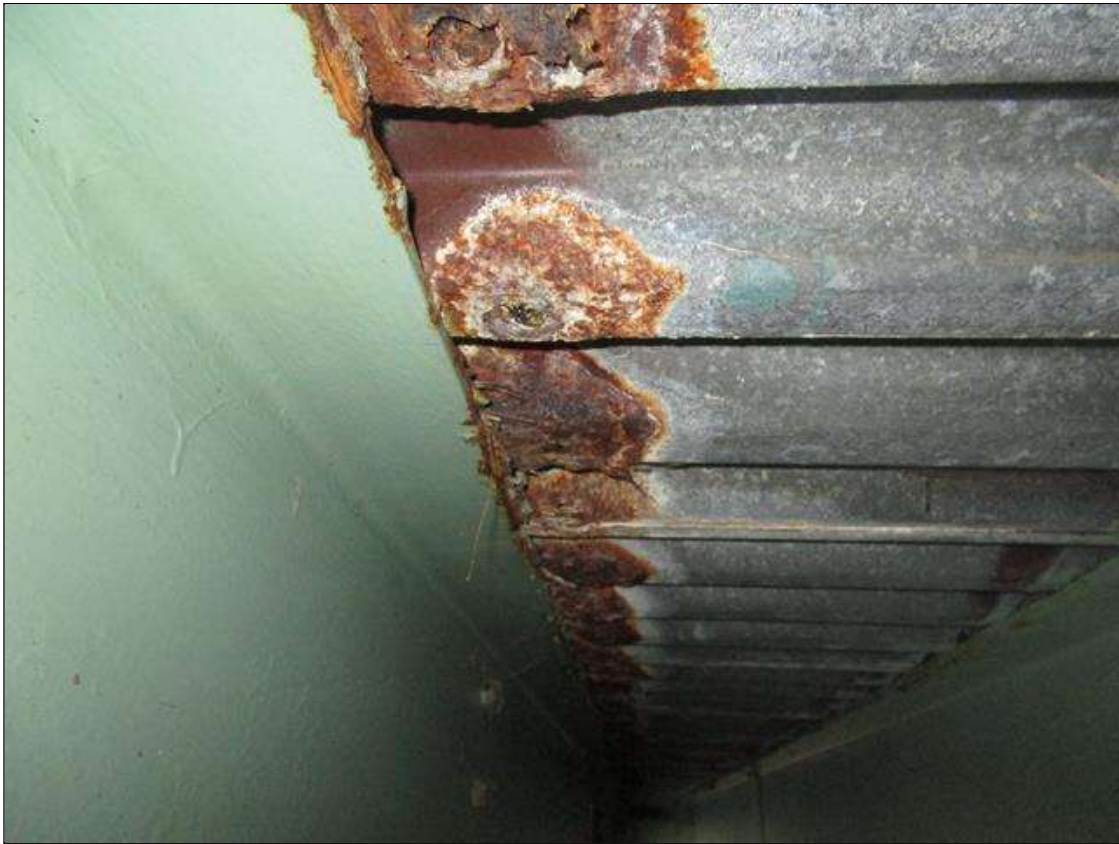
Span 3 Deck: BAY 11, 20FT X 6IN, CORROSION WITH 25% SECTION LOSS, PAR

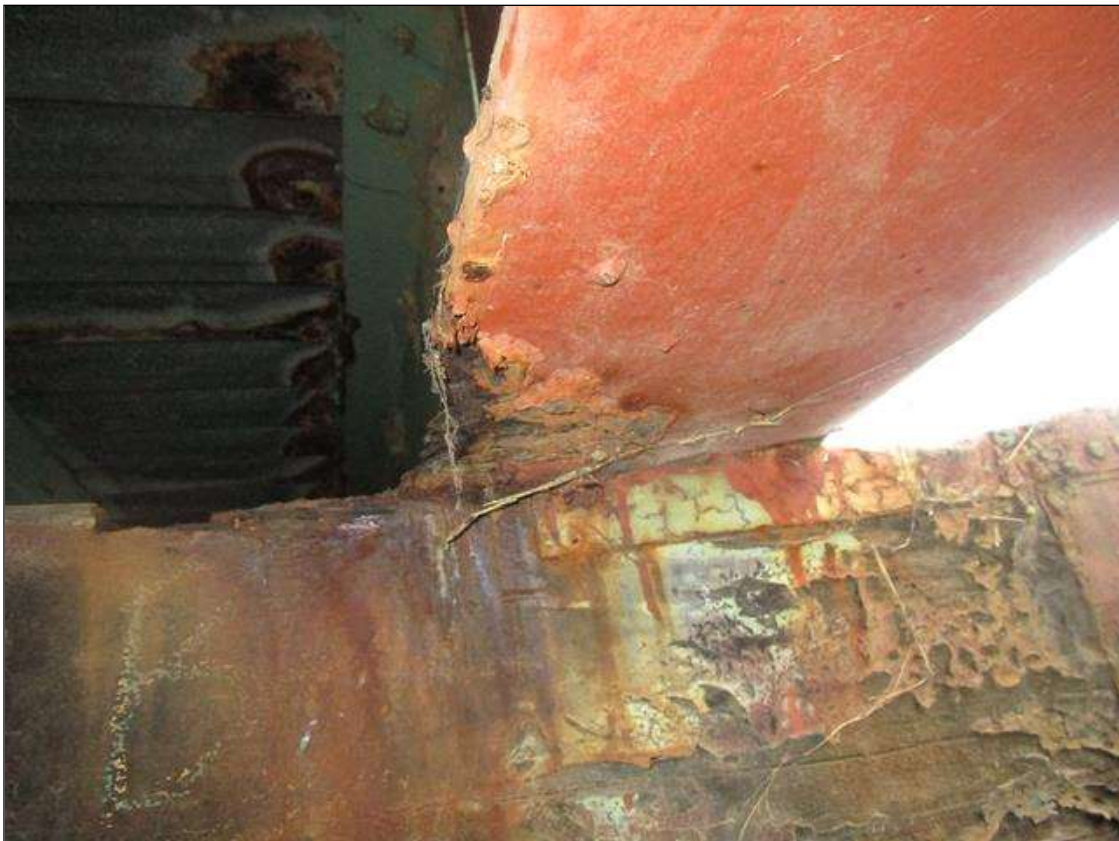
Span 1 Beam 12: SPAN 2, AT BENT 2, 1FT X 1IN WIDE AREA OF 100% SECTION LOSS IN BOTTOM FLANGE, PAR

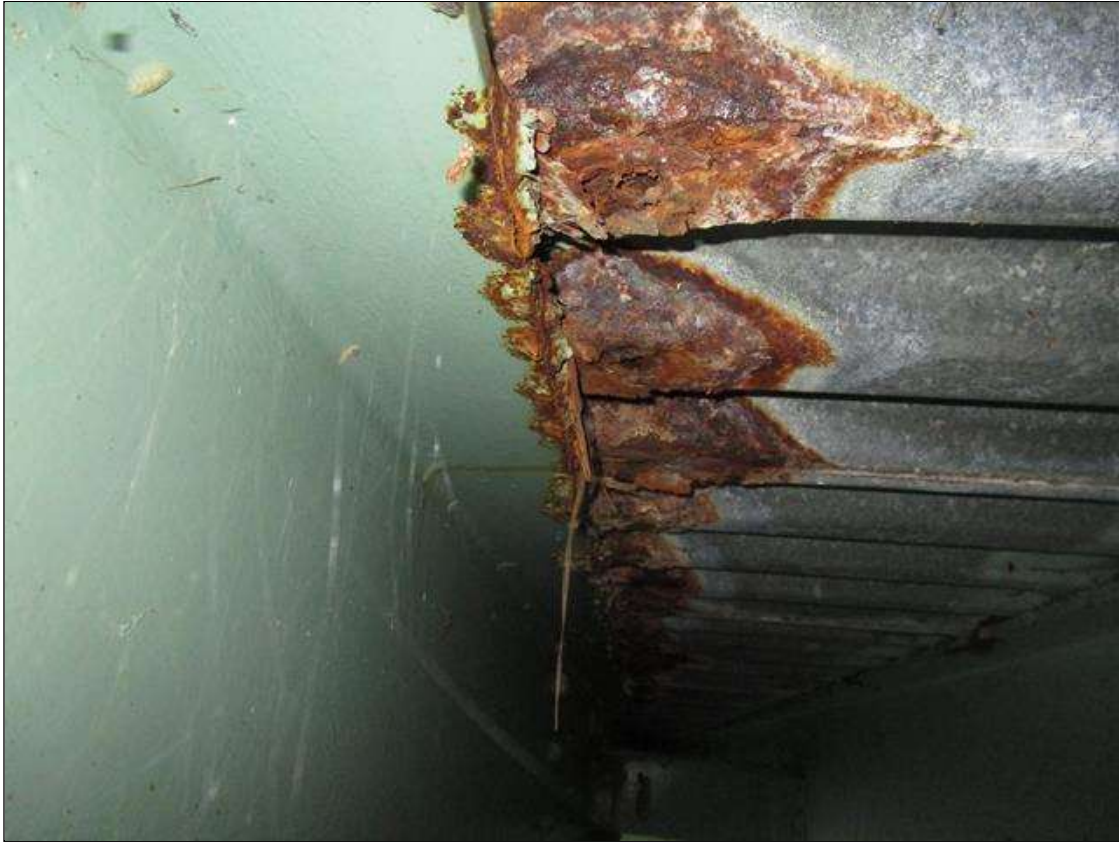
Span 2 Deck: BAY 11, 20FT X 6IN AREA OF CORROSION WITH 25% SECTION LOSS, PAR

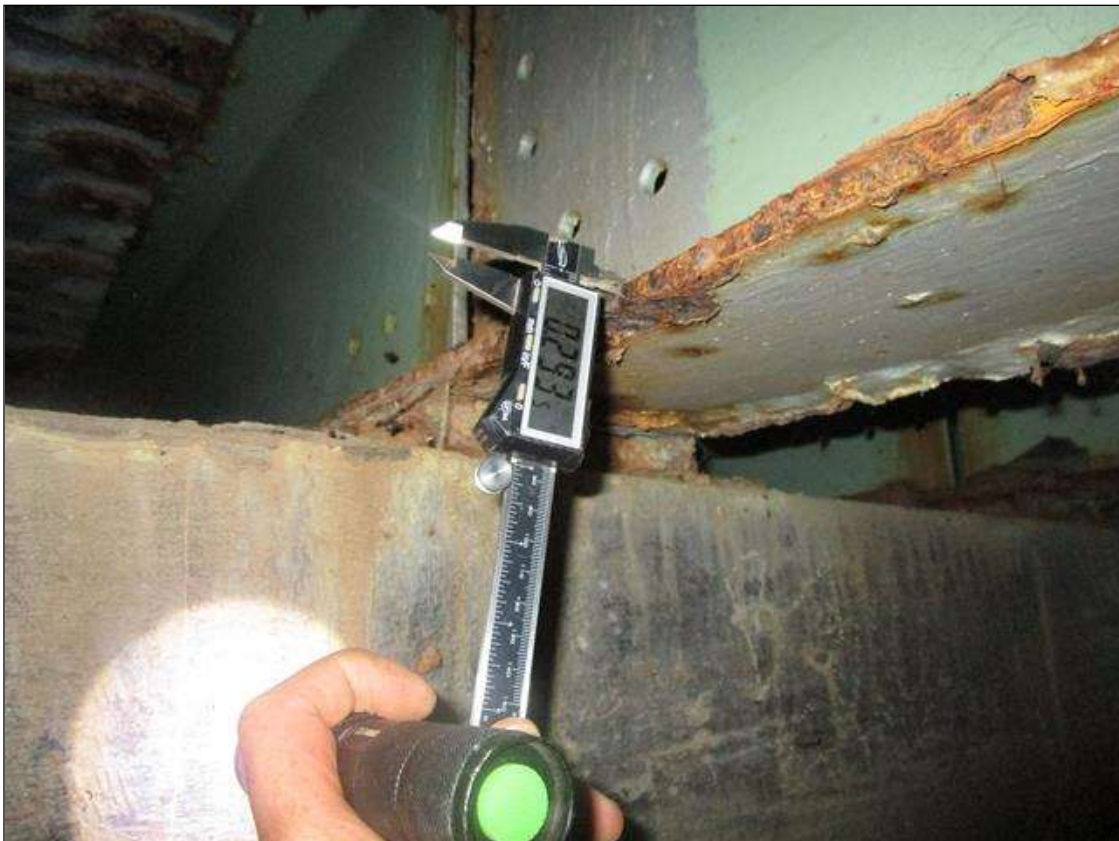
Span 1 Beam 7: SPAN 2, INTERMITTENT FULL LENGTH, SECTION LOSS IN BOTTOM FLANGE DOWN TO 0.293IN REMAINING, PAR
